# Karco Auto

6619 W. Cermak  
Berwyn

ILLINOIS MAIN  
STREET PROGRAM

Project Number 2008059 Sheet 1 of 1

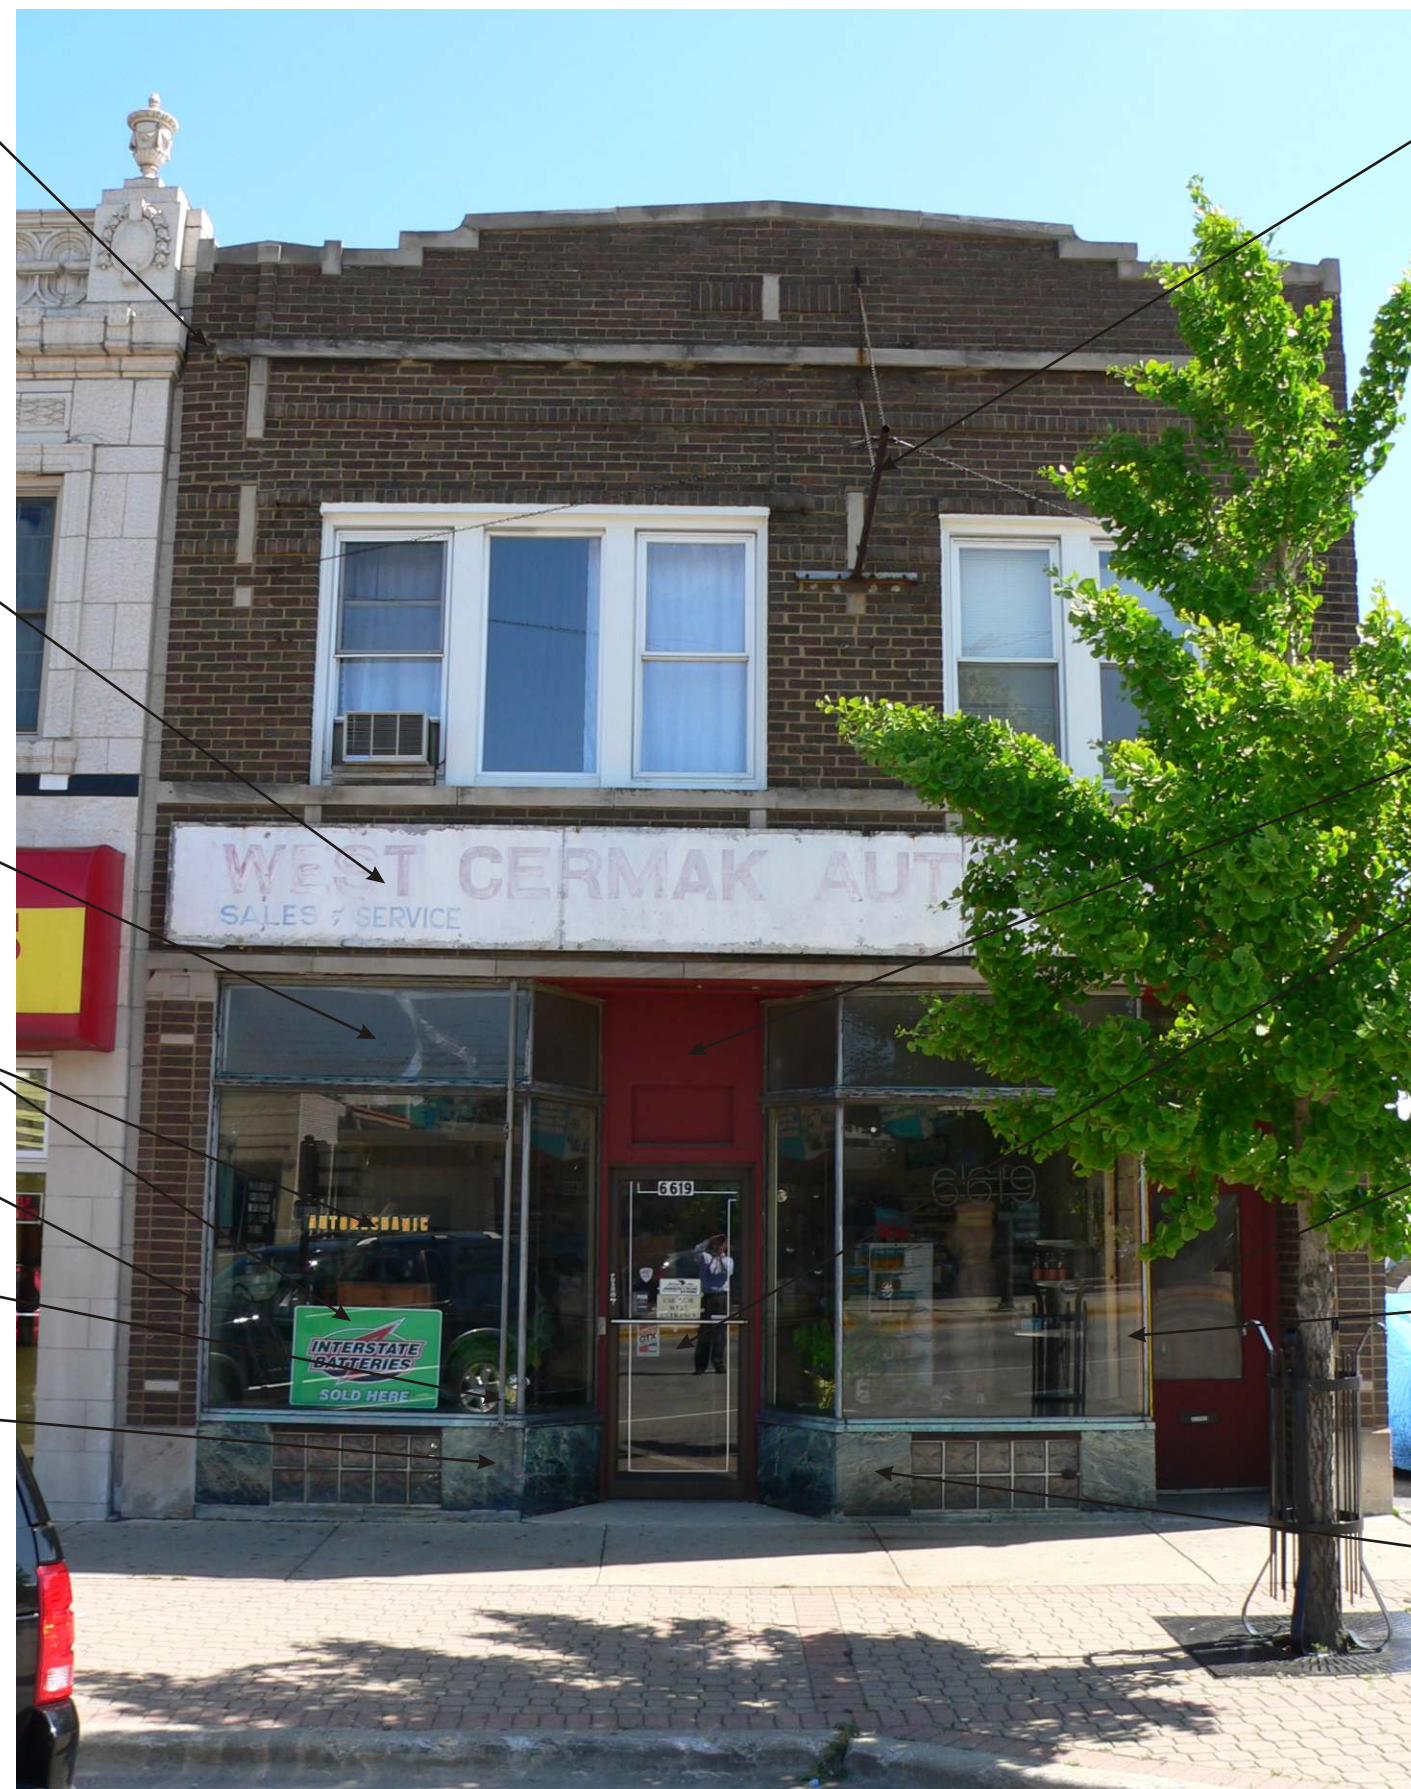
Investigate crack in the masonry. It can be caused by inadequate or improper flashing/drainage and water infiltration. Relay bricks or repoint using a lime-based mortar that matches the composition, color, joint profile and texture of the original. Do not paint any of the masonry.

Remove existing sign. It is faded and too large. This location may be reused for a flush-mounted horizontal sign, but the new sign would have to be properly scaled.

Replace broken piece of obscured transom glass with matching. The openness and transparency of the storefront must be maintained.

Remove all obsolete signs and graphics.

Remove obsolete vertical aluminum bar connected to the window frames.

Retain glass block windows in bulkheads. Rusted steel above each window should be scraped, primed and painted. Additional protection and visual enhancement can be provided in the form of external grilles. These should not be overly ornamental and more in keeping with the age of the storefront (1920s). Glass blocks can also be back lit with evenly distributed diffused light.

The existing sign armature may be kept if it is to be used to hang a sign. Prior to reuse, its connections should be inspected and the armature painted. Otherwise, it should be removed. All holes should be patched with mortar that matches the composition and visual characteristics of the original.

The main entrance door is not historic but it can be saved and reused. If it were to be replaced, the new door should be wood with a large bottom rail and less glazing.

Replace missing/broken display window glass in the recessed entry. The new glass can be laminated to prevent shattering.

Retain marble bulkheads. Evaluate substrate/bases of the bulkheads. Some marble pieces may need to be repositioned and reattached.

Retain copper window frames. Do not paint them or caulk the weep holes.

Install/reopen a glass transom above the main entry door.

Retain historic door and transom. Maybe repainted in any desired color.
