Concrete Restoration for Route 66 in Illinois

September 2012

The goal of this report is to outline treatment options for the primary Route 66 roadway conditions observed in Illinois as guidance for preserving that which remains of the historic concrete roadways. This study was based on

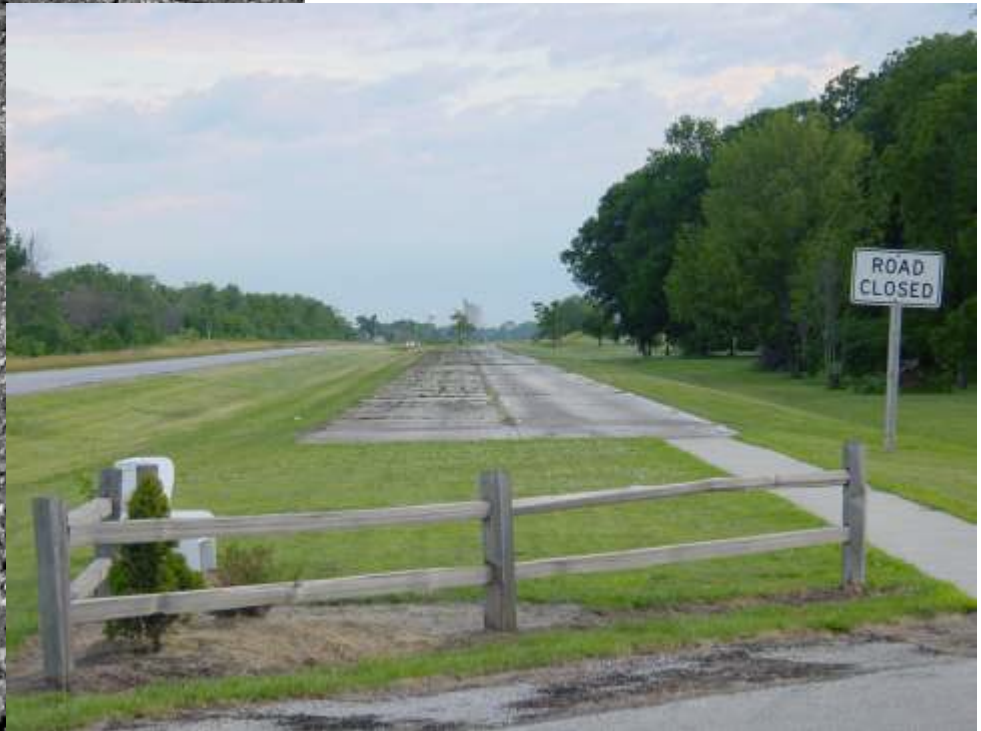
FIG. 27
Lexington, IL. Segment of Rt. 66 north of Lexington on Rt. 66 bypass. One lane of roadway has been torn up and replaced with grass. Camera facing north.
Photograph by Travis Ratermann, 2 July 2008.

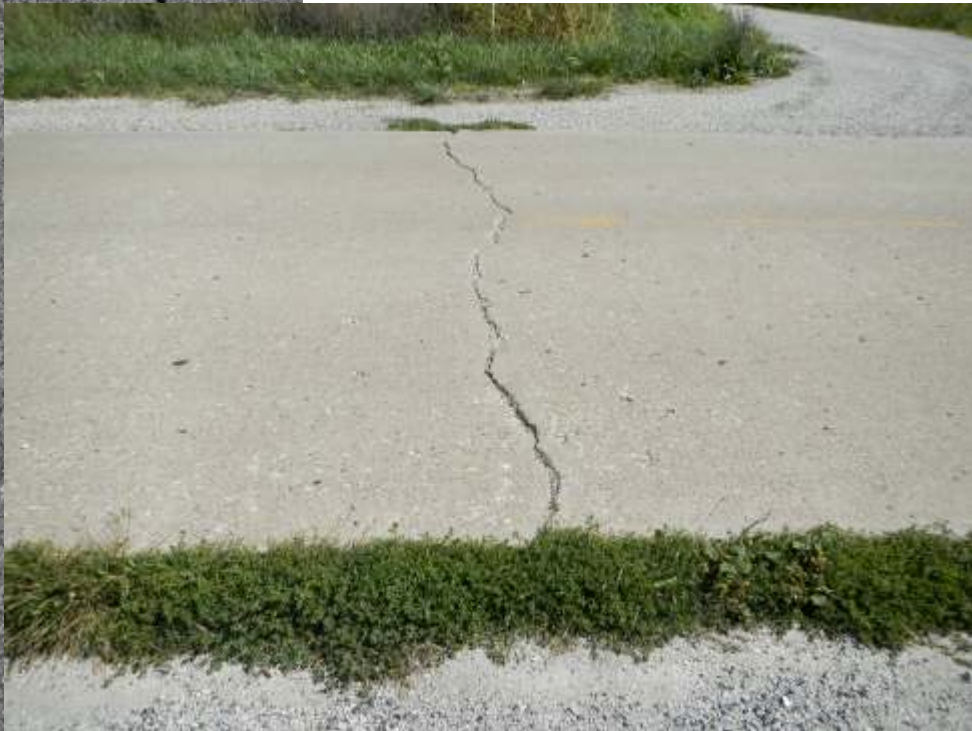
- Overall concrete is in good condition with minor weathering and pitting of the surface (Figure 01).
- No control joints were included in the original design and transverse cracking exists every 14 to 20 feet on centers along the length of the roadway (Figure 02). In general, the width of the concrete road is 18 to 20 feet.
- Cracks are raveled along the edges and vary in width from 1/2-inch up to 2 to 3-inches. Cracks are generally in-filled with small aggregates and minor grass growth.
- Some minor patching observed includes the use of asphalt in areas where small spalls have occurred along the cracks (Figure 03).

FIG. 1
Concrete in "good" condition (Girard, IL).

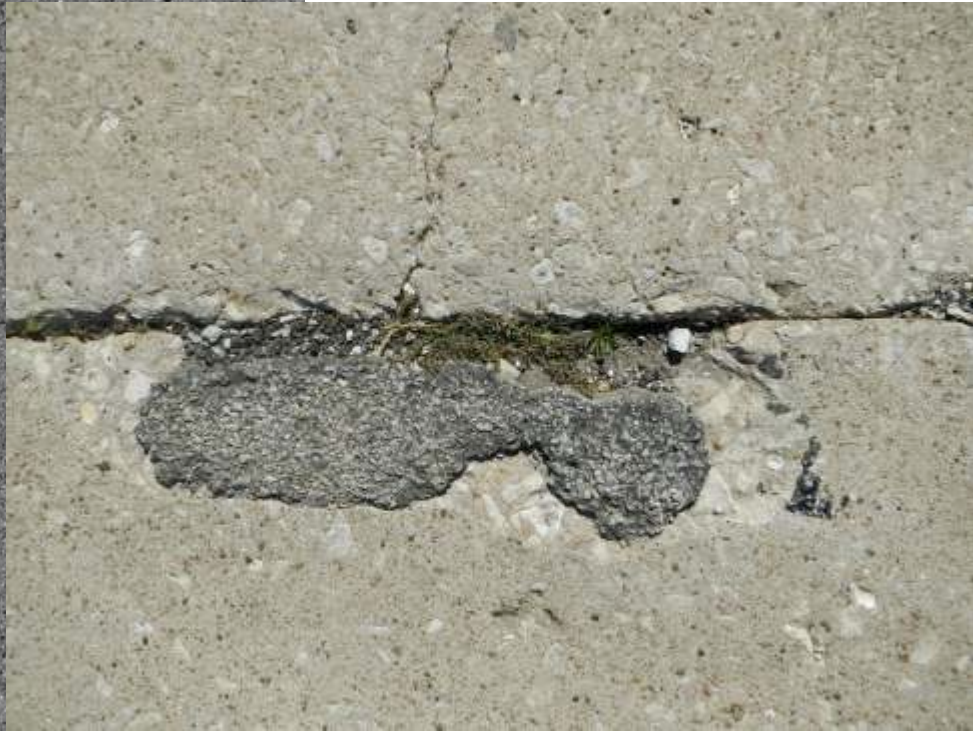
FIG. 2
Typical transverse cracking (Girard, IL).

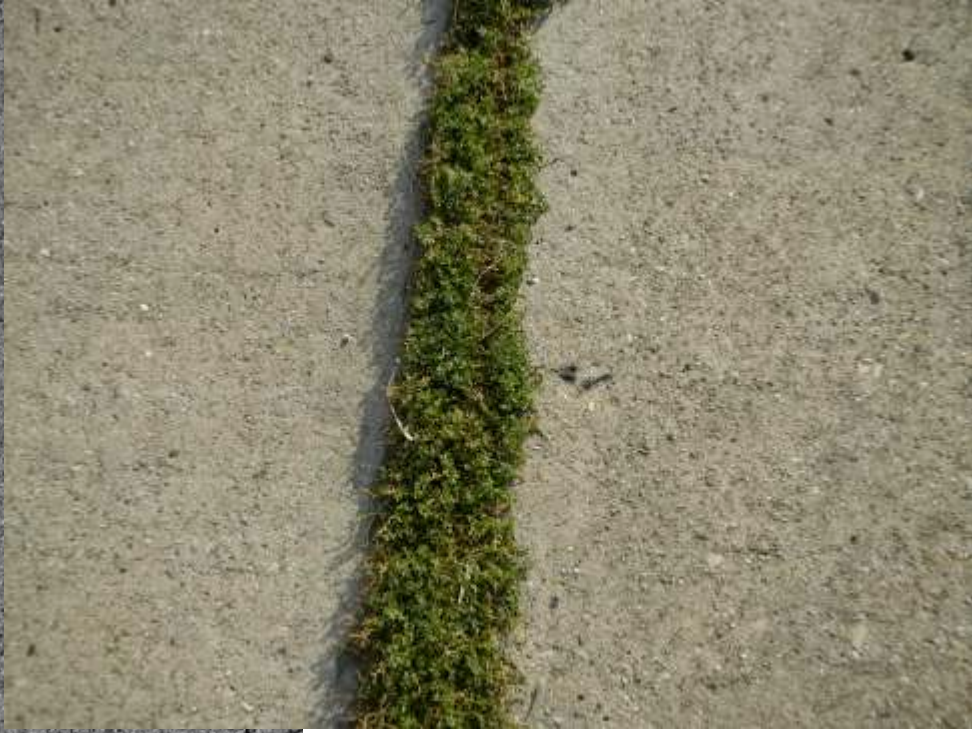
- Similar to the “good condition” concrete, except with more cracking, including longitudinal cracking (Figure 04).
- Grass growing within the cracks is more prominent and the crack width range is larger (Figure 05).
- A greater amount of small spalling along the cracks has occurred.
- In many cases repairs have been completed periodically along the roadway. Patches range from partial width to full width; some are concrete and others are patched using asphalt, neither match the existing concrete (Figures 06 and 07).
- In some cases the patches have small spalls and cracking (Figure 08).

FIG. 4
Concrete in "fair" condition (south of Girard, IL).

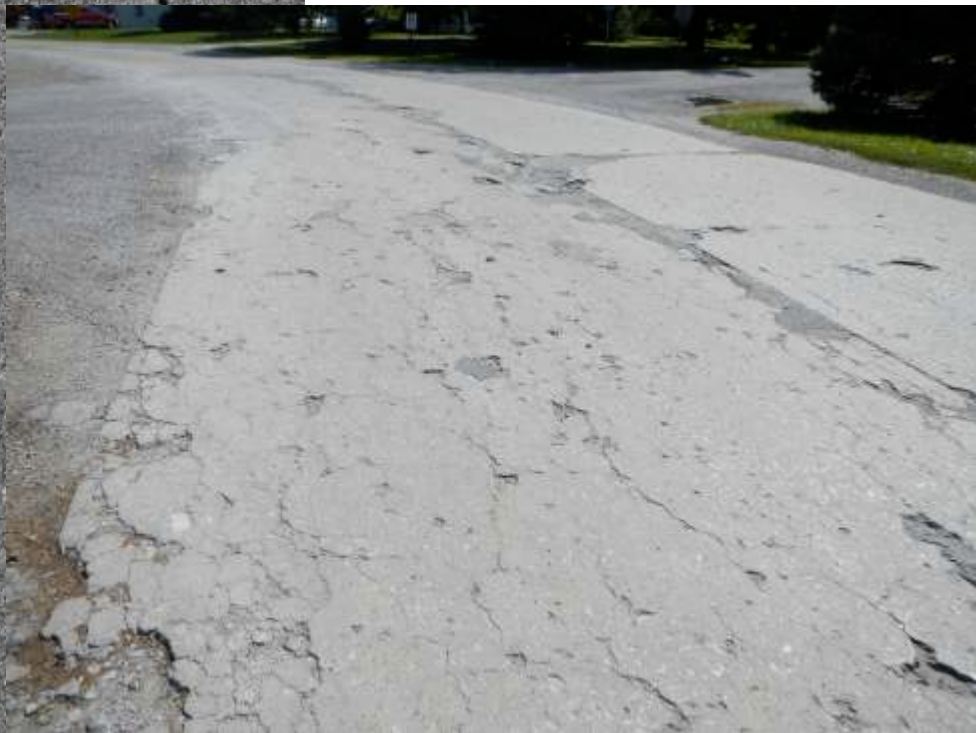
- Concrete in this condition has large quantities of multi-directional cracking along with spalling and pitting throughout. Limited portions of the “poor condition” concrete appear to be sound (Figures 09 and 10).
- In many cases a variety of patching has occurred, typically what would appear to be a temporary-type patch using asphalt. The patches have also cracked or debonded and contribute to an uneven surface condition.

FIG. 9
Concrete in "poor" condition with multi-directional cracking and previous asphalt patches with multi-directional cracking (Nilwood, IL).

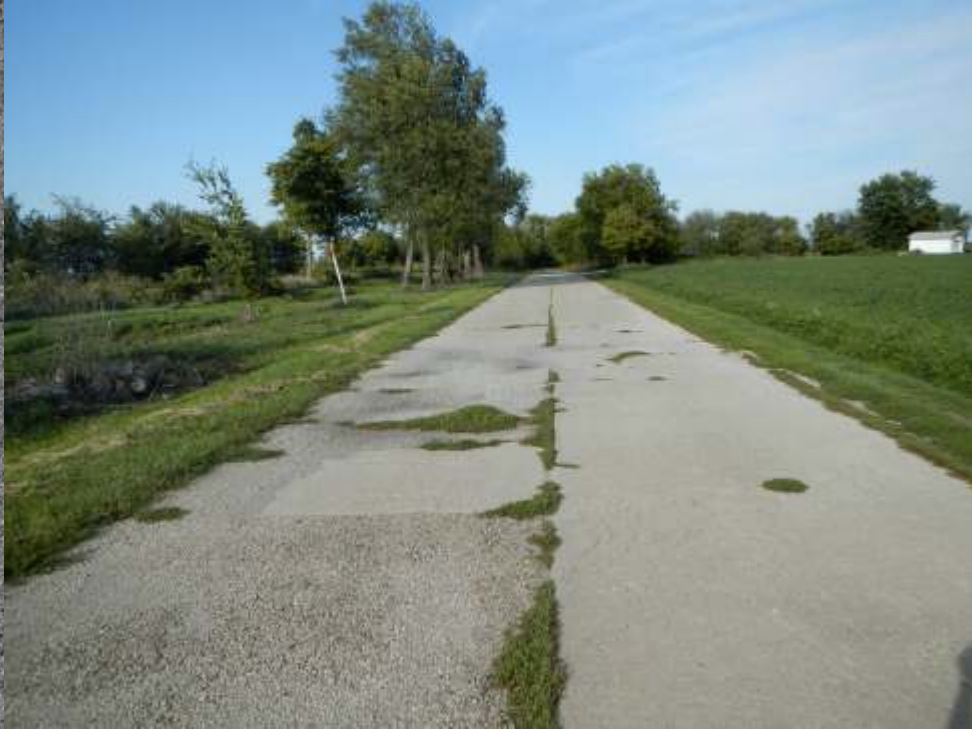
FIG. 10
Concrete in "poor" condition with craze cracking and pop-outs throughout section (Nilwood, IL).

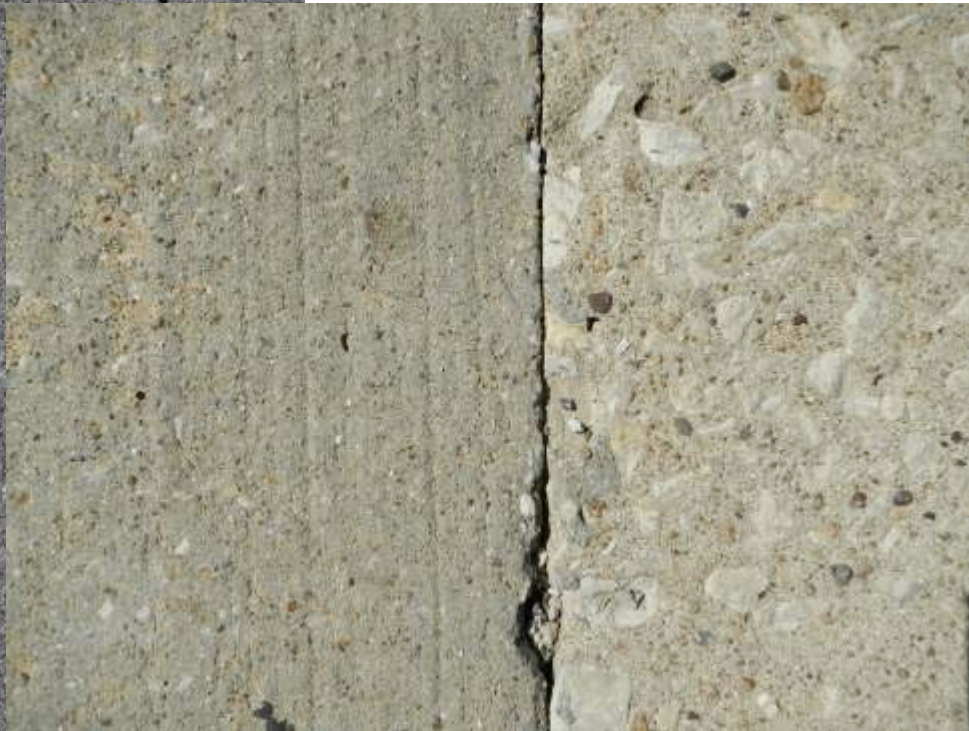
FIG. 32
New concrete repair patch finish (left) that does not match the original weathered concrete (right).

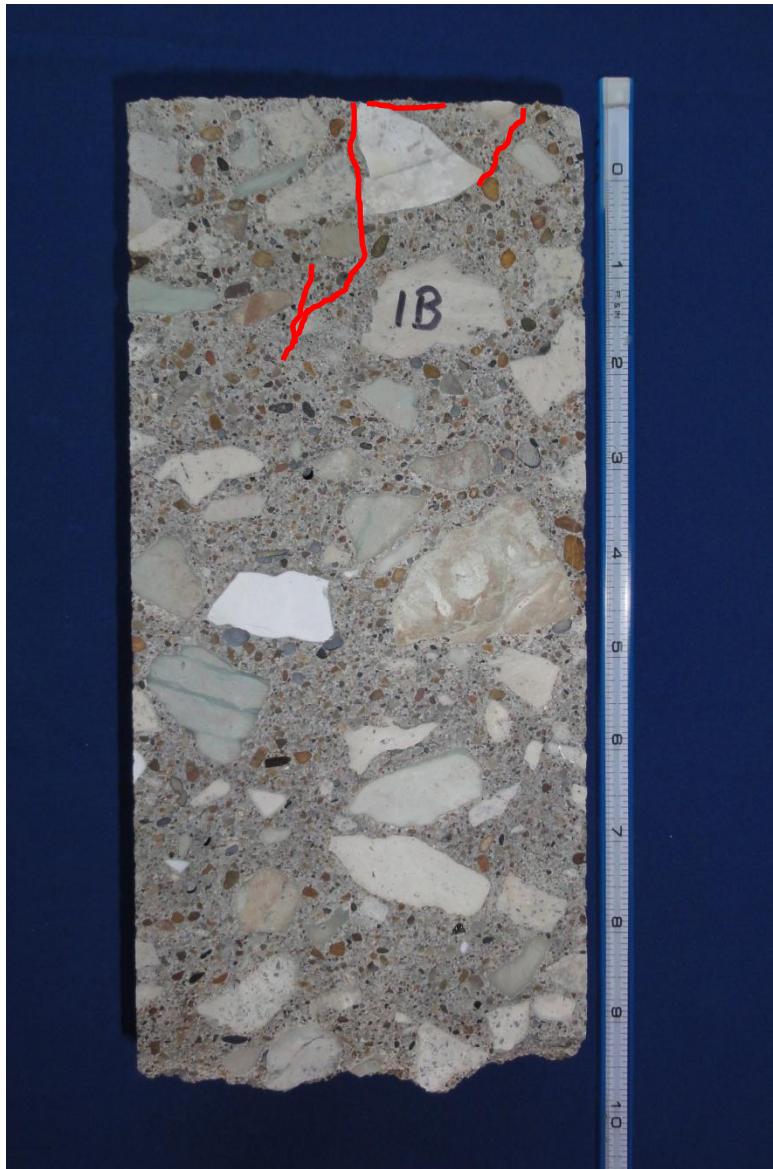
Figure 11. Lapped section of Core 1B. Crack locations are marked in red.

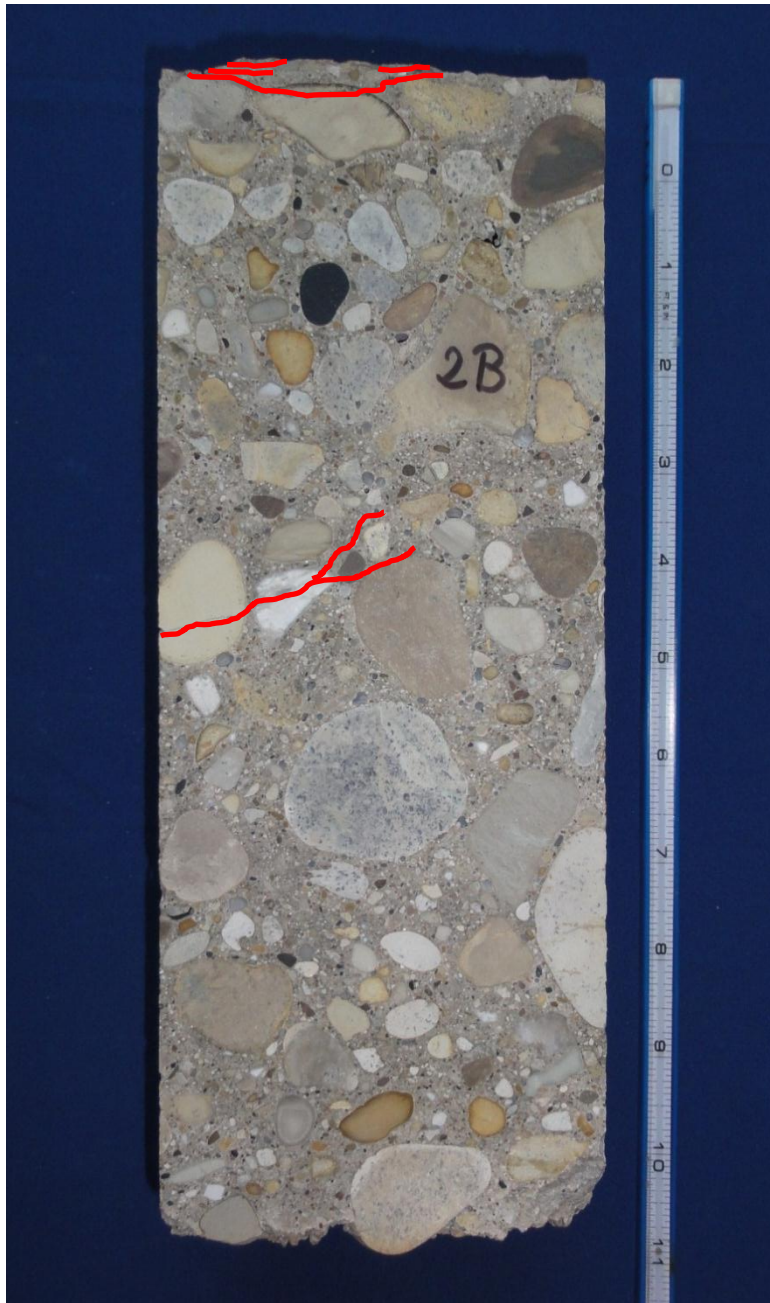
Figure 14. Lapped section of Core 2B. Crack locations are marked in red.

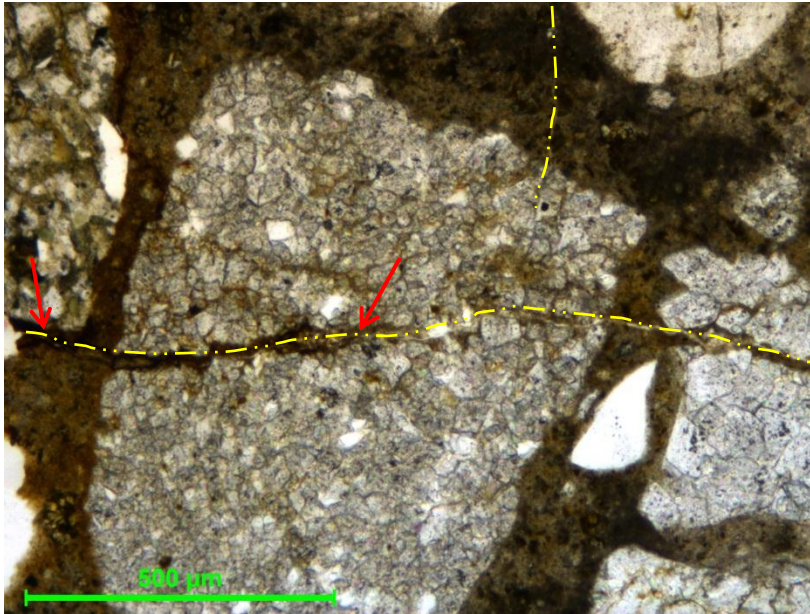
Figure 15. Core 2B - Microcracks are marked with yellow dashed lines. Red arrows show a section of a vertical microcrack that is filled with asphaltic material. Top surface is on left. Thin-section micrograph. Plane-polarized light.
