# The Auditorium Building

Roosevelt University

Getty Project Preparation Grant - Historic Interior Spaces

Conservation Master Plan

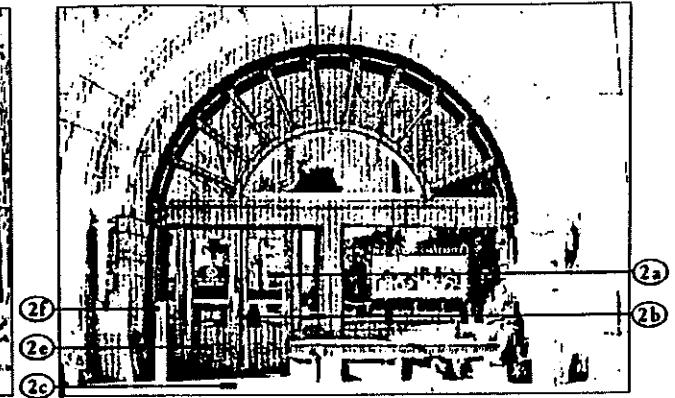
*Current condition of Michigan Avenue North entrance.*

2. Restore north exterior bay.
  - a. Remove accessible door, lites.
  - b. Install insulated glass panel and cast metal storefront to match existing. Weather seal per current standards.
  - c. Level interior and exterior ramps.
  - d. Repair interior mosaic floor.
  - e. Extend cast metal bench.
  - f. Remove electronic push pads.

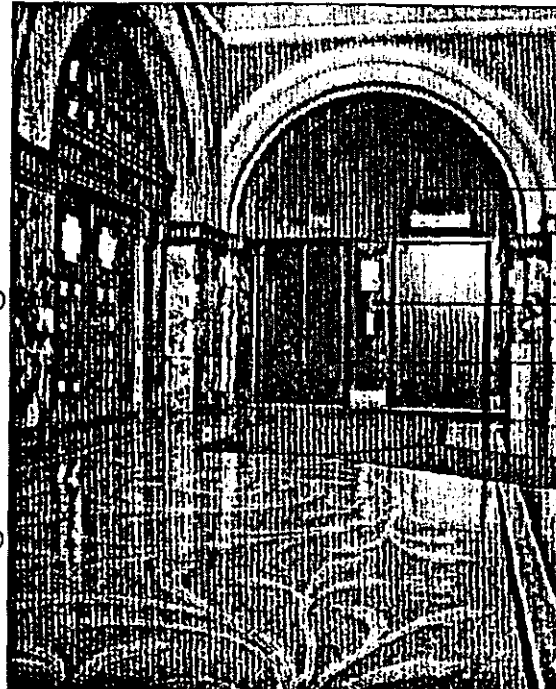
*Current condition of elevator vestibule.*

8. Reconstruct wall area around elevator doors.
  - a. Install wood panelling in lunette above doors to approximate original design.
  - b. Install wood panelling between doors. (no stained glass)
  - c. Install new bronze finish doors and frames at first, second, and tenth floors.

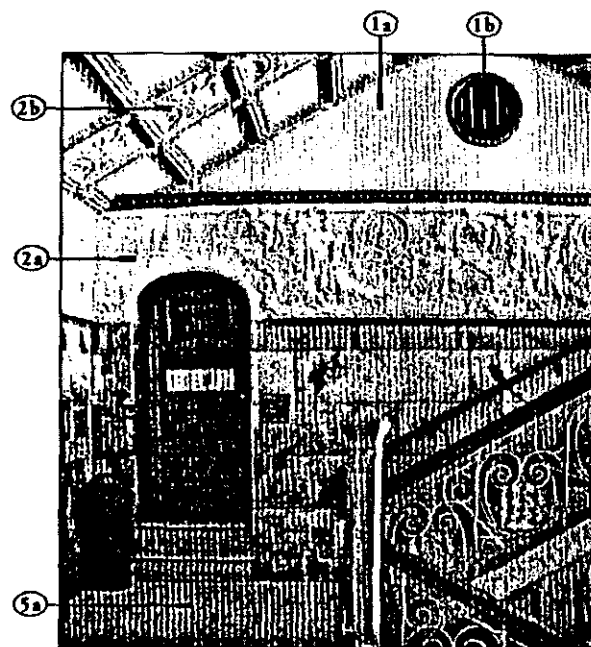
Current condition of first floor landing.

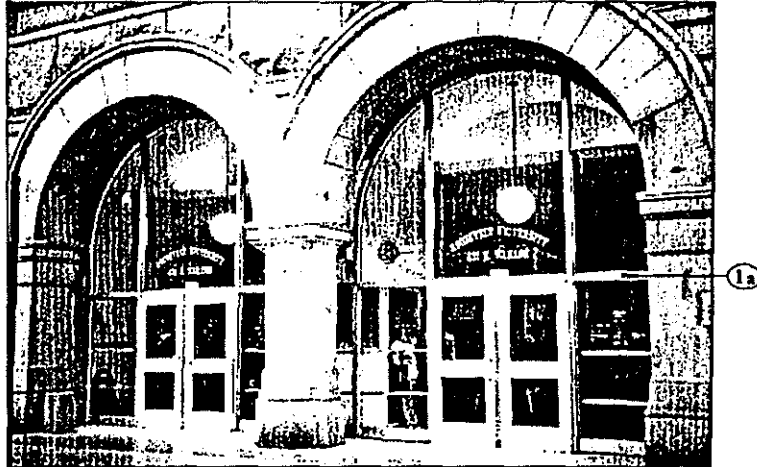
*Current condition of exterior facade.*

1. Construct and install cast metal storefront for exterior fenestration, door frame, and transom windows, using existing adjacent historic framing as guidelines.
  - a. Remove existing glass and aluminum curtain wall facade.
  - b. Recreate cast framing. Fan-shaped, semi-circular and circular gill insets to be tinted insulated. Panel behind column to be stamped with leaf decoration in Sullivan style.
  - c. Install oak panel doors with tinted insulated glass panels.
    - 2 sets of revolving doors;
    - 2 swing doors. Create shallow soffit above doors to accommodate lighting and exit signs. Face with marble.
  - d. Build out panel behind column at the interior to coordinate with mechanical duct risers.
  - e. Weather seal per current standards.
  - f. Install hammered iron door hardware.
  - g. Install more historic look exit signs.

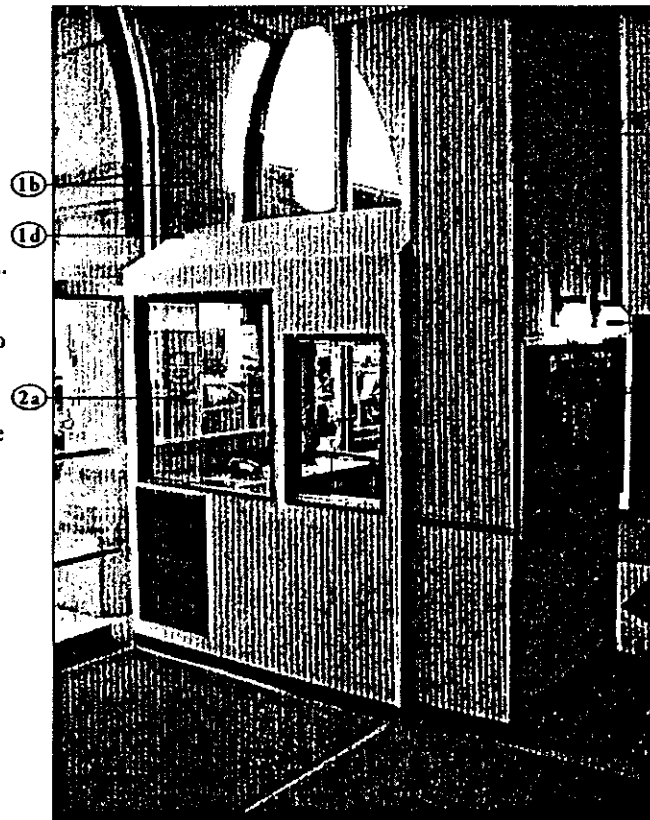
*Current Guard station.*

2. Redesign guard station to be less obtrusive and relocate.
  - a. Disassemble existing guard station, retaining control panels, as needed.
  - b. Build new marble paneled freestanding desk with wood shelf. Desktop to accommodate security system.
11. Lighting - Replace existing lighting with fixtures sensitive to the original character.
  - a. At the lobby.
  - b. At all landings throughout the stairwell.
  - c. Create a lightbox behind the "windowed" opening at the first landing.

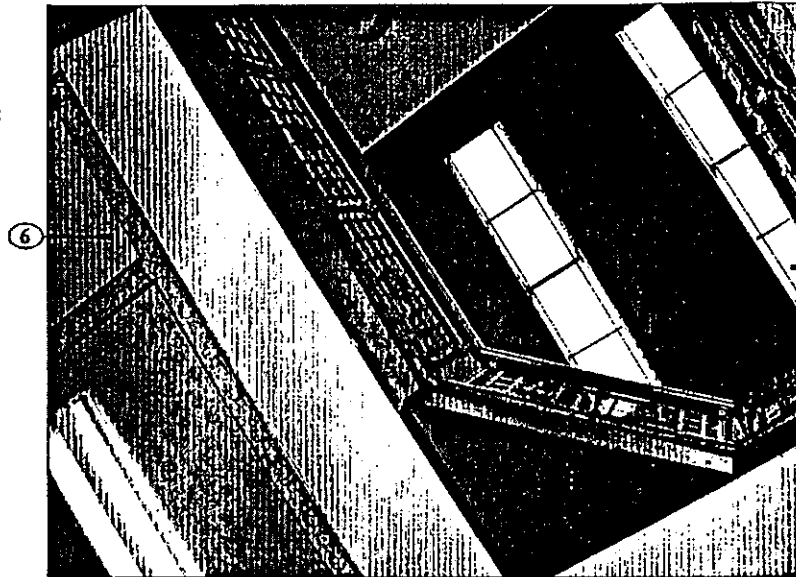
*Current condition of ninth floor ceiling and tenth floor skylight beyond.*

- a. Remove existing black painted skylight and fluorescent light fixtures.
- b. Install new skylight. Flash and seal to current standards.
- c. Install supplemental lighting.

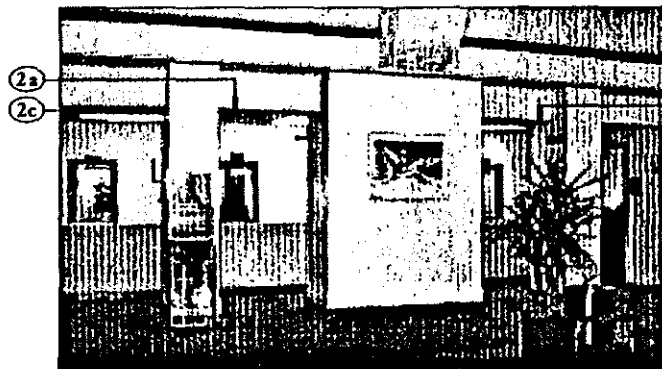
*Current condition of northwest wall.*

2. Reconstruct entrance to northwest offices
  - a. Restore and install two stained glass windows in new framing.
  - b. Reconstruct fireplace, using photo and other existing fireplaces (Sullivan and Faculty Lounge rooms). Brownish-purple marble with oak panelled mantel and surround.
  - c. Remove existing drop ceiling and install new raised drywall ceiling and lighting at raised height. 140 sq. ft.

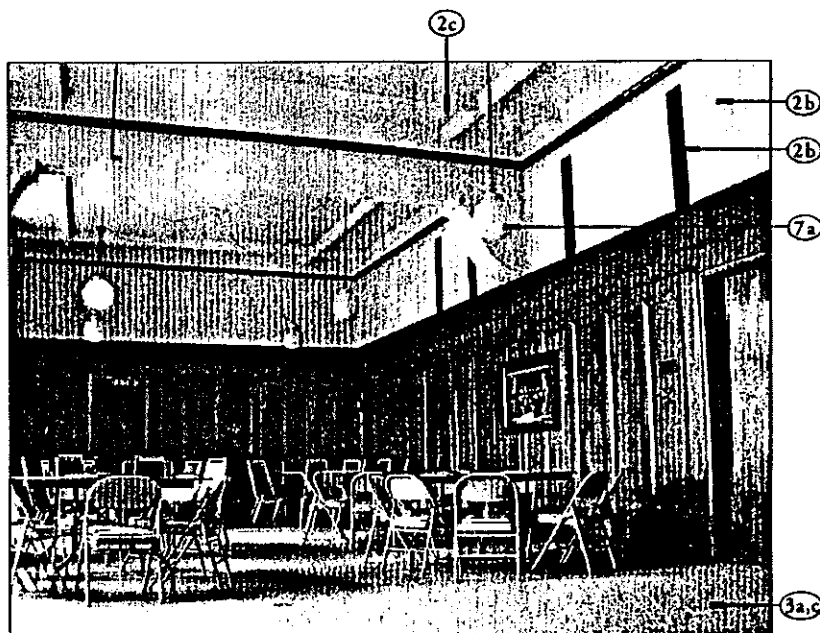
*Current condition of Faculty Lounge.*

- a. Replace pendant globes with pendant brass fixtures, based on historical photograph.
- b. Add historical sconces to perimeter wainscoting.
- c. Add additional lighting to balance light levels for meeting room standards.

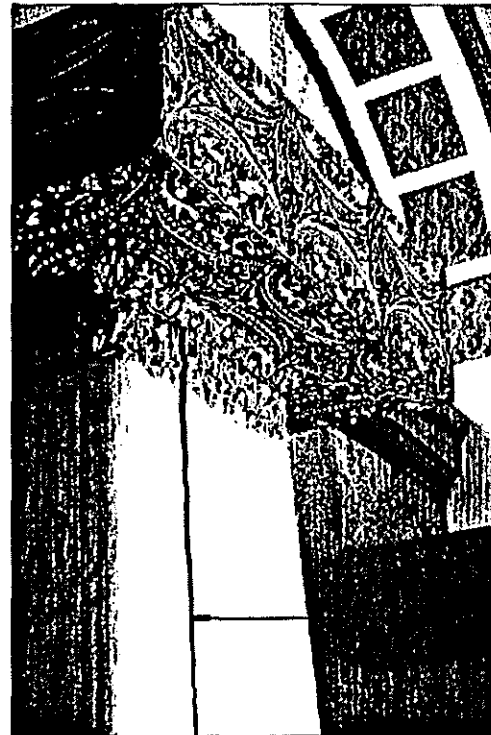
*Detail of cracking piers.*

- Some wood panels warped,
- Fretwork is loose,
- Piers are cracking.

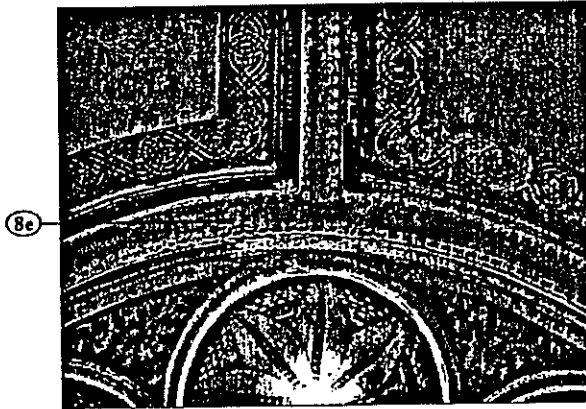
Detail of damaged plaster on ceiling in south wing.

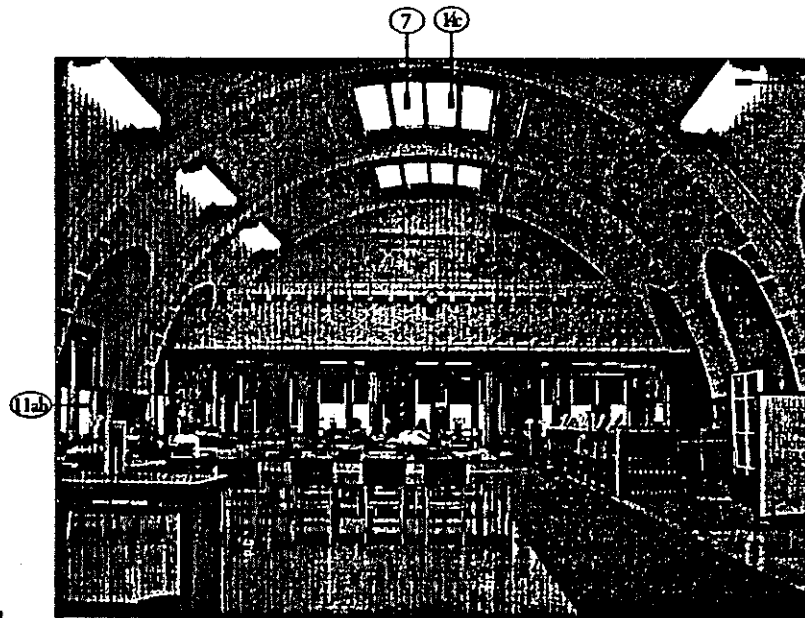
*Remove fluorescent lighting.*

14. Lighting - see "Lighting" section.
  - a. Remove surface-mounted fluorescents on main vault.
  - b. Restore arch soffit plaster settings.
  - c. Restore lighting around the columns (remove and reinstall mahogany panelling) and behind the skylights.
  - d. Reinstall period lighting in the north wing.
  - e. Supplement main hall and wings with auxiliary lighting, if necessary.
  - f. Install new lighting in the adjacent "periodical room", if necessary.
  - g. Replace pendant fixture above stairway with historic reproduction of original fixture.
