# The Auditorium Building

Roosevelt University

Conservation Master Plan

December 2000 Volume II

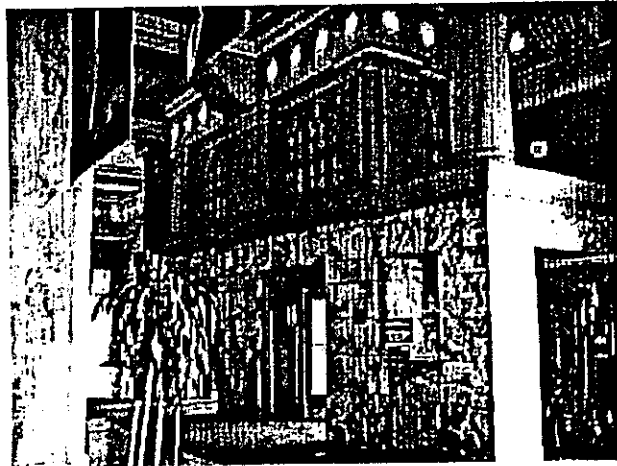
Photo A1 - Location of new supply air discharge in Michigan Avenue Lobby to be above revolving doors

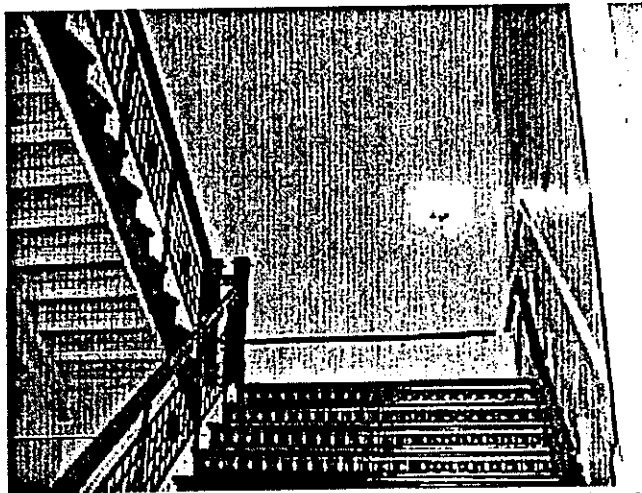
Photo A2 - Wall sconces in Wabash Stair to be replaced

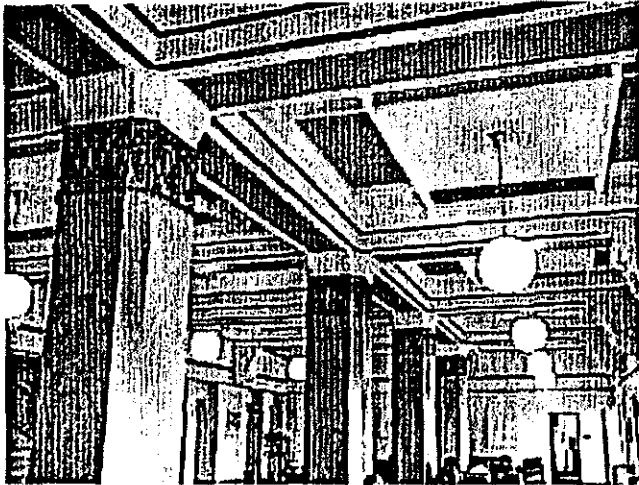
Photo A4 - Linear diffusers, fed from the 3<sup>rd</sup> floor above shall be used to serve Fainman Lounge

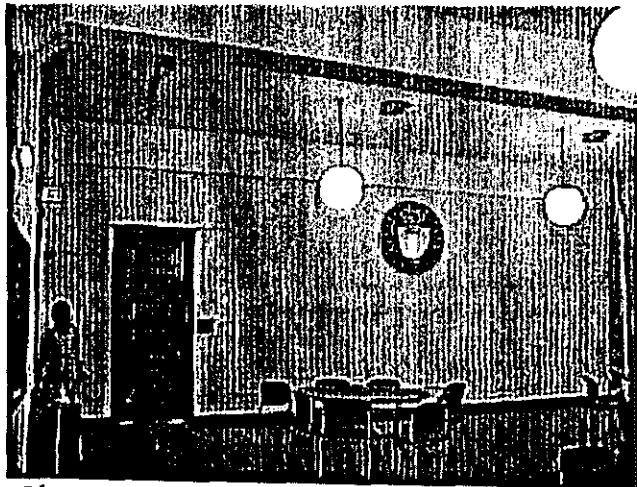
Photo A5 - Location of ductwork serving the Sullivan Room to be run exposed in the room west of the Sullivan

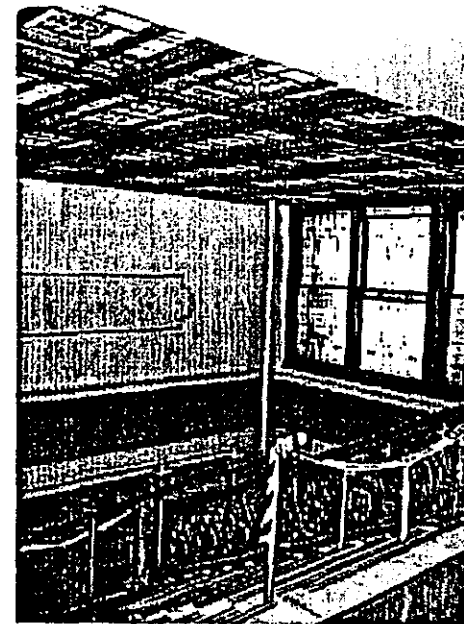
Photo A6 - Grand Stair stained glass to be relit with new back lighting

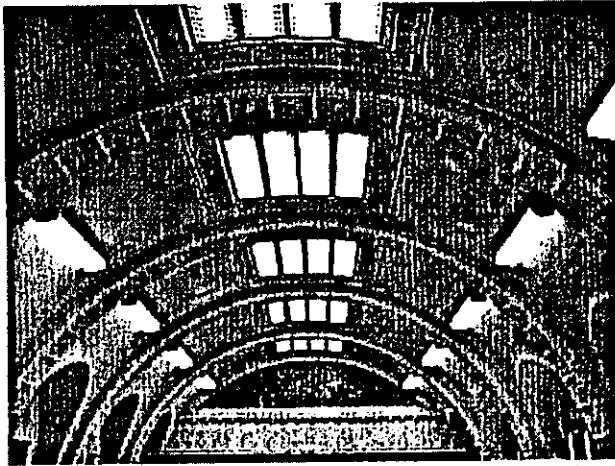
Photo A7 – Supply linear diffusers to be installed in barrel arch, near existing inactive skylights

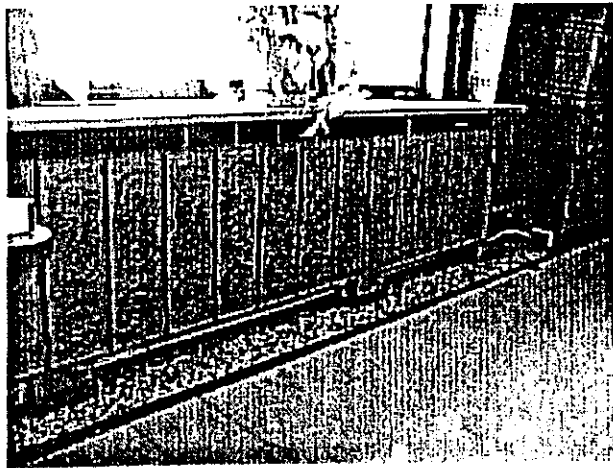
Photo A8 – Non functional cast iron radiators to be retained. Fin tube radiation located behind radiator to be replaced
