Concrete Restoration for Route 66 in Illinois

September 2012

THORNTON TOMASETTI, INC. (TT) WAS SOLICITED BY the Illinois Historic Preservation Agency (IHPA) to develop an historic concrete treatment guide and repair/restoration specifications for the limited remaining historic concrete roadway along Illinois' Route 66 corridor. As stated in IHPA's *Route 66: Finding Illinois' Original Roadbed Segments from Chicago to St. Louis* report, "In all of the research about US Route 66 throughout the United States, one area in particular has been left disengaged for the most part. That area consists of the original roadbed segments of US Route 66, which can still be found stretched along the Illinois landscape."

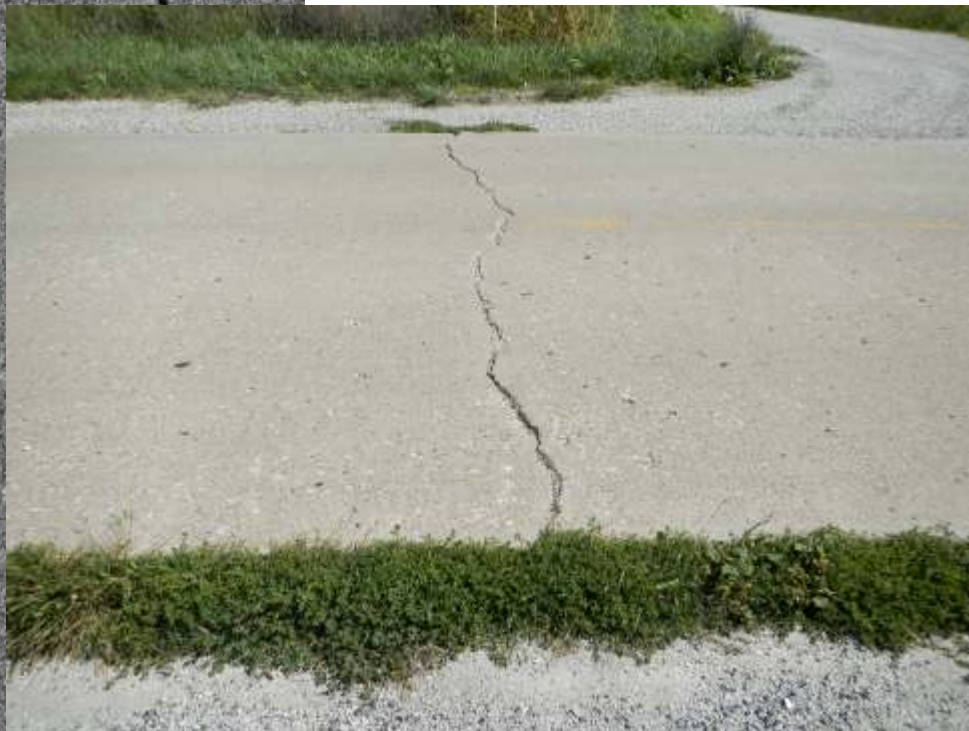
- Overall concrete is in good condition with minor weathering and pitting of the surface (Figure 01).
- No control joints were included in the original design and transverse cracking exists every 14 to 20 feet on centers along the length of the roadway (Figure 02). In general, the width of the concrete road is 18 to 20 feet.
- Cracks are raveled along the edges and vary in width from 1/2-inch up to 2 to 3-inches. Cracks are generally in-filled with small aggregates and minor grass growth.
- Some minor patching observed includes the use of asphalt in areas where small spalls have occurred along the cracks (Figure 03).

FIG. 1
Concrete in "good" condition (Girard, IL).

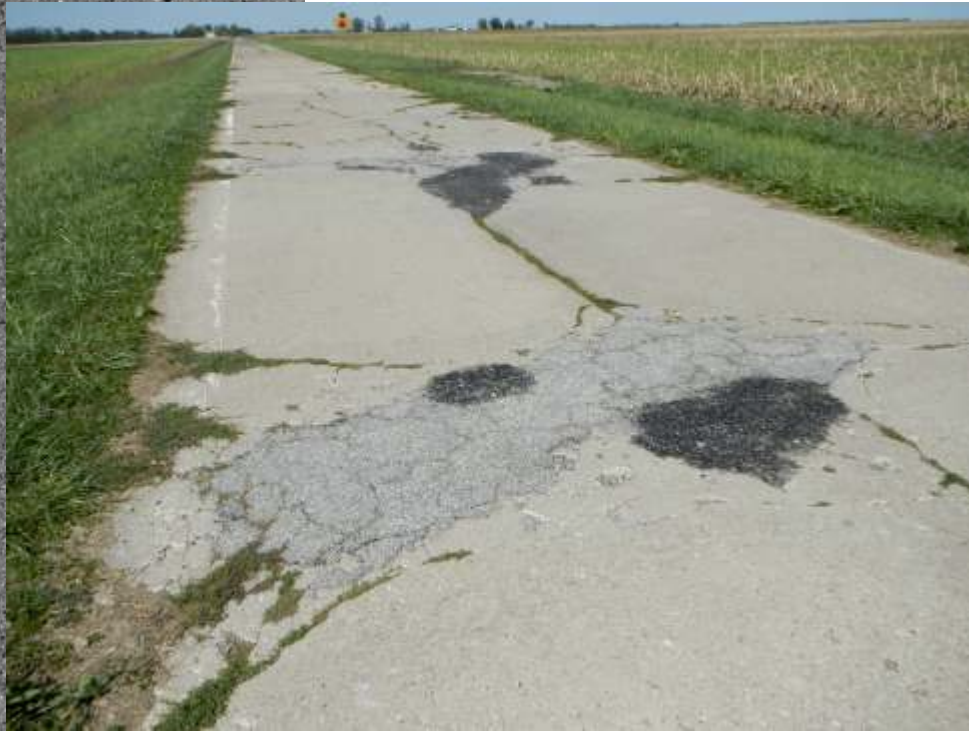
FIG. 7
Large previous patch that does not match existing concrete (south of Girard, IL).

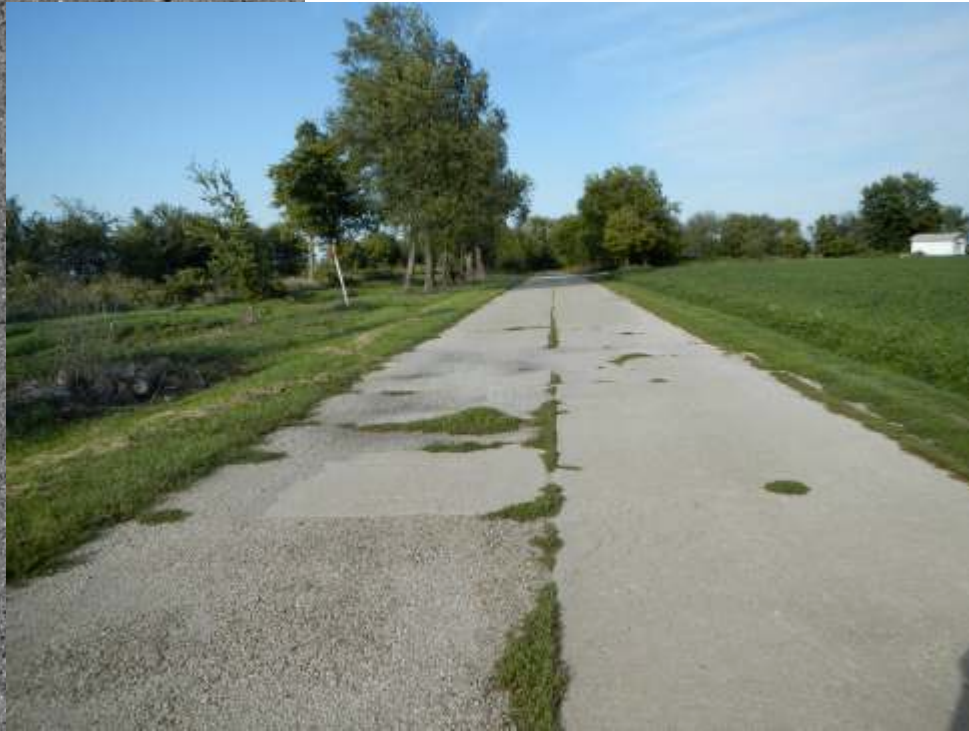
FIG. 10

- Concrete in this condition has large quantities of multi-directional cracking along with spalling and pitting throughout. Limited portions of the “poor condition” concrete appear to be sound (Figures 09 and 10).
- In many cases a variety of patching has occurred, typically what would appear to be a temporary-type patch using asphalt. The patches have also cracked or debonded and contribute to an uneven surface condition.

Concrete in "poor" condition with craze cracking and pop-outs throughout section (Nilwood, IL).

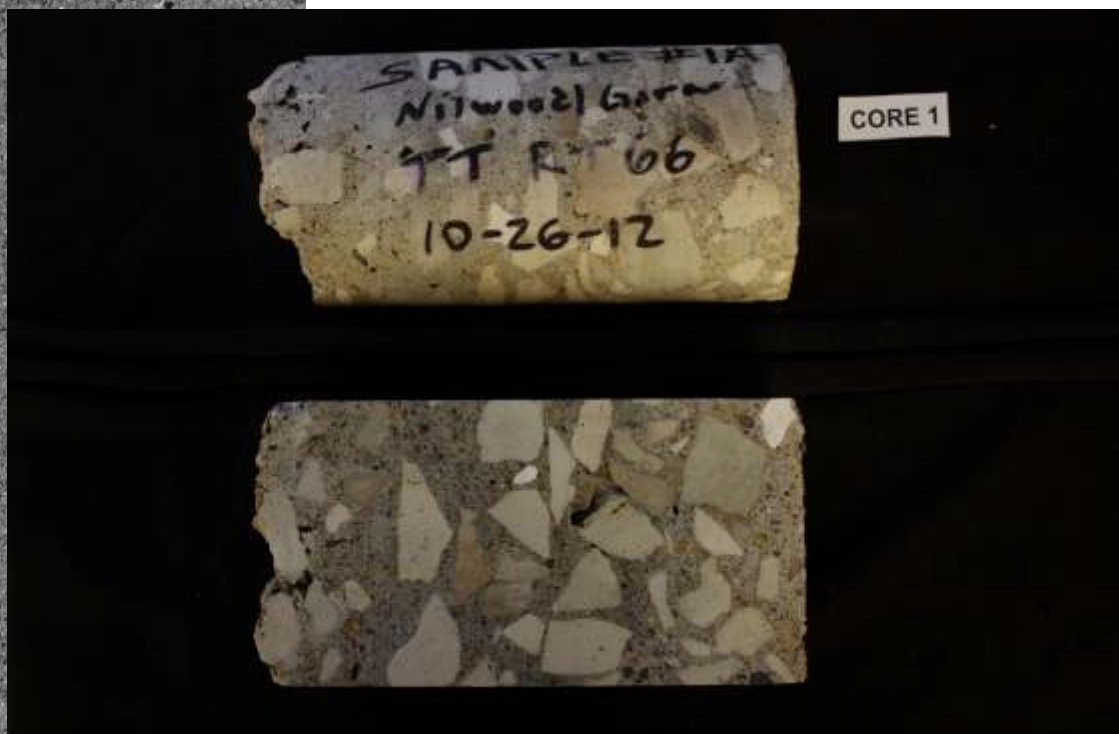
FIG. 21
Core 1 (Nilwood/Girard); lapped surfaced shown on lower half of the core sample.

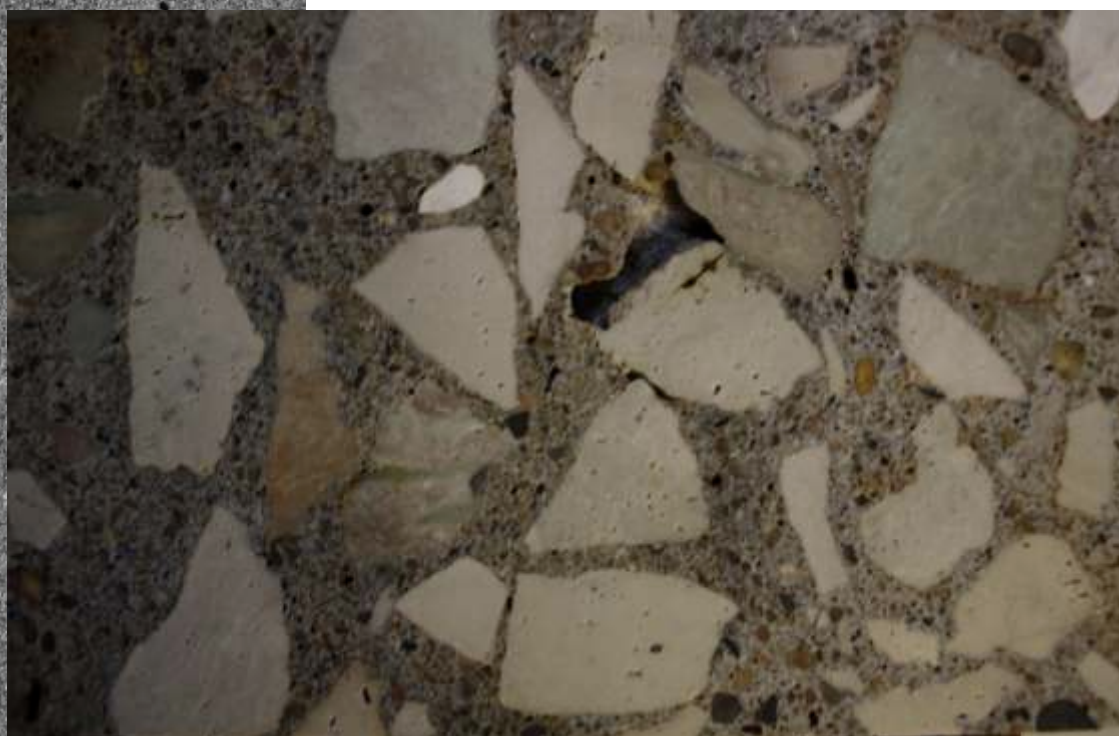
FIG. 22
Core 1 close-up of lapped surface showing crushed limestone aggregates within the cement paste matrix.

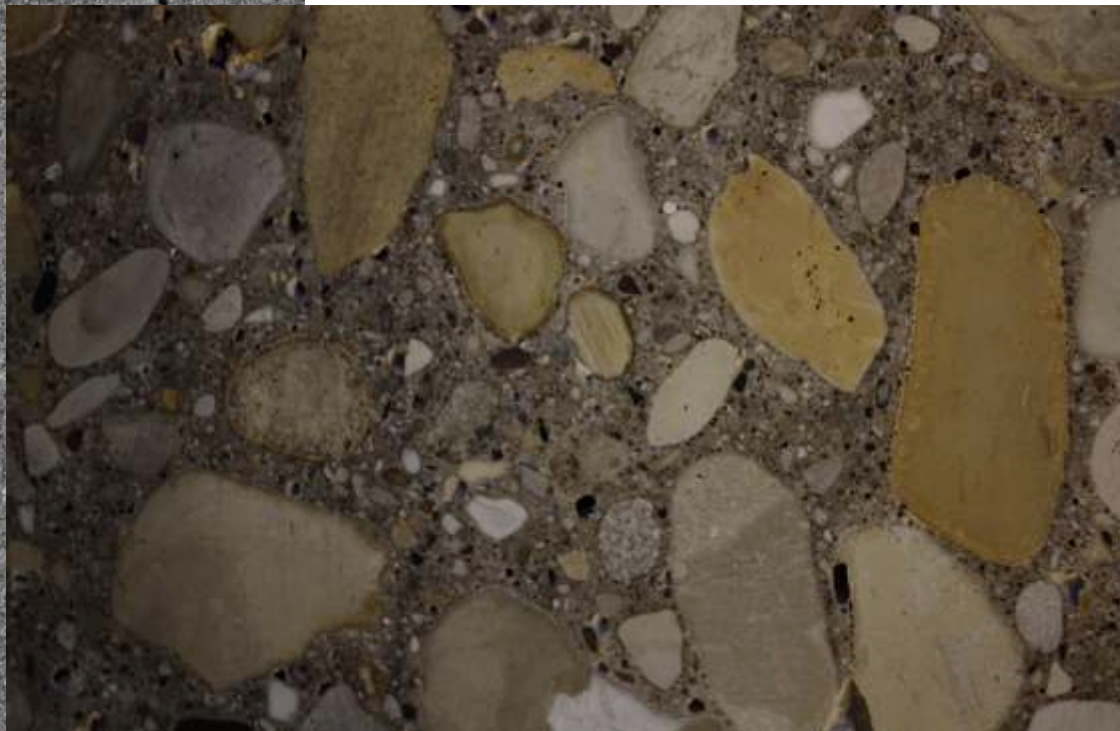
FIG. 24

Core 2 close-up of lapped surface showing rounded gravel aggregates within the cement paste matrix.

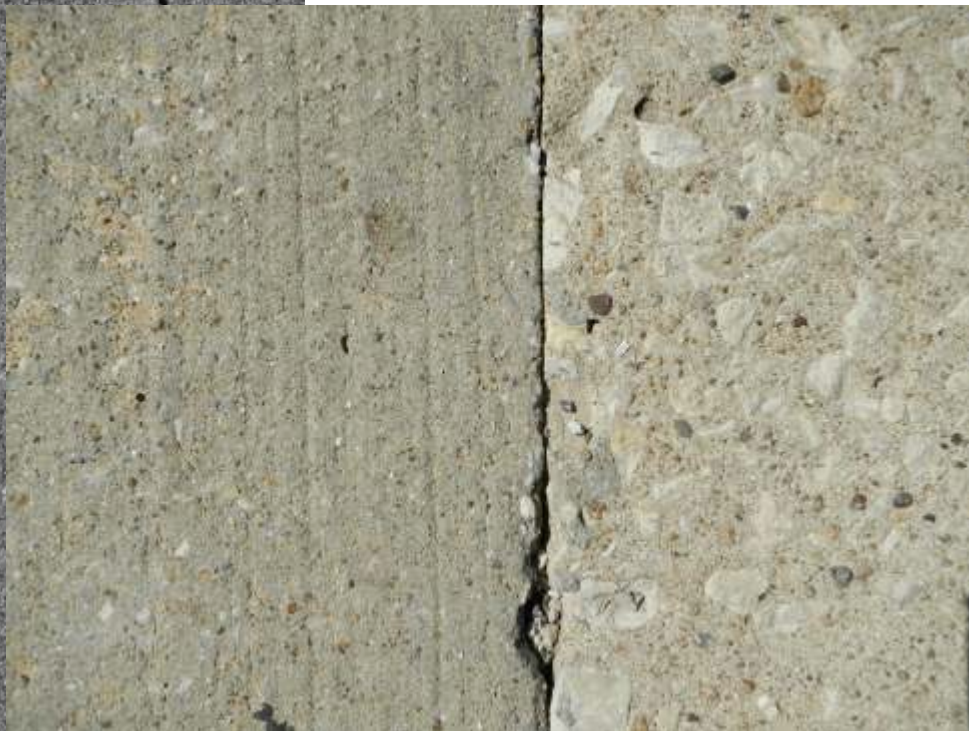
FIG. 32
New concrete repair patch finish (left) that does not match the original weathered concrete (right).

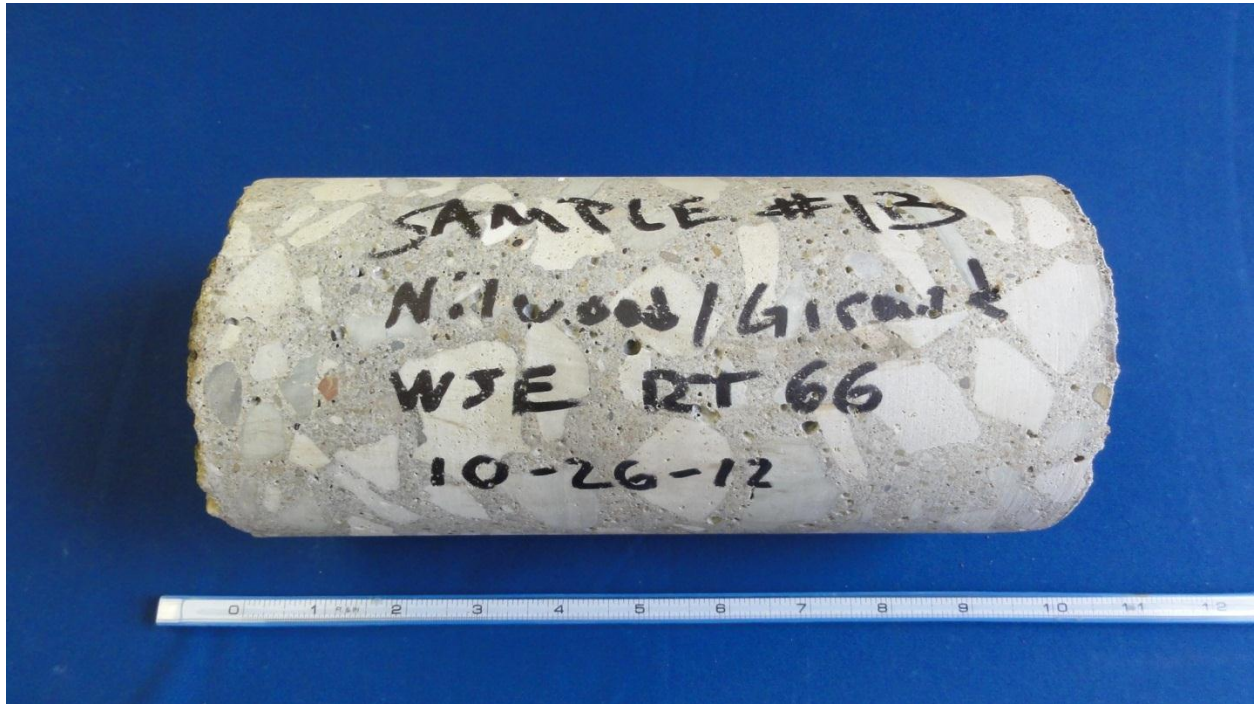
Figure 1. Core sample 1B as received. Top surface of the core is on the right of the photograph.

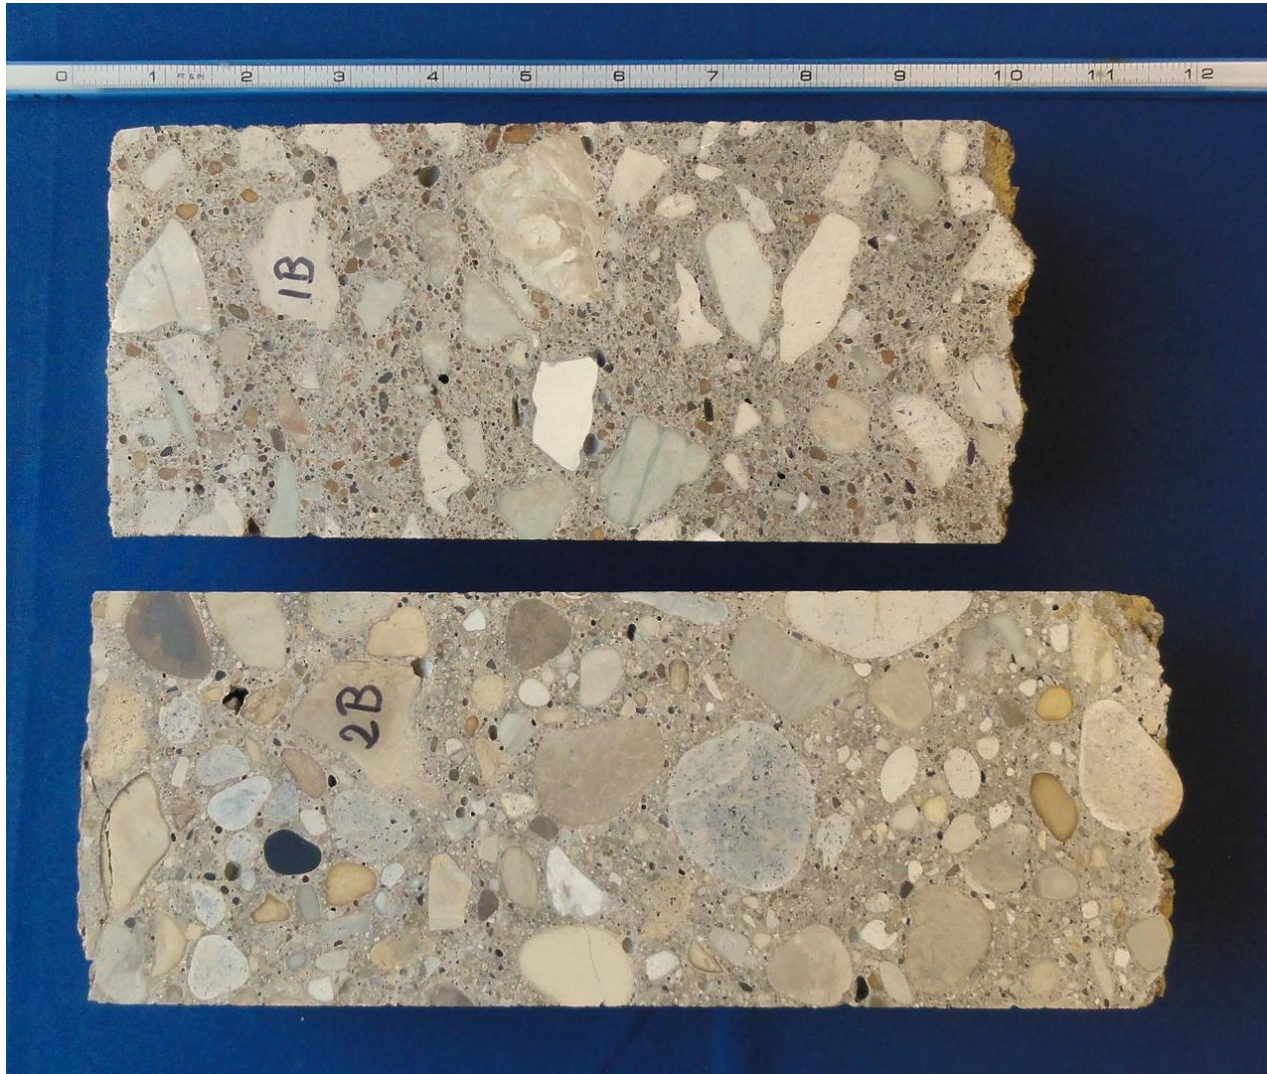
Figure 10. Lapped longitudinal cross sections of Cores 1B and 2B. Top surfaces of the cores are on the left of the photograph. Coarse aggregate in Core 1B is crushed limestone and in Core 2B it is natural calcareous and siliceous gravel. The distribution of the aggregates is uniform in both cores.

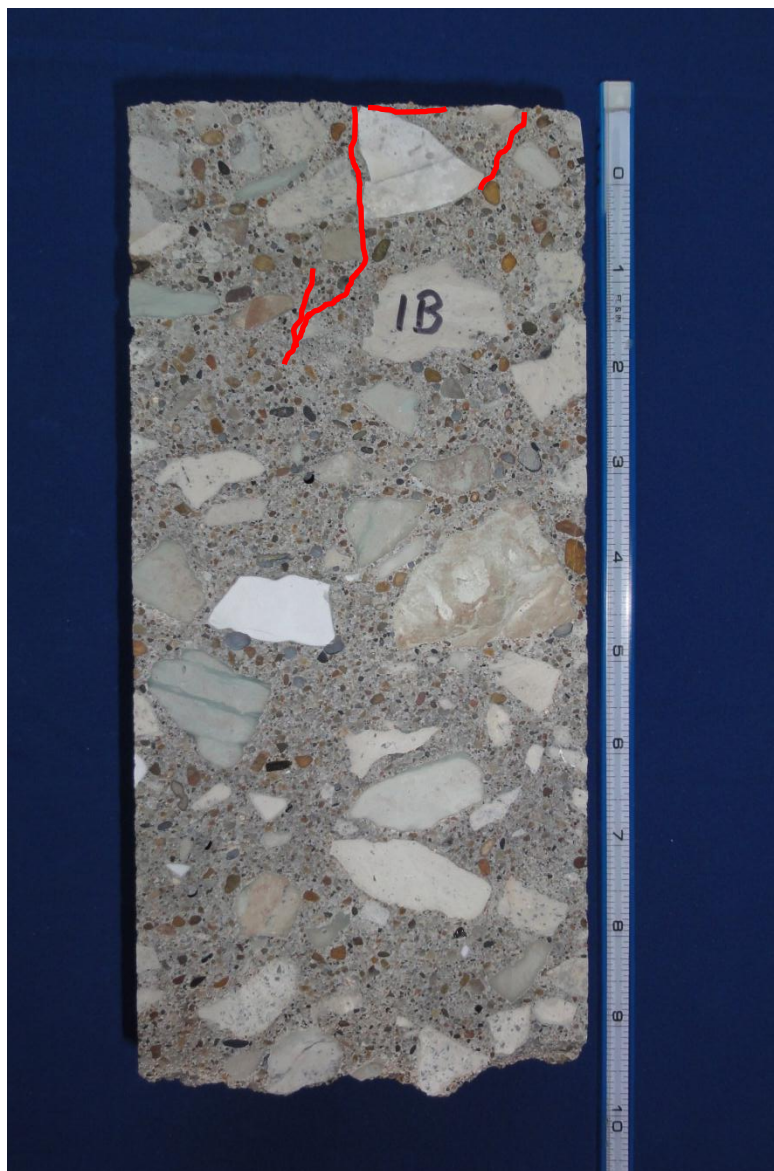
Figure 11. Lapped section of Core 1B. Crack locations are marked in red.

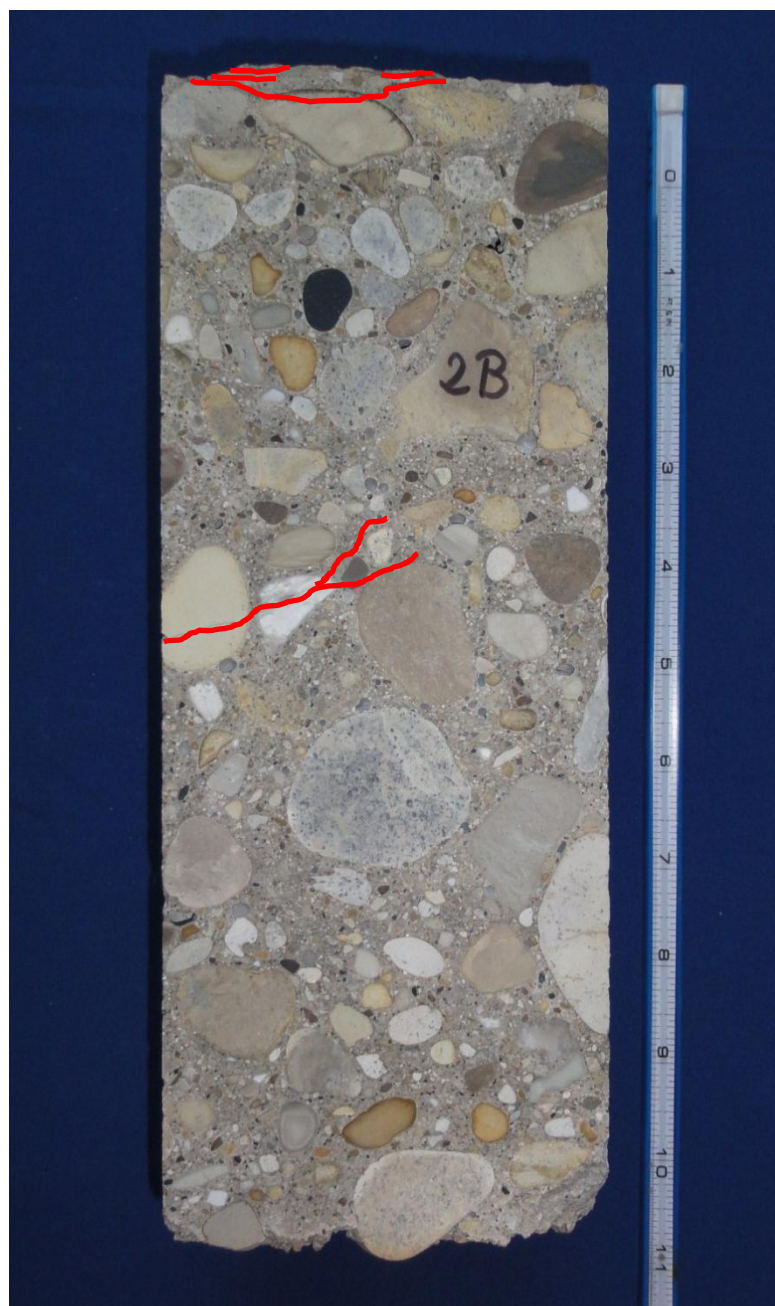
Figure 14. Lapped section of Core 2B. Crack locations are marked in red.
