HISTORIC STRUCTURE REPORT:

HOWARTH HOUSE AND BARN
WILDLIFE PRAIRIE STATE PARK, PEORIA COUNTY, ILLINOIS

Fever River Research
Springfield, Illinois

June 2002

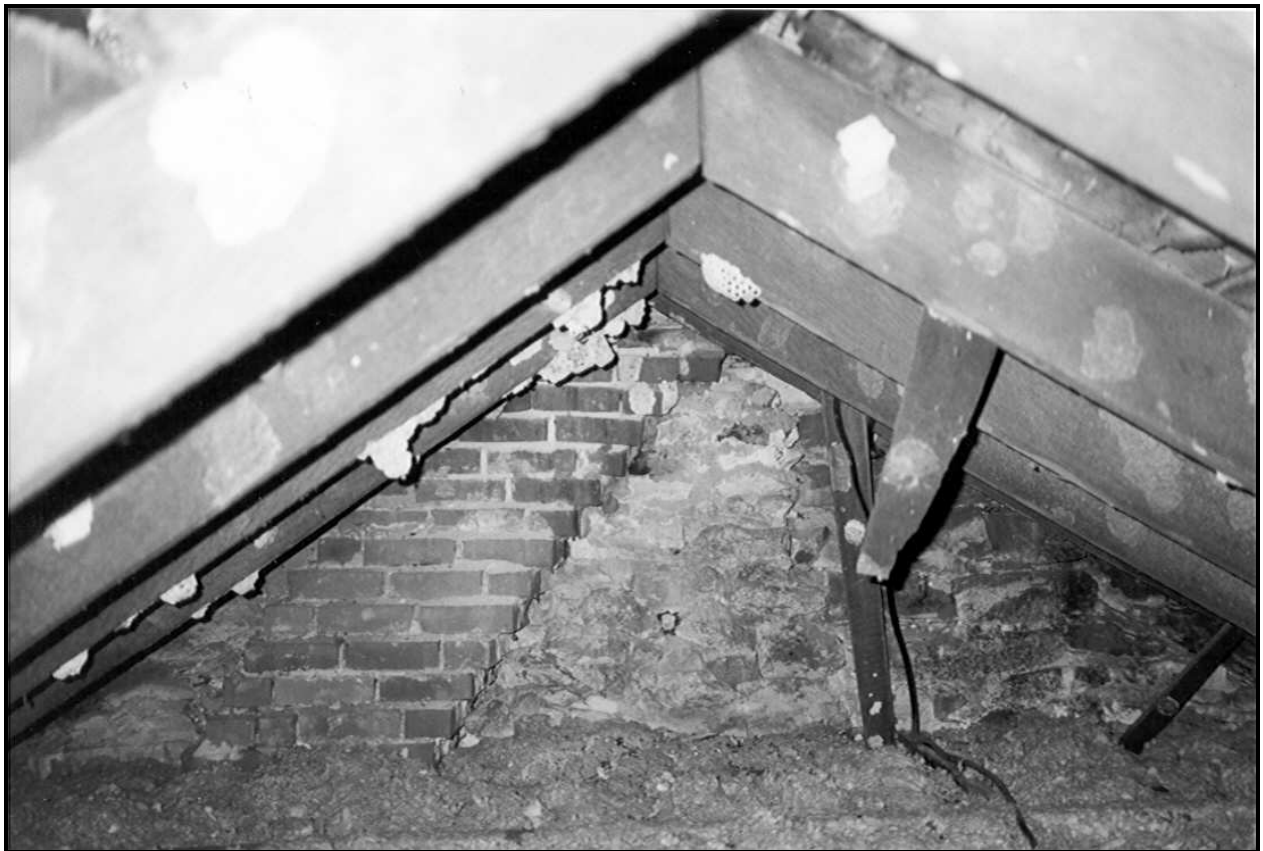
Figure 45. View of the interior brick chimney that is located on the east gable-end wall of the original house. An original feature to the house, this chimney is no longer in use and has had its stack removed below roof level (FRR June 2001).

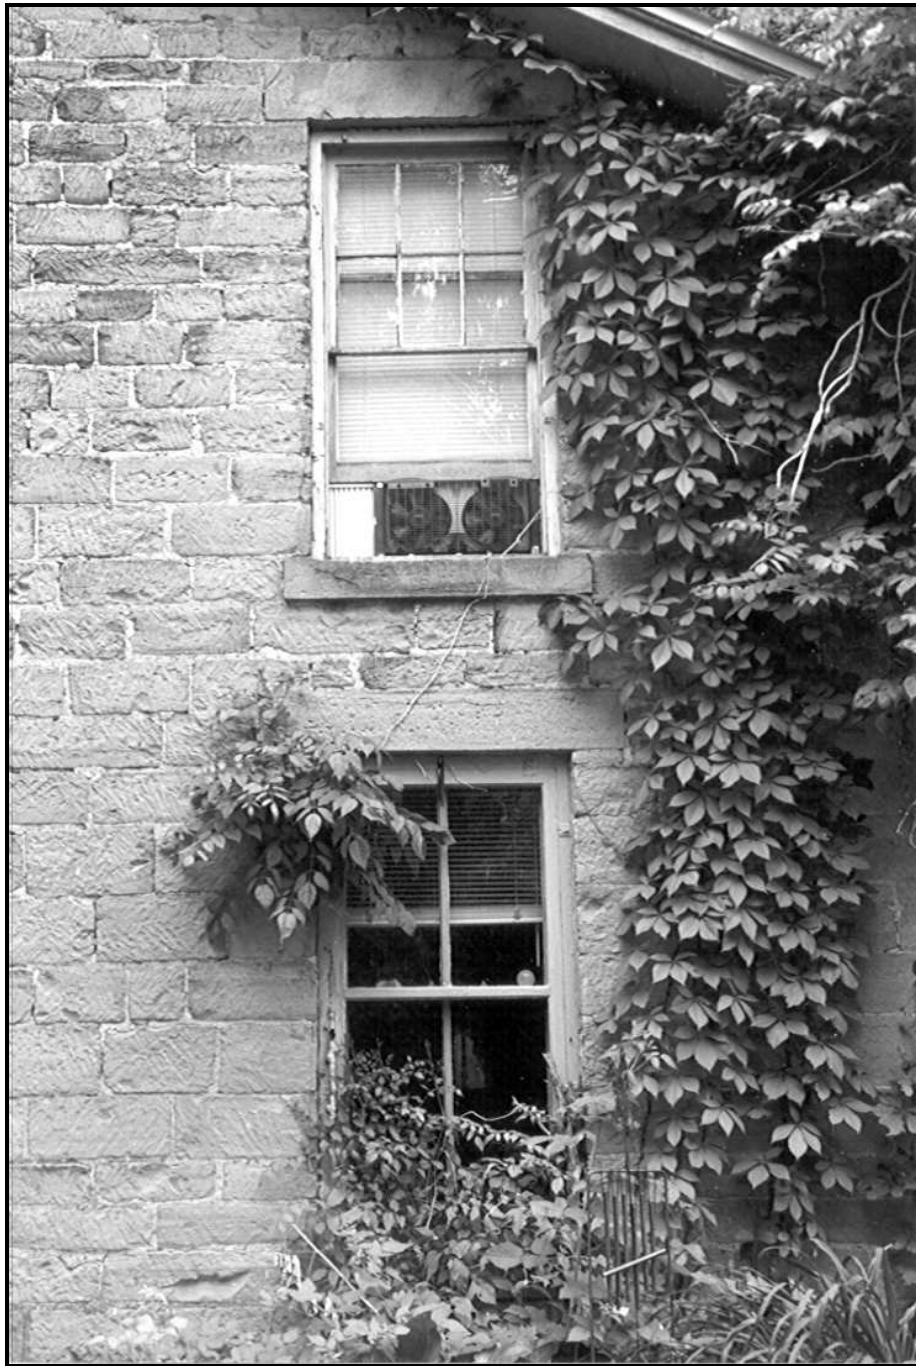
Figure 82. View of vine growth on the north elevation of the house. All vines such as these should be removed from the walls of the house and measures should be undertaken to prevent its growth there in the future (FRR June 2001).

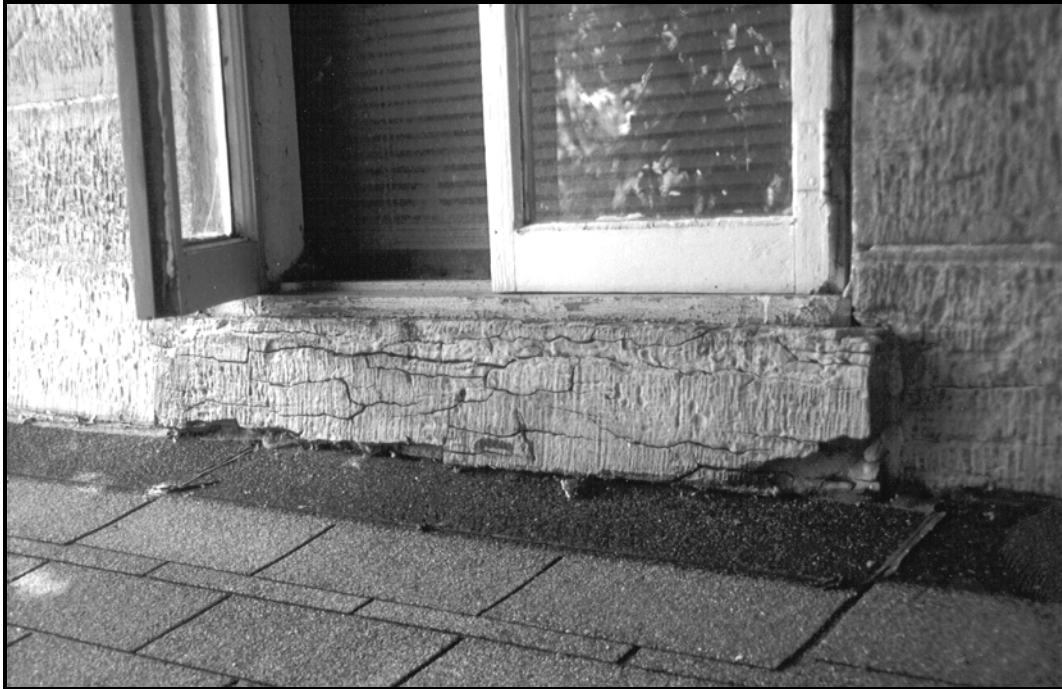
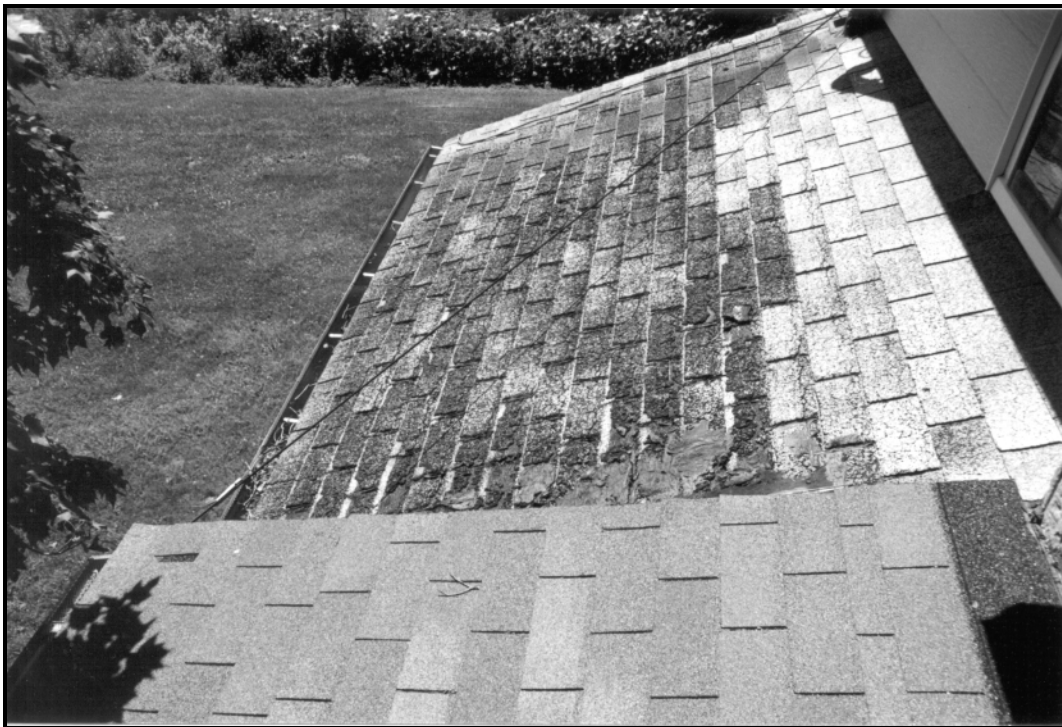
Figure 83. (Top) Cracked and fissured window sill on the south elevation of the house. (Bottom) Deteriorated roofing over the bathroom/laundry room addition (FRR July 2001).

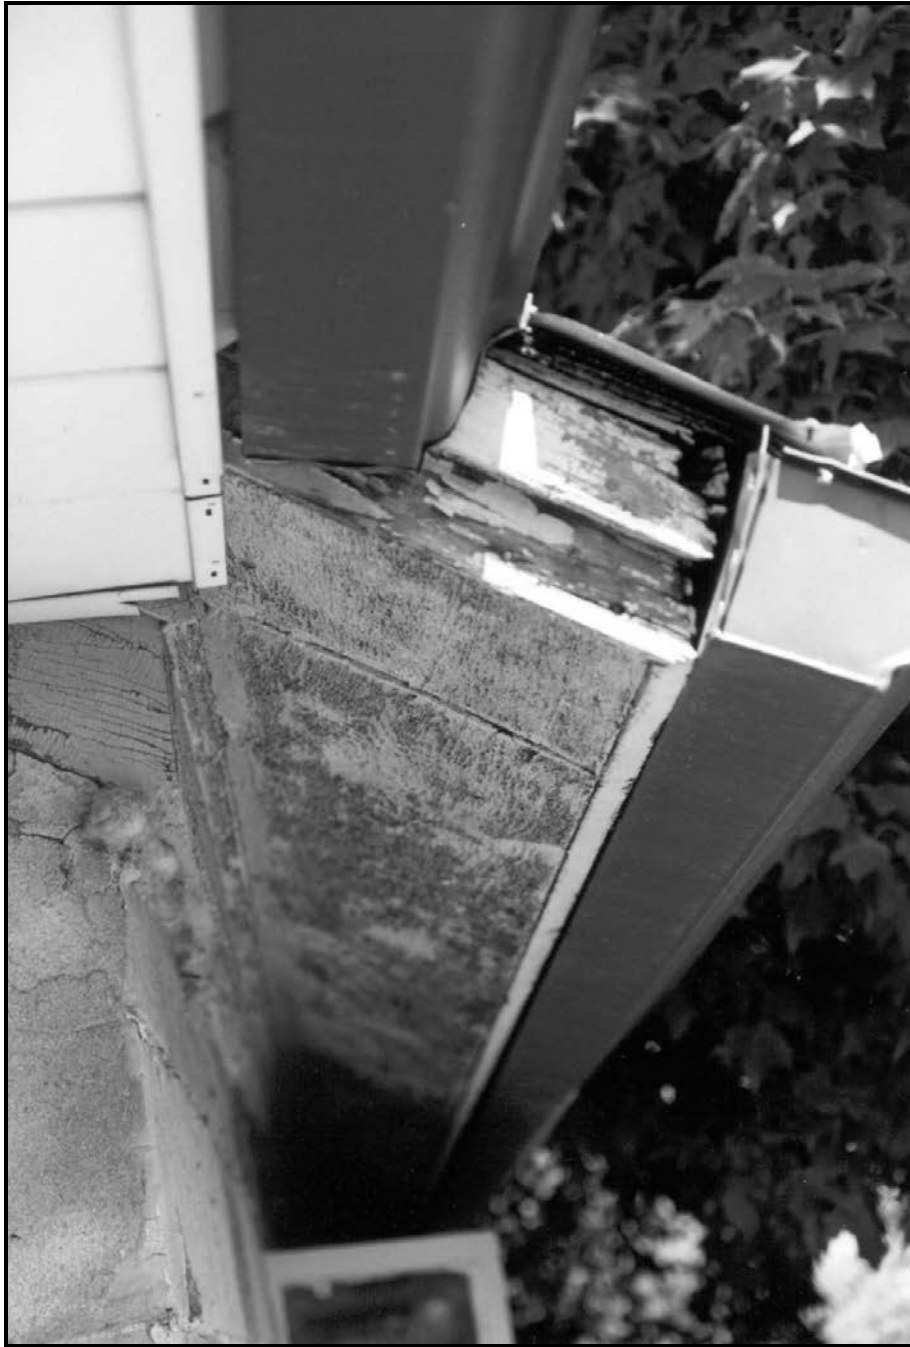
Figure 84. View of the eave at the southwest corner of the original house, illustrating the poor condition of the paint. The eaves on the original house and north addition should be scraped, primed, and painted (FRR July 2001).

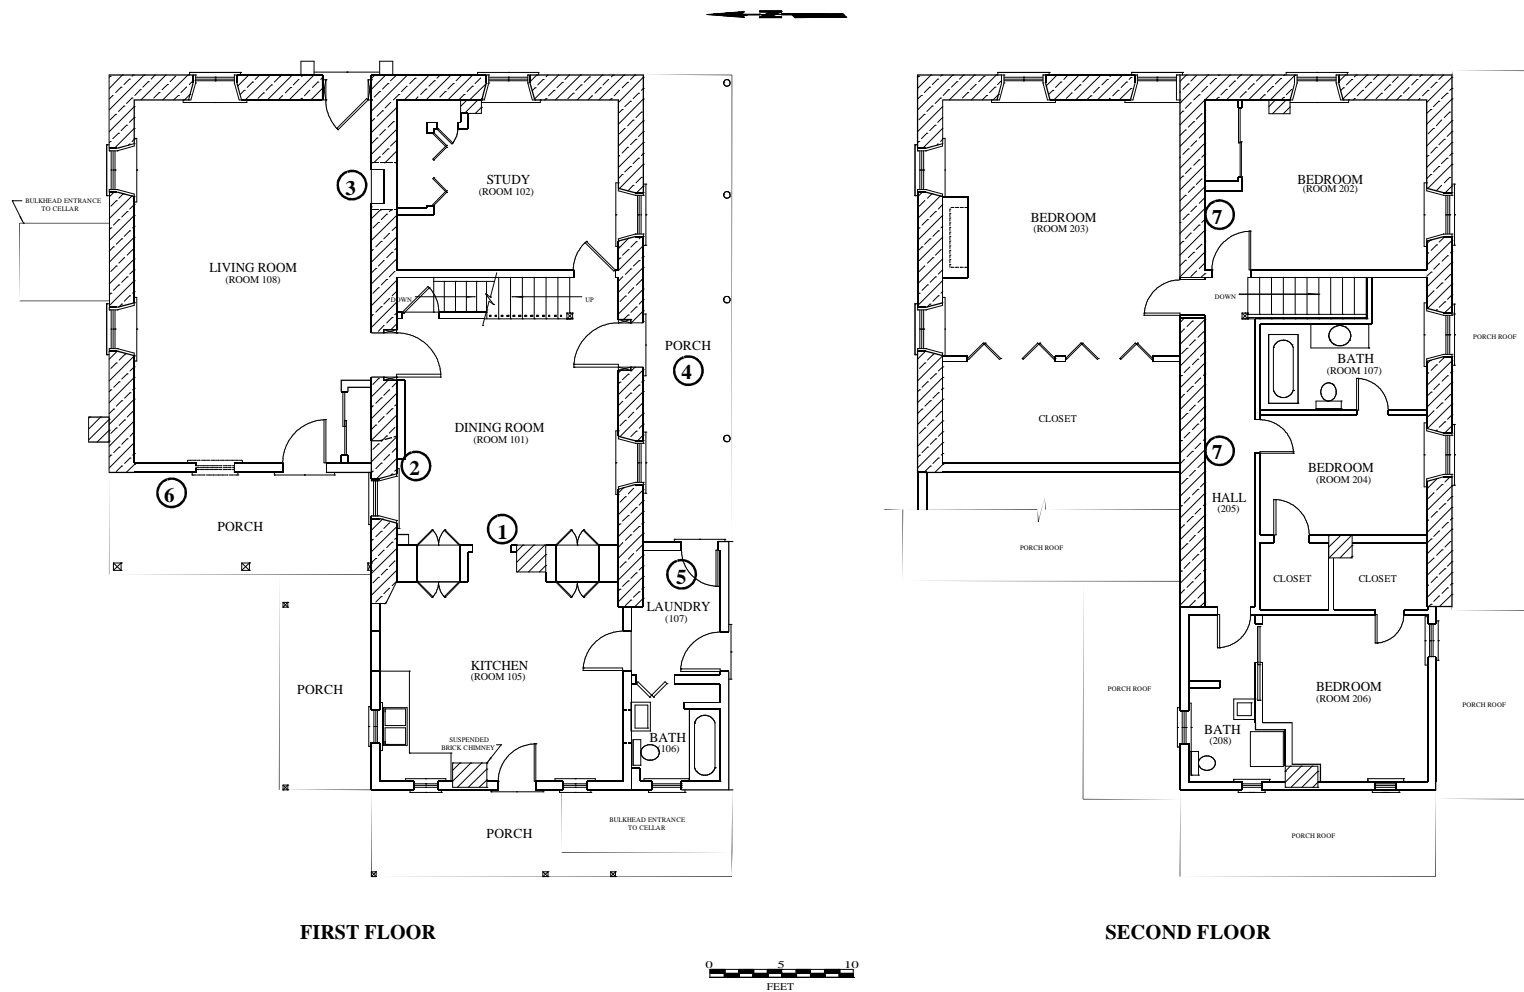
Figure 85. First and second floors plans of the Howarth House, showing existing conditions. The numbers reference points worthy of future investigation.

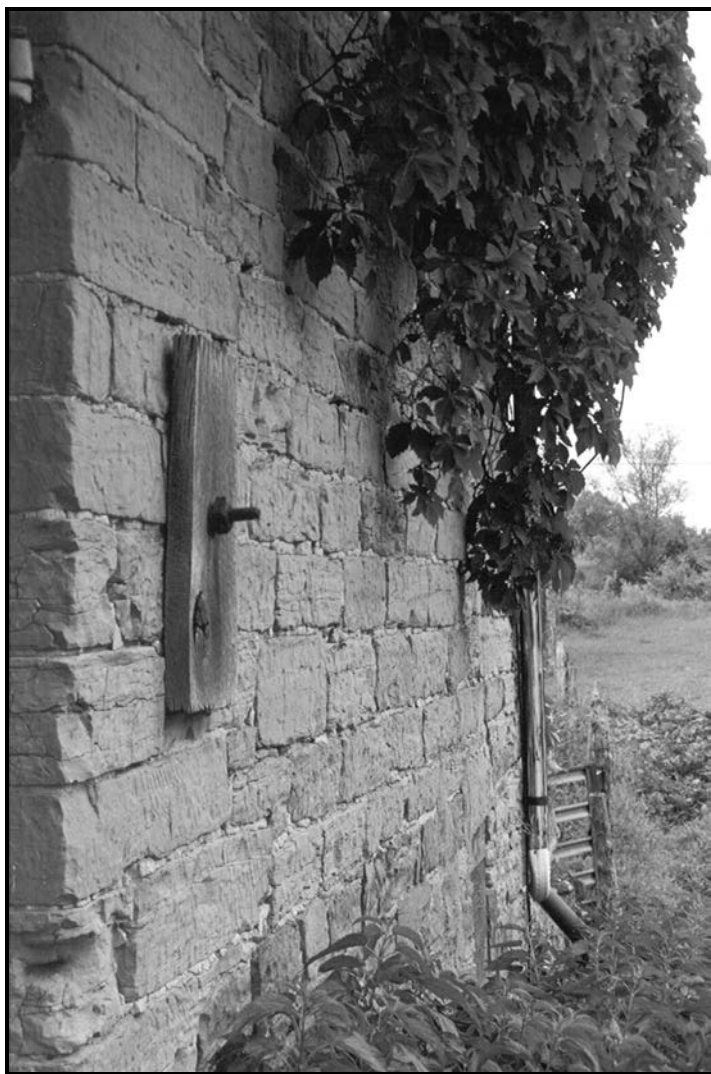
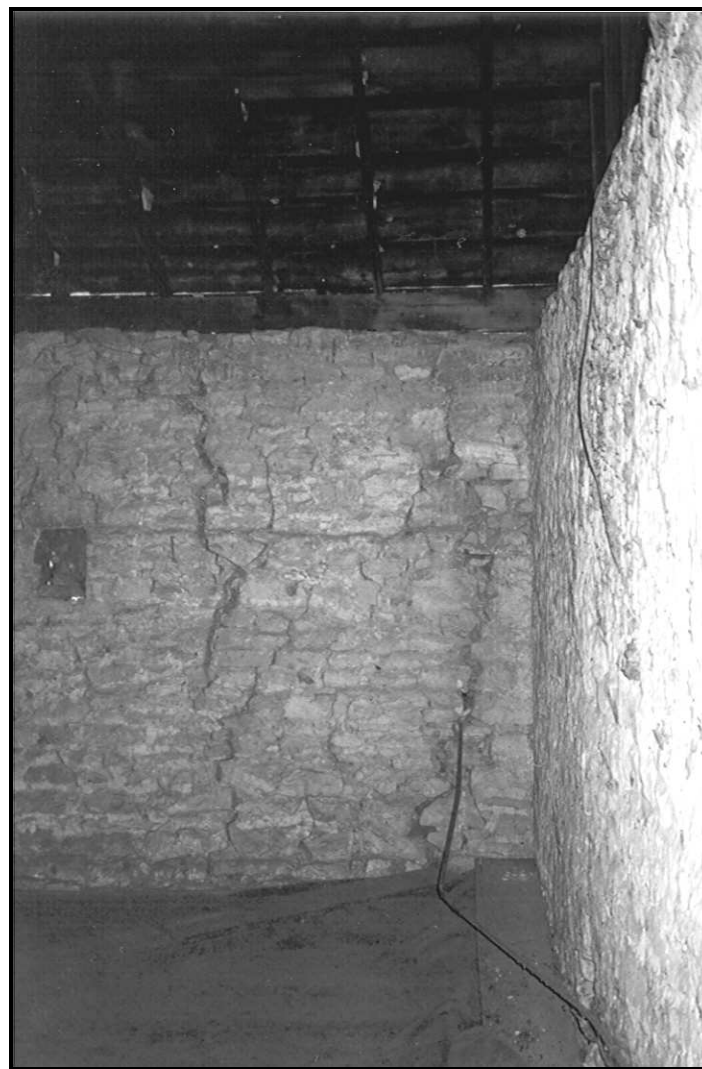
Figure 86. (Left) Section of wall on east side of barn that is bulging out. (Right) Stress fractures on interior of the west wall of barn (FRR June 2001).

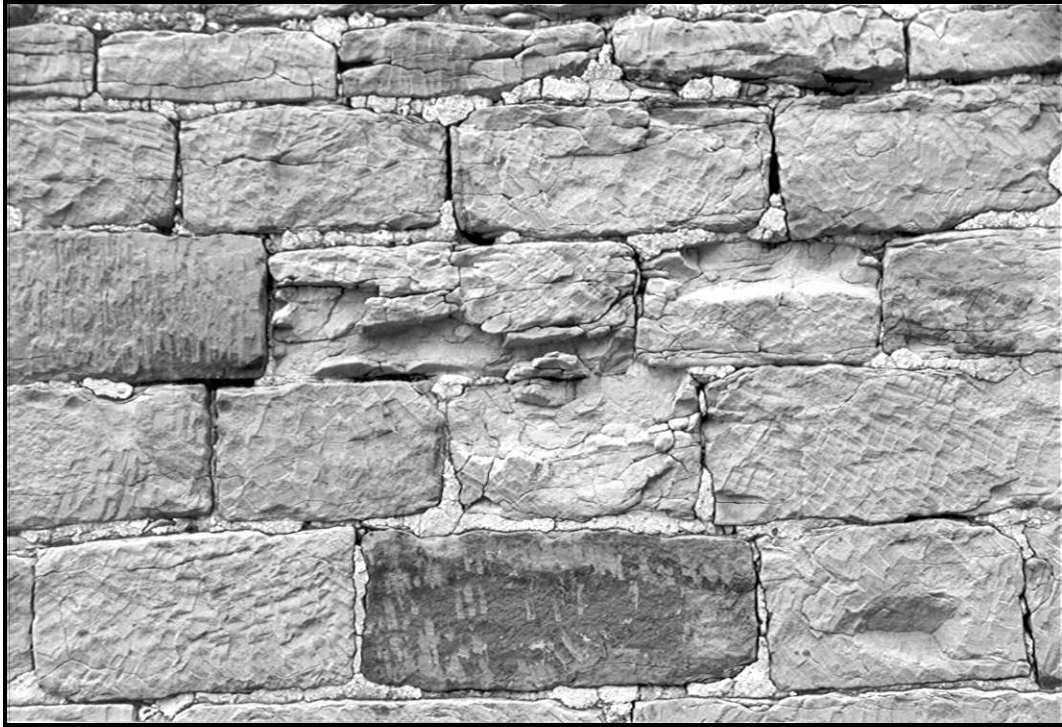
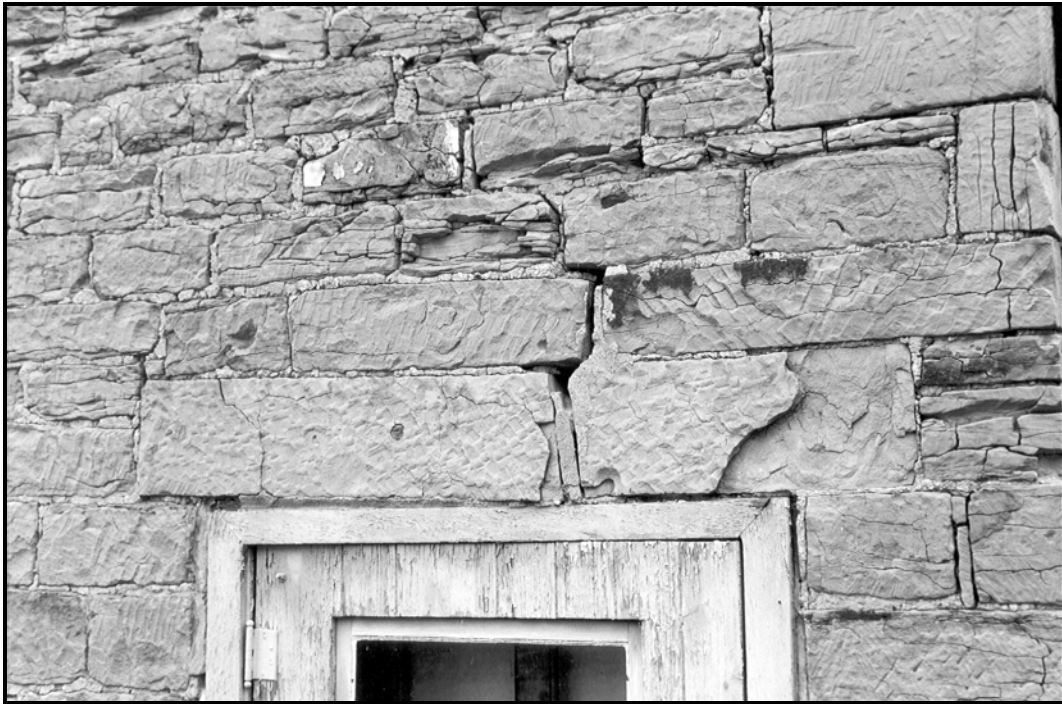
Figure 87. Two views of the differential weathering seen on the exterior of the barn. Cracking and spalling is prevalent (FRR June 2001).

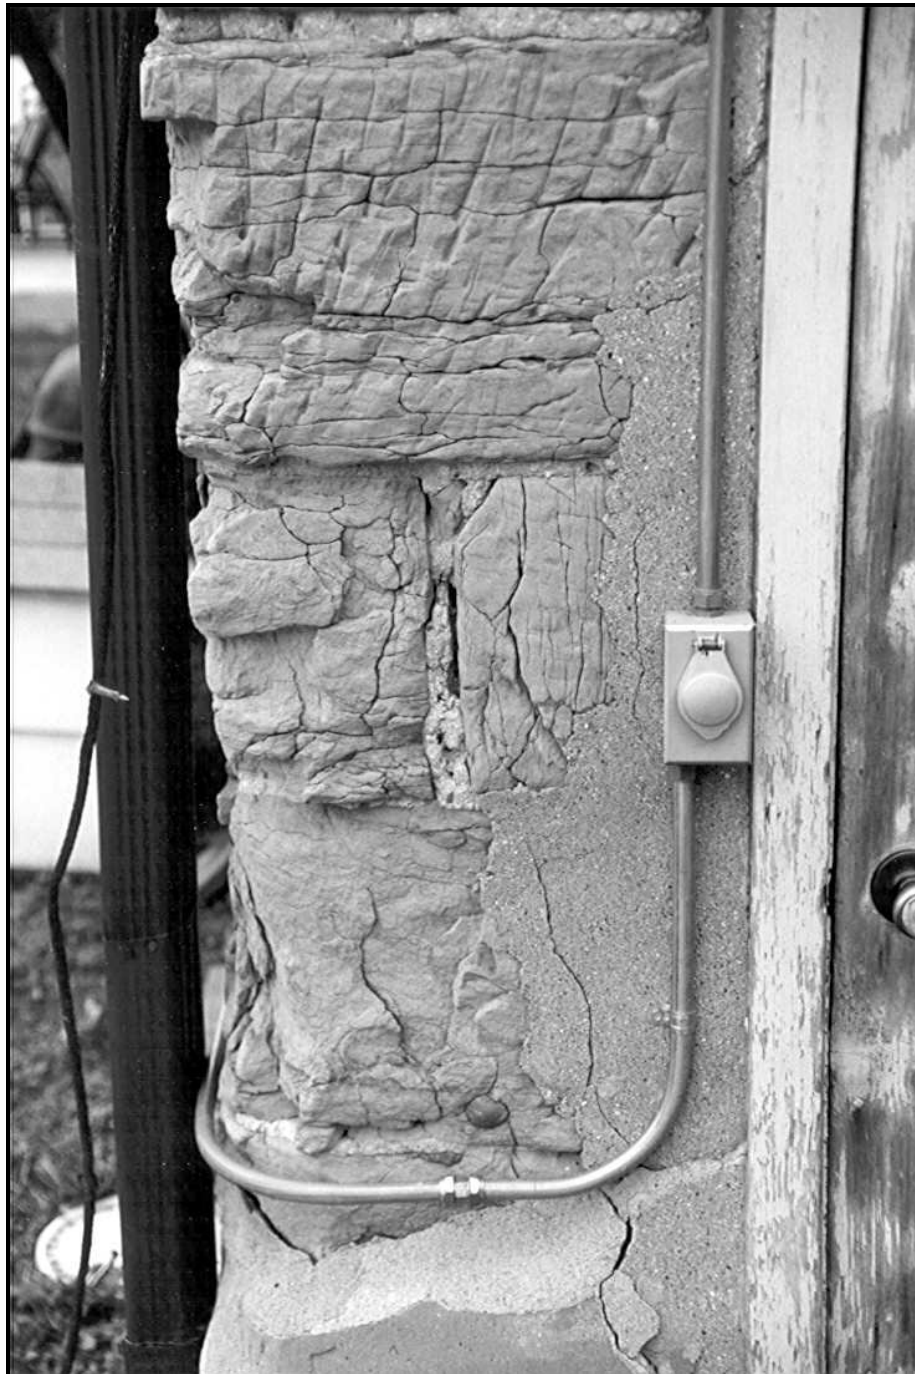
Figure 88. View of concrete parging that has been applied at the southwest corner of the barn. Future conservation efforts should avoid using such methods (FRR June 2001).

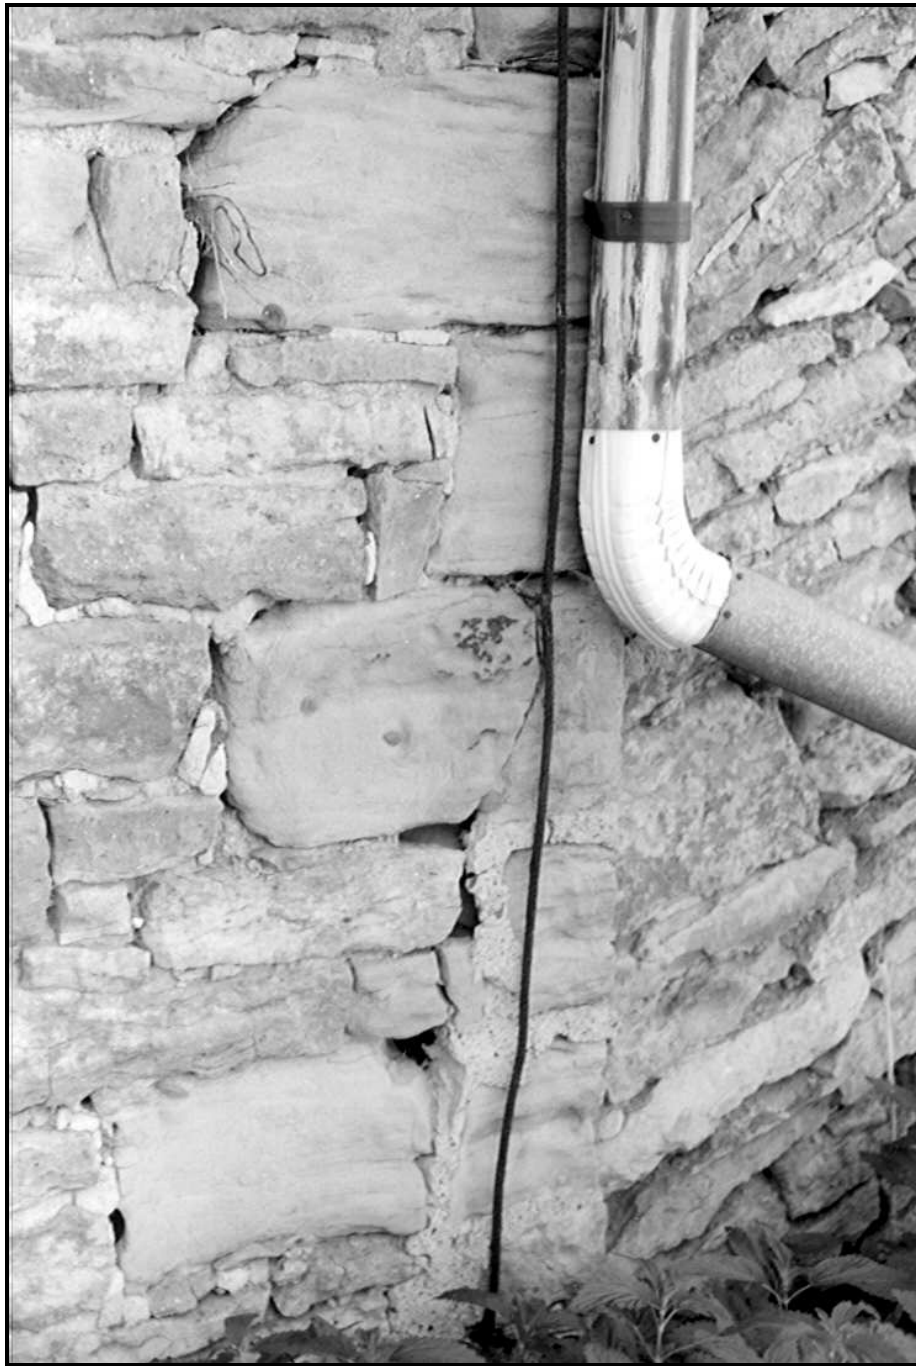
Figure 89. Poor drainage in the past has contributed to the deterioration of the exterior stonework on the barn. This view is of the northeast corner of the barn (FRR May 2001).

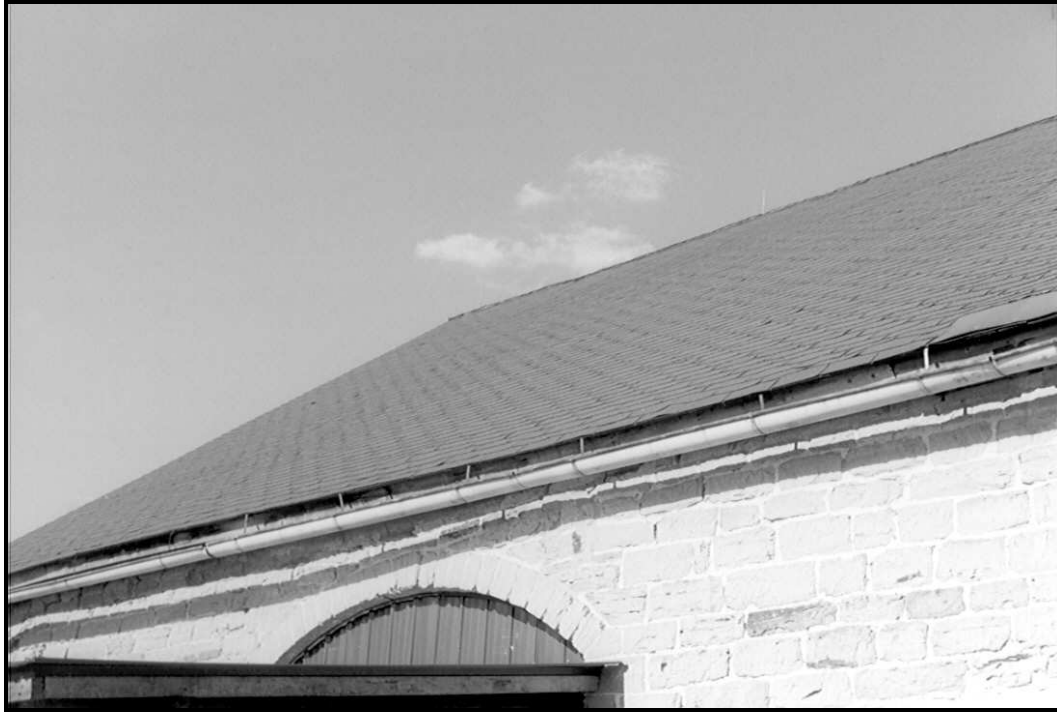
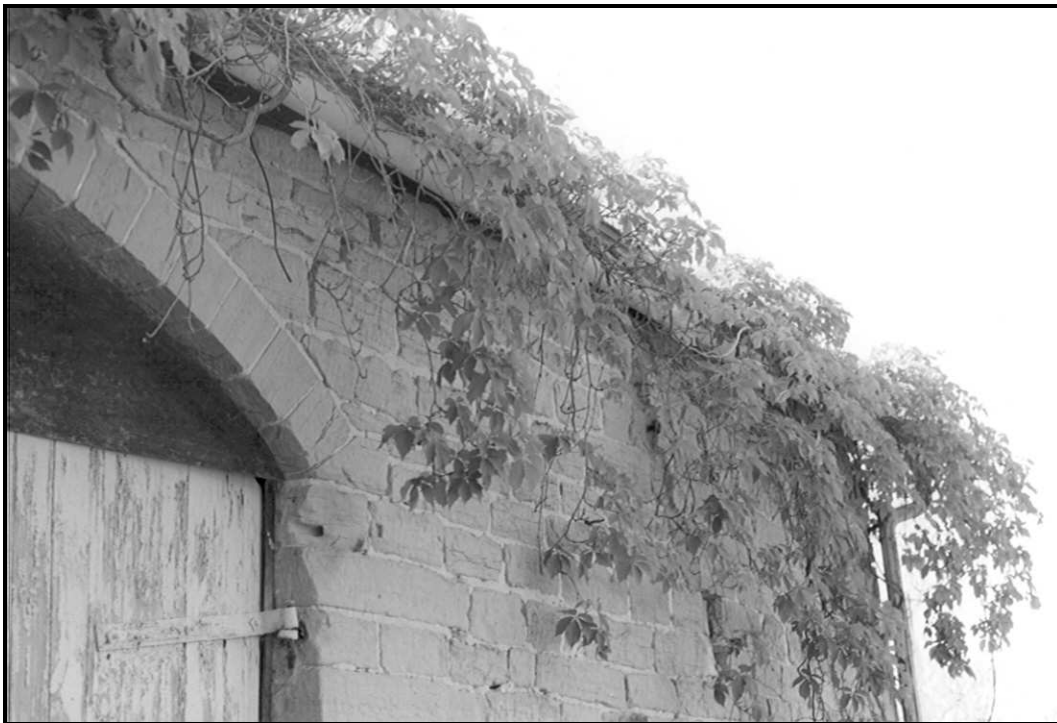
Figure 90. (Top) The existing guttering on the barn is adequate and needs to be replaced. (Bottom) All vines on the building need to removed, and any vegetation growing adjacent to it should be cut back, in order to reduce the moisture content (FRR May 2001).
