THE ARISTON CAFÉ – OLD ROUTE 66 – LITCHFIELD, ILLINOIS

CONDITION ASSESSMENT WITH TREATMENT RECOMMENDATIONS

Goldasich-Audo Architects & Planners, Inc.
630 East State Street, Suite 200 Jacksonville, Illinois 62650

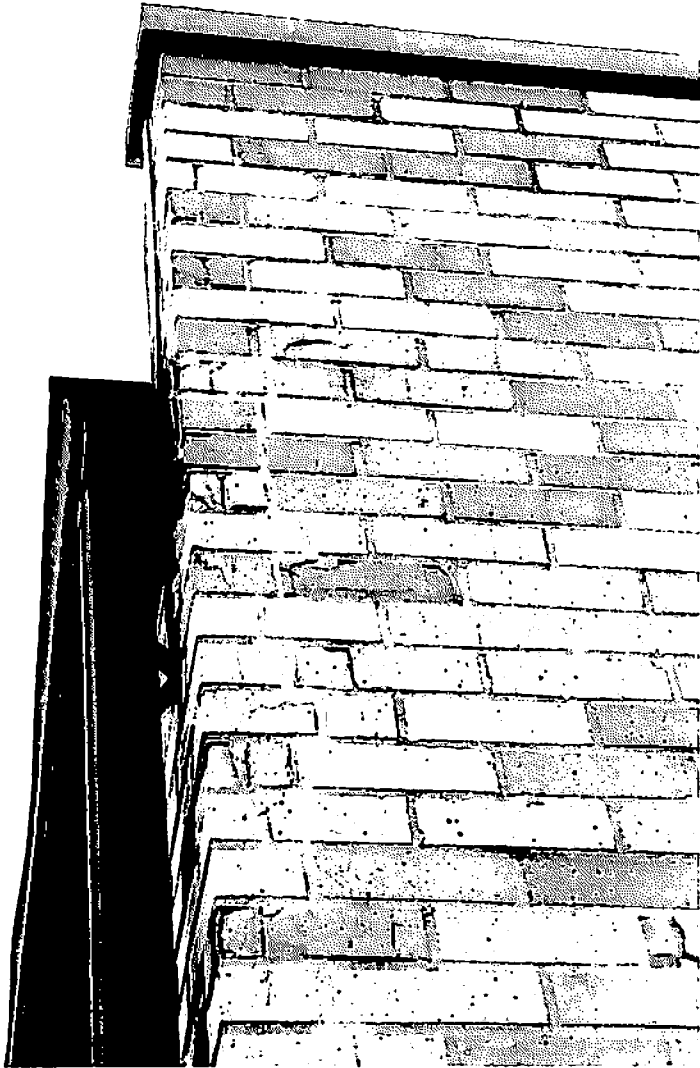
19

Overall the finishes, trim, and decorations are in very good condition with but a few exceptions. On the 1974 addition, there are areas of exterior face brick that have a fractured surface, which should be monitored, and repairs made if conditions become more serious than are present at this time. See photos 10, 19, and 28.

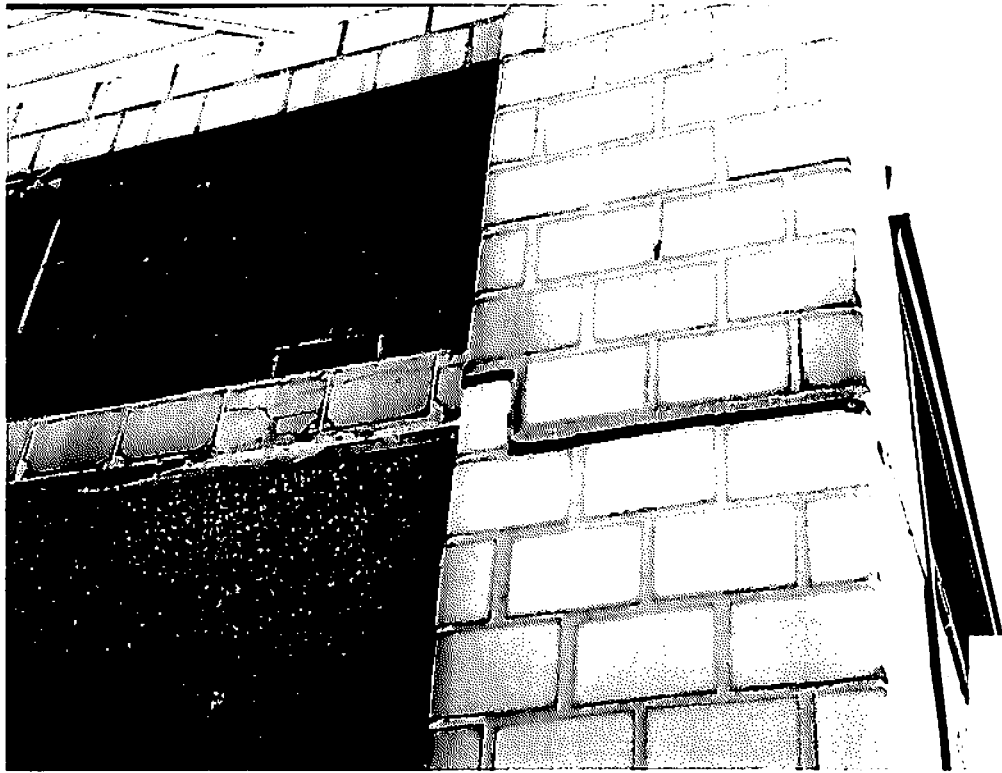
21

20. Close up of column showing face fracture in masonry.
21. Close up of column showing masonry displacement.
22. Detail at base of exterior freezer showing fracture of block unit.

2. Repair exterior corner columns and cracks in the masonry units at the service entrance. The existing columns are to be taken down piece by masonry piece to a point below the existing fractures. The interior will be examined and corrective action taken. The existing masonry units will be cleaned of old mortar and the column area affected will then be reconstructed. Mortar color will match the original. Estimated probable cost: Fourteen thousand two hundred fifty dollars (\$14,250).

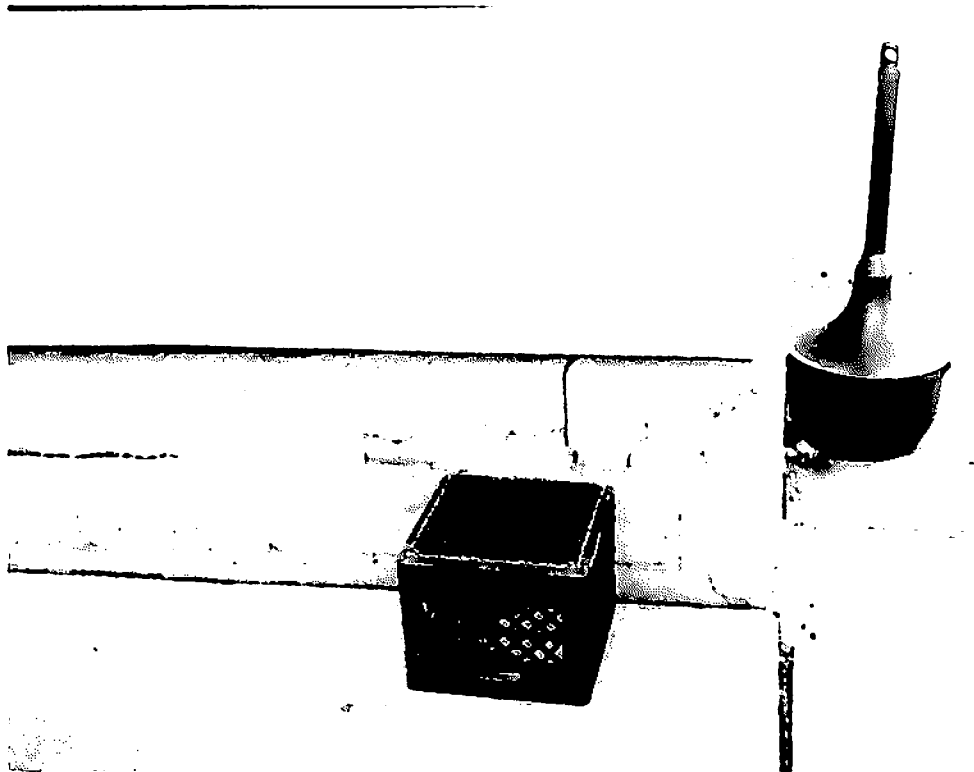
23

The building's foundation is concrete and is in generally good condition. The foundation supporting the freezer/cooler modules is block masonry units and these units need repair in some areas. See photos 22 and 23.

23. Foundation wall at freezer from north side of service area.
24. Building as viewed from east (Old Route 66) looking west at building entrance.
25. View looking at corner of 1974 addition.

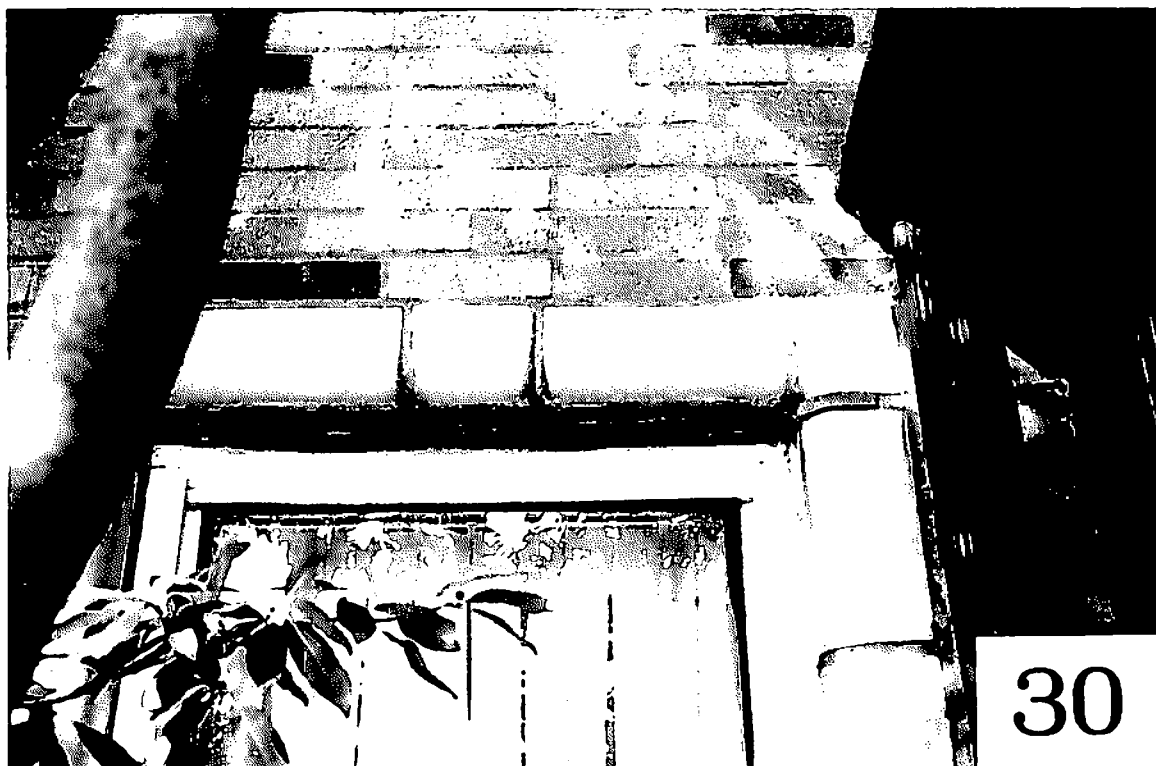
30

average with the primary concern being the severe deterioration of the steel lintels above the 1935 openings. See photos 12 and 13.

30. Window head of Southeast window – note deterioration of steel lintel.
31. View of exit door from 1974 building addition.
32. Photo of South façade of 1935 building element.

8. Replace deteriorated steel lintels at original building. Due to severely deteriorated lintels replacement will be necessary. Estimated probable cost: Two thousand dollars (\$2000).
