WILLIAM REDDICK MANSION

HISTORIC STRUCTURE REPORT

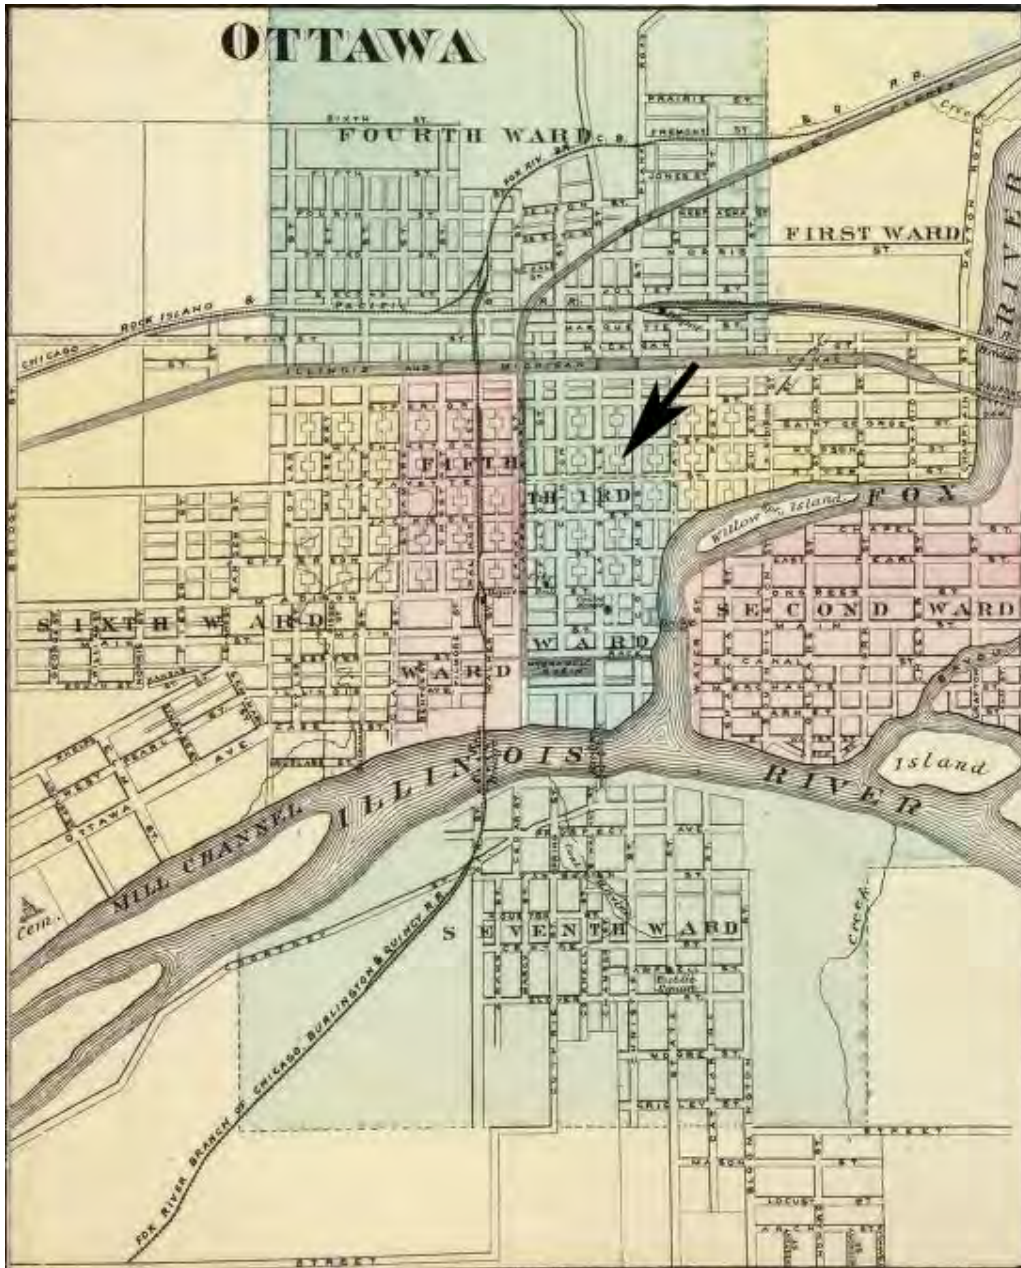
Photo Site - 1: Plat Map of Ottawa, 1876. (Map of Ottawa, Illinois. Union Atlas Co., Warner & Beers, Proprietors. Lakeside Building Cor: of Clark & Adams Sts. Chicago. 1876).

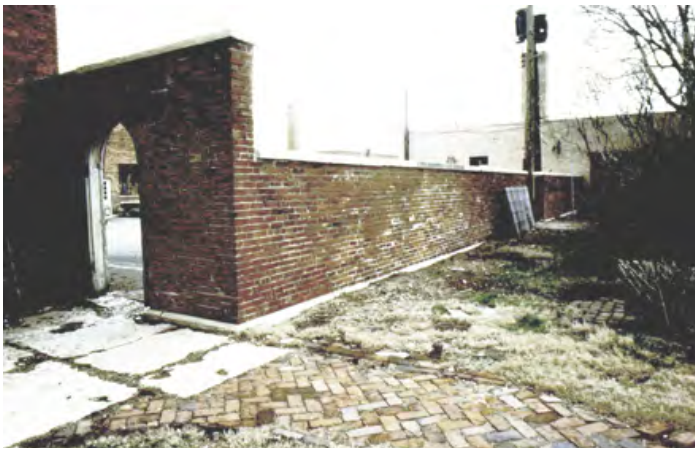
Photo Site - 14: Brick wall to the north of the Caretaker's House, as depicted in a c. 1970s photograph (Brookman collection). Note the brick walkway in the foreground. (RMA collection)

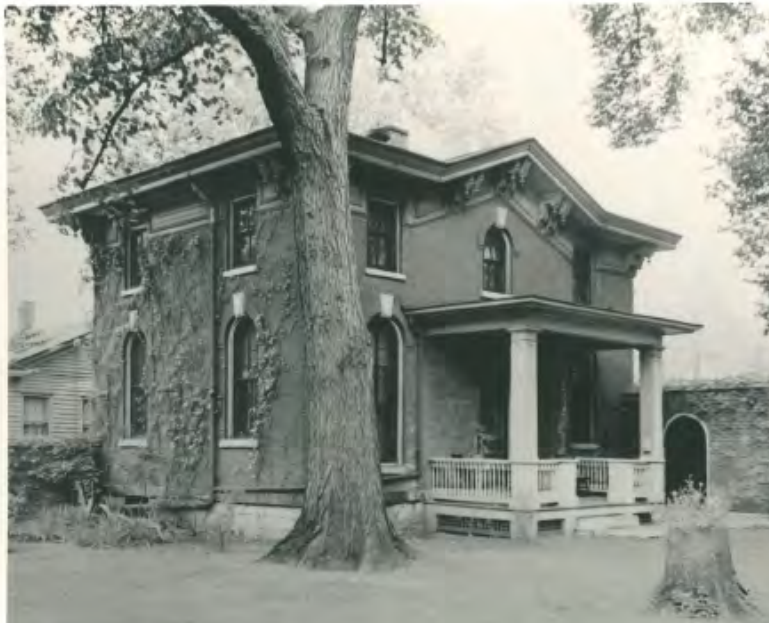
Photo Site – 21: Historic view of the Caretaker's House after 1914 when the second floor windows were added. (RMA collection)

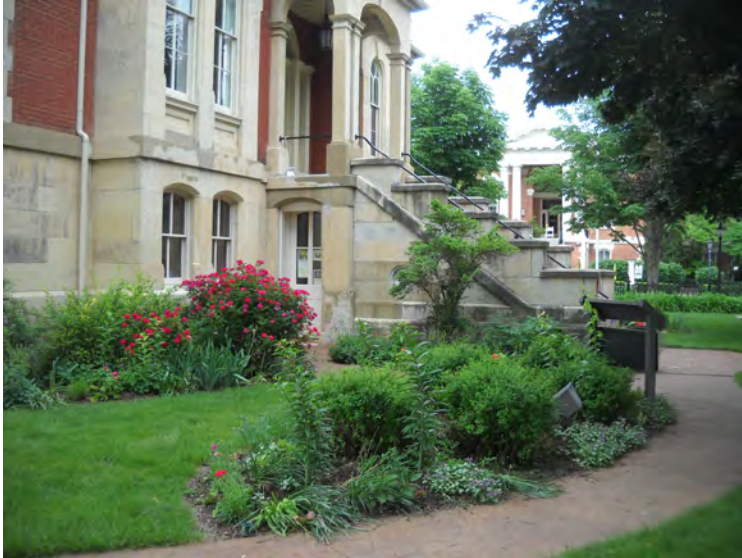
Photo Site – 22:
Current view of the pressed concrete walkway and landscaped plantings.

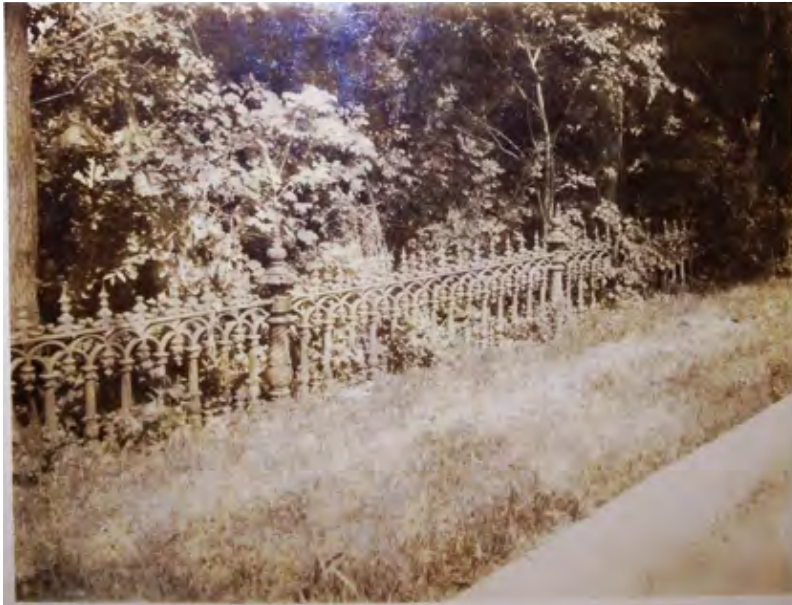
Photo Site - 26:
View of the cast iron fence when it was installed at the Jewish Cemetery.
(RMA collection)

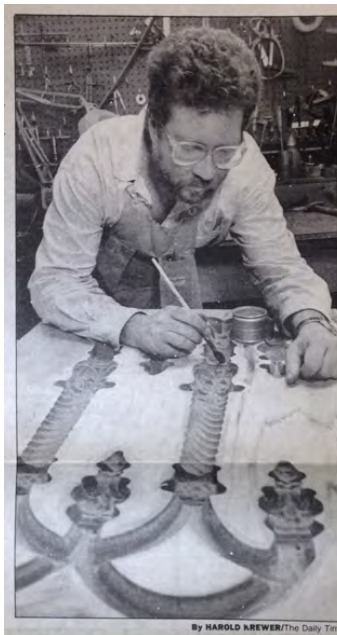
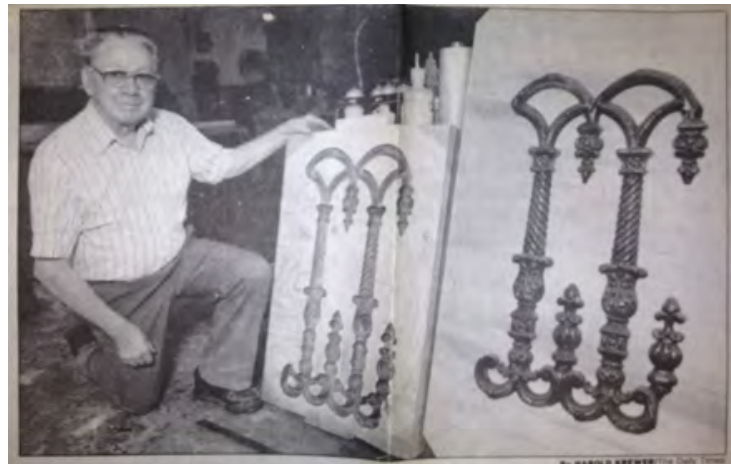
Photo Site - 29 and 30: In 1991 Keith Johnson (left) and his father Floyd Johnson donated considerable time and materials to fabricate patterns to be used for re-casting the missing fence cast iron elements. The casts were made from original fence pieces obtained from the Jewish Cemetery. (RMA collection)

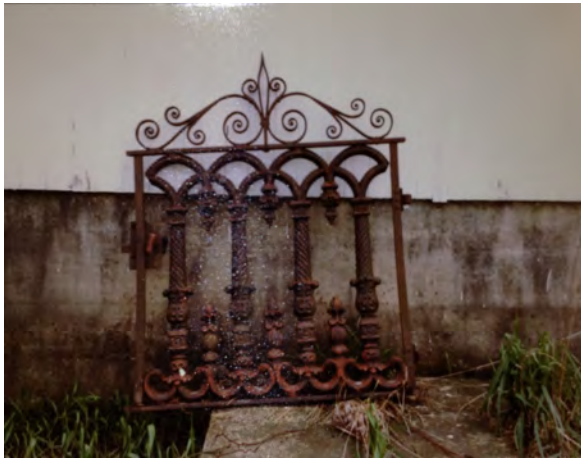
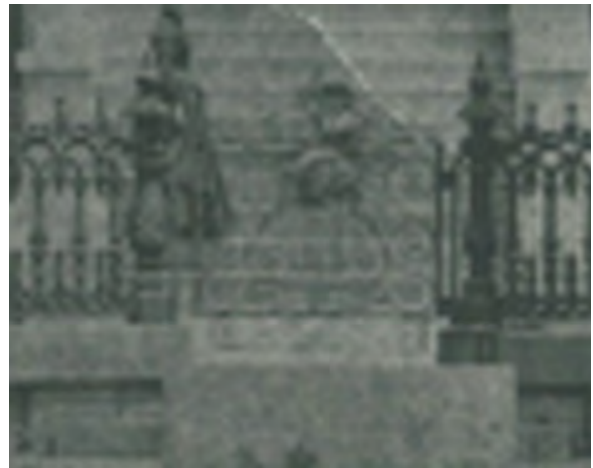
Photo Site – 31 (above left): Photograph of original gate, obtained from Harry (Delmar) Hayward in 1984. (RMA collection)

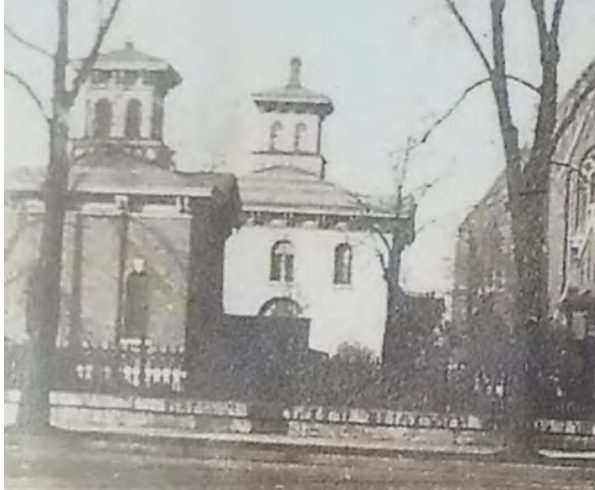
Photo C-1: View post 1910 from undated panoramic photograph in the RMA Museum collection showing the Caretaker's House with its original belvedere, and before the second floor windows or entry porch were installed. The original Carriage House is beyond.

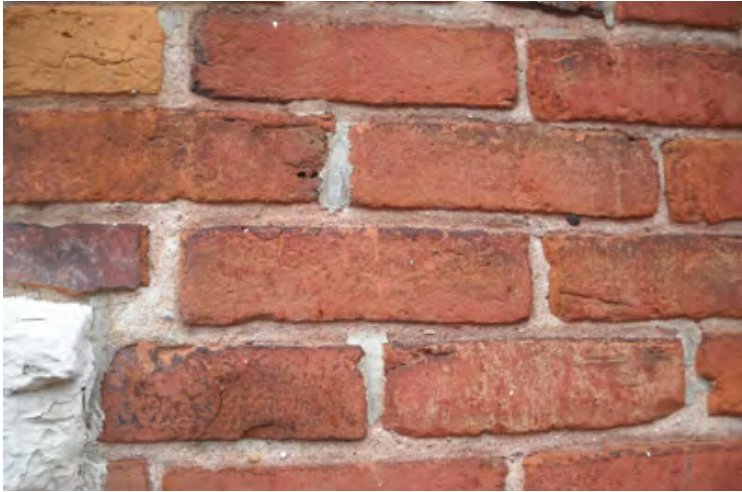
Photo C-6: Typical brick condition on the Caretaker's House. Notice the grey Portland cement vertical mortar joint repairs, and how other joints are tinted red. This is a remnant from when the building was painted red.

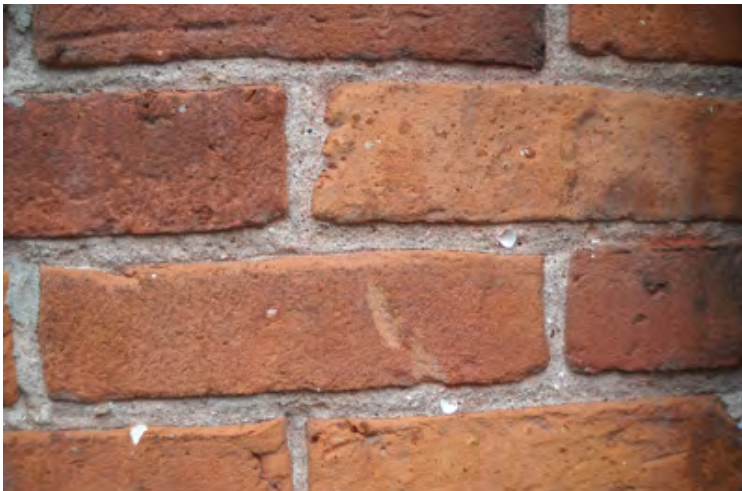
Photo C-7: Shell fragments were noted in the mortar on the east elevation.

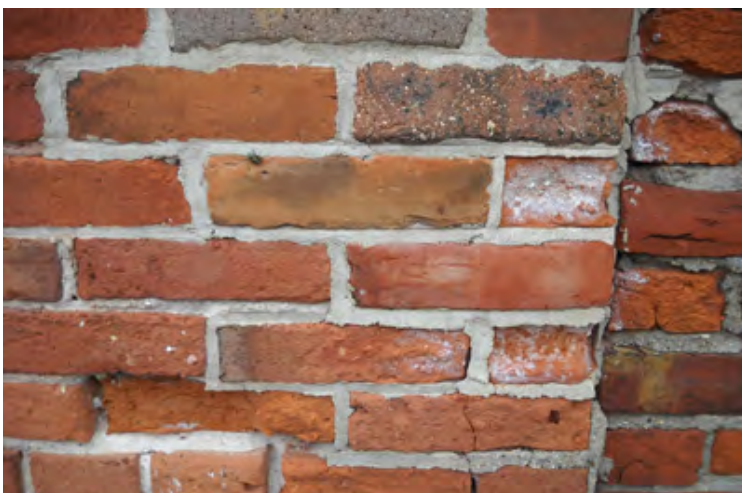
Photo C-8: Area on the southwest corner where the use of hard Portland cement has resulted in efflorescence (salt deposits) and cracked/spalling brick. This type of mortar is very harmful to older, softer historic bricks.

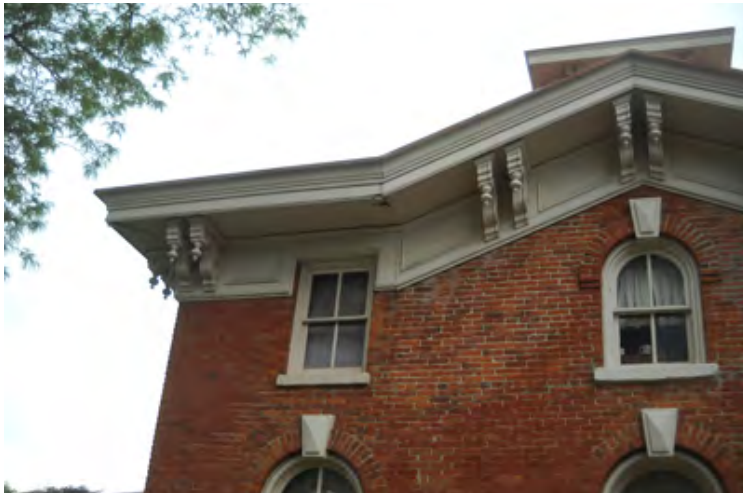
Photo C-9: View on the east elevation of the lighter, worn brick, to the left of the central second floor window.

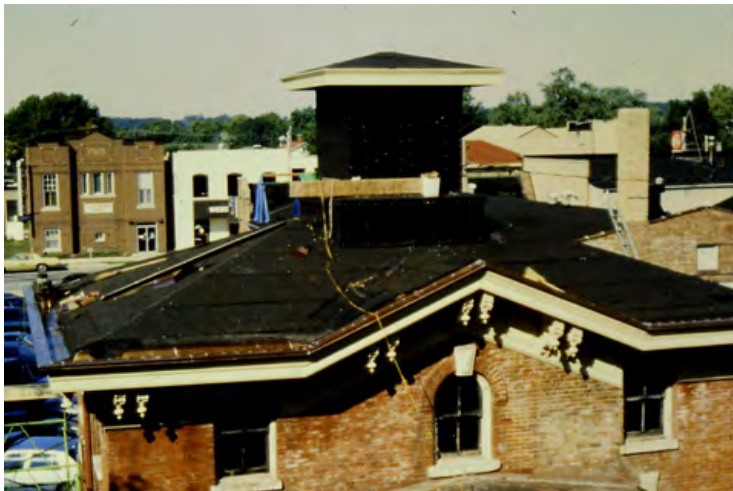
Photo C-10: This photograph, taken during the 1970s restoration work, shows that there was efflorescence on the brick at the second-floor level on either side of the center second-floor window.

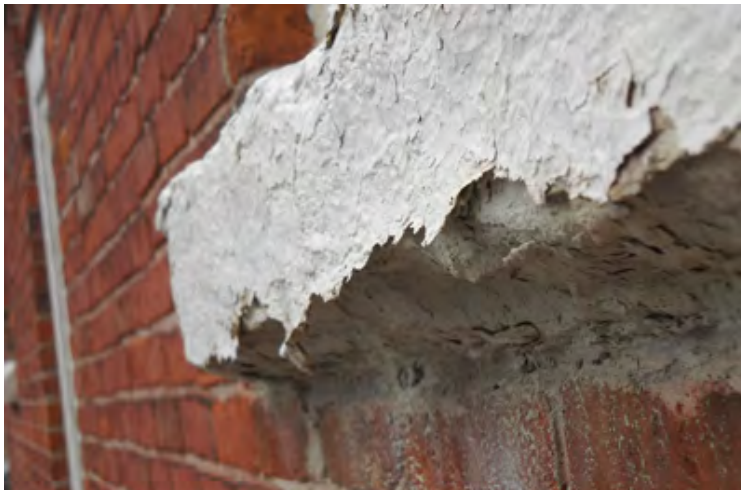
Photo C-12: A severely deteriorated limestone sill on the west elevation shows how paint can trap moisture and further exacerbate damage.

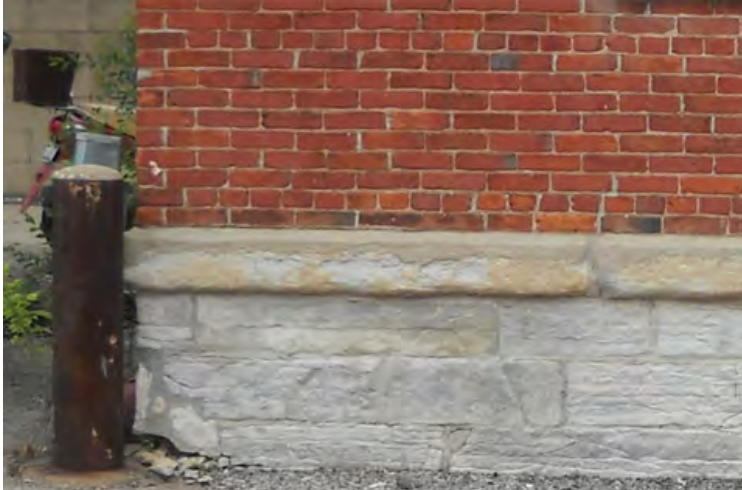
Photo C-13: The upper portion of the foundation wall is exposed on the Caretaker's House. It is topped by a limestone watercourse.

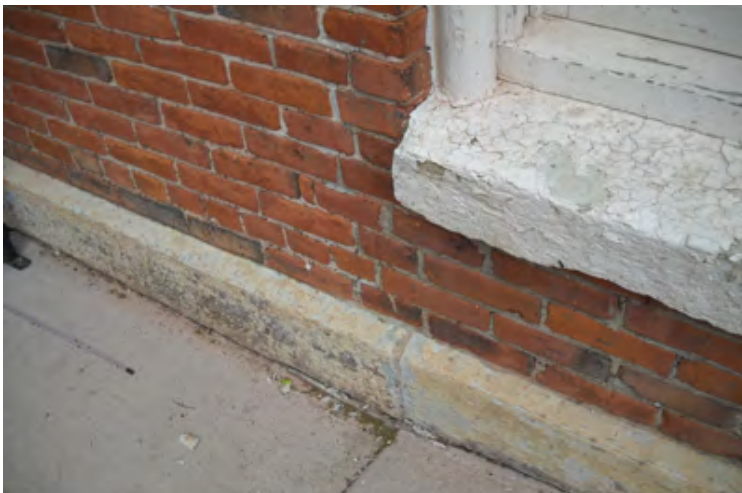
Photo C-14: View looking down at the limestone watercourse, illustrating how the concrete ramp / entry stair assembly was poured directly against the building.

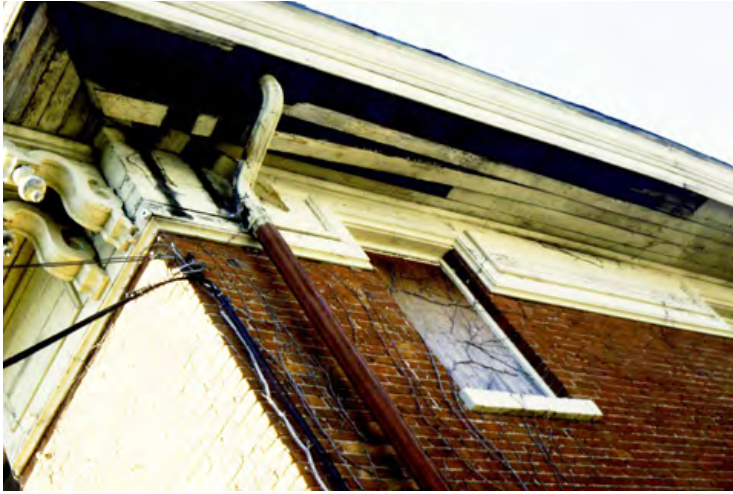
Photo C-15: 1970s view of severe water damage at the northeast corner of the cornice prior to cornice/roof restoration work.

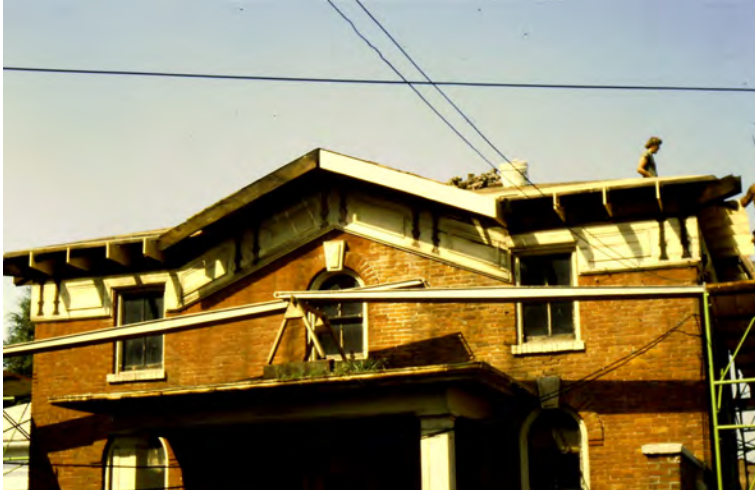
Photo C-16: This photo was taken during the 1970s restoration work on the cornice. It is a view of the east elevation. Note how much of the cornice was disassembled for repair.

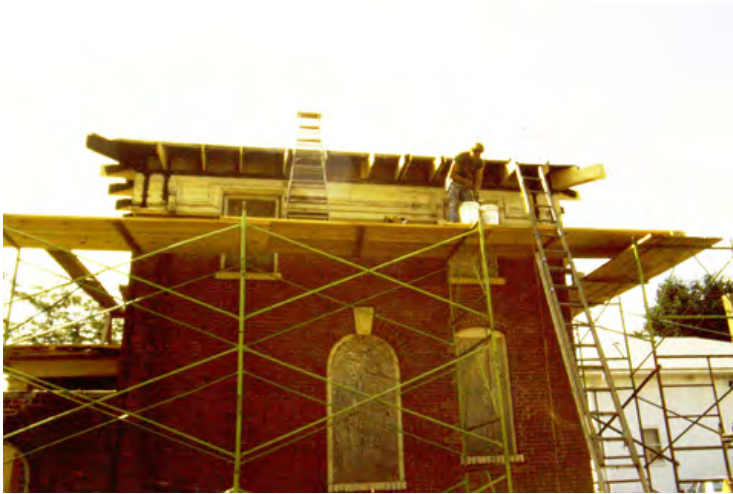
Photo C-17: View of the north elevation showing the outriggers that support the cornice assembly. The entire cornice soffit and gutter fascia were reconstructed here.

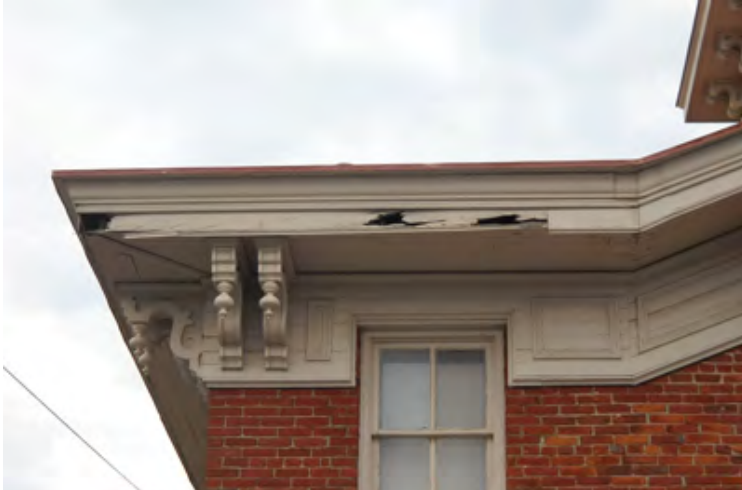
Photo C-19: Current view of water / animal damage on the west elevation at the cornice fascia.

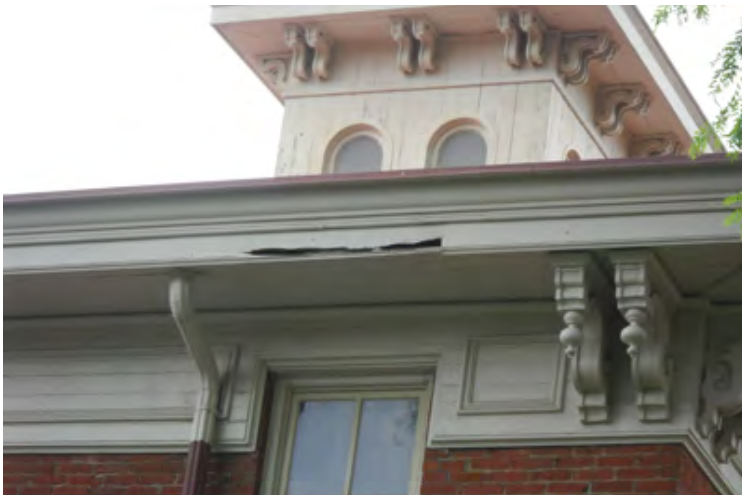
Photo C-20: Water damage/rot on the south elevation at the cornice fascia. Note that originally, paired decorative brackets were originally positioned about where the downspout leader is, to the left of the window. Of course, the second floor windows weren't there originally.

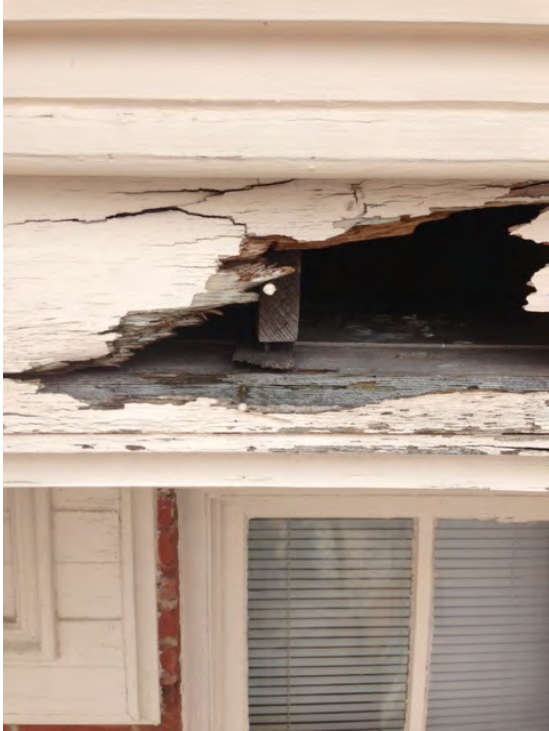
Photo C-21: Detail photograph of the rot in the gutter fascia board. Large openings like this allow birds and small animals to enter the attic.

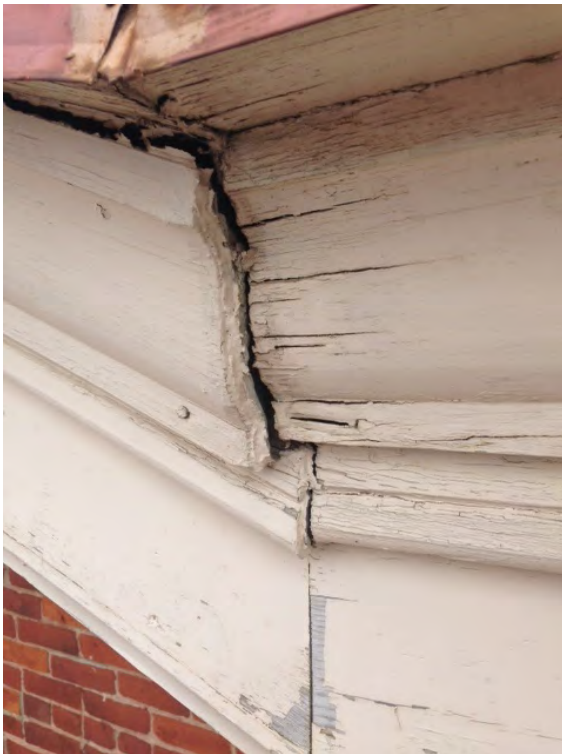
Photo C-22: Detail view of an open joint at the gutter fascia trim.

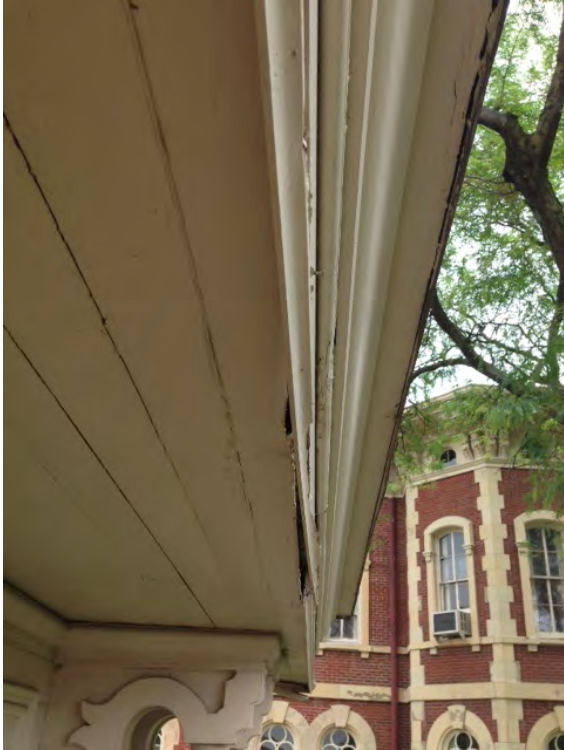
Photo C-23: Detail view of loose and bowing trim boards on the south elevation.

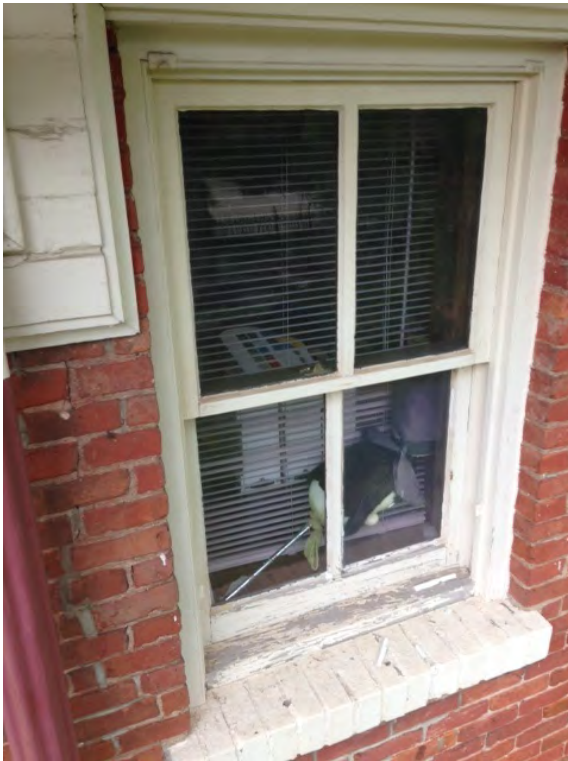
Photo C-24: The first-floor window on the north elevation is not original and was likely installed in 1914 when the building was converted for residential use. This window is in extremely poor condition; the upper sash bottom rail is ready to collapse.

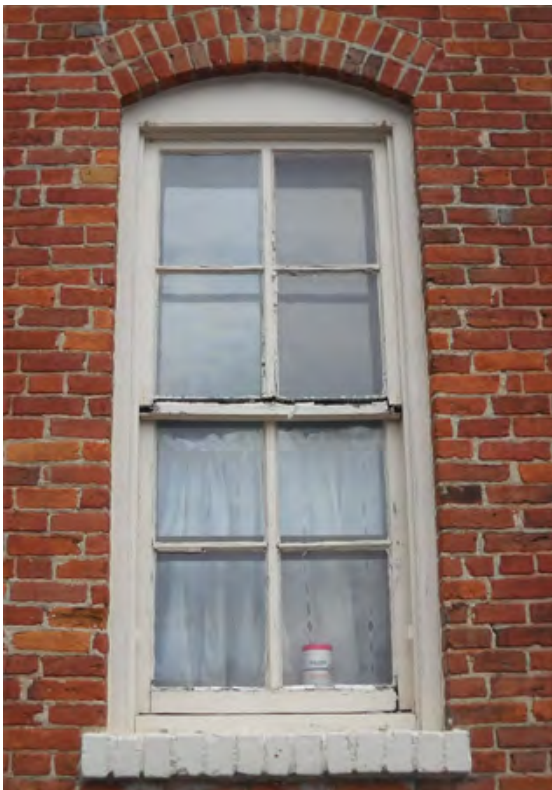
Photo C-25: Typical view of one of the c. 1914 second-floor windows. These windows are in fair condition; the bottom rail of the lower sash and the wood window sill are typically more deteriorated due to weather exposure.

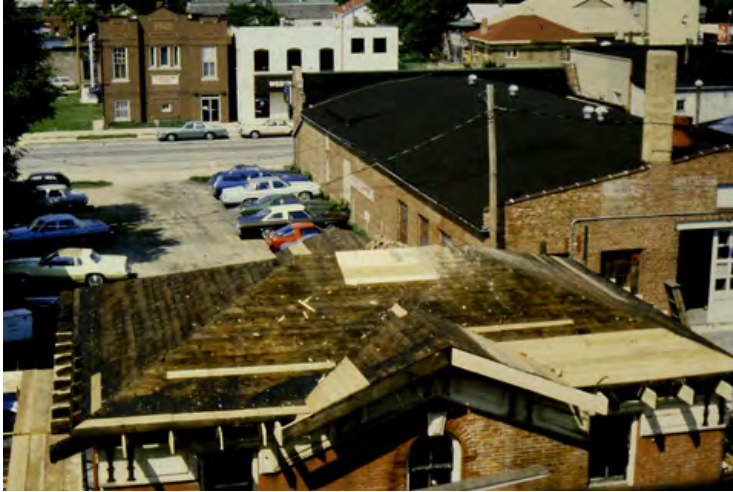
Photo C-26: View of the Caretaker's House roof, as taken from the third floor of the Mansion.

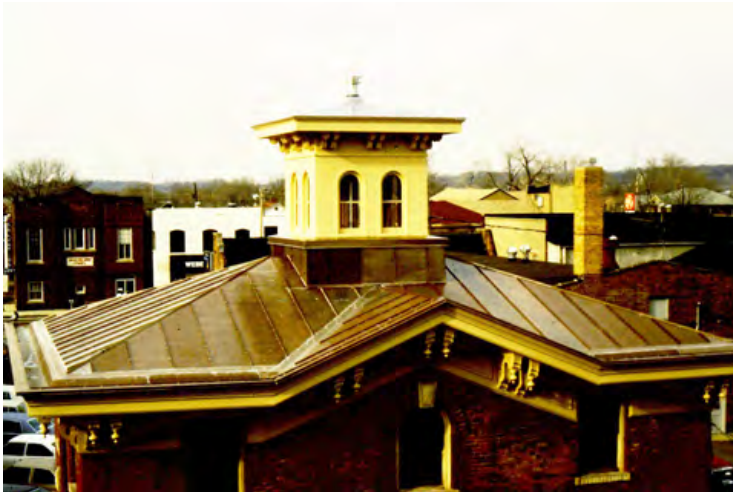
Photo C-27: 1970s view of the Caretaker's House roof after the existing roofing material had been removed and the wood roof sheathing exposed. Lighter areas are where sheathing was replaced

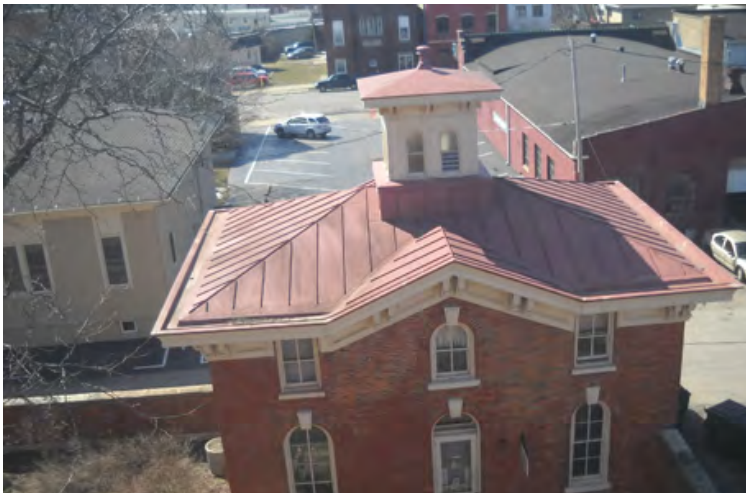
Photo C-28: 1970s view of the new roof and newly reconstructed belvedere

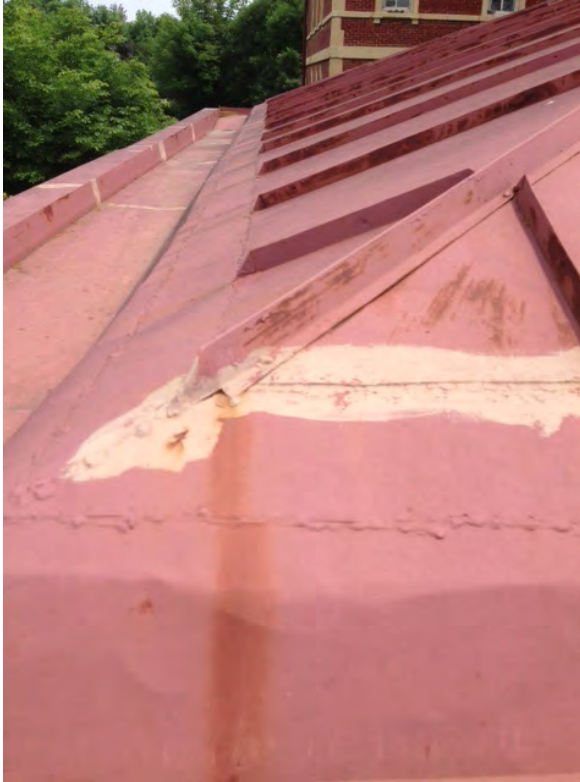
Photo C-29: Current detail view of the standing seam roof where it meets the lapped seam gutter. Note the rust staining and past caulk/paint “band aid” repairs.

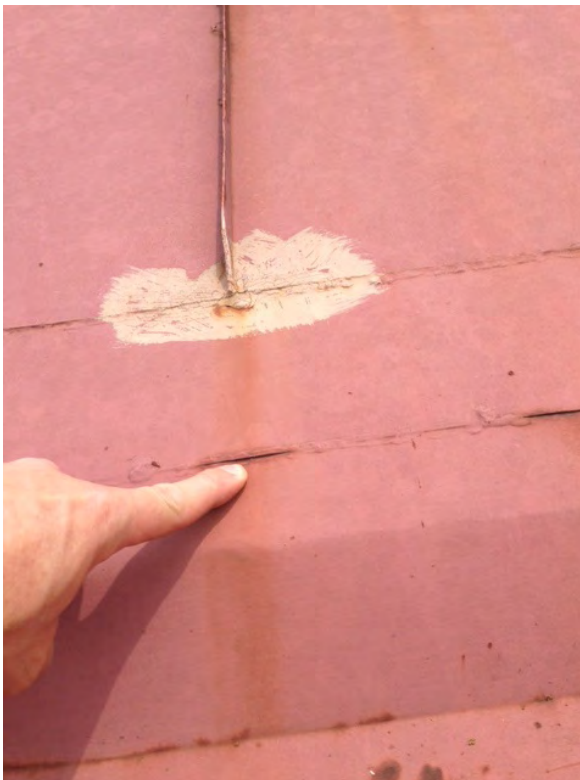
Photo C-30: Detail view showing how the lapped seam roofing was only “tacked” in place, leaving gaps where water can enter if the gutters become filled with water or ice.

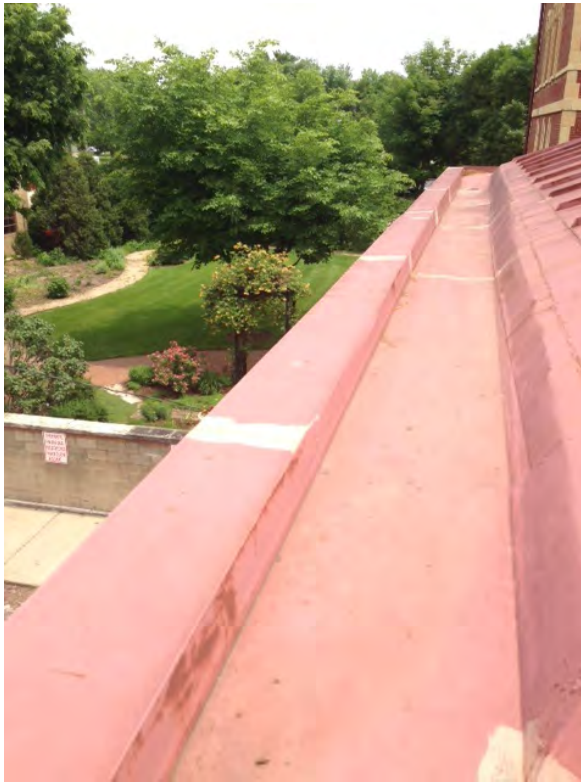
Photo C-31: View looking down the length of the built-in Caretaker's House gutters. Note the number of seams, which have the potential to be open, allowing water to enter and deteriorate the wood cornice below.

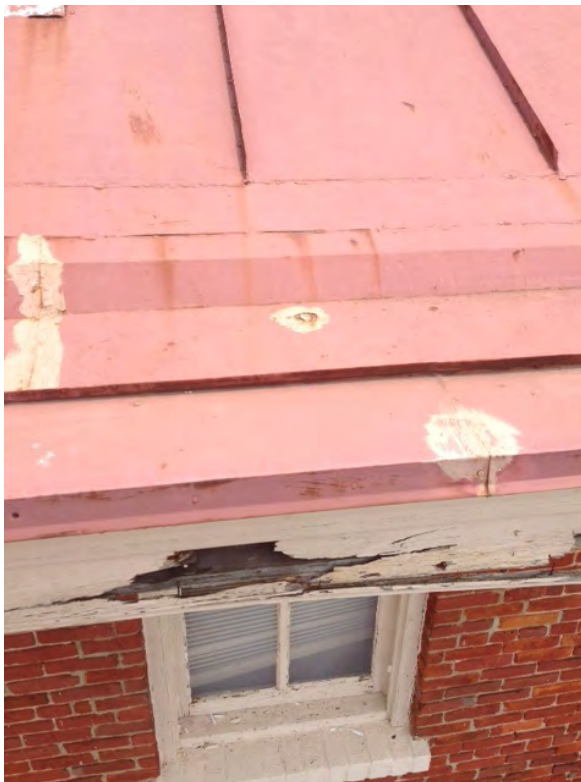
Photo C-32: Very informative photograph, showing open seams in the metal gutter immediately above severely deteriorated gutter fascia boards.

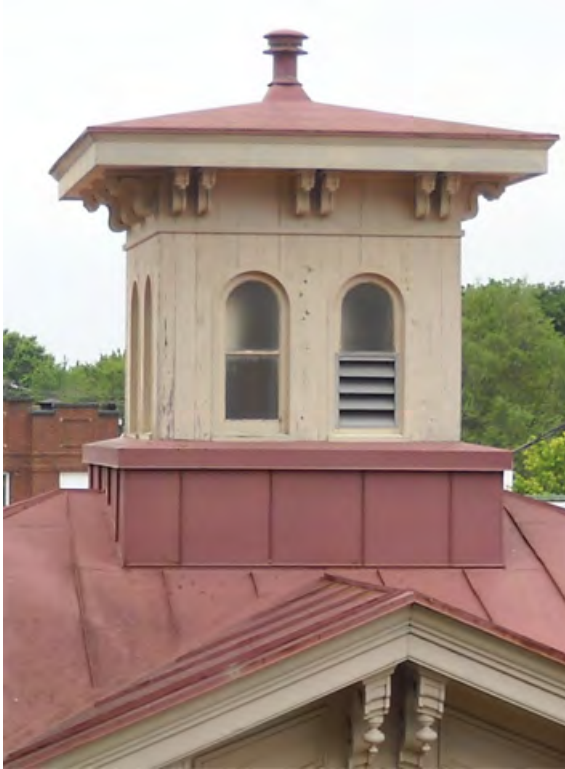
Photo C-33: Current view of the belvedere, which is in stable condition. The painted wood should be maintained and painted on a regular basis to prevent deterioration.

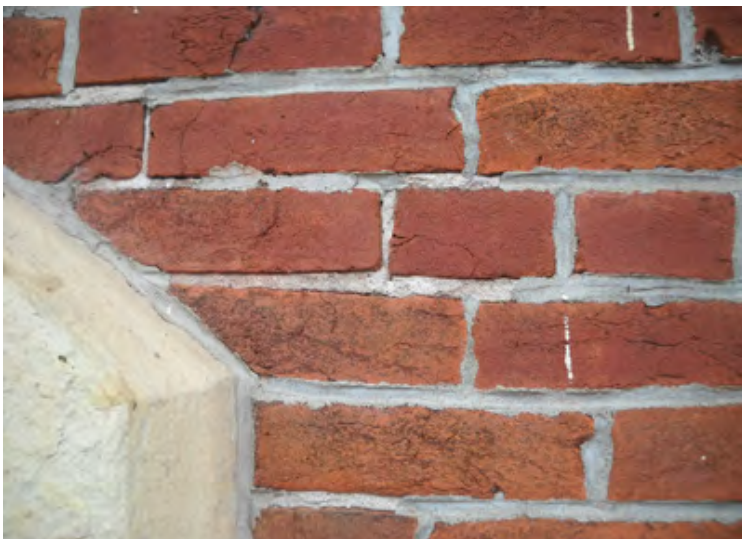
Photo E-3: Brick on the north and west elevations has been over-pointed in the past with an inappropriate Portland cement-based mortar, as shown to the left.

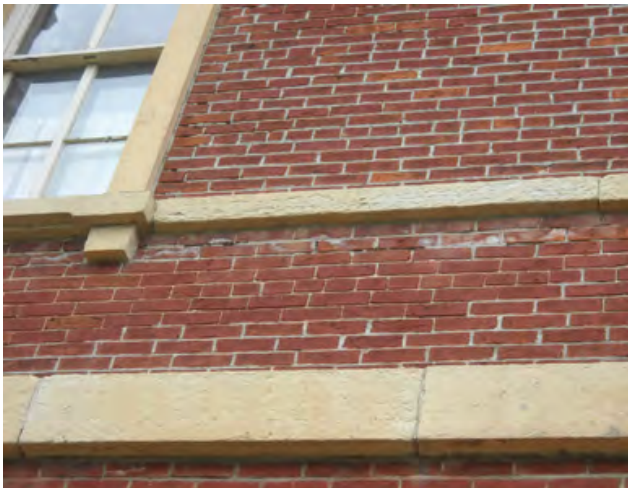
Photo E-4: Efflorescence was noted beneath the limestone stringcourses. This is likely because water enters the wall above the stringcourse and seeps down. It is not particularly of concern.

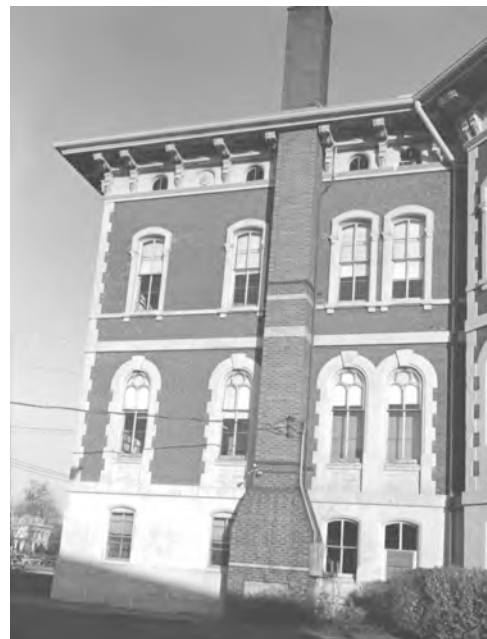
Photo E-5: View of the west elevation, taken by Sprague for his 1975 report, showing the c. 1920s chimney. The chimney was disassembled after being struck by lightning.

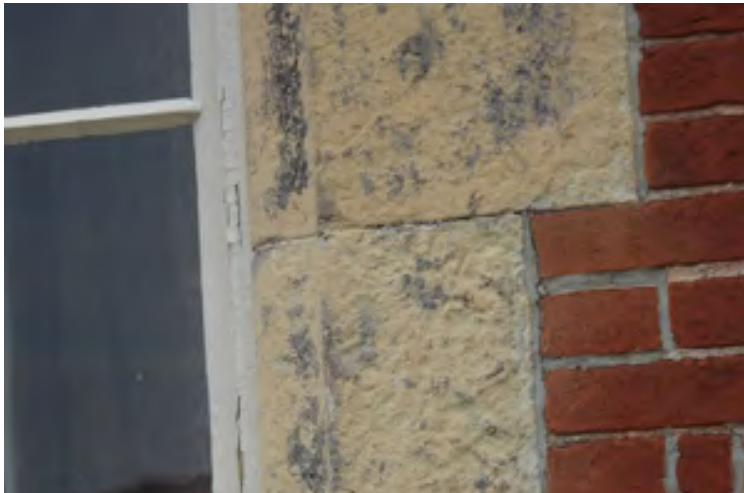
Photo E-6: Bituminous staining is apparent on some of the limestone at Reddick Mansion. It is inherent in the stone and does no harm.

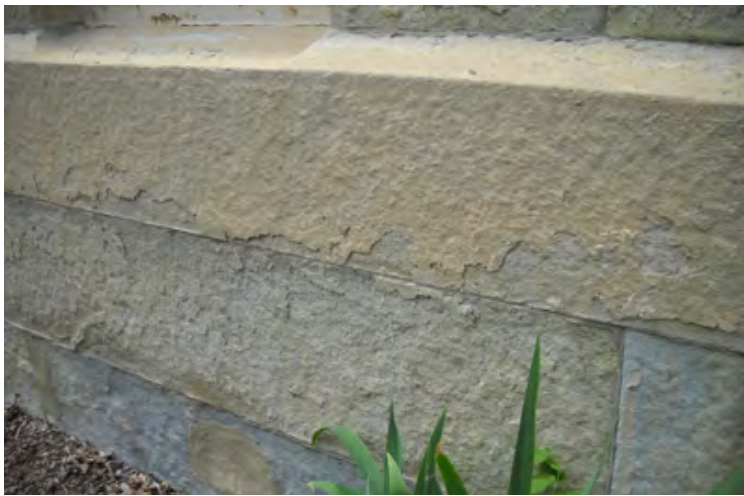
Photo E-7: Example of flaking limestone. This is a natural form of weathering, and while somewhat unsightly, is no cause for alarm.

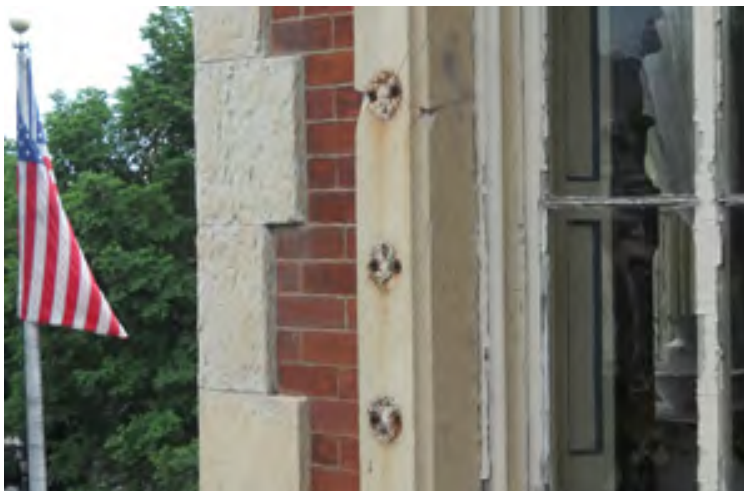
Photo E-8: Rust staining and limestone cracking at the Bedroom Level, east elevation, where the fire escape railings were once attached.

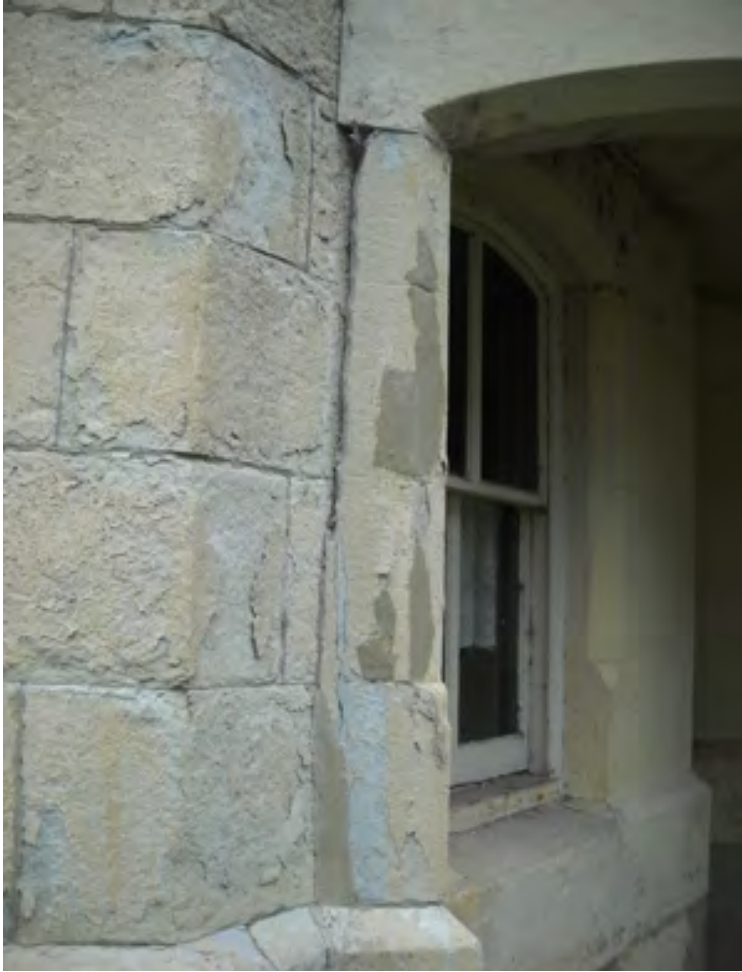
Photo E-9: Cracked stone comprising the north support of the east porch, at the Lower Floor level.

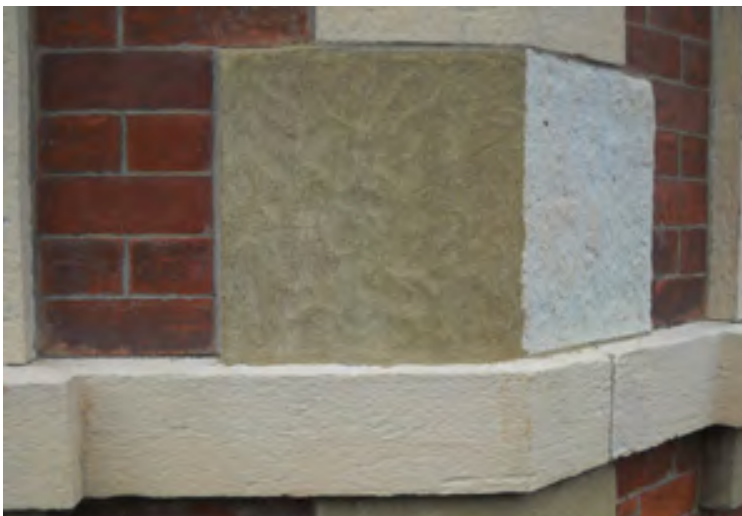
Photo E-10: View of previously patched limestone with inappropriate patch material.

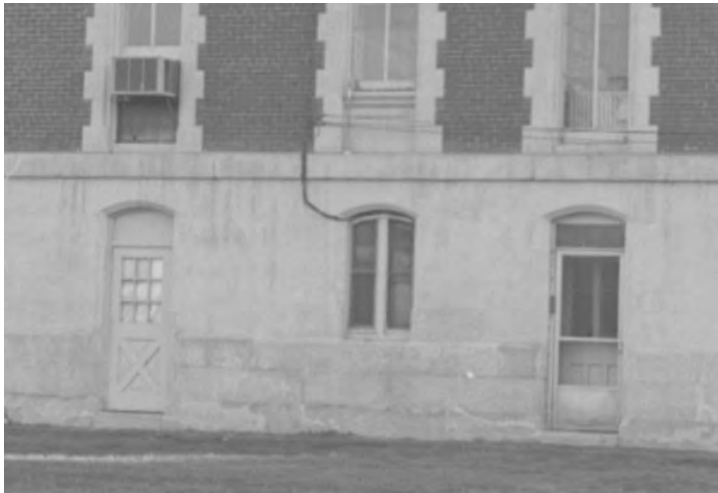
Photo E-11: Detail view from 1975 photograph taken by Dr. Sprague, showing a step of at least 6" beneath the north elevation doors.

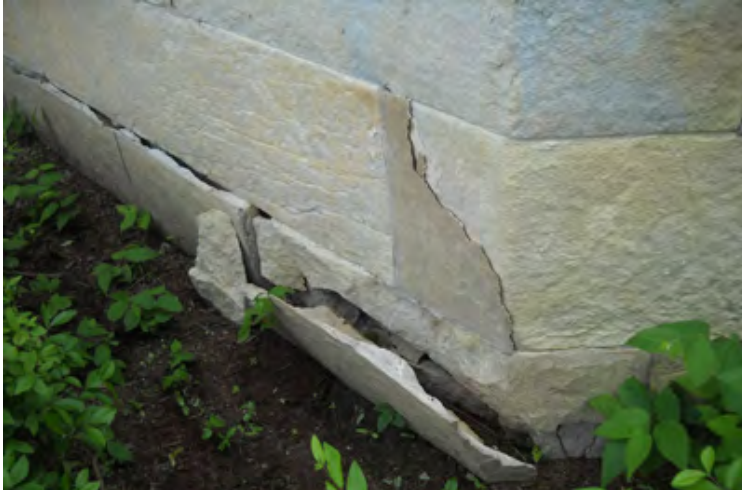
Photo E-14: Spalled stone at the base of the building due to the rise of grade as well as pressure from the Portland cement patches above.

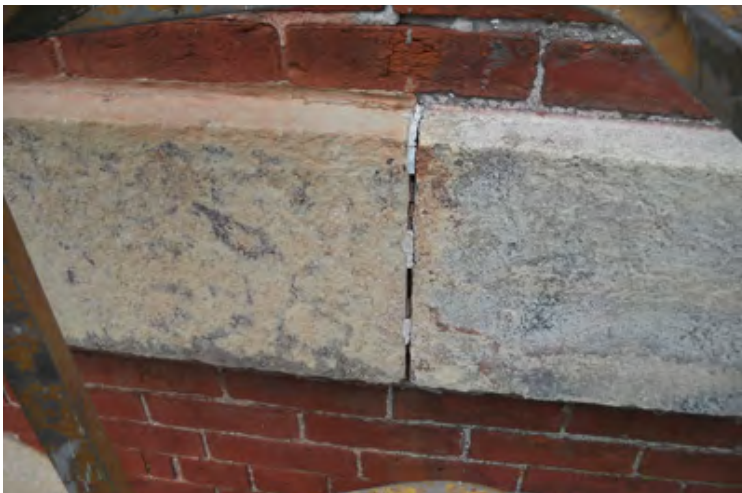
Photo E-15: Open joint in the limestone strong course can allow water into the wall system.

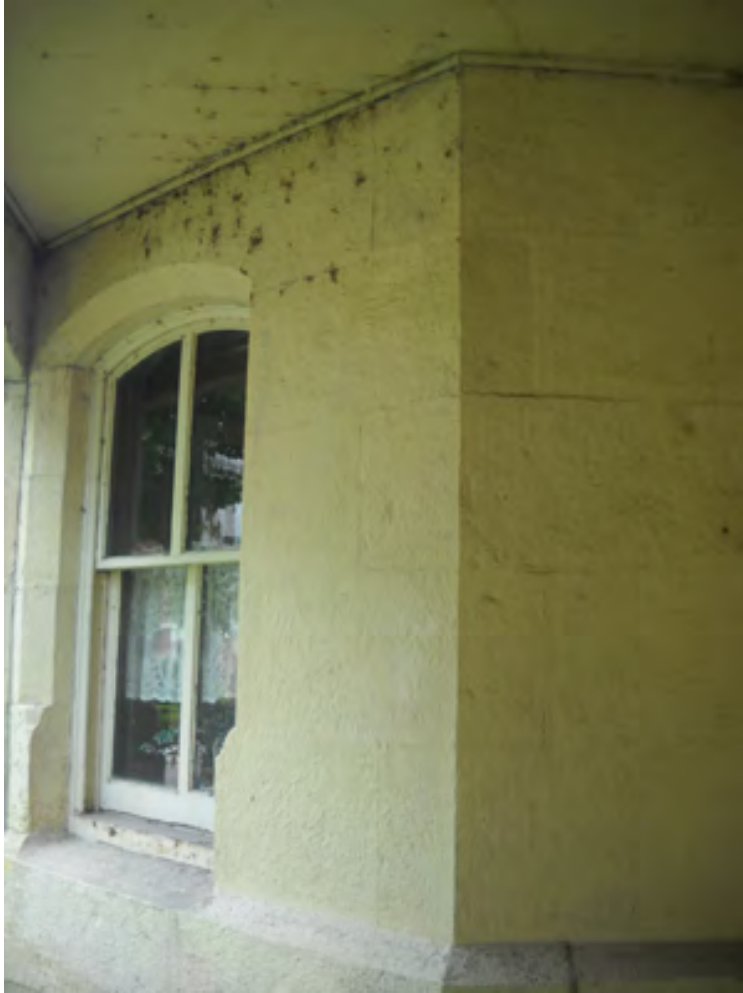
Photo E-16: The stone raised foundation beneath the porch overhang on the east elevation retains its painted surface because the area is protected. The stone is stable.

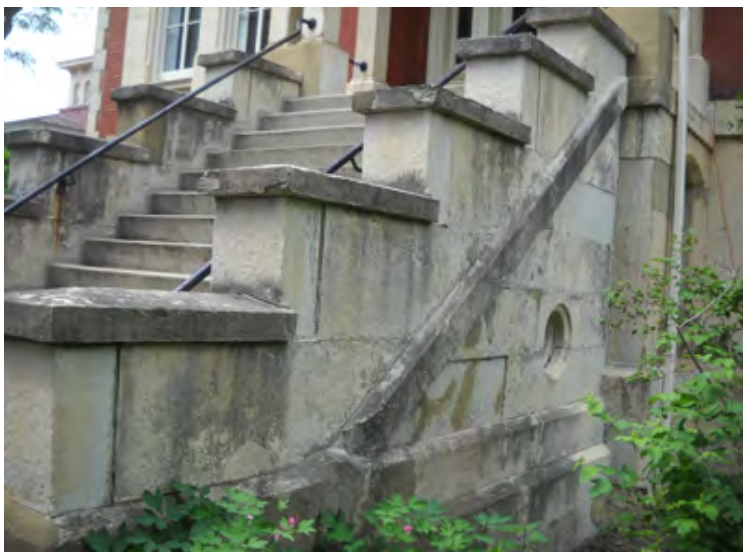
Photo E-17: The knee walls on either side of the main entry stair have many open joints, and the stone is deteriorated.

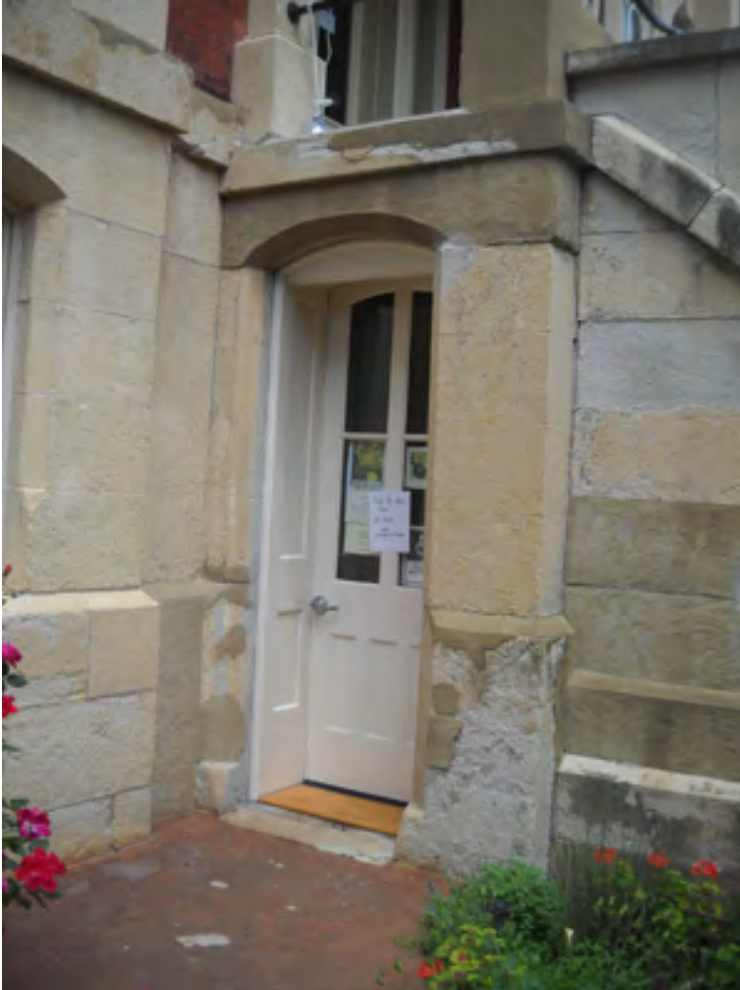
Photo E-18: There has been a fair amount of stone patching around the Lower Level main entry to the Museum. We noted one stone above and to the left of the entry that looks like it may spall. This loose stone should be removed.
