WILLIAM REDDICK MANSION

HISTORIC STRUCTURE REPORT

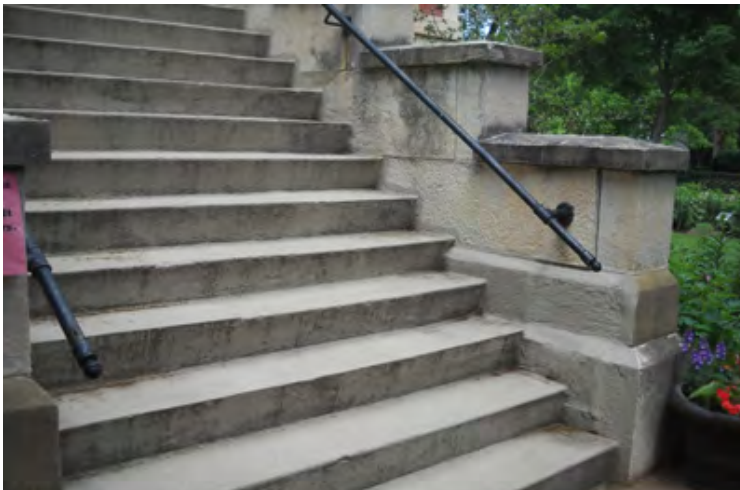
Photo E-19: The front entry steps are limestone, although they are covered with a durable rubberized coating system. This system may keep the water out, but it also traps the moisture in.

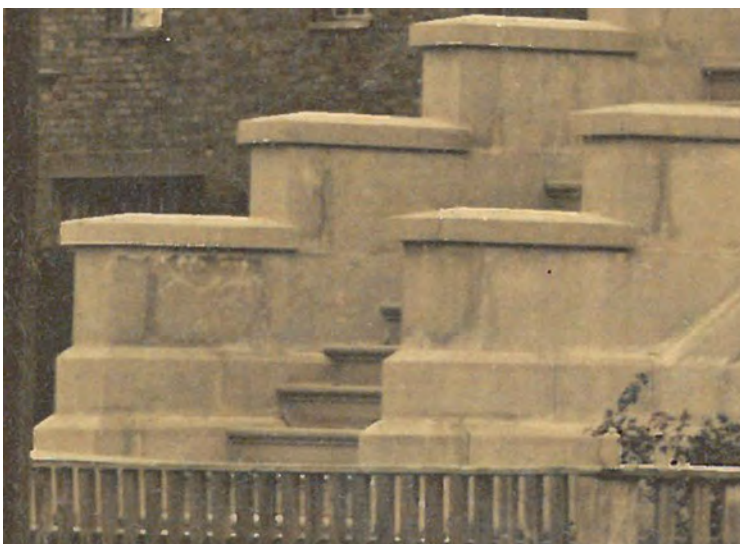
Photo E-20: Detail view from an early photograph shows how the treads once had a "lip" that overhung the risers.

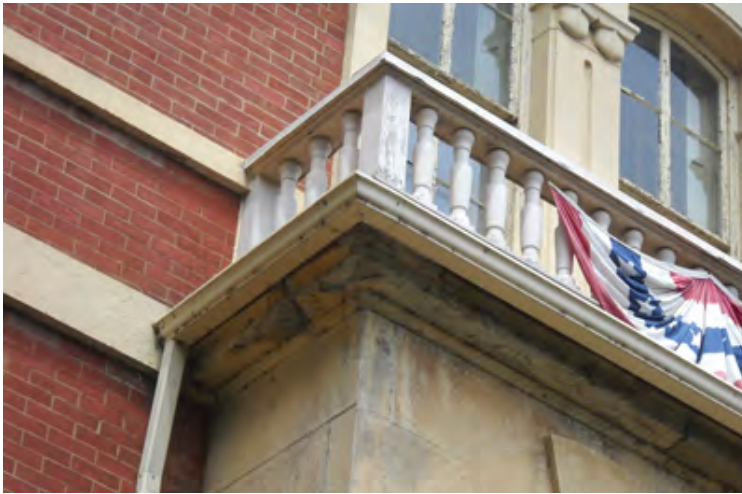
Photo E-21: The stone is deteriorated and chipping at the top of the window bays on the South elevation, behind the gutter.

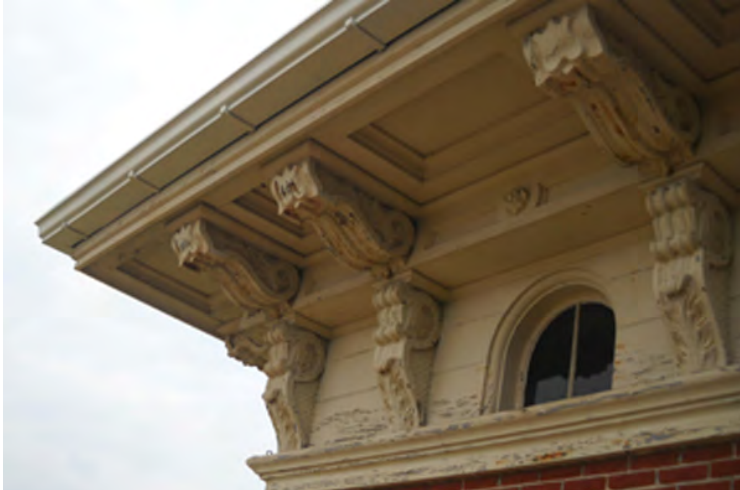
Photo E-22: Overall view of the cornice.

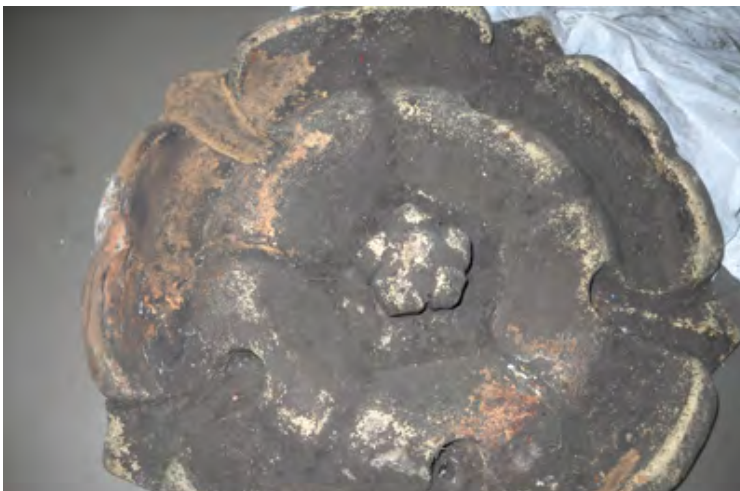
Photo E-24: This terra cotta ornament was found in the garden. It is not exactly like those found on the building, but it is very similar in style and may have been a rejected sample.

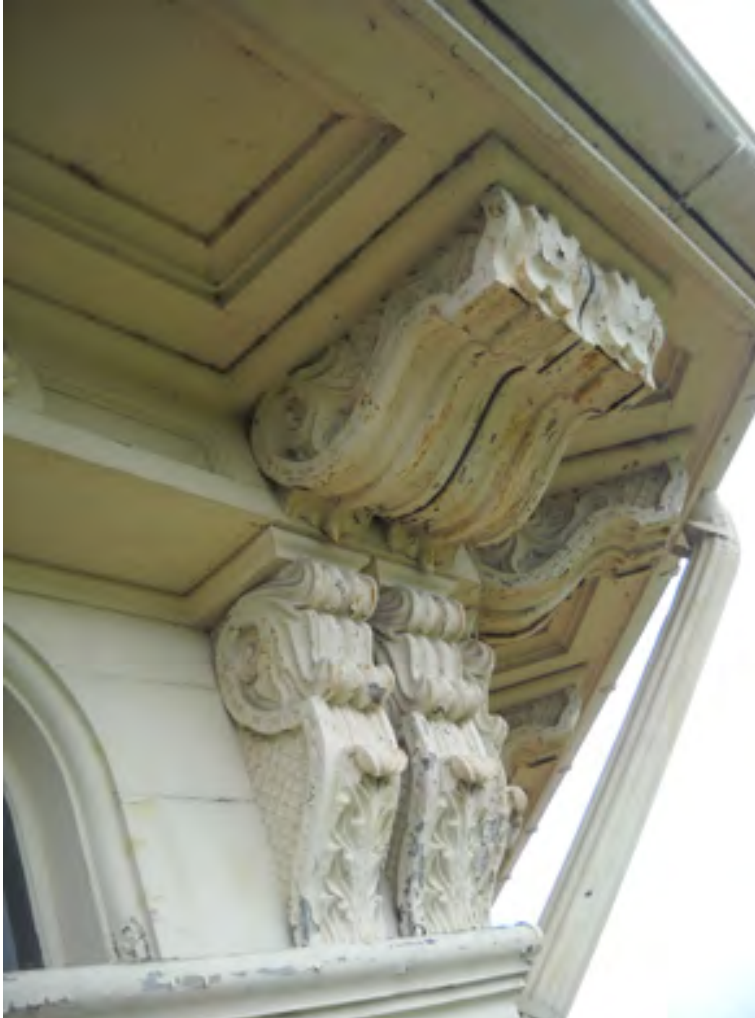
Photo E-25: View of the paired brackets on the cornice at the corners.

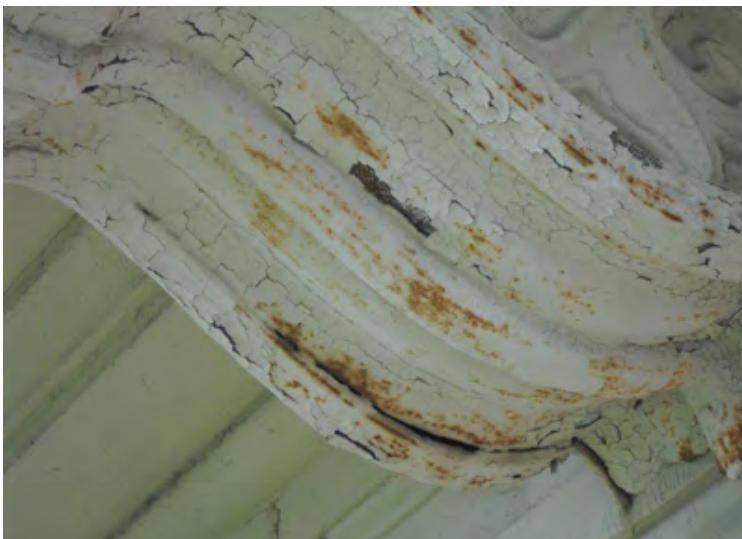
Photo E-26: Detail view of the cast-iron cornice brackets. They were constructed in three pieces—two sides and a front. The seams are visible, as is surface rusting beneath the deteriorated paint coating.

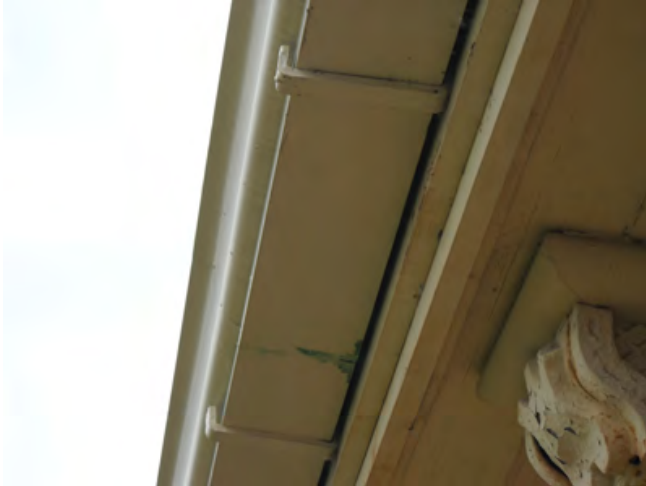
Photo E-27: View of the underside of the cornice gutter system (See **Photo E-53** for the top side).

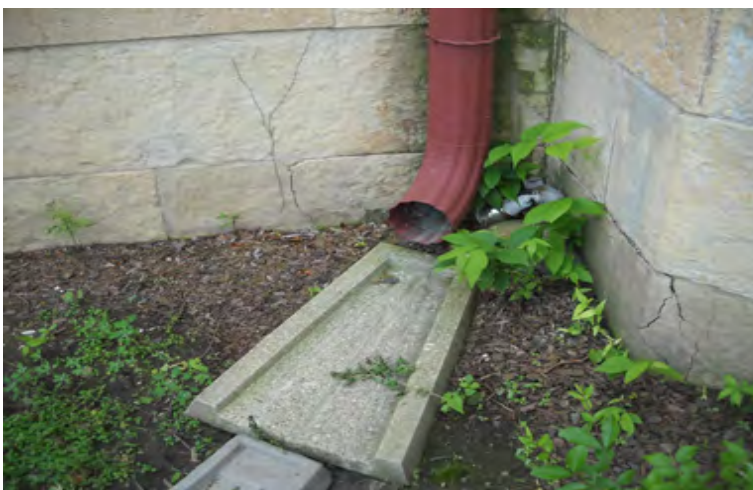
Photo E-29: The downspouts terminate near the base of the building at concrete splash blocks. Longer leaders should be provided; the splash blocks should be retained at the end of the leaders.

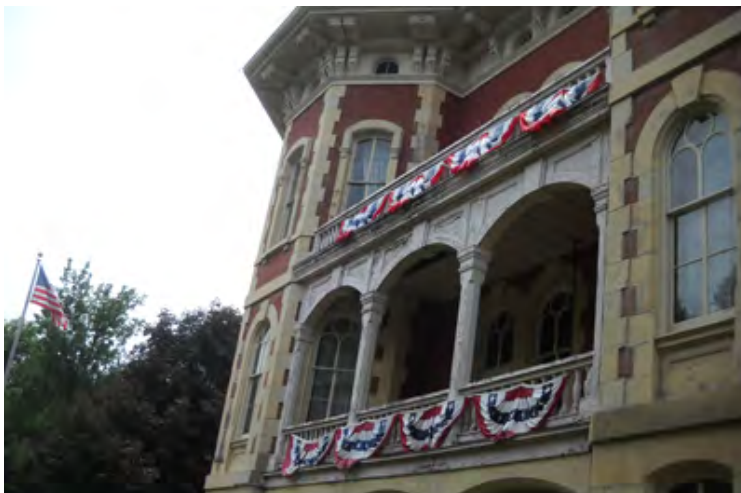
Photo E-30: General view of the east elevation two-story porch.

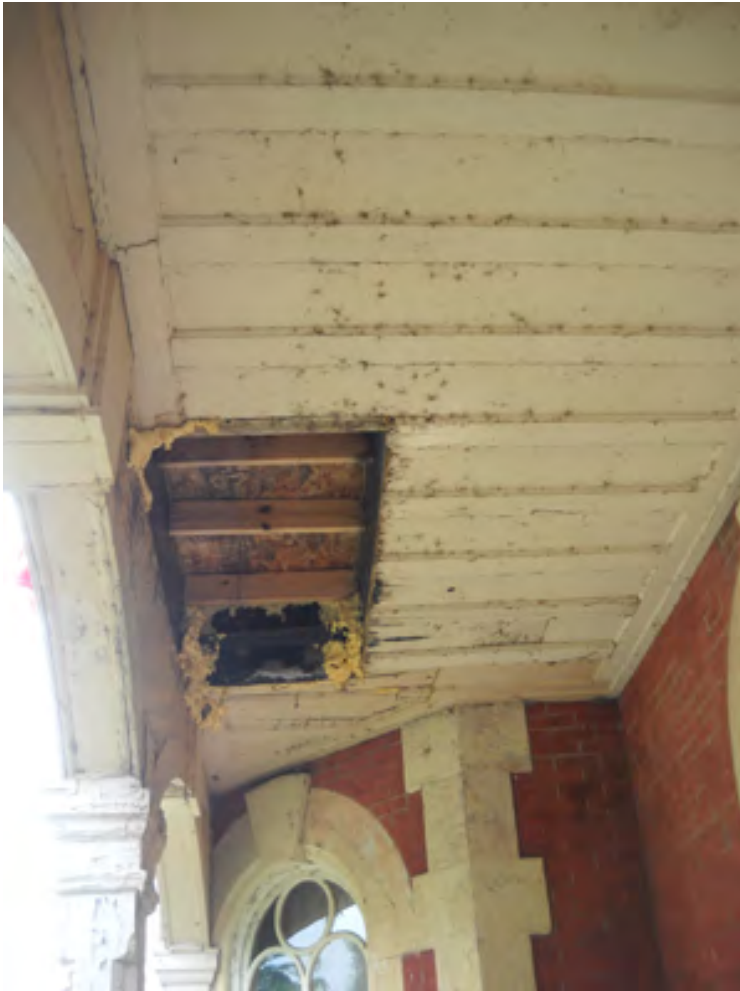
Photo E-31: View of the underside of the porch floor, as seen looking up from the Main Level/2nd Floor. The wood framed opening indicates where the fire escape opening was located.

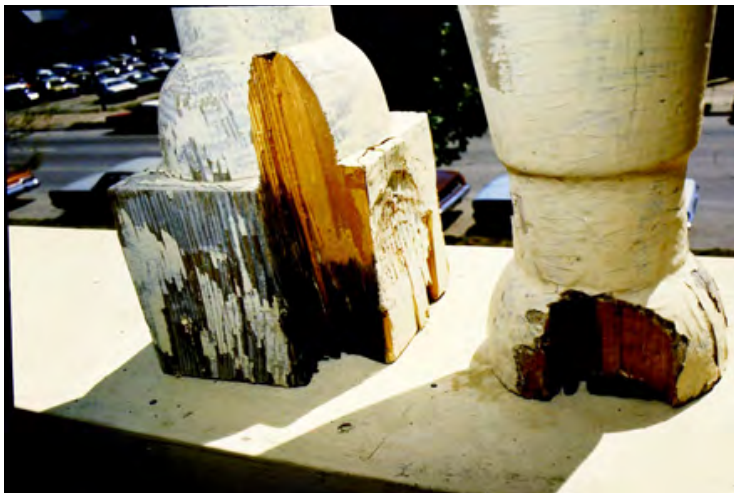
Photo E-33: 1970s photograph from the Brookman collection, showing how deteriorated the original wood rail spindles were at that time. Some of these were modified; some were replaced at that time.

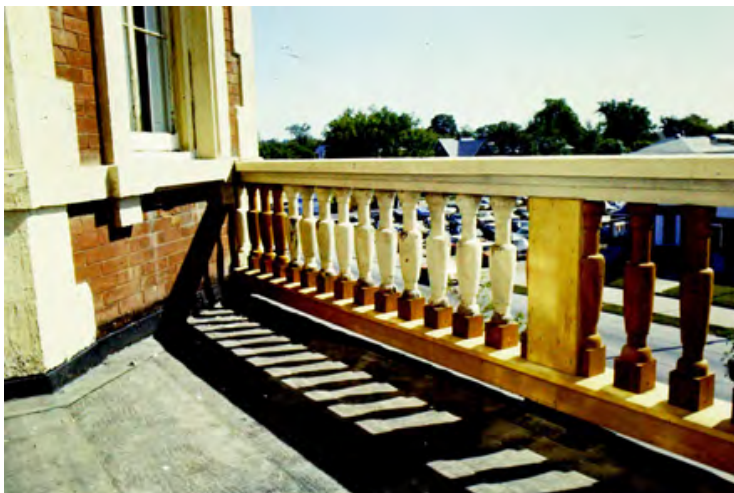
Photo E-34: 1970s photograph from the Brookman collection, showing the east elevation porch rail. We are fortunate to have this photo, as it shows original spindles with new blocks (left, still painted) and replacement spindles (right, unpainted).

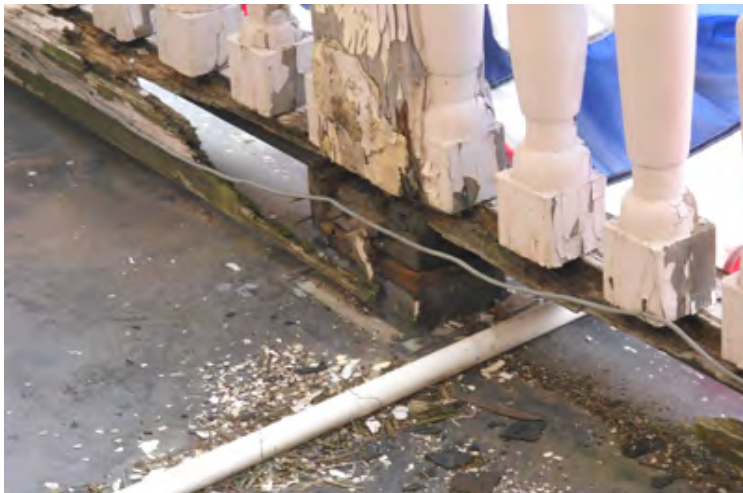
Photo E-35: The bottom member of the porch railing at the Bedroom Level/3rd Fl. has completely rotted due to excessive moisture from a condensate tube.

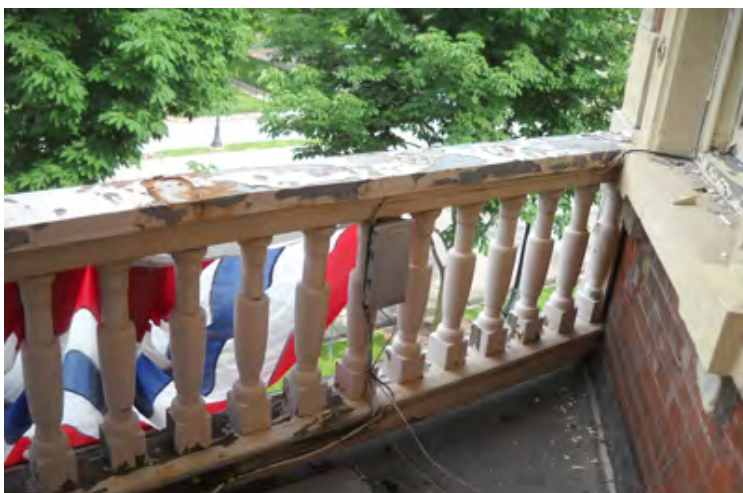
Photo E-36: View looking down on the railing, showing the galvanized sheet metal cap that was placed over the top of the rail. This helps protect the wood rail, but it has not been painted and is starting to rust.

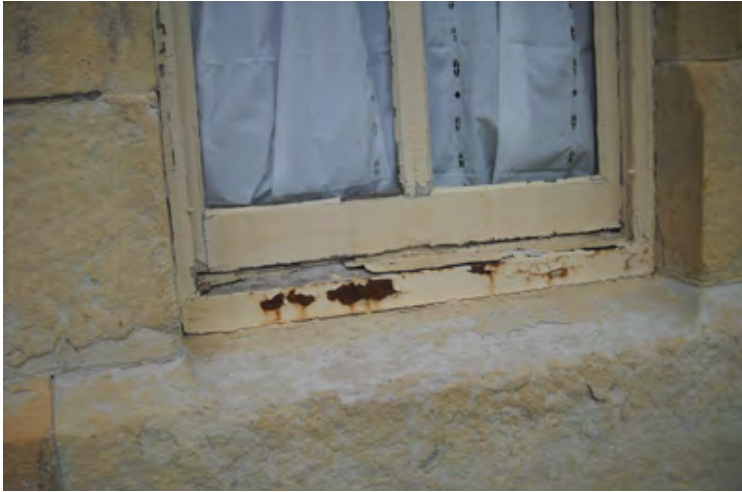
Photo E-37: The Lower Level/1st Fl. windows have their sills covered with iron sheet metal. They are severely corroding.

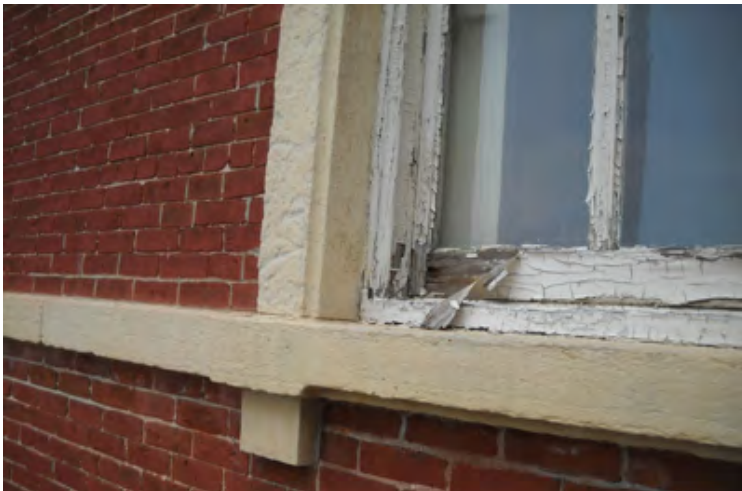
Photo E-38: Many window sills and bottom sash rails were repaired in the mid-20th century using epoxy-soaked fabric. This fabric is now failing and peeling off. Epoxy repair techniques for wood have since become more developed.

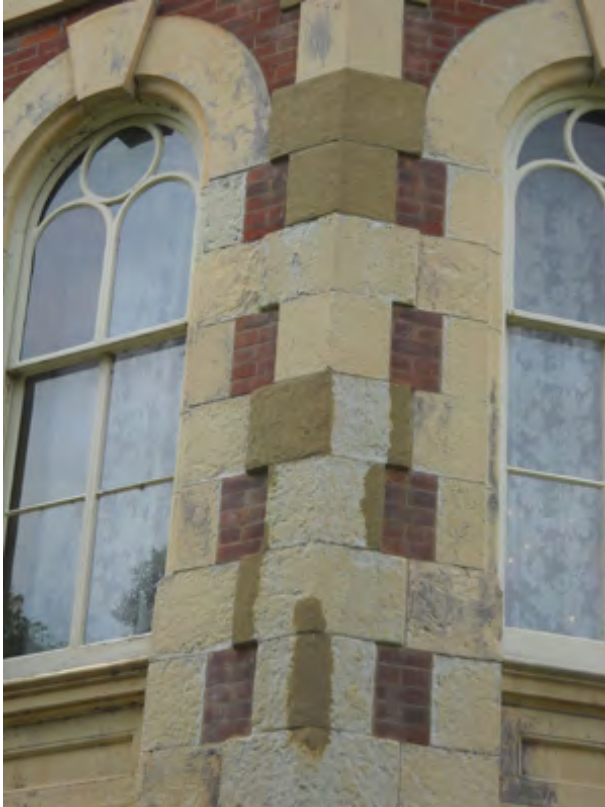
Photo E-39: View of Main Level/2nd Fl. Double-hung windows. They are in fair condition overall.

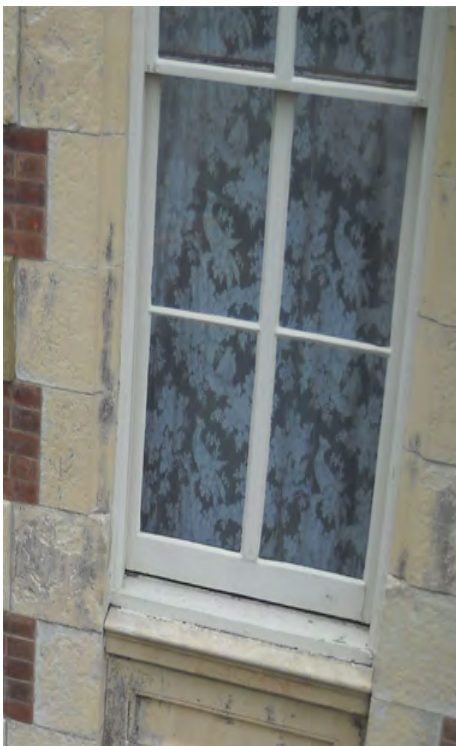
Photo E-40: View looking down at the bottom rail and sill of Main Level/2nd Fl. Double-hung windows. These sills are stable.

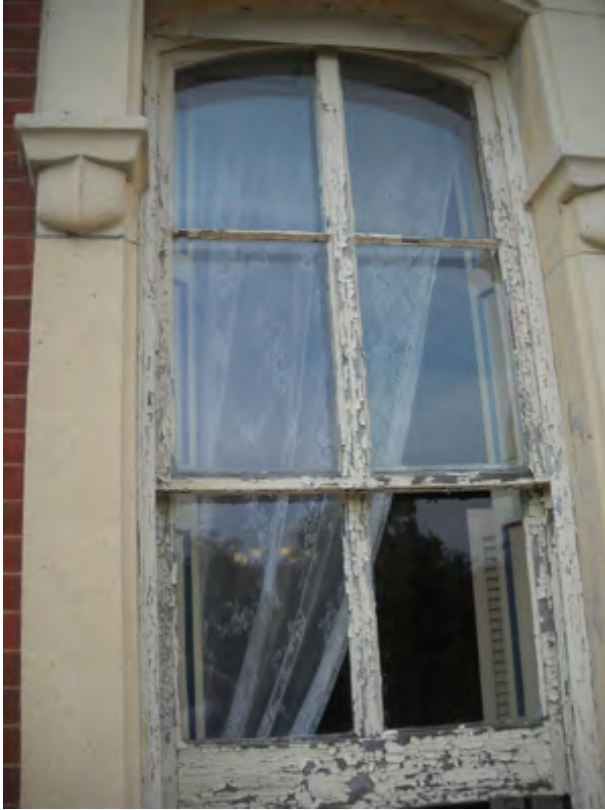
Photo E-41: View of typical Bedroom Level/3rd Fl. double-hung window. The paint, caulking and glazing putty on these windows is severely deteriorated.

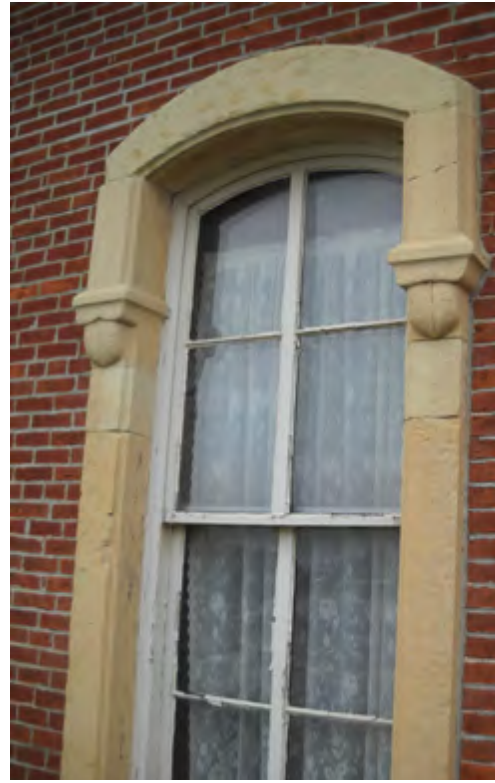
Photo E-42: View of another Bedroom Level window on a less-exposed elevation that is in fair to poor condition. The upper sash (more protected) is in better condition than the lower sash (where water collects).

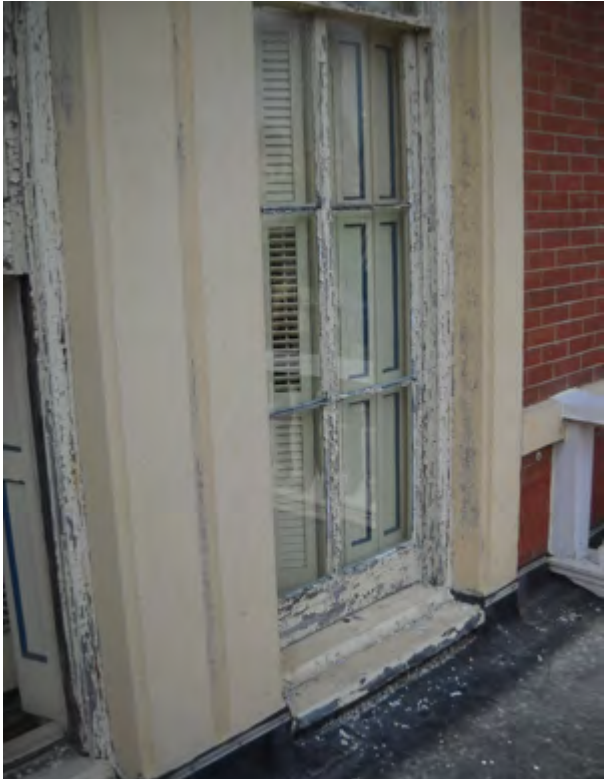
Photo E-43: View of a walk-through double-hung window over the entry portico on the south elevation. These windows are severely deteriorated.

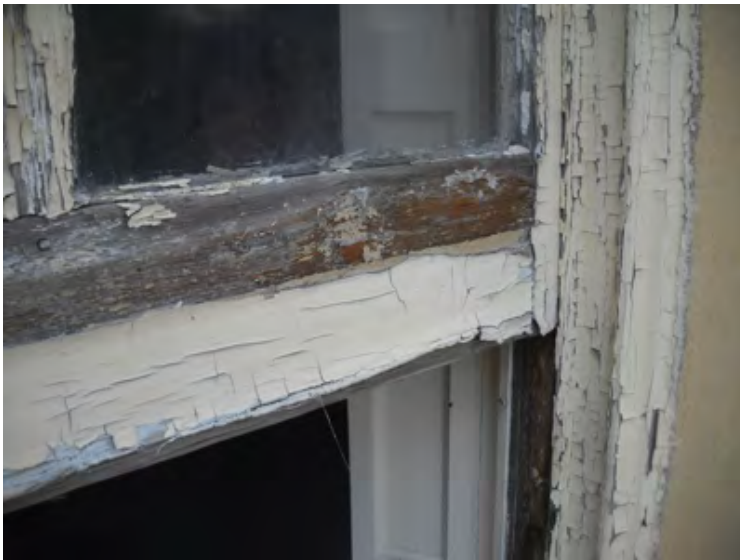
Photo E-44: Location where past epoxy repair fabric has pulled off the bottom window rail, exposing the wood. These patches have failed.

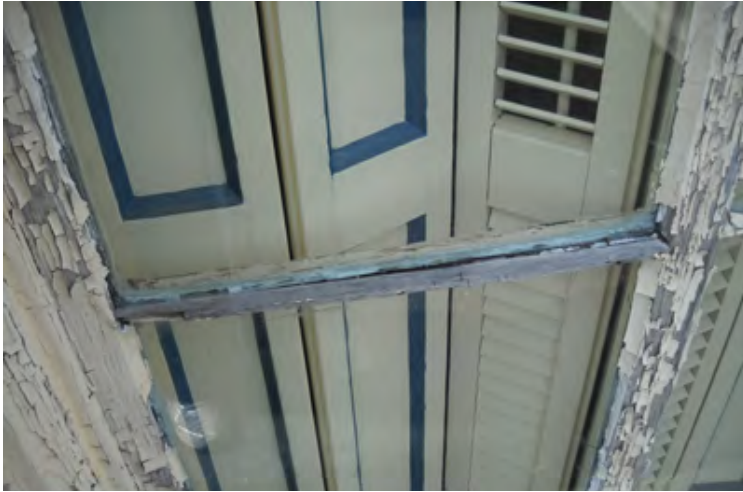
Photo E-45: In this window, ALL the glazing putty from the center mullion has cracked, broken and is gone. This leaves the glass precariously positioned.

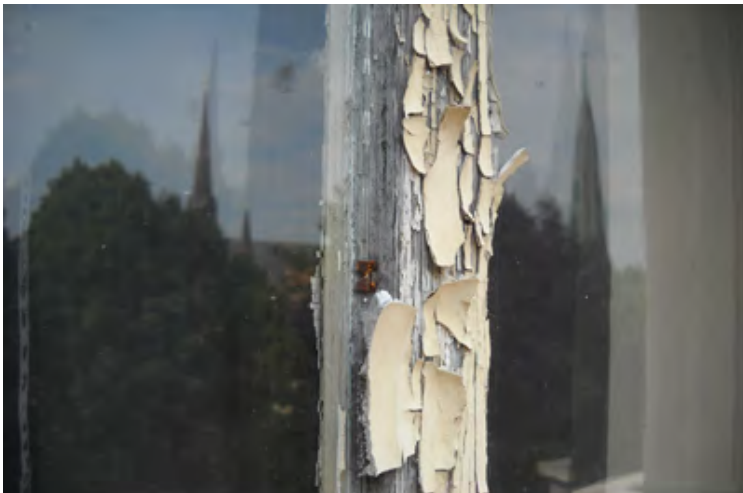
Photo E-46: Often-found condition of missing glazing putty and severely peeling paint on a window mullion. Although the wood looks deteriorated, proper window restoration should bring it back to operable condition.

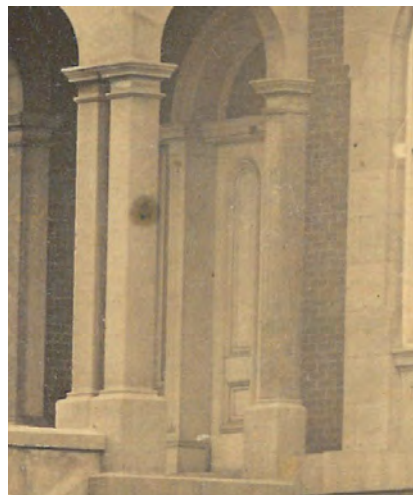
Photo E-47: This view was taken from a pre-1865 photograph of the Mansion (photo taken by Bowman), showing a solid front door panel.

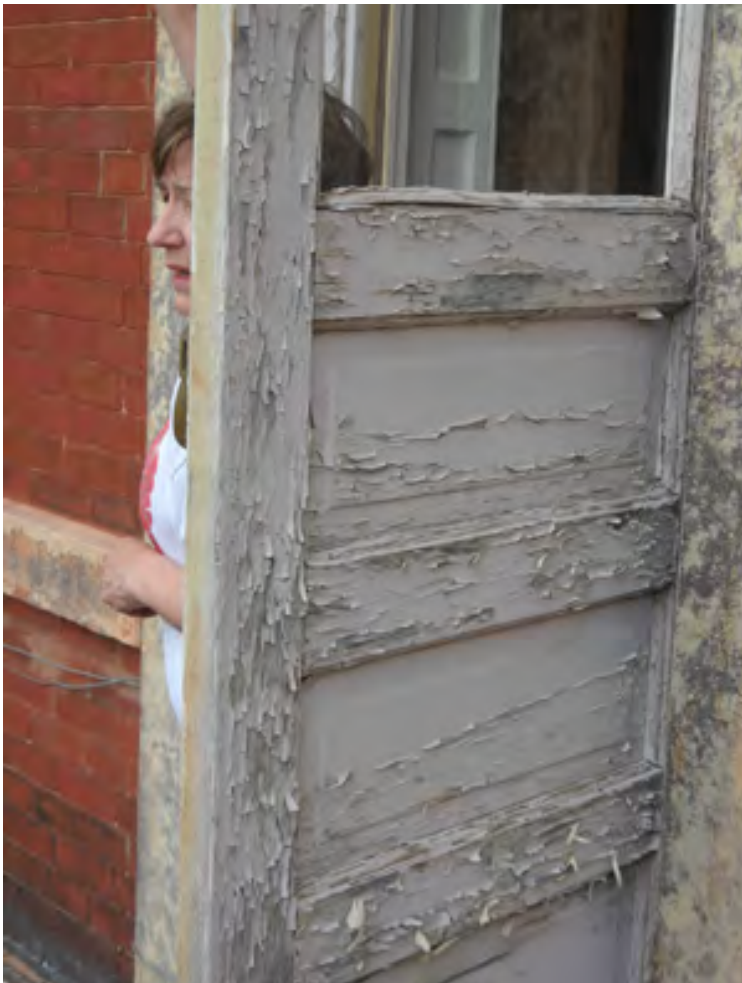
Photo E-48: Bedroom Level fire escape exit door on the east elevation. Due to lack of maintenance, the paint coatings on this door have failed and are peeling.

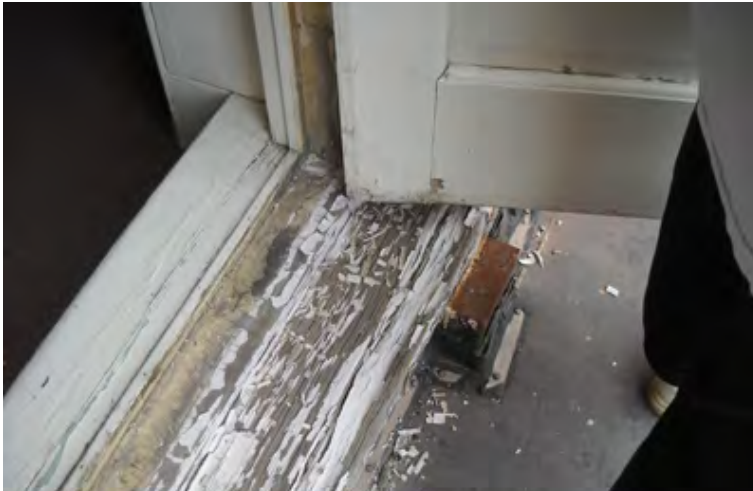
Photo E-49:
Deteriorated sill at east elevation fire escape door.

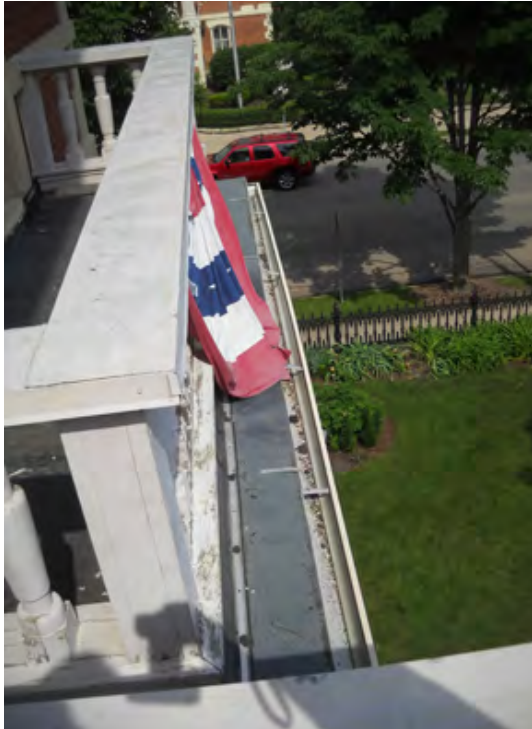
Photo E-54: View of the EPDM rolled rubber roofing on the east window bay roof, south elevation. The termination bars are visible just beneath the railing. Note also that the top of the rail is covered with sheet metal to protect it.

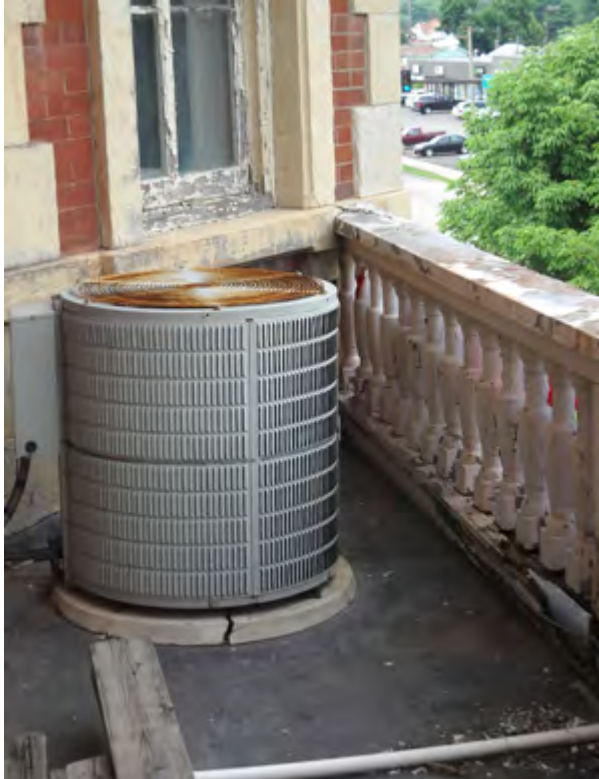
Photo E-55: A condensing unit is positioned on the Bedroom Level porch roof. The roof surface at this level has experienced greater sun exposure and weathering than the porch floor below.

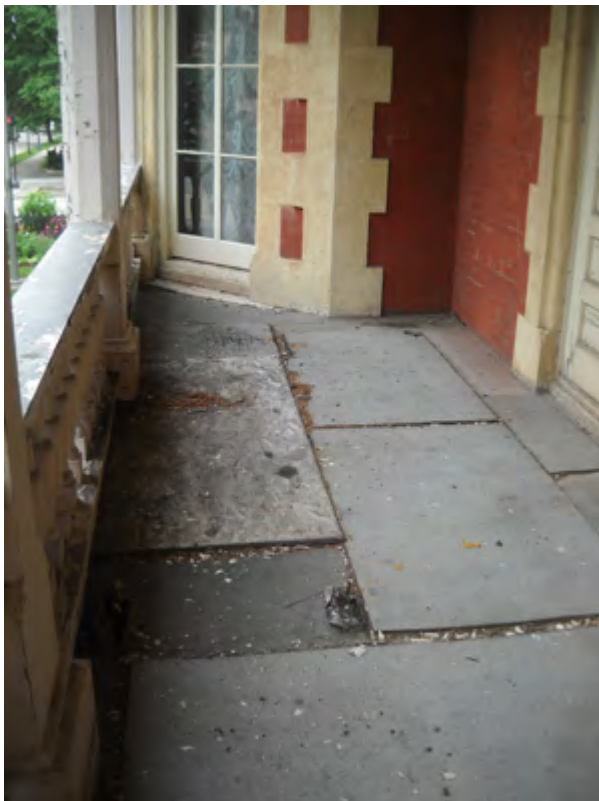
Photo E-56: The porch floor at the Main Level/2nd Fl. may have been more protected, but it is now covered with sheets of plywood. The former fire escape opening was in the upper left portion of the photograph.

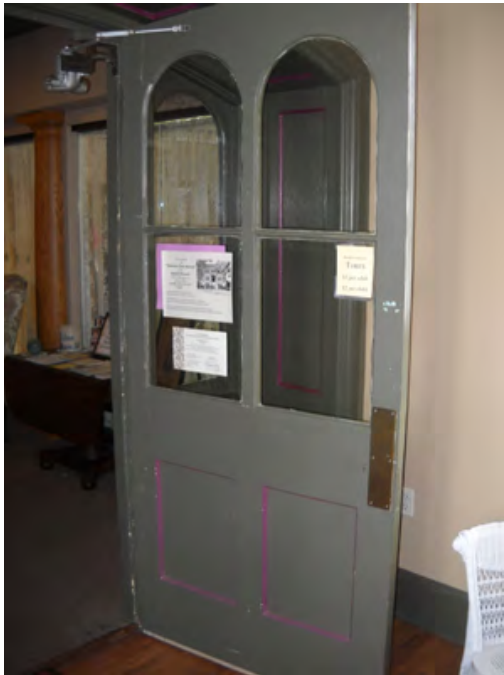
Photo LL-1: Original wood door leading from the Vestibule to the Central Hall.

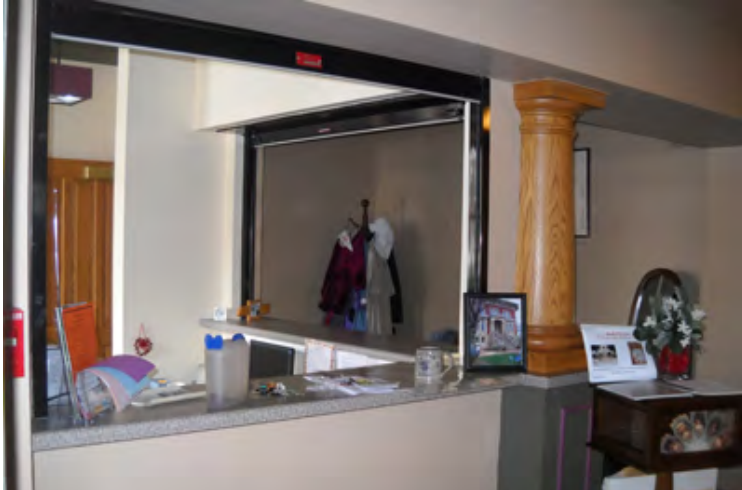
Photo LL-5: View of the Central Hall, looking south toward the Entry Vestibule.

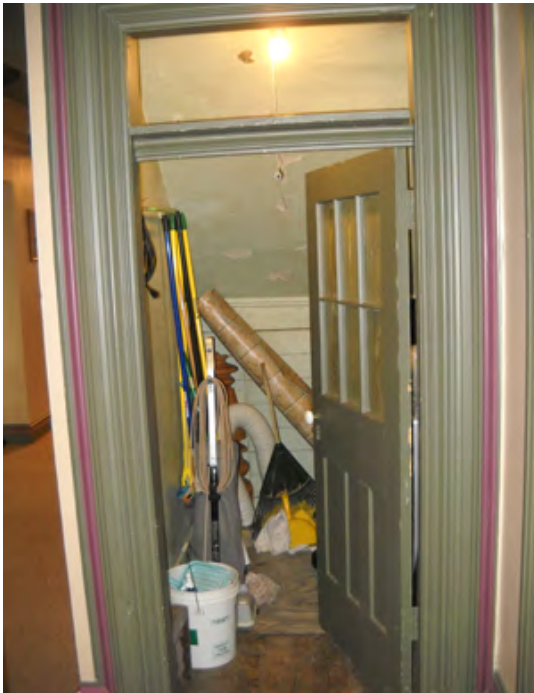
Photo LL-9: View in to the closet located beneath the servants' stair.

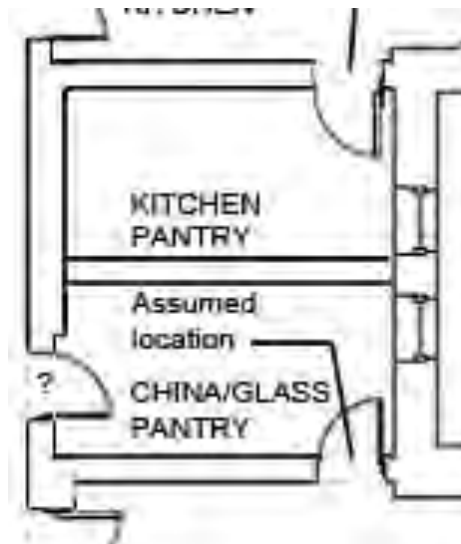
Diagram 1: Possible plan configuration of Center East Room on the Lower Level. The northernmost room would have served as the Kitchen Store Room; the Southern room as the linen and china/glassware pantry.

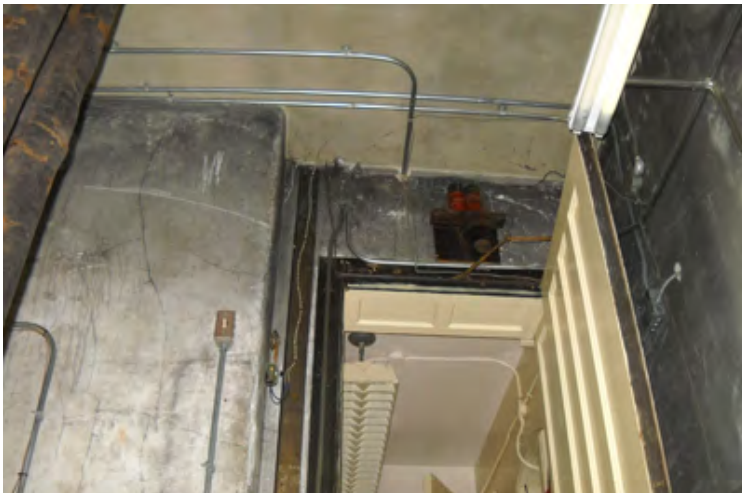
Photo LL-22: View of the door opening to the Kitchen Hall from the Boiler Room. Some antiquated alarm equipment is mounted above the door.

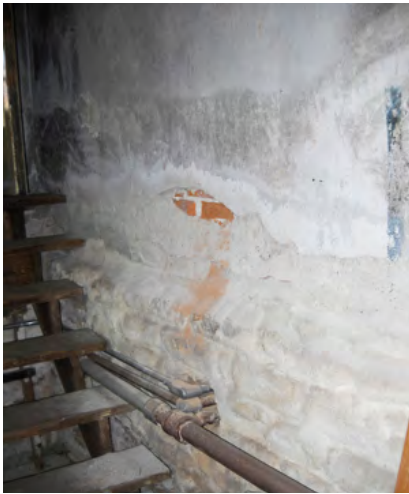
Photo LL-26: A ledge is formed where the foundation wall steps out, where it transitions from brick (above) to stone (below).

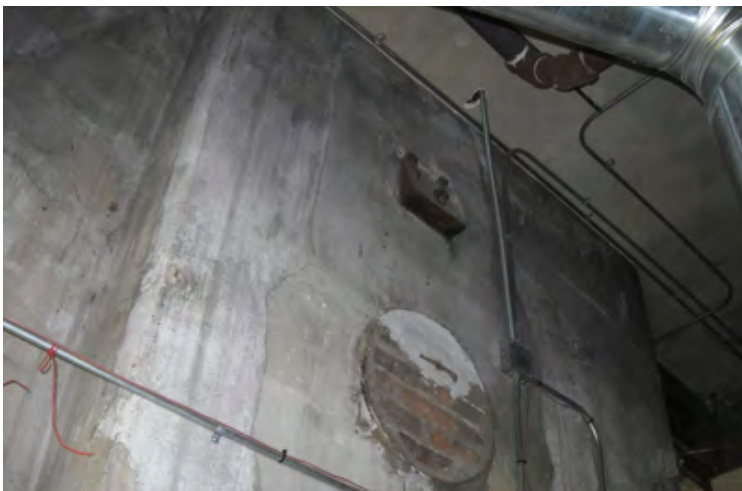
Photo LL-27: Two vent locations are positioned on the north wall chimneystack. The lower opening is for a former boiler. The upper opening, now a clean-out, was probably originally a vent opening for a stove.

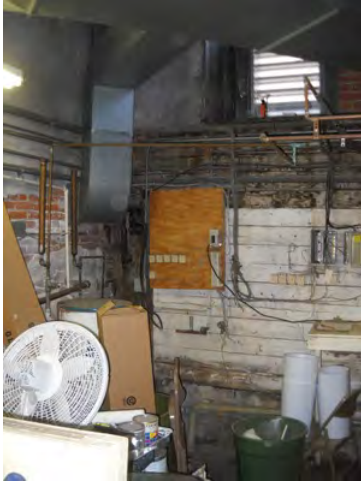
Photo LL-28: View toward the southwest corner of the Boiler Room, showing the water pump location.

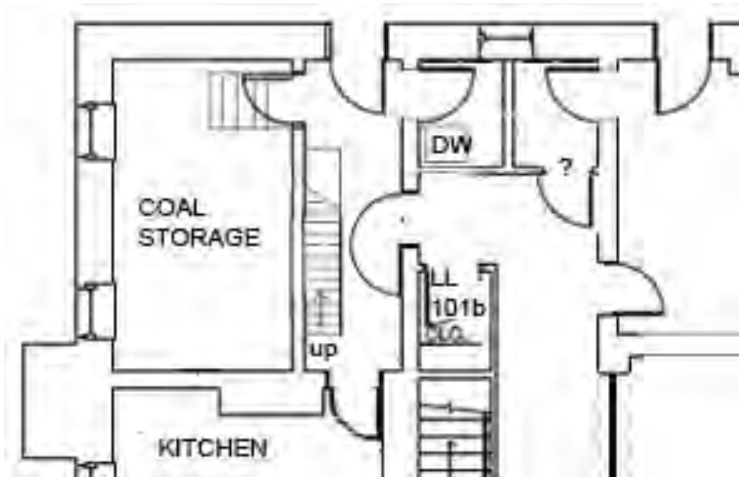
Diagram 2:
speculated
configuration
of the Kitchen
Hall stair.

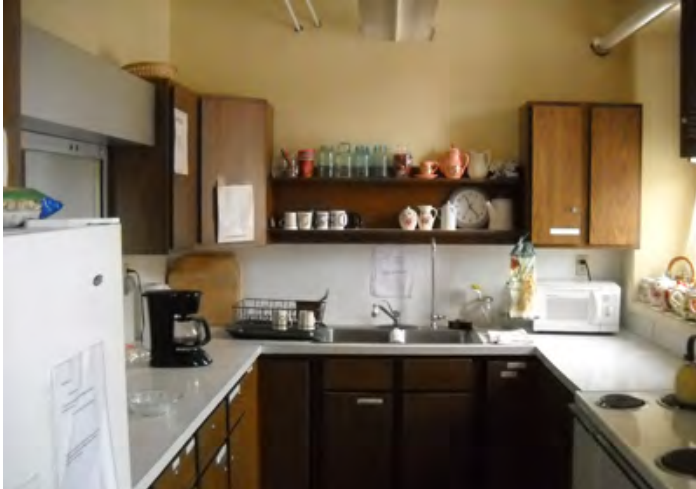
Photo LL-31: General view of the existing kitchen in the northwest corner.

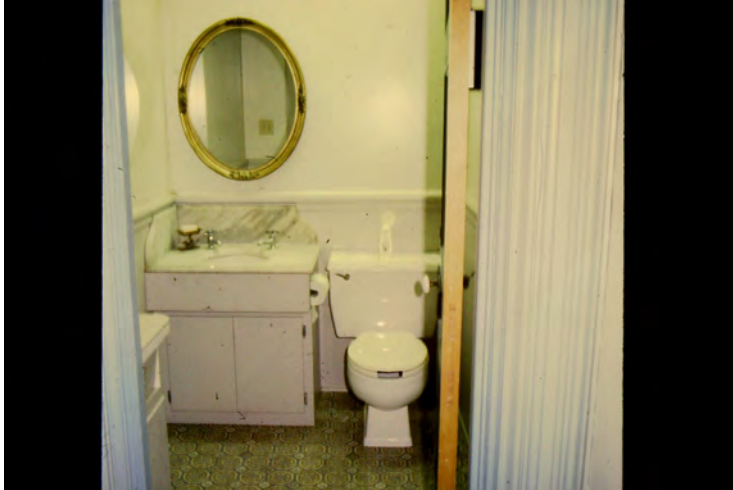
Photo LL-37: c. 1970s view of the Ladies Room before it was painted and refurbished.

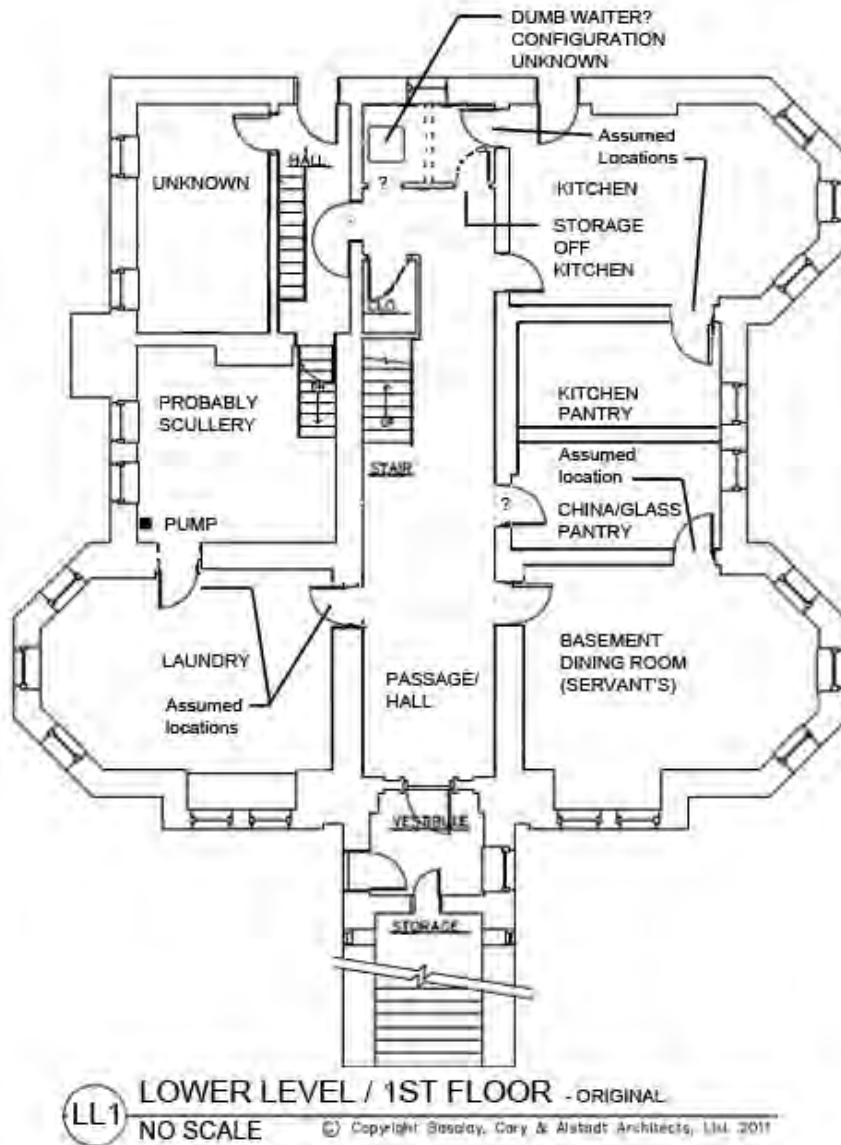
Diagram 3: Illustration showing our teams’ believed original configuration of the Lower Level based upon physical evidence, handwritten notes on the back-side of the original specifications, and from information in the inventory taken after Reddick’s death.

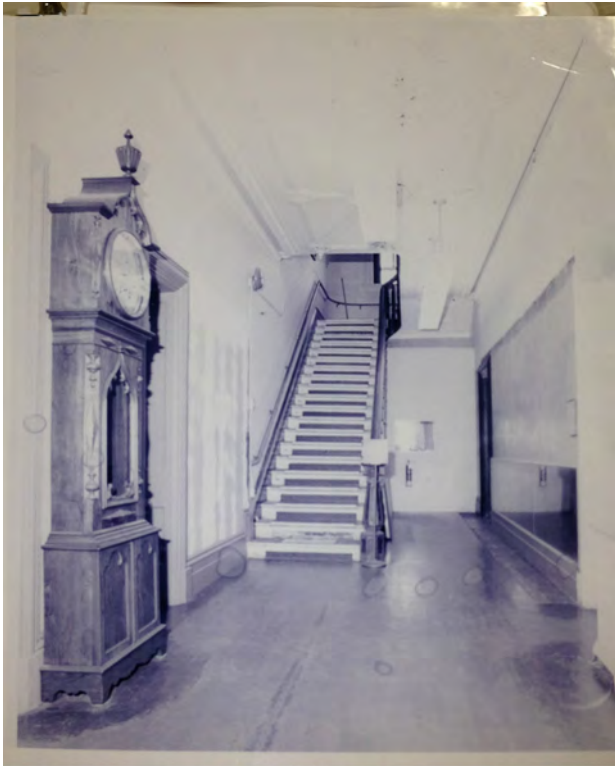
Photo M-7: This view was taken just after the RMA took possession of the building. The bookcases against the east wall had been removed, and the opening at the base of the stairs was enclosed. This photo was taken c.1976.

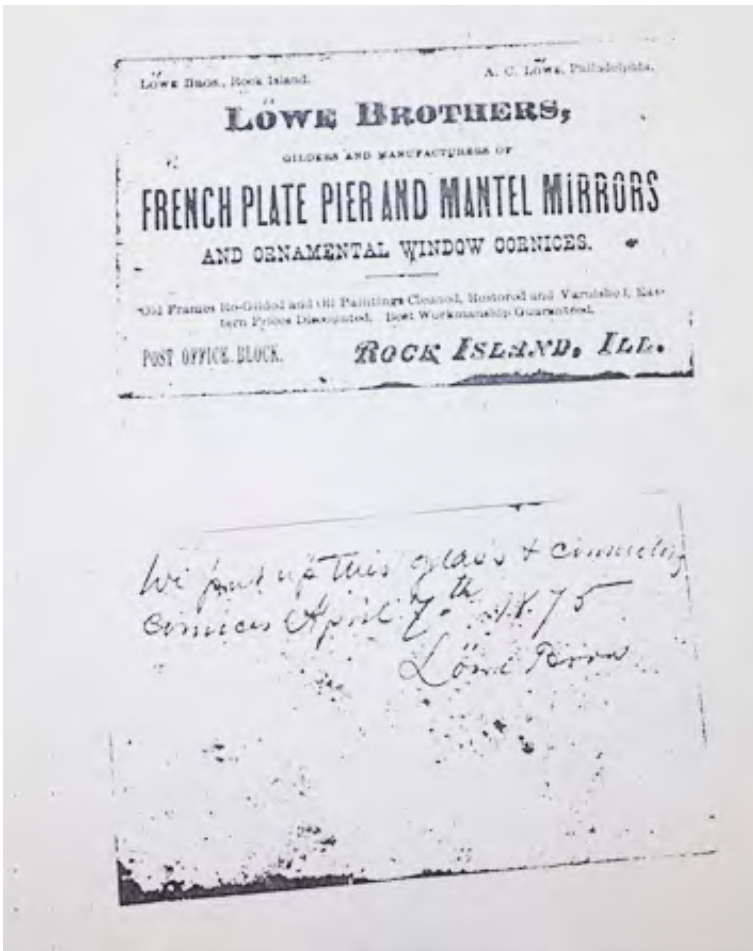
Photo M-26: Images of both sides of the calling card found behind the pier mirror.

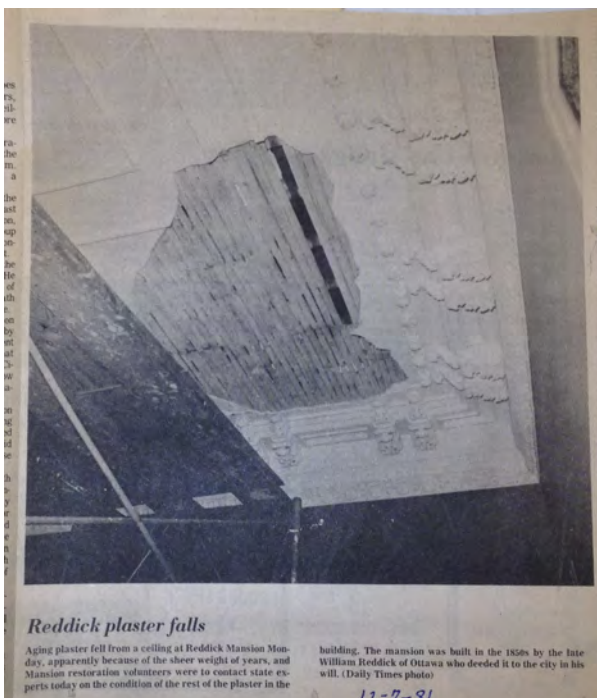
Photo M-38: Newspaper clipping from 1981 depicting the plaster damage in the southwest corner of the Dining Room.

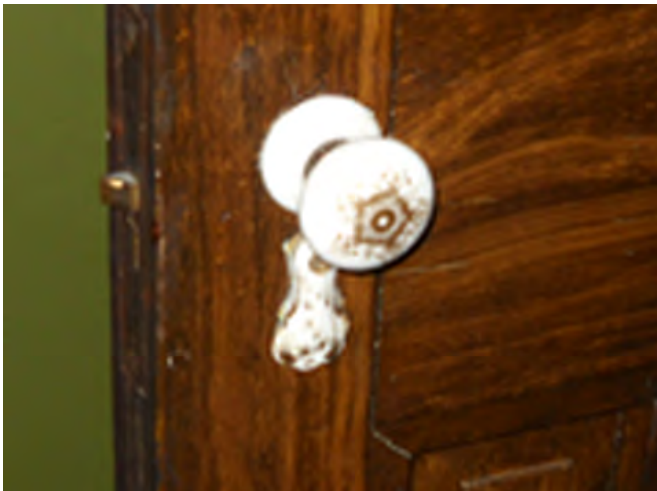
Photo M-40: Detail view of the typical Main Floor formal doorknobs and keyhole covers. Some doorknobs still retain their stenciled golden decoration. Others have either been replaced with plain white knobs or the pattern has worn off.

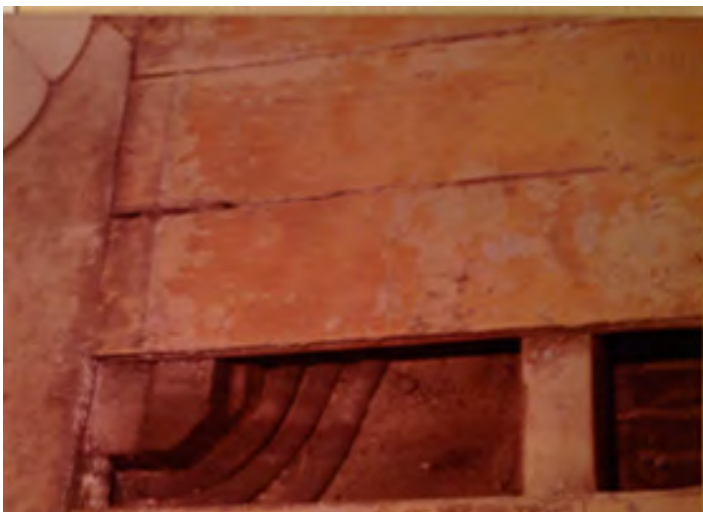
Photo M-41: Photograph taken during the 1978-9 restoration, showing a lead water pipe found under the floor at the west corner of the Dining Room fireplace.

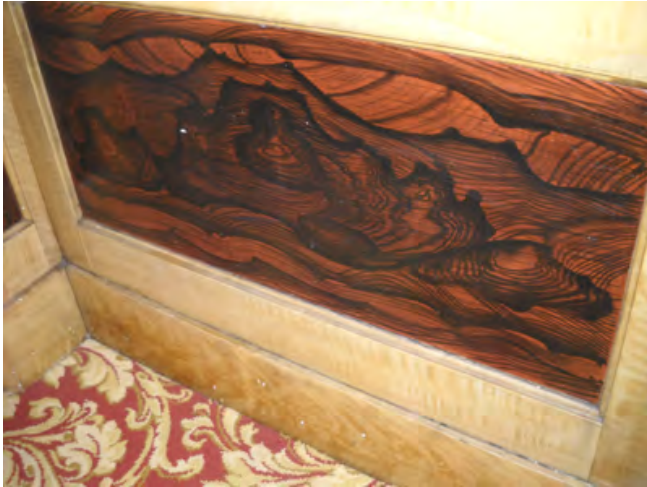
Photo M-42: Original faux wood graining on the spandrel panel beneath the center window in the Southeast Parlor window.

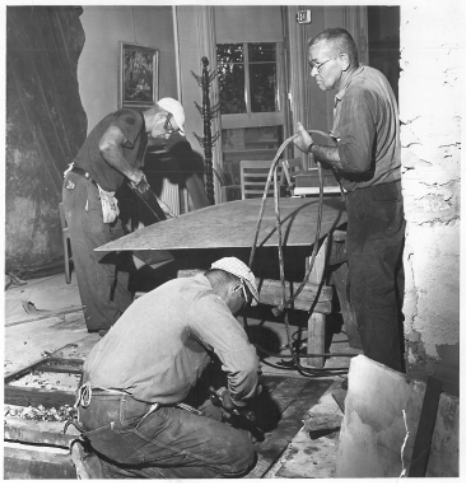
Photo M-51: We think this photo dates from 1953, when major structural repair were made to add structural beams beneath the Southwest Parlor floor.

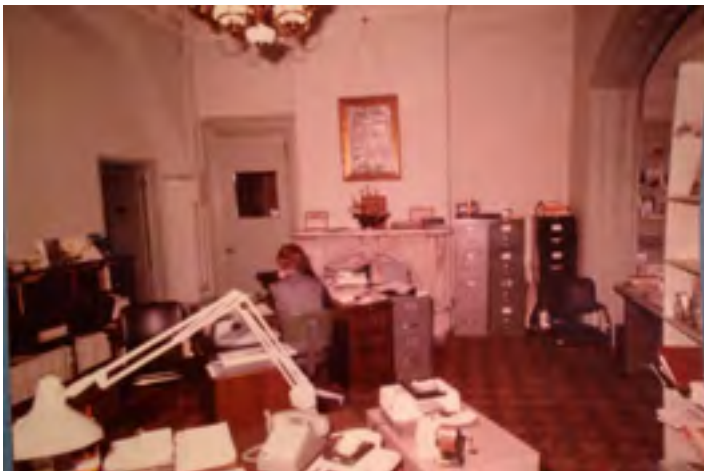
Photo M-52: 1980 view of the Southwest Parlor, when it served as an office for the Chamber of Commerce.

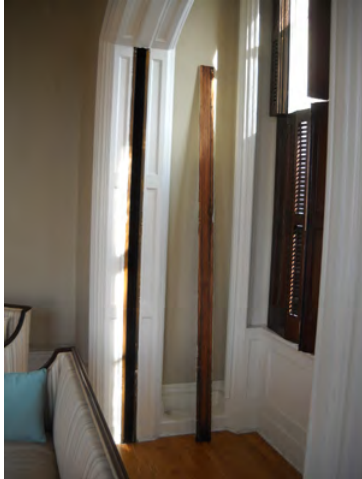
Photo M-53: A piece of trim was removed from the recessed bay window jamb to expose a door pocket. Unfortunately the door was missing. We do not know if other window bay doors are present in their pockets or not.
