WILLIAM REDDICK MANSION

HISTORIC STRUCTURE REPORT

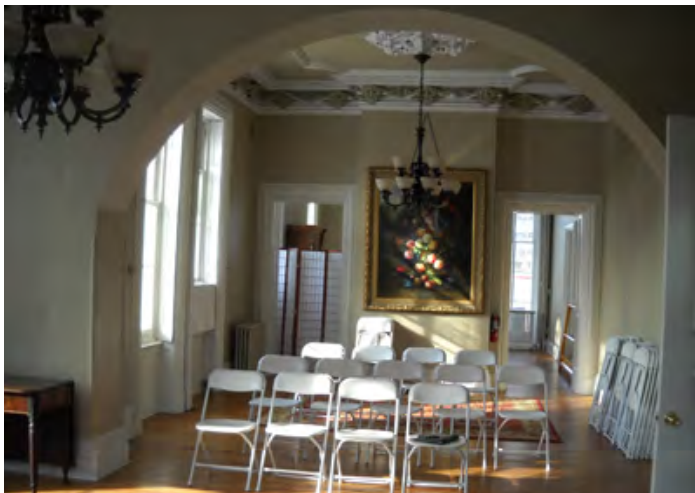
Photo M-54: Current view into the Center West Parlor/Library. Note the large arched opening between the two parlors (not original).

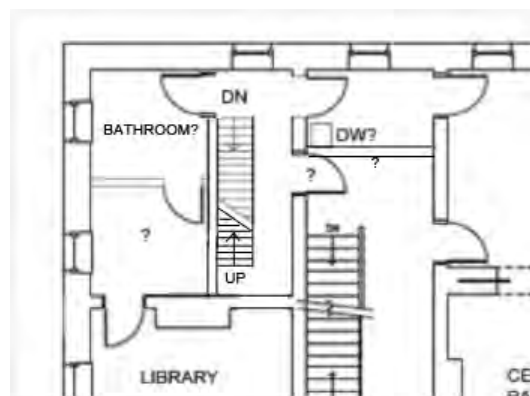
Diagram 3:
Possible configuration of original floor plan in northwest corner, Main Level.

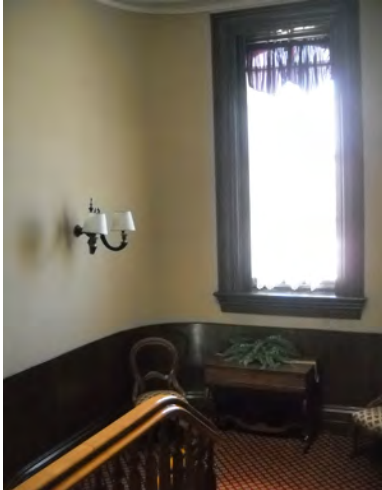
Photo BR-1: Current view of the north end of the Center Stair Hall.

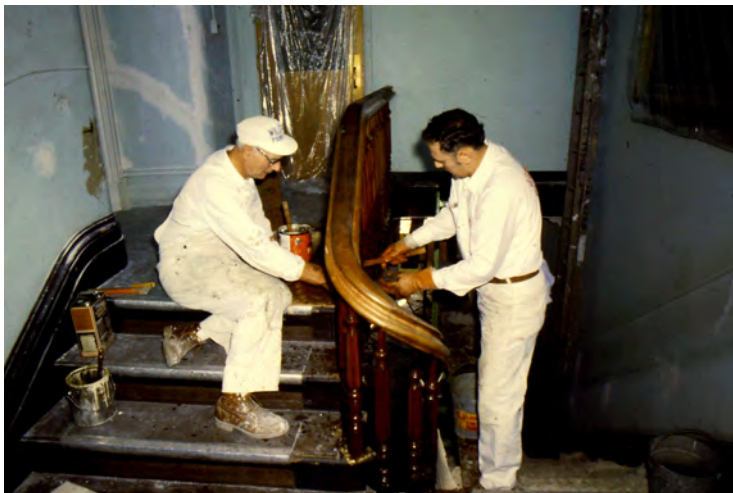
Photo BR-6: 1970s photograph showing workmen refinishing the stair railing and balustrade.

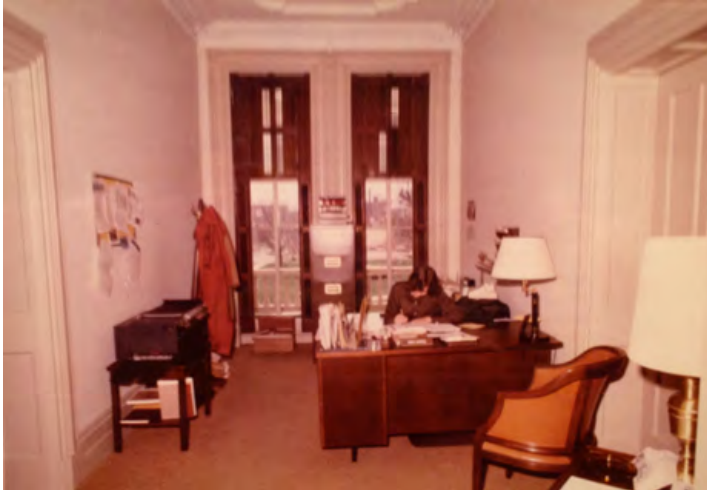
Photo BR-10: This photograph from 1980 shows the south end of the Central Hall when it was being used as a reception room for Congressman Tom Corcoran's office.

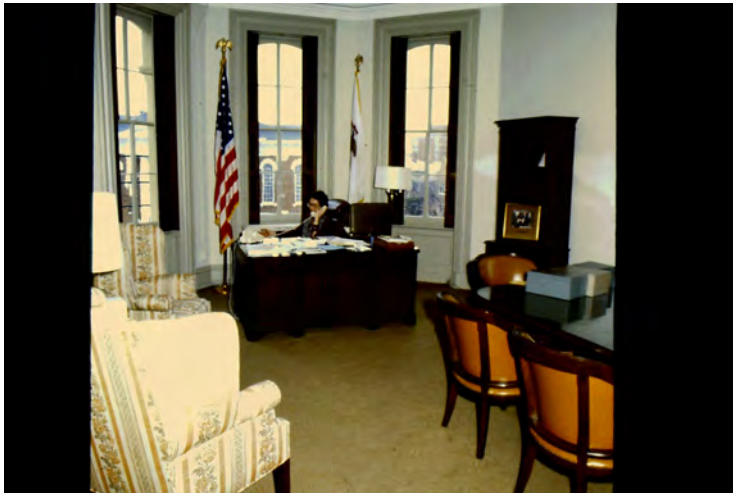
Photo BR-13: 1980 view of the Southeast Bedroom, when it was being used as the office for Representative Corcoran.

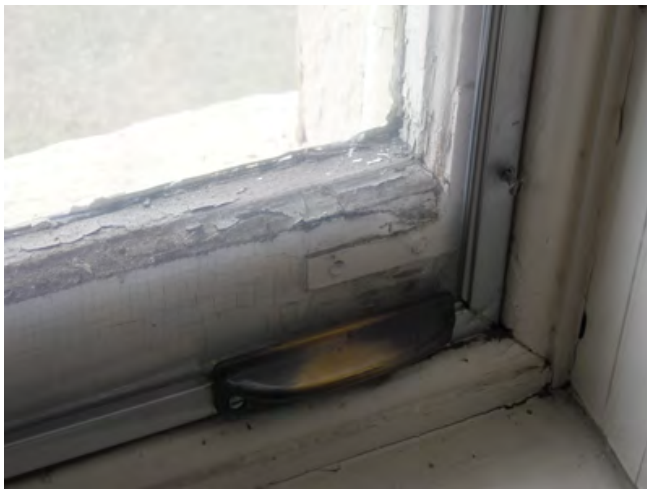
Photo BR-23: Detail view of the storm windows installed against the original window sash in 1981. These storms have accelerated the deterioration of the sash.

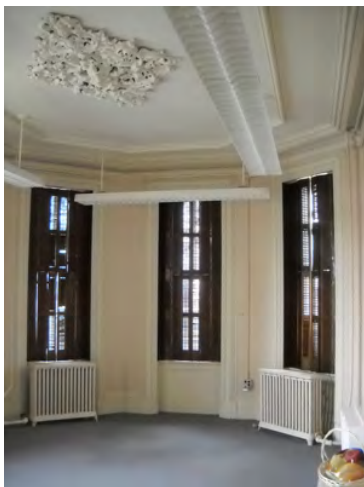
Photo BR-24: Current view of the Southwest Bedroom.

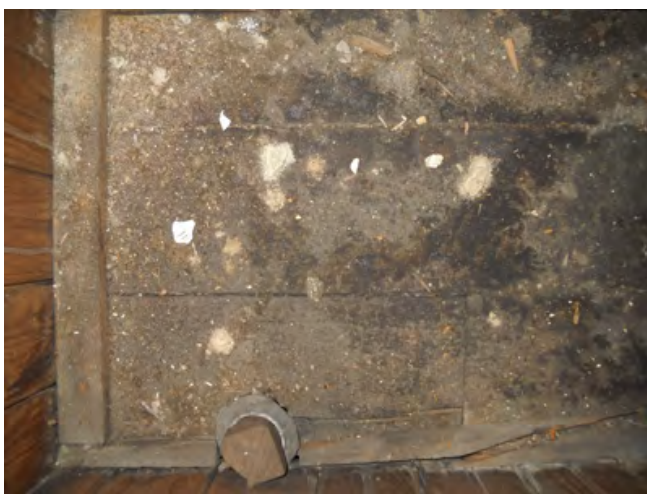
Photo BR-34: This view shows the floor of a cupboard in the toilet room, showing a capped water pipe (lower left).

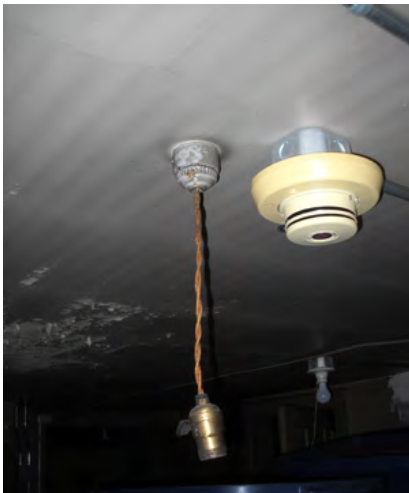
Photo SL-5: Early electrical hanging light fixtures can be found in most of the Servants' Level bedrooms.

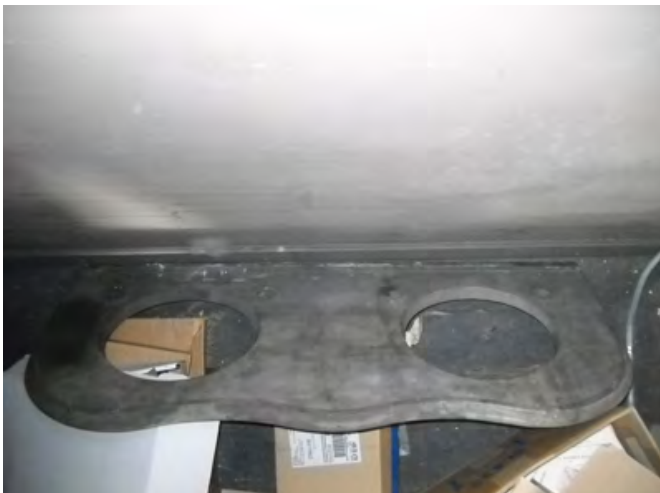
Photo SL-6: Parts of an old double-bowl sink were found in the closet in the Southeast Bedroom.

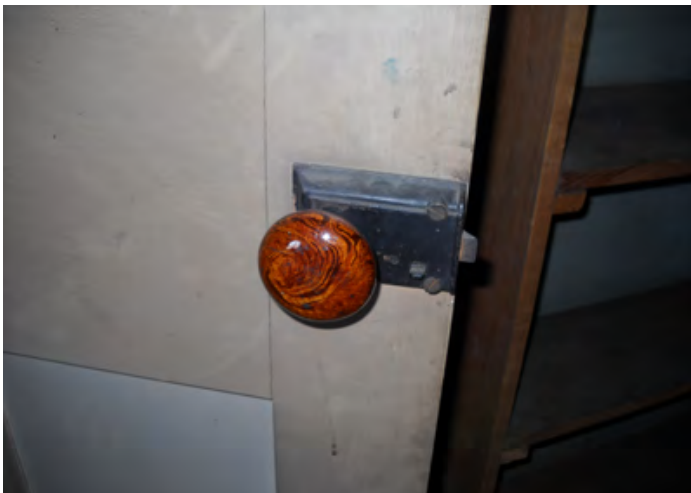
Photo SL-8: Servants' Level typical doorknobs and rim locks can be found on the original doors.

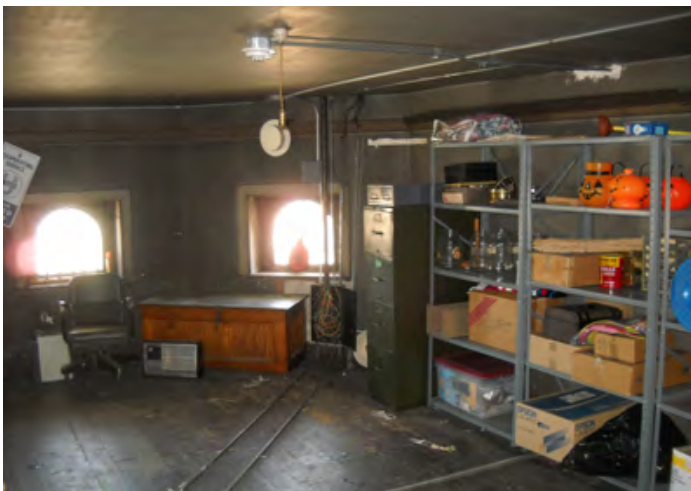
Photo SL-9: Current view of the Northeast Bedroom.

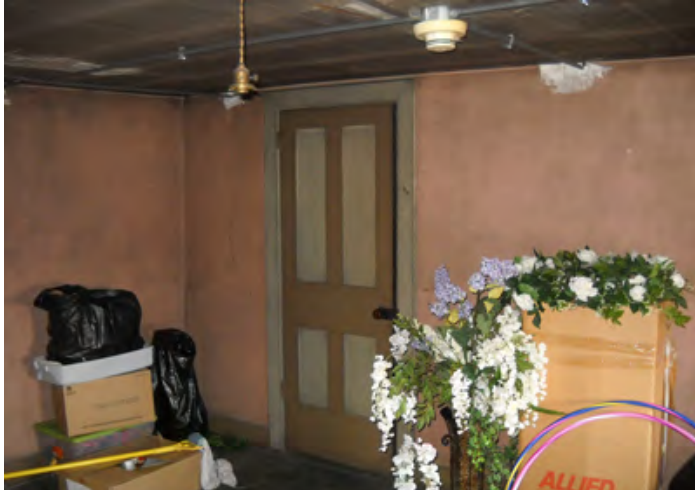
Photo SL-13: The Center West Bedroom was painted a light pink color, causing us to assume a female servant once occupied the space.

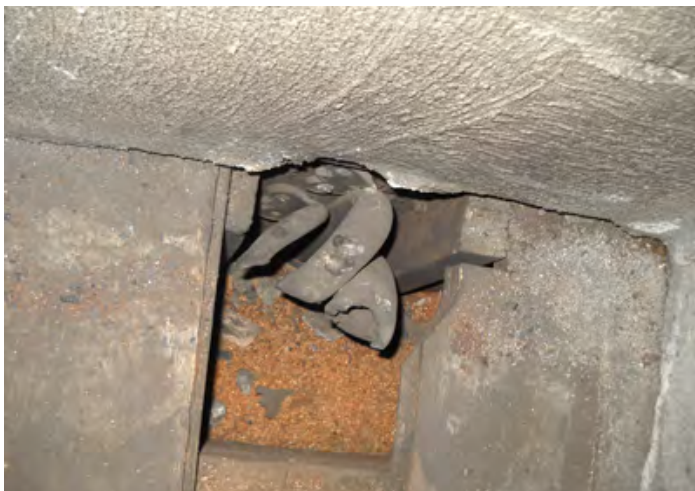
Photo SL-15: Capped lead water pipes were noted in the northeast corner of the room.

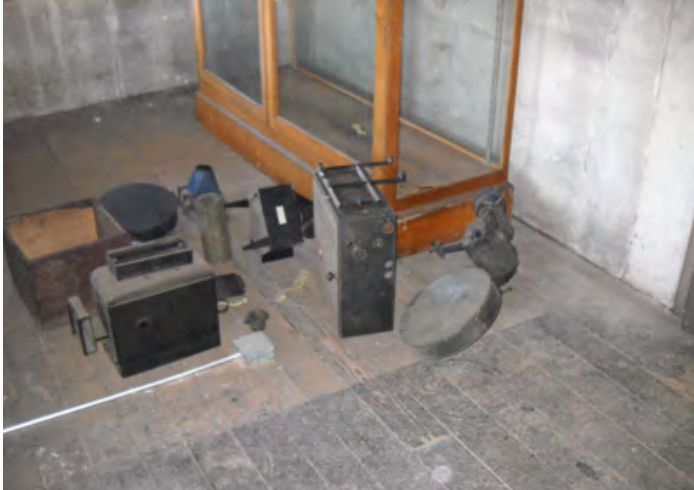
Photo SL-16: Marks on the walls and floor indicate where the lead water tank was originally positioned. Also pictured are pieces of what is thought to have been the original Balopticon machine (used for viewing moving picture shows during the Library period).

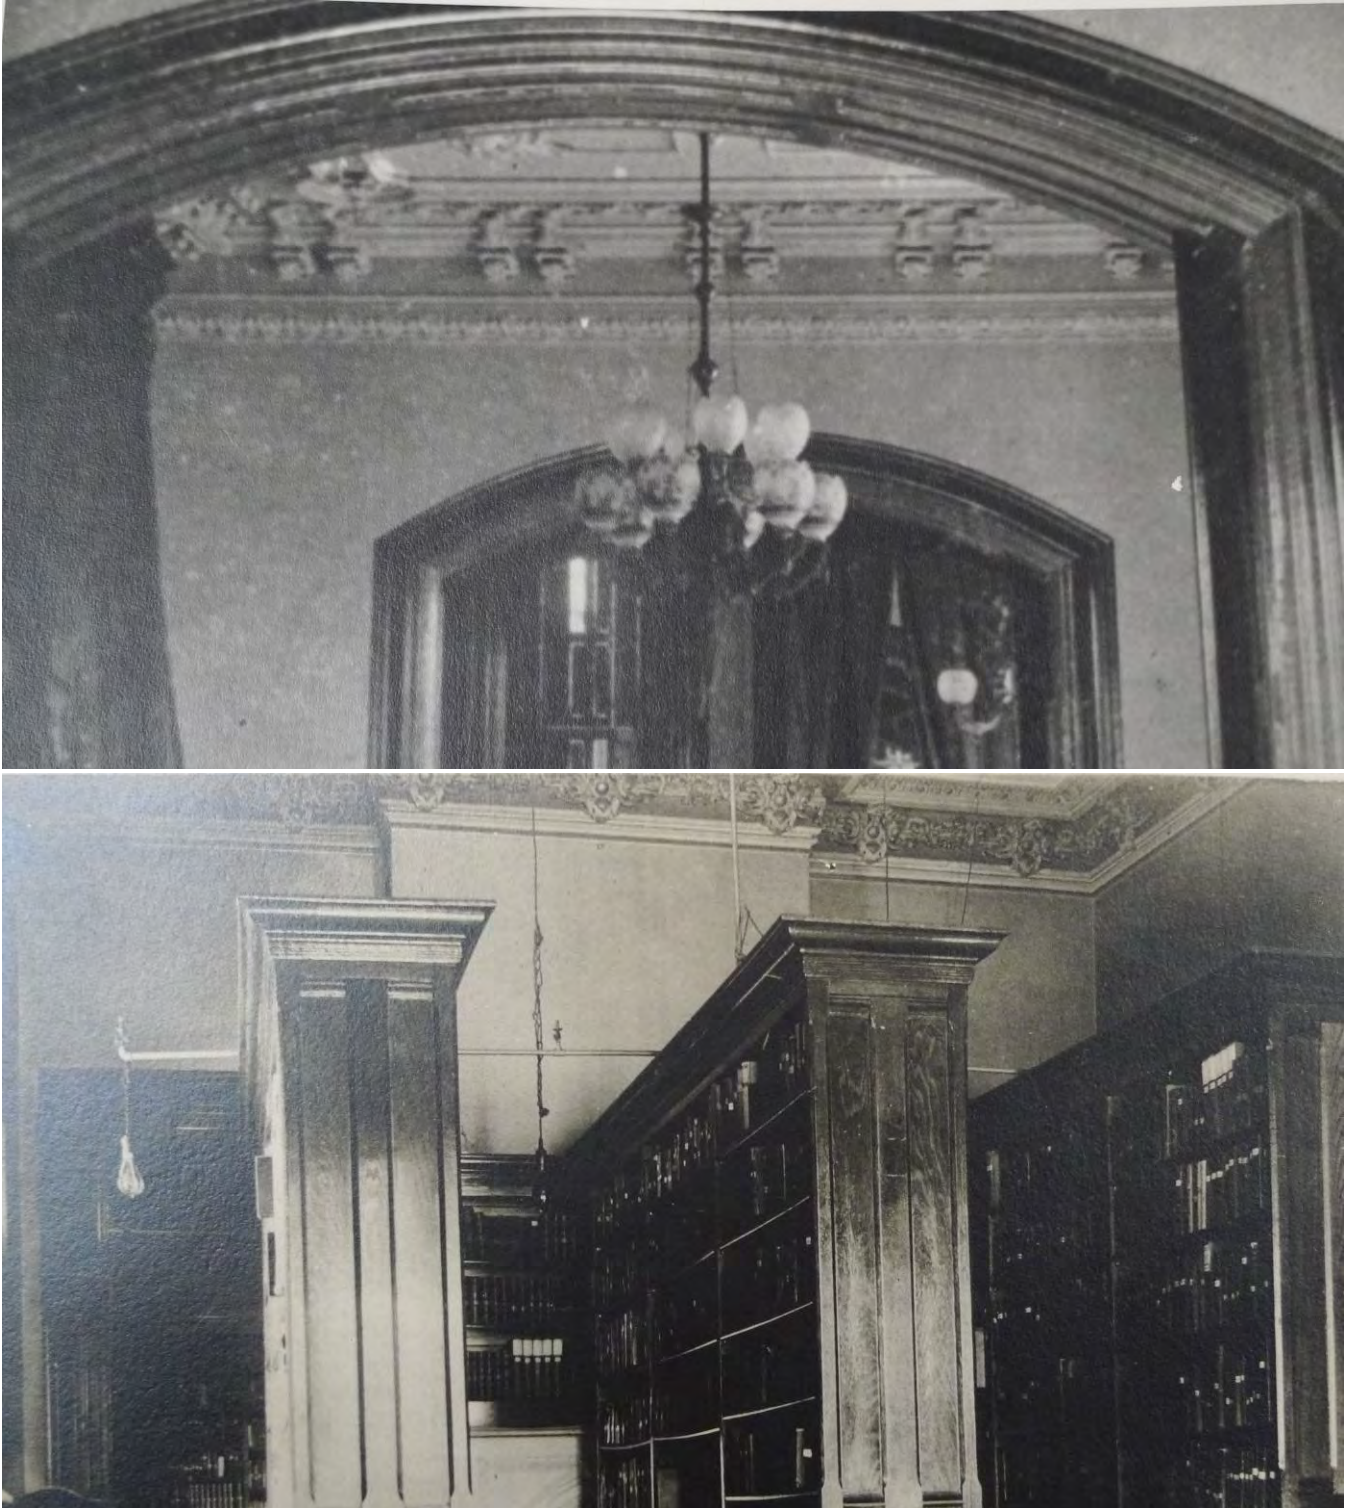
Figures 1 & 2: The photo above is a view into the SE Parlor during William Reddick's funeral in 1885. Aside from the painted wood grain on the door surround, no other type of painted decoration could be seen. The photo below is from the Center west Parlor early during the library period where the crown molding is clearly polychromed and has embellishments such as metallic finishes. Source: Ottawa Public Library Archives

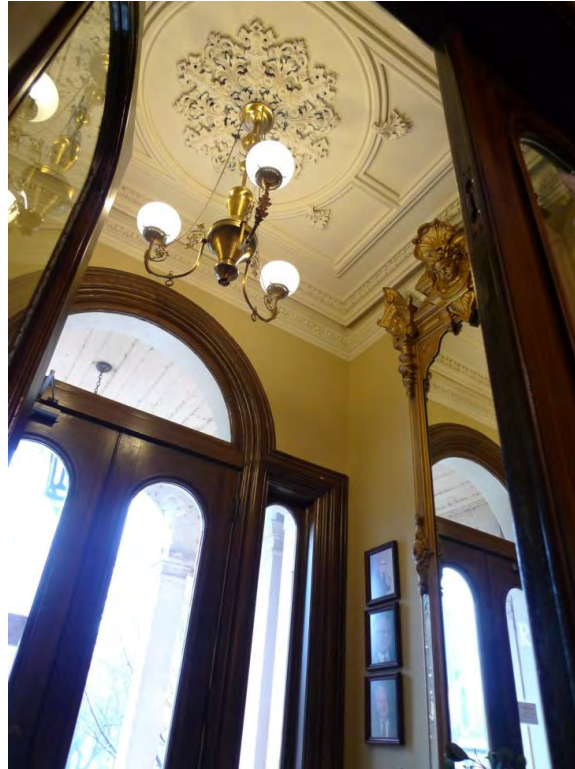
Room 200 / Main Level - Foyer

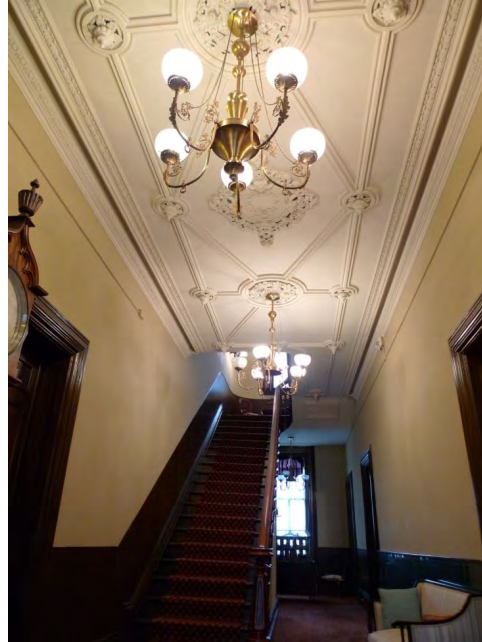
Room 201 & 201a / Main Level - Hallway

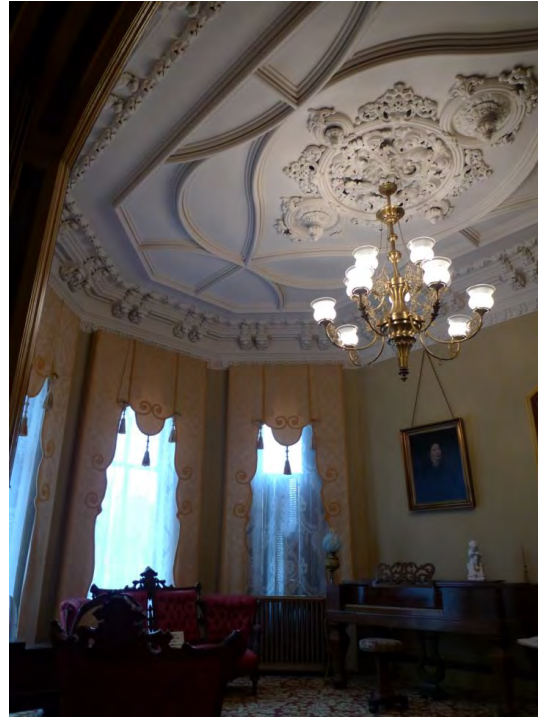
Room 202 / Main Level - SE Parlor

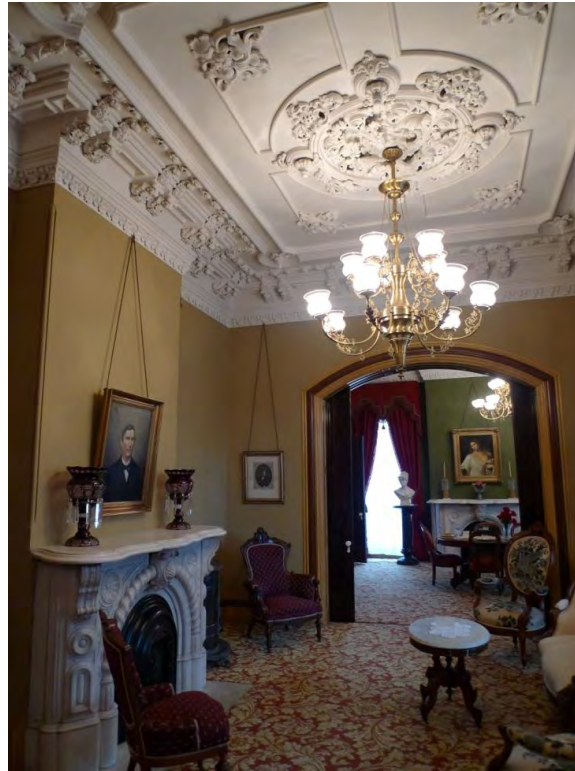
Room 203 / Main Level - CE Parlor

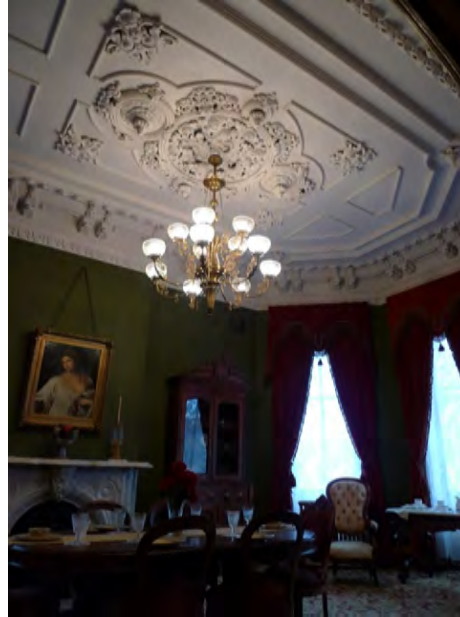
Room 204 / Main Level - NE Parlor

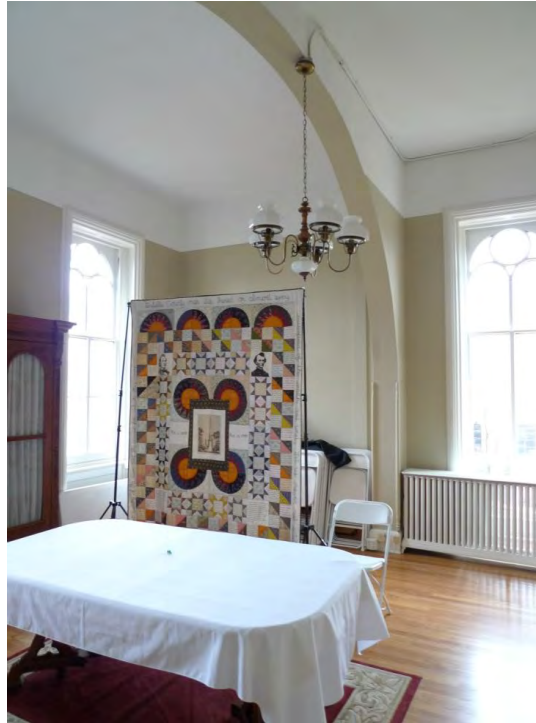
Room 207 (formerly 205) / Main Level - NW (Possibly Kitchen)

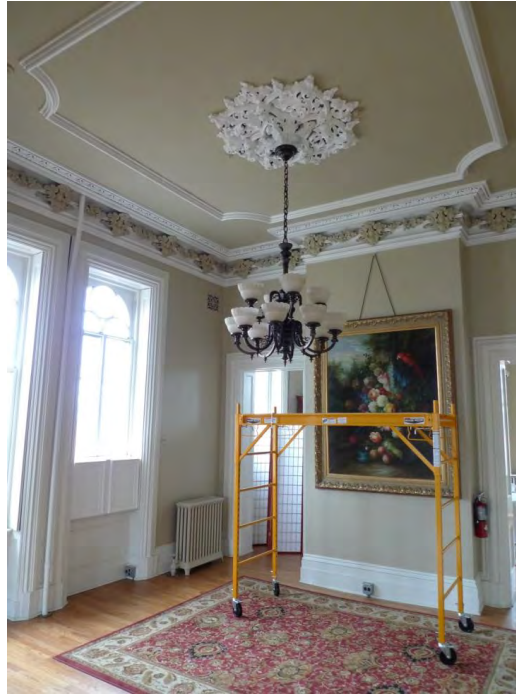
Room 206 / Main Level - CW Parlor

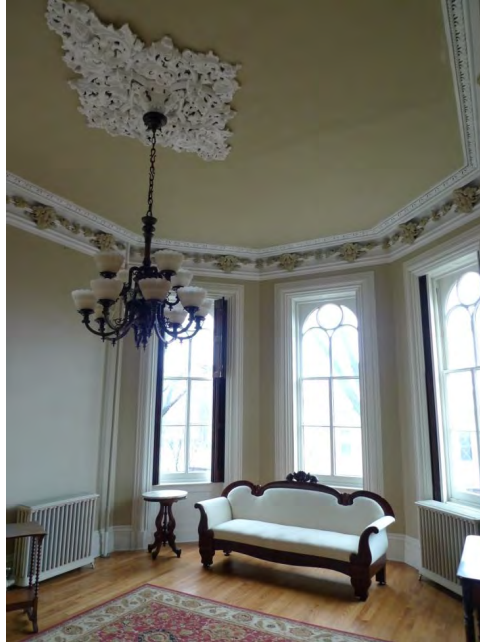
Room 205 (formerly 207)/ Main Level - SW Parlor

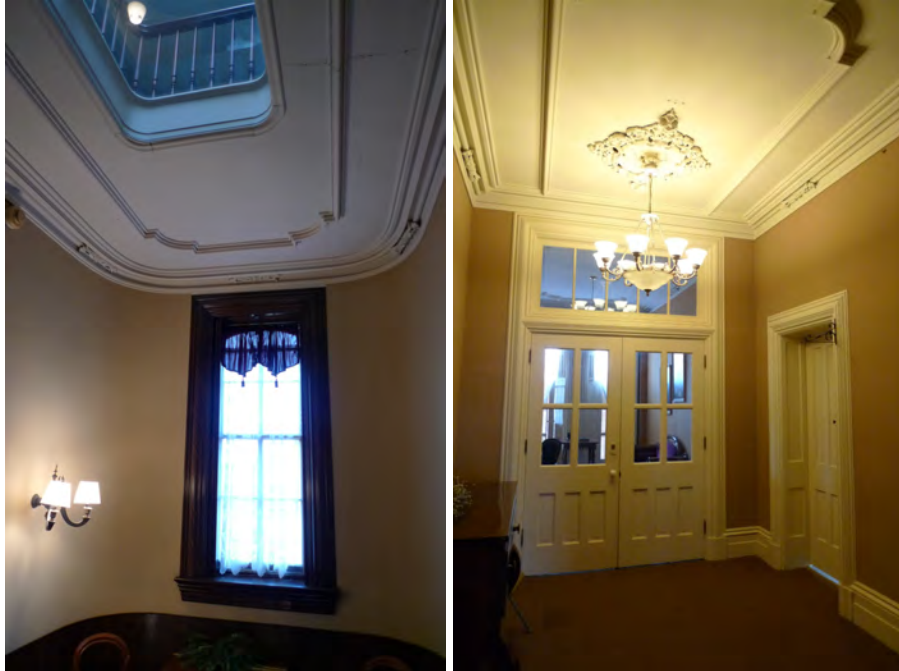
Room 301 (formerly 300) / Bedroom Level - Stair Hallway

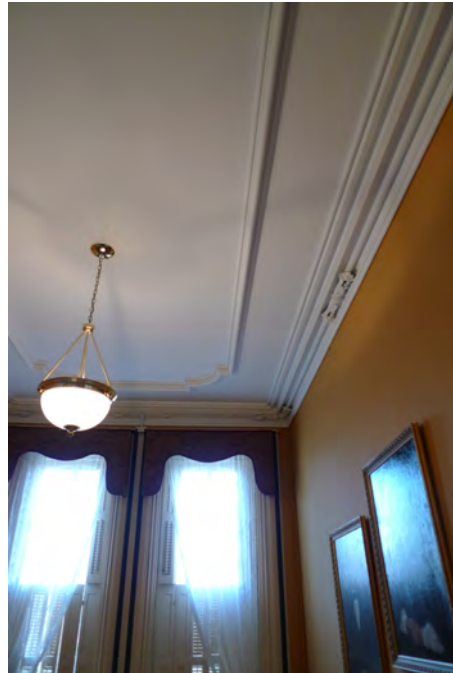
Room 301a (formerly 301) / Bedroom Level - South Hallway

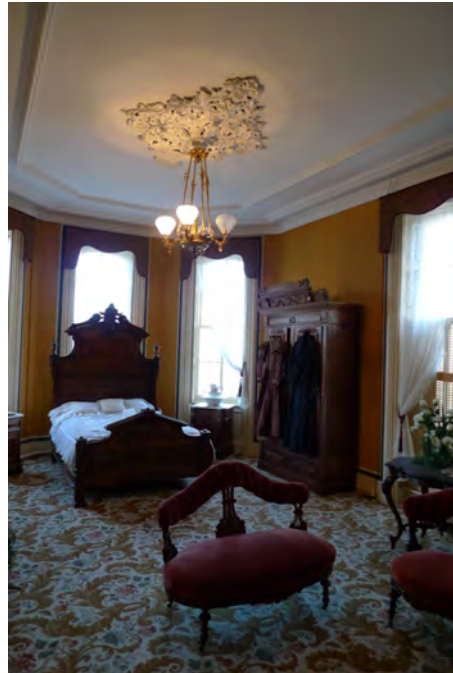
Room 302 / Bedroom Level - SE Bedroom

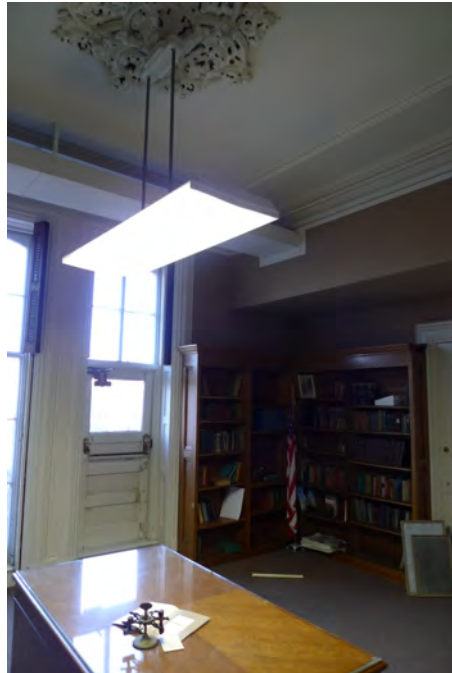
Room 303 / Bedroom Level - CE Bedroom

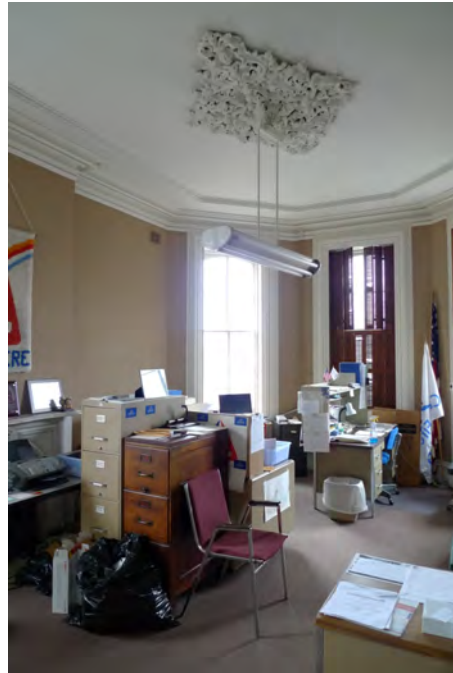
Room 304 / Bedroom Level - NE Bedroom

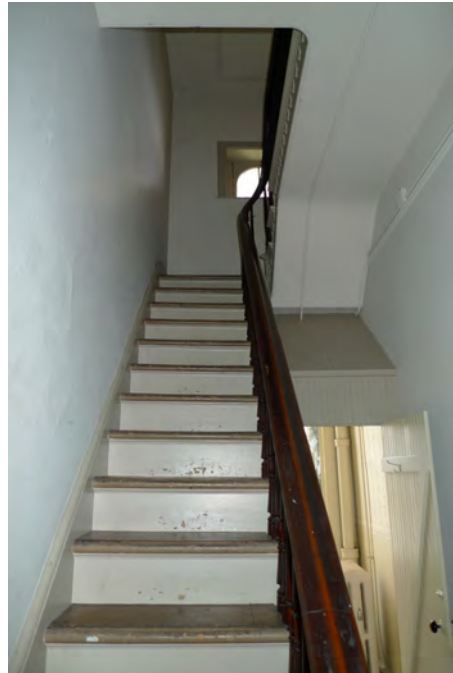
Room 308 (formerly 305) / Bedroom Level - Servants Stair

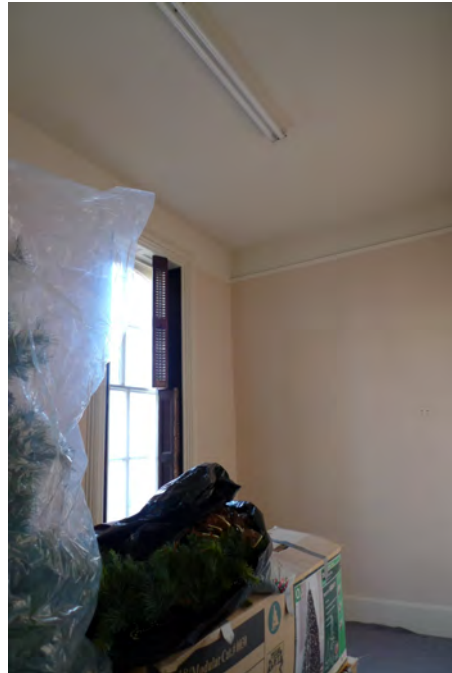
Room 307 / Bedroom Level - NW Room

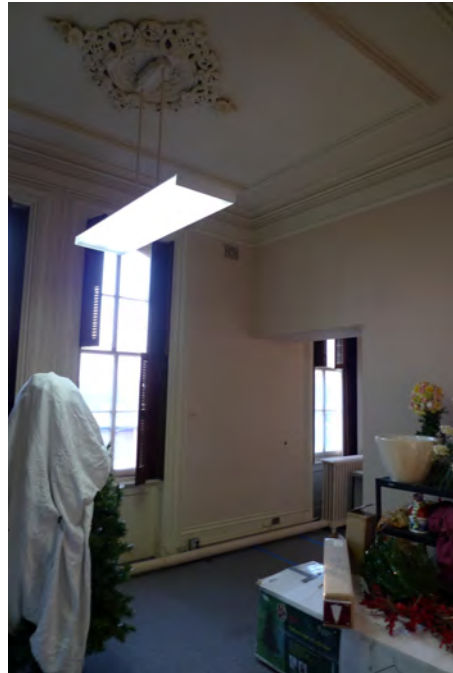
Room 306 (formerly 308) / Bedroom Level - CW Bedroom

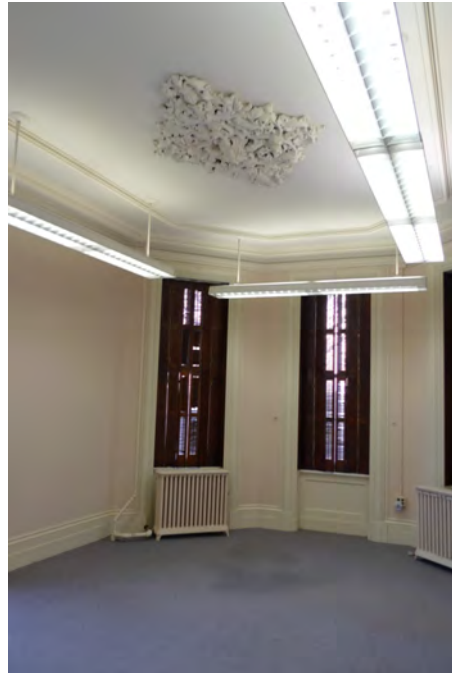
Room 305 (formerly 309) / Bedroom Level - SW Bedroom

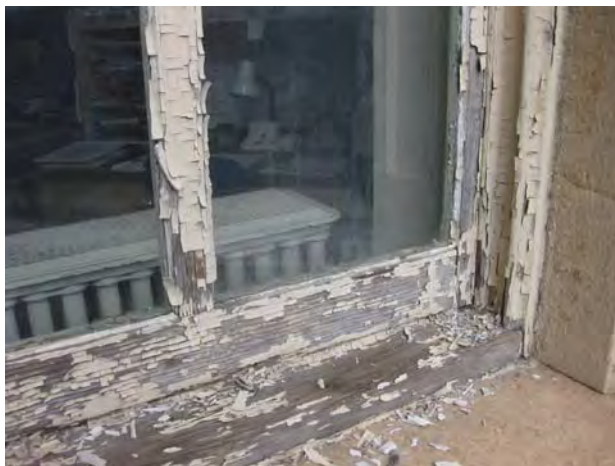
Window in Disrepair Allows Excessive Infiltration

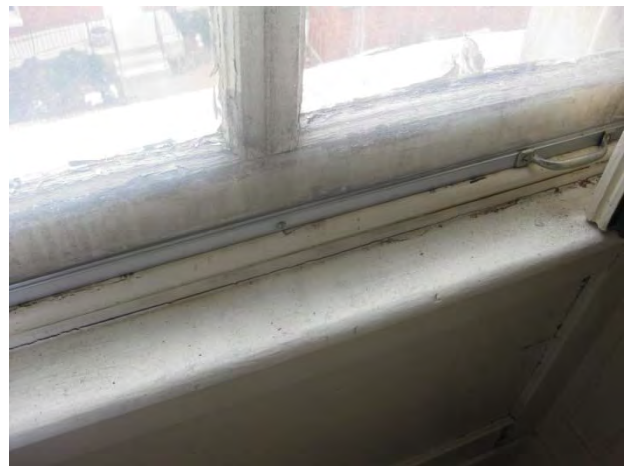
Window Fitted with Plexi-Glass Fixed Interior Storm Pane

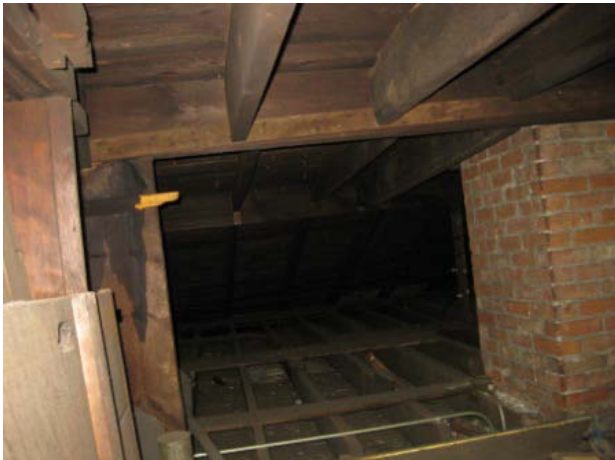
No Insulation in Roof or Floor Joists - Attic

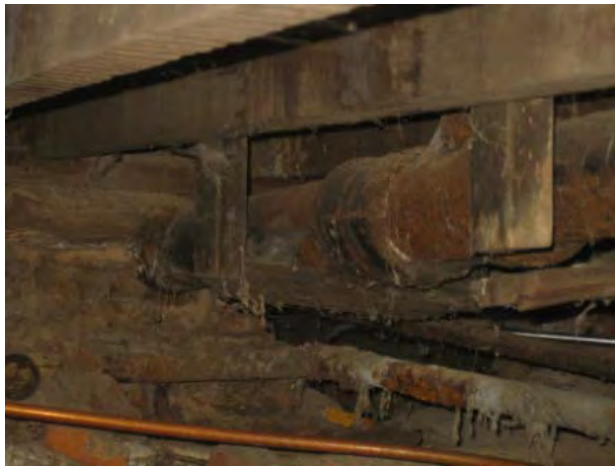
Abandoned Sanitary Piping - Crawlspace

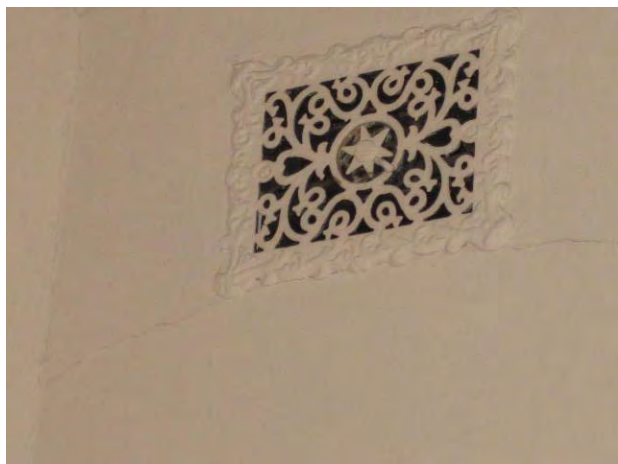
Wall Vent Opening – Star in Center was Connected to Chain Operators to Allow for Opening and Closing Operable Damper Installed Behind Vent Face (Typical)

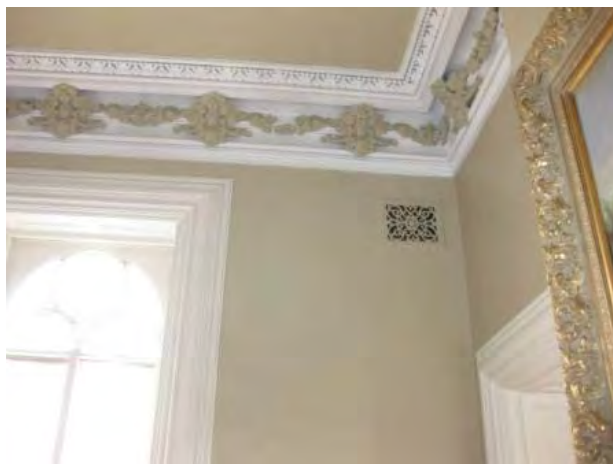
Typical Wall Vent Opening

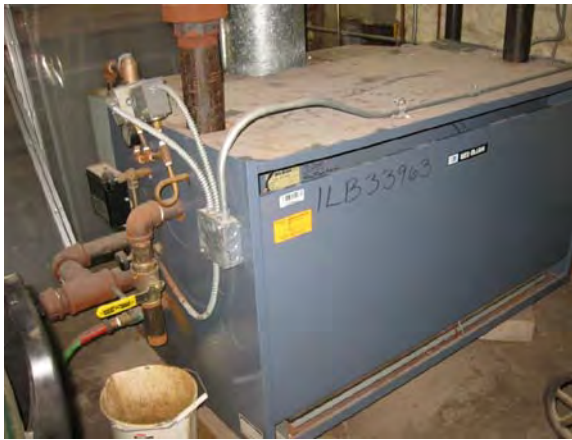
Existing Natural Gas Boiler

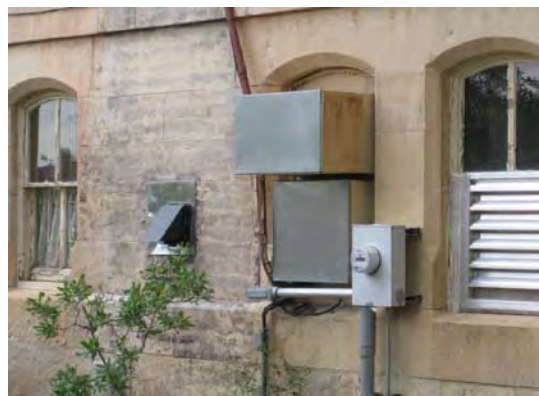
Boiler Forced Flue Vent Cap on Left, Combustion Air Louver on Right, Abandoned HVAC Ducts Penetrating Window Opening in Center

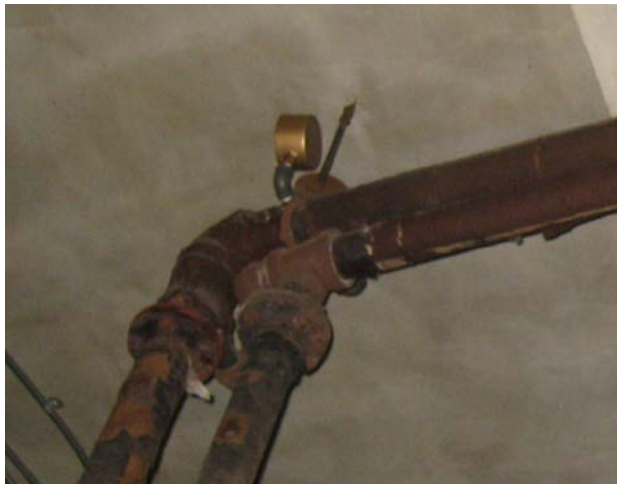
High Point Automatic Air Vent in Boiler Room

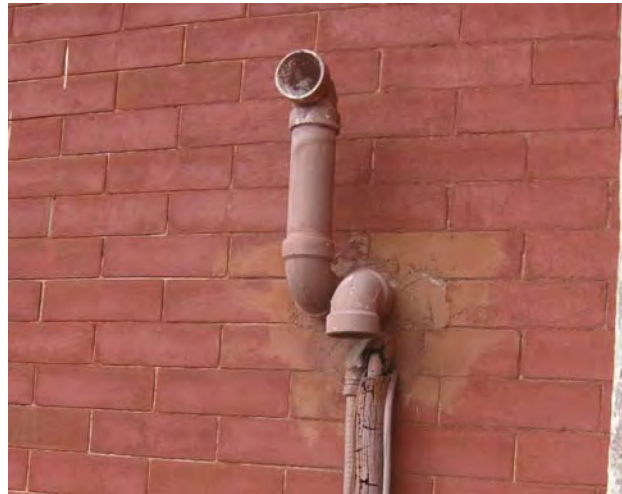
Furnace Flue, Intake and Refrigerant Piping – Painted to Match Adjacent Wall

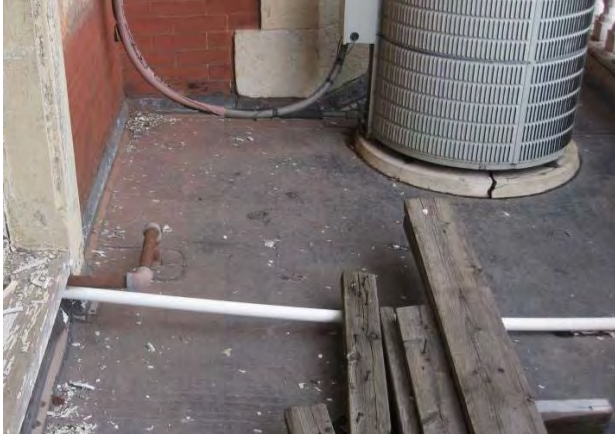
Gas Pipe & Condensate Drain for Furnace in Adjacent Office 303

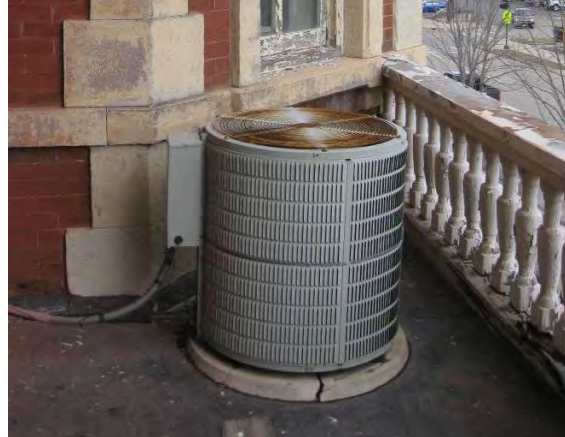
Condensing Unit for Furnace in Office 303

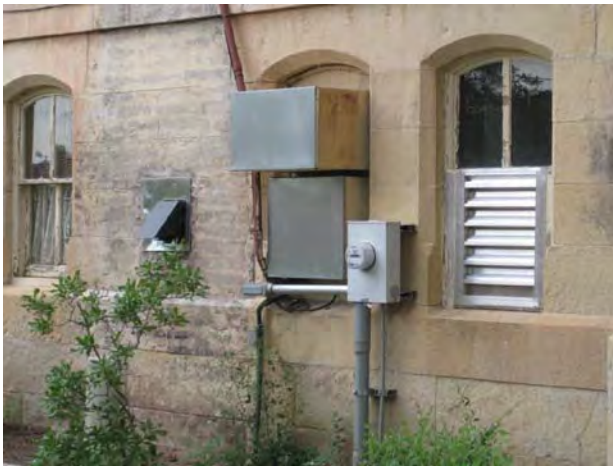
Duct from Demolished Air Conditioner at Boiler Room

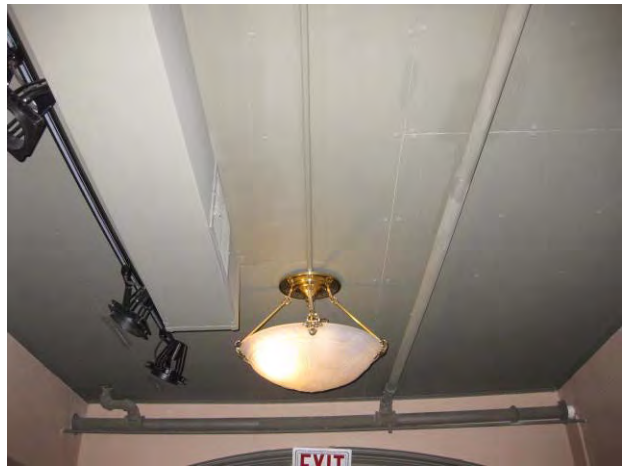
Duct in First Floor Main Hall

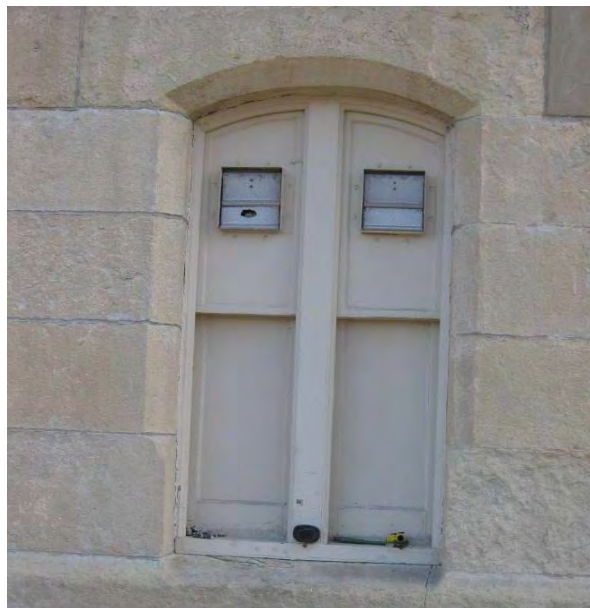
Exhaust Fan Discharge from First Floor Toilet Rooms

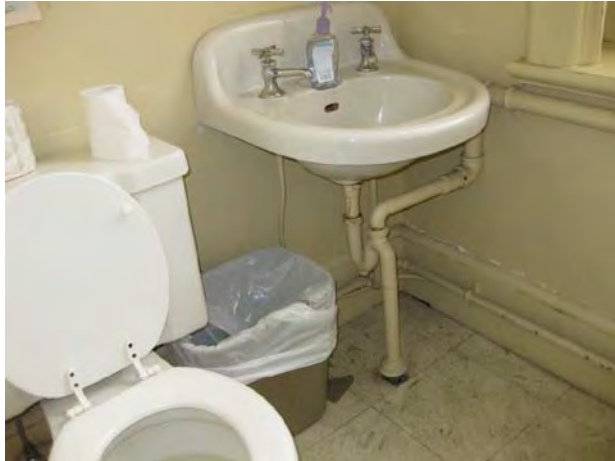
Third Floor Toilet Room

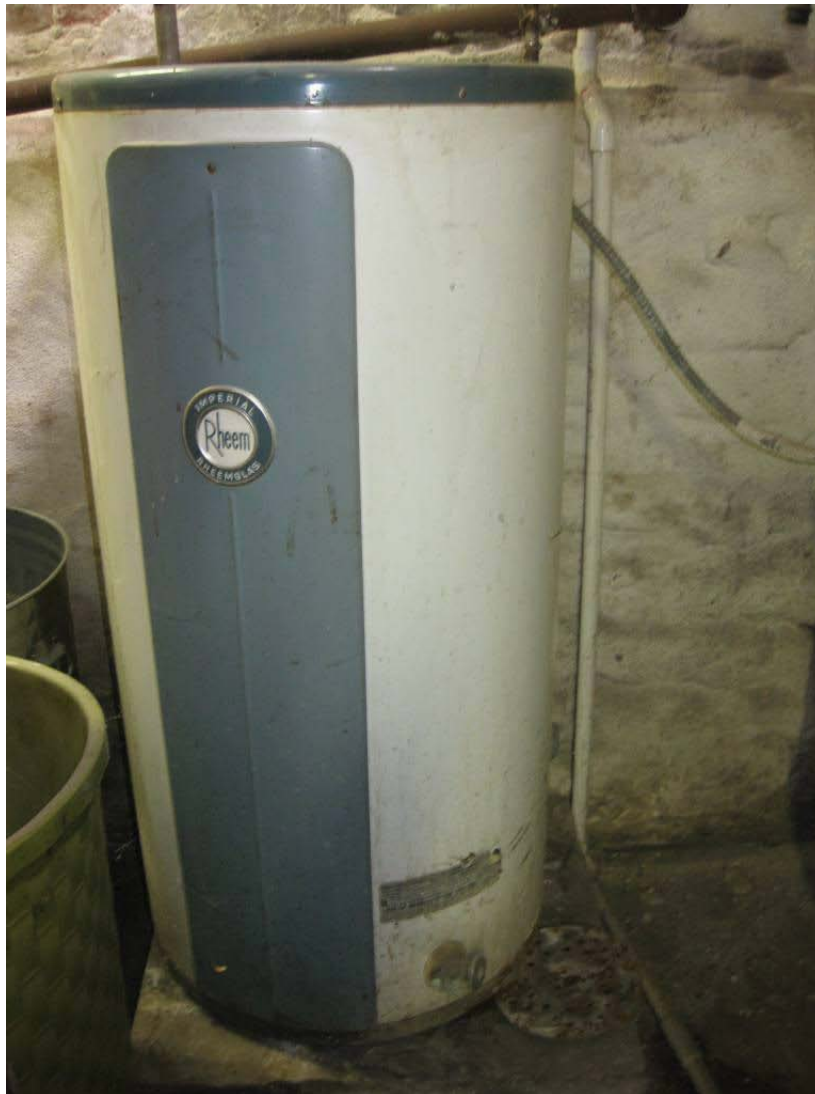
Electric Water Heater in Boiler Room

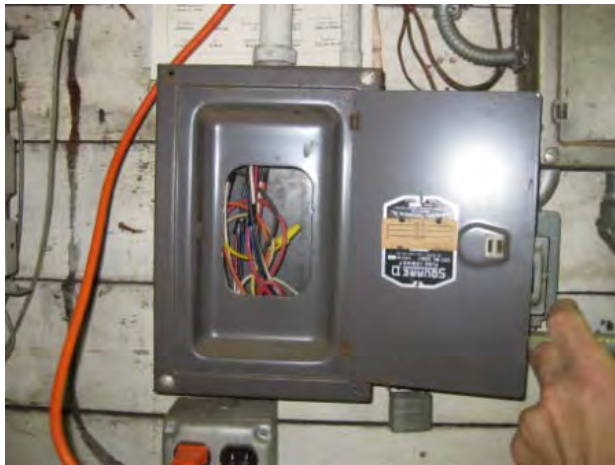
Main Service Panel – 200 Amp, 120-208 Volt, Three Phase

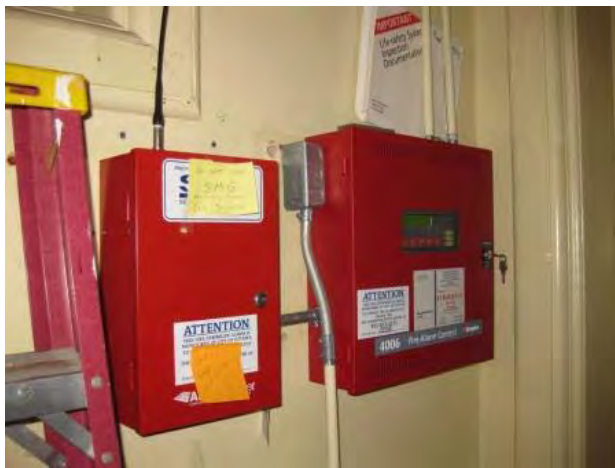
There is a supervised fire alarm system installed throughout the building with smoke and heat detectors mounted in most, if not all areas. These detectors are connected to a Fire Alarm Panel (Simplex 4006 Series). Smoke detectors in the system look to be a mixture of new and older models. Since detectors have a useful life of between five and ten years, many of these detectors have likely reached the end of their useful life.
