## MEMORANDUM

PROJECT: Demolition of 1206 17<sup>th</sup> Street SHPO Log #010102521

SUBJECT: Documentation of 1206 17<sup>th</sup> Street

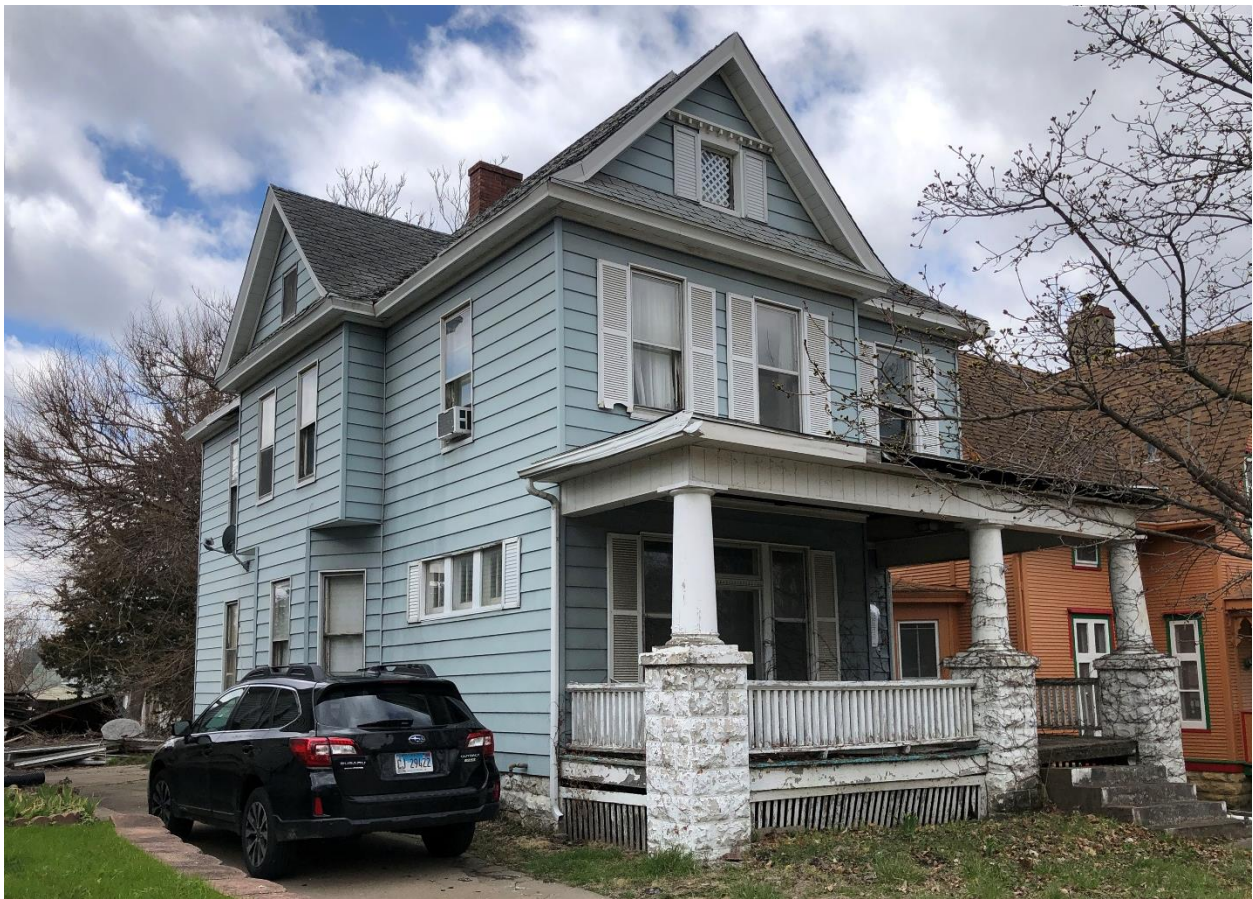
**Photograph No. 1:** View of the front (east) and side (south) façades of 1206 17<sup>th</sup> Street looking northwest with a view of the collapsed historic automobile garage in the background.

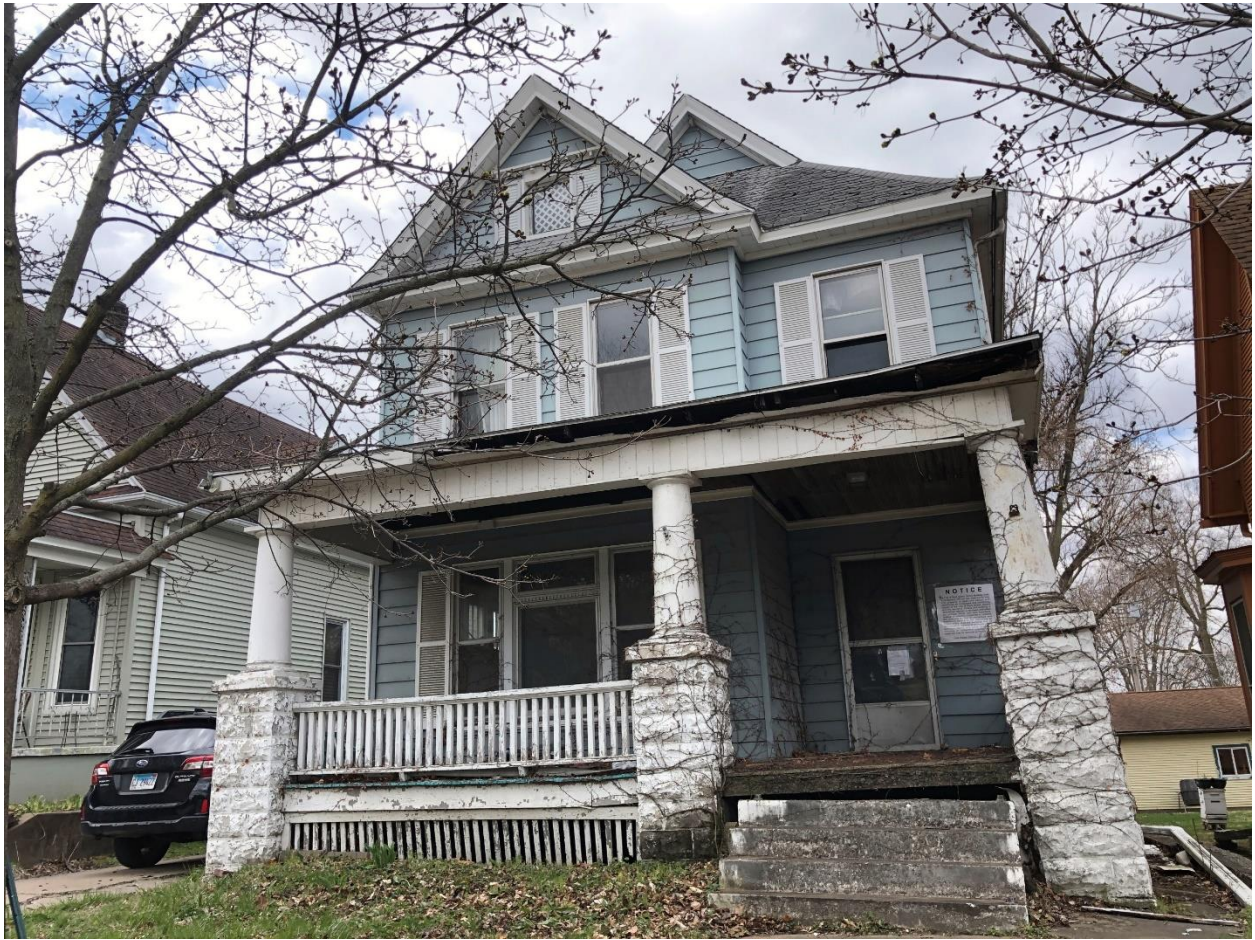
**Photograph No. 2:** View of the front (east) façade of 1206 17<sup>th</sup> Street looking west.

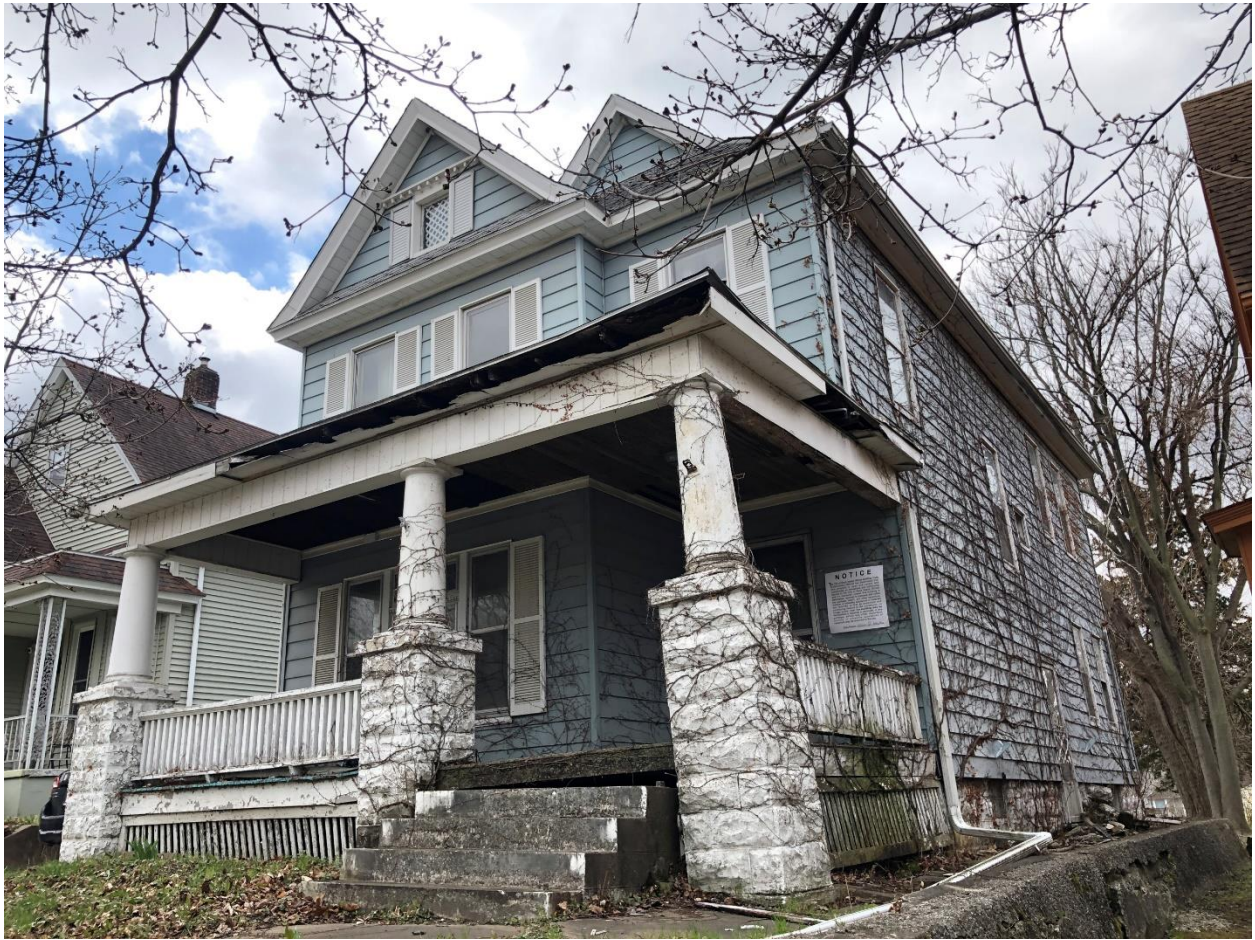
**Photograph No. 3:** View of the front (east) and side (north) façades of 1206 17<sup>th</sup> Street looking southwest.

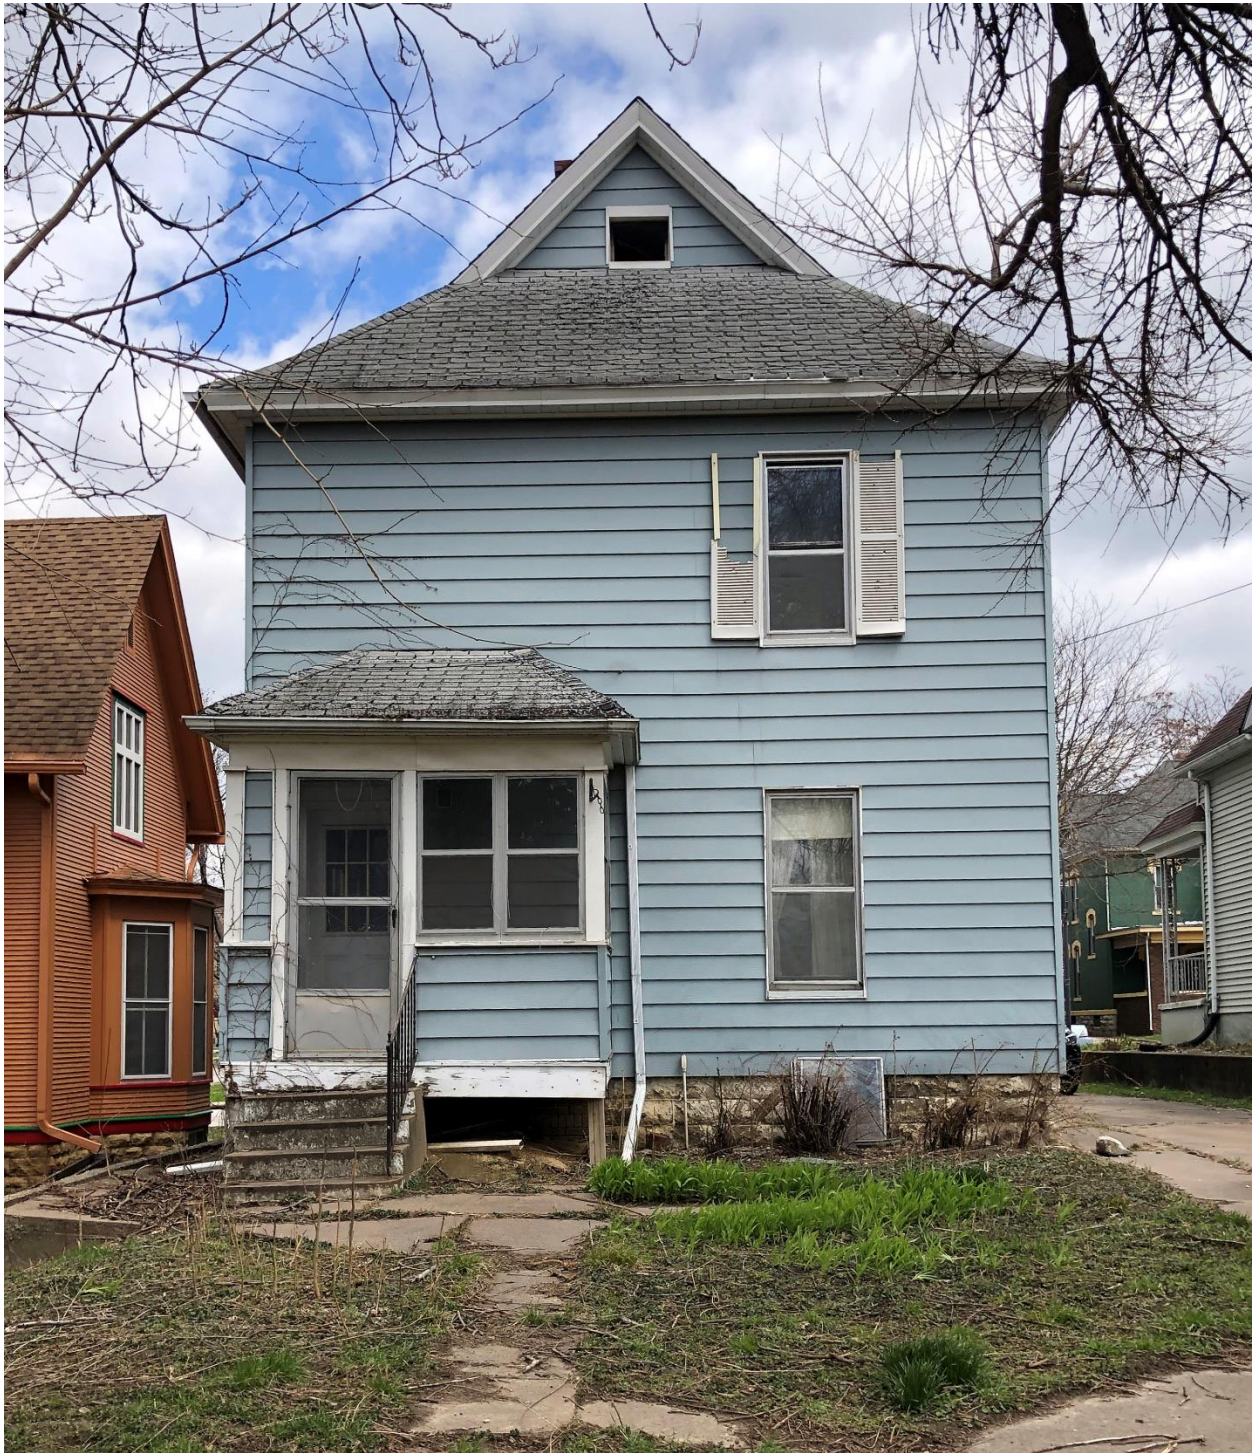
**Photograph No. 4:** View of the rear (west) façade of 1206 17<sup>th</sup> Street looking east.

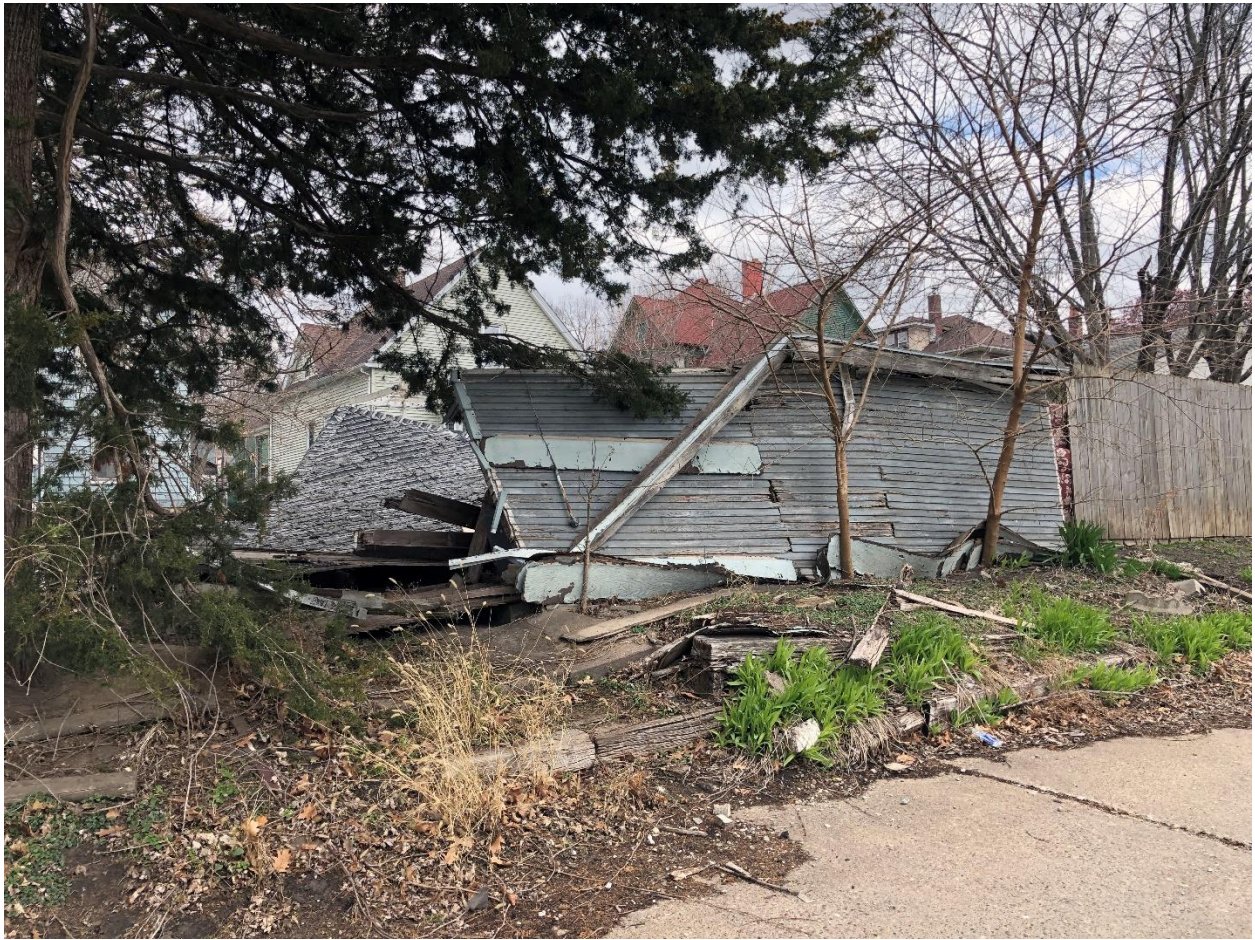
**Photograph No. 5:** View of the collapsed historic automobile garage looking southeast from the alley.
