Illinois State Capitol Historic Structure Report

March 17, 2009

Wiss, Janney, Elstner Associates, Inc.

WJE Project Number: 2007.0701

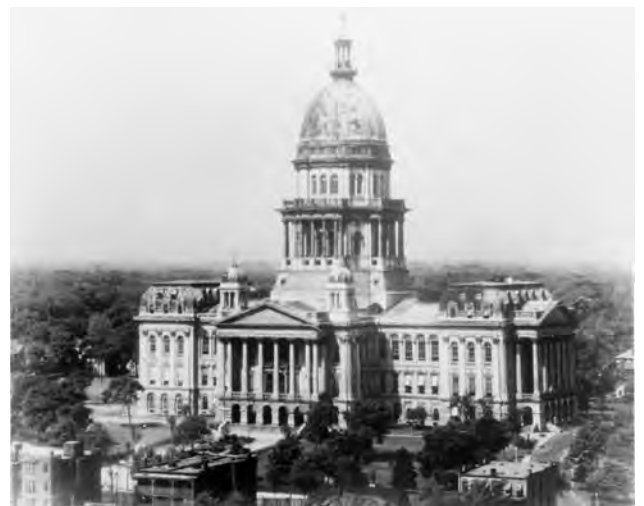
In the 1930s the dome was found to be in poor condition and in imminent need of repair (Figure A18).

Figure A18. In this early 20th Century photograph the poor condition of the dome cladding is readily noticeable.

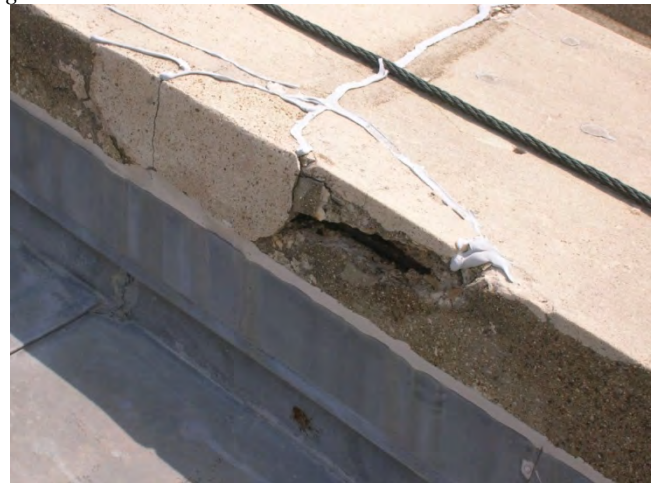
Figure C17. Deteriorated cast-in-place concrete at the east and west gables.

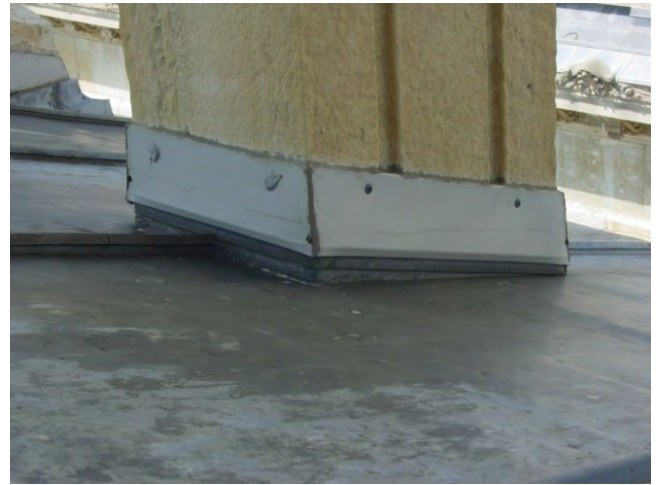
Figure C21. Previous repairs include the installation of membrane clad counterflashings at the base of the columns.

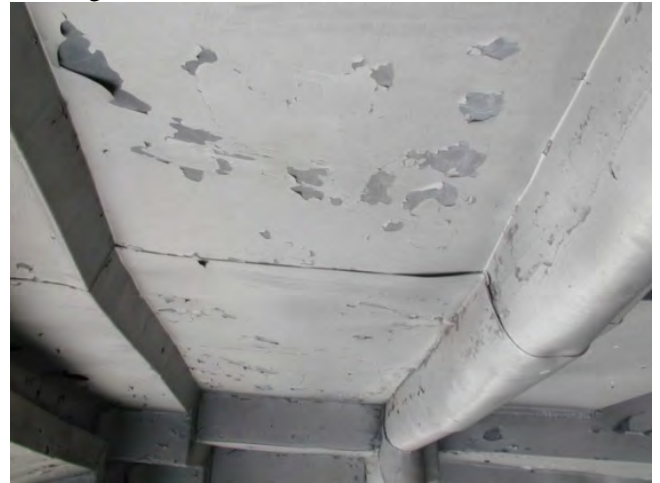
Figure C41. Peeling paint at dome cladding.

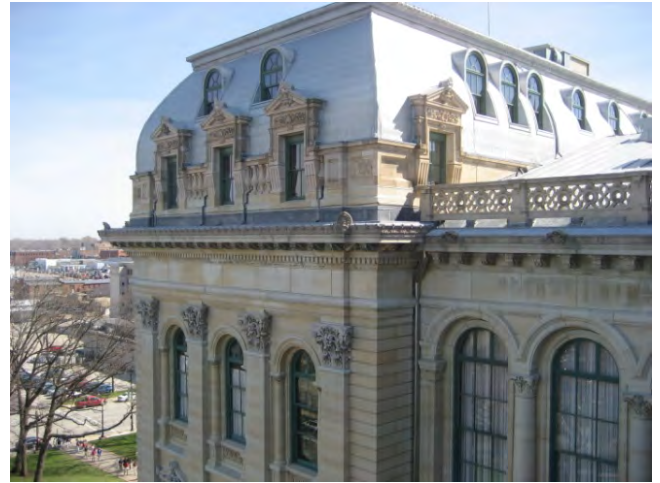
Figure C52. Surface erosion of limestone below cornice.

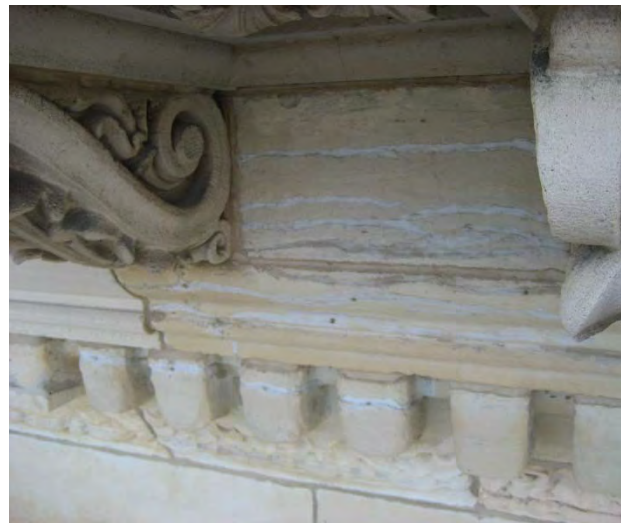
Figure C60. Epoxy injection repair of bedding plane.

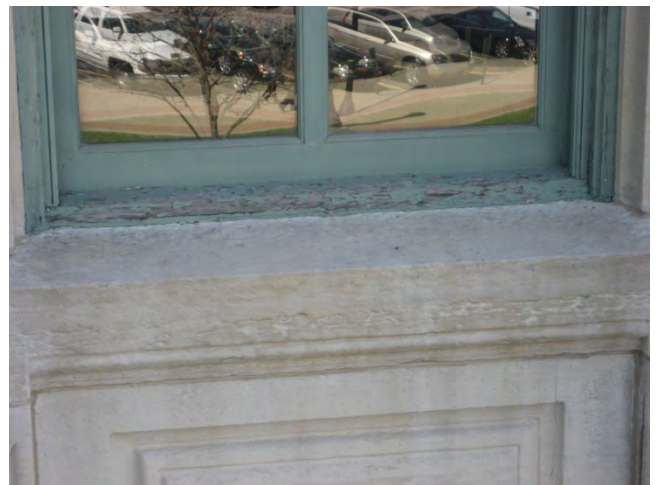
Figure C111. Paint failure and wood deterioration at sill.

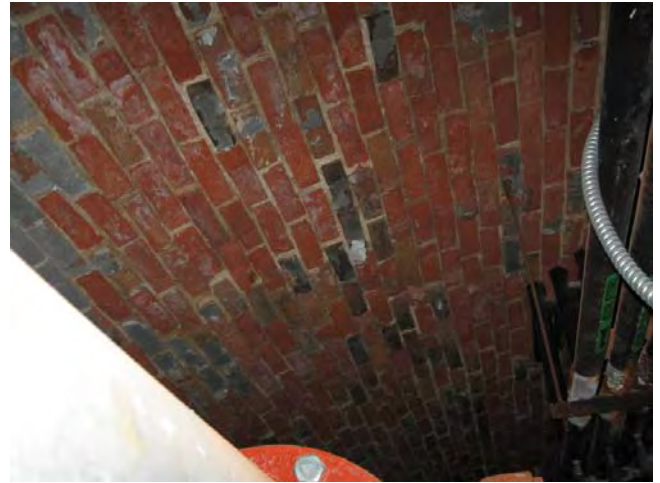
Figure C138. Spalling and flaking of brick arch on underside of vault beneath north portico.

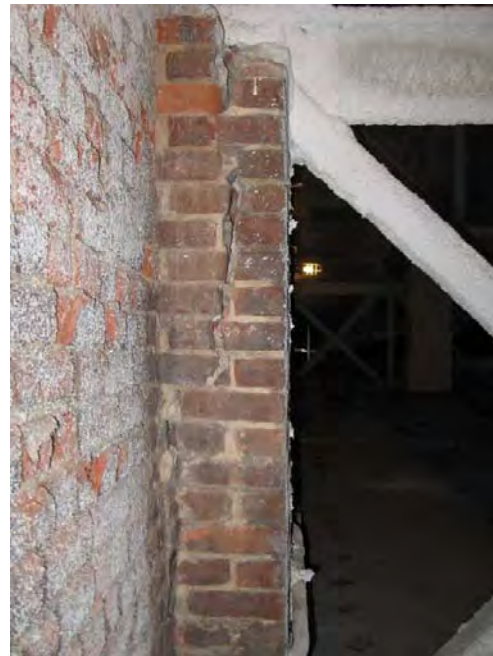
Figure C178. Significant cracking of integral masonry pier supporting main low truss. Also, note the spalling, flaking and efflorescence of the backup masonry wall.
