**A HISTORIC STRUCTURE ASSESSMENT
OF
THE ZEINE CABIN,
WILDLIFE PRAIRIE STATE PARK,
PEORIA COUNTY, ILLINOIS**

by
Christopher Stratton

Fever River Research
Springfield, Illinois

December 2001

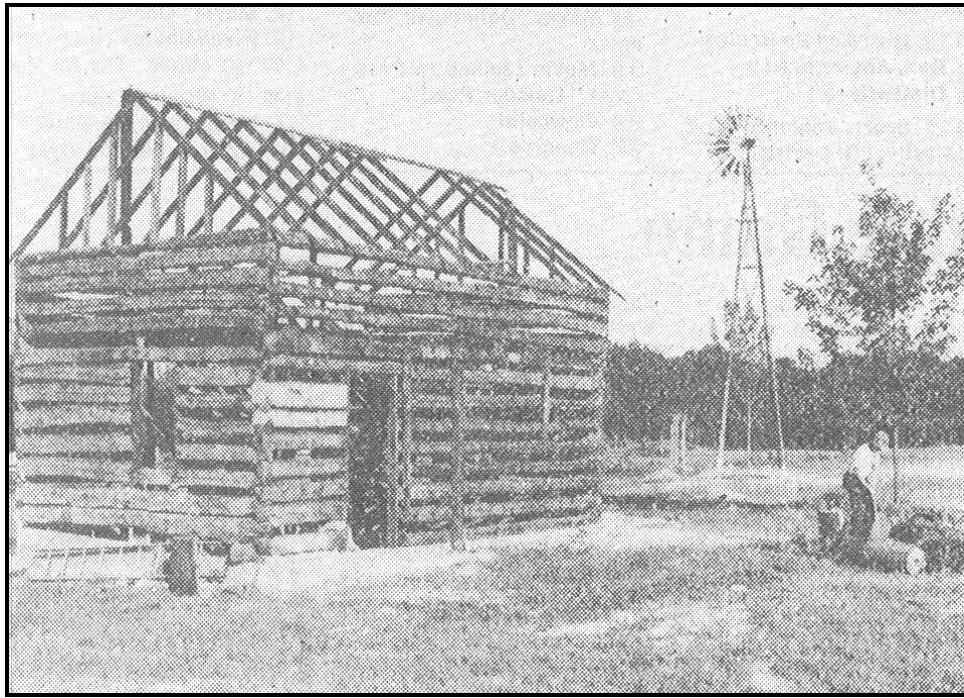
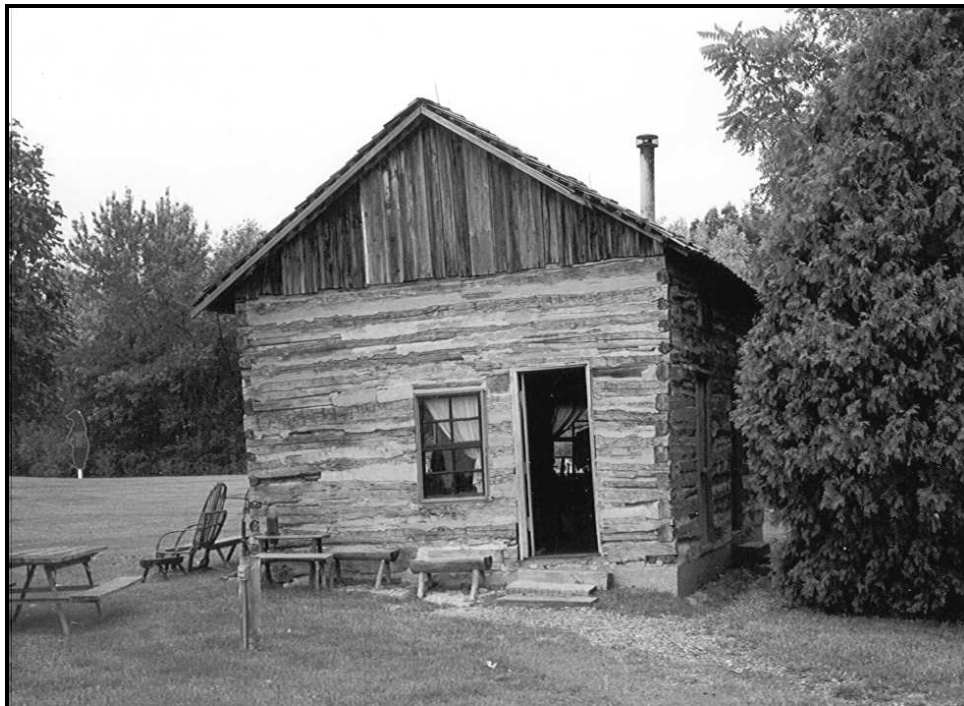
Figure 2. (Top) The Zeine Cabin during the course of its reconstruction in 1980. This view is looking toward the northeast (*Peoria Journal-Star* 25 August 1980). (Bottom) The south elevation of the cabin, showing existing conditions (FRR September 2001).

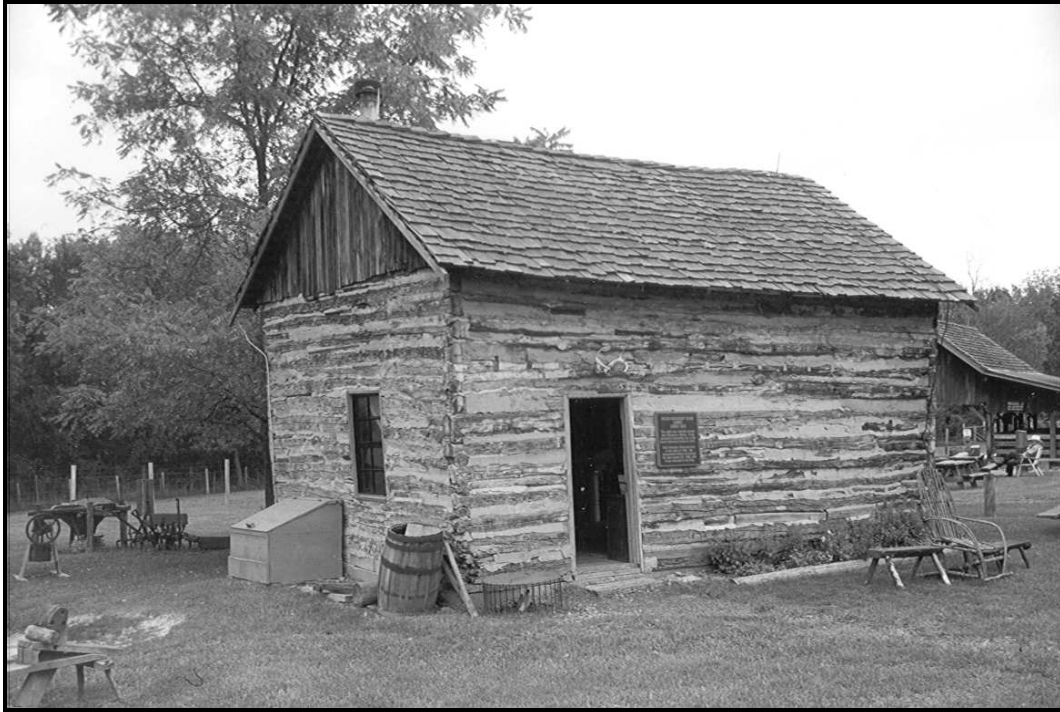
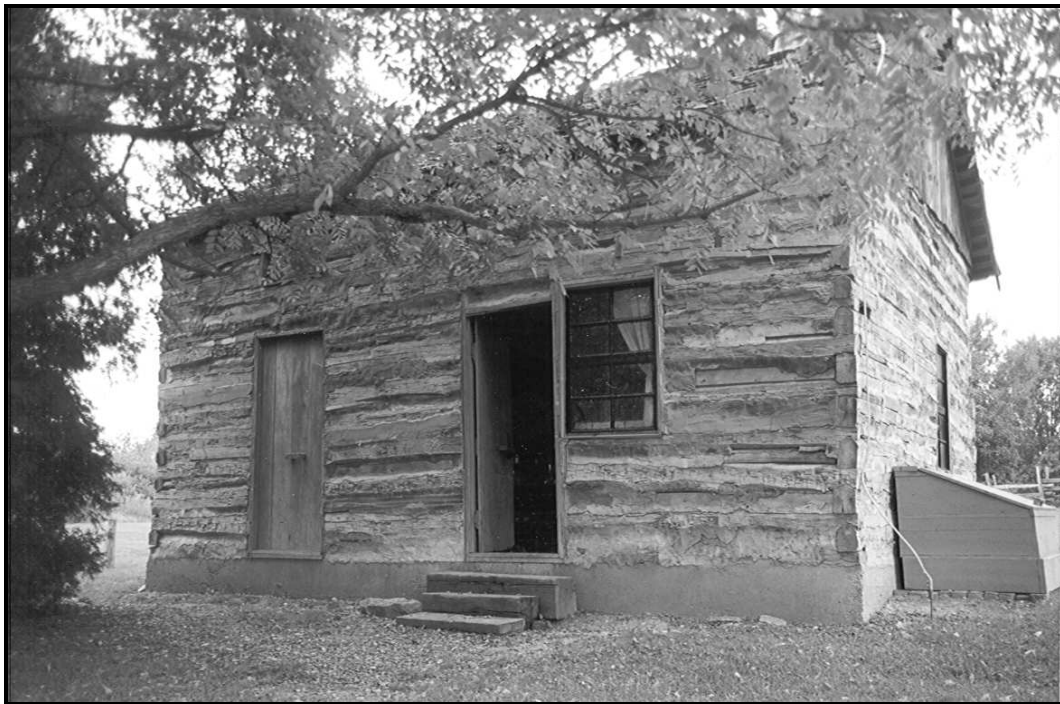
Figure 3. (Top) Oblique view, showing the west and north elevations of the cabin. (Bottom) View of the east elevation. The presence of two doorways here suggests that an addition may have once been present on this side of the dwelling, as was the case on the opposing elevation (FRR September 2001).

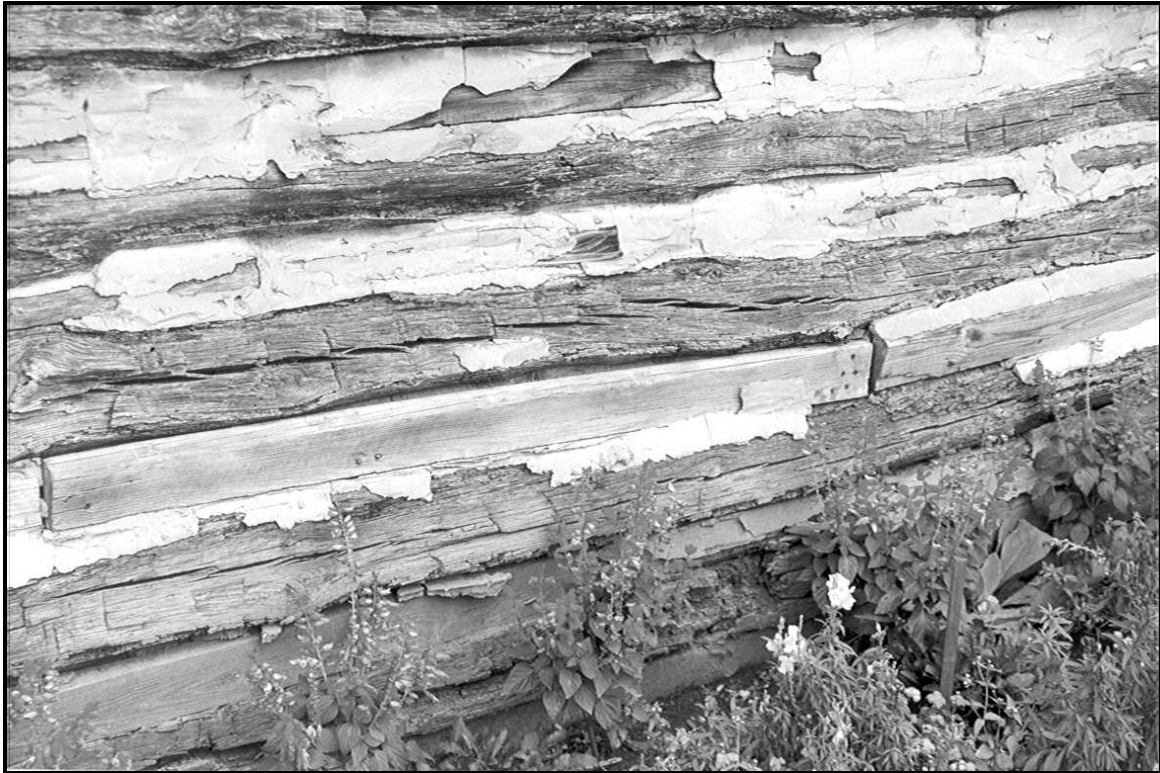
Overall, the wall logs of the Zeine Cabin generally are in good condition, in spite of the fact that they have been exposed to the elements for over twenty years. However, a number of logs have started to rot away. This deterioration is most pronounced on the lower logs, which are comparatively more exposed to moisture (rain and snow) and tend to be the last to dry out. The west elevation and northwest corner, in particular, have suffered from weathering, and the replacement lumber has had to be scabbed in at a number places where the logs have rotted out (see Figure 7 and 8). The continued deterioration of the lower logs will inevitably lead to a general structural failure of the cabin, since the wall logs are largely held in place by their own weight. The fact that the logs are relatively thin (6") and small in diameter gives the cabin's walls more flexibility than might otherwise be the case with a dwelling having larger logs. As it is, the east and west walls, which are the long walls of the cabin, have a pronounced bow or deflection to them (see Figure 8).

The chinking on the cabin also is in poor condition. When the building was reconstructed, the interstices between the logs were filled with sawn lumber and Portland-cement-based mortar. The lumber was used backing, while the mortar served as the facing material. Over the years, the mortar has cracked and, in some places, completely fallen away; this is not surprising, considering that the logs naturally expand and contract, whereas the harder mortar will not (Indeed, even historic chinking and daubing required constant attention and maintenance when it was unprotected by siding). Where the chinking has fallen away, the logs are even more susceptible to water damage, since water has the opportunity to collect in recesses where it cannot easily drain away, thus accelerating the rate the logs' deterioration.

Figure 7. Detail of the west wall of the cabin, illustrating the variety of problems facing the cabin. Note the deteriorated conditions of the lower logs, the modern replacement materials that have been used to stabilize the cabin, and the failed chinking (FRR September 2001).

The structural problems observed during the field investigation are largely linked to the fact that the exterior logs of the cabin are exposed and unprotected. Therefore, we strongly recommend that the exterior of the cabin be covered with horizontal weatherboard. This recommendation not only has a firm historical basis, but also has practical merits as well. The photographs that were taken during the dwelling's dismantlement in 1974 provide documentary evidence for the cabin having been covered with weatherboard previously. We also have physical evidence for the siding in the form of the nail patterns that were left behind after the furring strips for the siding were removed (see Figure 9). The nails used to attach the furring strips were machine cut, rather than wiredrawn, which strongly connotes a pre-1900 date for the siding.

We recommended that the exterior of the cabin be covered with beveled horizontal weatherboard with a 4-1/2" exposure. This siding appears to be similar to that originally used on the cabin and also would be appropriate for the period of construction. The siding should be nailed to vertical furring strips in the same manner as was originally utilized on the cabin. Figure 11 provides representative illustrations of the application of horizontal siding on two other log houses. The vertical plank siding now in place on the gable ends should be removed and

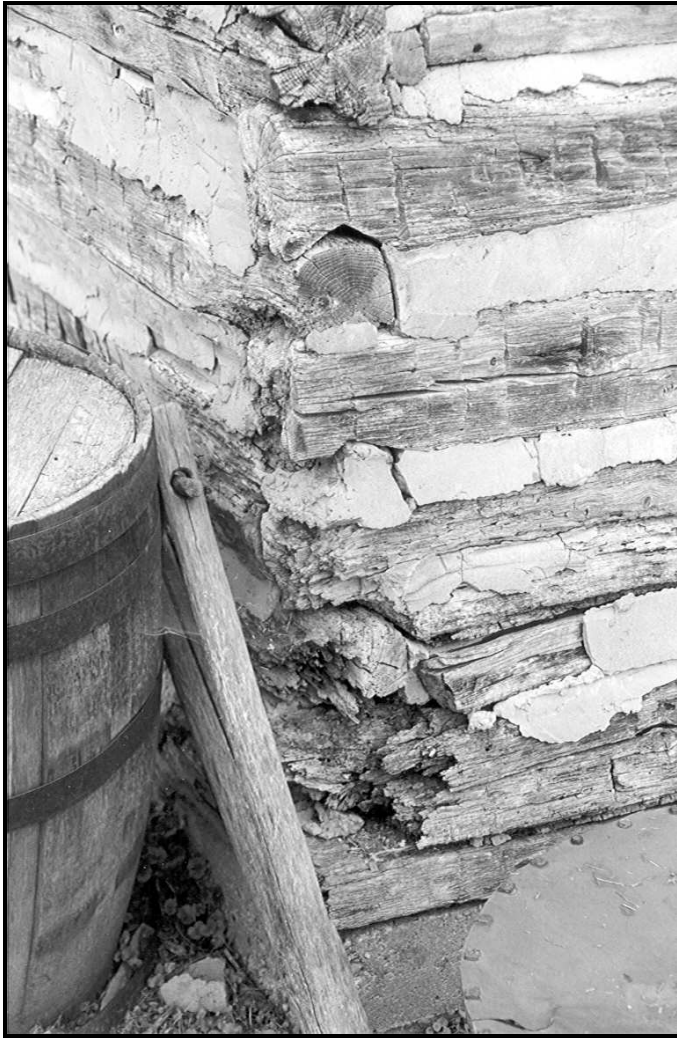
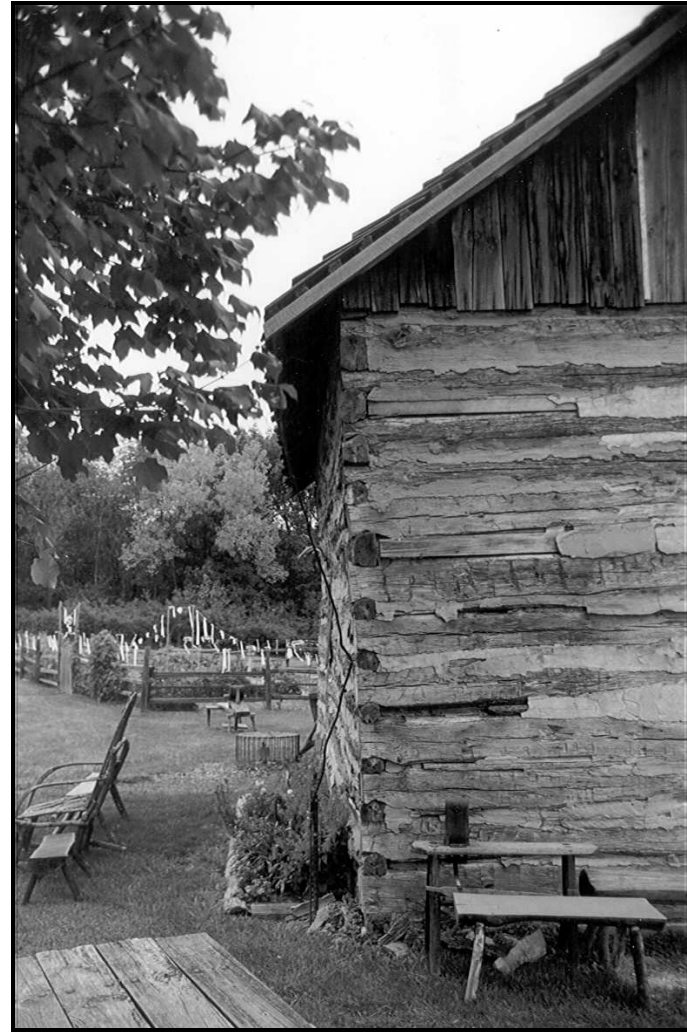
Figure 8. (Left) View of the northwest corner of the cabin, which is badly weathered. (Right) View down the west wall of the cabin (looking north), showing the deflection in the wall (FRR September 2001).

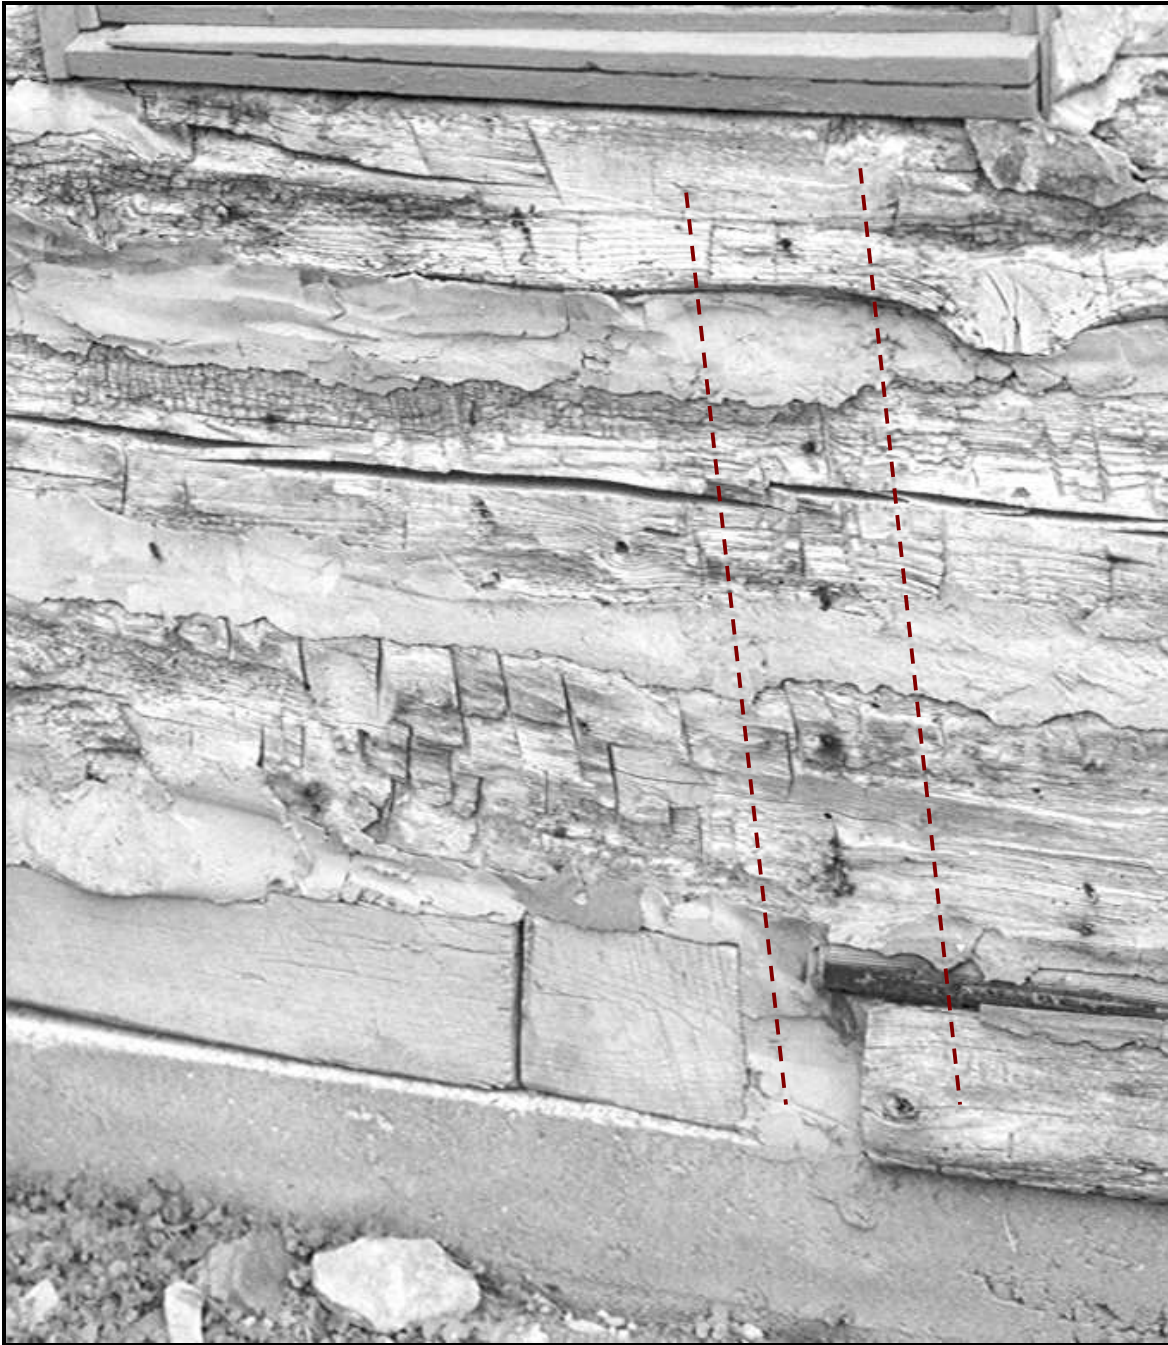
Figure 9. Nail pattern indicating the location of one of the furring strips to which the original exterior siding on the cabin was attached. The dashed lines represent the approximate edges of the furring strip (FRR September 2001).

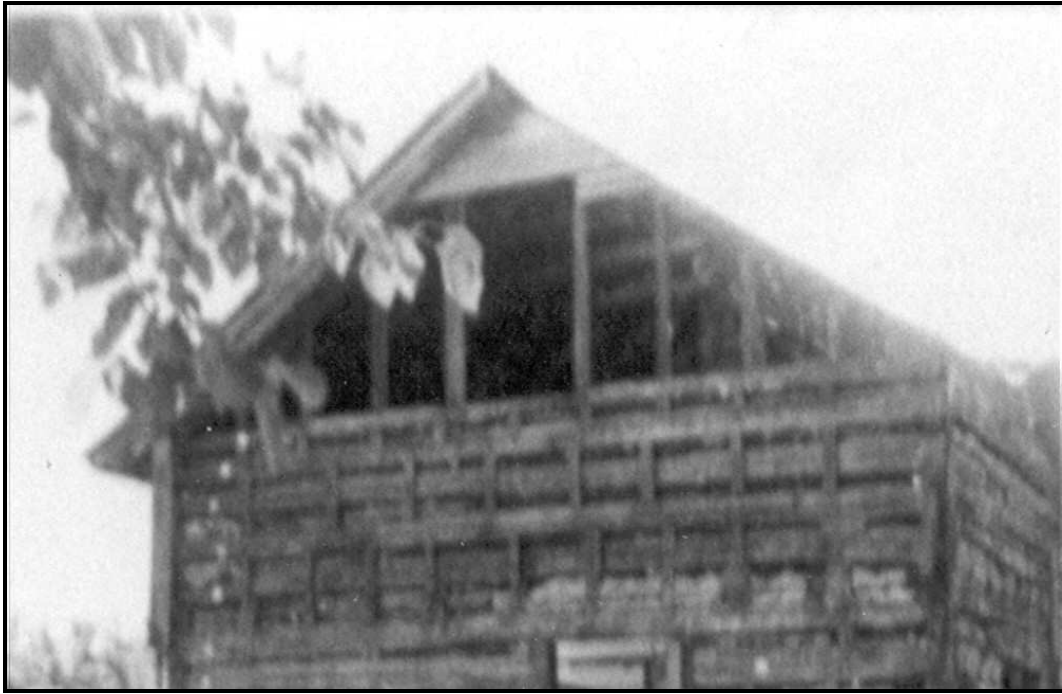
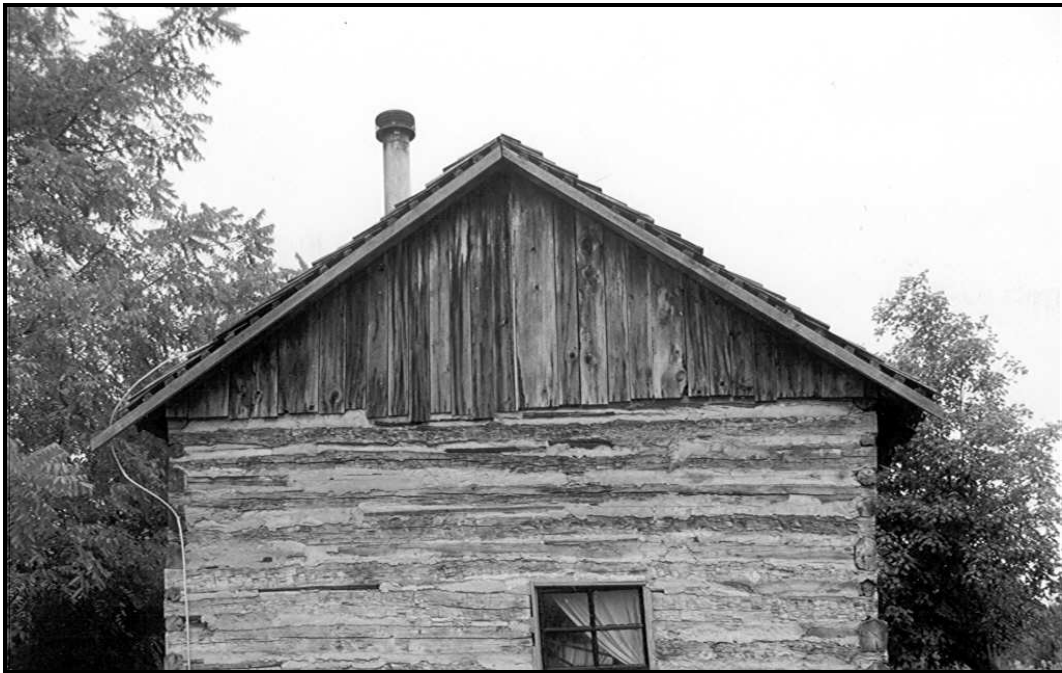
Figure 13. (Top) Detail of an 1974 photograph of the Zeine Cabin, showing the remnants of the horizontal siding originally used to enclose the north gable (WPSP August 1974). (Bottom) View of the vertical plank siding that currently encloses the north gable (FRR September 2001). It is recommended that the vertical planking be replaced with horizontal siding in event that the exterior of the cabin is sided.

replaced with horizontal weatherboard, as was the case prior to the cabin's dismantlement (see Figure 12). It would be appropriate to finish out the corners and openings with flat trim boards, perhaps 1"x4" or 1"x5" stock. The exterior siding should be primed and painted.
