Anna Margaret Barris

Illinois Historic Preservation Agency

Building a Sustainable Future

Sustaining Buildings for the Future

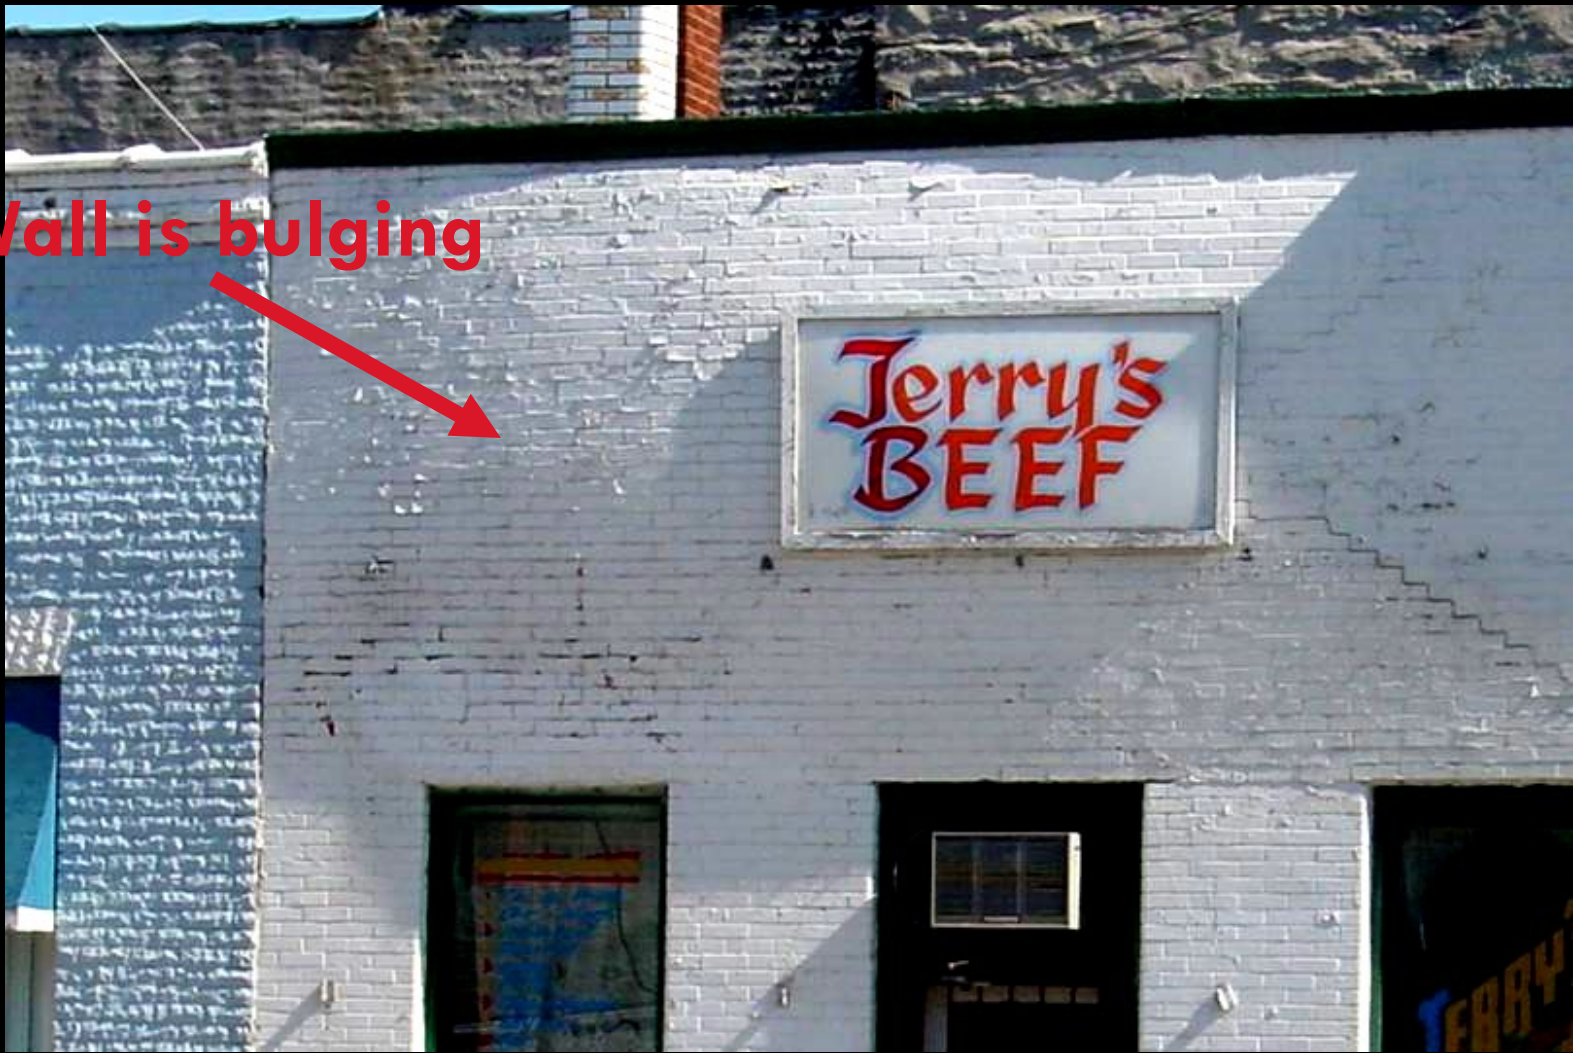
Wall is bulging

Water has caused the steel ties to rust. When steel rusts, it expands. Here it is pushing the masonry wall out of plane.

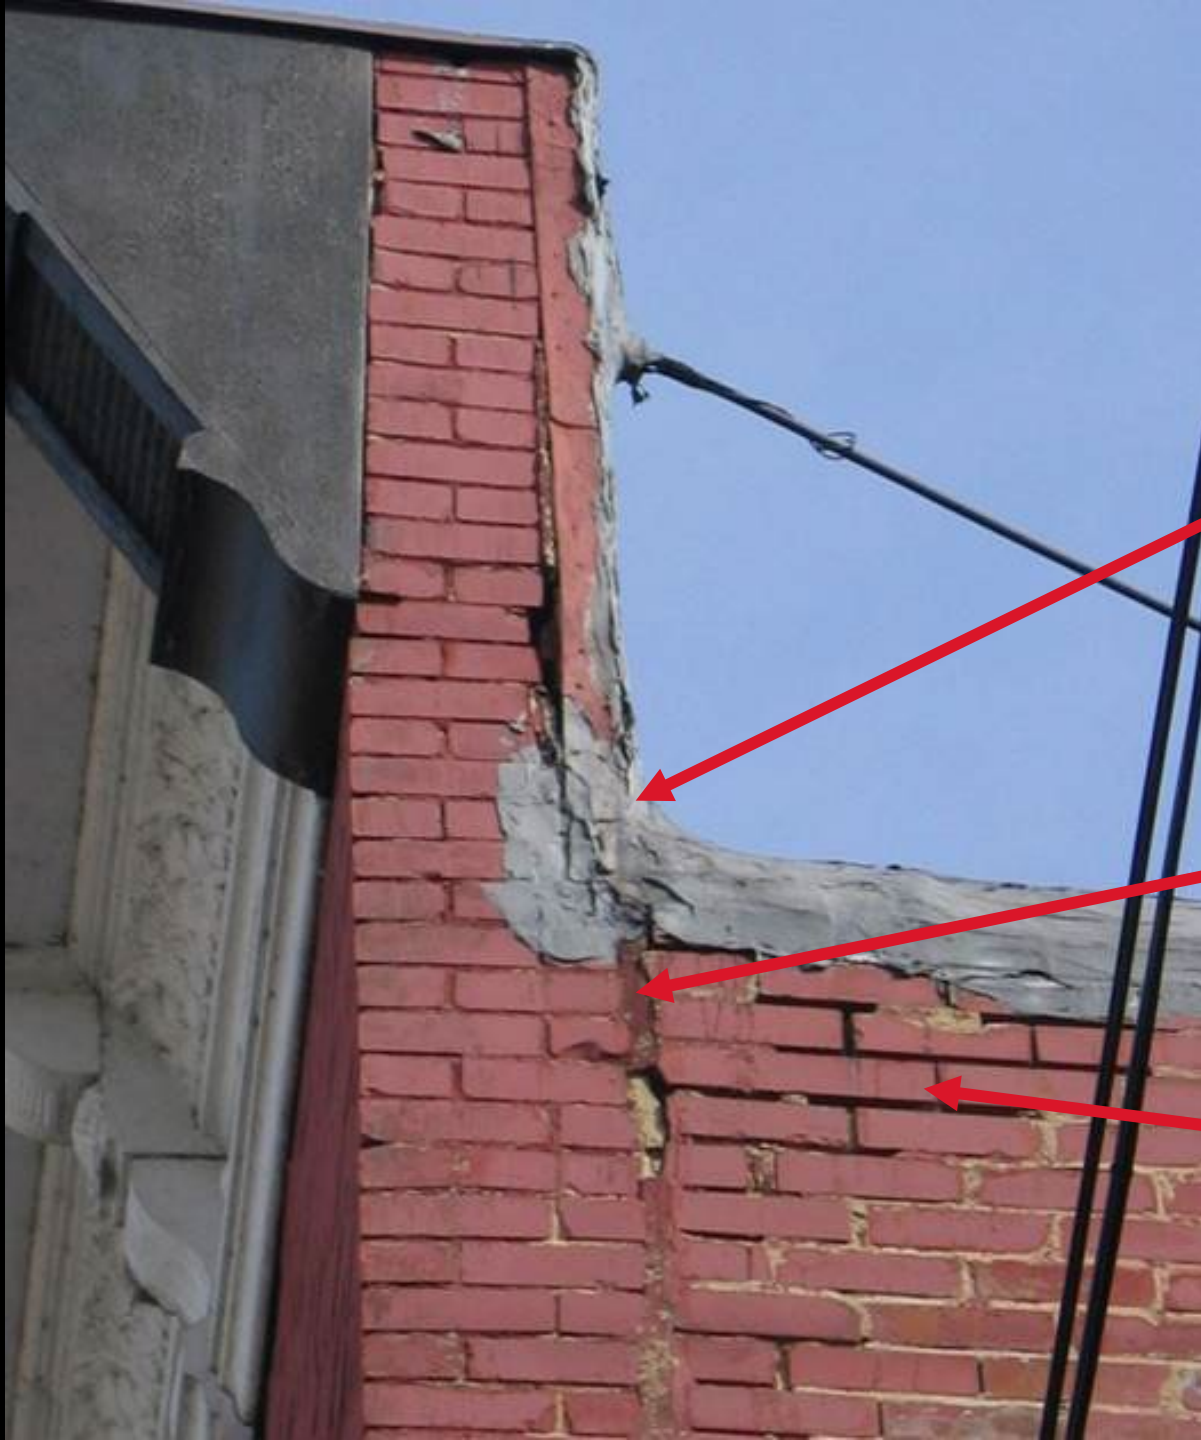
Inappropriate tar is letting water in.

Water is infiltrating the interior wall.

Mortar loss

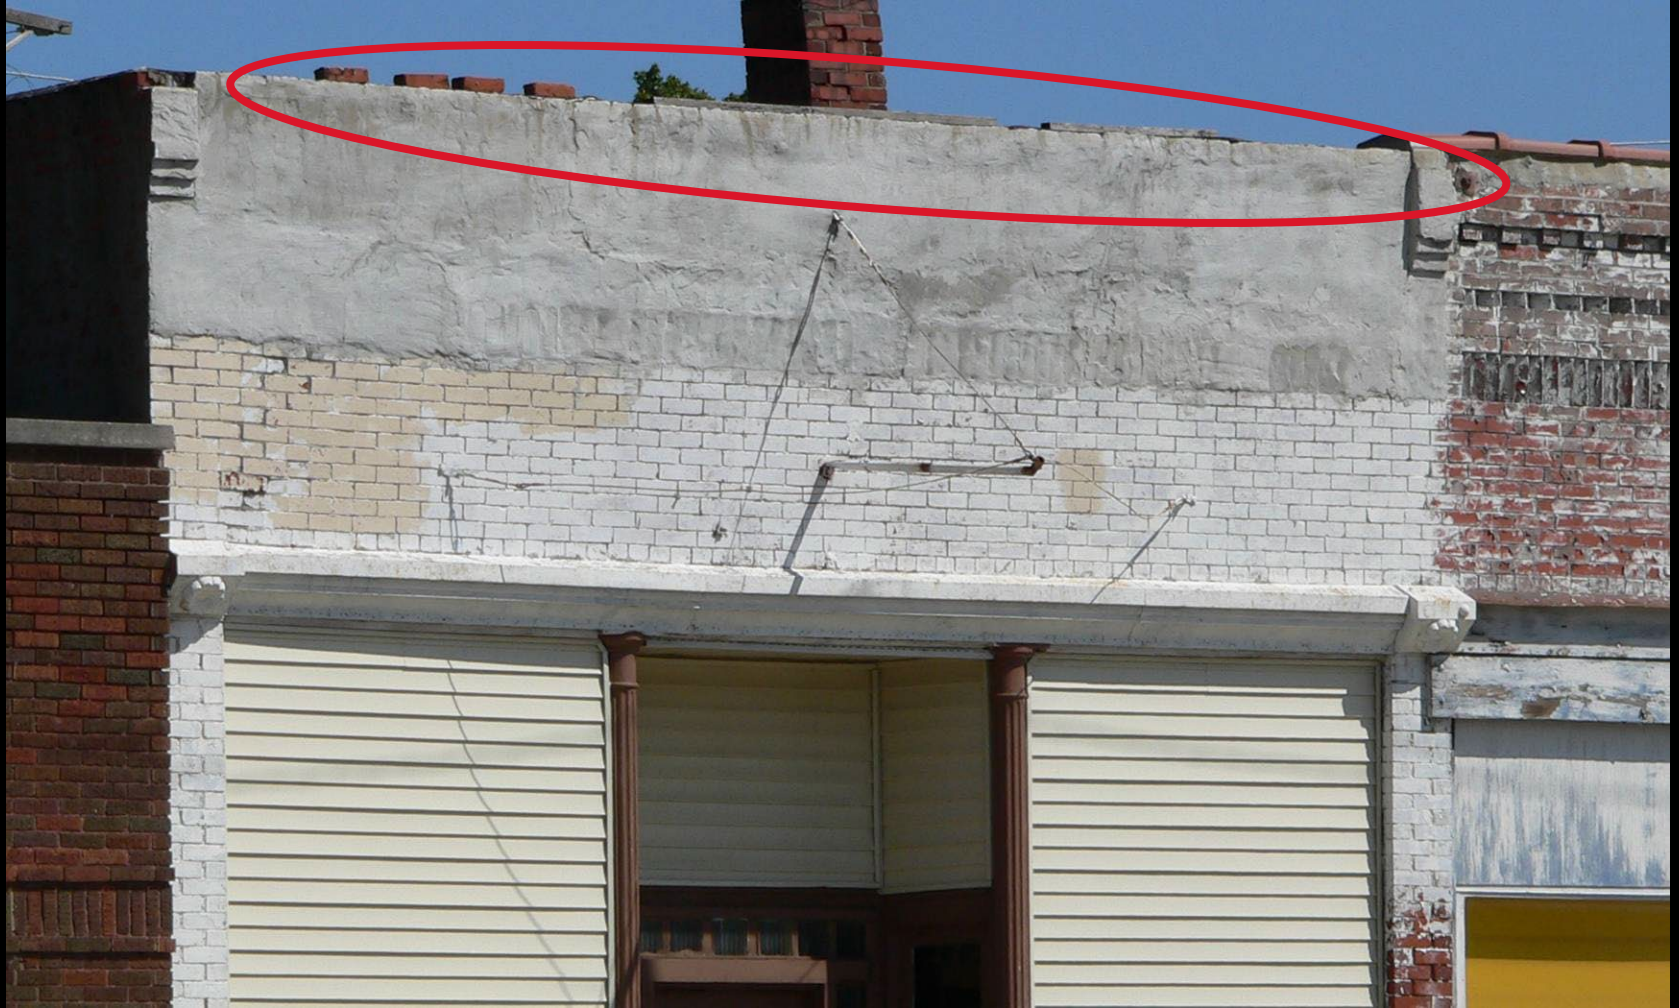
Missing parapet cap; water infiltrated wall.

Area was parged over.

Not a solution!

Parapet caps must be mortared in place

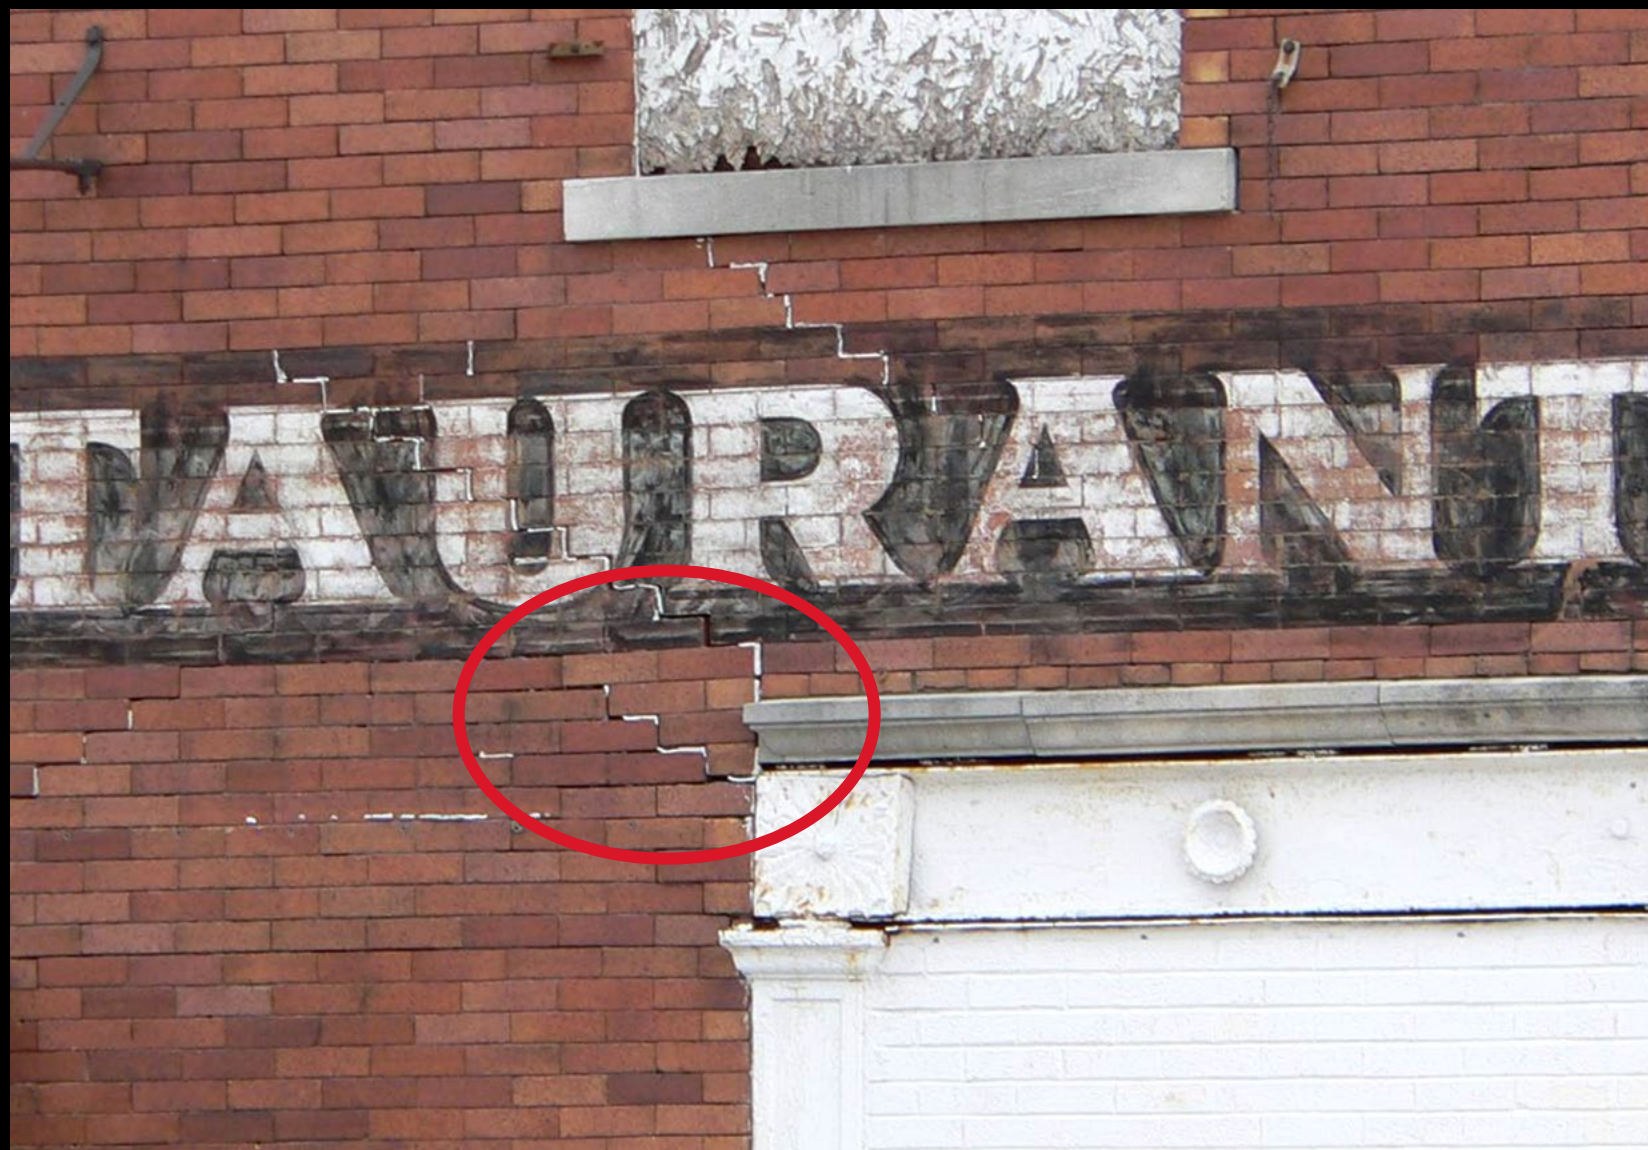
When water travels through the wall cavity, it can be stopped by a steel lintel. The lintel will rust, causing rust jacking.

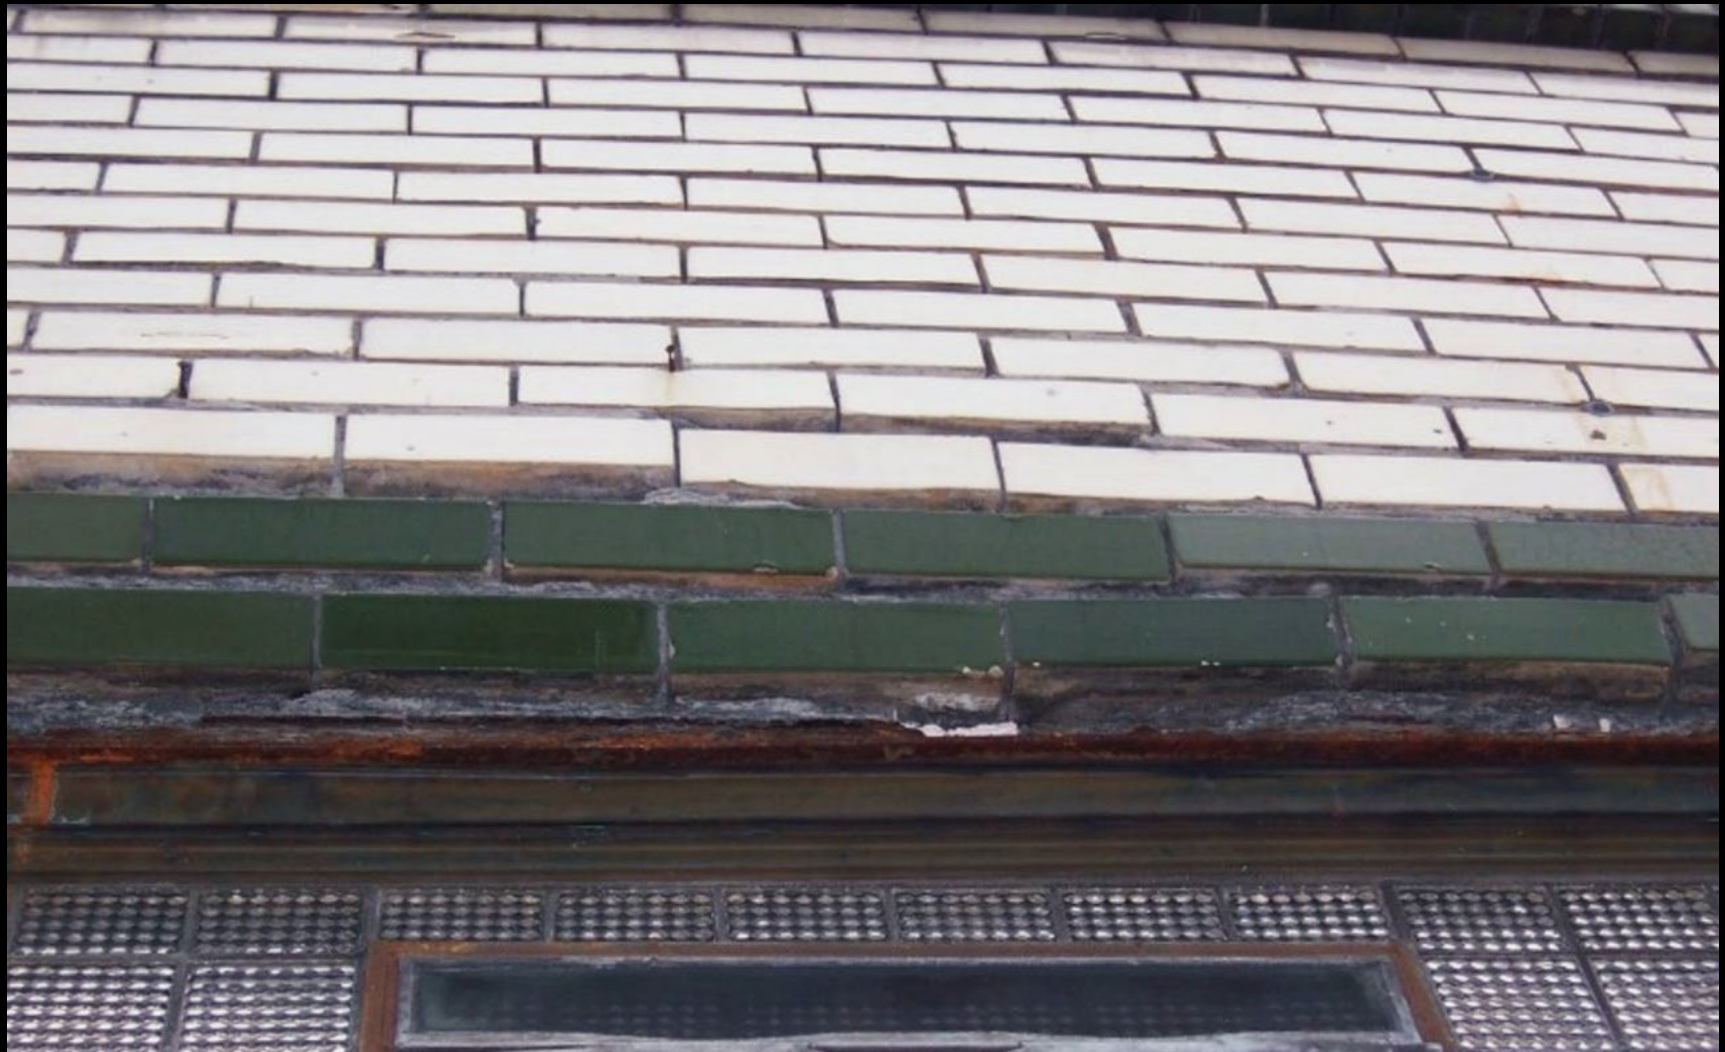
Rust jacking

Rust jacking weakened the mortar joints.

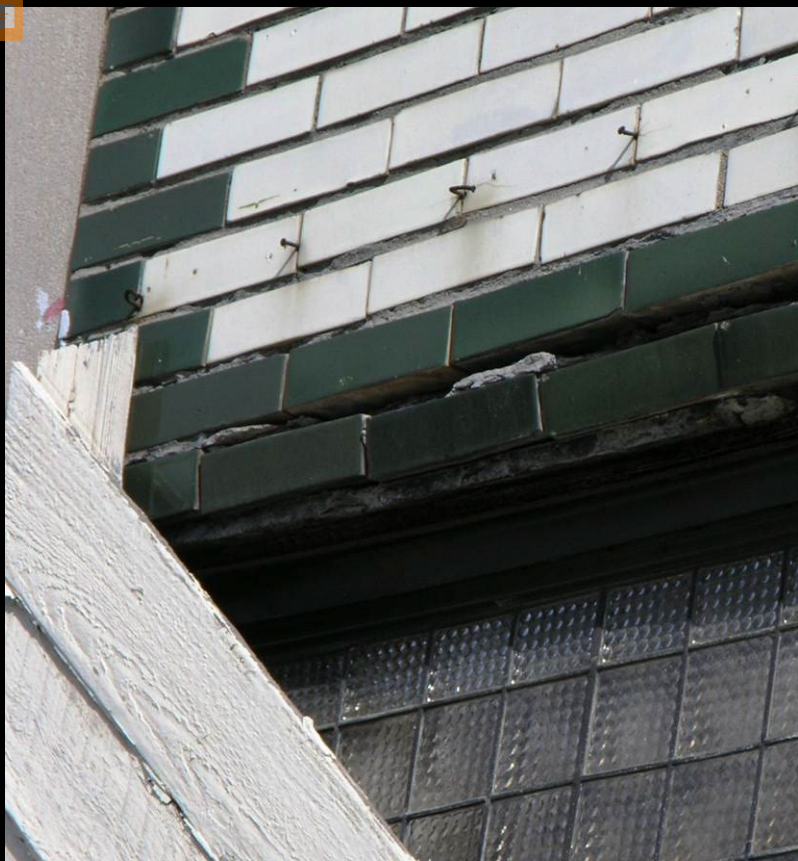
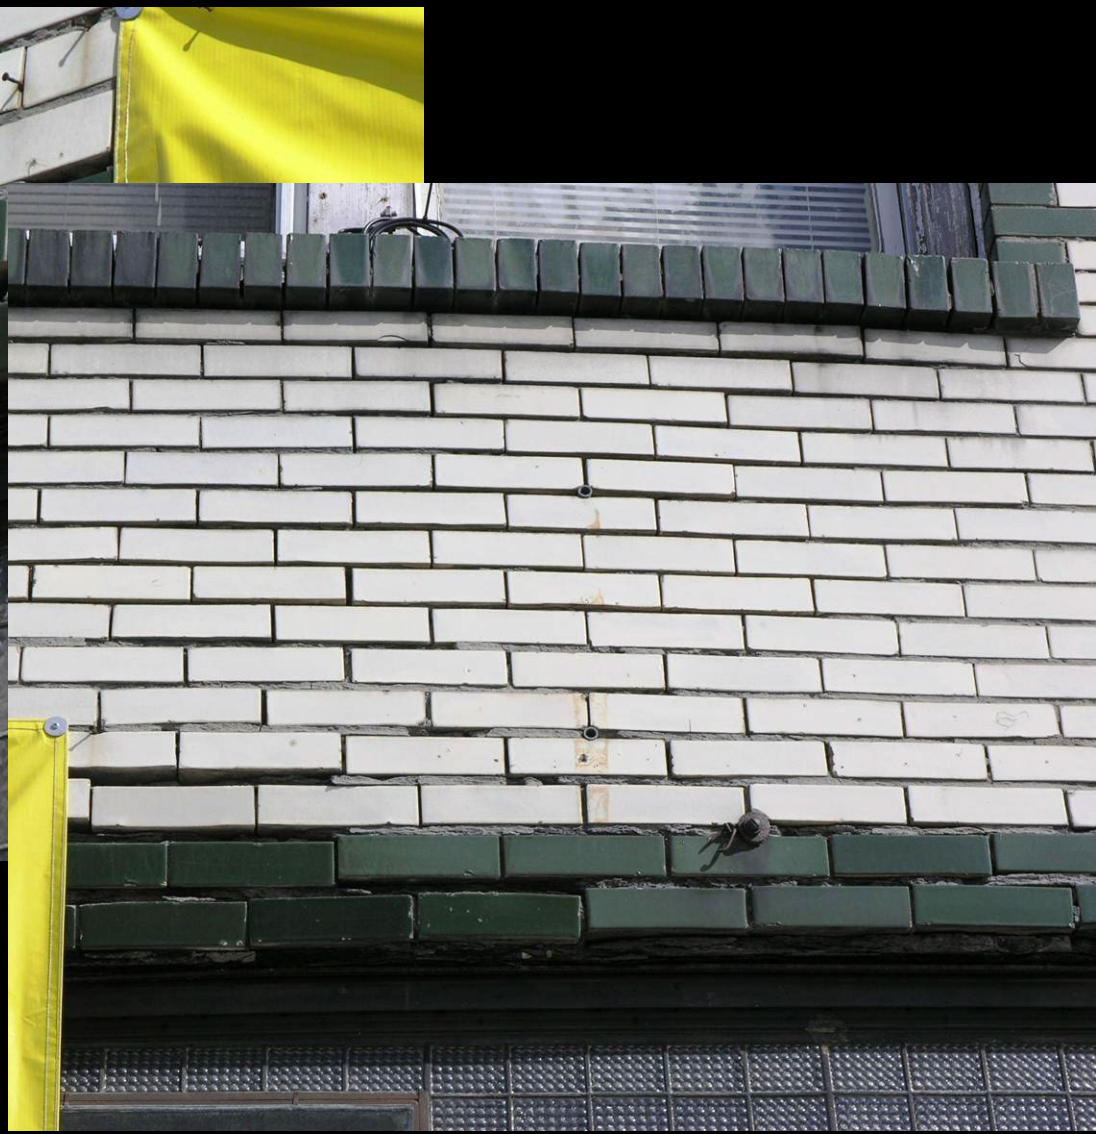
The lintel continues to expand, the caulk seals moisture inside the wall, does nothing to repair the problem

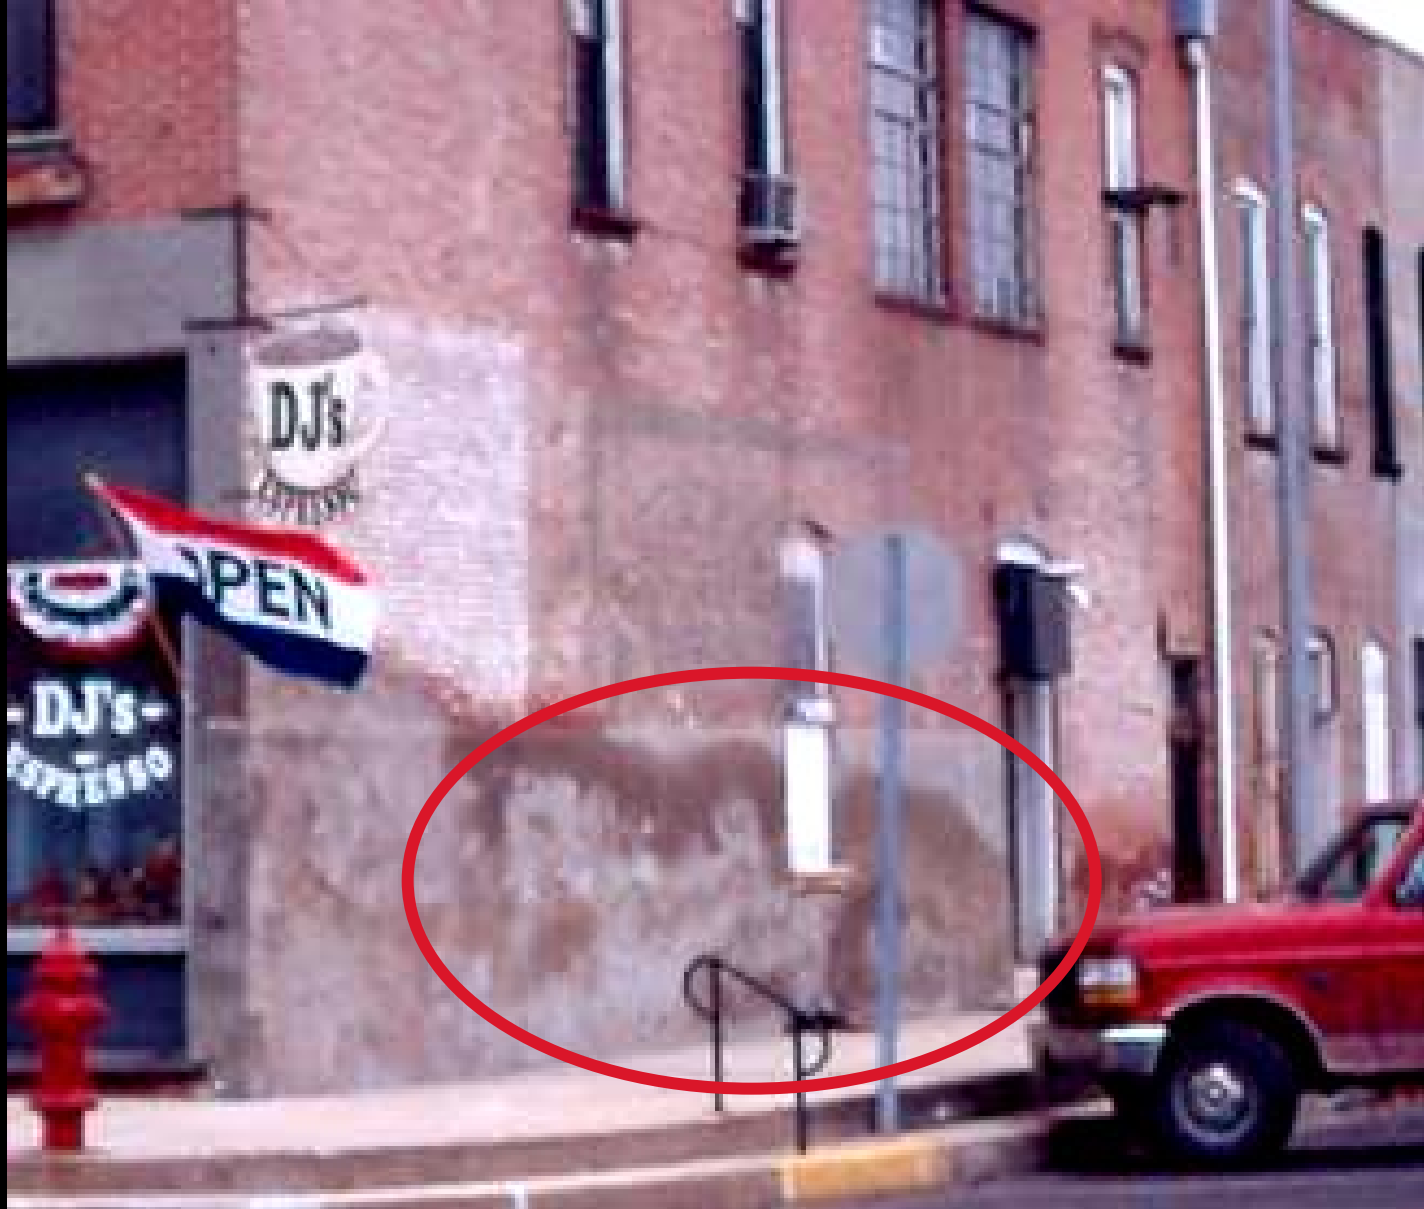
Parging brick makes the problem worse!

Water is trapped behind the parking, holding moisture against the brick.

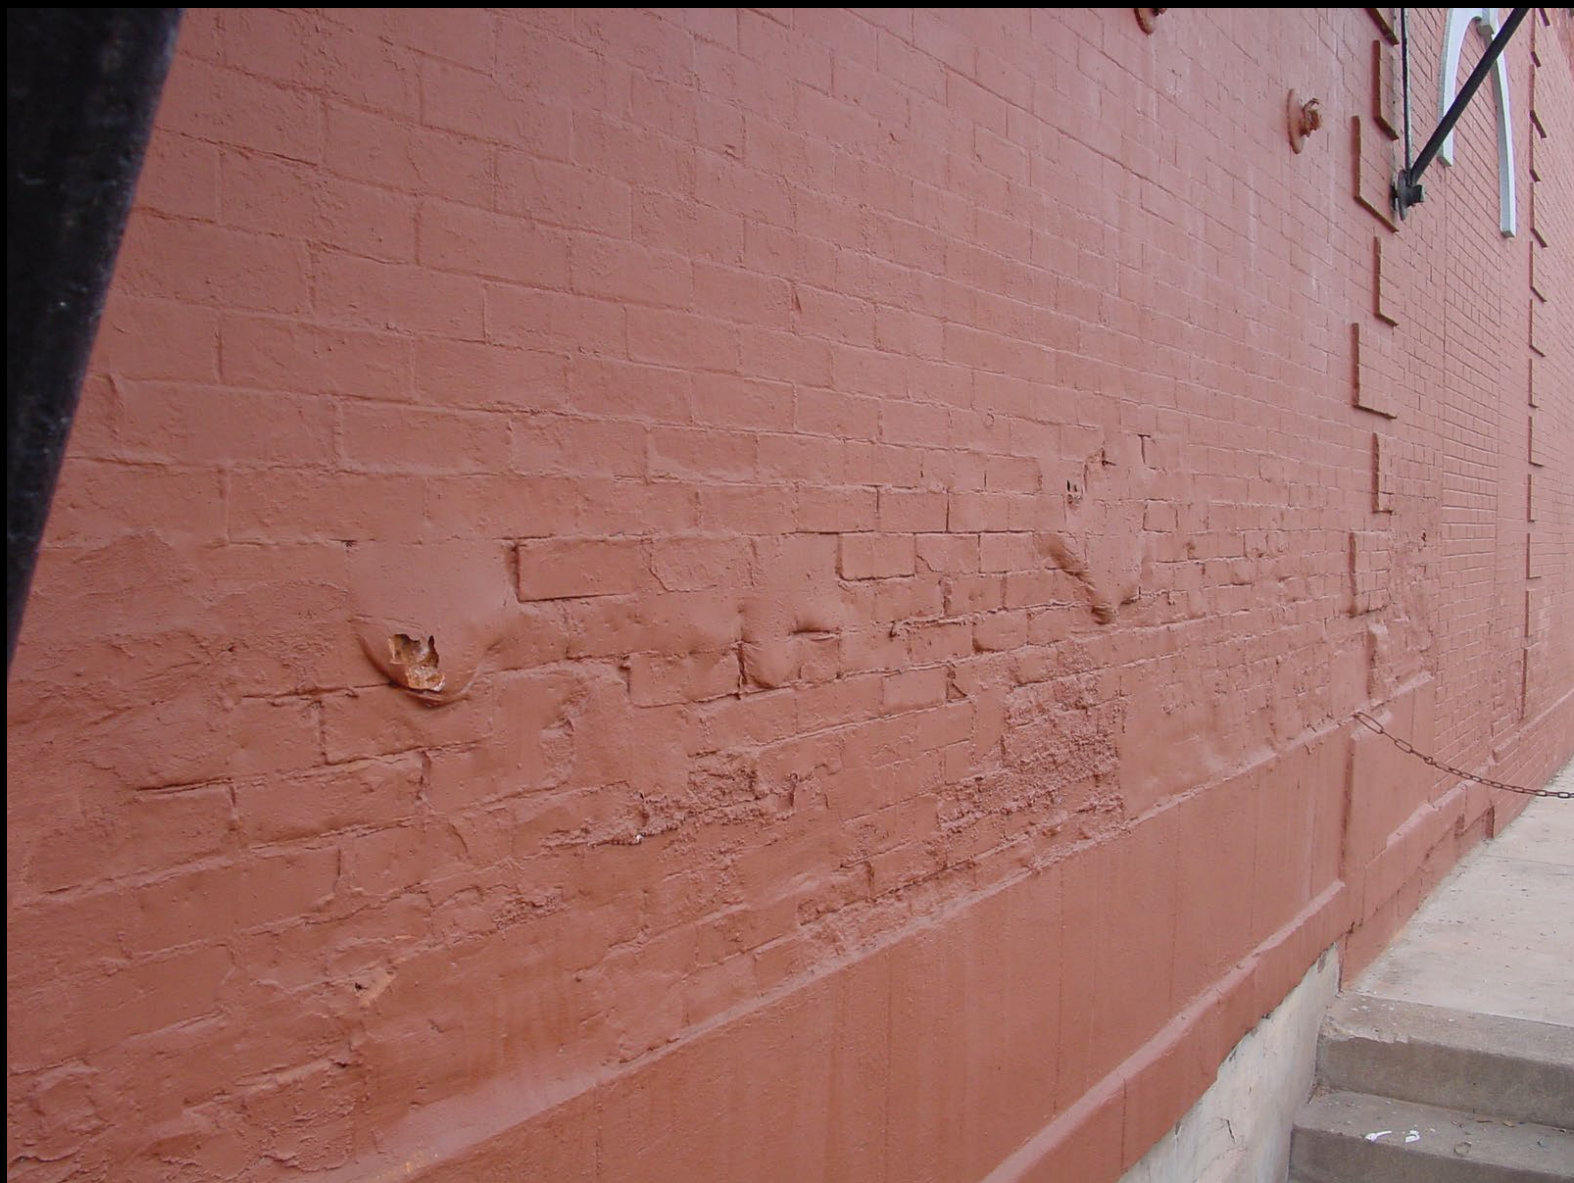
Coatings such as Modac will trap moisture in wall,
causing more spalling.

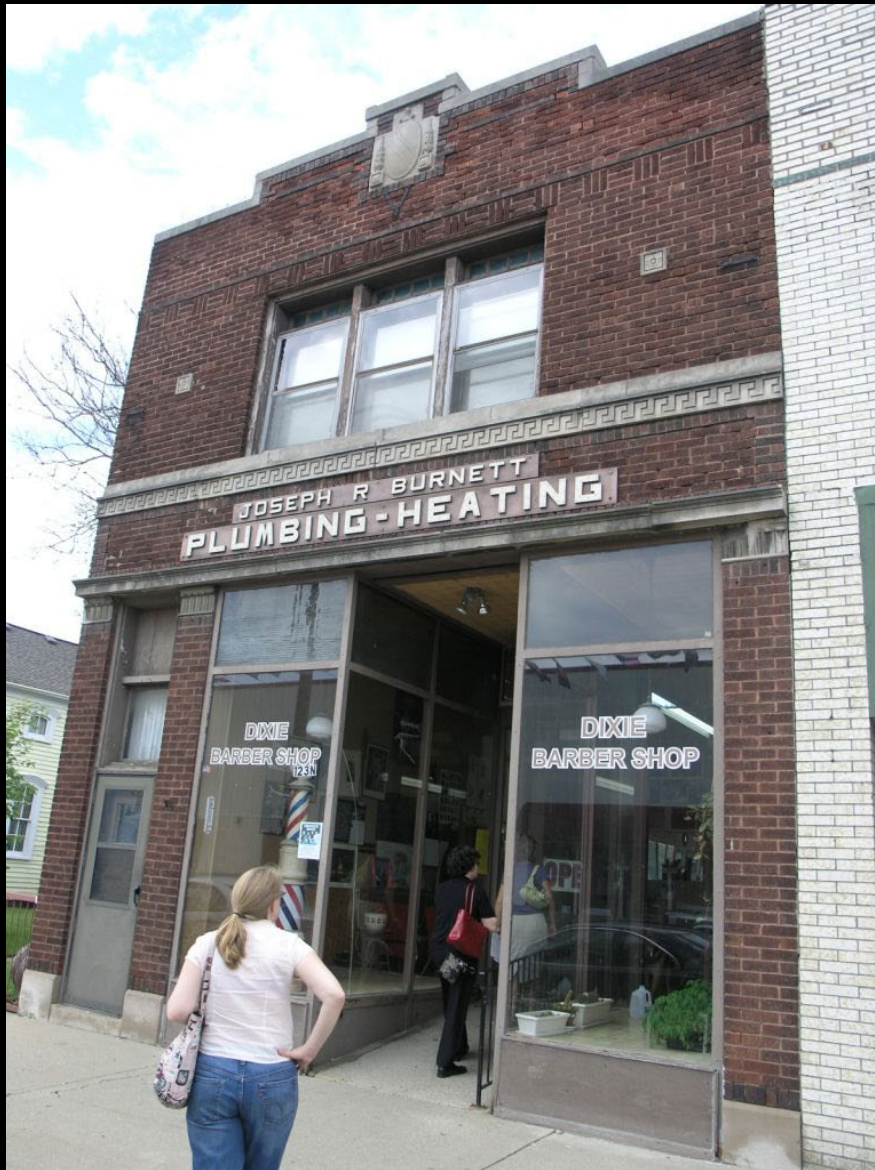
Technical Assistance
123 N. Dixie (Dixie Barber Shop)

○ Historic, original to storefront.
Glass is cracked in south display window at recessed entrance. Clear acrylic caulk can be used to infill the crack; eventually the glass should be replaced.

Water is infiltrating the parapet brick, most likely at the roof line or at the coping. Roof should be inspected for proper flashing and the coping joints examined.

Spalling is occurring at parapet. The mortar should be removed (by hand) and replaced with Type N or O mortar mixes, taking care not to get mortar on the face of the brick. Mortar should be tinted and joints should be raked to match historic joints.

○ Steel window frames should be scraped with a wire brush to remove rust and repainted.

Fix water problem at roof/coping
Repoint mortar at area above upper floor windows with correct mortar mix
Remove plywood from bulkheads and restore original material beneath.

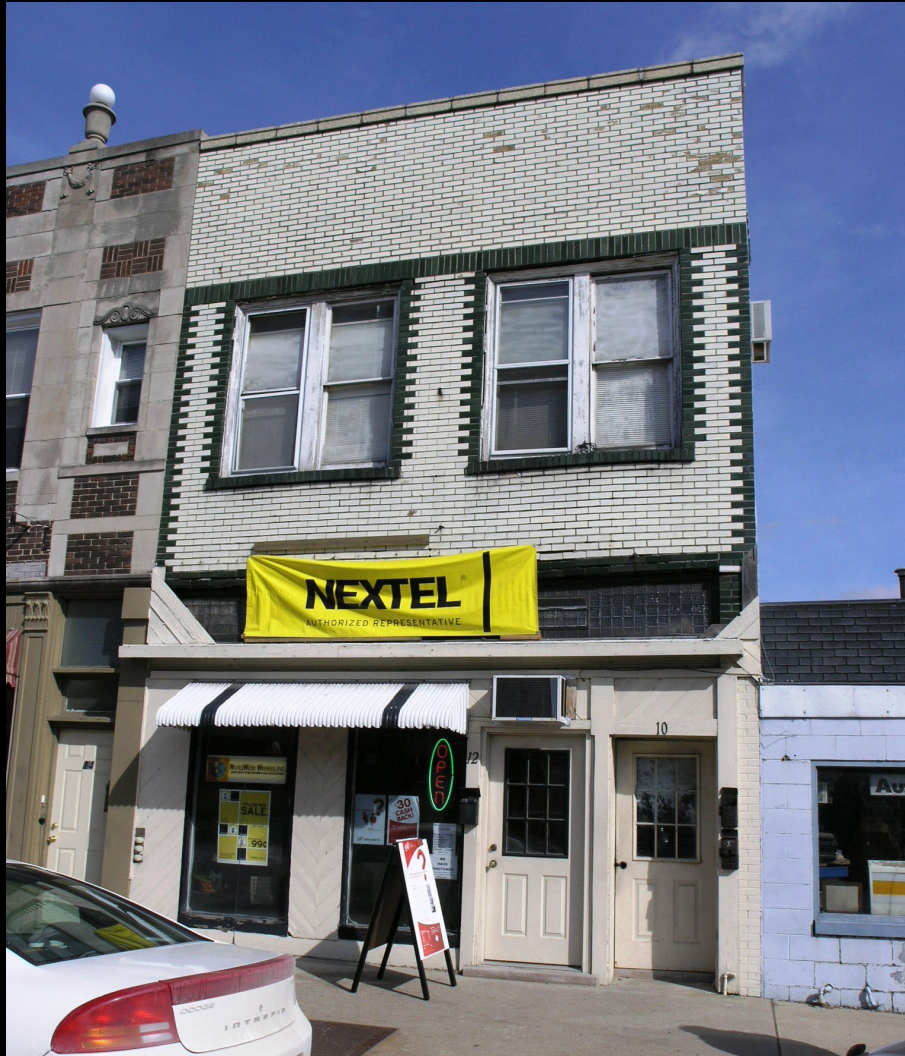
Technical Assistance
12 N. Dixie

Non historic with the exception of the prism glass transoms, which should be preserved and repaired. Altering the storefront would be costly and is not of high priority. At least, it should be maintained and painted, and a new fabric awning spanning the width of the façade should replace the existing.

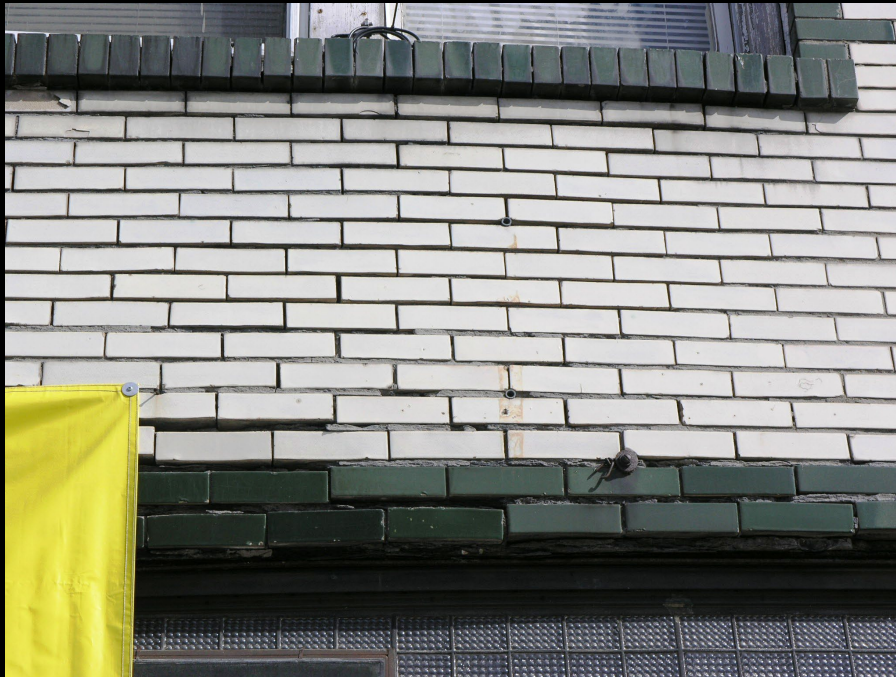
**Technical Assistance
12 N. Dixie**

The steel lintel above the storefront is significantly corroded and the adjacent Tiffany brick is structurally unstable. The face brick is likely debonded from the backup brick. At a minimum, the brick between the prism glass transom and the upper story windows will have to be removed, and the lintel replaced while stabilizing the rest of the masonry above. It may be necessary to install supplementary anchors to secure the Tiffany brick to the backup brick.

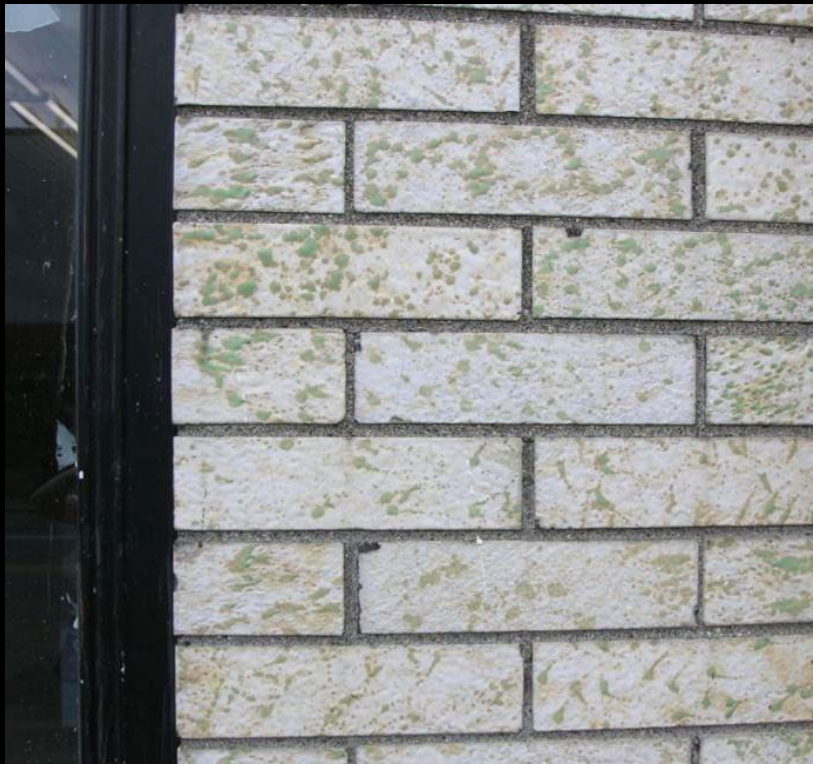
**Technical Assistance
125 N. Dixie**

Historic glazed Tiffany brick in fair condition, almost no signs of spalling. It appears that the mortar joints around window lintels have been inappropriately caulked and/or are significantly eroded. Caulking and any loose mortar should be removed and joints should be repointed with Type N or O mortar mix.

Scrape and paint steel lintels above upper floor windows

Repoint masonry
