CULTURAL RESOURCE MANAGEMENT PLAN

FORT SHERIDAN

NATIONAL HISTORIC LANDMARK DISTRICT FORT SHERIDAN, ILLINOIS

DECEMBER, 1997

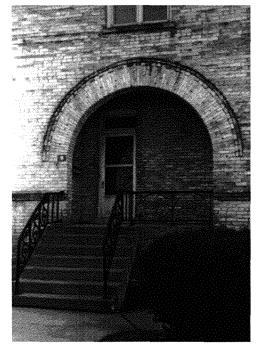
Condition⁵⁶: Mismatched brick has been used to replace some of the original cream-colored brick, and glass block with louvers has been used to infill some of the window openings. Some brick and limestone is in need of tuckpointing, and some of the brick is stained. Many of the original windows and doors have been replaced. Metal handrails evidence some corrosion.

Front entrance to Lieutenants' Quarters (#5), 1997. Photograph by Victoria Granacki

Alteration Guidelines: There will be no material changes to the front and side facades; alterations and additions will be allowed to rear facades. The line of additions may extend back from the rear facade and may encroach only on rear side yards. Excepted from this requirement is Building #7, where encroachment into the side yard adjacent to the rear yard may be permitted, provided that no encroachment may be greater than ten feet along the side facade of the building. The roofs will all be in slate gray color roofing material. Where windows are original, they will be retained and repaired. If retention is not practicable, reasons for removal must be documented and windows may be replaced in kind. Where windows are not original, they may be replaced with wood windows with historically compatible configuration, with no applied muntins permitted.57 Where mismatched brick is removed, it should be replaced with cream-colored brick that matches the existing to the extent reasonably practicable. Where original openings that have been filled in with replacement windows, glass block, or mismatched brick are changed, the infill should be replaced by wood windows or brick that matches the existing to the extent reasonably practicable. Skylights may not be added other than on additions. There may be no changes to location or size of the front porch or any exterior staircase on the front or side facades; where replacement of the front stair or any of the railing is necessary, the design of the detailing should be inspired by historic precedent found at the Fort. Nonhistoric features may be removed. Where original elements have been removed, they may but need not be replaced. In addition to the exterior features described above, the principal interior staircase and stairhall shall be preserved in all these buildings.

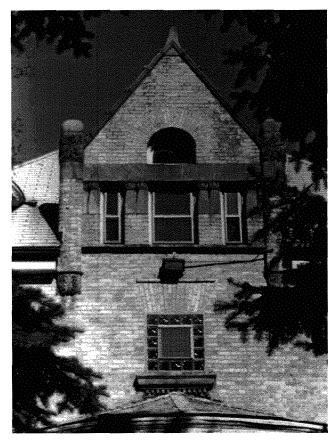
Post Commander's Residence (#9), 1997. Photograph by Victoria Granacki

Condition: Mismatched brick has been used to replace some of the original cream-colored brick, and glass block with louvers has been used to infill some of the window openings. Some brick and limestone is in

need of tuckpointing, and some of the brick is stained. Many of the original doors and windows have been replaced. Metal handrails evidence some corrosion. Building #8 has a one-story brick and glass block addition on the west side. Asphalt siding covers the dormers.

Alteration Guidelines: There will be no material changes to the front and side facades; alterations and additions will be allowed to rear facades. The line of additions may extend back from the rear facade and may encroach only on the rear side yard. The roofs will all be in slate gray color roofing material. Where windows are original, they will be retained and repaired. If retention is not practicable, reasons for removal must be documented and windows may be replaced in kind. Where windows are not original, they may be replaced with wood windows with historically compatible configuration, with no applied muntins permitted. Skylights may not be added other than on additions. Where mismatched brick is removed, it should be replaced with cream-colored brick that matches the existing to the extent reasonably practicable. There may be no changes to location or size of the front porch or any exterior staircase on the front or side facades; where replacement of the front stair or any railing is necessary, the design of the detailing should be inspired by historic precedent found at the Fort. Where original openings that have been filled in with replacement windows, glass block, or mismatched brick are changed, the infill should be replaced by wood windows or brick that matches the existing to the extent reasonably practicable. Nonhistoric features may be removed. Where original elements have been removed, they may but need not be replaced. In addition to the exterior features described above, the principal interior staircase and stairhall shall be preserved in Building #9.

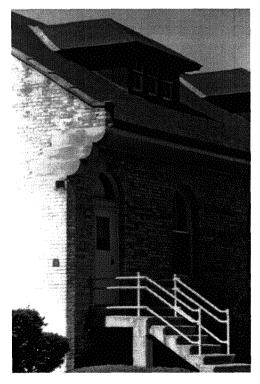
Quartermaster and Commissary Storehouse (#35), 1997. Photograph by Victoria Granacki

Condition: Mismatched brick has been used to replace some of the original cream-colored brick, and basement windows are filled with glass block. Glass block with louvers has been used to infill some other window openings. Some of the historic doors and windows have been replaced. A front central staircase has been added to the east side using mismatched brick. All of the entrances have been altered. Chimneys are in need of tuckpointing. A rear loading area has been partially enclosed with wood frame construction.

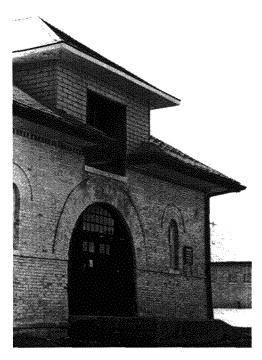
Condition: Mismatched brick has been used to replace some of the original cream-colored brick. Some of the historic doors have been replaced. Roof vents and some of the original dormers have been removed. The dormer walls have been covered with asphalt shingles. Metal pipes puncture the brick walls in places. At the ends of the buildings, arched openings have been squared off to accommodate overhead garage doors. Both buildings have rear additions, and there is a tall brick chimney stack.

Stables (#43), 1997. Photograph by Victoria Granacki

Alteration Guidelines: Additional openings and the enlargement of present openings on the front, side, and rear facades will be allowed to provide sufficient access, light, and ventilation for proposed residential use. Where windows are original and the opening is retained, the window will be retained and repaired. If retention is not practicable, reasons for removal must be documented and windows may be replaced in kind. Where windows are not original, they may be replaced with wood windows with historically compatible configuration, with no applied muntins permitted. Skylights may be added to the roof of the non-street facades. Where mismatched brick is removed, it should be replaced with cream-colored brick that matches the existing to the extent reasonably practicable. The roof will be slate gray color roofing material. The design of new elements required to modify the buildings for proposed residential use should be inspired by historic precedent found at the Fort. Nonhistoric features may be removed. Where original elements have been removed, they may but need not be replaced. Garage, porch, and other room additions should be allowed on the nonstreet facades.

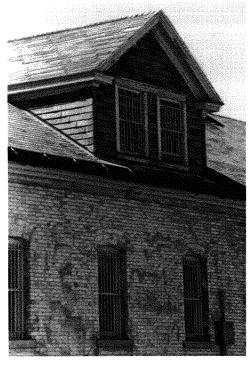
Quartermaster Storehouse (#85), 1997. Photograph by Victoria Granacki

Condition: A poured concrete ramp with tubular steel railings and a concrete loading dock are both located on the east side of the building. The dormer walls are sheathed in asphalt shingles. Openings are infilled with mismatched brick. Walls are in need of tuckpointing and are stained.

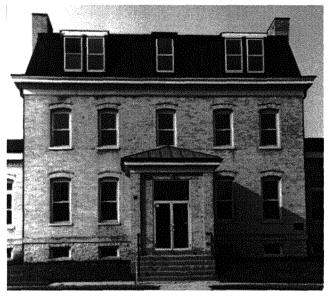
Post Hospital, main entrance (#1), 1997. Photograph by Victoria Granacki

Condition: There was a section, connecting the two buildings, that was removed in 1958. A third building that housed a contagious disease ward has been demolished. A large veranda, which had a decorative balustrade and once wrapped around three sides, and a wide central front porch, which had a pedimented entry, have been removed from Building #1. In addition, the original windows have been replaced with aluminum double- or triple-hung windows, and several of the windows have been infilled with mismatched brick. An enclosed brick vestibule with aluminum doors accessed by concrete stairs has been added to the front of Building #1. The dormers and mansard have been sheathed in standing seam metal. In Building #2, two-story wood porches have been removed and the original windows have been replaced with aluminum sash. Mismatched brick has
