360 West State, Jacksonville, 2002

- Stories: Three
- Historic use: Commercial/Meeting space
- New use: 1-one bedroom apartment on 2nd floor, 3rd floor remains vacant
- Exits: 1 from the 2nd floor to the back of the building; the 3rd floor is accessed through a hatch from the 2nd floor.
- Windows: 3 on front and 3 on rear, 3' x 9'
- Sq. footage: 2,000 sq. ft. building is 20' x 100'
- Construction: Brick load-bearing walls, plaster and lath interior partitions, wood roof and floor, stone foundation.

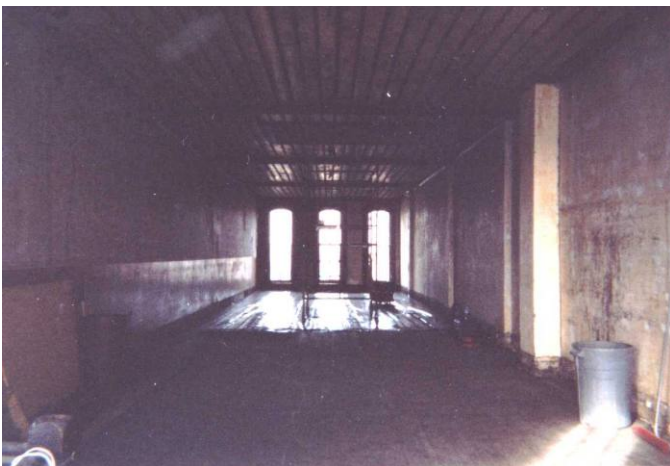
"Before" photo of second-floor space
