# Midcentury Commercial Design Evaluation and Preservation: An Opportunity for Commissions

By Carol J. Dyson, AIA

A Quarterly Journal of  
the National Alliance of  
Preservation Commissions  
Spring 2017

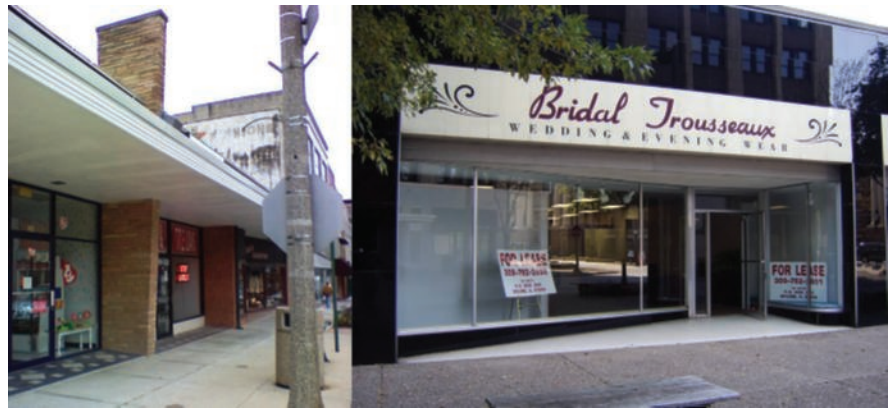
**Figure 2:** Other postwar design components that occurred parallel with, or as part of open-front designs were asymmetrical and angled fronts. On the left in Freeport, Illinois, angled rustic-stone pylons combine with a deep overhang to shield the open storefront windows from glare. On the right, in Moline, Illinois, is an example of a common postwar open storefront plan, shown here with structural glass surrounding large plate glass display windows that asymmetrically angle into the entrance.

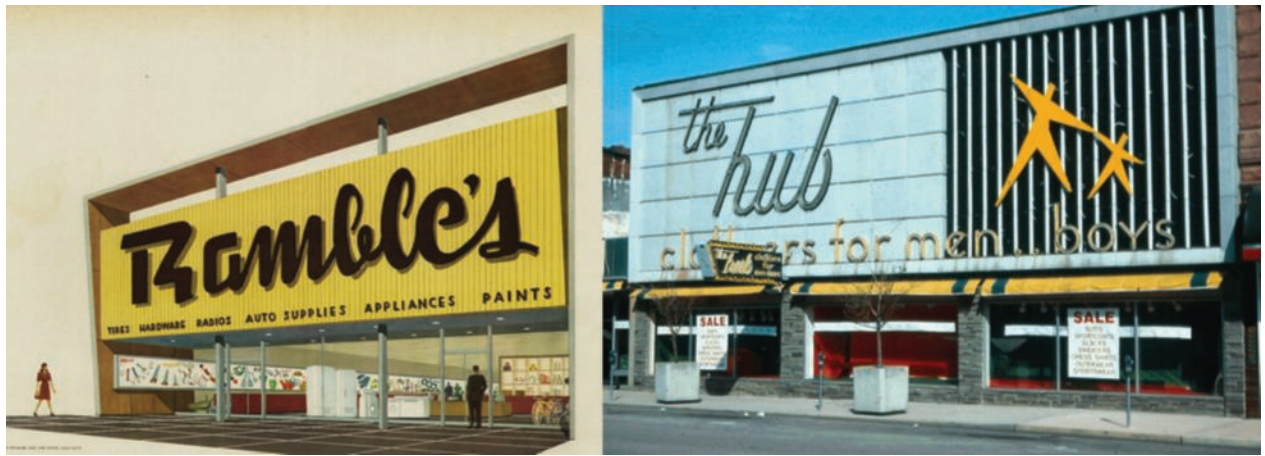
**Figure 3:** Signage was often a critical component of midcentury commercial design. The Ramble's Hardware Store design by Ketchum, Gina and Sharp combines dramatic signage with linear display boxes that run from the exterior through the open front and on into the store. The Hub Clothiers, formerly in Springfield, Illinois, displayed equally dramatic porcelain enamel graphics and signage on a granite-textured porcelain enamel backdrop above a stone veneer and plate glass lower floor.

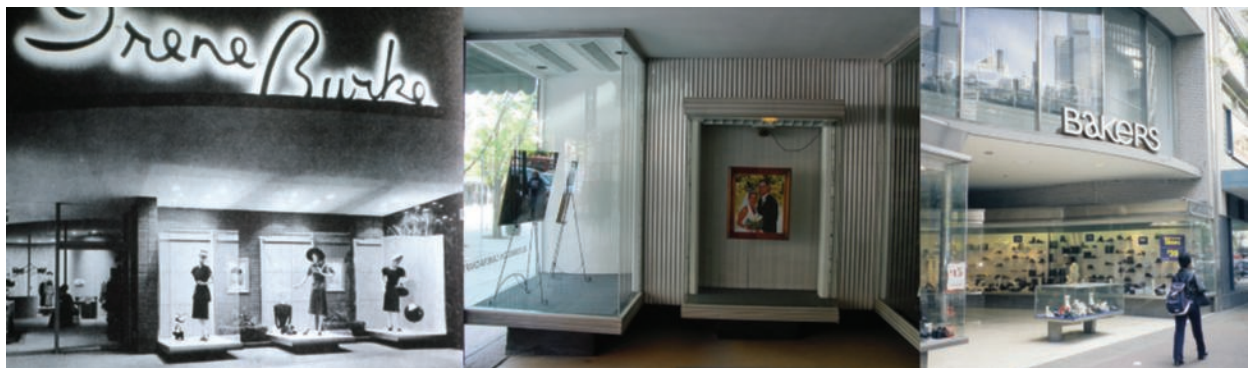
**Figure 4:** Cantilevered display cases in outdoor lobbies helped deconstruct the front plane of retail buildings. On the left is a 1948 design in Long Beach, California. In the center are similar displays in Bloomington, Illinois. On the right, the former Bakers Shoes in Chicago had a free-standing display "table," well-lit cantilevered display cases, and a curved open-front display window on the second floor.

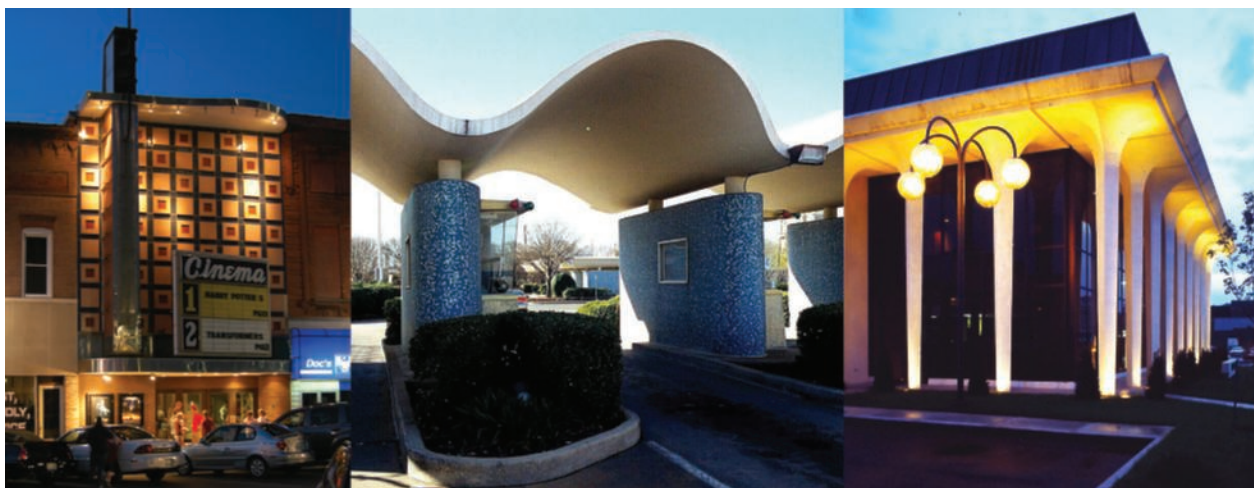
**Figure 5:** Structural innovations and dramatic space-age-inspired design also appeared on Main Street in a style named Exaggerated Modern by Chester Leibs in his seminal book *Main Street to Miracle Mile*. On the left the Taylorville, Illinois cinema was completely refaced in the mid-century with polychrome porcelain enamel panels, swooping stainless steel and aluminum canopy and cornice, and dramatic pylon. In the middle, the elegant Oklahoma City Central Motor Bank drive-up, built in 1959, combines a thin-shell concrete roof with bright blue mosaic tile encased piers. On the right, precast concrete columns surround a darkly glazed curtain wall on this Moline, Illinois bank, designed by John Van Scheltema, of the Illinois Bank Building Corporation in the 1970s.

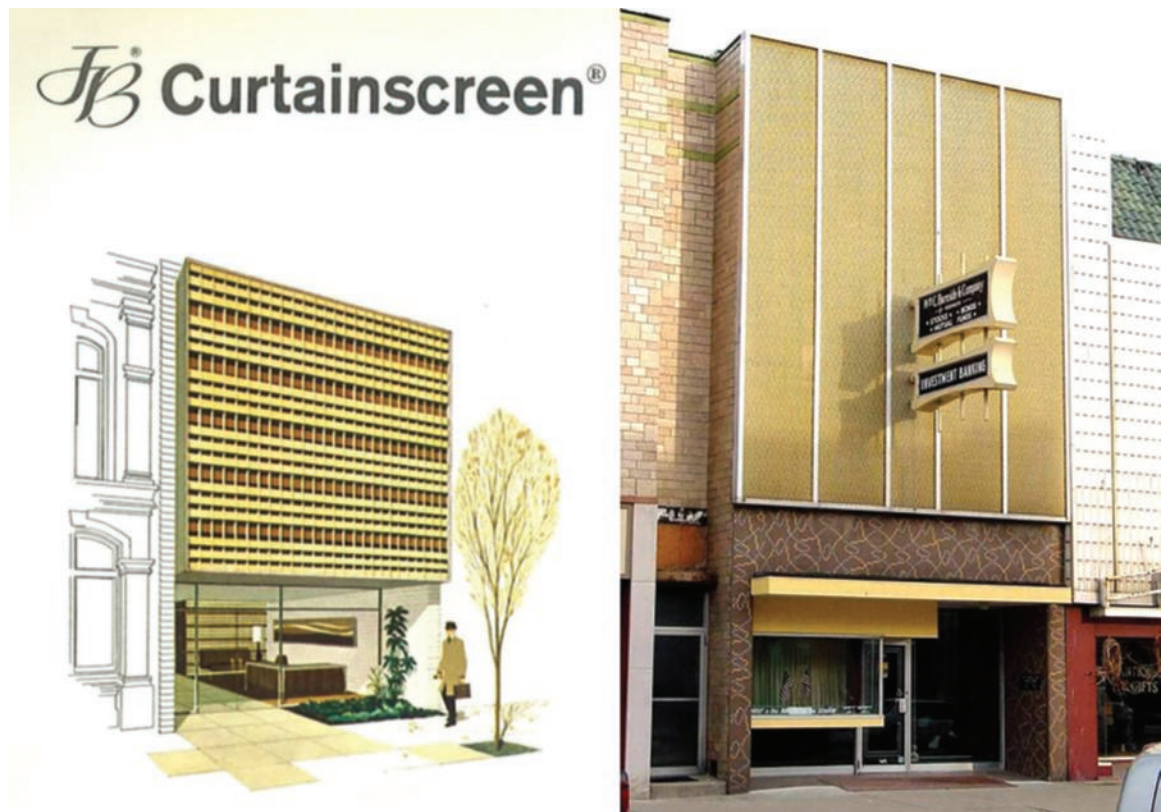
**Figure 6:** On the left is “The Art of Refacing the New Art in Architecture” Julius Blum & Co.’s JB Curtainscreen, 1965. On the right, Burnside and Co., in Danville, Illinois, is an excellent example of an unusually intact design with gold anodized aluminum slipcover, cantilevered display case, decoratively tiled storefront, and period signage and deserves preservation.

Is the building merely “slipcovered?” Rather than completely refaced was the building covered with a lightweight aluminum, plastic or steel facade, often with a screen or panelized motif? Does this building represent a good example of a midcentury design (such as the Danville, Illinois example in Figure 6)? Many slipcovers or facade alterations were well thought out designs to showcase an up-to-date style. In contrast, some buildings were inexpensively covered in the last part of the 20th century with panels or corrugated siding devoid of design or signage simply to avoid repainting or repointing, and may retain little significance. If it appears that this situation exists, first try to determine what the original slipcover (complete with signage) looked like before making an evaluation. Historic photos, or ghosting of earlier signage on the facade can be very useful.

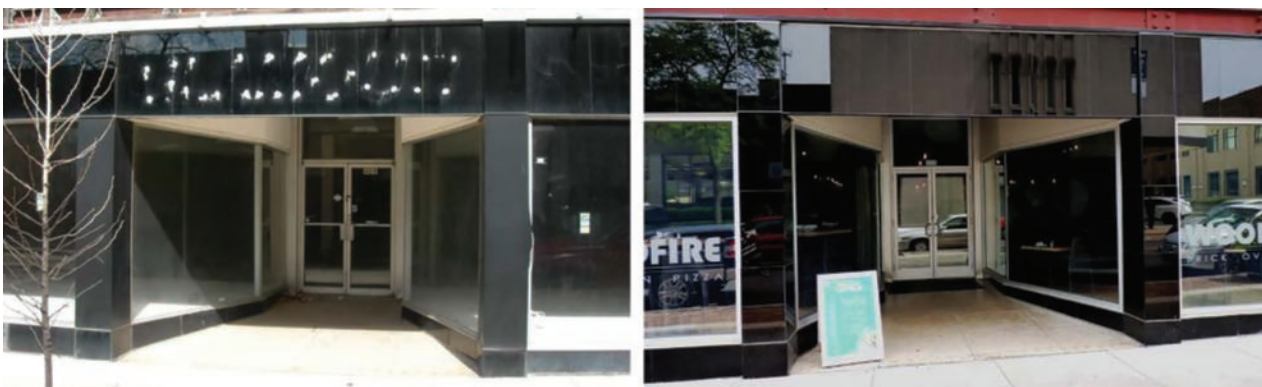
**Figure 7:** This black mid-twentieth century structural glass storefront was the third modernizing storefront for this mid-nineteenth century building in Rockford Illinois. The storefront was originally slated for demolition and replacement with an earlier neo-historic-style storefront. However, as part of the historic tax credit project the structural glass midcentury storefront was deemed a significant alteration and was retained, the sign damage was repaired and where necessary replaced by salvaged glass. The recessed terrazzo entrance lobby flooring was also retained. New signage was installed onto the storefront clear glass and did not damage the newly repaired structural glass transoms.

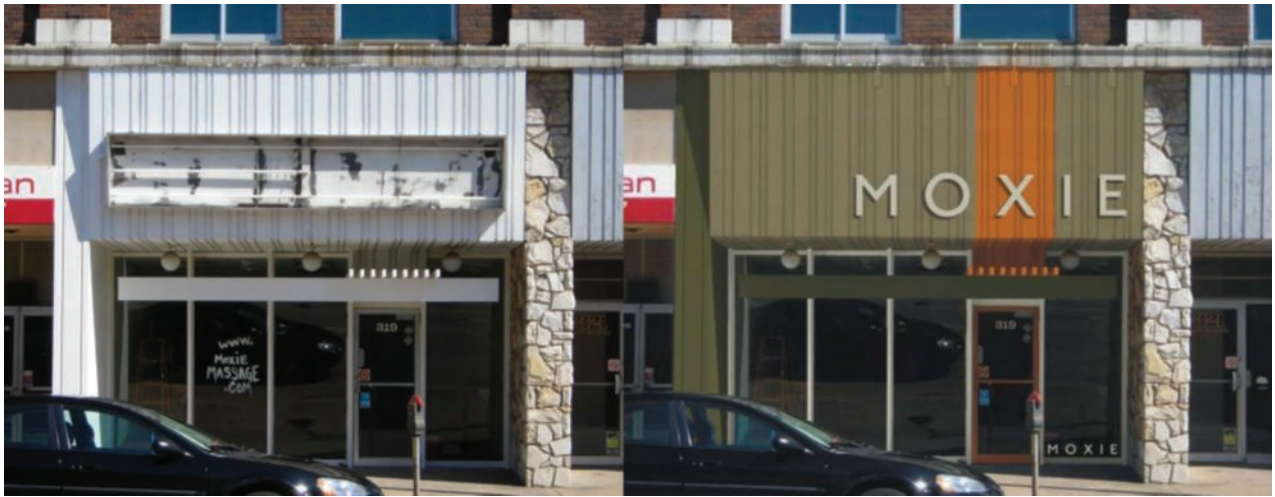
**Figure 8:** These before and after images show a design solution for a mid-century storefront in Springfield, Illinois. IHPA Project Designer, Anna Margaret Barris' design transformed this storefront with compatible signage and a new paint scheme. The original design intent became clear and attractive once more, and the owners now agree that it is worthy of retention.

What is the integrity of midcentury design? Can you still understand the design intent? Does the building still tell the story with most components, display windows, and materials still remaining? For many of these buildings loss of design impact may be due to the loss of the historic signage. Business or aesthetic changes may have caused removal of the original postwar signage and replaced it with either neutral or incompatibly designed signage. Many of these building designs were co-dependent on their midcentury modern signage. It is likely that the period signage does not remain and should not be given undue weight in evaluation. If it is missing, new signs can usually be designed that work with the midcentury storefront and help revive the design aesthetic (See Figures 8 and 9).

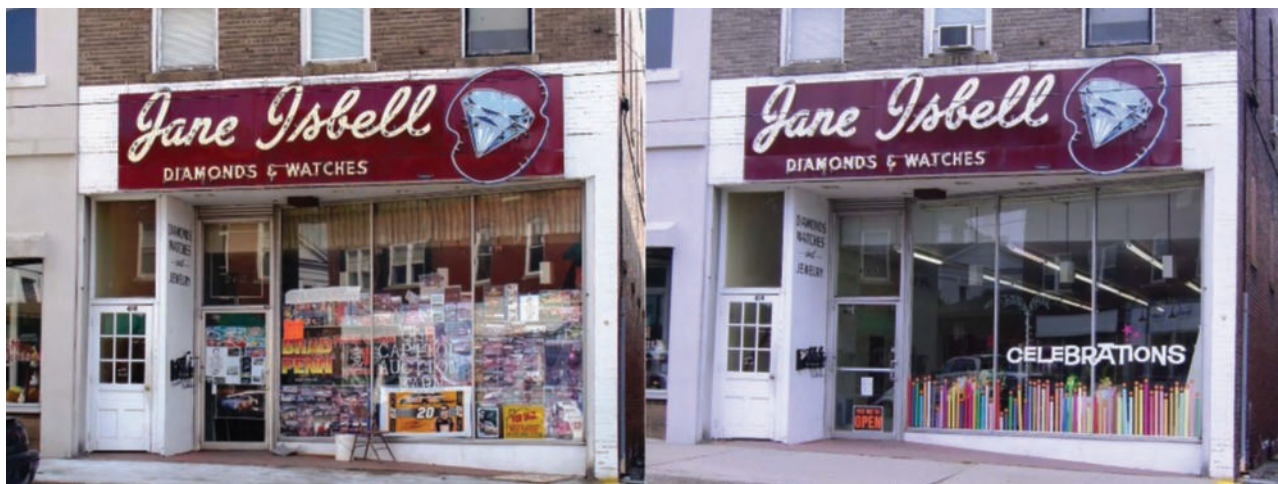
**Figure 9:** This angled, white-metal mid-century storefront in Vandalia, Illinois was surrounded by simple (now painted) brick but embellished with a spectacular neon sign that advertised a mid-century jewelry store complete with a neon-illuminated diamond. Although the new tenant, Celebrations, initially wanted to remove the neon sign and storefront, they realized that the sign had community significance and that it could also reinforce the location identity for their new business. The new Celebrations signage was applied to the glass based on a drawing by IHPA Project Designers Darius Bryjka and Anthony Rubano and kept at the pedestrian level, so it that didn't have to compete with the historic neon "Jane Isbell" sign up in the transom area.

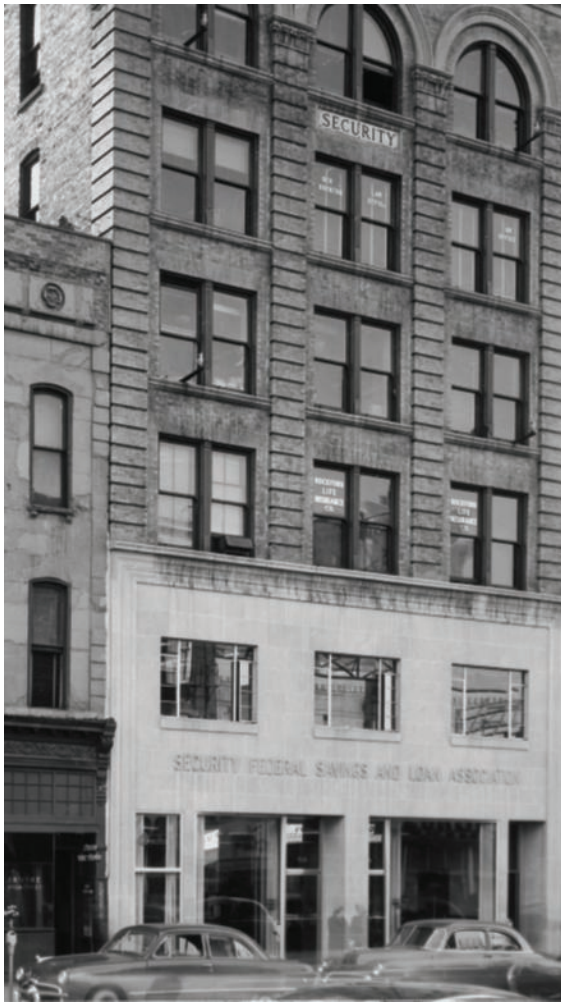
**Figure 3:** The early 20th century Booth Building in Springfield, Illinois received an elegant stone midcentury storefront ca. 1955.

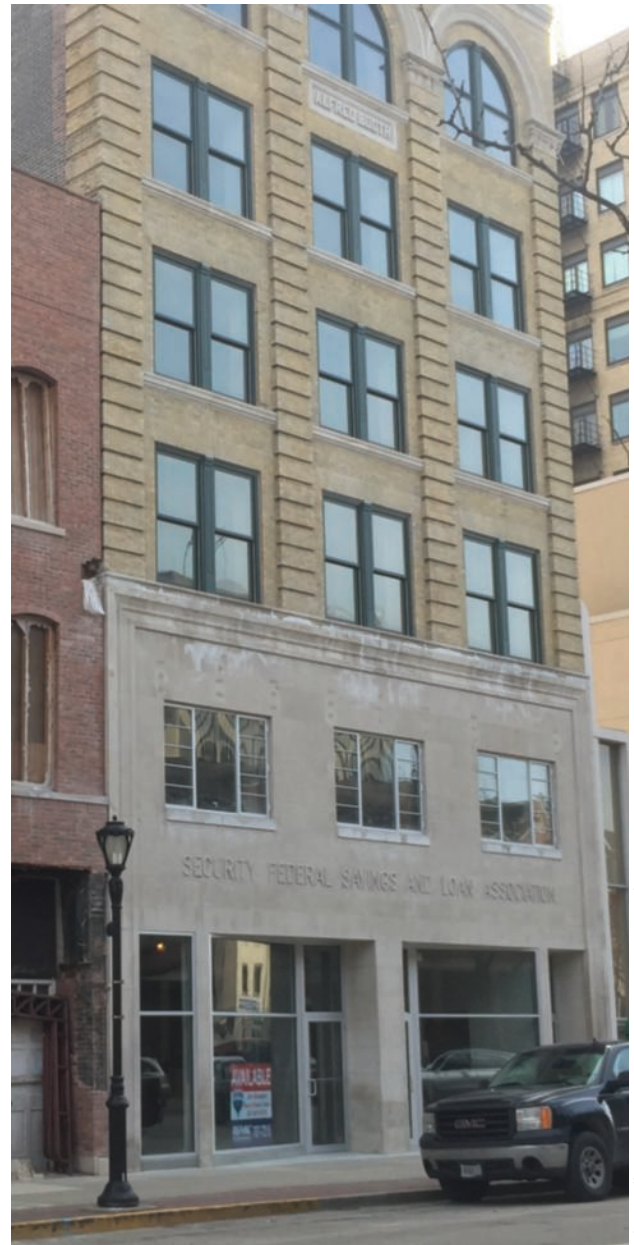
**Figure 5:** As part of an historic preservation tax credit project, the non-historic-period slipcover was removed to expose the original upper floors, and the midcentury storefront was preserved and retained.

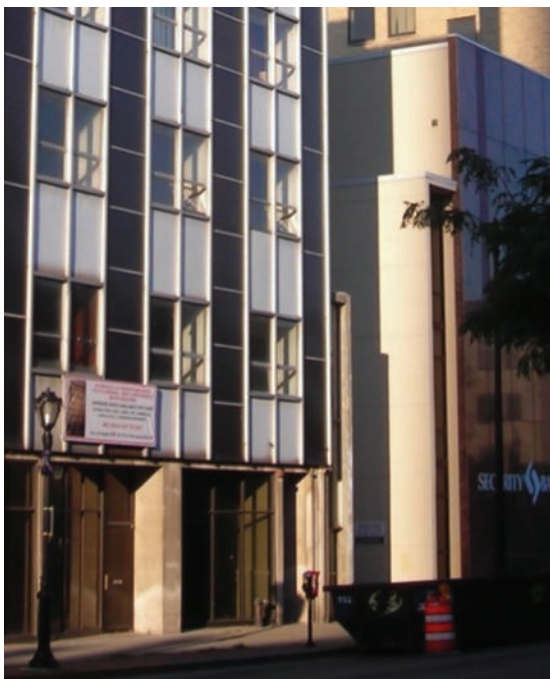
**Figure 4:** The Booth Building was clad in a panelized slipcover by the early 1970s concealing part of the storefront.

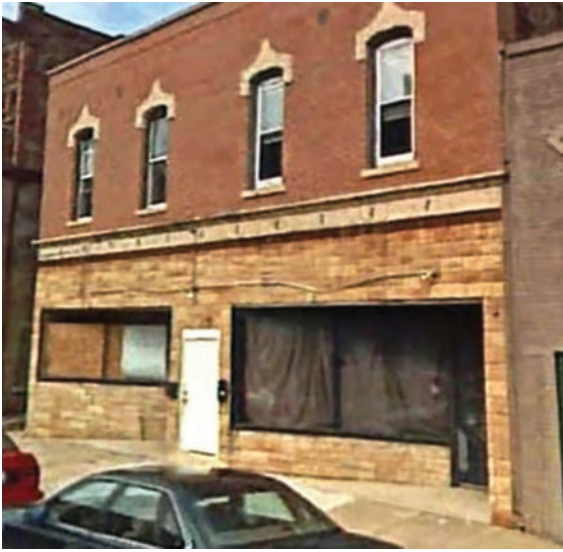
**Figure 6:** This ca. 1890 building in Rockford, Illinois received a number of alterations during the period of significance of the historic district, including the installation of an angled mid-century stone veneer storefront. Sometime after the period of significance the mid-century storefront window frames were painted dark and a later door installed.

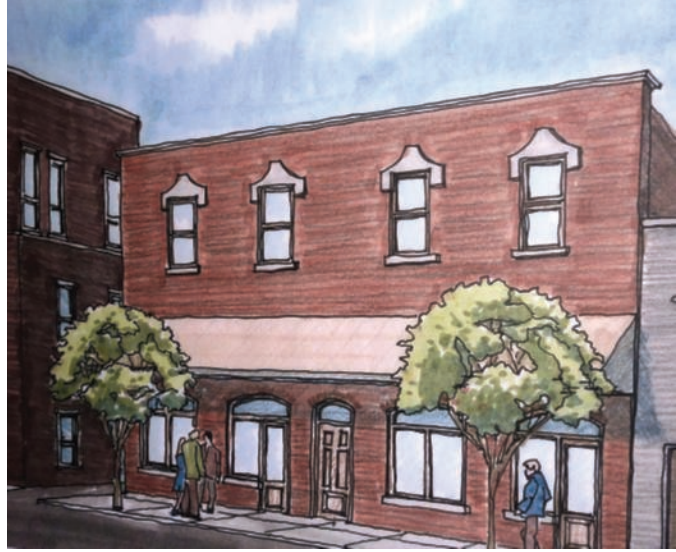
**Figure 7:** The rendering shows the design the owner first proposed, which included demolition of the historic mid-century storefront and installation of a completely new storefront.

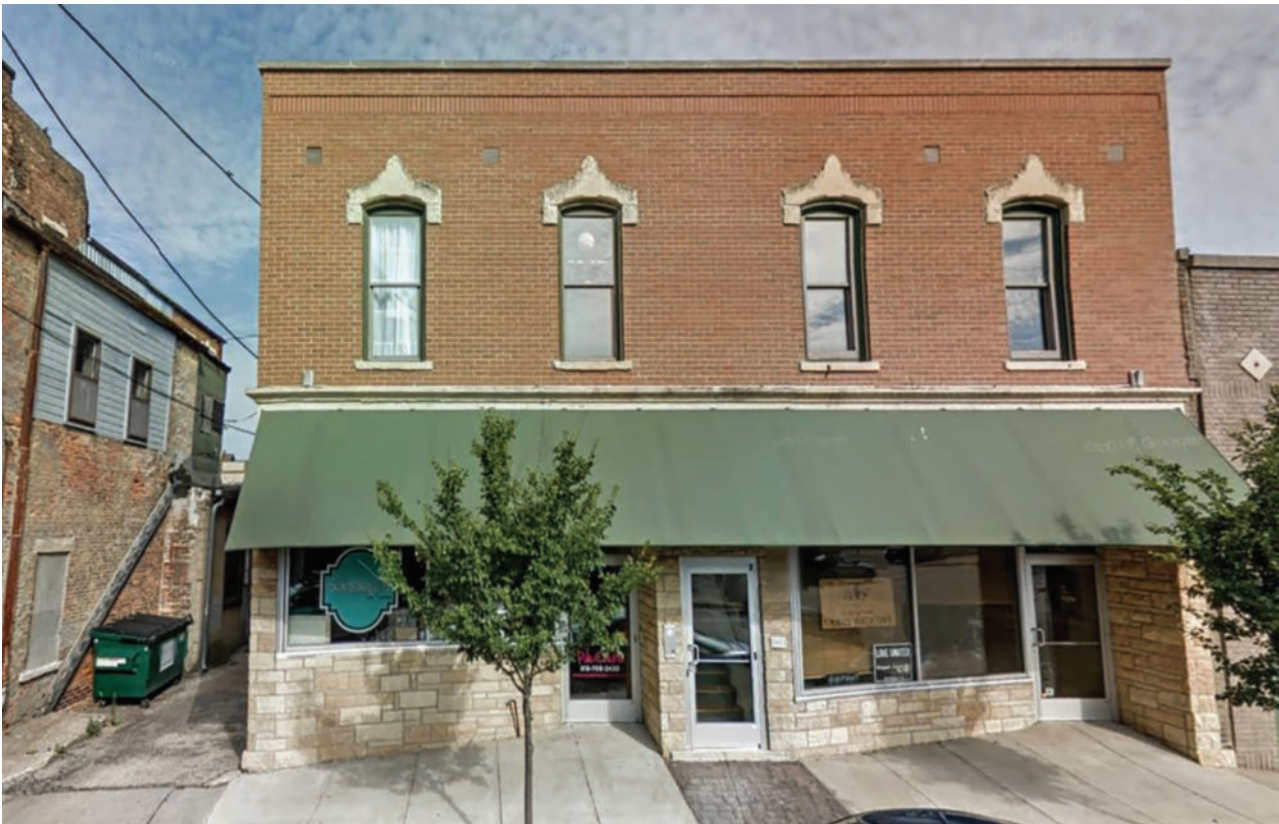
**Figure 8:** For purposes of the federal historic tax credit project the SHPO explained that the mid-century storefront was historic and required its retention. The owner kept the mid-century storefront and installed a compatible clear-view door, restored the white metal window framing and added a canvas awning.
