**ARCHAEOLOGICAL SURVEY SHORT REPORT:  
NATIONAL REGISTER OF HISTORIC PLACES ASSESSMENT  
OF THE DAAB-ZOELLER FARM SITE,  
ST. CLAIR COUNTY, ILLINOIS**

Prepared by  
Christopher Stratton  
and  
Floyd Mansberger

Fever River Research, Inc.  
Springfield, Illinois

**Project Type/Title:** National Register of Historic Places assessment of the Daab-Zoeller Farm Site.

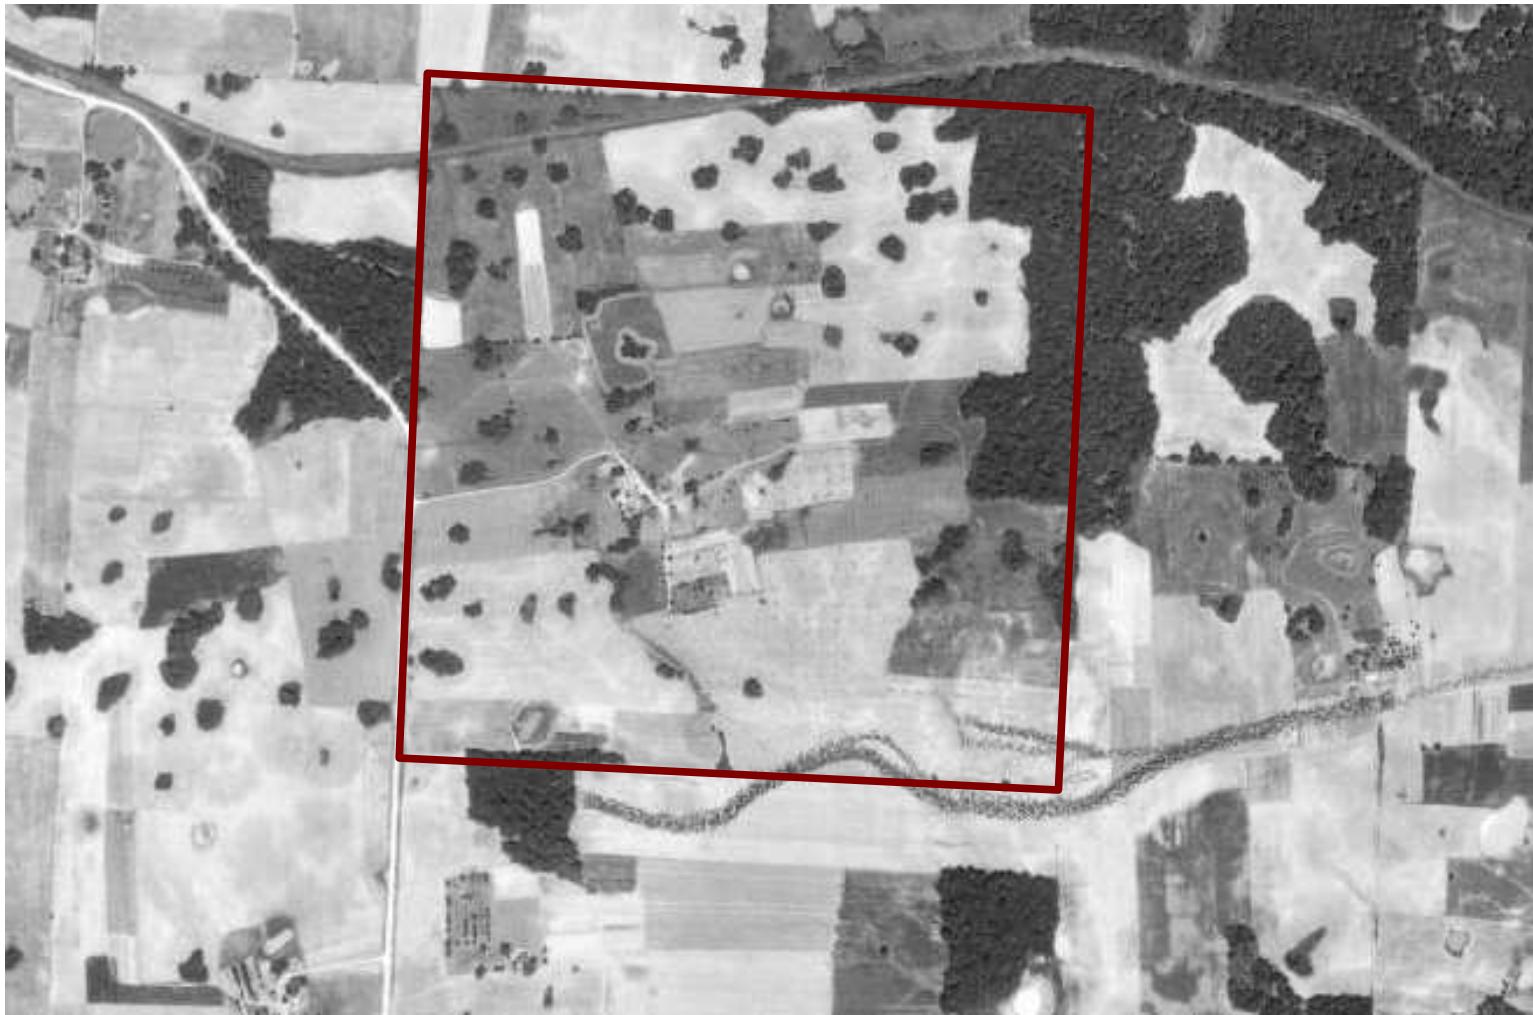
Figure 15. A 1940 aerial photograph showing the Zoeller Farmstead, outlined here in red (United States Department of Agriculture [USDA] 1940:SK-8A-26).

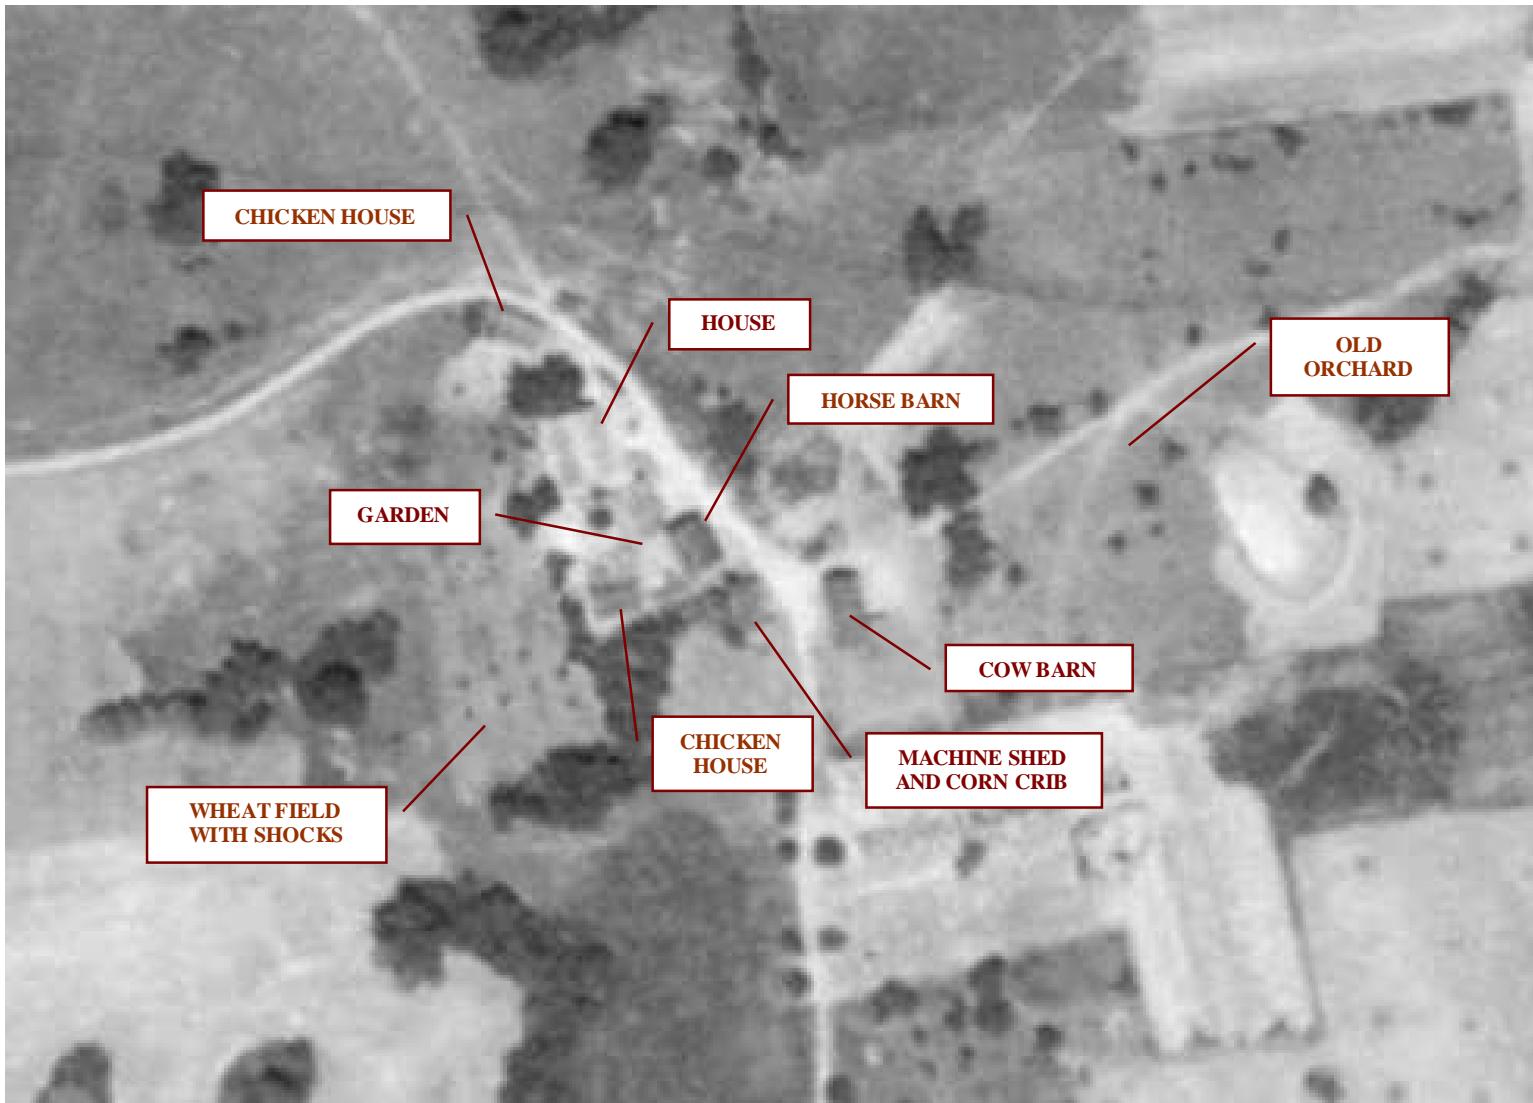
Figure 16. Detail of the previous photograph with main buildings and other areas on the Zoeller Farmstead labeled (United States USDA 1940:SK-8A-26).

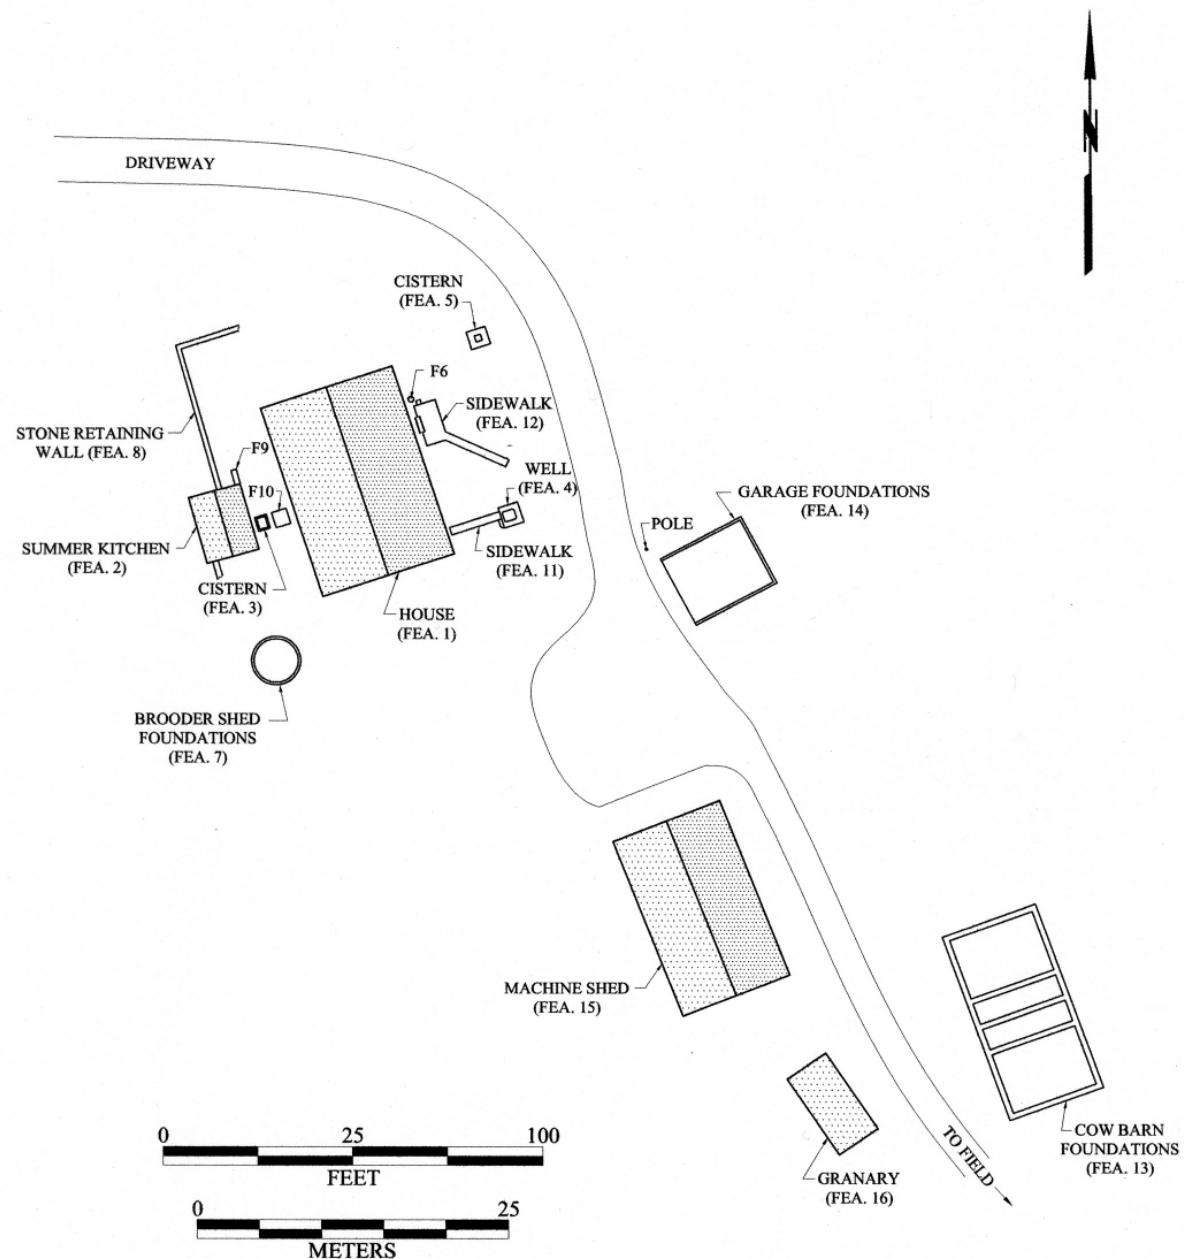
**Figure 20.** Site plan of the Daab-Zoeller Farmstead showing conditions in 2009, with structural features noted.

**Sites/Features Found:** The Daab-Zoeller Site presently has four standing buildings: a house, summer kitchen, machine-shed, and granary. The house (discussed as Feature 1) is the oldest building at the site. It was constructed in several episodes, the original dating to 1846. The summer kitchen (Feature 2) likely was constructed circa 1850-1860. The machine-shed (Feature 15) and granary (Feature 16) were constructed in the modern era, post-1950. The foundation remains of several other buildings are present, including those for a brooder shed (Feature 7), a cow barn (Feature 13), and a garage (Feature 14). Water-supply related features present at the site include a stone-lined well (Feature 4), a brick-lined cistern (Feature 3), a concrete cistern (Feature 5), and a steel drum through which a water line for an outdoor fountain was once run (Feature 6). Several landscape-related features were identified, including two concrete sidewalks (Features 11 and 12), a stone retaining wall (Feature 8), and a concrete pad (Feature 10). The locations of

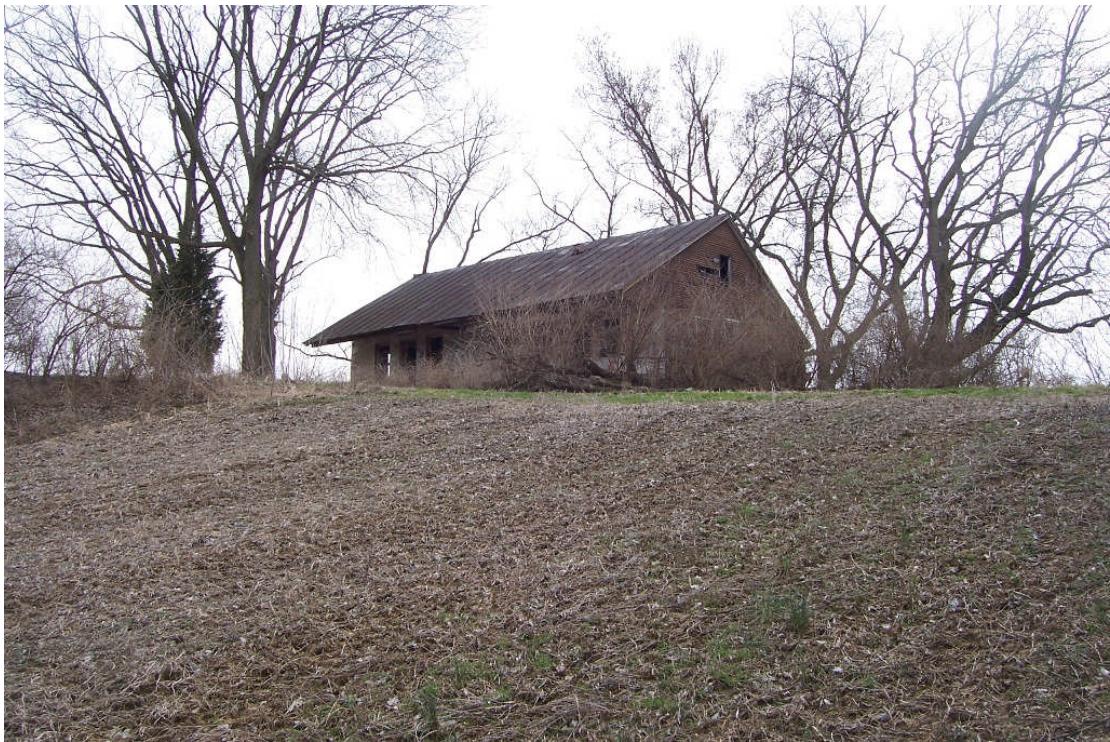
**Figure 21.** Present views of the Daab-Zoeller Farmstead looking southeast (TOP) and southwest (BOTTOM). These images well illustrate the karst topography in which the farmstead is located. The site lies on a narrow ridge with steep slopes descending to sinkholes on the east and west.

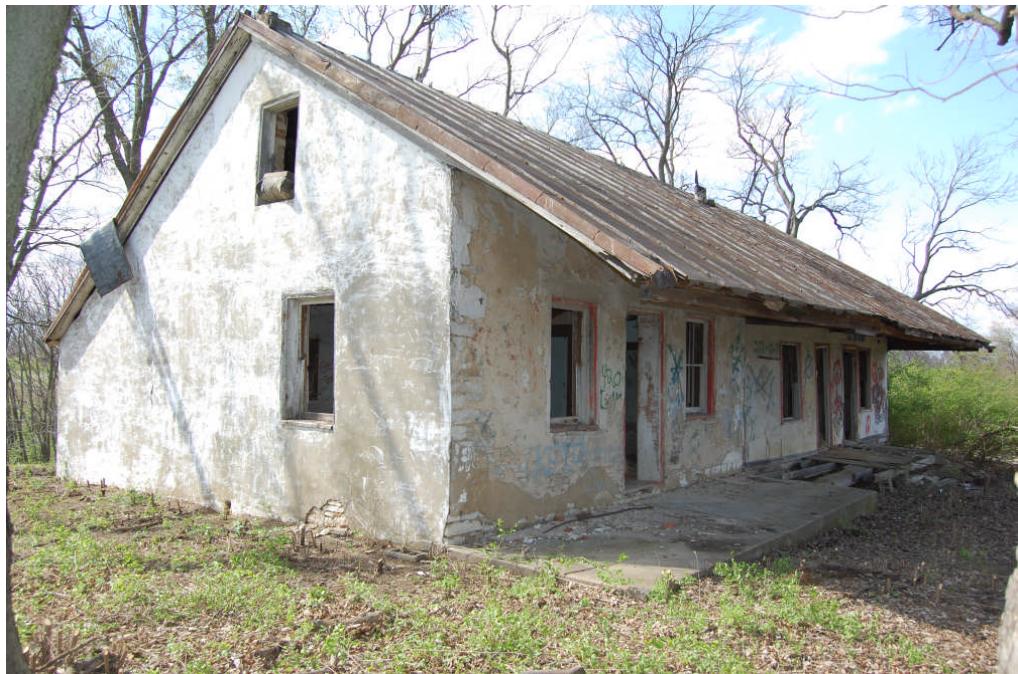
**Figure 22.** Exterior view of the house at the Daab-Zoeller Farmstead looking northwest and showing east and south elevations. This image is from the Spring of 2010.

House (Feature 1): The residence at the Daab-Zoeller Farmstead is located on the northern end of the site and faces east. It is a 1½-story, double-pile, side-gabled dwelling with a six-bay façade that measures 52'-8" (north/south) by 29'-7". A full-length porch stretches across the front (east) elevation. This porch is covered by the principal roof, which creates the impression of it being “incised” within the body of the house as opposed to simply attached (see Figures 22 through 28).

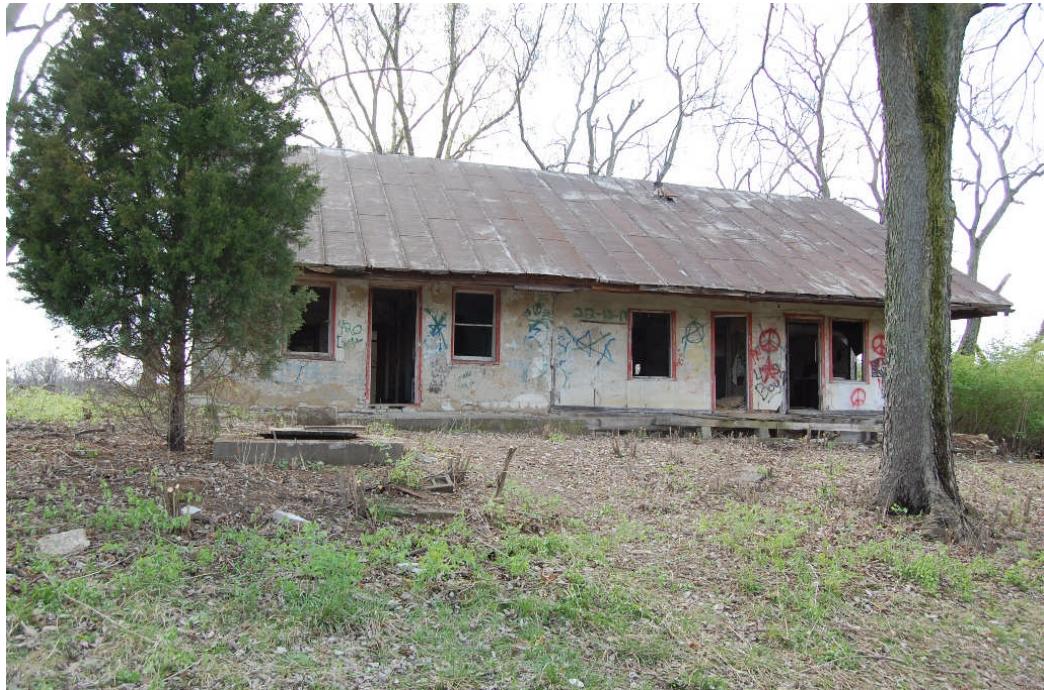
**Figure 23.** View of the east elevation of the house. The dwelling was constructed in two episodes. The earlier half-timbered section is at right, with the paired doorways. The later stone addition is at left. This image and those that follow show conditions in the Spring and Summer of 2009.

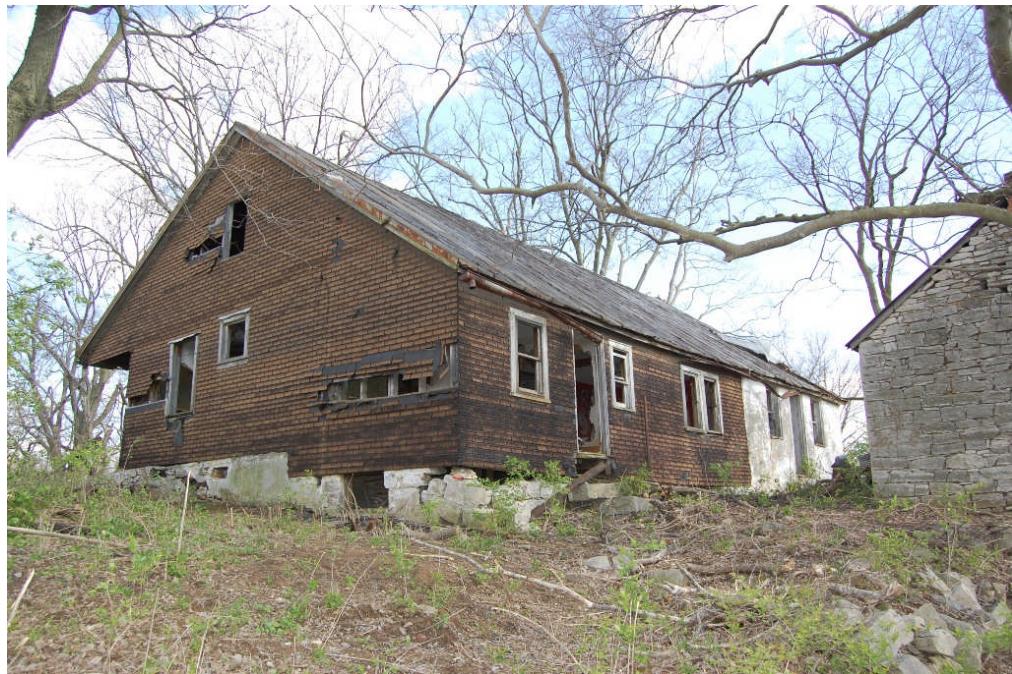
**Figure 24.** View of the northwest corner of Daab House, looking southeast. The asphalt siding covering the north and west (rear) elevations of the original house was added in the middle twentieth century.

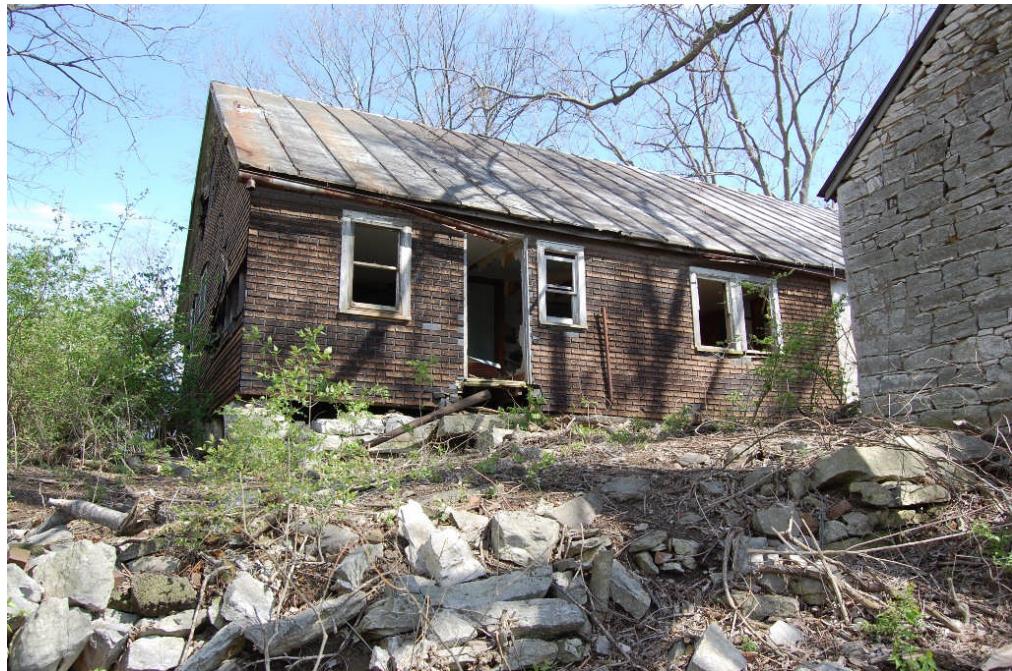
**Figure 25.** View of the northern end of the west elevation of the house. This wall was rebuilt in the late nineteenth century and remodeled once again the middle twentieth century.

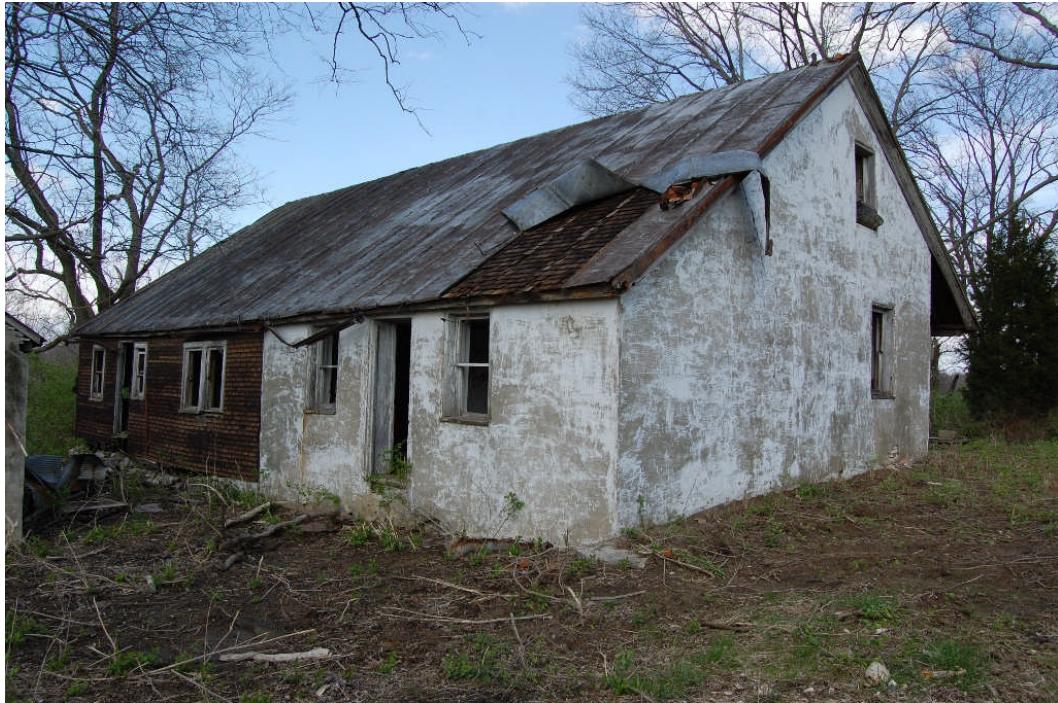
**Figure 26.** View of the southwest corner of the house looking northeast. The stone addition is fully covered with plaster/stucco on the exterior.

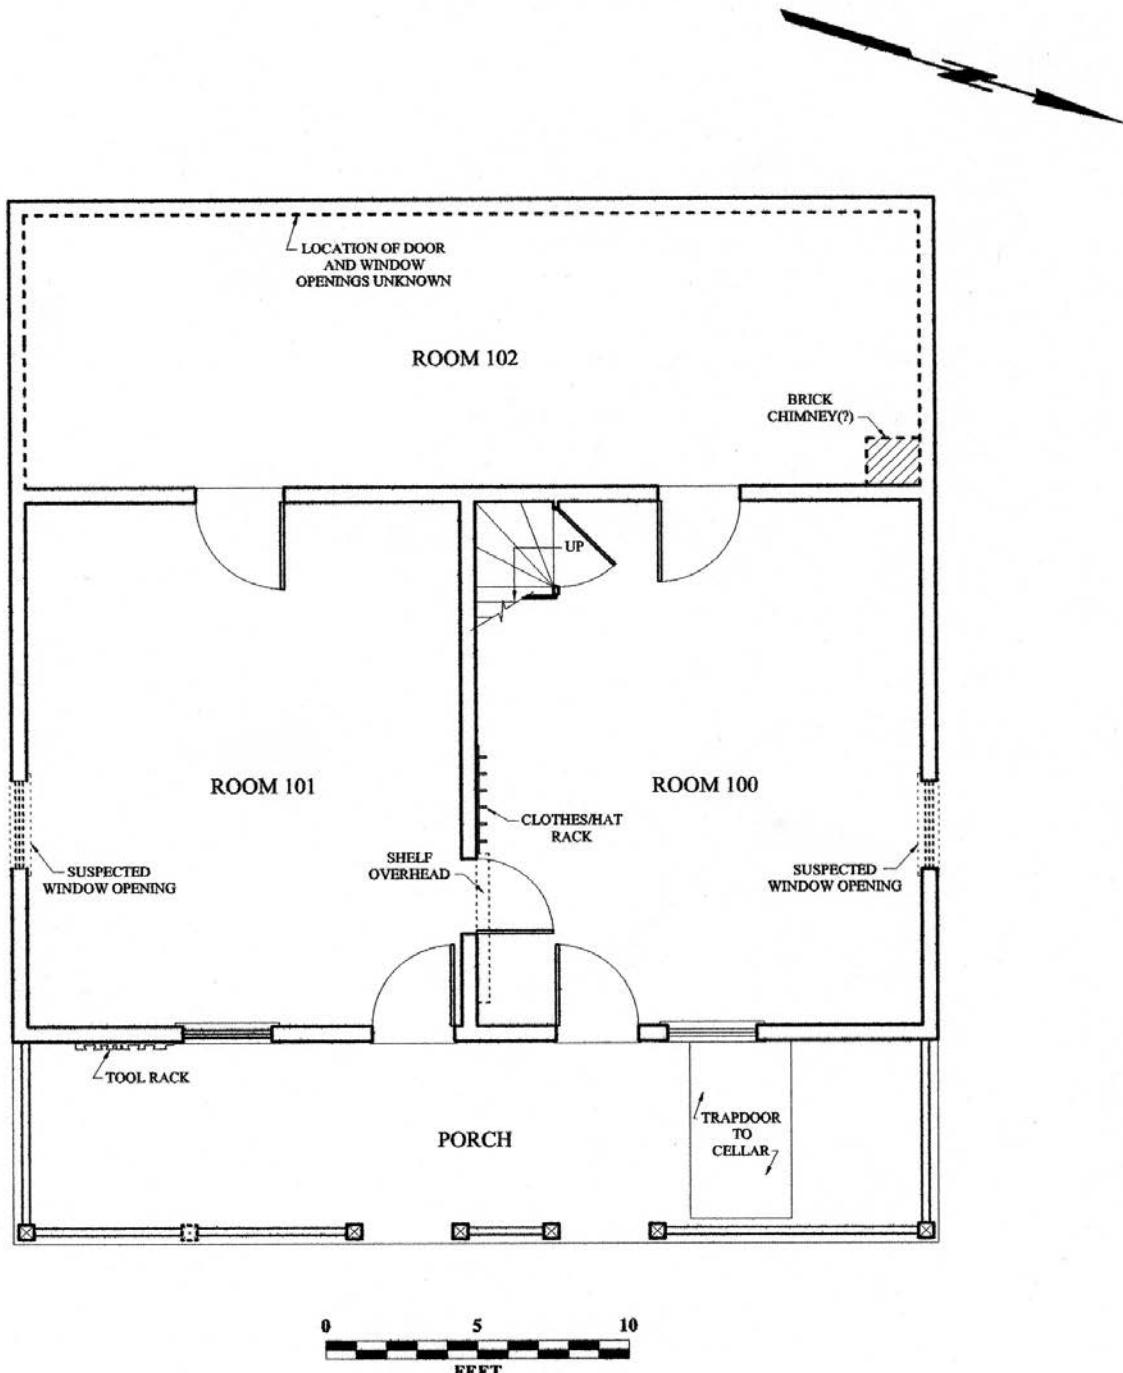
Figure 28. First plan of the house as originally constructed in 1846. The locations and door and window openings in the rear wing are not known due to the remodeling and removal of the original walls here.

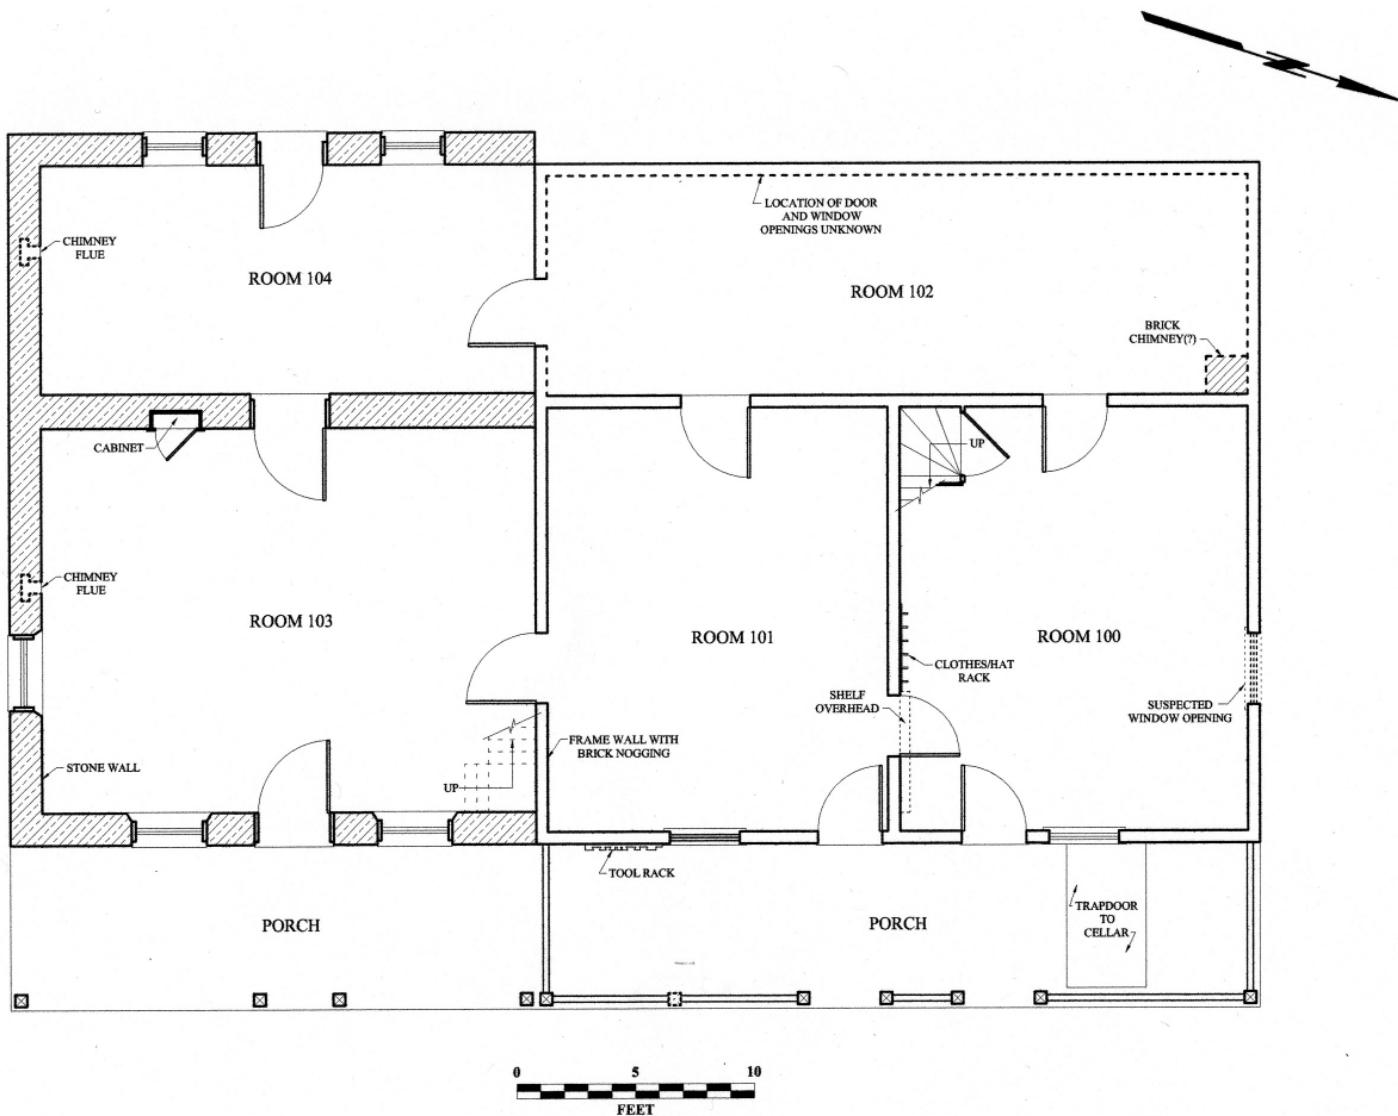
Figure 29. First floor plan of the house showing conditions circa 1860, following construction of the stone addition.

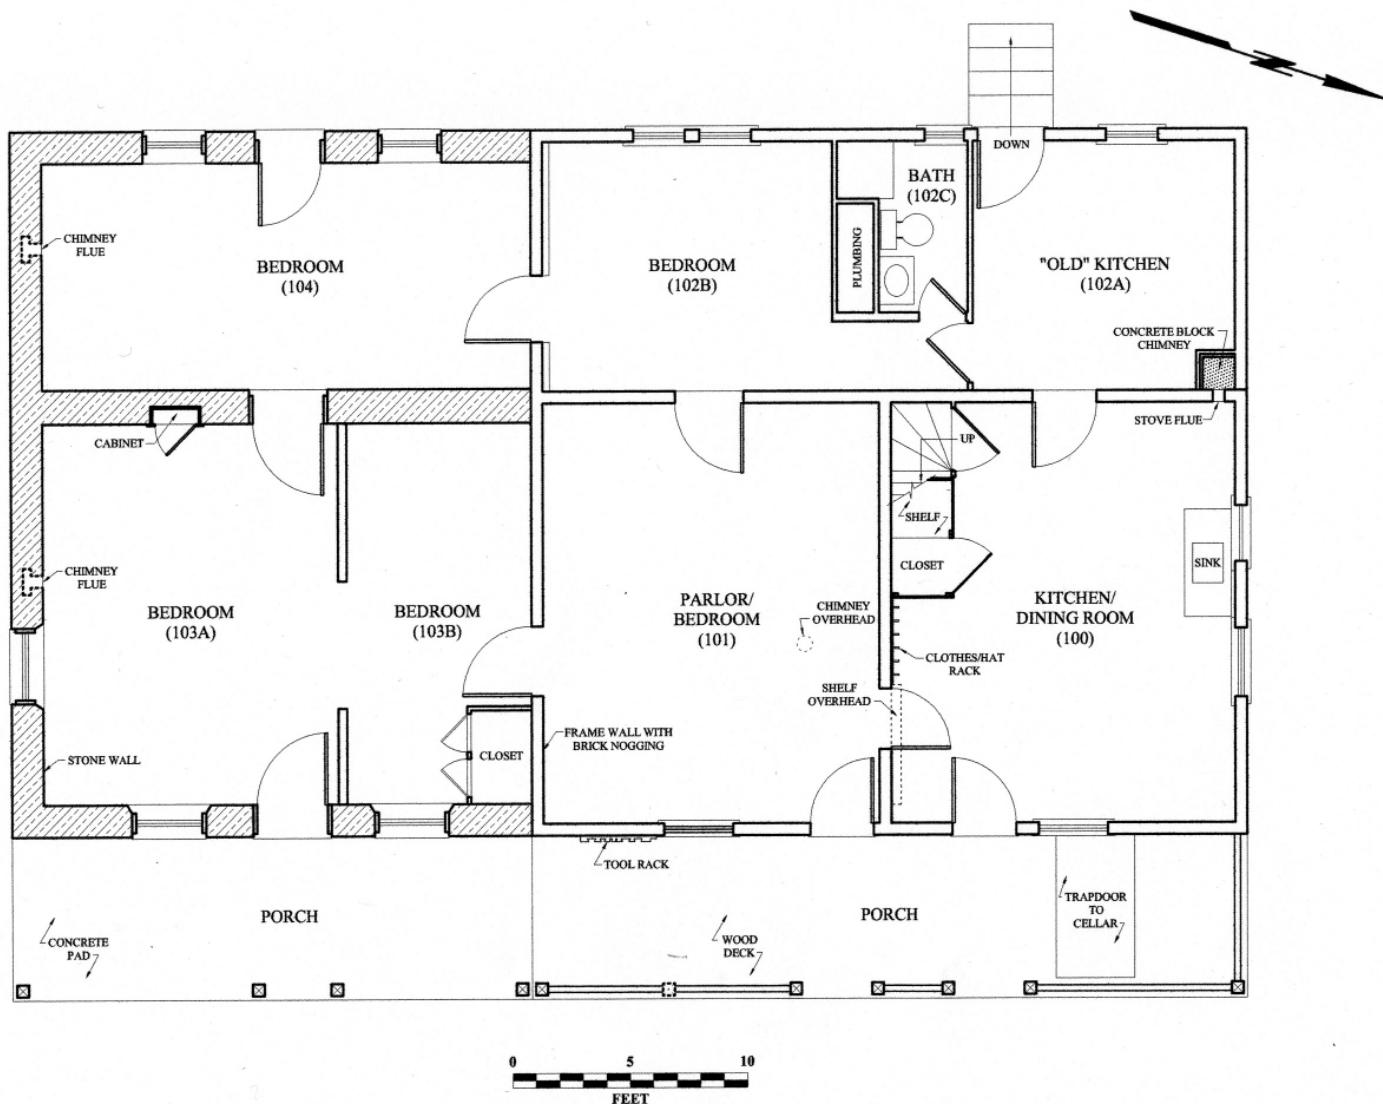
Figure 30. First floor plan of the house showing conditions circa 1955. By this date, Rooms 102 and 103 had been partitioned up into multiple rooms. This plan also reflects existing conditions at the house.

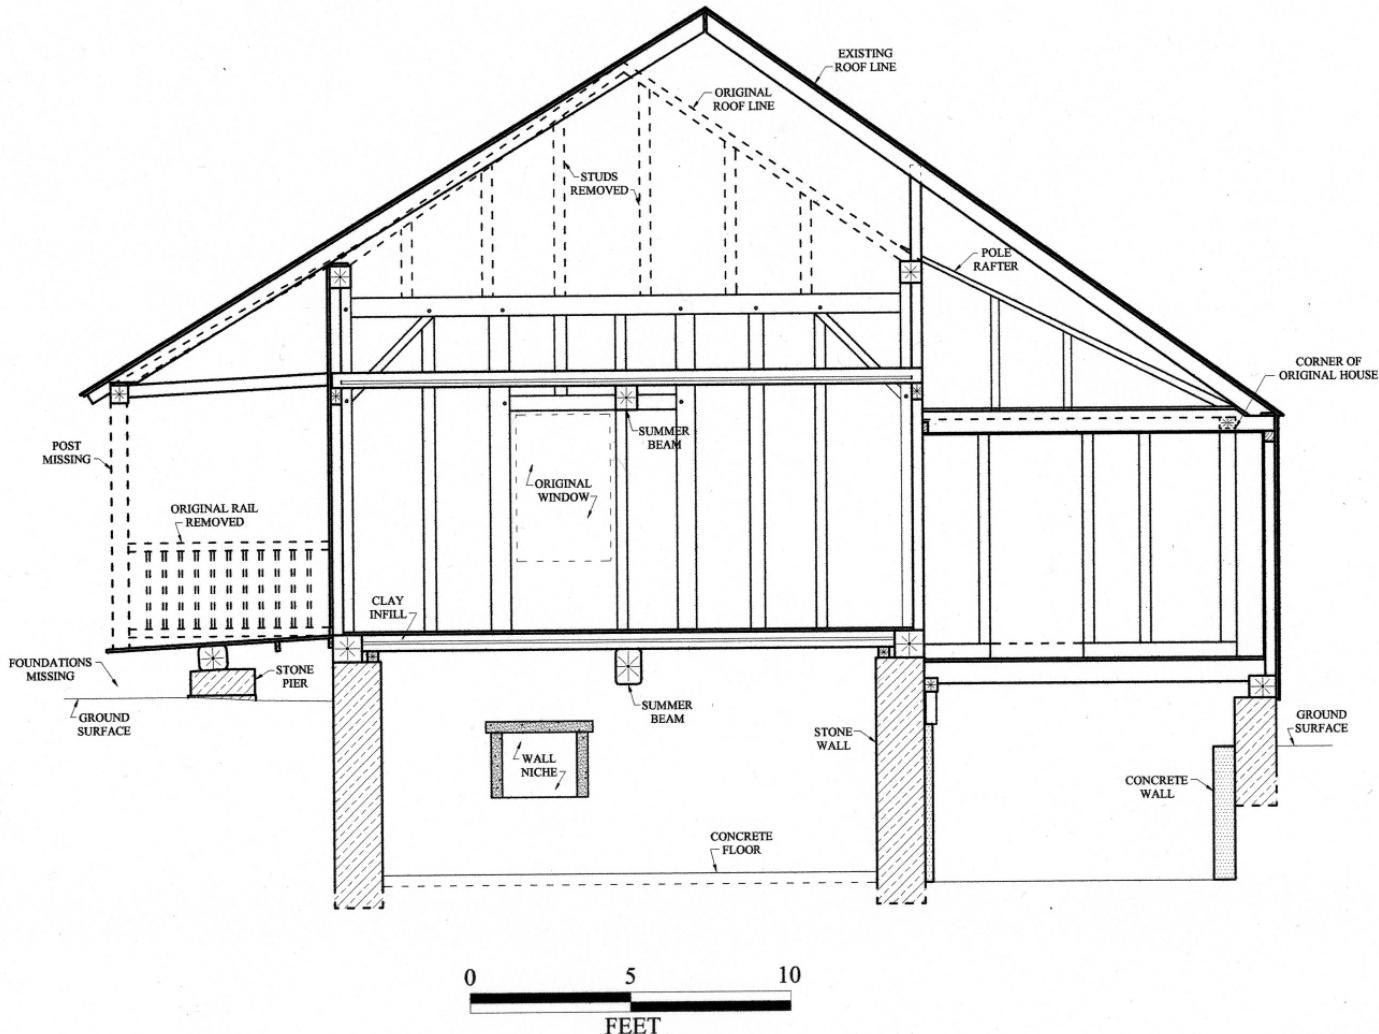
Figure 31. Sectional view through the original part of the house, looking south.

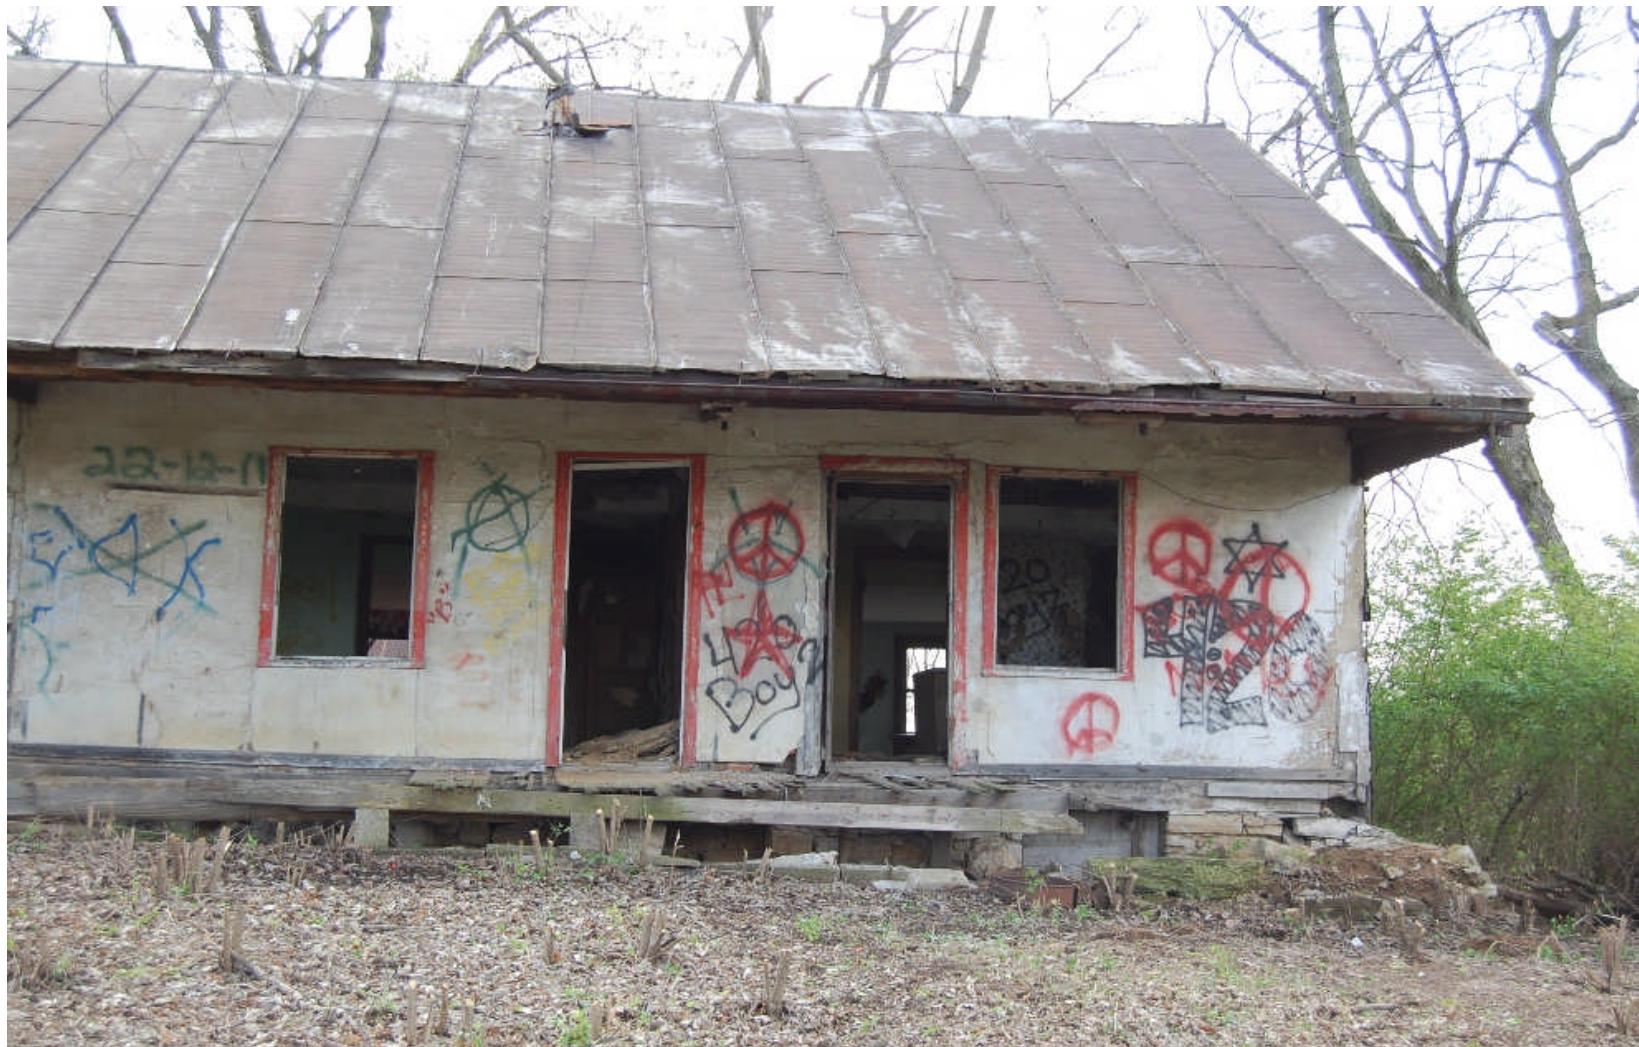
**Figure 32.** Front (east) elevation of the house, showing original section. Note the paired doorways accessing the two front rooms of the original house. Also of note is plastered façade, which is protected from elements within the deep porch. The plaster finish covers a half-timber frame with brick nogging.

As noted above, the house has full length porch, measuring approximately 7' wide, running along its east elevation (see Figures 33 through 42). The northern end of the porch, which fronts the original house, has a frame deck that is badly deteriorated and shows evidence of having been rebuilt at one other time in the past—likely in the early-to-middle twentieth century.<sup>10</sup> Structural evidence indicates that the porch deck originally had large, hand-hewn sills and central floor beam. The central beam and one of the end sills are still extant, but the remainder of the original framing has been replaced with nominal-sized, sawn joists and narrow tongue-and-groove flooring. There also is evidence of an early porch rail, the ends of which actually were mortised into the corner posts of the house. A bulkhead stairway entrance to the cellar is located at the north end of the original porch; this was covered by a trapdoor at one time. The section of porch fronting the stone addition presently has a concrete deck, but it originally was

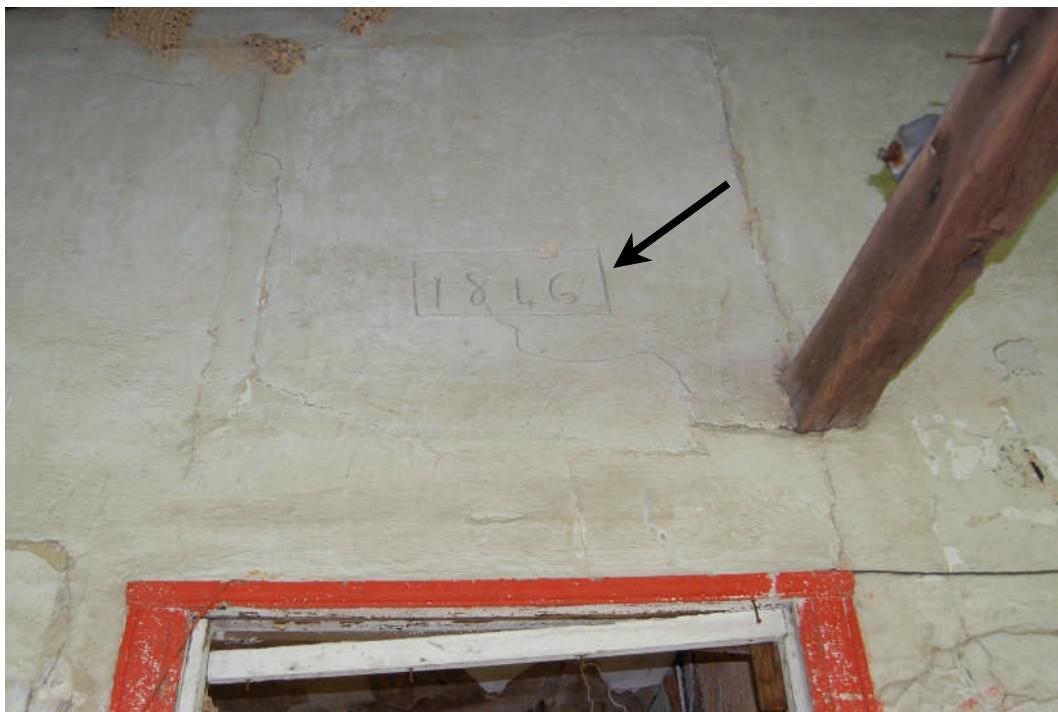
**Figure 33.** Views of the wall surface above the southern of the two original front doors showing location of an “1846” inscribed in the plaster. This is believed to reference the date of construction of the original house.

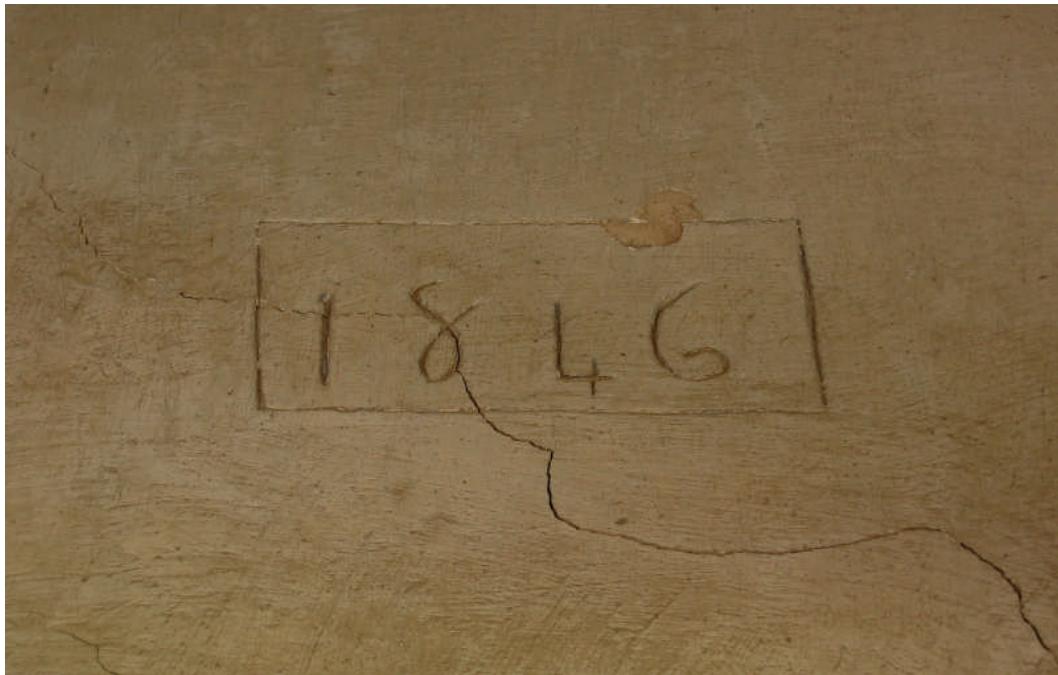
**Figure 34.** Detail of the suspected construction date above the front entrance. The house was built two years after John G. Daab purchased his farm.

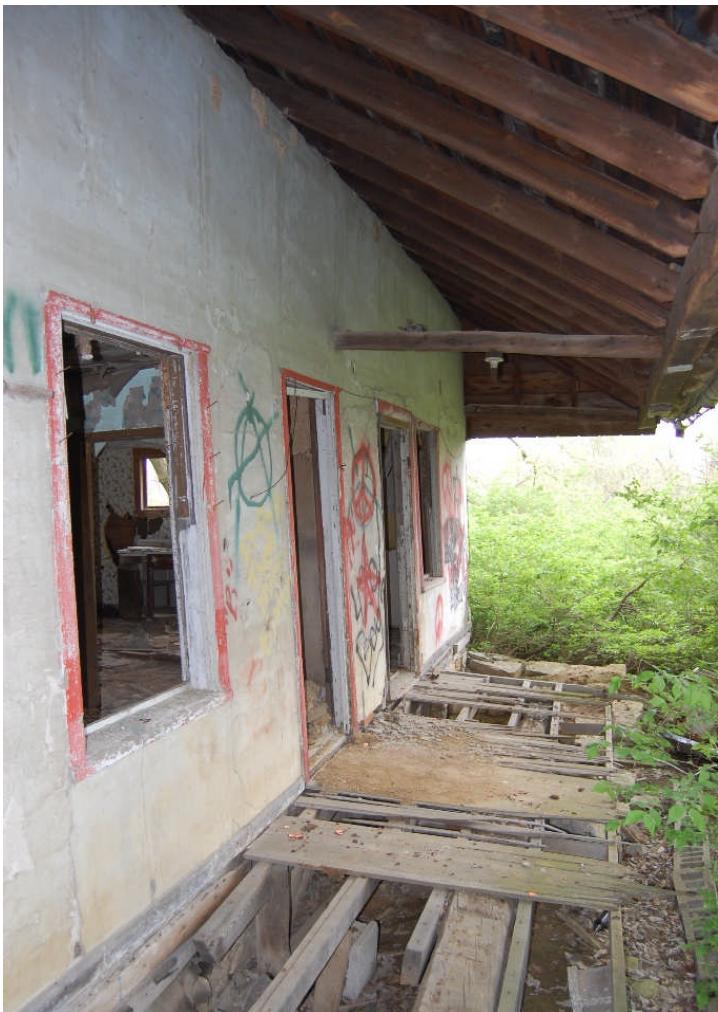
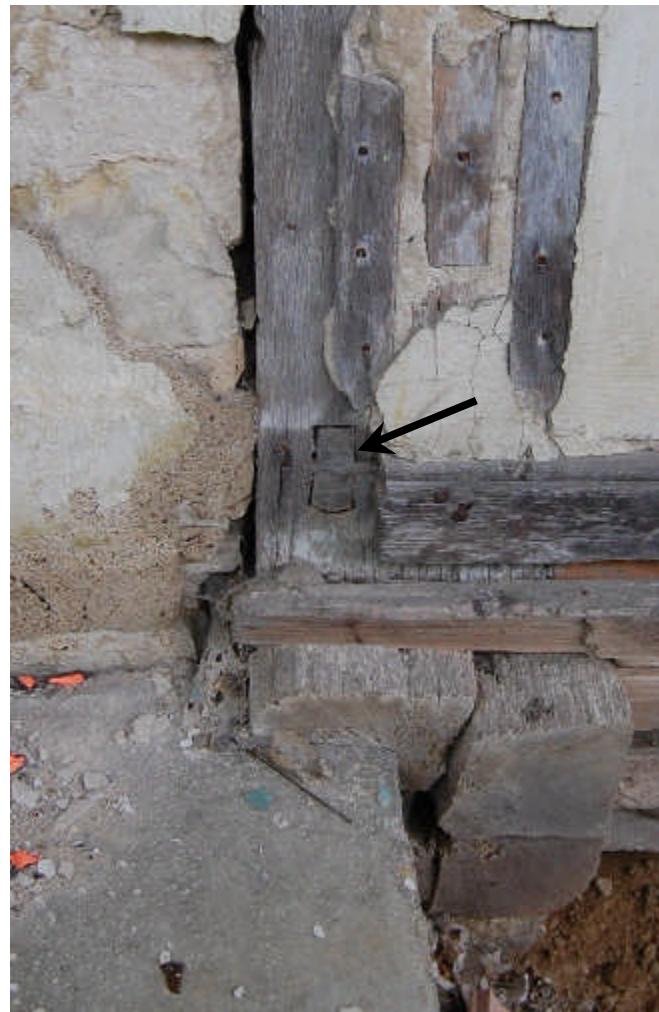
**Figure 35. (LEFT)** View of the front porch on the east side of the original house. The wood deck has been replaced at least once in the house's history and that which remains is badly deteriorated. **(RIGHT)** Detail of the south end of the original porch at its juncture with the stone addition. The southeast corner post of the original house is partially exposed, and there is evidence of a porch rail having been mortised into it at one time (marked with arrow). The hand-hewn oak sill of the original porch has been sawn off.

frame. The current concrete deck was poured in the middle-to-late twentieth century by the Zoellers and replaced a very dilapidated frame deck (Helen Shea and Jim Zoeller, pers. comm., 26 June 2009).

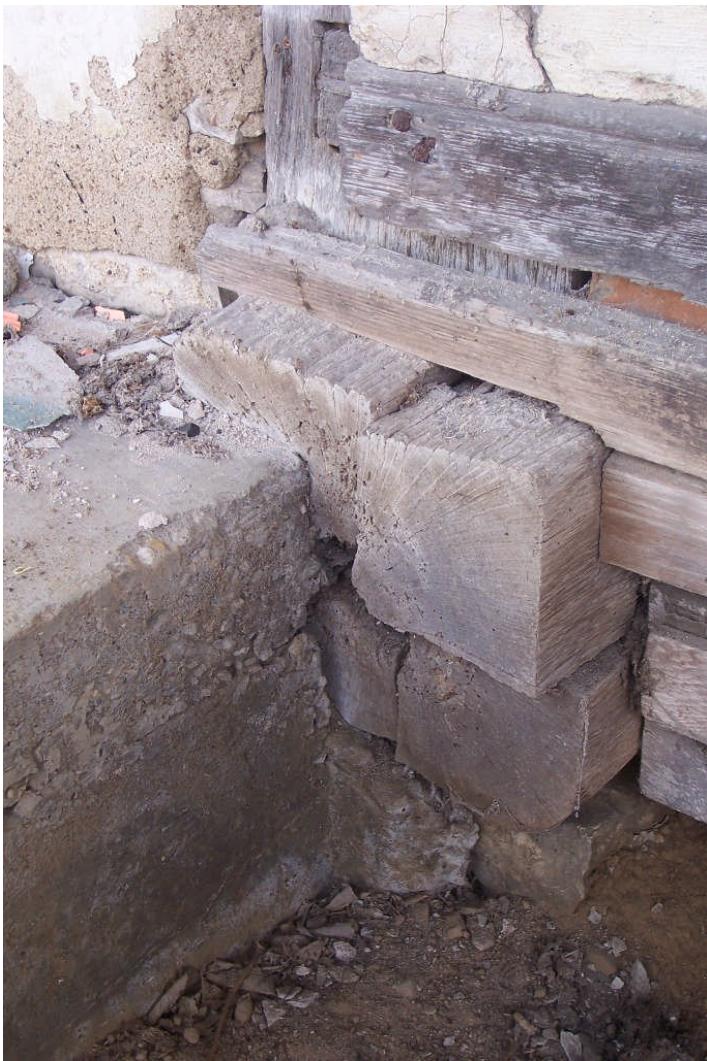
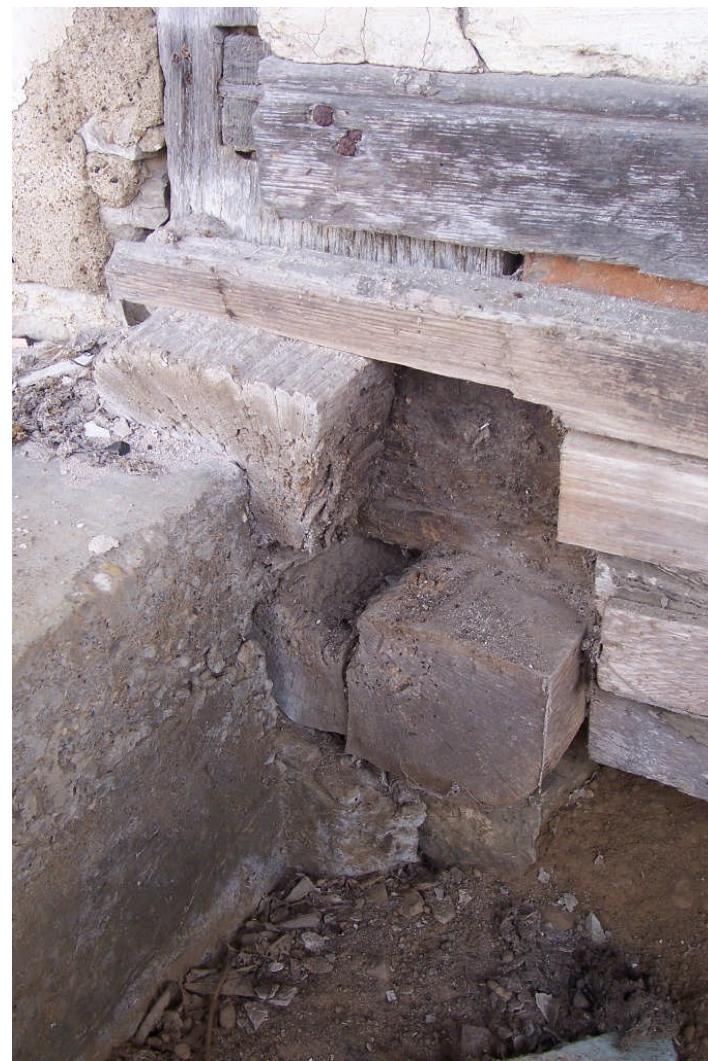
**Figure 36. Close-up views of the sawn-off sill on the south end of the original house, illustrating the manner in which the porch sill was half-lapped around the southern house sill plate, which was extended 3" inches beyond the wall plane to accommodate the former. The images show the porch sill remnant before and after removal.**
