**ARCHAEOLOGICAL SURVEY SHORT REPORT:  
NATIONAL REGISTER OF HISTORIC PLACES ASSESSMENT  
OF THE DAAB-ZOELLER FARM SITE,  
ST. CLAIR COUNTY, ILLINOIS**

Prepared by  
Christopher Stratton  
and  
Floyd Mansberger

Fever River Research, Inc.  
Springfield, Illinois

**Project Type/Title:** National Register of Historic Places assessment of the Daab-Zoeller Farm Site.

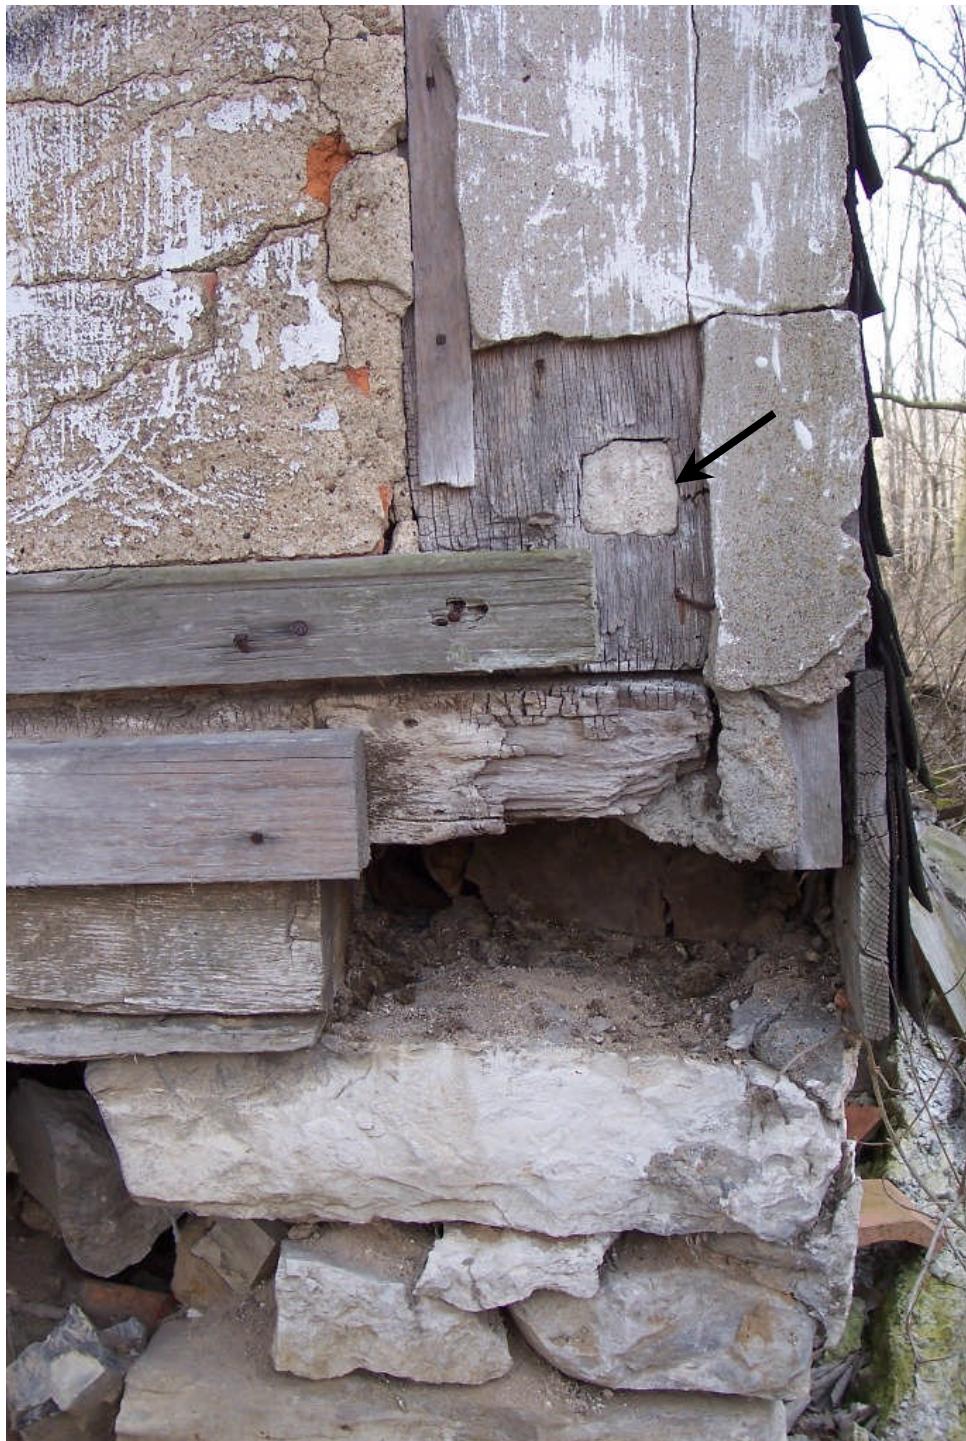
**Figure 37.** In contrast to the sill on the opposite end of the porch, the north porch sill was half-lapped around the eastern sill plate of the house. The porch here has fallen away from the house, but its location is marked by the void shown above. This image also shows the location of a long-removed porch rail (note arrow).

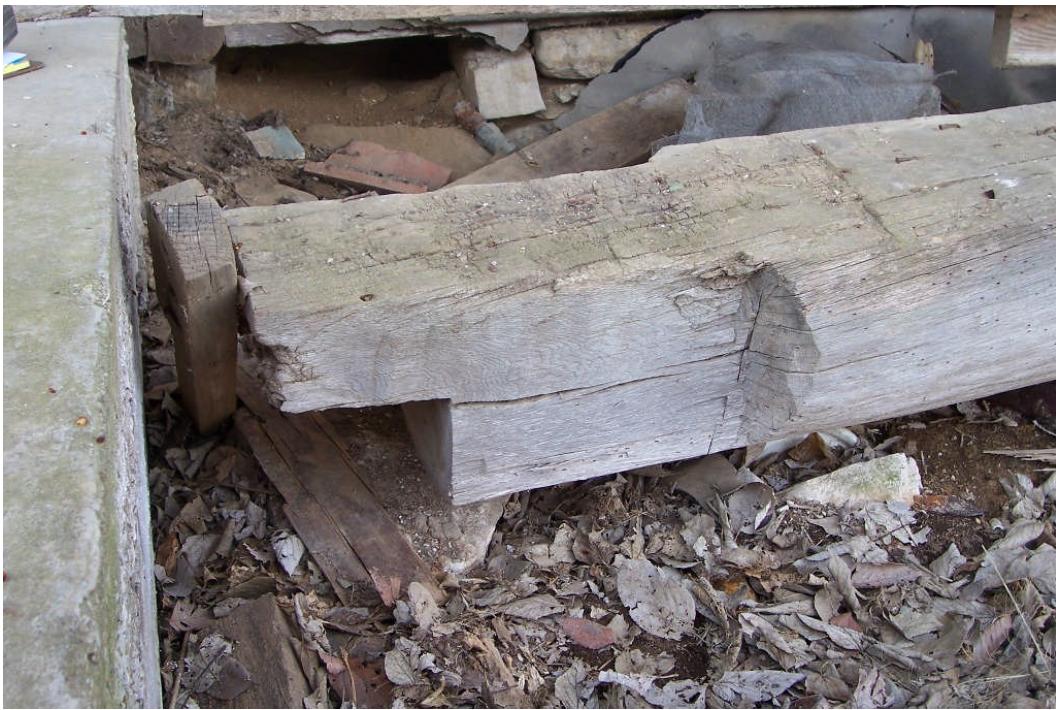
**Figure 38.** View of the south end of the center beam on the front porch of the original house showing method of notching used around to fit the beam around the sill.

As noted above, the house has full length porch, measuring approximately 7' wide, running along its east elevation (see Figures 33 through 42). The northern end of the porch, which fronts the original house, has a frame deck that is badly deteriorated and shows evidence of having been rebuilt at one other time in the past—likely in the early-to-middle twentieth century.<sup>10</sup> Structural evidence indicates that the porch deck originally had large, hand-hewn sills and central floor beam. The central beam and one of the end sills are still extant, but the remainder of the original framing has been replaced with nominal-sized, sawn joists and narrow tongue-and-groove flooring. There also is evidence of an early porch rail, the ends of which actually were mortised into the corner posts of the house. A bulkhead stairway entrance to the cellar is located at the north end of the original porch; this was covered by a trapdoor at one time. The section of porch fronting the stone addition presently has a concrete deck, but it originally was

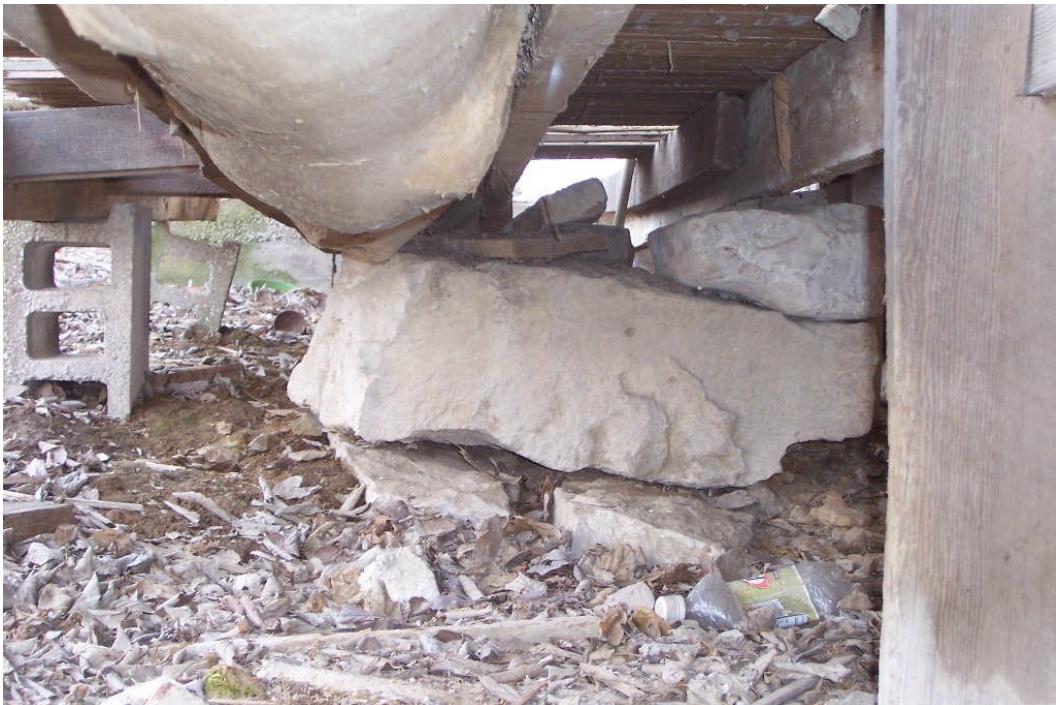
**Figure 39.** The center beam of the original porch was supported by a stone pier in the middle of its span, as shown above.

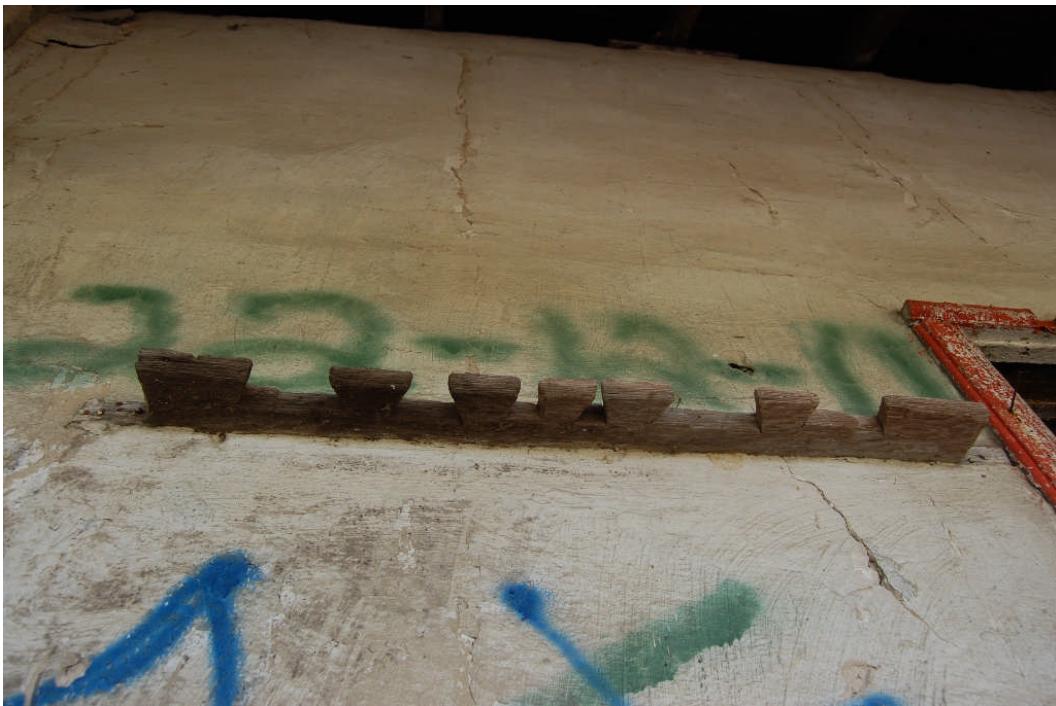
**Figure 40.** Incised into the north wall of the original house is a plank that has variably sized notches. This served as a rack for holding different tools, such as brooms. The tool rack appears to be original to the house, or at least was installed very early in the dwelling's history.

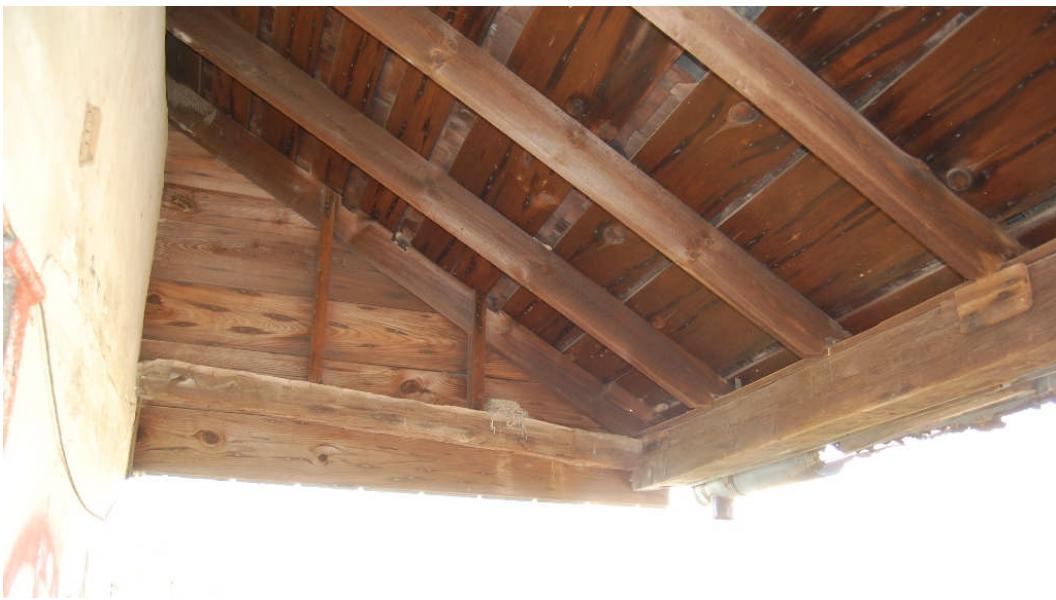
**Figure 41.** View of the roof framing on the north end of the house porch. The rafter plate is hand-hewn oak, as is the beam on the gable end. The rafters are sawn and were installed when the roof was replaced in the late nineteenth century.

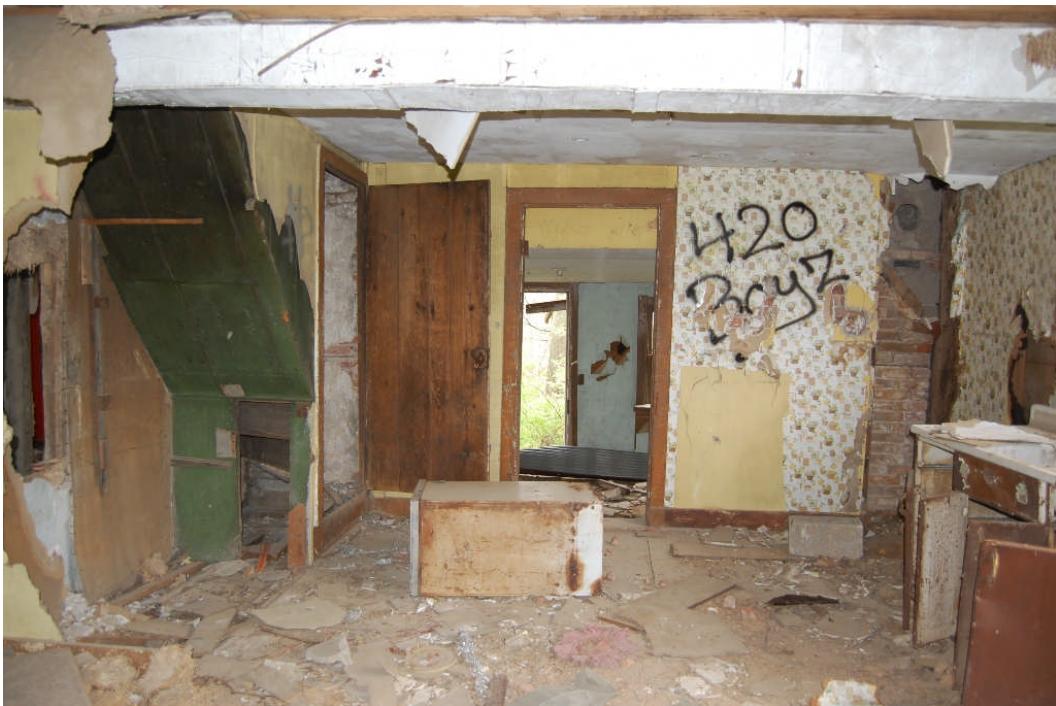
**Figure 42.** Interior view of Room 100 looking west. This space historically served as a kitchen and dining room. Note the enclosed stairway to the upper floor at left.

Room 100 is the northern of the two eastern rooms in the original house (see Figures 43 through 54). It measures 14' 8" x 17' -7"<sup>12</sup> and has two interior doorways—located on the south and the west—which access the two other original rooms on the first floor of the house (Rooms 101 and 102). An original window looking out onto the front porch flanks the exterior doorway on the east, while two other window openings are present on the north wall. The north wall of the house partially was rebuilt in the middle-to-late 1930s,<sup>13</sup> and the existing window openings were added that time; only one window is suspected to have been present here originally. A stairway accessing the upper floor of the house is located in the southwest corner of the room. This stairway is L-shaped and enclosed with planking. Early in the twentieth century, the area beneath the stairway was framed in to create a closet. Helen Shea and Jim Zoeller recall their parents referring to this closet as the *wandschrank*, which is German for “wall cabinet.” The family stored all sorts of things in it: old shoes down below, medicine, cattle medicine, maybe some vanilla and other kitchen supplies, and small tools like pliers and screwdrivers. Helen said just about everything the family needed was in the *wandschrank* (Helen Shea and Jim Zoeller, pers. comm., 26 June 2009). A clothes/hat rack is attached to the section of wall between the *wandschrank* and the doorway leading into Room 101. This rack appears to be quite old, as does the shelf located above the doorway to Room 101.

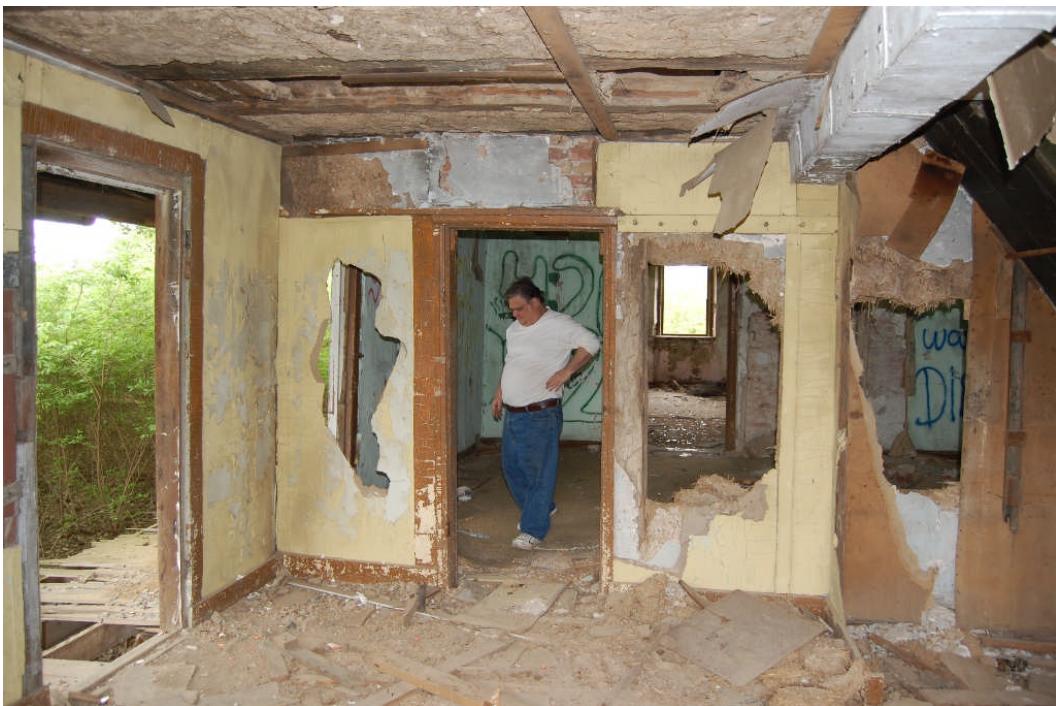
**Figure 43.** Interior view of Room 100 looking south into Room 101 beyond. Vandals have knocked out sections of the partition wall between the two walls. Joseph Phillippe pictured.

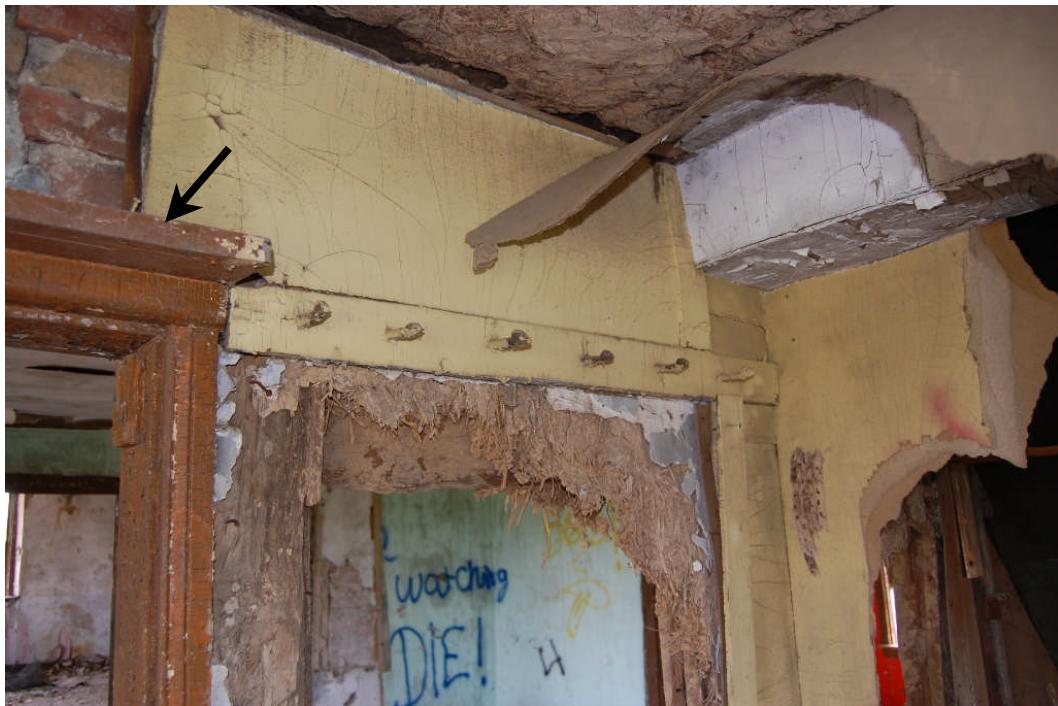
**Figure 44.** Detail of the south of Room 100 showing the shelf above the doorway between Rooms 100 and 101 (marked with arrow) and hat/clothes rack adjacent to it.

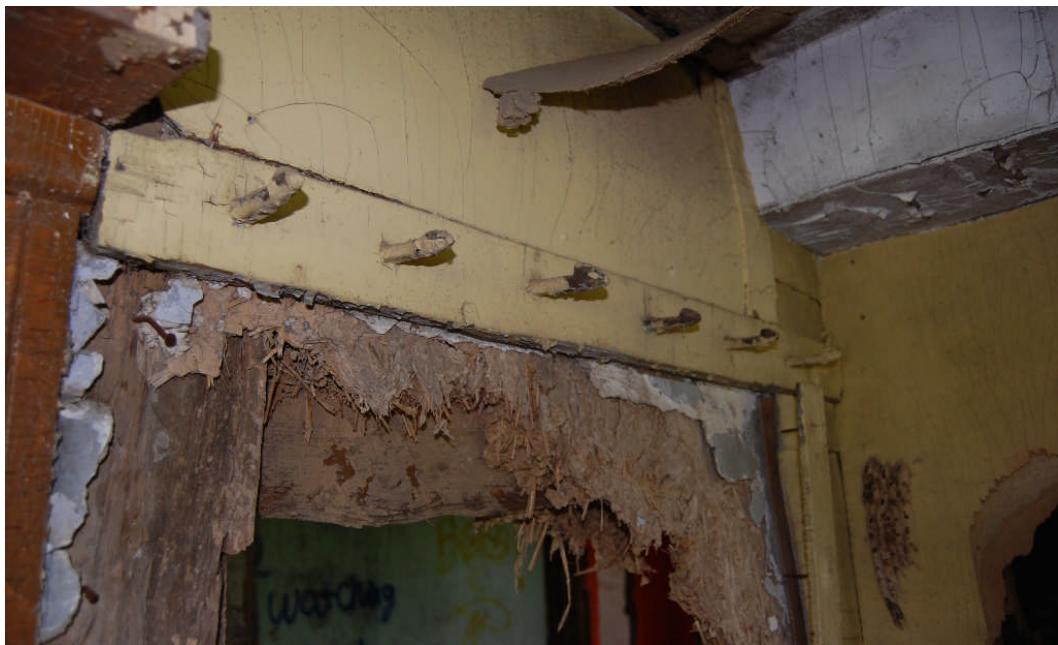
**Figure 45.** Close-up of the preview figure showing the hat/clothing rack in more detail. The hooks are carved wood. This image also illustrates the character of the partition wall between Rooms 100 and 101, which was enclosed with a straw-mud mixture applied over wide, rived, oak lath.

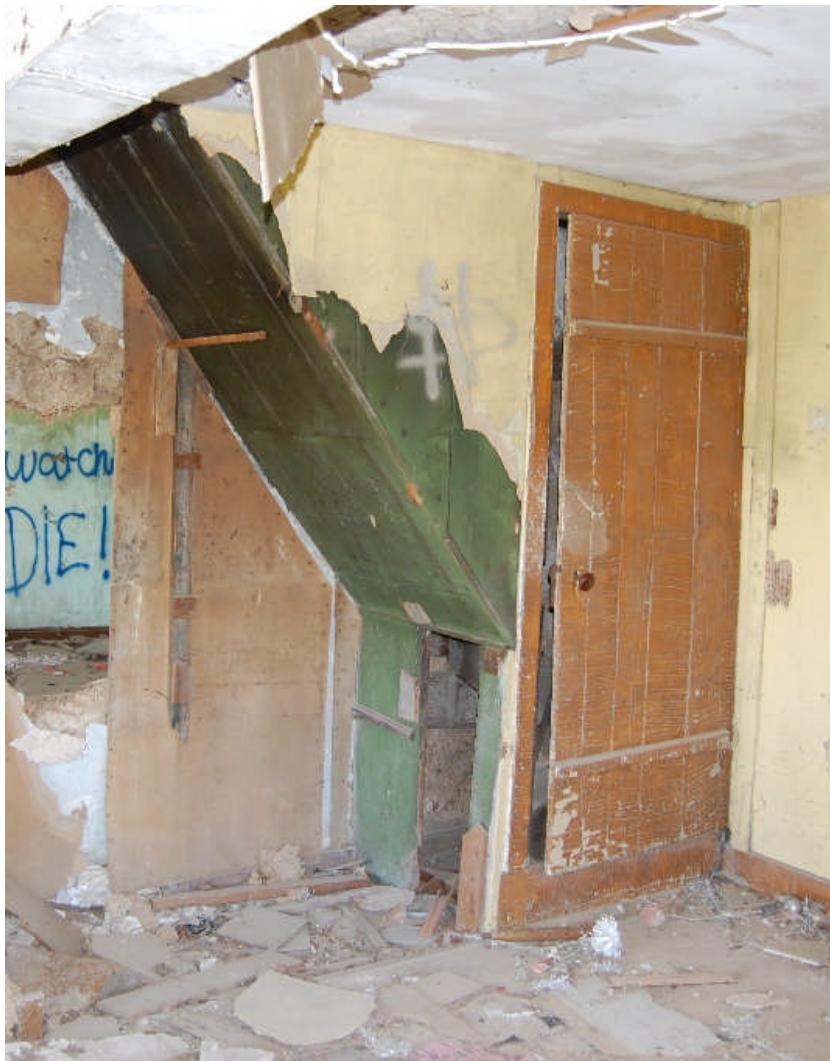
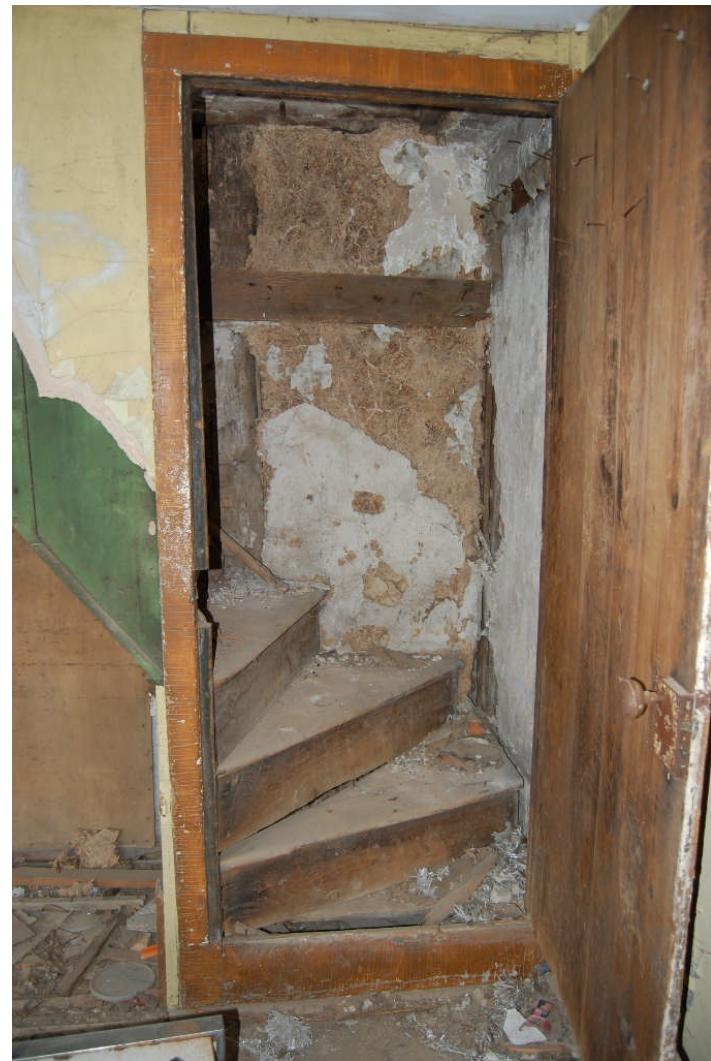
**Figure 46.** Two views of the enclosed stairway in the southwest corner of Room 100 leading to the upper story. The stairway is enclosed with planking, and the door is framed of vertical planks as well. The area beneath the stairway proper was enclosed with “Beaver Board”—a trade name for a manufactured fiberboard panel—during the first half of the twentieth century and was utilized as a closet.

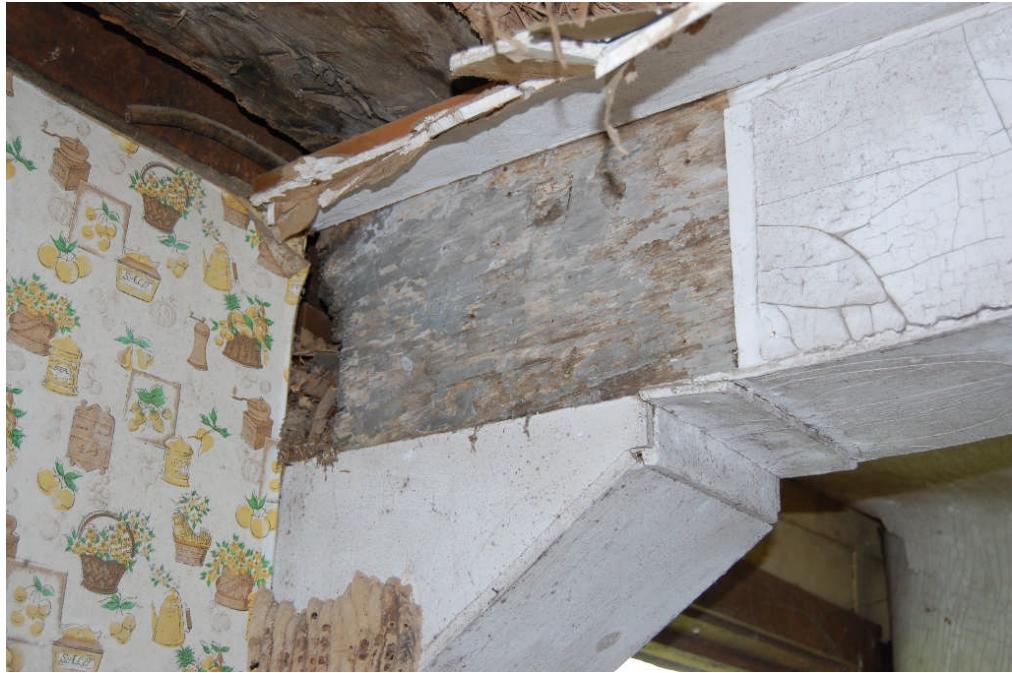
**Figure 48.** A large hand-hewn, oak summer beam supports the central span of the ceiling joists in Rooms 100 and 101. The image above shows the north end of the beam in Room 100. The diagonal brace was added when the north wall of the original house was rebuilt in the first half of the twentieth century.

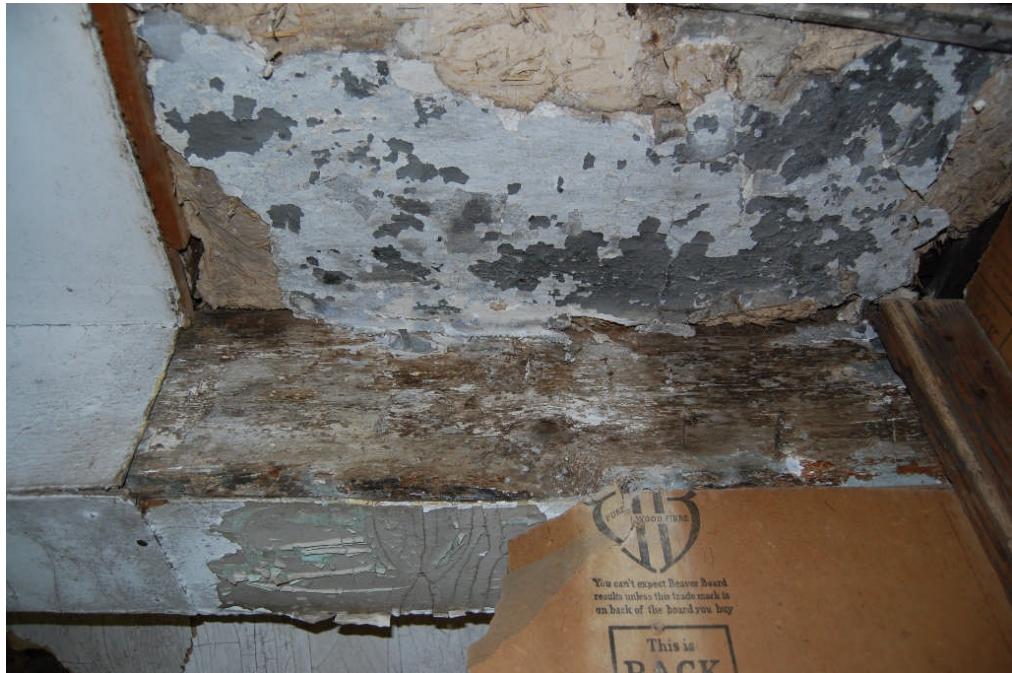
**Figure 49.** Detail of the central ceiling beam in Room 100. The beam originally was left exposed and whitewashed. It later was covered with Beaver Board.

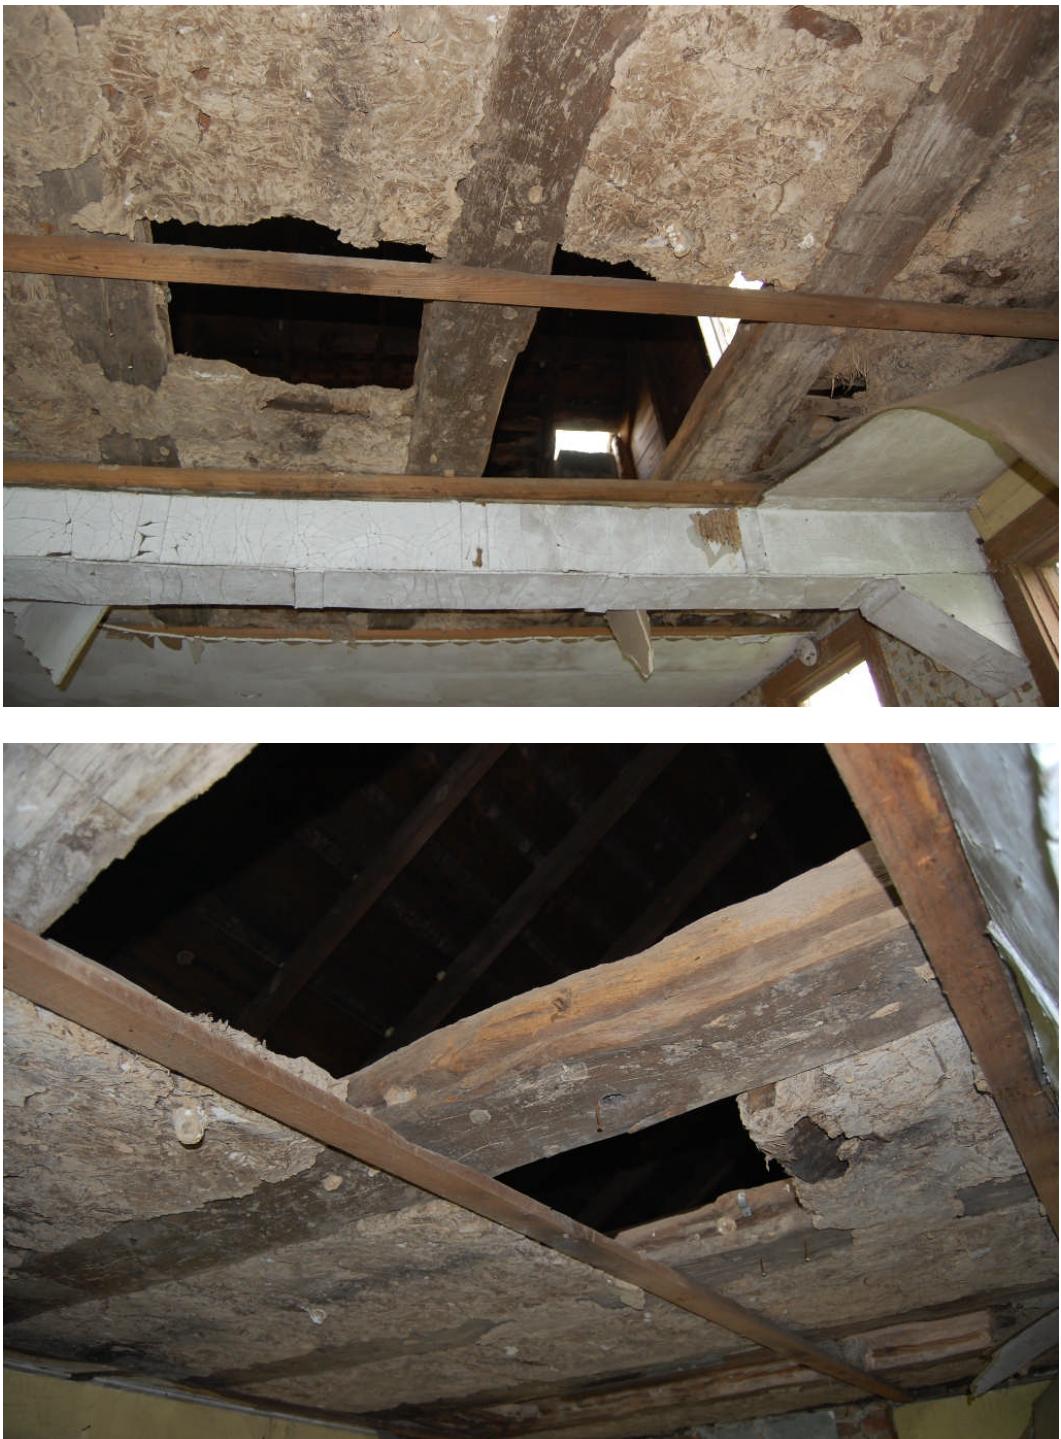
**Figure 50.** Details of the ceiling framing in Room 100. The ceiling is framed with widely spaced, hand-hewn oak joists that have been mitered to accommodate batts of insulation composed of a straw and mud mixture wrapped around rived oak planks/lath. This method of insulation is referred to by some sources as “Dutch biscuit.” After the batts were installed, the entire ceiling was then coated over and leveled off with a mud-based plaster and painted.

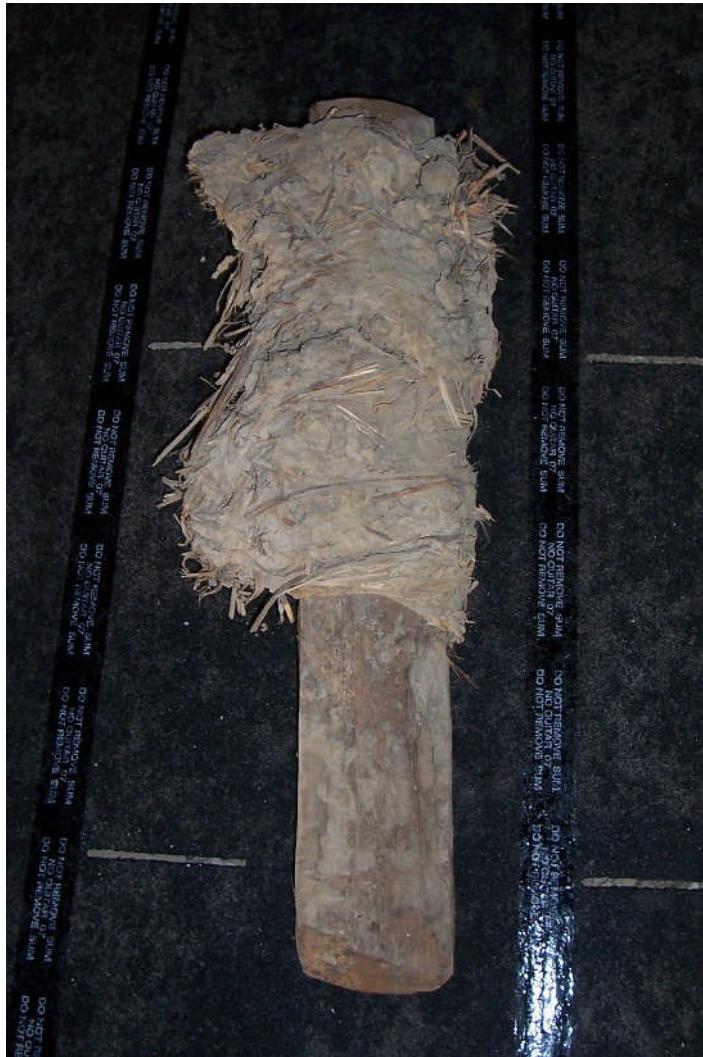
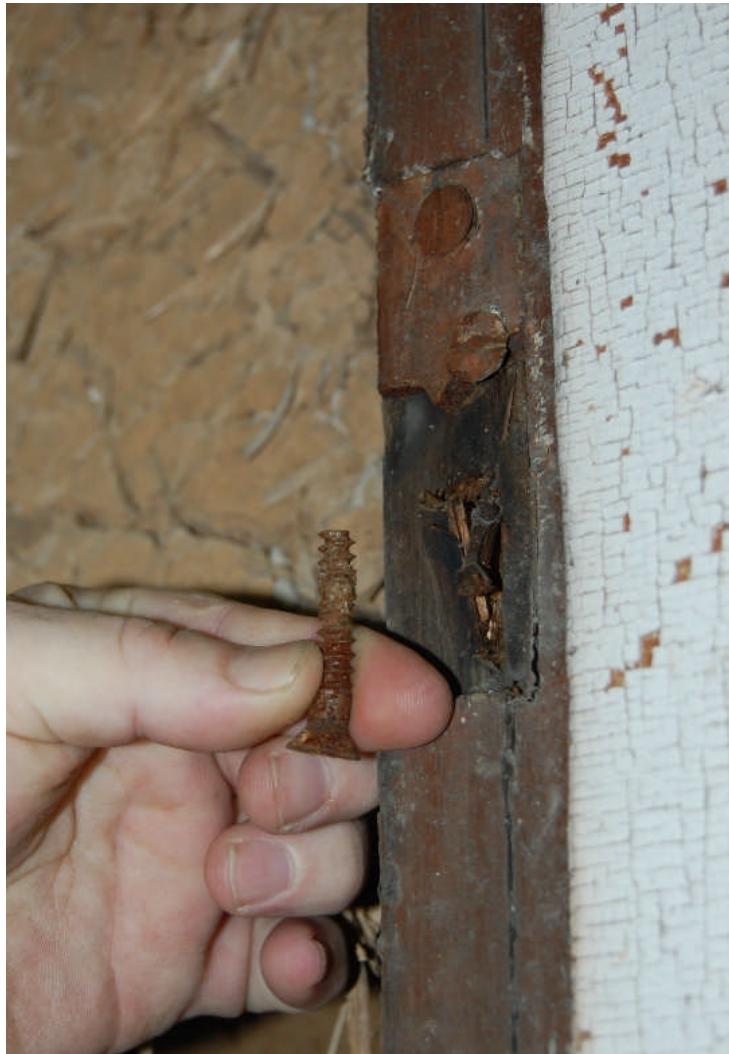
**Figure 51. (LEFT)** Clay and straw batt from the ceiling in the original house. Note the manner in which the straw and mud has been rolled or wrapped around the oak plank/lath. **(RIGHT)** Close-up of a hinge and screw from the doorway between Room 100 and 101. The screw is flat-tipped, which indicates a pre-1846 date of manufacture. This helps substantiate the 1846 date inscribed in the plaster above the front entrance door.

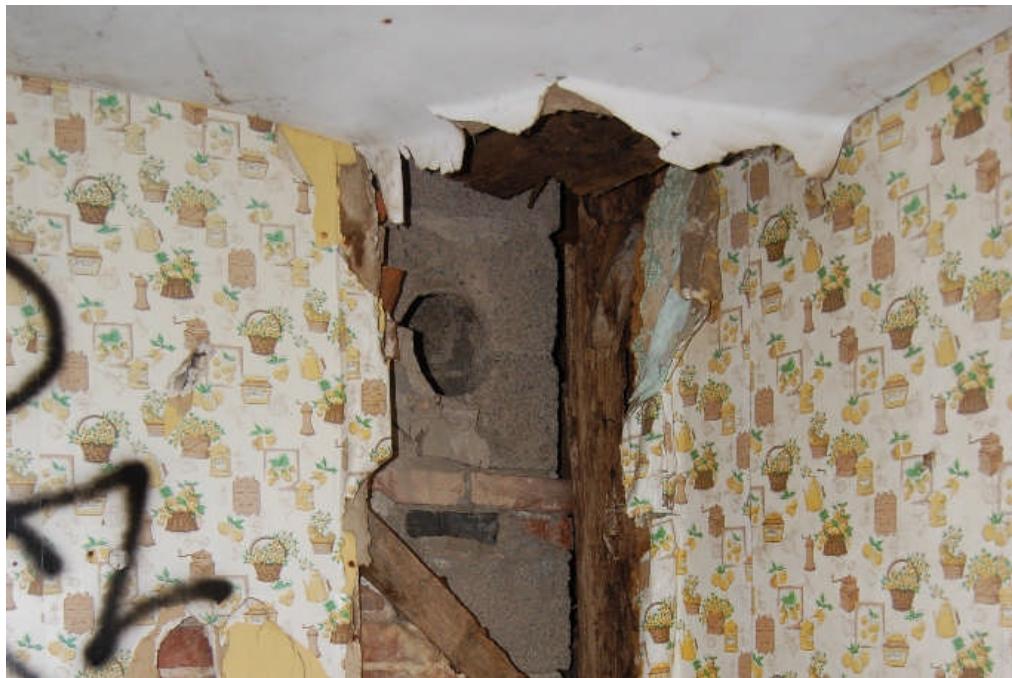
**Figure 52.** A concrete-block chimney is located along the common partition wall between Rooms 100 and 102A. This chimney has a flue vent facing into Room 100 (as shown above). The current stack appears to have replaced an early brick chimney, the base of which is still present in the basement.

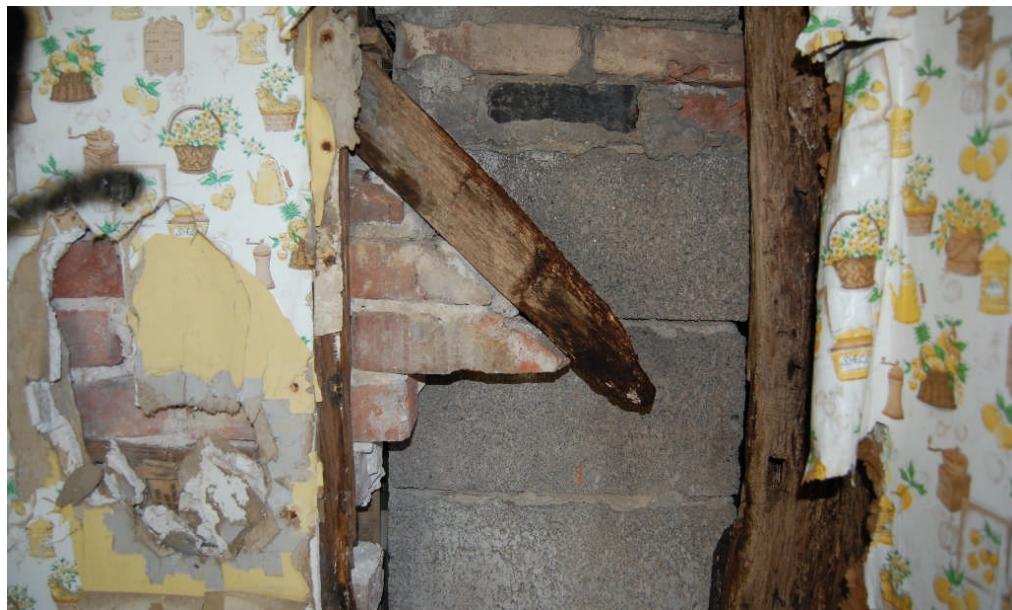
**Figure 53.** Deteriorated diagonal corner bracing in the northwest corner of Room 100, adjacent to the concrete-block. The deterioration appears have been caused by water leaking down through the chimney opening. Note the manner in which the brick nogging has been cut to fit the framing.

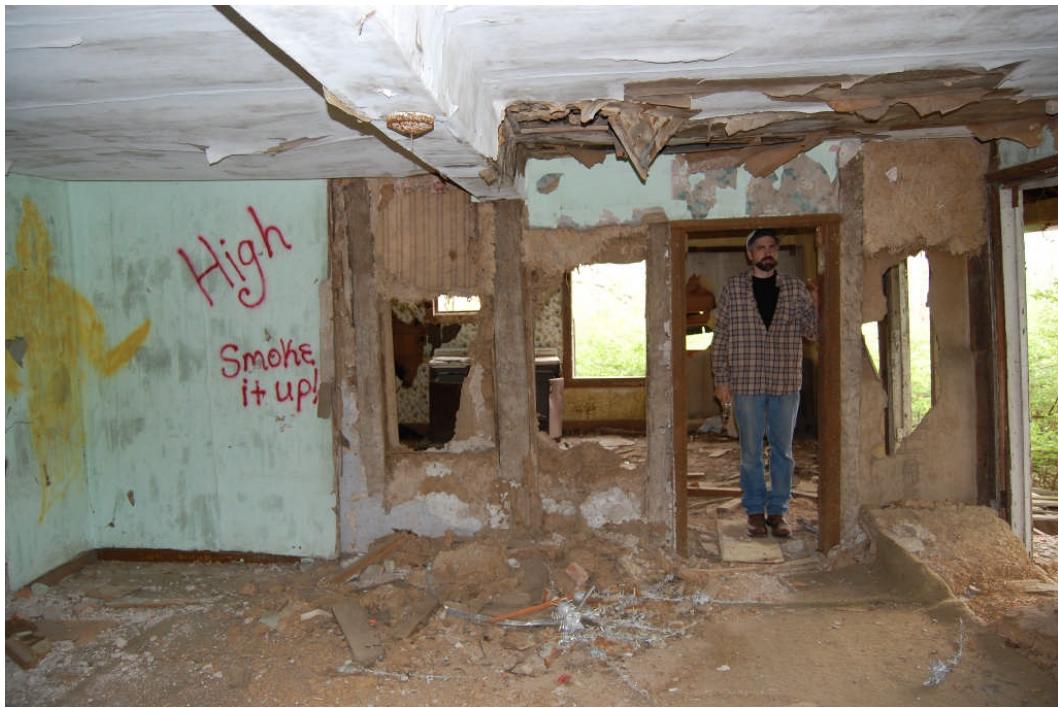
**Figure 54.** Interior view of Room 101 looking north. As noted previously, sections of the common wall between Rooms 101 and 100 to the north have been knocked out by vandals. Also note the central ceiling beam present here.

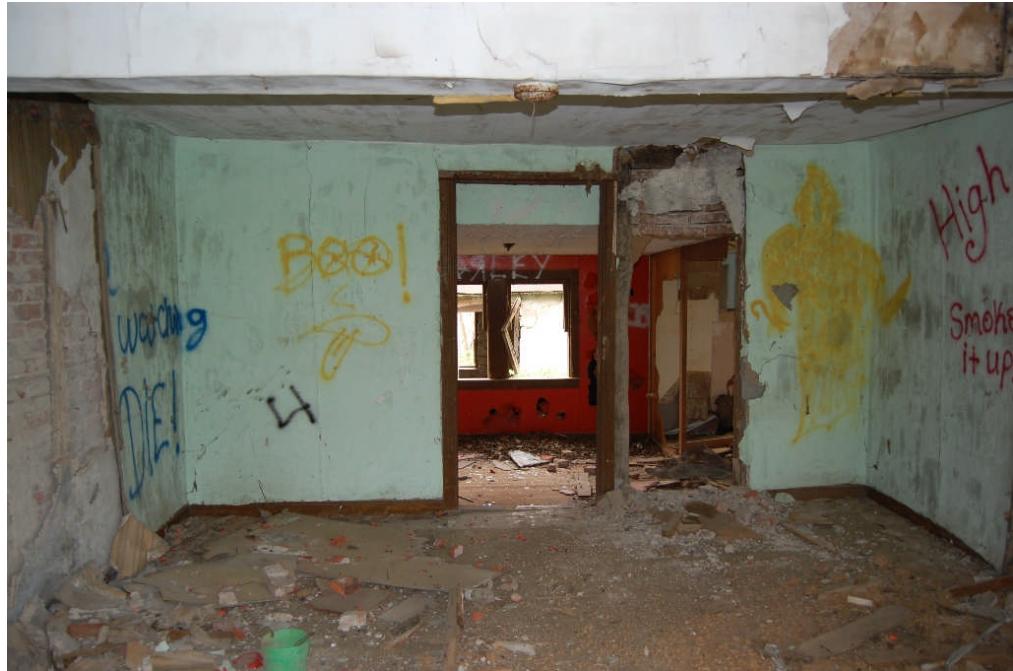
**Figure 55.** View of the west side of Room 101. The doorway leading into Room 102B in the background appears to be original.

Room 101 is the southern of the two eastern rooms in the original house (see Figures 55 through 61). It measures 14'-3-1/2" x 17'-7", making it nearly the same size as Room 100. Like the latter room, Room 101 has an exterior doorway and a window opening facing the front porch. It also has an interior doorway on the west leading into Room 102. Another interior doorway on the south currently accesses Room 103. The latter opening, however, was added following the construction of the stone addition; prior to that, a window is believed to have been located here. A flue for a chimney is present in the ceiling on the northern end of the room. The chimney with which this flue is associated was of riveted steel construction, and a section of it still survives in on the upper story. During Peter and Helen Zoeller's occupancy, Room 101 served as a living room and also was used as a dining room on occasion, especially at threshing time. There was couch in here that opened into a bed, which was used by the Zoeller boys (Jim and Sylvester) during the winter. Helen would also use this room for quilting during the winter months, often hosting neighbor ladies who would come over to quilt. The only heating stove the family had in the entire house was located in this room. There was a square wood stove here early on, and later an oil stove was used. It kept the room very hot during the winter while the other rooms tended to be cold. A telephone formerly was hung on the east wall next to the exterior door leading onto the front porch (Helen Shea and Jim Zoeller, pers. comm., 26 June 2009).

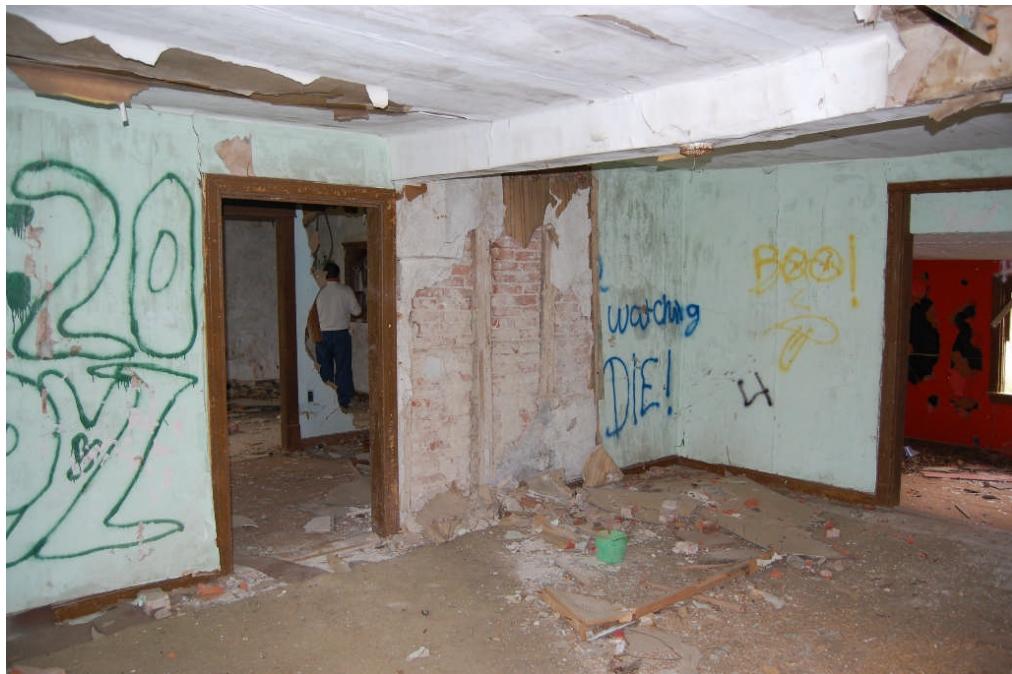
**Figure 56.** Interior view of Room 101 looking into the southwest corner and showing the doorways into Room 102B (right) and Room 103 (left). Also note summer beam.

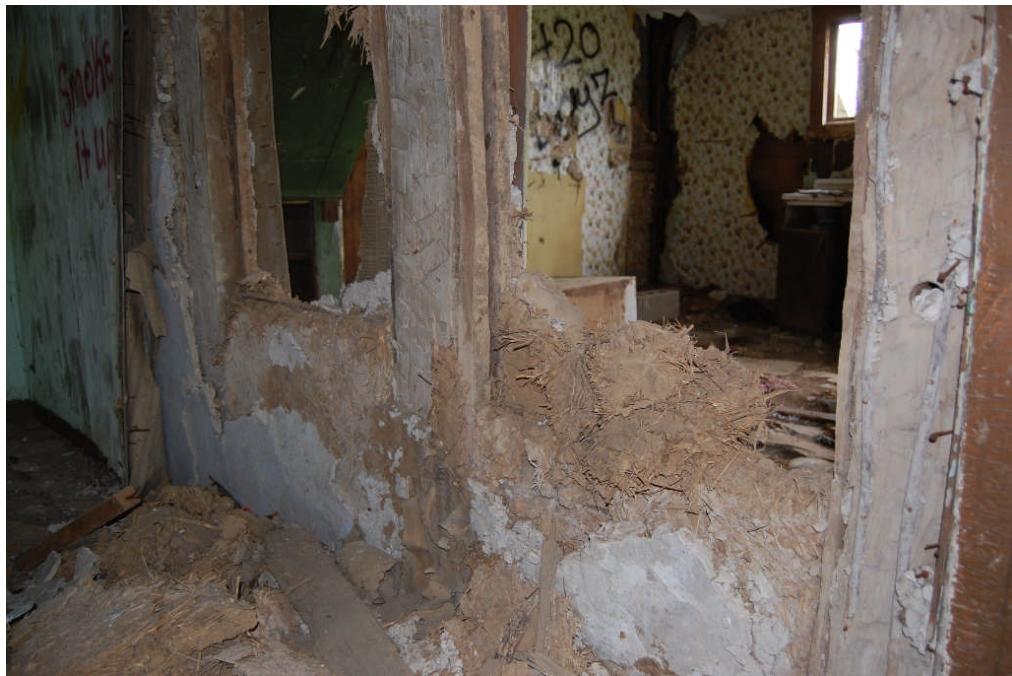
**Figure 57.** Detail of the partition wall between Rooms 100 and 101, as seen from Room 101. The wall is framed with widely spaced, hand-hewn, oak posts. In contrast to the ceiling joists (which are mitered to accommodate the lath), the posts have small-dimensional (approx. 1"x1") stock nailed to them to hold the lath, around which a straw-and-mud mixture is applied.

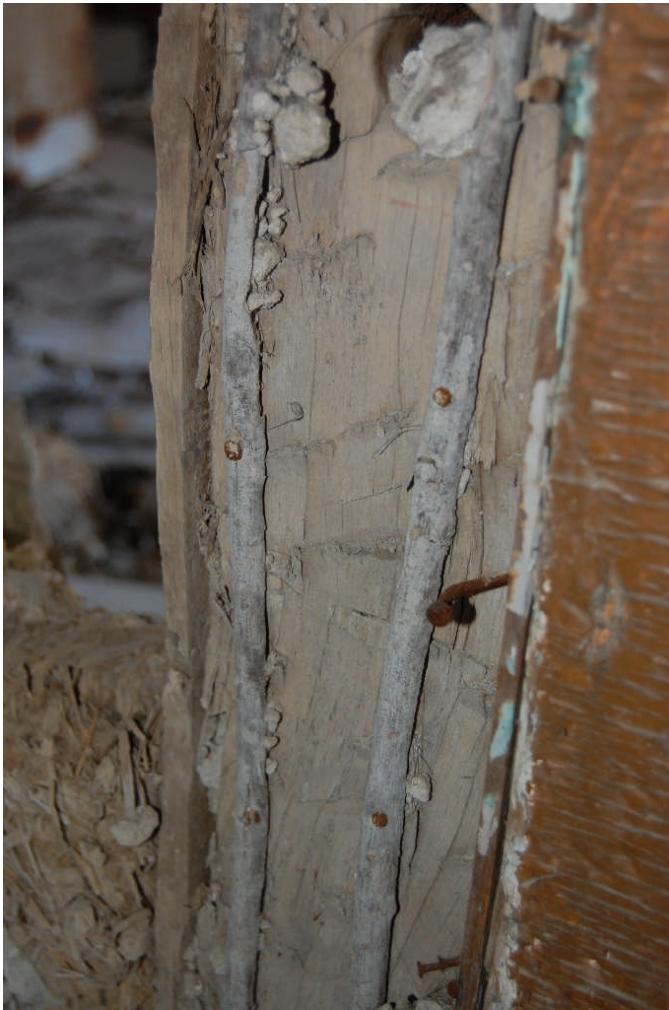
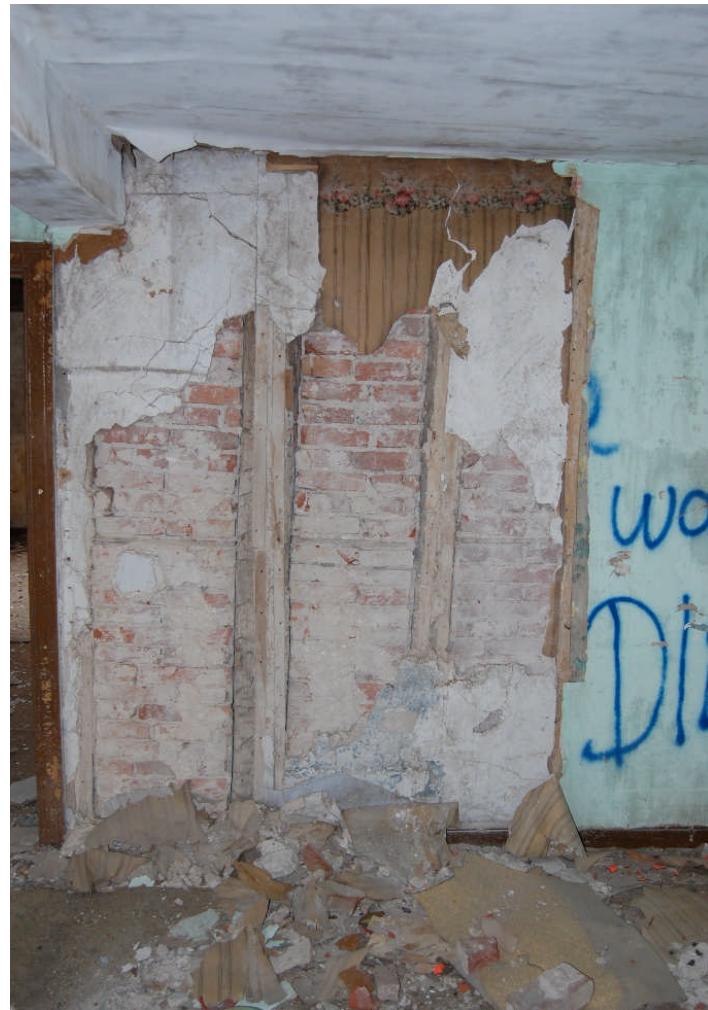
**Figure 58. (LEFT)** Detail of a hand-hewn post in the common partition wall between Rooms 100 and 101. Twigs have been nailed to surface of the post to provide a surface to which the mud plaster could adhere to. **(RIGHT)** View of the south wall in Room 101 showing the brick nogging used between the posts and posts on this wall. Brick nogging also was used on the other exterior walls of the original house, as well as in the partition wall between the front two rooms (100 and 101) and rear room (102).

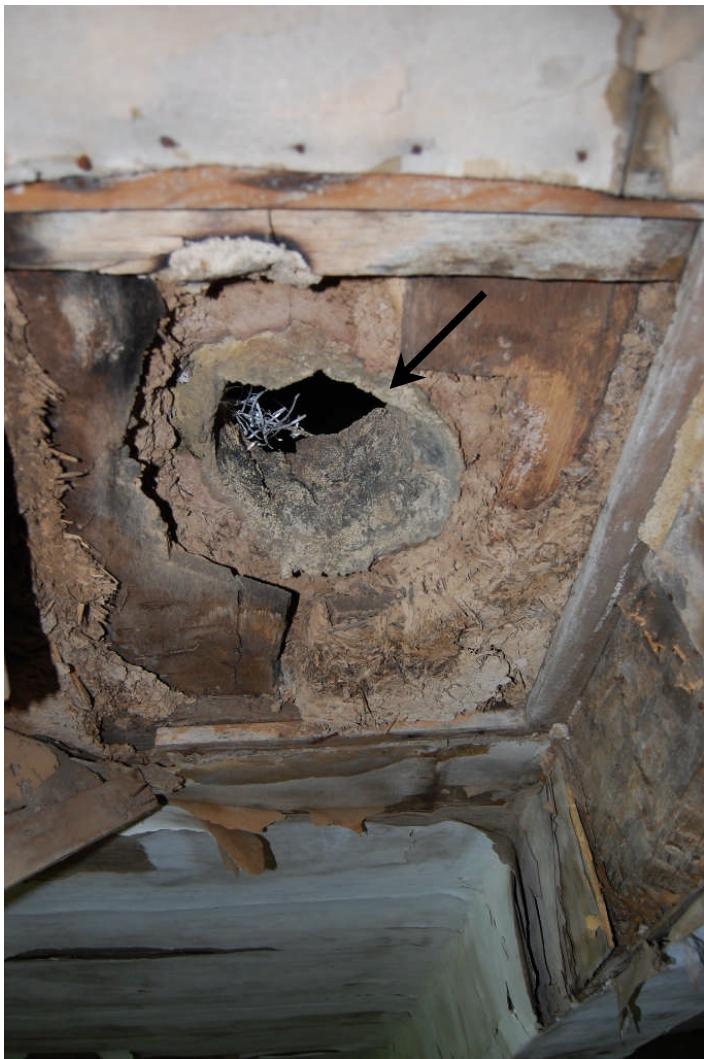
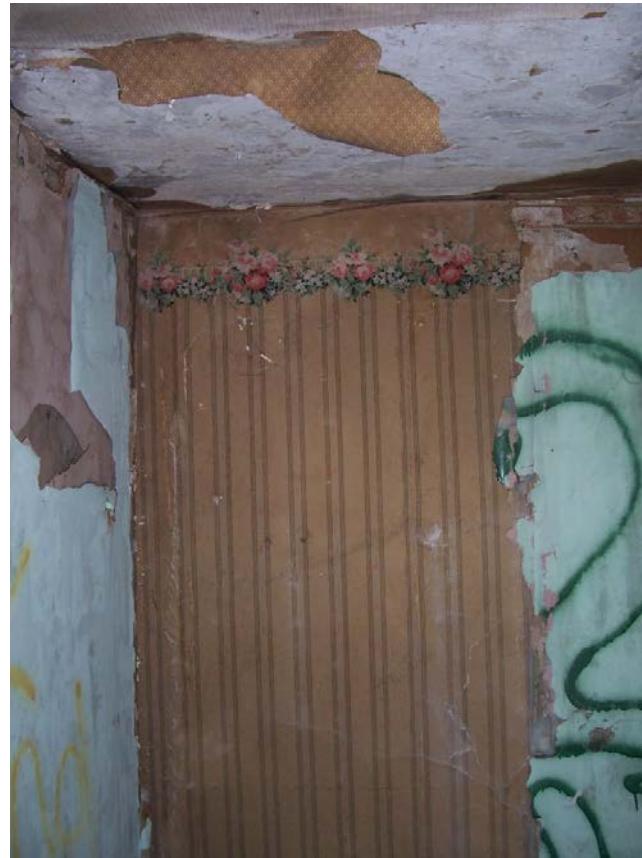
**Figure 59.** (LEFT) Opening for a stovepipe in the ceiling of Room 101. There is no evidence of a masonry chimney ever being present in this room. (RIGHT) Surviving section of wallpaper on the south side of Room 101. There is evidence of several generations of wallpaper on the walls and ceiling.
