**ARCHAEOLOGICAL SURVEY SHORT REPORT:  
NATIONAL REGISTER OF HISTORIC PLACES ASSESSMENT  
OF THE DAAB-ZOELLER FARM SITE,  
ST. CLAIR COUNTY, ILLINOIS**

Prepared by  
Christopher Stratton  
and  
Floyd Mansberger

Fever River Research, Inc.  
Springfield, Illinois

**Project Type/Title:** National Register of Historic Places assessment of the Daab-Zoeller Farm Site.

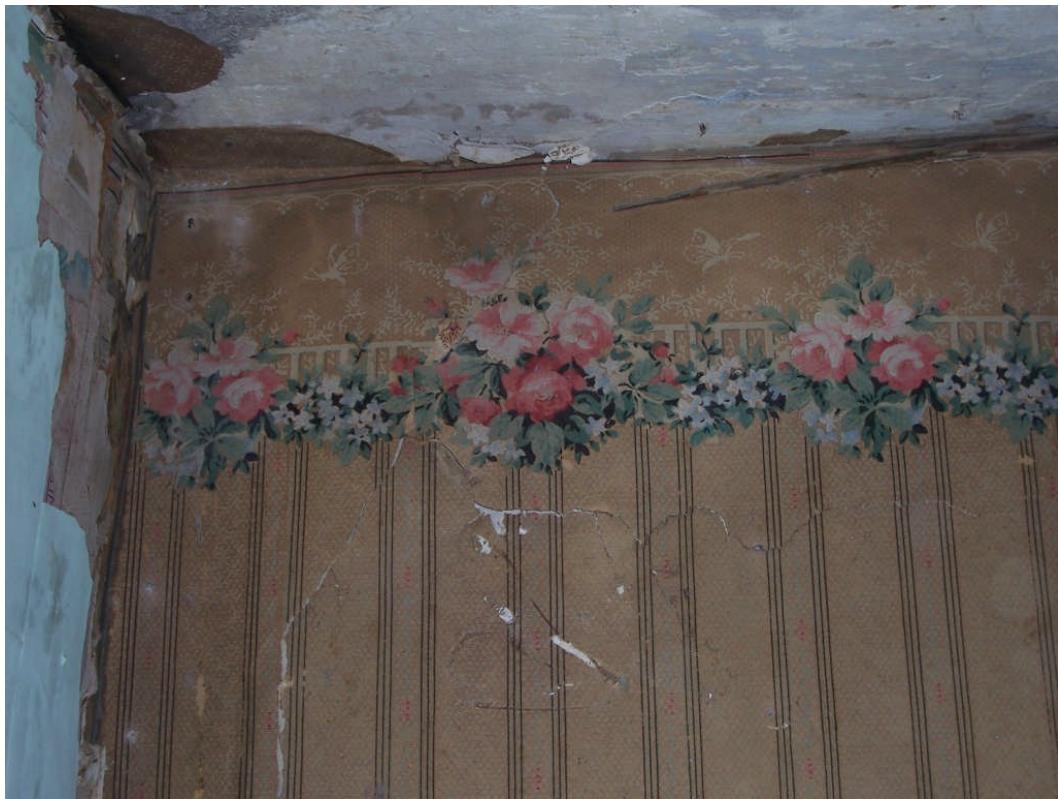
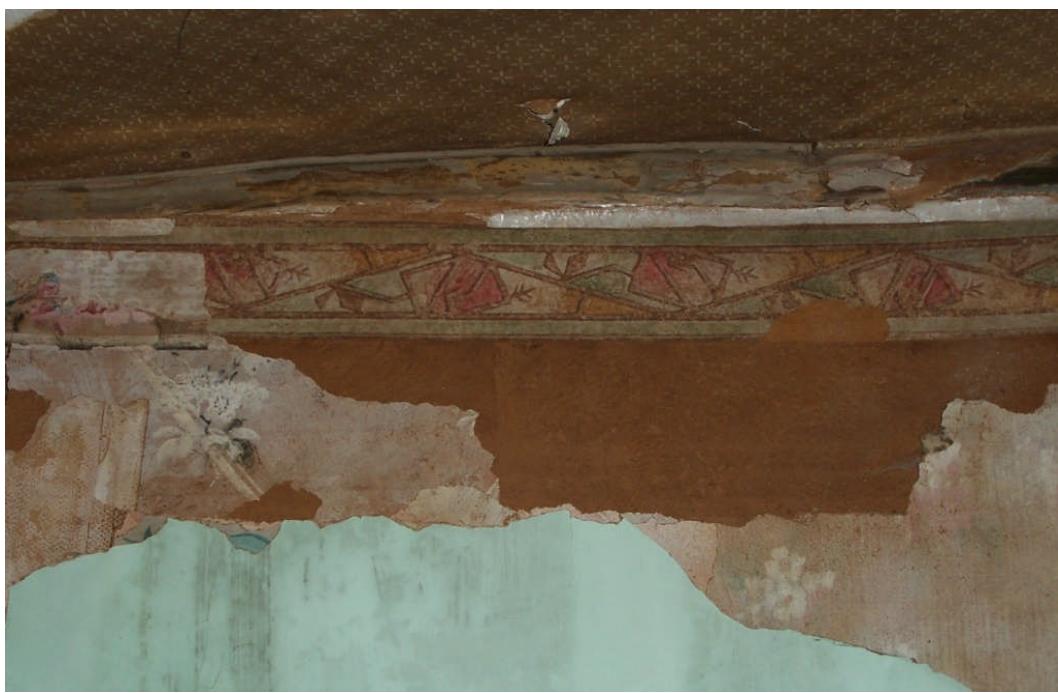
**Figure 60.** Wallpaper details from Room 101. Both of the patterns illustrated are suspected to date from the first half of the twentieth century.

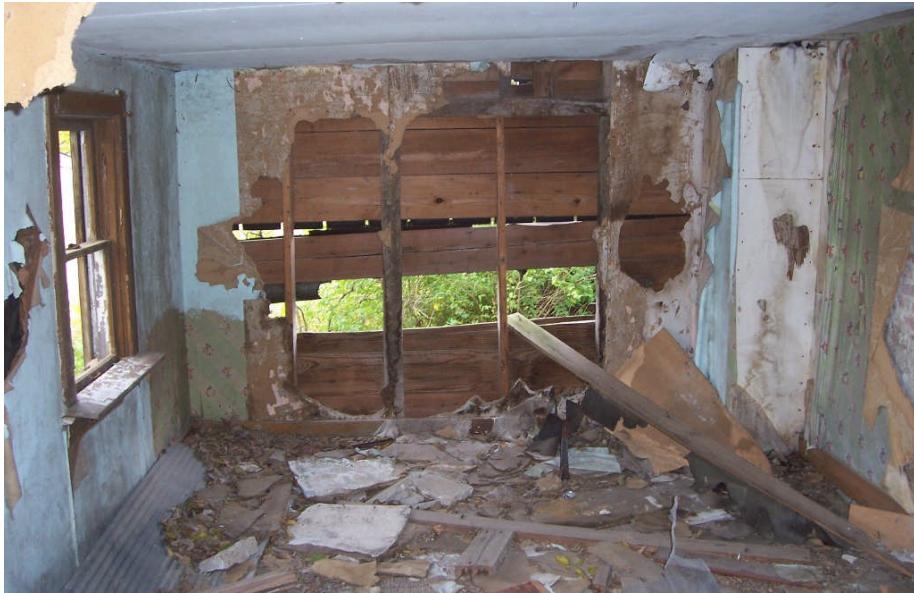
**Figure 61.** View of the northern of the rear (or west) wing of the original house showing the space discussed as Room 102A. In the middle twentieth century, this area was used by the Zoellers as the “old kitchen”, where messier kitchen-related activities were carried out. The northern end of the room has been rebuilt, as evidenced by the newer framing materials shown. The concrete-block chimney is located in the right corner of this view.

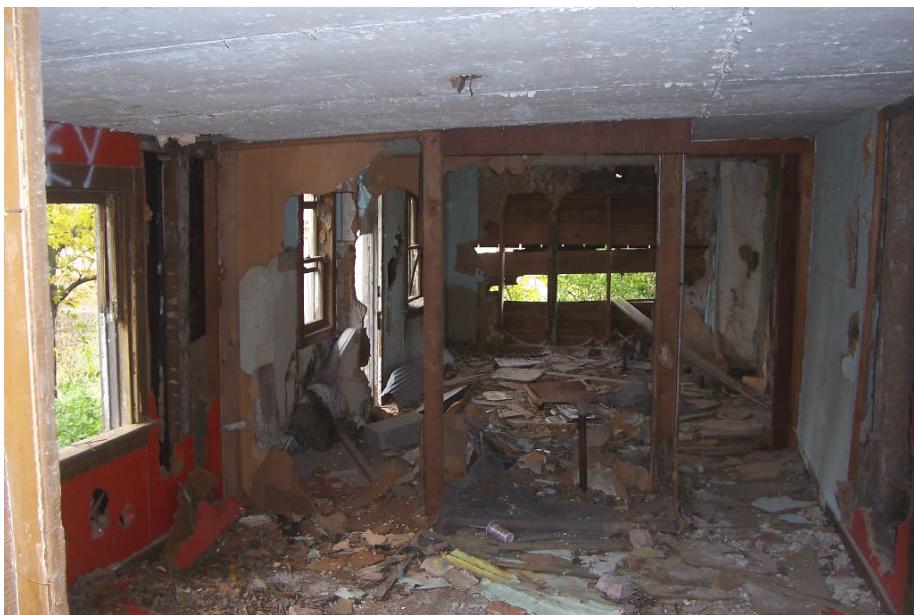
**Figure 62.** View looking down the length of the rear wing of the original house, looking north and showing the three rooms among which it presently is divided. The “old kitchen” (Room 102A) appears in far background, a bathroom (Room 102B) in middle distance, and a former bedroom (Room 102C) in foreground. This side of the house possibly consisted of a single open room, or perhaps two rooms, originally. The existing partition walls were added in the 1940s.

The western third of the original house originally consisted of a single room (102), whose floor level was set about 1' lower than that in the eastern rooms (see Figures 62 through 68). All evidence suggests that this room was original to the house, despite the difference in floor levels and the fact that it was covered by an extended shed roof originally. The western and northern walls in Room 102 have been rebuilt, but the southern wall is largely intact and shows that it too was of timber-frame construction with brick nogging. This wall also illustrates that Room 102 originally was narrower than at present. As built, the room measured about 29'-6" x 9'-2". During the late nineteenth century, the western wall of the room was pushed out to be on-line with the stone addition, thus expanding the interior width of the room to 10'-7". The location of the original door and window openings is not known due to the reworking of the walls. At some point following the construction of the stone addition, an interior doorway was put in the south wall of the room in order to provide access to Room 104.

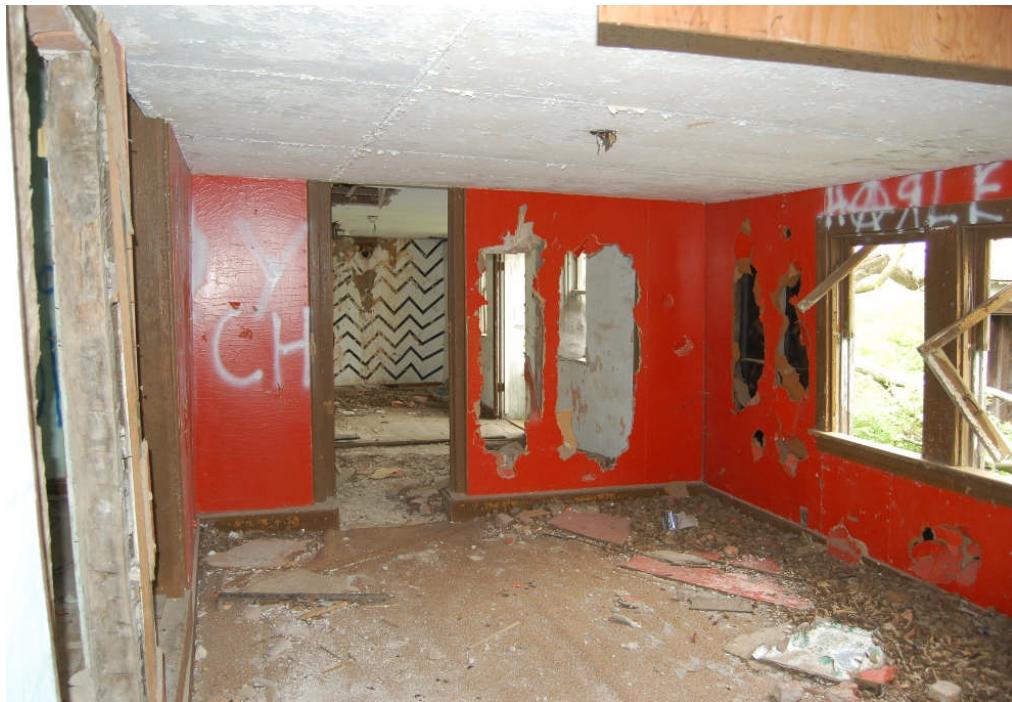
**Figure 63.** Interior view of Room 102C, a former bedroom, looking south. The doorway shown was added after the stone addition was construction.

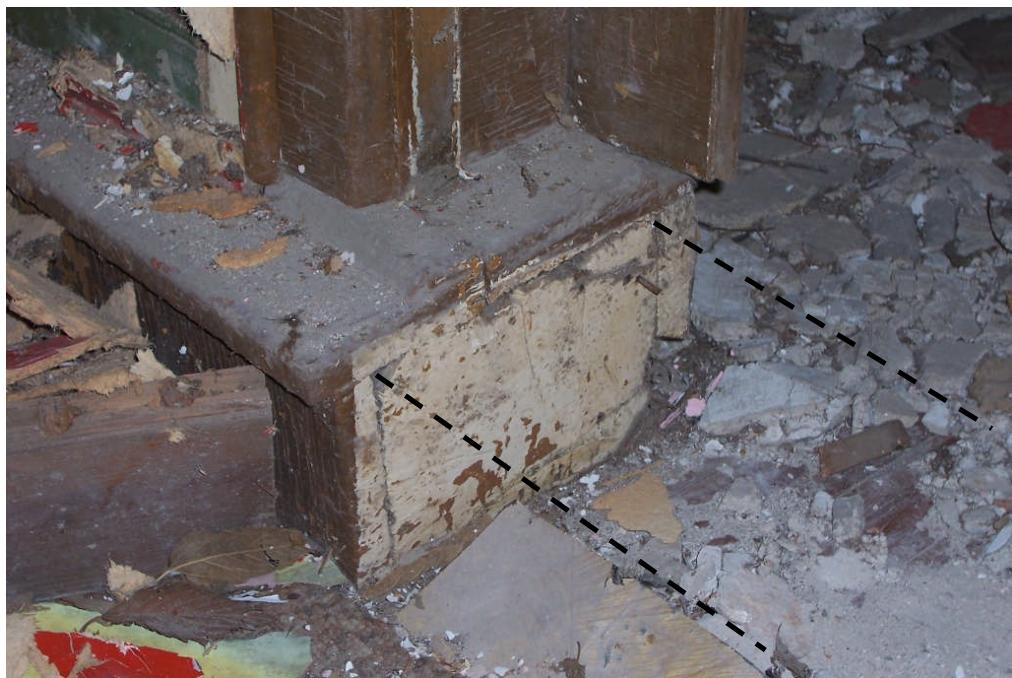
**Figure 64.** Close-up of the base of the doorway shown in the previous figure, between Rooms 102C and 104. The original sill plate was sawn off to install this opening, and the remaining sill was boxed in with trim. The dashed lines indicate continuation of the sill plate.

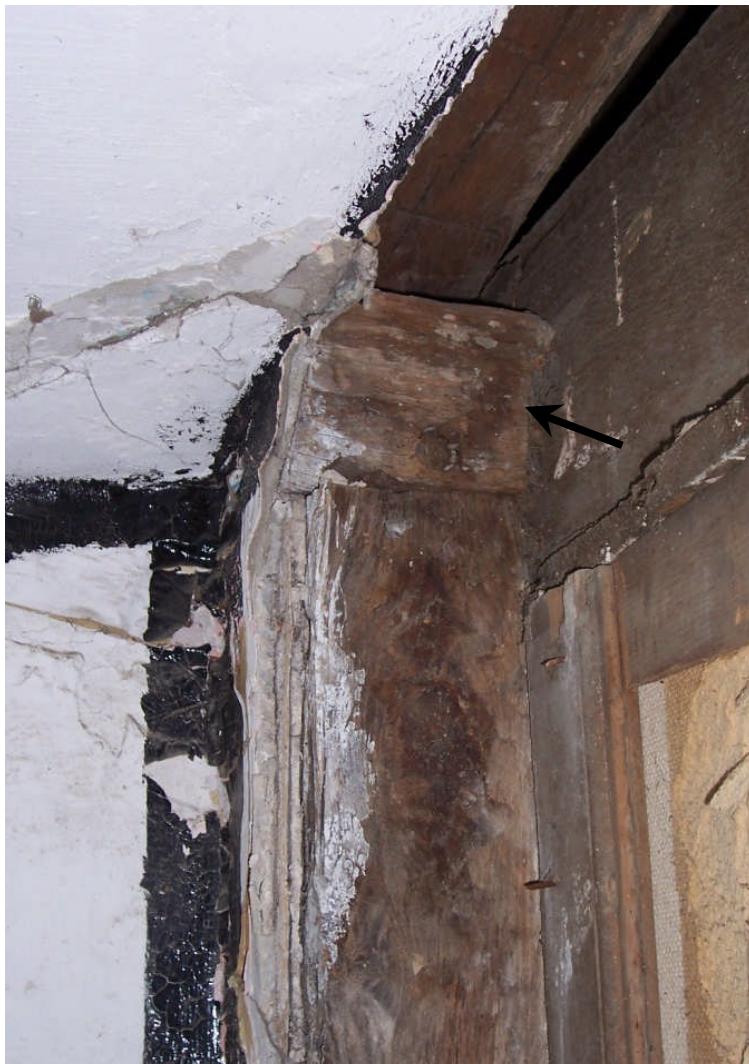
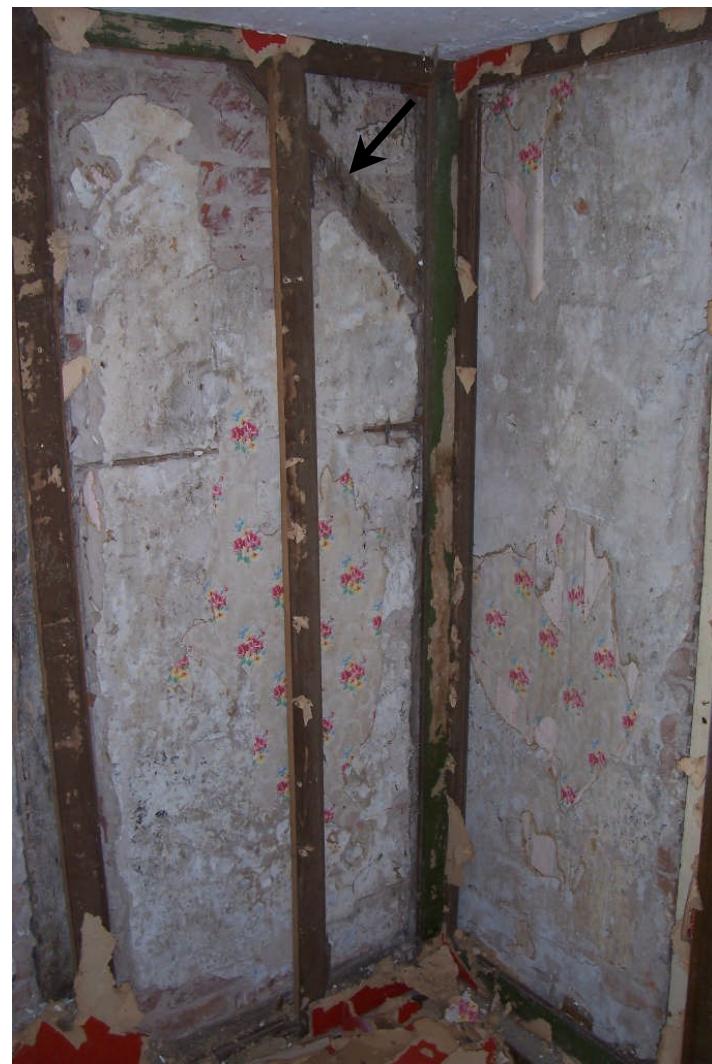
Figure 65. (LEFT) View of a remnant of the original rafter plate from the rear wing of the original house (marked with arrow). This plate was sawn off when the west wall of the wing was pushed outward late in the nineteenth century. The plate and post below it are hand-hewn oak. (RIGHT) View of the southeast corner of Room 102C showing original wall finishes. The walls shown have brick noggin between the framing and are plastered. Note the diagonal bracing.

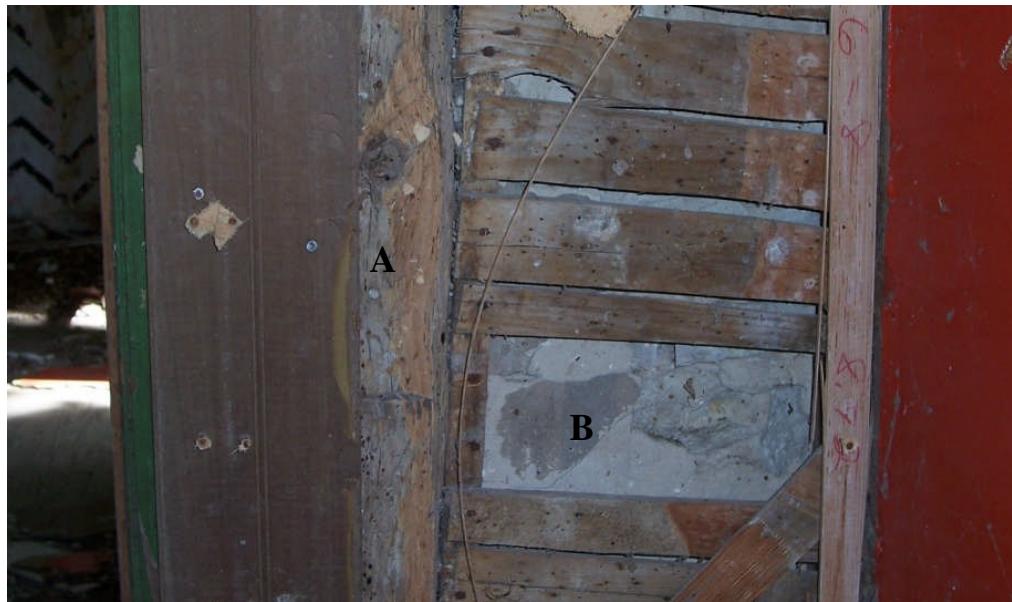
**Figure 66.** Detail of the southwest corner of Room 102C showing the junction of between the original rear wing and stone addition. “A” indicates the original southwest corner post of the rear wing. “B” marks the north end of the west wall of the stone addition, which originally extended just past the wall plain of the original frame wing and was plastered over. Late in the nineteenth century, the west wall of the frame wing was pushed outward to be even with the stone addition, and the formerly exposed end of stone wall was covered over with lath shown.

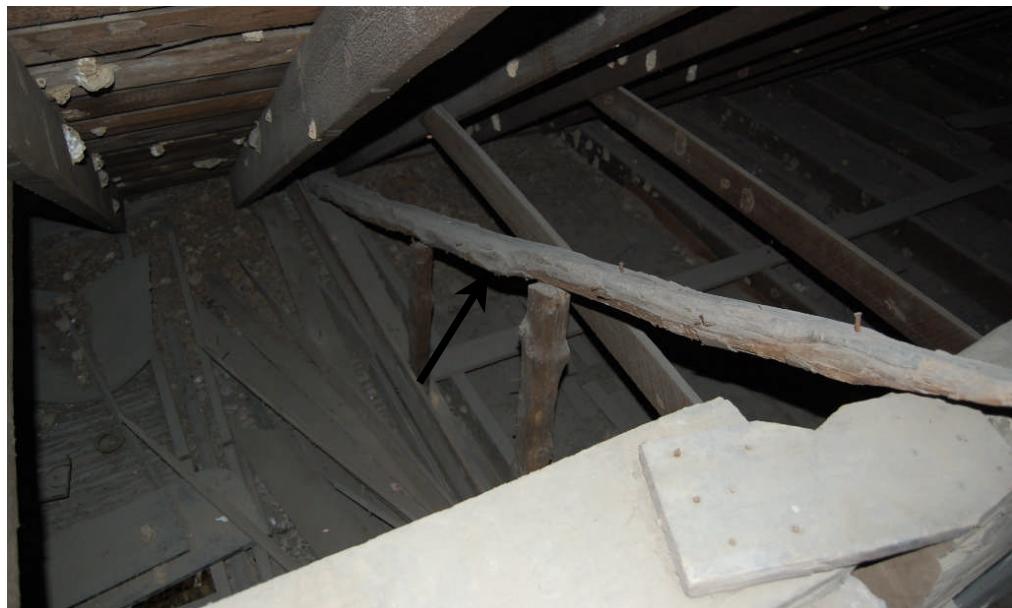
**Figure 67.** View of a surviving pole rafter associated with the early roof over the rear wing of the original house. The existing roof pitch over the wing is much steeper than what it was originally.

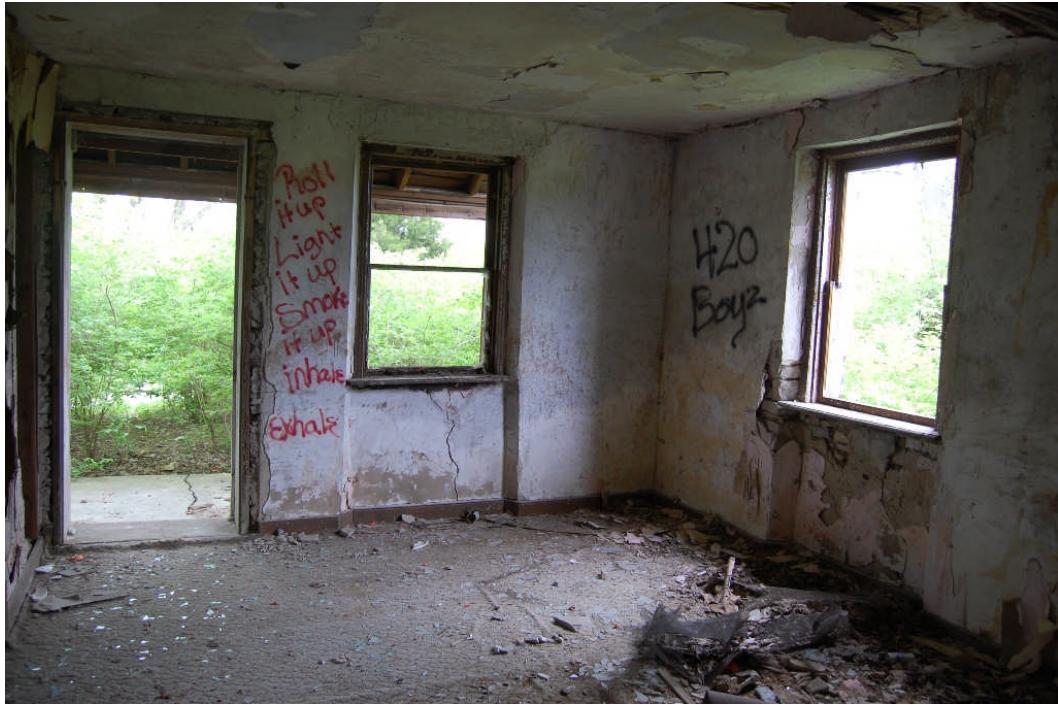
**Figure 68.** Interior view of Room 103, the front (or east) room of the stone addition, looking into the southeast corner. Note the manner in which the walls are recessed below the window openings.

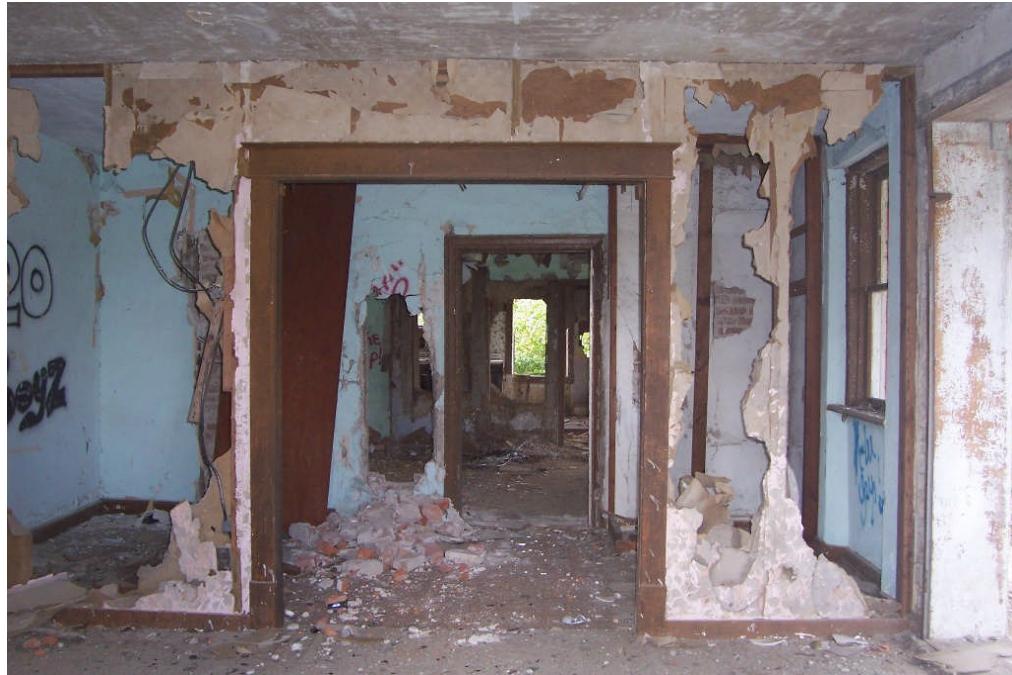
**Figure 69.** View of the northern end of Room 103. This end of room was partitioned off during the first half of the twentieth century for use as a bedroom. Room 101 is visible in background through doorway.

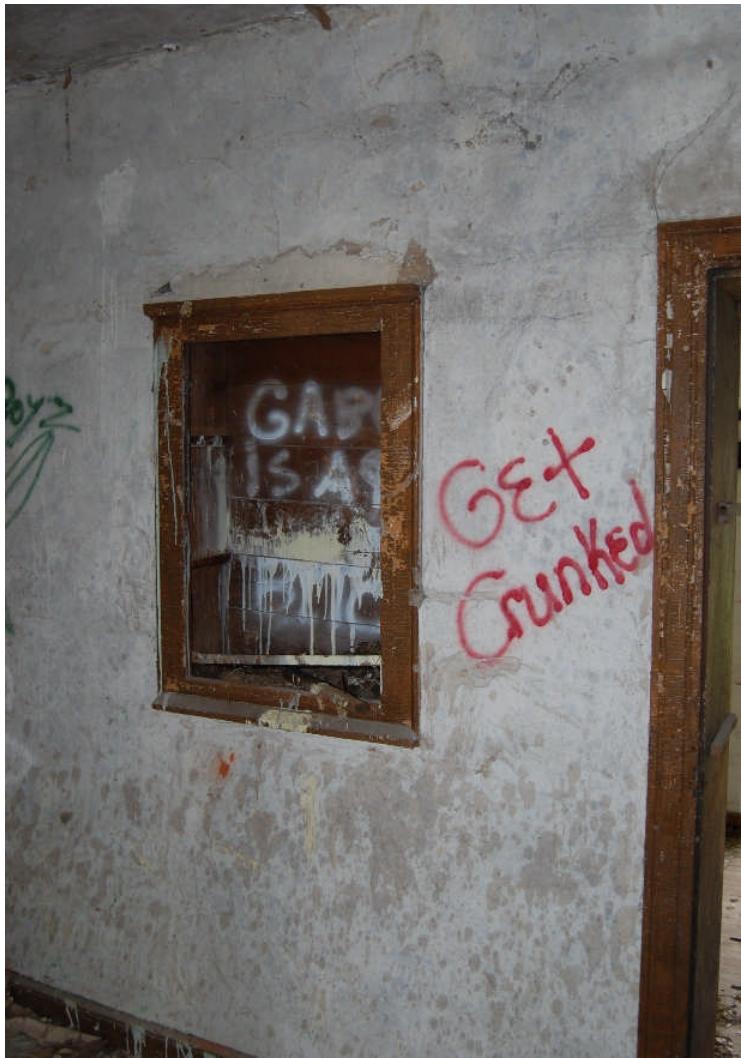
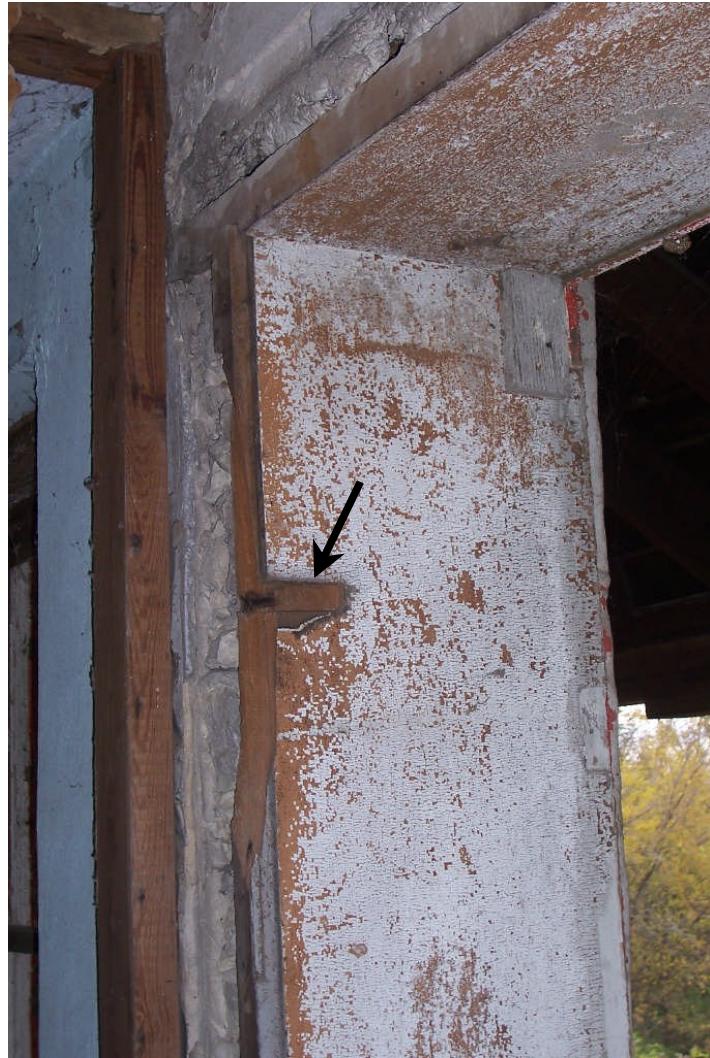
**Figure 70. (LEFT)** One of the interesting features of Room 102 is a built-in cabinet in the west wall. This cabinet appears to be original to the room. **(RIGHT)** Detail of the exterior entrance door to Room 102. Although the doorway has been damaged, there is clear evidence of a transom window having been present at one time, as evidenced by mortises in the jamb (note arrow).

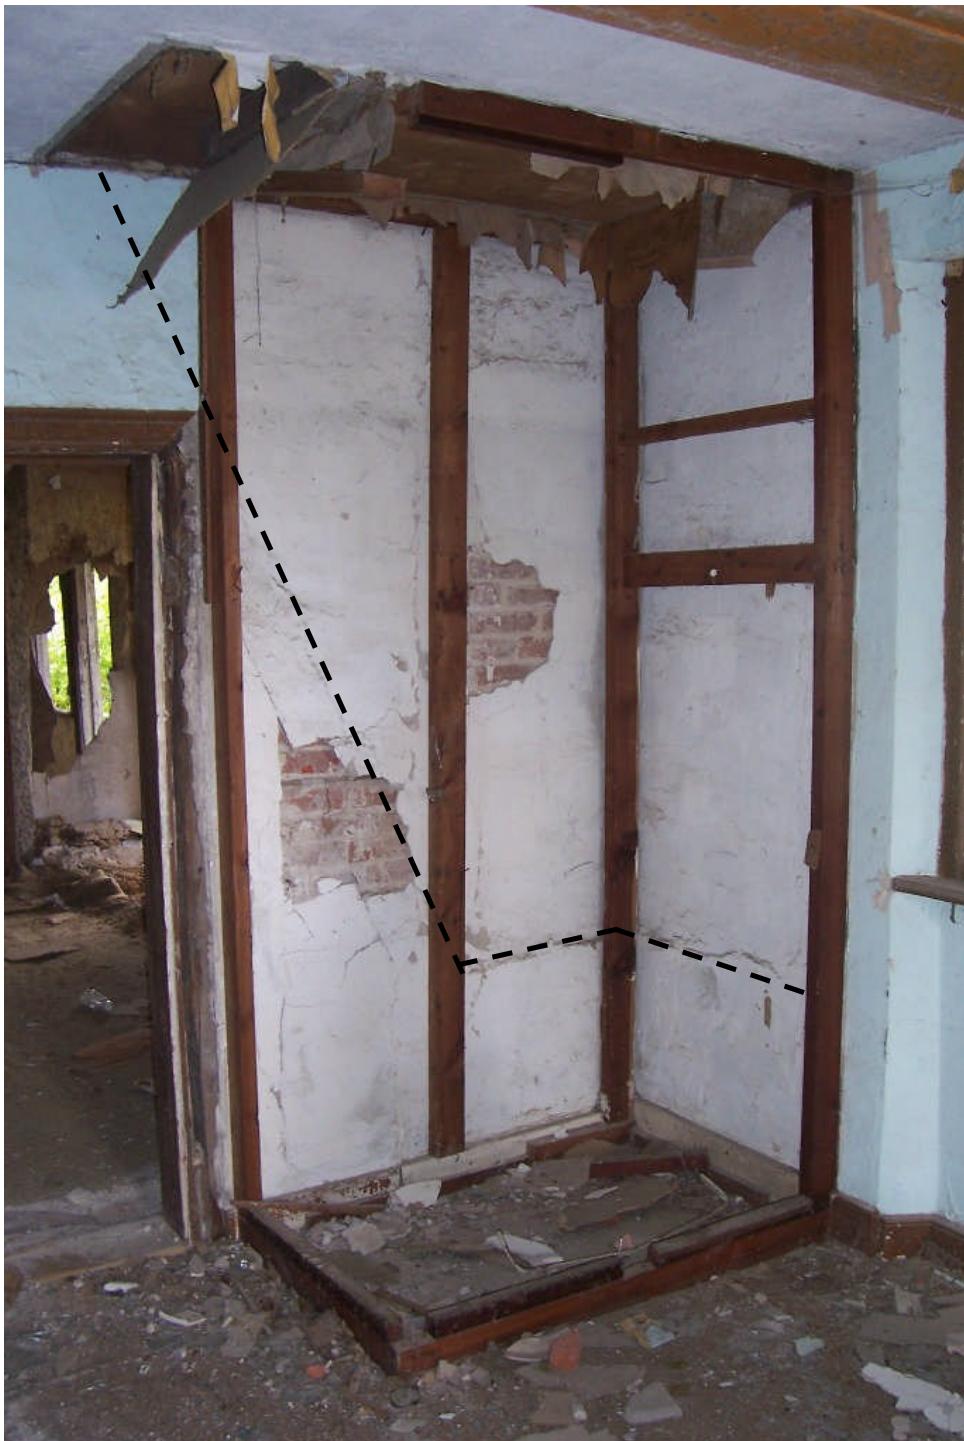
**Figure 71.** View of the northeast corner of Room 104. A stairway to the attic formerly was located here. The dashed line indicates the line of the stairway, which was quite steep and had a lower landing. In the early-to-middle twentieth century, the stairway was abandoned and removed, and a closet was added at this location. The opening for the stairway is still visible in the attic.

As noted above, the stone addition has two rooms on the first floor, aligned east-to-west of one another. The eastern of these rooms (Room 103) can be entered through an exterior doorway off the front porch (see Figures 69 through 72). The doorway once had a transom window above it. It flanked to either side by a window opening, thus providing a symmetrical three-bay façade for the addition. Room 103, as built, measured 20'-10"x15'-11-1/2". In addition to the two windows already mentioned, a third window was located on the south. The wall beneath all three of these windows is inset several inches from the adjoining wall surfaces, creating the effect of a bay. A small built-in cabinet is present on the west wall. The cabinet appears to be an original design feature to the room and once had hinged doors and shelving on its interior. There is evidence of a stairway to the upper floor having been located in the northeast corner of the room at one time. A stove vent was present in the south wall. During the early-to-middle twentieth century, a partition wall with a wide doorway was built across Room 103, thereby creating two semi-private chambers (Rooms 103a and 103b). A closet also was built in the northeast corner of Room 103b, where the stairway formerly was located.

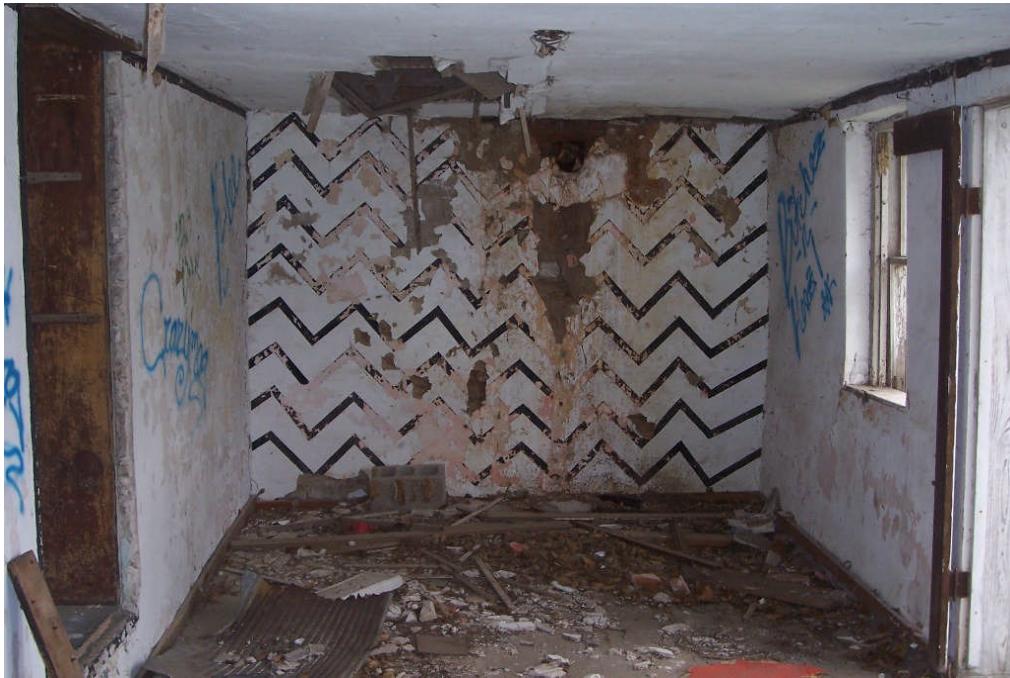
**Figure 72.** View of the south end of Room 104. This room has an exterior doorway on its west side and a chimney flue in the south wall.

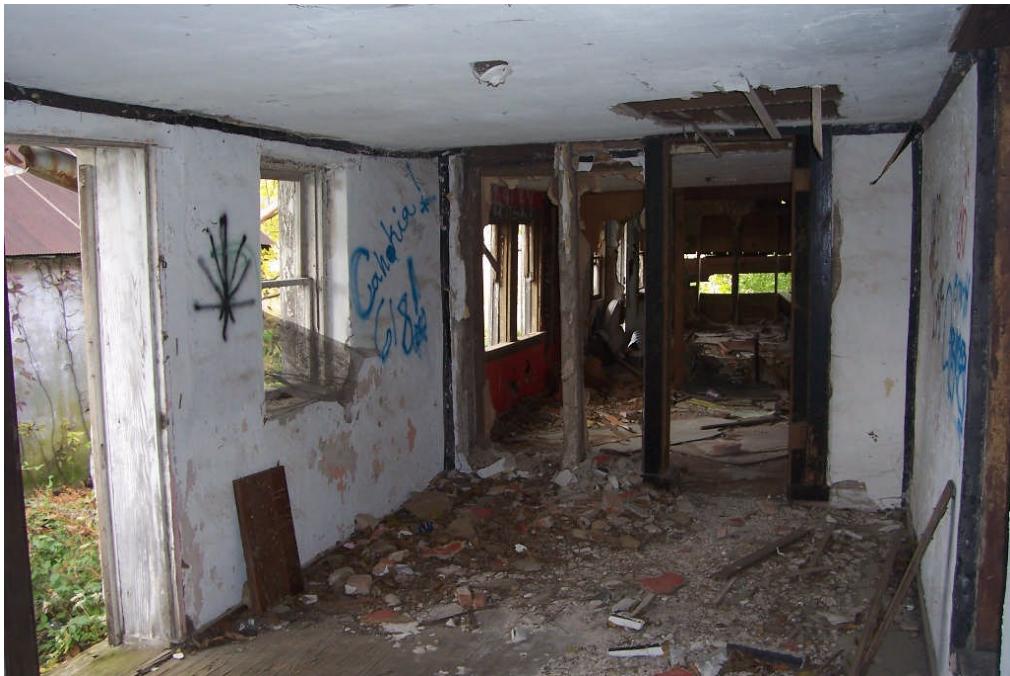
**Figure 73.** View of the north end of Room 104 showing exterior doorway at left and interior doorway accessing Room 102C. During the 1930s and 1940s, Room 104 served as the bedroom for Frederick Zoeller, Paul Zoeller's father.

A doorway on the west side of Room 103 opens into the rear room in the stone addition, which is discussed as Room 104 (see Figures 73 and 74). Room 104 measures 20'-10"x9'-6-1/2" and has a floor that is set lower than in Room 103 (like Room 102 in the original house). The ceiling height here also is lower than in Room 103. There is an exterior doorway centered on the west wall, and framing this are two windows. An

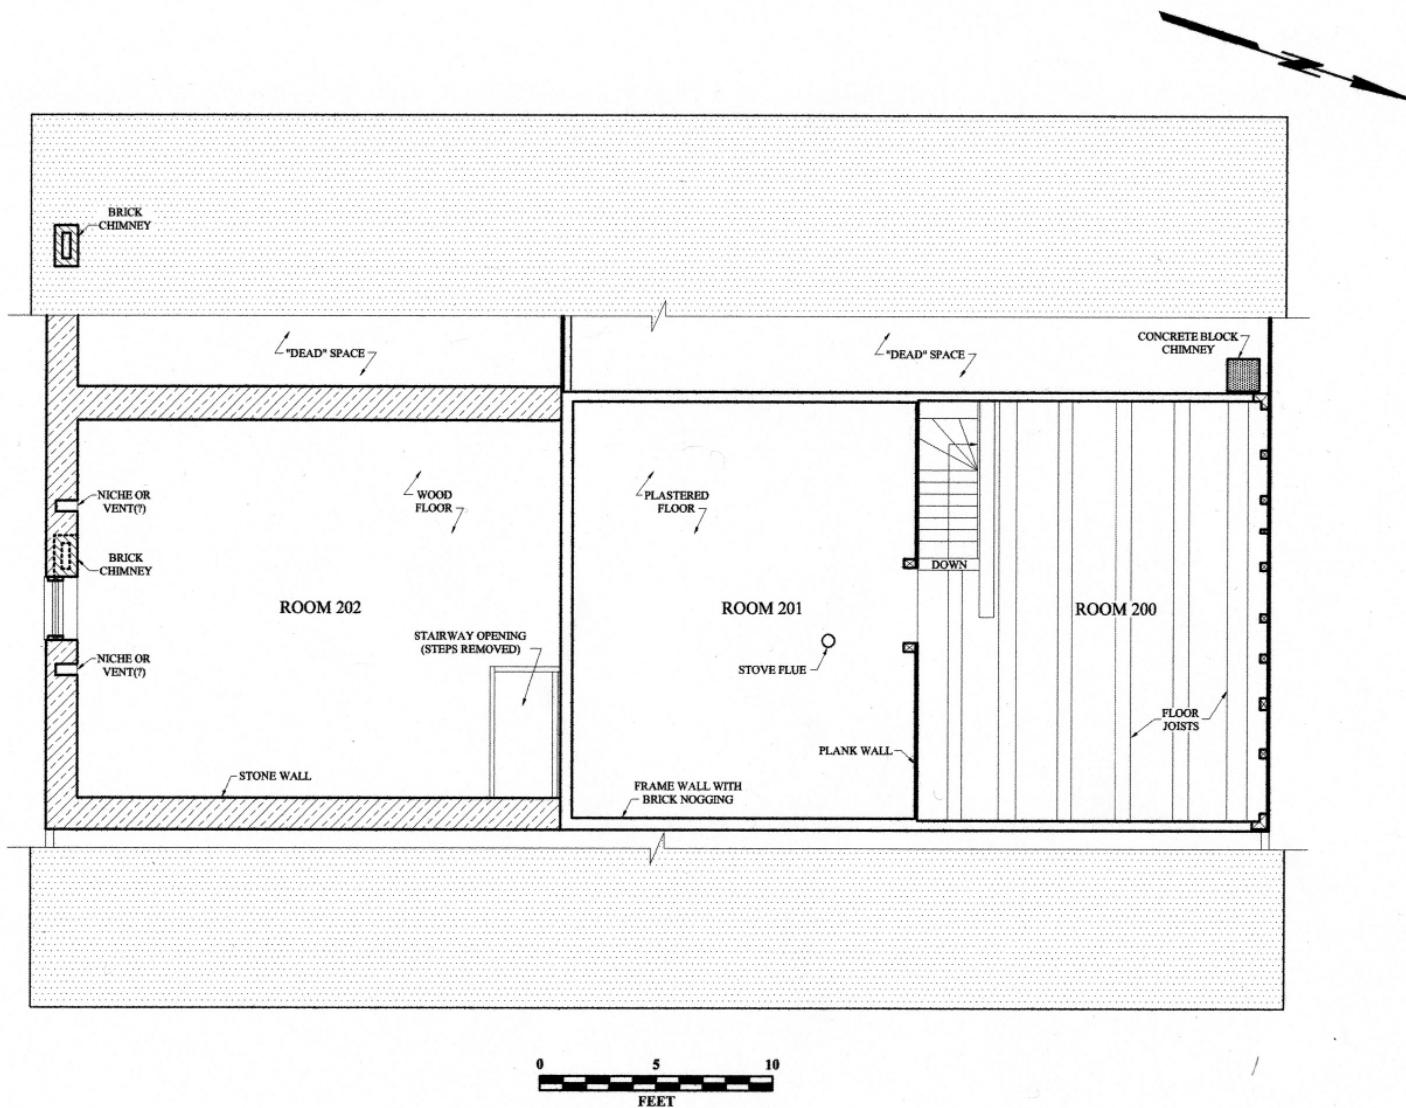
Figure 74. Second floor plan of the house, showing existing conditions. Rooms 200 and 201 are located within the original (1846) house, while Room 202 is part of the stone addition.

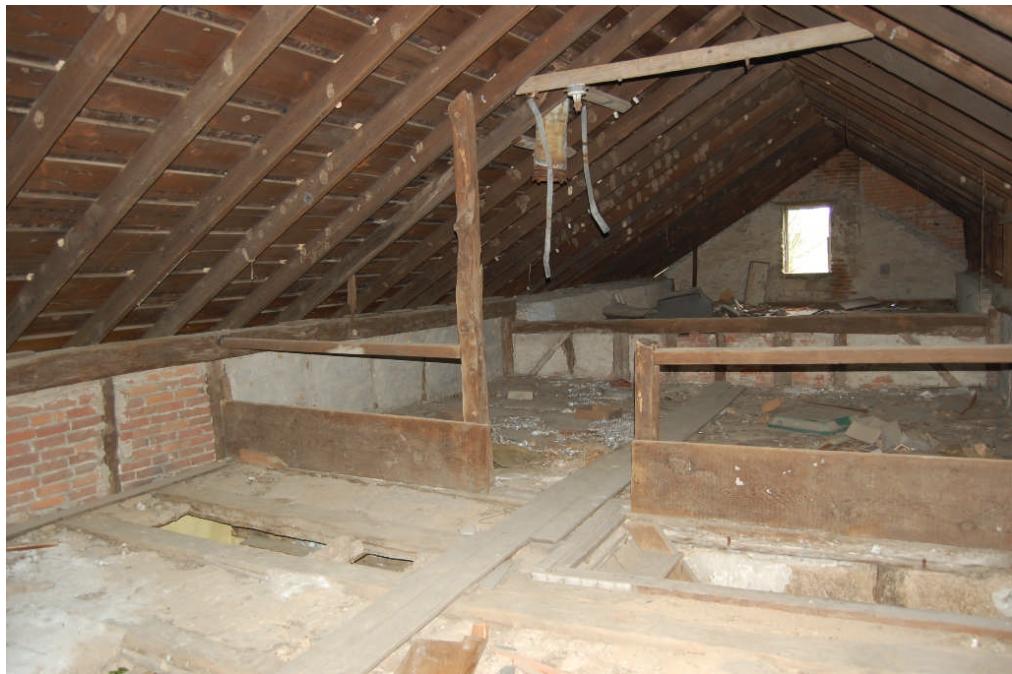
**Figure 75.** General view of the attic in the house, looking north to south and showing all three rooms on this floor. Although not fully partitioned from one another at present, these rooms are quite distinct from another. Room 200 appears in the foreground, Room 201 in middle distance, and Room 202 in the background.

The second floor of the house is a half-story and is divided into three rooms, two of which are located within the original frame section of the dwelling and third that is within the stone addition (see Figures 75 through 84). The northern of these rooms is located above Room 200 and essentially conforms to the dimensions of the latter (see Figures . It can be accessed via the enclosed stairway that rises from the southwest corner of Room 100. Room 200 was never finished out in any manner. All of the framing was left exposed, including the joists,<sup>15</sup> and the brick infill between the wall posts is visible. A window opening is present in the north gable-end wall. A rude partition wall (built of planks) on the south side of the room separates it from Room 201 to the south. These two rooms provide an interesting contrast to one another in that whereas Room 200 was never finished out, Room 201 was to some degree—despite the fact the stairway accessing the floor opens into the former rather than the latter. The exterior walls within Room 201 were provided with thin coat of plaster and whitewashed. Similarly, a layer a plaster was spread out over the joists and Dutch biscuit infill, thereby providing a firm surface to stand on. The use of plaster, rather than wood flooring, on the floor is rather unique and certainly has an “Old World” character about it. Room 201 possibly had a window located on its south side originally, but such an opening would have been rendered superfluous after the construction of the stone addition and eventually would have been eliminated altogether after the framing above the upper beam was removed (which possibly occurred after the roof was rebuilt in the late nineteenth century).

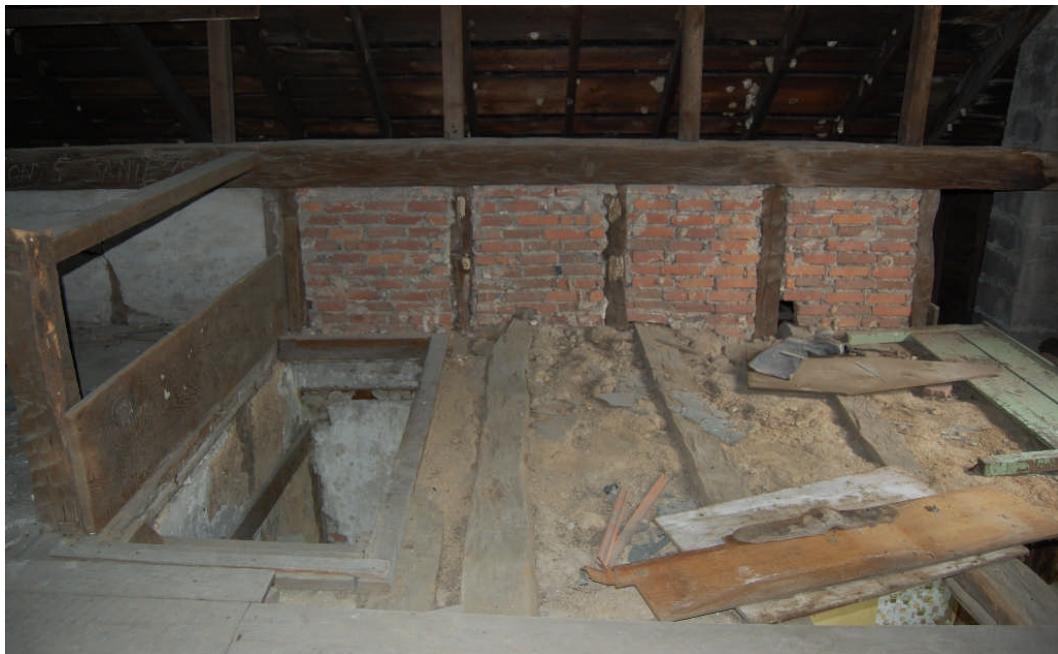
**Figure 76.** Room 200, looking north. The walls and floor in this room were never finished, which suggests that it was not intended to have regular use. Note the exposed floor joists, posts, and brick nogging. The stairway accessing the attic from Room 100 appears at lower left.

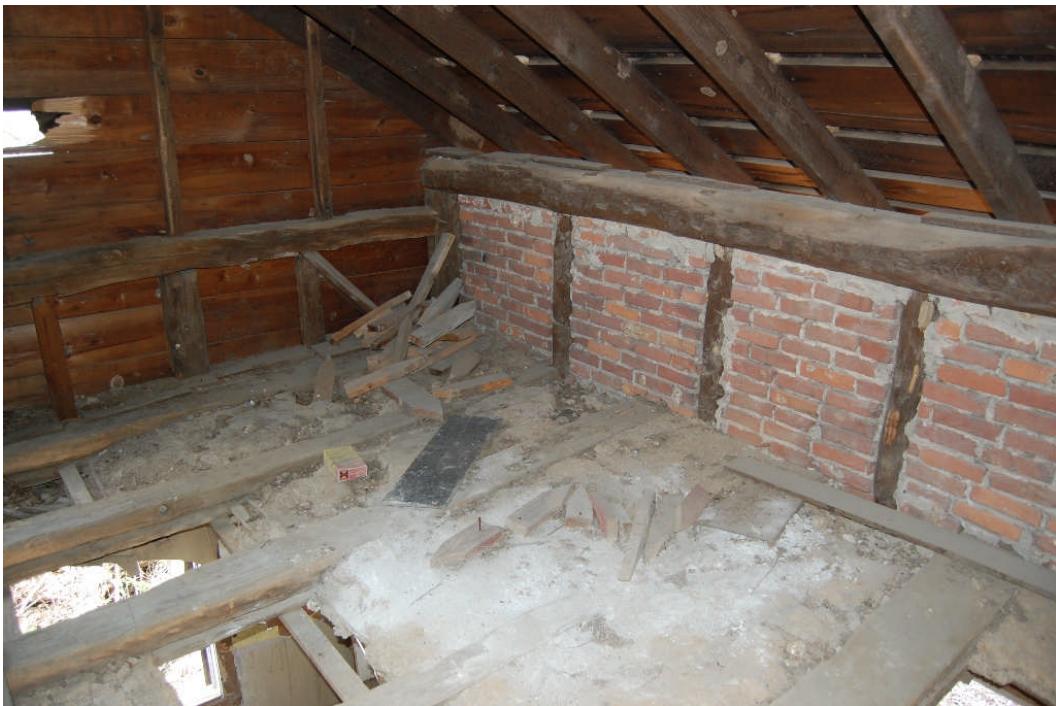
**Figure 77.** View into the northeast corner of Room 200. The north wall (at left) was partially rebuilt in the twentieth century.

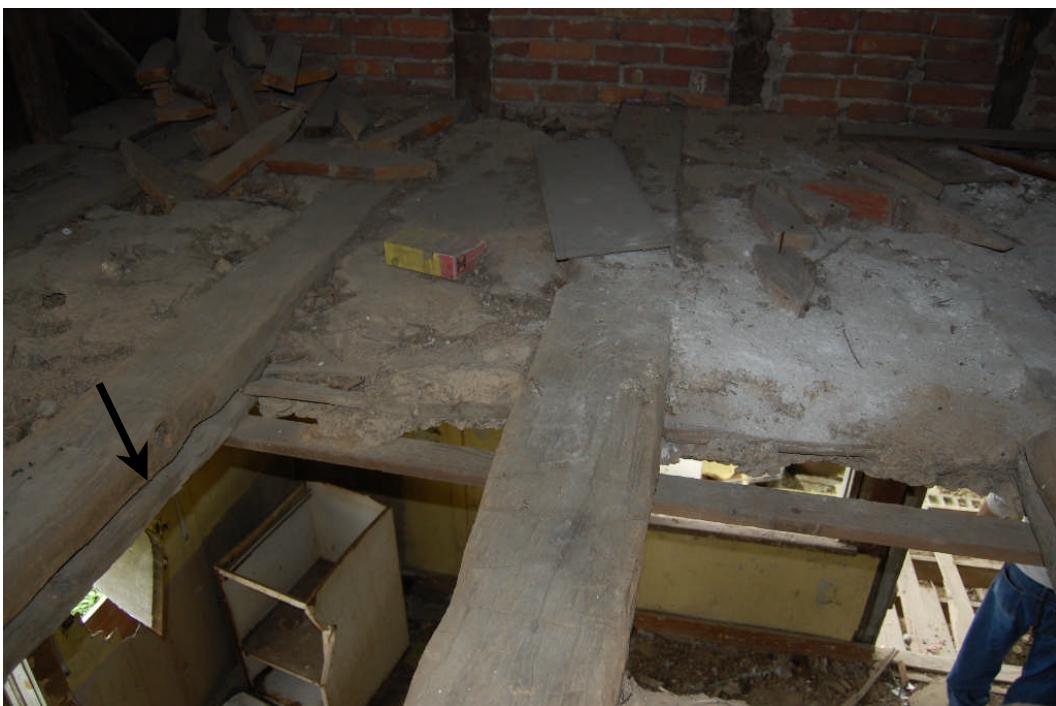
**Figure 78.** Detail of the floor joists in Room 200. Note mitered channel on side of joists into which the straw-and-clay batts were inserted.

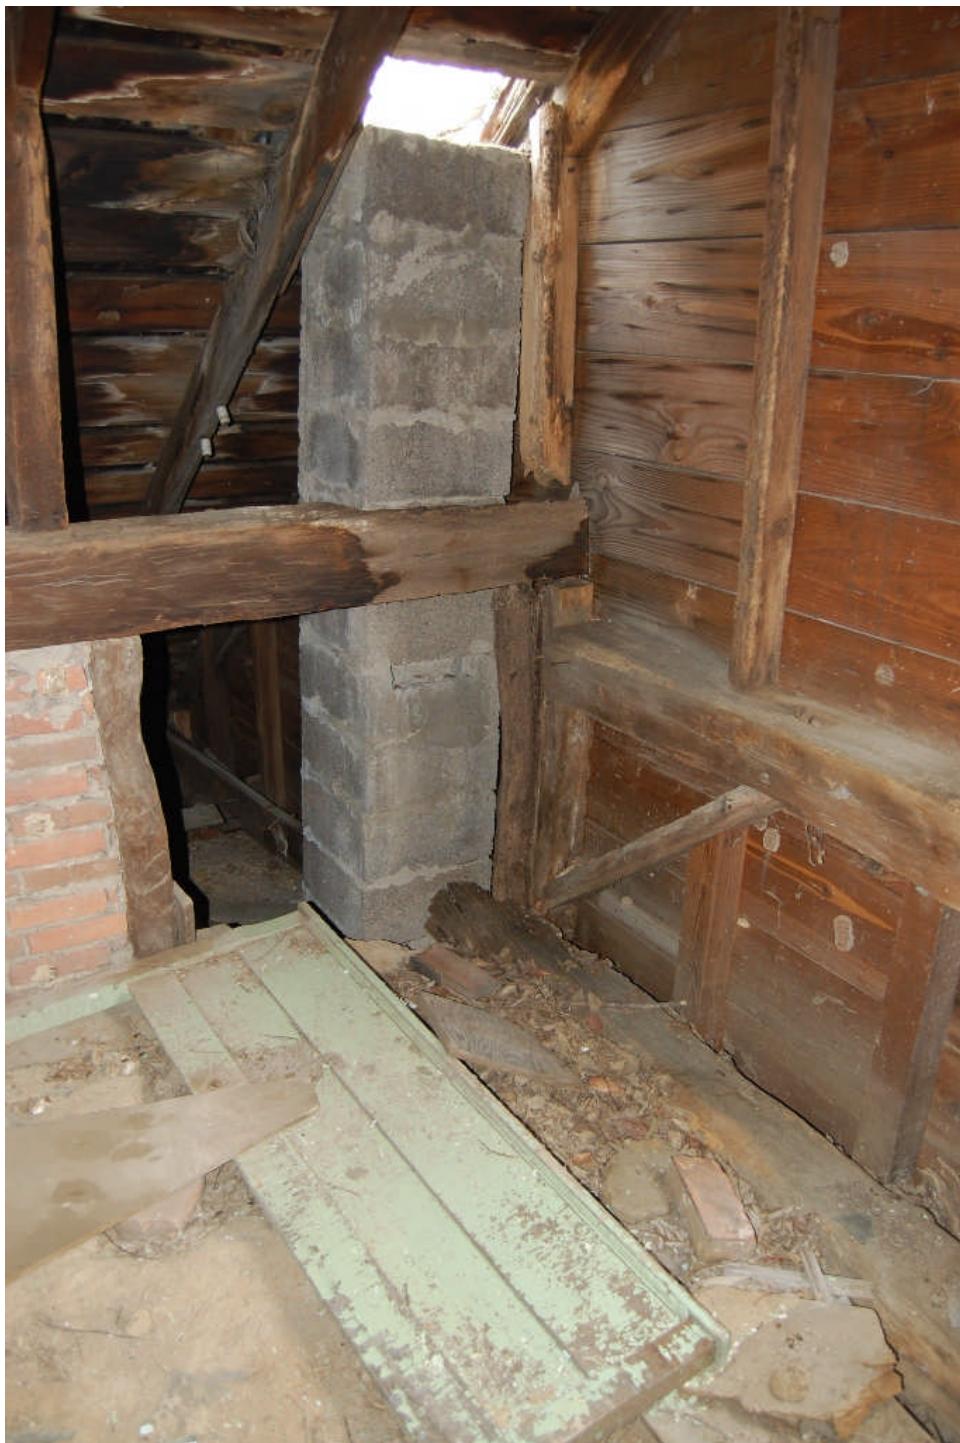
**Figure 79. Northwest corner of Room 200, showing the top of the concrete-block chimney. The chimney no longer extends through the roof, but the roof opening was never closed off. This has caused some water damage to the framing adjacent to the chimney.**

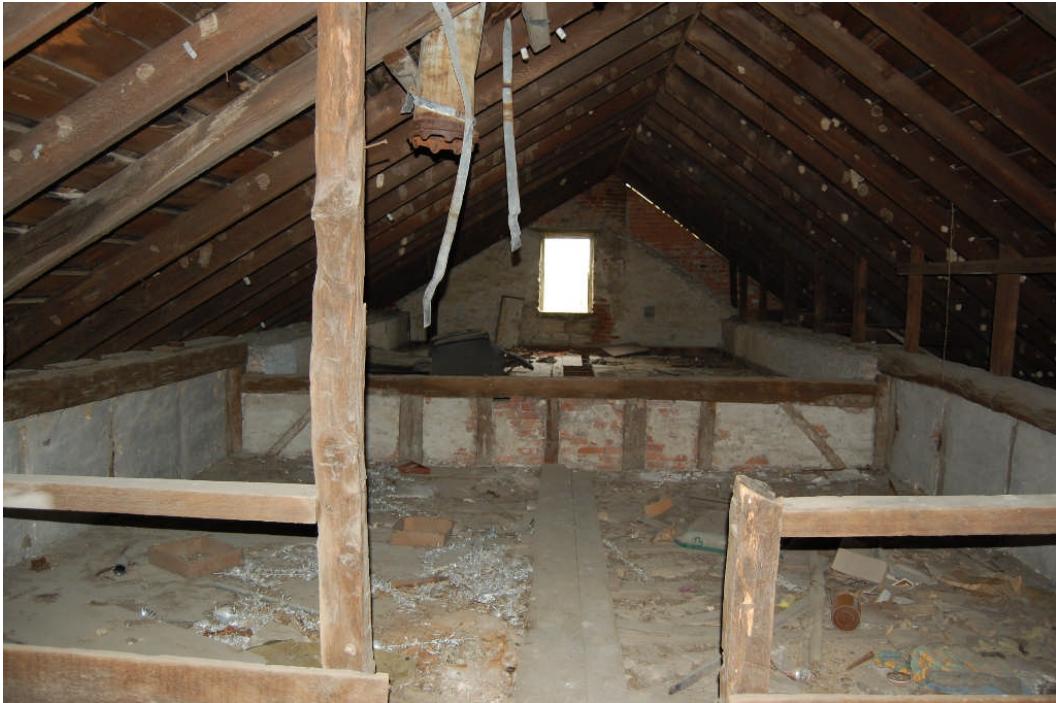
**Figure 80.** View of Room 201 looking south. In contrast to Room 200, the walls in this area have been plastered and the floor has as well. The wall in the foreground—which separates Rooms 200 and 201—is of horizontal plank construction but has been partially demolished. A section of stovepipe from Room 102 also is shown passing through the roof.

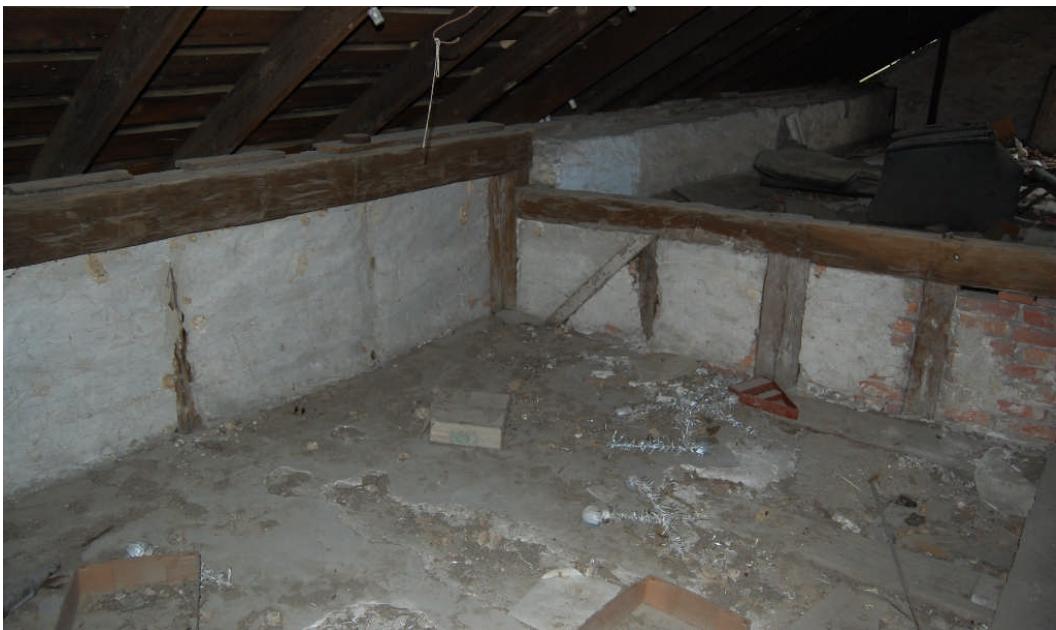
**Figure 81.** View into the southeast corner of Room 201 showing character of plastered walls and floor. The plaster on the walls is quite thin, leaving the framing partially exposed in some instances.
