**ARCHAEOLOGICAL SURVEY SHORT REPORT:  
NATIONAL REGISTER OF HISTORIC PLACES ASSESSMENT  
OF THE DAAB-ZOELLER FARM SITE,  
ST. CLAIR COUNTY, ILLINOIS**

Prepared by  
Christopher Stratton  
and  
Floyd Mansberger

Fever River Research, Inc.  
Springfield, Illinois

**Project Type/Title:** National Register of Historic Places assessment of the Daab-Zoeller Farm Site.

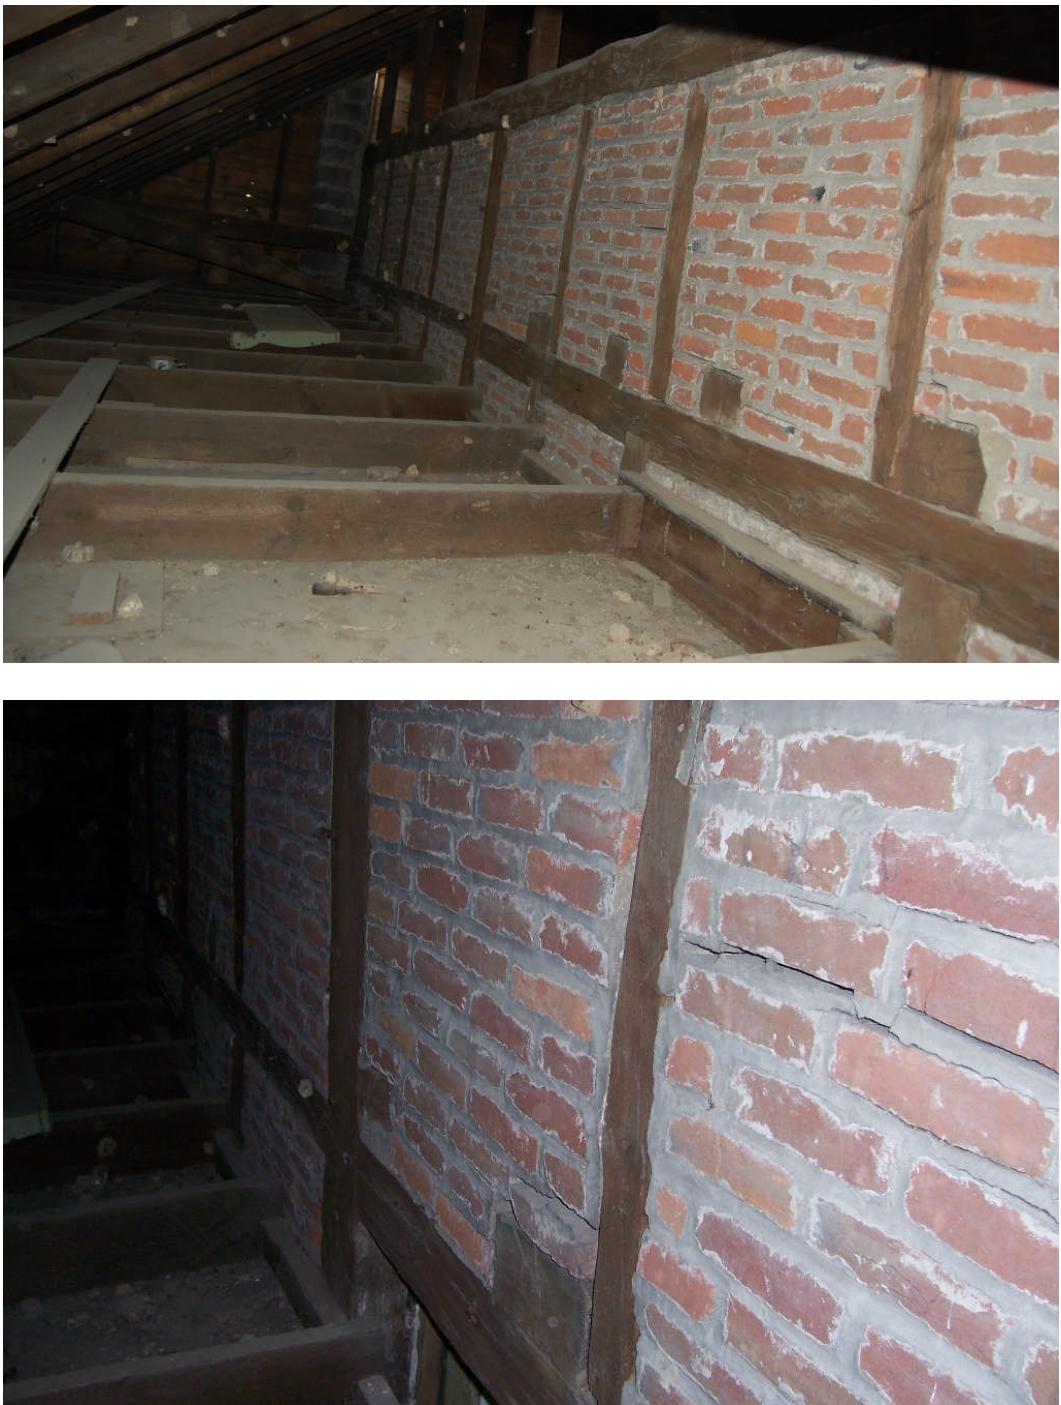
**Figure 82.** Two views of the rear (or west) side of the wall of Rooms 200 and 201. Unlike the front elevation of the house, the brick nogging here shows no evidence of ever having been plastered over. The mortar joints also are in exceptionally good condition. These facts support the impression that the original house always had a rear wing. These images also illustrate the manner of framing employed in the original house, with the posts being mortised—and slightly inset—into a girt, which serves a ceiling plate on which the joists rest directly on top of (as opposed to being notched into or around).

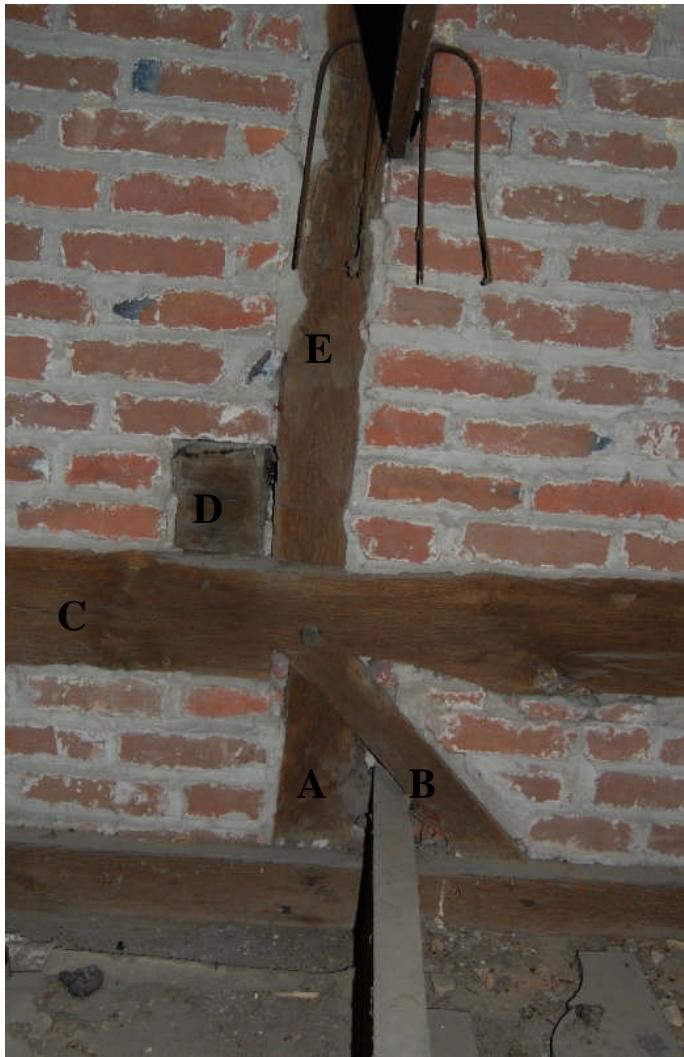
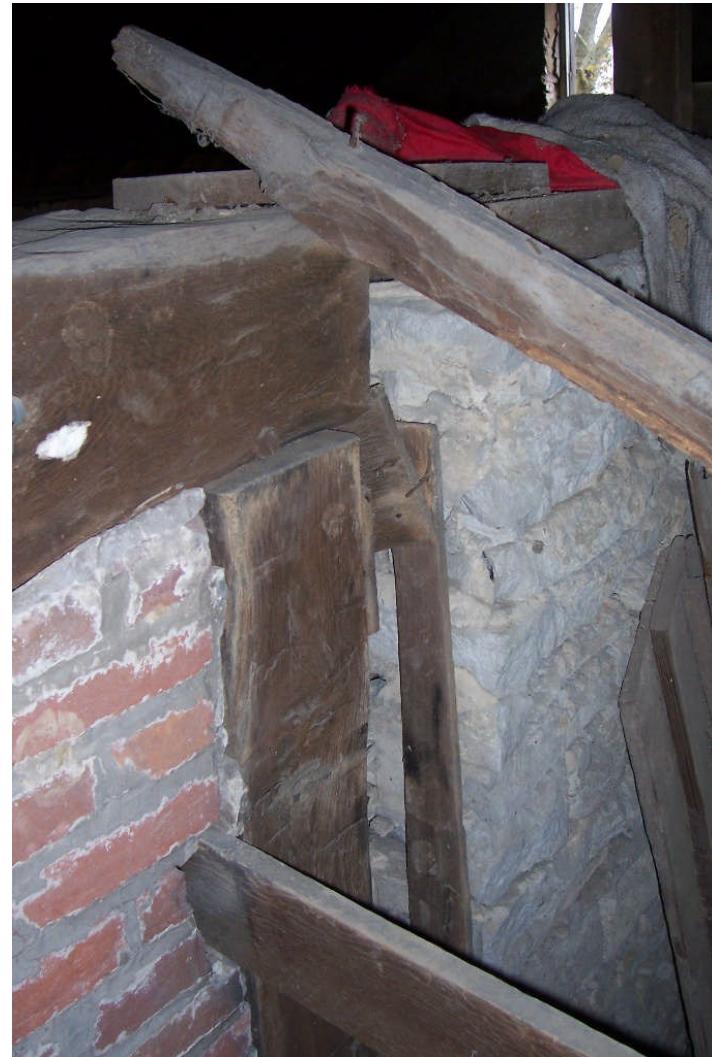
**Figure 83. (LEFT)** Detail showing main framing members on original house: A) post, B) bracing, C) girt, D) ceiling joist, and E) upper post for attic knee wall. **(RIGHT)** Interior juncture of the original frame house and the stone addition. This image also shows a corner post and the large girt that originally served as a rafter plate. The remnant pole rafter associated with rear wing also is pictured.

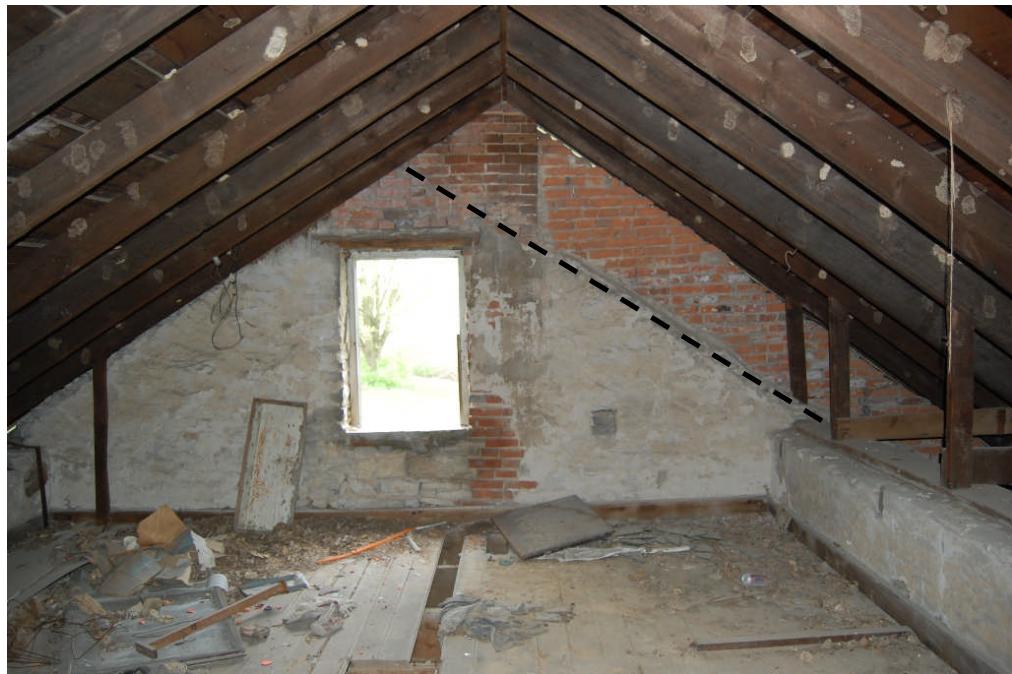
**Figure 84.** View into Room 202, the attic room in the stone addition, looking south. This space potentially was used as extra bedroom or storage space originally but saw little use during the house's later decades of occupation. The dashed line indicates the pitch of the original roof. Brick was used to infill the gap created when the existing roof was added late in the nineteenth century.

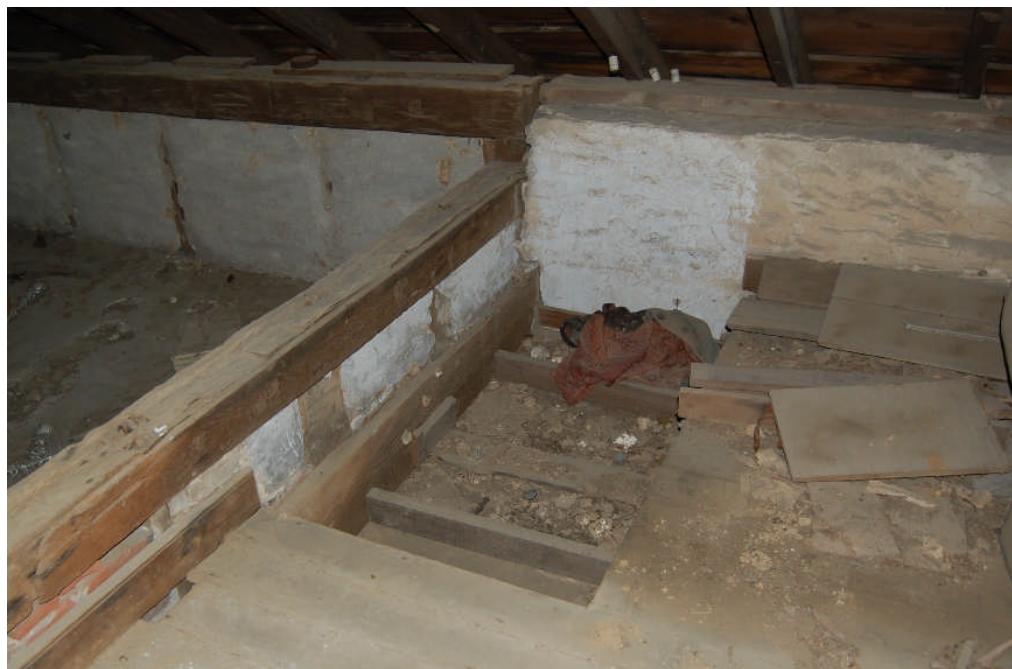
**Figure 85.** Infilled stair opening in the northeast corner of Room 202. The stairway once located here allowed access to the attic from Room 103 below.

The third room on upper floor—Room 202—is located within the stone addition and has the same dimensions as Room 103 (prior to its division) below it (see Figures 85 through 92). Originally, Room 203 could be accessed via a separate stairway located in its northeast corner. The stairway in question is no longer present, but physical evidence of it remains of an enclosed stair opening in the floor and plain/plaster lines on in walls in the northeast corner of Room 103 below. This evidence suggests that the stairway was L-shaped (similar to that in Room 100) and was quite steep. Room 203 has a finished appearance and seems to have been designed as living space originally. It has tongue-and-groove wood flooring and beaded baseboard, and the stone walls are plastered. A window opening is centered in the south gable-end wall. Two small niches are present to

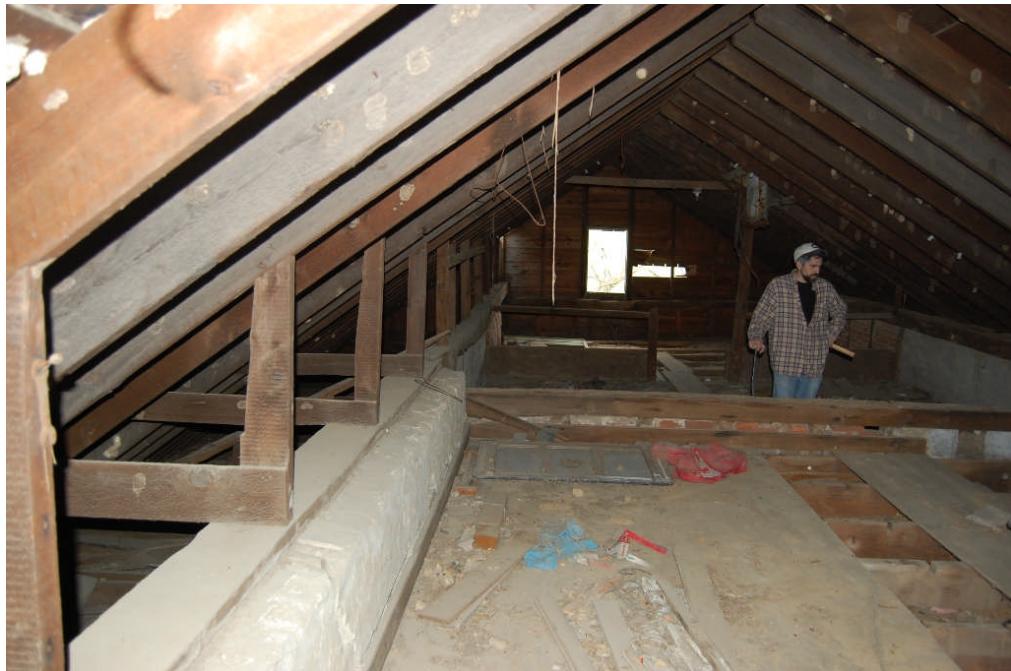
**Figure 87.** View of west side of Room 202 showing the studs and collar beams added to support the rafters for the late-nineteenth-century replacement roof.

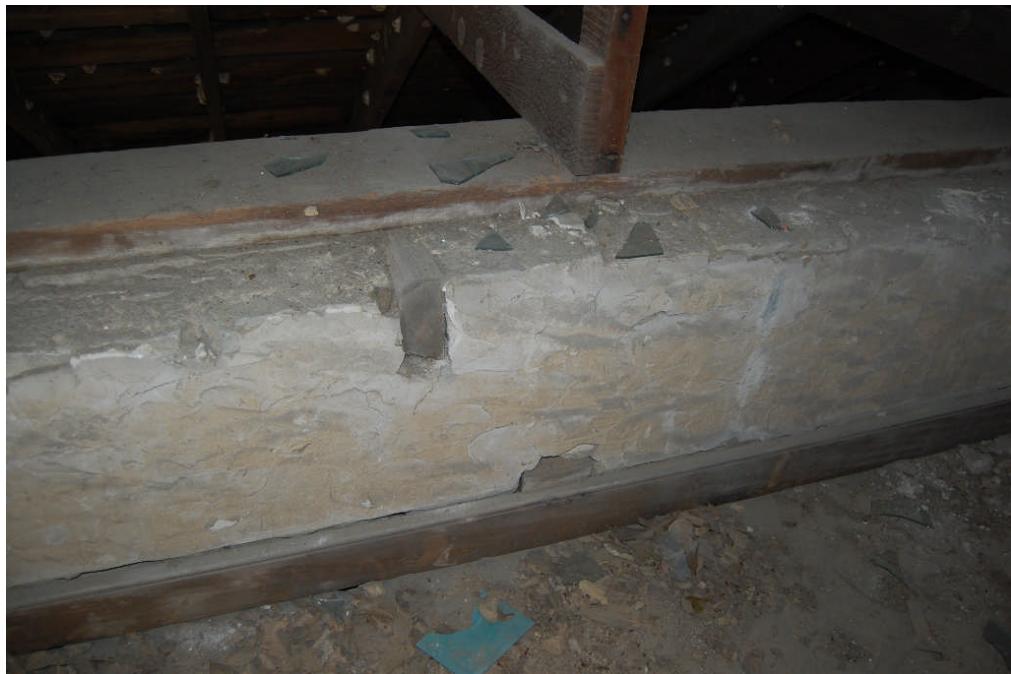
**Figure 88.** Knee wall on west side of Room 202 showing original rafter plate (A) and associated nailer block (B) integrated within the stonewall. Similar nailer blocks were used for the baseboard below.

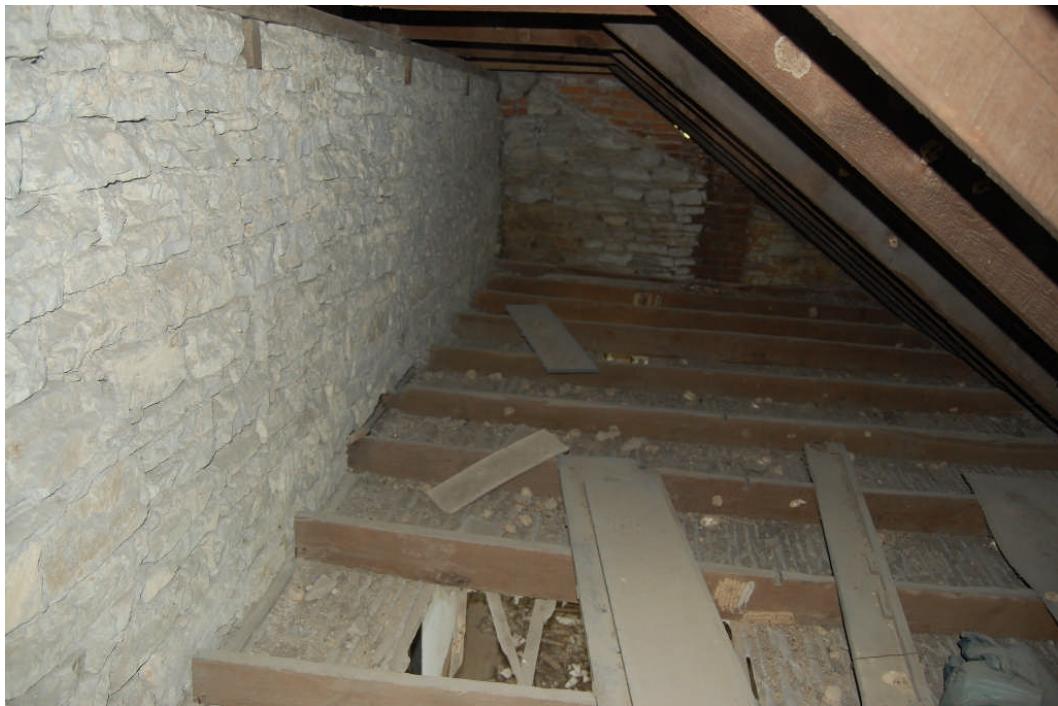
**Figure 90.** View of the attic “dead space” above Room 104. The stonework here was never exposed and hence no need to be plastered.

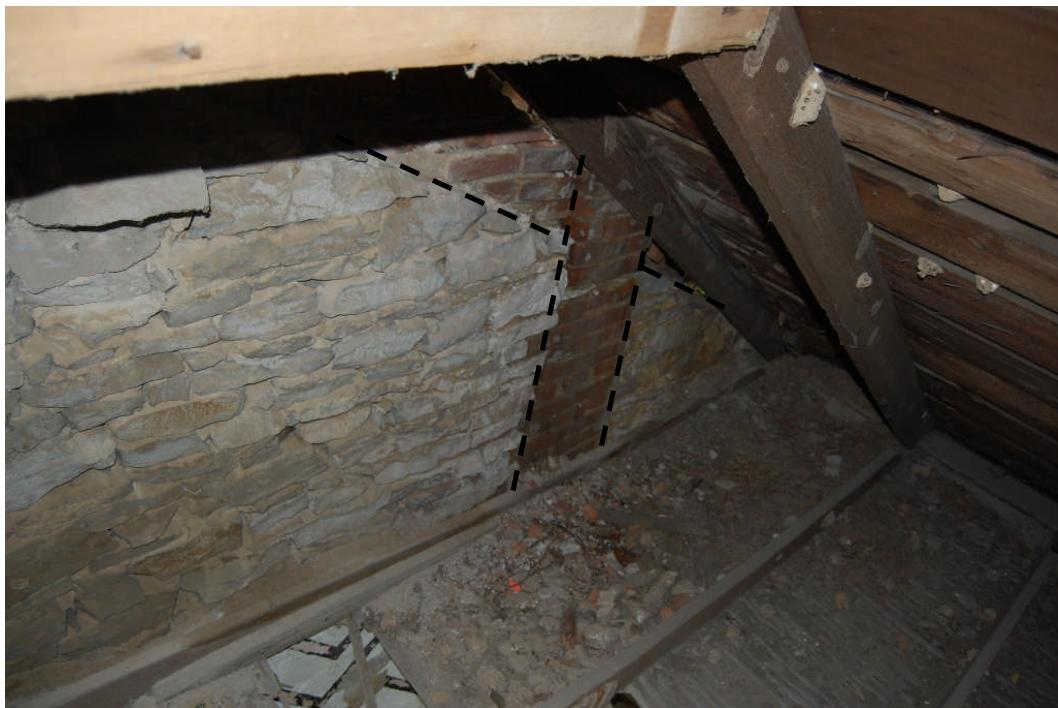
**Figure 91.** Inside of the south-gable-end wall of the stone addition in attic “dead space” above Room 104. Dashed lines indicate the location of a brick chimney integrated within the stone wall, and also the original roof line.

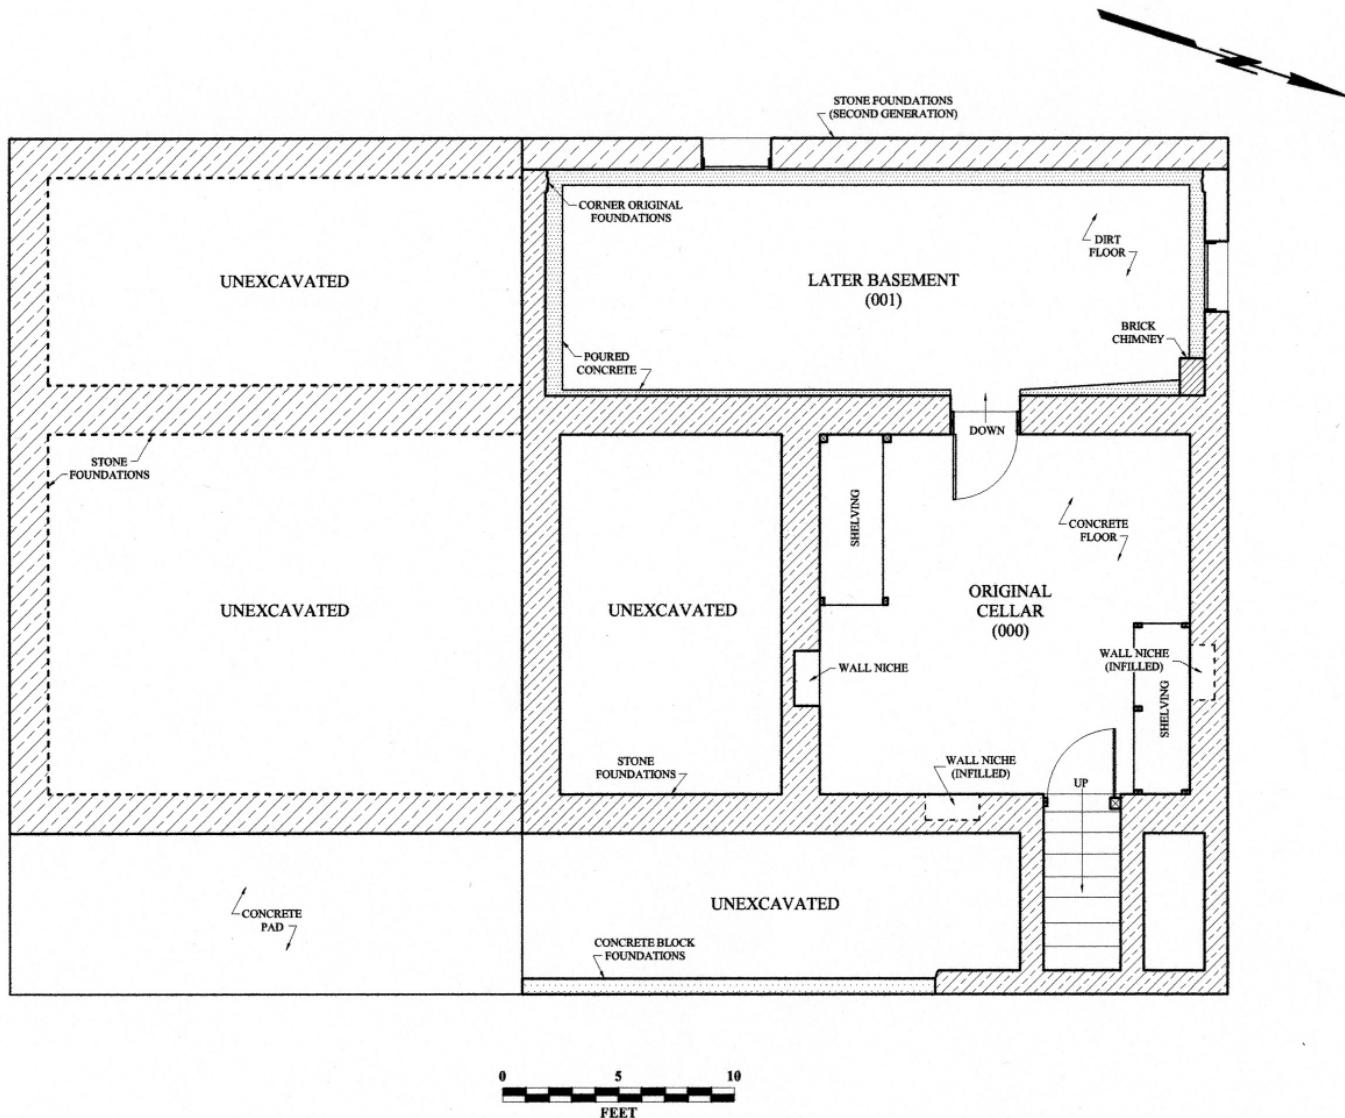
Figure 92. Basement plan of the house showing existing conditions. Room 000 represents the original cellar. A new basement room (001) was excavated circa 1940.

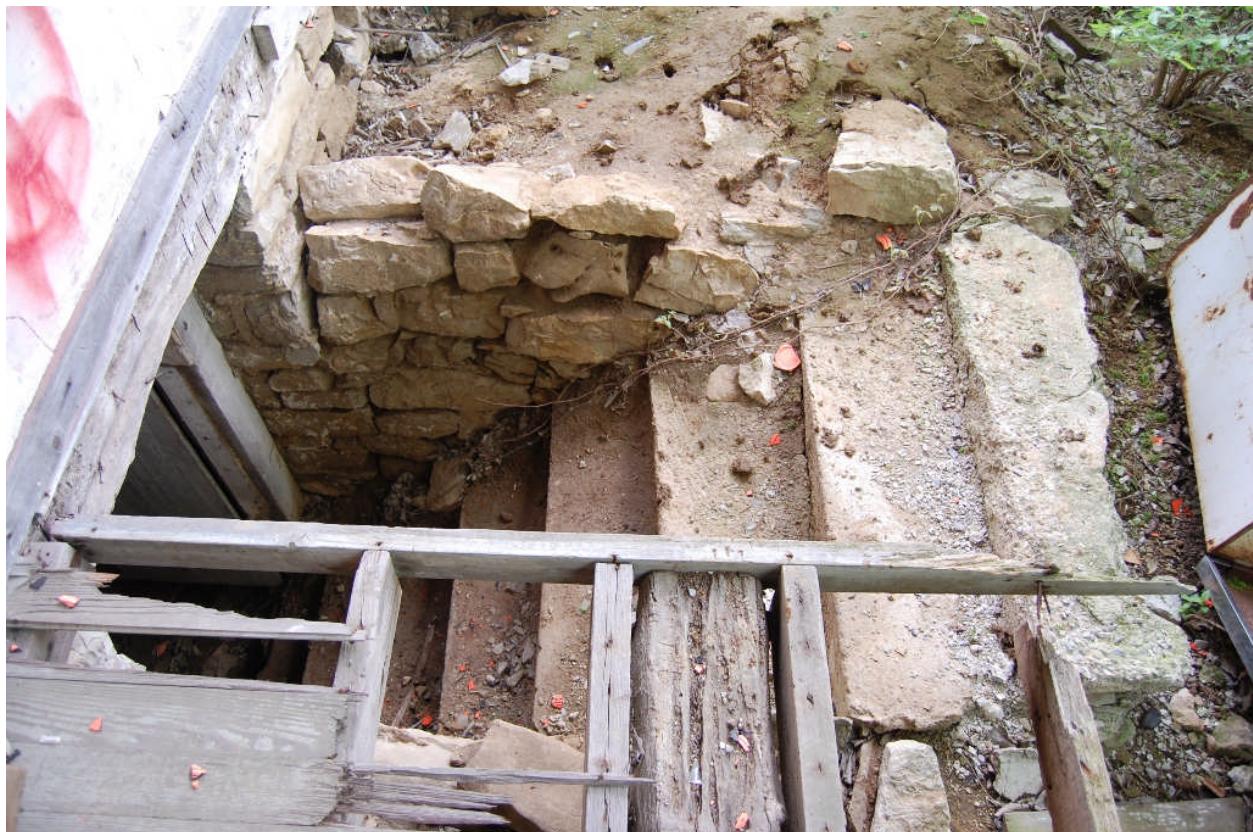
**Figure 93.** View of the stairway to the cellar beneath the original house. The stairway, which is accessed from the north end of the front porch, has stone bulkhead walls and concrete steps. The concrete steps likely date from the twentieth century. The stairway originally had a trap door over it, flush with the porch deck.

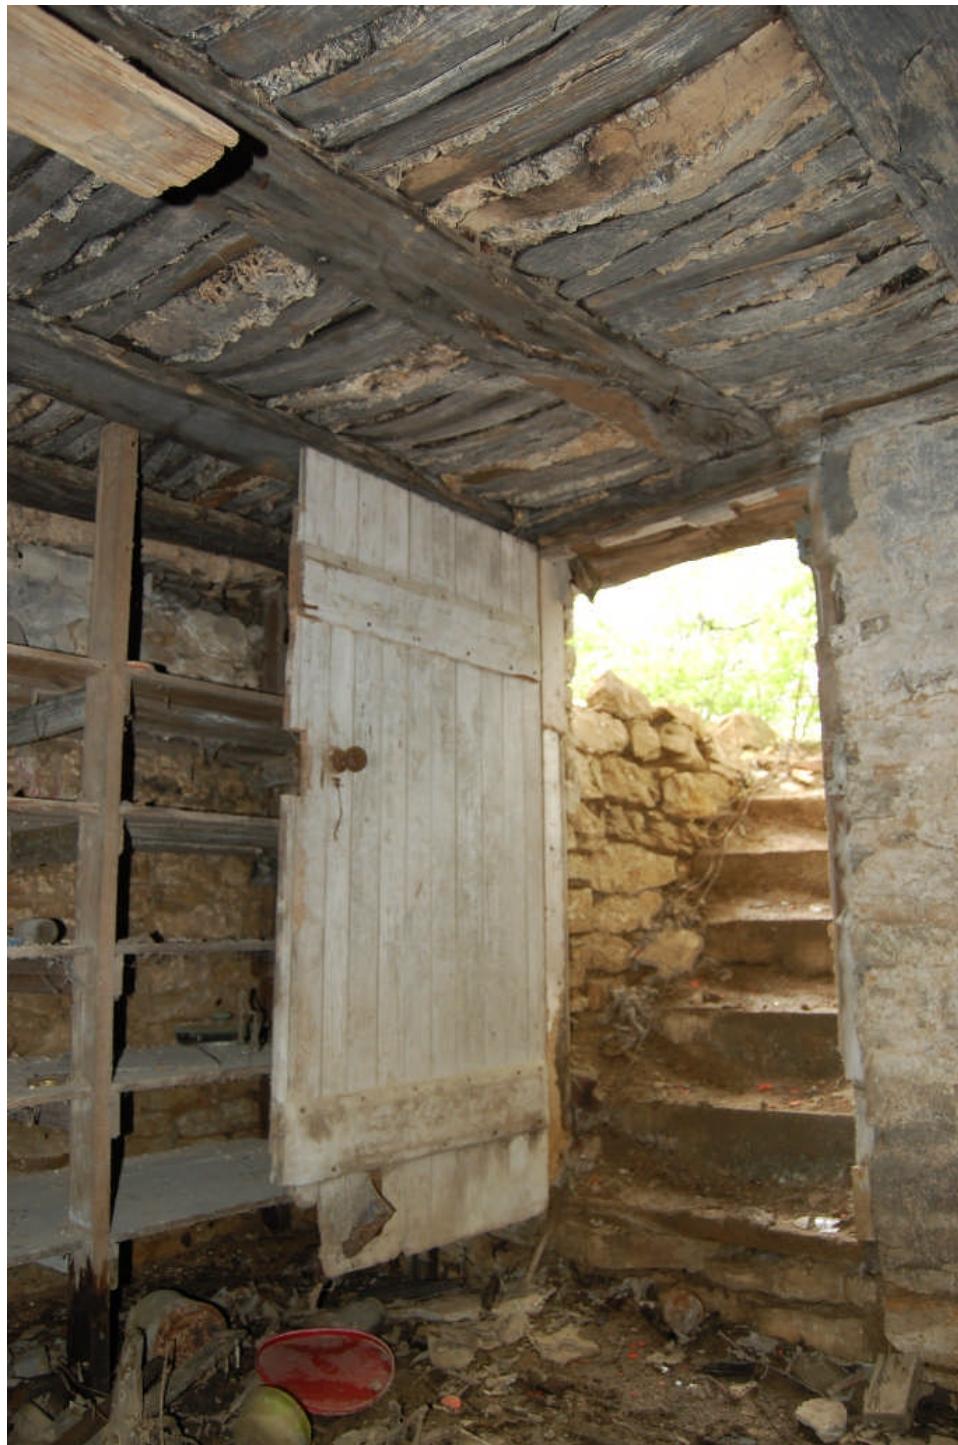
**Figure 94.** View of the entrance door from the original cellar (Room 000). The ceiling joists are similar to those used on the floor above and employed a similar method of “Dutch biscuit” insulation.

The house has a partial basement beneath it, comprising two rooms (000 and 001) located under the frame section of the house (see Figures 93 through 104). The basement is accessed via an exterior bulkhead stairway located on the north end of the front porch. This stairway has concrete steps and descends into Room 000, which represents the original cellar. Room 000 measures 16'-0" x 15'-3", has exposed stone walls, and a ceiling height of 6'-11". Like room above it, the ceiling in Room 000 is insulated with clay, though a slightly different technique was used here; rather than having a clay-and-straw mixture wrapped around the slats (the classic “Dutch biscuit” method), a layer of clay simply was used to fill the void between the slats and first-floor flooring. Another interesting feature in Room 000 is the presence of a niche—measuring 2'-4" wide, 2' high, and 1'-1" deep—in the south wall. This was one of three such niches originally present in this cellar room. Another was located in the east wall, and third in the north; however, both were later filled in with stone. Similar niches have been documented at other homes in the region, and appear to represent a cultural indicator of this ethnic group.<sup>16</sup> These niches have been documented in multiple sizes with some having wooden doors and interior shelves. Although the primary function of these niches appears to have been associated with cellar storage, the objects stored in them are not known. Whereas foodstuffs is the most likely candidate for items stored in these niches, the presence of small niches in close proximity to bulkhead entrances and/or stairs leading into the cellars may suggest that they functioned as small receptacles for lamps and/or candles (lighting). Although the most likely use for these niches was as a cold-storage area for foodstuffs, they may have been used for other purposes as well.

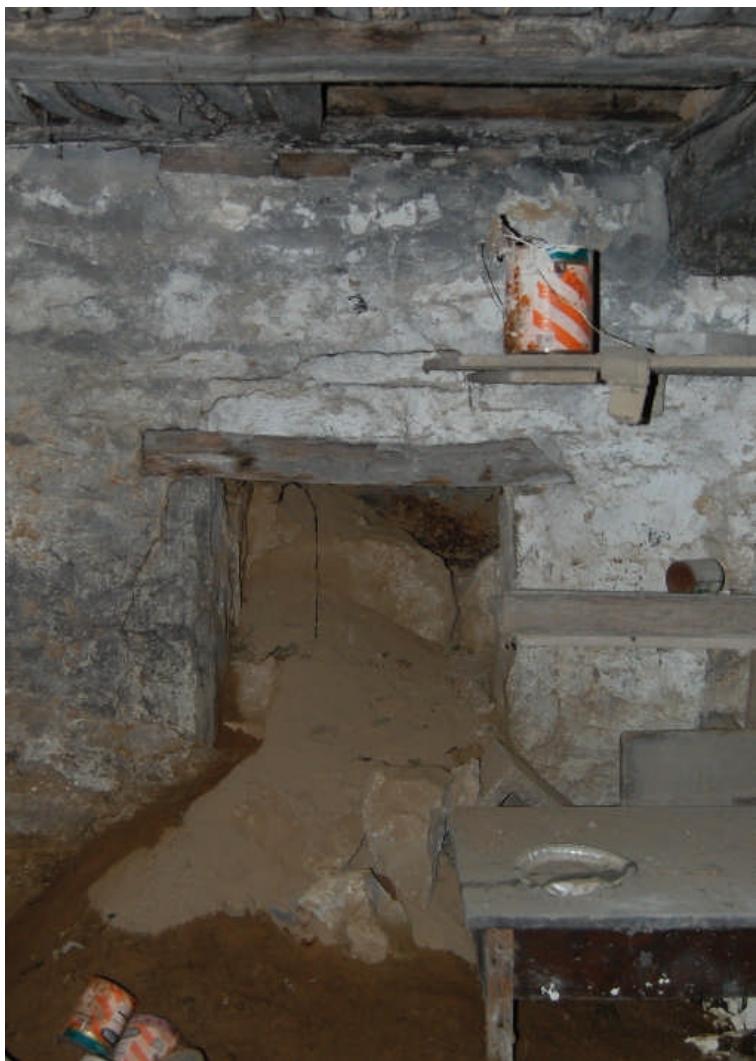
Figure 97. (LEFT) The original cellar entrance door appears to have been hung from hand-forged pintle, one of which is shown here. The existing door is hung with strap hinges. (RIGHT) View of a wall niche on the south side of Room 000. This is one of three once present in the cellar. Such niches have been documented at several other German farmstead in southwest Illinois.

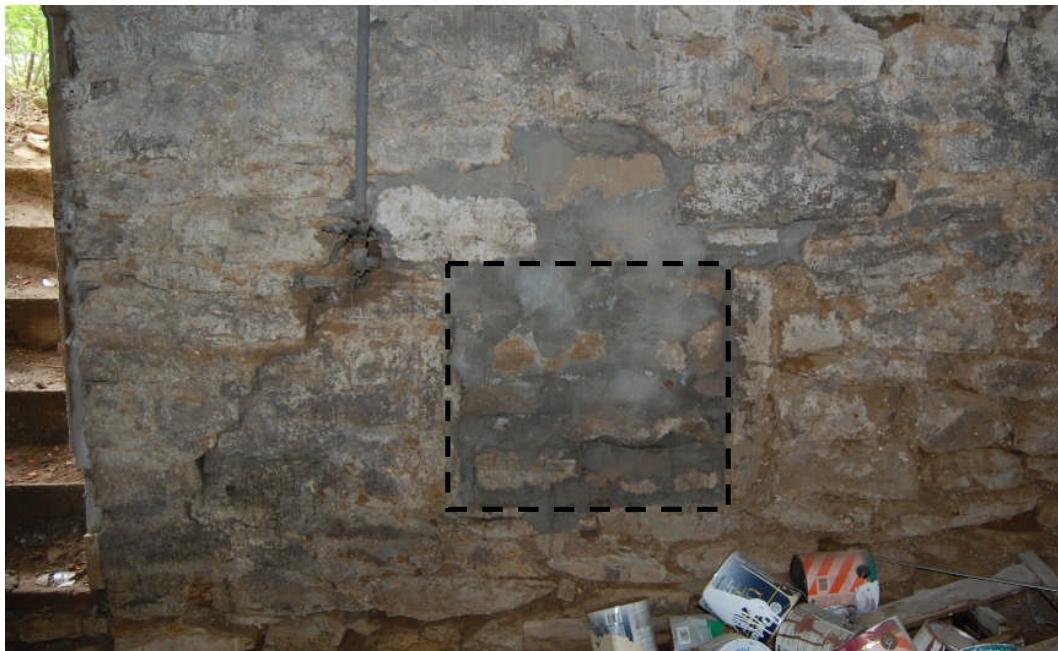
**Figure 98.** View of an infilled wall niche on the east side of Room 000. The dashed line delineates the outline of the niche.

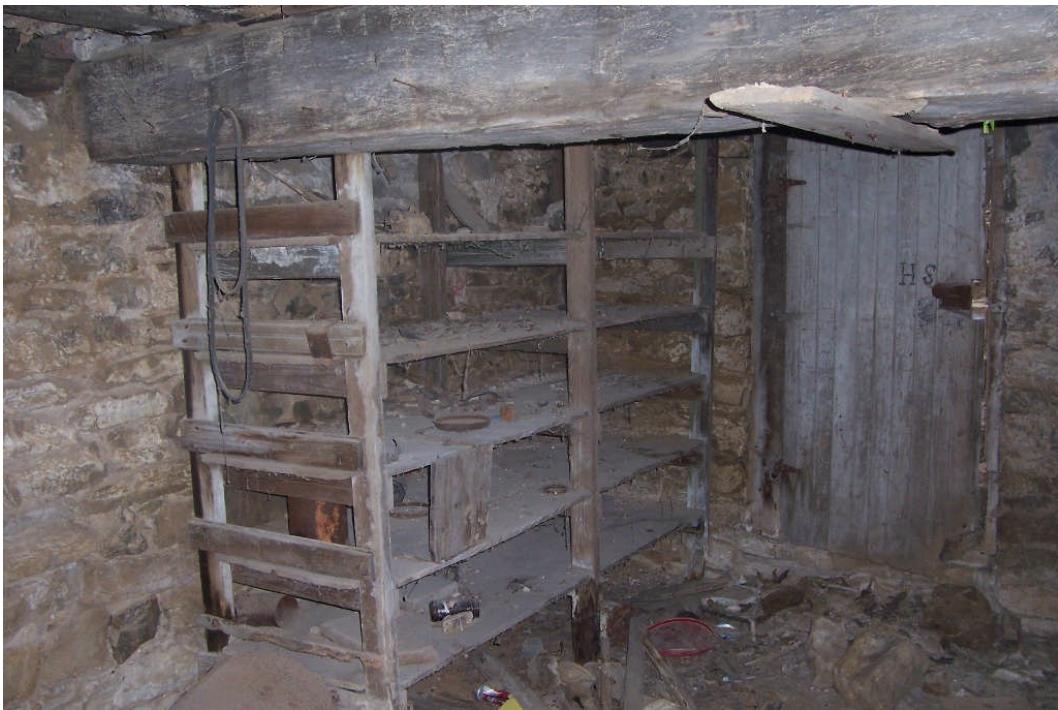
**Figure 99.** View of the built-in shelving located in the northeast corner of Room 000. During the Zoellers' period of ownership, this portion of the cellar used for the preparation and storage of canned home goods.

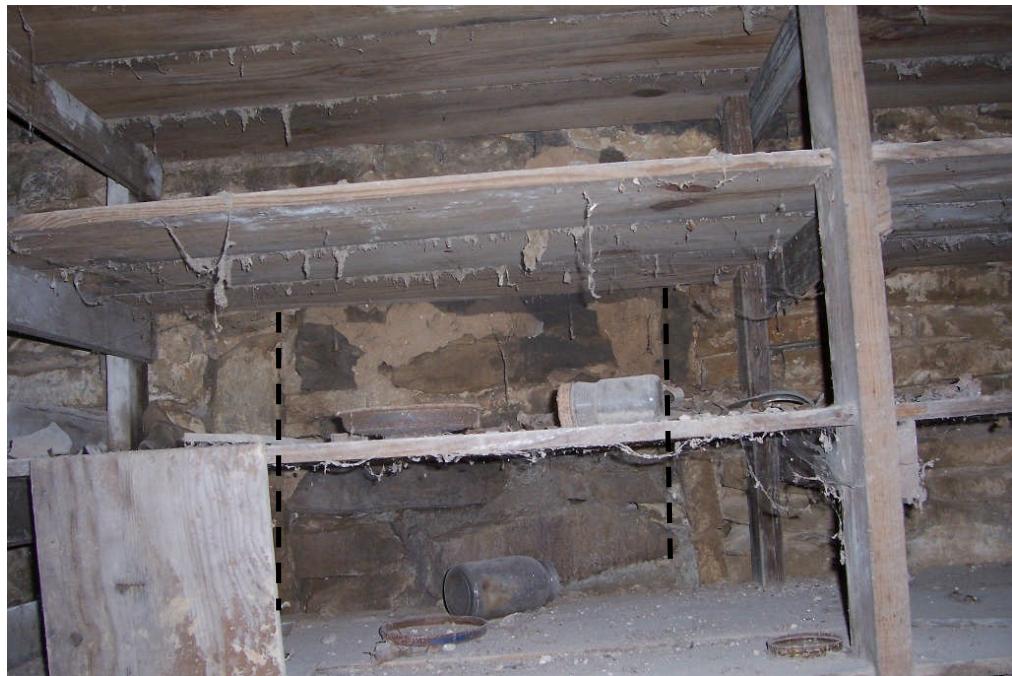
**Figure 100.** There also appears to have been a wall niche in the north wall of Room 000 (behind the existing shelving), which is delineated here by the dashed lines.

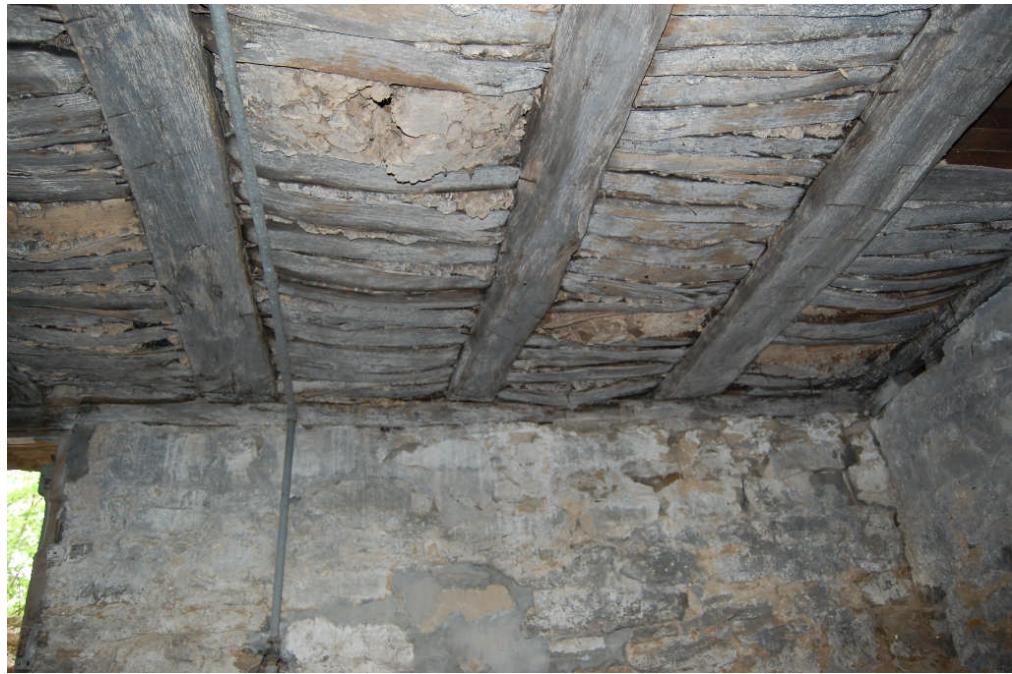
**Figure 101.** Like the ceilings in Rooms 100 and 101, that in Room 000 is insulated with clay and straw. However, the straw-and-clay mixture was not rolled around the rived oak planks/lath to form a batt, but rather was deposited in a distinct layer on top of latter and then covered over with tongue-and-groove flooring.

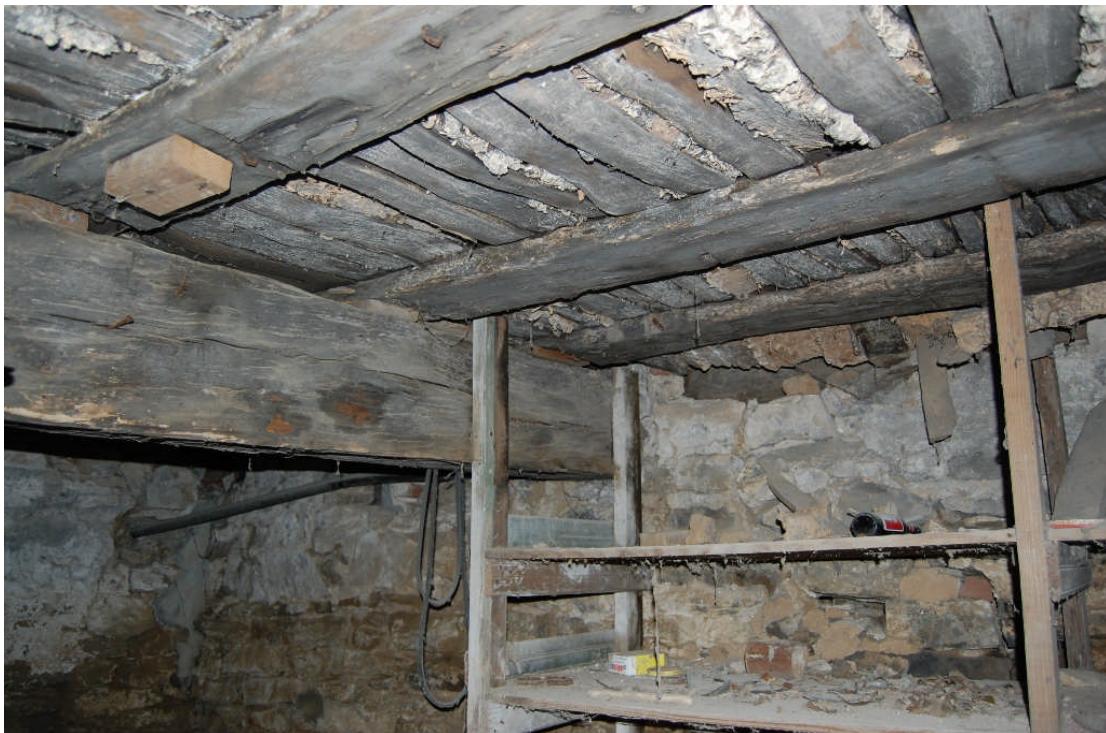
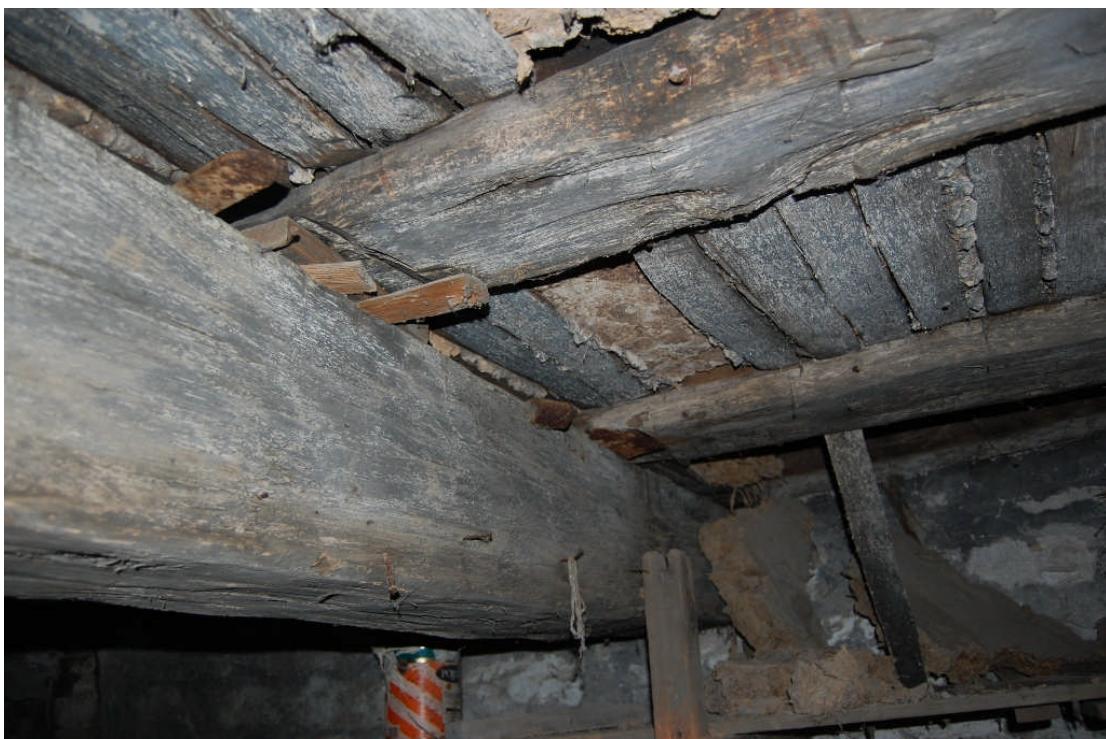
**Figure 102.** Two views of the large summer beam that supports the joists in the ceiling of Room 000 (showing its northern end). The summer beam is hand-hewn oak and runs east/west, essentially mirroring the system employed on the floor above.

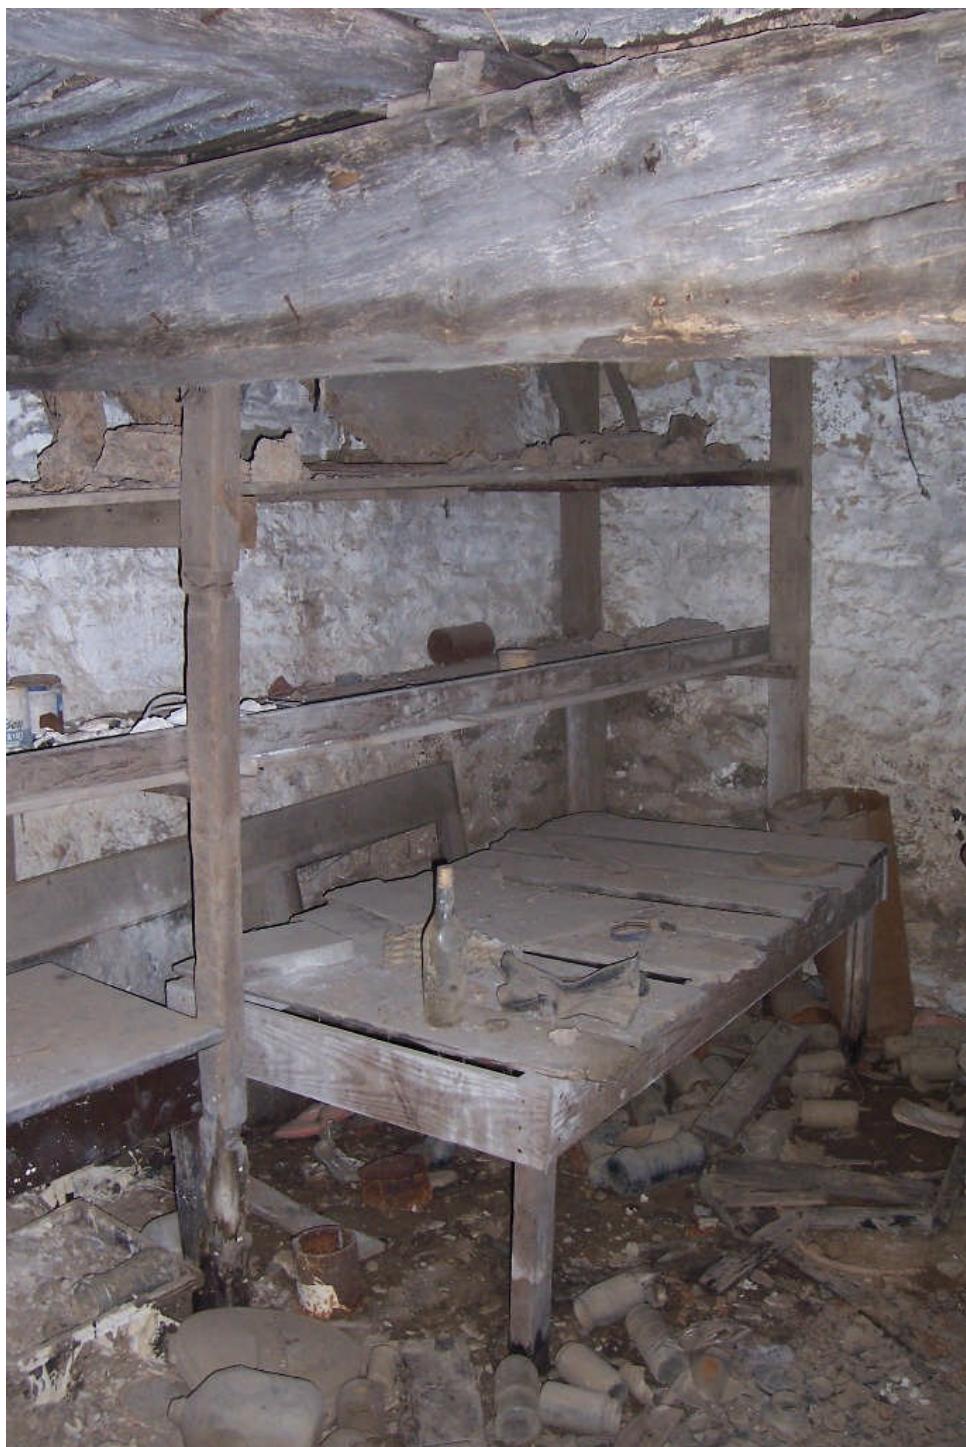
**Figure 103.** View of the southwest corner of Room 000, showing the built-in shelving and work table located here.

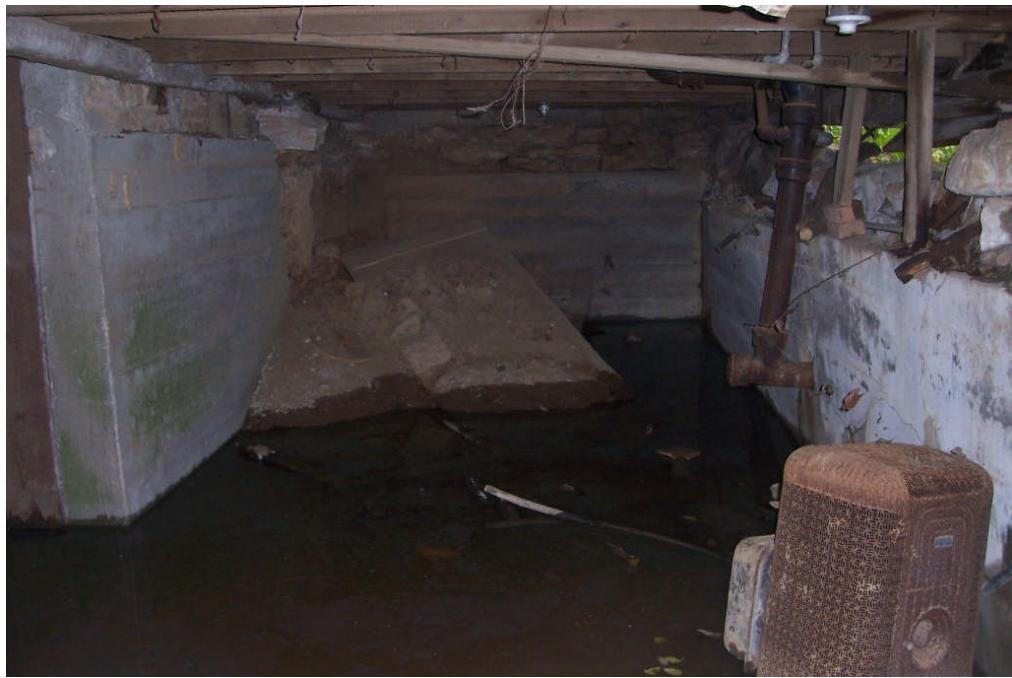
**Figure 104.** Interior view of Room 001, the “new” basement excavated in the 1940s, looking south. The room has concrete walls/foundations, a section of which have collapsed, as seen in this view. Note oil heating stove at lower right.

In the early 1940s, the basement was expanded to the west by excavating a whole new rear beneath the original rear wing (see Figures 105 through 109). Concrete walls were poured around the perimeter of the new room (those in the north, east, west being inset slightly from earlier shallow stone foundations in order to prevent destabilizing them during excavation). The room created (Room 001) measures 8'-9" wide, has two windows on its west side and a third window on the north. The chimney previously discussed in regards to Rooms 100 and 101 actually extends into the northeast corner of Room 001. Rather than being concrete-block, however, the chimney base is brick. It is possible that this base represents the remnant of an earlier generation of chimney that later was replaced by the current concrete-block stack. A flue vent is located in the west face of the chimney base. The presence of this vent indicates that the room was once heated—or at least had the ability to be—at one time.

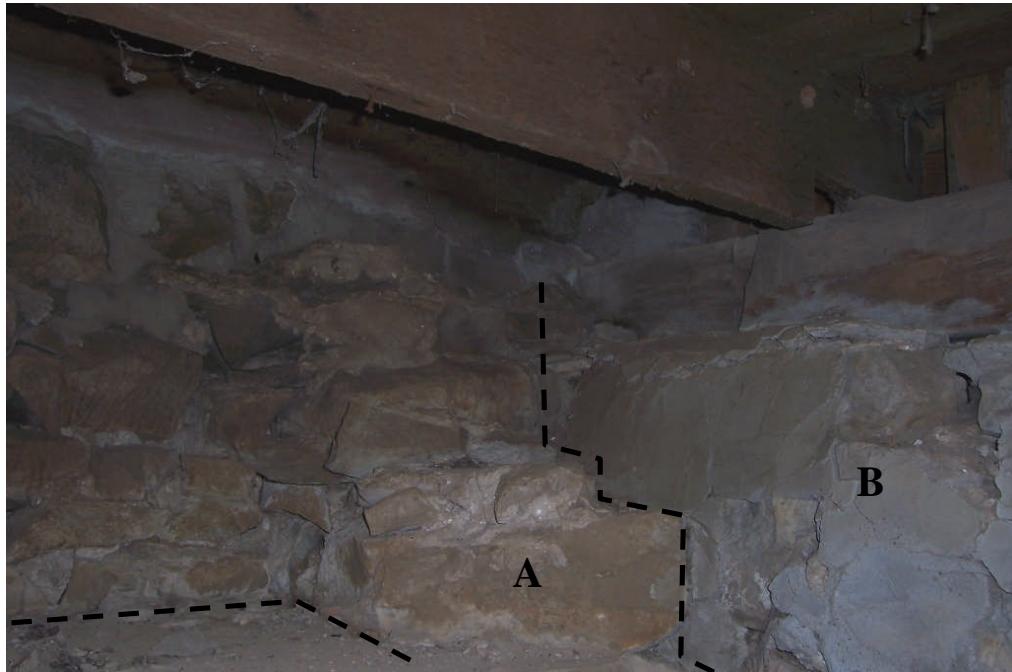
**Figure 105.** View of the southwest corner of Room 001 showing the remnant of the stone foundations associated with the original frame rear wing, which are marked here by the dashed lines and the “A”. When the west wall of the wing was pushed outward in the late nineteenth century, a new set of stone foundations (“B”) were built below the new wall.

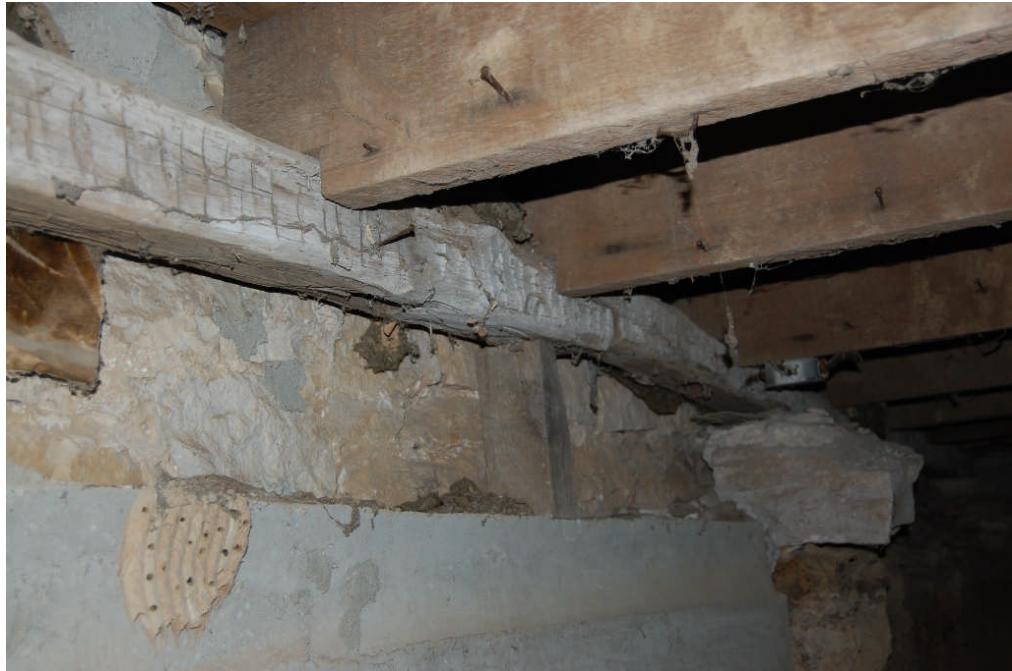
**Figure 106.** View of the sill plate on the east side of Room 001. The plate is hand-hewn oak and has mortises on its lower side, which suggests that it is reused stock salvaged from an unknown location. The existing joists are pine and were installed as part of the late-nineteenth-century rebuilding of the rear wing on the original house.
