**ARCHAEOLOGICAL SURVEY SHORT REPORT:  
NATIONAL REGISTER OF HISTORIC PLACES ASSESSMENT  
OF THE DAAB-ZOELLER FARM SITE,  
ST. CLAIR COUNTY, ILLINOIS**

Prepared by  
Christopher Stratton  
and  
Floyd Mansberger

Fever River Research, Inc.  
Springfield, Illinois

**Project Type/Title:** National Register of Historic Places assessment of the Daab-Zoeller Farm Site.

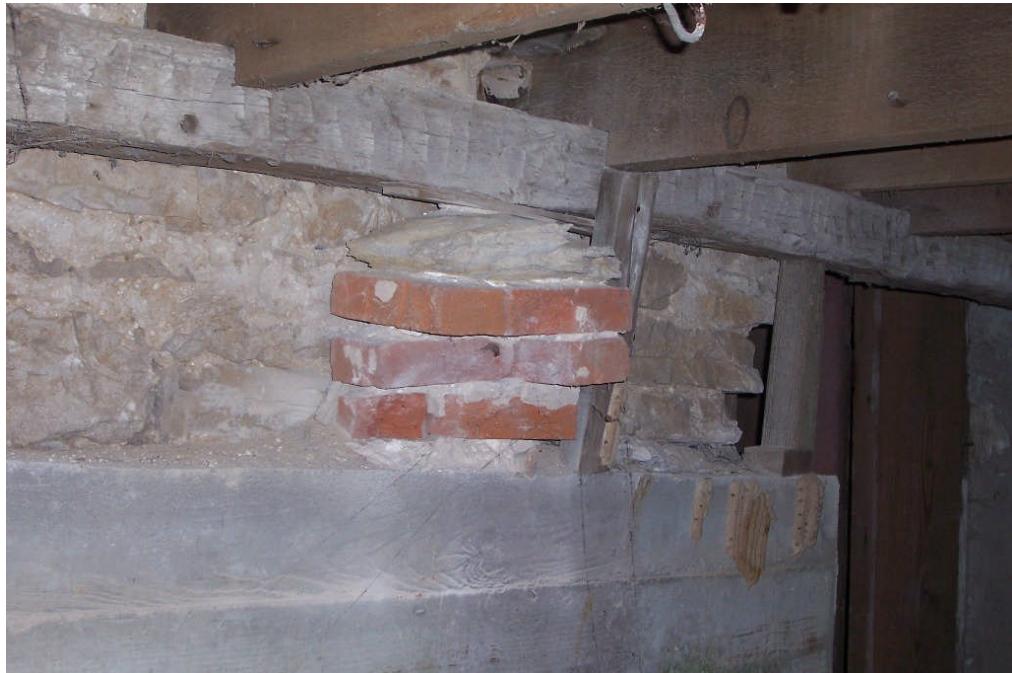
**Figure 107.** Another view of the eastern sill plate in Room 001, showing fragment of a brick pier retained after this basement room was excavated in the 1940s. Note new concrete wall below the pier.

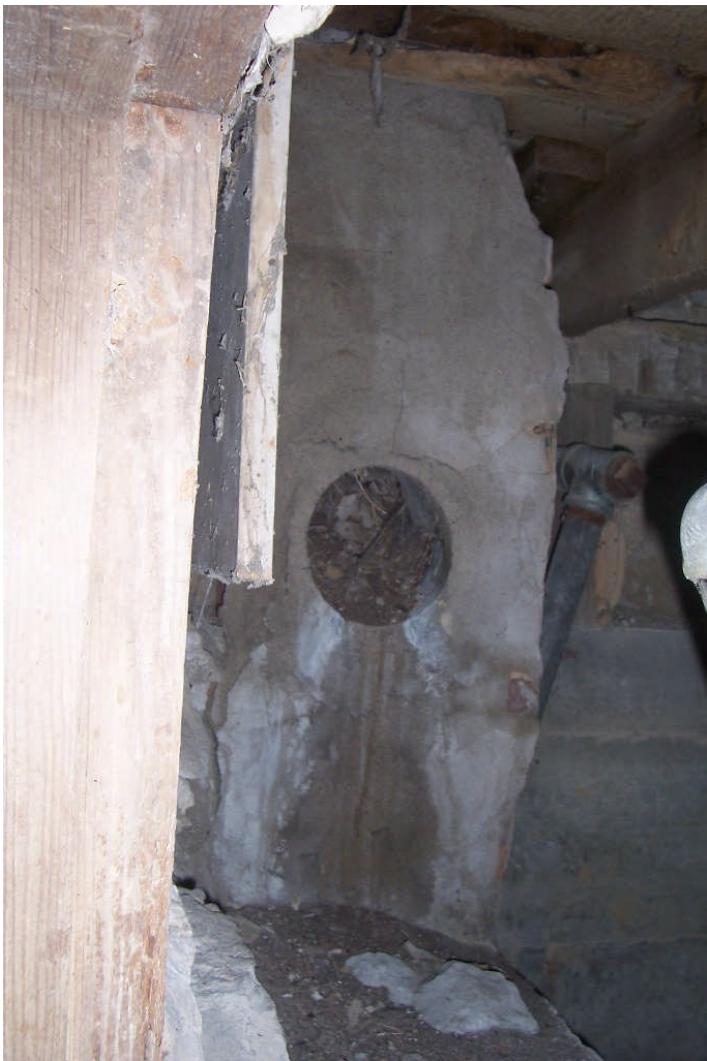
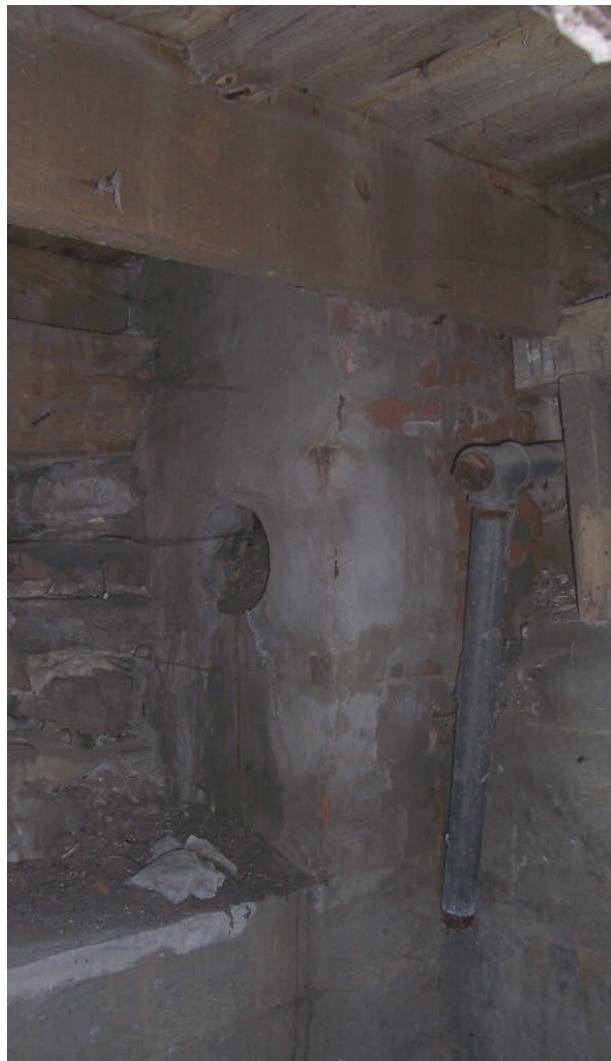
**Figure 108.** Two views of the brick chimney located in the northeast corner of Room 001. This is connected to the concrete-block chimney that presently rises through Room 101A—thereby suggesting that the latter is a replacement of an earlier brick stack. A stove vent is present in the north side of the chimney.

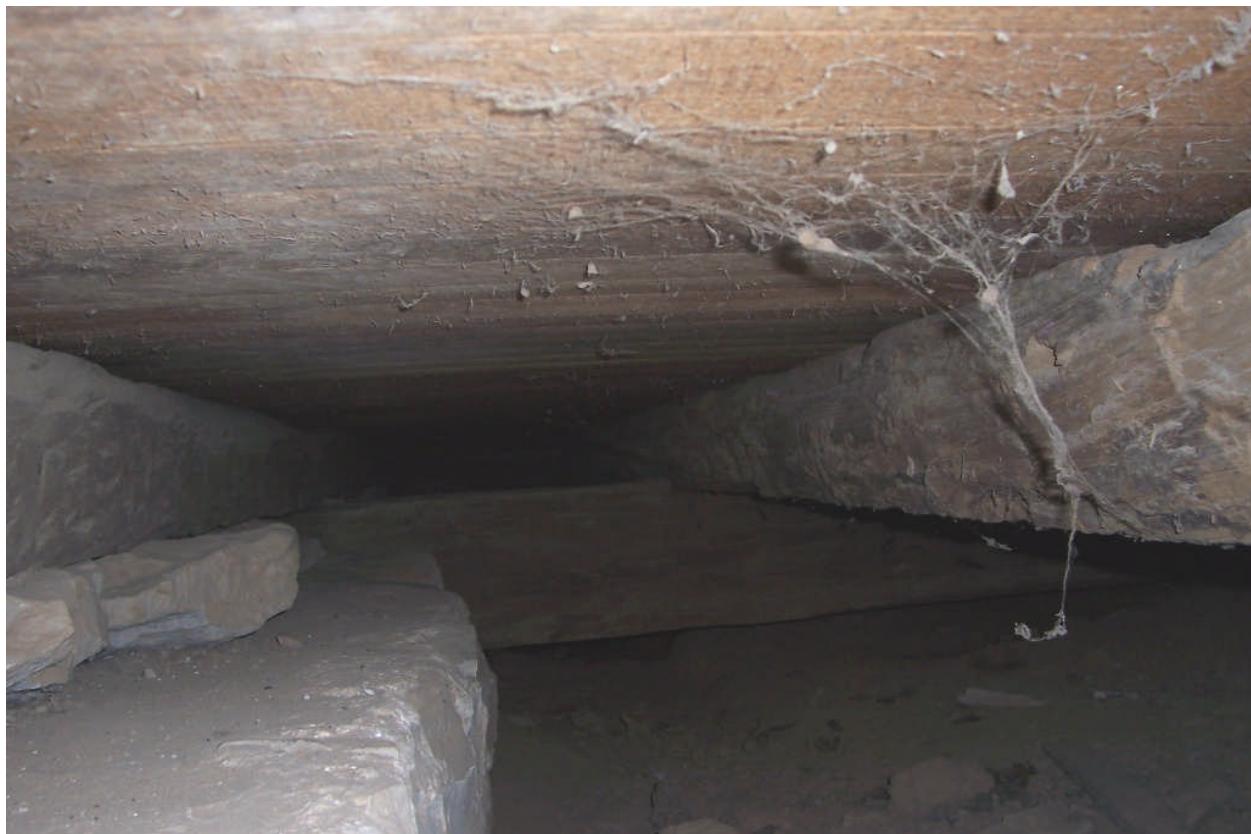
**Figure 109.** View of the crawlspace beneath Room 101. Here, as in adjacent Room 100, the flooring is supported by widely-spaced, hand-hewn oak joists that rest upon a summer beam. However, there is no insulating layer of straw and mud—an absence possibly explained by the fact that there is no cellar here.

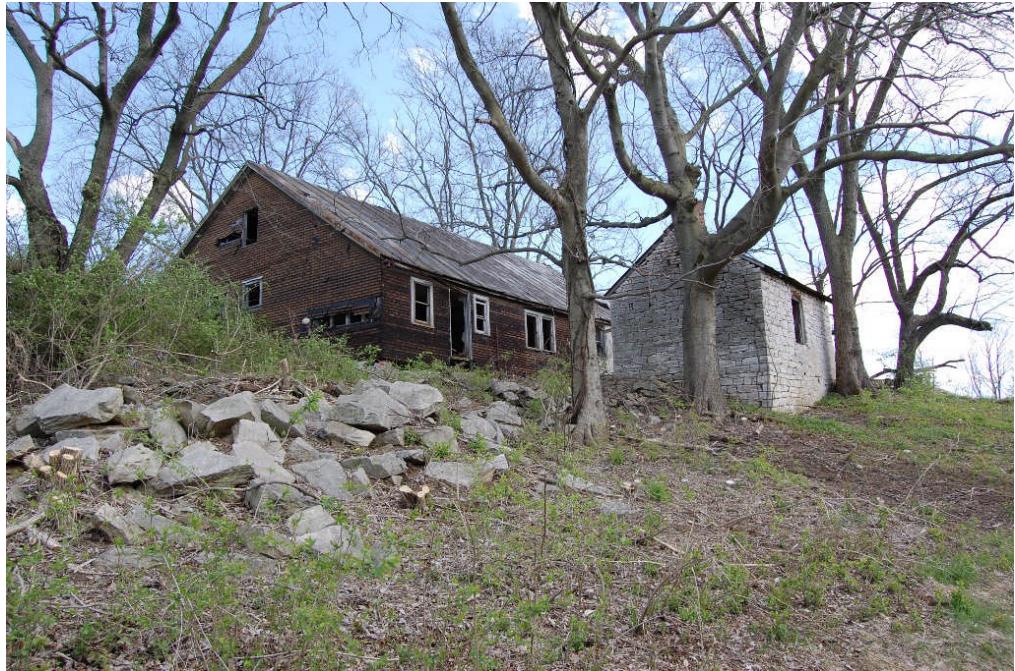
**Figure 110.** View of the yard to the northwest (and rear) and the Daab-Zoller House, showing the collapsed stone retaining wall here (in foreground) and stone summer kitchen beyond. The hillside is quite steep.

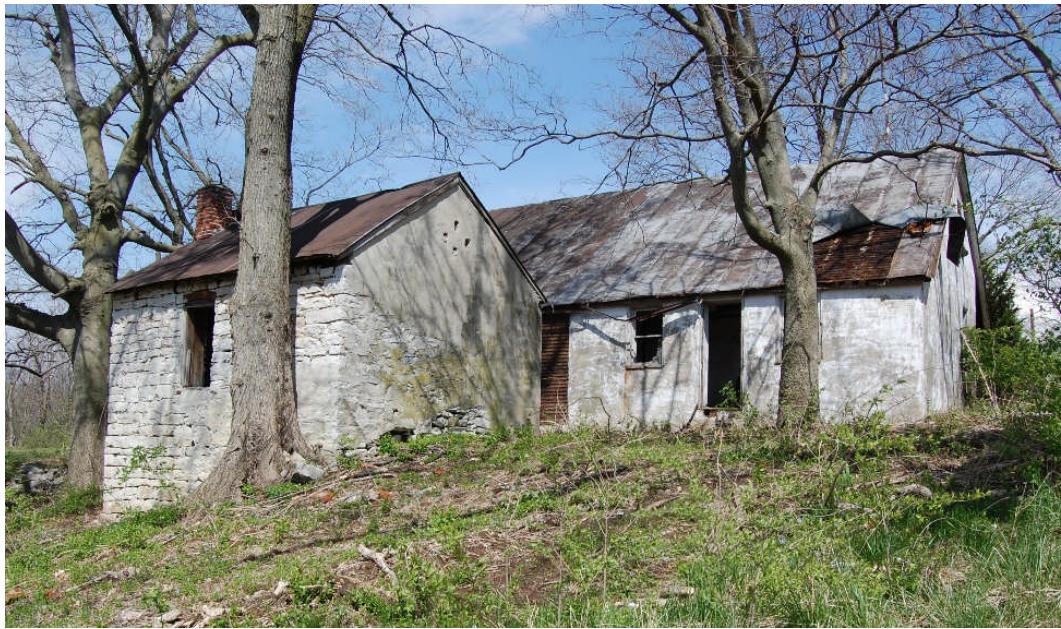
**Figure 111.** View of the rear (west) yard illustrating relationship of summer kitchen to the house. They lie only 12' apart from one another.

Summer Kitchen (Feature 2): A one-story, side-gabled stone summer kitchen is located directly to the rear of the house, being separated from the latter by only 12' (see Figures 111 through 121). The extreme closeness of the summer kitchen would have been of

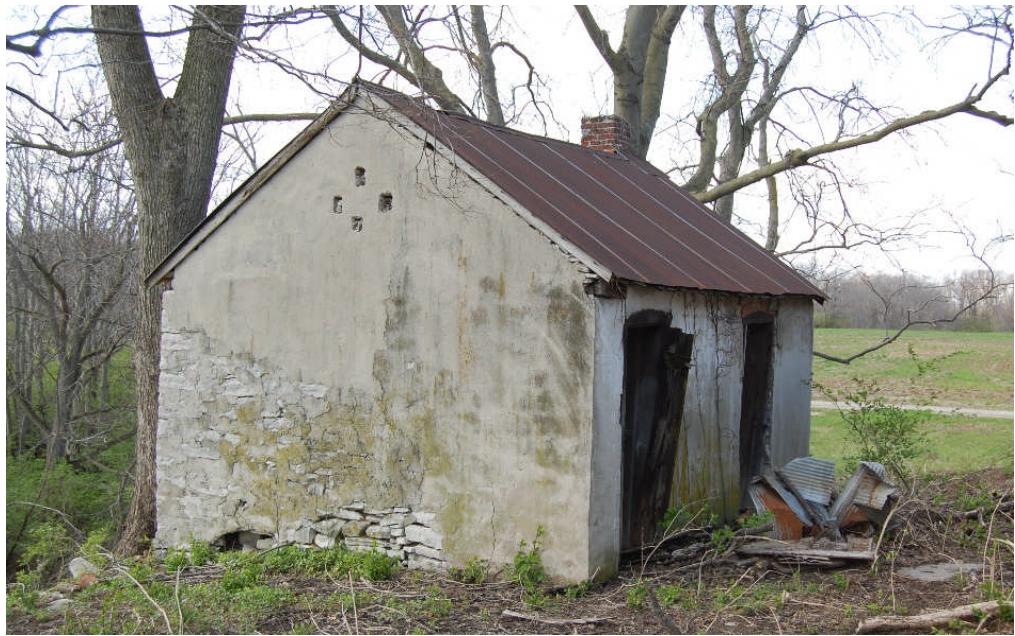
**Figure 112.** View of the summer kitchen looking northwest. The south and east elevations are shown. Note the vents in the gable end and plastered exterior. On its interior, the building is divided into rooms: a smokehouse and a washroom.

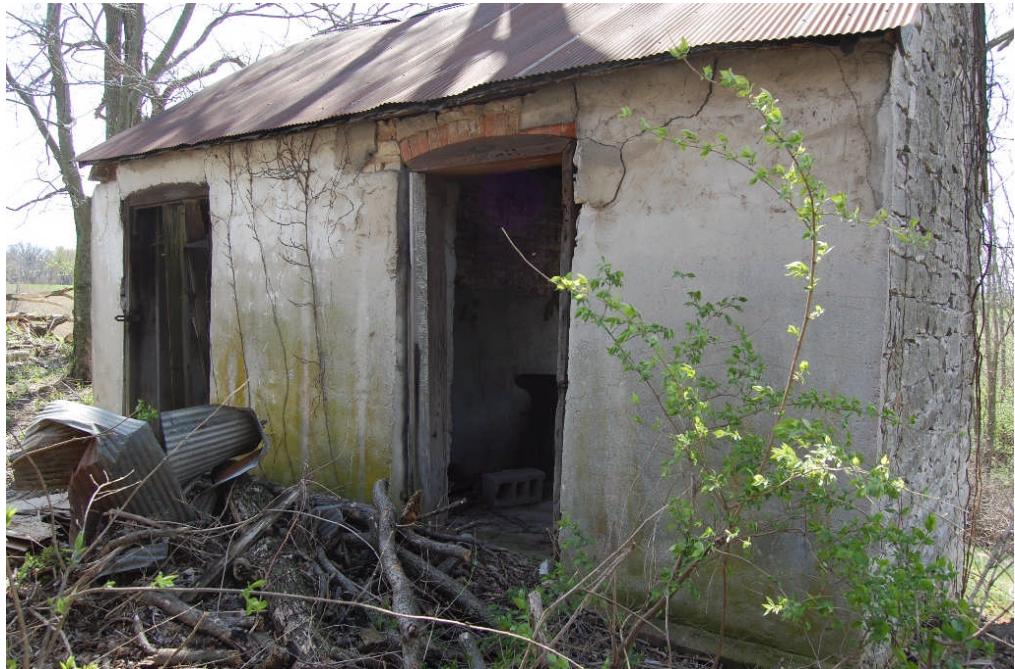
**Figure 113.** East elevation of the summer kitchen, which faces towards the house. The door at left opens into the smokehouse, while that at right accesses the washroom, which is the larger of the two rooms. The debris piled in between the doorways obscures the opening to a brick-lined cistern.

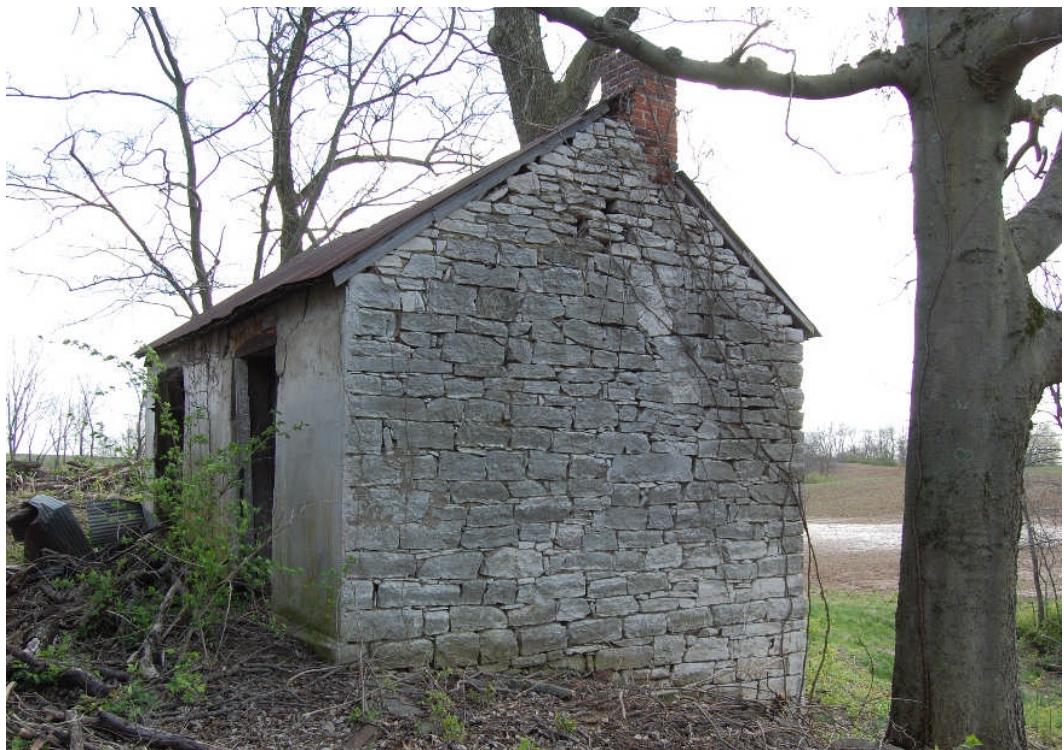
**Figure 114.** North elevation of the summer kitchen, looking southwest.

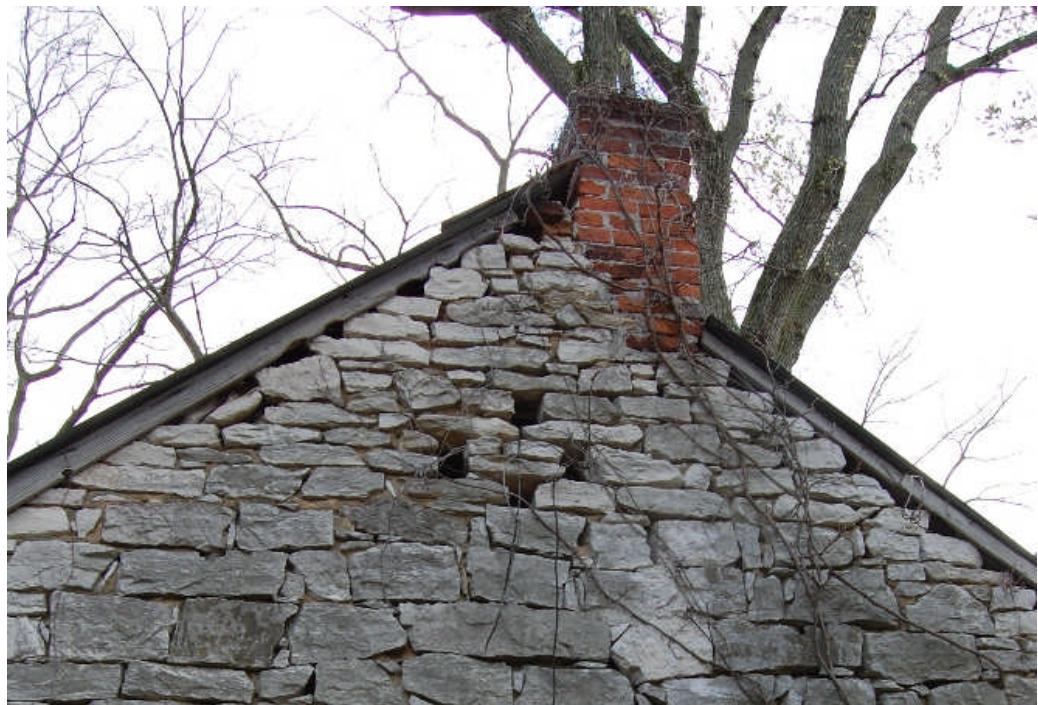
**Figure 115.** Detail of the north gable of the summer kitchen showing attic vents (arranged in a diamond pattern) and the brick chimney stack present here. The chimney vented a stove in the washroom.

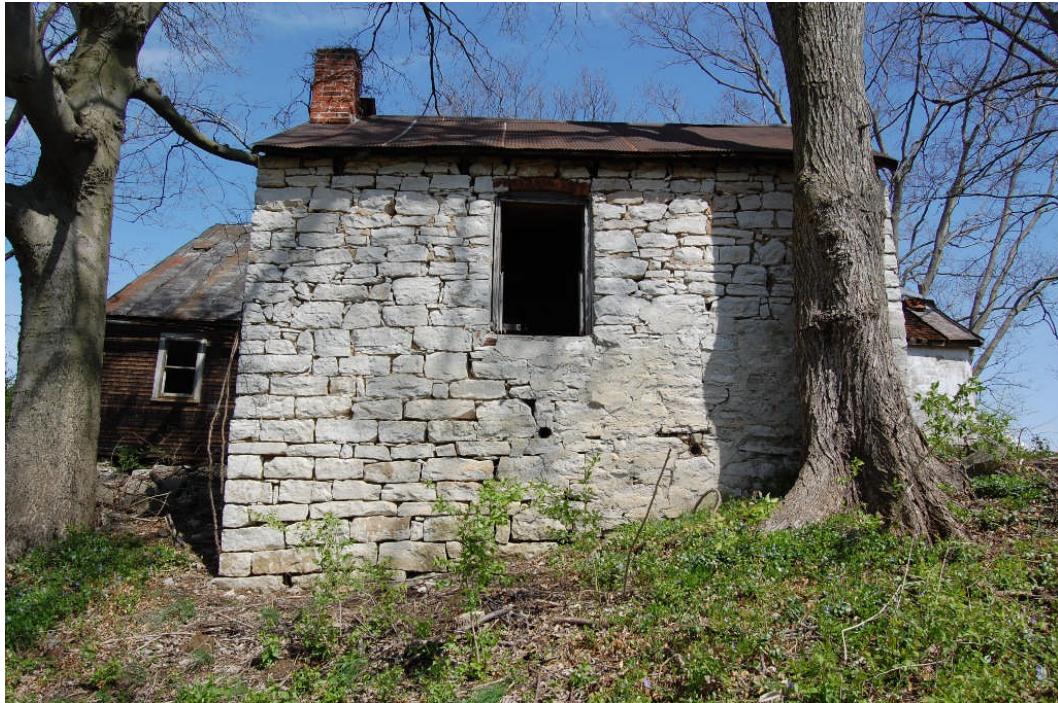
**Figure 116.** West elevation of the summer kitchen. The window shown is the only one in the building and illuminates the washroom.

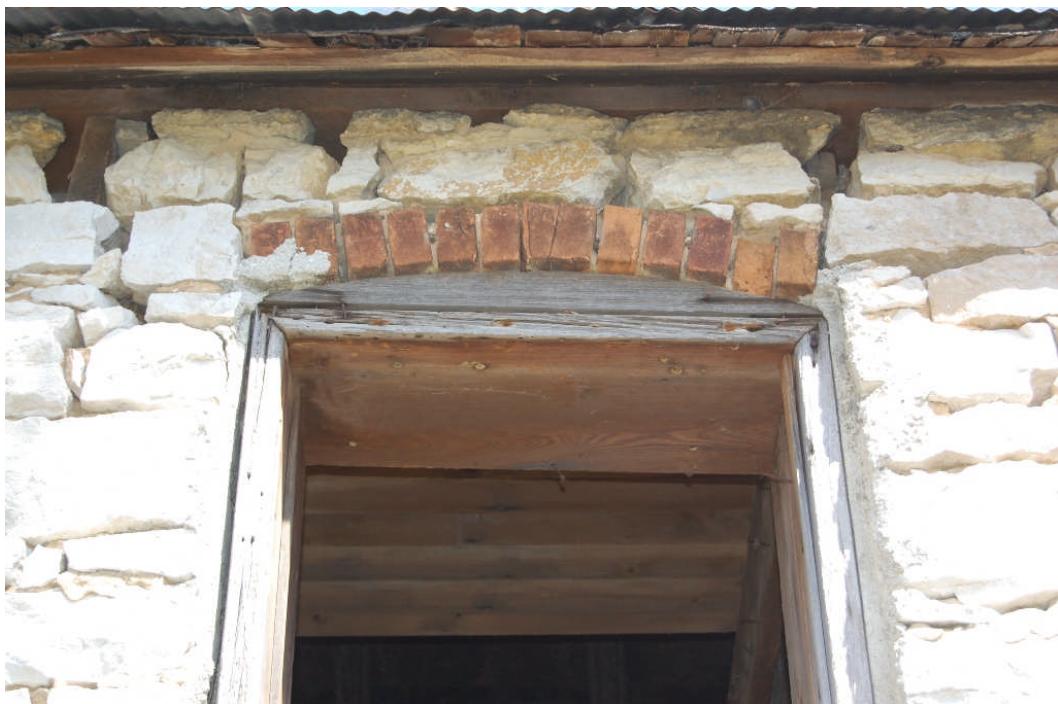
**Figure 117.** Detail of the window opening in the summer kitchen. Bricks were used to form the segmental arched opening, being arranged in a single rowlock.

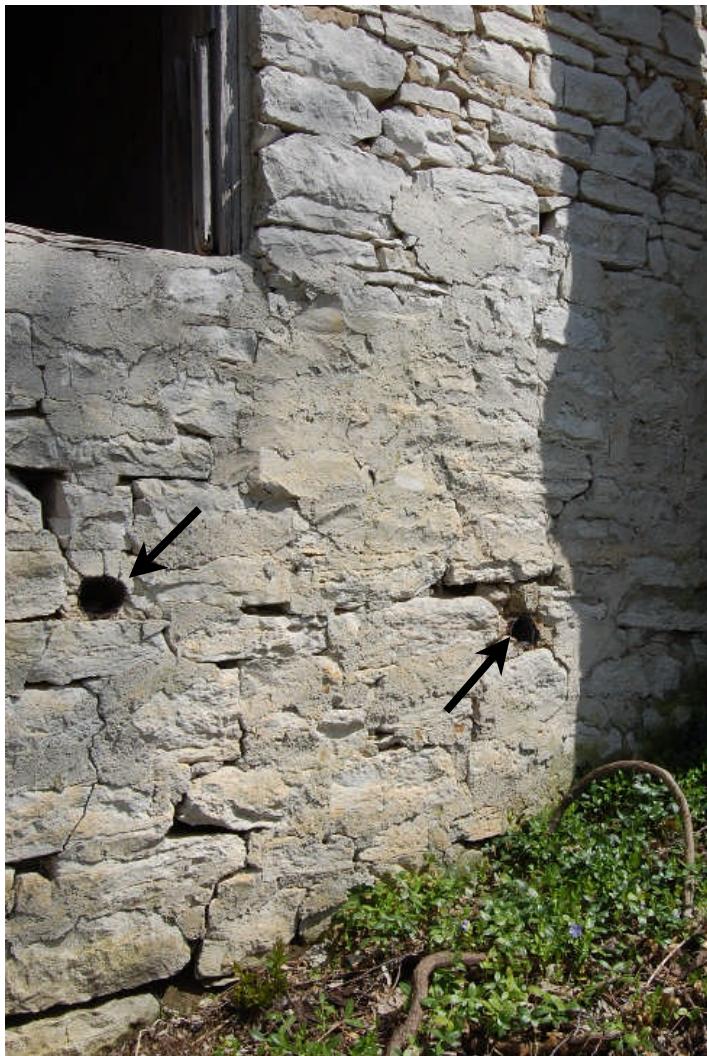
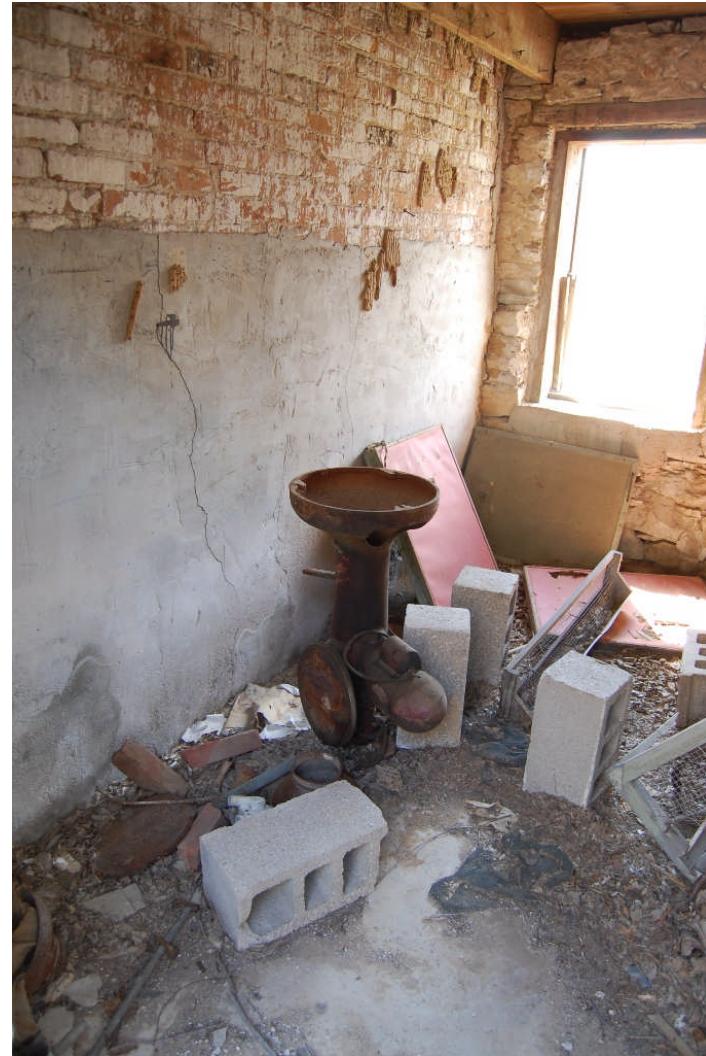
**Figure 118.** (LEFT) Detail of the west elevation of the summer kitchen showing the two drain pipes here (marked by arrows). Each pipe is connected to a floor drain in the two rooms on the interior. (RIGHT) Interior view of the washroom looking west. The machine shown is a cream separator. The brick wall separates the washroom from the adjacent smokehouse. This wall has been whitewashed in the past and later had been its lower half paged with concrete.

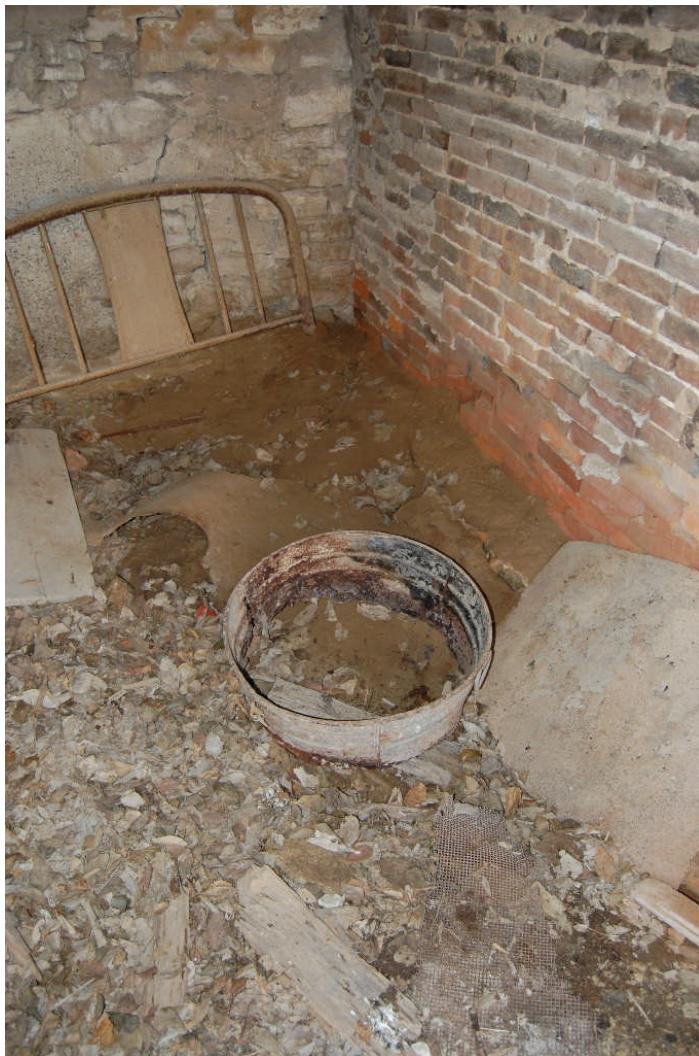
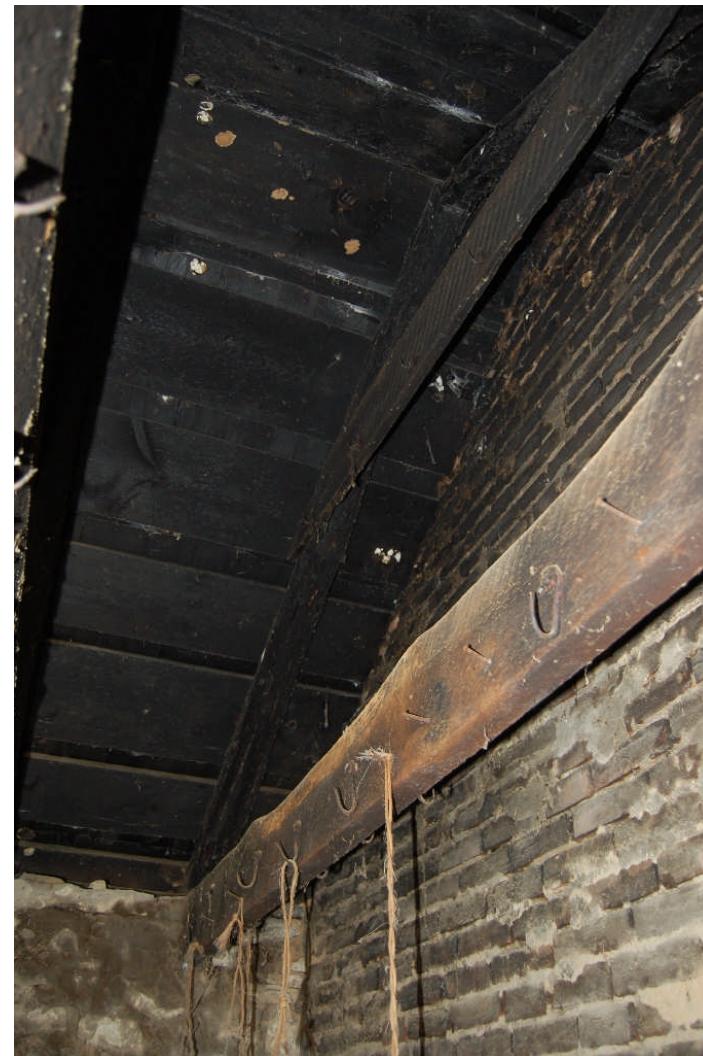
Figure 119. Interior views of the smokehouse room in the summer kitchen. (LEFT) In contrast the washroom, the smokehouse has a dirt floor. The steel tub shown appears to have been used to contain the smoldering fire used to cure the meat hung in the room. (RIGHT) The ceiling of the smokehouse was left open to the rafters and is blackened from years of smoking. Meat was hung from hooks and nails attached to the ceiling joists.

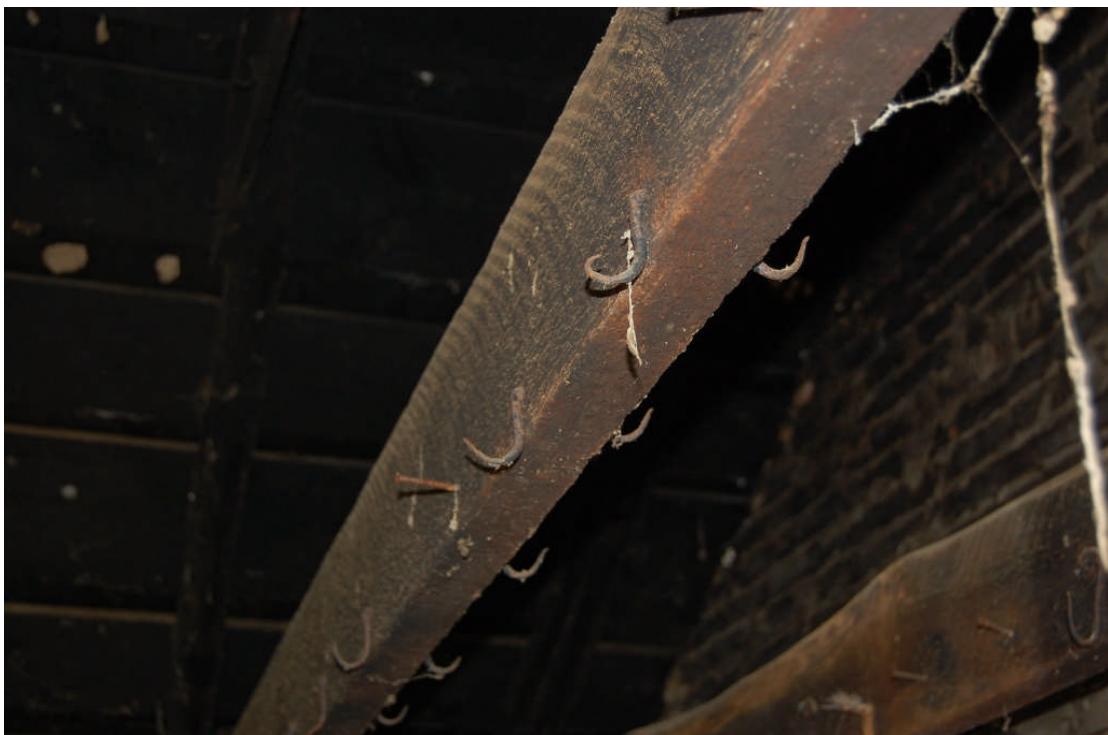
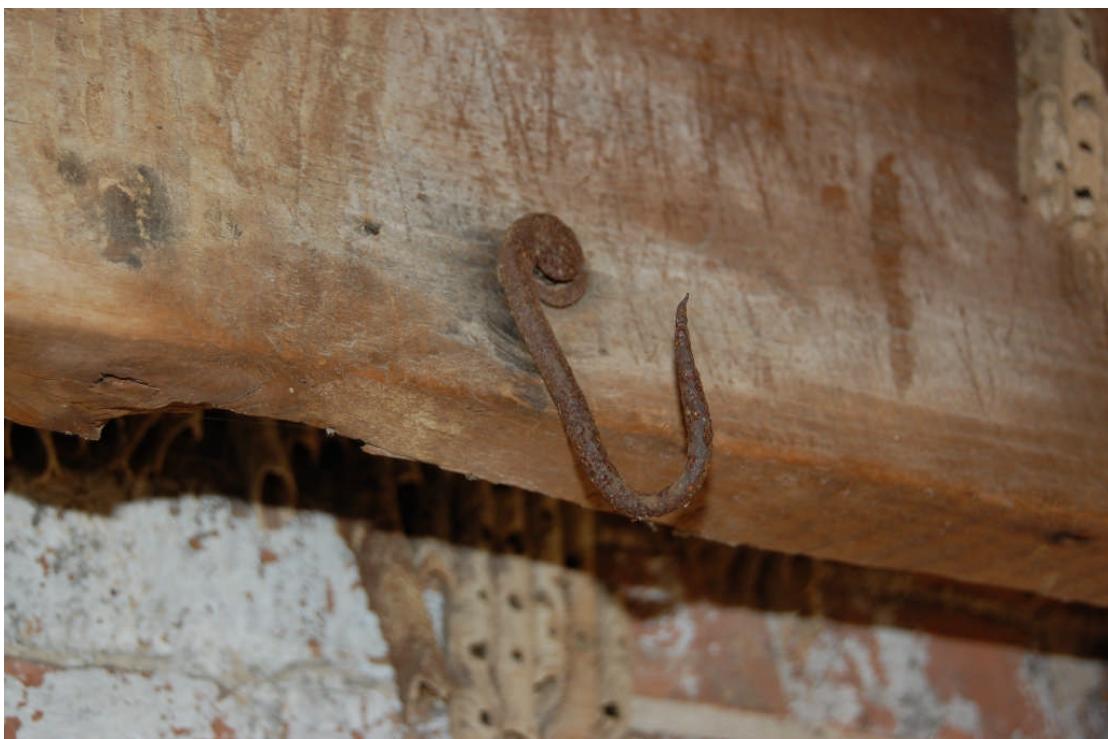
**Figure 120. Details of the hooks and nails from which meat was hung in the smokehouse.**

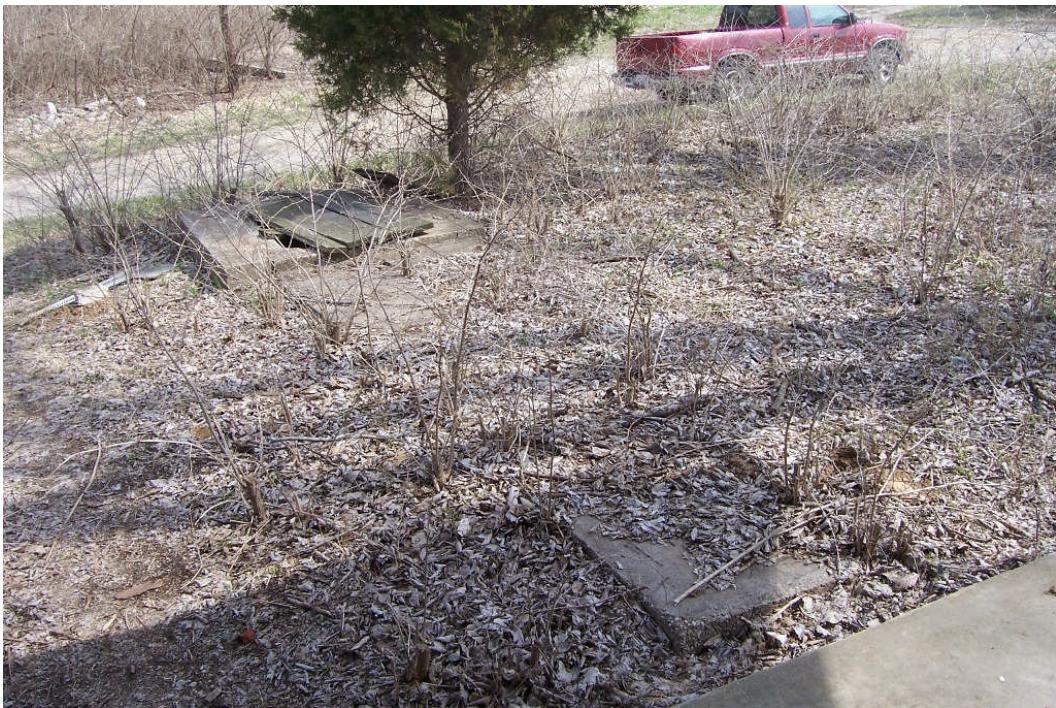
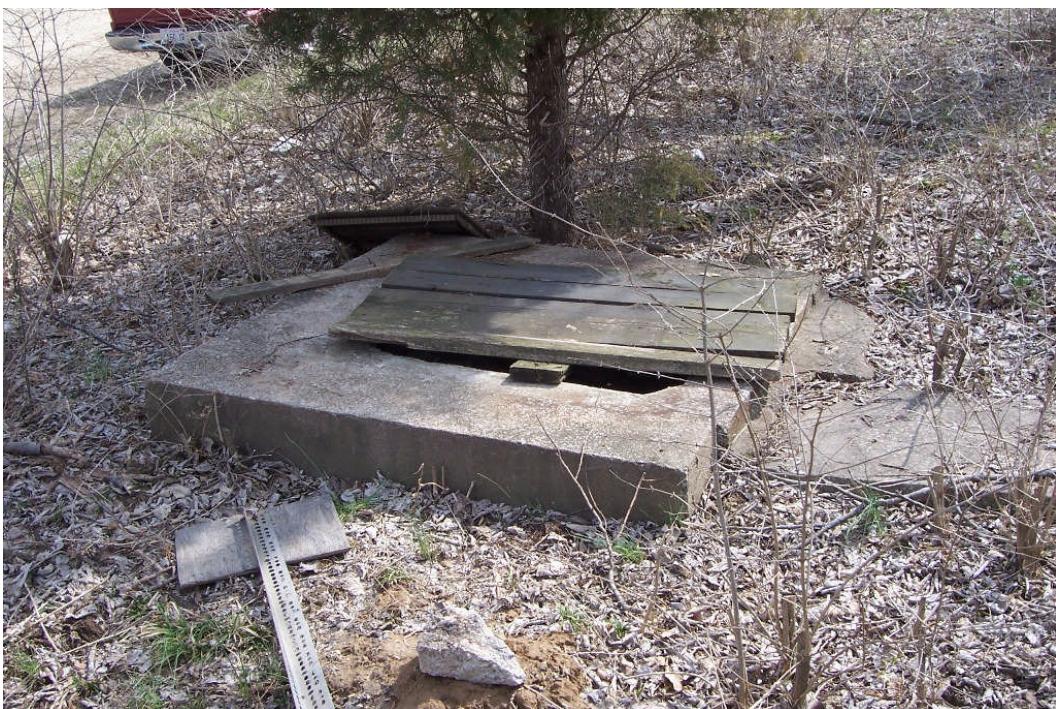
**Figure 121.** Two views illustrating the location and surface character of the early well shaft at the farmstead. The well is located in the front (east) yard of the house and is connected to the southern front porch by a concrete sidewalk. The well opening has a concrete pavement poured around it, but the shaft itself is lined with stone. A frame well house formerly was located above it.

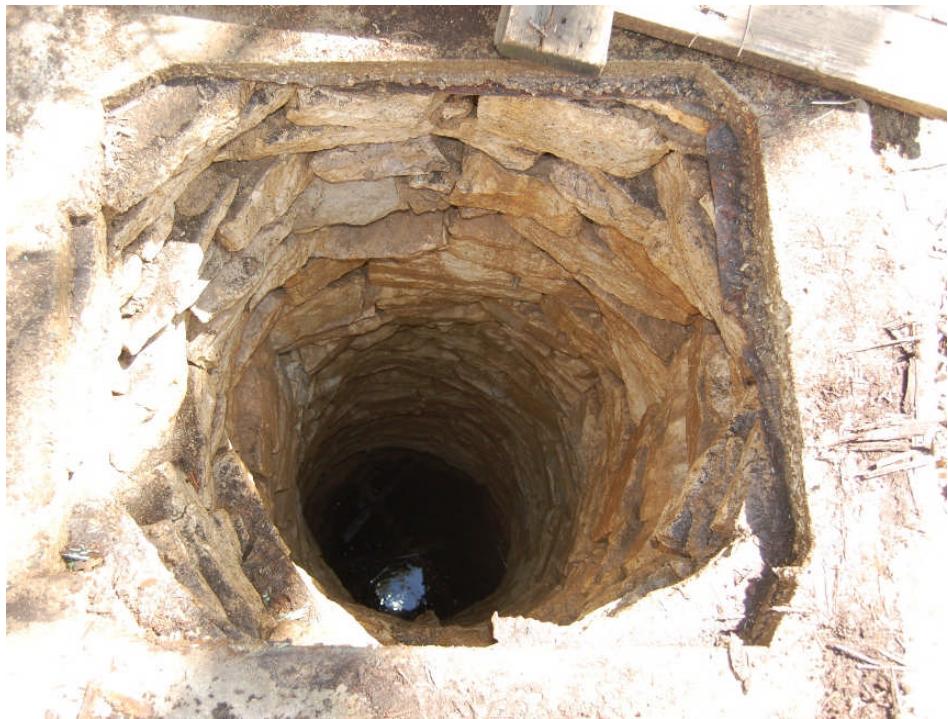
**Figure 122.** View looking down the stone-lined well shaft. The water level lies approximately 27' below grade.

A well and two cisterns are located in the yard area surrounding the house. The well (Feature 4) has a stone-lined shaft with an interior diameter of 3' (see Figures 122 and 123). The well is fairly deep; a measurement taken in the spring of 2009 found the water surface 27' below grade, with the shaft continuing at least 10' beyond that for a total depth of 37' approximately. A concrete curb has been poured around the top of the well. By the middle twentieth century, a frame well house had been constructed over the well by the Zoeller (see Figure 19). The well house is no longer present. The Zoeller siblings remember the well as always having cold, good-tasting water—so much so that their father often would return to the farm after retiring just to fill jugs of water from it to take home. The Zoellers also used the well shaft for storing their milk prior to artificial refrigeration being available in the farm. The water was always hand drawn; a pump was never installed on it.

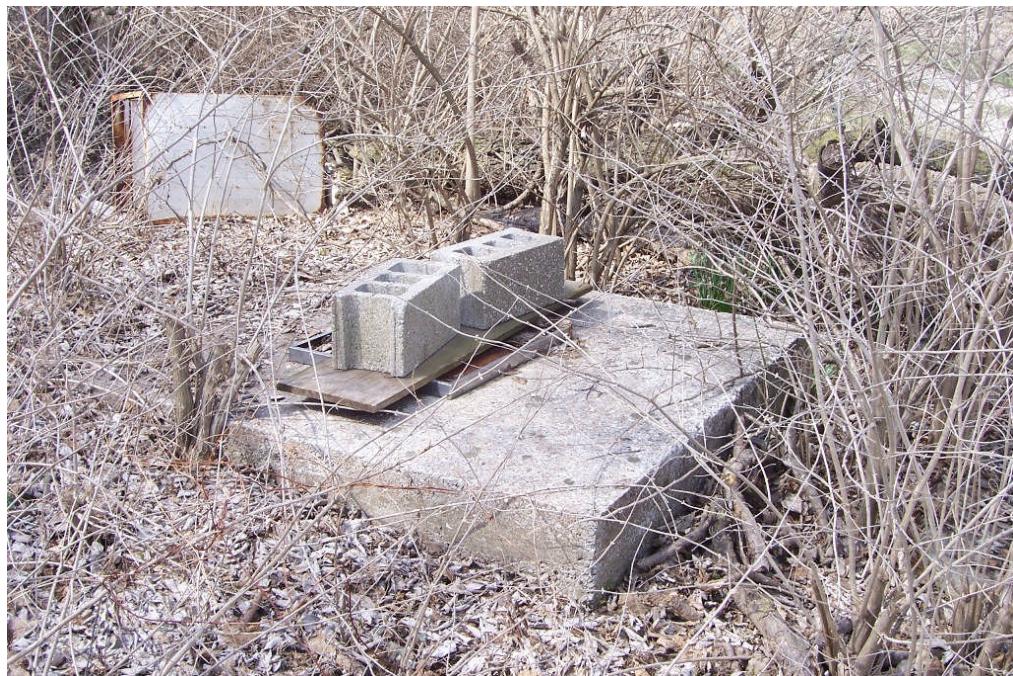
**Figure 123.** View of the concrete-lined cistern located off the northeast corner of the house.

A large concrete-lined cistern (Feature 5) is located on the north end of the front yard (see Figure 124). It is capped with a concrete pad measuring 4'-11"x5'-2." The pump formerly located here has been removed. The interior diameter and depth of the cistern was not determined. Of the two cisterns on the property, this was the one the Zoellers primarily used in the middle twentieth century. However, it saw little use towards the end of their occupancy. Like the well, it was never equipped with a pump, and therefore any water from it had to be carried into the house. The cistern is suspected to date to the early twentieth century.

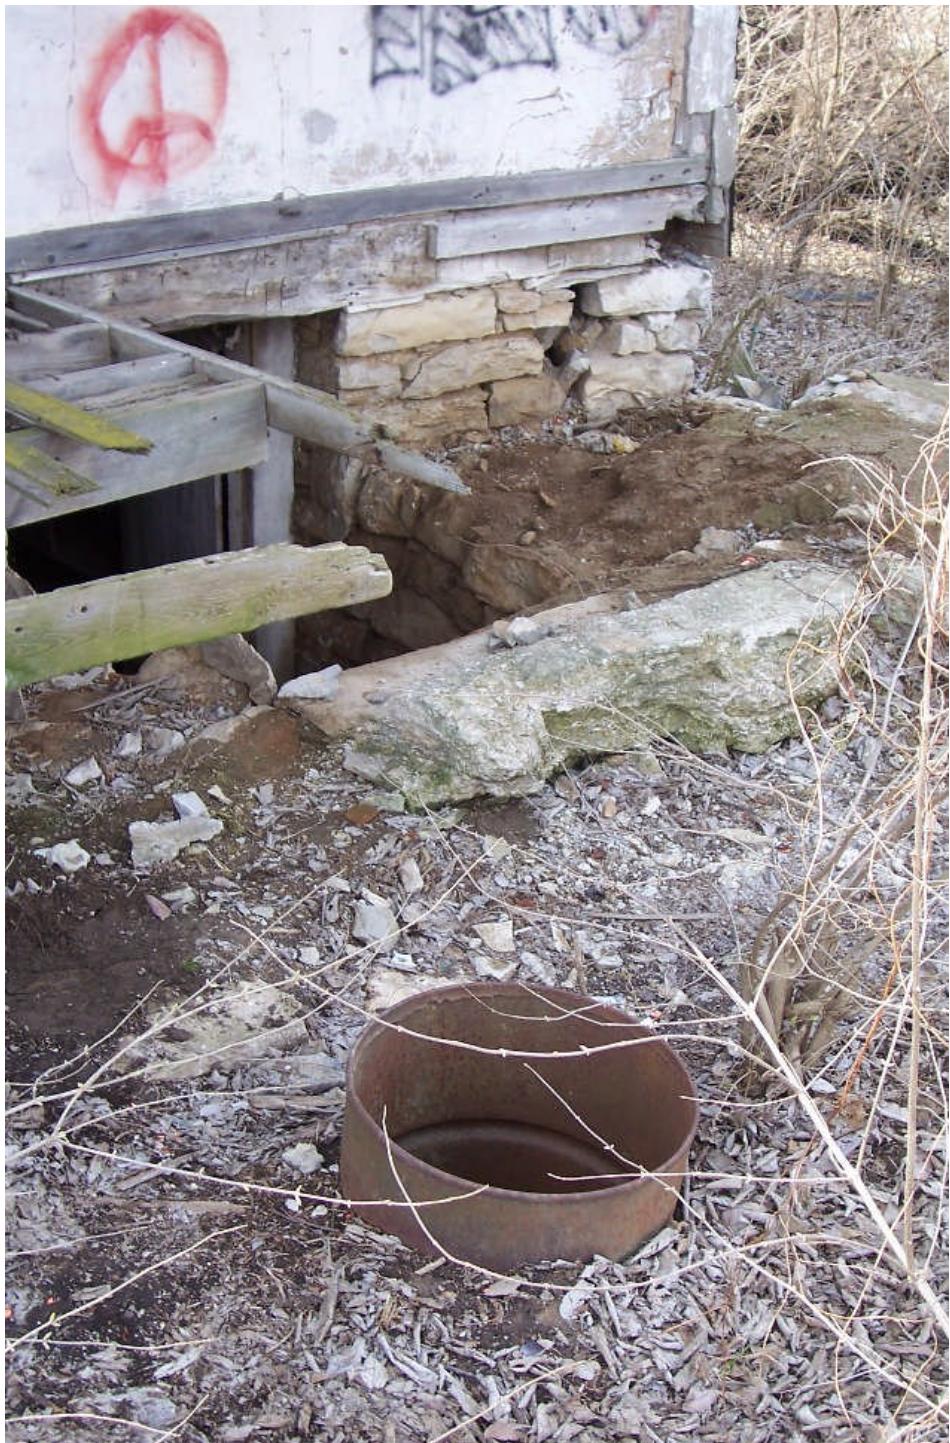
**Figure 124.** The farmstead also had an outdoor drinking fountain in its front yard during the middle twentieth century. The supply pipe for the drinking fountain ran up through the steel drum shown in the image above.

Feature 6 is a 2'-diameter steel barrel partially buried in the front yard of the house (see Figure 125). This was associated with a “water fountain” (drinking fountain) and was intended to keep the water line for the fountain freezing during the winter. The Zoellers would pack the barrel with straw and wrap rags around the section of exposed piping above it. The water line had a shutoff valve could be turned off if it got real cold out. The water was pumped from the well “down below” the house, which was sunk circa 1940.

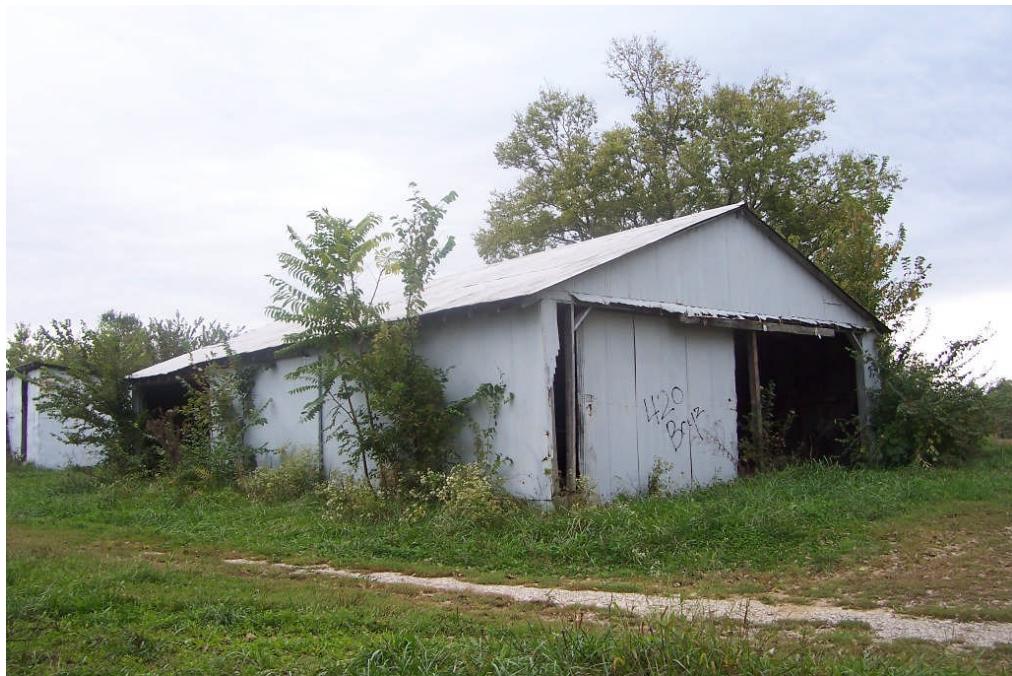
**Figure 125.** View of the middle-twentieth-century-era machine shed located at the farmstead, which is located south of the house. It is a pole building.

A modern machine-shed (Feature 15; see Figure 126) is located to the south of the house. The machine-shed is front-gabled, frame building with metal siding and measures 30'x50'. Large vehicle doors are located in its north and east sides. The building has concrete perimeter foundations but has a dirt floor. The current farm tenant uses the building for storing agricultural equipment. Jim Zoeller believes the shed was built in the early 1950s (or “certainly after the war...because tin wasn’t available then”). The old horse barn was torn down make way for its construction.

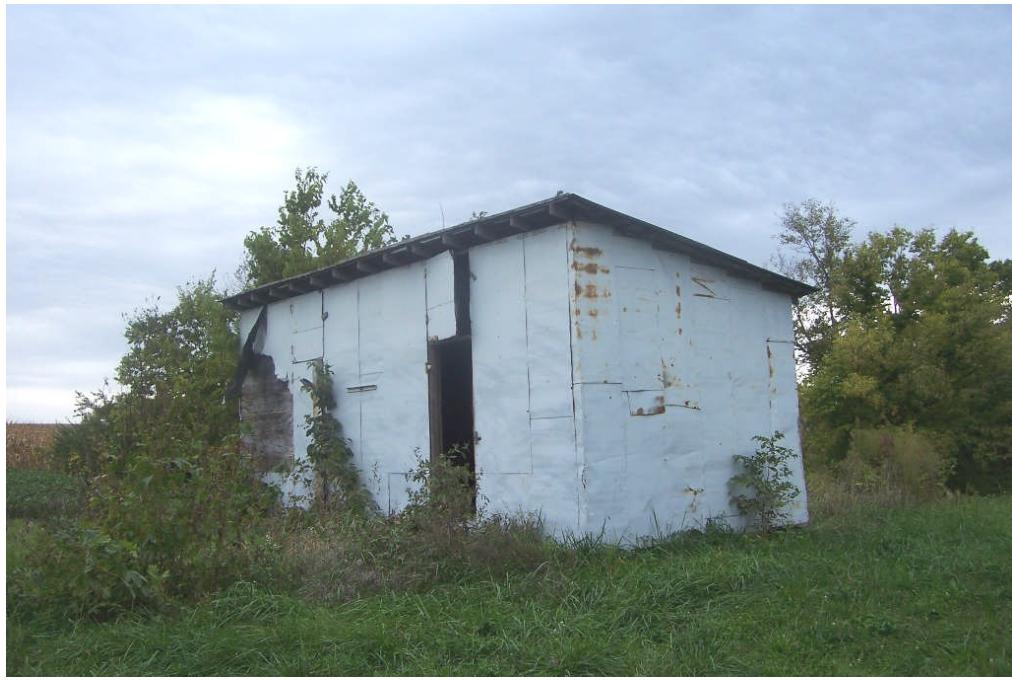
**Figure 126.** View of the granary on the southern end of the farmstead. This structure is of frame construction, has corrugated-steel siding, and dates to the middle twentieth century.

Lying to the south of the machine shed is a granary (Feasture 16; see Figure 127). It is a shed-roofed, frame building measuring 12'-3"x24'-3". It has two doorways in its east side but has a single room on the interior. The granary was constructed post 1950.

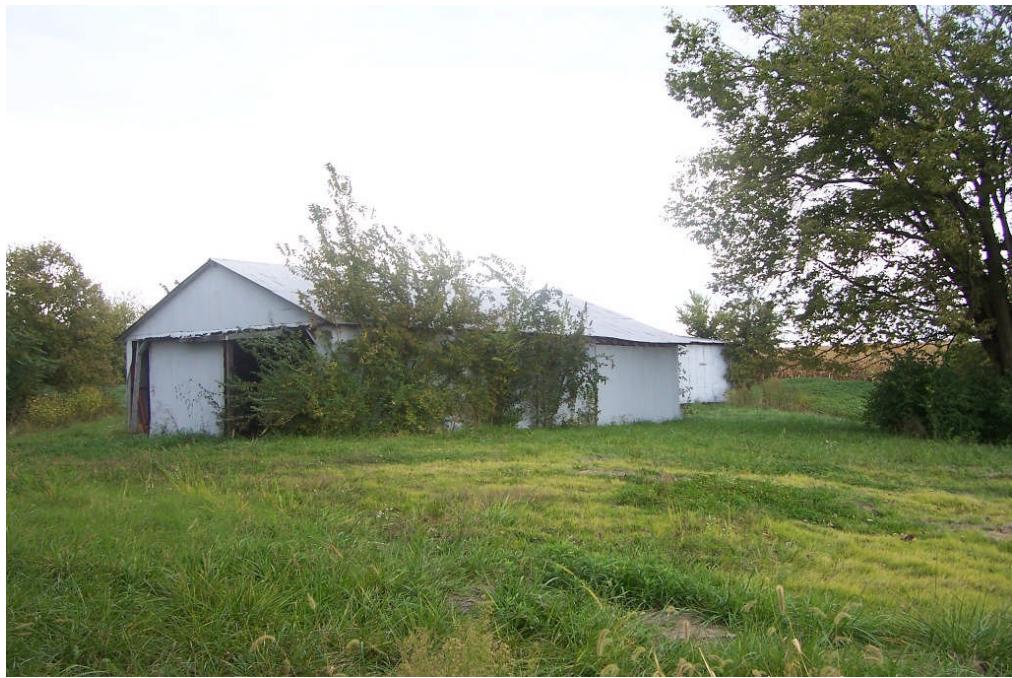
**Figure 127.** View of the yard on the west side of machine shed (and south of the house), which formerly was utilized as garden space by the Zoeller family.

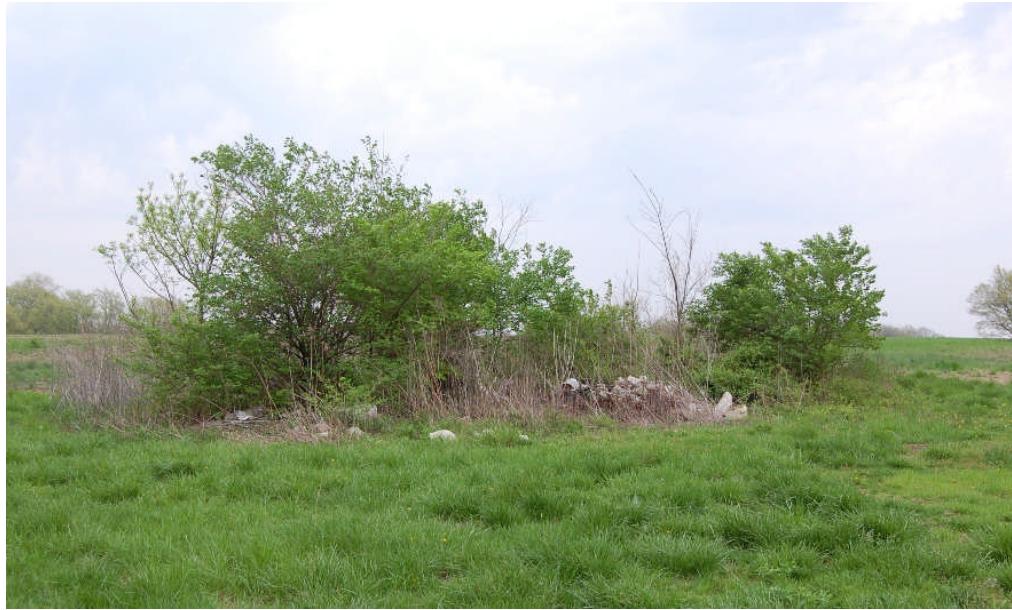
**Figure 128.** The clump of trees and brush in the center of this view marks the former location of the cow barn at the farmstead. The barn site lies directly east of the extant granary.
