**ARCHAEOLOGICAL SURVEY SHORT REPORT:  
NATIONAL REGISTER OF HISTORIC PLACES ASSESSMENT  
OF THE DAAB-ZOELLER FARM SITE,  
ST. CLAIR COUNTY, ILLINOIS**

Prepared by  
Christopher Stratton  
and  
Floyd Mansberger

Fever River Research, Inc.  
Springfield, Illinois

**Project Type/Title:** National Register of Historic Places assessment of the Daab-Zoeller Farm Site.

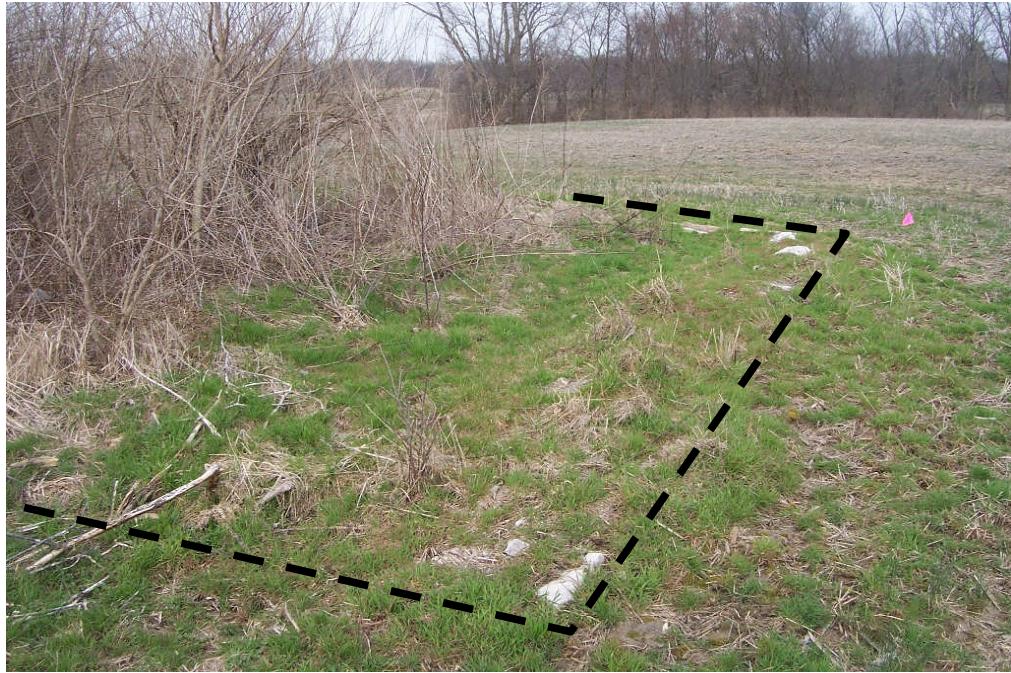
**Figure 129.** South end of the cow barn foundations. The dashed lines indicate the outer limits of the stone foundations, which have been reduced to grade here. Stone is visible at the corners.

The stone perimeter foundations associated with the cow barn (Feature 13) are located on the southern end of the site, on the east side of the farm lane (see Figures 129 through 131). The foundations are built of local limestone and measure 16" to 18" thick. In respect to overall dimensions, the barn measured approximately 26'x52'. On its interior, the barn appears to have been divided into three bays, each measuring roughly 18' wide. The one historic photograph we have of the barn (Figure 12) suggests that the central bay had a floored walkway (also substantiated by the foundation remains) whereas the two outer bays were not floored and had large doorways in their west end—or at least had them by the time this photograph was taken circa 1940. The Zoellers typically kept around eight to twelve cows on the farm during this period.

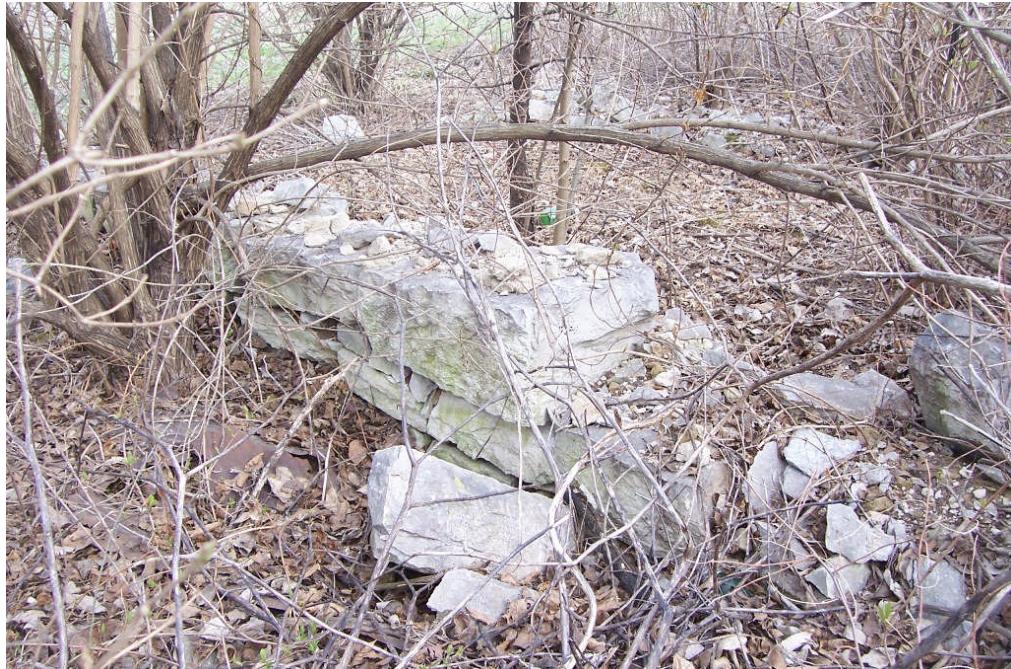
**Figure 130.** The interior foundations of the cow barn are somewhat more extant, as illustrated by the image above.

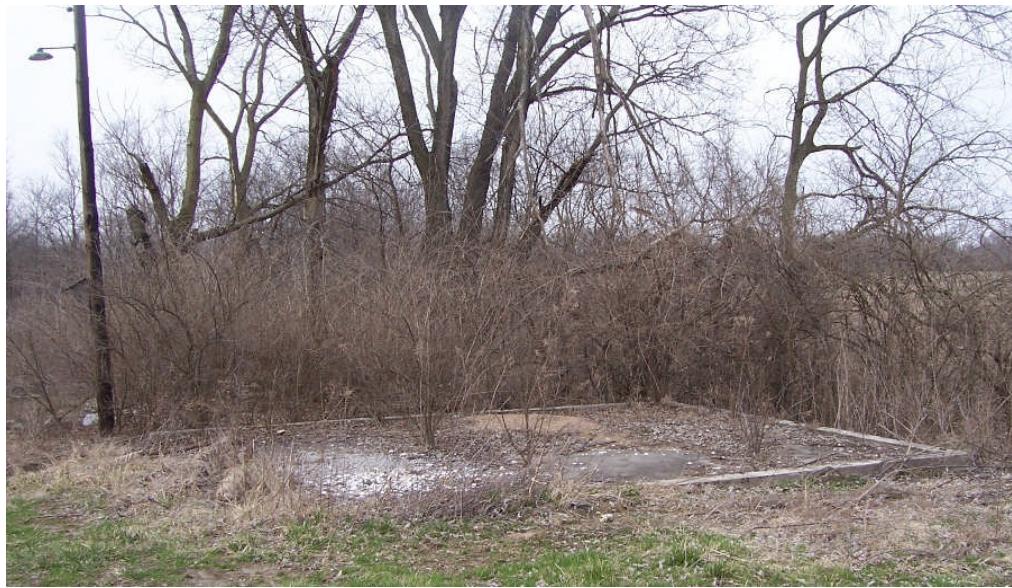
**Figure 131.** View of the foundation remains of the garage at the farmstead, looking north. During the 1940s and 1950s, the Zoellers used the garage for processing turkeys sold throughout the Thanksgiving and Christmas seasons.

A frame garage formerly was located southeast of the house, on the opposite side of the driveway. All that remains of it are the concrete perimeter foundations and interior pad (Feature 14; see Figure 132). The outer dimensions of the foundations measure 20'x24'. The Zoellers utilized the garage for processing turkeys in November and December.

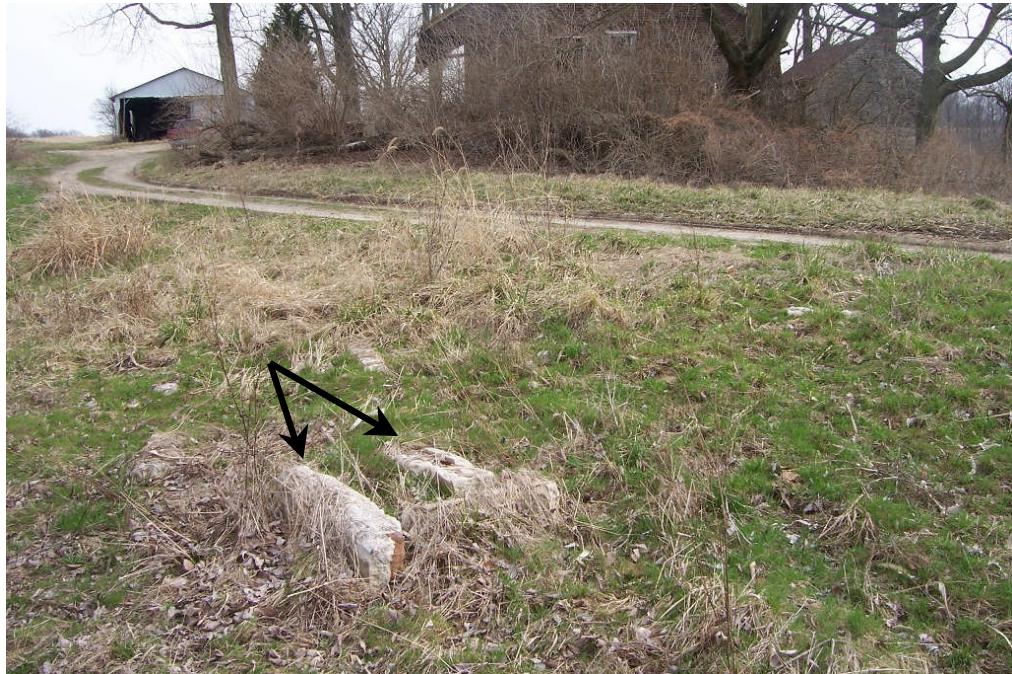
**Figure 132.** Little remains of the chicken house once present on the north end of the farmstead other a few scattered concrete foundation remnants. The image above shows some of the foundations (marked with arrows) and their relationship to the rest of the farmstead.
