City of DeKalb

Downtown Architectural

And Historical Survey

Final Report with Addendum

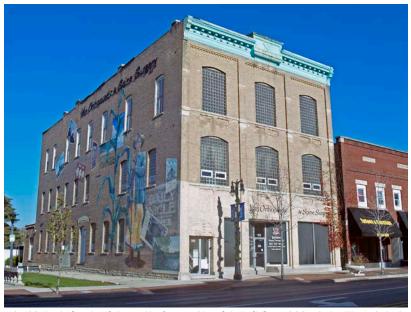
119-123 East Lincoln Highway, the former Chronicle Building, 1889, photo: The Lakota Group

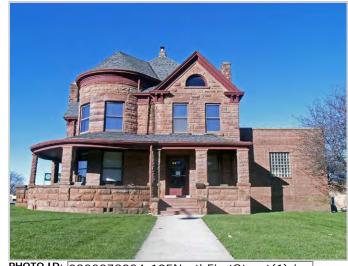
PHOTO ID: 0822278034-105NorthFirstStreet(1).jpg

A two-and-half story masonry Queen Anne house in cross-gabled roof form with a distinctive two-story round tower bay canted to the left of the main entrance on its east elevation; the tower bay sits above the pedimented gable bay that incorporates the main entrance on the first floor. The first floor also includes a wrap-around porch that extends to the south elevation. A two-story gable-ell extension is also featured on teh north elevation where the one-story addition is connected. During the 1980s and 90s, the house has been rehabilitated by the Elks Club, including its roof and wrought iron fence.

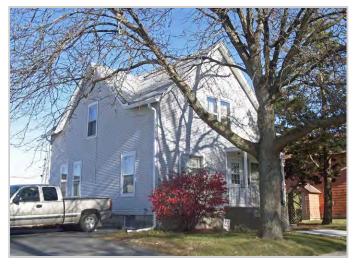
0822428003-115FranklinStreet(2).jpg

Exterior elevations re-sided in vinyl; Windows replaced; porch has been replaced n south elevation; secondary entrance added on east elevation; soffits have been replaced.

A simple Queen Anne house characterized with gables on west, south and east elevations; a main entry porch is located to the east side of the south elevation. A paired window defines the south elevation gable while single windows define the other gable elevations; a larger picture window with transom is placed in the first floor west of the main entry. This house has been re-sided with vinyl on all elevations and is therefore considered non-contributing.

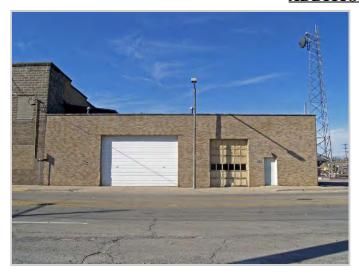
0823327004-117NorthSeventhStreet(3).jpg

The east elevation features stone roof line coping with two garage doors, one larger than the other; one appears to date to the 1920s, the other recently replaced. A service entry door is also located on the east elevation. Building elevations appear to have been recently refaced with new brick. The north elevation features a stepped parapet with clay coping and two small square windows and a loading door. This building has undergone a series of additions and alterations over the decades.

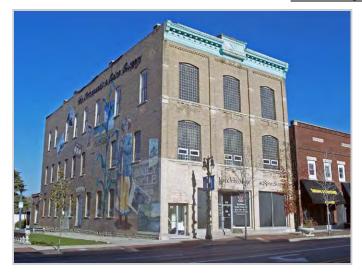
An Italianate-styled two-part commercial building with elaborate copper-cornice and a south elevation divided by four piers into three vertical bays. The upper floors consist of three large arched window openings within each bay; each window opening arch has a soldier course arch header, the second and third floors are defined by a stone string course. The storefront level has most likely been modified and infilled from its original configuration. Windows openings on both the east and west elevations have been infilled; wall murals have been painted on teh west elevation.

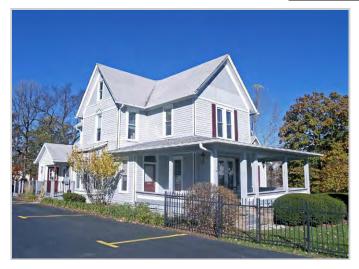
0822278014-125NorthFirstStreet(2).jpg

DATE SOURCE		CONTRIBUTING/NON-CONTRIBUTING Contributing BUILDING DESCRIPTION
	O Architectural and Historical Survey	A two-story Queen Anne style house converted to office use. It has a T plan
WALL MATERIAL (CURRENT) WALL MATERIAL 2 (CURRENT)		massing with a wide, wrap-around front porch. The siding is a mix of horizontal
		clapboard and fish scale shingles. The roof is gabled for each wing. Large additions are located at the rear and in a side yard; the side addition mimics the
	F TYPE Cross-Gabled	original design and detailing of the main house. Windows are double hung with
<u> </u>	OUNDATION Stone PORCH Full Front	casing; some have a decorative hood. Detached two car garage wood siding with
	WINDOW MATERIAL 2	concrete foundation and pyramidal shingle roof.
WINDOW TYPE Double Hung	WINDOW CONFIGURATION 1/1	
ARCHITECTURAL FEATURES		
Full-front porch on east elevation elevation.	n; bay window with shed roof on south

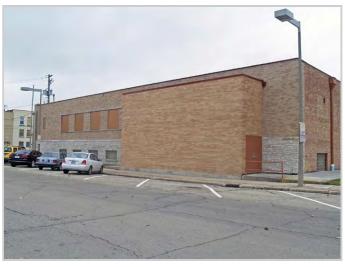
0823333001-126SouthFifthStreet(2).jpg

L.	V CONFIGURATION	brick matching the original has been constructed; an entrance is located on th
ARCHITECTURAL FEATURES		addition's south elevation. The building's main south elevation includes an enclosed loading dock at its southeast corner; four odd size windows punctuat

esign with a architectural its glazing lannon stone sidelights and htly-projecting exterior wainscoting wainscoting, the n brick with window ave been covered the roof line with is located on the includes an enclosed loading dock at its southeast corner; four odd size windows punctuate the elevation toward the roof line.

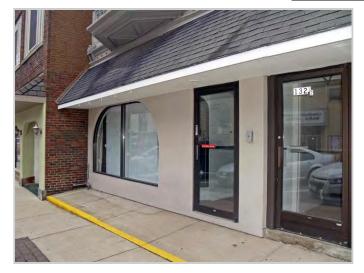
windows; dentils above windows in bay and in single window above storefront	
CONSTRUCTION YEAR Circa late 1890s. OTHER YEAR	featuring a polygonal window bay; the window bay has four double-hung windows
DATE SOURCE	that have been slightly modified with panel additions above the window line. A double-hung window exist to the south the window bay ornamented with a crown
Sanborn Maps, 1990 DeKalb CBD Architectural and Historical Survey	and crown dentils; this same ornamentation is also found the perimeter of the
WALL MATERIAL (CURRENT) Stone WALL MATERIAL 2 (CURRENT) PLAN Rectangular	polygonal window bay. The storefront level has been significantly altered with the
NO OF STORIES 2 ROOF TYPE Flat ROOF MATERIAL Unknown	installation of a large arched/semi-circular display window set within an EIFS-covered wall. A slanted canopy has also been installed over the storefront
FOUNDATION Undetermined PORCH	extending to the adjacent building. The upper facade is crowned with a heavy

cornice that incorporates a square panel pattern through the length of the cornice.
WINDOW MATERIAL Wood WINDOW MATERIAL 2 Aluminum Frame	
WINDOW TYPE Double Hung WINDOW CONFIGURATION 1/1	
ARCHITECTURAL FEATURES Wood corpice: second story hav window in tip and wood	
Wood cornice; second story bay window in tin and wood. BUILDING ALTERATIONS	
Windows in upper level polygonal bay and side window opening may have be	een
modified with panels above the windows. STOREFRONT FEATURES/STOREFRONT ALTERATIONS

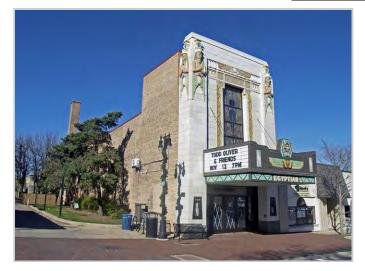
0823158005-EgyptianTheatre-135NorthSecondStreet(2).jpg

n at roof line on east and south elevations; ful	
	nined glass window frame; Egyptian-styled wi	
other terra cotta panels.	window and within an incised terra cotta pan	STOREFRONT FEATURES/STOREFRONT ALTERATIONS SIGNIFICANCE
CONSTRUCTION YEAR 1929	OTHER YEAR	A highly decorative Egyptian Revival design with glazed terra cotta and sculpted
DATE SOURCE		pharaohs and details.
	Nomination, 1990 DeKalb CBD Architectural	and CONTRIBUTING/NON-CONTRIBUTING Contributing
Historical Survey WALL MATERIAL (CURRENT)	Towns Catta	BUILDING DESCRIPTION A highly decorative terra cotta theater facade in an Egyptian Revivial style. The
WALL MATERIAL 2 (CURRENT)		facade is clad in white terra cotta with colored, glazed ornamentation of Egyptian
	OF TYPE Flat	details such as bundled reeds, a winged bird and carved pharaoh representations at the upper corners. The marquee is a metal with similar decorative features an
ROOF MATERIAL Undetermine		has angled metal tie-backs into the terra cotta above. At the center of the facade

TERIAL Stained Glass	is a large, vertically oriented art glass window with a scarab and sun design. The entry has four doors in a row. Side elevations are plain common brick with no
		entry has four doors in a row. Side elevations are plain common brick with no windows.
WINDOW CONFIGURATION	WINDOW TYPE Fixed	<u> </u>
WINDOW CONFIGURATION ARCHITECTURAL FEATURES		
	ture with half-turned columns; marquee	
suspended from east elevation fa

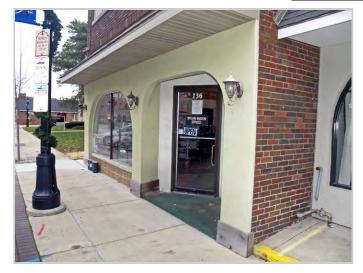
0823160035-136NorthThirdStreet(2).jpg

A two story commercial building in the early 20th century commercial style with a brick upper facade, end brick piers and brick soldier courses at lintels. Upper windows were in large openings but have been replaced and infilled with plywood and smaller windows. There is no cornice; only a plain parapet cap. The storefront has been altered with arched openings and EIFS piers. It has a display window to one side with a recessed entry vestibule on the other side. The entry vestibule has an aluminum door for the storefront and one for the upper floor access. A wood canopy with asphalt shingles has been added.

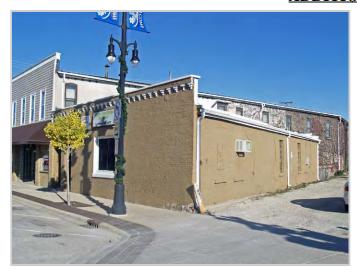
0823163013-138-140SouthSecondStreet(2).jpg

DETAILS Brick corbel dentils at				torefront opening per se, but t	
CONSTRUCTION YEAR Circa 1		┬'	opening and two reces	sed entry doors to the interior.	. There seems to have been
DATE SOURCE Sanborn Maps	WALL MATERIAL (CURRE	ENT) Brick	SIGNIFICANCE	s on the front that have been in	nfilled with brick.
WALL MATERIAL 2 (CURRENT)	PLAN L-Shaped	Triangular		N-CONTRIBUTING Contribu	ting
NO OF STORIES 1 ROOI	TYPE Flat		BUILDING DESCRIPT		
ROOF MATERIAL Undetermined		rmined]	al structure added to the adjace	
	IDOW MATERIAL Wood			 It is of painted brick constructions. There is a small window 	
WINDOW MATERIAL 2	WINDOW TYPE Fixed			ways. It is otherwise unadorne	
WINDOW CONFIGURATION	ARCHITECTURAL FE	ATURES	some glass block windo	ows and bricked in window ope	enings.
BUILDING ALTERATIONS	, moninizational re				
Door on west elevation is new; d	isplay window replaced: brick	painted.			
		P

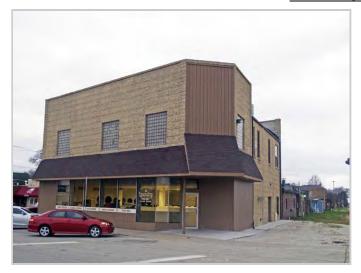
0823165007-141SouthThirdStreet(2).jpg

A two-story commercial building of concrete block construction (now covered in cementitious parging). The northwest corner is clipped at an angle with a recessed entry at that corner. The upper facade appears to have bands of more decorative concrete block every other course and narrow piers at the corners. Large window openings are now filled with glass block. The storefronts have been altered but retain extensive glazing.

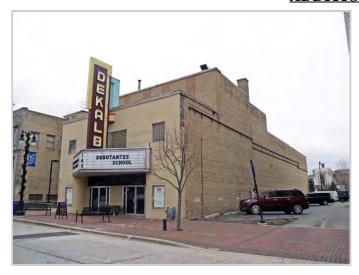
0823159029-145NorthThirdStreet(2).jpg

N. A. COLT.	ONAL REGISTER
NR DISTRICT CONTRIB/NON-CONTRIB WITHIN DISTRICT? No NR LANDMARK? No YEAR	NR ELIGIBLE? No CRITERIA ALTERNATE ADDRESS?
CATEGORY Commercial CONDITION Good INTEGRITY Good CURRENT USE Commercial - Office HISTORIC USE Commercial - The	AL INFORMATION SECONDARY STRUCTURE NR SECOND SEATER
ARCHITEC	TURAL DESCRIPTION
ARCHITECTURAL CLASSIFICATION Art Deco/Art Moderne	SIGNIFICANCE
DETAILS Exterior brick color bands on stepped facade, east elevation; movie poster display windows on first floor; three-line stone course at roof line.	Excellent example of an Art Moderne theater building in DeKalb. CONTRIBUTING/NON-CONTRIBUTING Contributing BUILDING DESCRIPTION
CONSTRUCTION YEAR 1947 - 1949 OTHER YEAR	An excellent example of the Art Moderne style featuring a marquee and pylon
DATE SOURCE	sign and stepped front elevation with a lower portion faced in painted pigmented
Sanborn Maps, 1990 DeKalb CBD Architectural and Historical Survey	glass panels. The main entry level is recessed with two double-door aluminum entrances just below the marquee; flanking these entrances are two poster

WALL MATERIAL (CURRENT) Brick	display windows. The second floor features a large glass block window behind the
WALL MATERIAL 2 (CURRENT) Block Masonry PLAN Rectangular	pylon neon sign flanked by two double-hung windows. The side elevations are constructed in a tannish brick.
NO OF STORIES 2 ROOF TYPE Flat	
ROOF MATERIAL Undetermined FOUNDATION PORCH	Marquee, pigmented glass panels
WINDOW MATERIAL 2 Vinyl	Storefront: curved walls at recessed entry, pigmented glass panels, alum doors, poster display cases
WINDOW TYPE Double Hung WINDOW CONFIGURATION	
ARCHITECTURAL FEATURES	
Steel projecting marquee with pylon-attached neon "DeKalb" sign in dark reyellow colors. BUILDING ALTERATIONS	d and
Facade/east elevation painted, some glass panels replaced, stucco at entry related been added at a later date, main entrance altered. STOREFRONT FEATURES/STOREFRONT ALTERATIONS	may

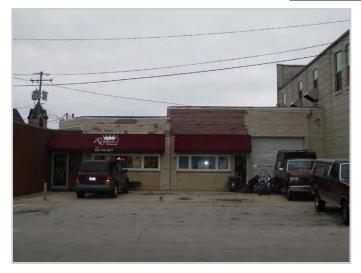
0823165008-147-151SouthThirdStreet(2).jpg

END STREET NUMBER STREET # SUFFIX STREET NAME PIN D823165008		
LOCAL WITHIN LOCAL DISTRICT? No LOCAL DIST CONTRIB/NON-CONTRIB LOCAL LANDMARK? No YEAR LOCAL LANDMARK ELIGIBLE? No CRITERIA	(a) Gardinipan, 815.756.5359	
NATIONAI	рното ID: 0823165008-147-151SouthThirdStreet(1).jpg REGISTER	
NR DISTRICT CONTRIB NN CRITERIA ALTERNATE ADDRESS? NITHIN DISTRICT? No NR LANDMARK? No YEAR NO NR LANDMARK? NO YEAR		
CATEGORY Commercial CONDITION Fair INTEGRITY Poor CURRENT USE Retail HISTORIC USE Gas Station	SECONDARY STRUCTURE NR SECOND	
	AL DESCRIPTION	
ARCHITECTURAL CLASSIFICATION CONSTRUCTION YEAR C. 1930s OTHER YEAR Altered and expanded c. 1950s DATE SOURCE WALL MATERIAL (CURRENT) Brick WALL MATERIAL 2 (CURRENT) PLAN NO OF STORIES 1 ROOF TYPE Flat ROOF MATERIAL Unknown (BUR) FOUNDATION Undetermined PORCH WINDOW MATERIAL WINDOW MATERIAL WINDOW TYPE WINDOW CONFIGURATION ARCHITECTURAL FEATURES BUILDING ALTERATIONS Originally a corner gas station with open canopy, car bays and canopy infilled for new commercial use, new addition added at corner STOREFRONT FEATURES/STOREFRONT ALTERATIONS	CONTRIBUTING/NON-CONTRIBUTING Non-Contributing BUILDING DESCRIPTION Originally a gas station complex, it is now divided into small commercial spaces. At the rear are the original station and service bays in brick of mixed colors. The larger openings have been infilled with brick and smaller windows. One garage bay door remains; the other has been converted into a storefront entry and display. At the corner, where the gas pumps likely were, is a small red brick commercial structure of one story. It has a recessed entry at the corner and small window openings. There are fabric awnings over the windows. The facade is topped with a concrete cap.

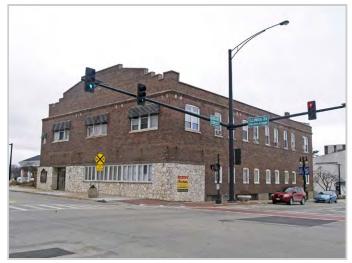
0823160031-151NorthFourthStreet(2).jpg

PORCH WINDOW MAT		level driveway garage entrance is located on the west elevation. Basement-level window openings are located on both the north and west elevations.
WINDOW MATERIAL 2 Vinyl	WINDOW TYPE Double Hung	window openings are located on both the north and west elevations.
WINDOW CONFIGURATION 1		
<u></u>	stepped brickfront parapet on east elevation.	
on North Fourth Street altered, po	, stone cladding added, windows and main entry ortions of original openings visible, windows on en replaced, window awnings added on east

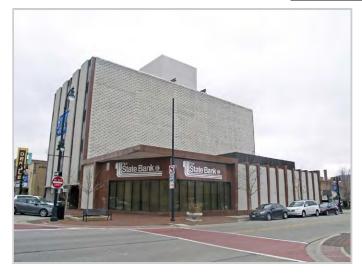
0823159052-155NorthThirdStreet(2).jpg

DEKALB, IL 60115-3285		
BEGINNING STREET NUMBER END STREET NUMBER STREET # SUFFIX STREET NAME	155	
LOCAL WITHIN LOCAL DISTRICT? No LOCAL DIST CONTRIB/NON-CO LOCAL LANDMARK? No YEAR LOCAL LANDMARK ELIGIBLE? CRITERIA	ONTRIB	PHOTO ID: 0823159052-155NorthThirdStreet(1).jpg
	NATIONAI	L REGISTER
NR DISTRICT CONTRIB/NON-0 WITHIN DISTRICT? No		NR ELIGIBLE? No CRITERIA ALTERNATE ADDRESS?
CATEGORY Commercial COI	NDITION Excellent INTEGRITY Excellent	NFORMATION SECONDARY STRUCTURE NR SECOND
	ARCHITECTURA	AL DESCRIPTION
ROOF MATERIAL Undetermine	PION Mid Century Modern DETAILS 960s OTHER YEAR Concrete Block Stucco PLAN L-Shaped F TYPE Flat	SIGNIFICANCE CONTRIBUTING Contributing BUILDING DESCRIPTION A Mid-Century Modern style office and bank - prominent vertical building, major bank building in DeKalb that occupies a prominent corner site. The banking hall sits at the corner and is one story. It is clad with brown granite tiles and concrete panels. The glazed corner is angled with a projecting canopy faced with the granite tiles. The north elevation includes angled granite piers separating the concrete paneled bays. A five-story office tower sits at the south end of the complex and is clad mostly in concrete panels with slender vertical bays of

complex and is clad mostly in concrete panels with slender vertical bays of aluminum windows and spandrel panels. The north and south tower elevations have concrete panels with a basket weave pattern and no windows. At the base of the tower is an office lobby entry of floor to ceiling glazing and an open bay for the bank drive-through.

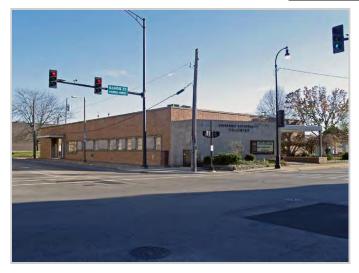
0823161001-158NorthFourthStreet(2).jpg

CONSTRUCTION YEAR Circa 1		industrial building features a distinctive angled entry with projecting canopy
DATE SOURCE Sanborn Maps	WALL MATERIAL (CURRENT) Brick	supported by round steel posts based within a brick and stone planter bed. the canopy is then connected to stone panel-faced vestibule entry. The building's we
WALL MATERIAL 2 (CURRENT)		elevation facing the main entry consists of stacked red roman brick. The north a
	F TYPE Flat	south elevations are of salmon-orange brick construction; the north elevation is articulated with a continuous window band with stone surrounds and alternating
ROOF MATERIAL Undetermine	d FOUNDATION Concrete	stone panels. A secondary entrance with projecting metal canopy, aluminum
PORCH WINDOW MA	TERIAL Aluminum Frame	doors and sidelights is also located on the north elevation.
WINDOW MATERIAL 2	WINDOW TYPE Awning	
WINDOW CONFIGURATION	Multi Light	
ARCHITECTURAL FEATURES	A-I

Angled entry with projecting me	rai canony on west elevation

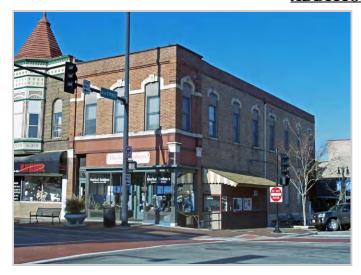
0823158020-161EastLincolnHighway(2).jpg

A two-part Romanesque Revival commercial building with stone arched window hoods connected by stone banding that extends from south to east elevations; a second stone band course extends below the window sill line. All window openings have been reduced in size. The storefront level dates from the 1920s and is relatively intact. The storefront is recessed and includes full size display Windows, wood and copper bulkheads, copper framing and cladding, and wood doors. The original transom area above has been covered; the side entrance maintains a wood door and two transom windows. Storefront piers have also maintained their stone capitals, although the masonry has been repointed.

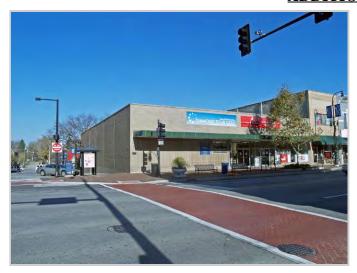
0823159035-203EastLincolnHighway(2).jpg

Storefront: full size display Wind	ows, alum frames and entry,	angled recessed	CONTRIBUTING/NON-CONTRIBUTING Contributing
entry, canopy CONSTRUCTION YEAR 1964	OTHER YEAR		BUILDING DESCRIPTION A one-part commercial building of plain Mid-Century design with extended
DATE SOURCE Wall plate, Sanl			storefront of aluminum framing and projecting metal canopy. Constructed in
WALL MATERIAL (CURRENT)			brown brick, the building is rectangular in shape with a stone coping at the roof
WALL MATERIAL 2 (CURRENT) PLAN Rectangul	lar	line and a recessed storefront in aluminum framing and brick bulkheads. The storefront has a double-door entry at the center with a separate single door entry
NO OF STORIES 1 ROOF TYPE Flat			to the right. Plywood paneling covers the storefront display window to the left of
ROOF MATERIAL Undetermine	ed FOUNDATION Concre	ete	the main entry.
	ATERIAL Aluminum Frame		
WINDOW MATERIAL 2	WINDOW TYPE Fixed

WINDOW CONFIGURATION			
<u>'-</u>	Storefront canopy		
BUILDING ALTERATIONS	z.z. s.r c.r. sanopy

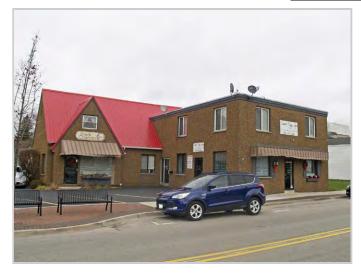
0823156014-0823156006-203-211EastLocustStreet(2).jpg

NATIONA	AL REGISTER
NR DISTRICT CONTRIB/NON WITHIN DISTRICT? No	-CONTRIB NR LANDMARK? NO YEAR	NR ELIGIBLE? NO CRITERIA ALTERNATE ADDRESS?
CATEGORY Commercial CC CURRENT USE Commercial-Of	DNDITION Excellent INTEGRITY Poor	INFORMATION SECONDARY STRUCTURE NR SECOND
	ARCHITECTUI	RAL DESCRIPTION
ARCHITECTURAL CLASSIFICA	ATION Two Part Commercial Block	CONTRIBUTING/NON-CONTRIBUTING Non-Contributing
DETAILS CONSTRUC	TION YEAR Circa 1940s	BUILDING DESCRIPTION
	SOURCE	An L-shaped building with a two-story rectangular wing facing south and a two-
WALL MATERIAL (CURRENT)	Pebble Aggregate Panel	story pitched roof, gable-fronted wing extending to the west. The south wing
WALL MATERIAL 2 (CURRENT		features a metal roof and a south elevation dominant gable incorporating an entrance and display window below a fixed awning. Joined just below the
NO OF STORIES 2 ROOF TYPE Pitched		dominant ridgeline of the west wing, the south wing has a flat roof with a first

ROOF MATERIAL Standing Seam Metal FOUNDATION Undetermined		floor doorway entrance under a fixed awning. Both wings are faced with pebble- aggregate panels installed during a recent renovation; the panels may be covering
PORCH WINDOW MATERIAL Vinyl		the building's concrete block construction, as evidenced on the east elevation. All
WINDOW MATERIAL 2 Alumi		elevations except the east feature regularly-spaced window openings with a mix of vinyl-clad sliding casement and fixed aluminum windows. The east elevation
WINDOW CONFIGURATION		has only two window openings.
ARCHITECTURAL FEATURES	Single Pane	
	main entrance facing Locust Street; original	
multi-pane double-hung window		
BUILDING ALTERATIONS		
	tially altered with pebble aggregate panels as a later	
addition; all windows with the ex	exception of the double-hung in the gable apex	
have been replaced. STOREFRONT FEATURES/STO	ADEEDONIT ALTERATIONS	
SIUKERKUNI FEATURES/SIU	KETRONI ALIEKATIONS

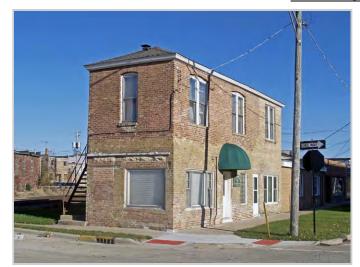
DATE SOURCE Sanborn Maps WALL MATERIAL (CURRENT) Brick		flanking the entries to the right and left are Chicago windows, most likely later
WALL MATERIAL 2 (CURRENT) PLAN Triangular		alterations. Above the first floor are three window openings featuring paired windows in arched openings with soldier course, with the exception of the far right
NO OF STORIES 2 ROOF TYPE Hipped		opening, which is flat. On the west elevation, a bricked-in door entry flanks a
ROOF MATERIAL Undetermined FOUNDATION Undetermined		large single-pane display window; bother the bricked-in doorway and display windows have limestone headers above. The north elevation features two arched
PORCH WINDOW MATERIAL Wood		windows, one flat window opening, a small double-hung window, and a entry
WINDOW MATERIAL 2 Storm Windows WINDOW TYPE Double Hung		accessed by a wood stair all on the second story. The wall elevations feature different brick colors, indicating the building had experienced a series of

WINDOW CONFIGURATION 2	ARCHITECTURAL FEATURES	alterations and maintenance actions over the decades.
BUILDING ALTERATIONS		
limestone header; aluminum stori	n altered and bricked in with remaining m windows installed; canvas awning on south south elevation; brick re-facing on south

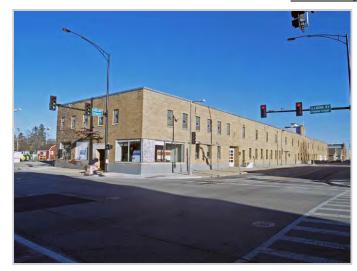
A two-story commercial-manufacturing building that was once the home of the Ellwood Manufacturing Company, principal holder of patents for the Glidden barbed wire. The building is faced with tan-brown brick with a cement bulkhead that wraps the bottom of the building on its west, south and north elevations. The south elevation features a regular rhythm of window openings with stone sills; a one-story garage opening is placed in front of concrete steps to a secondary entrance; the first floor windows have been replaced with metal multi-pane windows the second story with glass block. The window pattern is repeated on the north elevation, although the second story windows maintain their brick hoods, an indication of its earlier construction. The building also features an earlier shed section and to other modern additions on its north elevation. A small, one-story gate house is located on teh north elevation near Fourth Street. The west and south elevations were once covered with a stone veneer.

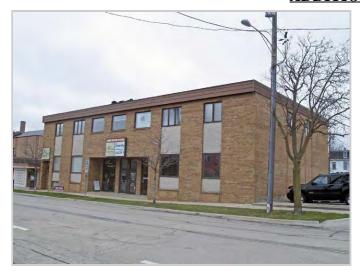
0823155013-205NorthSecondStreet(2).jpg

A Contemporary commercial-office building with elements of the International Style, including alternating brick bays and window bays; the window bays are defined by pebble aggregate spandrel panels below the first and second floor windows. The building's main entrance, located on its east elevation features three aluminum framed double-door entrances with transoms; the middle entrance services the second story offices, the two side entries service the first floor office suites. A concrete pad serves as the only step to the doorway entrances. A second recessed entry is located at the building's southernmost corner, an entry servicing a rear office suite. All windows, with the exception of those flanking the second story middle bay, are fixed aluminum; the windows flanking the middle bay are organized as three aluminum casement windows within a single opening. The north and west elevations feature two windows on the second story framed by a flat brown window course extending down to the ground floor of the building.

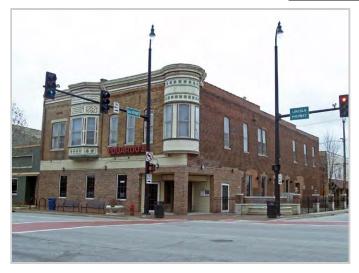
0823163001-206EastLincolnHighway(2).jpg

Scrollwork detailing in cornice, d	ecorative panel work in polygonal window bays.	a character-defining second-story turret and polygonal bay window on its north elevation. The north elevation bay window is flanked by a paired grouping of
DATE SOURCE Sanborn Maps	WALL MATERIAL (CURRENT) Brick	double-hung windows on the left with a stone lintel and sill; to the right exists
		three separate double-hungs with soldier course arched headers and stone sills. Both the turret and polygonal bay feature decorative panels with the exception of
WALL MATERIAL 2 (CURRENT)		the turret below the window band which is not ornamented. A heavy decorative
	F TYPE Flat	cornice is a significant architectural feature of the north elevation, the cornice was likely removed on the west elevation. The west elevation mainly features
ROOF MATERIAL Undetermine		a series of double-hung windows with brick arched headers; window openings

TERIAL Wood	have slightly modified on the ground floor. The north elevation storefront extending around to the west elevation has been extensively altered with brick
WINDOW MATERIAL 2	WINDOW TYPE Double Hung	infill; the storefront configuration is recessed and may have been altered as well.
WINDOW CONFIGURATION 1 ARCHITECTURAL FEATURES	/1	
	west corner, polygonal window bay on north	
elevation.	and the second s

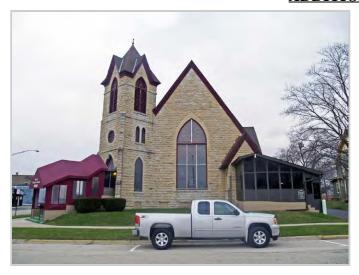
0823303001-210GroveStreet(2).jpg

A visually prominent Gothic Revival church building constructed in Joliet limestone. Wtes main elevation features a dominant two-story bell tower canted to the northwest with belfry and steeply pitched tower roof; the belfry also features a Gothic arched opening with lover vents. A round window above the arched main entry also adorns the canted tower. To the south is a secondary entry bay now made accessible through a covered canopy. Between both entrances is the dominant gothic arched window opening filled with fixed stained glass panels. The church's nave is steeply pitched and forms the building's overall volume; below along the north and south elevations are window bays with Gothic arch openings and buttresses. Along the east elevation is an addition constructed in stucco with a raised gable bay incorporating a dominant Gothic arched stained glass window bay flanked by one smaller one; the arches are also defined by artificial stone/keystone. The addition completes the building's truncated cruciform plan with an secondary entry added along an arched opening with transom stained glass.

corner, good Gothic Revival design

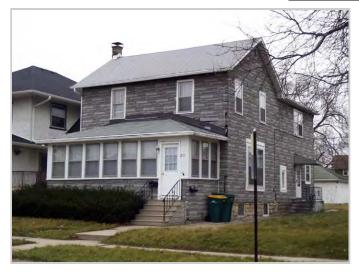
0823303007-211SouthThirdStreet(2).jpg

ARC	CHITECTURAL	<u>L DESCRIPTION</u>
ARCHITECTURAL CLASSIFICAT	TION I-House DETAILS		STOREFRONT FEATURES/STOREFRONT ALTERATIONS
CONSTRUCTION YEAR Circa 1	880s - 1890s OTHER YEAR		SIGNIFICANCE
DATE SOURCE Sanborn Maps			CONTRIBUTING/NON-CONTRIBUTING Contributing
	asphalt siding	Г	A two-story, side gabled house that is likely an I house form. There is a large
WALL MATERIAL 2 (CURRENT)	PLAN I House Plan	_	wing in back and a full width front porch. The entire house has been clad with
	TYPE Side Gabled		aux stone asphalt siding. Most of the windows are original wood, double hungs with a three over one configuration. The porch has the same window type and
ROOF MATERIAL Asphalt Shing			may have been enclosed historically. The door is new and reached by a modern
	MATERIAL Wood	ŀ	concrete stoop.
WINDOW MATERIAL 2	WINDOW TYPE Double Hun	ng	
WINDOW CONFIGURATION 3			
ARCHITECTURAL FEATURES E	Enclosed front porch.

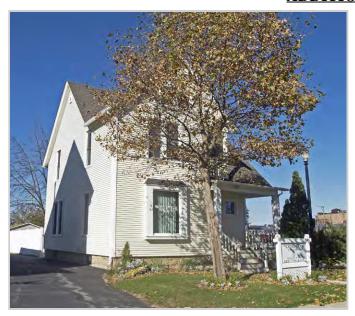
0822428004-213SouthSecondStreet(2).jpg

verted to offices, with a corner porch roof. There is also a small porch above the from the house sits on a cut stone foundation replacements but appear to be in original od spindle railing that appears to be newer. DeKalb CBD Architectural and Historical en faced with asbestos siding and its porch

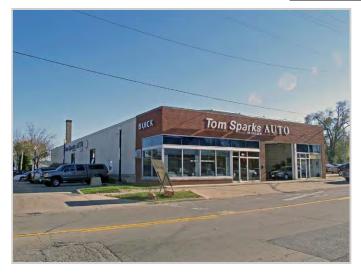
$\boxed{0822285008\text{-}0822285003\text{-}0822428001\text{-}0822428002\text{-}216Sou.jpg}$

77.1 mz 0.3.1		8-0822285003-0822428001-0822428002-216Sou.jpg
		AL REGIS	<u>TER</u>
NR DISTRICT CONTRIB/NON-0 WITHIN DISTRICT? NO N	IR LANDMARK? No YEAR	NR ELIGII	BLE? No CRITERIA ALTERNATE ADDRESS?
	GENERAL NDITION Very Good INTEGRITY Good HISTORIC USE Commercial	Z INFORMA SECONDA	ATION RY STRUCTURE NR SECOND
ARCHITECTURAL CLASSIFICAT	ARCHITECTU TION One Part Commercial Block		CRIPTION ONT FEATURES/STOREFRONT ALTERATIONS
OTHER YEAR DATE SO	DURCE Sanborn Maps Brick	and doors. transom sp	storefront features large glass display windows with aluminum frames. The display windows rest on a red brick bulkhead. A blue-colored glass pans the width of the storefront. At the service bay, there is an garage door and modern aluminum storefront system.
WALL MATERIAL 2 (CURRENT)		SIGNIFIC	· · · · · · · · · · · · · · · · · · ·
NO OF STORIES 1 ROOI	TYPE Beautruss		UTING/NON-CONTRIBUTING Contributing
ROOF MATERIAL Undetermined	FOUNDATION PORCH		G DESCRIPTION ry commercial building with a red brick facade. The upper facade is

WINDOW MATERIAL Aluminur	n Frame WINDOW MATERIAL 2	plain brick	with a stone cap. Most of the facade is storefront; some of the brick is
WINDOW TYPE Fixed with Tran	nsom WINDOW CONFIGURATION		ulkheads and piers. The storefront is divided into a retail/display room and a vehicle service bay on the right. The storefronts have large
ARCHITECTURAL FEATURES		' '	ndows with aluminum frames and doors. A blue-colored glass transom
BUILDING ALTERATIONS	rankagad at the comice have side alougitions		iss the retail storefront. The service bay features one garage door and um storefront/entry. Side walls are masonry and aluminum siding with
altered with new aluminum siding	replaced at the service bay; side elevations and entries.	some mod	ern entries and windows.
		_

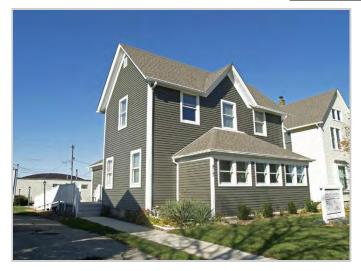
DATE SOURCE Sanborn Maps WALL MATERIAL (CURRENT) Vinyl Siding	south elevation, all elevations have been sided in vinyl; all windows replaced; Gothic vergeboard detailing in second floor gable has been removed; the second-
WALL MATERIAL 2 (CURRENT) PLAN Rectangular	story double-hung window once had an arched upper sash opening.
NO OF STORIES 2 ROOF TYPE Side Gabled	STOREFRONT FEATURES/STOREFRONT ALTERATIONS
ROOF MATERIAL Asphalt Shingle FOUNDATION Stone	SIGNIFICANCE CONTRIBUTING Non-Contributing
PORCH WINDOW MATERIAL Vinyl	BUILDING DESCRIPTION
	A two story house in what appears to have been an I - House or Gothic Revival
	house that has lost its ornamentation. The house has a side gable roof with a front gable peak at the center. A partial width front porch has been enclosed and
WINDOW CONFIGURATION 1/1 ARCHITECTURAL FEATURES Central gable bay on east elevation.	no longer has an entry. A one story rear addition has the main entry accessed by

Central gable bay on east elevation.	a long wood ramp. All of the exterior has been clad with vinyl siding. The double hung windows appear to be in original locations but are replacements.
	inding willidows appear to be in original locations but are replacements.

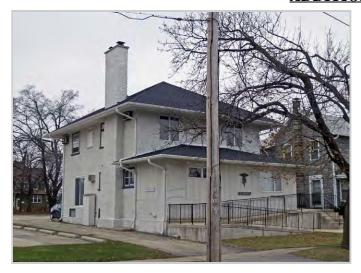
0823303008-217SouthThirdStreet(2).jpg

ARCHITECTURAL CLASSIFICATION American Foursquare	BUILDING ALTERATIONS
DETAILS Deep roofline eaves	Porch enclosed; new entry and stair wing added to side, covered in stucco;
CONSTRUCTION YEAR Circa 1910s - 1920s OTHER YEAR	windows replaced; accessible ramp added to front.
DATE SOURCE Sanborn Maps WALL MATERIAL (CURRENT) Stucco	STOREFRONT FEATURES/STOREFRONT ALTERATIONS
Canasin maps , states	SIGNIFICANCE
WALL MATERIAL 2 (CURRENT) PLAN Square	CONTRIBUTING/NON-CONTRIBUTING Contributing
NO OF STORIES 2 ROOF TYPE Hipped	BUILDING DESCRIPTION
ROOF MATERIAL Asphalt Shingle FOUNDATION Undetermined	Originally a stucco American Foursquare house, it has been converted into an office building. It is two story and clad completely in gray stucco and has a hip
PORCH Full Front WINDOW MATERIAL Vinyl Replacement	roof with projecting eaves. An original full width front porch with stucco piers has
WINDOW MATERIAL 2 WINDOW TYPE Casement	been infilled with wood paneling and is now the office entry. An extensive concrete ramp leads up to the entry.

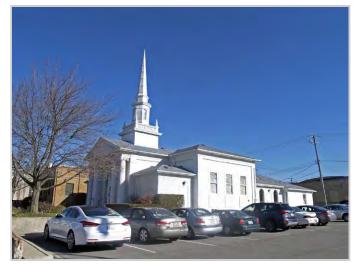
An American Colonial Revival religious building constructed in 1909 in a cruciform plan with Classical features and ornamentation, including a temple front and pediment with Ionic capital columns. All building elevations feature stucco surfaces suggesting a Prairie stylistic influences, although it is unclear if the stucco wall treatment was a later alteration. The temple front on the building's west elevation feature four columns grouped in two flanking the main doorway; the main doorway includes a single wood door with three square lights below a broken pediment centered by an urn ornament; square sidelights surround the doorway entrance. The main entrance is also accessed by three concrete steps with the two outer portico columns resting on the outer porch pedestal, in the inner two on the top step. The columns support a Classical pediment with architrave; set back from the pediment is a Colonial Revival steeple with square base topped by a railing and finials on all corners; the base also features a cornice line. Two of the columns are believed to be later additions. Above the base, a multi-sided belfry with alternating windows sits below the spire; the spire is a believed to be a later addition. The north and south building elevations feature three double hung stained glass windows with trim and a decorative square panel below; each elevation is also slightly recessed to articulate columns at the corners and extending fascia below the roof line. There are two addition on the building's east elevation.

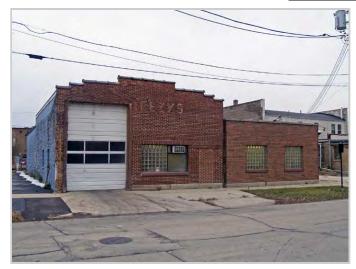
WALL MATERIAL 2 (CURRENT)		ed	back from the sidewalk. The building is constructed in red variegated brick featuring a flat roof with stone coping, a canted main entrance that transitions the
	F TYPE Flat		Grove Street facade with that of the South Third Street elevation. Three window
ROOF MATERIAL Undetermined	d FOUNDATION Conc	rete	openings infilled with glass bock with soldier course above and stone sills below line the Grove and South Third Street facades. Two window openings with multi-
PORCH WINDOW MA	TERIAL Glass Block		pane double hungs are located further to the north along the Third Street
WINDOW MATERIAL 2	WINDOW TYPE		elevation and flanking a garage door opening; to the south of the garage door is a standard entrance. The north wing, slightly higher in height than the south wing
WINDOW CONFIGURATION	ARCHITECTURAL	FEATURES	features one large vertical garage door with hood, loading dock and sunken ramp; towards the western end is a simple entrance door. Both wings rest on a concrete

Three windows on south and eas doors on both elevations have als	so been replaced with the ex		foundation.
vertical garage door on south elev			
SIGNIFICANCE CONTRIBUTING/NON-CONTRI

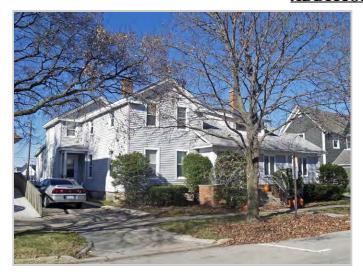
0822428006-223SouthSecondStreet(2).jpg

DEKALB, IL 60115	
BEGINNING STREET NUMBER 223	WANTED AND THE WANTED
END STREET NUMBER	WHAT WE SEE THE SEE TH
STREET # SUFFIX	
STREET NAME South Second Street	
0822428006	
LOCAL WITHIN LOCAL DISTRICT? No LOCAL DIST CONTRIB/NON-CONTRIB LOCAL LANDMARK? No YEAR LOCAL LANDMARK ELIGIBLE? No CRITERIA	
NA TIA	PHOTO ID: 0822428006-223SouthSecondStreet(1).jpg
	ONAL REGISTER
NR DISTRICT CONTRIB/NON-CONTRIB WITHIN DISTRICT? No NR LANDMARK? No YEAR	NR ELIGIBLE? NO CRITERIA ALTERNATE ADDRESS?
GENER	AL INFORMATION
CATEGORY Residential CONDITION Excellent INTEGRITY Poor CURRENT USE Multi-Family Residential HISTORIC USE Single-Family Residential	SECONDARY STRUCTURE NR SECOND
ARCHITEC	TURAL DESCRIPTION
ARCHITECTURAL CLASSIFICATION Greek Revival	SIGNIFICANCE
DETAILS East elevation gable return. CONSTRUCTION YEAR Circa 1860s - 1870s OTHER YEAR	CONTRIBUTING/NON-CONTRIBUTING Non-Contributing BUILDING DESCRIPTION
DATE SOURCE Sanborn Maps WALL MATERIAL (CURRENT) Vinyl Sid	Although extensively altered, the original Upright & Wing form of this house is

WALL MATERIAL 2 (CURRENT) Brick	apparent. The Upright portion of the original house is 1 1/2 stories with a gable front featuring returns of the gable ends. The elevation features four double hung
PLAN L-Shape (original); Rectangular (currently) NO OF STORIES 2	windows, vinyl siding and sits on a stone foundation. The Wing portion has been
ROOF TYPE Pitched ROOF MATERIAL Asphalt Shingle	altered to extend out front of the upright (wings were typically recessed) and was built in the early 20th century in a bungalow style with a shed dormer. The entry
FOUNDATION Stone PORCH WINDOW MATERIAL Vinyl	has a plain concrete stoop. Another 2 story addition was added at the rear of the
WINDOW MATERIAL 2 WINDOW TYPE Double Hung	upright portion and has its own separate entry.
WINDOW CONFIGURATION 1/1 ARCHITECTURAL FEATURES	
BUILDING ALTERATIONS	
Circa 1910 Craftsman-styled bungalow addition on north elevation with brick foundation; addition includes shed roof dormer on east elevation; house has lextensively resided with vinyl; window sills replaced; porch on east end addit has been enclosed. STOREFRONT FEATURES/STOREFRONT ALTERATIONS	been

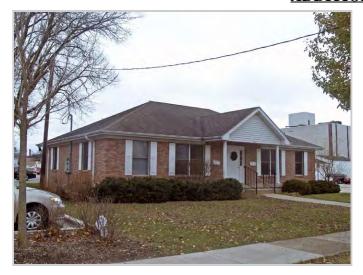
0823156003-224NorthSecondStreet(2).jpg

A Colonial Revival of recent construction featuring a square building plan with pyramidal asphalt-shingled hipped roof with entrance portico. Entrance portico is supported by two slender white columns with simple bases and low profile capitals supporting a triangular pediment with boxed corners and white vinyl siding; the portico floor is of concrete construction. The main entrance features a doorway with two half sidelight panels; window lights are above the door knob. Window openings are provided on each elevation with the west elevation consisting of paired windows flanked by one window opening; all windows are double-hung in configuration. Windows are decorated with fixed shutters.

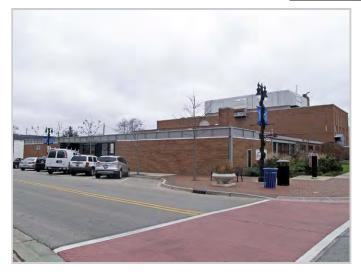
0823156013-225EastLocustStreet(2).jpg

DEKALB, IL 60115-3203			
BEGINNING STREET NUMBER 225			
END STREET NUMBER			
STREET # SUFFIX			
STREET NAME East Locust Street			
PIN 0823156013			
		M	
LOCAL			
WITHIN LOCAL DISTRICT? No			
LOCAL DIST CONTRIB/NON-CONTRIB			
LOCAL LANDMARK? No			
YEAR _			
LOCAL LANDMARK ELIGIBLE? No			
CRITERIA			
		PHOTO ID: 0823156013-225EastLocustStreet(1).jpg	
	NATIONAI	L REGISTER	
NR DISTRICT CONTRIB/NON-CONTRIB	<u></u>	NR ELIGIBLE? No CRITERIA ALTERNATE ADDRESS?	
WITHIN DISTRICT? No NR LANDMARK? No	YEAR	NR ELIGIBLE: NO CRITERIA ALTERNATE ADDRESS:	
	_		
	GENERAL IN	NFORMATION	
CATEGORY Commercial CONDITION Excellent	INTEGRITY Excellent		
CURRENT USE Commercial HISTORIC USE	TINTEGRITI EXCellent	SECONDARY STRUCTURE NR SECOND	
CORREINT USE Commercial HISTORIC USE			
	ARCHITECTUR	AL DESCRIPTION	
ARCHITECTURAL CLASSIFICATION International St	yle DETAILS	BUILDING DESCRIPTION	
CONSTRUCTION YEAR Circa late 1960s - early 1970s	OTHER YEAR	A late example of the International style but with a red brick facade with a st- panel frame ringing the office wings roof line. An entrance way lined with a gla curtain wall with aluminum frames, base and entries, and recessed with terra- and iron railings is located on the complex's south elevation; the east elevation include a smaller glass curtain wall opening where the roof line steel panel line

DATE SOURCE WALL MATERIAL (CURRENT	F) Brick		
WALL MATERIAL 2 (CURRENT) Steel PLAN U-S	shape		
NO OF STORIES 1 ROOF TYPE Flat		ends; flanking the window is a regular rhythm of clerestory until the meet larg	
ROOF MATERIAL Undetermined FOUNDATION C	Concrete	rear wing housing telecommunications equipment. Approximately two and on half stories in height, the telecommunications wing features nine bays separa	
PORCH WINDOW MATERIAL Aluminum Frame		by brick piers; rectangular casement windows are found in four alternating by	
WINDOW MATERIAL 2 WINDOW TYPE Fix	xed		
WINDOW CONFIGURATION Single Pane			
ARCHITECTURAL FEATURES Exposed steel roof fram	ing of the office wing.		
BUILDING ALTERATIONS STOREFRONT FEATURES/STOREFRONT ALTERATIO	NS		
SIGNIFICANCE SIGNIFICANCE

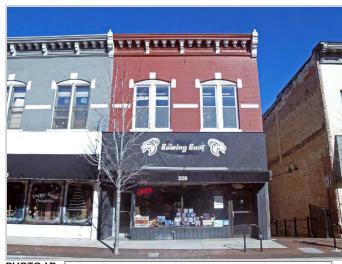
PHOTO ID: 0823159051-229EastLincolnHighway(1).jpg

Constructed circa 1880, 229 East Lincoln Highway is Two-Part, Romanesque Revival commercial building featuring arched windows and an elaborate cornice on the upper facade. The storefront level has been altered as the transom area had been infilled and the storefront materials replaced. Despite the alterations, the survey evaluated the building as potential contributing. In 2018, the upper facade and storefront had been refaced with new brick and storefront materials. Given the recent alterations and the loss of integrity, the building is now non-contributing to a potential National Register District.

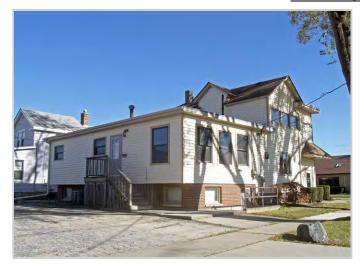
WALL MATERIAL 2 (CURRENT)	PLAN Square	difficult to determine its original form and massing. The house was two stories
NO OF STORIES 2 1/2 ROO	F TYPE Pitched	with cross gable roofs but has had additions on two sides. On the front side is a two story addition with a flat roof and few windows. The back side has a one story
ROOF MATERIAL Asphalt Shing	JIE FOUNDATION Concrete Block	addition with a flat roof. Most of the structure is covered in vinyl siding. The
PORCH WINDOW MA	TERIAL Vinyl	original house sits on a concrete block foundation. The front addition has a plain concrete block foundation; the rear addition is red brick. The detached garage is
WINDOW MATERIAL 2	WINDOW TYPE Casement	vinyl sided with concrete foundation; pitched roof with asphalt shingles.
WINDOW CONFIGURATION F	ixed Windows	
ARCHITECTURAL FEATURES		
BUILDING ALTERATIONS		
	ossible original porch has been enclosed and canopy projection over original porch; one story

wing added to the west elevation:

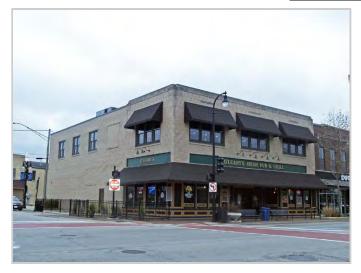
0823163011-260EastLincolnHighway(2).jpg

DATE SOURCE			modified over time. The building's north elevation features a refined stone
Sanborn Maps, 1990 DeKalb CBI WALL MATERIAL (CURRENT)		al Survey	ribbed/fluted cornice line with rib columns descending down the building corners three groupings of three-window openings are placed above a sign panel with or
WALL MATERIAL 2 (CURRENT)	PLAN Square		grouping extending to the east elevation; all window groups have fabric awnings
	F TYPE Flat		The east elevation features four window bays with groupings of two and three windows with stone sills. The original 1930s storefront has been modified;
ROOF MATERIAL Undetermine		termined	however, the
	TERIAL Vinyl Replacemen		original storefront terrazzo flooring extends into the new interior of the storefront.
WINDOW MATERIAL 2	WINDOW TYPE Double		5.61.61.61.61
WINDOW MATERIAL 2 WINDOW CONFIGURATION		-	
BUILDING ALTERATIONS	ARGINIECTORALI	LATURES	
STOREFRONT FEATURES/STO	 REFRONT ALTERATIONS

Storefront level has been significand window framing to imitate a	cantly modified to incorporate

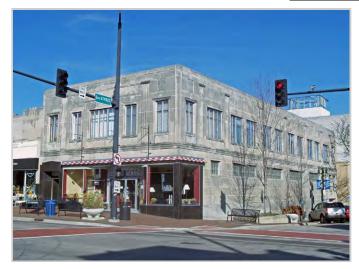
0823159025-263EastLincolnHighway(2).jpg

A two-part Art Deco commercial building faced in grey Bedford limestone on the upper-story and black granite at the storefront level. In the center of the upper façade, the building's name description, "Drs Smith," is inscribed in a central stone panel above second story windows, flanked by recessed flouted pilasters topped by crowns. Window bays are located to the east and west of pilasters with dentil crowns and caduceus reliefs in the window spandrel; decorative reliefs are located above these second story windows; beneath the second story window bay includes a three-lined string course. The storefronts appears to be original with curved window bays to the recessed entrance; storefront framing includes aluminum with a decorative diamond pattern on top. The storefront features recessed entrance ways with metal door replacements; storefront knee walls are polished granite in good condition; awning canopy cover above storefront windows appears to be original. Transoms above the entrance way has been replaced as well as storefront floor tile. Polished granite surrounds around entrance way to second floor on south elevation; upper floor of east elevation features groupings of two window bays surrounded by flouted column pilasters resting in a threelined string course; first floor east elevation features transom areas with glass block; at northeast end features a second first floor smaller storefront with a grouping of three windows above; east elevation contains same ornamental reliefs as south elevation; north elevation features brick wall with window openings. The building has a high level of integrity.

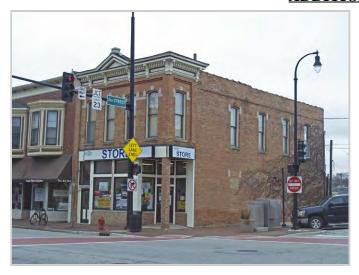
CONSTRUCTION YEAR Circa 1		AR	CONTRIBUTING/NON-CONTRIBUTING Contributing
DATE SOURCE Sanborn Maps,		nd Historical Survey	BUILDING DESCRIPTION
WALL MATERIAL (CURRENT)		ia motorioai dai voj	A two-part brick commercial building with pedimented heavy cornice on north
WALL MATERIAL 2 (CURRENT)	PLAN Rectangu	ılar	elevation including brackets and dentils. The second story features brick and stone window headers with stone lentils. The west elevation features four double
NO OF STORIES 2 ROO	F TYPE Flat		hung windows on second story; the first story features three window openings
ROOF MATERIAL Undetermine	d FOUNDATION Undet	ermined	that have been bricked in. Double-hung window over storefront entrance features corbled piers; storefront level appears to have been modified/reconstructed with
	TERIAL Wood		brick knee walls and wood window framing, with brick column supports second
WINDOW MATERIAL 2	WINDOW TYPE Double	Huna	story in front of storefront entrance.

WINDOW CONFIGURATION 2		9	
ARCHITECTURAL FEATURES	-14		
Procketed corpice with dentils or	ad triangular padiment

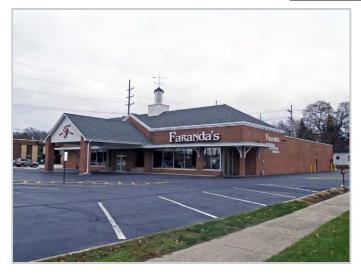
0823304002-302GroveStreet(2).jpg

DEKALB, IL 60115-3704				
BEGINNING STREET NUMBER	302			
END STREET NUMBER	302			
STREET # SUFFIX				
STREET NAME	Grove Street		1	
PIN	0823304002		+	
		_		III .
LOCA				
WITHIN LOCAL DISTRICT? No			BANQUETS RECEPTIONS NEETHORS	Faranda's
LOCAL DIST CONTRIB/NON-CO	ONTRIB [
LOCAL LANDMARK? No				
YEAR				
LOCAL LANDMARK ELIGIBLE?	No			
CRITERIA 🗌		_	1	
			РНОТО I D : 0823304002-302	CraveStreet(1) ind
		NIA TOTONIA I		:Grovestreet(1).jpg
		NATIONAL	REGISTER	
WITHIN DISTRICT? No N	NR LANDMARK? No	YEAR	NR ELIGIBLE? No CRITERIA	ALTERNATE ADDRESS?
	NDITION Excellent II	GENERAL IN NTEGRITY Good	FORMATION SECONDARY STRUCTURE NR SEC	OND
ARCHITECTURAL CLASSIFICAT		ARCHITECTURA	L DESCRIPTION BUILDING DESCRIPTION	
DETAILS			A late Colonial Revival commercial once hous	
Knee brackets supporting metal		gabled porte-cochere	entry/porte-cochere and roof cupola as its distinction of the double-door entry are two display	
CONSTRUCTION YEAR Circa 1			windows are large display window divided into	four panes by aluminum framing;

Brick	an additional display window of two panes is leelevation. A metal canopy supported by knee	
WALL MATERIAL 2 (CURRENT)		Recatngular	window bays. The porte-cohere connects to m	ain building at a center gable; a
	F TYPE Hipped		hipped roof defines the overall volume of the troof defines the volume of the building's rear	
ROOF MATERIAL Asphalt Shing			siding in the porte-cochere gables, the buildin	
PORCH Entrance Canopy WI	NDOW MATERIAL Alum	ninum Frame		
WINDOW MATERIAL 2	WINDOW TYPE Fixed]		
<u></u>	ixed Windows Cupola at roof ridgeline, bu	ilding center.		
BUILDING ALTERATIONS	sapaia at roor riagoniie, bu	g contor.		
Porte cochere added, new entry				
STOREFRONT FEATURES/STOR	REFRONT ALTERATIONS			
SIGNIFICANCE CONTRIBUTING/NON-CONTRI	BUTING Contributing

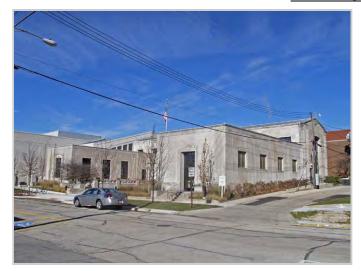
at desks; niche on west elevation r windows, metal windows.	nain courtyard, metal grills over v	estibule	STOREFRONT FEATURES/STOREFRONT ALTERATIONS SIGNIFICANCE
CONSTRUCTION YEAR 1930	OTHER YEAR		An outstanding example of the Art Moderne in DeKalb and designed by Charles
DATE SOURCE			White, a significant architect in the Chicago area during the early part of the 20th
Inscription between fluted piers ov	ver main entrance vestibule; City of	of DeKalb Six	century. CONTRIBUTING/NON-CONTRIBUTING Contributing
Self-Guided Walking Tours.			BUILDING DESCRIPTION
WALL MATERIAL (CURRENT) S WALL MATERIAL 2 (CURRENT)	PLAN U-Shaped Court	vard	A sprawling Art Deco style library with a central courtyard on the original building
	TYPE Flat ROOF MATERIA		and a large modern addition to the west of the original. It is clad in limestone and
		L	features two, one-story projecting wings flanking a courtyard to the original entry (modern wing now has the main entry). The main wing is two stories high with

FOUNDATION Undetermined	PORCH		clerestory windows. The elevations feature fluted pilasters, bas relief sculpture
WINDOW MATERIAL Aluminum WINDOW MATERIAL 2 Storm W		ed	and stylized swags. The original windows were steel with divided lights but some have been replaced. The modern addition is of concrete to match the color of the
WINDOW CONFIGURATION Mu			stone and has a massing in scale with the original.
ARCHITECTURAL FEATURES	nti Ligiti		
Main entrance courtyard, fluted co	olumn piers dividing window bays,	step out

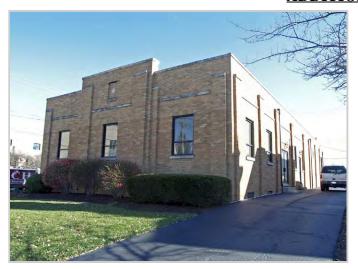
A one-story brown brick building designed in a spare, abstract Art Deco/Moderne with a series of piers defining separate window bays and the main entrance on the building's north elevation. The piers, topped with stone capital and joined together on elevations by a stone belt course, are abstracted buttresses, perhaps signaling a religious connotation to the building. The main entrance is located to the southern end of the north elevation and is accessed by a concrete ramp and stairs covered by a cloth canopy. Above the aluminum door with sidelights is a stone square panel with a stone diamond surrounded with bricks set in a chevron patterns, this stone square is also found on the building's west elevation. The entrance bay, along with the center bay along the west elevation, include two broad piers offset from the bay corner and then flanking a half pier from the adjoining bay; the entrance bay and the west elevation center bay have stepped parapets. Within each bay below the stone belt course line is an aluminum frame window with stone sills. The regular bay rhythm is interrupted towards the eastern end of the north elevation with an extended bay accommodating a loading bay; this bay is defined by three slender aluminum-framed windows. The east elevation features a three bay definition with a loading at the northeast corner.

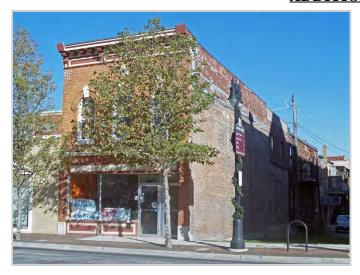
0823160018-311EastLincolnHighway(2).jpg

DEKALB, IL 60115		
BEGINNING STREET NUMBER END STREET NUMBER STREET # SUFFIX STREET NAME PIN East Lincoln 0823160018 LOCAL WITHIN LOCAL DISTRICT? No LOCAL DIST CONTRIB/NON-CONTRIB LOCAL LANDMARK? No YEAR LOCAL LANDMARK ELIGIBLE? Yes CRITERIA		STORE TO PRODUCE THE PRODUCE T
		рното ID: 0823160018-311EastLincolnHighway(1).jpg
INTEGRITY Good CURRENT USE Comm	K? NO YEAR GENERAL IN NDITION Excellent	NR ELIGIBLE? NO CRITERIA ALTERNATE ADDRESS? NFORMATION NR SECOND
ARCHITECTURAL DESCRIPTION		
NO OF STORIES 2 ROOF TYPE Flat FOUNDATION Stone PORCH WINDOW MATERIAL Vinyl Replacement	ling detail; brick arched surrounds nes; stone window sills on ndary lean to addition in the rear cade; Sanborn Maps. AN Rectangular ROOF MATERIAL WINDOW MATERIAL 2 CONFIGURATION 1/1	Storefront has been altered and framed in aluminum and new wooden bulkheads; side entry to second story also replaced with aluminum framing and door. Original storefront configuration is documented in an undated historic photo from the NIU Ritzman Photo Collection. SIGNIFICANCE CONTRIBUTING/NON-CONTRIBUTING Contributing BUILDING DESCRIPTION A two-part Italianate commercial building with a flat roof and a heavy-bracketed cornice and dentil line; below dentil lines are panels flanked by brackets. The upper facade is constructed in brick with three window openings with brick corbeled round arches; however, the original round arch double-hung windows have been replaced. The storefront level features wood bulkheads that slant to the storefront entry with full glazing; a secondary entry to the upper-floor is located to the east. The storefront transom is currently covered by a wooden panel; above the panel is a stone storefront cornice topped by a brick soldier course. The building has a rear addition construction circa 1880s - 1890s.

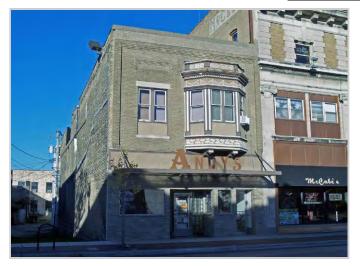
A two-part Queen Anne commercial building constructed in a brown-tannish brick featuring a polygonal bay window with decorative swag and dentil lines and two scroll brackets below. The upper facade consists of a corbel line above the bay window connecting to two side piers that are corbeled at the bottom at the storefront line. Flanking the bay window to the left is a window opening with stone header and sill for two double-hung windows; however, the opening has been modified and shortened, as they have been in the bay window. A square brick inset panel is located above the window. The storefront level has been extensively modified with a a new brick facing, canopy and covered transom area.

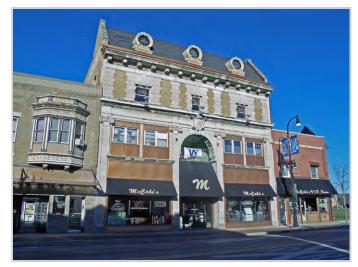
An exuberant example of Beaux Arts commercial style in Downtown DeKalb. On its south elevation, the building features four pilasters with ionic capitals framing the first level storefront, window bays and central entrance; the two story atrium entrance is topped with arch and cartouche with "CTSB" community trust savings bank initials; the second story is capped with a wide entablature. The third story consists of three window bays framed with elaborate stone surrounds and keystones; above this window band is a heavy stone cornice with dentils. The fourth floor consists of a roof attic with three porthole dormer windows with elaborate scroll work.

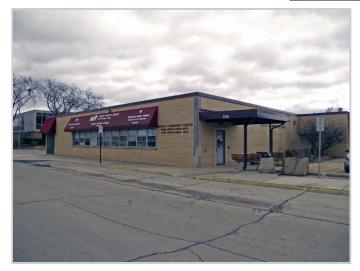
A one-story commercial/institutional building of Mid-Century design featuring a stone enframed main entrance with side aluminum window panels at the southwest corner of Grove Avenue and South Fourth Street. West of the main entrance on the building's north elevation is an enframed fixed window band in divided lights with a fixed fabric awning above; the east elevation features five vertical window openings in divided lights and stone sills with six window opening filled in; a small three-light wind opening is also present. To the south of a door bay are four square multi-paned windows with two openings filled in. The north elevation features an entrance with canopy at the building's northwest corner and loading bays towards the elevation's south end. The building is constructed in tannish-yellow brick.

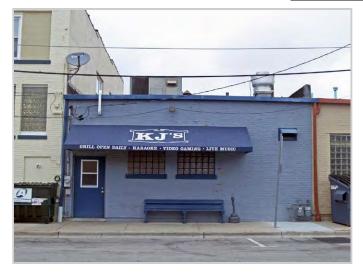
0823331011-518EastLincolnHighway(2).jpg

DEKALB, IL 60115-2309			
	518 st Lincoln Highway 23331011		
LOCAL WITHIN LOCAL DISTRICT? No LOCAL DIST CONTRIB/NON-CONTR LOCAL LANDMARK? No YEAR LOCAL LANDMARK ELIGIBLE? No CRITERIA		Maring E	
NR DISTRICT CONTRIB/NON-CONT WITHIN DISTRICT? NO NR LA		PHOTO ID: 0823331011-518EastLincolnHighway(1).jpg L REGISTER NR ELIGIBLE? NO CRITERIA ALTERNATE ADDRESS?	
CATEGORY Commercial CONDITION Good INTEGRITY Good SECONDARY STRUCTURE NR SECOND CURRENT USE Commercial HISTORIC USE Commercial			
ARCHITECTURAL DESCRIPTION			
ARCHITECTURAL CLASSIFICATION Two Part Commercial - Commercial V DETAILS	<u> </u>	STOREFRONT FEATURES/STOREFRONT ALTERATIONS Intact storefront, full-size display windows, wood base, recessed entries, copper frames, wood doors, glass sheet transoms	
Cast stone cap at roof line with diamond facade. CONSTRUCTION YEAR Circa late 19	ond-shaped stone inserts in extended upper 920s. OTHER YEAR	SIGNIFICANCE CONTRIBUTING/NON-CONTRIBUTING Contributing BUILDING DESCRIPTION

WALL MATERIAL 2 (CURRENT) NO OF STORIES 1 ROOF TYI ROOF MATERIAL Undetermined PORCH WINDOW MATERI	FOUNDATION Undetermined AL	Similar to 520 East Lincoln Highway, a vernacular one-part commercial brickfront with intact storefront materials and configuration. Building facade consists of brown-colored hard-wired cut brick with cast stone cap and diamond-shaped details above the storefront. The exterior has been painted. Storefront level is intact with full-size display windows, wood bulkheads, copper framing and wood doors within a recessed entry; transom arae has been covered. Storefront bulkheads rest on a concrete base.	
WINDOW MATERIAL 2 WI	NDOW TYPE

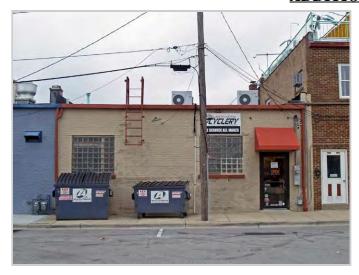
0823331012-520EastLincolnHighway(2).jpg

A vernacular one-part commercial brickfront with intact storefront materials and configuration. Building facade consists of brown-colored hard-wired cut brick with cast stone cap and diamond-shaped details above the storefront. Storefront level is intact with full-size display windows, wood bulkheads, copper framing and wood doors within a recessed entry; transoms are of clear sheet glass. Storefront bulkheads rest on a concrete base. A fabric awning has been installed over the storefront entry, but extends to the adjacent building to the east. The buildings south elevation (rear) features the same brick treatment, although painted in brown color, and an aluminum doorway entrance towards the east; two windows have been altered with glass block infill.

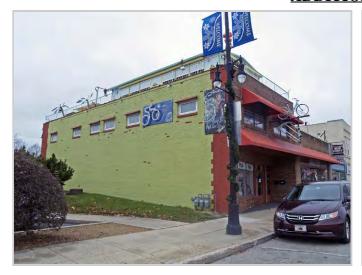
77.4		PHOTO ID: 0823331005-534EastLincolnHighway(1).jpg
	<u>NA</u>	TIONAL RI	<u>egister</u>
NR DISTRICT CONTRIB/NON-C WITHIN DISTRICT? No	CONTRIB	NR	ELIGIBLE? No CRITERIA ALTERNATE ADDRESS?
	GEN NDITION Excellent INTEGRITY HISTORIC USE Commercial	Fair SE	RMATION CONDARY STRUCTURE NR SECOND
	ARCHIT	ECTURAL 1	<u>DESCRIPTION</u>
ARCHITECTURAL CLASSIFICAT		SIC	GNIFICANCE
Two Part Commercial - Mid Center DETAILS CONSTRUCT	ury Vernacular TON YEAR Circa 1950s.		NTRIBUTING/NON-CONTRIBUTING Non-Contributing
			ILDING DESCRIPTION
OTHER YEAR DATE SO WALL MATERIAL (CURRENT)	DURCE Sanborn Maps.		two-part commercial building constructed in colored wire cut brick with slanted refront of wood framing and brick bulkheads. Doorway entrances towards the
WALL MATERIAL (CORRENT)			stern end of the storefront lead to the interior first floor retail spaces and the cond story. Two four window casement window groupings define upper story

•	F TYPE Flat ROOF MATERIAL		th elevation. The building has extensive alterations to the roof including a
FOUNDATION PORCH			Iding addition and patio on roof, upper story railing, and access stairs from ghboring property. The east elevation brick facade has been painted red with
WINDOW MATERIAL 2 Alumin		cas	sement windows punctured as a clerestory band towards the roof; the windows
	WINDOW CONFIGURATION	ma	y be later alterations.
ARCHITECTURAL FEATURES			
Slanted storefront; casement wir brick facing. BUILDING ALTERATIONS	ndow groupings on upper story; colore	d wire	
	th third floor addition, parapet railing a	and metal	
stairway from adjacent building fr
