City of DeKalb

Downtown Architectural

And Historical Survey

Final Report with Addendum

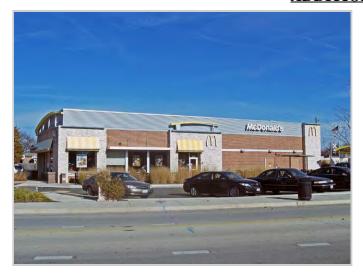
0823326005-545EastLincolnHighway(2).jpg

DEKALB, IL 60115-3805	
DECLAMANA OFFICE ANAMOND	
BEGINNING STREET NUMBER 545	
END STREET NUMBER	The second secon
STREET # SUFFIX	
STREET NAME East Lincoln Highway	
PIN 0823326005	No.
LOCAL	
	MA MARINE
WITHIN LOCAL DISTRICT? No	
LOCAL DIST CONTRIB/NON-CONTRIB	
LOCAL LANDMARK? No	
YEAR	
LOCAL LANDMARK ELIGIBLE? No	
CRITERIA 🗌	
	PHOTO ID: 0823326005-545EastLincolnHighway(1).jpg
NATION	NAL REGISTER
	AL REGISTER
NR DISTRICT CONTRIB/NON-CONTRIB	NR ELIGIBLE? No CRITERIA ALTERNATE ADDRESS?
WITHIN DISTRICT? No NR LANDMARK? No YEAR	
<u>GENERAI</u>	<u>LINFORMATION</u>
CATEGORY Commercial CONDITION Excellent INTEGRITY	SECONDARY STRUCTURE NR SECOND
CURRENT USE Commercial HISTORIC USE	SECONDARY STROCTORE NIK SECOND
Commercial motorito del	
ARCHITECTU	URAL DESCRIPTION
ARCHITECTURAL CLASSIFICATION Contemporary DETAILS	BUILDING ALTERATIONS
CONSTRUCTION YEAR Circa 2000s OTHER YEAR	STOREFRONT FEATURES/STOREFRONT ALTERATIONS
	SIGNIFICANCE

DATE SOURCE WALL MATERIAL (CURRENT) Brick	CONTRIBUTING/NON-CONTRIBUTING Non-Contributing
WALL MATERIAL 2 (CURRENT) Stone PLAN Rectangular	BUILDING DESCRIPTION
NO OF STORIES 1 ROOF TYPE Flat	This building is of contemporary franchise design constructed with brick and
ROOF MATERIAL Undetermined FOUNDATION Concrete	stone with aluminum fixed windows, fabric awnings and yellow arch features installed at the roof line. A box with metal siding sits on top of the roof line hiding
PORCH WINDOW MATERIAL	the building's mechanical systems.
WINDOW MATERIAL 2 WINDOW TYPE	
WINDOW CONFIGURATION ARCHITECTURAL FEATURES

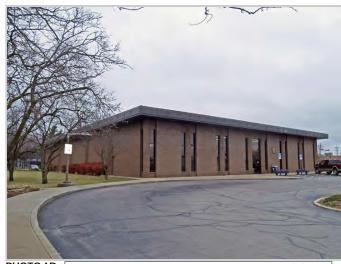
PHOTO ID: 0823333014-600EastLincolnHighway(1).jpg

BEGINNING STREET NUMBER	600
END STREET NUMBER	
STREET # SUFFIX	
STREET NAME	East Lincoln Highway
PIN	0823333014
LOCA	<u>.L</u>
WITHIN LOCAL DISTRICT? No	
LOCAL DIST CONTRIB/NON-CO	
LOCAL LANDMARK? No	
YEAR 🗌	
LOCAL LANDMARK ELIGIBLE?	П
CRITERIA 🗌	
	NATION
NR DISTRICT CONTRIB/NON-0	
	IR LANDMARK? No YEAR
1 110	
	GENERAI
CATEGORY Institutional - Gover	
	ENT USE Institutional - Government
HISTORIC USE	mstitutional - Government
III STOKIC USE	
	ARCHITECTI
ARCHITECTURAL CLASSIFICAT	
One Part Commercial Block - Cor DETAILS	ntemporary
	th protruding rectangular boxes in fascia; triple
faxed windows flank chamfered p	iers.
CONSTRUCTION YEAR Circa 19	
DATE SOURCE WALL I	MATERIAL (CURRENT) Brick
WALL MATERIAL 2 (CURRENT)	PLAN Rectangular
NO OF STORIES 1 1/2 ROO	F TYPE Flat ROOF MATERIAL
FOUNDATION PORCH	WINDOW MATERIAL aluminum
WINDOW MATERIAL 2	WINDOW TYPE Fixed
WINDOW CONFIGURATION	ARCHITECTURAL FEATURES
BUILDING ALTERATIONS	
STOREFRONT FEATURES/STOR	REFRONT ALTERATIONS

SIGNIFICANCE	
CONTRIBUTING/NON-CONTRI	BUTING Non-Contributing

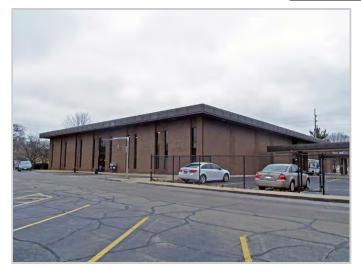
0823333014-600EastLincolnHighway(2).jpg

A spare rectangular one-part building housing the U.S. Post Office. The building is constructed in dark brown brick with paired narrow openings from a brick bulkheads to a brick panel just below the roof line puncturing the wall surface at regular intervals on all elevations; window openings are lined with a brick soldier course surround. The main entrance along the north elevation consists of aluminum double doors with an expansive transom above the door entries; an aluminum canopy crowns the roof line with the fascia lined with square panels. The roof canopy treatment is extended on the building's west elevation on two one-story covered walkways that serves as loading bays to the postal delivery truck. Other service bays are located on the building's south elevation.

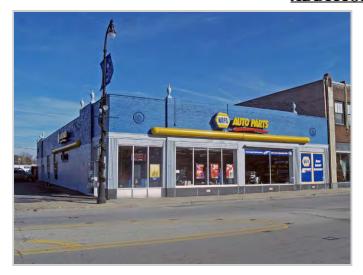
0823327008-607EastLincolnHighway(2).jpg

DEKALB, IL 60115-3808	
BEGINNING STREET NUMBER 607	
END STREET NUMBER	
STREET # SUFFIX	
STREET NAME East Lincoln Highway	
PIN 0823327008	
LOCAL	NAPA ANTO PARTS
WITHIN LOCAL DISTRICT? No	
LOCAL DIST CONTRIB/NON-CONTRIB	
LOCAL LANDMARK? No	
YEAR	
LOCAL LANDMARK ELIGIBLE? No	
CRITERIA 🗌	
	State of the state
	PHOTO ID: 0823327008-607EastLincolnHighway(1).jpg
	0023327000-007EastEineonin ngriway(17.jpg
	NATIONAL REGISTER
NR DISTRICT CONTRIB/NON-CONTRIB WITHIN DISTRICT? No NR LANDMARK? No YEAR	NR ELIGIBLE? No CRITERIA ALTERNATE ADDRESS?
	ENERAL INFORMATION TY Good SECONDARY STRUCTURE NR SECOND
ARCH	HITECTURAL DESCRIPTION
ARCHITECTURAL CLASSIFICATION Classical Revival	BUILDING ALTERATIONS
DETAILS	Brick and terra cotta painted, display Windows replaced, recessed corner entry infilled.
Terra cotta piers and details Storefronts: full size display Windows, Terra cotta base, piers and li	
originally had a recessed corner entry, wood doors	Terra cotta storefront bulkheads fluted piers have been painted.

CONSTRUCTION YEAR Circa 1930s OTHER YEAR	SIGNIFICANCE
DATE SOURCE WALL MATERIAL (CURRENT) Brick	CONTRIBUTING/NON-CONTRIBUTING Contributing
WALL MATERIAL 2 (CURRENT) Terra Cotta PLAN	BUILDING DESCRIPTION
NO OF STORIES 1 ROOF TYPE Flat	A one-part commercial building with Classical Revival features, including fluted pilasters/piers at the storefront level and urns placed above piers at the roof line.
ROOF MATERIAL Unknown (BUR) FOUNDATION Concrete	The building is constructed in brick with the exception of the storefront level
PORCH WINDOW MATERIAL	where the bulkheads are in terra cotta. The far west storefront bay was originally open serving as the entrance bay into the interior commercial space; the current
	bay has aluminum framing and bulkheads.
WINDOW MATERIAL 2 WINDOW TYPE ARCHITECTURAL FEATURE	DEC

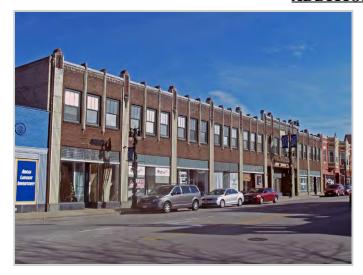
0823327003-637EastLincolnHighway(2).jpg

A significant building architecturally in downtown DeKalb, the Fargo Theater consists of a two-story commercial block wing with seven storefronts, the main theater entrance bay, and upper story apartments/offices; and the theater auditorium extending perpendicular to the eastern end of the commercial block. The building's south elevation is constructed in deep brown brick with storefronts divided by the terra cotta columns extending to the roof line. Storefronts contain a high level of integrity with terra cotta bulkheads, copper framing and Luxfer-type transom glass; storefronts also appear to retain their original doorways. On the upper facade, the fluted column piers define separate bays of three windows further divided by Gothic-inspired rib columns in cream-colored terra cotta. Windows are three-over-one double hung. Although the original marquee canopy has been removed, the theater entrance appears to be in its original configuration, although its glazing/transom area has been enclosed. The entrance to the second story apartments/offices is to the west of the theater entrance between two column piers.

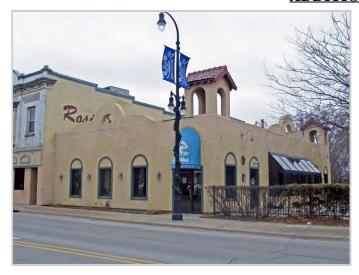
0823332019-642EastLincolnHighway(2).jpg

BEGINNING STREET NUMBER END STREET NUMBER STREET # SUFFIX STREET NAME East Lincoln Highway PIN LOCAL WITHIN LOCAL DISTRICT? NO LOCAL DIST CONTRIB/NON-CONTRIB LOCAL LANDMARK? NO YEAR LOCAL LANDMARK ELIGIBLE? NO CRITERIA	Ratio Carter Control of the Control	
	DHOTO ID: PORGES OF A 1977 WHILE A 1971 A 1971	
NIA TELONIA I	PHOTO ID: 0823332019-642EastLincolnHighway(1).jpg	
NR DISTRICT CONTRIB/NON-CONTRIB WITHIN DISTRICT? No NR LANDMARK? No YEAR	L REGISTER NR ELIGIBLE? NO CRITERIA ALTERNATE ADDRESS?	
CATEGORY Commercial CONDITION Excellent INTEGRITY SECONDARY STRUCTURE NR SECOND CURRENT USE Commercial HISTORIC USE		
ADCHITECTUD	A L DECCRIPTION	
ARCHITECTURAL ARCHITECTURAL ARCHITECTURAL ARCHITECTURAL ARCHITECTURAL ARCHITECTURAL CONSTRUCTION One Part Commercial Block - Neo Revival DETAILS CONSTRUCTION YEAR Circa 1960s - 1970s. OTHER YEAR DATE SOURCE WALL MATERIAL (CURRENT) EIFS WALL MATERIAL 2 (CURRENT) PLAN Square NO OF STORIES 1 ROOF TYPE Flat ROOF MATERIAL FOUNDATION Concrete PORCH WINDOW MATERIAL Aluminum Frame WINDOW MATERIAL 2 WINDOW TYPE Fixed WINDOW CONFIGURATION Multi Light ARCHITECTURAL FEATURES Spanish Revival-styled tower copulas on northwest and southwest corners of north and west elevations; arched pediment above roof line, north elevation. BUILDING ALTERATIONS STOREFRONT FEATURES/STOREFRONT ALTERATIONS SIGNIFICANCE CONTRIBUTING Non-Contributing	AL DESCRIPTION BUILDING DESCRIPTION A rectangular building designed in a Spanish Revival style with EIFS cladding painted in a sand color. Revival-styled copulas/bell towers with red clay-tiled roofs rise above the first floor roof line at the northwest and southwest corners of the building. On the first floor, window openings with blind top arches define the exterior rhythm on the north elevation extending to west elevation where an outdoor patio space has been installed. The blind arches are in EIFS; a band of silhouette arches rises above the windows and differentiated in a different shade of sand color. The main entrance on the north elevation features two aluminum doors with a fabric canopy within an arched frame above. It is unclear if this is a latter alteration to a building that may have been constructed post 1950.

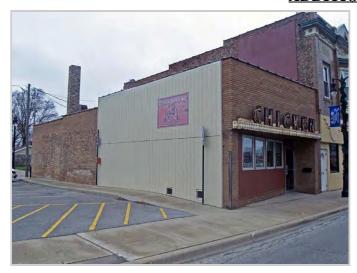
0823332009-644EastLincolnHighway(2).jpg

DEKALB, IL 60115	
BEGINNING STREET NUMBER 644	
END STREET NUMBER	
STREET # SUFFIX	
STREET NAME East Lincoln Highway	A the
PIN 0823332009	
LOCAL	
WITHIN LOCAL DISTRICT? No	
LOCAL DIST CONTRIB/NON-CONTRIB	
LOCAL LANDMARK? No	OTH SON'S MEET CLOSE.
YEAR	The same of the sa
LOCAL LANDMARK ELIGIBLE? No	
CRITERIA 🗌	
	PHOTO ID: 0823332009-644EastLincolnHighway(1).jpg
NAT	IONAL REGISTER
NR DISTRICT CONTRIB/NON-CONTRIB	
WITHIN DISTRICT? No NR LANDMARK? NO YEAR	NR ELIGIBLE? No CRITERIA ALTERNATE ADDRESS?
CENE	RAL INFORMATION
CATEGORY Commercial CONDITION Excellent INTEGRITY GO	SECONDARY STRUCTURE NR SECOND
CURRENT USE Commercial HISTORIC USE Commercial	
ARCHITE	CTURAL DESCRIPTION
	STOREFRONT FEATURES/STOREFRONT ALTERATIONS
ARCHITECTURAL CLASSIFICATION One Part Commercial - Mid Century Vernacular	Storefront glazing pattern altered with vertical wood siding that partially encloses
DETAILS	the original storefront opening.
Tile coping joints at roof line; neon lighted sign with bulb band above store	efront SIGNIFICANCE SIGNIFICANCE

in poor condition; slanted storefront, wire cut brick facade. CONSTRUCTION YEAR Circa 1900s/1950s. OTHER YEAR	CONTRIBUTING/NON-CONTRIBUTING Contributing BUILDING DESCRIPTION
DATE SOURCE	A one-story late 1940s-Mid-Century vernacular commercial building constructed
Sanborn Maps; 1990 DeKalb CBD Architectural and Historical Survey.	in brown brick. The building features a slanted storefront, although its original
WALL MATERIAL (CURRENT) Brick	opening has been altered with vertical board siding. Above the storefront is the building's distinctive marguee-type lighted metal canopy with a neon lettered
WALL MATERIAL 2 (CURRENT) PLAN Rectangular	"Chicken" sign above. The metal canopy is rusting, as well as the neon sign, are in
NO OF STORIES 1 ROOF TYPE Flat ROOF MATERIAL	poor condition. The building is entered through an aluminum door. It is unclear whether this building dates from the 1940s or 1950s as entirely new construction,

FOUNDATION PORCH WINDOW MATERIAL Vinyl	or is an alteration of older building dating from much earlier. The 1990 DeKalb
WINDOW MATERIAL 2 WINDOW TYPE Fixed	CBD Architectural and Historical Survey documents the building as being of circa 1900 construction.
WINDOW CONFIGURATION	
ARCHITECTURAL FEATURES	
Distinctive neon sign with lighted canopy above storefront.	
BUILDING ALTERATIONS Word siding installed on east elevation adjacent to parking lot.	
1
