## HISTORIC ILLINOIS BUILDINGS SURVEY

### HARVEY FARMSTEAD (Overside Farm)

HIBS No. KE-2026-1

**Location:** 16929 North Ridge Road, Minooka, Seward Township, Kendall County, Illinois, 60447

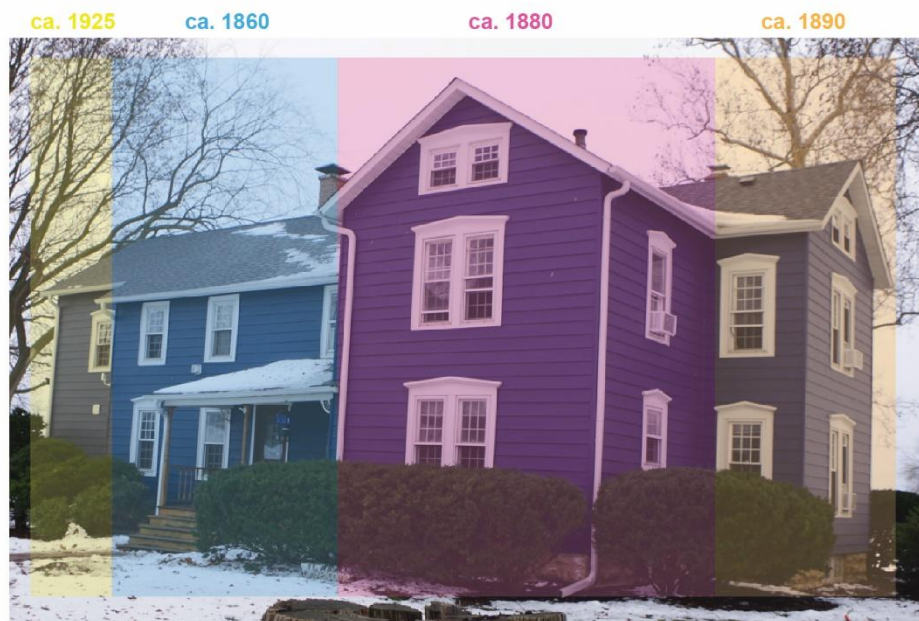
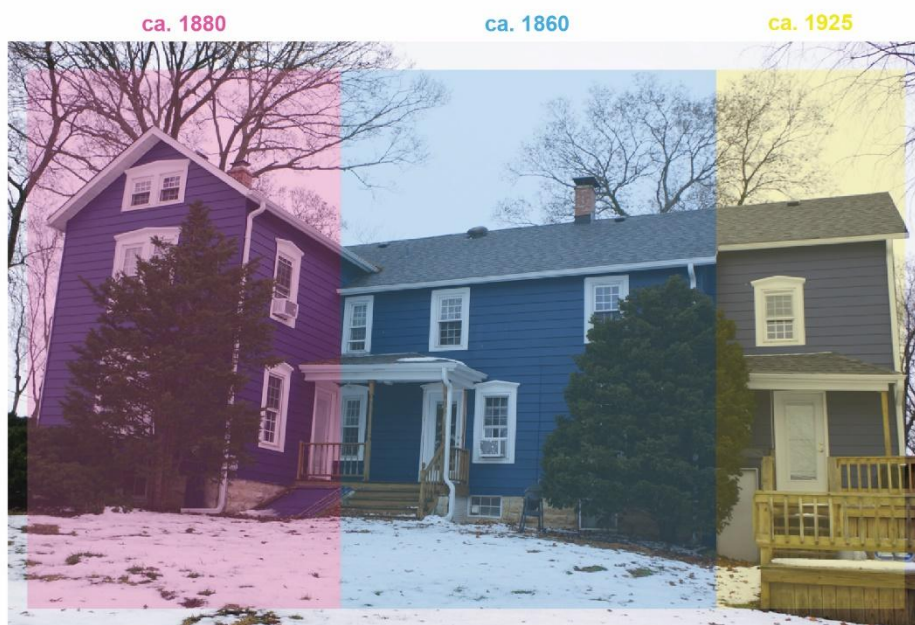
**HARVEY FARMSTEAD**  
**BUILDING CHRONOLOGY**  
Dwelling

ca. 1880: A two-story addition at the west side of the ca. 1860 volume forming a T-shaped plan.

ca. 1890: Additional dwelling expansion in the form of a two-story, two-bay addition that increased the size of the living space.

ca. 1925: Dwelling modernization in the form of a two-story, gabled addition that created additional living space at the rear of the house.

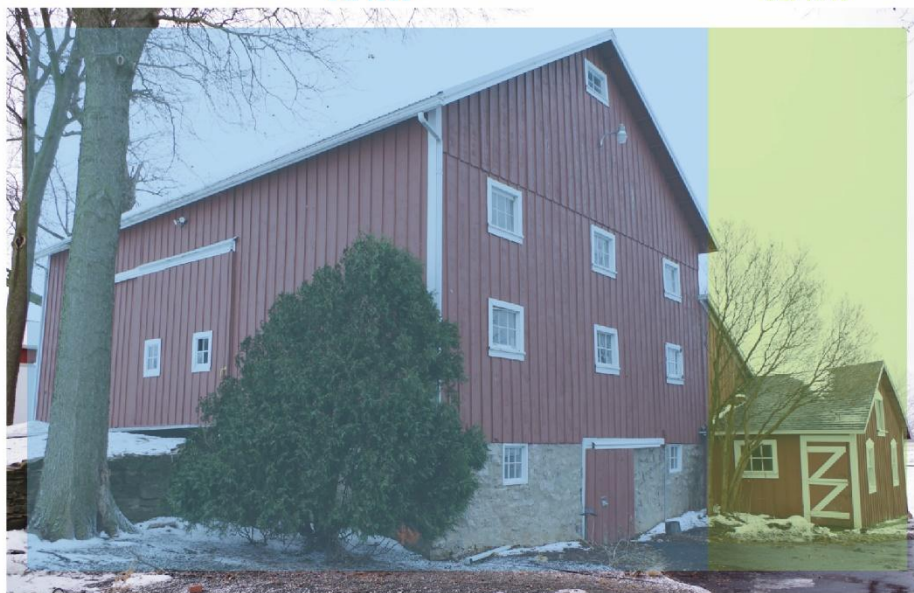
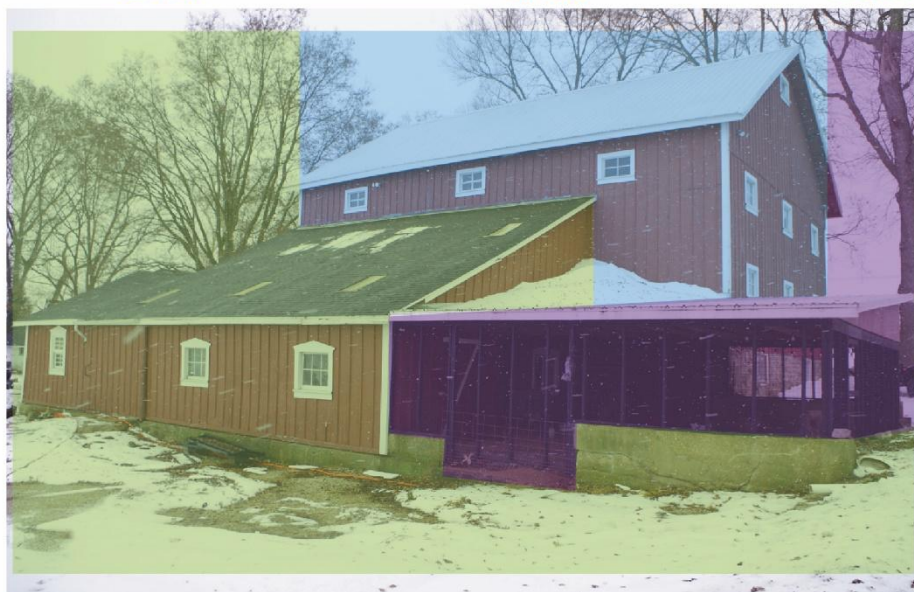
**HARVEY FARMSTEAD**  
**BUILDING CHRONOLOGY**  
Barn

ca. 1940: Major barn additions at the east side to expand capacity, consisting of a shed-roofed wing with a gabled extension at its south elevation.

1983–1998: Loss of agricultural fabric through demolition of the eastern wing of the barn. Historic aerial imagery shows the barn complex with a larger eastern footprint in the late twentieth century that was demolished between 1983 and 1998.

ca. 2005: Chicken coop addition. The frame structure appears to rest on an earlier foundation that likely corresponds to a portion of the barn wing that was demolished between 1983 and 1998.

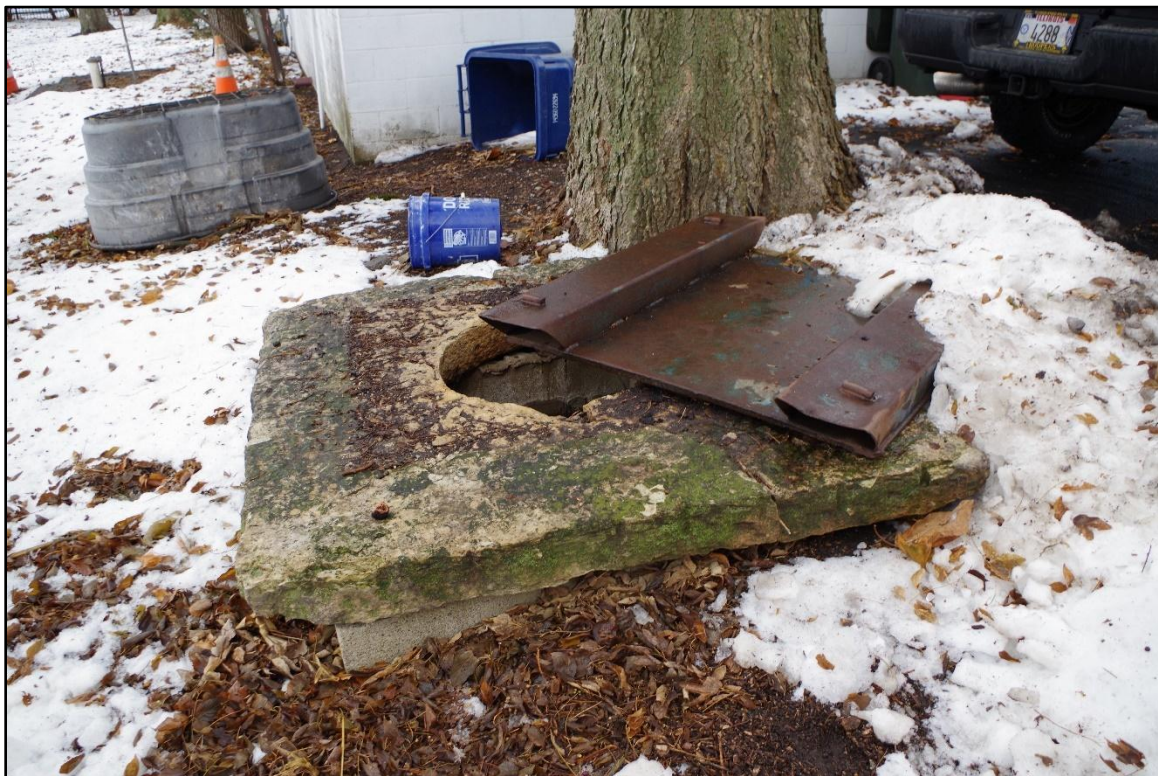
A limestone-lined cistern positioned between the house and barn supplied water for domestic and farm use, reinforcing the functional relationship between the two principal buildings. Additional outbuildings may have been present on the farmstead during its early history, and later buildings, including the ca. 1910 cold storage building and a ca. 1945 concrete block garage, were integrated into the historic layout.

*Photograph 12: View of the ca. 1860 cistern, camera facing south. December 2025.*

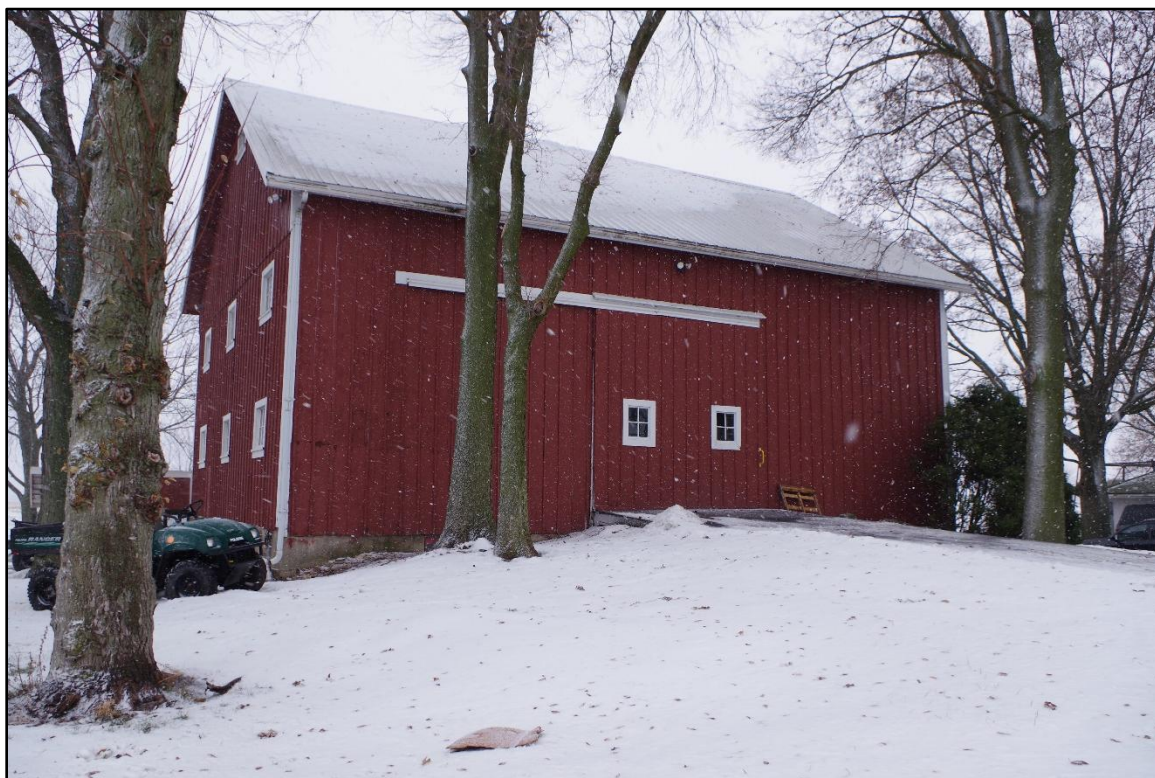
The barn retains its original ca. 1860 core and mid-twentieth-century additions, and the limestone foundation shows stabilization at the front wall. The exterior wood siding appears to date to the mid-to-late twentieth century and exhibits typical weathering consistent with age. The cold storage building, garage, cistern, and windpump base remain extant and in similar, aged condition.

The barn rests on a continuous masonry foundation of uncoursed, roughly square limestone units. The front (west-facing) foundation wall was replaced by a mix of cast-in-place concrete (at the north end) and concrete masonry units.

*Photograph 14: View of the barn, camera facing northeast. December 2025.*

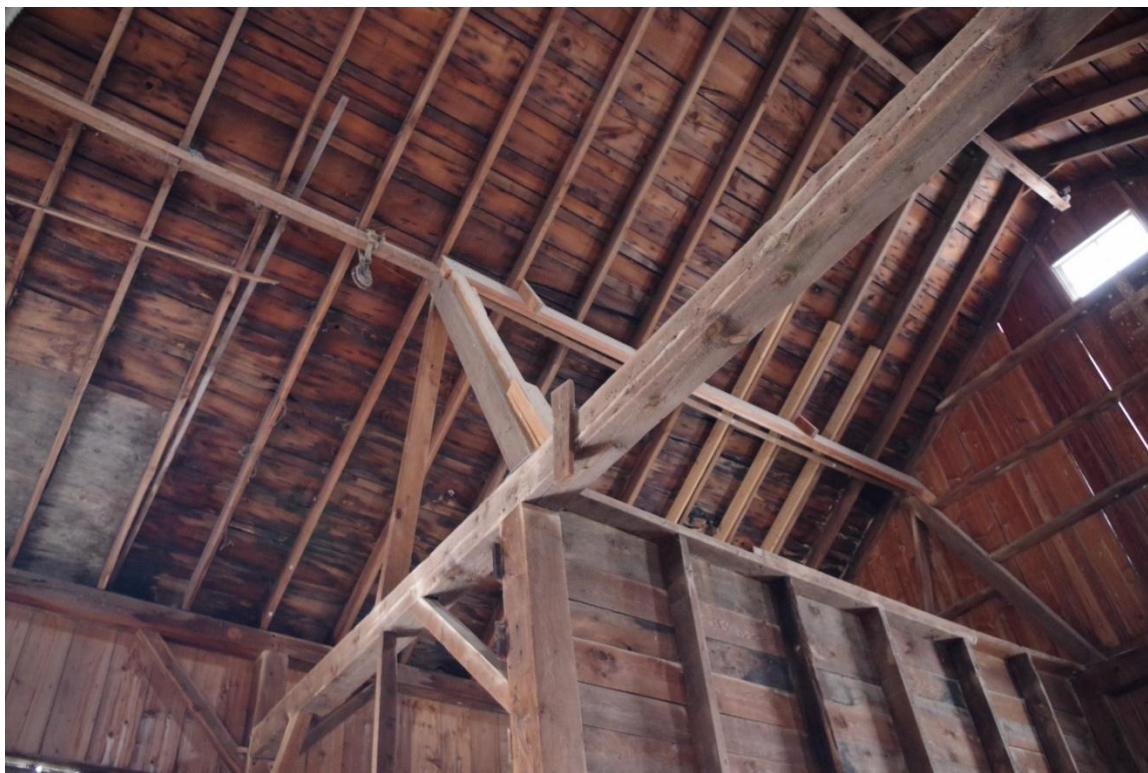
beam structure. The masonry foundation walls and heavy timber posts carry timber beams and rafters to support the upper plank floors. Interior stalls were constructed by attaching wood board partitions to interior timber posts. The later additions were constructed using dimensional lumber. Many areas of the interior framing have been replaced with or reinforced by non-historic dimensional lumber. The roof framing uses common rafters and board sheathing.

*Photograph 39: View of barn interior, truss detail from second level, looking northwest.*

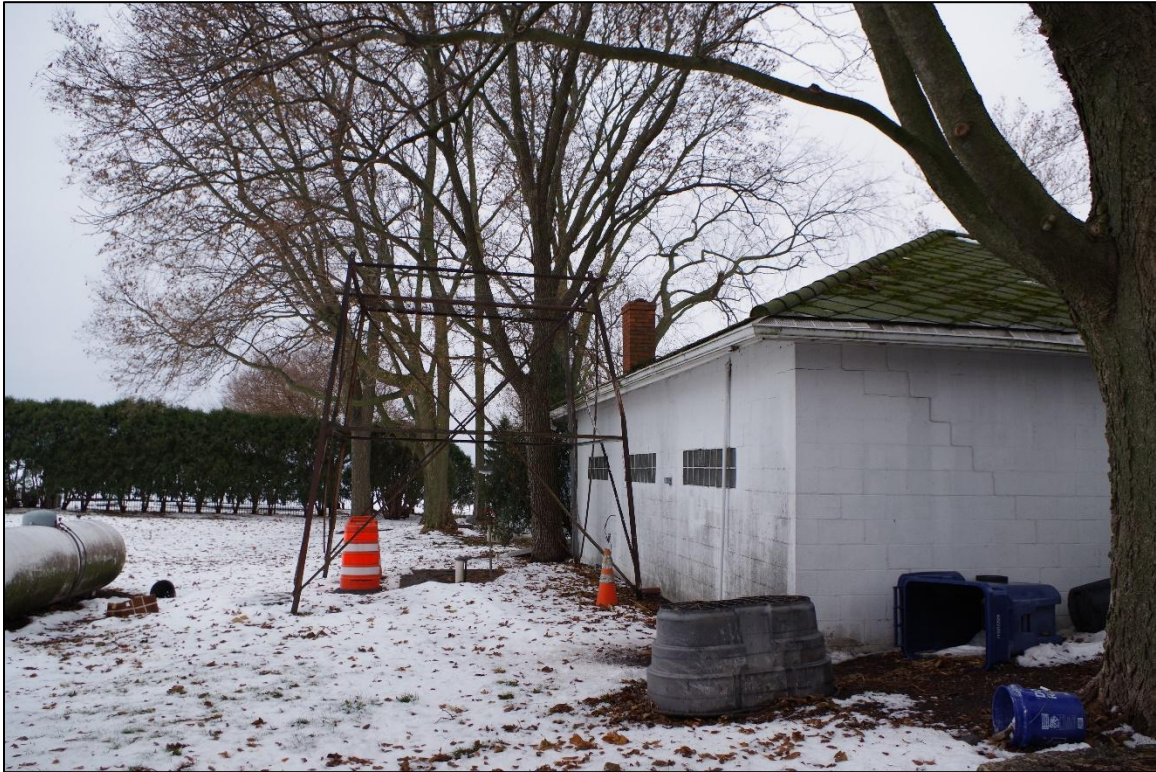
ca. 1930: Installation of the Aeromotor wind pump, adding mechanized water infrastructure in keeping with improving technology.

*Photograph 43: View of the Aeromotor windpump base, camera facing south.*

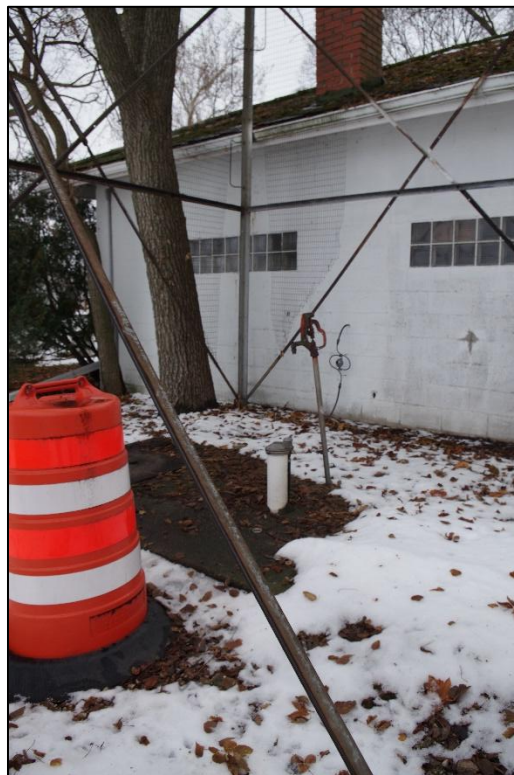
*Photograph 44: View of windpump base, detail showing later pump and concrete slab, camera facing southwest.*

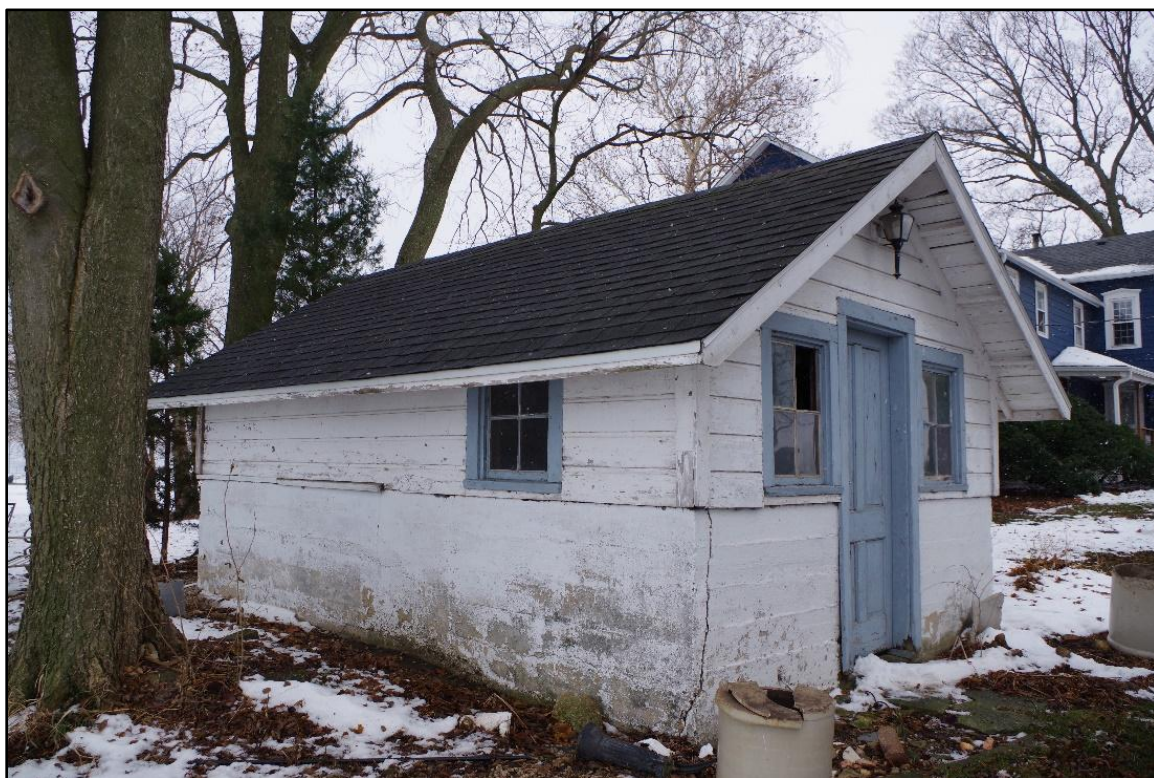
The cold storage building rests on a cast-in-place, board-formed concrete foundation that extends nearly a story below grade at the south half of the building to form a subterranean storage chamber. The concrete foundation walls extend approximately 3 feet above grade and support an upper frame wall structure.

The windows on the cold storage building are a mix of original, fixed, four-light wood windows on the north, east, and west elevations and a larger, six-over-six vinyl replacement unit on the south elevation. The windows on the north, east, and west elevations provide light to the entry room interior, while the much larger window on the south elevation lights the storage chamber.

*Photograph 51: View of the cold storage building, looking southwest.*
