Williamson House  
Lot 6, Block 1  
Original Town of Evansville  
Randolph County  
Illinois

IL HABS No. R-1996-2

WRITTEN HISTORICAL AND DESCRIPTIVE DATA

WILLIAMSON HOUSE

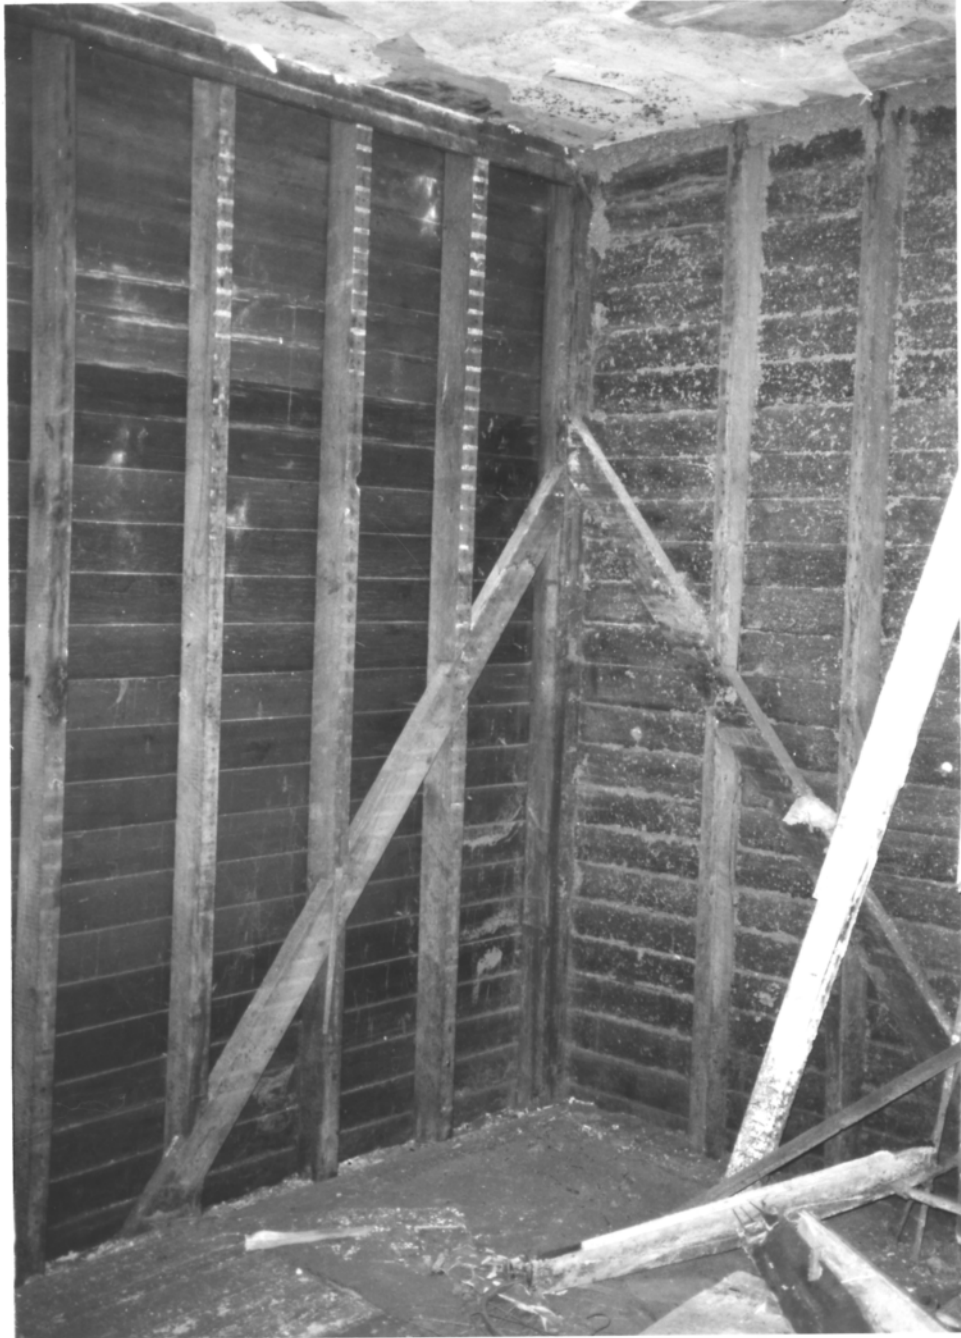
WILLIAMSON HOUSE  
IL HABS No. R-1996-2.12

- R-1996-2.11 Interior view of the Williamson House, showing chimney and cupboard details located in the rear addition.
- R-1996-2.12 Interior view of the Williamson House, showing balloon frame construction details with inlet knee braces.
- R-1996-2.13 View of entrance to the root cellar at the Williamson House.
- R-1996-2.14 View of frame outbuilding at the Williamson House.
