Barber-Colman Buildings 10, 17 & 19
City of Rockford
Winnebago County
Illinois

PHOTOGRAPHS
WRITTEN HISTORICAL AND DESCRIPTIVE DATA
SUPPLEMENTAL MATERIALS

**HISTORIC AMERICAN BUILDING SURVEY
BARBER COLMAN BUILDINGS 10, 17 & 19**

IL HABS No. WO-2004-01C
IL HABS No. WO-2004-01D
IL HABS No. WO-2004-01E
(Page 1)

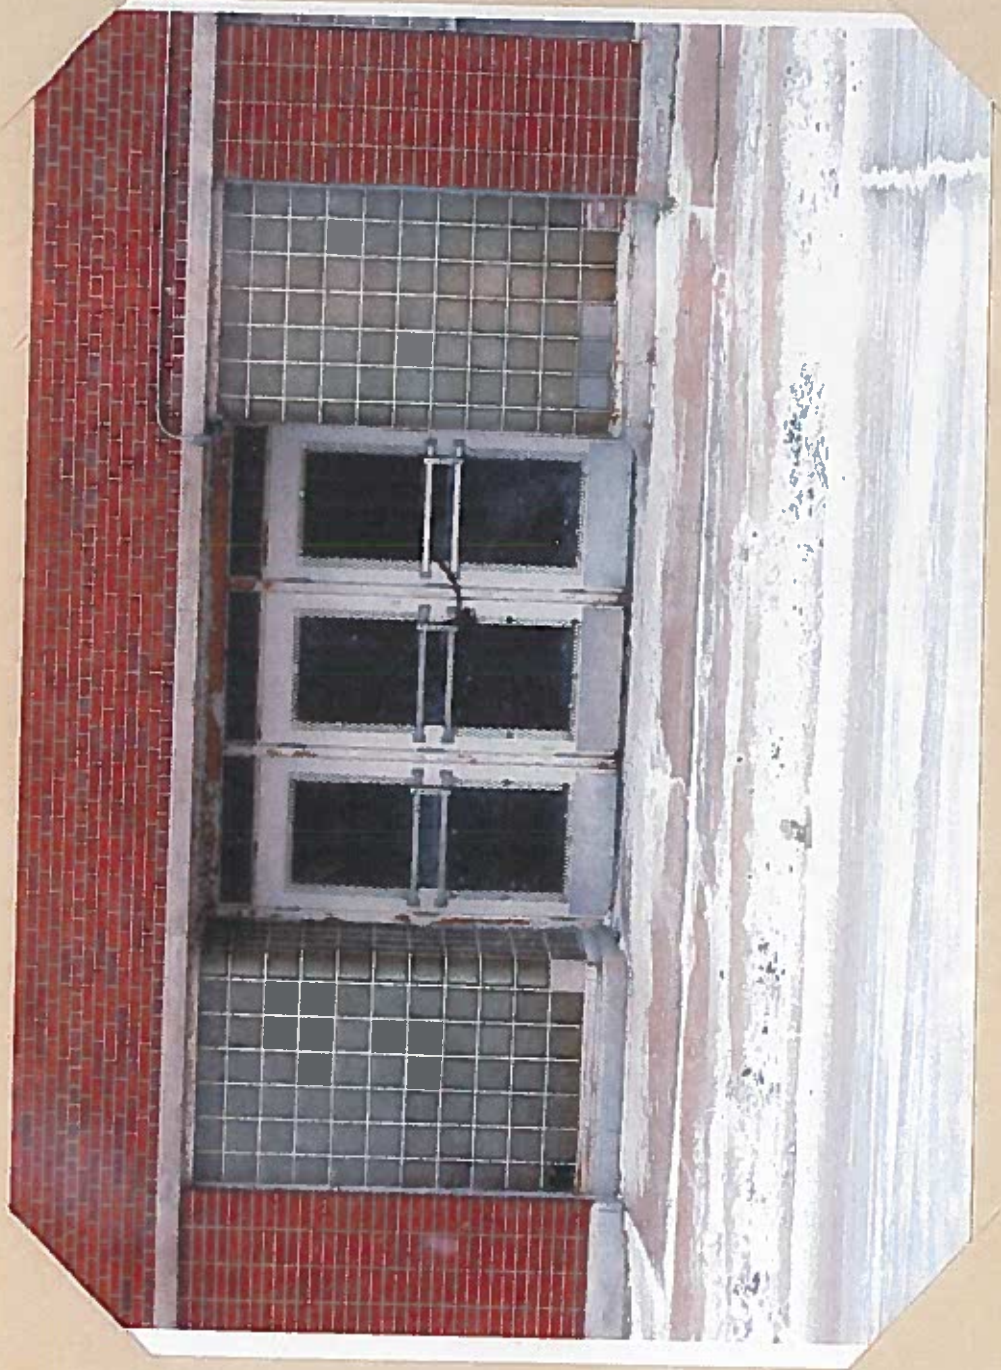
IL HAB'S No WO-2004-01C.18
SEE INDEX OF PHOTOGRAPHS
FOR CAPTION

WO-2004-01C.18	Close-up of employee entrance on west façade
WO-2004-01C.19	Close-up of main (southern) entrance on west façade

The main front entry is in the center bay and is one of the most significant features in the building. It contains Art Deco elements, specifically stacked bond brickwork piers that step inward to highlight the entrance. (See photograph WO-2004-01C.19.) There is a second entry in the second bay from the north. This has three recessed metal entry doors and three narrow rectangular transoms above. Full height glass block walls curve inward at the corners to accentuate this second entrance, shown in photograph WO-2004-01C.18.

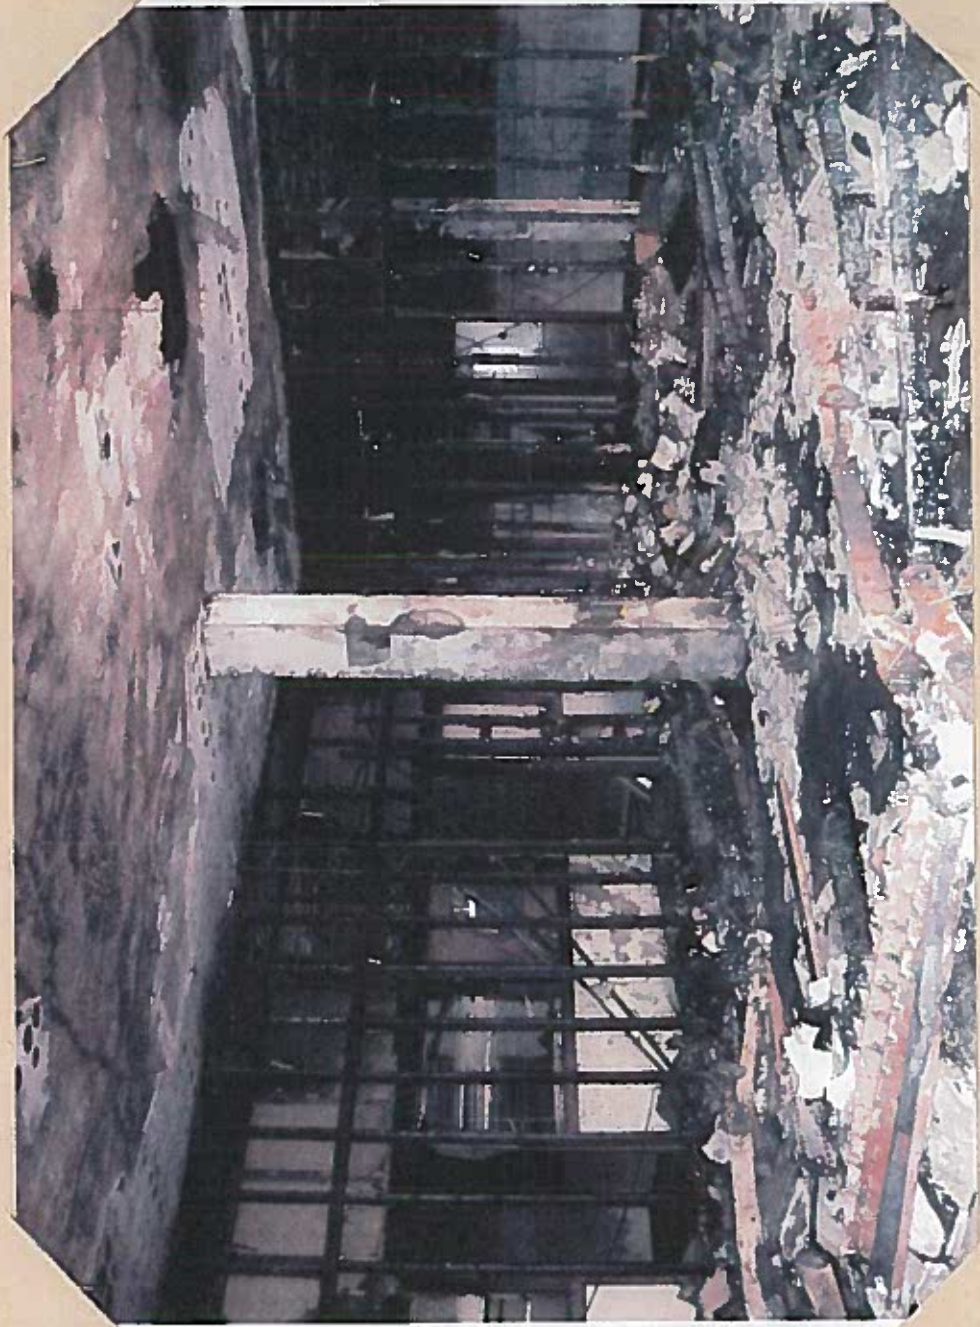
IL HAB5 No. WD-2004-0K, 35
SEE INDEX TO PHOTOGRAPH:
FOR CAPTION

6. Decorative features and trim: Other than the stainless steel on the escalators, the only attempt at any sort of decorative trim appears to be the paneling added inside the north entrance. Unfortunately the decorative parts of the Motostair escalator have been stripped by scavengers. A photo of this as it was is on page 52 of the National Register nomination for Barber-Colman. Its current appearance is shown in photograph WO-2004-01C.35.
