**NATIONAL REGISTER OF HISTORIC PLACES
ASSESSMENT OF THE
VALENTINE SITE (11MO954),
ILLINOIS CAVERNS STATE NATURAL AREA,
RURAL MONROE COUNTY, ILLINOIS**

ARCHAEOLOGICAL TESTING SHORT REPORT

Project type/title: National Register Assessment of the Valentine Site (11MO954),
Illinois Caverns State Natural Area

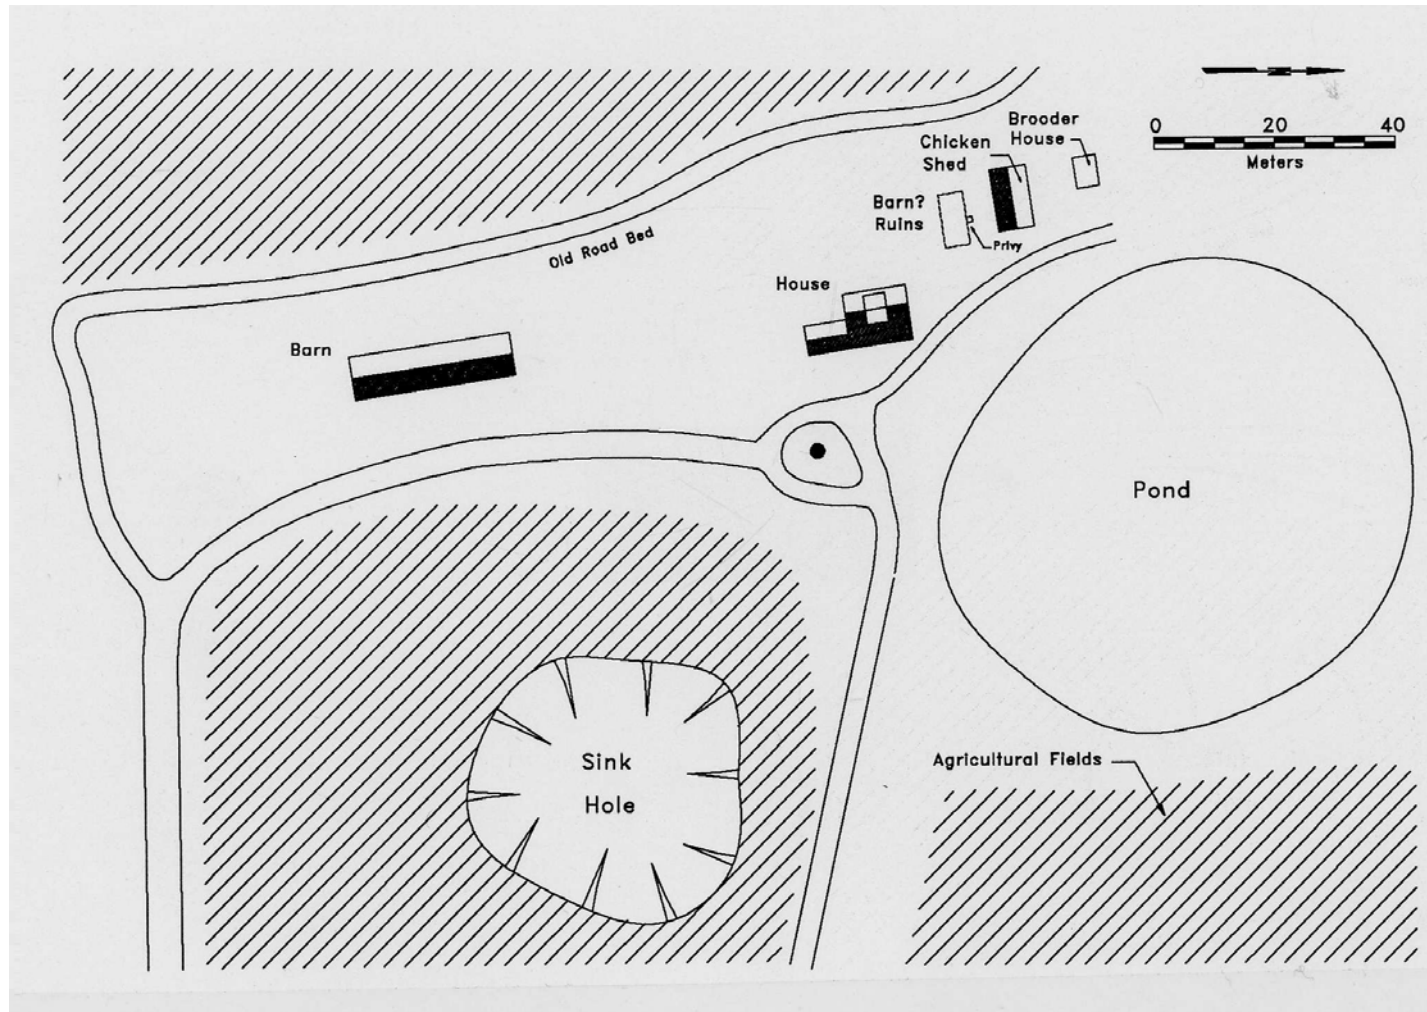
Figure 2. The Valentine Site plan.

The site limits of the Valentine Site consist of an area encompassing approximately 18 meters around the house. Contributing elements of this archaeological site include the remains of the house, the cistern, and the well. Collectively, these contributing elements have given us insights into the domestic housing requirements of the middle-nineteenth century, German-immigrant family in western Monroe County. Detailed architectural drawings (consisting of basement plan, first floor plan, second story plan, and sectional view) of the Valentine House, as well as notes on the unfilled cistern and well, have been prepared for the Valentine Site.

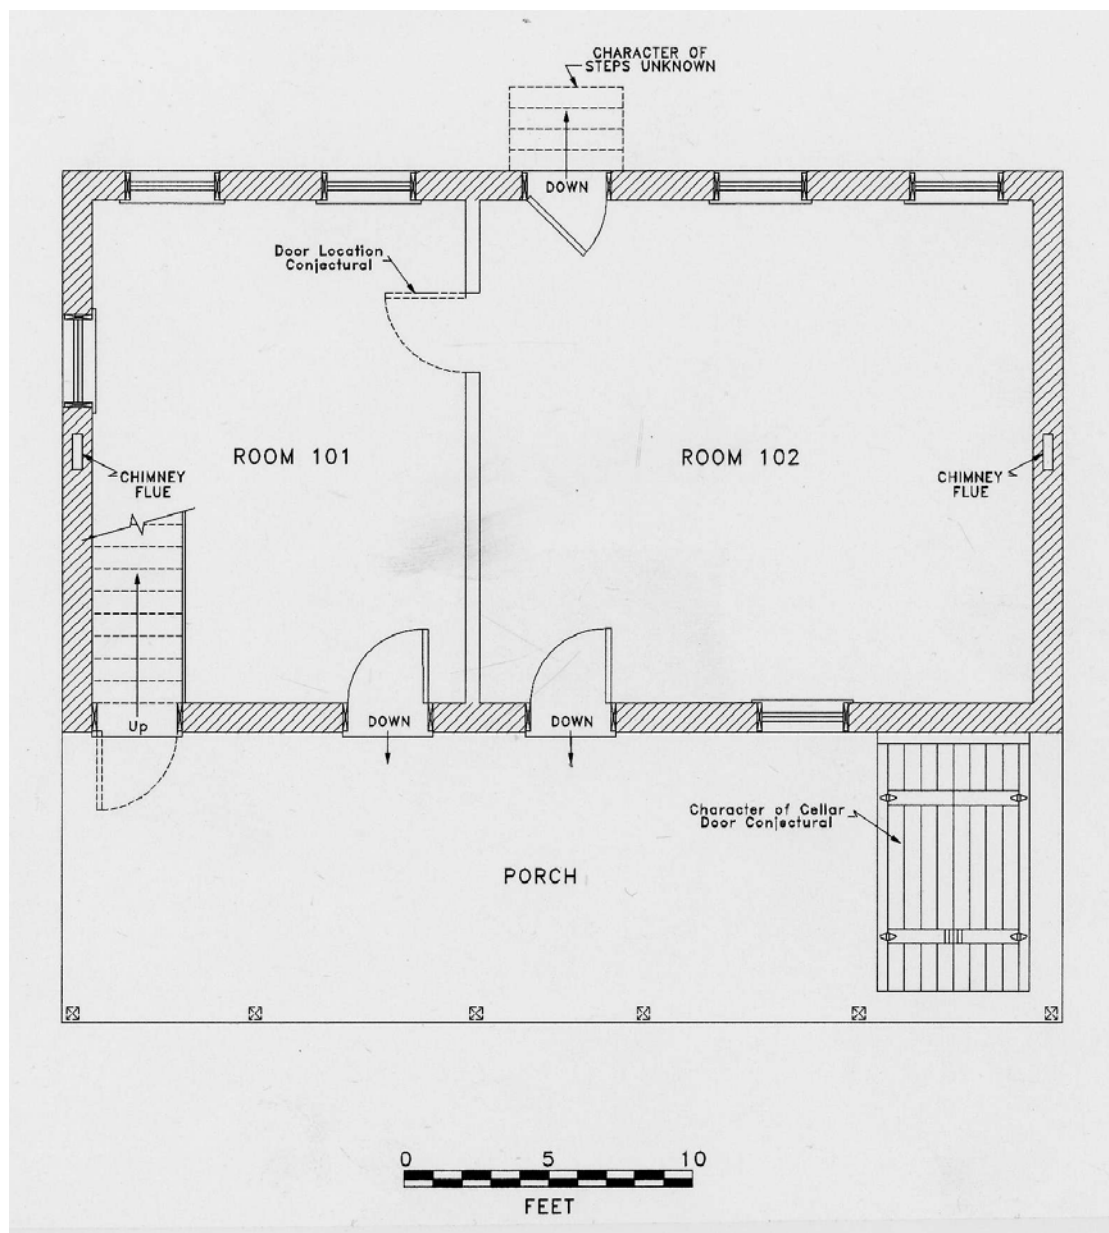
Figure 8. First floor plan of the Valentine House as originally constructed (ca. 1855).

A close examination of the wall and ceiling surfaces on the first floor of the house reveals that there have been three generations of partition walls separating the two rooms there. As originally constructed, the southern of the two rooms (Room 101) measured 17'-10" (east/west) by 13'-10" (north/south). This room was lit by two windows in its west wall and by a third window on the south. A plank partition in the southeast corner of the room enclosed a stairway leading to the upper floor of the house; this stairway was accessed via an exterior doorway off the rear porch, rather than the interior of the house. Room 101 had two doorways, one of which was located in its east wall and accessed the rear porch. A second doorway was located in its north wall and allowed access to the northern room on the first floor (Room 102), which was larger and measured 17'-10"x19'-5". Room 102 could be entered from the outside through the formal entrance on the house's west side, as well from the rear porch. It had two windows in its west wall and a single window on the east. The walls of both first floor rooms were plastered, but their ceilings were left unfinished except for a coat of whitewash applied over the exposed ceiling joists. Each room had a chimney flue in their respective gable-end wall for a stove.

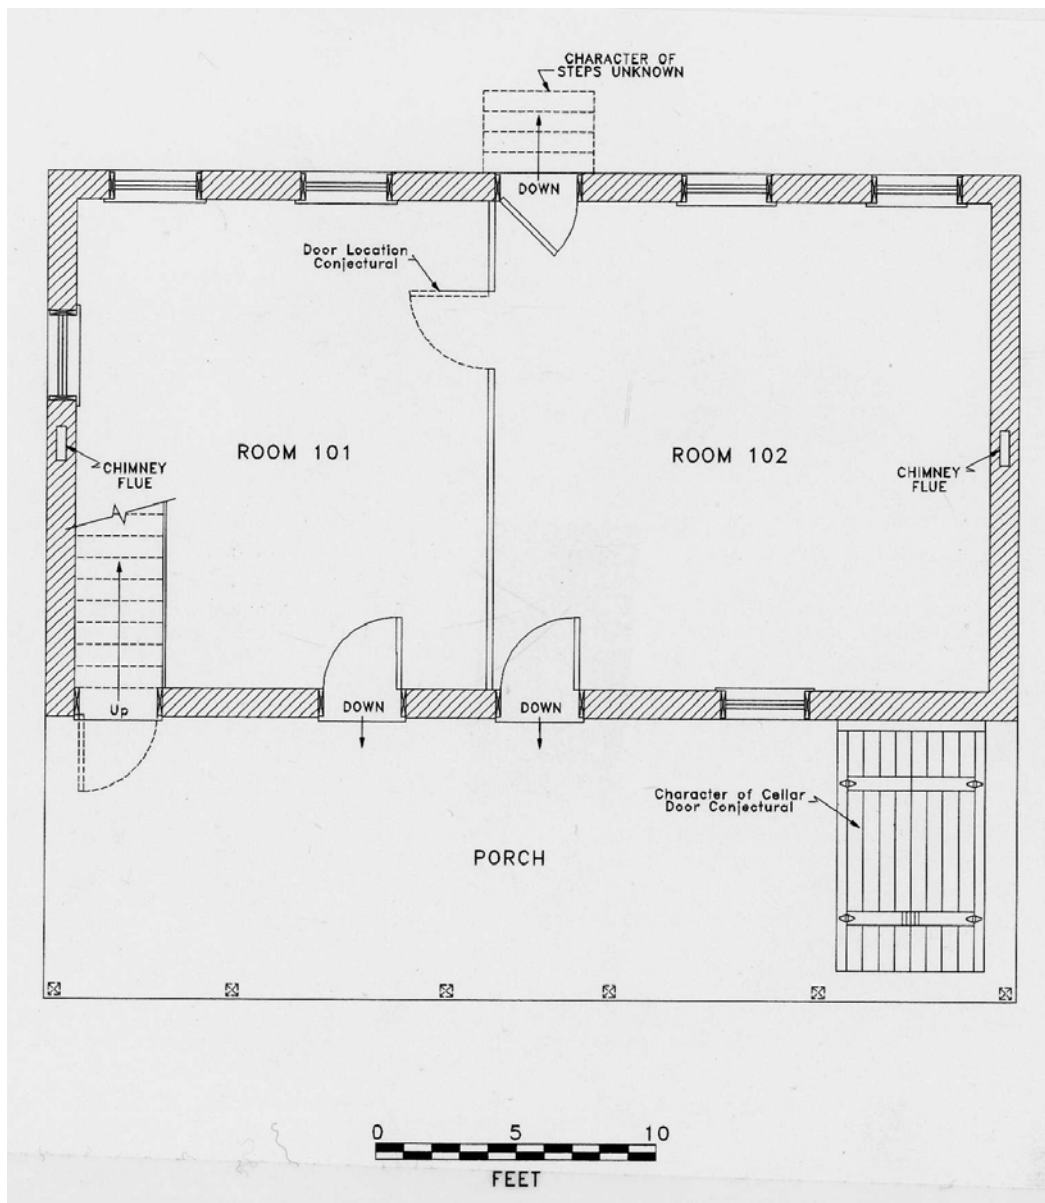
Figure 9. First floor plan of the Valentine House, showing alteration to partition wall (ca. 1875).

During the middle to late nineteenth century, the partition wall between Rooms 101 and 102 was removed and moved a short distance to the north, nearly abutting the front doorway. This alteration expanded Room 101's dimensions to 17'-10"x14'-10" and reduced Room 102's to 17'-10"x17'-11". The exact function of either of these rooms during the nineteenth century is unknown, although it's likely that one room served as a multi-purpose dining room, kitchen, and living room, while the other functioned as a master bedroom. Given the larger size of Room 102, it's possible that it served as the multi-purpose kitchen. Either room, however, could have served this purpose since they both had direct access to the rear porch. The rear porch during this period was open and would have served as an ancillary work area. A bulkhead entrance at the north end of the porch allowed access to a cellar located beneath the house proper. The cistern and well were located off the south end of the porch.

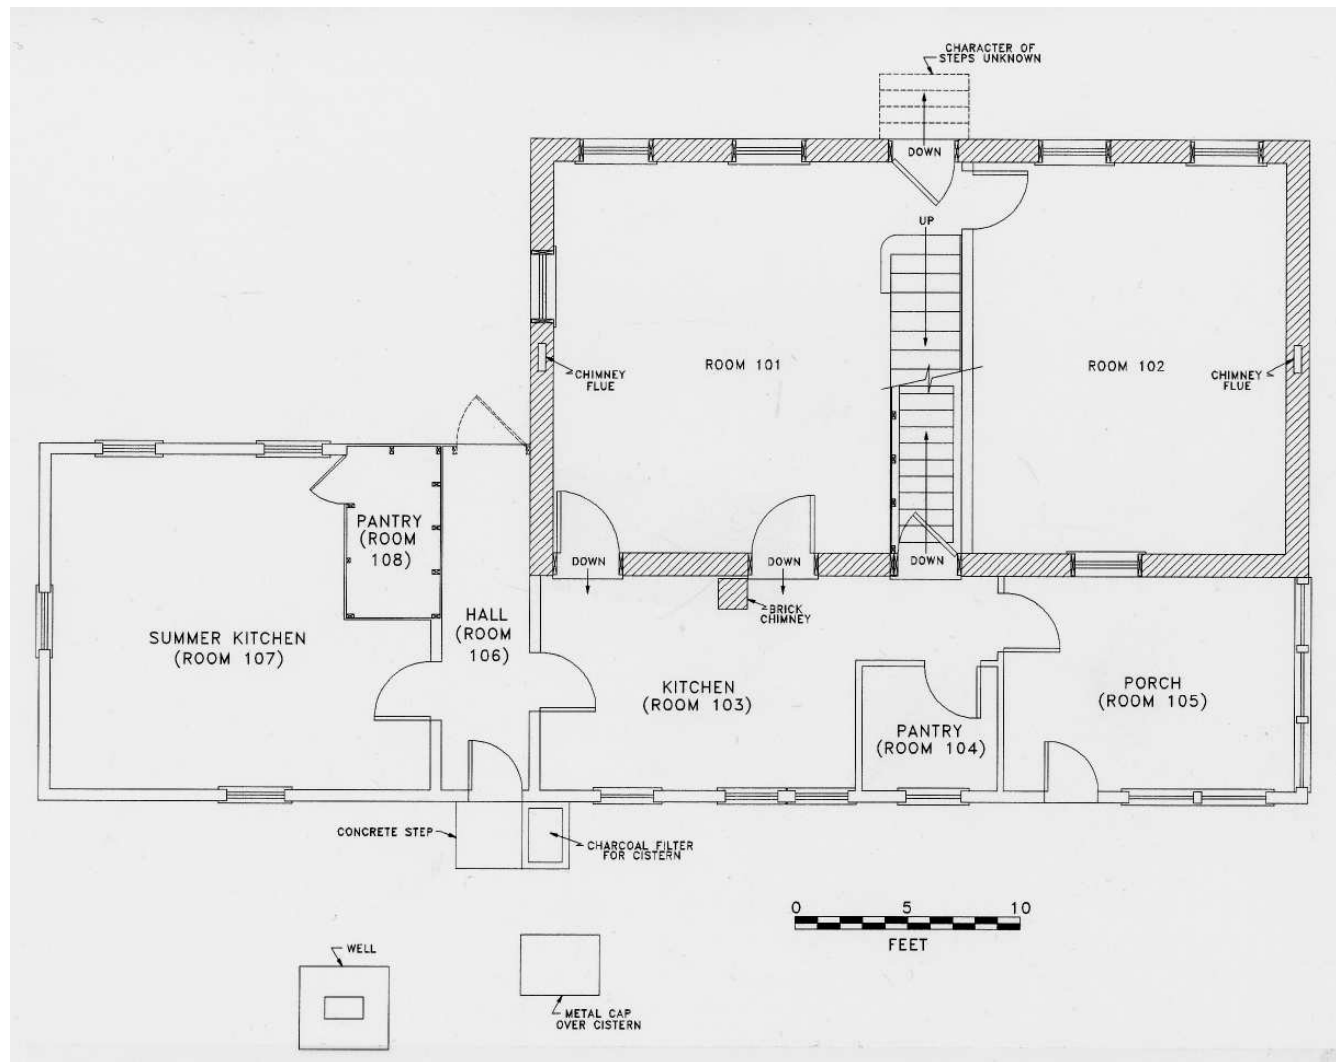
Figure 10. First floor plan of the Valentine House, showing early twentieth century additions (ca. 1925)

The Valentine House took on its present appearance during the early twentieth century (ca. 1910-1925) when it was heavily remodeled. As part of this remodeling, the dividing wall between Rooms 101 and 102 was removed, and a new partition wall was built several feet to the north—to the other side of the front door. This alteration enlarged Room 101 to its present 17'-10"x18'-5", while reducing Room 102 to 17'-10"x14'-10". Contemporary with this alteration was the construction of the present stairway leading to the second floor, which is open and rises from west to east, along the east side of Room 101. When this stairway was constructed, the original stairway in the southeast corner of Room 101 was removed. The ceiling height in Rooms 101 and 102 is 8'-8".

Around the same time Rooms 101 and 102 underwent their final remodeling, the rear porch was framed in and was divided into three rooms. The largest of these rooms (Room 103) is a modern kitchen located at the south end of the porch. The main area of the kitchen measures 9'-7"x14'-4" and is lit by three windows on its east side. A brick chimney situated along the west wall of the kitchen presumably vented a cooking stove at one time, but has most recently vented a oil burning heater. The chimney stack has been removed below the roof level. A short, 3'-9"x 6'-5" hallway off the north end of the kitchen allows access to the two other rooms on the rear porch. To the east of the hall is a 5'-8"x6'-2" room (Room 104) that may have originally served as a pantry. This small room has a single window in its east wall. The room at the north end of the rear porch (Room 105) measures 9'-11"x13'-4" and is lit by grouped awning windows on the north and east. An exterior door is located on the room's east side. The original function of Room 105 is unknown, but it is possible that it served as an enclosed porch. Most recently, the room has been used as a work room. A work bench with a vise is located along the west side of the room. Shelving is found on the south. The ceiling height on the rear porch is 7'-6".

Another alteration that was made to the Valentine House during the early twentieth century was the construction of a frame summer kitchen on the south side of the dwelling. The summer kitchen addition is divided into three rooms and is accessible from Room 103. The first room entered is a 3'-11" wide hallway (Room 106). This hall has an exterior door on its west side and may have also once had an exterior doorway on the west; if so, the hall would have functioned as a breezeway separating the main house from the summer kitchen. The west end of the hall is currently framed in and has shelving built across the opening. An interior doorway on the south side of the hall leads into the summer kitchen proper (Room 107), which is an L-shaped room that measures 15'-5"x17'-5" at its widest points. As originally constructed, Room 107 had two windows on its side, one window each on the south and east. There is evidence of a stove flue passing through the roof above the southwest corner of the room. During the middle to late nineteenth century, Room 107 was turned into a garage—a modification that involved the removal of 8' of the south wall for the large garage door. A wood or junk bin has been erected along the west wall of the room. The third room in the summer kitchen addition is a 7'-9"x4'-4" room that is suspected to have once functioned as a pantry (Room 108). This room was originally accessible through a doorway from Room 107. This doorway was sealed off, however, when the latter room was converted into a garage or after the bin was installed. Room 108 is currently entered through a new doorway that has been constructed between it and the hall.

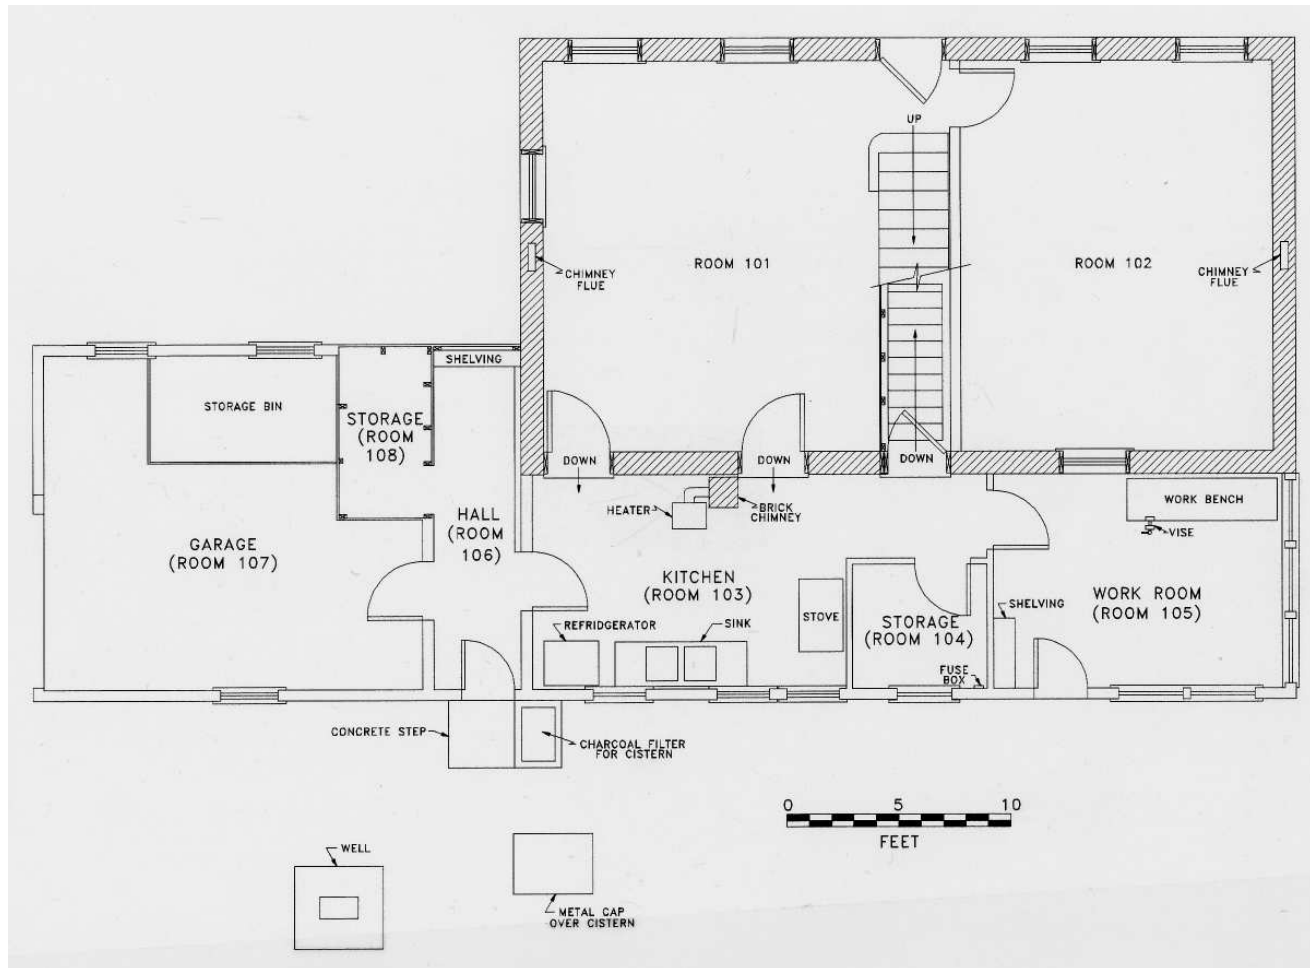
Figure 11. First floor plan of the Valentine House, illustrating present condition.

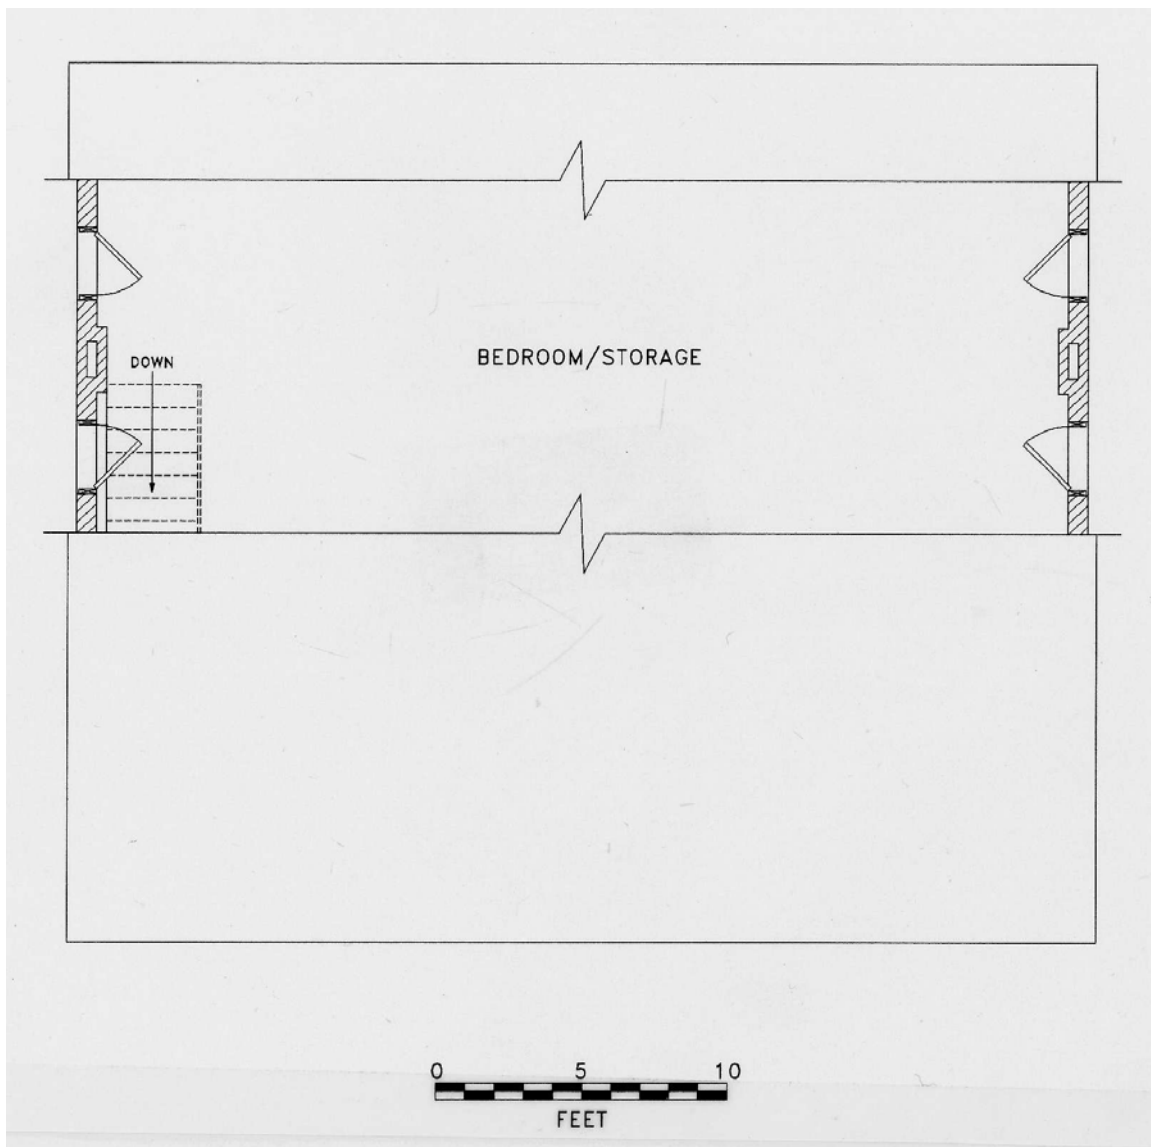
Figure 12. Second floor plan of the Valentine House as originally constructed (circa 1855).

from east to west along the south gable end of the house and opened onto a single, unpartitioned room on the second floor. Two casement windows were located at each gable end, flanking the chimneys. When the present stairway was installed during the early twentieth century, its opening on the second floor was enclosed with a studded beadboard partition. This partition wall roughly divides the floor into east and west halves, although access between them is unrestricted on the west. The stairway ends at a landing that has doorways on the north and south. The second floor has also been altered by the addition of two large, shed roof dormers. These dormers are located on opposite slopes of the roof and have three windows each. Throughout the history of the house, the second floor has been used as bedroom and storage space.

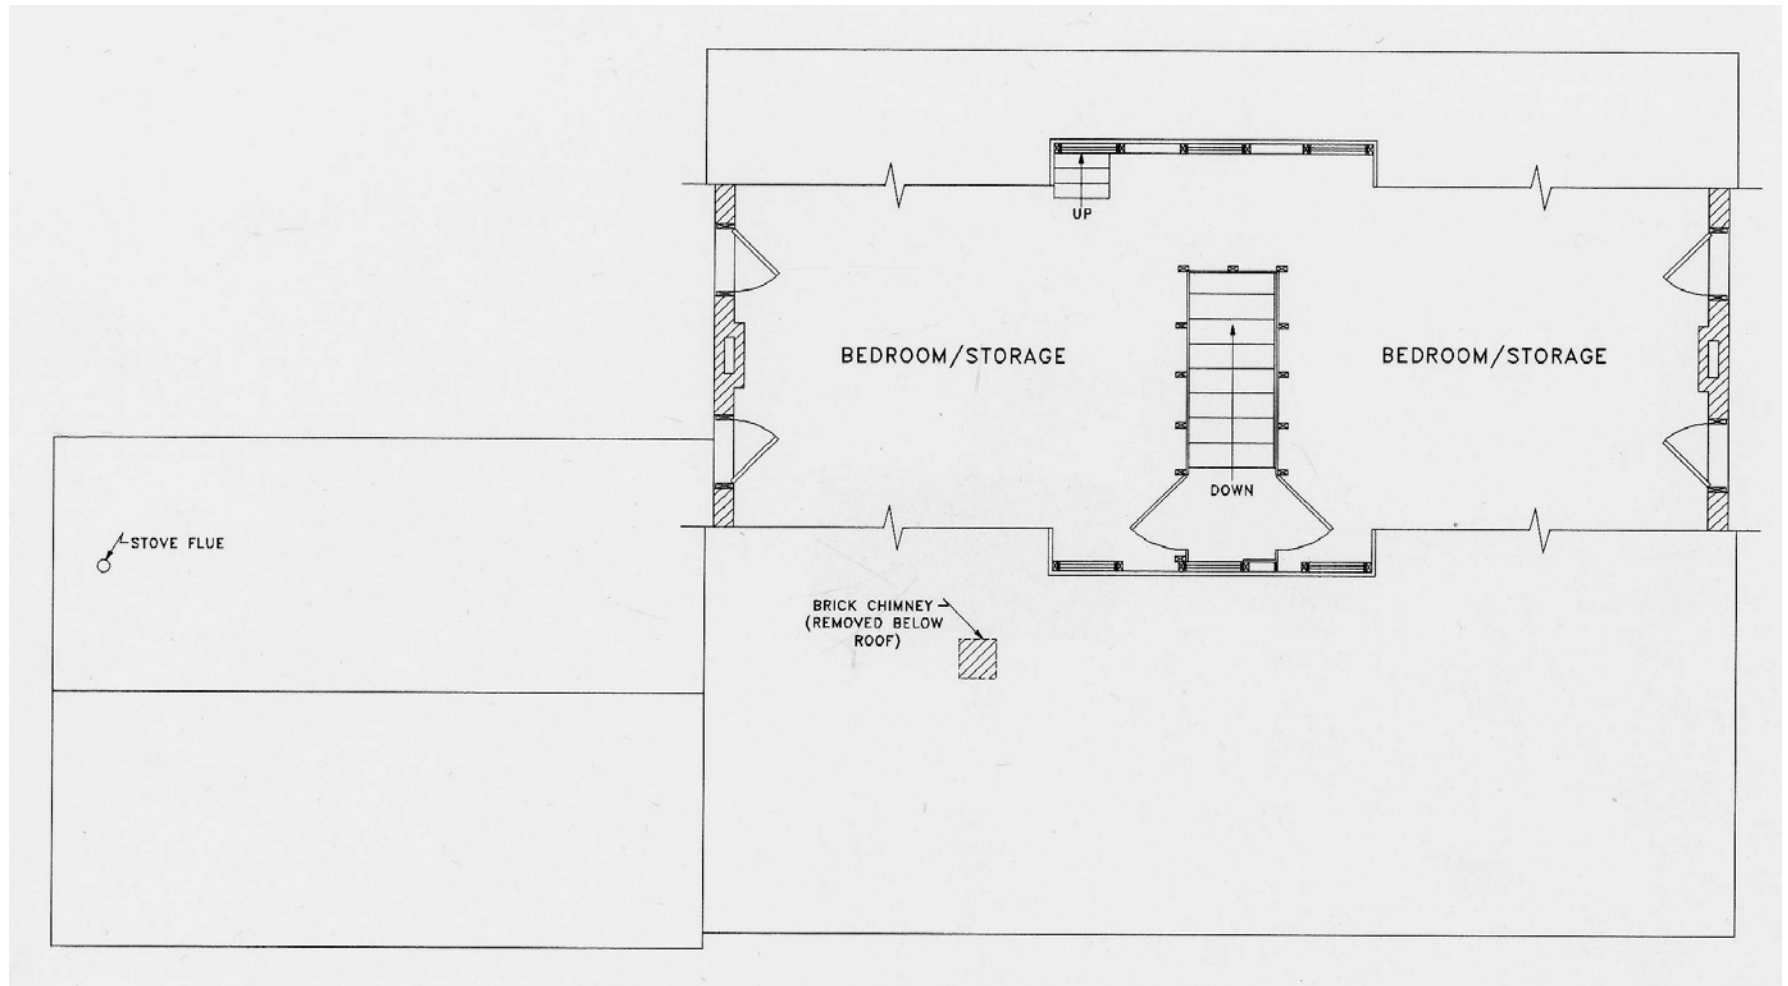
Figure 13. Second floor plan of the Valentine House, showing twentieth century modifications.

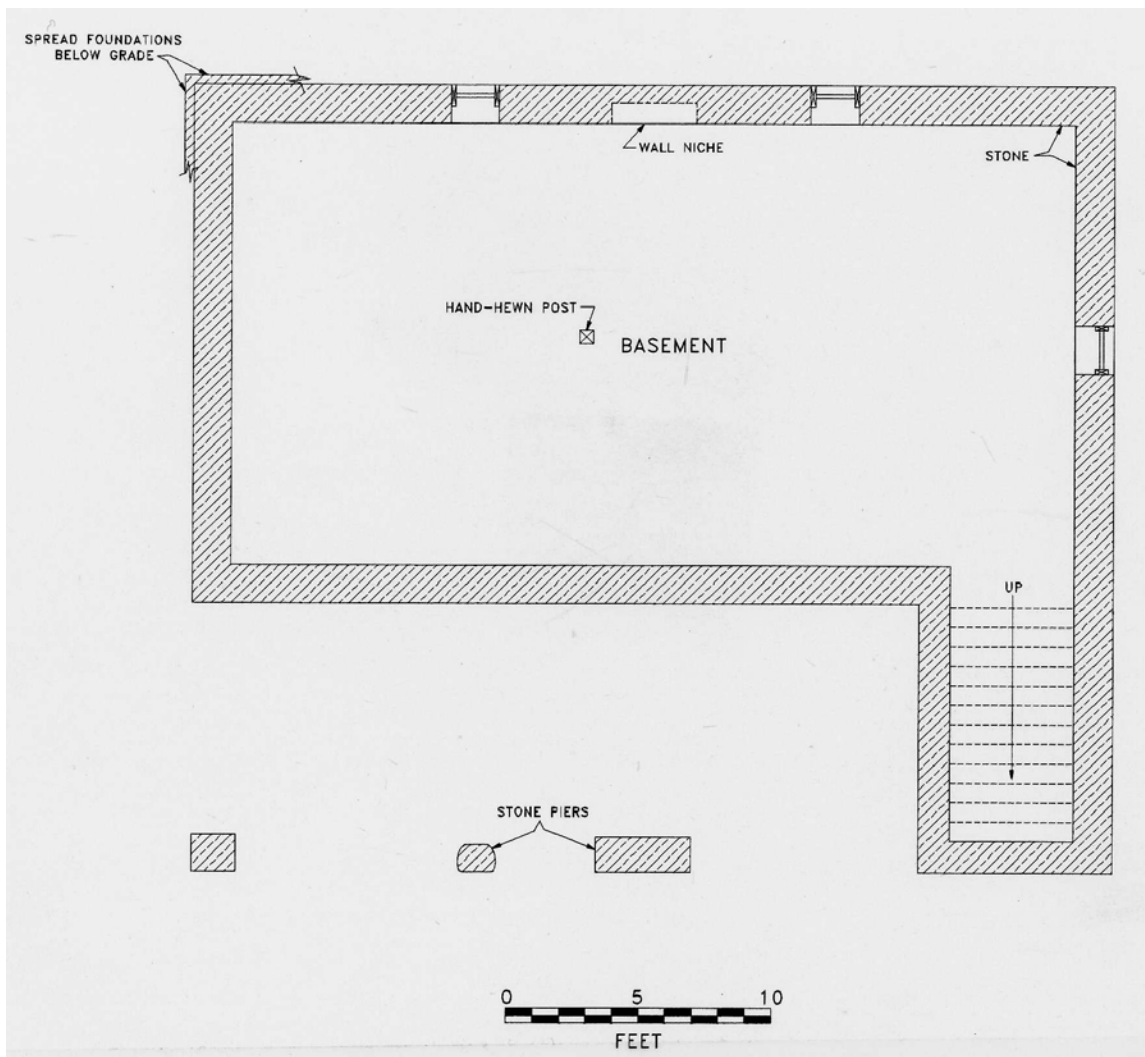
Figure 14. Basement and foundation plan of the Valentine House as originally constructed.

The Valentine House has a full basement located beneath the main block of the house. The basement is unpartitioned and measures approximately 32'-2"x17'-1". There are three small windows in the basement, two of which are located on the west, while the third is on the north. A 3'-3"x2'-6" wall niche is centrally located along the west wall. The depth of the niche is unknown due to the fact that it has been infilled with poured concrete. Similar wall niches have been documented in southwestern Illinois and are suspected to have been used for cold storage purposes prior to the introduction of refrigeration --particularly by German families. The large size of the basement and its relatively tall ceiling height (7'-9-1/2") suggests that the builder of the house was concerned with having ample cold storage space. The basement was originally accessed via a 4'-6"-wide, bulkhead stairway off the rear porch. This stairway ceased to be used during the early twentieth century and is currently sealed off with a concrete wall. It came to be superseded by an interior stairway located beneath the present stairway leading to the second floor resulting in a window being converted into a door. This stairway can be accessed from the hallway off the north end of Room 103.

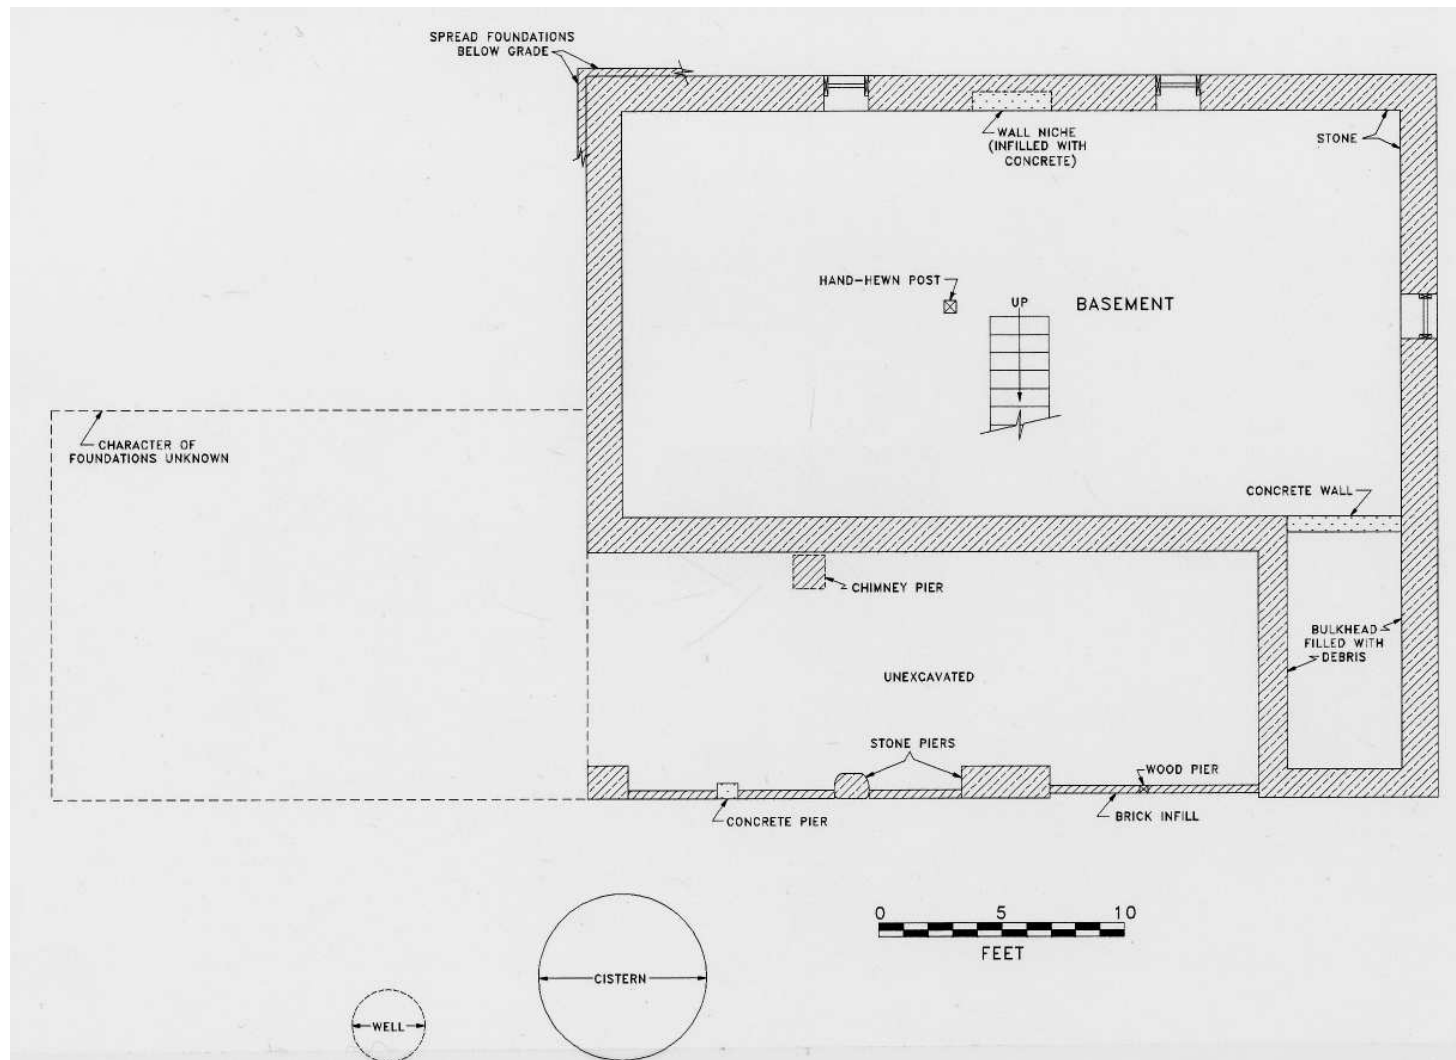
Figure 15. Basement and foundation plan of the Valentine House, illustrating present condition.

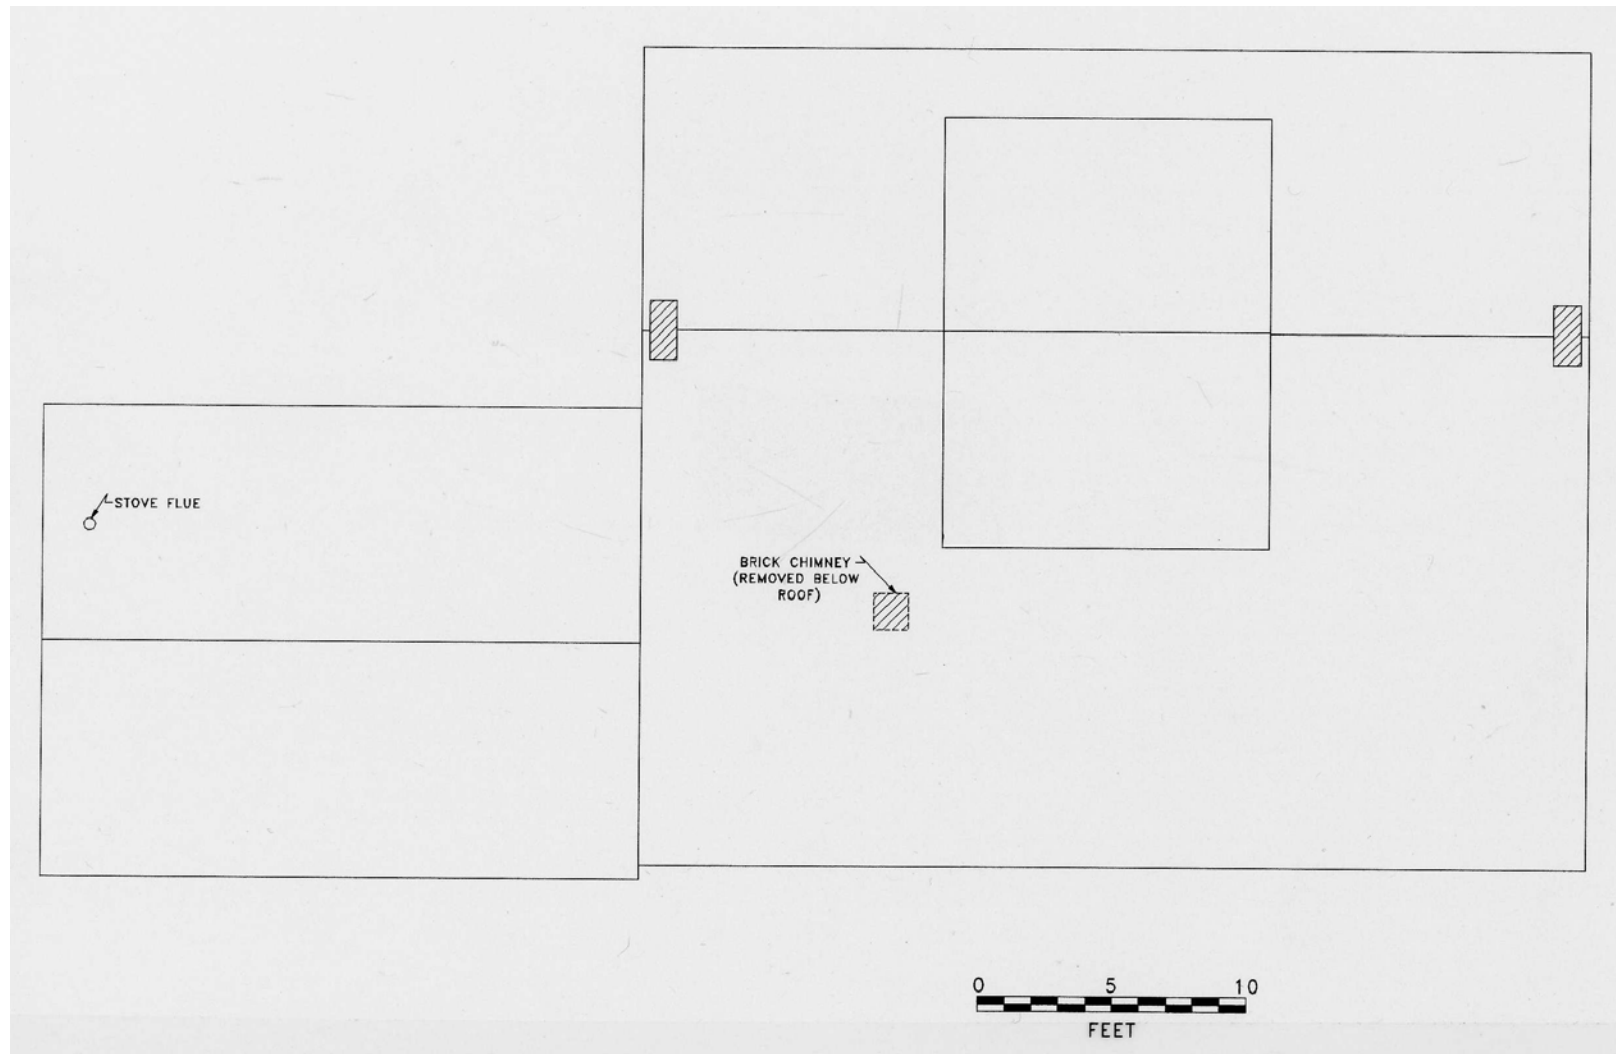
Figure 16. Roof plan of the Valentine House.

The second story floor joists are 2"x10", unsurfaced, vertical-sawn(?), white pine and are set approximately 1'-6" on-center. The rafters are 2"x5-1/2", circular-sawn oak with 1'-4" centers. The ends of the rafters come to rest on a 2-1/4"x8" plate. The roof sheathing varies in size between 1/2" and 3/4" thick and 12" to 15" wide. It has been planked with circular saw but is unedged. The present roof covering is corrugated steel. The eave of the west side of the house has been extended during the early twentieth century, outward by scabbing in short rafters to the originals. In order to prevent the walls of the house from pushing outward, several strap-iron braces have been run at a diagonal between the rafter plate and the floor joists. Additional support is lent by 2"x4" and 2"x6" studs that run along the east and west sides of the second floor. These studs, which appear to be non-original to the house, are placed approximately 2' in from the wall and extend from a 2"x6" plate laid along the floor to the rafters above. A number of collar ties also extend between the rafters.

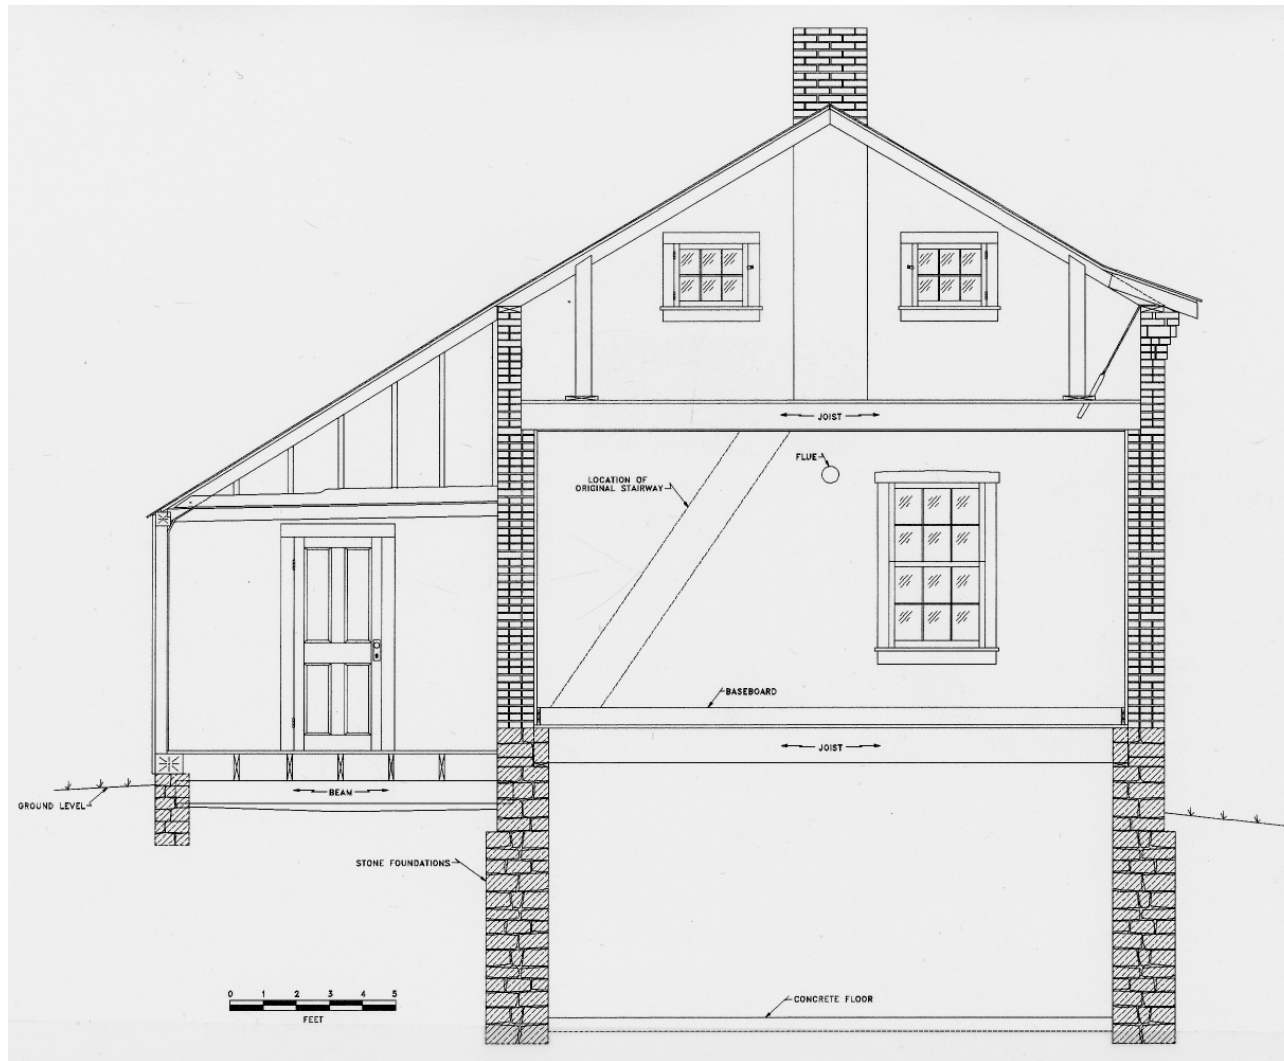
Figure 17. Sectional view of the Valentine House, showing west gable-end wall.

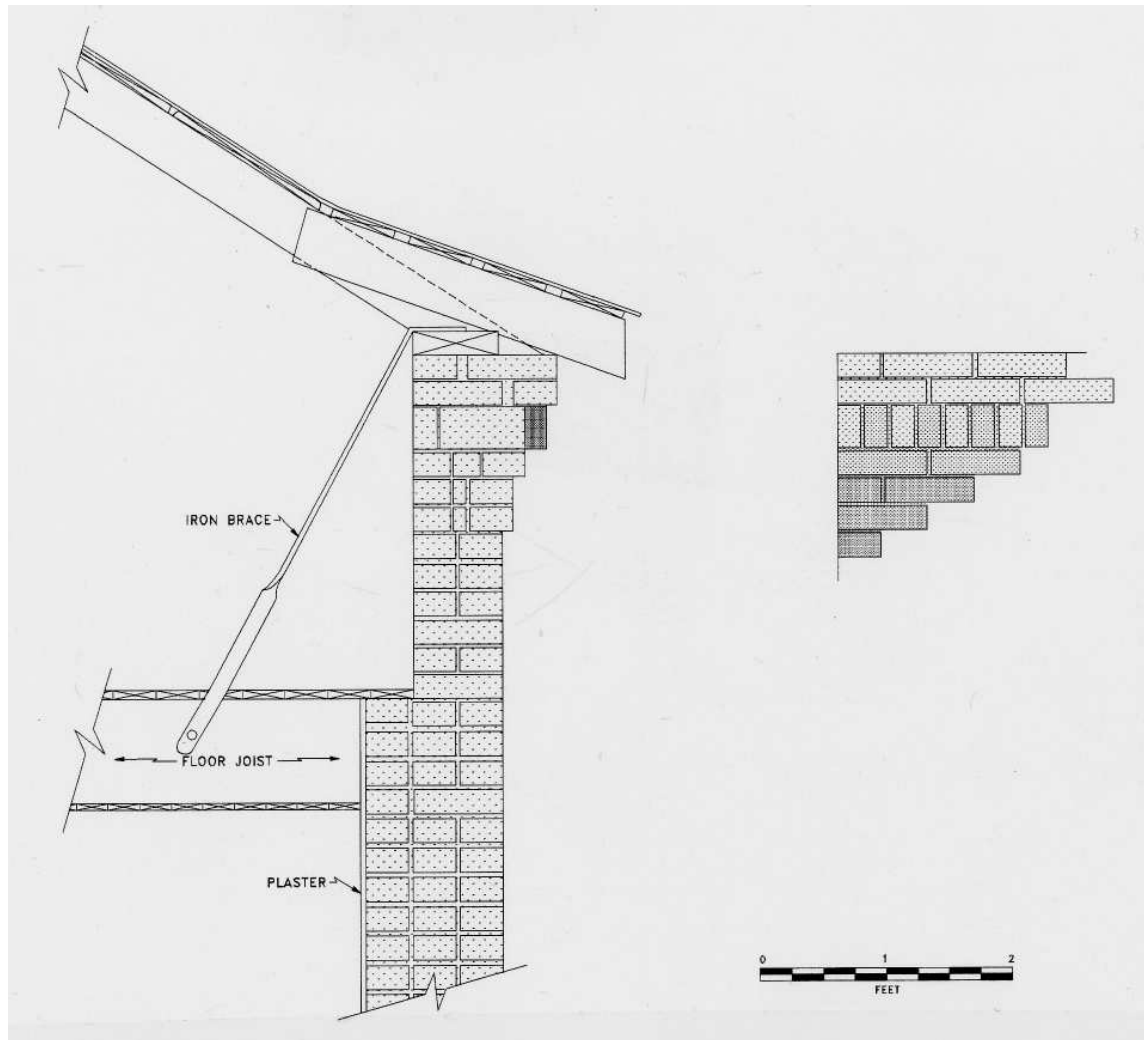
Figure 18. Detail of the north cornice of the Valentine House.

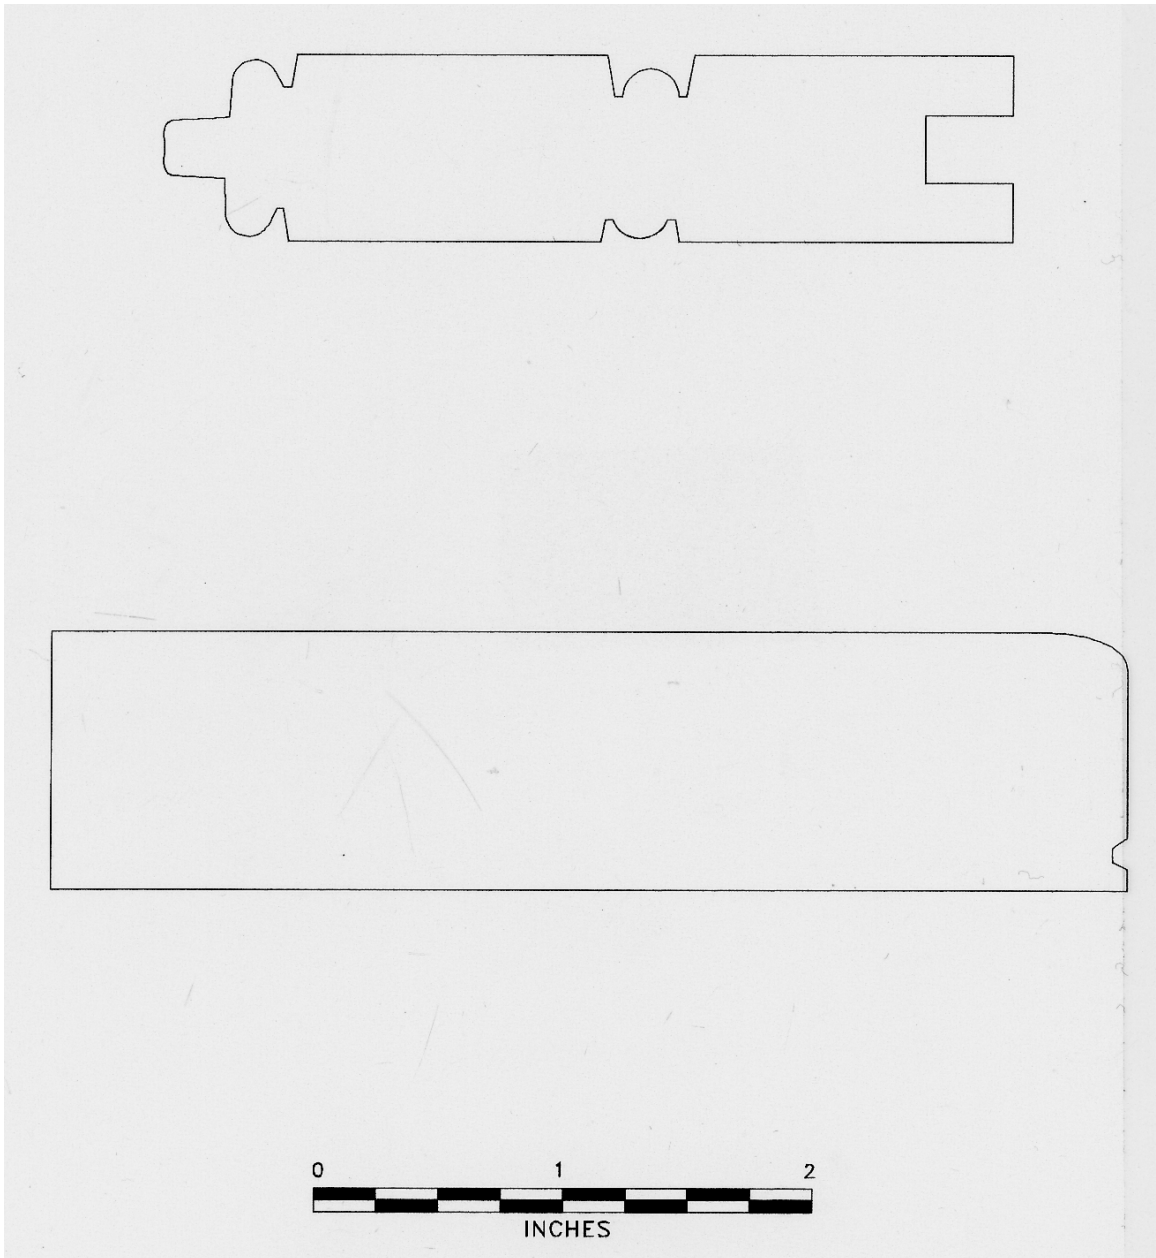
Figure 19. Trim samples from the Valentine House. TOP: Yellow pine beadboard used to finish walls and ceilings in the early twentieth century. BELOW: Original white pine window trim.

The door and window openings are cased with 1"x4-3/8" molded white pine trim and pedimented hoods. The doors are four-paneled, have through tenons, are constructed of white pine, and measure 2'-9-3/4"x6'-9-3/4"x1-3/8". Original doors are hung with 2-3/4"x4" butt hinges and have rim locks with porcelain knobs. One of the rim locks is stamped with what appears to be a December 17, 1840 patent date and a December 13, 1850 patent extension date.⁶ These dates, particularly the later extension date, jibe well with the construction date for the house. Later doors have mortise locks as well as "Emerald Design" lock plates and knobs with a brass finish.⁷ The windows measure 2'-10-3/4"x5'-1/2" and have sills located 2'-3" above the floor.

The character of the foundations beneath the summer kitchen addition is difficult to determine due to the build-up of the grade around the building. The foundations that are visible consist of single-course, concrete block piers. The building itself is constructed with nominal sized, surfaced-two-sides, yellow pine lumber. The studs, ceiling joists, and rafters all measure 1-5/8"x3-1/2". The exterior is covered with shiplap siding, while the interior walls and ceiling are covered with yellow pine beadboard (double beaded).
