**NATIONAL REGISTER OF HISTORIC PLACES
ASSESSMENT OF THE
VALENTINE SITE (11MO954),
ILLINOIS CAVERNS STATE NATURAL AREA,
RURAL MONROE COUNTY, ILLINOIS**

ARCHAEOLOGICAL TESTING SHORT REPORT

Project type/title: National Register Assessment of the Valentine Site (11MO954),
Illinois Caverns State Natural Area

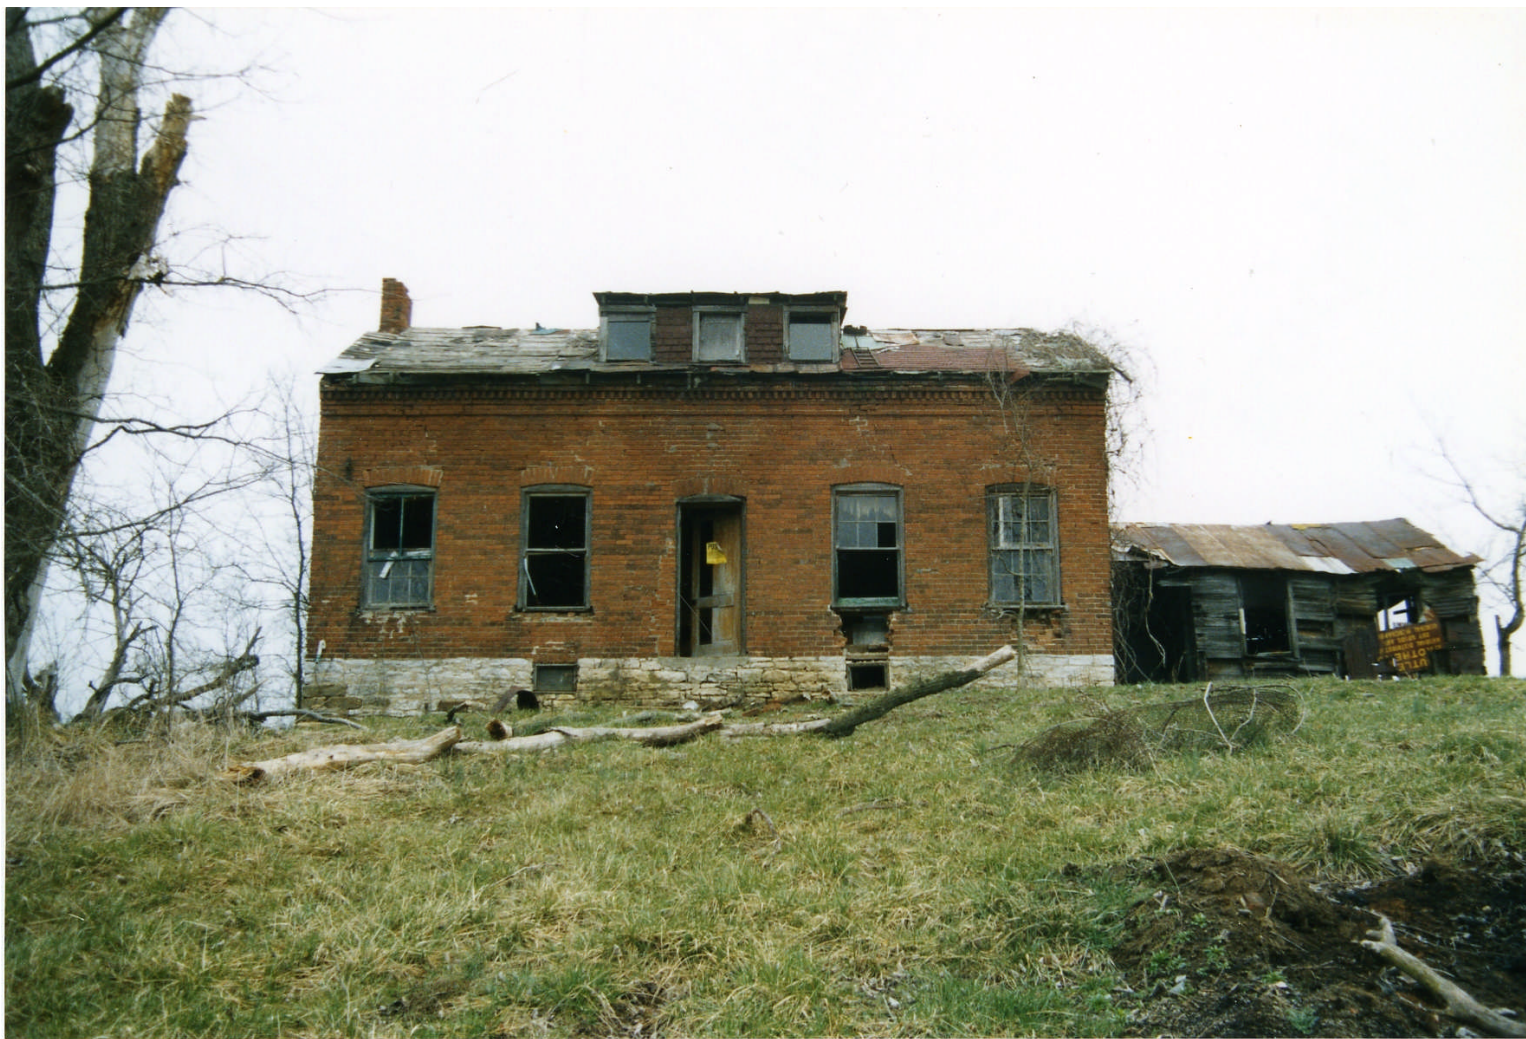
Figure 21. Front elevation of the Valentine House.

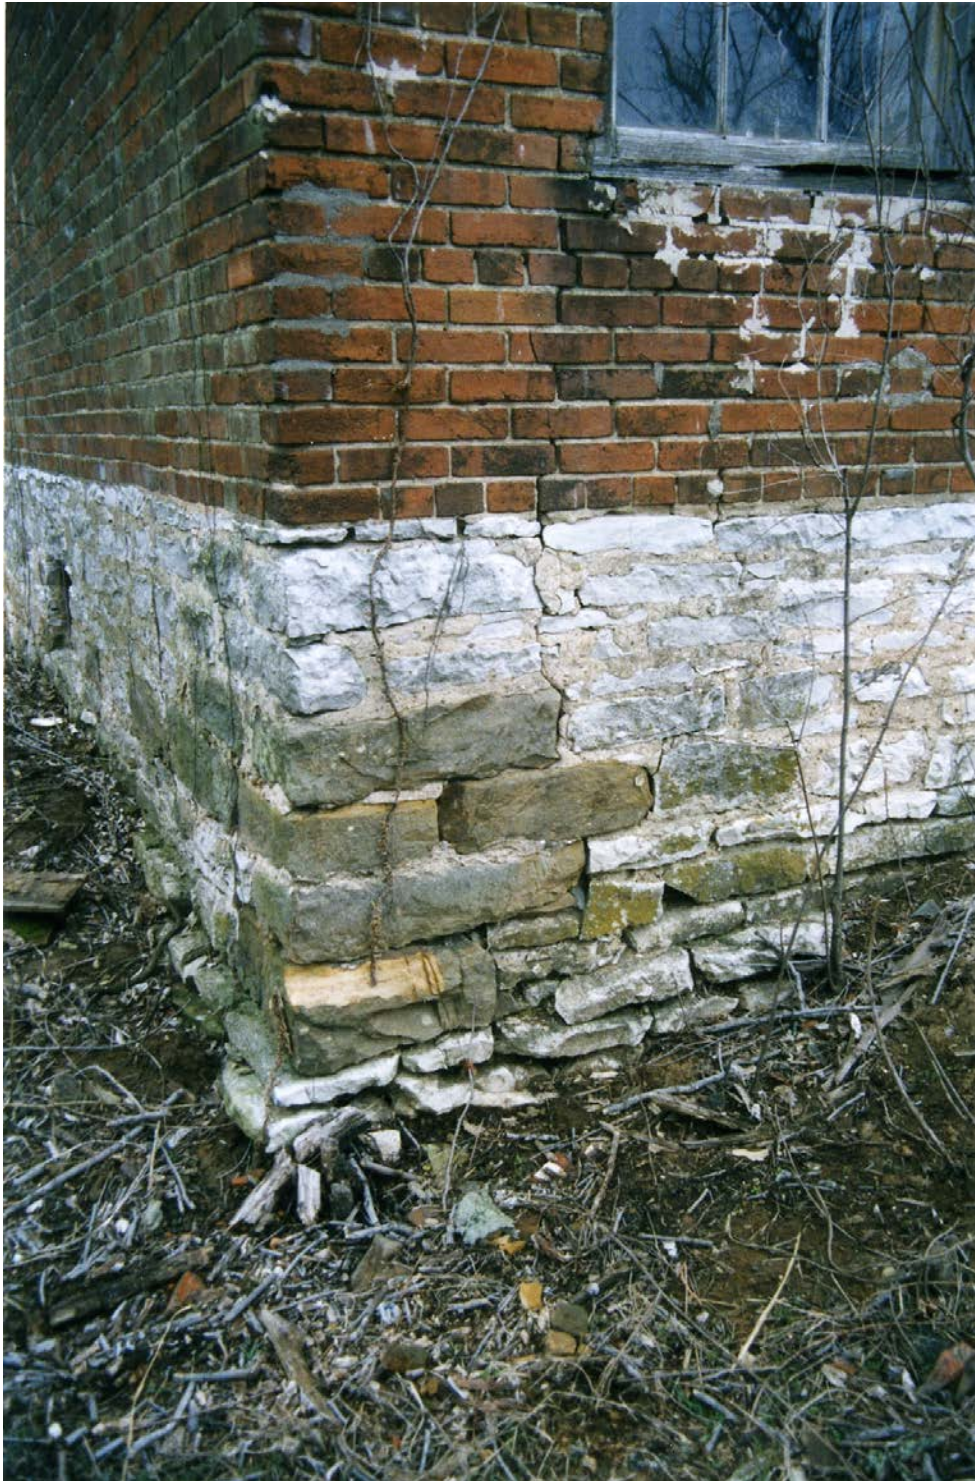
Figure 24. Valentine House foundation detail. Note the use of both limestone and sandstone.

The main block of the Valentine House rests on irregularly-coursed, rough-cut, foundations which are predominately limestone with some occasional sandstone having been used. The foundations are 1'-6" thick on their upper 3', and then step out to 1'-10" below grade. The first floor of the house is supported by 2"x12"-13" joists that are set on 2' centers and run parallel to the east/west axis of the building. These joists represent a mixture of circular- and vertical-sawn, unsurfaced, oak and white pine stock, with vertical-sawn, white pine joists predominating. One of the joists is an 8"x8", hand-hewn oak beam that carried the original partition wall between Rooms 101 and 102 above. This beam is supported by a 7"x7", hand-hewn, vertical oak post. The ends of the floor joists rest on a 1"x6" plate and have stone infill between them.. The walls of the main block are of brick

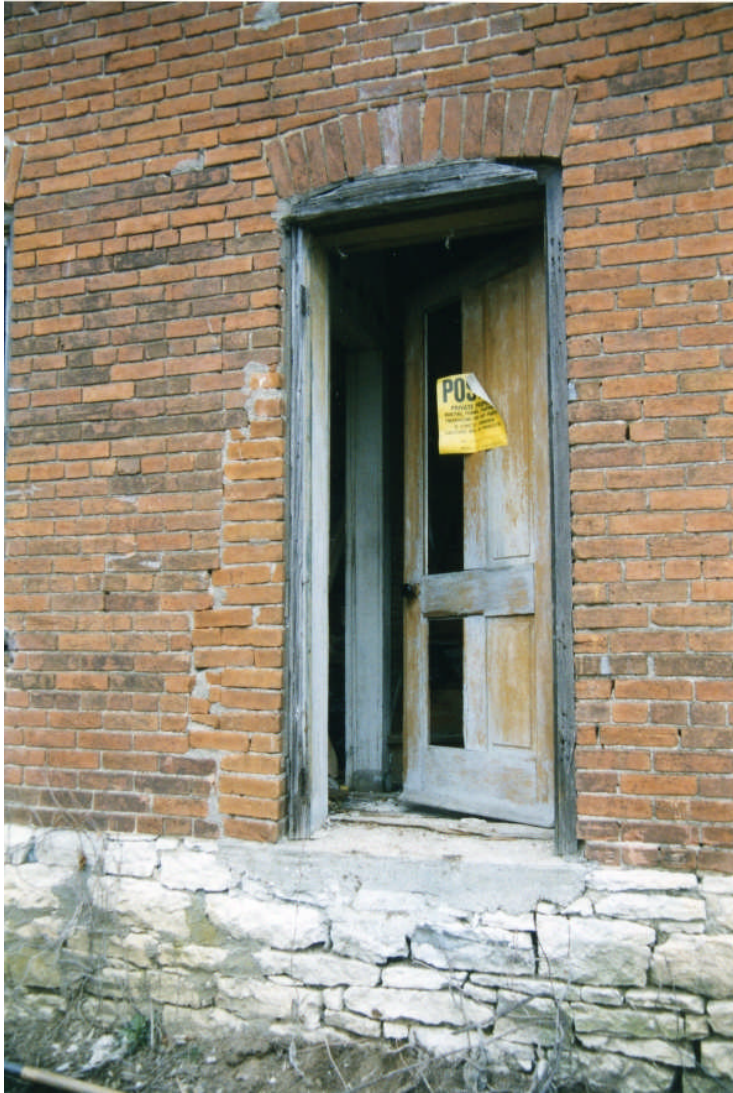
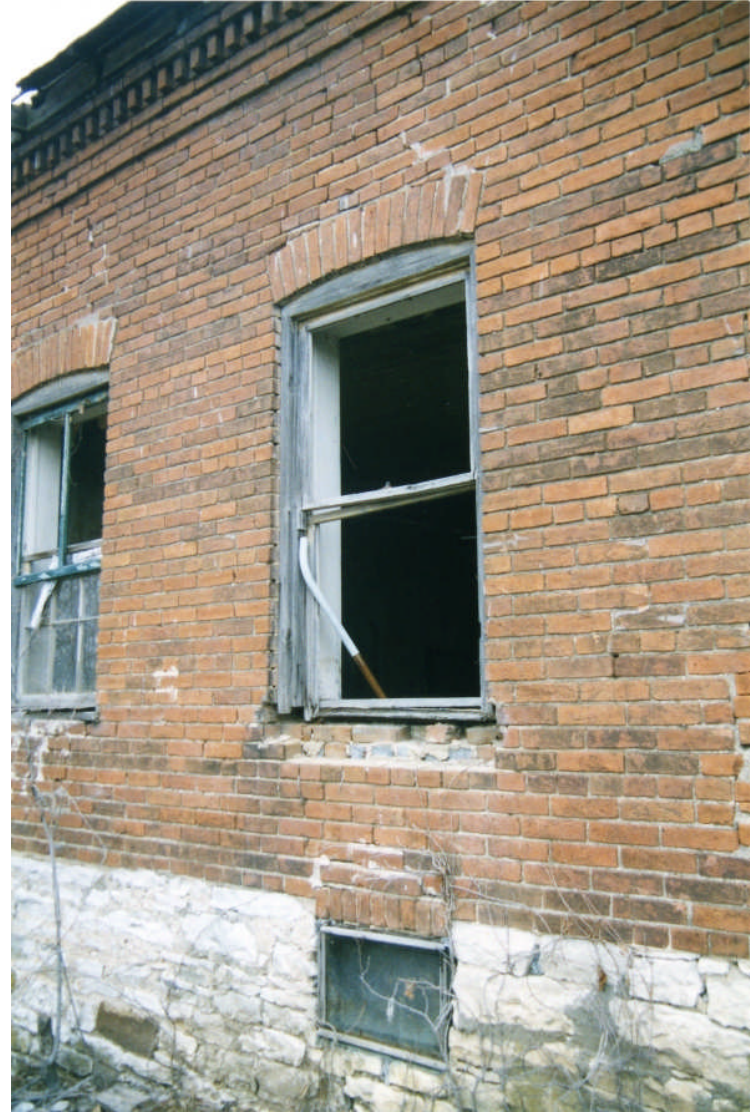
Figure 25. Valentine House door and window detail.

The door and window openings are cased with 1"x4-3/8" molded white pine trim and pedimented hoods. The doors are four-paneled, have through tenons, are constructed of white pine, and measure 2'-9-3/4"x6'-9-3/4"x1-3/8". Original doors are hung with 2-3/4"x4" butt hinges and have rim locks with porcelain knobs. One of the rim locks is stamped with what appears to be a December 17, 1840 patent date and a December 13, 1850 patent extension date.⁶ These dates, particularly the later extension date, jibe well with the construction date for the house. Later doors have mortise locks as well as "Emerald Design" lock plates and knobs with a brass finish.⁷ The windows measure 2'-10-3/4"x5'-1/2" and have sills located 2'-3" above the floor.

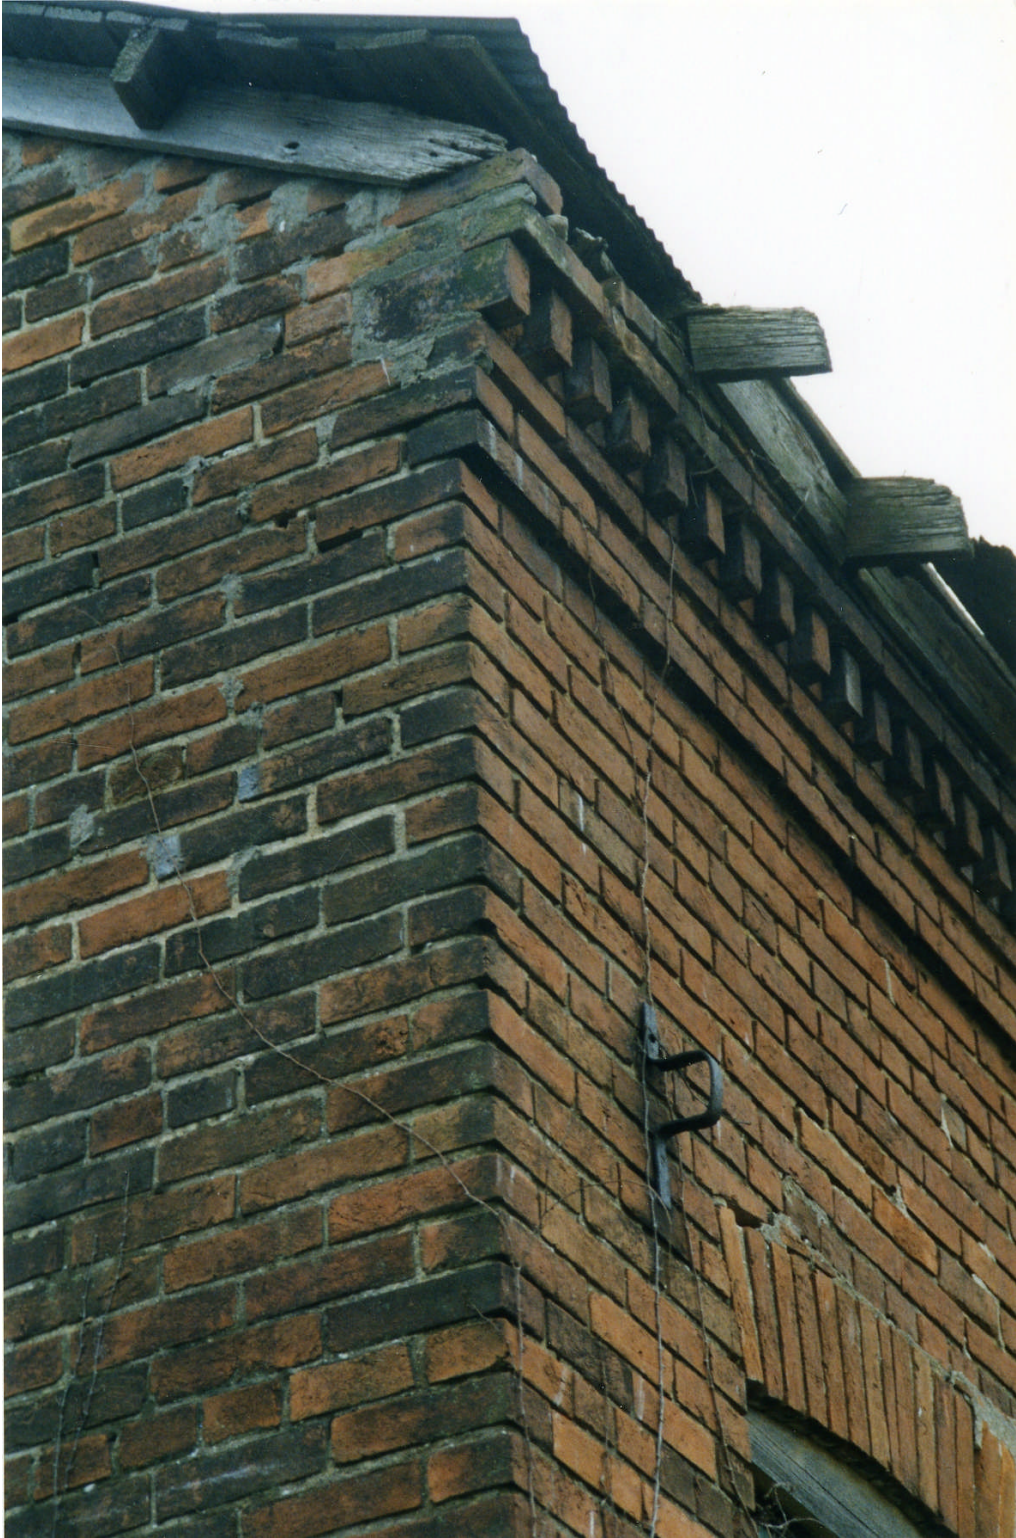
Figure 26. Cornice and eave detail at the Valentine House.

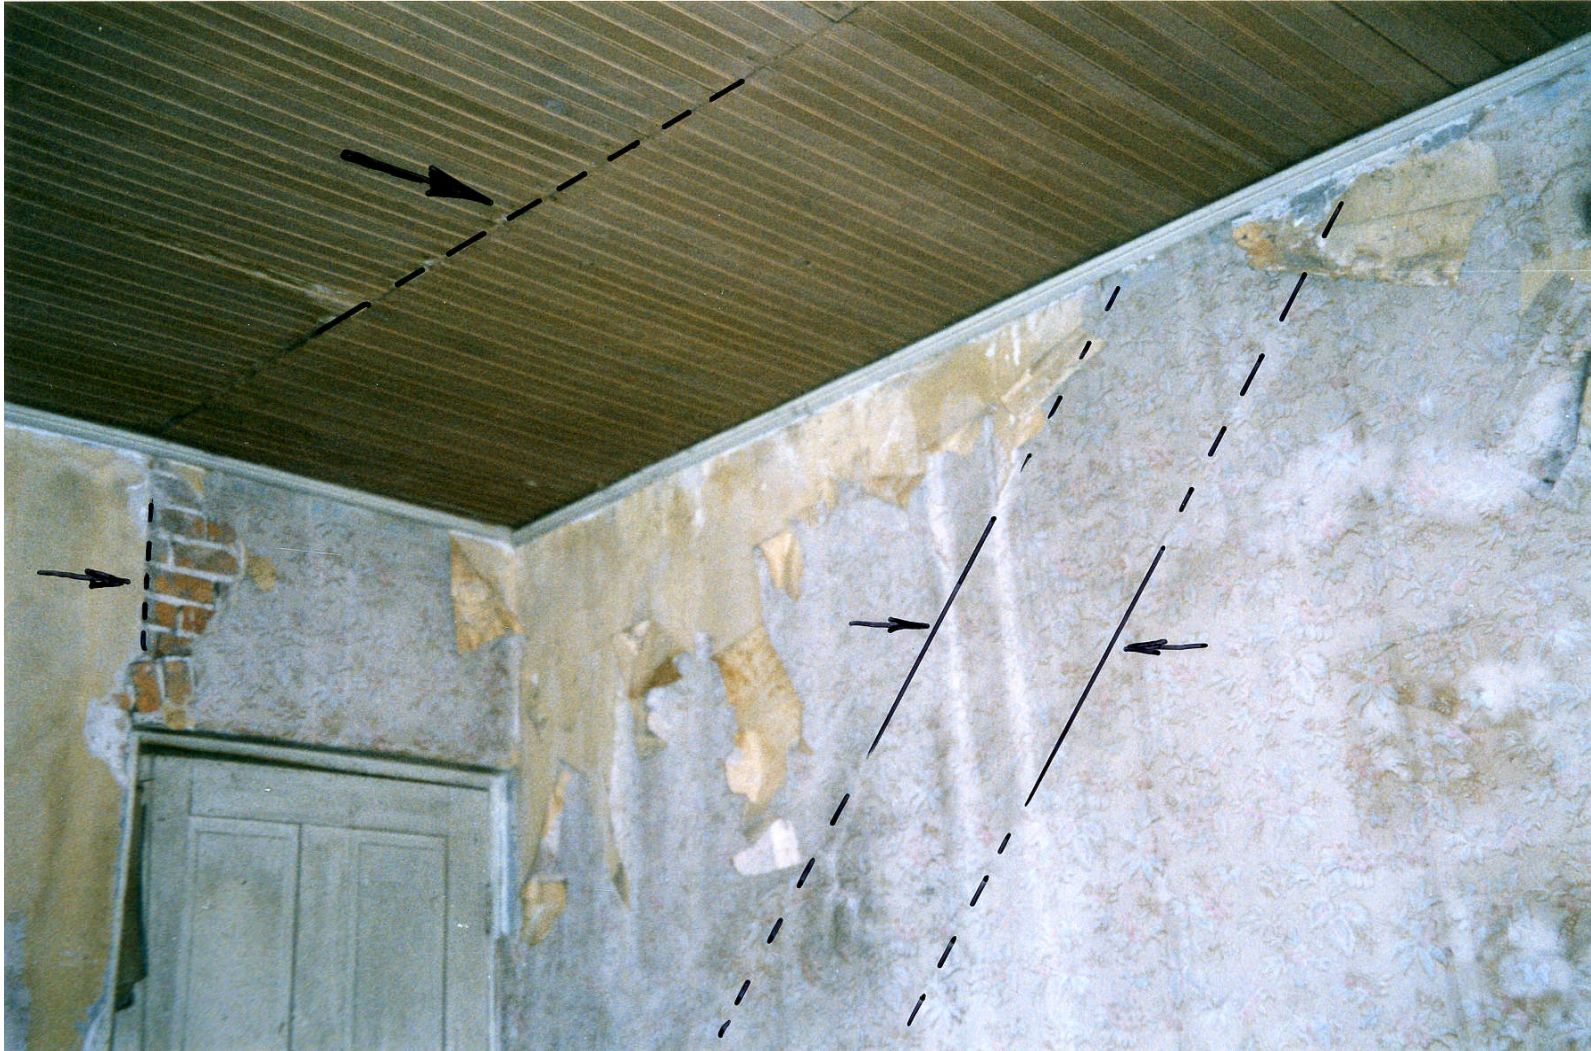
Figure 27. Interior details illustrating the original stairway leading from the rear porch. Note the evidence of the plank wall in the plaster above the door and in the ceiling above. Also note the ghost of the stringers along the back wall.

As mentioned above, the second floor of the Valentine House was originally accessed via an enclosed stairway that was entered by way of the rear porch. Although this stairway orientation seems odd (particularly by modern standards) similar stairways with exterior, rather than interior, entrances have been found on several other houses in southwestern Illinois that have been examined by the investigators.⁵ This stairway rose

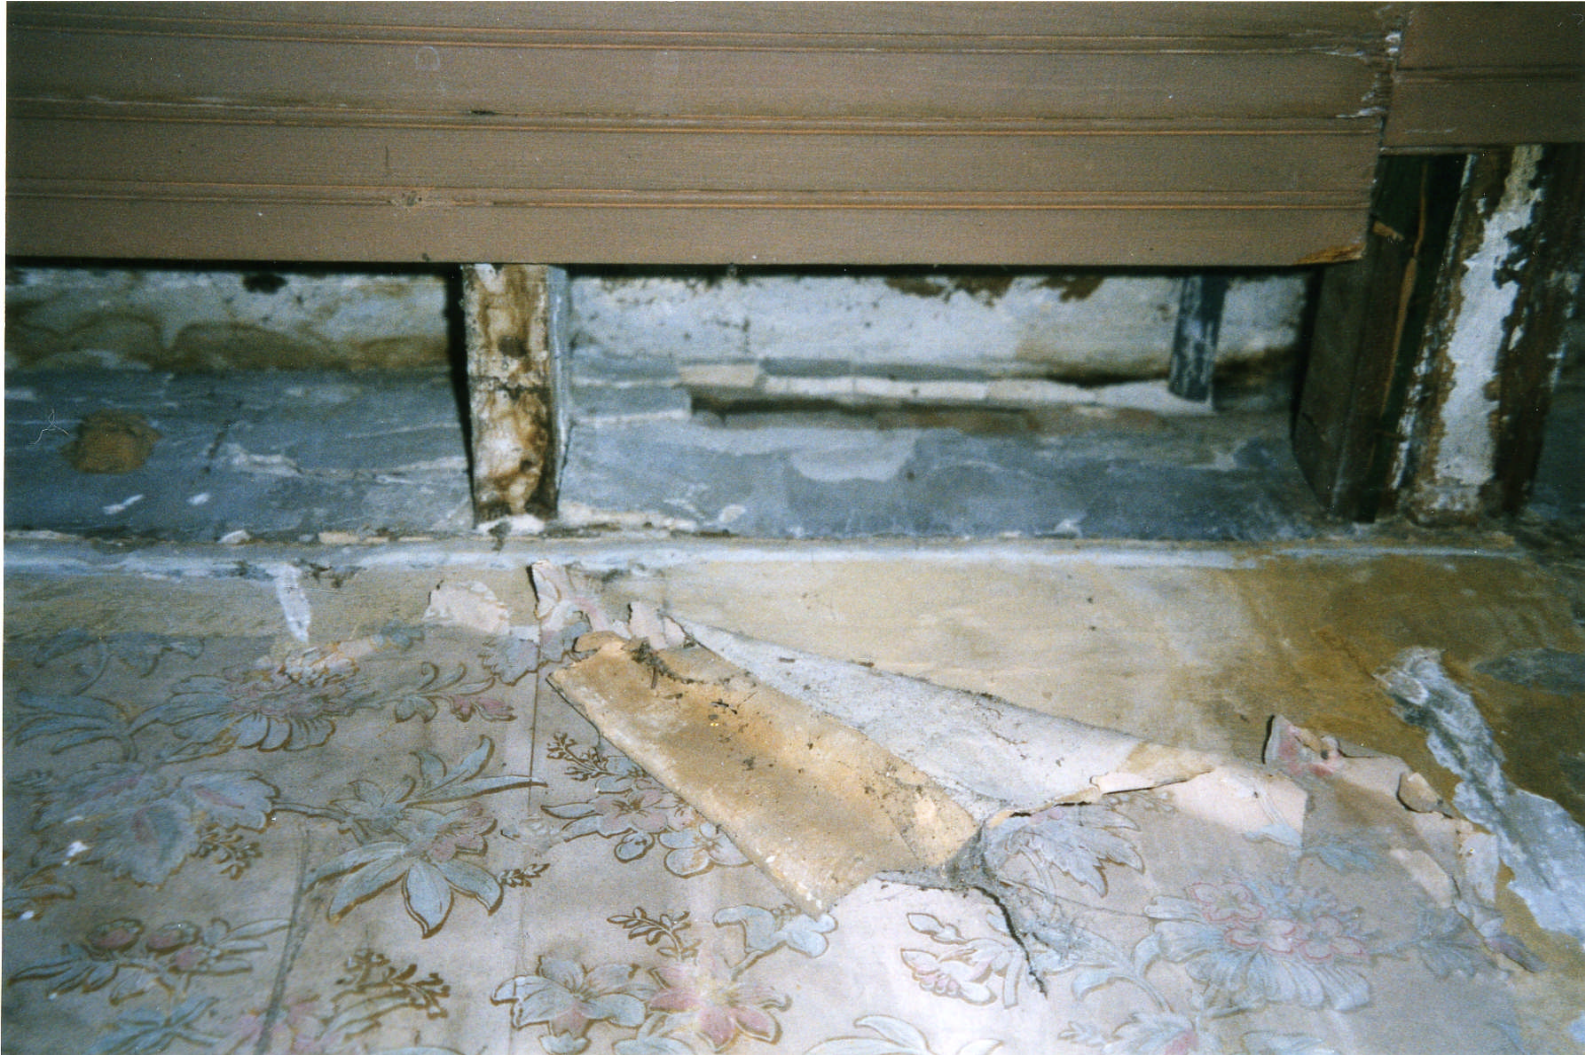
Figure 28. Detail of the original ceiling finish on the lower story. Note the multiple coats of whitewash on both the joists and the underside of the upper floor.

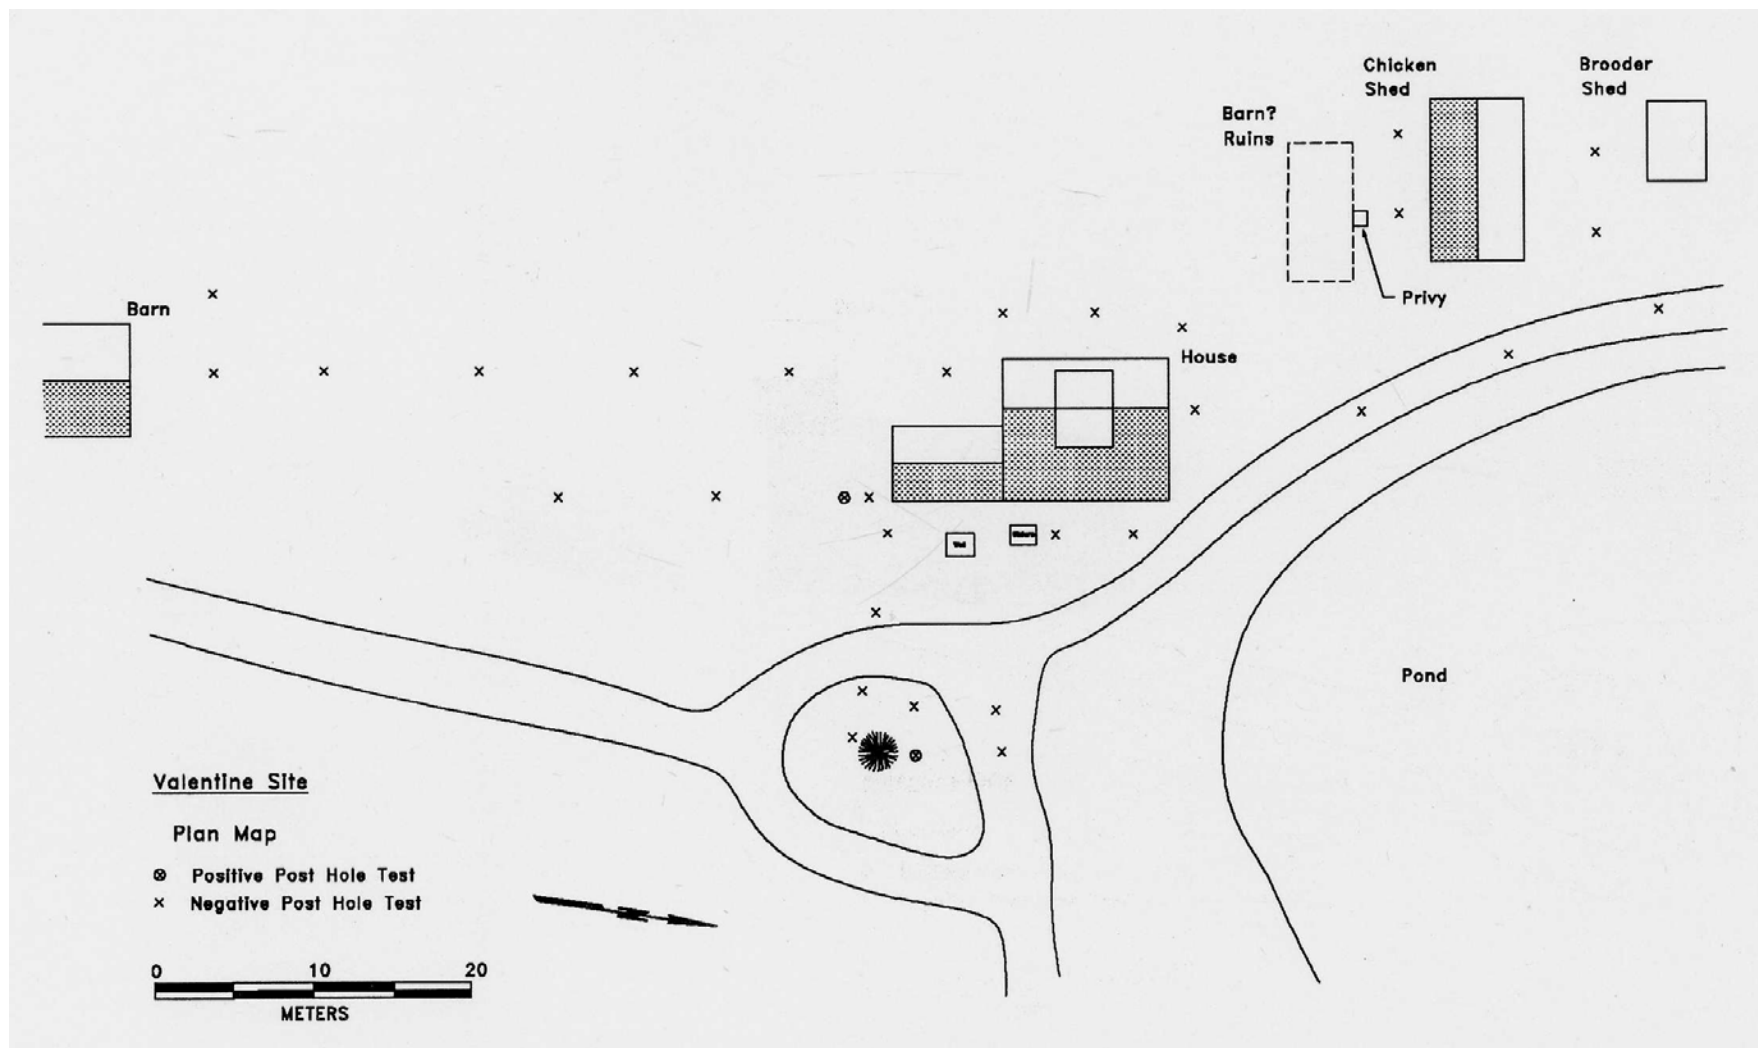
Figure 33. Posthole Testing Plan, Valentine Site.

The archaeological testing at this site included the use of screened post hole tests and hand excavated test units (trenches). The post hole tests were excavated to determine the character of the soils and to determine the nature of the historic middens around the site. The post hole tests were excavated at 10 meter intervals across the back, side and front yards of the house. The test units were excavated in the back and side yard areas to locate potential subsurface features. Lengths of these test units varied from one meter to 3 meters in length and from 0.5 to 1.5 meters in width. A total of 33 post hole tests and 7 test units were excavated. The total linear quantity of the units was 21.5 meters and the total area excavated was 13.25 square meters.

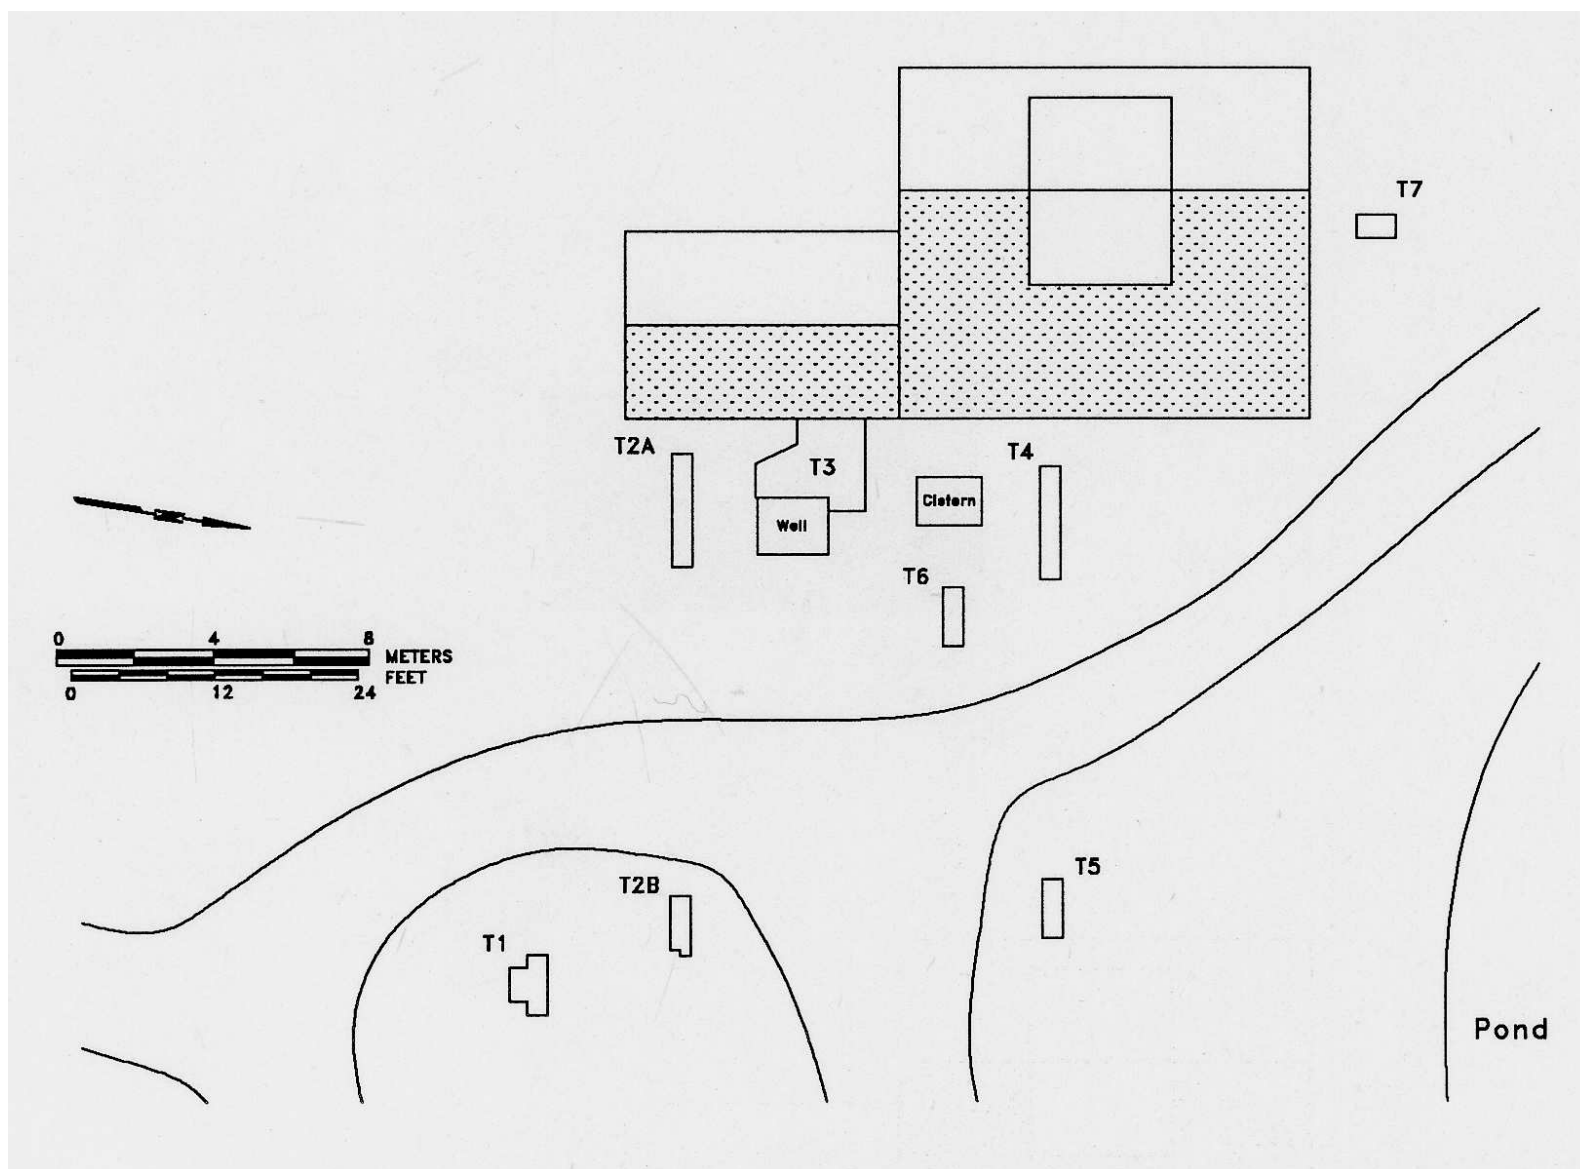
Figure 34. Test Trench Plan, Valentine Site.

Test 1 was positioned over a shallow depression. Suspecting a subsurface feature with the potential of being a privy, the unit came down on a tree stain which was sectioned and determined as such. Test 3 located a flag-stone surface which extends across the back of the house and also appears in Test 7. This stone pavement continues out 2.5 meters from the foundation and appears to terminate in a limestone curbing at the north-east corner of the house. It also extends out to the edge of the well and cistern. The function of the stone probably was to prevent erosion around the house due to runoff and back yard activities. It also, of course, would add a decorative element to the heavily trafficked back yard area. Although this material could date to the original construction, evidence to date indicates a later, twentieth century construction of this feature. The remaining tests offered negative evidence for feature or midden clusters. The majority of period artifacts appear to be on the outer edges of the site down slope in a pattern that suggests much erosion, which fits well with the soil profiles gained from both the test units and post hole test units. Extensive probing in the rear yard area failed to locate any additional subsurface features.

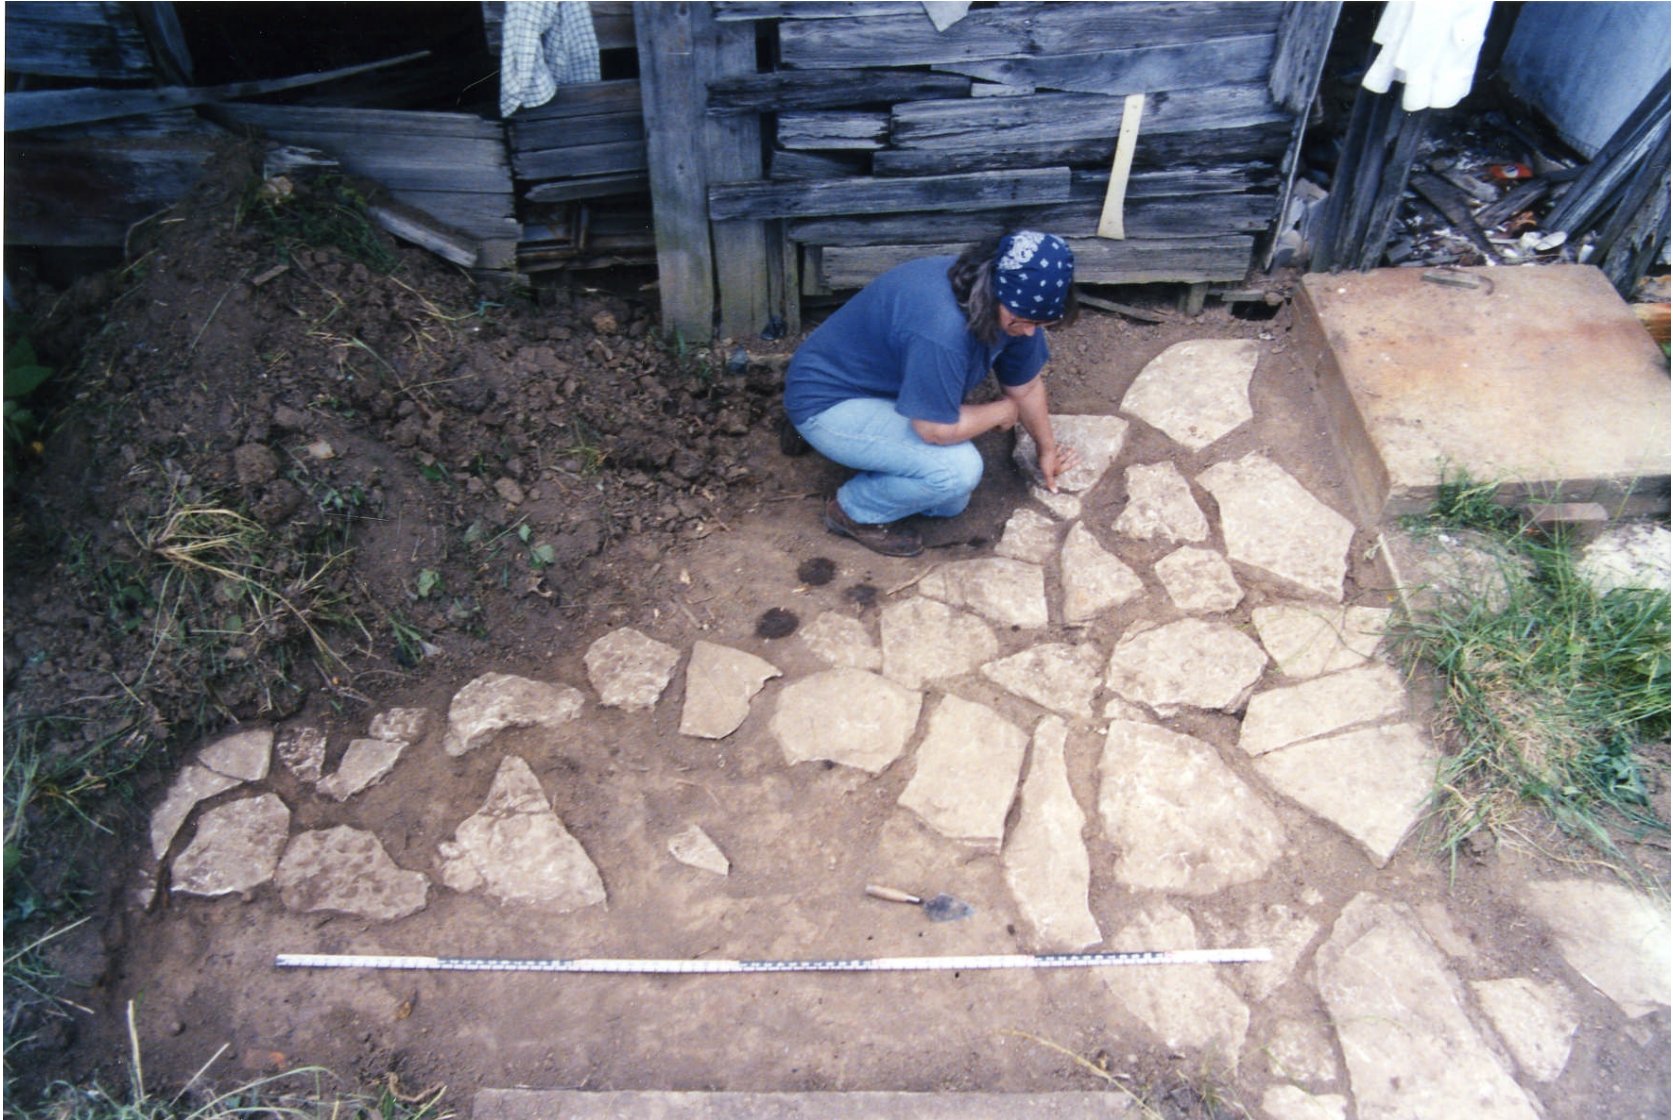
Figure 35. Stone pavement uncovered around the cistern and well adjacent to the rear entrance of the Valentine House. This pavement appears to be twentieth century in age.

The east side or rear of the house appears to be the area most likely to contain features. On the surface a well, and a cistern (with concrete filter) are clearly visible. Testing demonstrated that the upper fill and/or soil zones are mottled, relatively shallow, and at times scoured away. Much of the material recovered from these excavation units dated from the twentieth century. Only an occasional small piece of nineteenth century material was recovered. A nineteenth-century midden, however, was not defined in this area as we suspected it would be. The limited artifacts recovered are inventoried in Appendix II.
