**NATIONAL REGISTER OF HISTORIC PLACES ASSESSMENT
OF
THE WHITE BARN
A TRANSVERSE-FRAME/CRIB BARN LOCATED AT
TRAIL-OF-TEARS STATE FOREST, UNION COUNTY, ILLINOIS**

prepared for:
Illinois Department of Natural Resources
Springfield, Illinois

July 2000

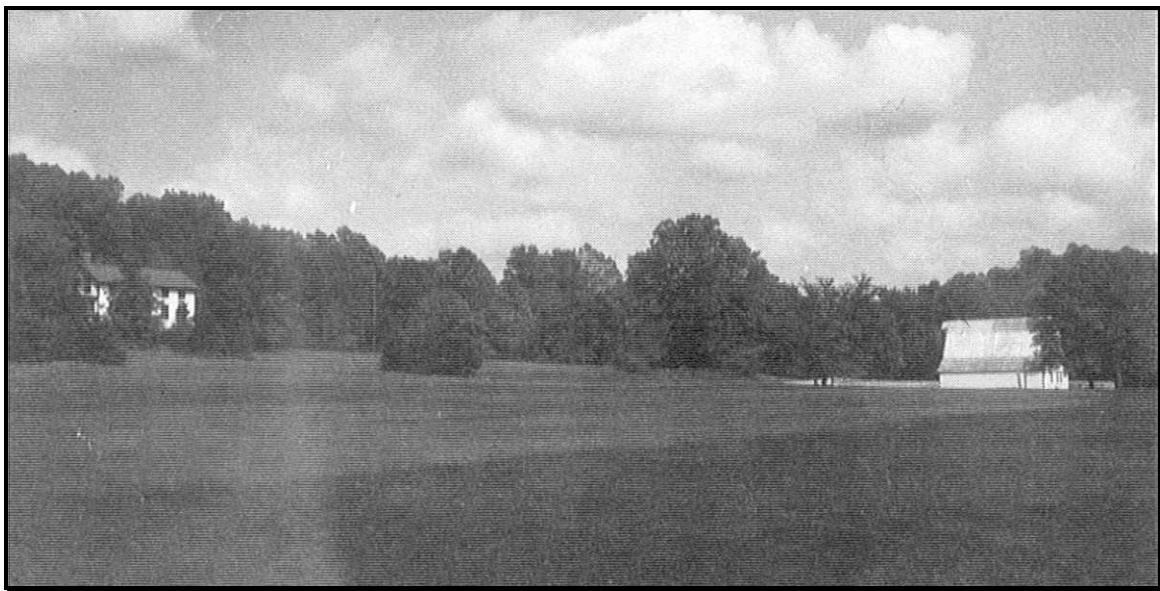
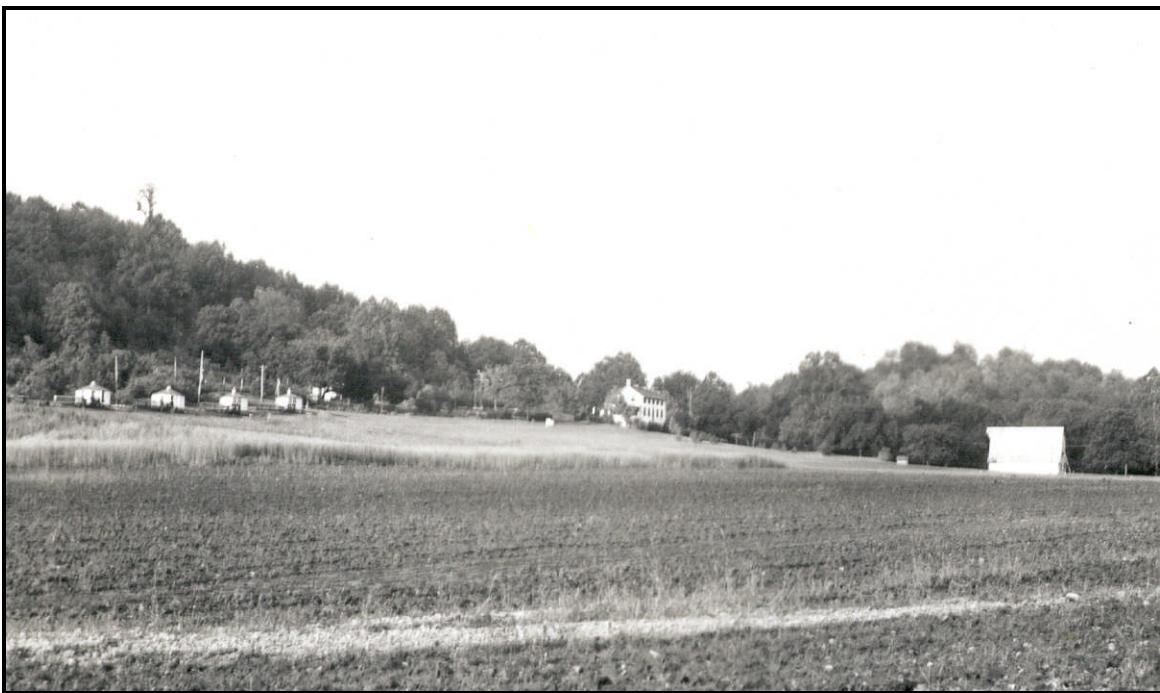
Figure 13. Two views of the White Barn and Lyerle House, looking northeast, ca. 1940. By this time, the Lyerle House had been moved upslope from its original location and renovated for use by the superintendent of the state forest (Union State Nursery Photographic Collection).

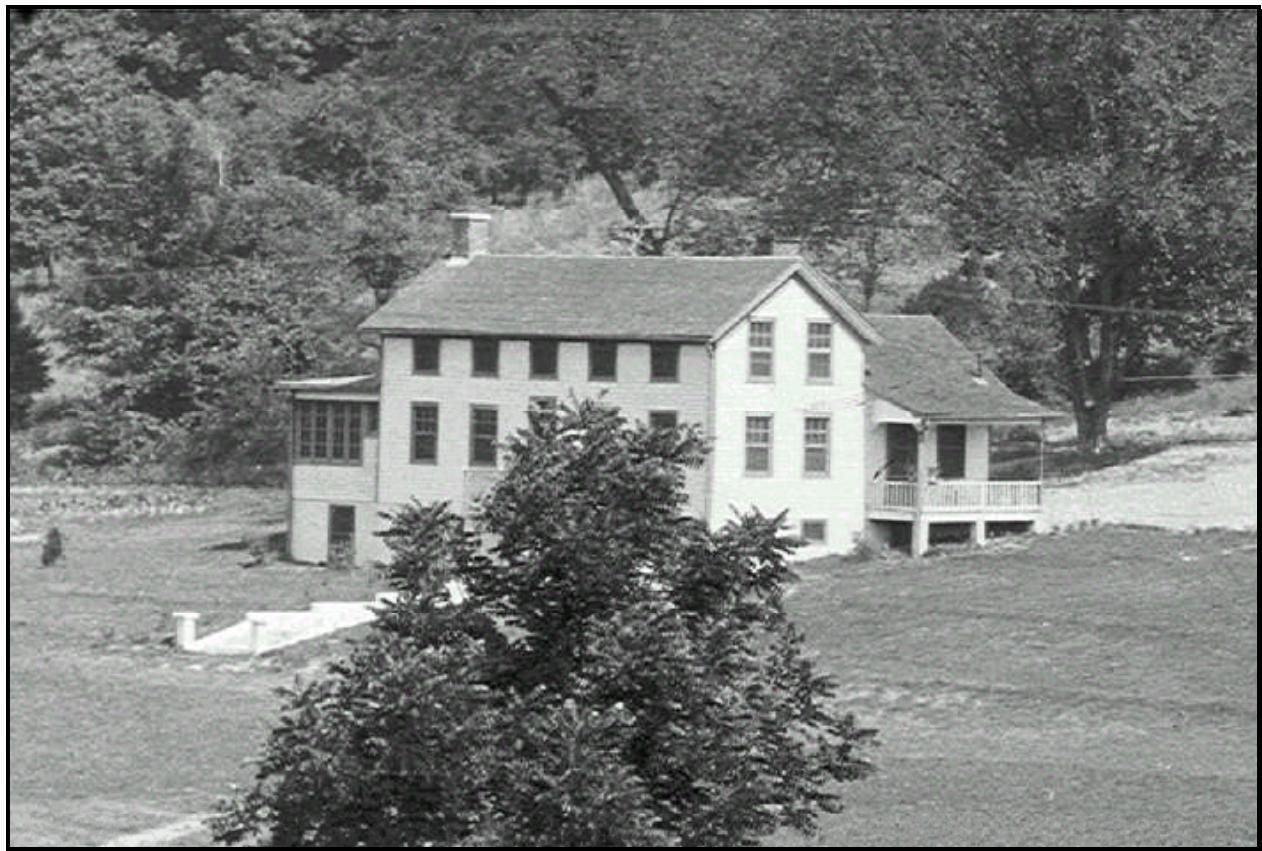
Figure 14. View of the Lyerle House ca. 1940, looking northwest, after its relocation and renovation for use as the superintendent's residence. The sunroom on the west and side porch on the east were added as part of the renovation (Union State Nursery Photographic Collection).

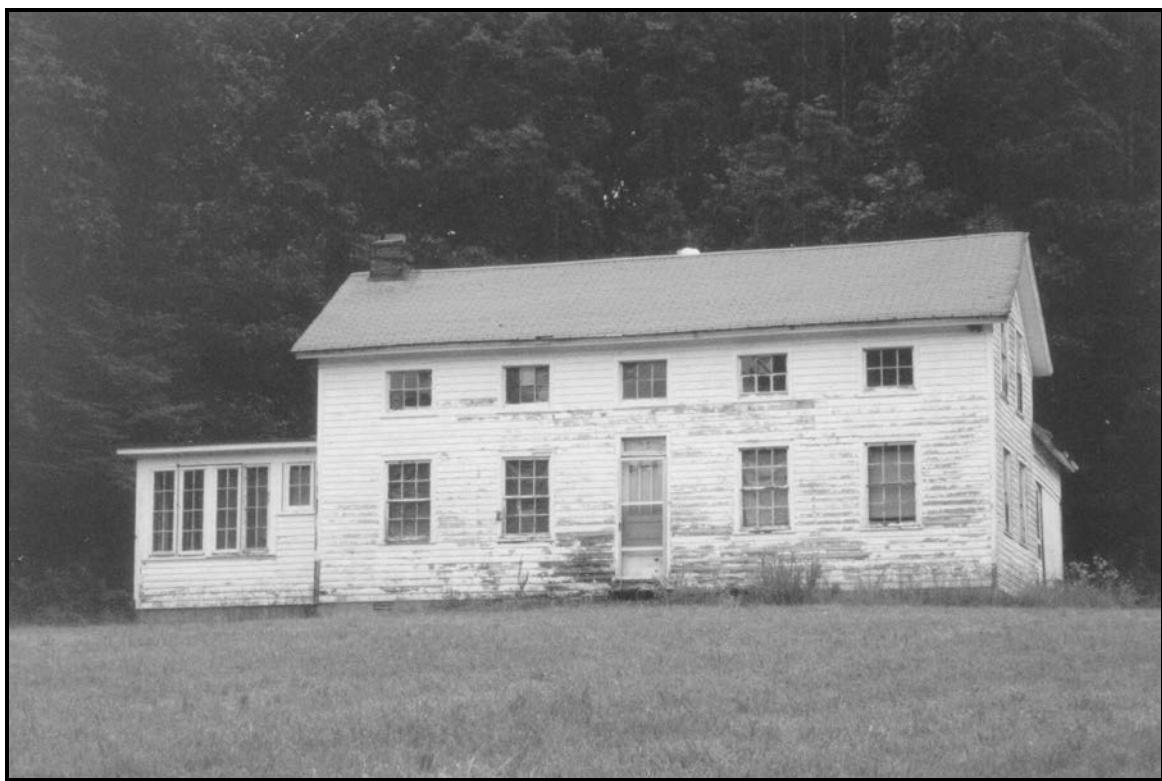
Figure 16. View of the Lyerle House at its present location, east of Trail of Tears State Forest. (2000) The house was moved from the forest during the middle 1980s. It presently is unoccupied.

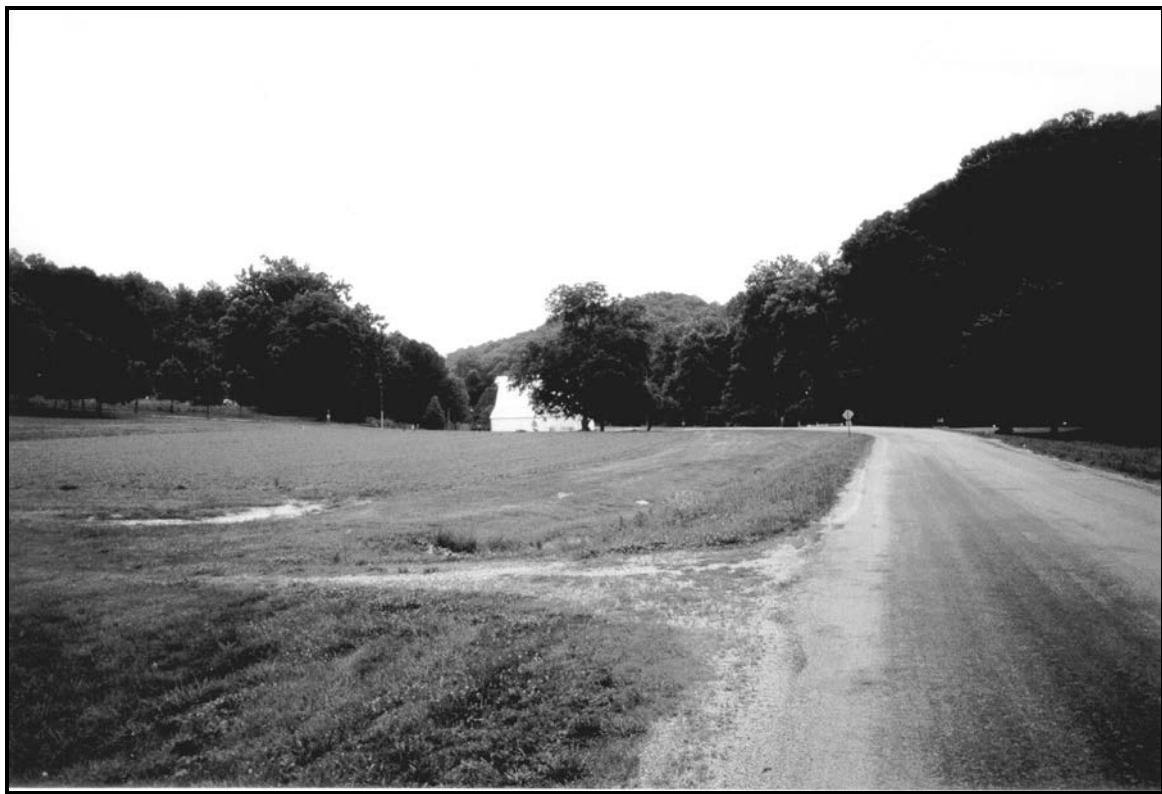
Figure 17. View of the White Barn, looking east up the hollow in which it is located (2000). The Lyerle House formerly stood on the slope that rises to the left of the view.

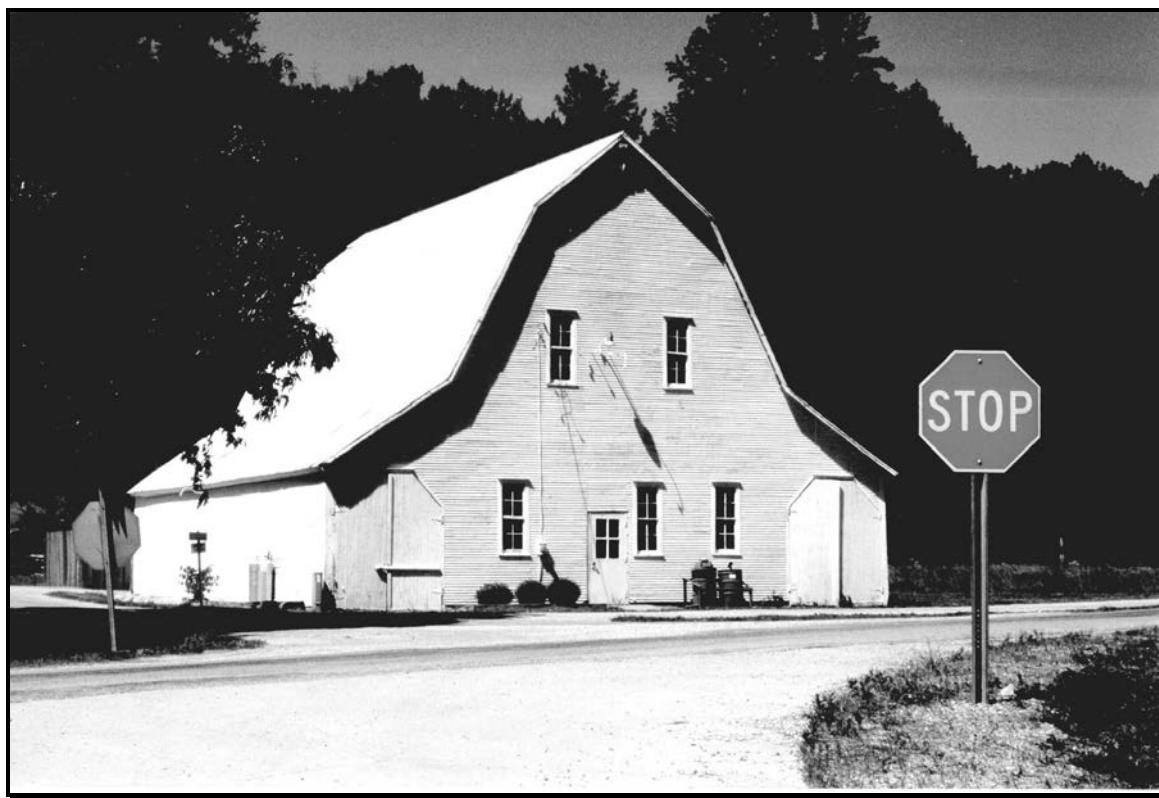
Figure 18. View of the south and west elevations of the White Barn. Except for the lowering of the central doorway on the south and the addition of shiplap siding around the exterior, these elevations retain their historic character.

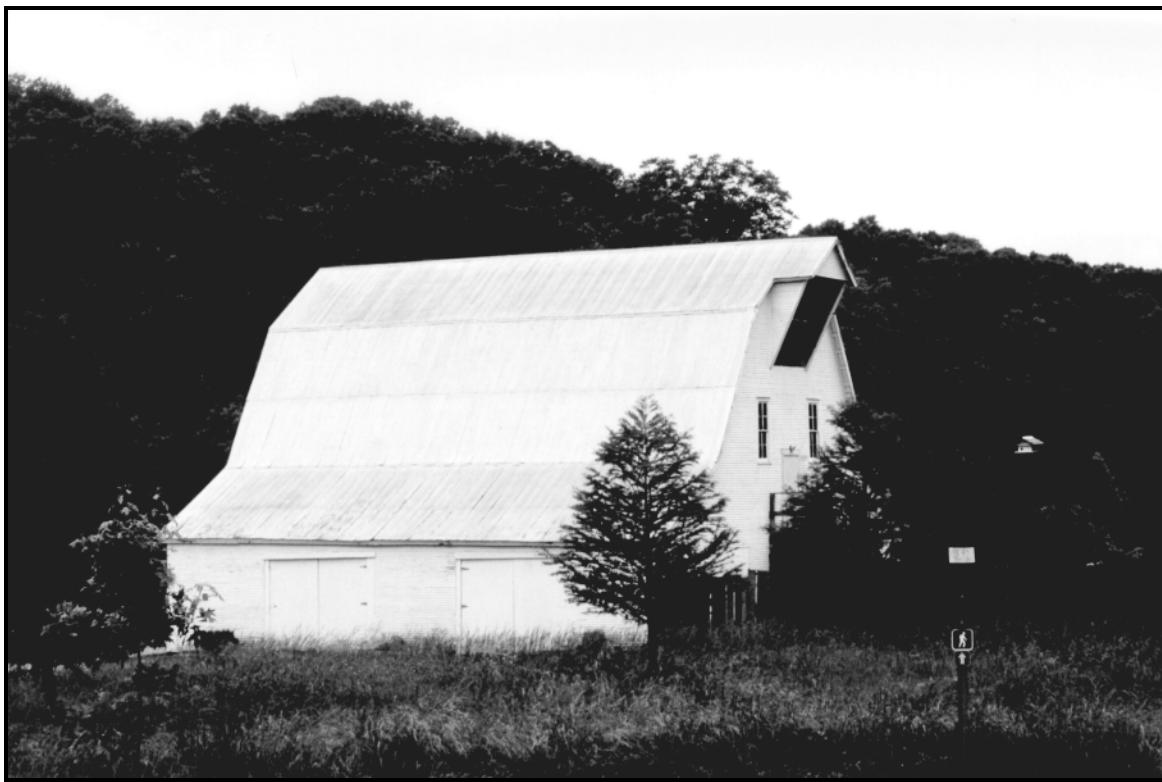
Figure 19. View of the east and north elevations of the White Barn (2000). The two sets of double doors on the east elevation originally were added during the 1930s and have since been remodeled. Note the large hay bonnet on the north.

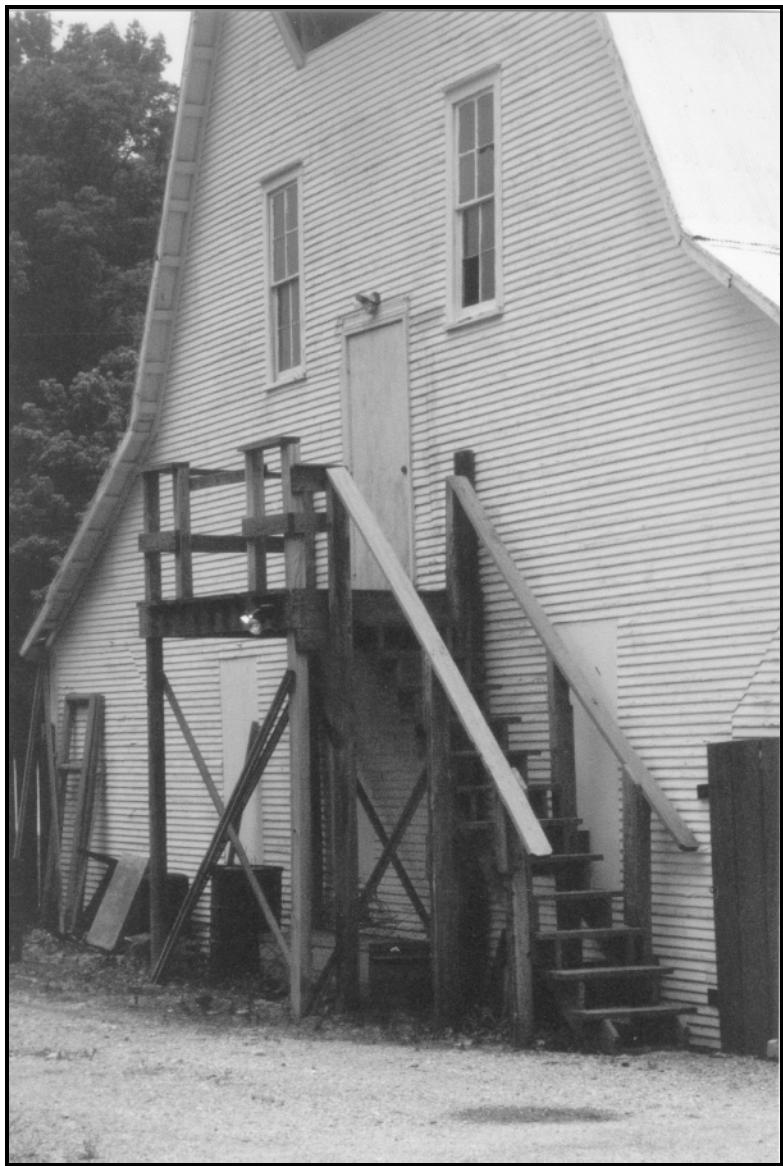
Figure 20. View of the north elevation of the White Barn (2000). The door and window openings on the first floor of this elevation have been closed-off. The rear stairway is a fairly recent addition.

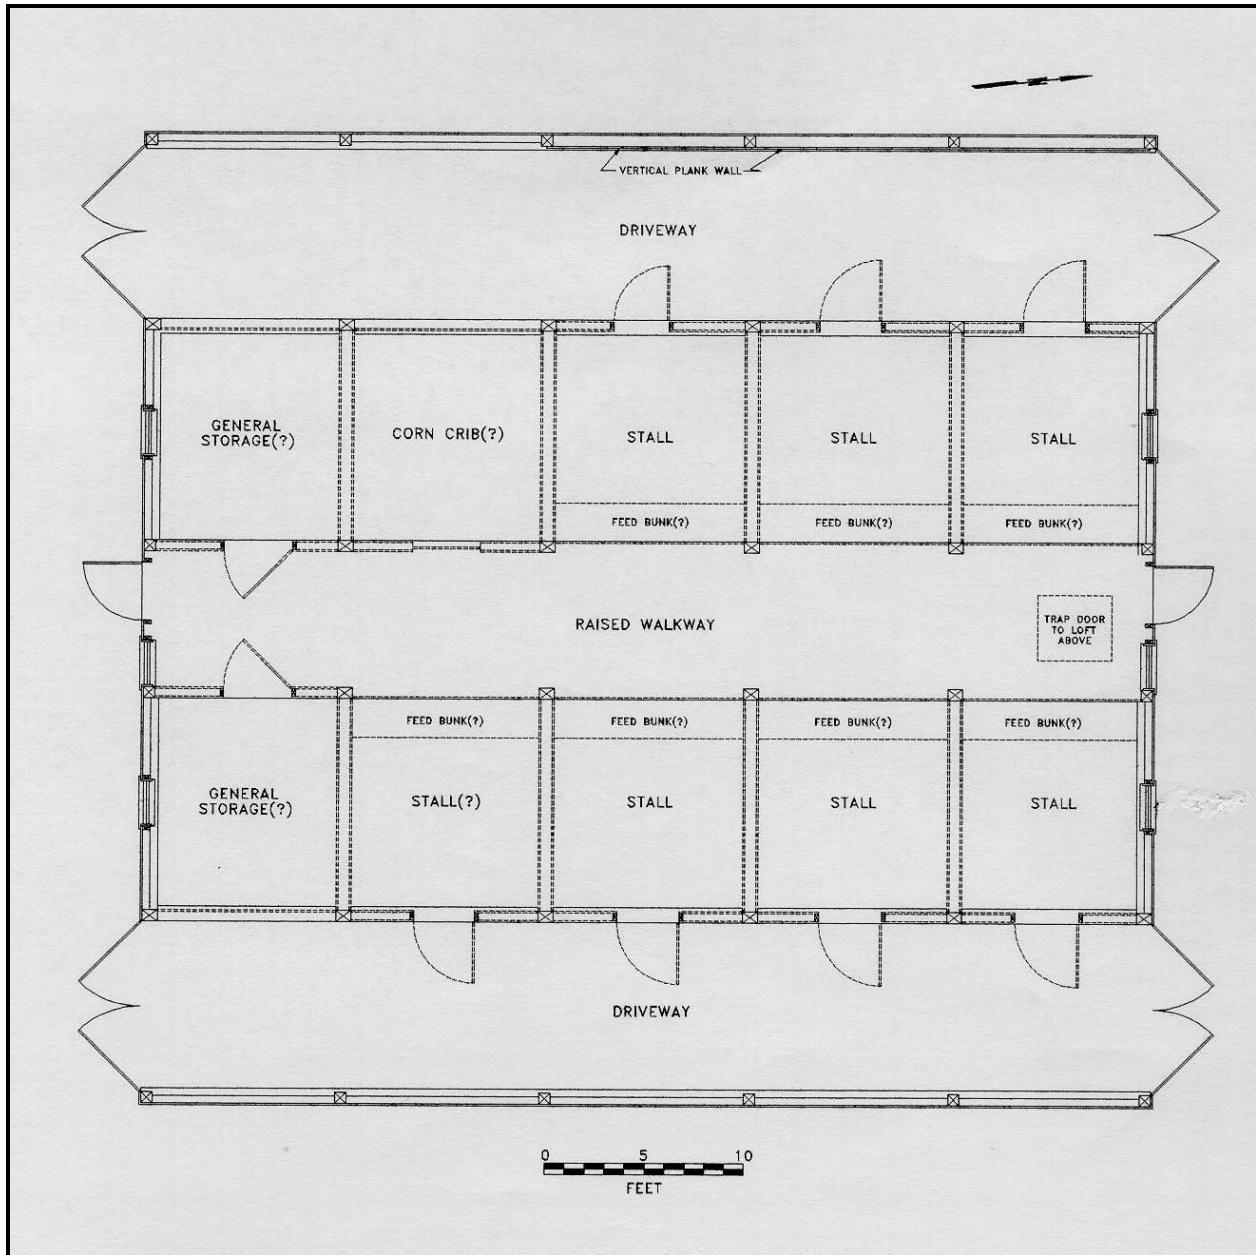
Figure 21. First floor plan of the White Barn, as originally constructed. Dashed lines indicate features that are believed to have been present but have since been removed.

The White Barn varies from the basic transverse-frame barn-form in several important respects. For one, the central aisle on the first floor of the barn was built to accommodate a raised frame walkway, rather than a driveway (see sectional views included as Figures 23 and 24). Thus, on its exterior, the barn has a common access door --measuring approximately 3’ wide-- in the center of its north and south elevations, instead of the wide double doors that are usually found in those barns with a central drive. Another aspect that sets the White Barn apart is the fact that it was constructed with two side wings. As mentioned earlier, side wings are quite common on transverse-frame barns, but they typically represent later additions, rather than an integral component to the original barn design. With the wings, the barn has five aisles on its lower floor, as opposed to three, and has a nearly square footprint. The structure measures 48'-7" wide (east/west) and 50'-4" long (north/south). Floor plans and sectional views of the White Barn are included as Figures 21 through 24.

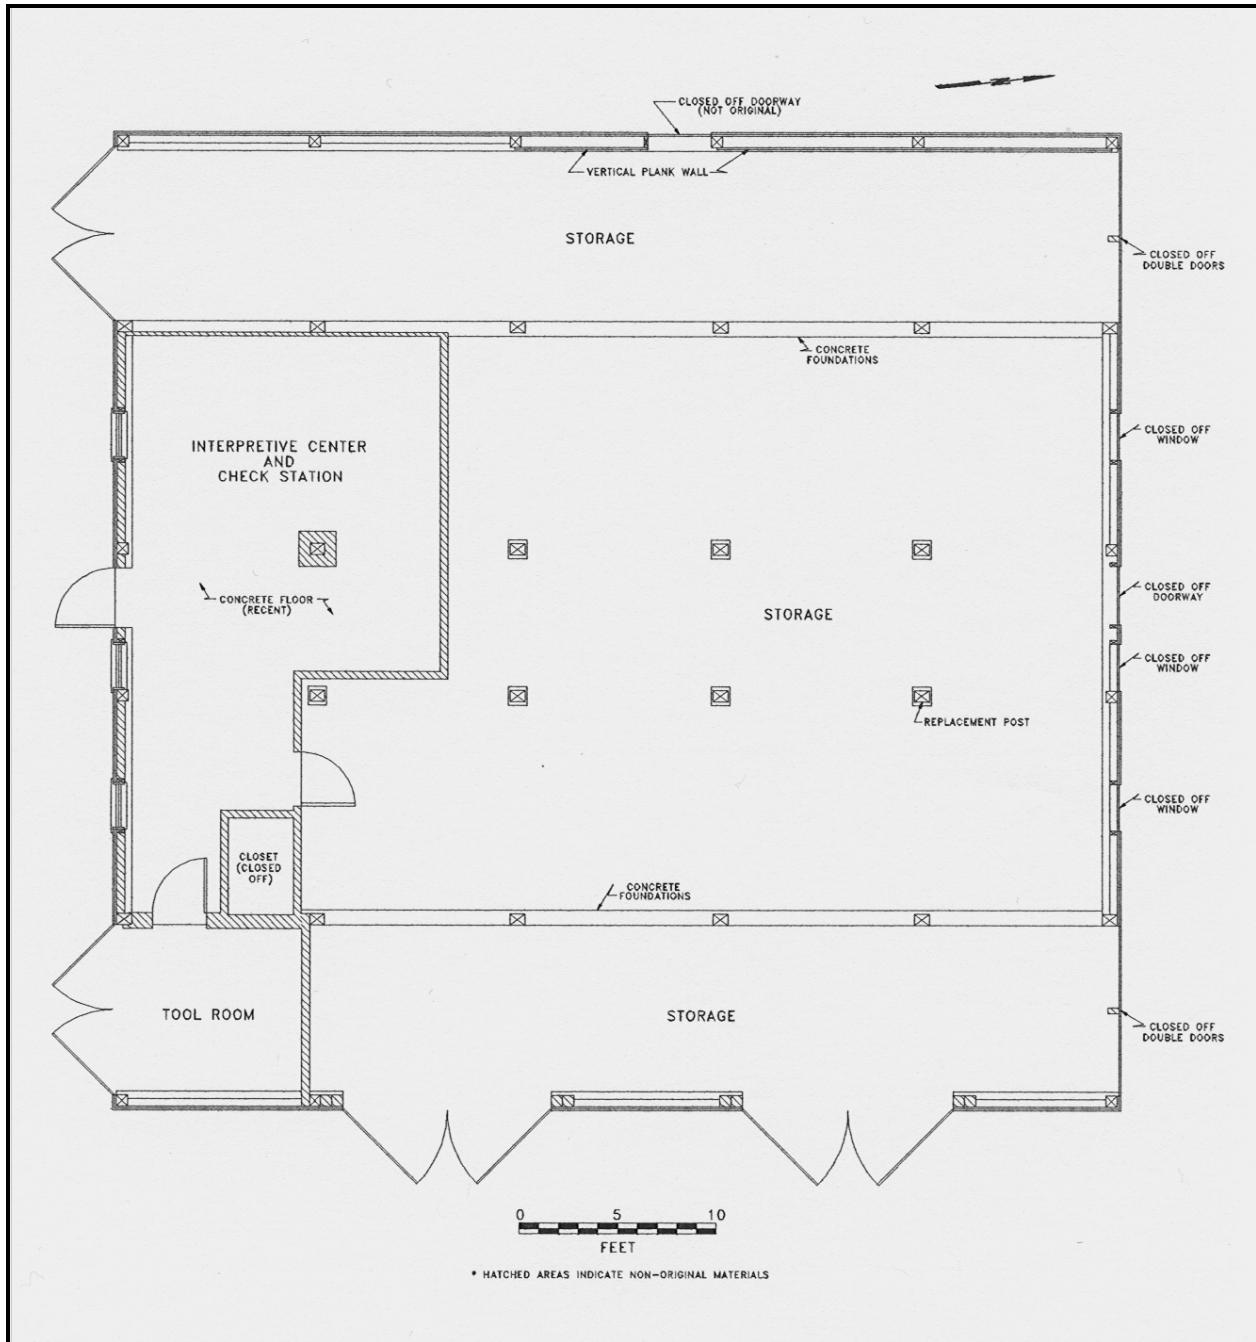
Figure 22. First floor plan of the White Barn, showing existing conditions.

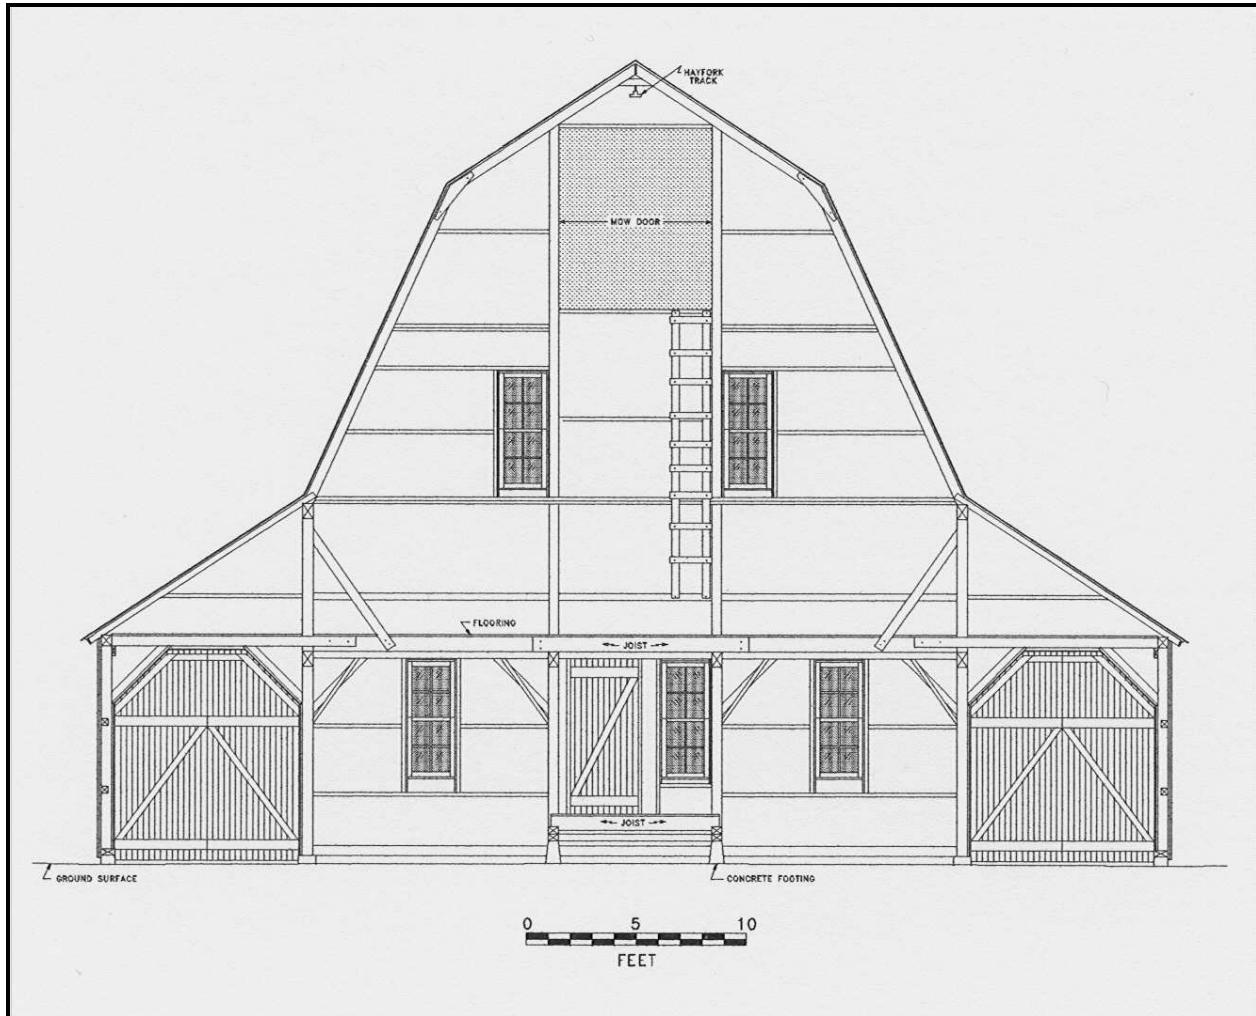
Figure 23. Sectional view through the White Barn, looking north. The raised walkway in the central aisle (which is no longer present) has been pictured. The stalls that originally flanked the walkway have not been pictured.

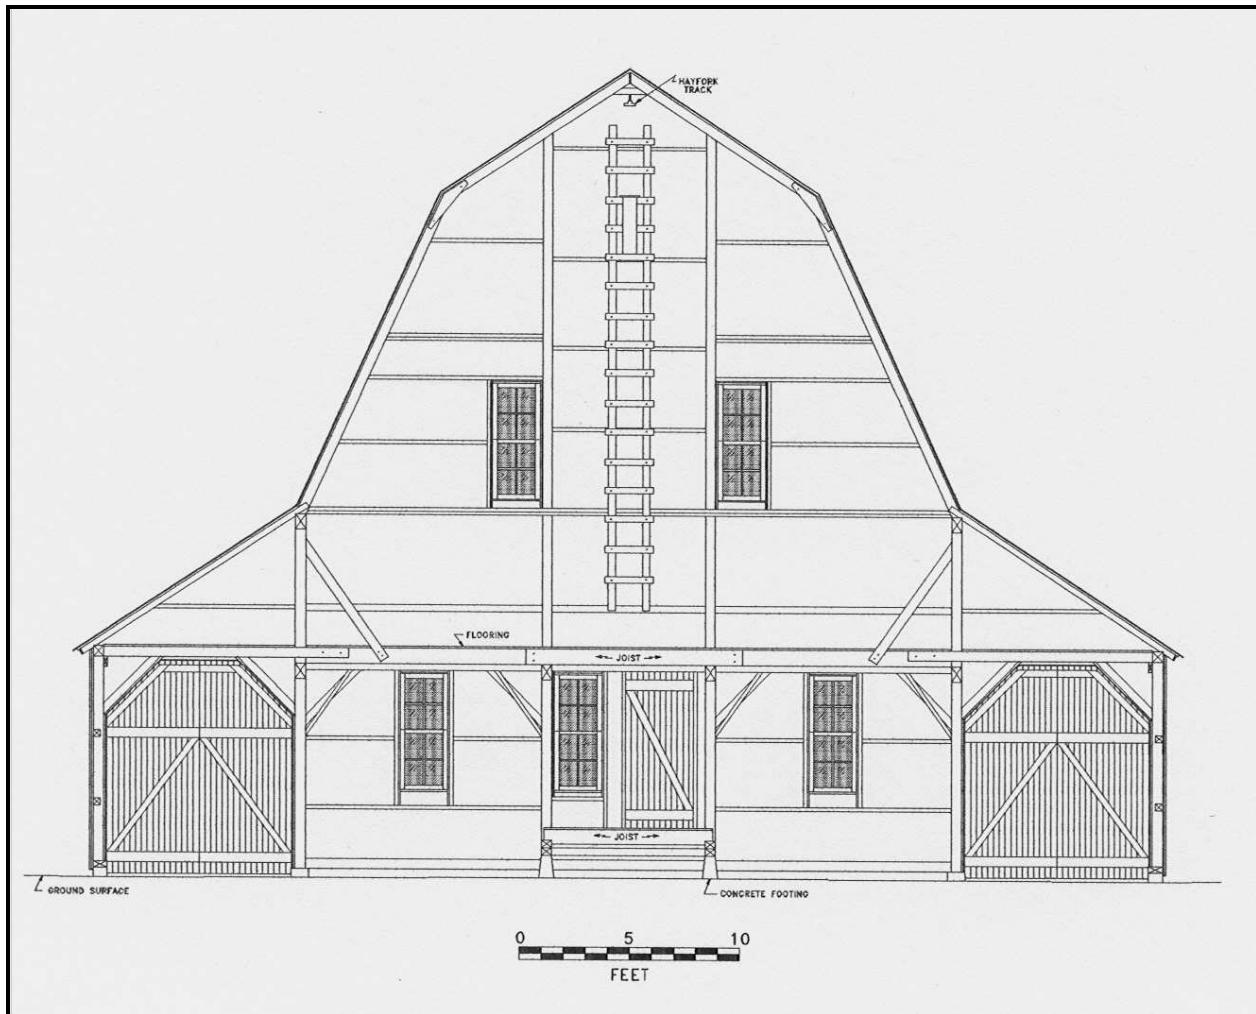
Figure 24. Sectional view through the White Barn, looking south. As in the previous illustration, the raised walkway has been pictured, but the stalls and cribs flanking have not.

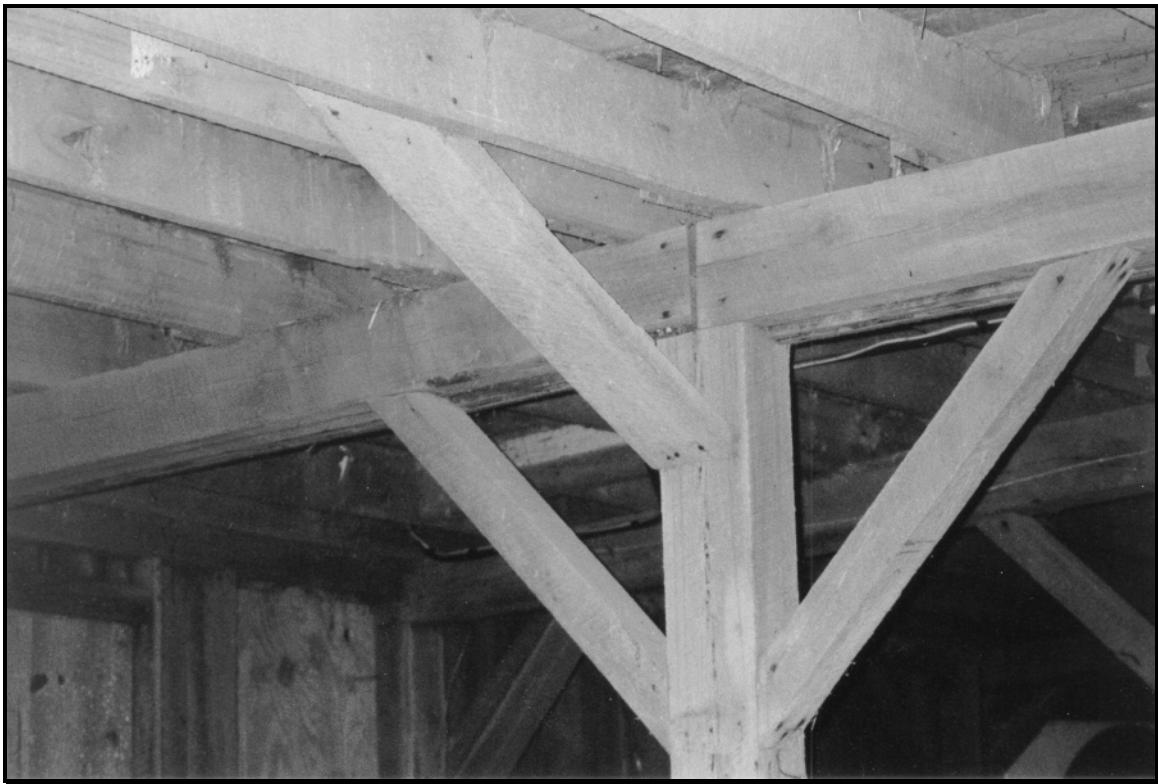
Figure 25. Detail of the framing utilized on the first floor of the White Barn (2000). This view shows the juncture of a post and girt in the central core of the barn.

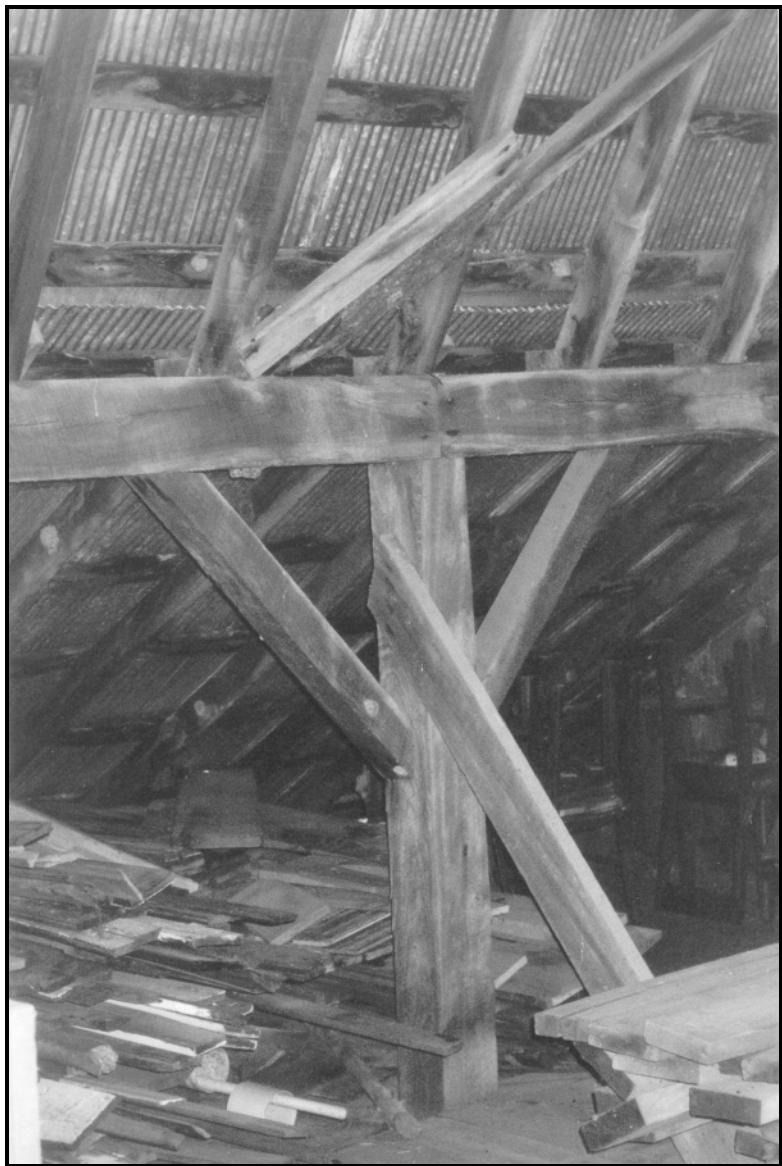
Figure 26. Detail of the juncture of a post and rafter plate in the central core of the barn (2000). The brace that runs diagonally down from the post extends through the floor and ties into one of the hayloft floor joists.

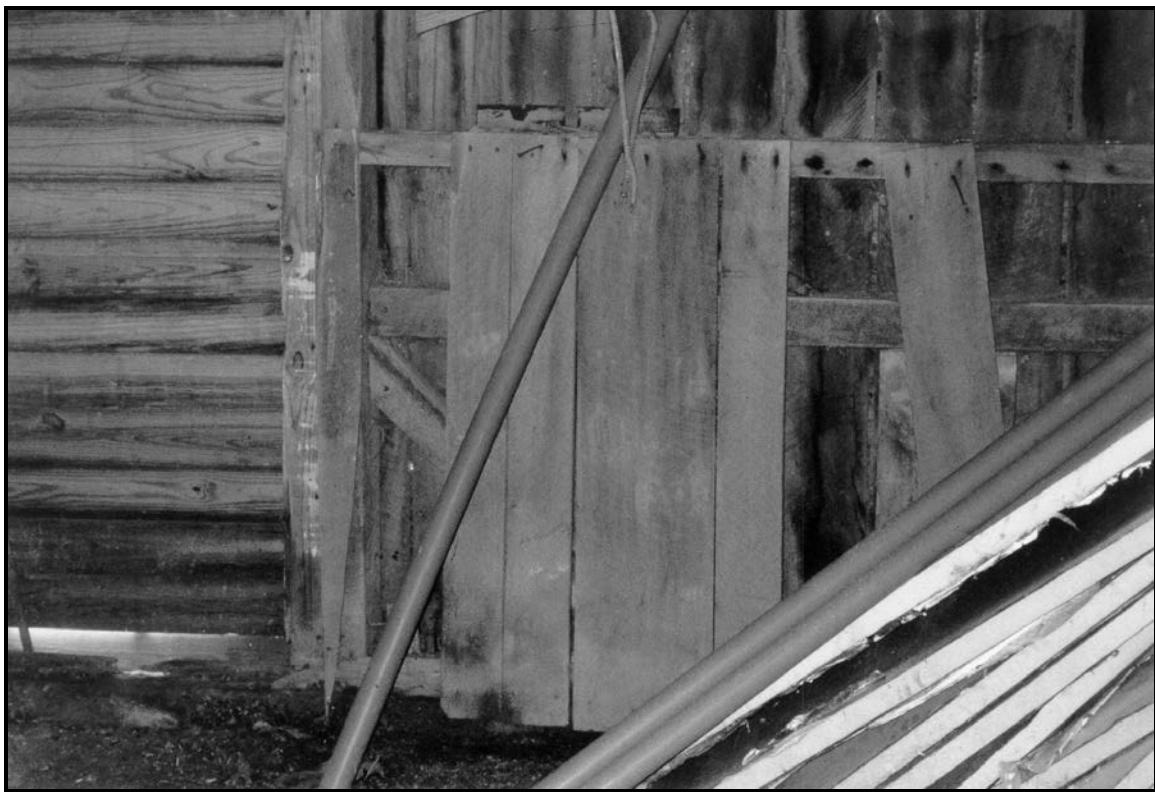
Figure 27. Remnants of the plank siding lining the interior of the western driveway in the White Barn (2000). The same type of planking was likely used to frame out the stalls in the barn.

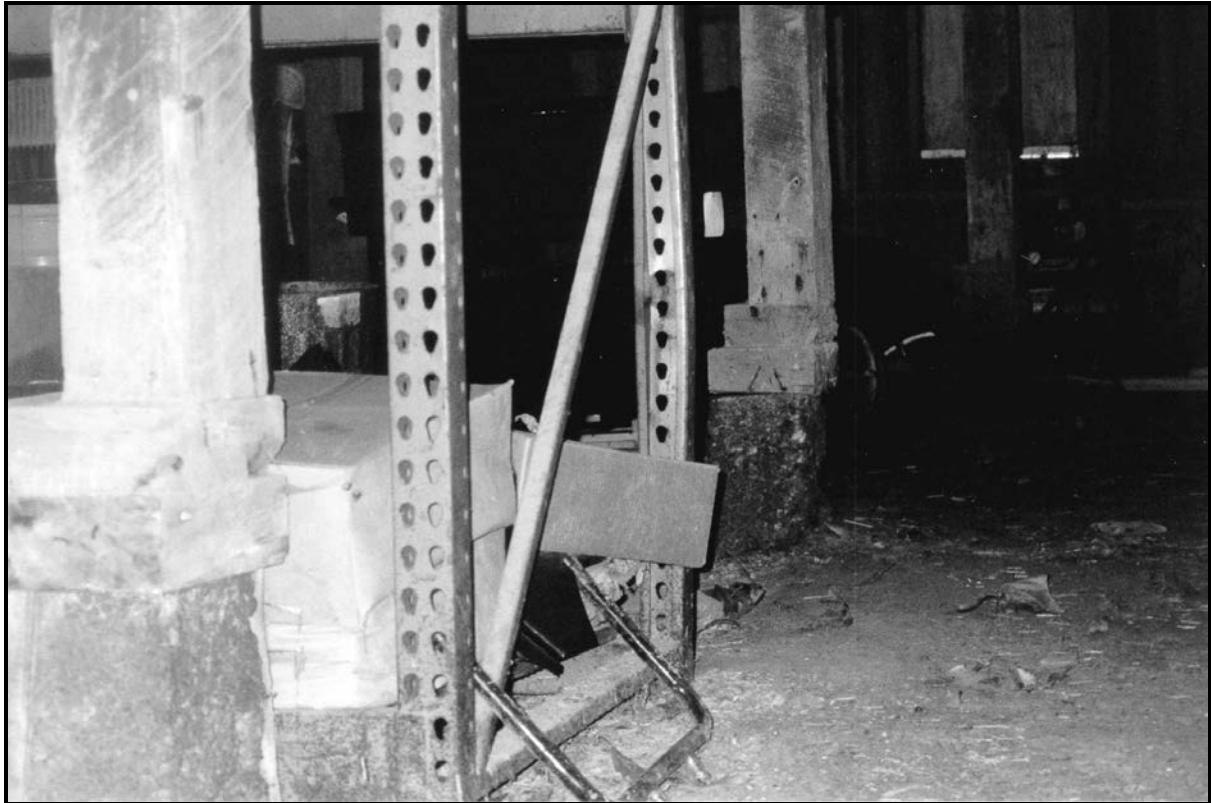
Figure 28. View of the lower ends of two of the posts lining the central aisle in the barn (2000). The blocks on which the posts are resting actually represent sections of a sill plat that was cut out when the raised walkway was removed. Nail and “ghost” patterns found near the base of the posts indicate the location of the floor joists that formerly carried the walkway.

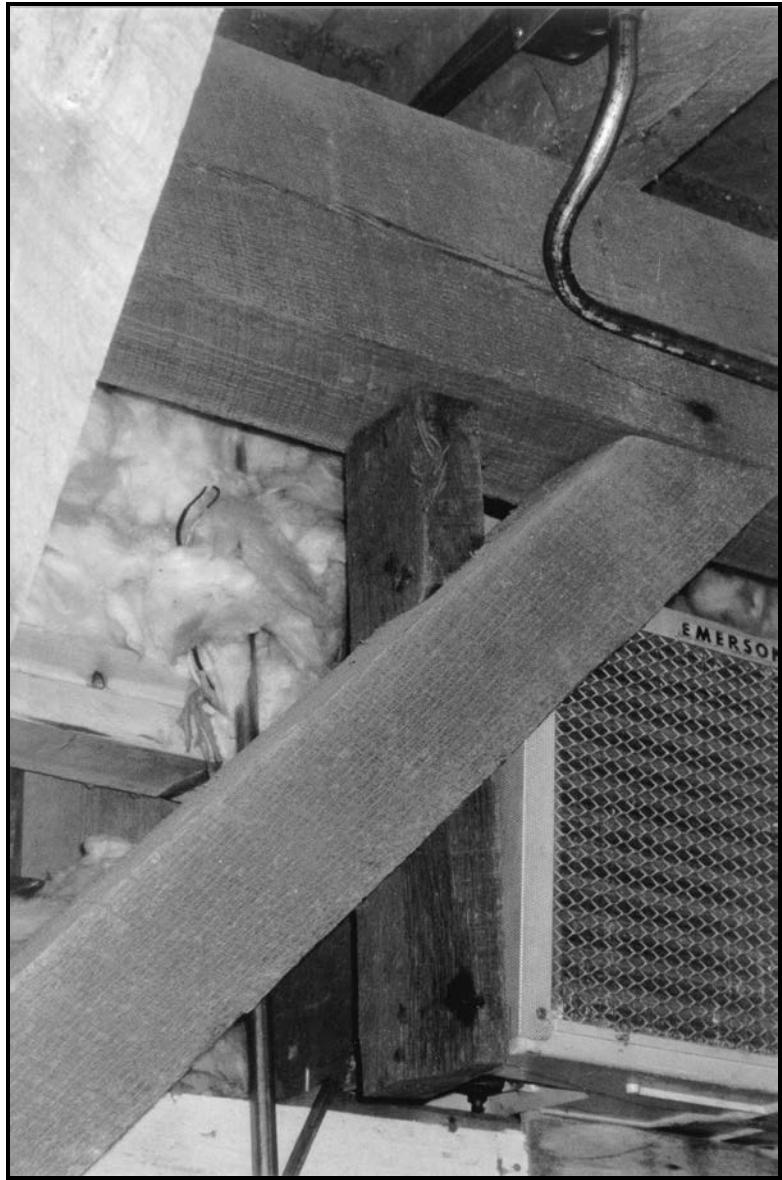
Figure 29. The stud fragment running along the left side of the air conditioner in this view formerly framed in one of the cribs in the barn (2000). The other studs framing the cribs and stalls have been removed. The stud shown here has been notched around the diagonal "knee" brace that runs between the post and girt.

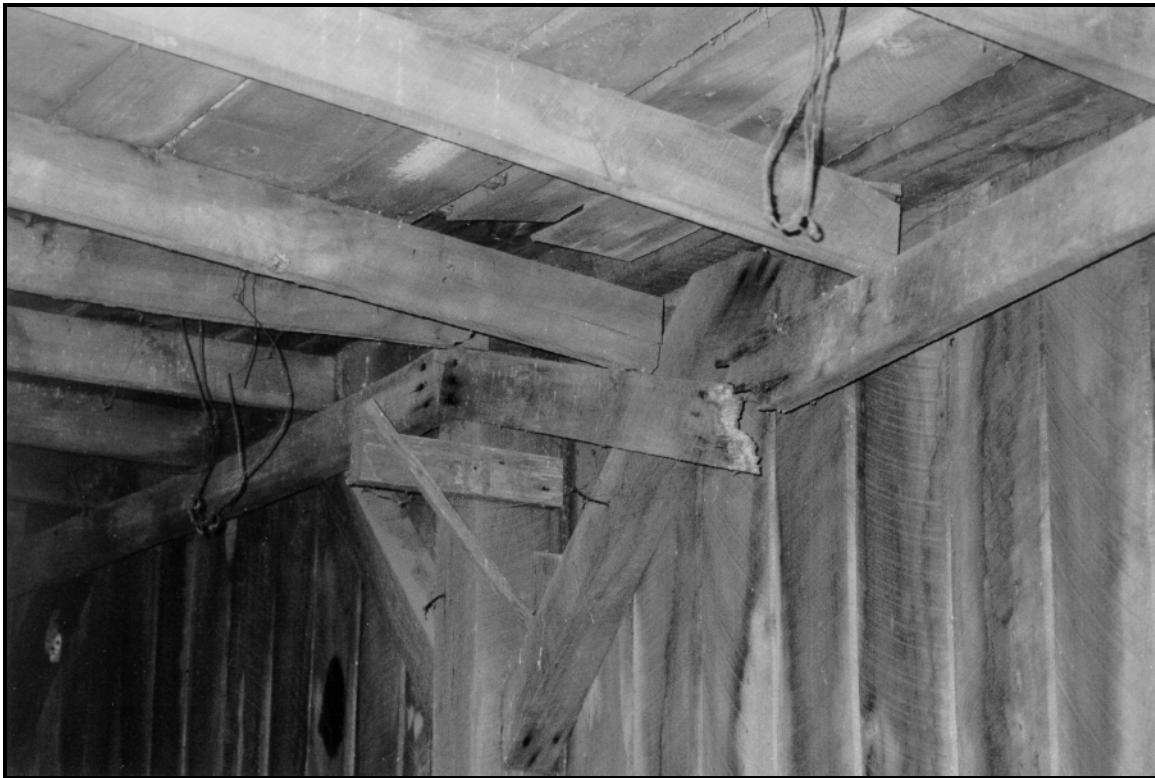
Figure 30. While the White Barn is structurally sound on the whole, it does present a number of structural concerns. The most serious of these is the deterioration of the ribbons that carry the upper story floor joists in the side wings. This view shows a damaged section of ribbon in the east wing (2000).

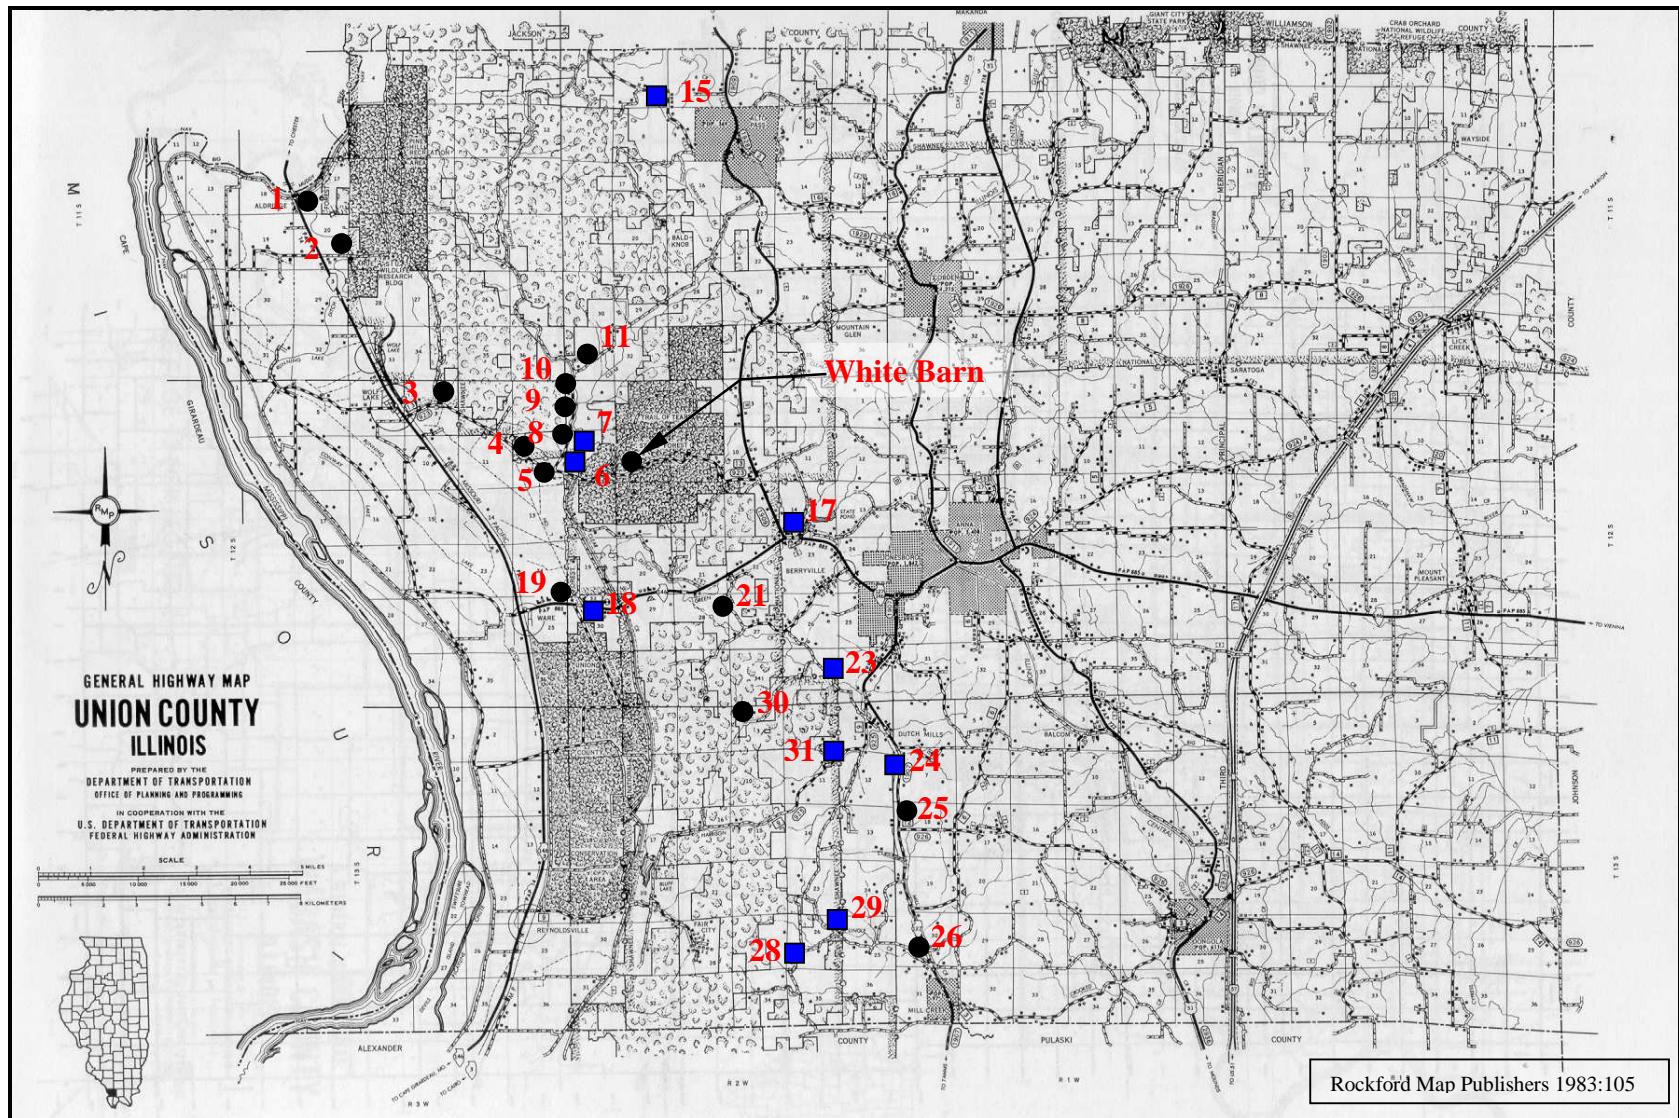
Figure 31. Map showing the locations of transverse-frame barns found during the windshield survey. The circles indicate barns identified as transverse-frame (including the White Barn), while the squares designate barns that are potentially transverse-frame.

Despite the restrictions imposed on the windshield survey, fourteen barns that clearly fit the transverse-frame form were identified. Thirteen of these follow the classic transverse-frame plan of a central driveway flanked by stalls and cribs. Ten of the fourteen have gambrel roofs, while the remaining four have gable roofs. There was only one barn identified in the survey definitely that has a raised central walkway like that found in the White Barn. This barn has a gambrel roof and will be discussed in more detail below. An additional ten barns were identified during the survey that might possibly be transverse-frame but could not be conclusively identified as such; two of these may have a raised central walkway. Five of the ten potential transverse-frame barns have gable roofs, while the other five have gambrel roofs (see Figure 31).

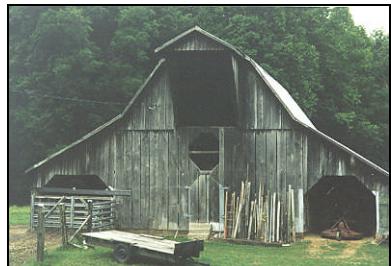
Lloyd Smith Barn (No. 10)

Figure 32. Transverse-frame barns located in the Clear Creek Valley, west of Trail of Tears State Forest. This group is representative of the variety found in the barn type in western Union County.
