**NATIONAL REGISTER OF HISTORIC PLACES ASSESSMENT
OF
THE WHITE BARN
A TRANSVERSE-FRAME/CRIB BARN LOCATED AT
TRAIL-OF-TEARS STATE FOREST, UNION COUNTY, ILLINOIS**

prepared for:
Illinois Department of Natural Resources
Springfield, Illinois

July 2000

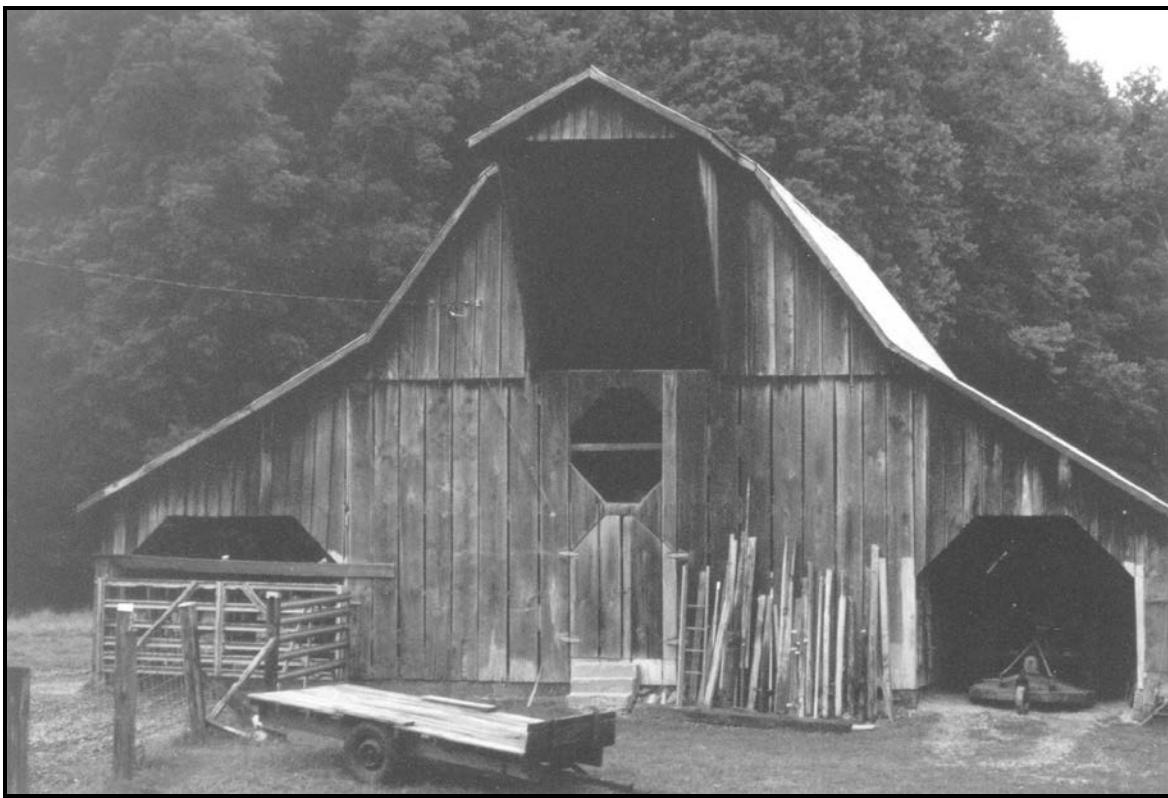
Figure 33. View of the front side of the Lloyd Smith Barn (2000; Survey No. 10). Although smaller in size, structure has a similar design and framing system to the White Barn.

used for equipment storage. The framing in the Smith Barn is also very similar to the White Barn. The current owners believe the barn to have been constructed by Lloyd Smith “about fifty years ago” (Randalls 2000)

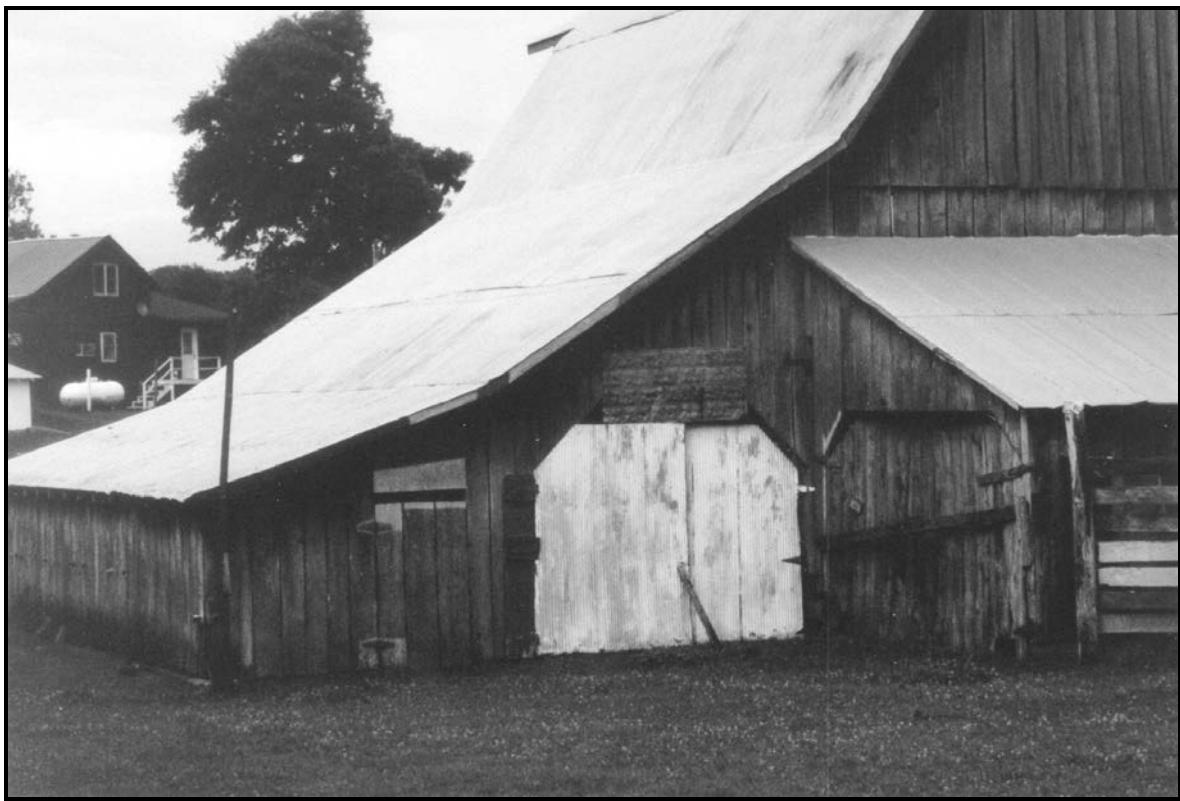
Figure 34. View of the rear side of the Lloyd Smith Barn (2000). The side and rear wings serve as covered driveways that can also be used for equipment storage.

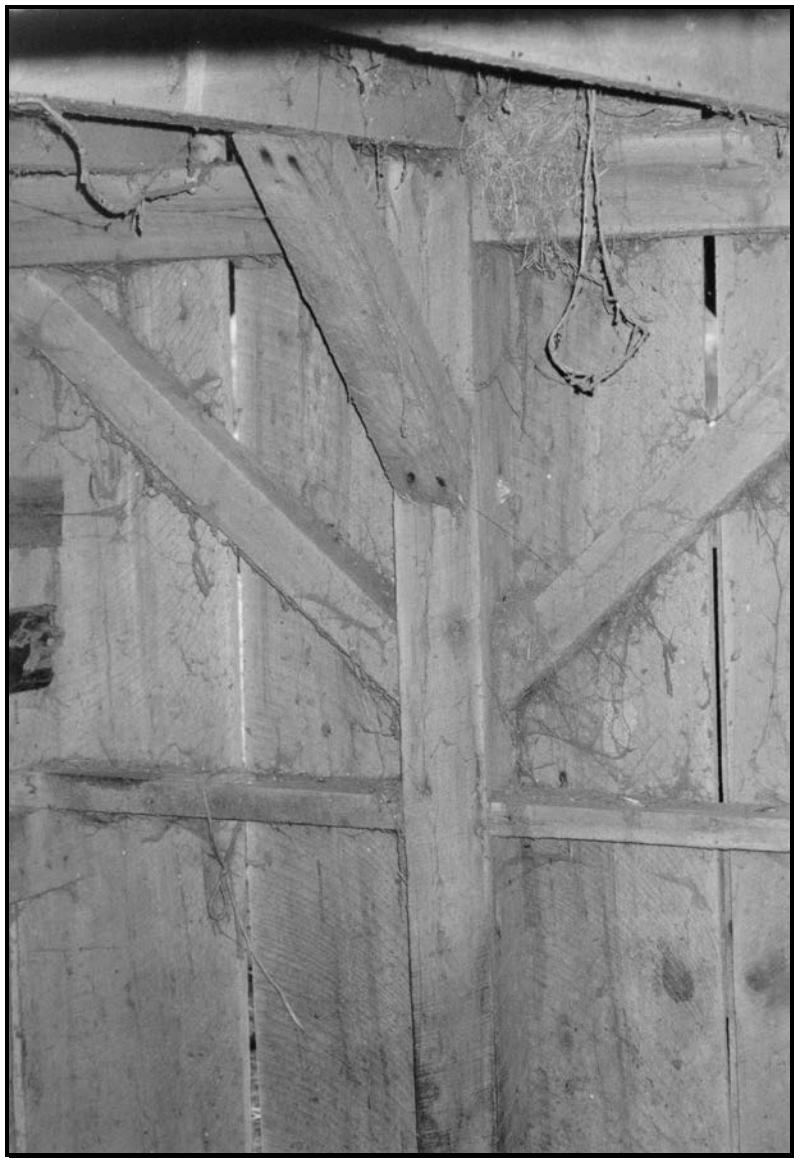
Figure 35. Detail of the framing found in the Lloyd Smith Barn (2000). The double bracing utilized between the posts and girts resembles that used in the White Barn.

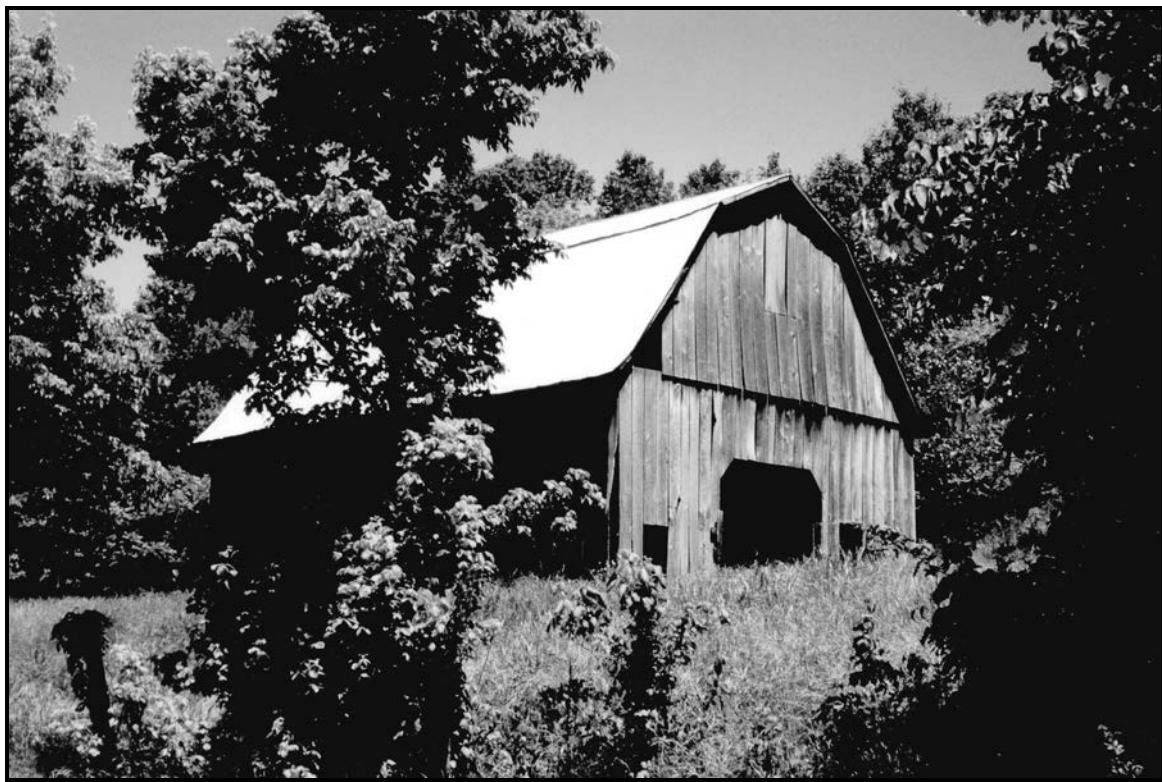
Figure 36. View of a transverse-frame barn (Survey No. 26) that is located on Lingle Road, north of the village of Mill Creek, in southwestern Union County (2000). This barn has a central driveway and no side wings. The stalls and cribs in this barn are still intact.
