Anna Margaret Barris

Illinois Historic Preservation Agency

Building a Sustainable Future

Sustaining Buildings for the Future

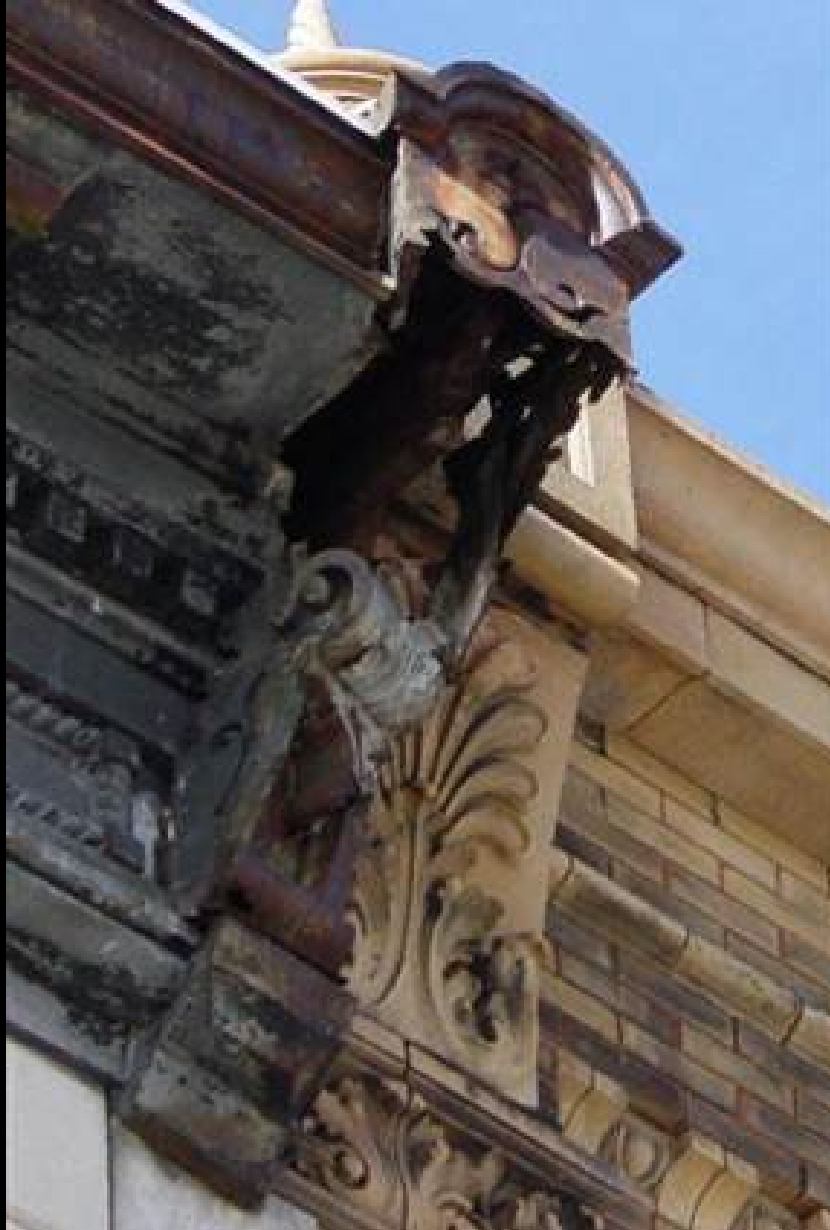
Rust can literally erode away the metal.

Rusting metals should be painted

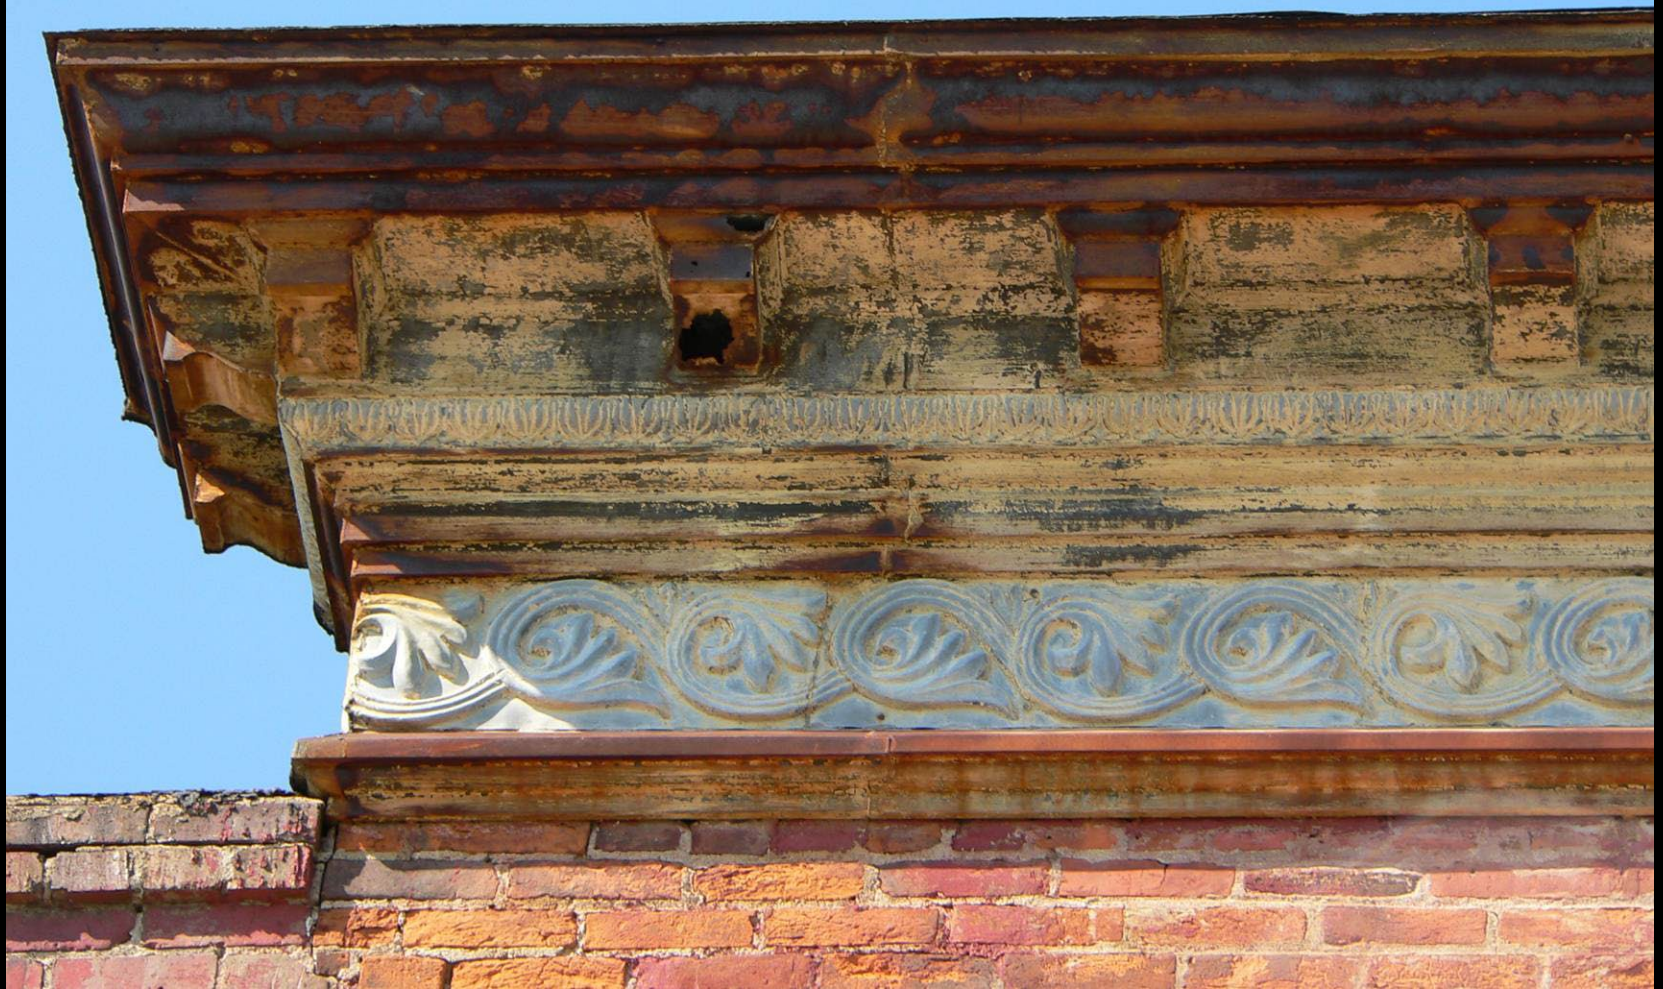
Lose detail

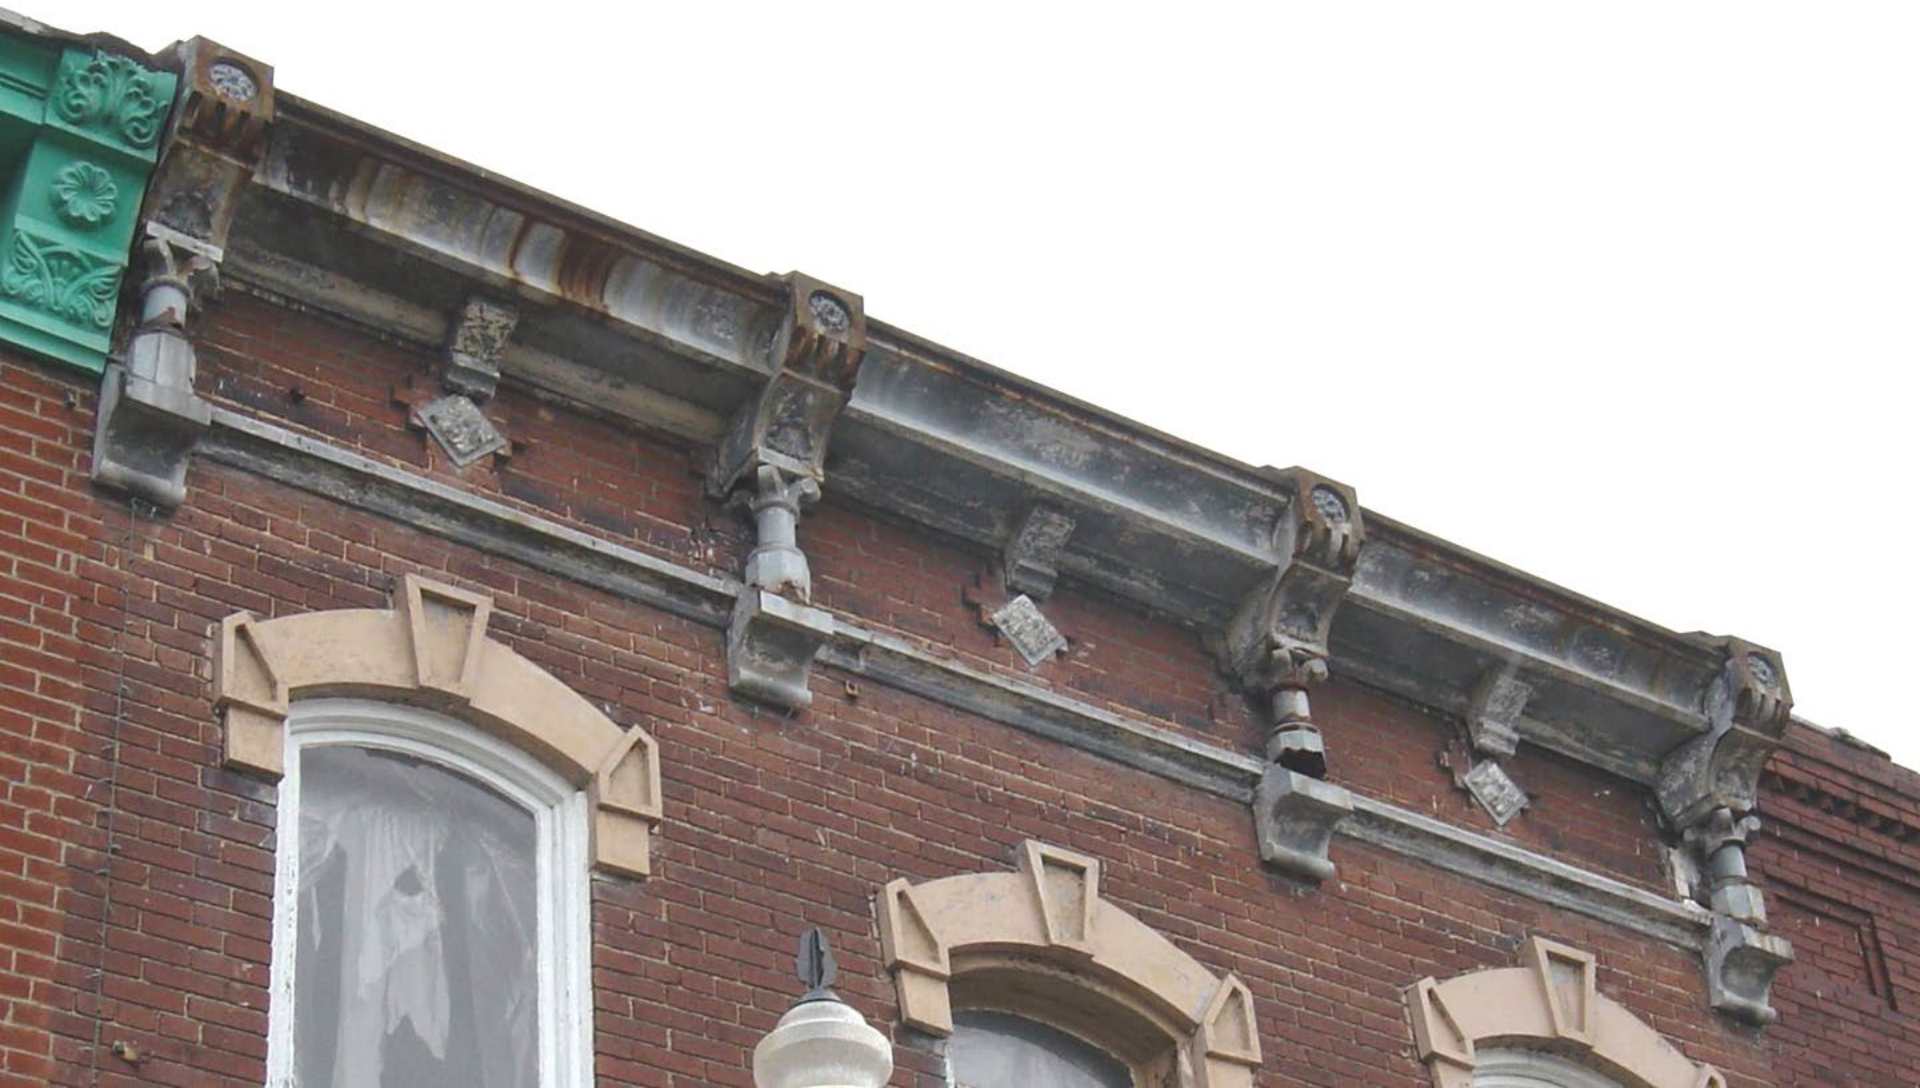
Damages ornament

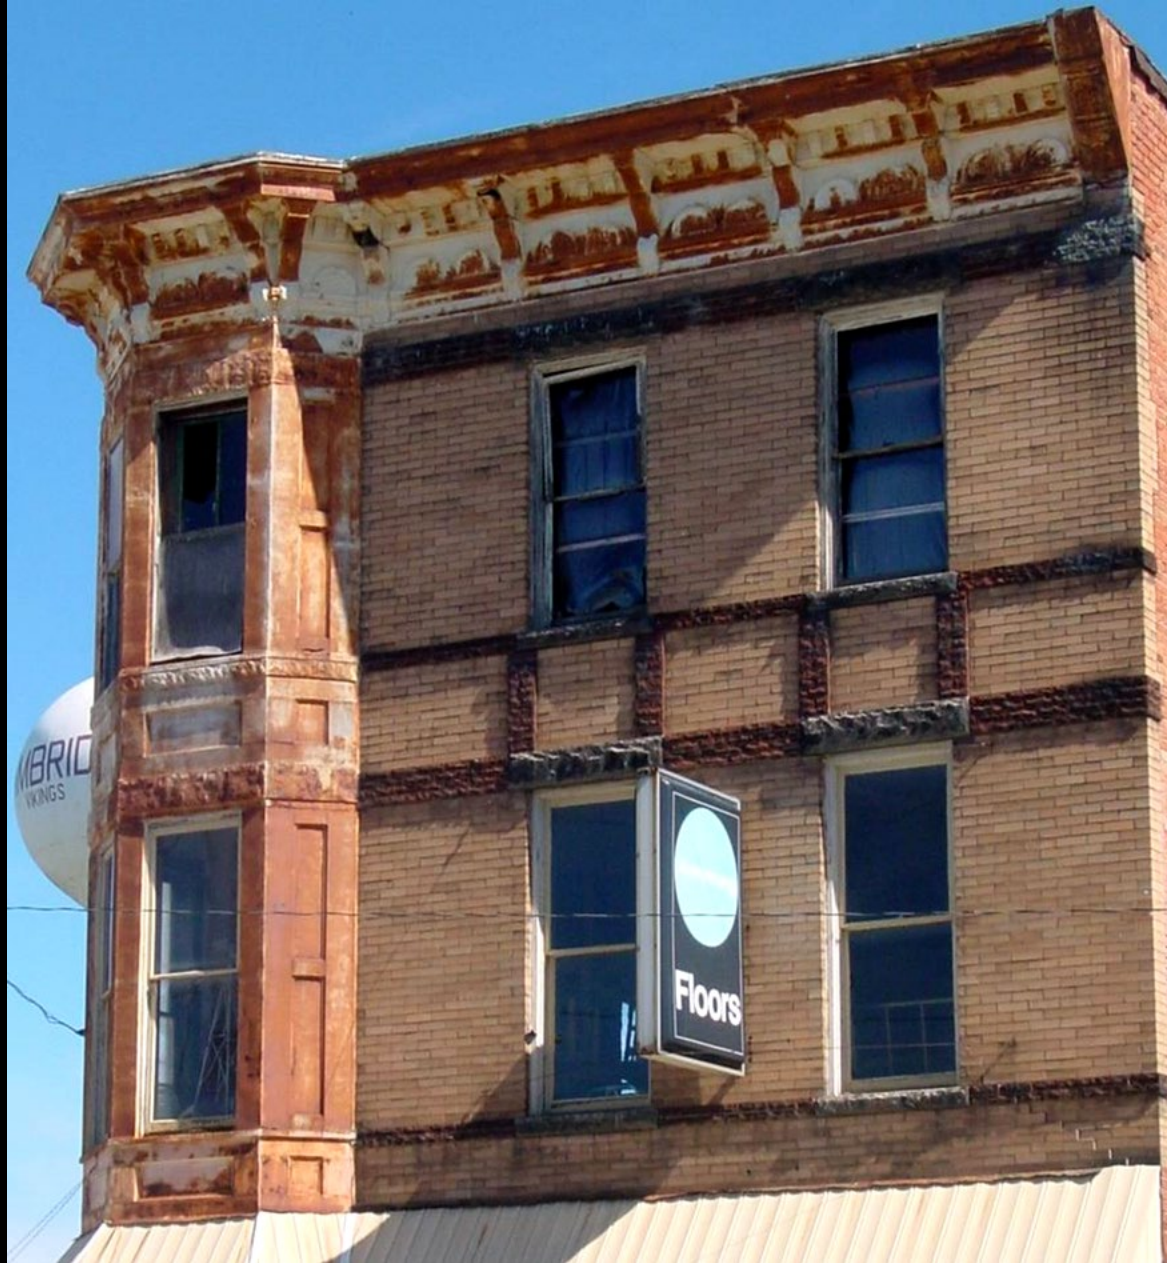
Rust looks bad!

To prevent further rusting, steel and iron should be scraped with a wire brush, primed, and painted.

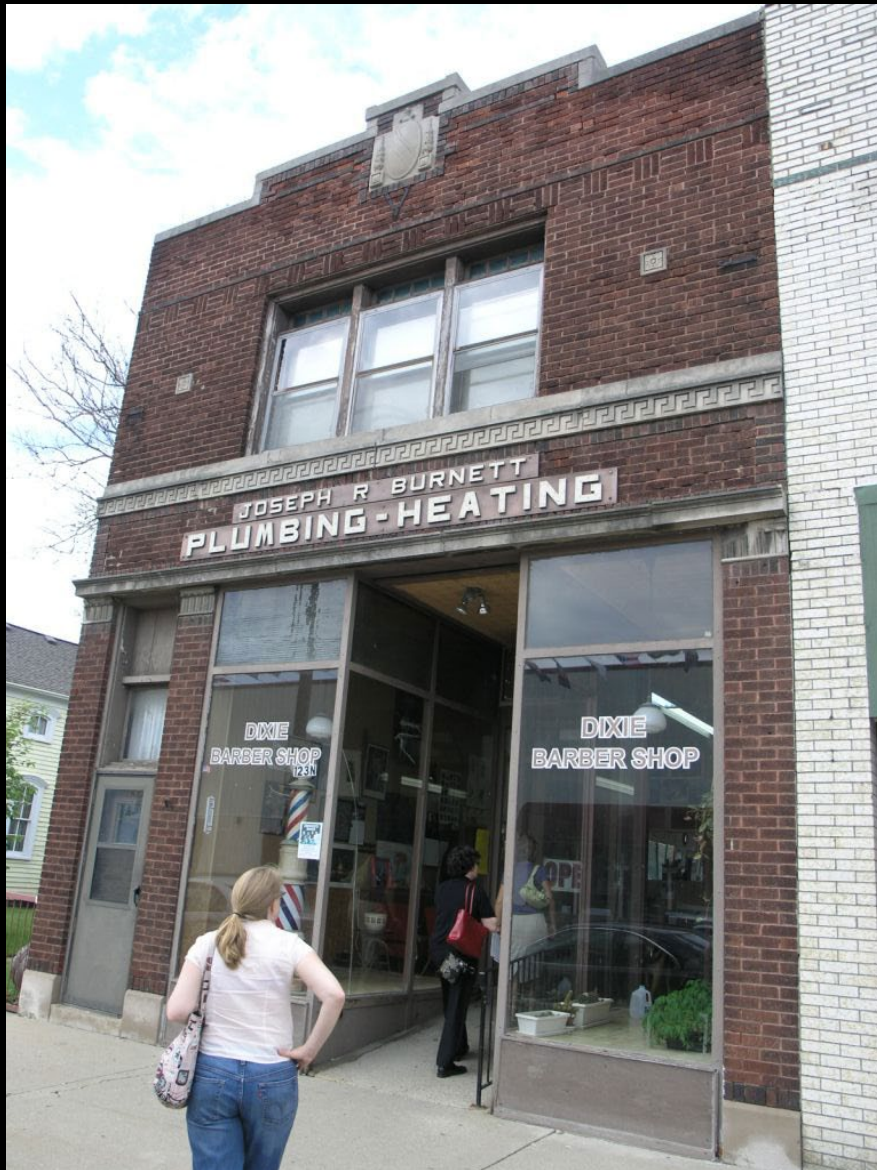
123 N. Dixie (Dixie Barber Shop)

The original prismatic glass transoms are in very good condition.

Historic door is in good condition. It should be repainted when the storefront is repainted.

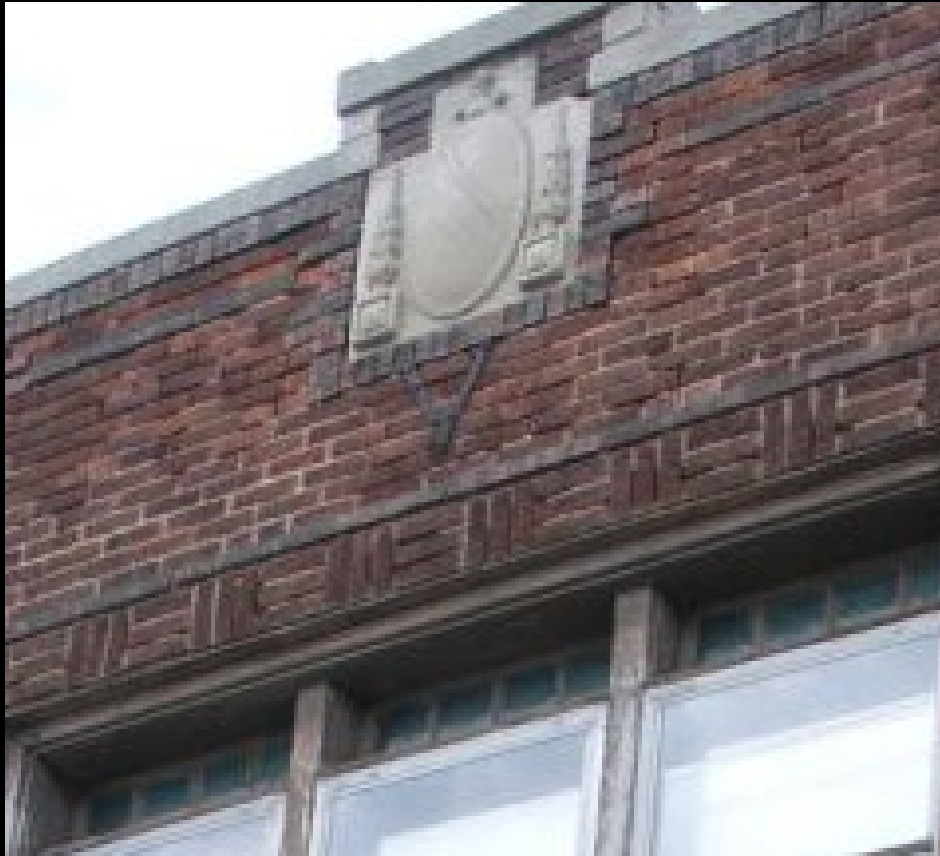
Water is infiltrating the parapet brick, most likely at the roof line or at the coping. Roof should be inspected for proper flashing and the coping joints examined.

Spalling is occurring at parapet. The mortar should be removed (by hand) and replaced with Type N or O mortar mixes, taking care not to get mortar on the face of the brick. Mortar should be tinted and joints should be raked to match historic joints.

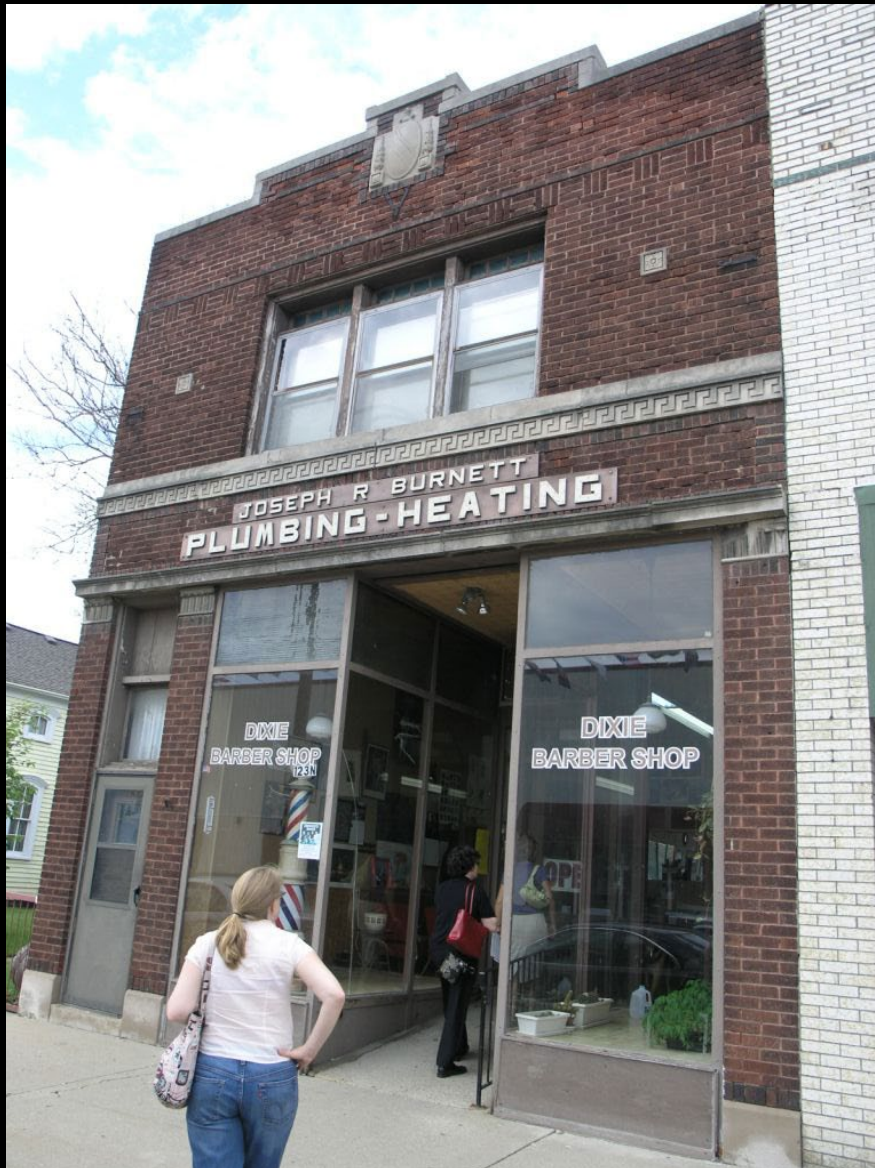
123 N. Dixie (Dixie Barber Shop)

Historic Tiffany brick. Any spalling glaze should be flaked off and those areas painted with acrylic paint (Thorosheen).

Historic. Appear to be in fair condition. Should be repaired and painted.

The steel lintel above the storefront is significantly corroded and the adjacent Tiffany brick is structurally unstable. The face brick is likely debonded from the backup brick. At a minimum, the brick between the prism glass transom and the upper story windows will have to be removed, and the lintel replaced while stabilizing the rest of the masonry above. It may be necessary to install supplementary anchors to secure the Tiffany brick to the backup brick.

Replace storefront lintel and secure the Tiffany brick

Repair the transom windows

Repair the upper story windows

Repair areas of spalled brick

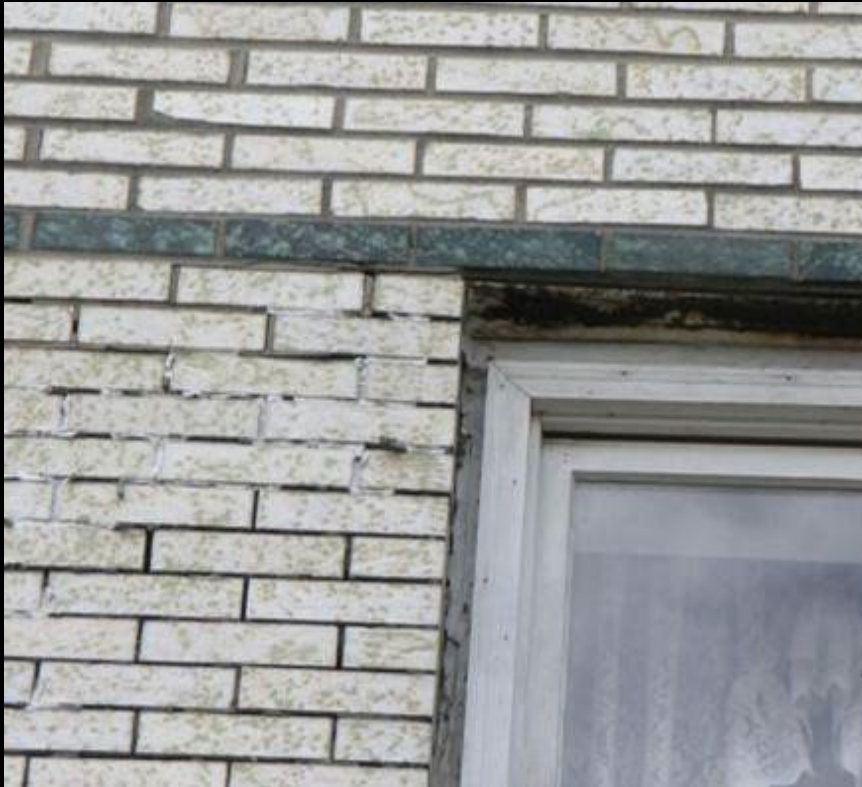
- Non-historic aluminum windows in wood frames (inappropriate proportions). These should be replaced with new wood windows that fill the entire masonry opening.
- Historic sills should be scraped and cleaned with a nylon bristle brush.
- Steel lintels should be scraped of rust and repainted.

Historic glazed Tiffany brick in fair condition, almost no signs of spalling. It appears that the mortar joints around window lintels have been inappropriately caulked and/or are significantly eroded. Caulking and any loose mortar should be removed and joints should be repointed with Type N or O mortar mix.

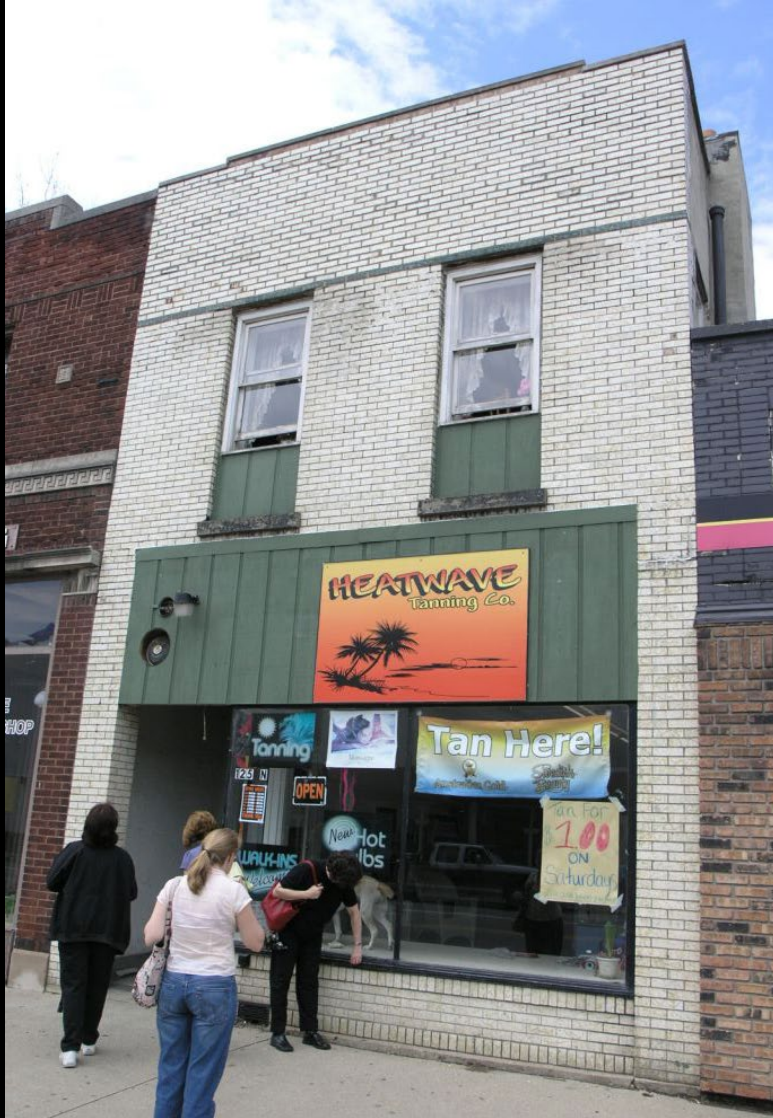
There are no evident structural issues.
