Concrete Restoration for Route 66 in Illinois

September 2012

The goal of this report is to outline treatment options for the primary Route 66 roadway conditions observed in Illinois as guidance for preserving that which remains of the historic concrete roadways. This study was based on

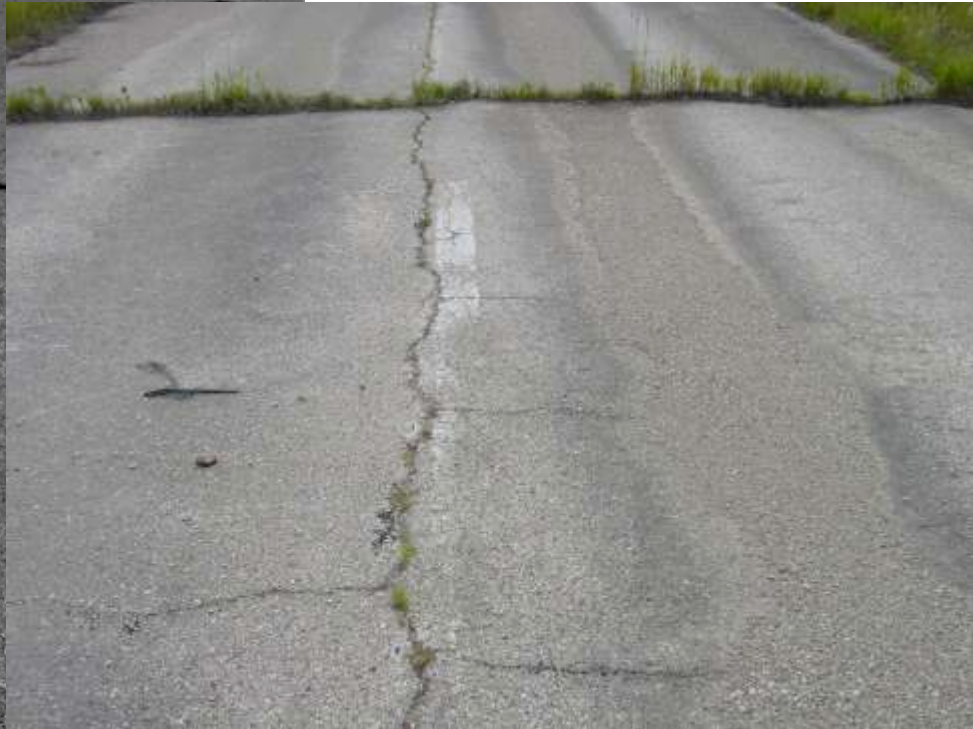
FIG. 7
Near Dwight, IL. Close-up of Rt. 66 bypass by Mazon Rd. Camera looking south.
Photograph by Travis Ratermann, 2 July 2008.

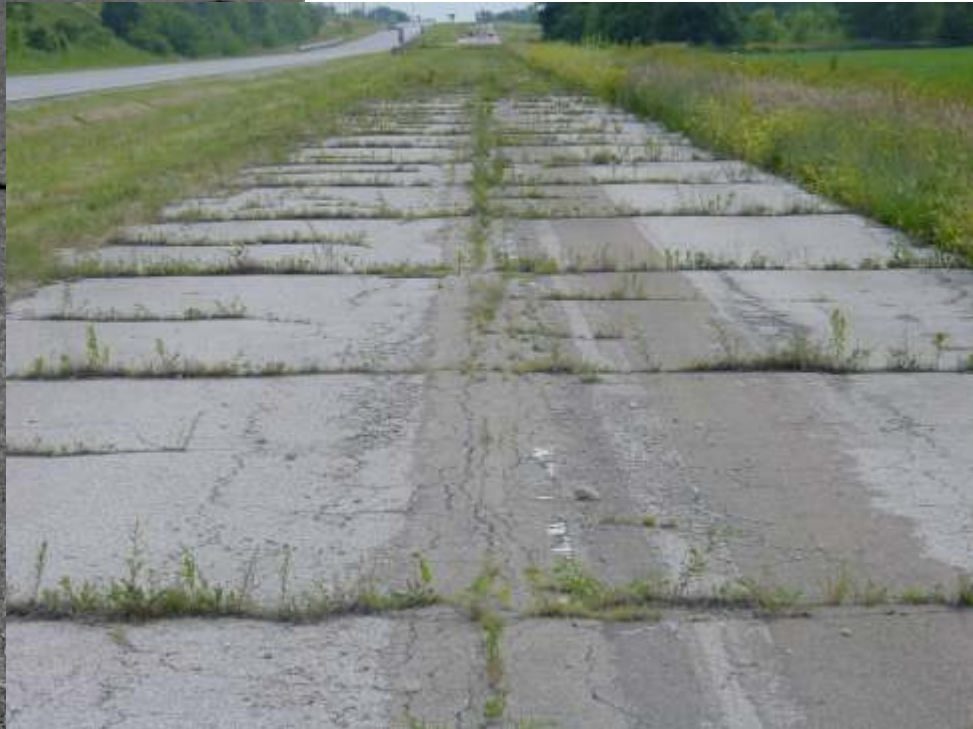
FIG. 13
Odell, IL. Segment between Odell and Pontiac looking up close at the pavement. Camera facing north.
Photograph by Travis Ratermann, 2 July 2008.

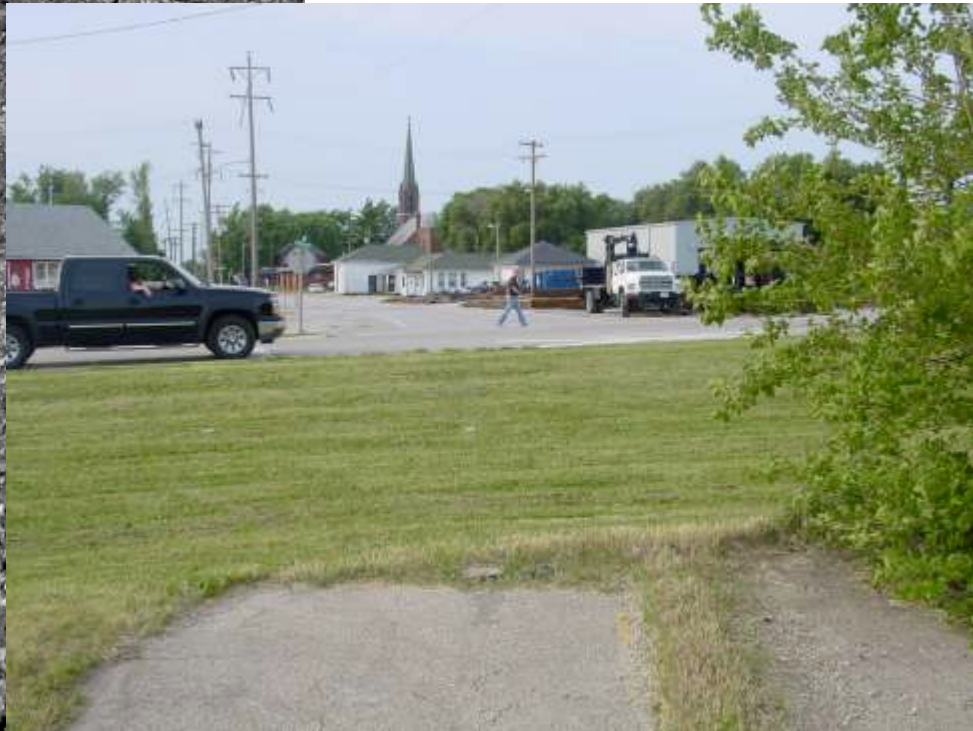
FIG. 20
Chenoa, IL. Abandoned 1926-30 segment of Rt. 66 off of Moorehead and Cemetery Rds. Runs along RR tracks. Camera facing northeast.
Photograph by Travis Ratermann, 2 July 2008.

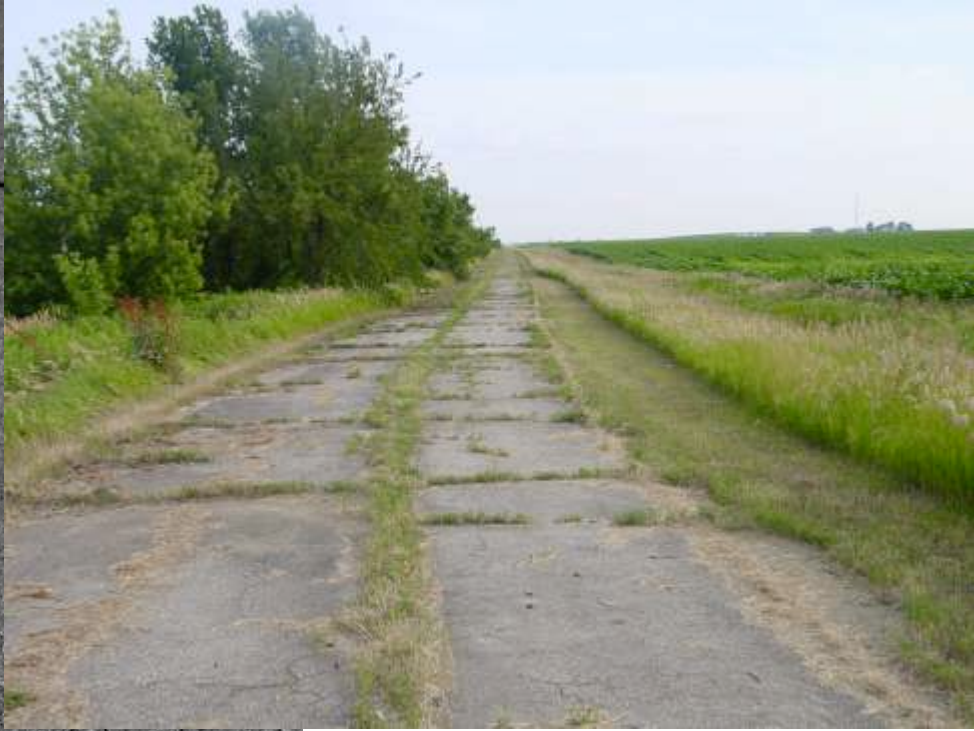
FIG. 21
Chenoa, IL. Abandoned 1926-30 segment of Rt. 66 off of Moorehead and Cemetery Rds. Runs along RR tracks not visible to the left due to trees. Camera facing southeast.
Photograph by Travis Ratermann, 2 July 2008.

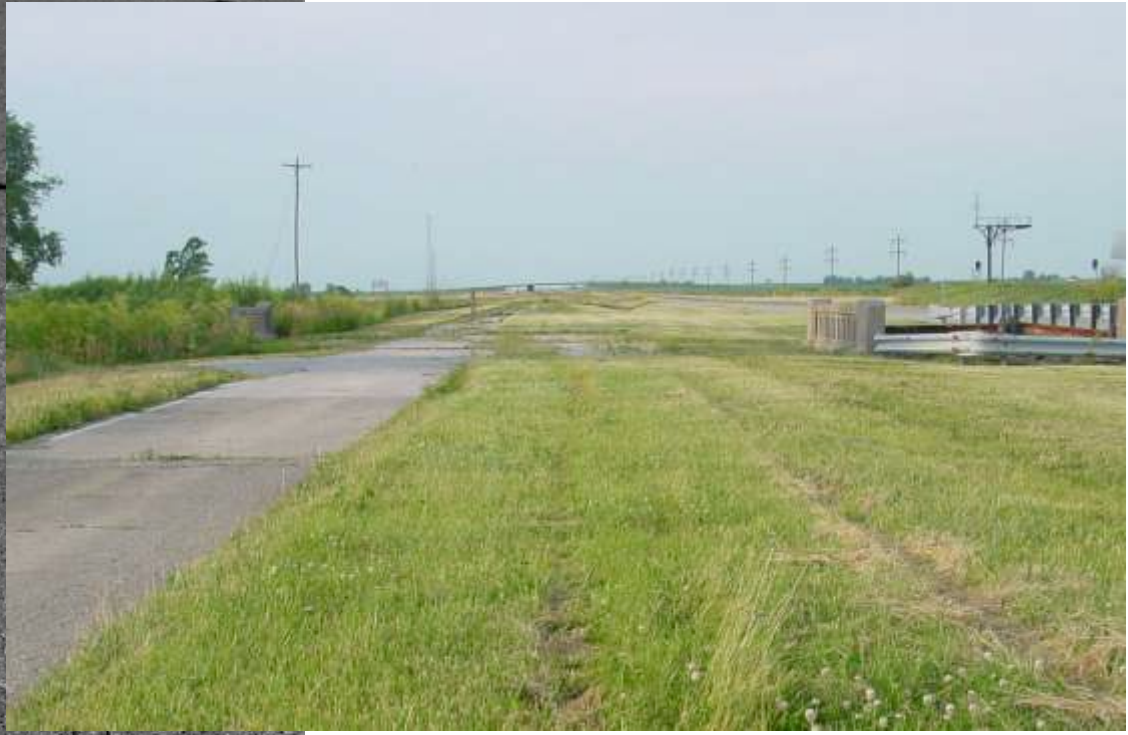
FIG. 27
Lexington, IL. Segment of Rt. 66 north of Lexington on Rt. 66 bypass. One lane of roadway has been torn up and replaced with grass. Camera facing north.
Photograph by Travis Ratermann, 2 July 2008.

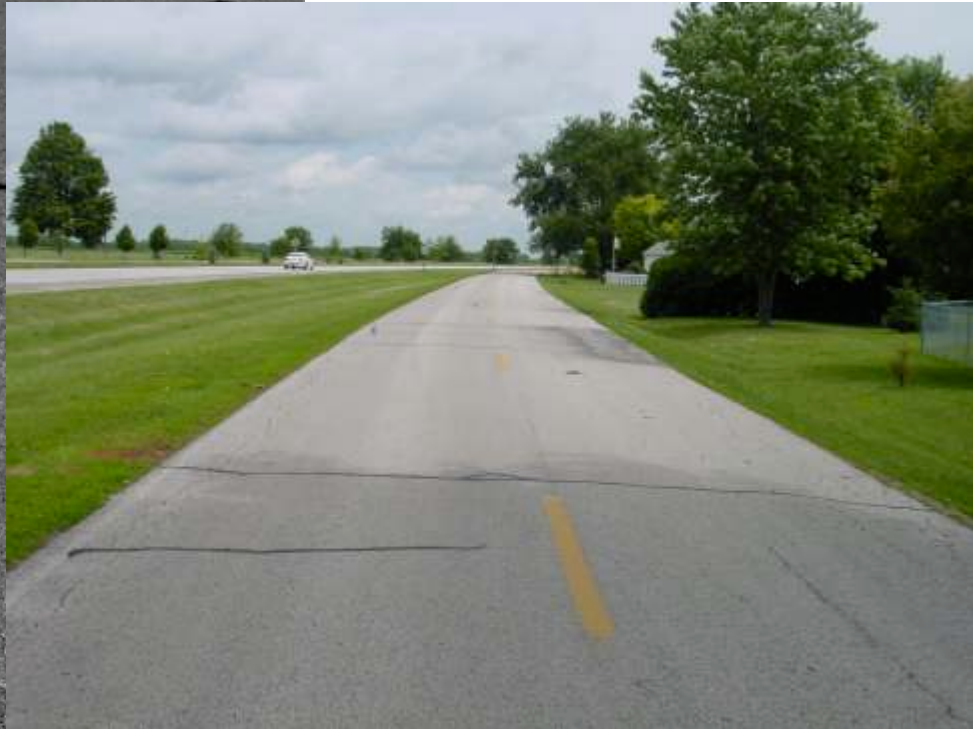
FIG. 29
Towanda, IL. Rt. 66 segment (Jackson St.) that has been paved over. Camera facing south.
Photograph by Emilie Eggemeyer, 8 July 2008.

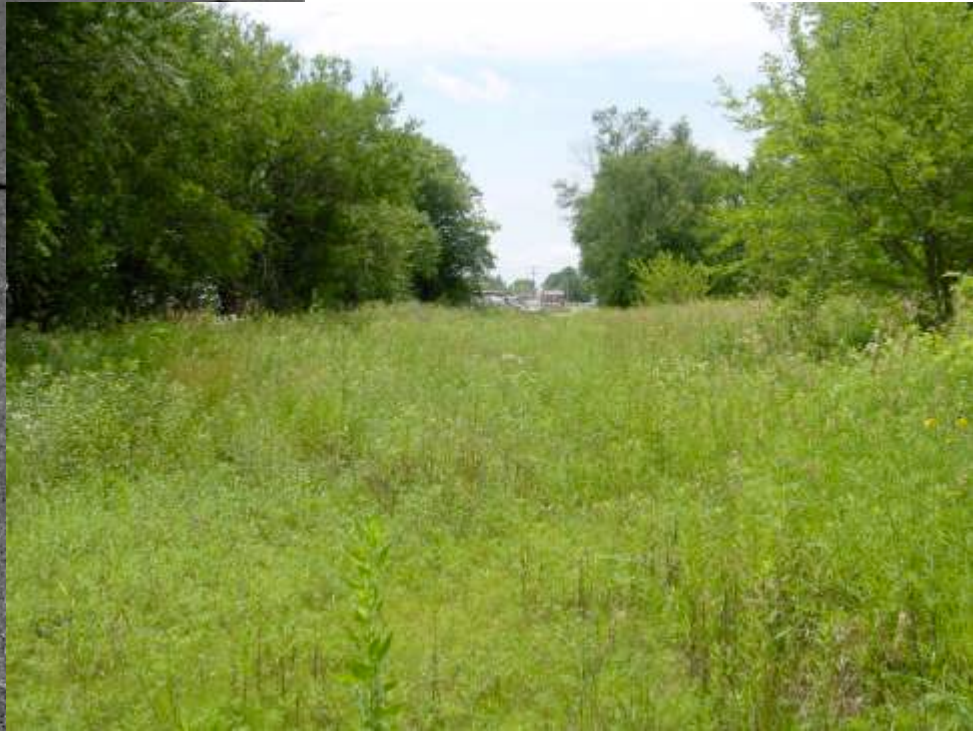
FIG. 37
Atlanta, IL. Rt. 66 in Atlanta 1926-30 segment. Portion is along RR tracks and a farm. Golf course is located on other side of RR tracks. Camera facing south.
Photograph by Emilie Eggemeyer, 8 July 2008.

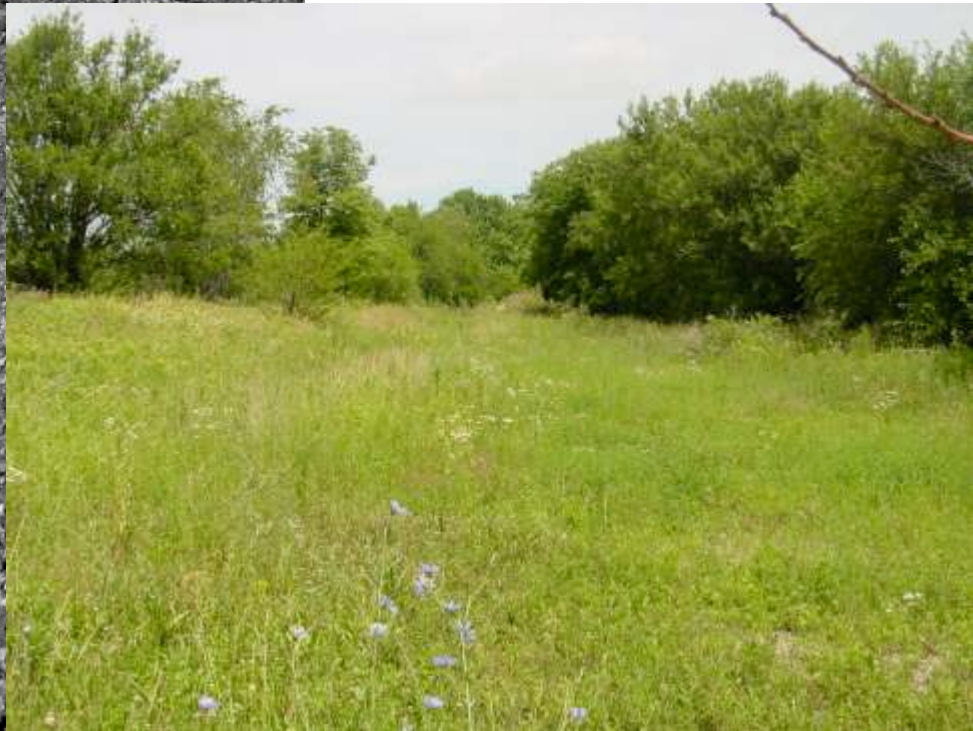
FIG. 38
Atlanta, IL. Rt. 66 in Atlanta 1926-30 segment. Portion is along RR tracks and a farm. Golf course is located on other side of RR tracks. Camera facing north.
Photograph by Emilie Eggemeyer, 8 July 2008.

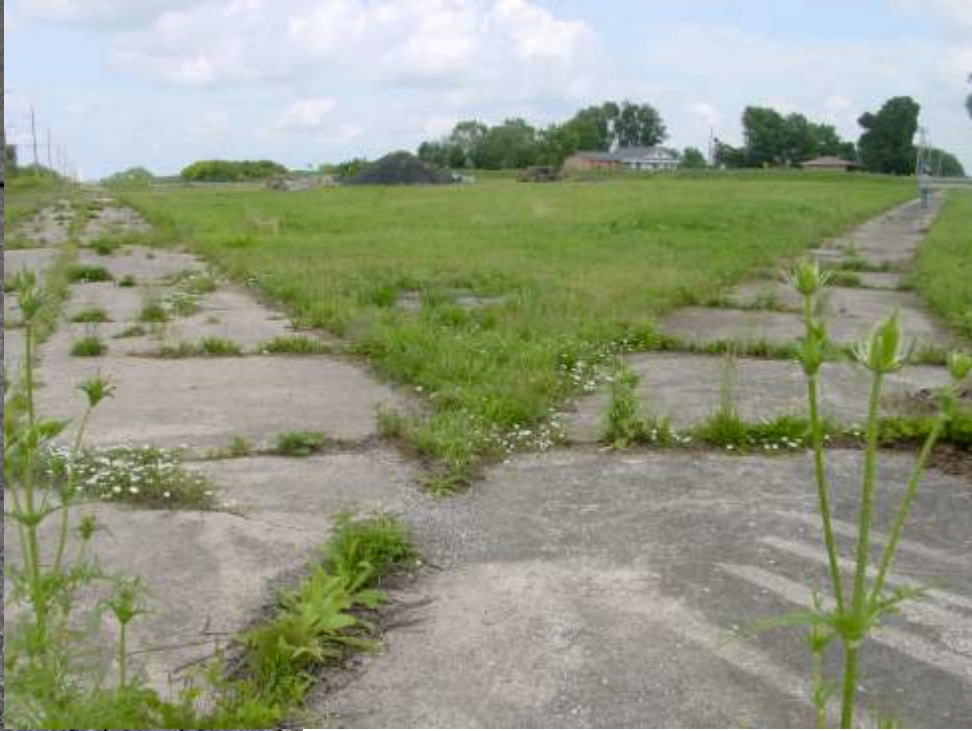
FIG. 43
Lincoln, IL. Segment of Rt. 66 West of the Lincoln Rt. 66 Bypass looking at the split in the road.
Camera facing northeast.
Photograph by Emilie Eggemeyer, 8 July 2008.

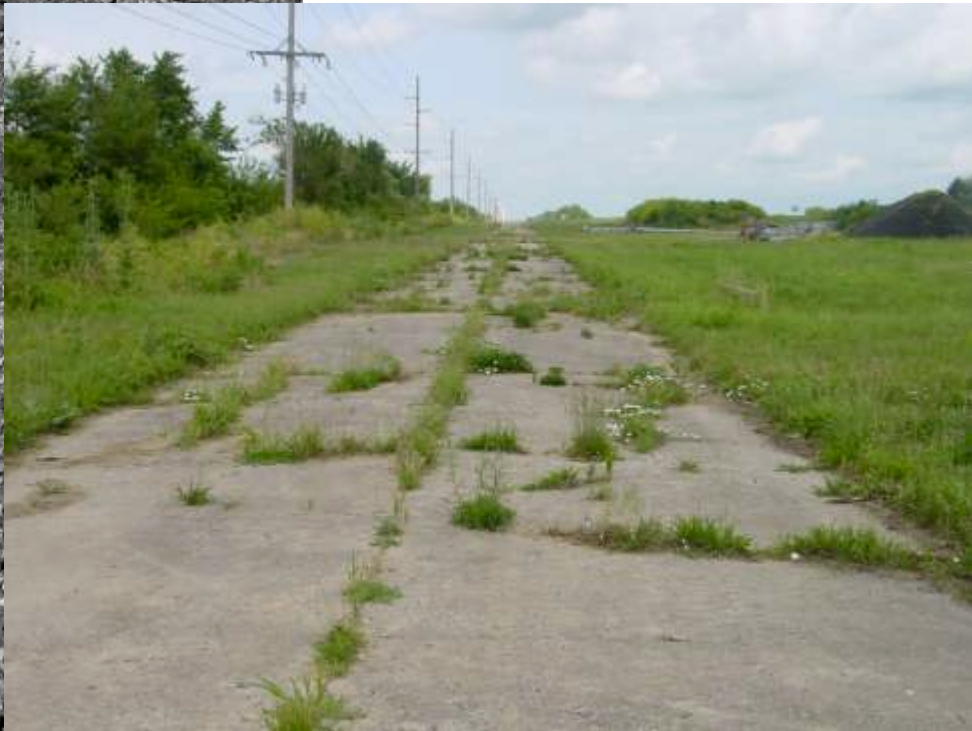
FIG. 44
Lincoln, IL. Segment of Rt. 66 west of the Lincoln Rt. 66 Bypass. Camera facing north.
Photograph by Emilie Eggemeyer, 8 July 2008.

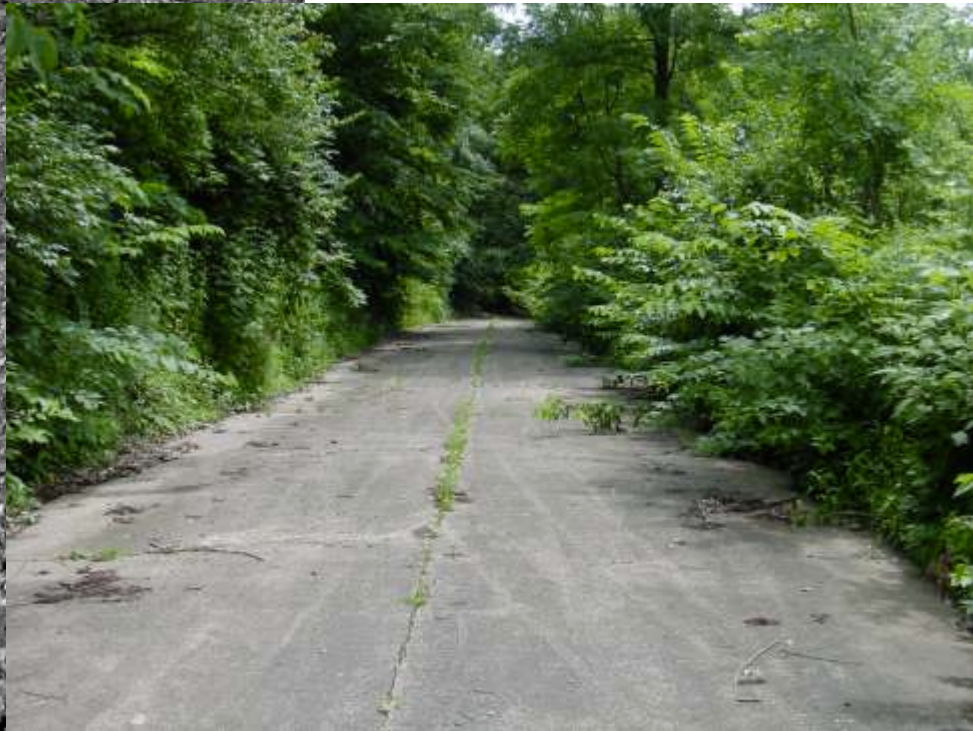
FIG. 46
Lincoln, IL. Rt. 66 segment off of Cobblestone Ave. within the cemetery in Lincoln, IL. Camera facing south.
Photograph by Emilie Eggemeyer, 8 July 2008.

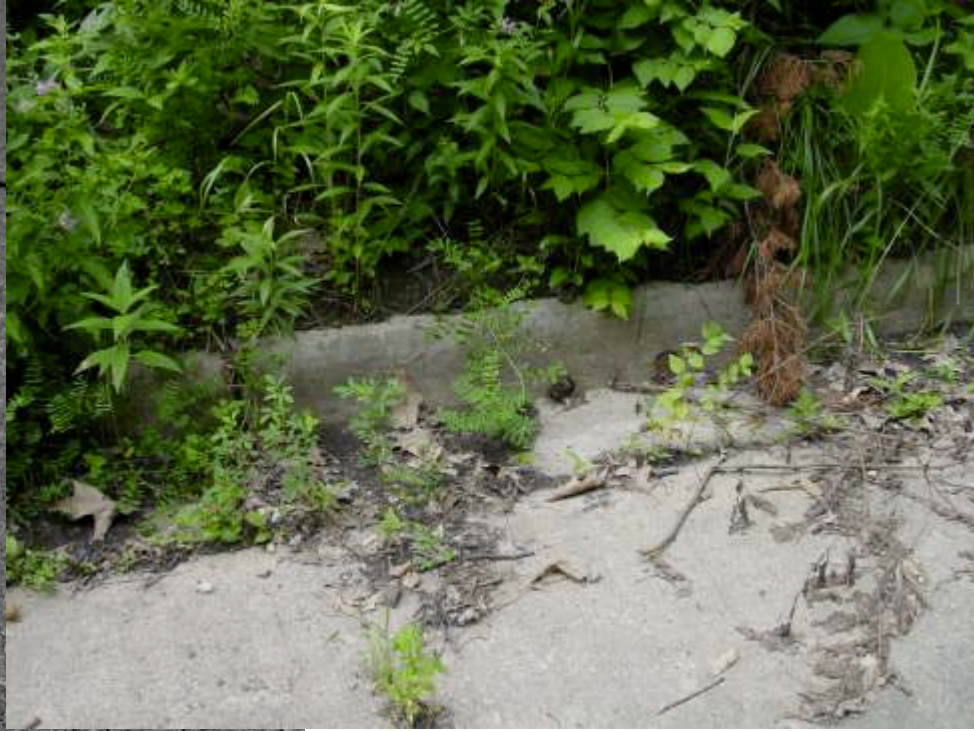
FIG. 47
Lincoln, IL. Rt. 66 Segment off of Cobblestone Ave with in the cemetery in Lincoln, IL. Picture shows curbing along stretch of roadway. Camera facing east.
Photograph by Emilie Eggemeyer, 8 July 2008.

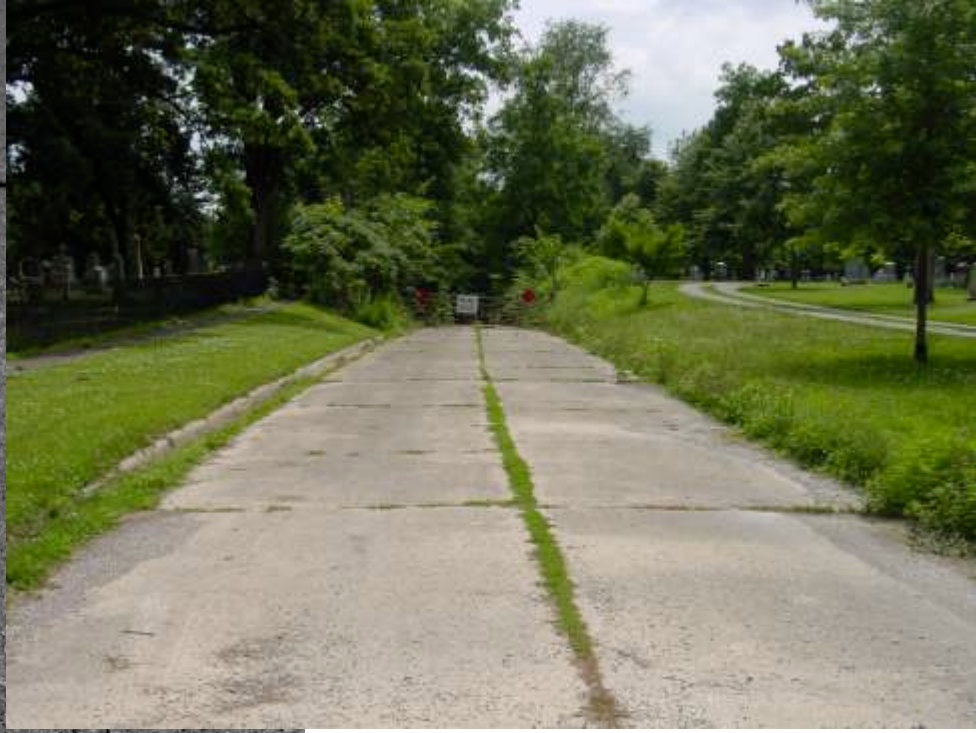
FIG. 49
Lincoln, IL. Rt. 66 Segment off of Cobblestone Ave within the cemetery in Lincoln, IL. Camera facing south.
Photograph by Emilie Eggemeyer, 8 July 2008.

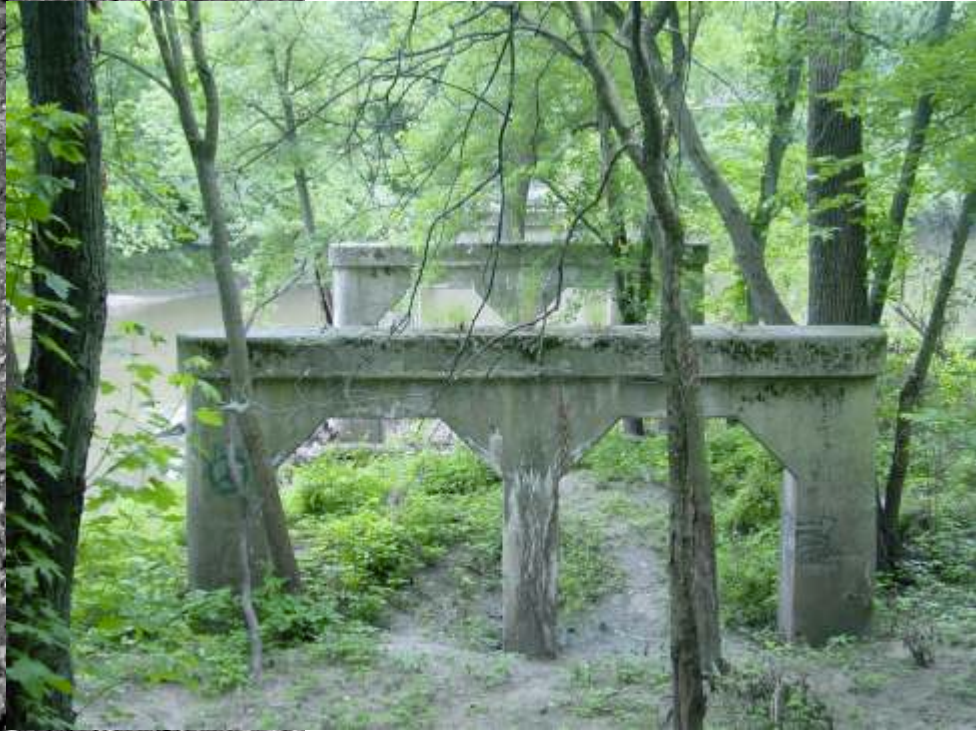
FIG. 50
Lincoln, IL. Rt. 66 Segment off of Cobblestone Ave within the cemetery in Lincoln, IL. Shows Ghost bridge at end of roadway crossing over river. Camera facing south.
Photograph by Emilie Eggemeyer, 8 July 2008.

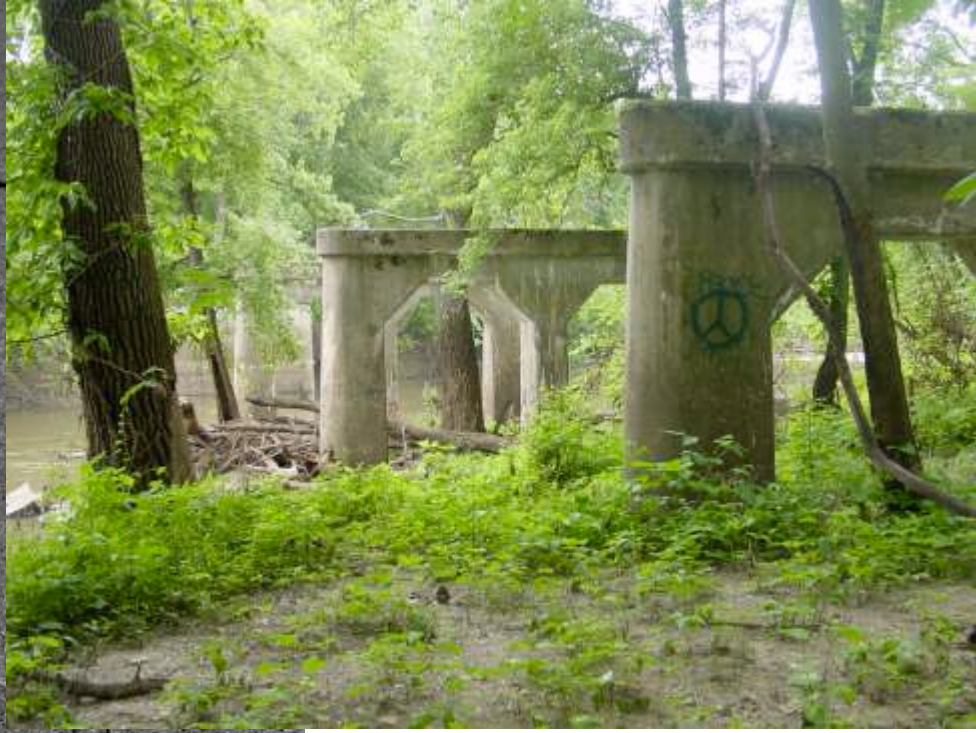
FIG. 51
Lincoln, IL. Rt. 66 Segment off of Cobblestone Ave with in the cemetery in Lincoln, IL. Shows the Ghost Bridge at end of roadway crossing over Deer Creek River. Camera facing south.
Photograph by Emilie Eggemeyer, 8 July 2008.

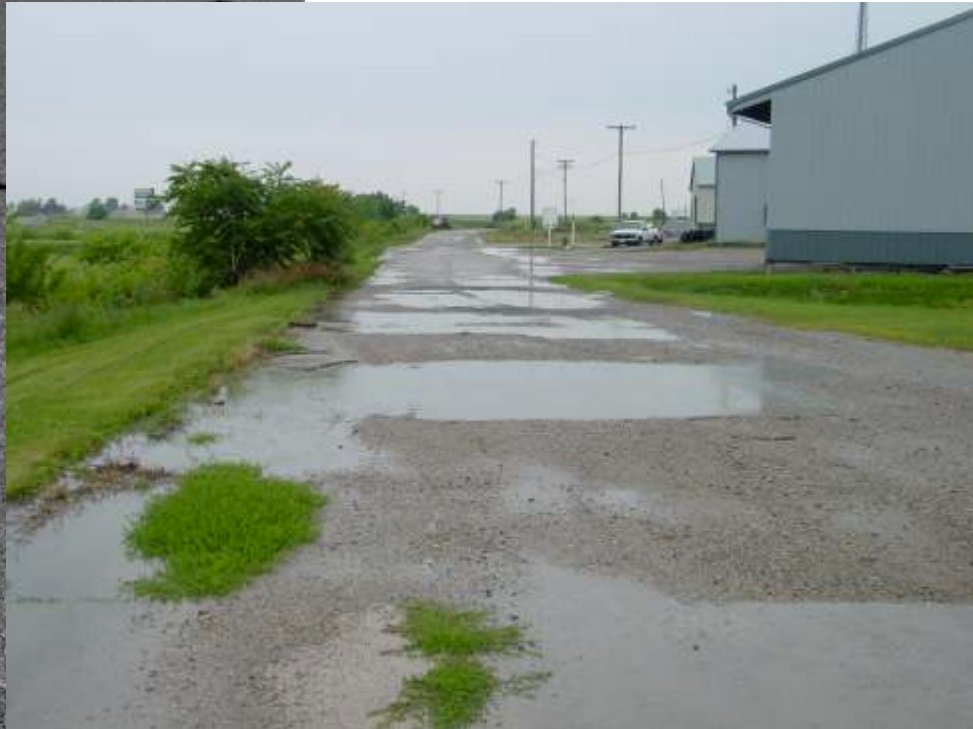
FIG. 53
Elkhart, IL. Rt. 66 1926-30 Segment along ditch behind trucking company. Camera facing north.
Photograph by Travis Ratermann, 3 July 2008.

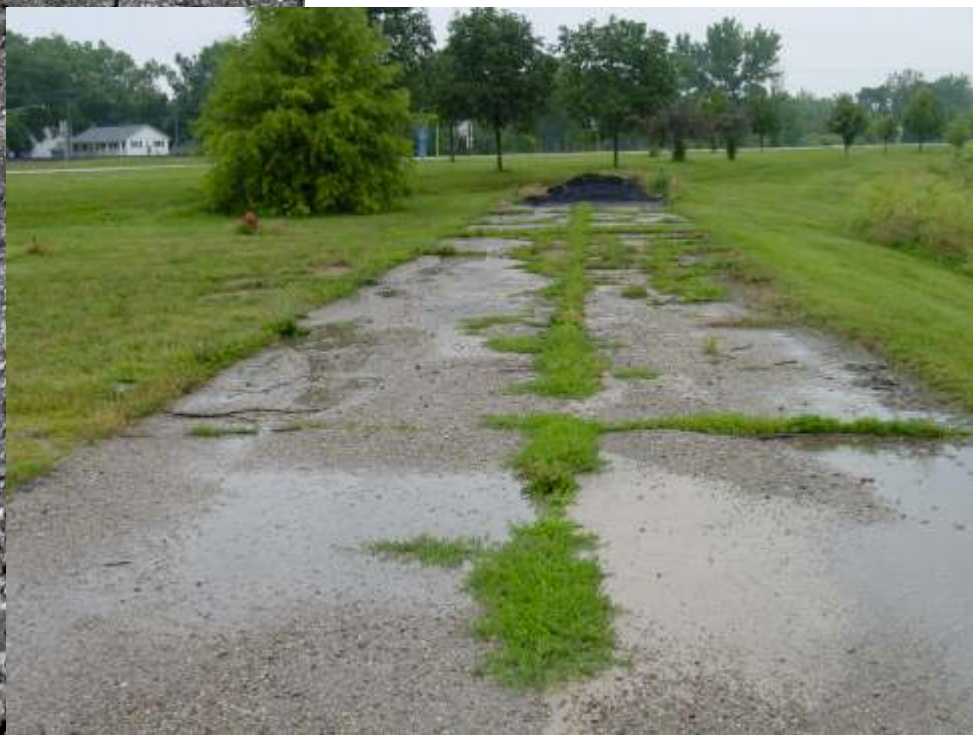
FIG. 54
Elkhart, IL. Rt. 66 1926-30 segment along ditch behind radio tower. Camera facing southeast.
Photograph by Travis Ratermann, 3 July 2008.

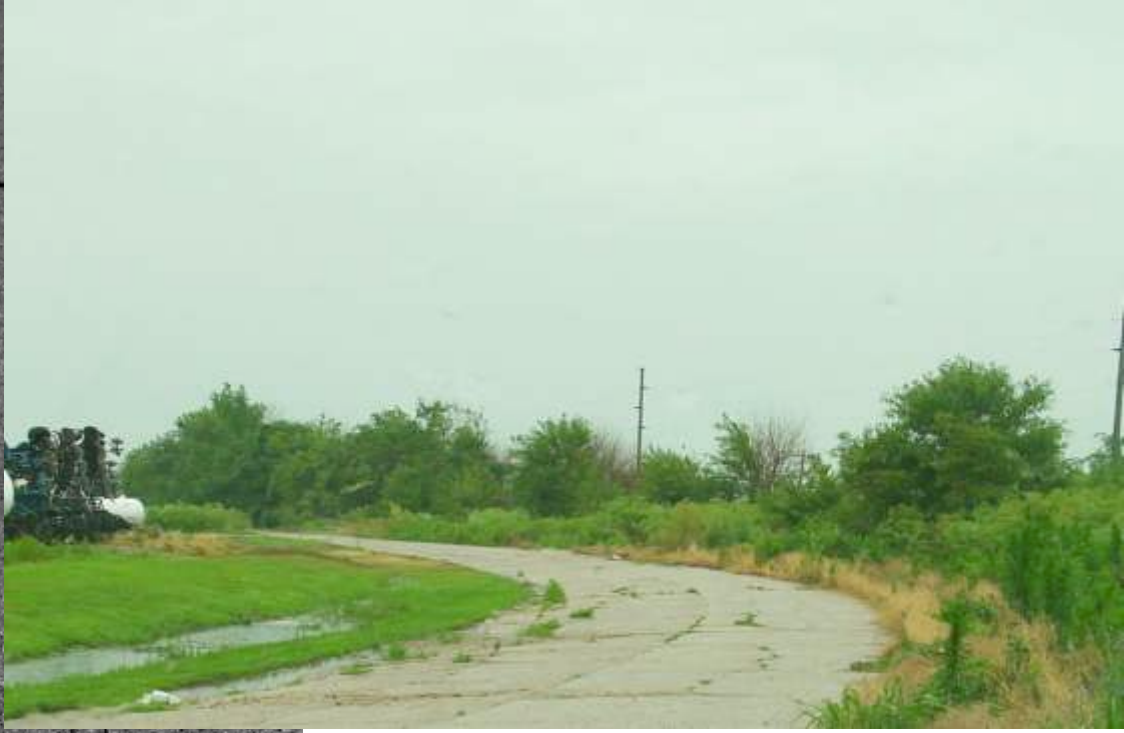
FIG. 55
Williamsville, IL. Segment of Rt. 66 1926-30 along Taylor St. By Brandt Consolidated. Camera facing north.
Photograph by Travis Ratermann, 3 July 2008.

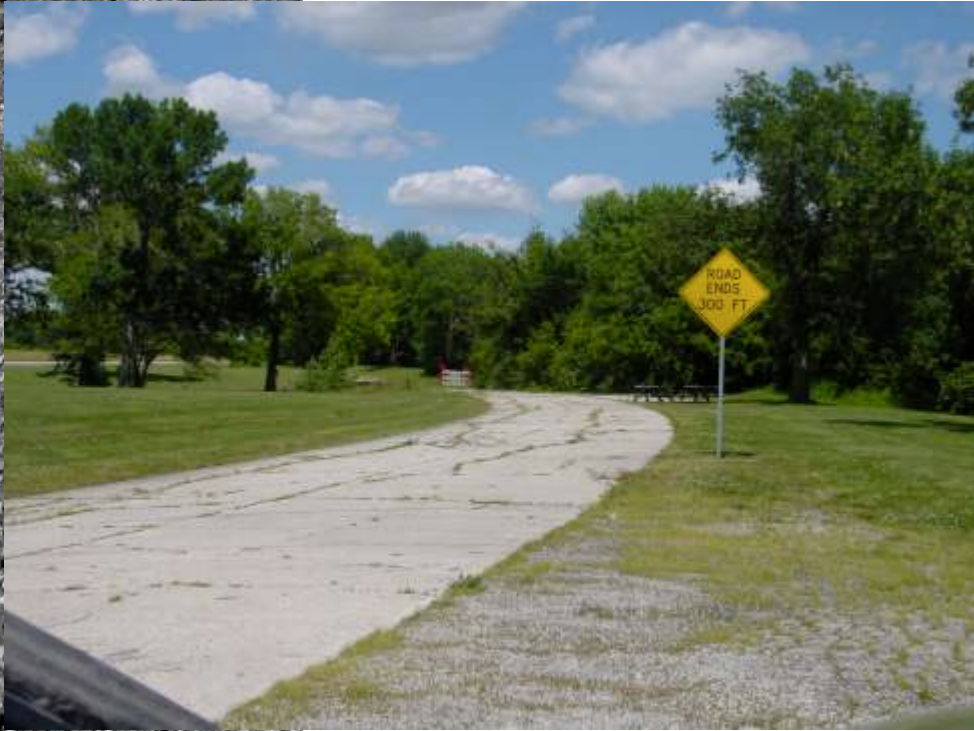
FIG. 56
Sherman, IL. Linear view of Rt. 66 Park in Sherman along with original roadbed segment. Camera facing north.
Photograph by Travis Ratermann, 23 June 2008.

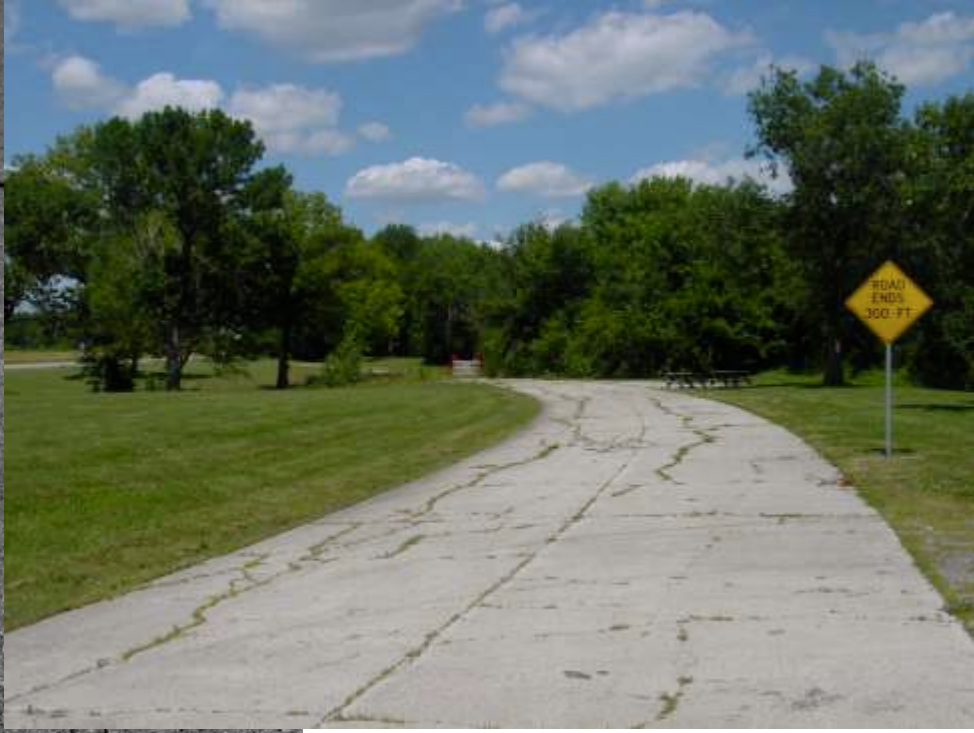
FIG. 57
Sherman, IL. Linear view of Rt. 66 Park in Sherman, road bed continues north of the road closed sign. Camera facing north.
Photograph by Travis Ratermann, 23 June 2008.

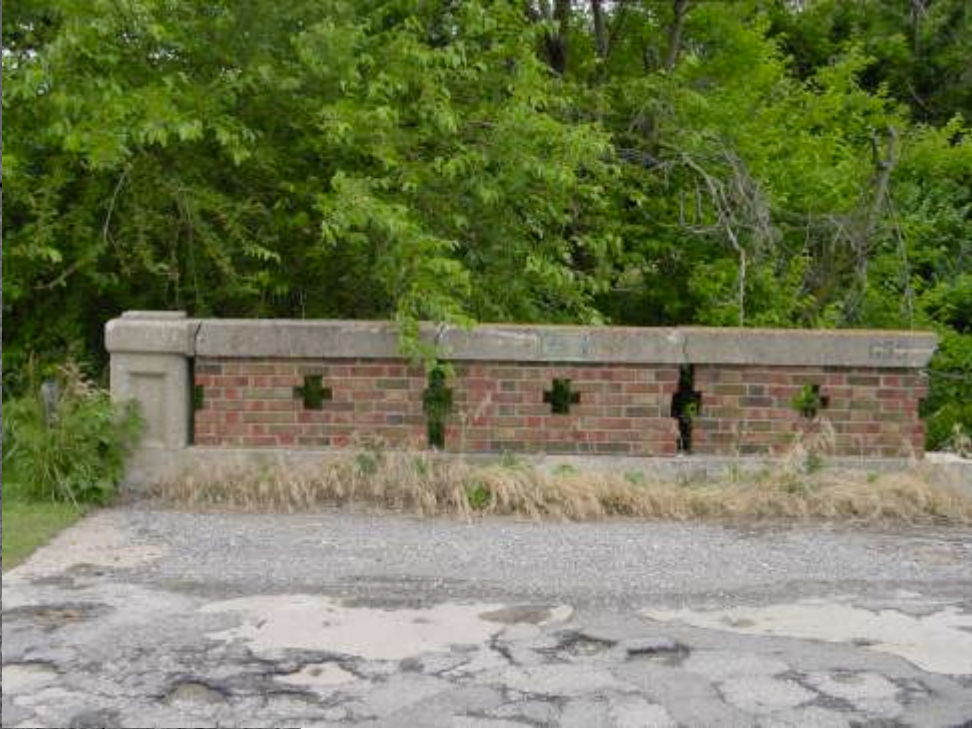
FIG. 73
 Girard, IL. Bridge marked Station 1616-70 on Cambridge Rd. Concrete still visible under blacktop. Camera facing west.
 Photograph by Travis Ratermann, 24 June 2008.

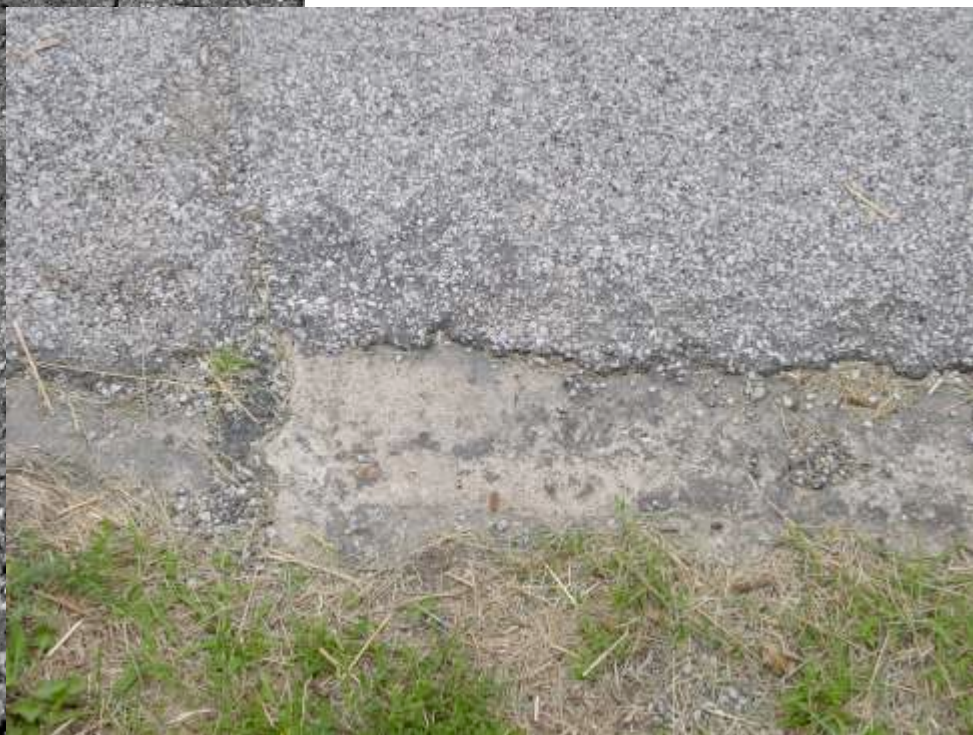
FIG. 82
Carlinsville, IL. Rt. 66 segment on Deerfield Dr. Portland is covered by rock and chip that is crumbling. Camera facing south and down.
Photograph by Travis Ratermann, 24 June 2008.

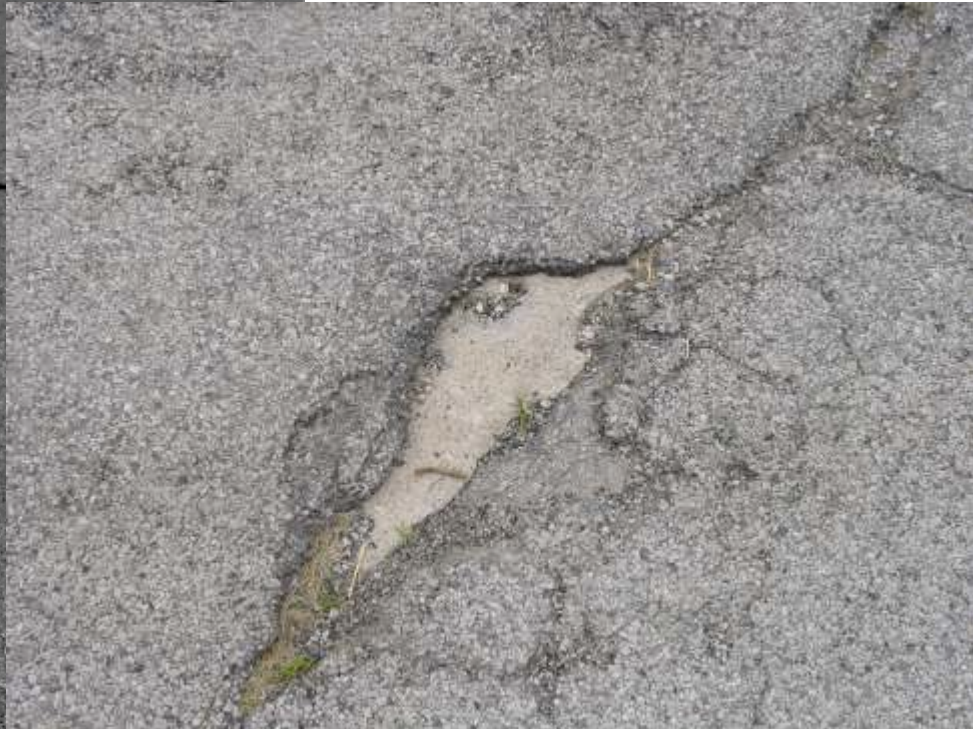
FIG. 83
Carlinville, IL. Rt. 66 segment on Deerfield Dr. Portland is covered by rock and chip that is crumbling. Camera facing south and down.
Photograph by Travis Ratermann, 24 June 2008.

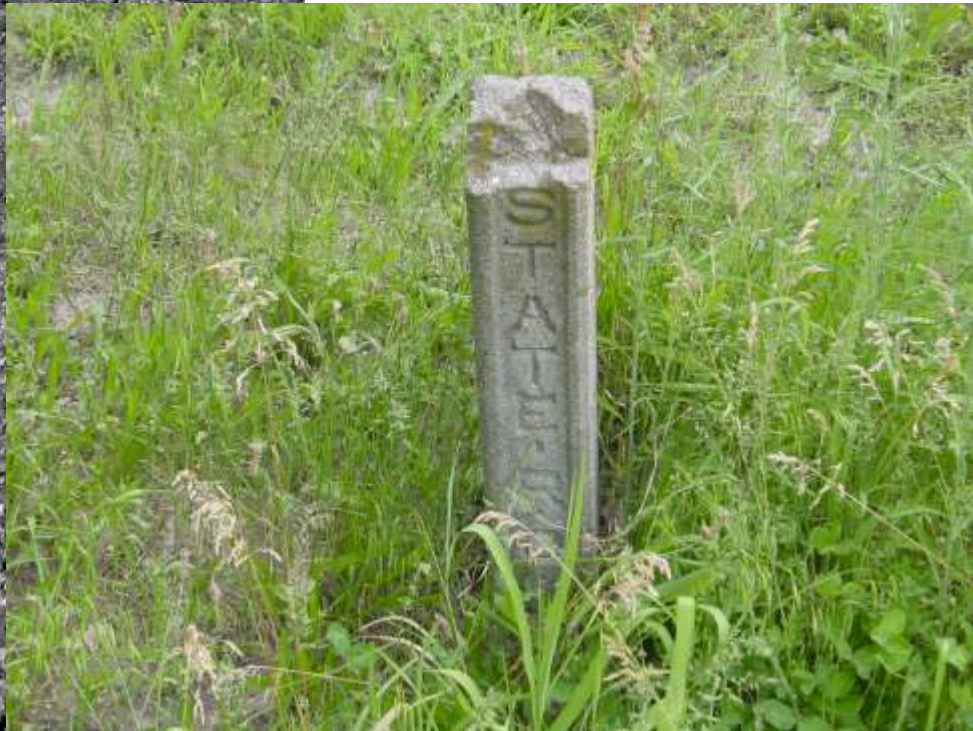
FIG. 88
Carlinville, IL. 2nd segment. State ROW (Right of Way) marker on the north end of the road within the Carlinville, IL cemetery. Camera facing east.
Photograph by Travis Ratermann, 24 June 2008.

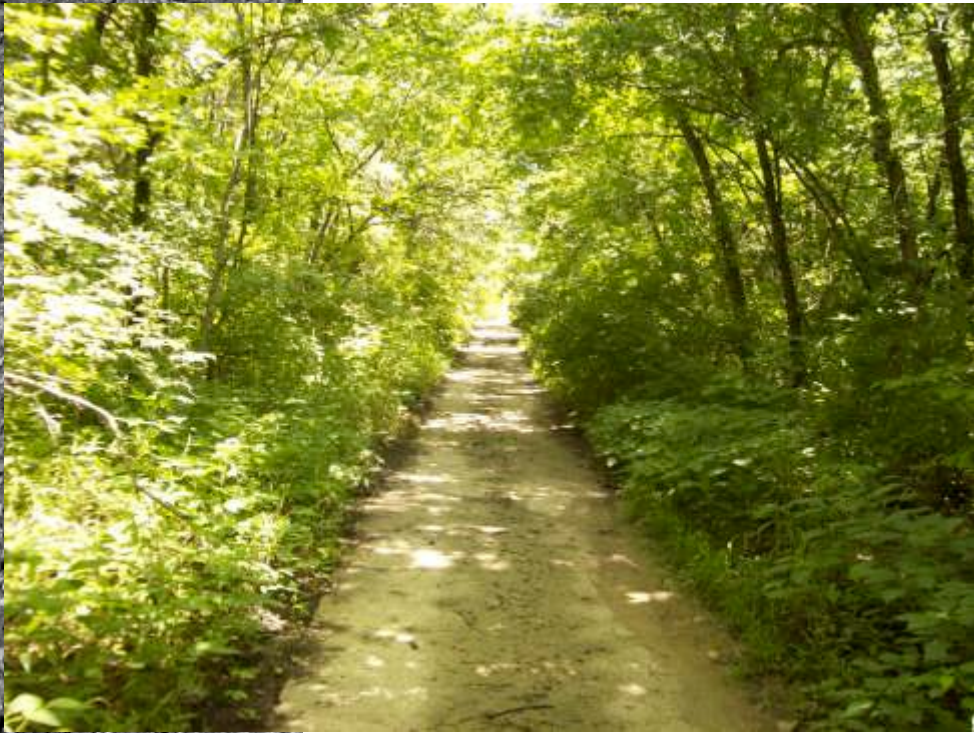
FIG. 94
Carlenville, IL. 4th segment of Rt. 66 south of Carlenville. Located at 17500 N or Barnett Lane. Narrow portion in the woods. Camera facing south.
Photograph by Emilie Eggemeyer, 9 July 2008.

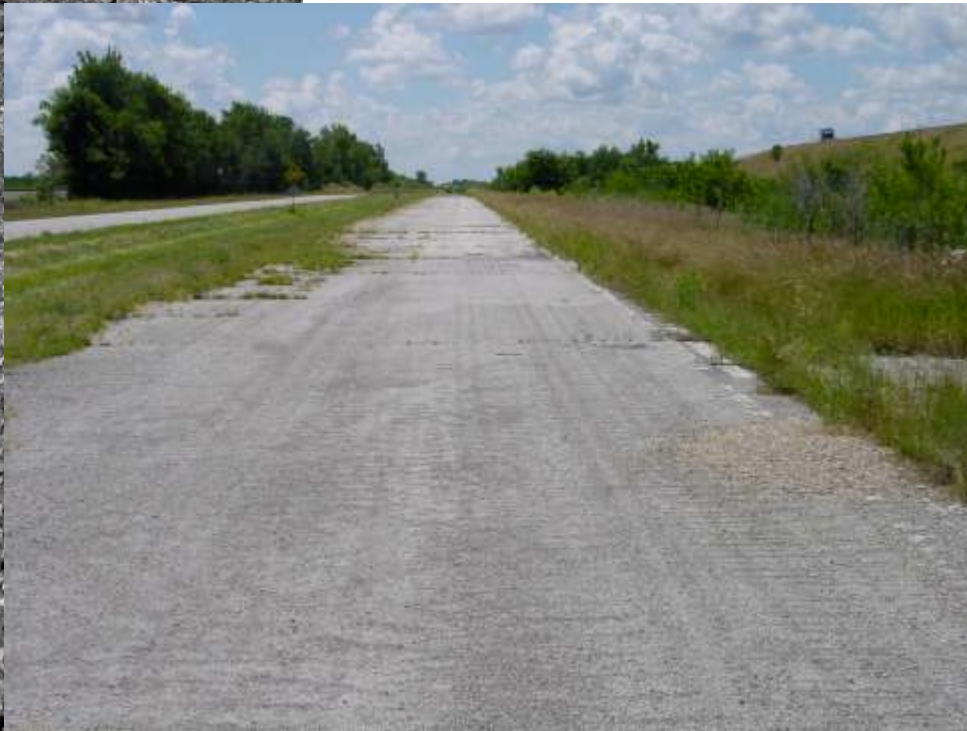
FIG. 108
Litchfield, IL. Rt. 66 bypass segments. Most of this section is covered with multiple layers of rock and oil. Camera facing south.
Photograph by Travis Ratermann, 30 June 2008.

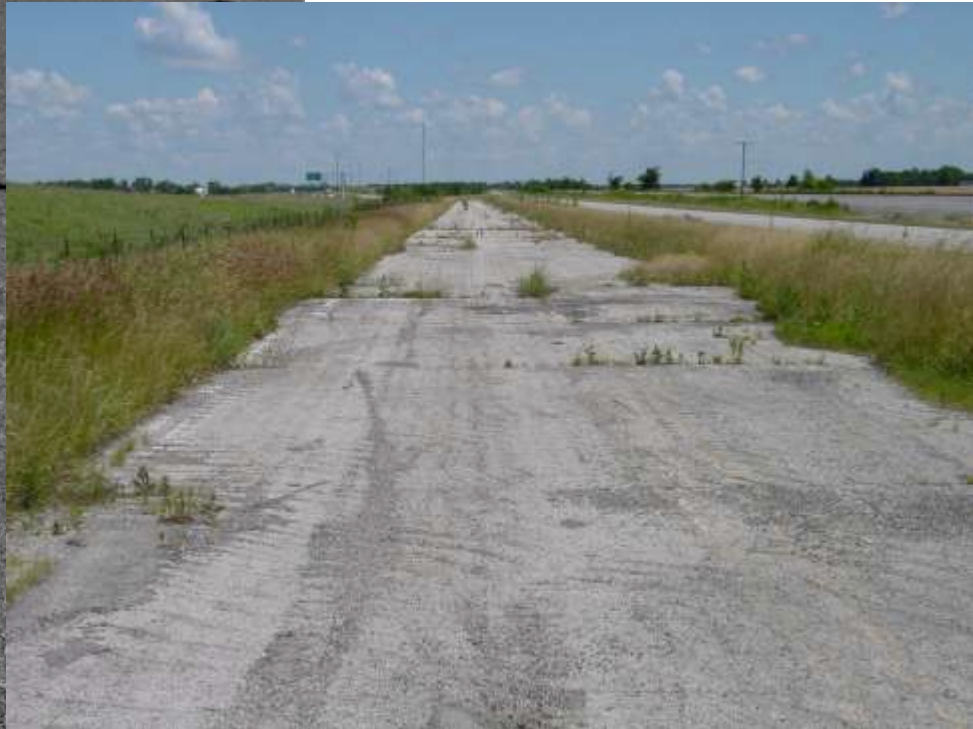
FIG. 109
Litchfield, IL. Rt. 66 bypass segments. Most of this section is covered with multiple layers of rock and oil. Camera facing north.
Photograph by Travis Ratermann, 30 June 2008.

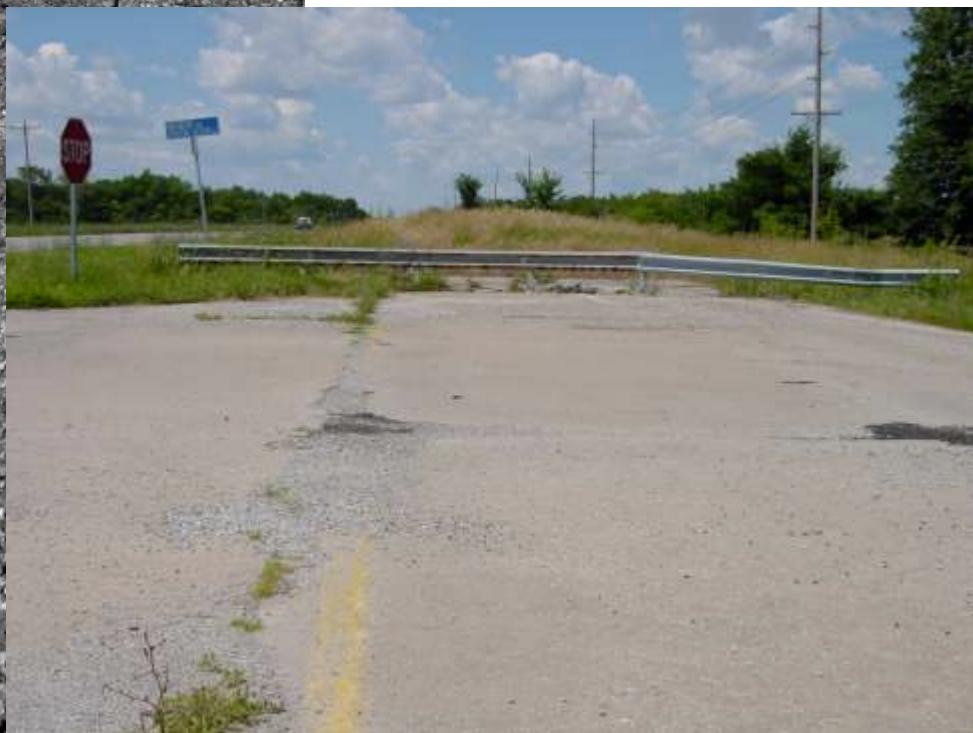
FIG. 115
Litchfield, IL. Segment on east side of bypass just north of the old RR bridge. Large embankment to the right has rolled over on to the roadway. Camera facing north.
Photograph by Emilie Eggemeyer, 9 July 2008.

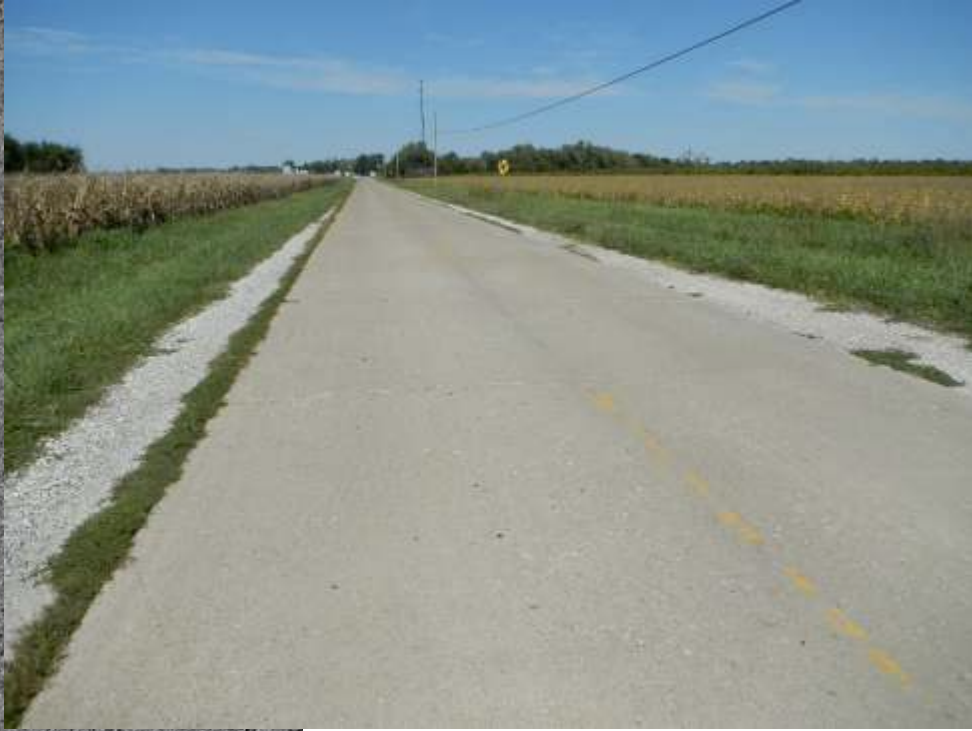
FIG. 1
Concrete in "good" condition (Girard, IL).

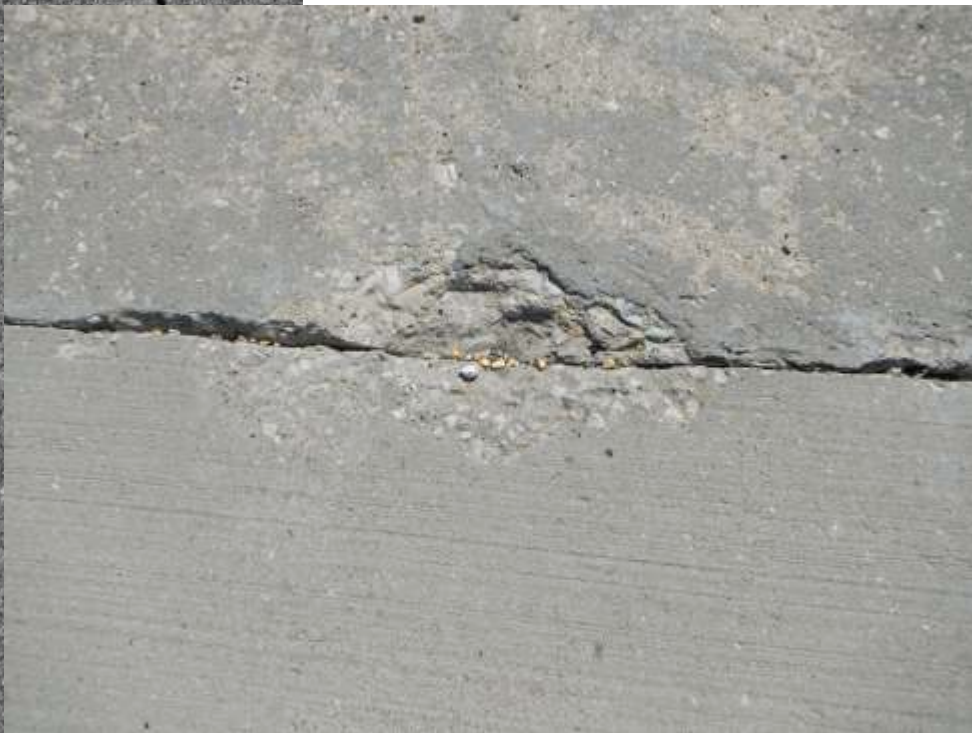
FIG. 8
Small spall at edge of patch and in existing concrete (south of Girard, IL).
