Concrete Restoration for Route 66 in Illinois

September 2012

The goal of this report is to outline treatment options for the primary Route 66 roadway conditions observed in Illinois as guidance for preserving that which remains of the historic concrete roadways. This study was based on

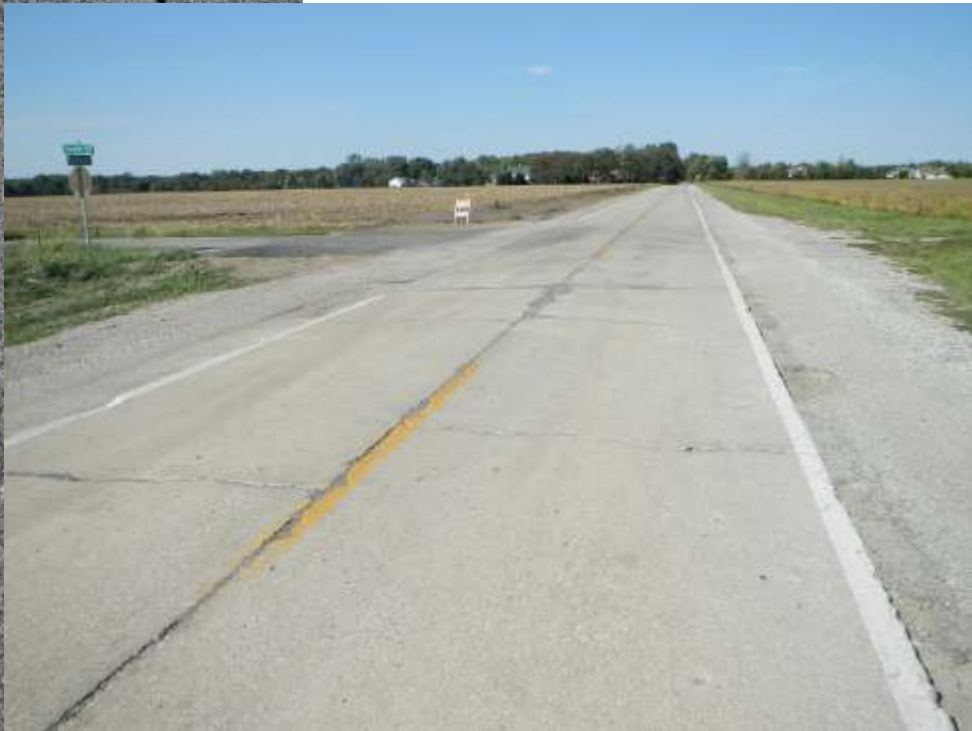
located along a heavily used corridor. These segments of the roadway generally have inadequate width for the type and level of traffic. In one area south of Lake Springfield, the road is heavily used, not only by cars, but by school buses and trucks regularly (Figure 12).

FIG. 12
Original concrete segment at a high traffic roadway (south of Lake Springfield, IL).

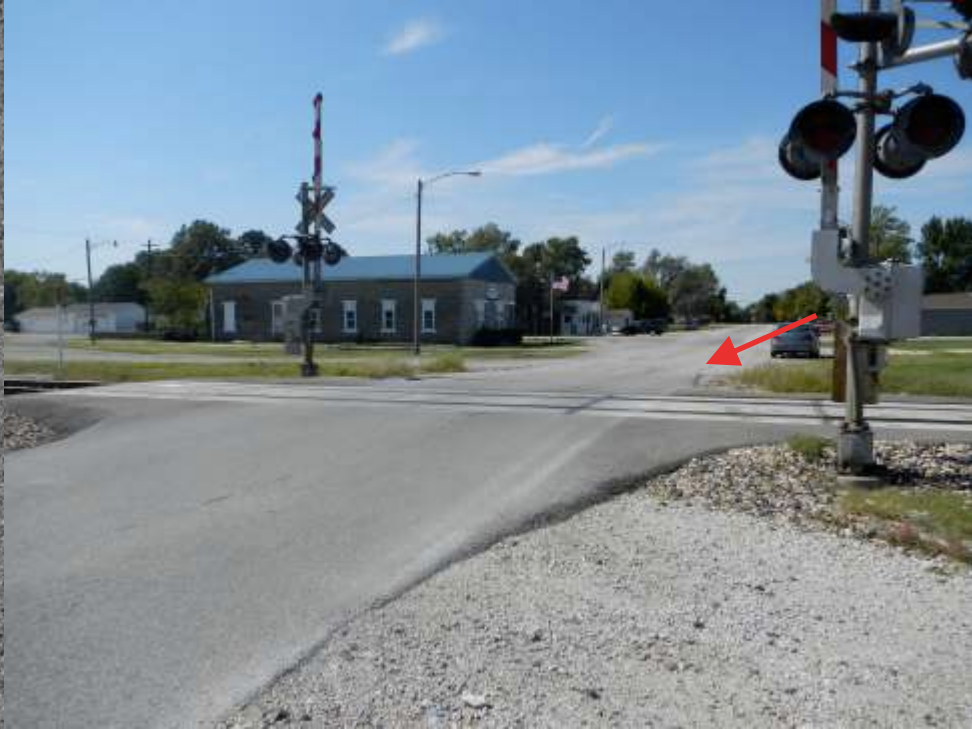
FIG. 13
Asphalt has been used to accommodate level changes at railroad crossings. Red arrow indicates where the asphalt ends and the original concrete continues (Nilwood, IL).

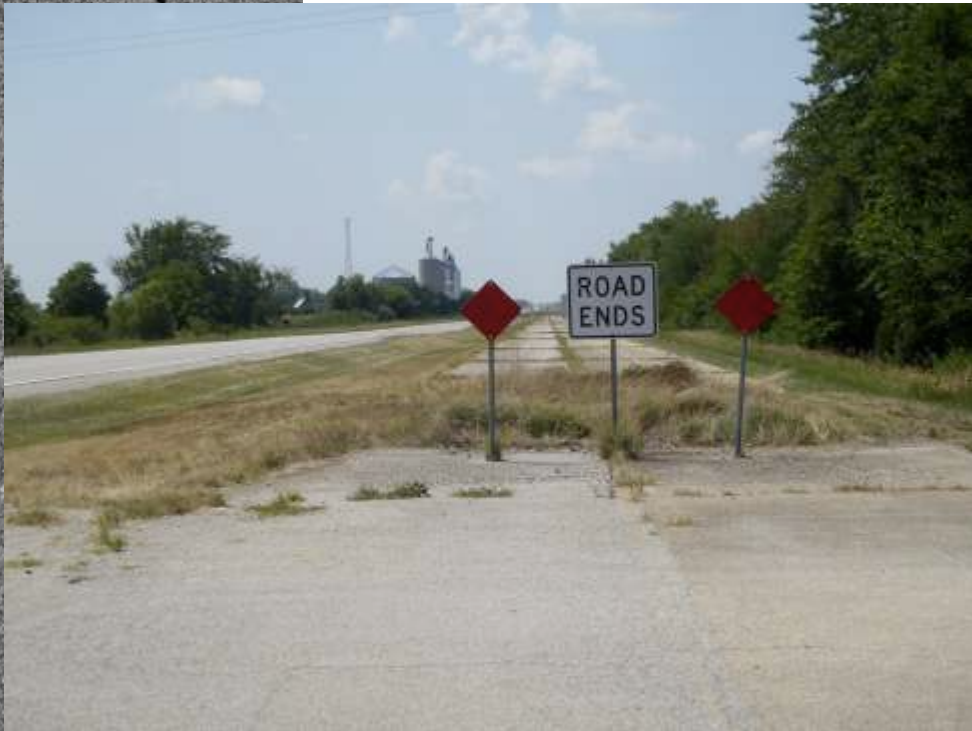
FIG. 14
Asphalt overlays have been applied to both the 1920s and the 1940s segments of roadway; circa 1927 roadway is now abandoned (Pontiac, IL).

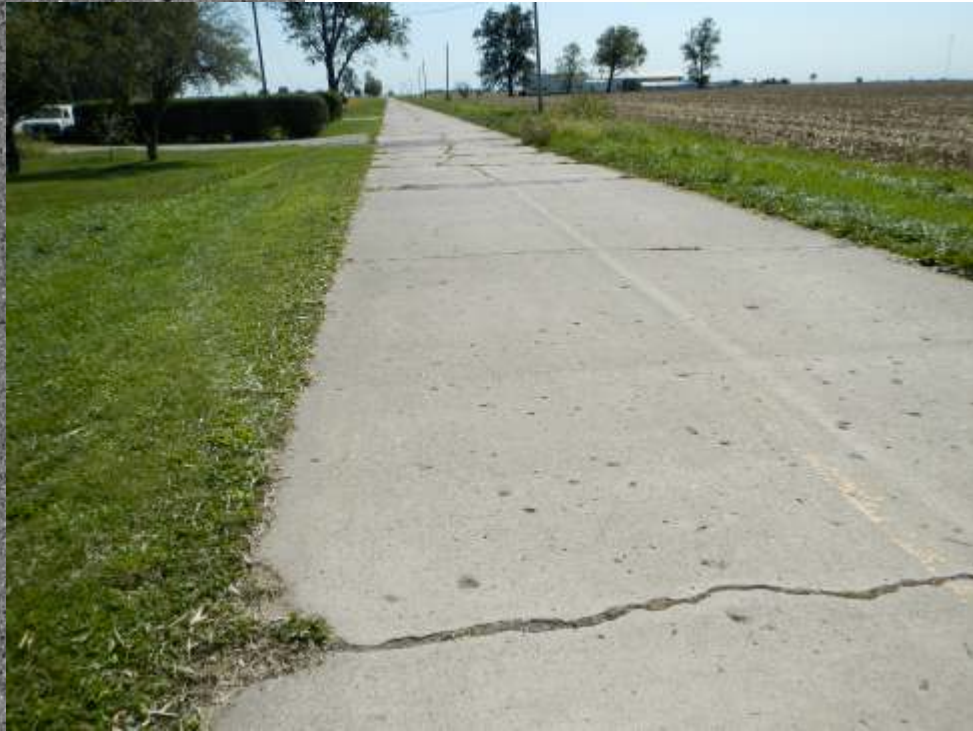
FIG. 15
Grass apron along rural low traffic roadway (south of Nilwood, IL).

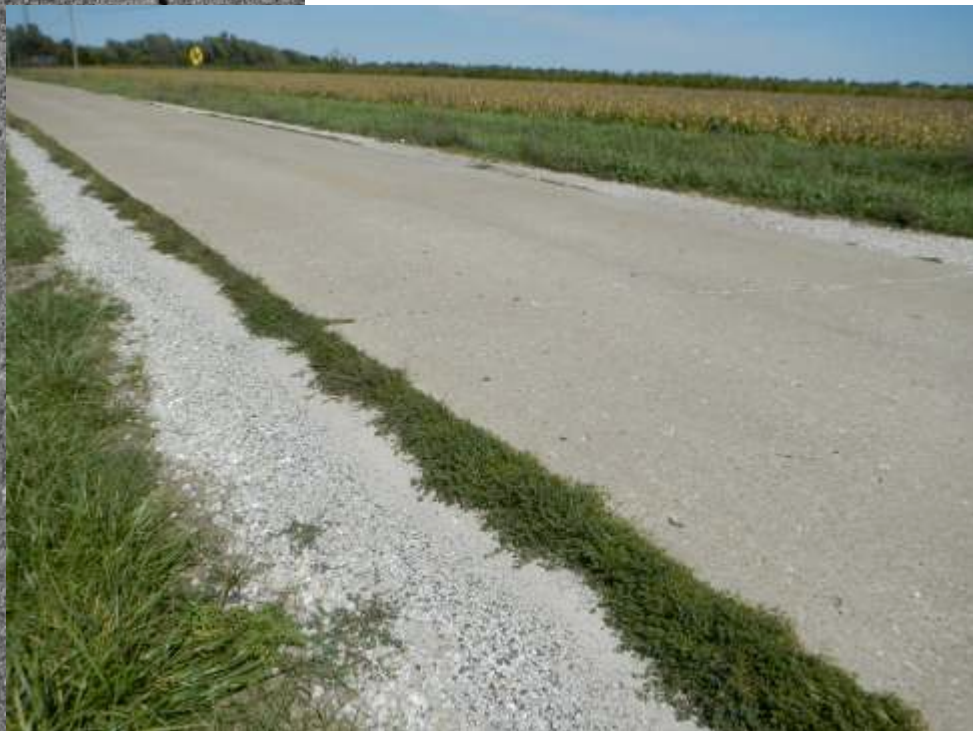
FIG. 16
Gravel apron along rural moderate traffic roadway (Girard, IL).

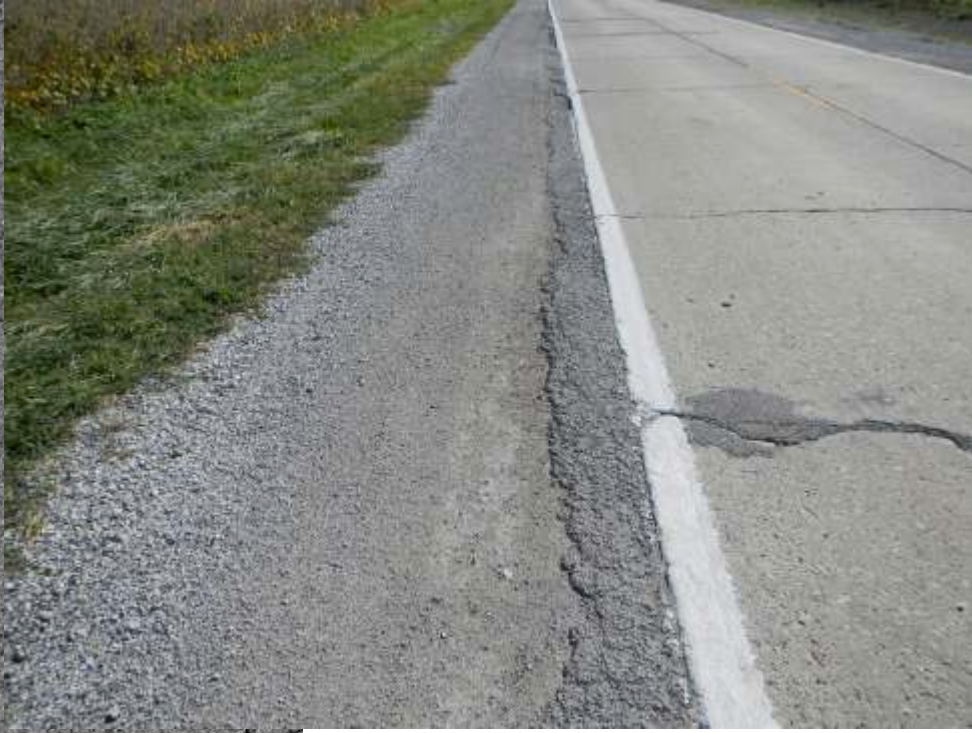
FIG. 17
Asphalt and gravel apron along suburban heavy traffic roadway
(south of Lake Springfield, IL).

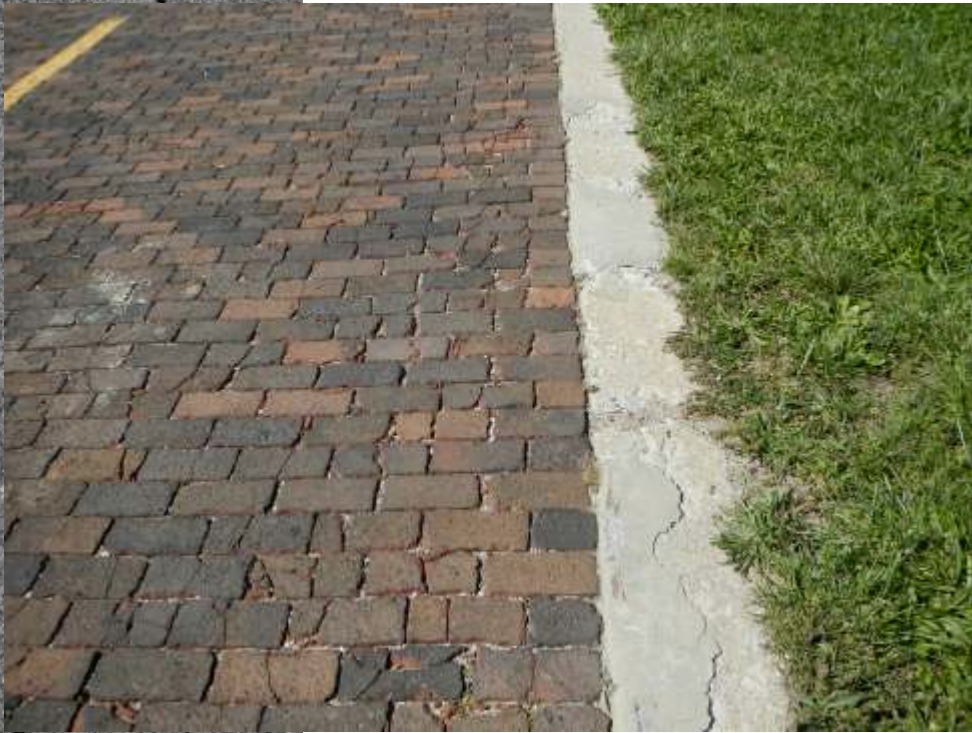
FIG. 18
Concrete apron along brick light traffic roadway (north of Auburn, IL).

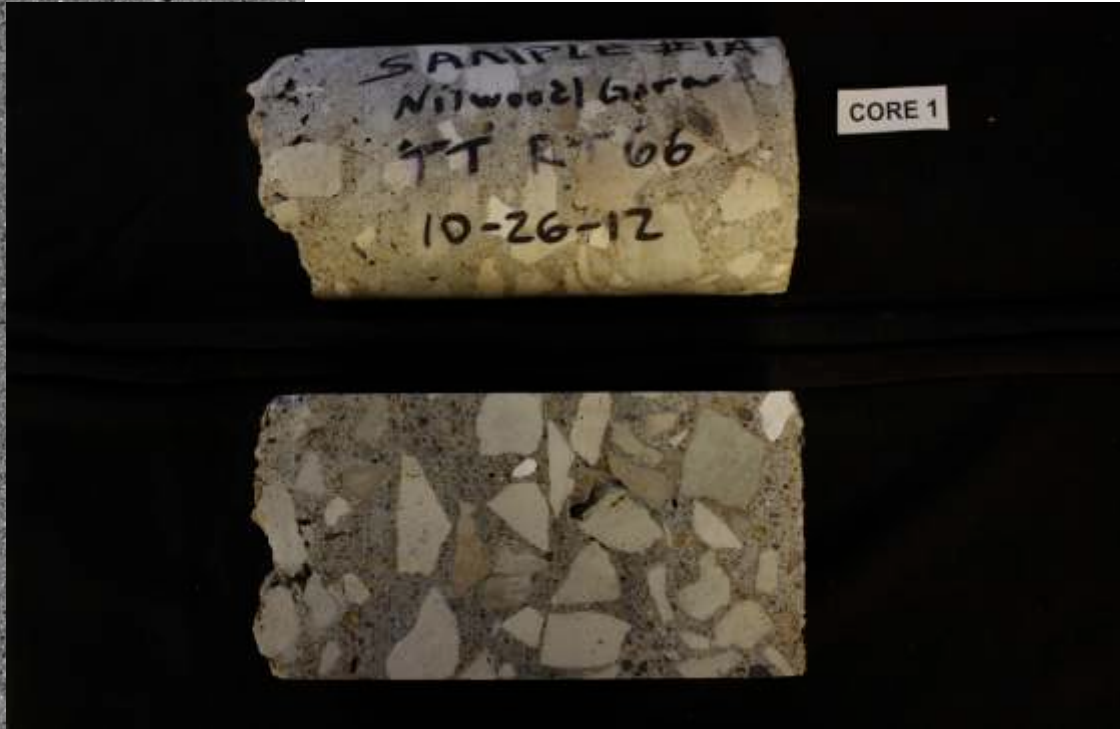
FIG. 21
Core 1 (Nilwood/Girard); lapped surfaced shown on lower half of the core sample.

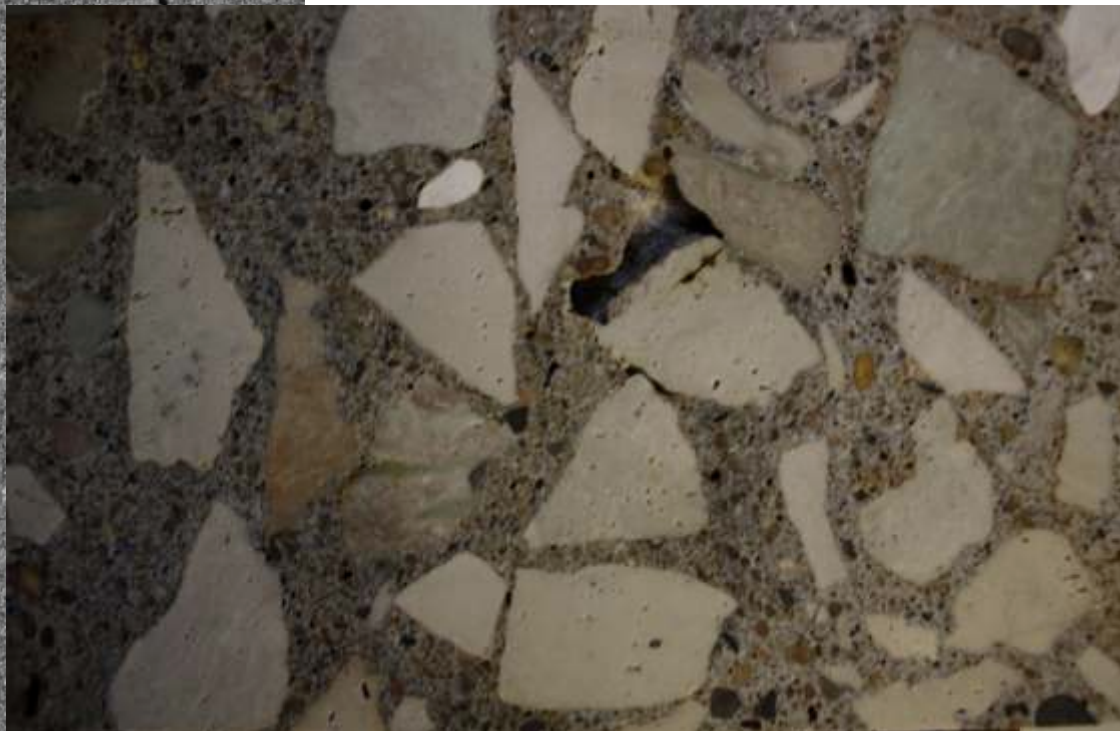
FIG. 22
Core 1 close-up of lapped surface showing crushed limestone aggregates within the cement paste matrix.

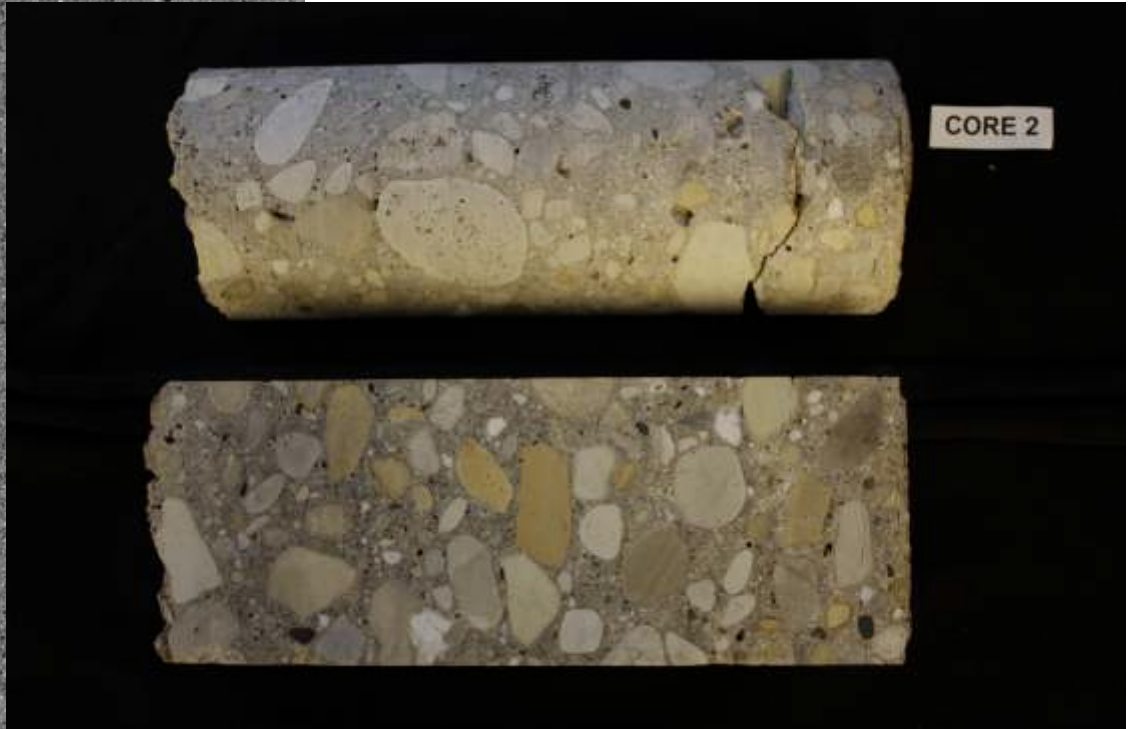
FIG. 23
Core 2 (Pontiac/Dwight); lapped surfaced shown on lower half of the core sample.

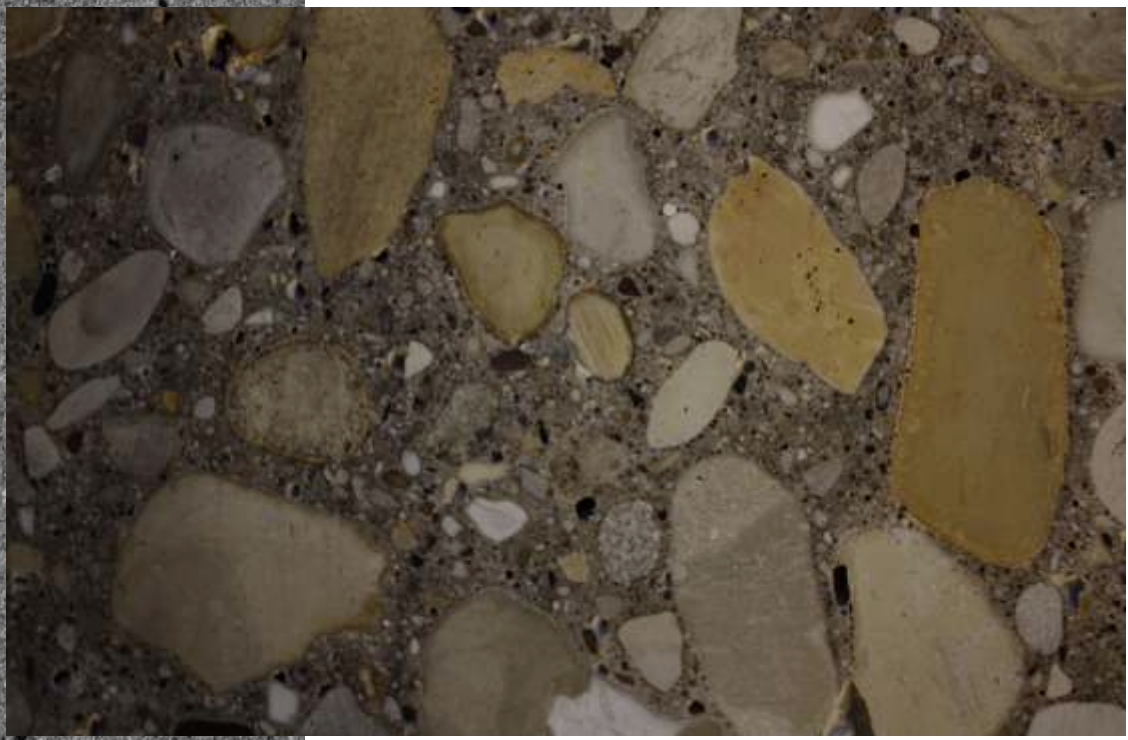
FIG. 24
Core 2 close-up of lapped surface showing rounded gravel aggregates within the cement paste matrix.

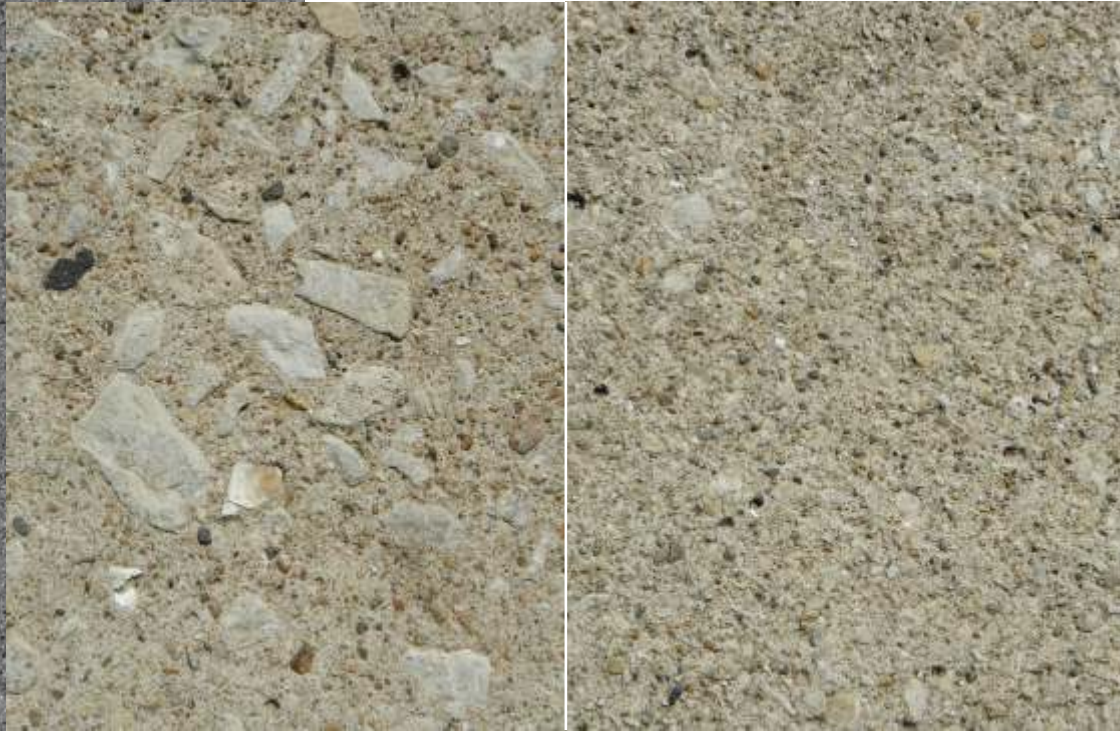
FIG. 25
Weathered surface finish differs throughout roadway segments. (Left) crushed limestone coarse aggregate and sand is exposed and (Right) rounded pea gravel and sand is exposed.

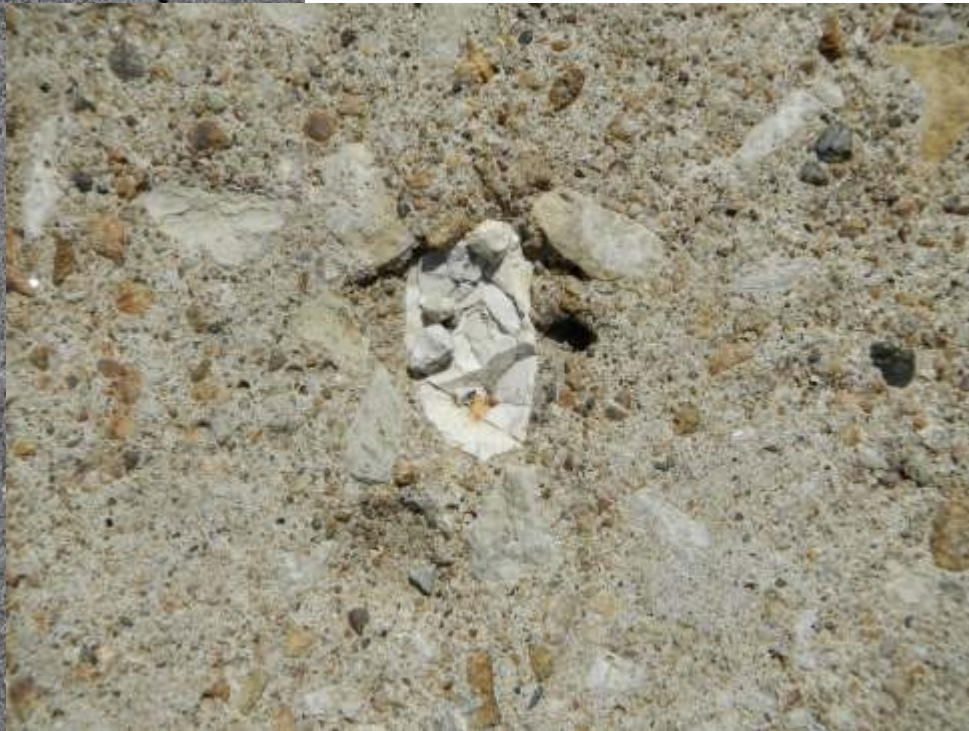
FIG. 26
Chert aggregate in original concrete that has cracked and created a pop-out in the concrete surface.

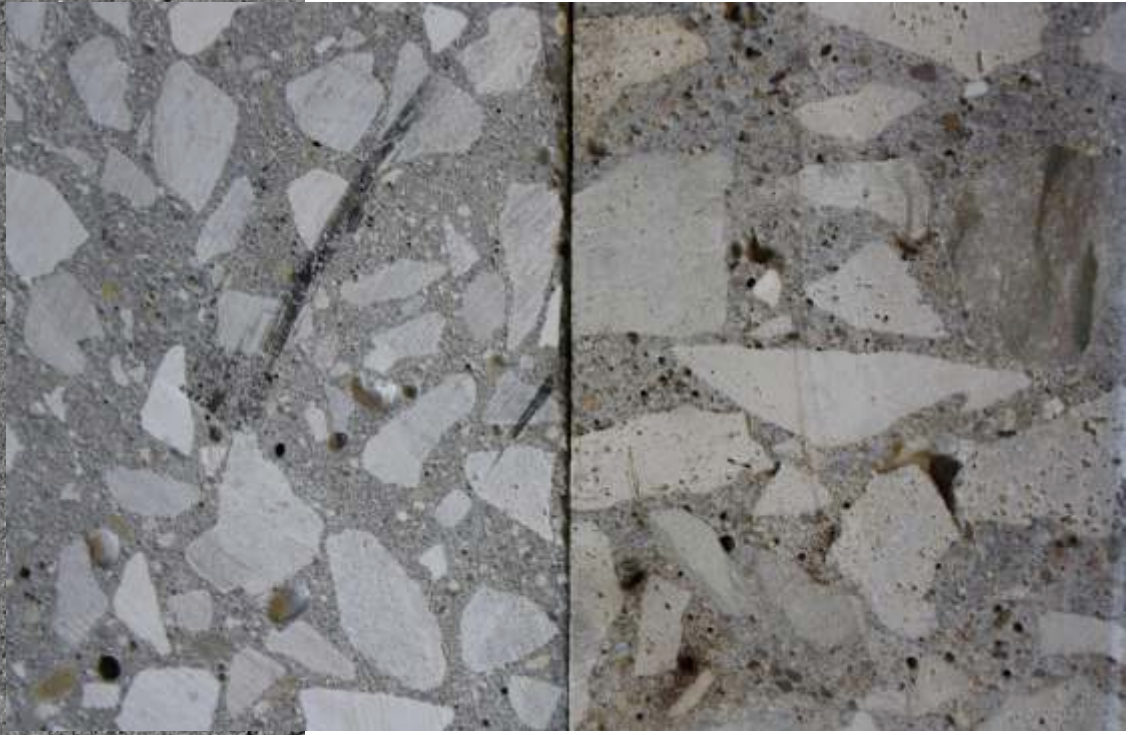
FIG. 27
Currently available crushed limestone (left) compared to aggregates in Core 1 (samples from Ozinga).

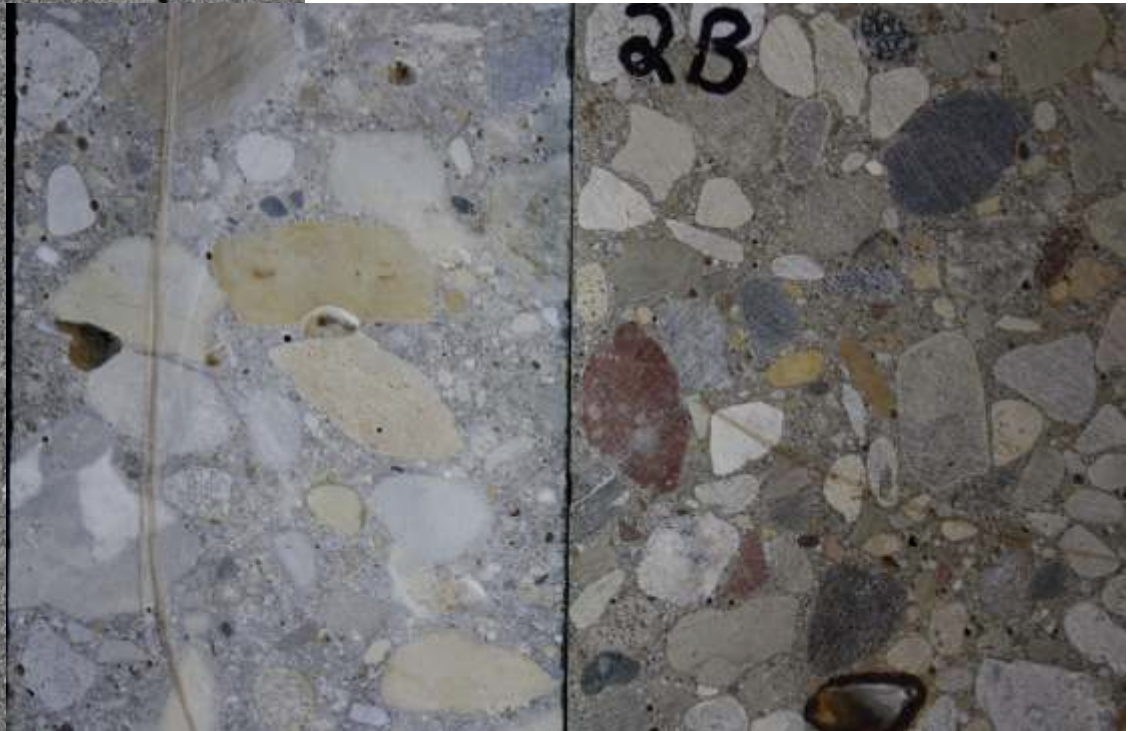
FIG. 28
Currently available uncrushed gravel (left) compared to aggregates in Core 2 (samples from Ozinga).

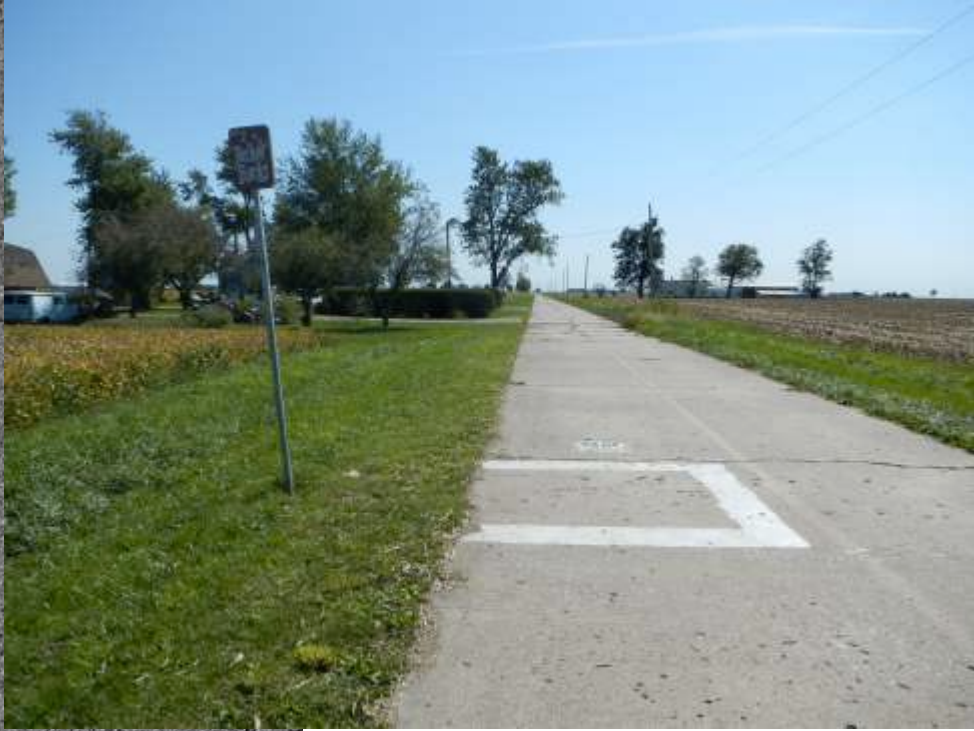
FIG. 33
Historic Route 66 'Turkey Trot' area south of Nilwood, IL.

Some areas and segments along Old Route 66 should be left in place and not altered or repaired. An example of this is an area south of Nilwood where some alleged turkeys trotted in the fresh concrete in the 1920s (Figure 33). This area has been marked and signage added to signify this portion of the concrete. Treatment of this area should be restricted for the preservation of this special area.

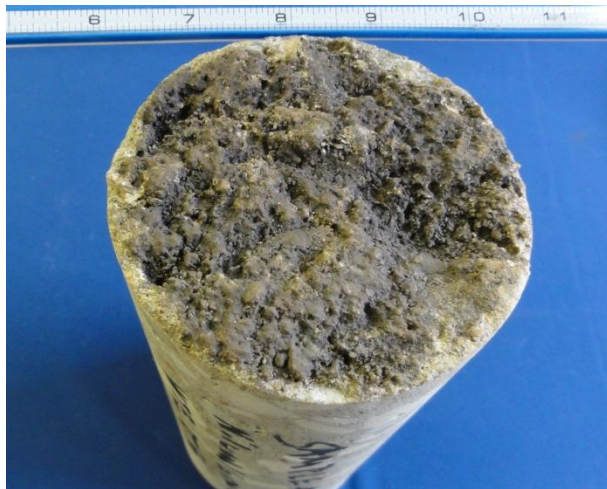
Figure 2. Core 1B; bottom surface of the core as received.

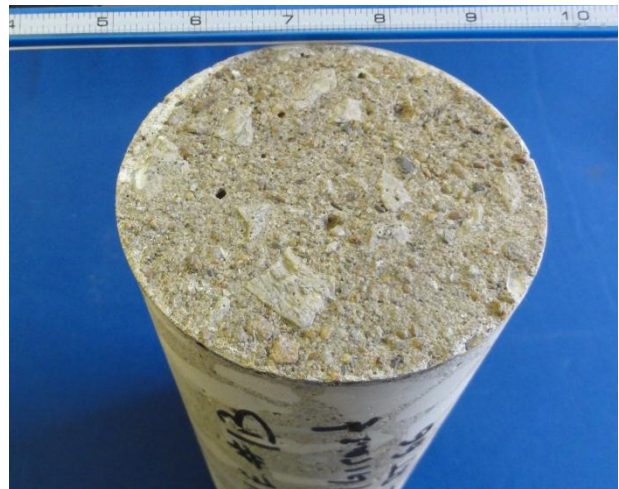
Figure 3. Core 1B; weathered top surface of the core as received.

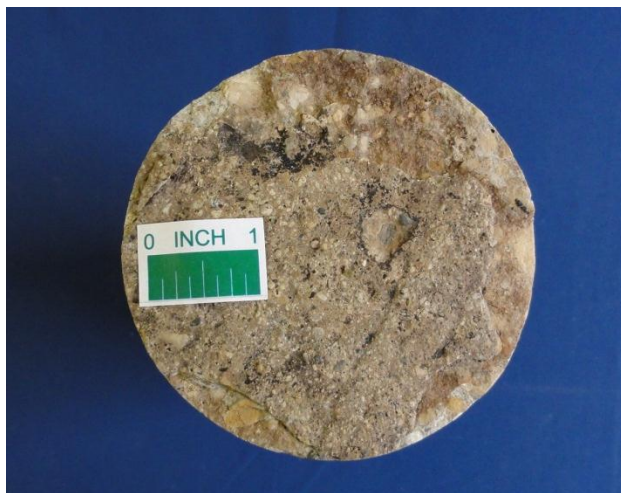
The concrete is in good general condition considering the age of the pavement. The top surface of the core is weathered and partially scaled. Aggregate particles protrude above the surface mortar layer. A few sub-horizontal cracks were observed within the top 0.4 inch of the core. These cracks pass through aggregate particle and are attributed to cyclic freezing and thawing. A transverse narrow crack extends through approximately half of the core diameter at a depth of 4 to 5 inches. This crack passes around and through aggregate particles and is attributed to alkali-silica reaction (ASR). Secondary deposits of alkali-silica gel were detected in several air voids throughout the core. The gel was mostly associated with chert particles. Crack locations are shown in Figure 14. A short vertical microcrack at the top of the core is shown in Figure 15. The crack is partially filled with asphaltic material. Constituents and characteristics of the concrete are described in greater detail below.

Figure 5. Core 2B; partially weathered, scaled top surface of the core as received.

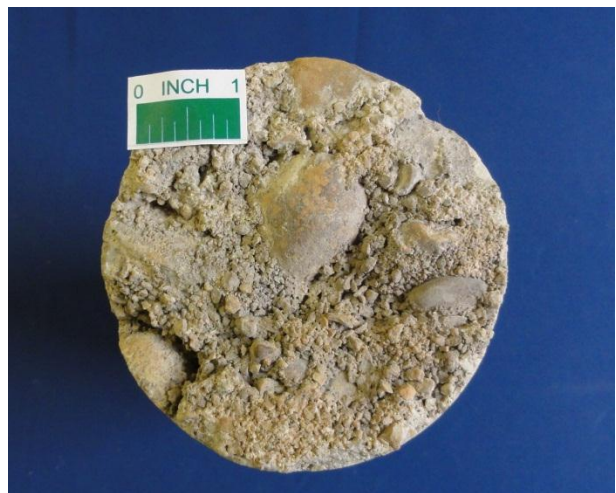
Figure 6. Core 2B; bottom surface of the core as received.

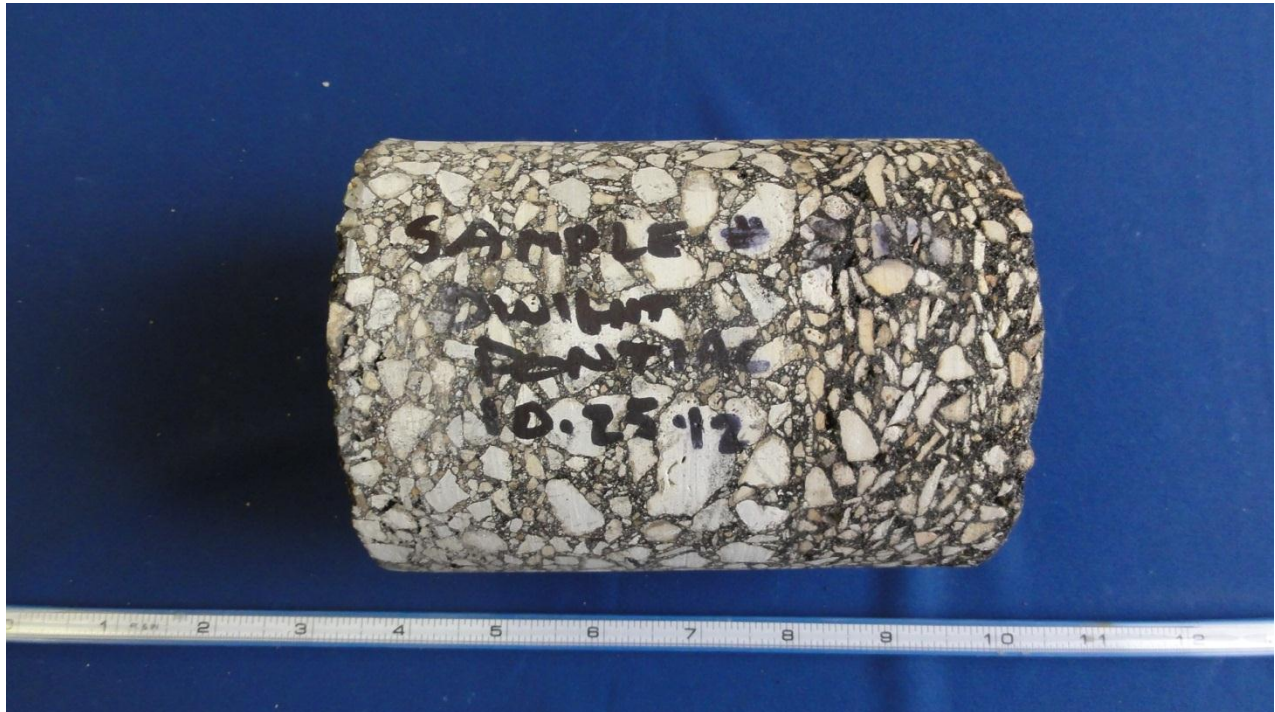
The asphaltic core has a diameter of 4 inches and is 5 inches long. The top surface is somewhat weathered and exhibits protruding aggregates. The bottom surface had been formed against the substrate concrete and appears to have debonded. The core appears to contain at least three distinct horizontal layers as indicated by the size distribution of the aggregate particles and by the presence of semi-continuous planar features. The asphaltic material is well consolidated. The aggregate particles are uniformly coated with binder and appear to be of adequate quality; no aggregate degradation was observed. The as-received core is shown in Figures 7 thru 9.

Figure 7. Asphaltic Core identified as Dwight /Pontiac (number designation illegible) as received. Top surface of the core is on the left of the photograph.

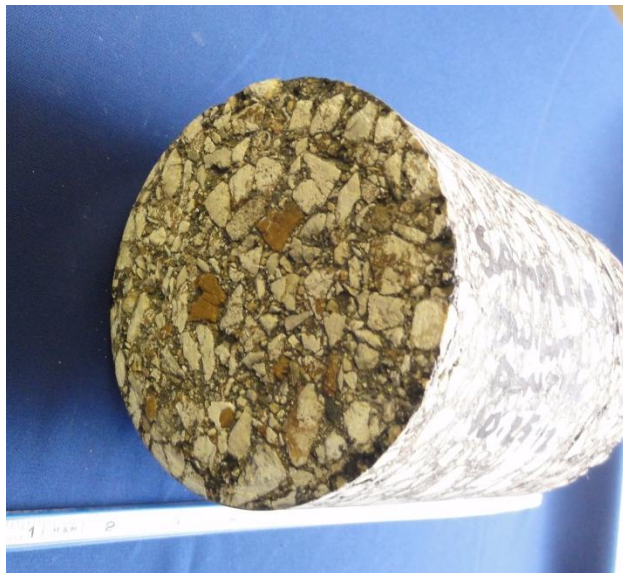
Figure 8. Top surface of the asphaltic core

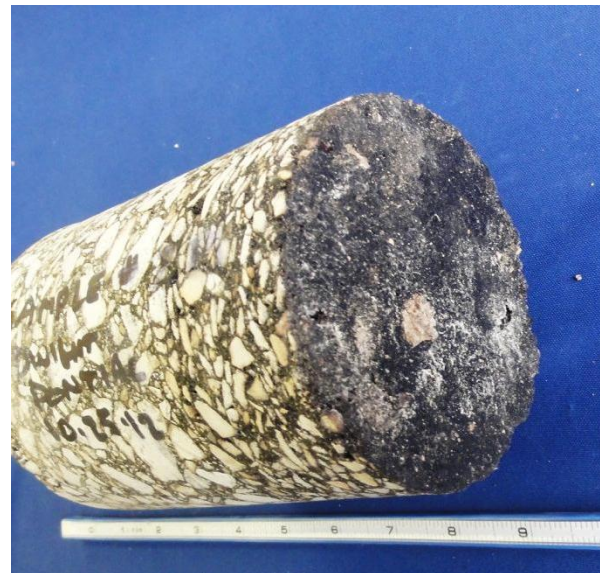
Figure 9. Bottom surface of the asphaltic core.

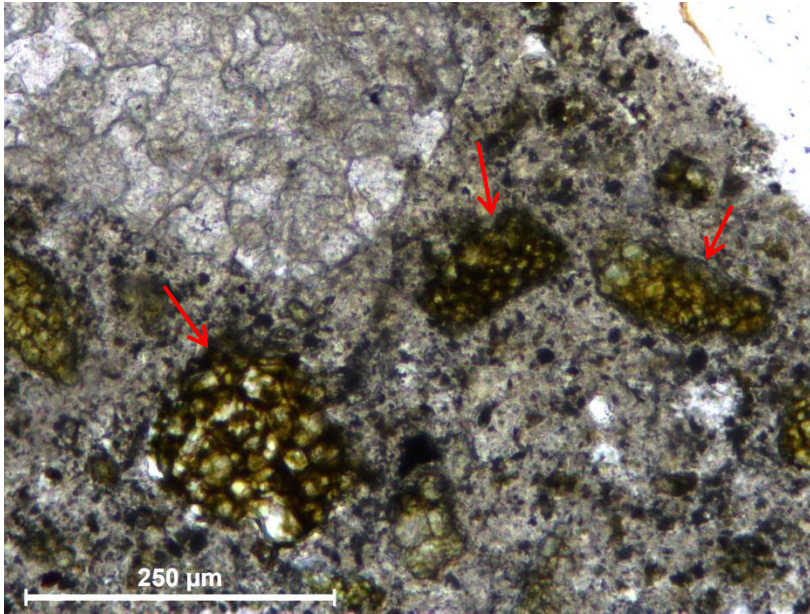
The paste contains moderate amounts of large residual unhydrated and partially hydrated portland cement particles. Residual cement particles were occasionally up to 300 microns (0.01 inch) in diameter (Figures 12 and 13); coarse particle size is a common characteristic of early 1900s portland cement. Hydration of the cement is generally advanced. Trace amounts of carbonate crusher fines were observed in the paste. Supplementary cementitious materials such as fly ash or ground granulated blast furnace slag were not observed, nor would these materials be expected in 1920s - 1930s pavement concrete.

Figure 12. Core 1B - Arrows show examples of large residual portland cement particles. Thin-section photomicrograph. Plane-polarized light.

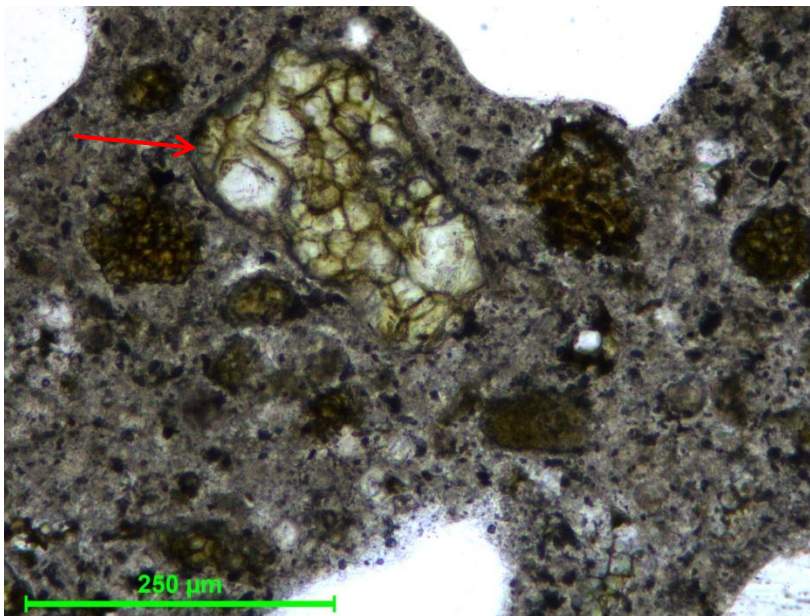
Figure 13. Core 1B - Arrow shows cement particle that is similar in size to small fine aggregate particles. Thin-section photomicrograph. Plane-polarized light.

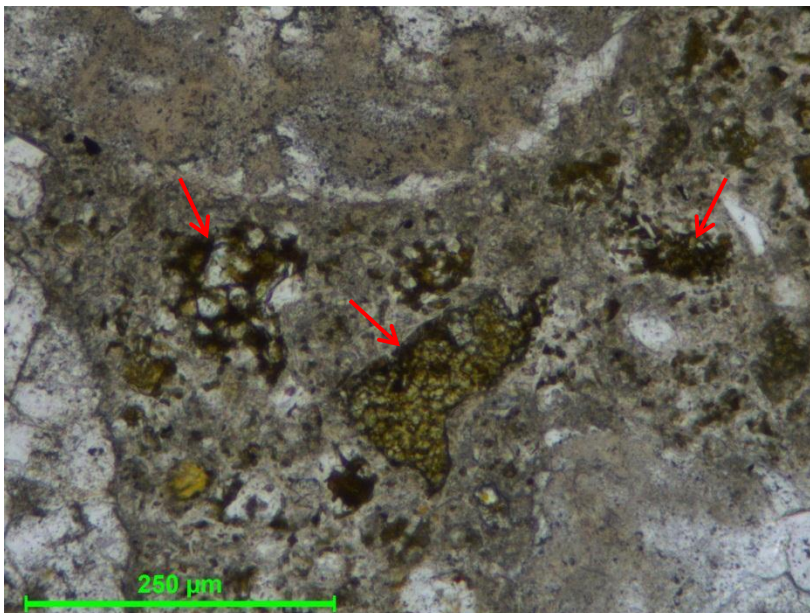
The paste contains moderate amounts of large residual unhydrated and partially hydrated portland cement particles. Residual cement particles were large, similar in size to the residual cement particles in Core 1B (Figure 16). Hydration of the cement is moderately advanced. Large amounts of carbonate dust were observed in the paste (Figure 17) indicating that the aggregate had not been sufficiently washed.

Figure 16. Core 2B - Arrows show examples of large residual portland cement particles. Thin-section photomicrograph. Plane-polarized light

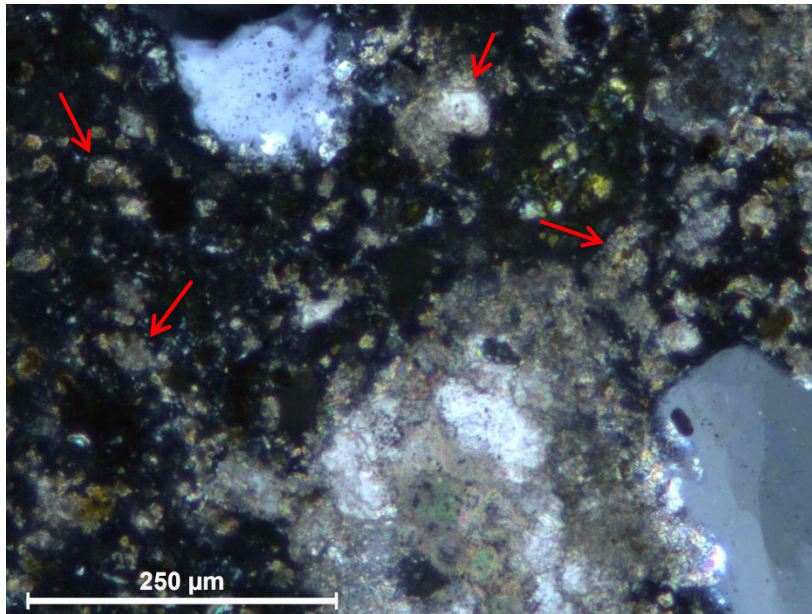
Figure 17. Core 2B - Arrows show examples of dust-size carbonate particles in the paste. Thin-section photomicrograph. Cross-polarized light.
