# The Auditorium Building

Roosevelt University

Getty Project Preparation Grant - Historic Interior Spaces

Conservation Master Plan

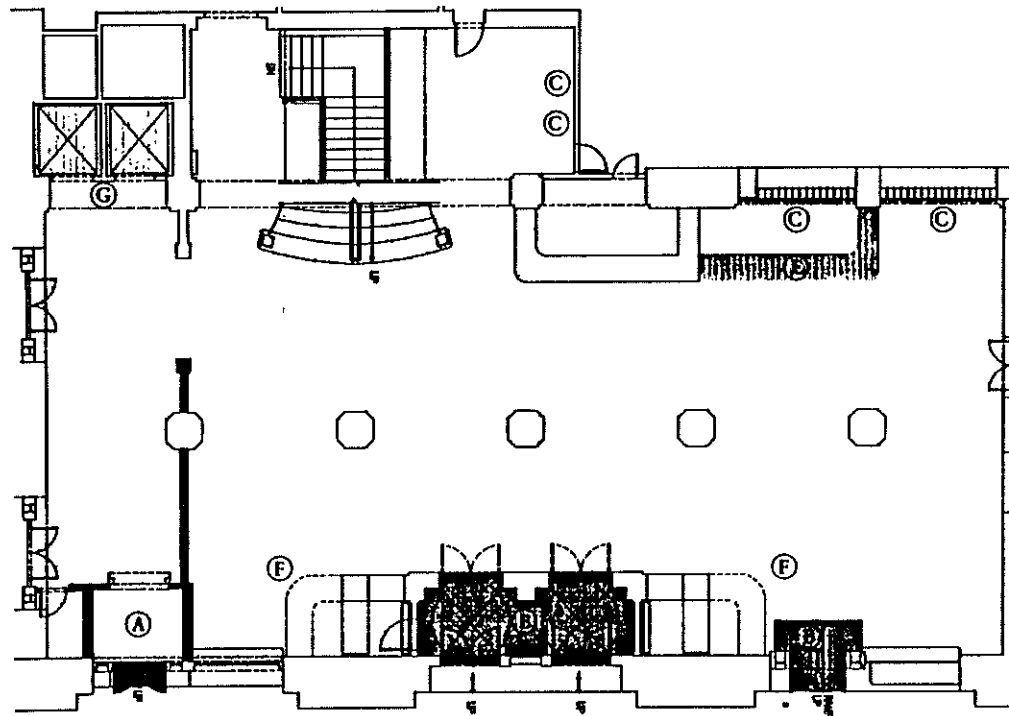
Existing Plan - Michigan Avenue Lobby, First Floor

- Partition wall removed.
- Partition wall onyx used to face replacement candy stand.
- Mosaic floor under partition wall patched.
- Window near entrance replaced with a door.

- Main double doors replaced with revolving oak doors.
- Handicap ramp and entrance installed at north bay.

### **1782** Two stained glass lunettes to north of desk and two stained glass double-hung windows in wall to west of desk removed.

- ### **D.** Original ceiling stencils covered.
- Replaced with stencils on vinyl.

- Manually operated hydraulic replaced with automatic electric cabs in 1950s.
- Oak and stained glass doors and surrounds disassembled.

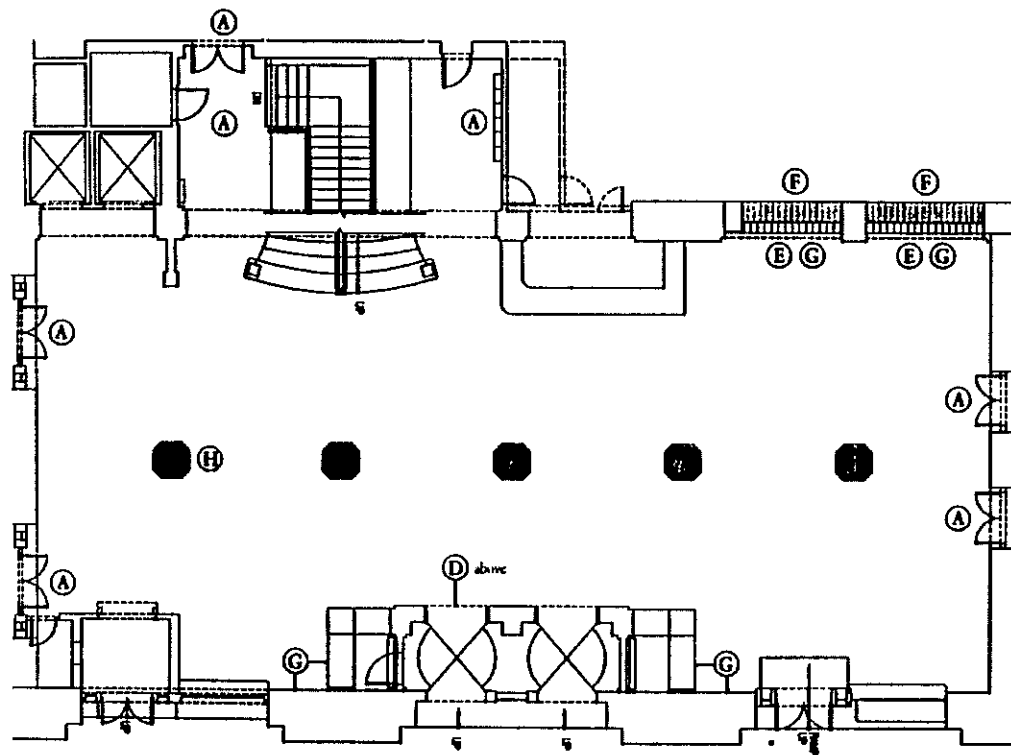
Plan, Remodeling - Michigan Avenue Lobby, First Floor

- Rubber-tile flooring was removed to expose the marble-mosaic flooring.
- Repaired mosaic floor using marble tesserae found in basement.
- Area carpet to protect damaged tile in high traffic areas.

### D. Damaged oak grills concealing heating units above the lobby entrance were recreated in masonite.

- Character of grain and richness of original color lost.
- New stain much lighter than the original.

- Applied to walls where damage occurred around the main entrance.
- Applied around mailboxes to continue decorative onyx.

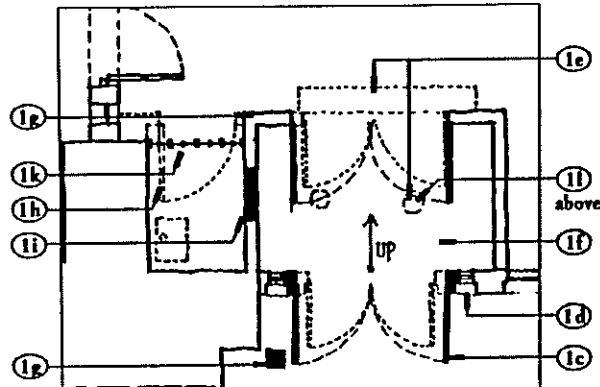
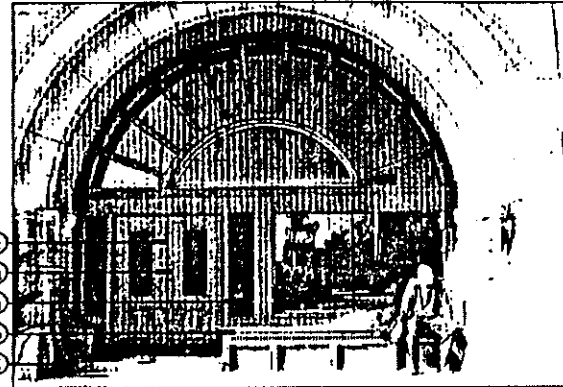
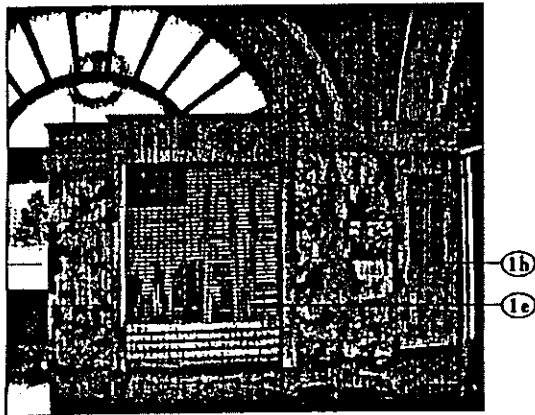
*Current condition of Michigan Avenue South entrance.*

*Interior view of Michigan Avenue South entrance*

1. Reconstruct south entrance to be ADA accessible.
  - a. Reconstruct exterior cast metal storefront panels to accommodate wider doors, narrower side lites (retain center stile and header). Weather seal per current standards.

- g. Install electronic push pads at exterior and interior.
  - h. Remove adjacent door, wall, sink.
  - i. Infill stud wall, face with onyx.
  - j. Repair interior mosaic floor and any adjacent woodwork.

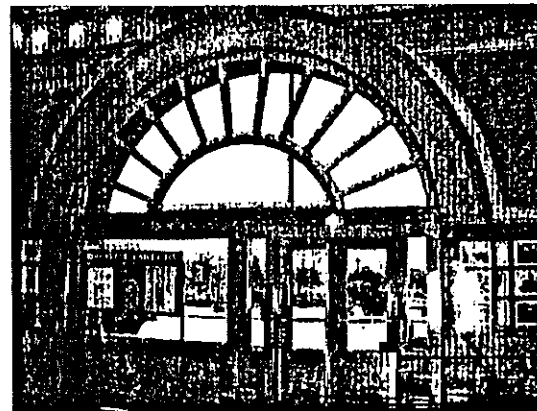
*Interior view of Michigan Avenue North entrance.*

2. Restore north exterior bay.
  - a. Remove accessible door, lites.
  - b. Install insulated glass panel and cast metal storefront to match existing. Weather seal per current standards.
  - c. Level interior and exterior ramps.
  - d. Repair interior mosaic floor.
  - e. Extend cast metal bench.
  - f. Remove electronic push pads.

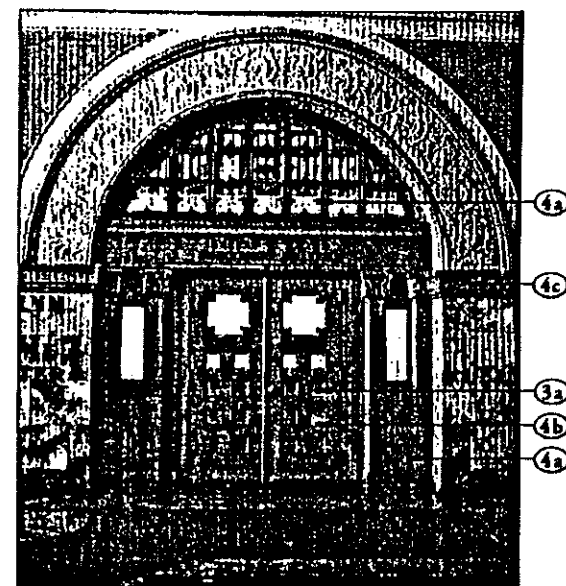
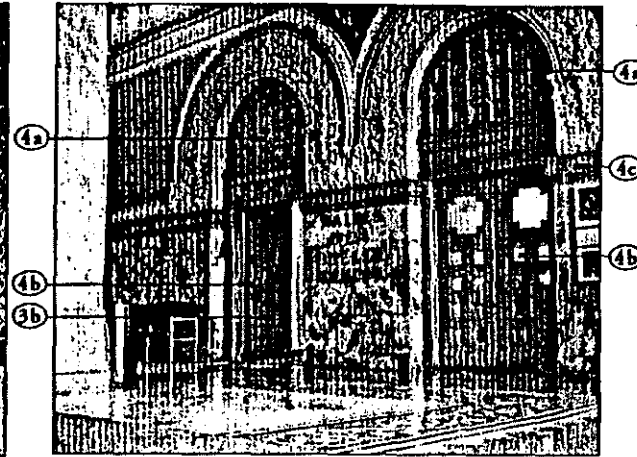
Current design of the doors on the south lobby wall.

*Current placement of the doors on the north lobby wall.*

3. Doors
  - a. South wall:
    - Install two pairs of oak panel doors to match original. Use door leading to service closet and historic photo as templates.
  - b. North wall:
    - Duplicate oak panel double doors from east entry and install in west entry.
  - c. Hardware to be light-oxidized silver.
4. Restore oak and restain to approximate original color.
  - a. Tympanum, lintel, columns, and framing at north and south doors (4).
  - b. All doors (including doors at first landing of Grand Staircase)
  - c. All dado molding (360 l.f. x 1 ft.)

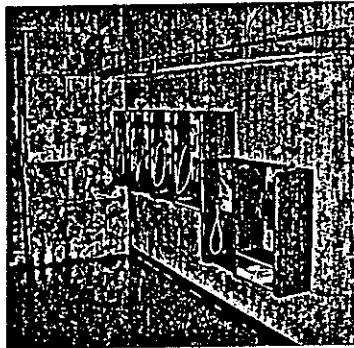
*Interior view behind Grand Staircase.*

- a. Remove fluorescent lighting at phones behind Grand Staircase. Replace with less obtrusive fixture.

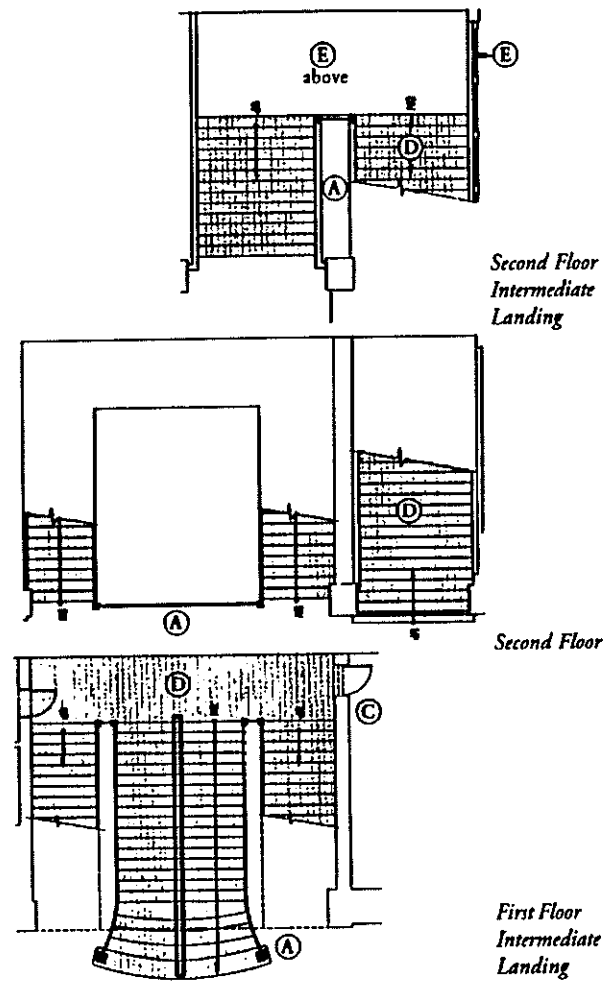
Existing Plan - Staircase and Landings, Michigan Avenue Entrance.

- A. Balustrades, newel posts and plaster ornament covered in layers of paint. Intermediate handrail installed at wide runs for code purposes.
- B. Removed exposed light bulbs in surrounding plaster friezes.
- C. First landing
  - North entrance to the mezzanine level was enlarged by cutting an arch into the plaster frieze.
  - Circular opening cut into adjacent wall.
- D. White-marble stairtreads and the mosaic floor on the first landing were replaced with white terrazzo.

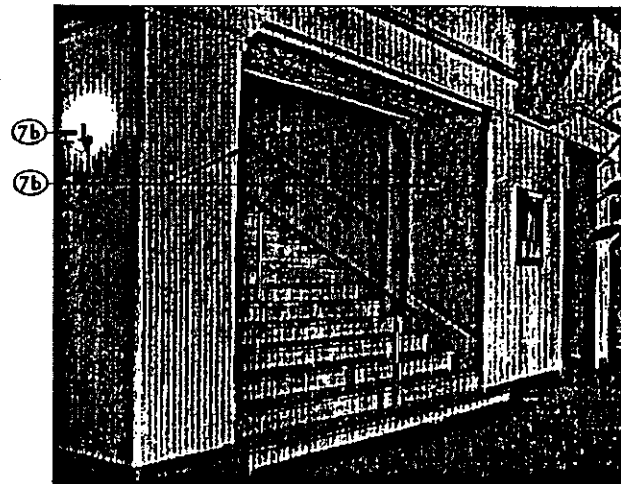
*At second floor, stairs leading from Fainman Hall.*

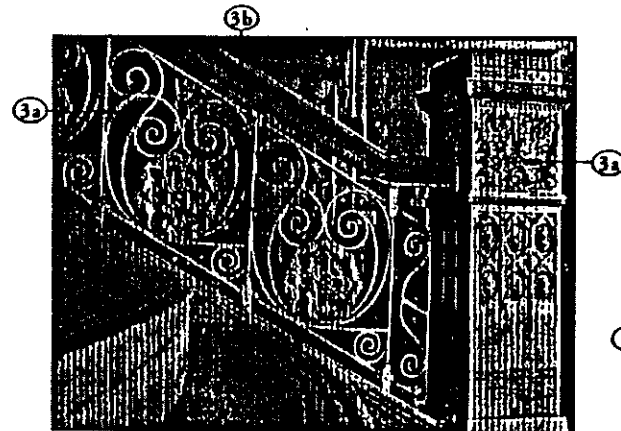
*Iron newel post and balustrade of Grand Staircase.*

1. Determine original color scheme at Grand Staircase.
2. Clean and repaint plaster ornament at Grand Staircase. Replace where needed.
3. Stairs- all ten floors
  - Strip and clean the iron newel posts and balustrades in situ.
  - Strip paint from and refinish all handrails to original mahogany.
4. Patch and paint entire stairway.
5. Mosaic floor
  - Install mosaic floor on the first landing.
  - Repair mosaic floor on the second landing.
6. New heating and cooling system -see "Mechanical" section.
7. Lighting -see "Lighting" section.
  - Reactivate original lighting located in the frieze at first and second floors.
  - Replace and reinstall historic sconces at second and third floors.
  - Replace fluorescent lighting behind leaded-glass "skylights" at second floor.
  - Install wall sconces to match original and install supplemental lighting in entire stairway.

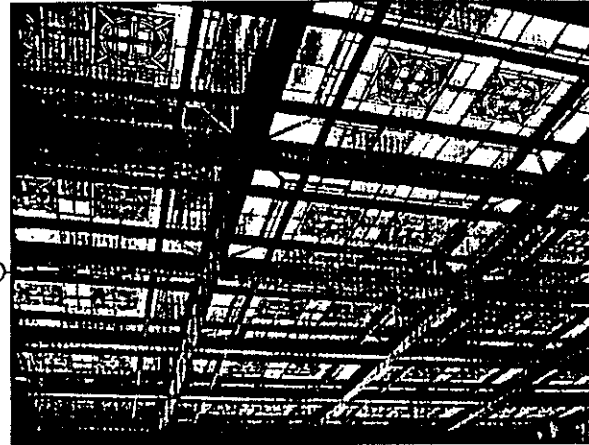
*Stained glass in second floor landing.*

7. Lighting
  - a. Replace lighting in the frieze at first and second landings.
  - b. Replace and reinstall sconces at second and third floor, and under staircase at first floor.
  - c. Replace fluorescent lighting behind stained glass, which currently creates a linear pattern, detracting from the glass, at second floor landing.
  - d. Install wall sconces to match original and add supplemental lighting in entire stairway.

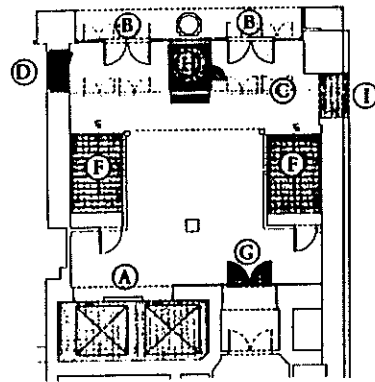
Existing Plan - Wahash Lobby, First Floor

- Removed original cast iron framing and mullions.
- Replaced fenestration with aluminum curtain wall.

- Removed marble wainscoting and marble at underside of stairs. Marble "beams" remain on ceiling near elevators.
- Replaced with drywall and paint.
- Wallpaper added.

- Ornamental balustrades replaced with simple iron balustrades sporadically.
- Iron treads and risers still in place.

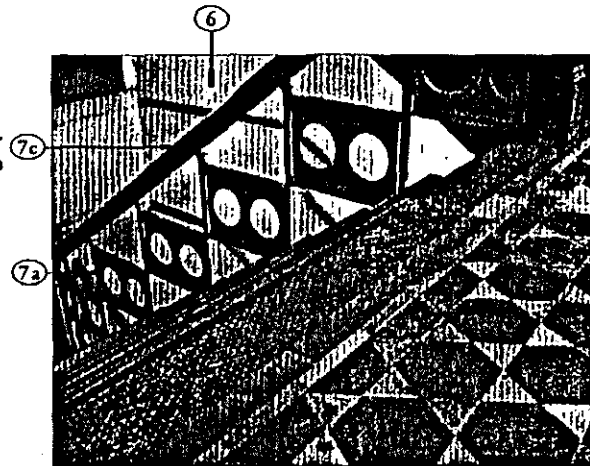
*Balustrade on second flight of stairs.*

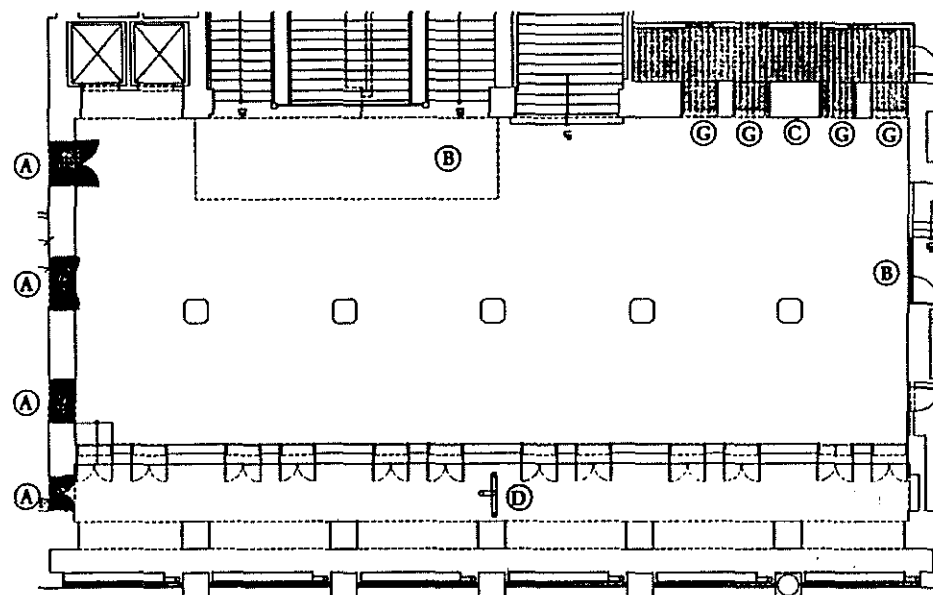
Existing Plan - Fainman Memorial Hall, Second Floor

**H** Original carpeting replaced.

**I** Original furnishings replaced.

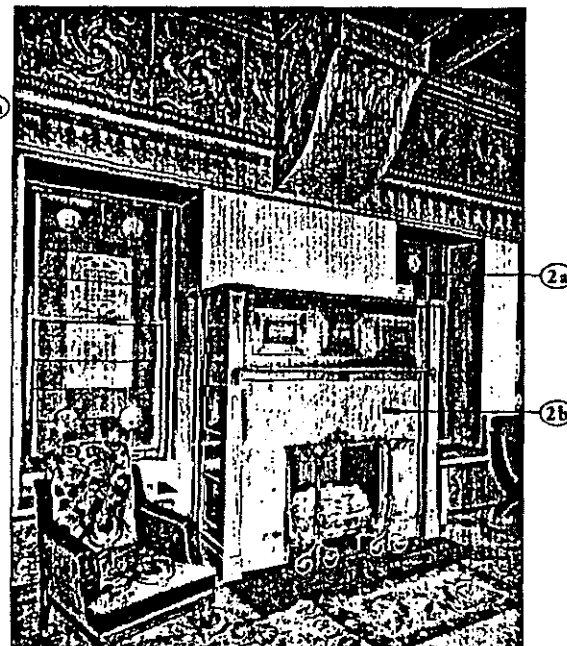
*Original condition of northwest wall. (Garczynski)*

2. Reconstruct entrance to northwest offices
  - a. Restore and install two stained glass windows in new framing.
  - b. Reconstruct fireplace, using photo and other existing fireplaces (Sullivan and Faculty Lounge rooms). Brownish-purple marble with oak panelled mantel and surround.
  - c. Remove existing drop ceiling and install new raised drywall ceiling and lighting at raised height. 140 sq. ft.

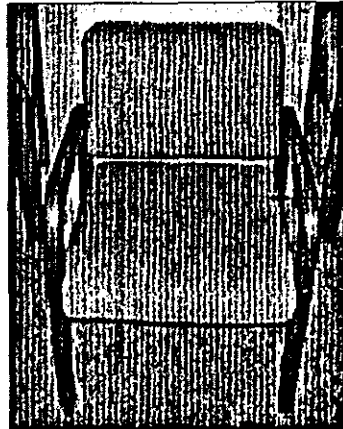
5a

*Current furniture.*

5. Replace existing furniture with new that is sensitive to the original.

- a. 28 lounge chairs
- b. 7 sofas
- c. 24 stacking chairs (loggia)
- d. 6 tables (loggia)

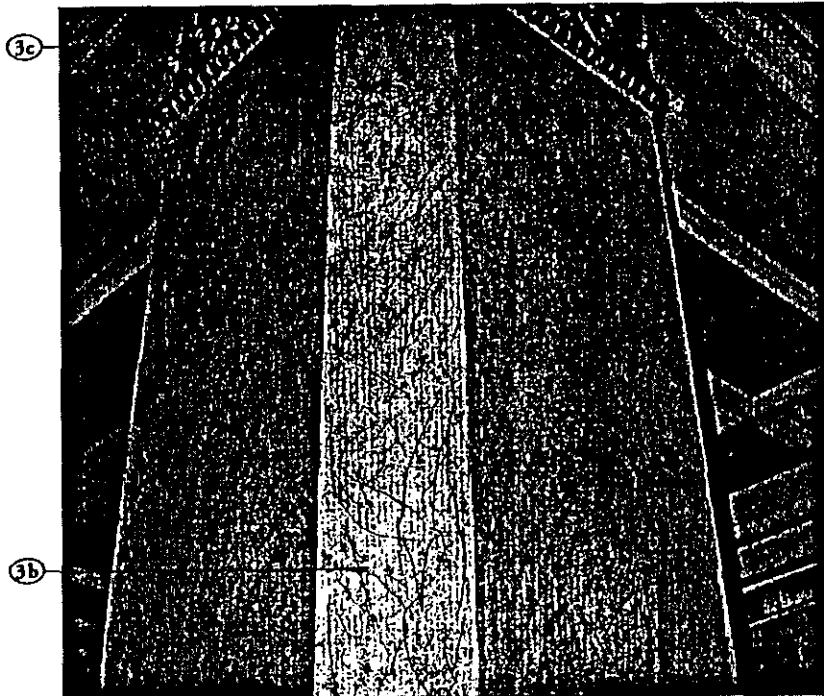
*Detail at southernmost scagliola column*

- a. Determine original color scheme and repaint.
- b. Repair and clean scagliola (5) columns. Southernmost column in need of new scagliola finish. Coordinate timing with new electrical and telecom wiring as needed.
- c. Apply gold leaf to the column capitals and moldings.
- d. Repair damaged plaster and stencils at locations of new mechanical grills, likely to be at north-south beam locations, and new electrical and telecom wiring.
- e. Repair minor damaged stencil and plaster work.
- f. At plaster frieze, strip existing layers of paint, and hand tool plaster. If required, cast new panels.
- g. Remove existing doors at north wall office entries. Install historic profile doors to match those at south wall.

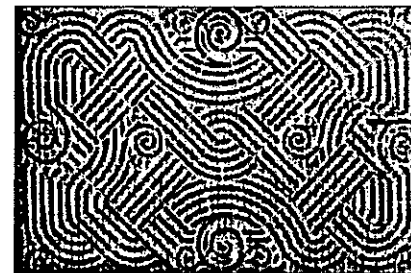
3c

*Stencil pattern under beams.*

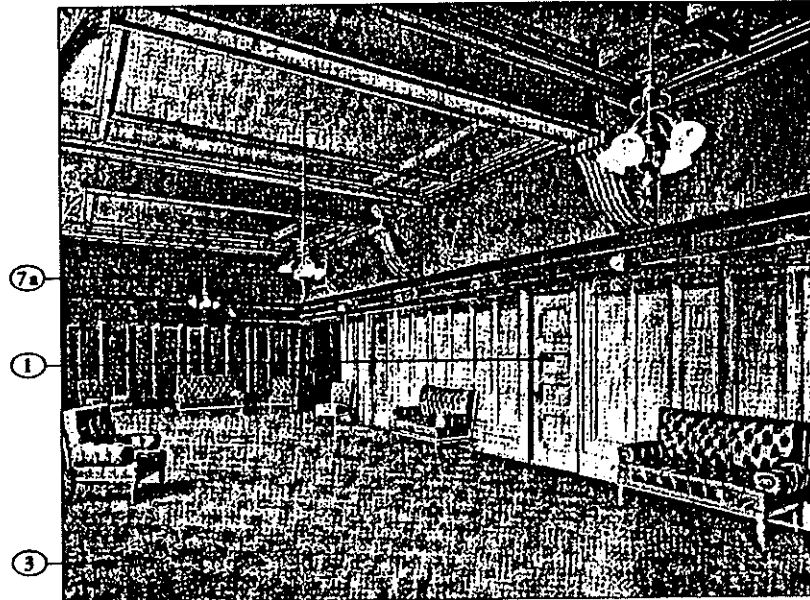
*Original condition of Faculty Lounge. (Garczynski)*

1. Install new paneled oak doors similar to the ones retained throughout the building. Stain to match wall panels.
3. Flooring:
  - a. Remove existing linoleum.
  - b. Remove existing carpeting.
  - c. Install new carpeting and underlayment throughout. Carpeting to be similar to that reproduced for the Auditorium Theatre. 1,015 sq. ft.

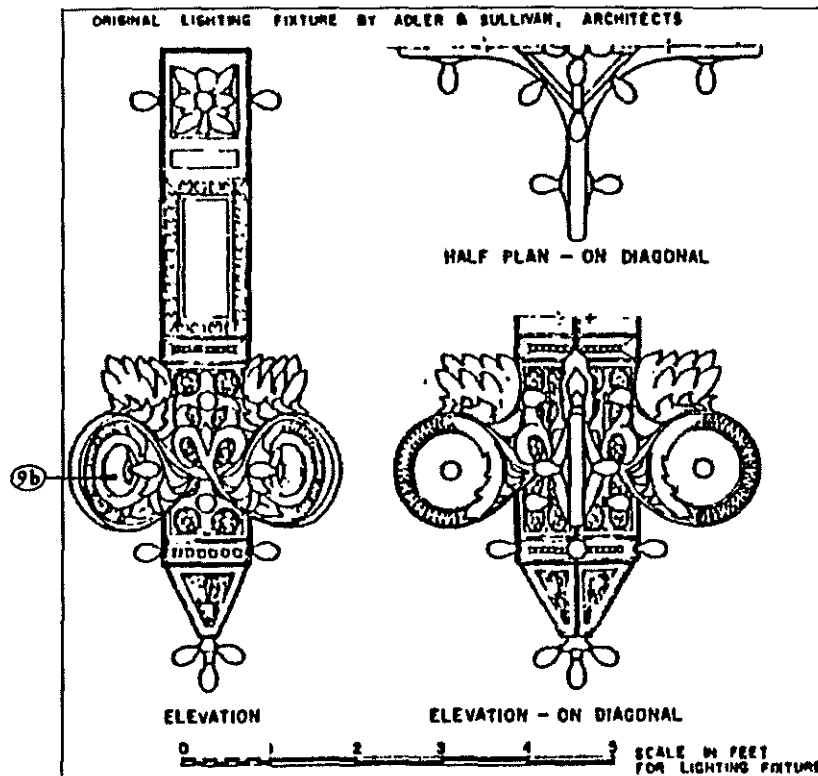
HABS drawing of electroliers.

9. Lighting - see "Lighting" section
  - a. Remove existing pendant fixtures.
  - b. Reproduce eight pendant electroliers from photographs and drawings. Original metal connection points remain. Coordinate with lighting and acoustical consultants.  
*Note:* Metal anchor straps to be gilded.
  - c. Install supplemental hall lighting, if needed.
  - d. Install stage lighting to better meet current standards without detracting from ceiling detail.
  - e. Install additional lighting and metal tube structure at exterior to highlight stained glass.

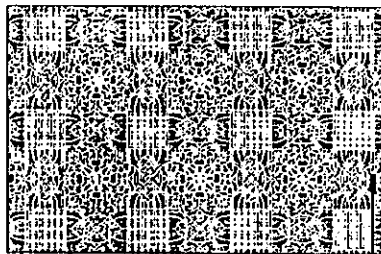
*Stencil on various panels below lunettes.*

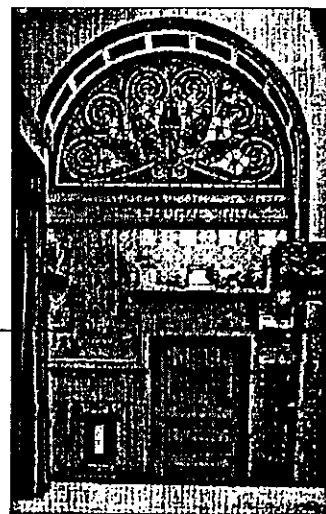
*Photo detail of stencil on foil.*

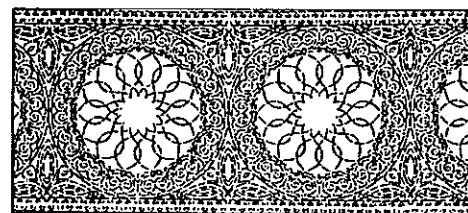
*Stencil above wainscoting in ladies waiting area.*

a. Replace two pair metal doors with custom birch panel doors to match existing. Hardware to match existing historic hardware.

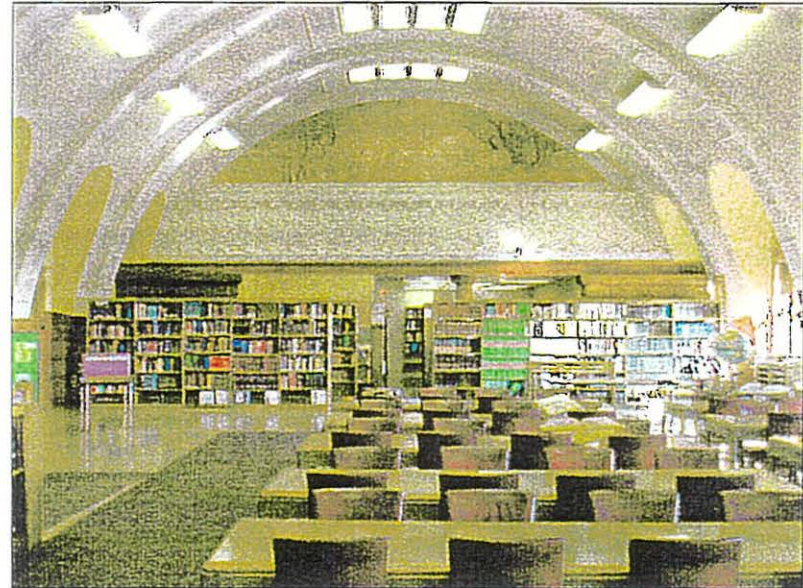
*Current Condition*

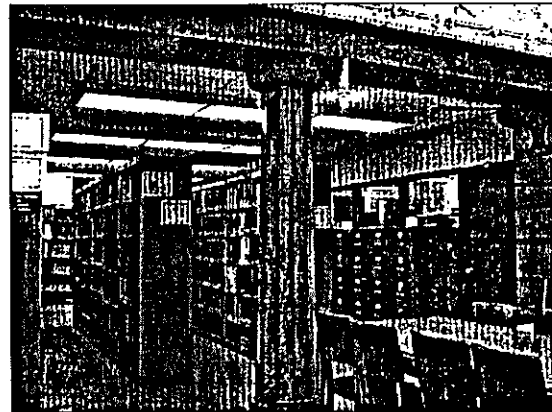
*View of staff offices (on right) and drop ceiling in the north wing.*

2. Reorganize north wing. Relocate the library staff offices.
  - a. Remove wall partitions, stacks and furniture.
  - b. Repair plaster and woodwork.
5. Remove dropped ceiling in north wing, to expose the original coffered ceiling. *Note:* New lighting fixtures and mechanical distribution will be required.

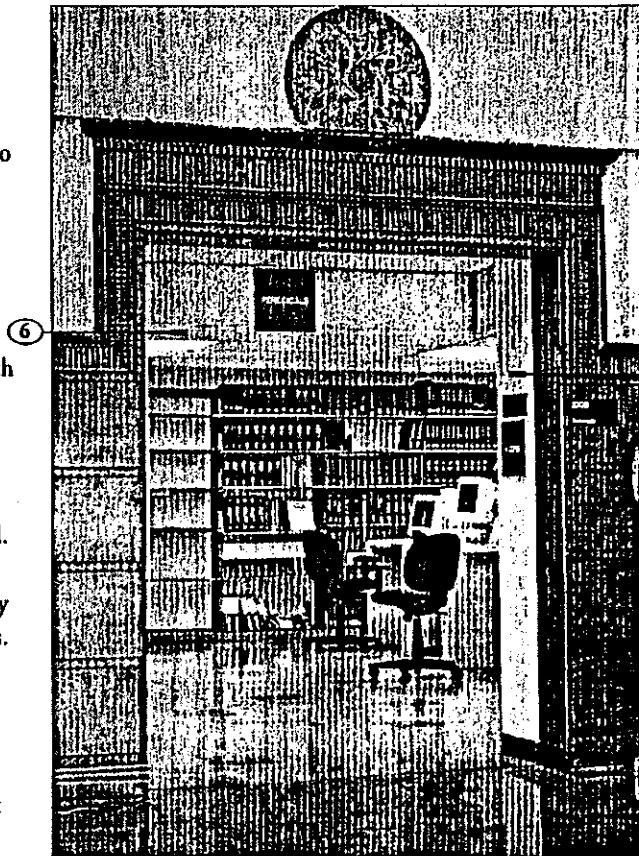
*North entrance to periodical room on west wall.*

9. Reconstruct mahogany doors with fretwork panels on the west side of the main hall, and mahogany paneling in south wing.
  - a. Remove built-in bookshelves, and concrete masonry unit wall.
  - b. Construct and install two pair solid-core doors with mahogany finish and insert fretwork panels.
  - c. Add dull brass hardware (push panels) to doors.
  - d. Finish trim at doors as needed.*Note:* This design is to be copied for cladding of doors at reconstructed north wing also.
  - e. Construct and install mahogany paneling at west wall of south wing. Door under mahogany "transom" to remain. 40 sq. ft.

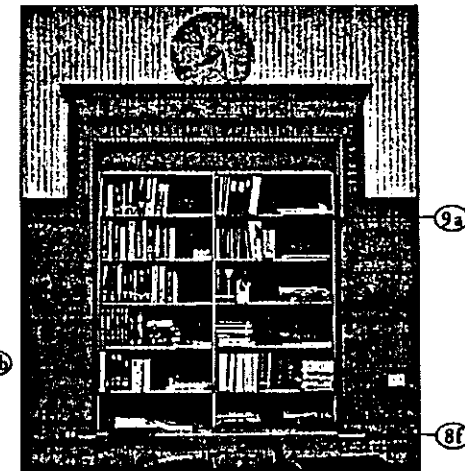
*South entrance blocked and bookcase added.*

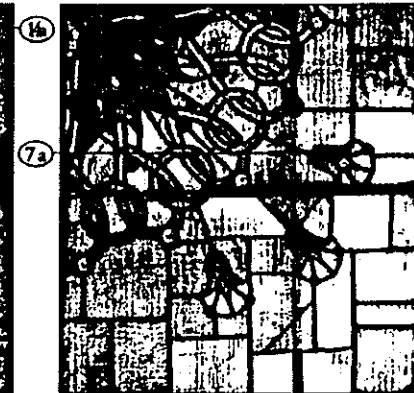
*Fragment of original skylight.*

4. Install new double hung wood windows to match those in the South wing.
  - a. 8 @ 3'-6" x 7'-0"
  - b. 17 @ 2'-6" x 7'-0"
  - c. Brass hardware to match.
7. Restore skylights on the vaulted ceiling. See "Structural," "Lighting," and "Mechanical" sections.
  - a. Reproduce 16-panel stained glass skylights, from existing fragment. 6 @ 50 sq. ft.
  - b. Use natural light, if possible. Install new exterior skylights. Flash and seal per current standards. Install supplemental lighting.
  - c. Relocate mechanical ducts.
11. Install horizontal wooden venetian blinds to control glare.
  - a. 13 at 3'-6" x 7'-0"
  - b. 27 at 2'-6" x 7'-0"

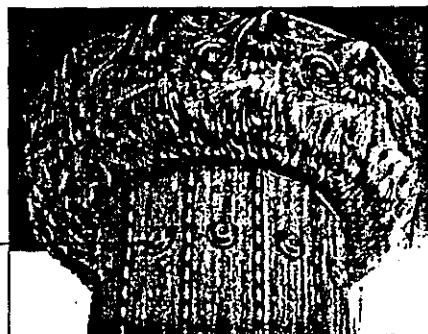
*Restore light setting around columns.*

14. Lighting - see "Lighting" section.
  - a. Remove surface-mounted fluorescents on main vault.
  - b. Restore arch soffit plaster settings.
  - c. Restore lighting around the columns (remove and reinstall mahogany panelling) and behind the skylights.
  - d. Reinstall period lighting in the north wing.
  - e. Supplement main hall and wings with auxiliary lighting, if necessary.
  - f. Install new lighting in the adjacent "periodical room", if necessary.
  - g. Replace pendant fixture above stairway with historic reproduction of original fixture.

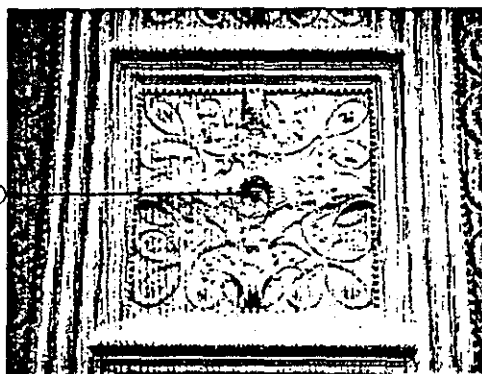
*Restore arch soffit plaster light settings.*
