Concrete Restoration for Route 66 in Illinois

September 2012

THORNTON TOMASETTI, INC. (TT) WAS SOLICITED BY the Illinois Historic Preservation Agency (IHPA) to develop an historic concrete treatment guide and repair/restoration specifications for the limited remaining historic concrete roadway along Illinois' Route 66 corridor. As stated in IHPA's *Route 66: Finding Illinois' Original Roadbed Segments from Chicago to St. Louis* report, "In all of the research about US Route 66 throughout the United States, one area in particular has been left disengaged for the most part. That area consists of the original roadbed segments of US Route 66, which can still be found stretched along the Illinois landscape."

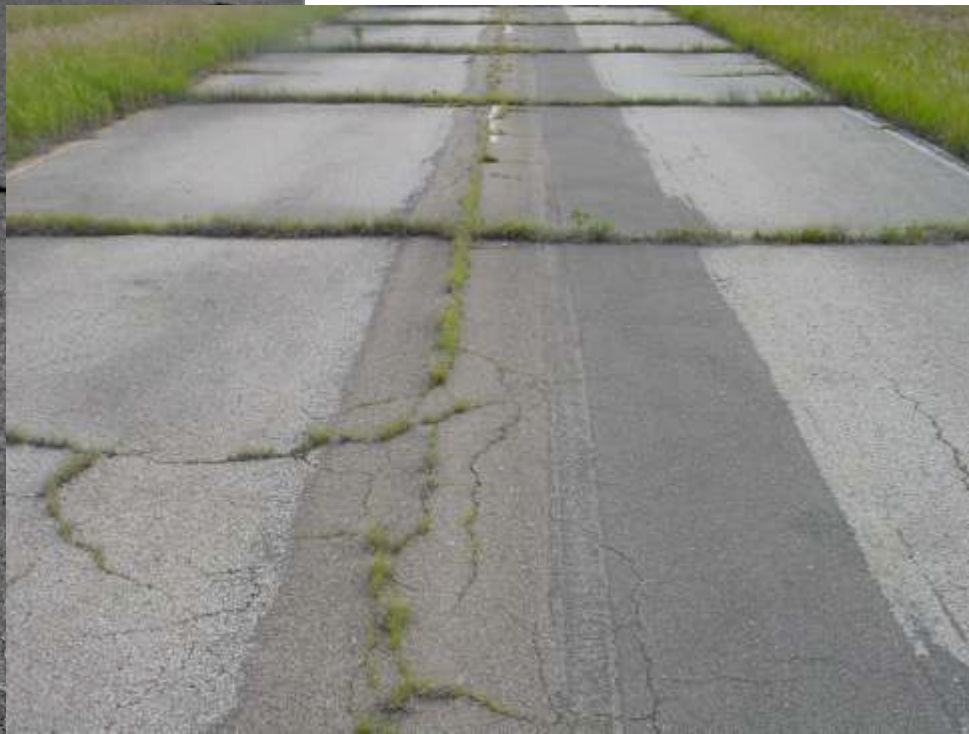
FIG. 11
Odell, IL. Segment of Rt. 66 bypass. Camera facing south.
Photograph by Travis Ratermann, 2 July 2008.

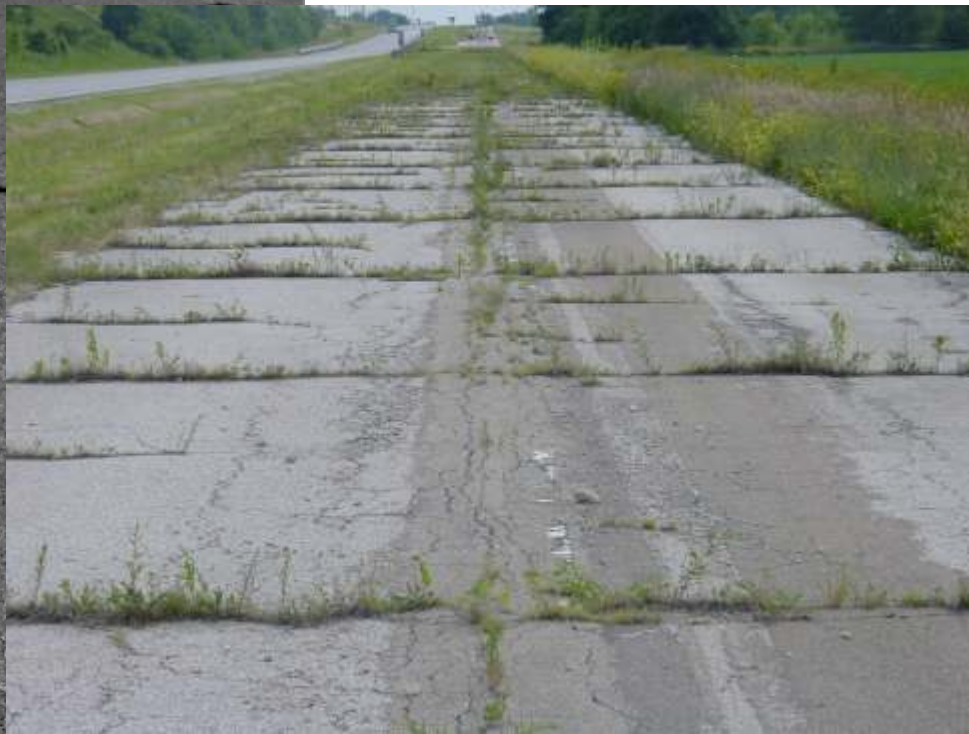
FIG. 13
Odell, IL. Segment between Odell and Pontiac looking up close at the pavement. Camera facing north.
Photograph by Travis Ratermann, 2 July 2008.

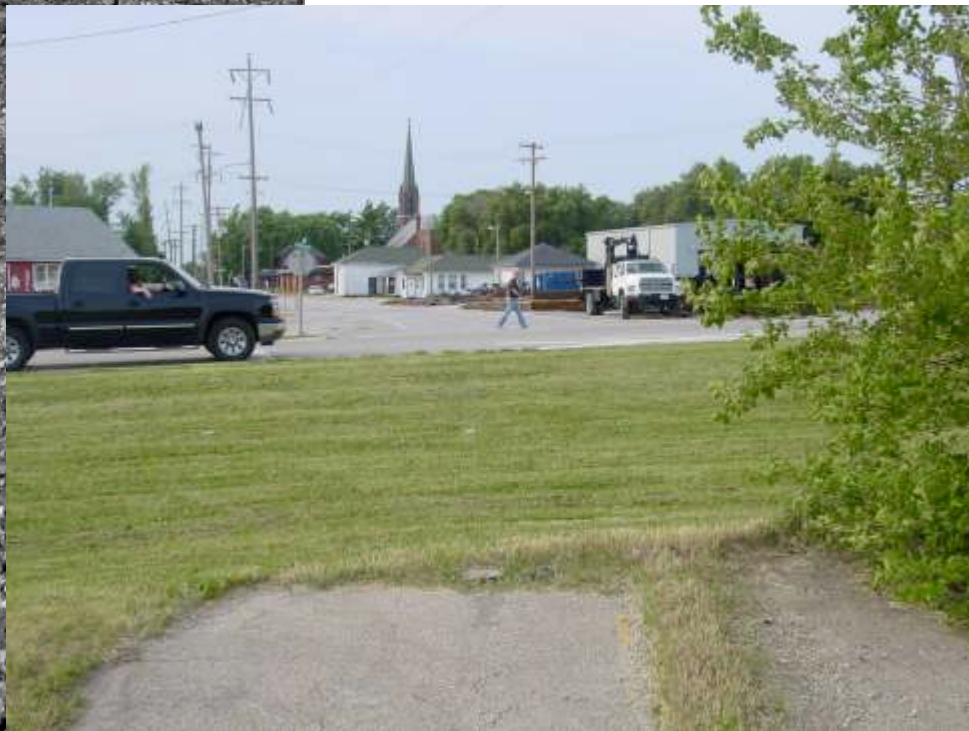
FIG. 20
Chenoa, IL. Abandoned 1926-30 segment of Rt. 66 off of Moorehead and Cemetery Rds. Runs
along RR tracks. Camera facing northeast.
Photograph by Travis Ratermann, 2 July 2008.

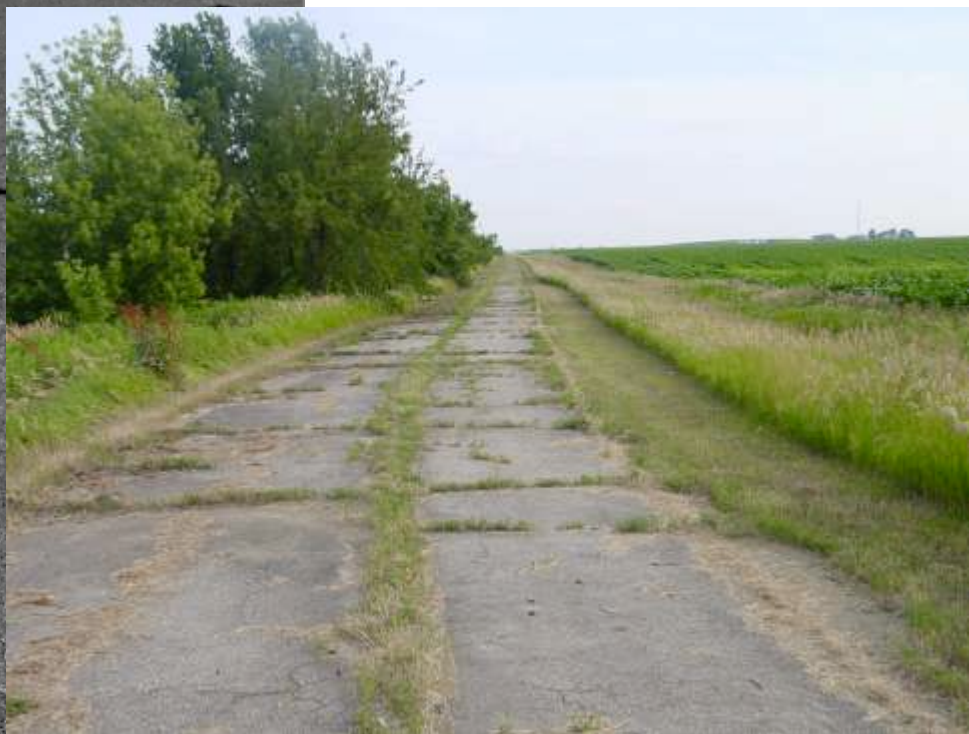
FIG. 21
Chenoi, IL. Abandoned 1926-30 segment of Rt. 66 off of Moorehead and Cemetery Rds. Runs along RR tracks not visible to the left due to trees. Camera facing southeast.
Photograph by Travis Ratermann, 2 July 2008.

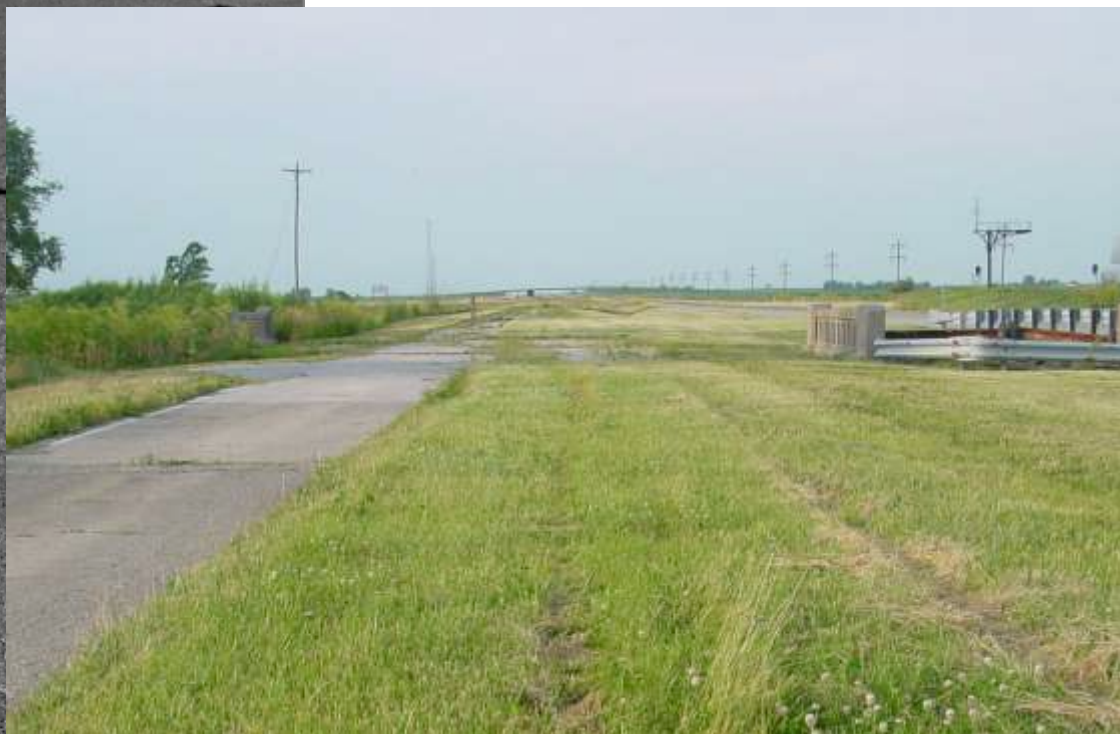
FIG. 27

Lexington, IL. Segment of Rt. 66 north of Lexington on Rt. 66 bypass. One lane of roadway has been torn up and replaced with grass. Camera facing north.

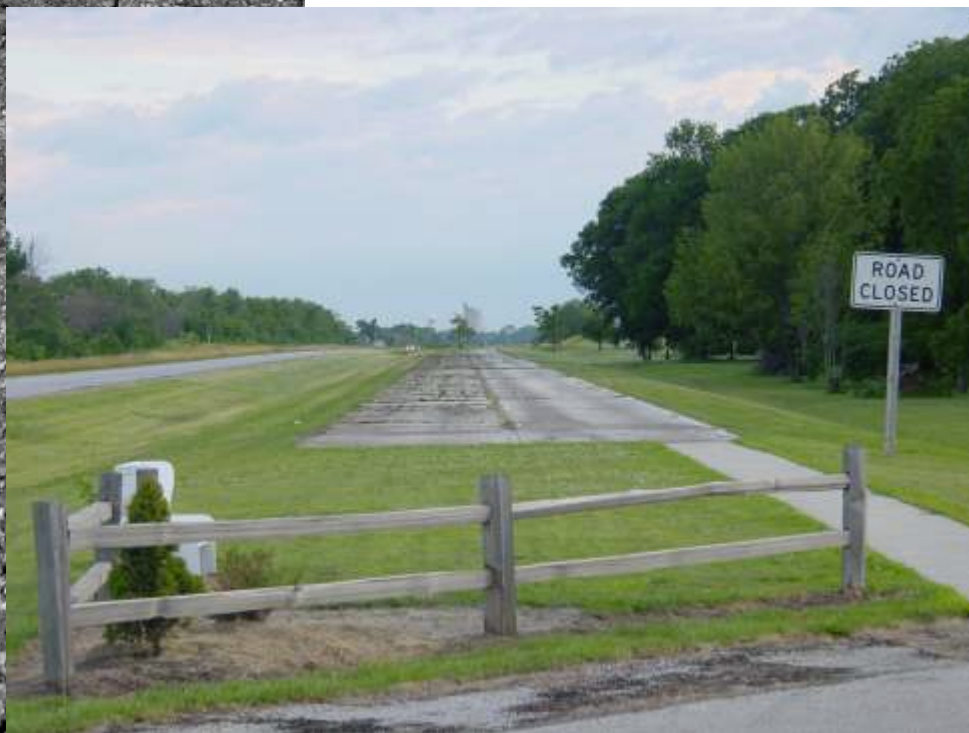
FIG. 28

Towanda, IL. Rt. 66 bypass north of Towanda. Now used as a bike path. Camera facing south.

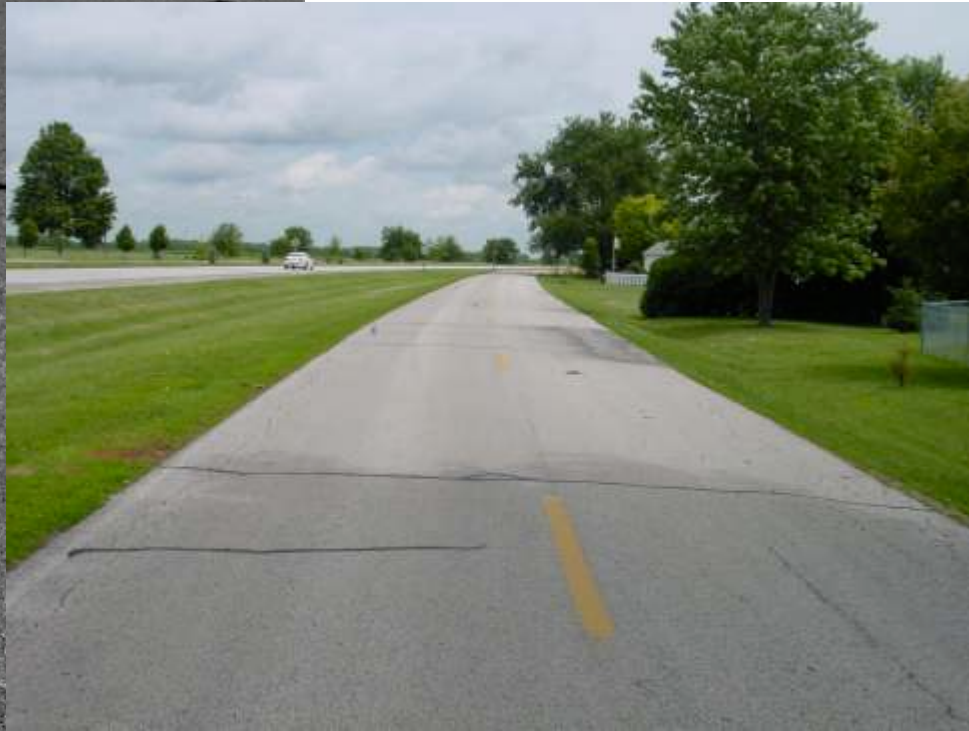
FIG. 29
Towanda, IL. Rt. 66 segment (Jackson St.) that has been paved over. Camera facing south.
Photograph by Emilie Eggemeyer, 8 July 2008.

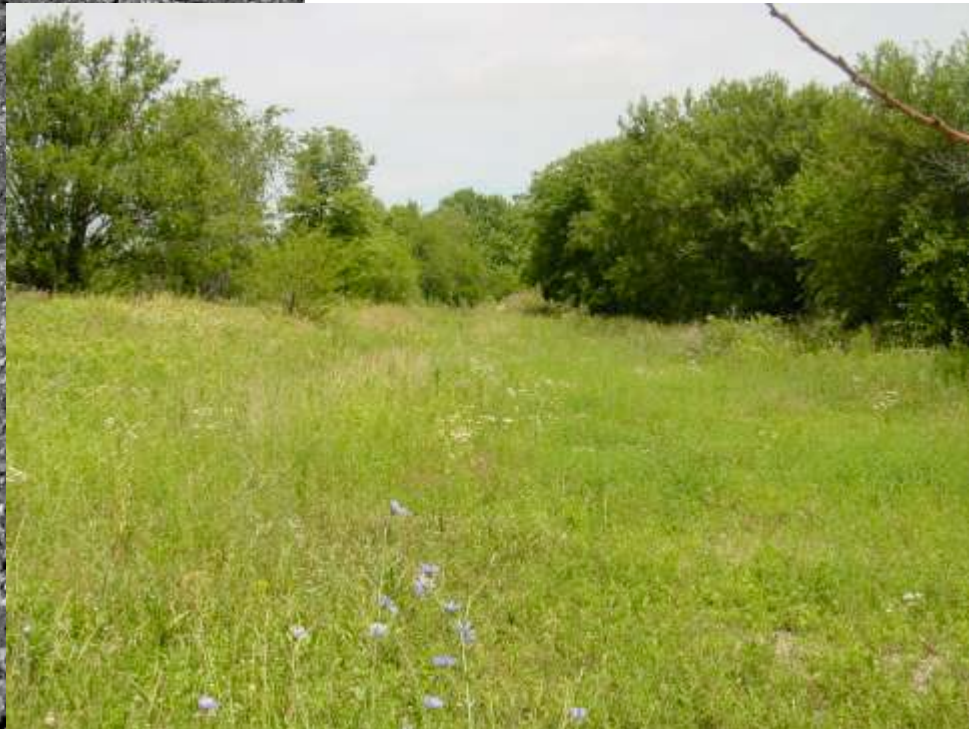
FIG. 38

Atlanta, IL. Rt. 66 in Atlanta 1926-30 segment. Portion is along RR tracks and a farm. Golf course is located on other side of RR tracks. Camera facing north.

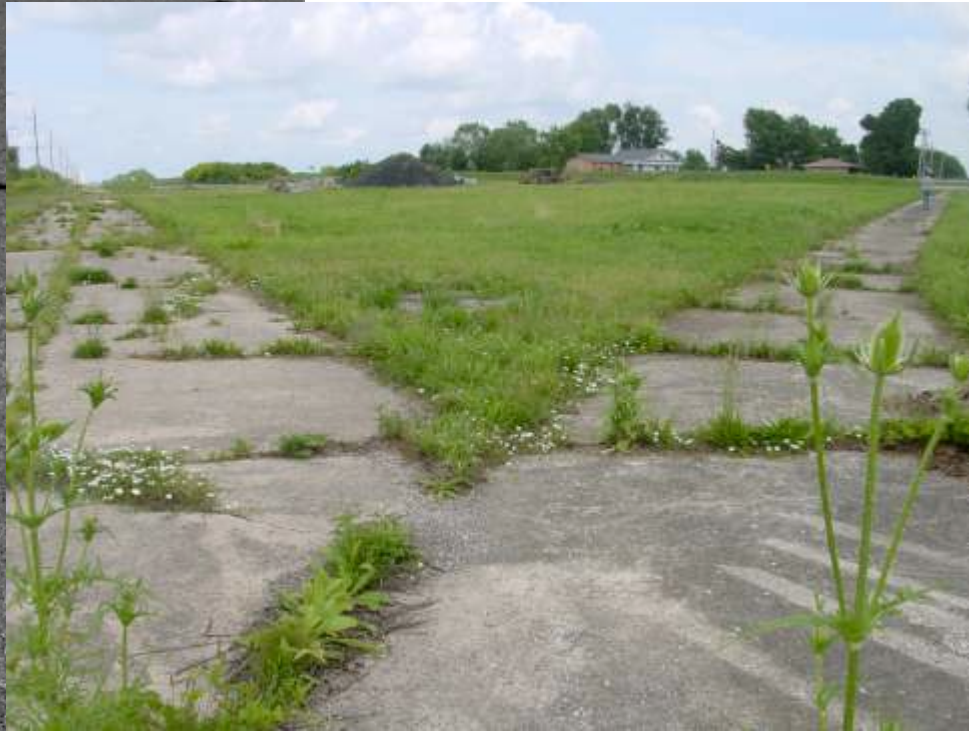
FIG. 43
Lincoln, IL. Segment of Rt. 66 West of the Lincoln Rt. 66 Bypass looking at the split in the road.
Camera facing northeast.
Photograph by Emilie Eggemeyer, 8 July 2008.

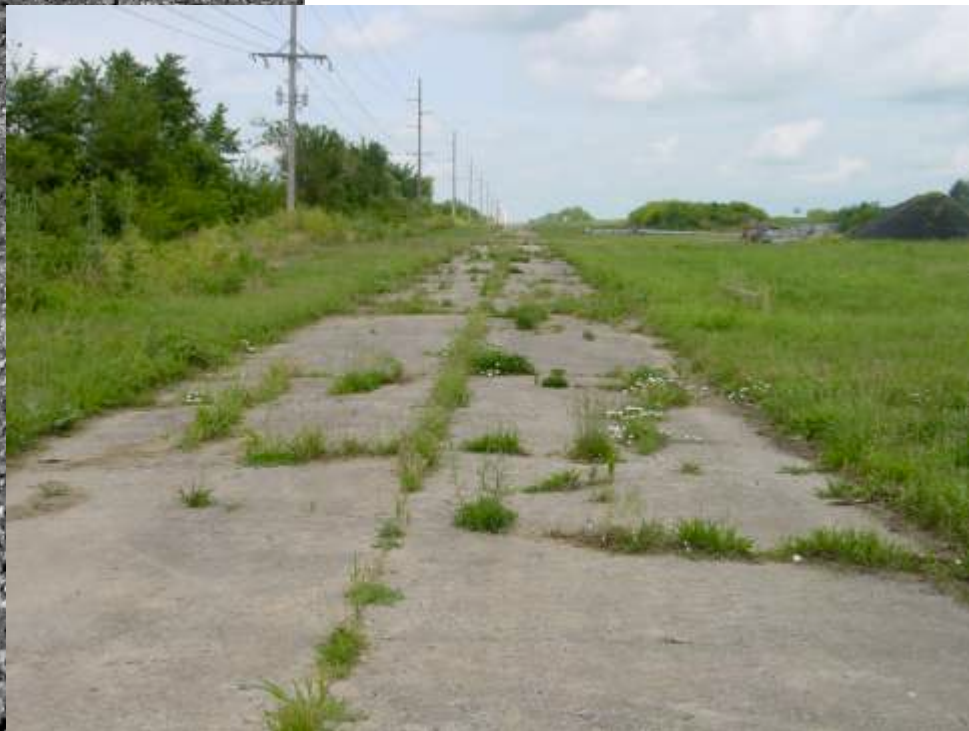
FIG. 44
Lincoln, IL. Segment of Rt. 66 west of the Lincoln Rt. 66 Bypass. Camera facing north.
Photograph by Emilie Eggemeyer, 8 July 2008.

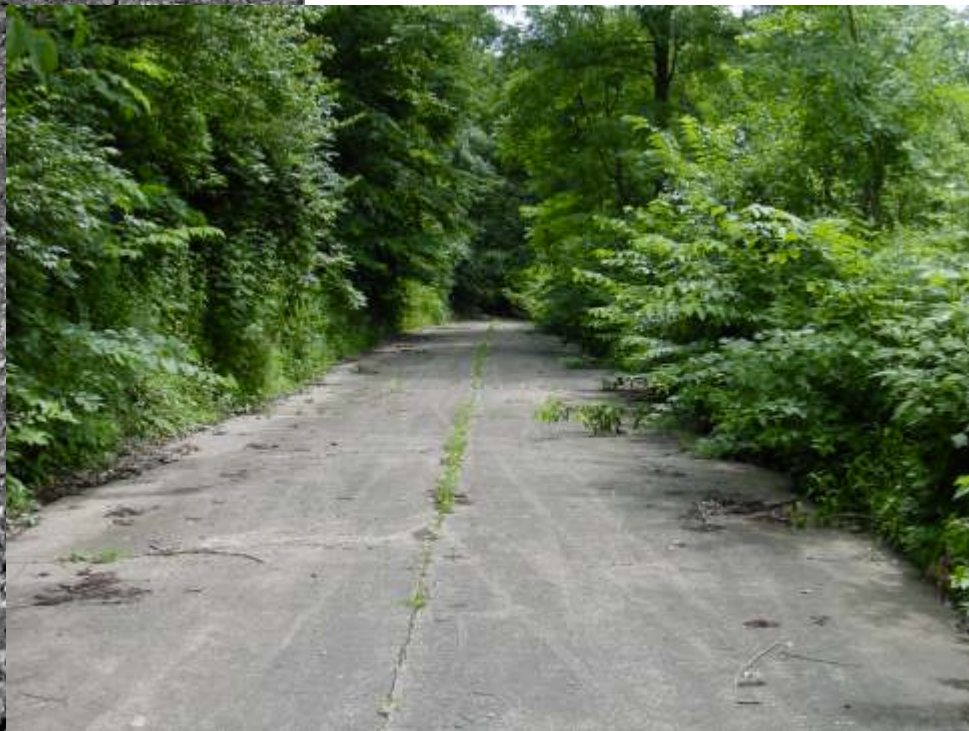
FIG. 46
Lincoln, IL. Rt. 66 segment off of Cobblestone Ave. with in the cemetery in Lincoln, IL. Camera facing south.
Photograph by Emilie Eggemeyer, 8 July 2008.

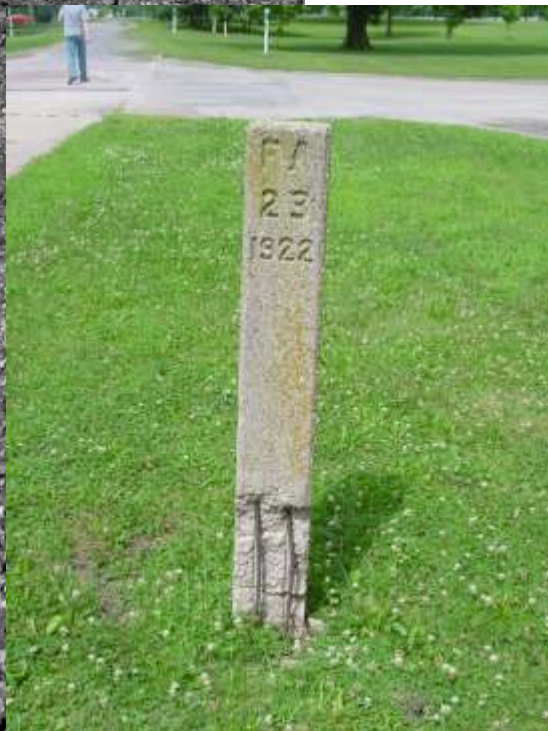
FIG. 48

Lincoln, IL. On the south side of the city within boundaries of a cemetery. Marker reads - FA 23 1922 N - Cemetery is the Logan County Cemetery Dist. Camera facing north.

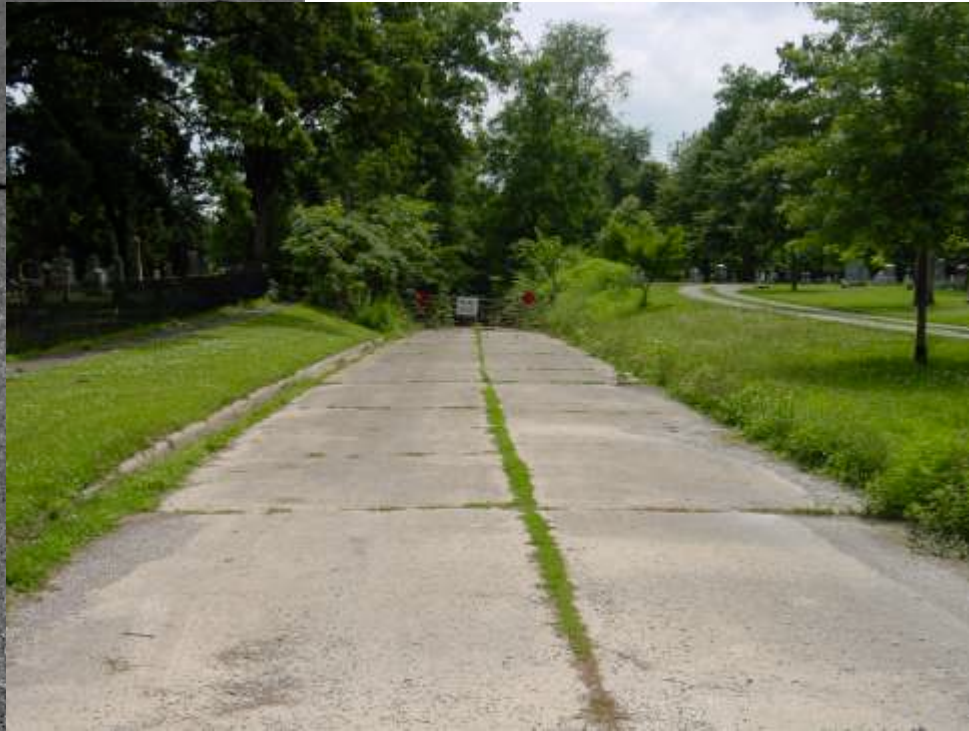
FIG. 49
Lincoln, IL. Rt. 66 Segment off of Cobblestone Ave within the cemetery in Lincoln, IL. Camera facing south.
Photograph by Emilie Eggemeyer, 8 July 2008.

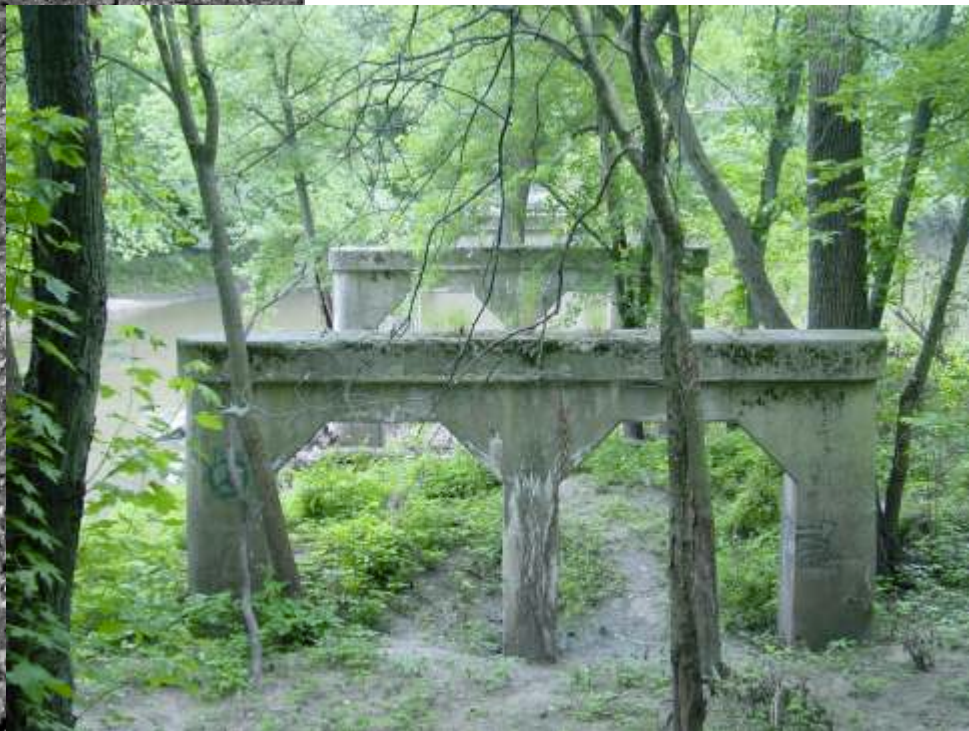
FIG. 50
Lincoln, IL. Rt. 66 Segment off of Cobblestone Ave within the cemetery in Lincoln, IL. Shows Ghost bridge at end of roadway crossing over river. Camera facing south.
Photograph by Emilie Eggemeyer, 8 July 2008.

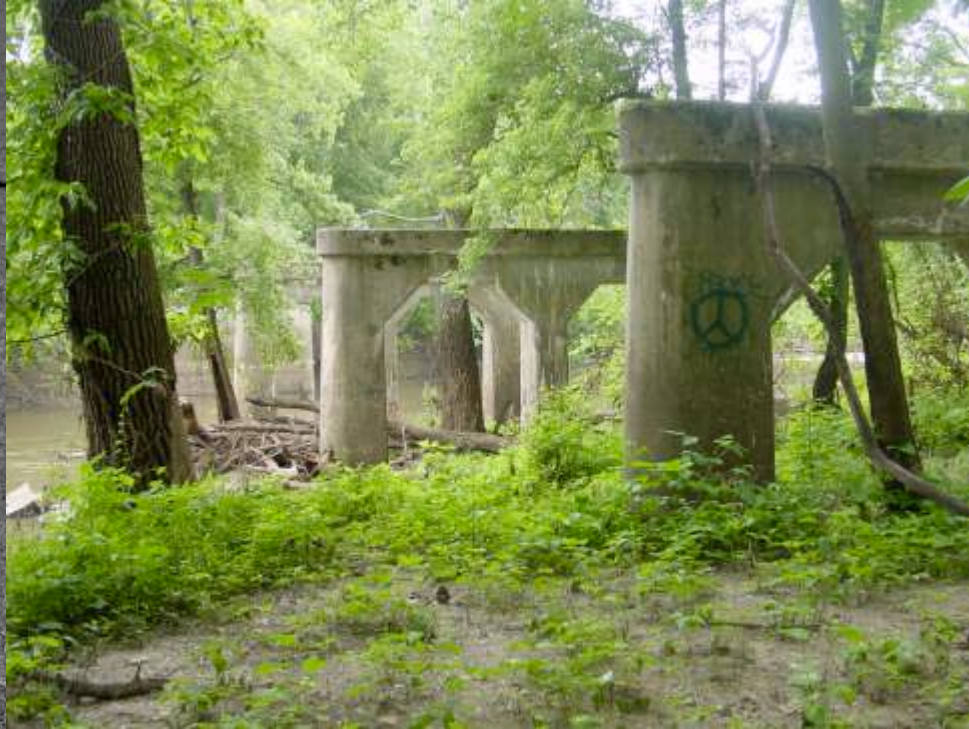
FIG. 51
Lincoln, IL. Rt. 66 Segment off of Cobblestone Ave with in the cemetery in Lincoln, IL. Shows the Ghost Bridge at end of roadway crossing over Deer Creek River. Camera facing south.
Photograph by Emilie Eggemeyer, 8 July 2008.

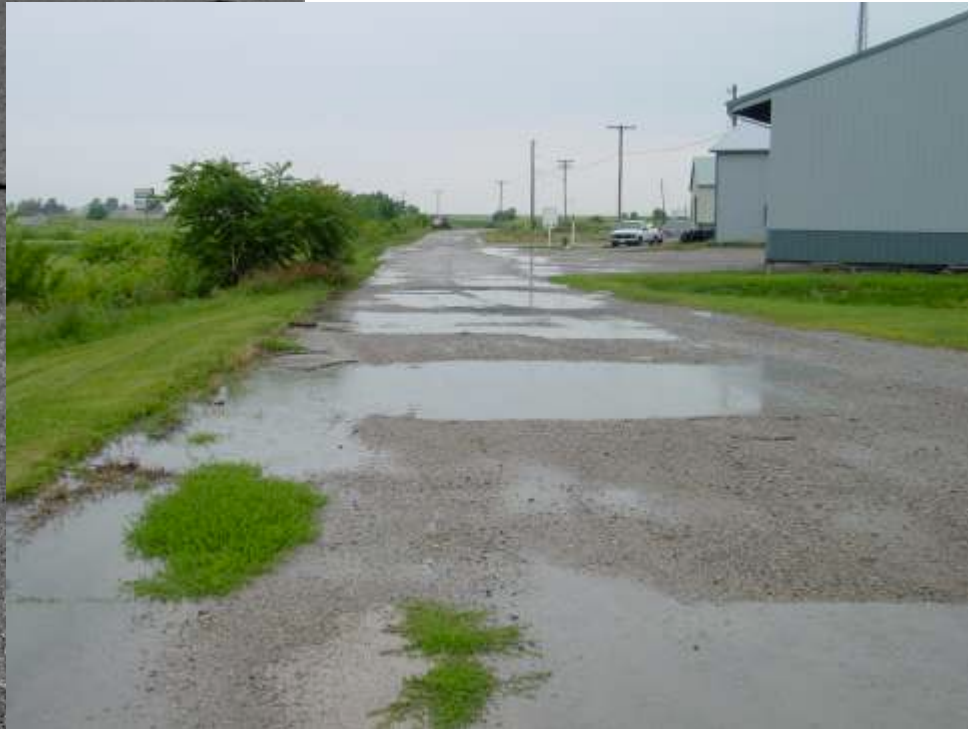
FIG. 53
Elkhart, IL. Rt. 66 1926-30 Segment along ditch behind trucking company. Camera facing north.
Photograph by Travis Ratermann, 3 July 2008.

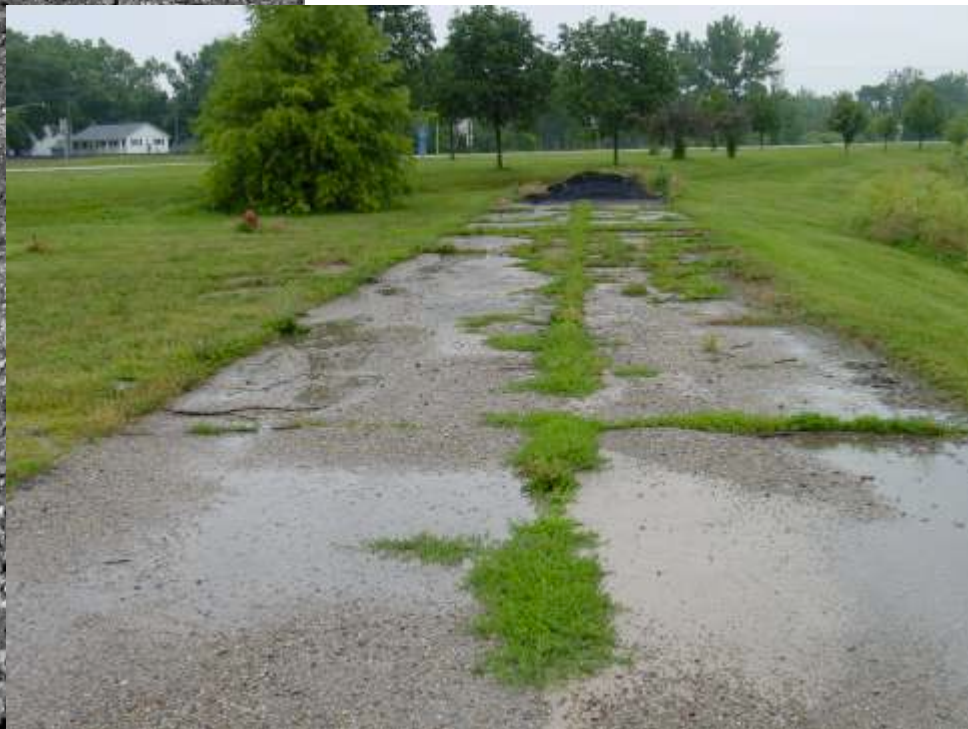
FIG. 54
Elkhart, IL. Rt. 66 1926-30 segment along ditch behind radio tower. Camera facing southeast.
Photograph by Travis Ratermann, 3 July 2008.

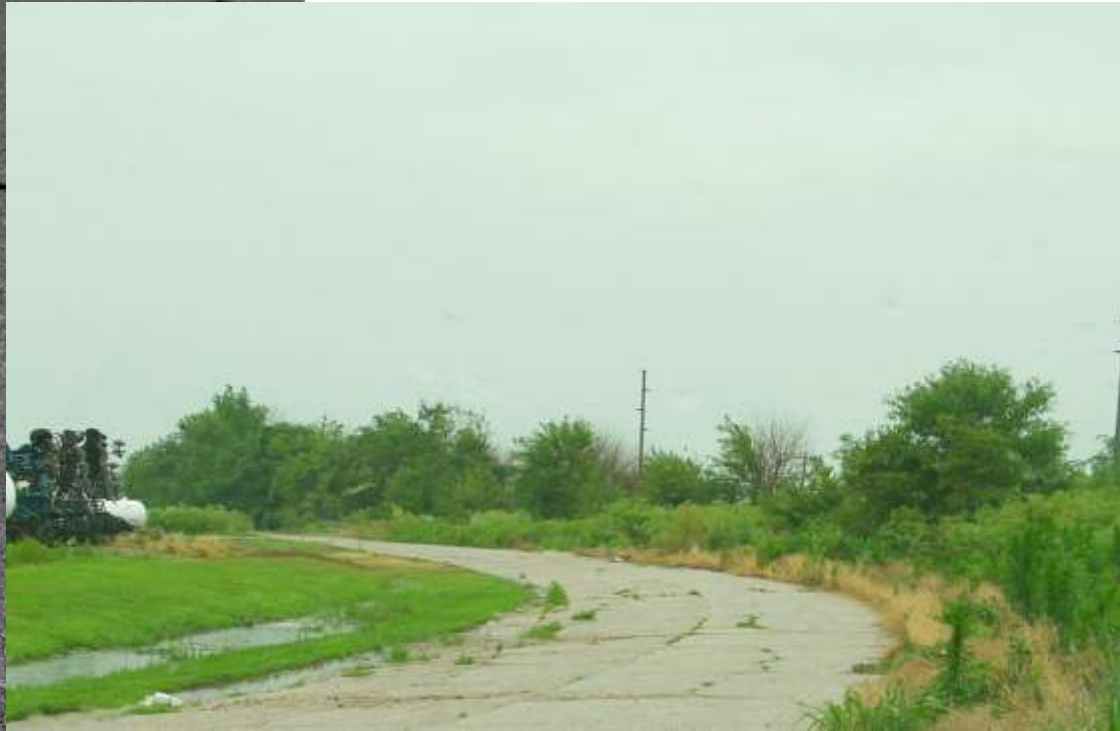
FIG. 55
Williamsville, IL. Segment of Rt. 66 1926-30 along Taylor St. By Brandt Consolidated. Camera facing north.
Photograph by Travis Ratermann, 3 July 2008.

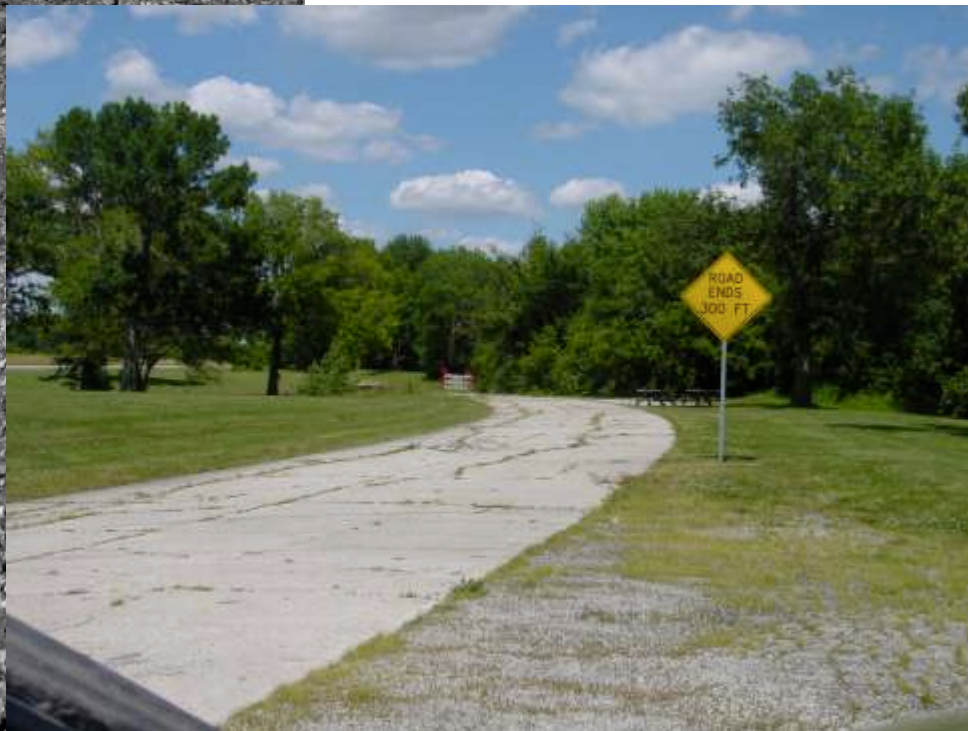
FIG. 56
Sherman, IL. Linear view of Rt. 66 Park in Sherman along with original roadbed segment. Camera facing north.
Photograph by Travis Ratermann, 23 June 2008.

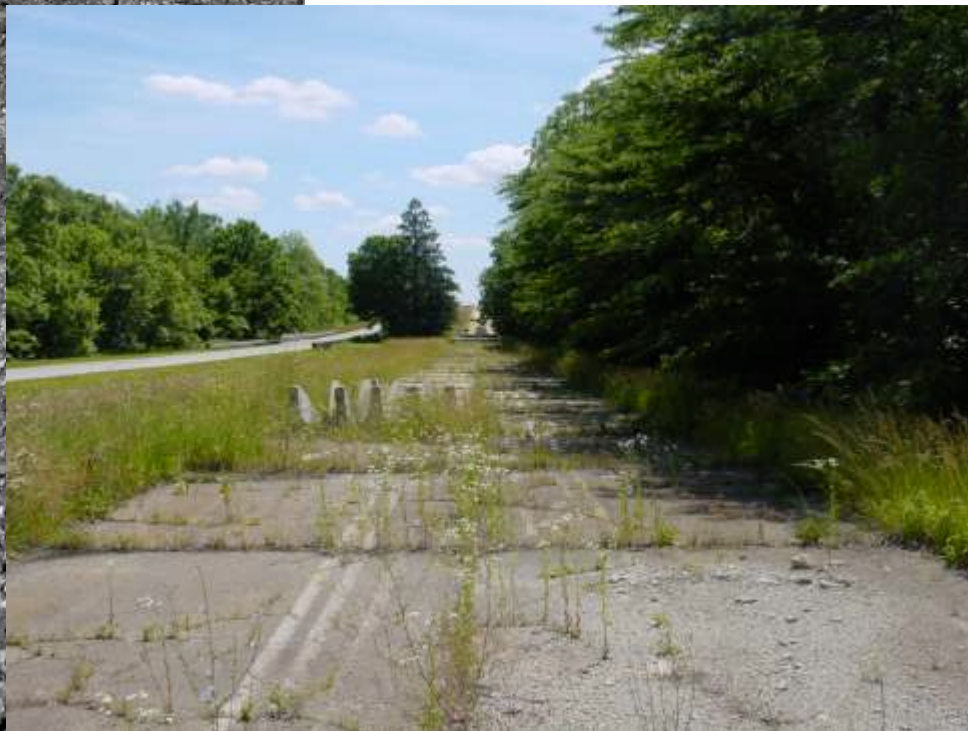
FIG. 60
Sherman, IL. Rt. 66 bypass north bound lane, within the Median of Business 55 as it heads out
toward I-55. Camera facing south.
Photograph by Travis Ratermann, 23 June 2008.

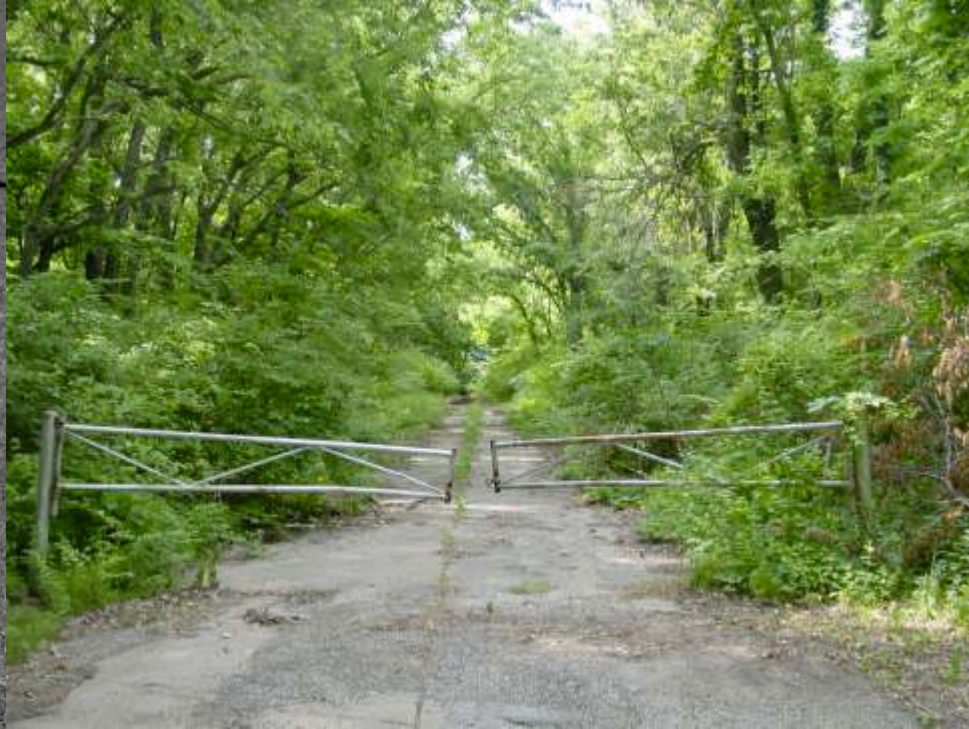
FIG. 63
Springfield, IL. The section of Rt.66 which runs in to Lake Springfield. Section is south of North Cotton Hill Rd. Camera facing south.
Photograph by Travis Ratermann, 24 June 2008.

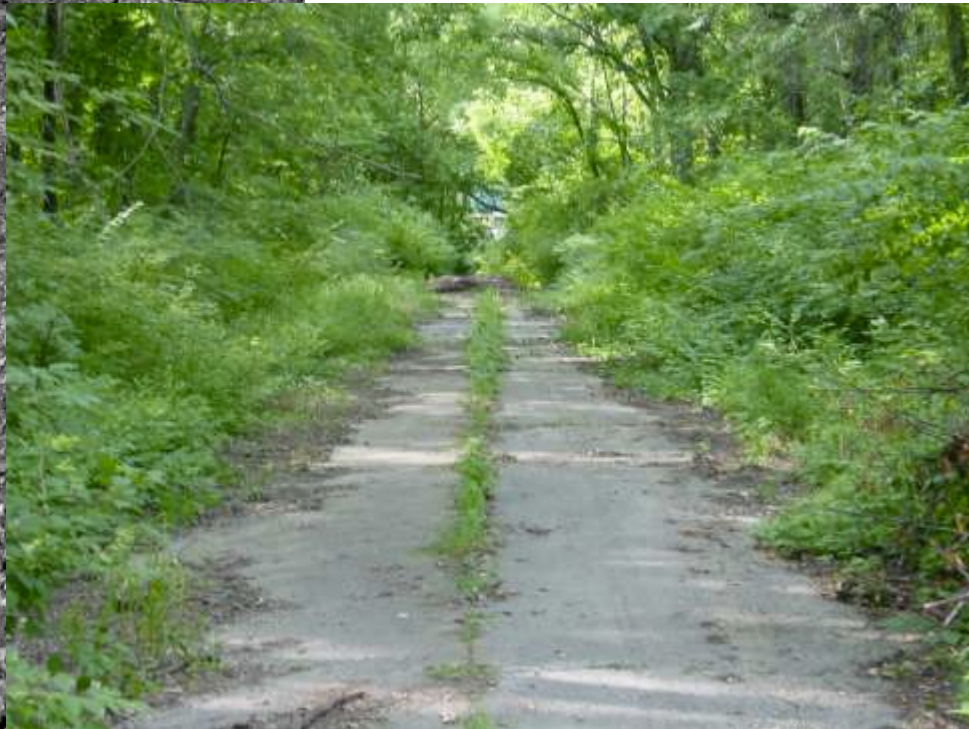
FIG. 64
Springfield, IL. The section of Rt.66 which runs in to Lake Springfield. Section is south of North Cotton Hill Rd. Camera facing south.
Photograph by Travis Ratermann, 24 June 2008.

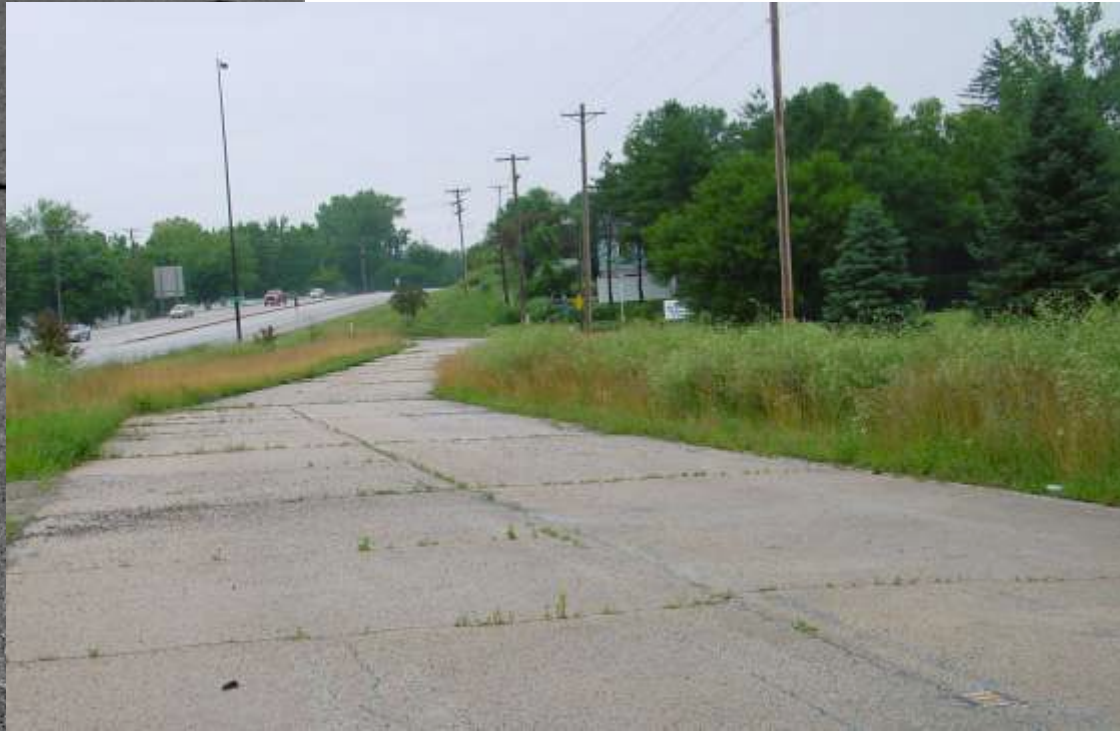
FIG. 65
Springfield, IL. Rt. 66 1926-30 segment at the intersection of Peoria Rd. and Evergreene. Camera looking north.
Photograph by Travis Ratermann, 3 July 2008.

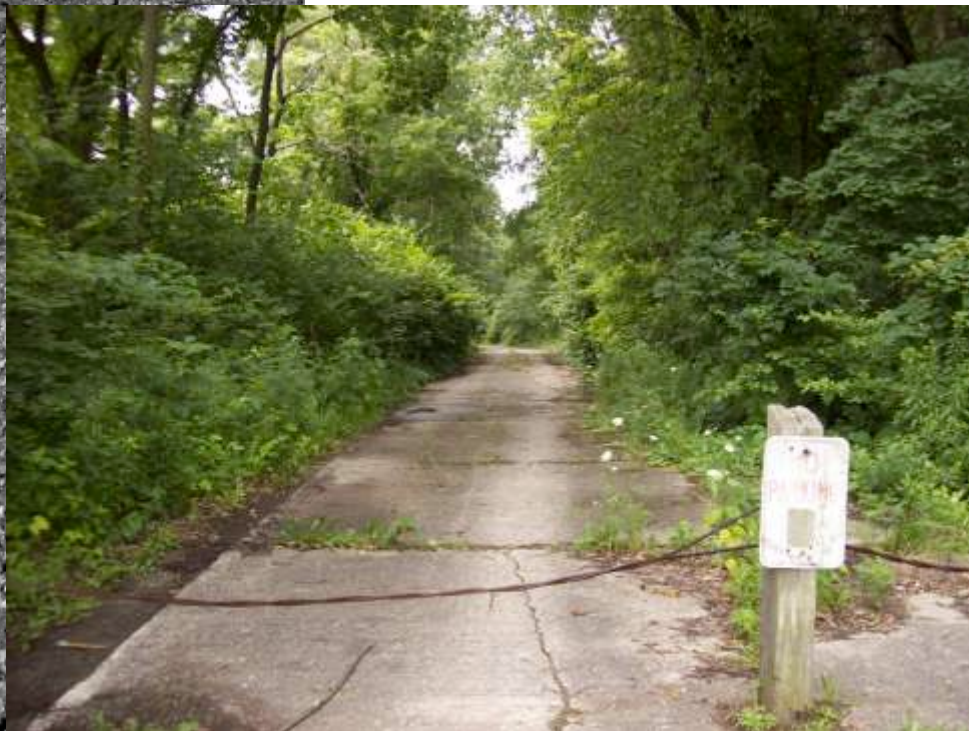
FIG. 66
Springfield, IL. Rt. 66 segment in Carpenter Park adjacent to The Rail Golf Course. Camera facing south.
Photograph by Emilie Eggemeyer, 8 July 2008.

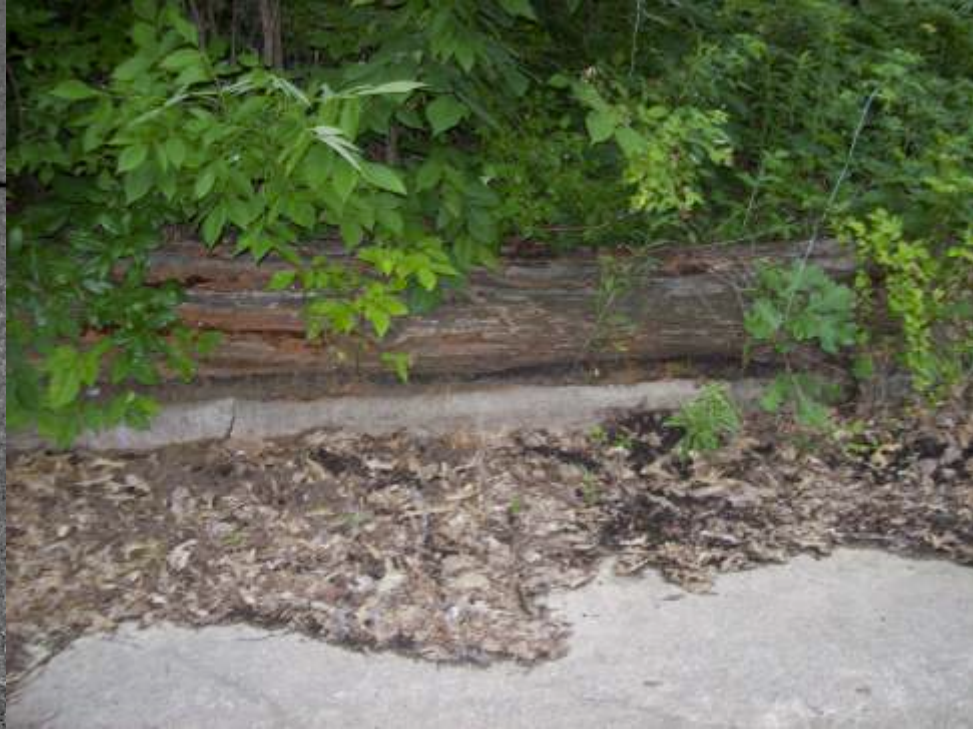
FIG. 67
Springfield, IL. Rt. 66 segment in Carpenter Park adjacent to The Rail Golf Course. Photo showing the guttering of the old road. Camera facing south.
Photograph by Emilie Eggemeyer, 8 July 2008.

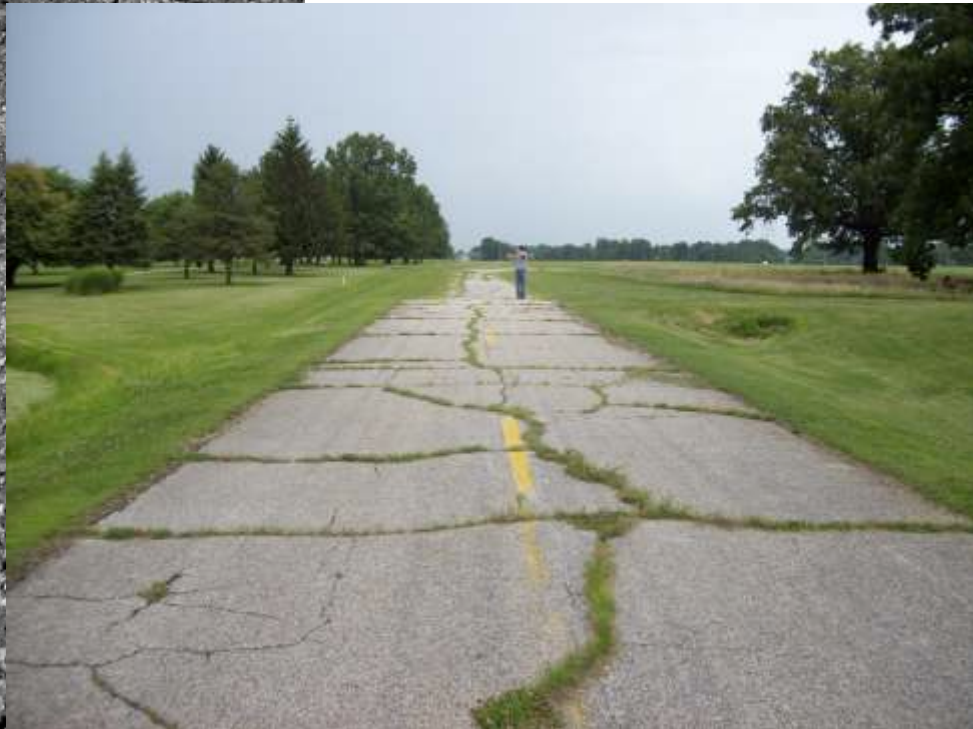
FIG. 68
Springfield, IL. Rt. 66 segment in Carpenter Park adjacent to The Rail Golf Course. Camera facing north.
Photograph by Emilie Eggemeyer, 8 July 2008.

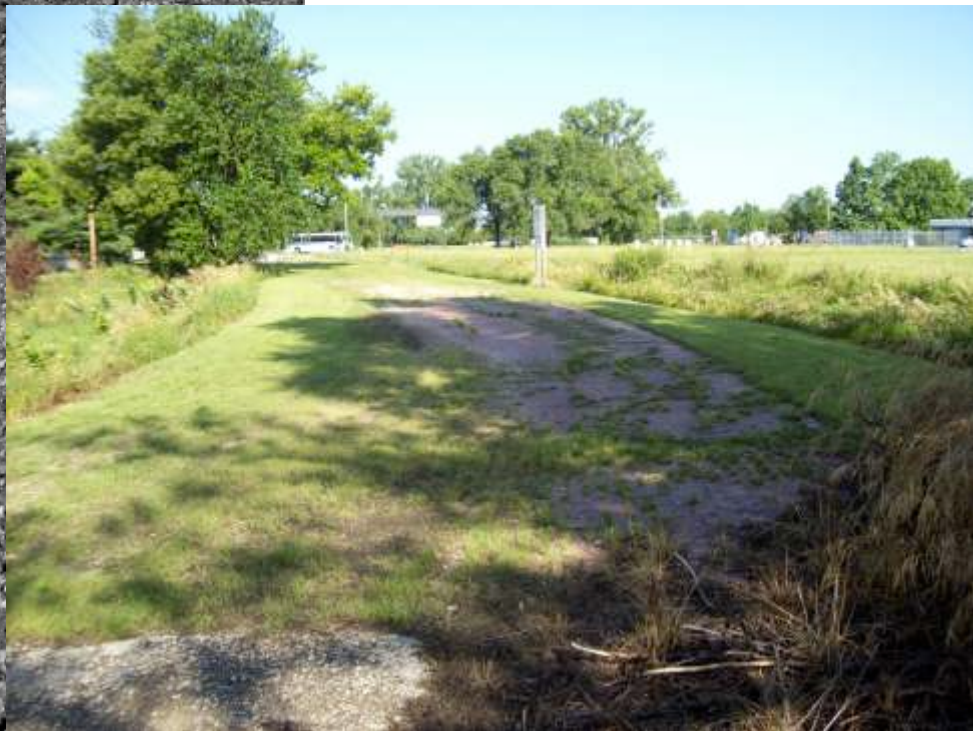
FIG. 70

Springfield, IL. Hidden on the right of North Cotton Hill Road parallel to first left corner. Camera facing west from north end of visible brick.

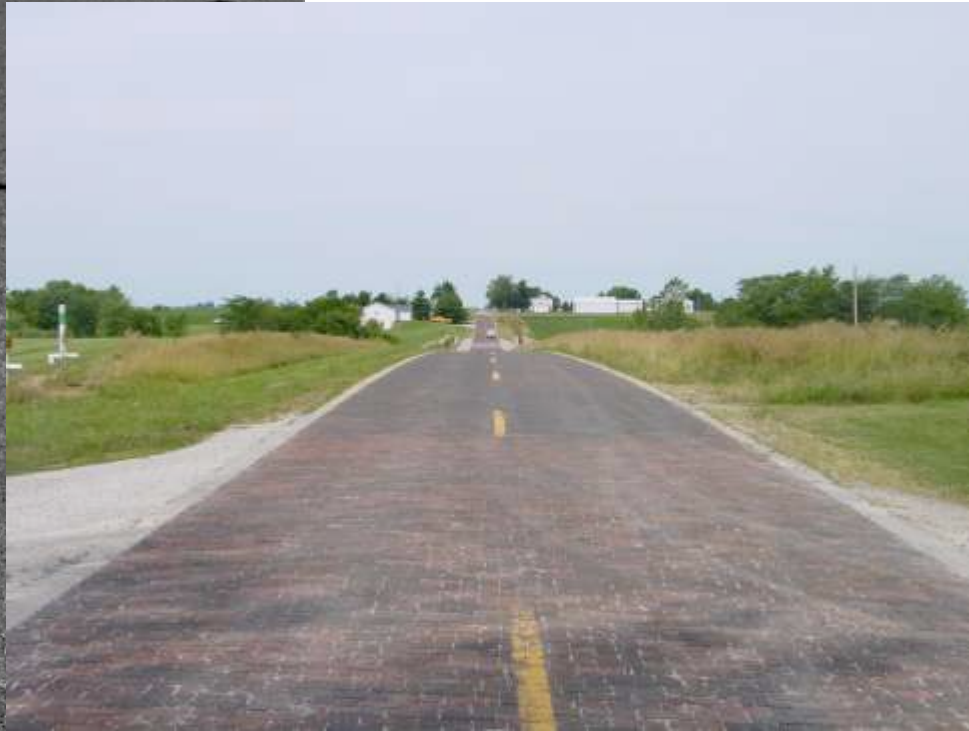
FIG. 71
Auburn, IL. Brick section of Old Rt. 66, Snell Rd. Brick done during the depression, after the route had changed. Camera facing west.
Photograph by Travis Ratermann, 24 June 2008.

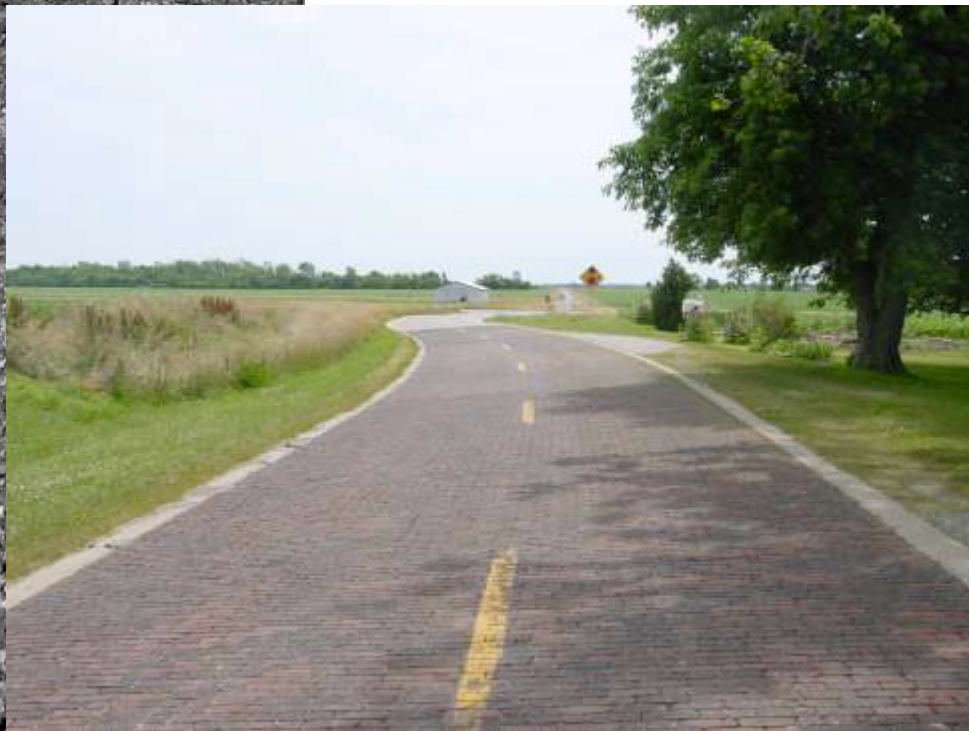
FIG. 72
Auburn, IL. Brick section of Old Rt. 66, Snell Rd. Camera facing east.
Photograph by Travis Ratermann, 24 June 2008.

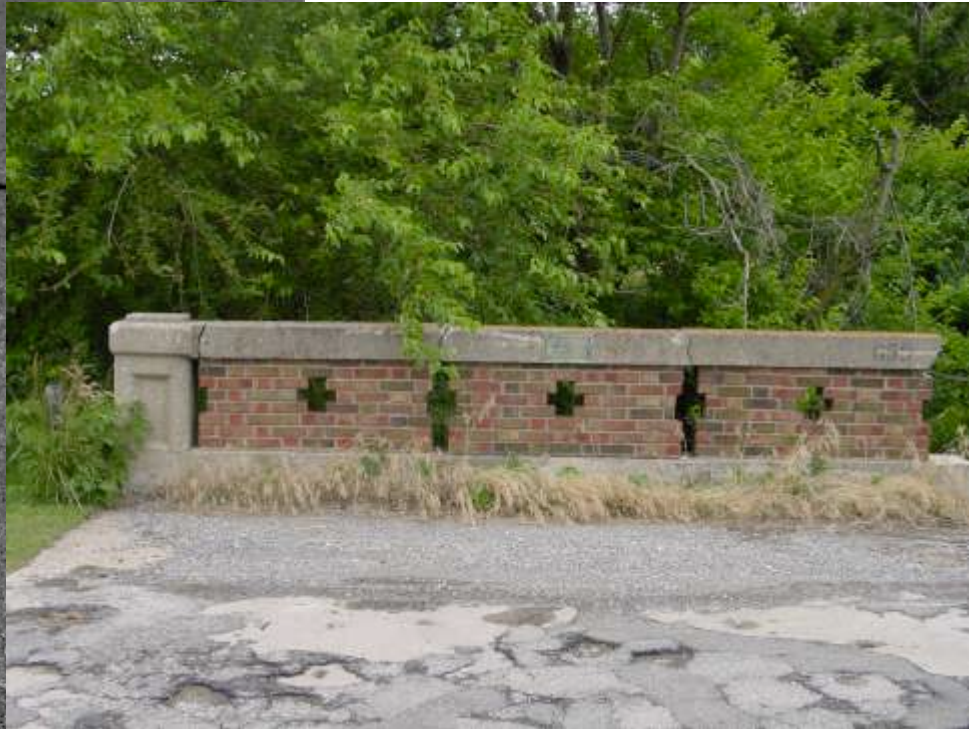
FIG. 73
Girard, IL. Bridge marked Station 1616-70 on Cambridge Rd. Concrete still visible under blacktop. Camera facing west.
Photograph by Travis Ratermann, 24 June 2008.
