Concrete Restoration for Route 66 in Illinois

September 2012

THORNTON TOMASETTI, INC. (TT) WAS SOLICITED BY the Illinois Historic Preservation Agency (IHPA) to develop an historic concrete treatment guide and repair/restoration specifications for the limited remaining historic concrete roadway along Illinois' Route 66 corridor. As stated in IHPA's *Route 66: Finding Illinois' Original Roadbed Segments from Chicago to St. Louis* report, "In all of the research about US Route 66 throughout the United States, one area in particular has been left disengaged for the most part. That area consists of the original roadbed segments of US Route 66, which can still be found stretched along the Illinois landscape."

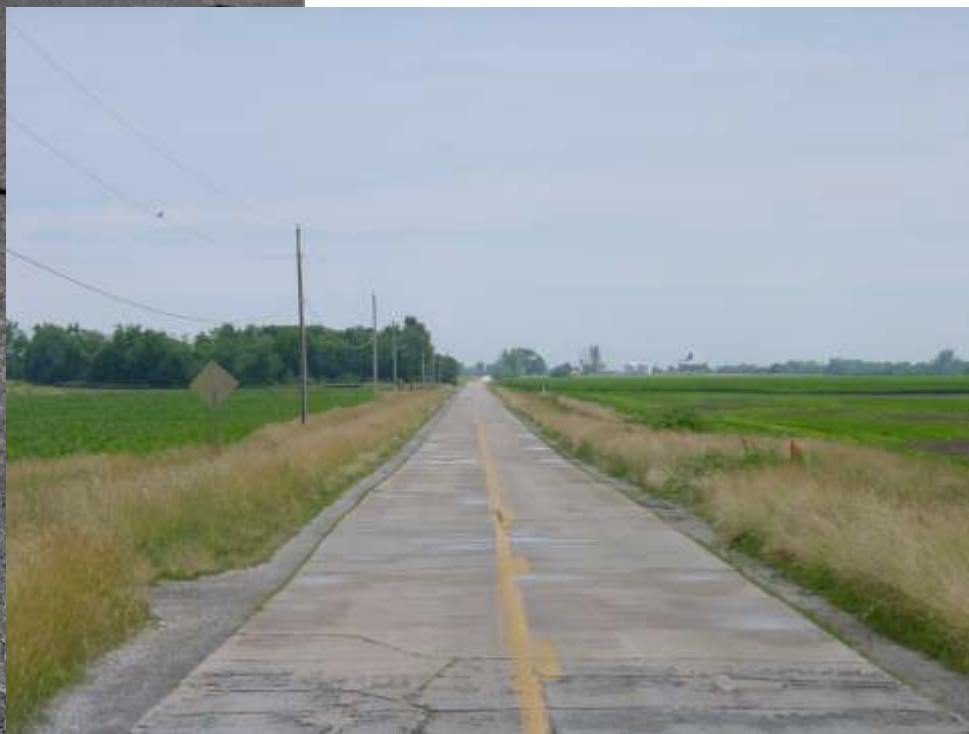
FIG. 75
Girard-Nilwood, IL. Section of Rt. 66 located on Cambridge-Wylder-Morean Rd. Camera facing south.
Photograph by Travis Ratermann, 24 June 2008.

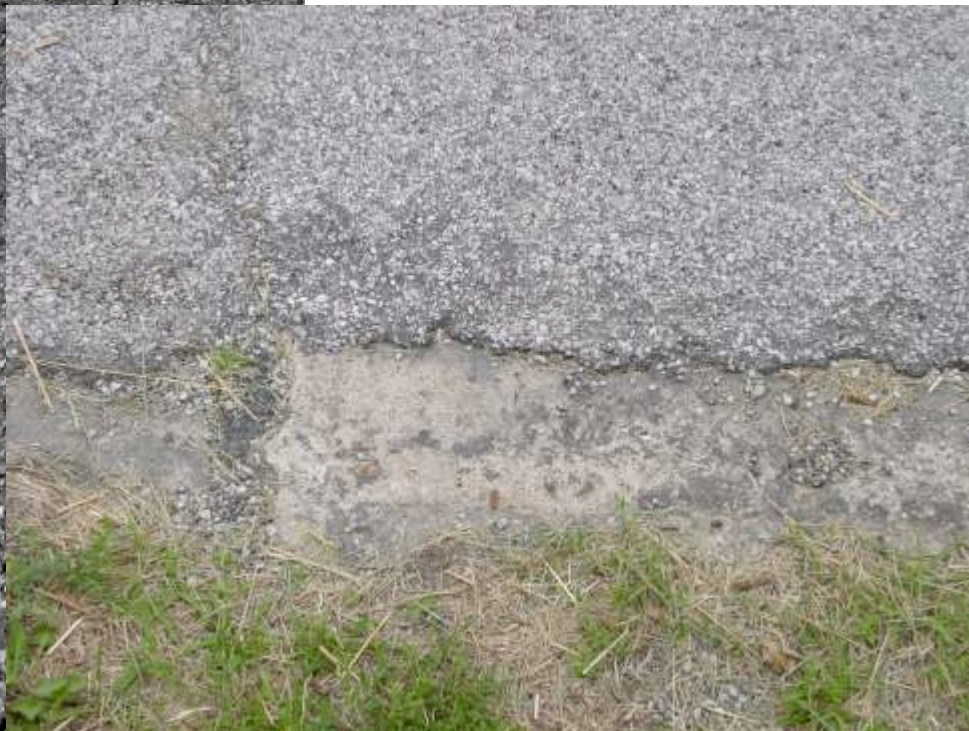
FIG. 82
Carllinville, IL. Rt. 66 segment on Deerfield Dr. Portland is covered by rock and chip that is crumbling. Camera facing south and down.
Photograph by Travis Ratermann, 24 June 2008.

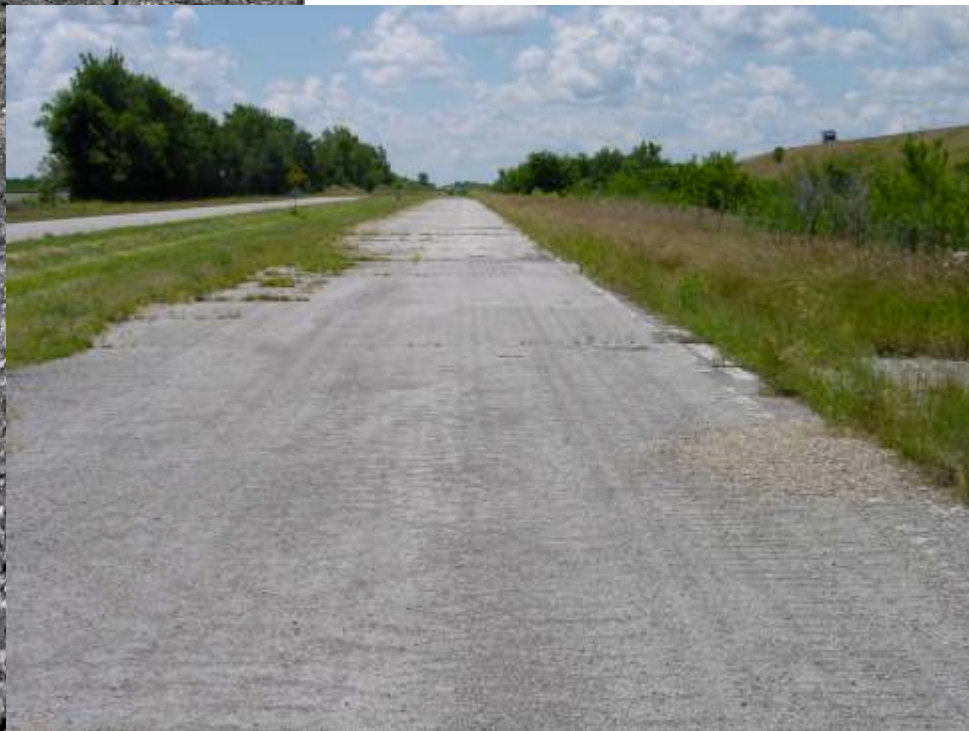
FIG. 108
Litchfield, IL. Rt. 66 bypass segments. Most of this section is covered with multiple layers of rock and oil. Camera facing south.
Photograph by Travis Ratermann, 30 June 2008.

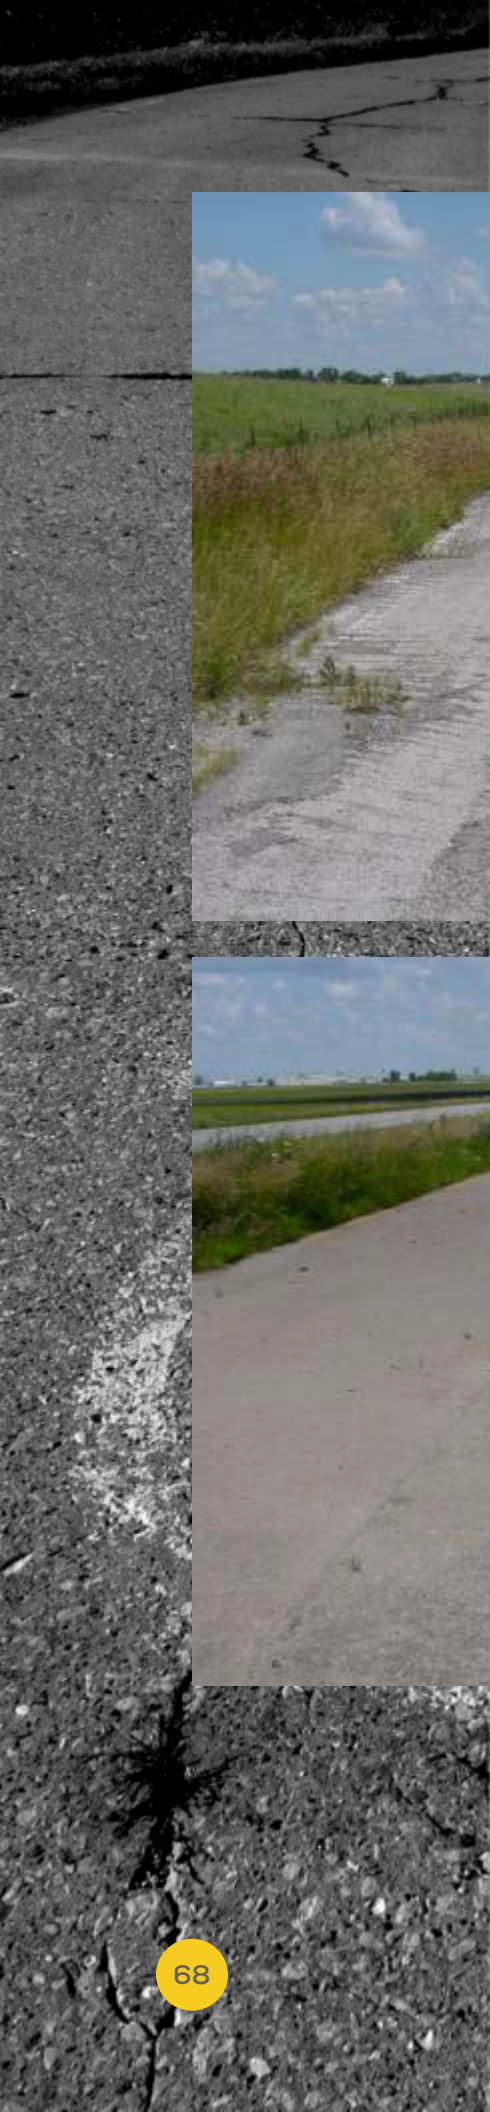
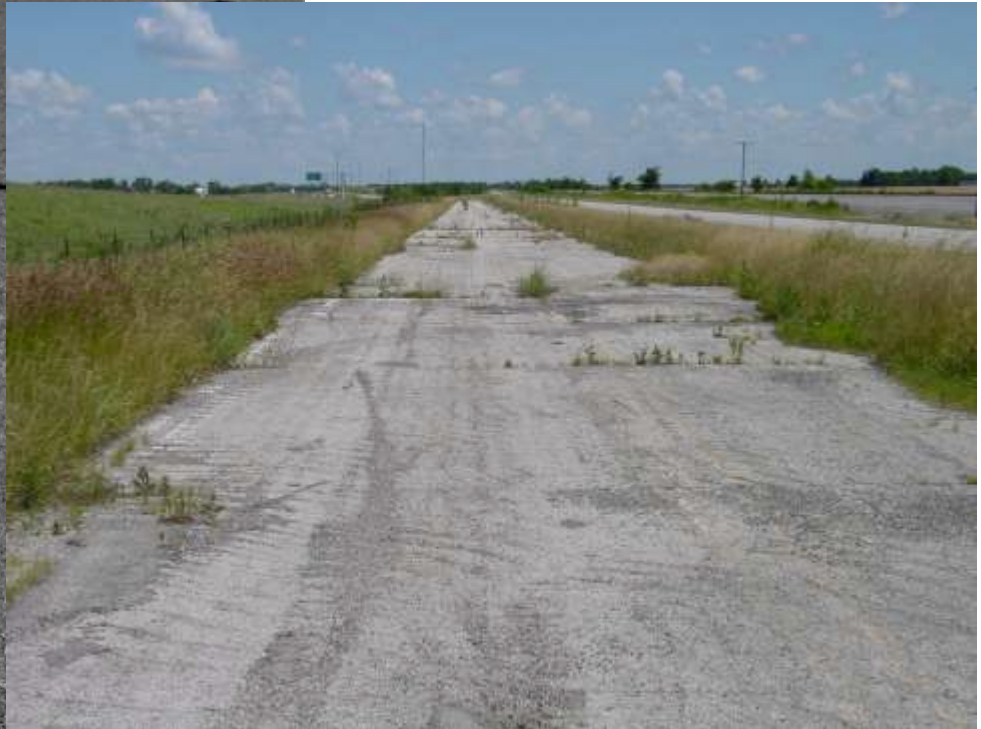
FIG. 109
Litchfield, IL. Rt. 66 bypass segments. Most of this section is covered with multiple layers of rock and oil. Camera facing north.
Photograph by Travis Ratermann, 30 June 2008.

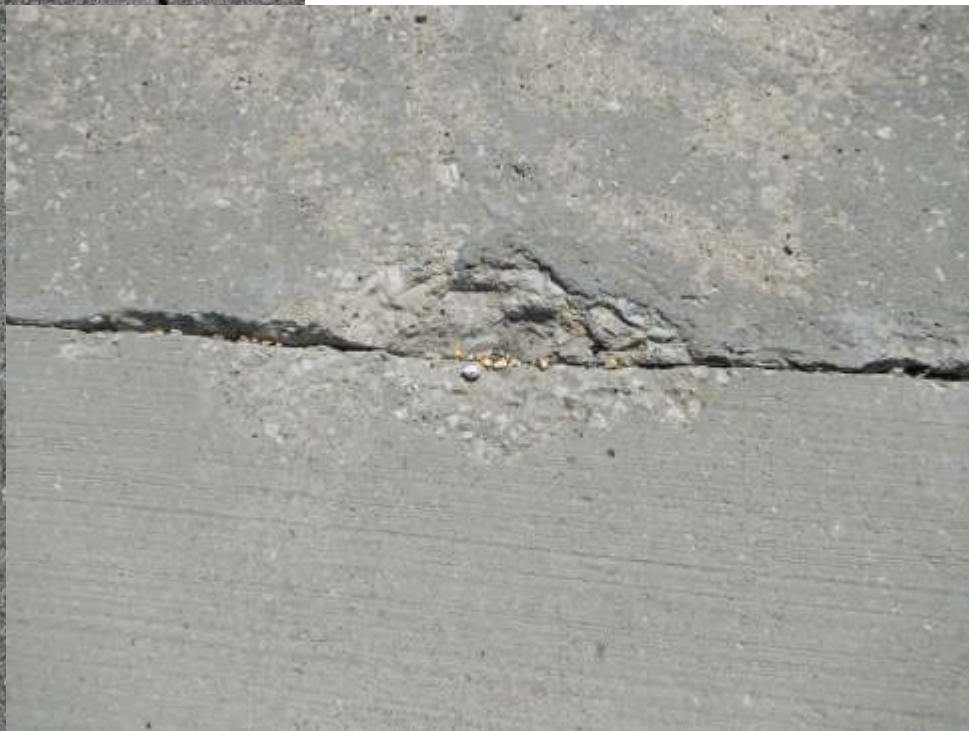
FIG. 8
Small spall at edge of patch and in existing concrete (south of Girard, IL).

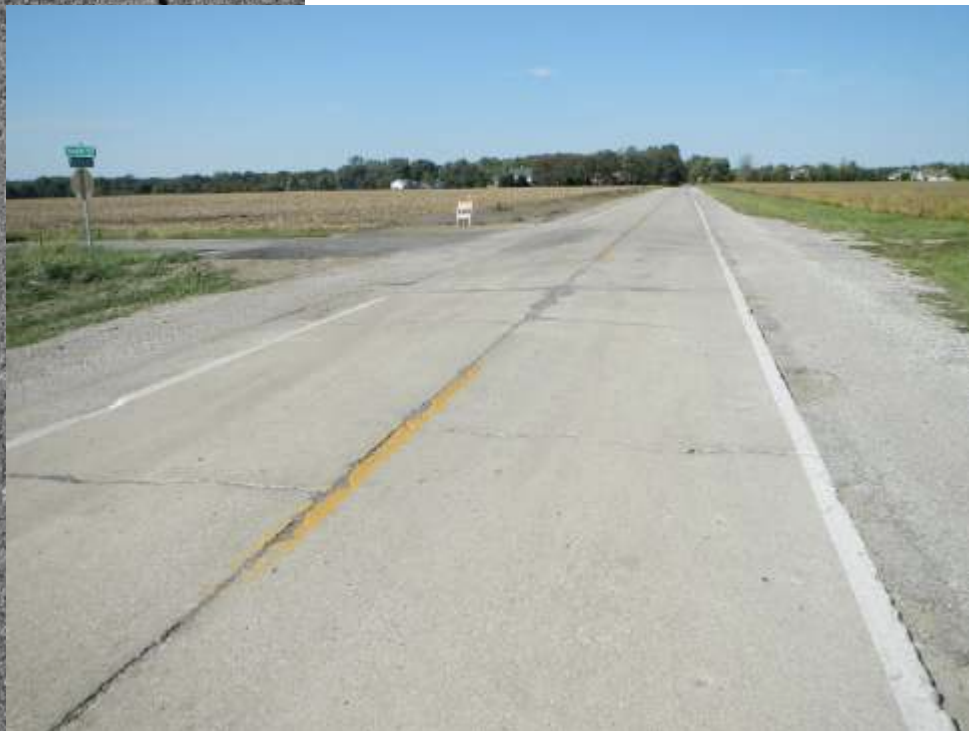
FIG. 12

located along a heavily used corridor. These segments of the roadway generally have inadequate width for the type and level of traffic. In one area south of Lake Springfield, the road is heavily used, not only by cars, but by school buses and trucks regularly (Figure 12).

Original concrete segment at a high traffic roadway (south of Lake Springfield, IL).

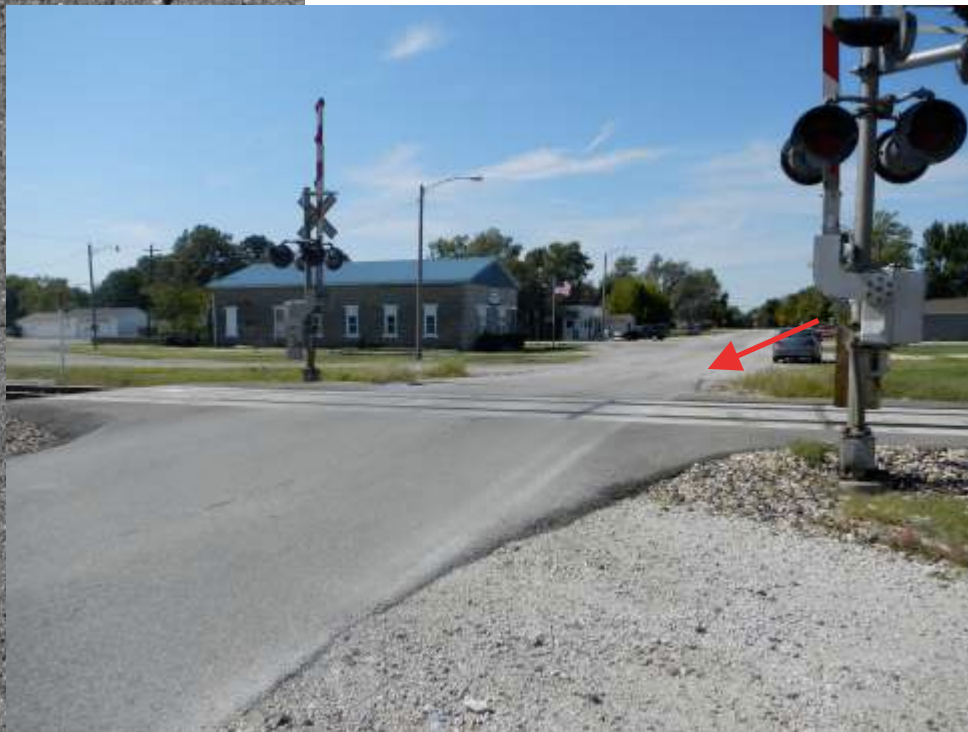
FIG. 13

- At locations where railway lines cross the roadway, asphalt has been used where elevation transitions occur (Figure 13).

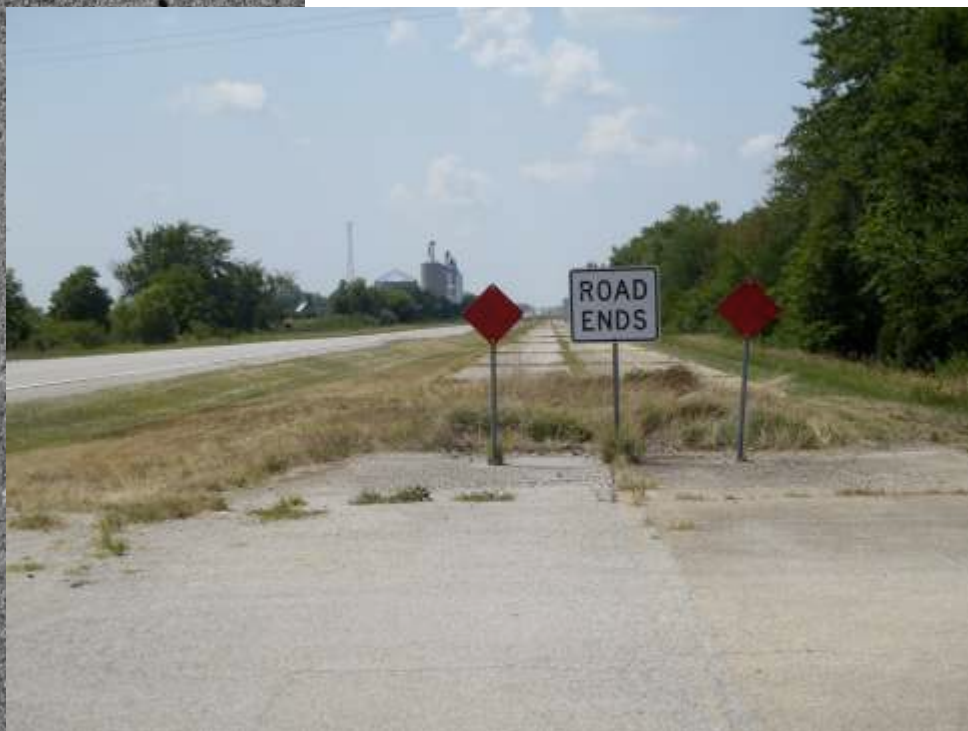
FIG. 14

- Asphalt overlays have been added to a substantial amount of the historic roadways to maintain a smooth driving surface for moderate to heavy traffic load. The most extensive overlay area is the frontage road adjacent to IL I-55 Highway where a parallel two-lane road was constructed in the 1940s adjacent to the two-lane road from 1927 to create a four-lane divided highway. Currently, the 1927 lanes are abandoned and the 1942 lanes are in use as a two-lane highway (Figure 14).

Asphalt overlays have been applied to both the 1920s and the 1940s segments of roadway; circa 1927 roadway is now abandoned (Pontiac, IL).

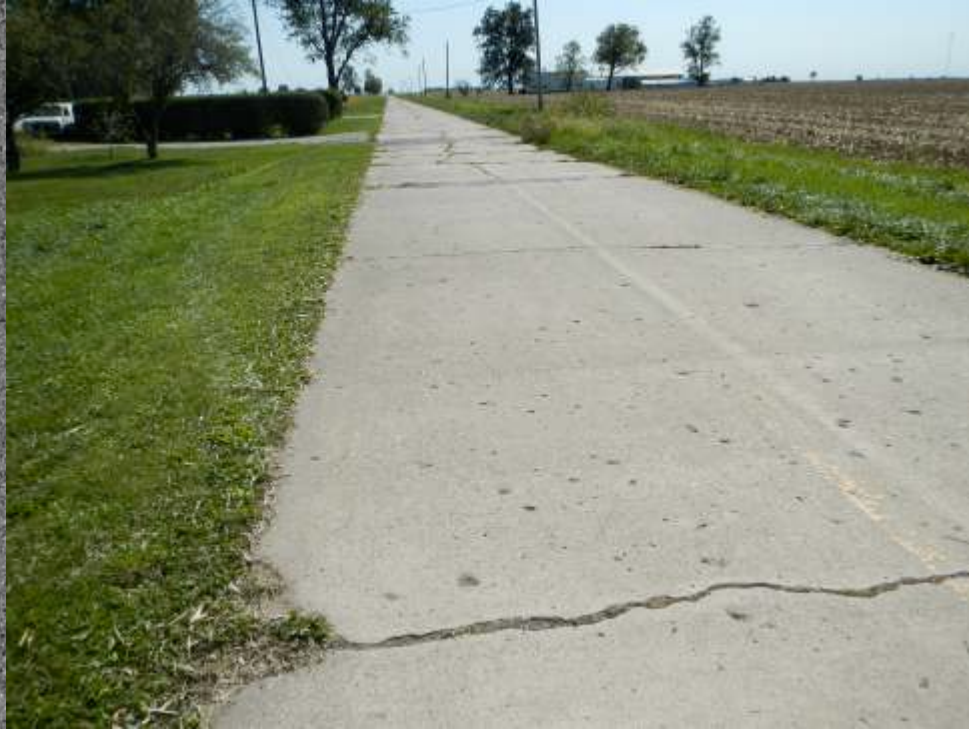
FIG. 15
Grass apron along rural low traffic roadway (south of Nilwood, IL).

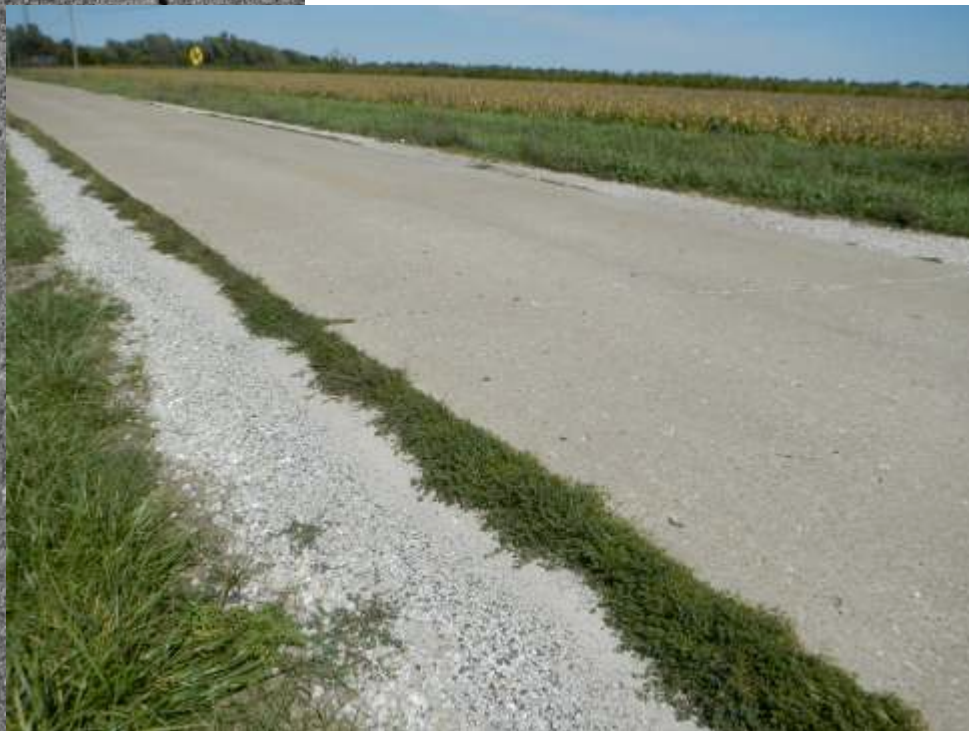
FIG. 16
Gravel apron along rural moderate traffic roadway (Girard, IL).

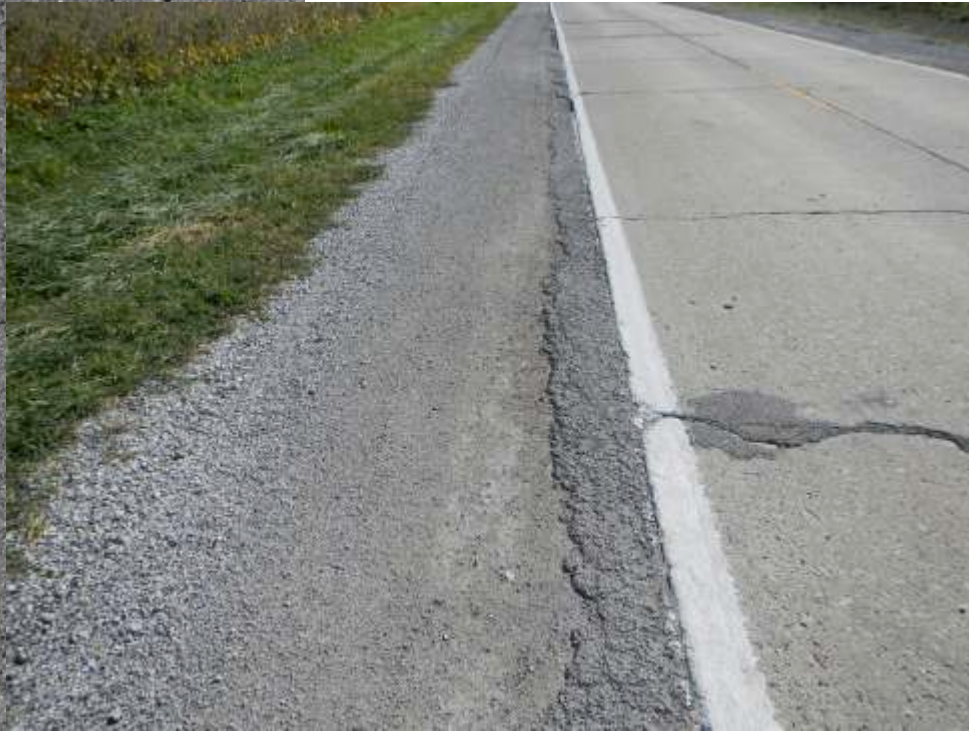
FIG. 17
Asphalt and gravel apron along suburban heavy traffic roadway
(south of Lake Springfield, IL).

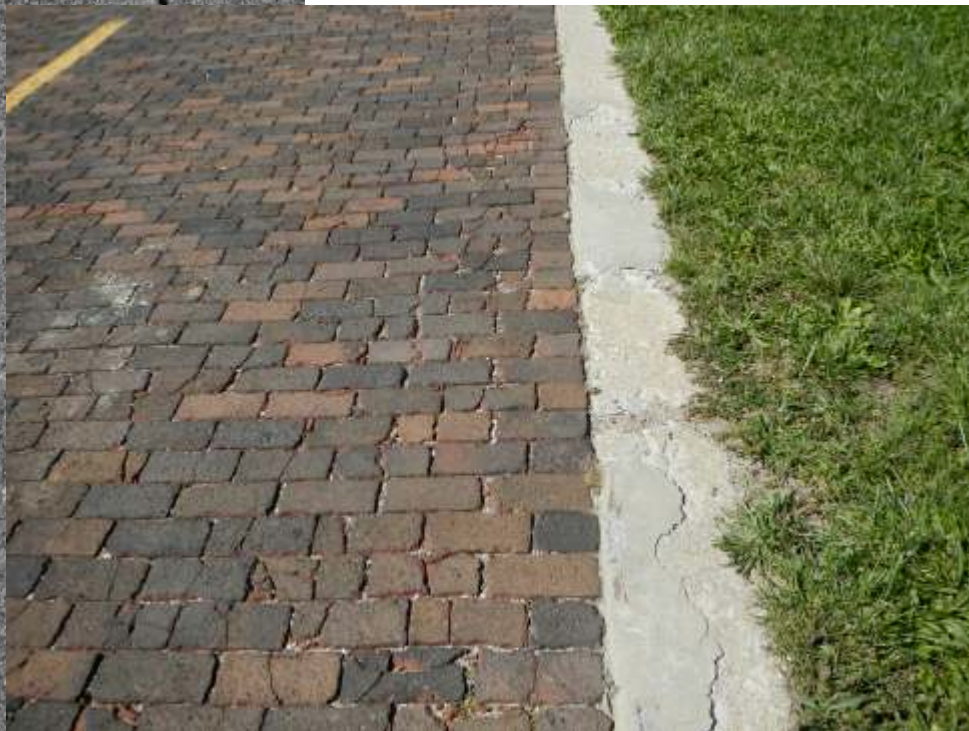
FIG. 18
Concrete apron along brick light traffic roadway (north of Auburn, IL).

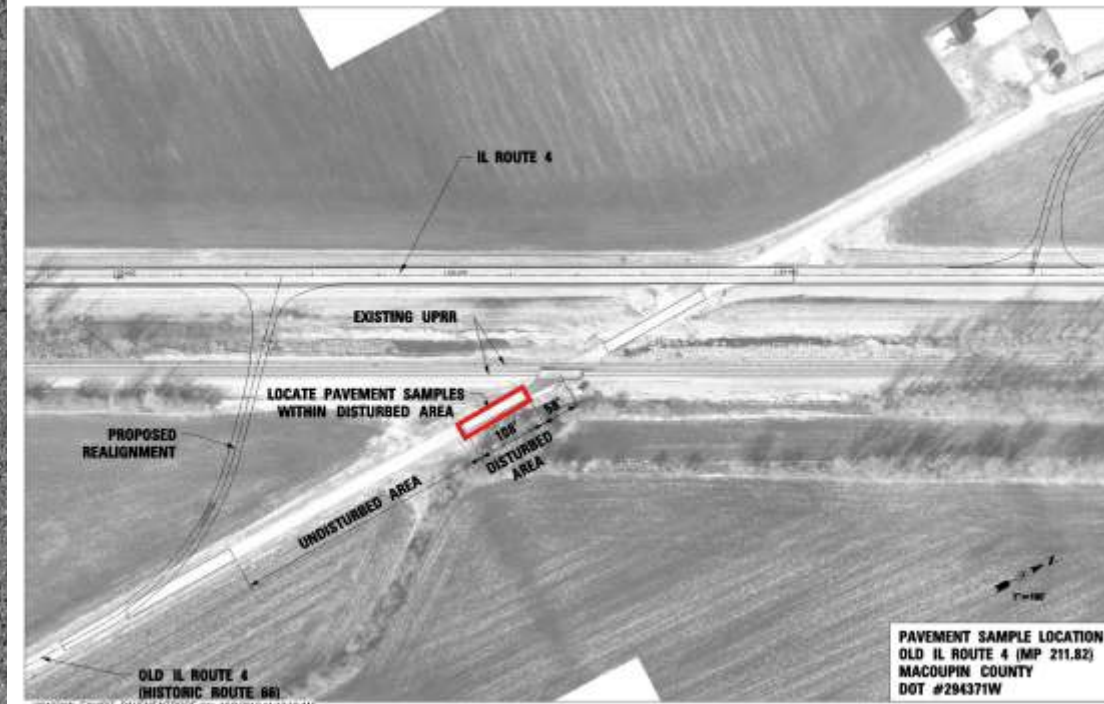
FIG. 19
Core 1 location near Nilwood/Girard, Illinois (IDOT image).

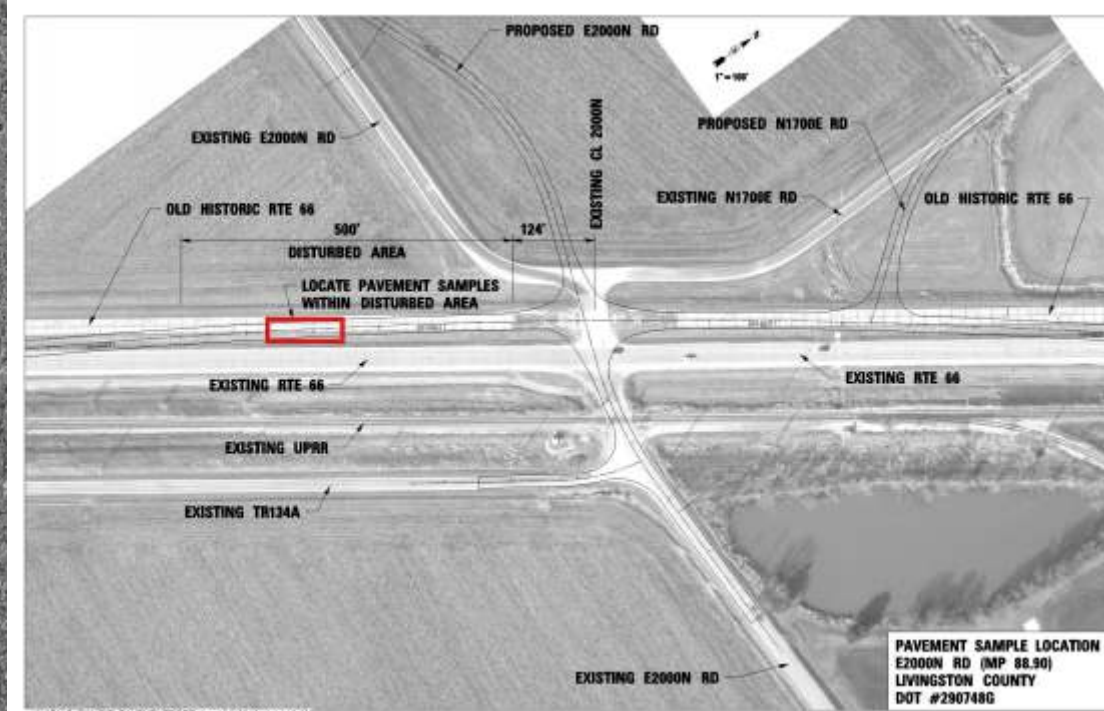
FIG. 20
Core 2 location near Pontiac/Dwight, Illinois (IDOT image).

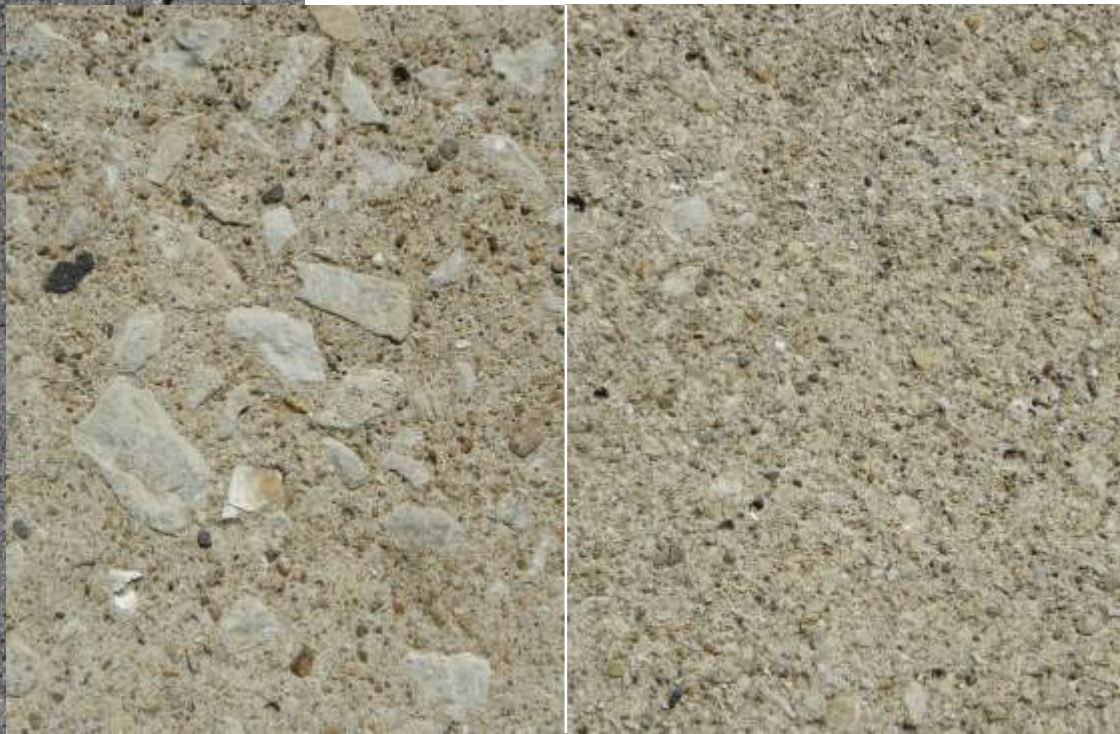
FIG. 25

GENERAL PARAMETERS IMPORTANT IN MATCHING historic concrete include matching the color, type, and size of the aggregates, the cement paste matrix (cementitious materials) color, proportions of the repair mix components, and the finish and texture of the weathered concrete. The strength and general concrete properties need to be compatible and not cause additional damage to the original concrete. In order to create repairs that are durable, the repair mix needs to meet current quality standards. Figure 25 illustrates differences in the existing surface finish at two different road segments.

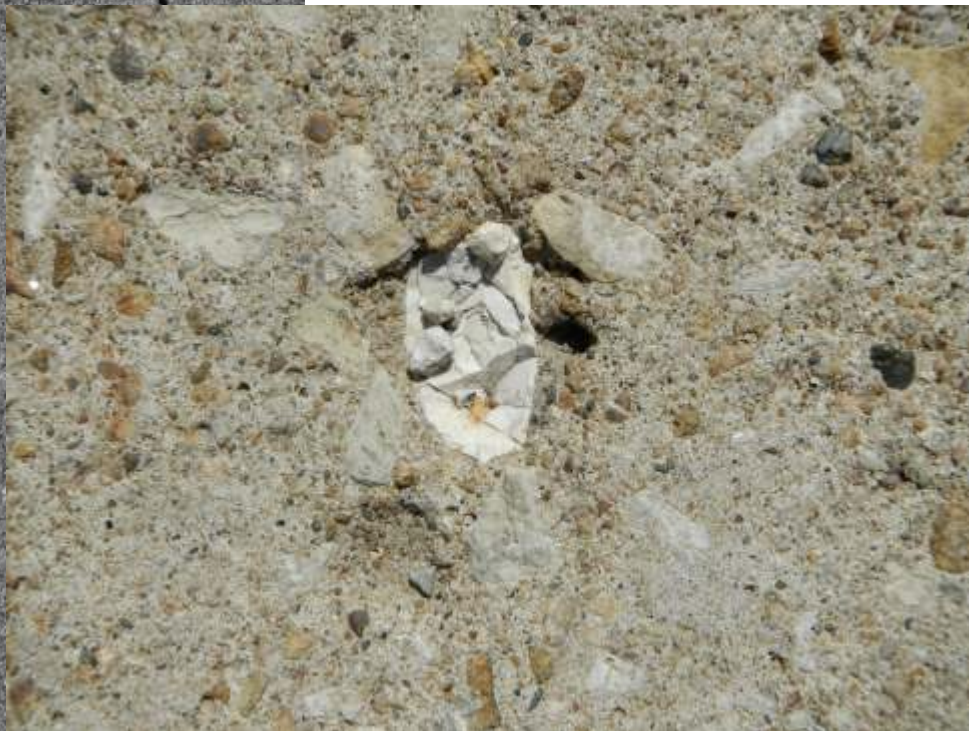
FIG. 26

Aggregates not meeting current standards may lead to detrimental damage such as alkali-silica reaction within the concrete or high amounts of chert that tend to crack and create pop-outs in the concrete surfaces (Figure 26). Poor quality aggregates can affect the durability of the concrete. For Route 66 road repairs, aggregates meeting current ASTM and IDOT standards should be used. The overall type and shape of aggregate and sand can be generally matched, but should be properly graded and of a quality to be used with concrete (meeting ASTM C33). An attempt should be made to select the colors and shapes of aggregate that match the existing to a reasonable degree.

Chert aggregate in original concrete that has cracked and created a pop-out in the concrete surface.

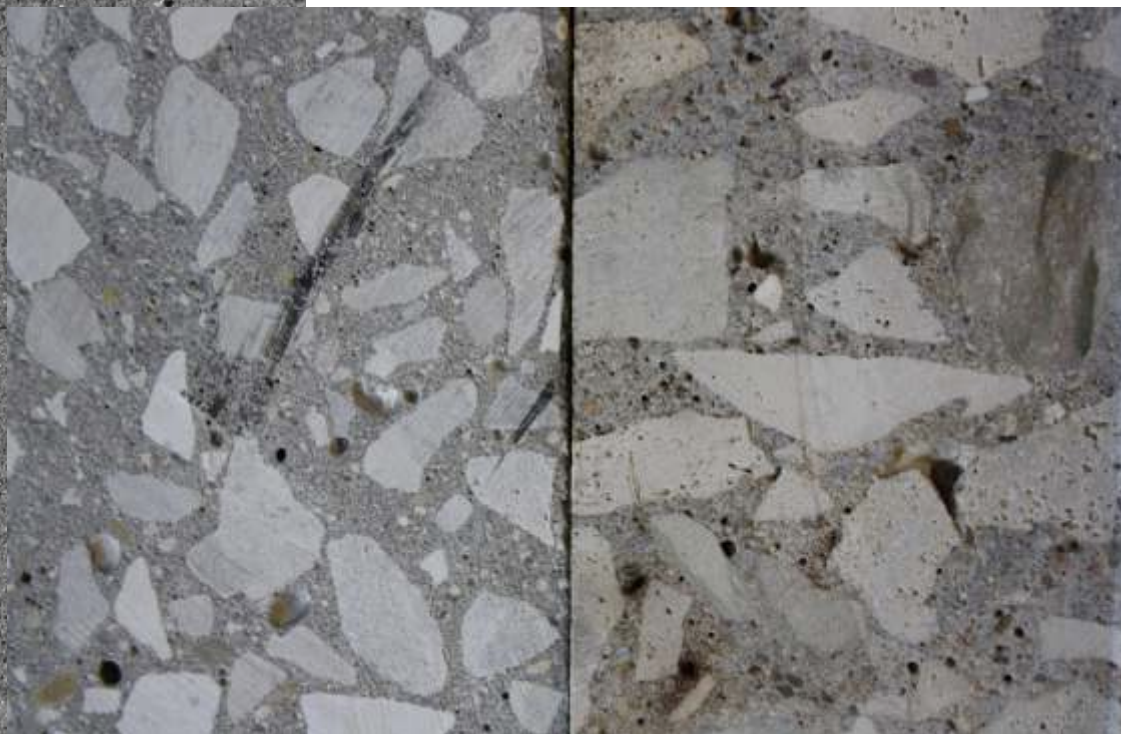
FIG. 27
Currently available crushed limestone (left) compared to aggregates in Core 1 (samples from Ozinga).

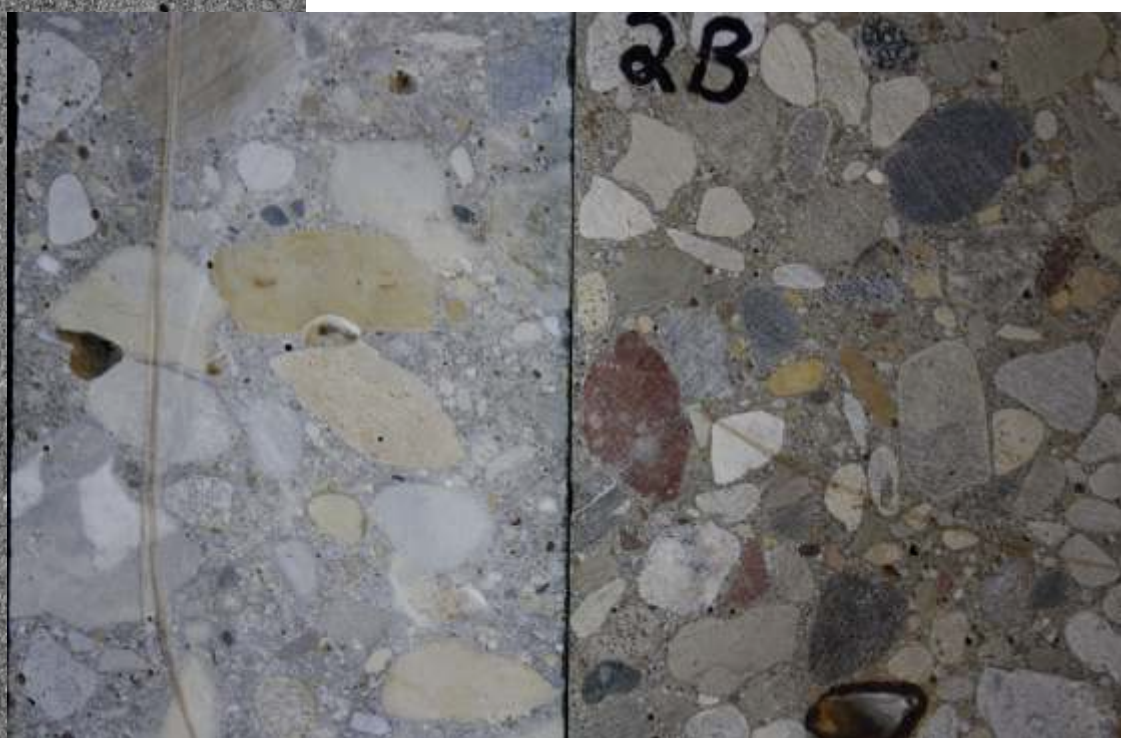
FIG. 28
Currently available uncrushed gravel (left) compared to aggregates in Core 2 (samples from Ozinga).

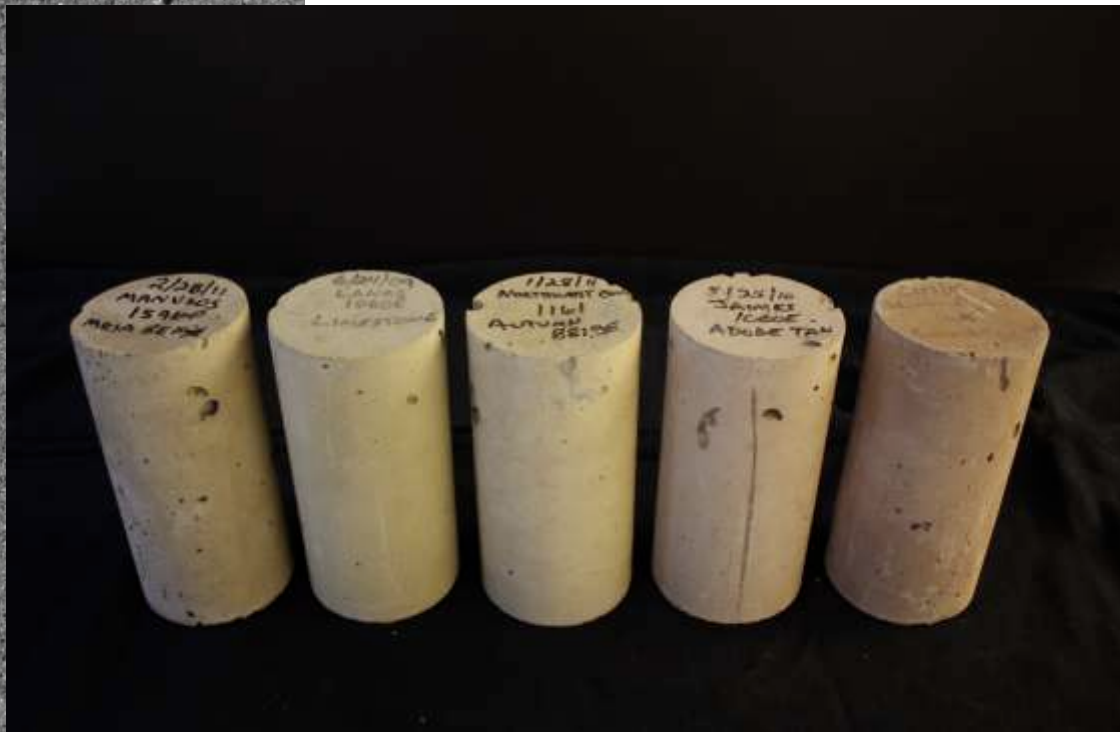
FIG. 29
Examples of a variety of mineral color concrete samples (samples from Ozinga).

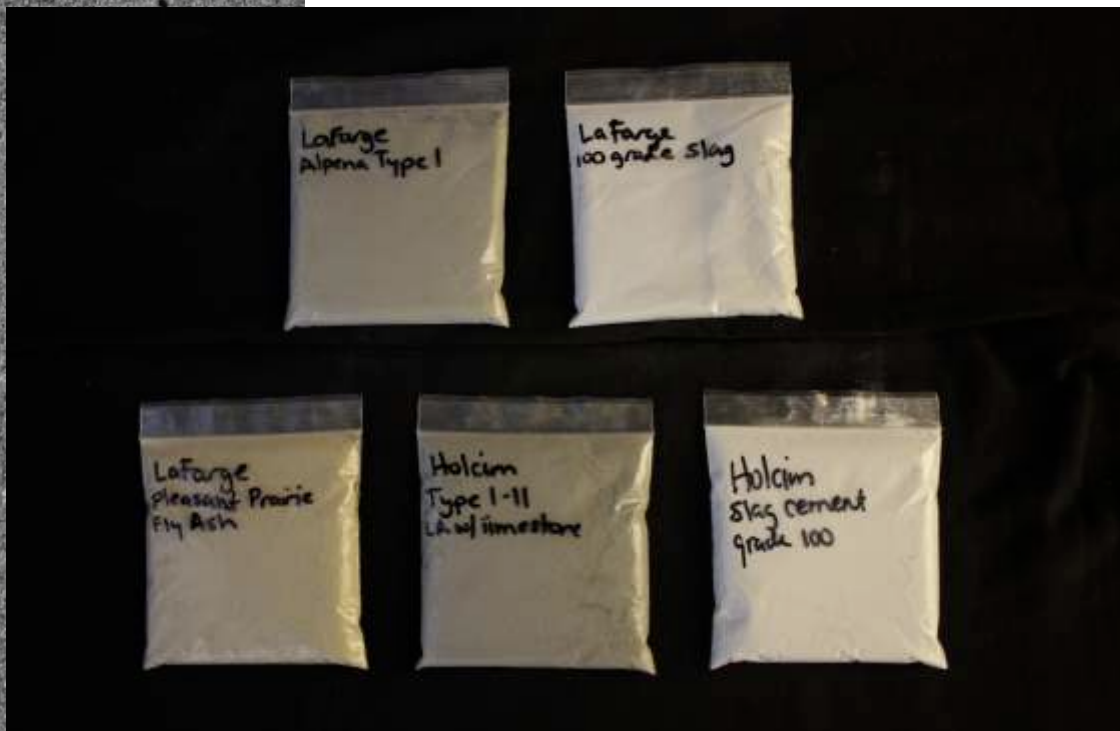
FIG. 30
Cements and pozzolan samples illustrating their variety of colors (samples from LaFarge and Holcim).

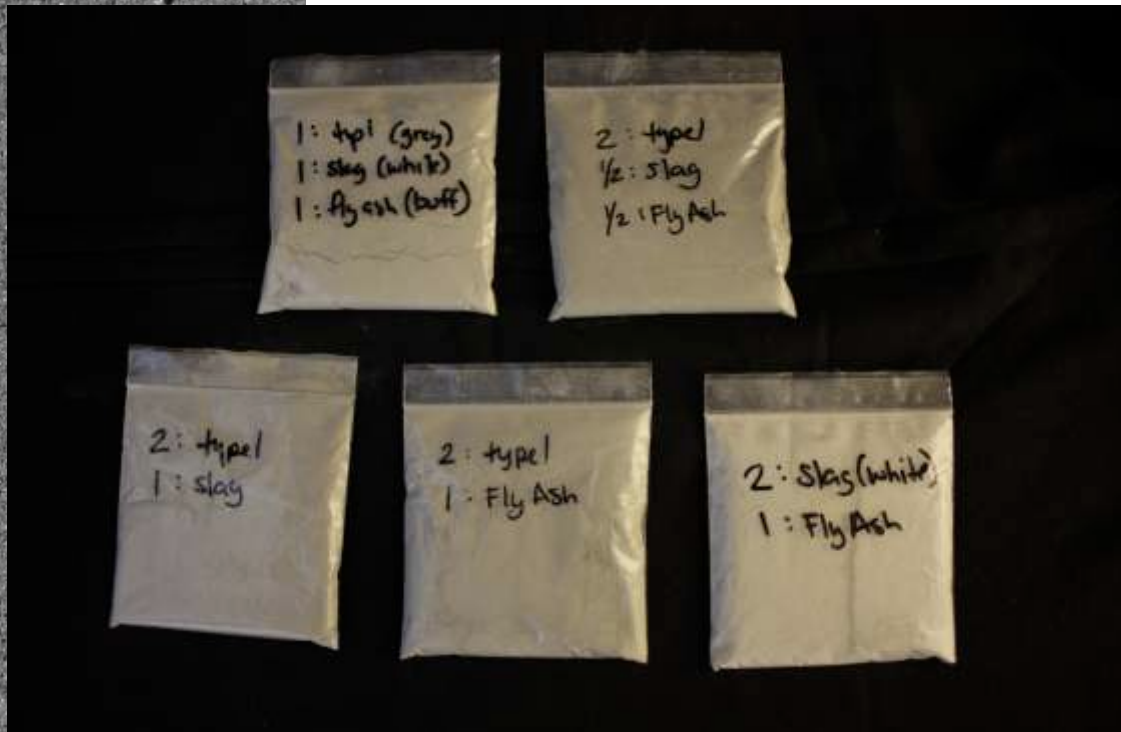
FIG. 31
Blends of cements and pozzolans to create a 'light grey buff tone' cementitious color.

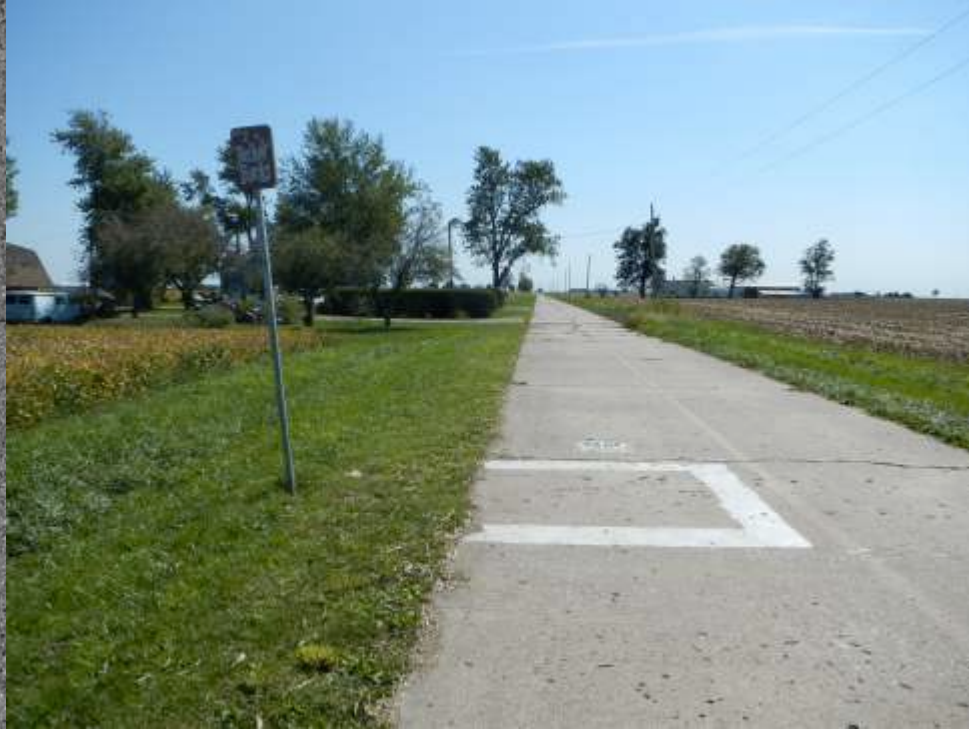
Some areas and segments along Old Route 66 should be left in place and not altered or repaired. An example of this is an area south of Nilwood where some alleged turkeys trotted in the fresh concrete in the 1920s (Figure 33). This area has been marked and signage added to signify this portion of the concrete. Treatment of this area should be restricted for the preservation of this special area.

FIG. 33
Historic Route 66 'Turkey Trot' area south of Nilwood, IL.

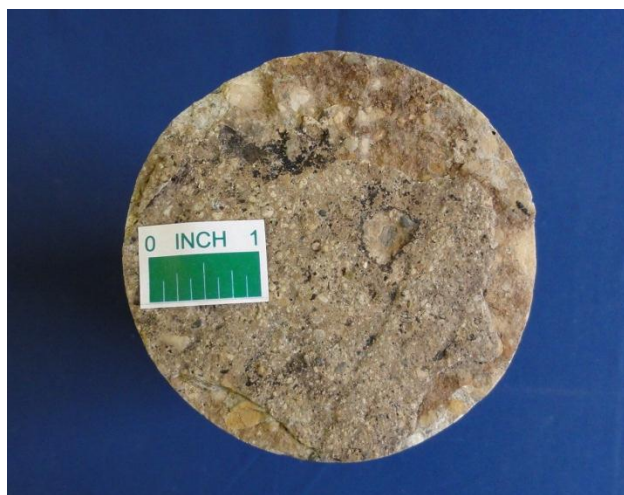
The concrete is in good general condition considering the age of the pavement. The top surface of the core is weathered and partially scaled. Aggregate particles protrude above the surface mortar layer. A few sub-horizontal cracks were observed within the top 0.4 inch of the core. These cracks pass through aggregate particle and are attributed to cyclic freezing and thawing. A transverse narrow crack extends through approximately half of the core diameter at a depth of 4 to 5 inches. This crack passes around and through aggregate particles and is attributed to alkali-silica reaction (ASR). Secondary deposits of alkali-silica gel were detected in several air voids throughout the core. The gel was mostly associated with chert particles. Crack locations are shown in Figure 14. A short vertical microcrack at the top of the core is shown in Figure 15. The crack is partially filled with asphaltic material. Constituents and characteristics of the concrete are described in greater detail below.

Figure 5. Core 2B; partially weathered, scaled top surface of the core as received.

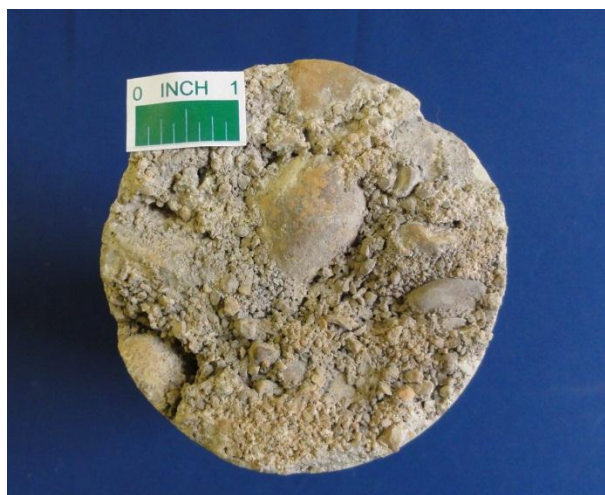
Figure 6. Core 2B; bottom surface of the core as received.

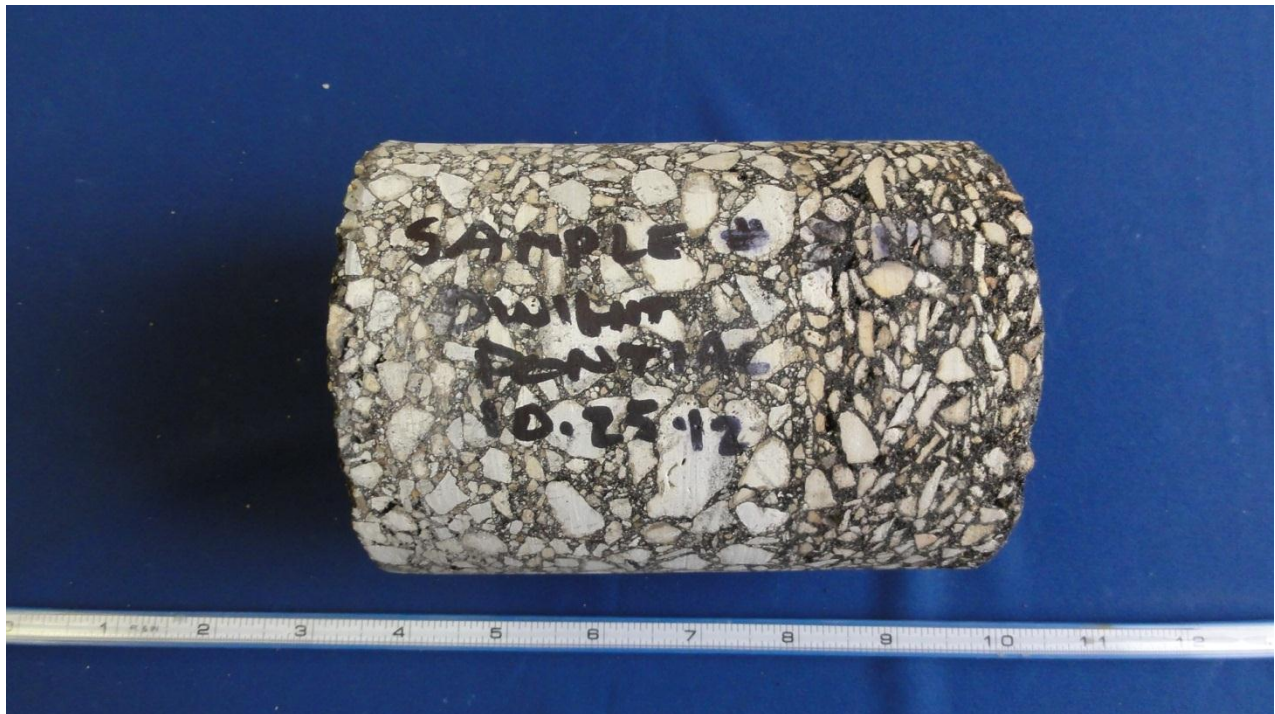
The asphaltic core has a diameter of 4 inches and is 5 inches long. The top surface is somewhat weathered and exhibits protruding aggregates. The bottom surface had been formed against the substrate concrete and appears to have debonded. The core appears to contain at least three distinct horizontal layers as indicated by the size distribution of the aggregate particles and by the presence of semi-continuous planar features. The asphaltic material is well consolidated. The aggregate particles are uniformly coated with binder and appear to be of adequate quality; no aggregate degradation was observed. The as-received core is shown in Figures 7 thru 9.

Figure 7. Asphaltic Core identified as Dwight /Pontiac (number designation illegible) as received. Top surface of the core is on the left of the photograph.

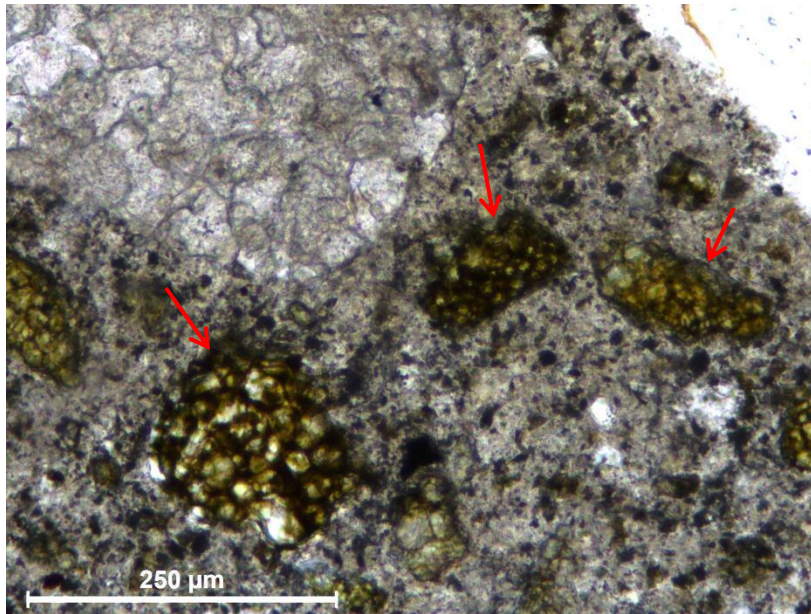
The paste contains moderate amounts of large residual unhydrated and partially hydrated portland cement particles. Residual cement particles were occasionally up to 300 microns (0.01 inch) in diameter (Figures 12 and 13); coarse particle size is a common characteristic of early 1900s portland cement. Hydration of the cement is generally advanced. Trace amounts of carbonate crusher fines were observed in the paste. Supplementary cementitious materials such as fly ash or ground granulated blast furnace slag were not observed, nor would these materials be expected in 1920s - 1930s pavement concrete.

Figure 12. Core 1B - Arrows show examples of large residual portland cement particles. Thin-section photomicrograph. Plane-polarized light.

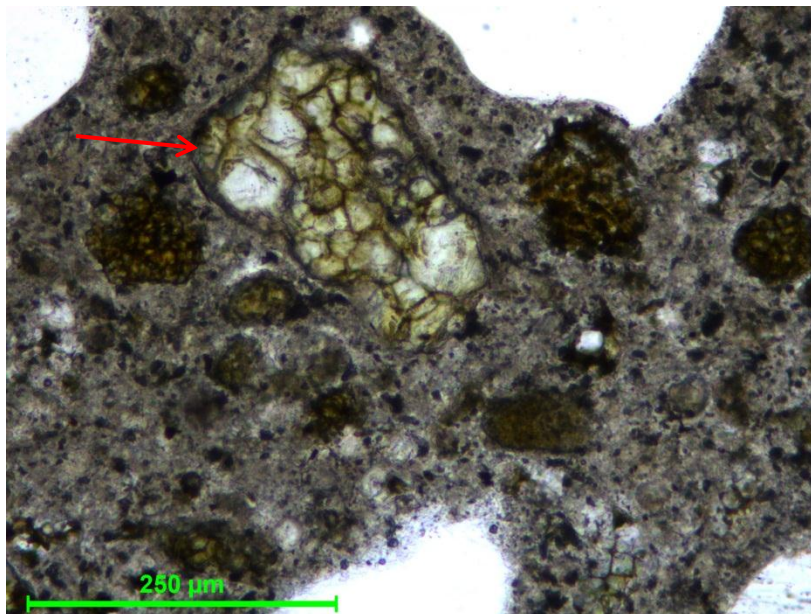
Figure 13. Core 1B - Arrow shows cement particle that is similar in size to small fine aggregate particles. Thin-section photomicrograph. Plane-polarized light.

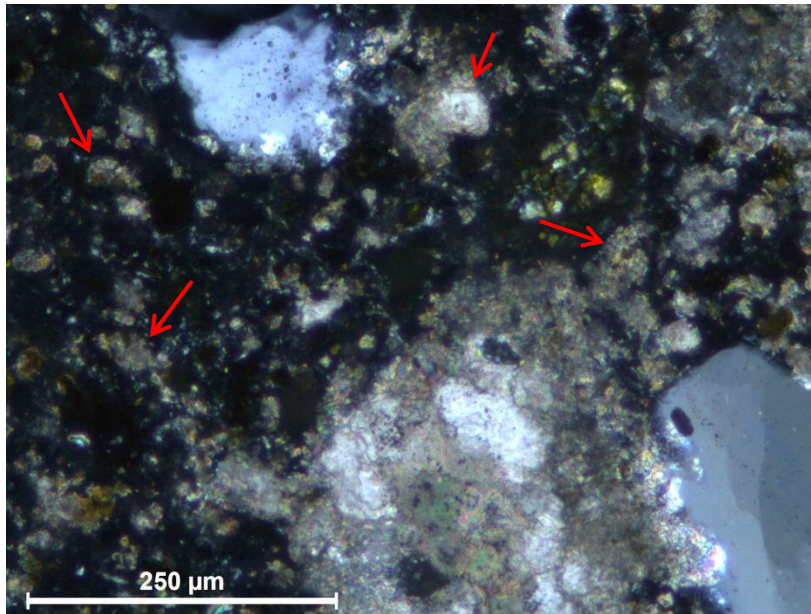
The paste contains moderate amounts of large residual unhydrated and partially hydrated portland cement particles. Residual cement particles were large, similar in size to the residual cement particles in Core 1B (Figure 16). Hydration of the cement is moderately advanced. Large amounts of carbonate dust were observed in the paste (Figure 17) indicating that the aggregate had not been sufficiently washed.

Figure 17. Core 2B - Arrows show examples of dust-size carbonate particles in the paste. Thin-section photomicrograph. Cross-polarized light.
