CULTURAL RESOURCE MANAGEMENT PLAN

FORT SHERIDAN

NATIONAL HISTORIC LANDMARK DISTRICT FORT SHERIDAN, ILLINOIS

DECEMBER, 1997

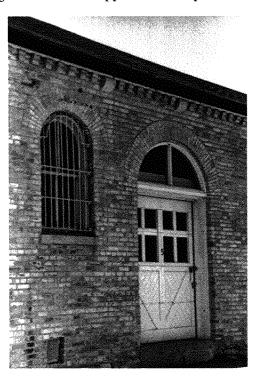
Workshops (#36), 1997. Photograph by Victoria Granacki

Condition: Original skylights have been removed. Mismatched brick has been used to replaced some of the original cream-colored brick. Some openings have been infilled with mismatched brick. Some windows have broken panes. Brick walls are stained.

Alteration Guidelines: Additional openings and the enlargement of present openings on the front, side, and rear facades will be allowed to provide sufficient access, light, and ventilation for proposed residential use. Alterations and additions may be made to the rear facade. The roof will be slate gray color roofing material. Where windows are original and the opening is retained, the window will be retained and repaired. If retention is not practicable, reasons for removal must be documented and windows may be replaced in kind. Where windows are not original, they may be replaced with wood windows with historically compatible configuration, with no applied muntins permitted.

The bars may be removed from the windows. Skylights may be added to the roof of the nonstreet facade only. Where mismatched brick is removed, it should be
