HISTORIC STRUCTURE REPORT:

HOWARTH HOUSE AND BARN
WILDLIFE PRAIRIE STATE PARK, PEORIA COUNTY, ILLINOIS

Fever River Research
Springfield, Illinois

June 2002

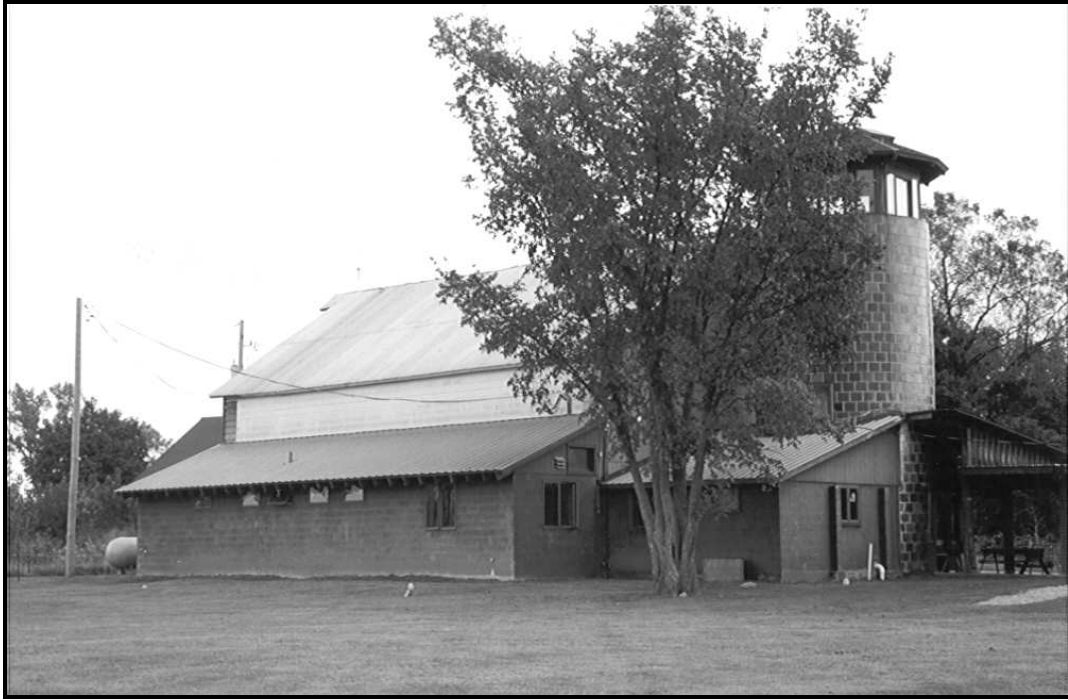
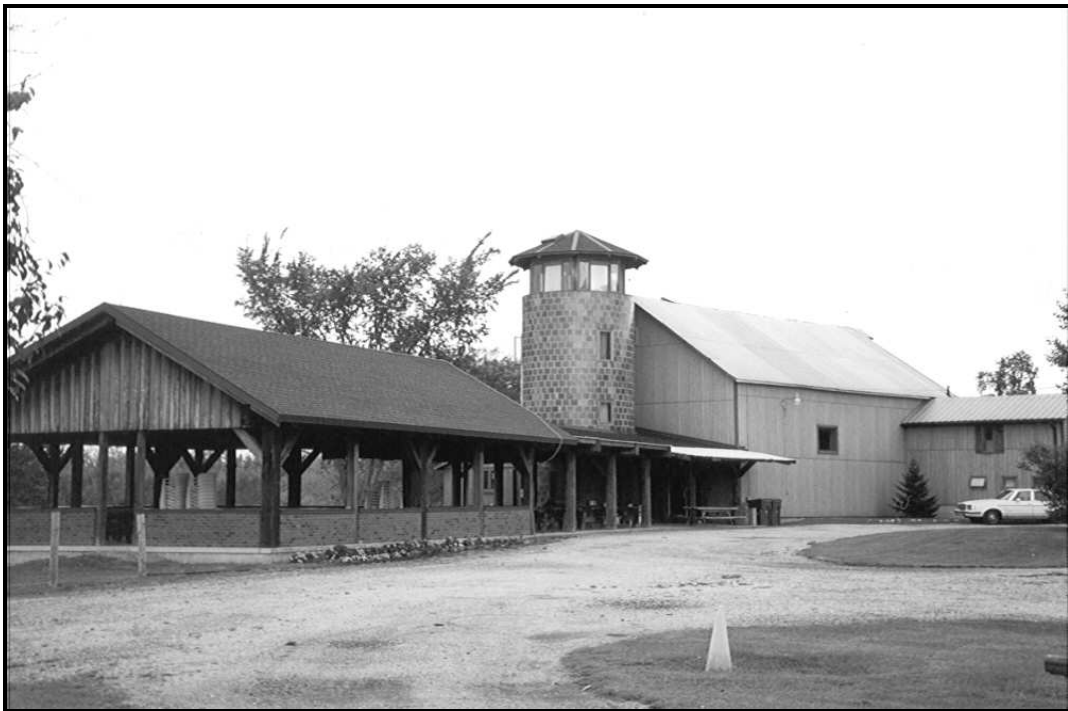
Figure 28. (Top) Dairy barn and silo at the Howarth Farmstead, looking northeast. Erected during the twentieth century, these structures have been modified and expanded for use as staff housing (FRR September 2001). (Bottom) View of the pavilion that has been added onto the southern end of the dairy barn (FRR September 2001).

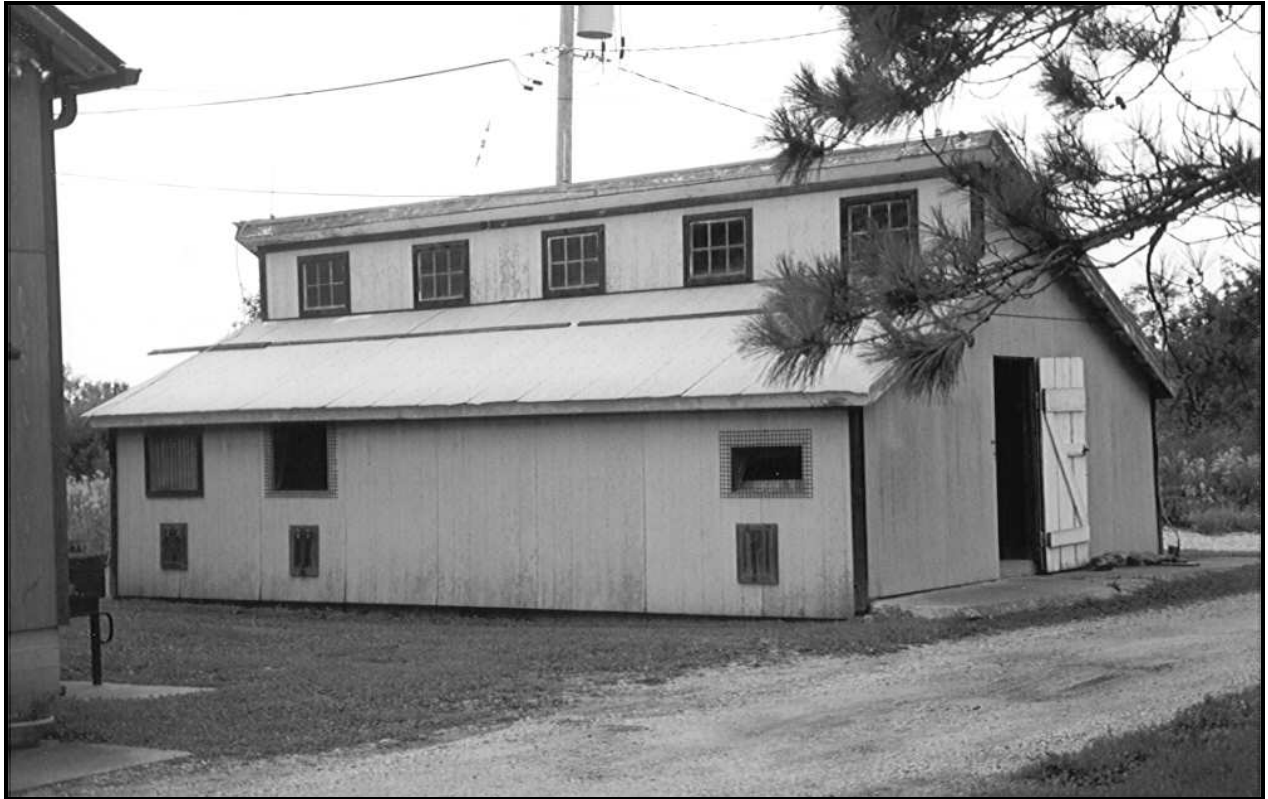
Figure 29. View of the frame chicken house at the Howarth Farmstead. Like the dairy darn, this building was erected during the twentieth century (FRR September 2001).

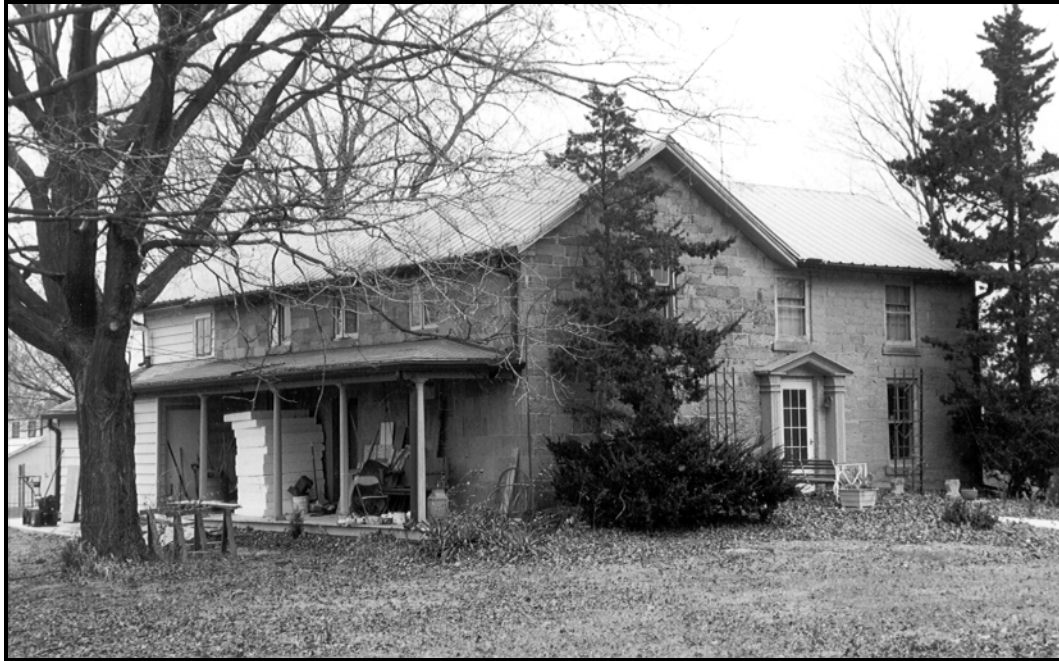
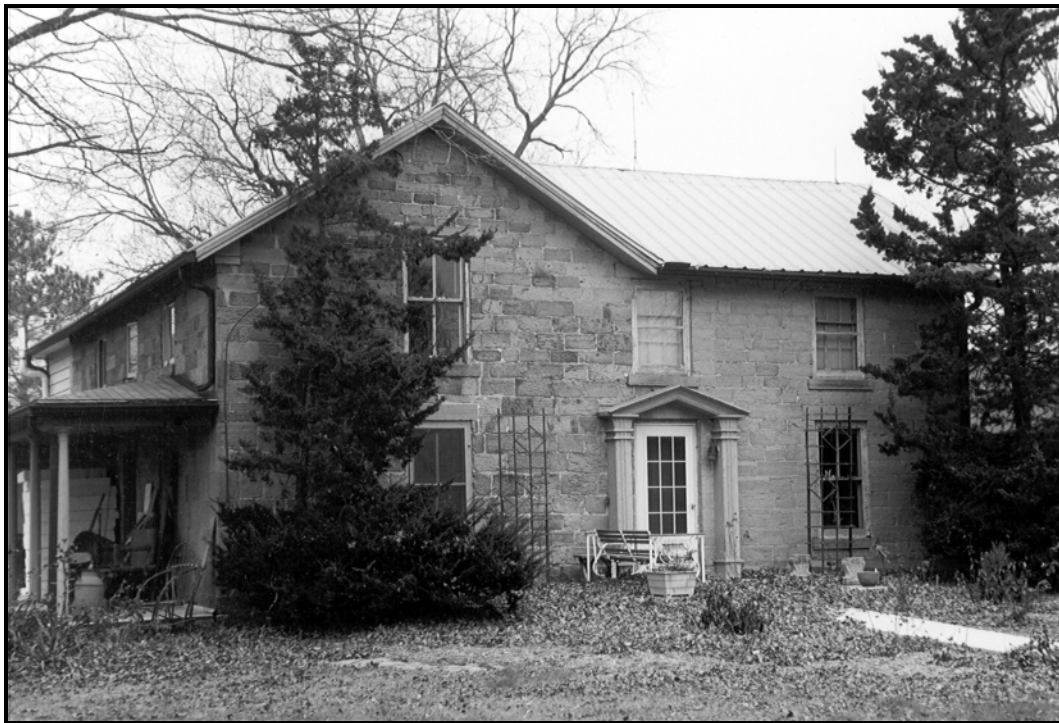
Figure 30. (Top) View of the Howarth House, looking northwest, showing the south and east elevations of the dwelling. The south elevation (shown with the porch stretching across it) represents the original formal façade of the house. (Bottom) View of the east elevation of the house, showing the existing formal entrance (FRR November 2000).

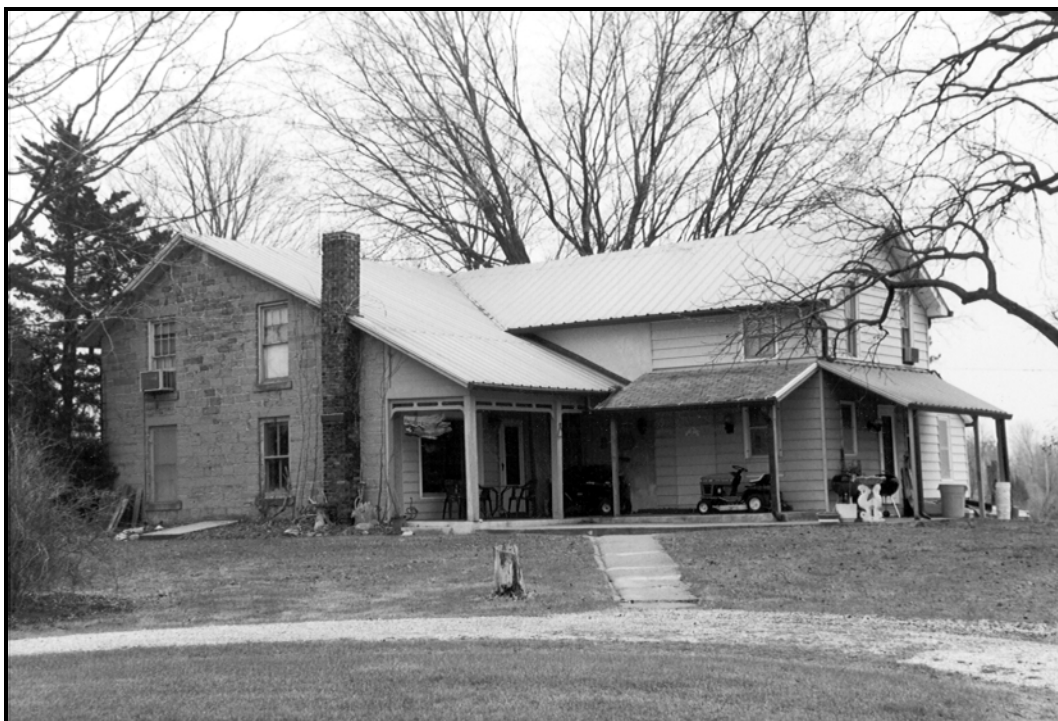
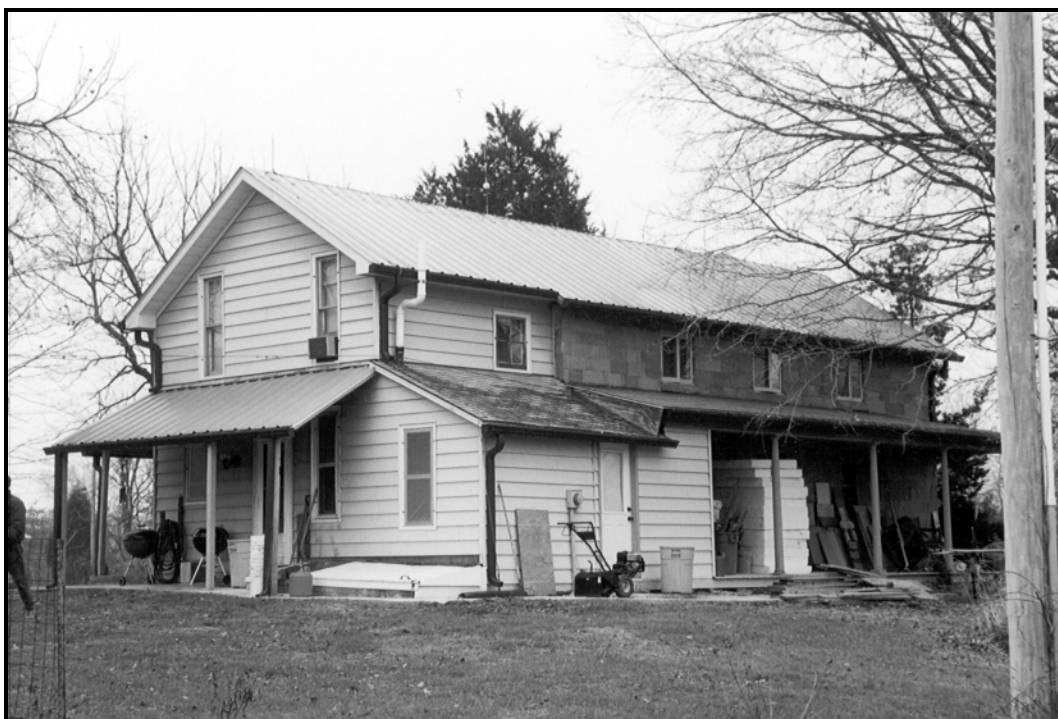
Figure 31. (Top) View of the Howarth House, looking southeast, showing the north and west elevations. The frame extension on the west end of the house is a twentieth-century addition. (Bottom) View of the house, looking northeast, showing the south and west elevations (FRR November 2000).

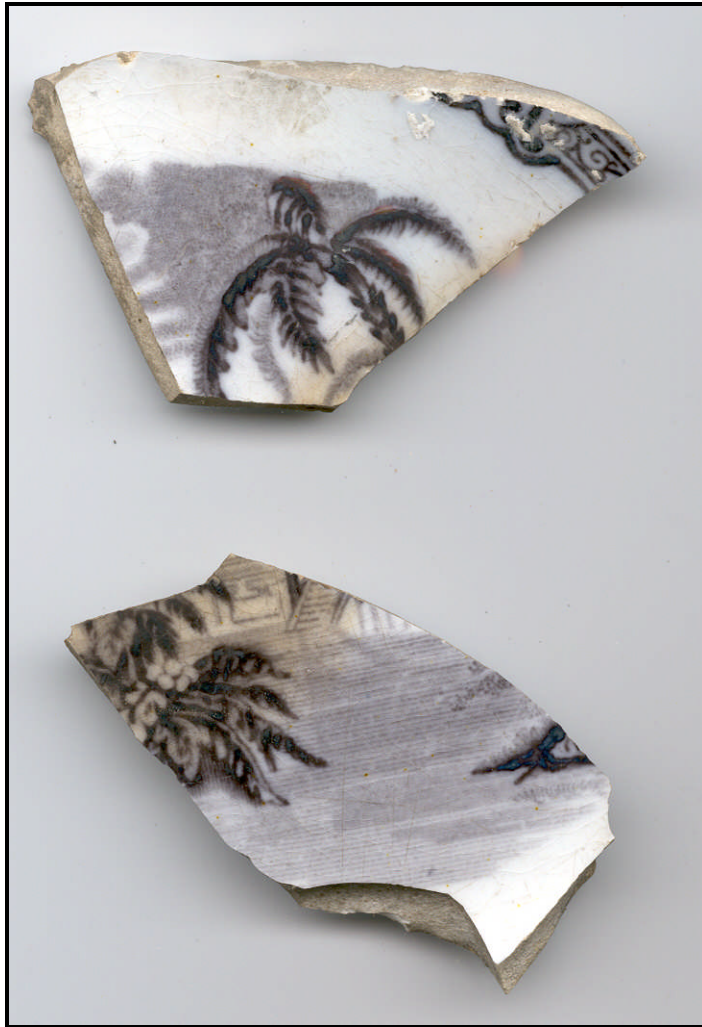
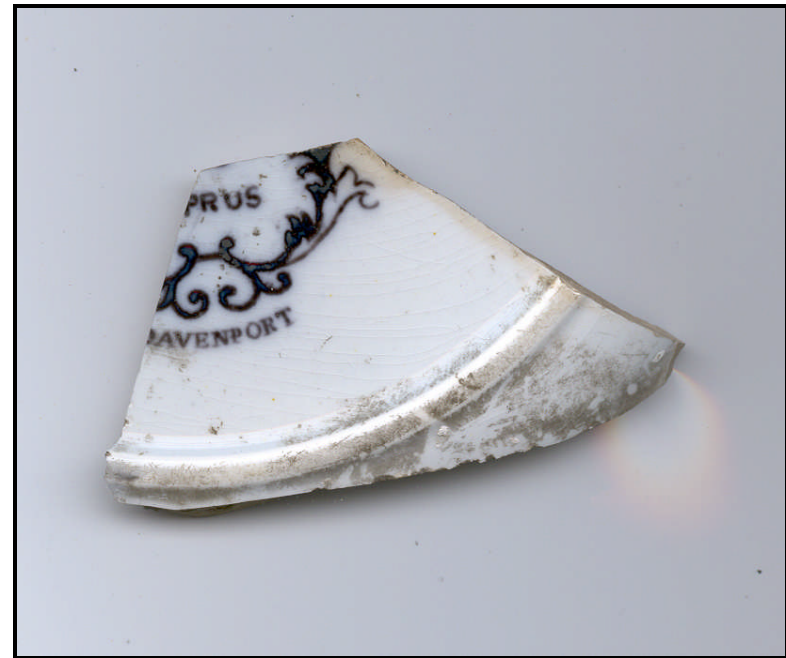
An examination of the foundation walls in the original cellar resulted in the discovery of two sherds of black transfer-printed whiteware that had been mixed in with the mortar (see Figure

Figure 32. (Left) Two fragments from a black transfer-printed plate that were found incorporated into the foundations of the original house. (Right) The backstamp one of the sherds, indicating the manufacturer (Davenport) and the pattern (Cyprus). The plate likely was manufactured in the 1840s.

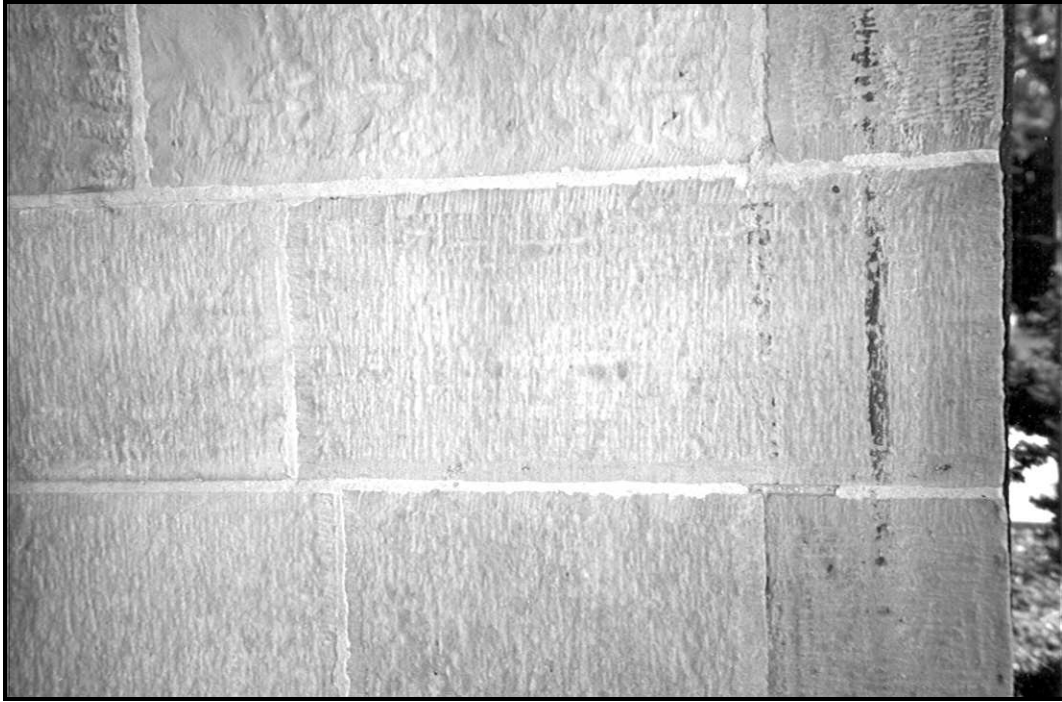
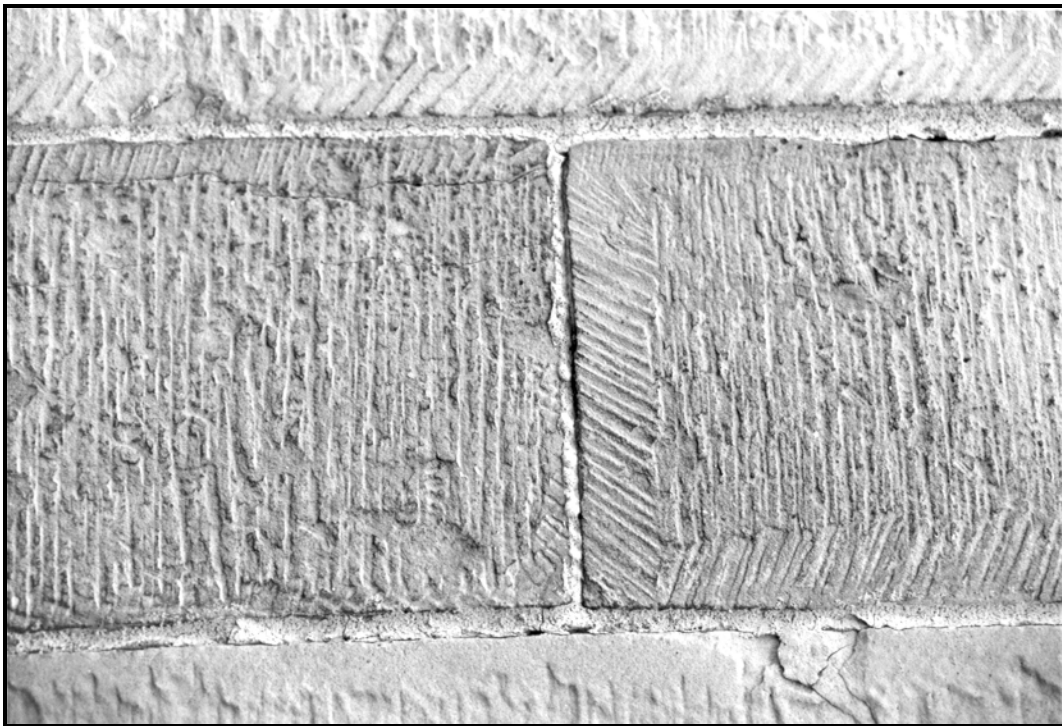
Figure 33. Details of the dressing used on the stonework on the south elevation of the original house. This dressing is finer than that used on other elevations and was meant to create a formal façade (FRR June 2001).

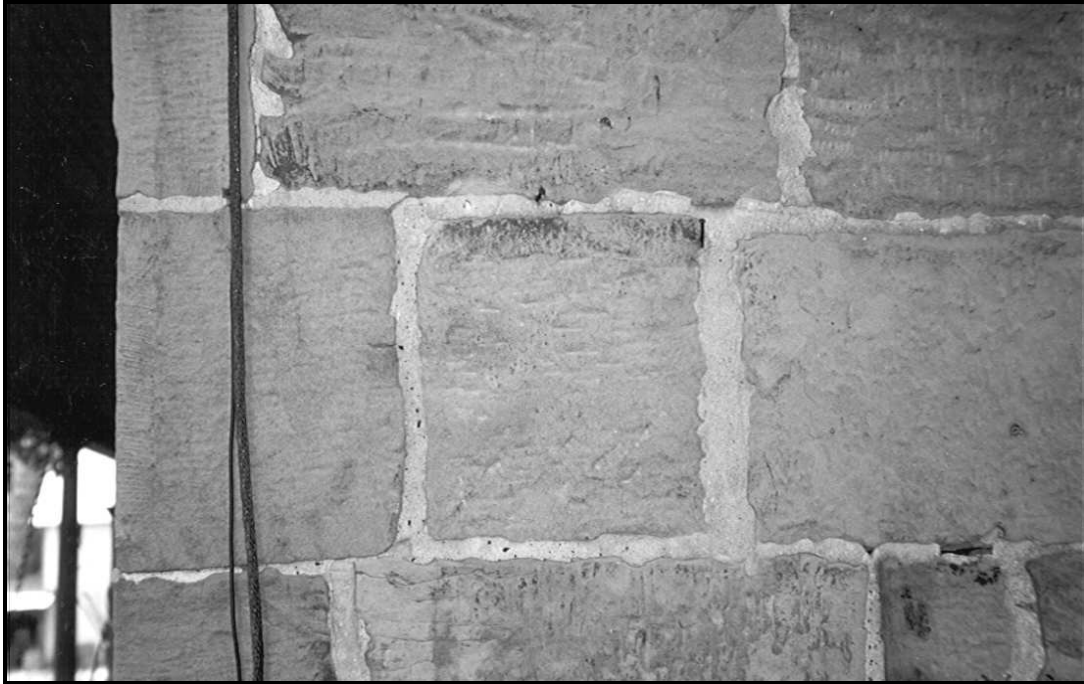
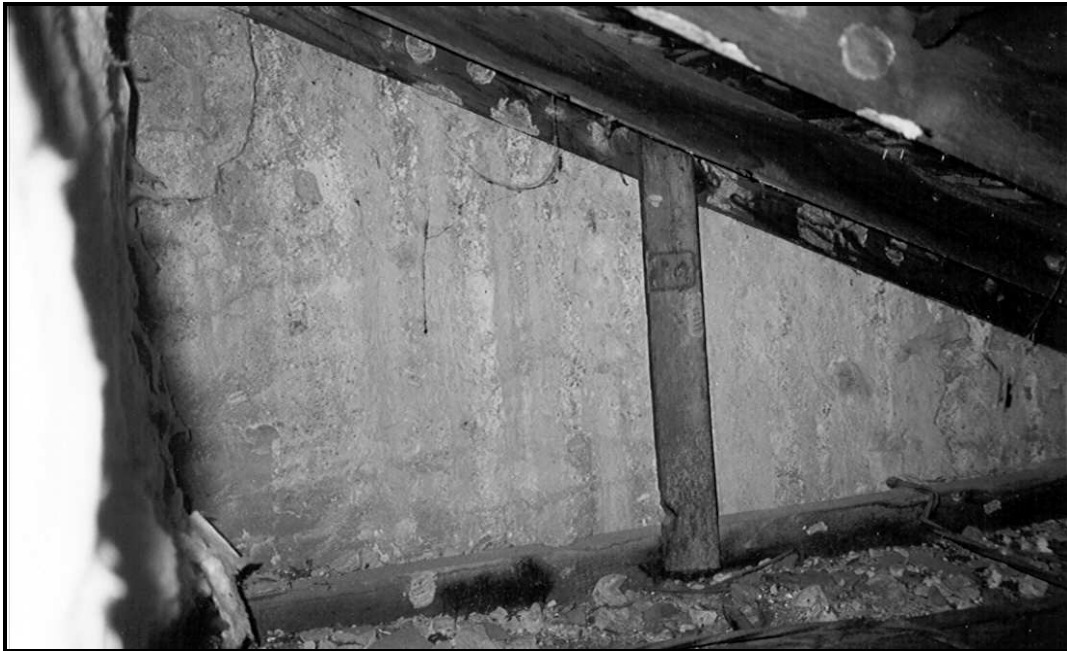
Figure 34. (TOP) Detail of the stonework on the southwest corner of the Howarth House, illustrating the different dressing techniques used. The stones to the right face east and have been roughly dressed with pointwork, while those on the far left are associated with the façade of the original house and have a finer finish. (BOTTOM) View of the stucco that covers the north elevation of the original house, looking from the attic of the porch that stretches across the west side of the north wing. The date of the stucco's application has yet to be determined (FRR June 2001).

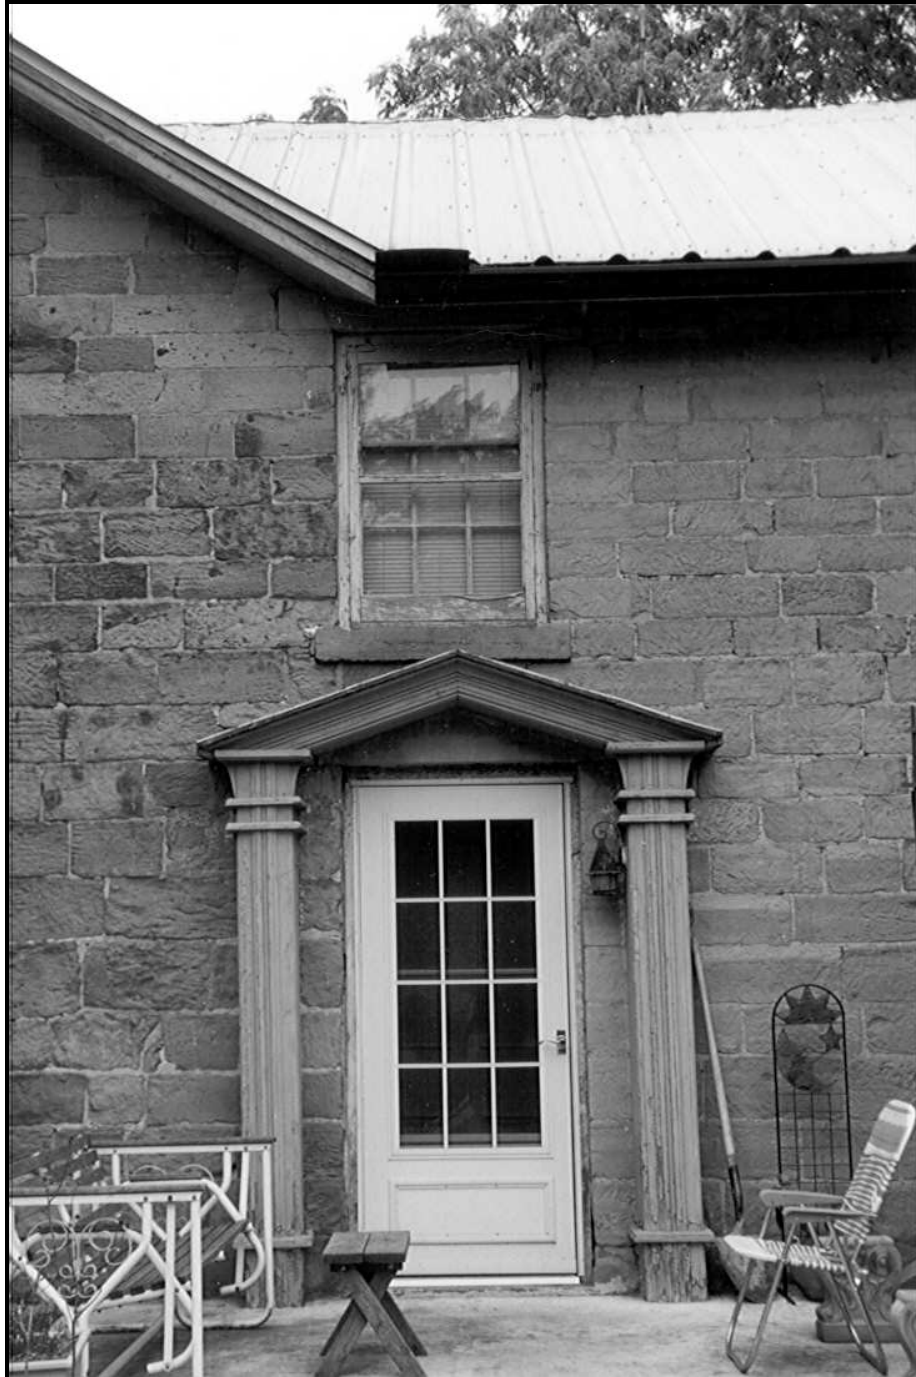
Figure 35. View of the juncture between the original house and the north wing. The window and door opening shown butt into the southeast corner of the original house.

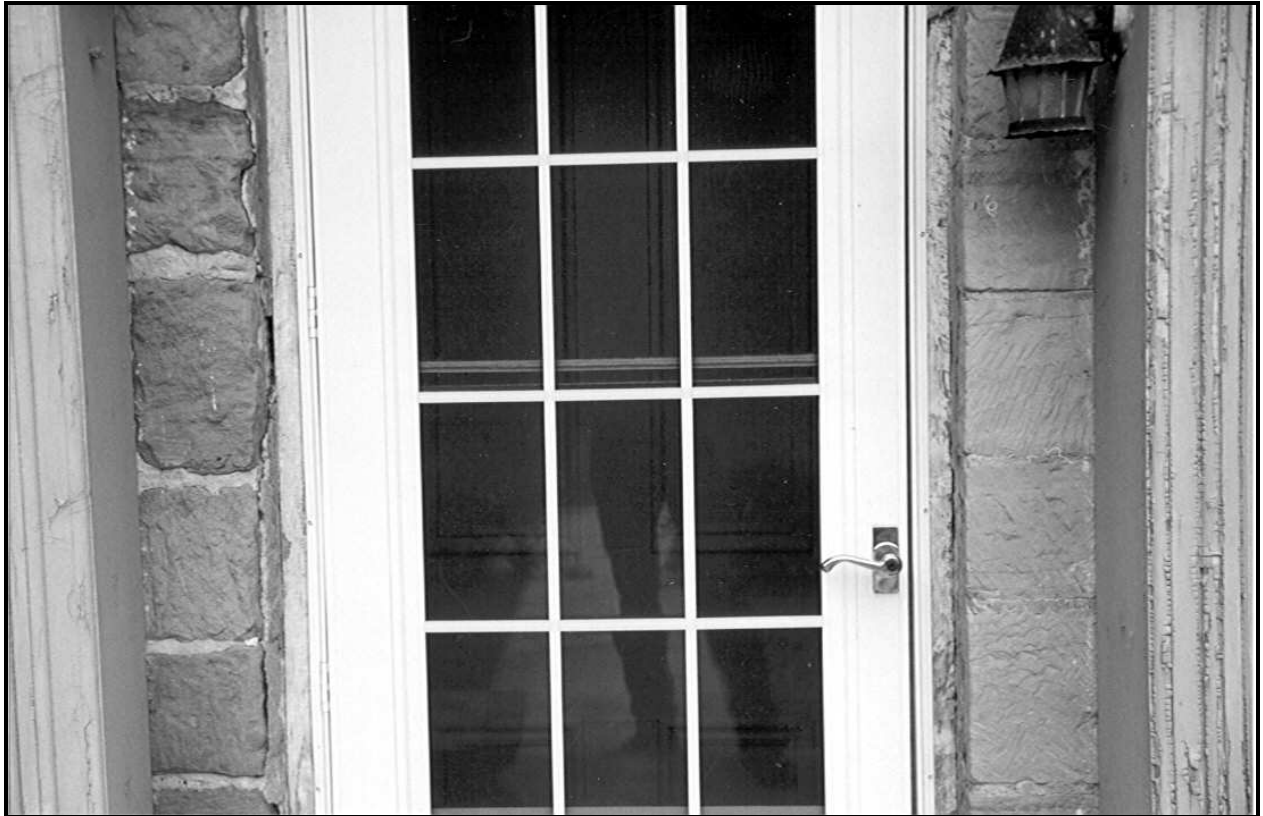
Figure 36. View of the east doorway, illustrating the different stone dressings found on the original house and the north wing. The stone to the left of the door is part of the original house and has been dressed with a point. The stonework on the north wing was dressed with a chisel (FRR June 2001).

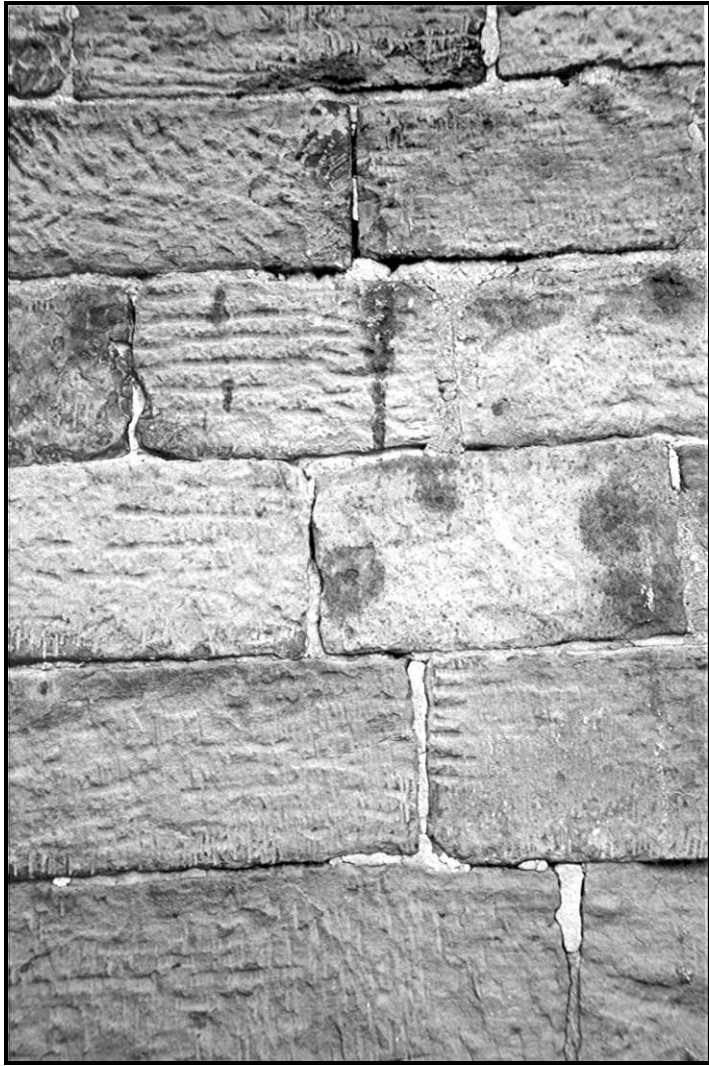
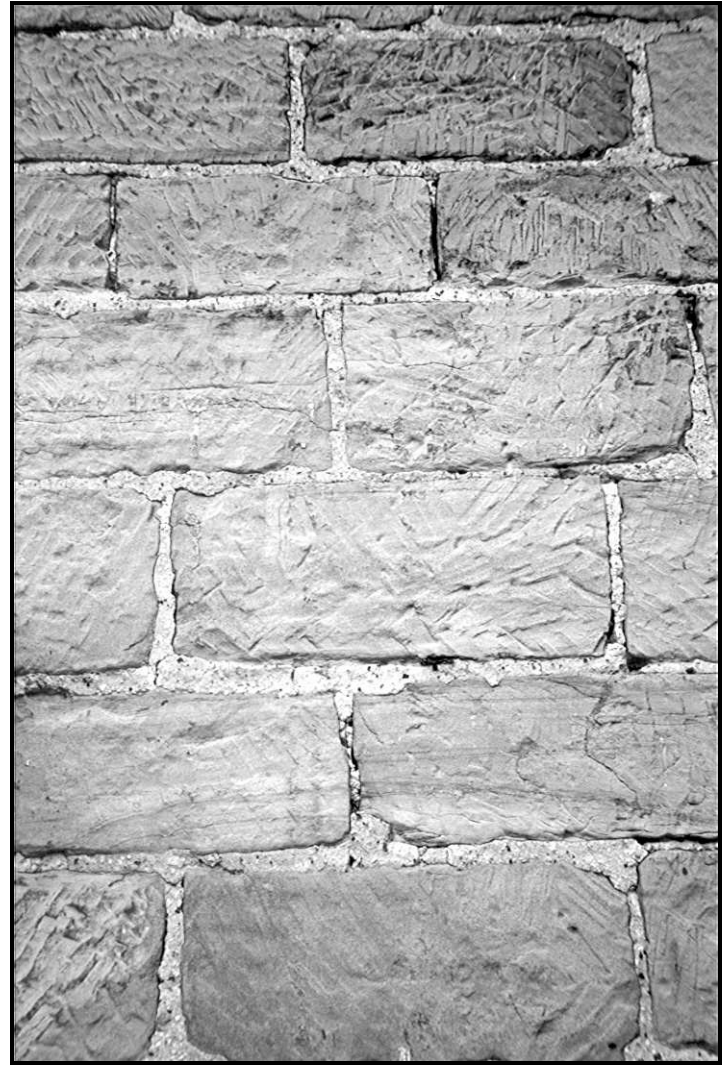
Figure 37. Comparison of the different dressings used on the stone sections of the Howarth House. The stones on the left are found on the east elevation of the original house, while those on the right are from the north wing (FRR June 2001).

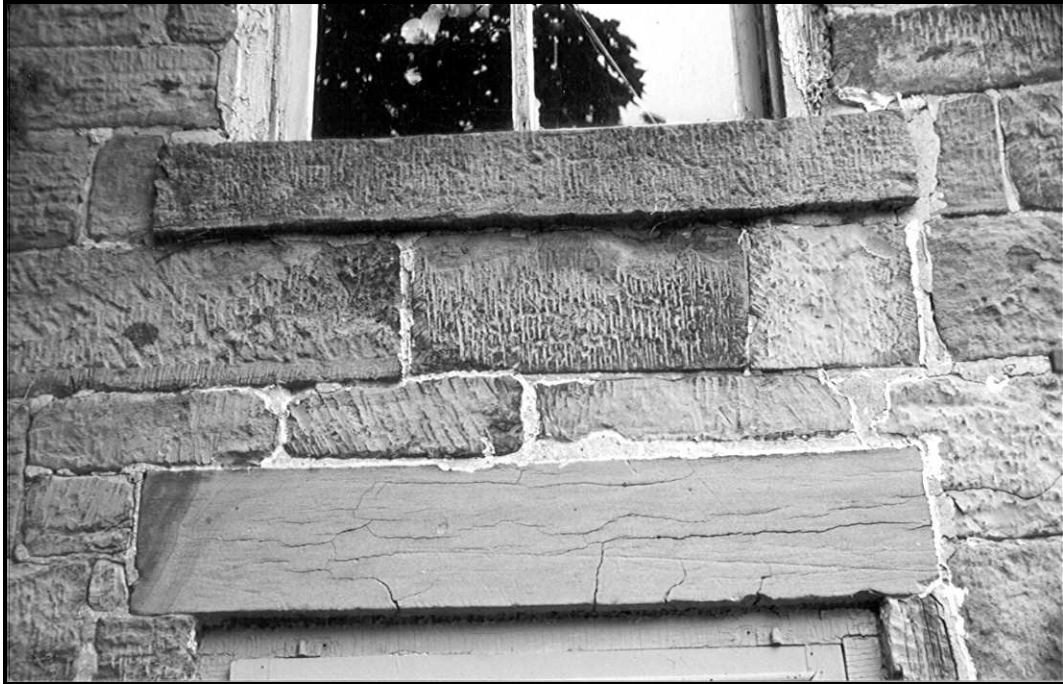
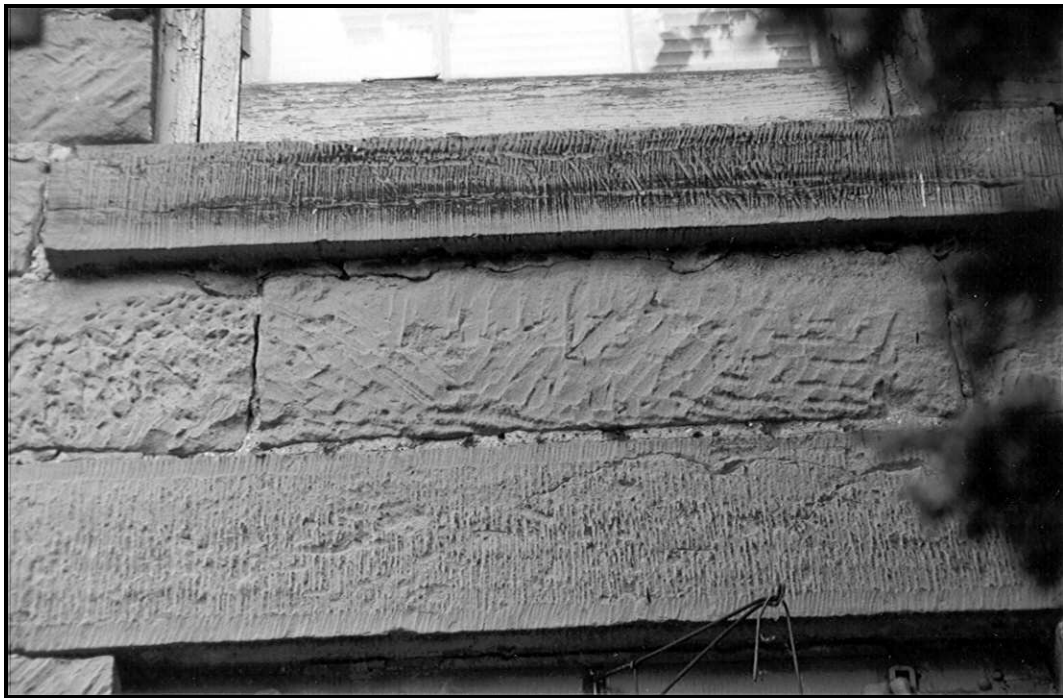
Figure 38. Another comparison of the different stone dressings used on the Howarth House, emphasizing the window sill and lintel treatments. The TOP photograph shows window openings in the original house, while the BOTTOM view is of openings in the north wing (FRR June 2001).

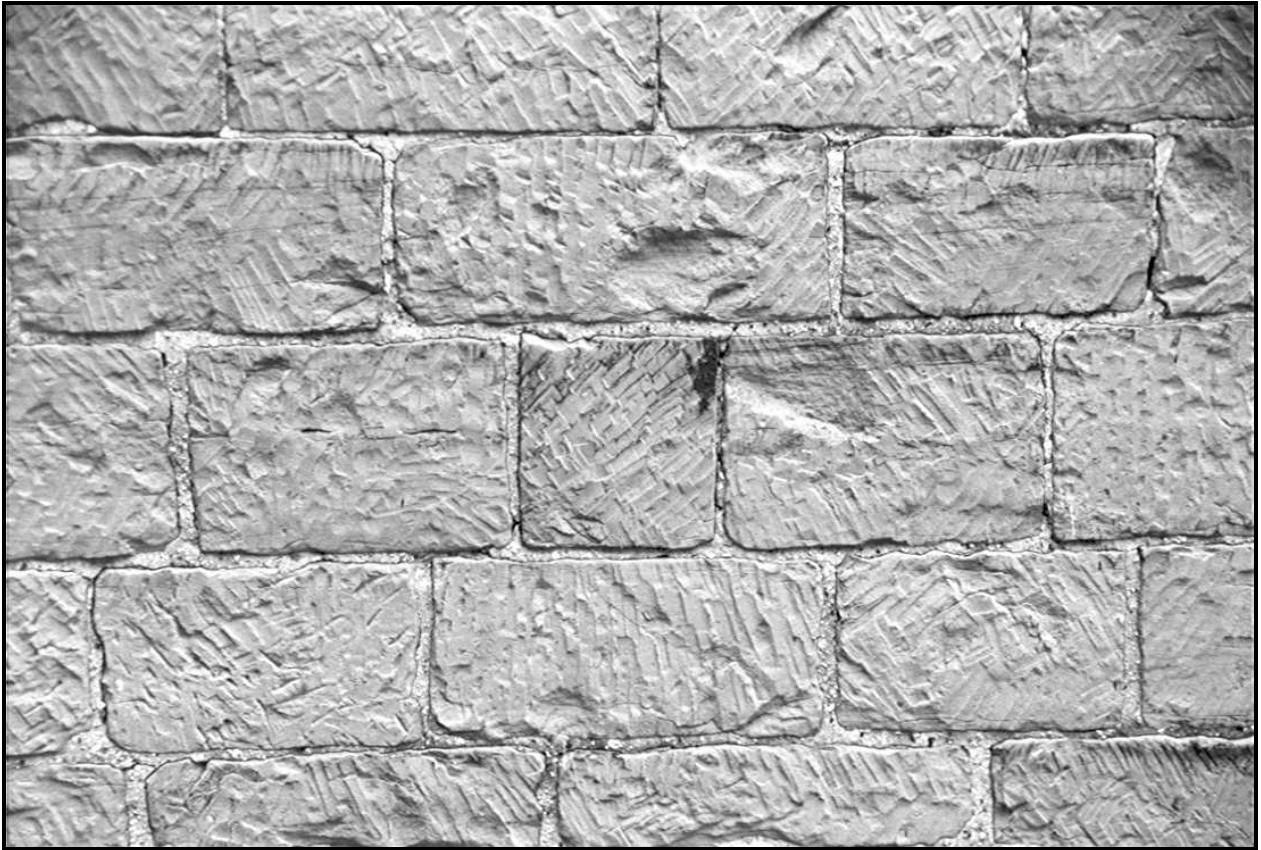
Figure 39. Representative view of the stonework used on the north wing of the house. Note the ashlar character of the stone and the chisel work used to dress it (FRR June 2001).

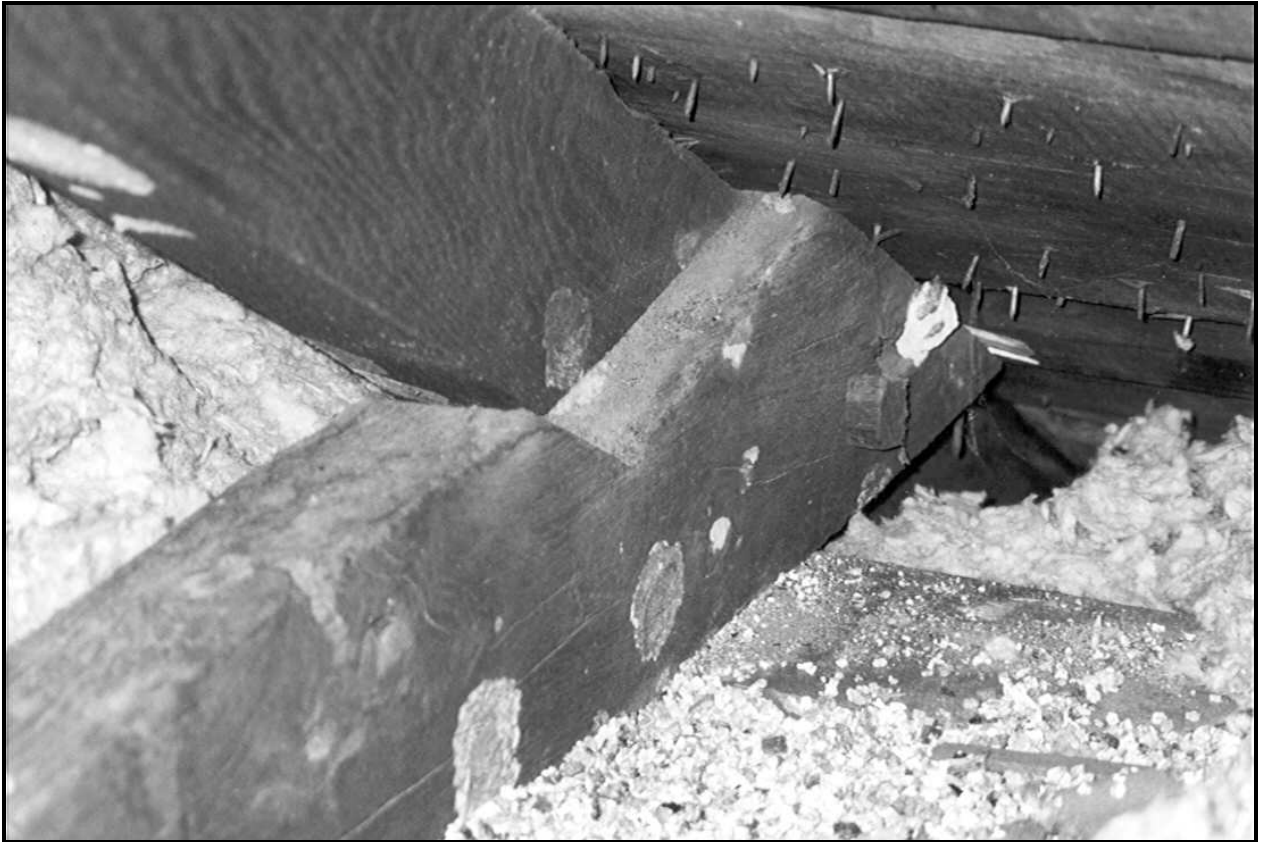
Figure 40. View of the joint between a rafter and ceiling joist in the original house. The ceiling joist also functions as a collar brace. It and the rafter are rabbitted together, and their joint is fixed with a wood dowel.

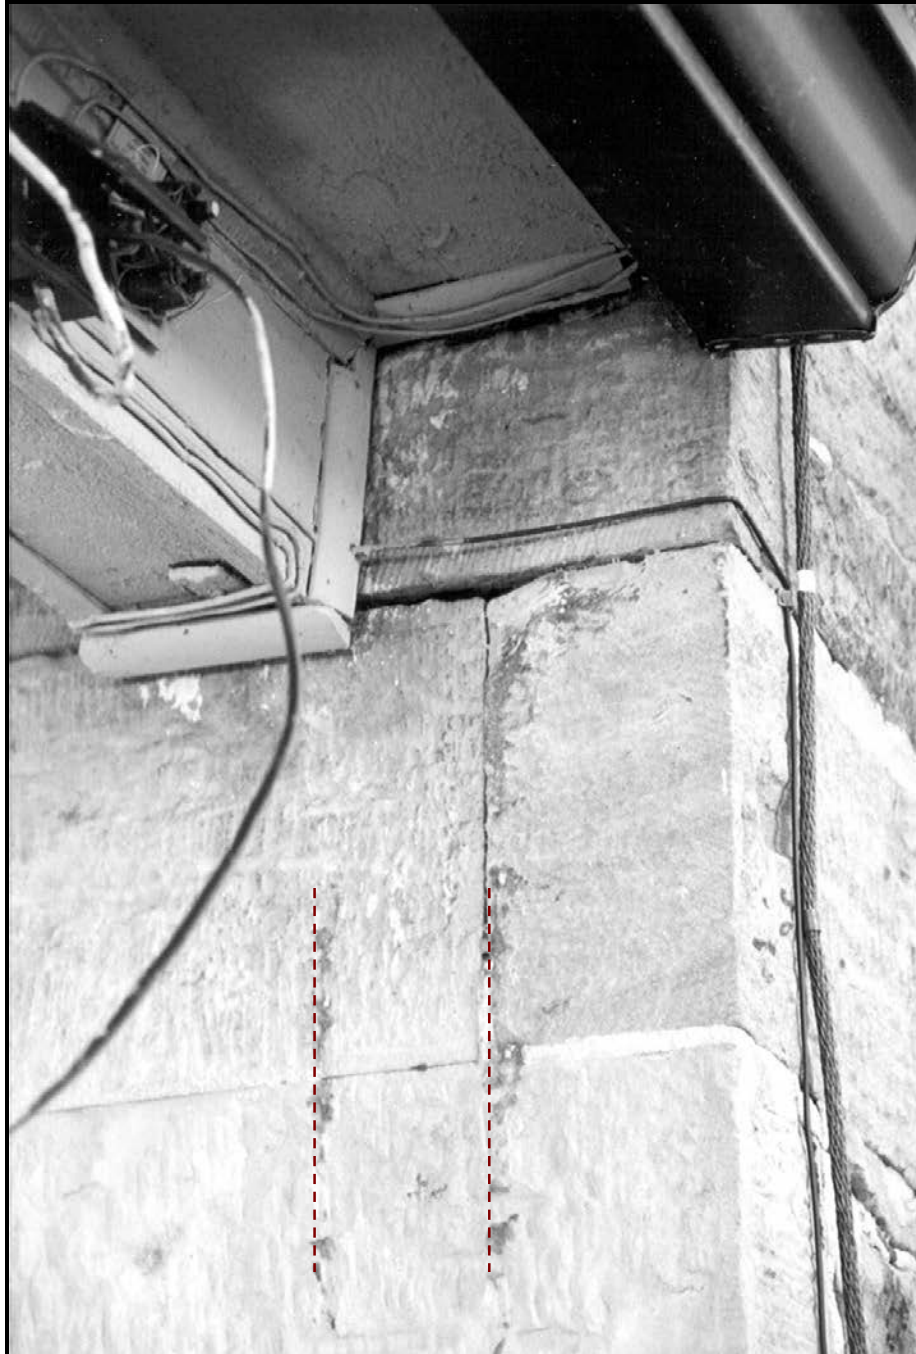
Figure 42. View of the paint line (or “ghost”) of a porch post that was left behind after the midde-nineteenth-century-era south porch was removed during the early twentieth century. The two dashed lines indicate the edges of the removed post (FRR June 2001).

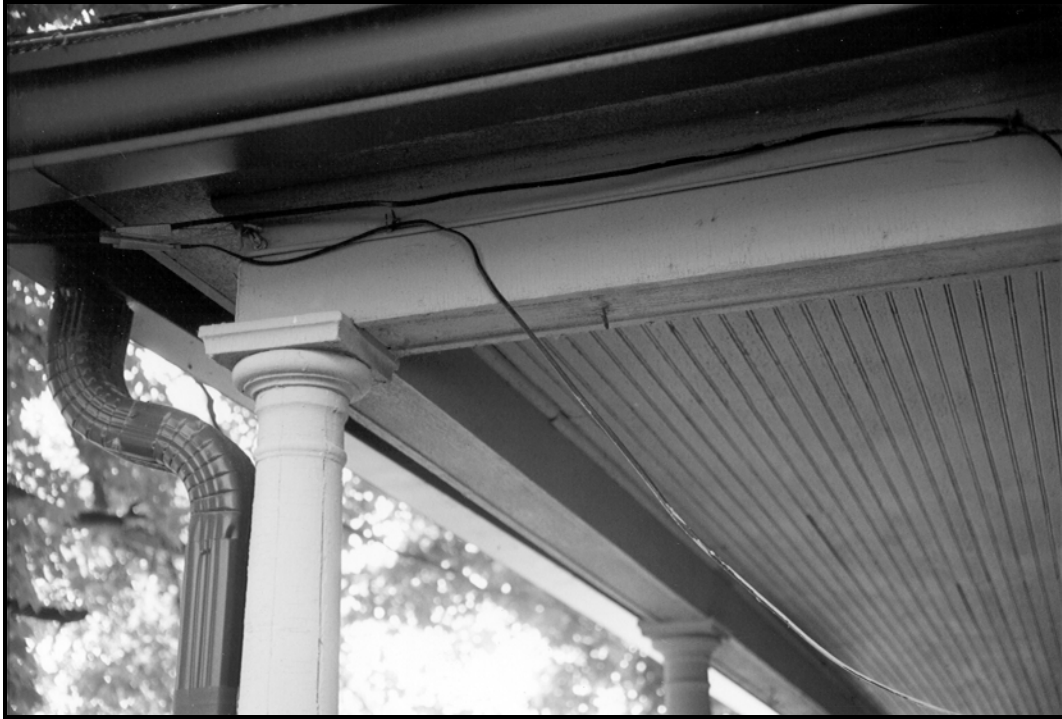
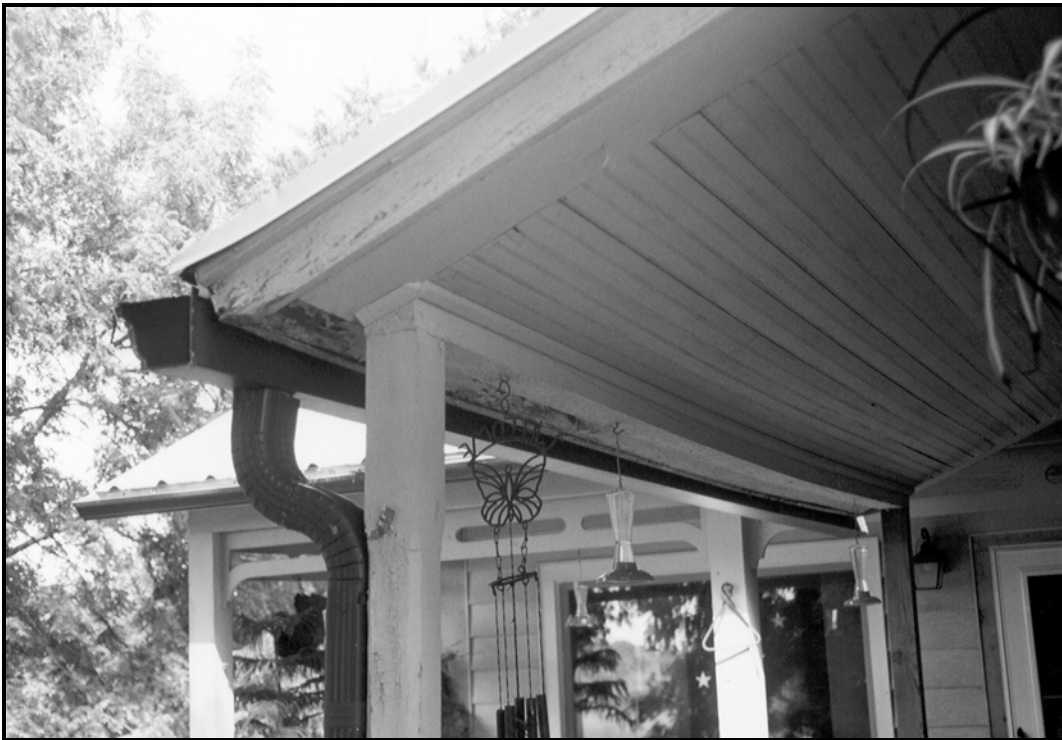
Figure 43. (TOP) Detail of the porch posts, cornice, and ceiling on the existing south porch. This classically inspired porch was added during the early twentieth century. (BOTTOM) A similar view of the porch that extends across the north side of the west wing. This porch is simpler and more utilitarian than the one shown above (FRR June 2001).

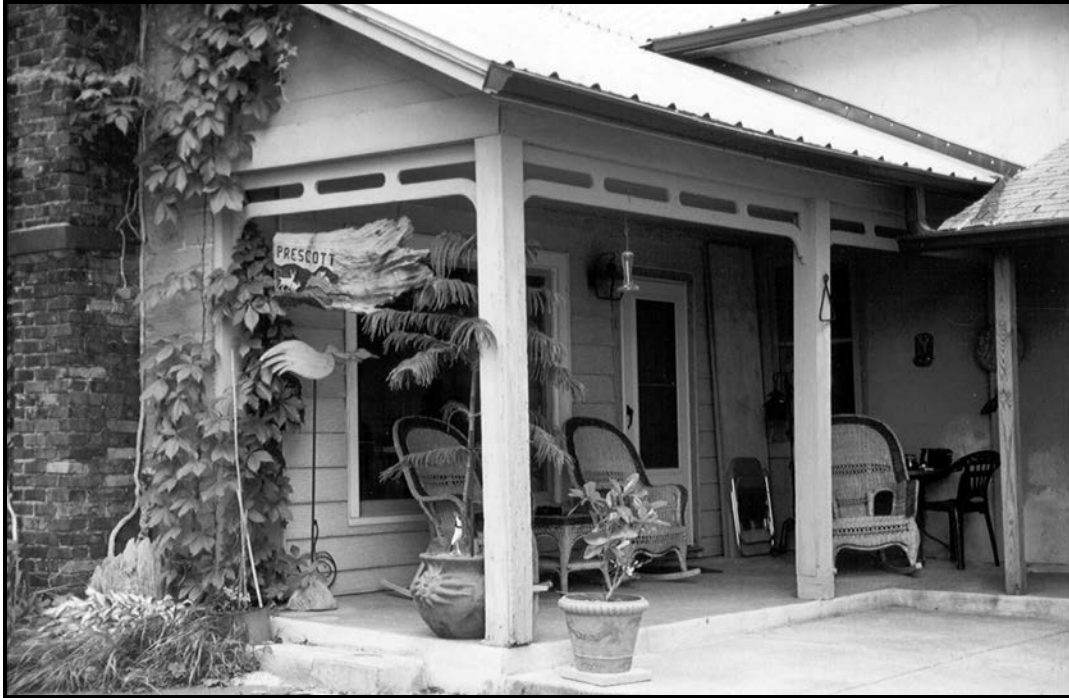
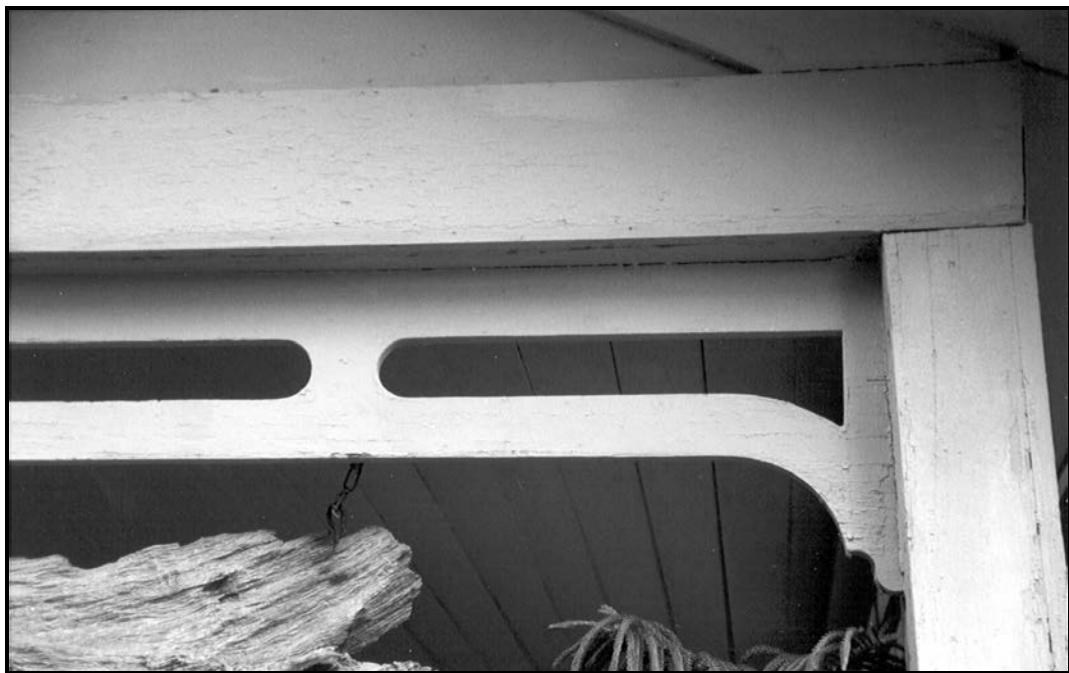
Figure 44. (TOP) View of the west porch on the north wing. An original feature to the wing, this porch retains all its historic fabric except for its wood deck, which has been replaced a modern poured-concrete pad. (BOTTOM) Close-up of the Gothic-Revival-inspired corner brackets on the porch (FRR June 2002).
