HISTORIC STRUCTURE REPORT:

HOWARTH HOUSE AND BARN
WILDLIFE PRAIRIE STATE PARK, PEORIA COUNTY, ILLINOIS

Fever River Research
Springfield, Illinois

June 2002

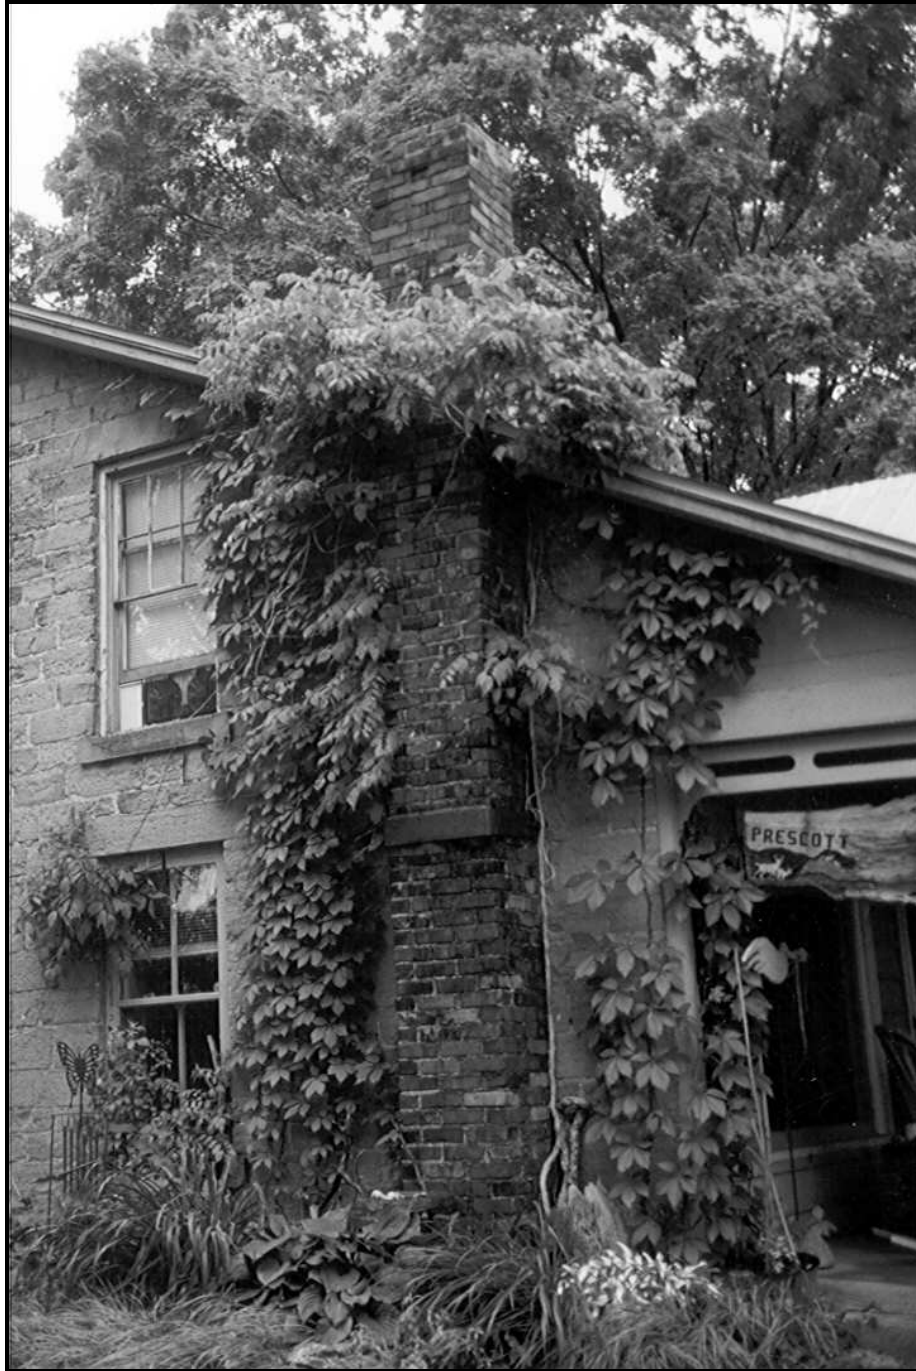
Figure 46. Photograph of the northwest corner of the north wing, showing the exterior brick chimney that vents the boiler currently used to heat the house. A hot-water heating system was installed in the house during the early twentieth century (FRR June 2001).

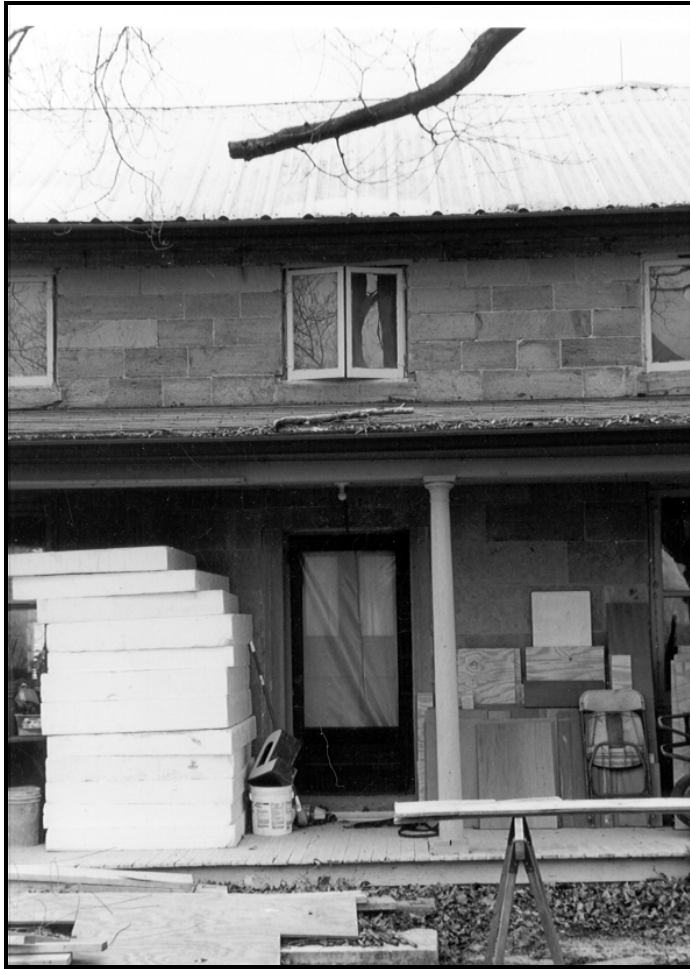
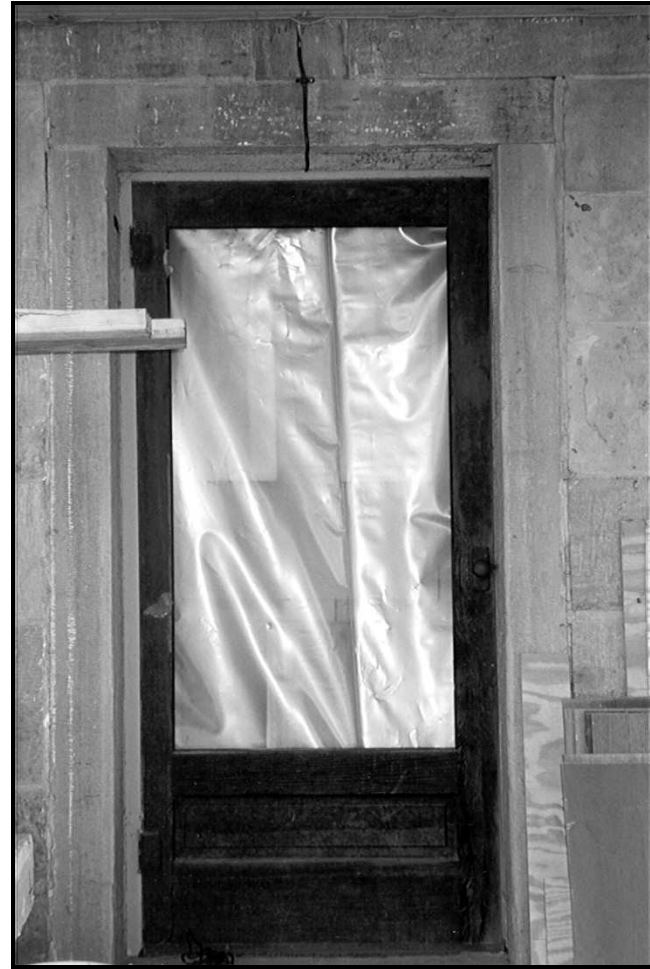
Figure 47. (Left) View of the south elevation of the Howarth House, showing the original front entrance to the house and the short windows in the second floor of the house. The casement windows currently present on the second story represent modern replacement. (Right) View of the original front entrance to the house, showing the finely dressed stonework flanking the doorway (FRR November 2000).

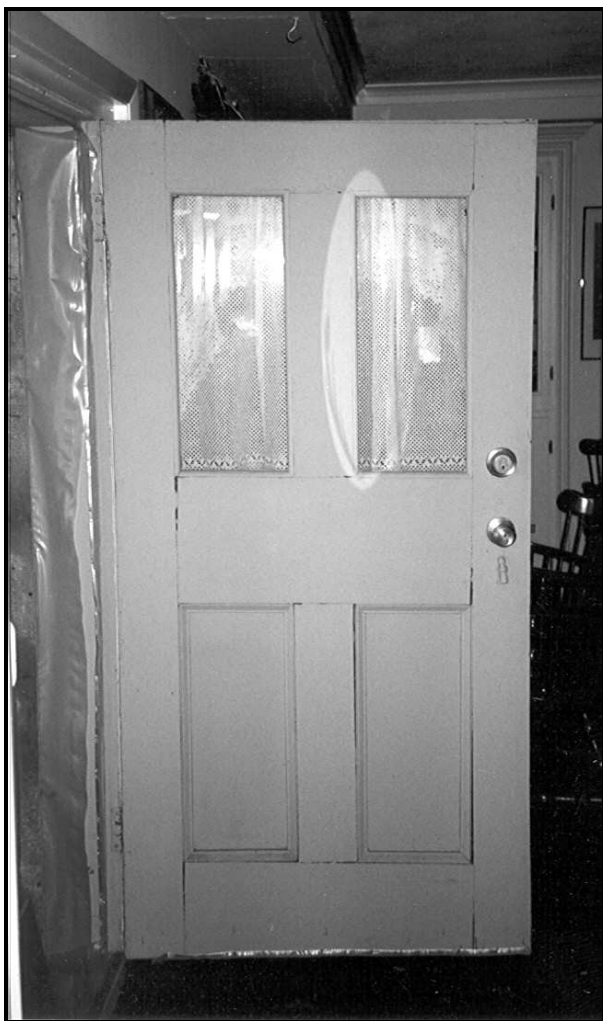
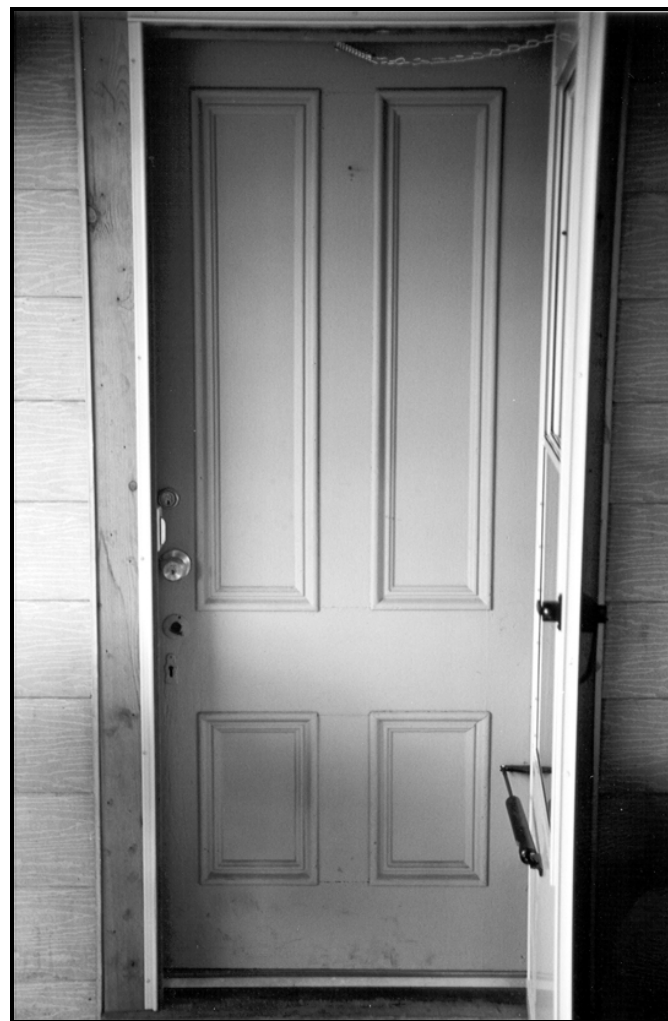
elevation is of frame construction rather than of stone. Nevertheless, the door associated with this entrance is of exact same style and type of construction as the east door, though it is slightly smaller (2'-9"x6'-5"x1-¾") (see Figure 48).

Figure 48. (LEFT) Photograph of the four-paneled door that is present on the south exterior entrance to the original house. The upper panels on this door would have been solid originally; the glazing represents a modification. (RIGHT) View of the west exterior door on the north wing. The eastern exterior door on the wing is similar in character (FRR June 2001).

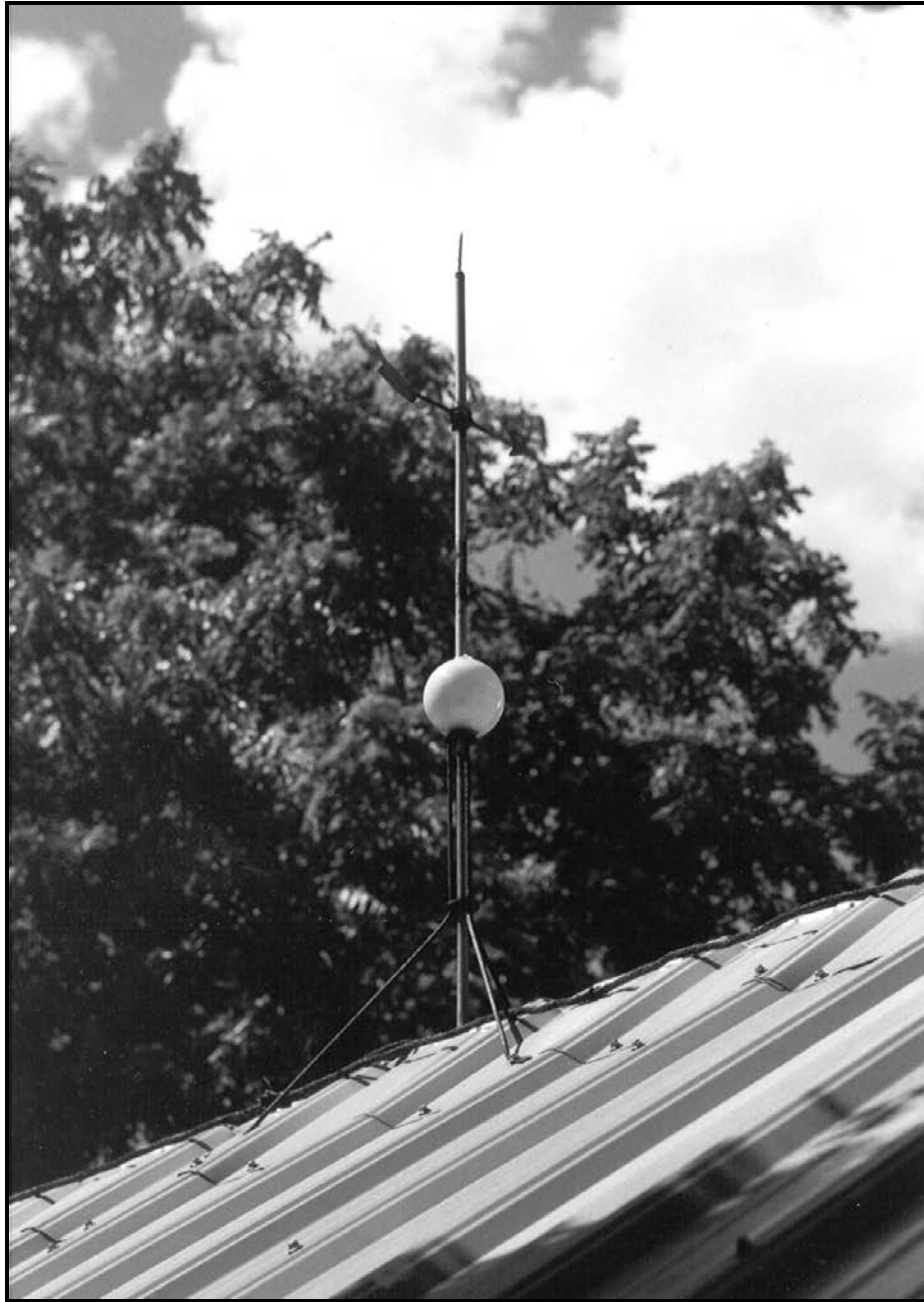
The 1873 lithograph of the farmstead does not illustrate any lightening rods on the house. However, there are pieces of old, solid-strand, lightening rod cable stored in the attic space above the porch on the west side of the north wing. At present, there are a number of older-style copper lightening rods, with glass balls, along the roof ridge (see Figure 49).

Figure 49. View of one of the lightning rods that is present on the roof the house. Also note the ribbed-metal roofing that has been installed in recent years (FRR June 2001).

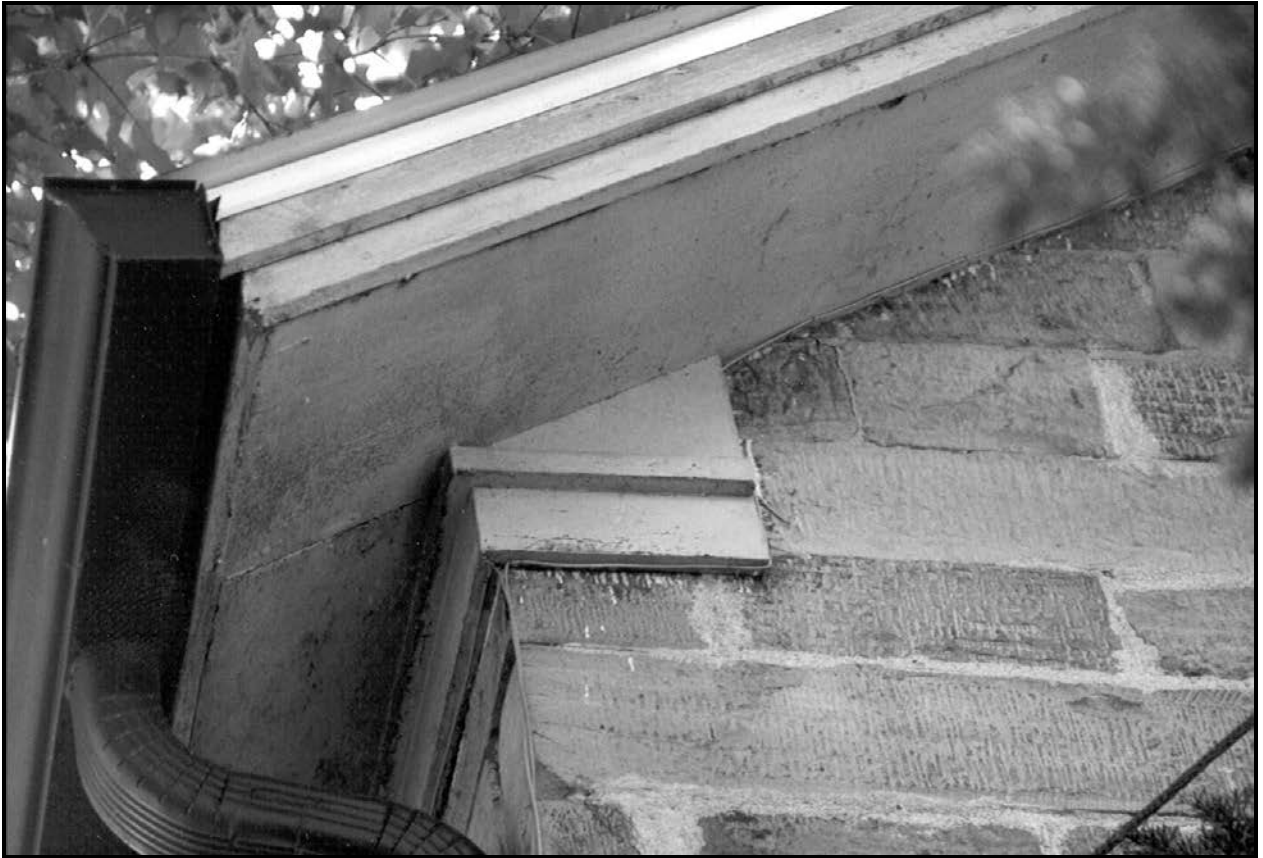
Figure 50. View of the cornice and eave on the southwest corner of the original house (FRR June 2001).

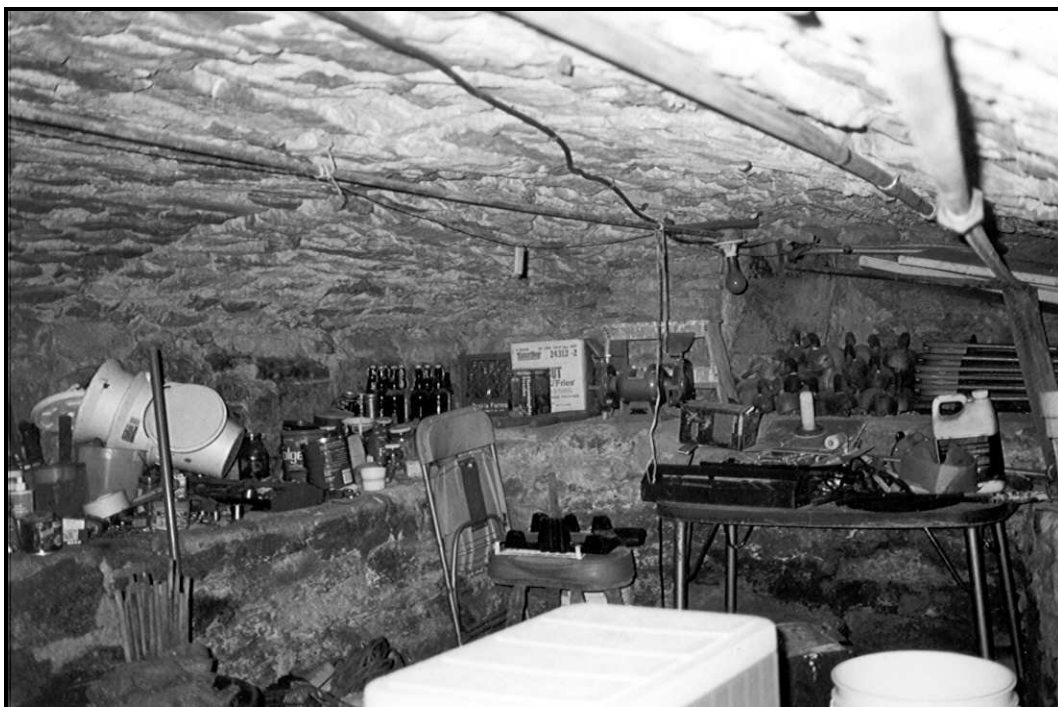
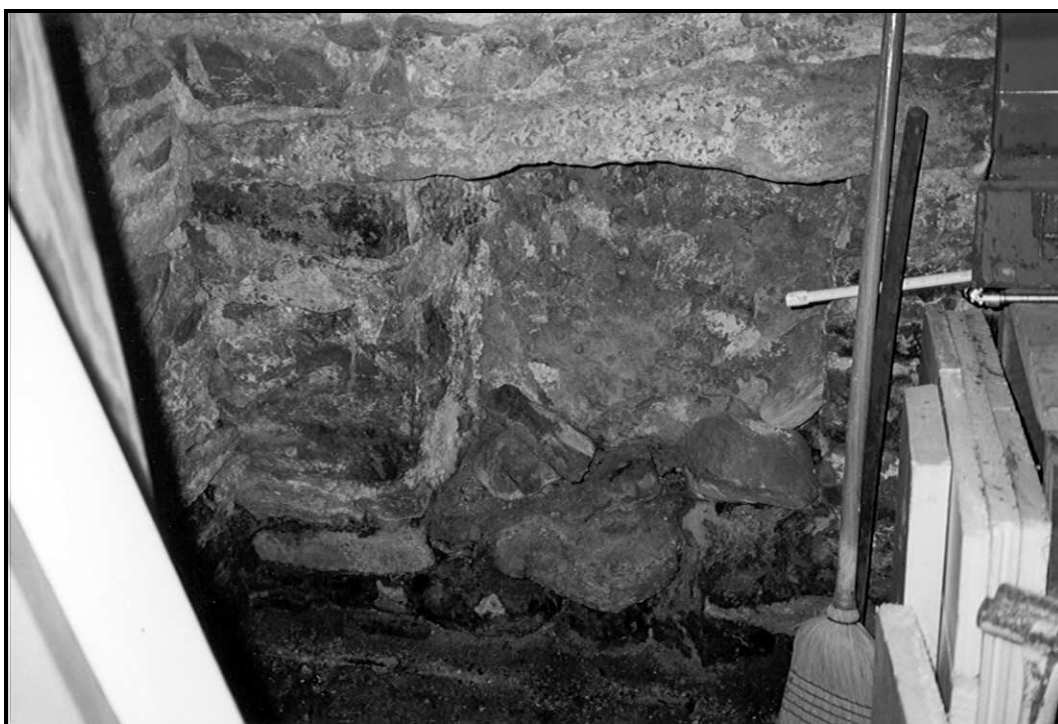
Figure 57. (TOP) View of vaulted cellar room located beneath original house, looking west. (BOTTOM) View of one of the two wall niches that are present along the south side of the vaulted cellar room. Niches of this type often were used as cold storage chambers for food and/or drink (FRR June 2001).

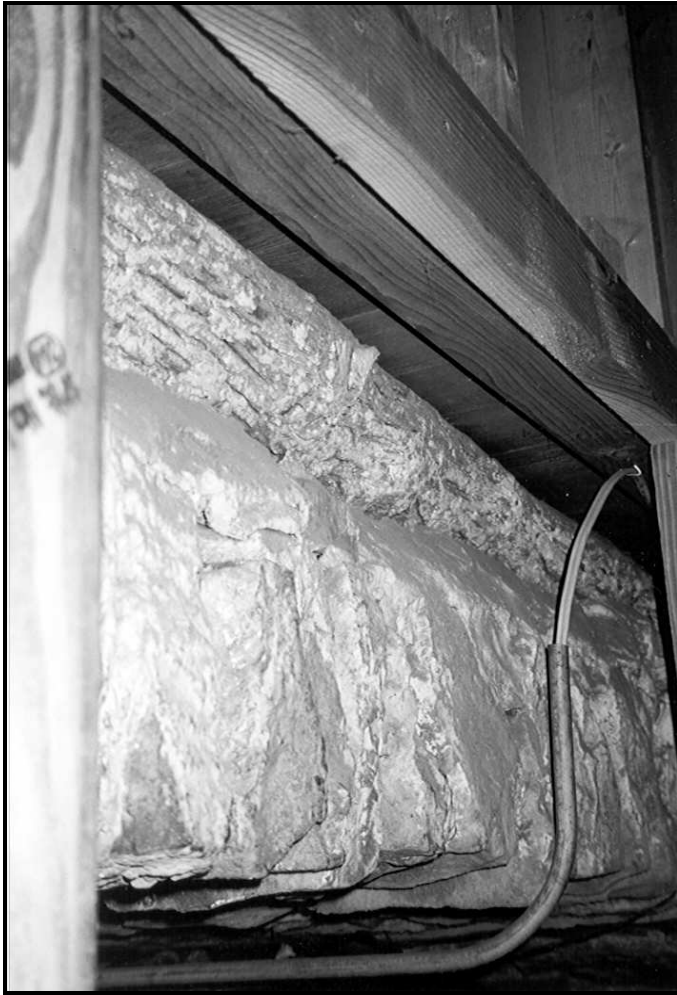
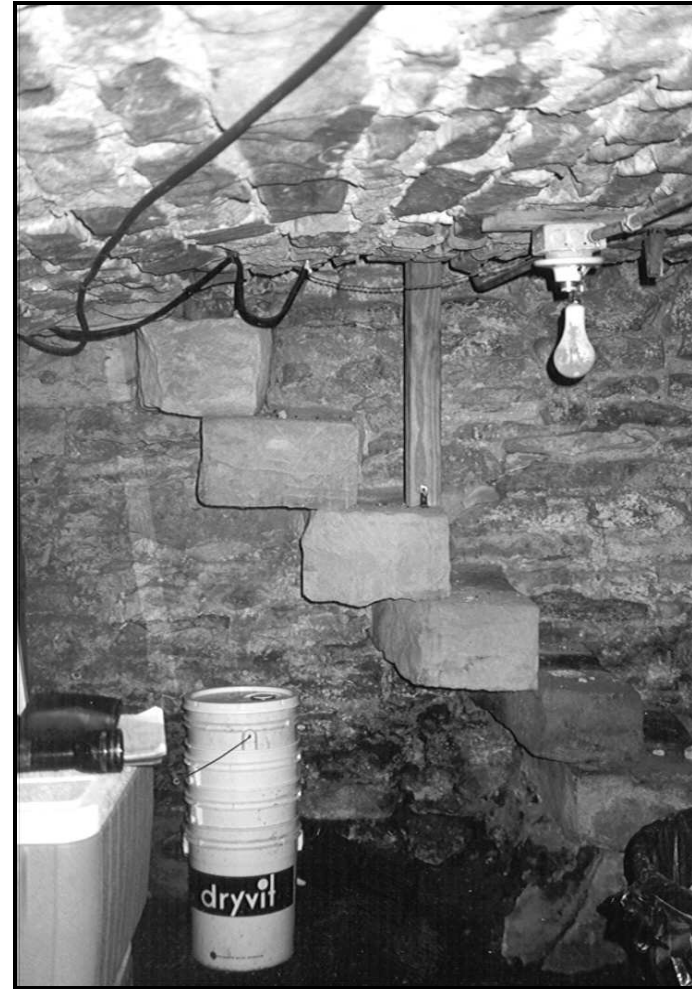
Stairways: The interior stairway leading to the basement is located below the second-floor stairs and descends from north to south. The basement stairway is quite unique in that it is comprised of large stone slabs that extend out from the adjacent foundation wall and hang in mid-air, with no stringer to support them (see Figure 58). There are nine stone steps that rise to a frame

Figure 58. (Left) View of the top of the stone vault over the original cellar room. Note the log floor joist (or “sleeper”) above the vault. (Right) The interior stairway leading between first floor and original cellar room. The stone steps are tied into the foundations and are suspended without the aid of a stringer.

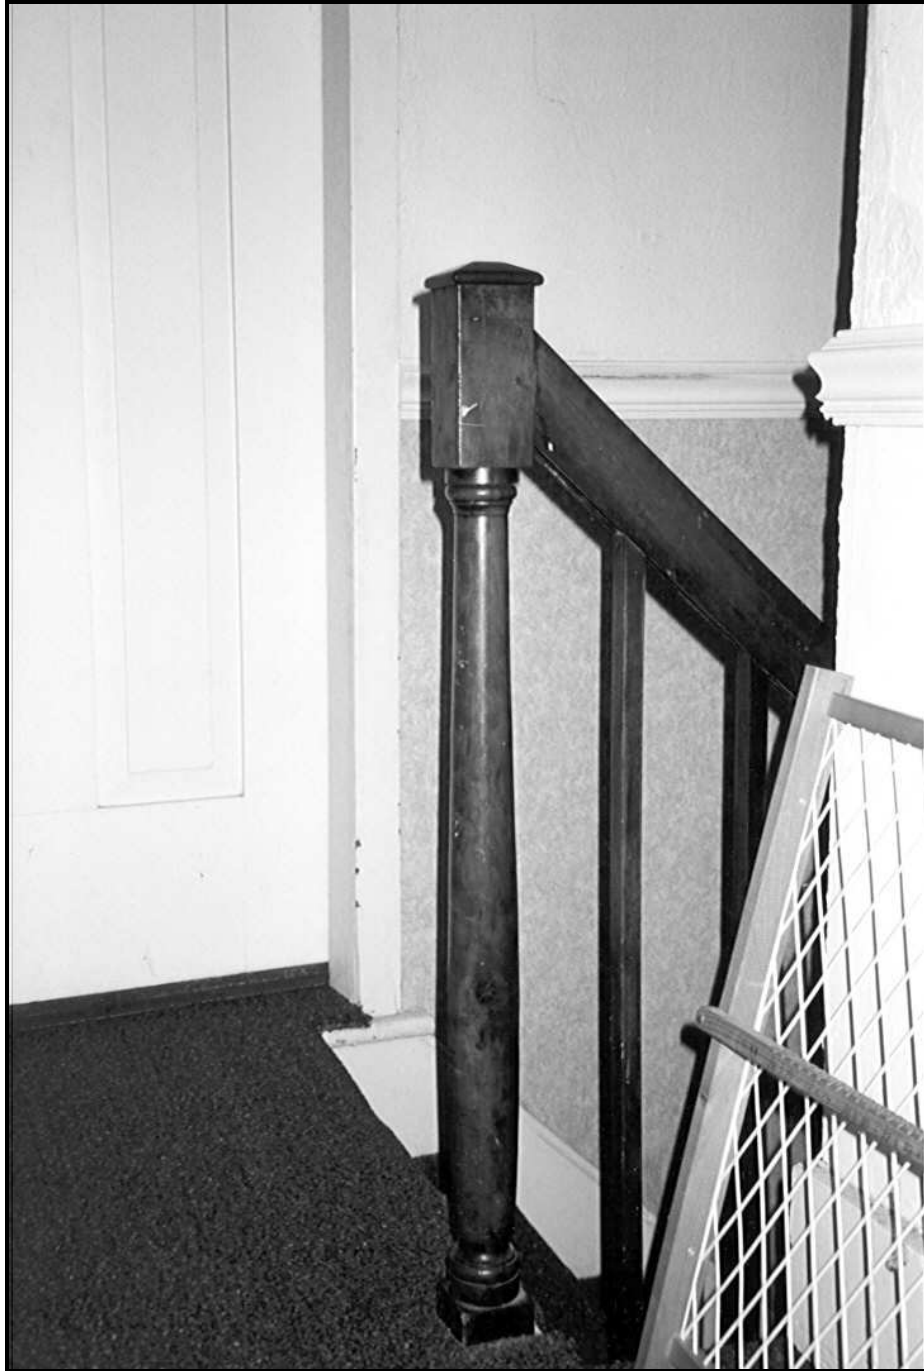
Figure 59. View of the newel post and balustrade present at the top of the second-floor stairway (FRR June 2001).

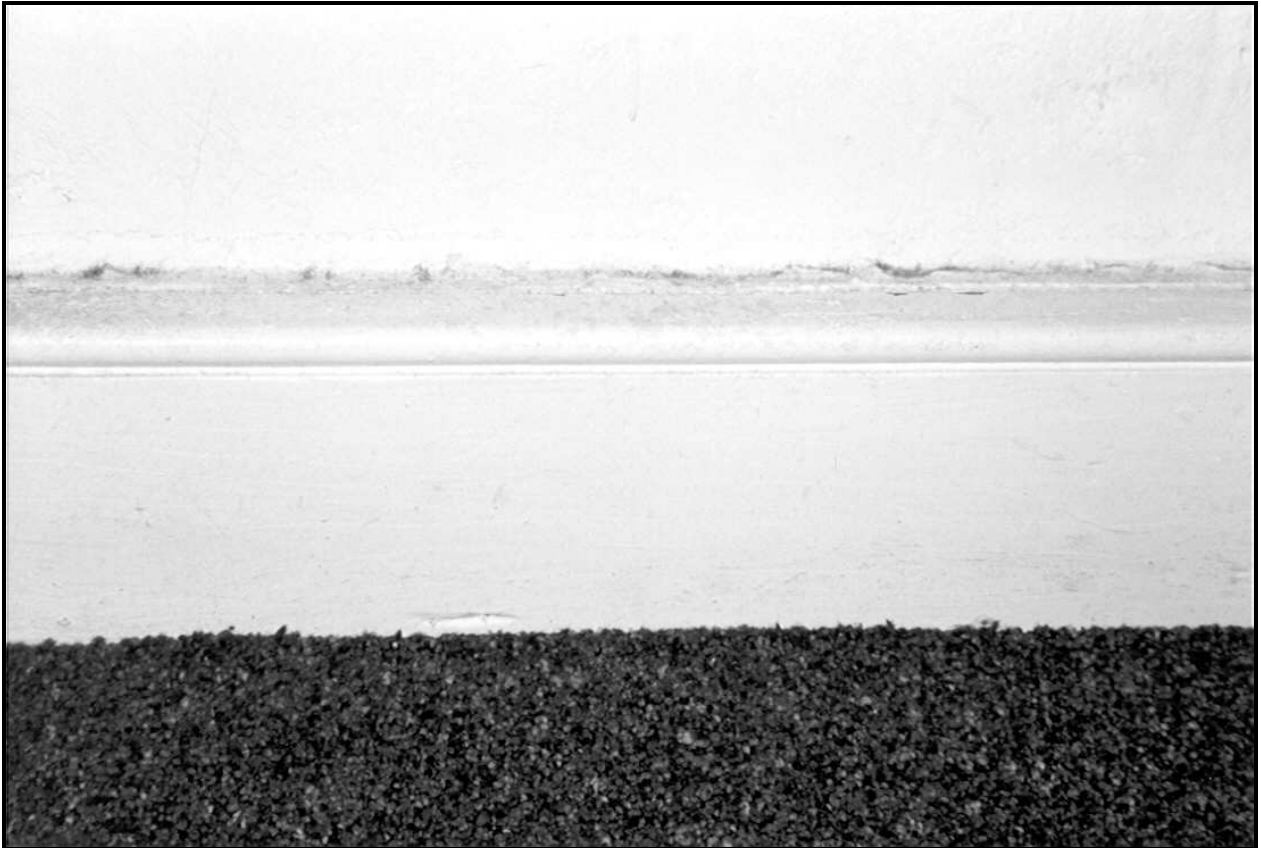
Figure 61. Original beaded baseboard found on the second floor of the house.

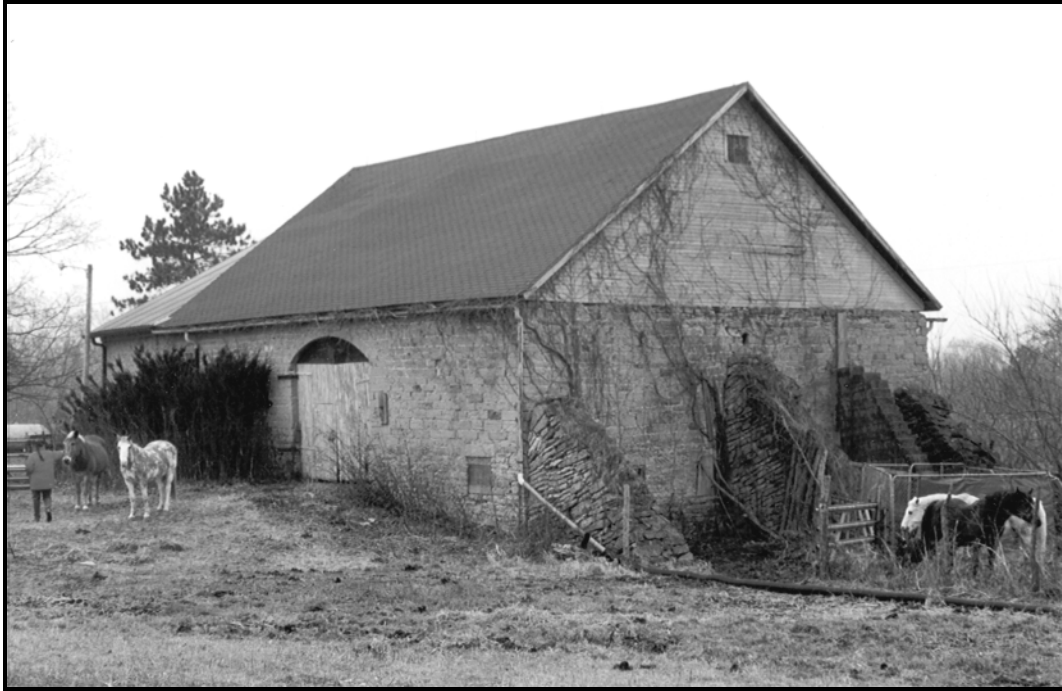
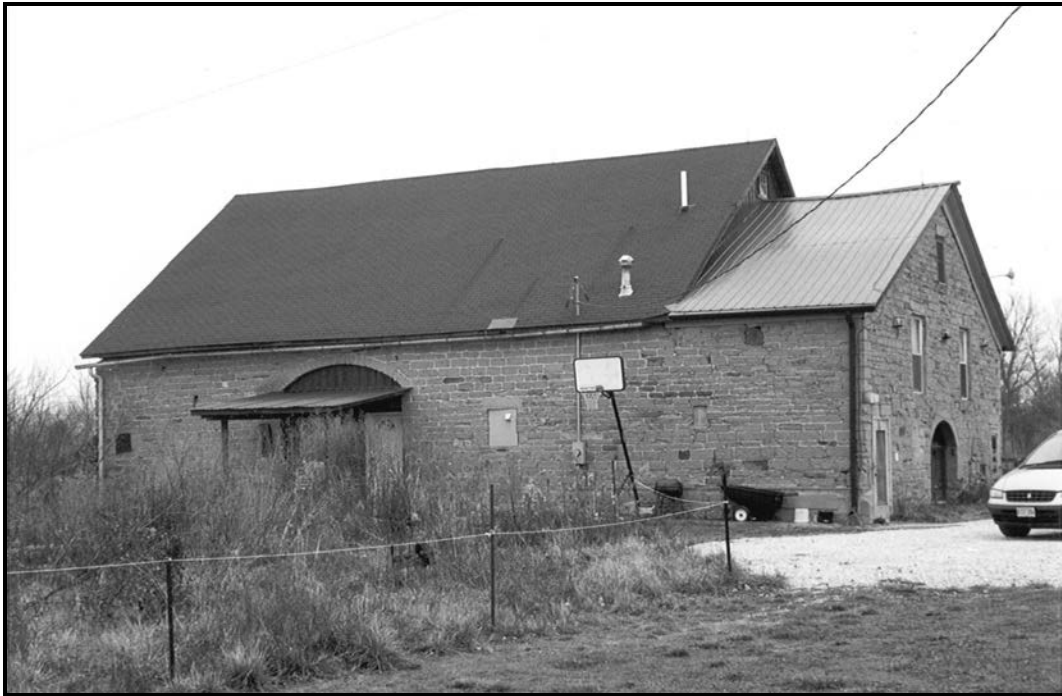
In addition to standard window openings, air vents are interspersed around the periphery of the barn, as well as along the interior wall that separates the cow house from the main barn (see Figure 73). The vents vary in size between 8"x8" and 10"x12." Oral tradition holds that these openings originally were intended to serve as gun slits for fighting off the Indians (*Peoria Journal-Star* 5 December 1963, p. E-3). This hardly seems likely, however, considering that the barn was constructed more than two decades after the last Native-American groups were removed from Illinois. Instead, the openings served an equally functional, but agricultural, role in venting the interior of the barn. The storage of large amounts of cut hay in an enclosed space always posed a threat of spontaneous combustion, so it was a matter of prime importance to assure adequate ventilation in the barn. Three of the six vents originally present in the north gable-end wall were eliminated when the upper section of this wall was demolished in circa 1900 (compare Figures 64 and 65).

Figure 64. (Top) The Howarth Barn, looking northwest. (Bottom) View of the barn, looking northeast (FRR November 2000).

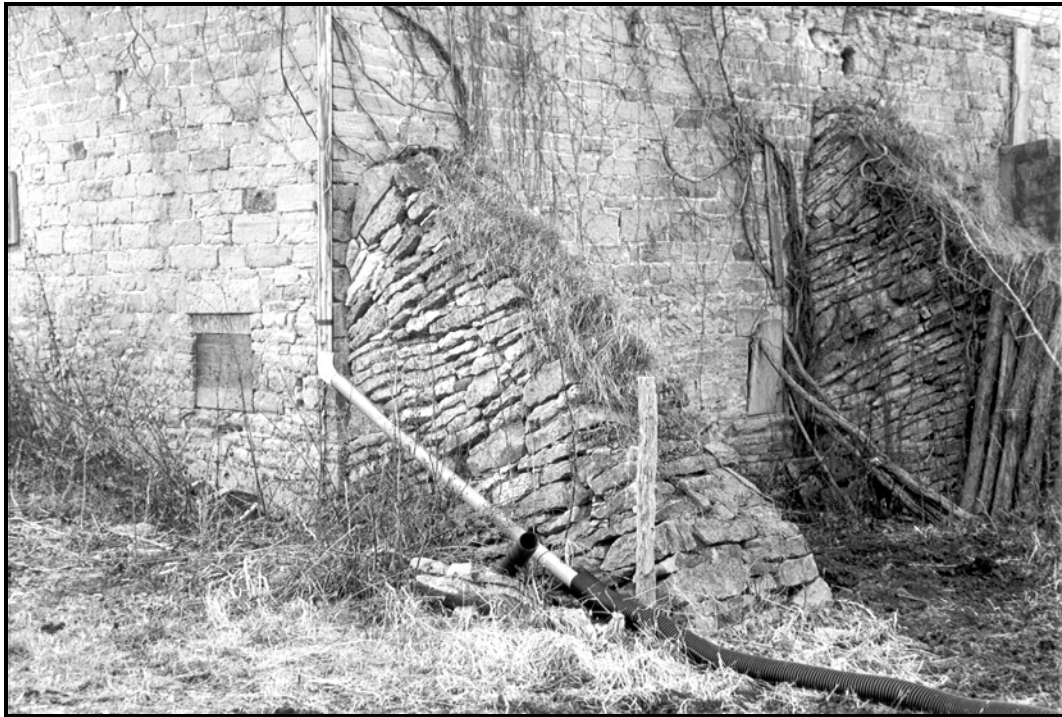
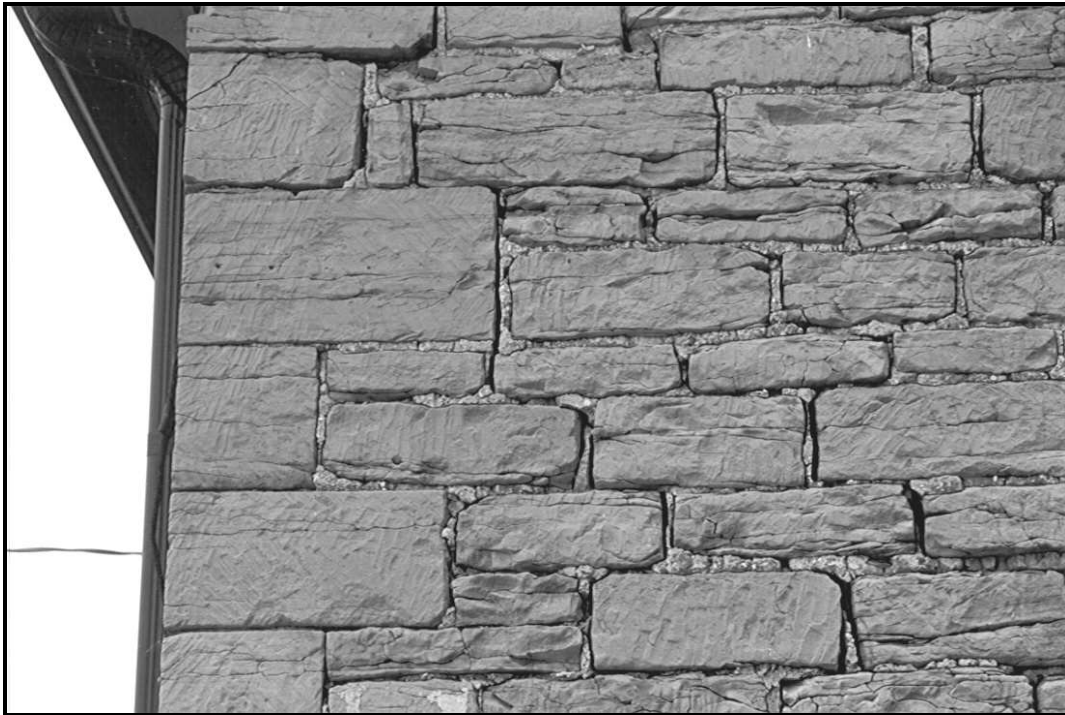
Walls: The walls of the barn are constructed of sandstone and generally measure 1'-6” to 1'-8” thick. The exterior stonework is regularly coursed ashlar and has been dressed with a chisel. It coursing varies between 6” and 12” in thickness. The stones on the corners of the building are larger and have a slightly neater finish, which gives them the appearance of quoins (see Figure 66).

Figure 66. (Top) View of the stone buttresses that were added to bolster the north wall. (Bottom) Detail of the stonework on the barn, showing the southwest corner (FRR November 2000).

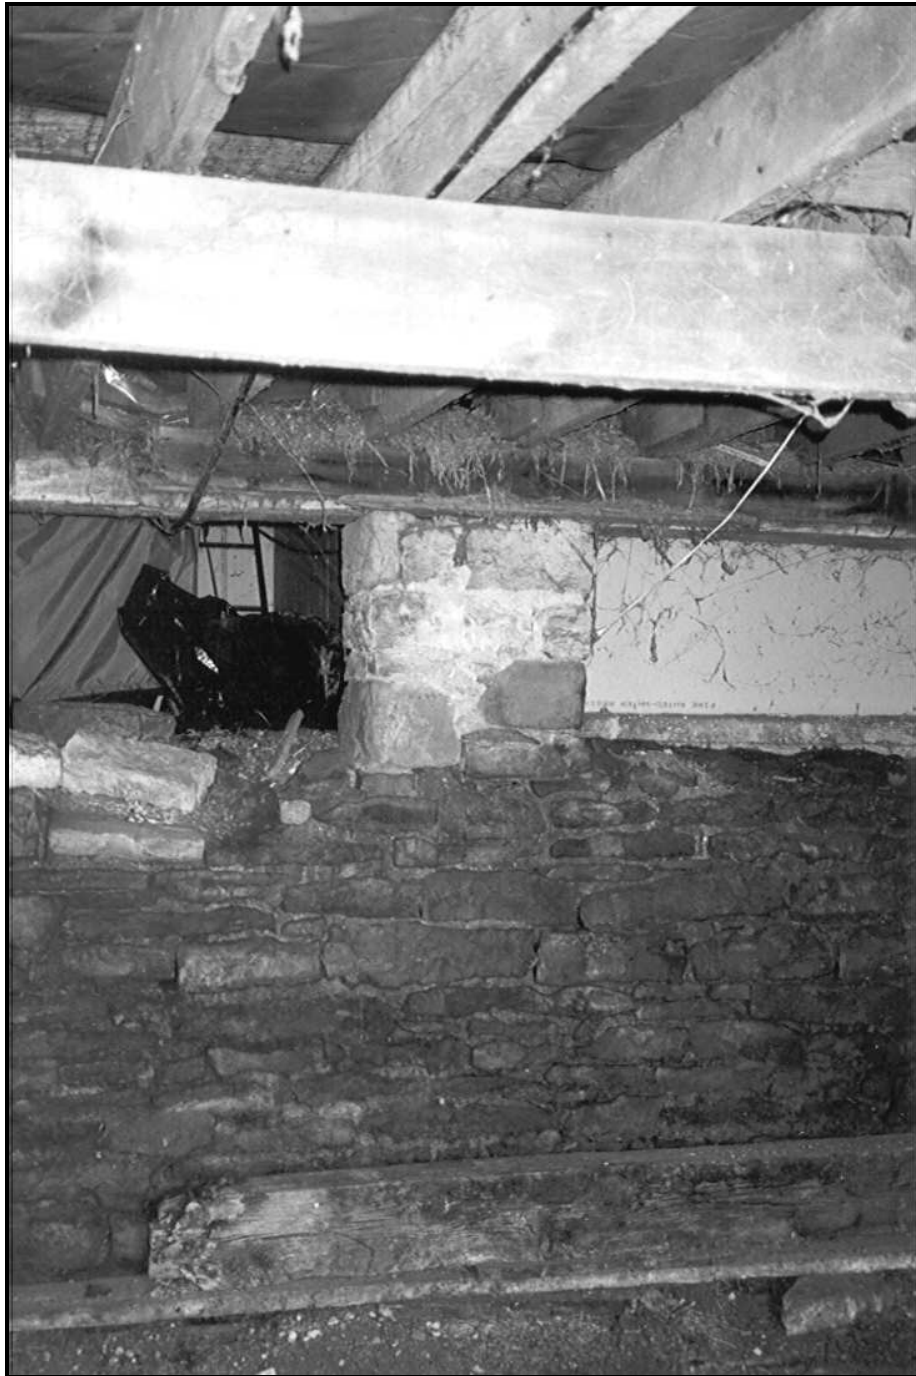
Foundations: The foundations of the barn built with regularly coursed, rough-cut sandstone. The perimeter foundations measure 1'-6” to 1'-8” thick, while the interior basement foundations generally measure 1'-3” thick (see Figure 67).

Figure 67. View of the interior foundations along the south side of the basement. The pier on top of the foundation wall helps support the north framing bent in the barn (FRR June 2001).

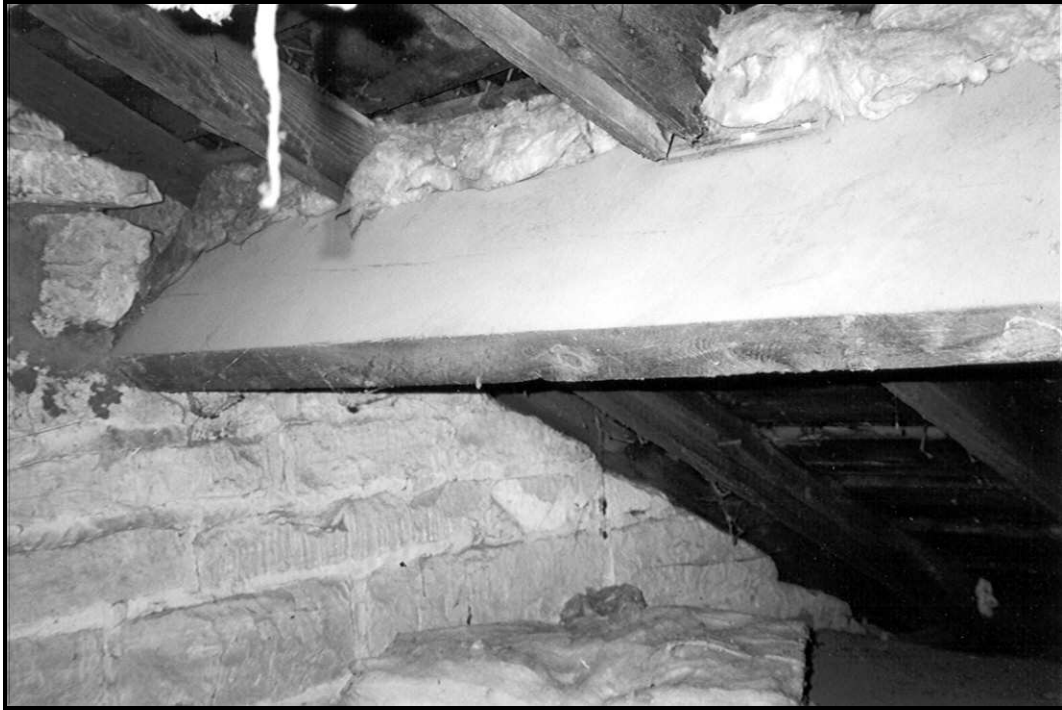
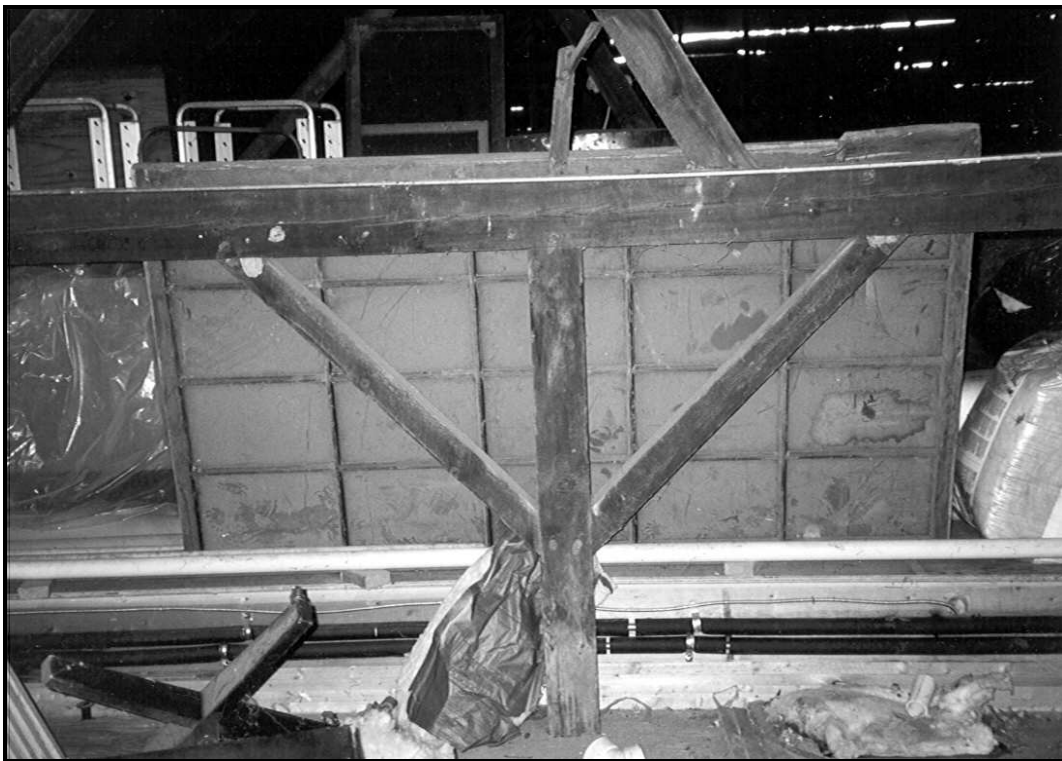
Structural System, Framing: The exterior walls of the Howarth Barn are of stone construction, as is the interior wall that divides the main barn from the cow house. All of the lofts in the barn are carried by 2"x8" white pine joists, which have been edged with a circular saw and planked with a vertical saw. The outer ends of the joists are set within pockets in the stone walls. In the case of the upper loft in the main barn, two joists (which are overlapped and nailed together) were used to span the distance between the east and west walls; these joists are supported from below two large, hand-hewn, oak girts. The only portion of the original roof that remains intact is located over the cow house section. The roof is carried by 2"x4" white pine rafters set 1'-10" to 2'-0" on-center. Like the floor joists, the rafters have been edged with a circular saw and planked with a vertical saw. A 3"x10-1/2" circular-sawn, white pine purlin is positioned below the central span of the rafters on each slope of the roof (see Figure 68). The rafter plate is 7-1/2"x8", hand-hewn oak.

Figure 68. (Top) View of the roof framing in the cow house, showing the rafters and supporting purlin. (Bottom) View of a post and girt with diagonal bracing, located in the main barn. This framing was installed circa 1900, at the same time that the roof was replaced (FRR June 2001).

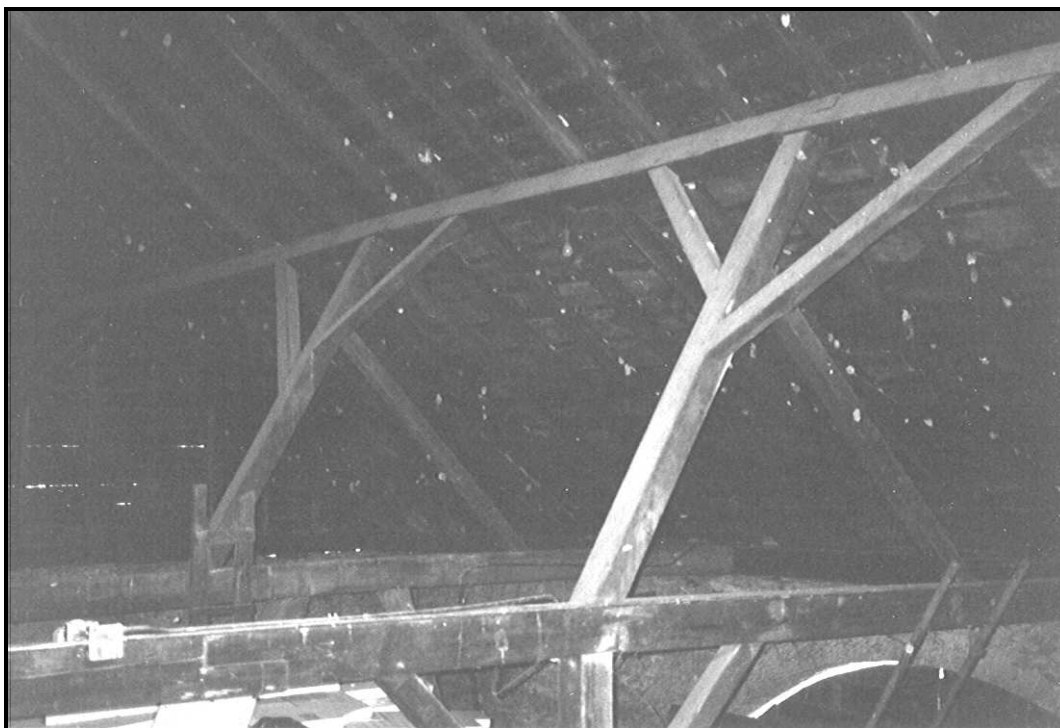
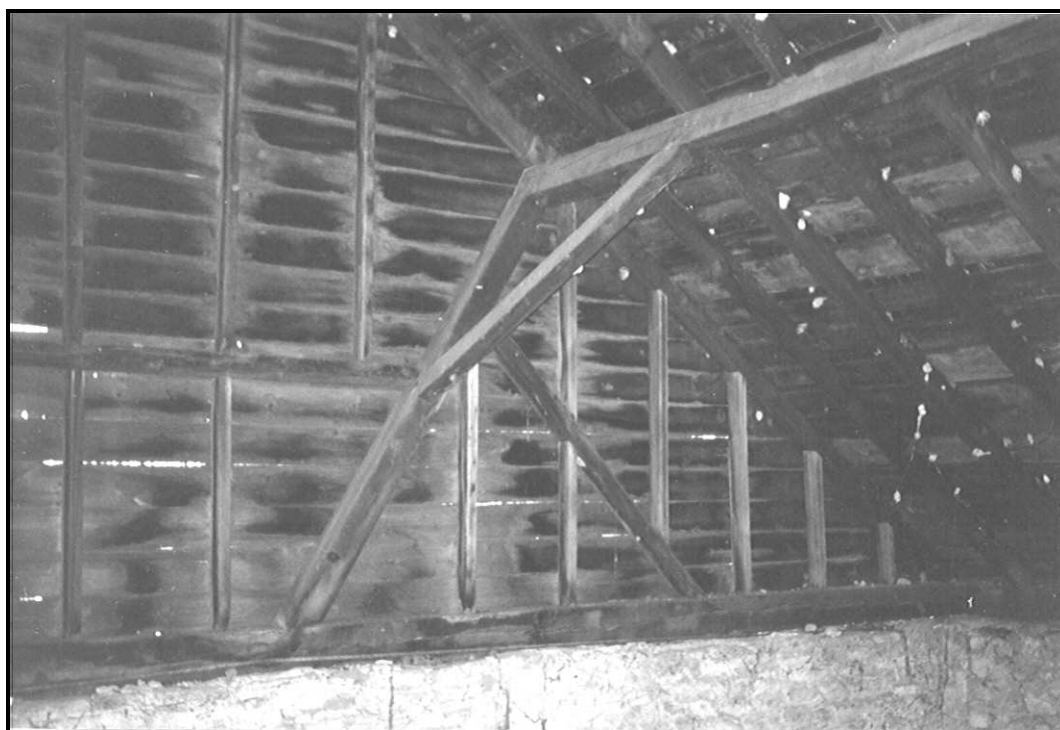
The roof framing in the main section of the barn is fairly intricate and includes a braced purlin system, which employs fairly large diameter stock (8"x8" plates, 6"x6" posts, 5-1/2" x7-1/2" purlins, and 4"x4" braces) connected with mortise-and-tenon joints. The purlin system is illustrated in Figures 68, 69, 77, and 78. The rafters measure 2"x6" and are placed 2' on-center, while the roof sheathing varies in size from 1"x6" to 1"x10". All of the lumber used in the construction of the new roof is yellow pine. The lumber is not surfaced planed (i.e. rough on all four sides), and the sawing method used in its production varies: some materials being all circular-sawn or vertical (band?)-sawn, and others being edged with one type of saw and planked with another. Broadly speaking, the character of this stock—the species of wood,¹ rough finish, and mixture of full-dimensional and nominal-sized material—is indicative of the period 1890-1910. Hence, we have suggested a circa 1900 construction date for the new roof system, a dating we feel also is supported by the mixture of machine-cut and wire-drawn nails used (see discussion of hardware below).

Figure 69. (Top) View of the roof system in the main barn, showing the underframing. (Bottom) View of the framing at the north gable. The stonework originally present in the gable has been removed down the level of the rafter plate (FRR June 2001).

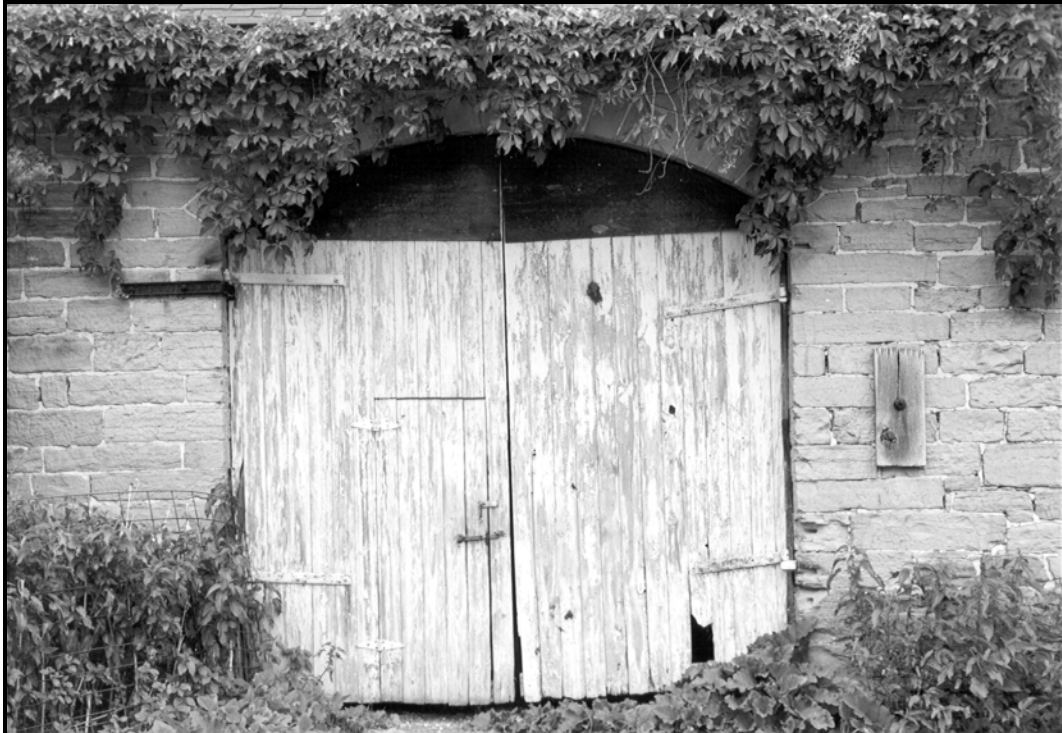
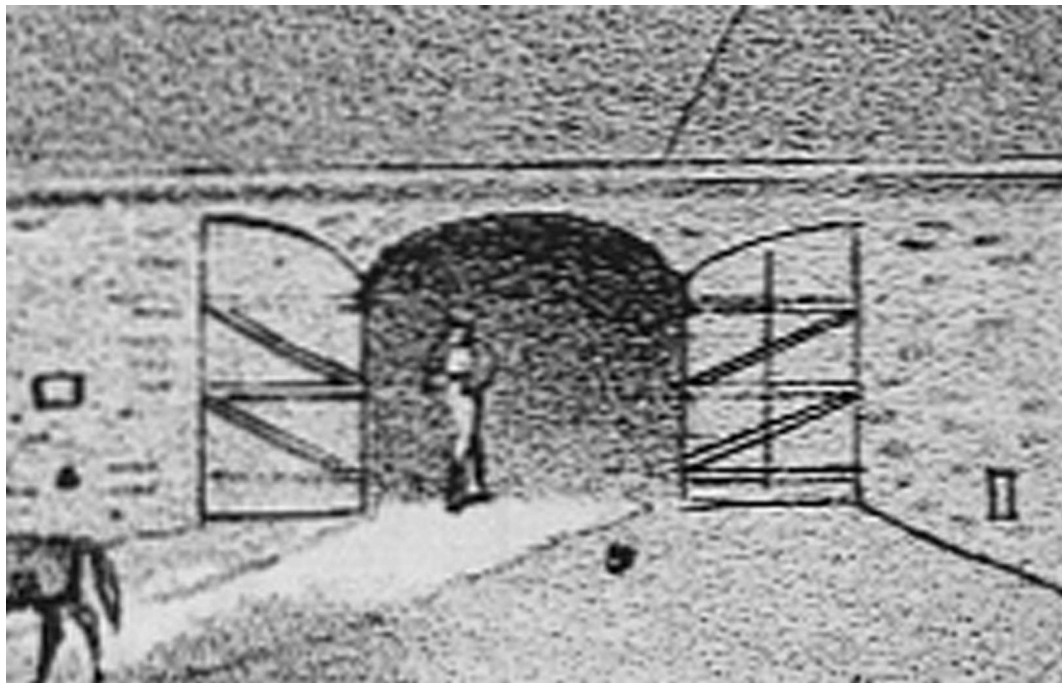
Doorways and Doors: The barn was built with a total of eight exterior doorways. Two of these were located at opposite ends of the central drive on the east and west elevations of the barn. These doorways measured 11'-0" wide, had arched openings, and held large double doors (see Figure 70). A third arched entrance was centrally located on the south elevation and allowed access to the feeding aisle in the cow house. Although narrower and shorter than the two driveway entrances, this opening nonetheless quite wide (8'-0") and originally was enclosed with double doors (see Figure 71). Lying to either side of

Figure 70. (Top) Arched doorway on the east elevation of the barn. This entrance formerly accessed the central aisle and threshing floor in the building. The current doors are twentieth-century replacements (FRR June 2001). (Bottom) Detail of the 1873 lithograph, illustrating the character of the original doors present on the east entrance. Also note the small window openings located to either side of the doorway (Andreas 1873).
