HISTORIC STRUCTURE REPORT:

HOWARTH HOUSE AND BARN
WILDLIFE PRAIRIE STATE PARK, PEORIA COUNTY, ILLINOIS

Fever River Research
Springfield, Illinois

June 2002

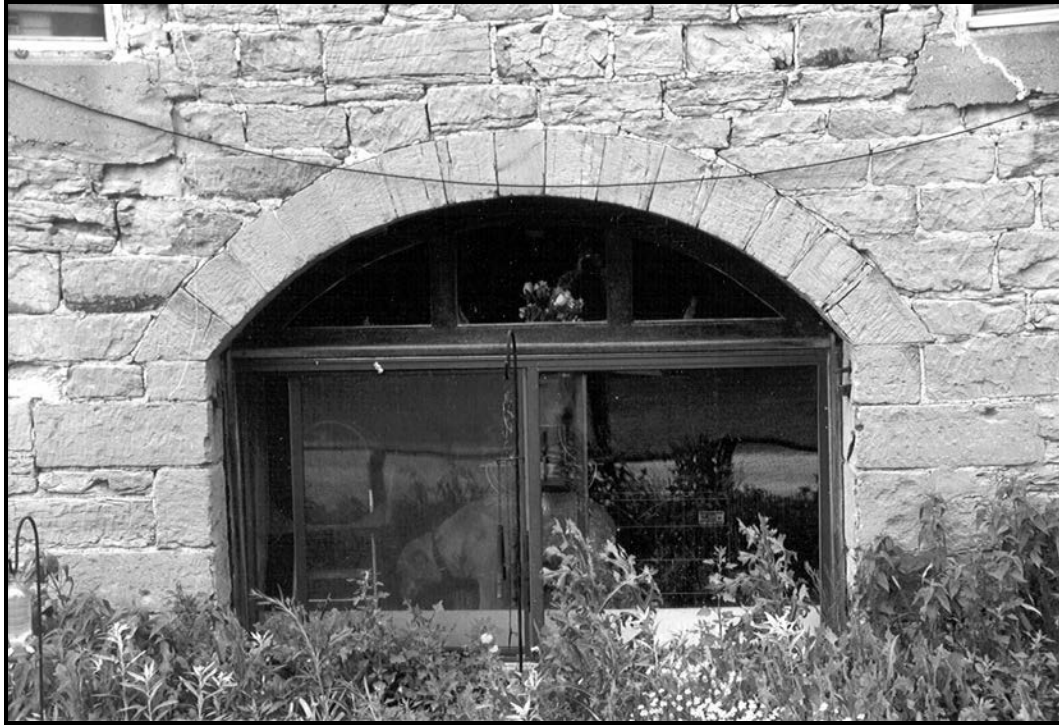
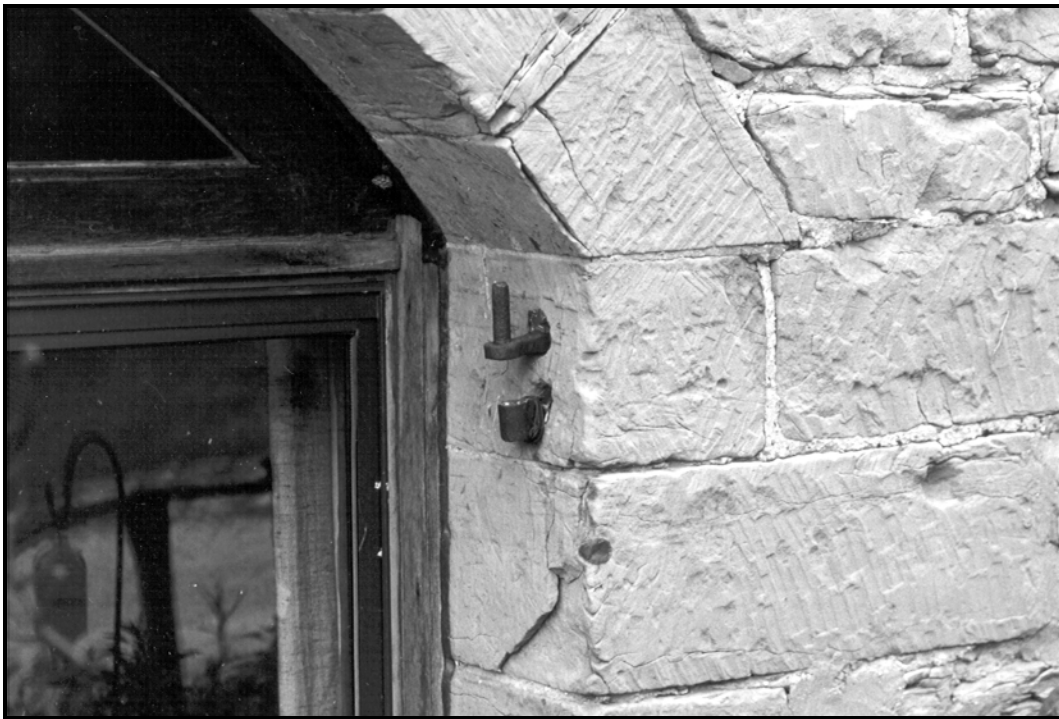
Figure 71. (Top) View of the central arched entrance in the cow house. The doors have been removed and the opening converted into a window. (Bottom) Detail of the arched doorway for the cow house, showing one of the pintels on which the original doors were hung (FRR June 2001).

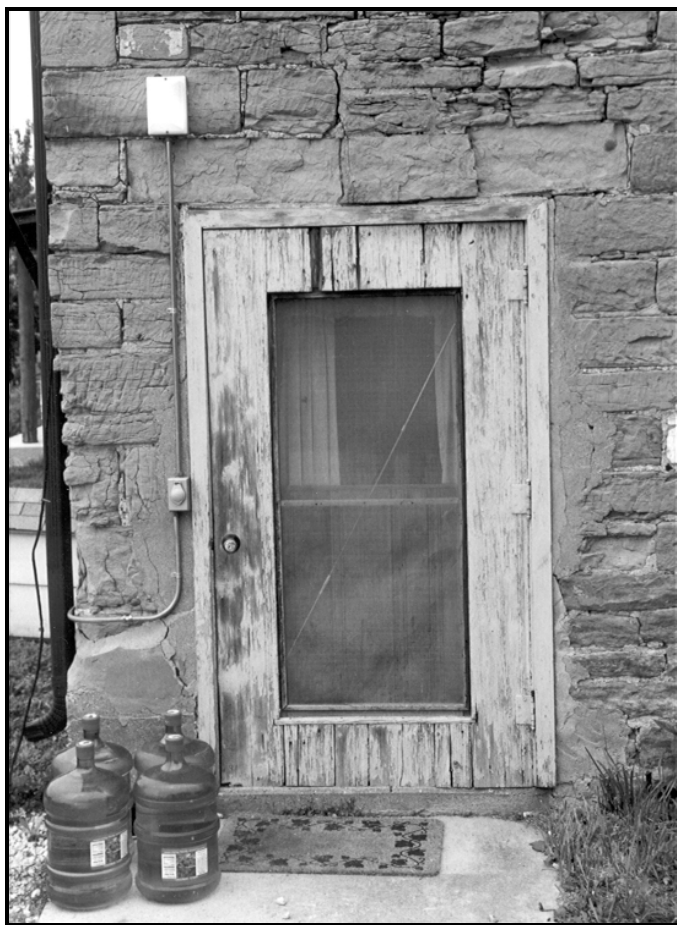
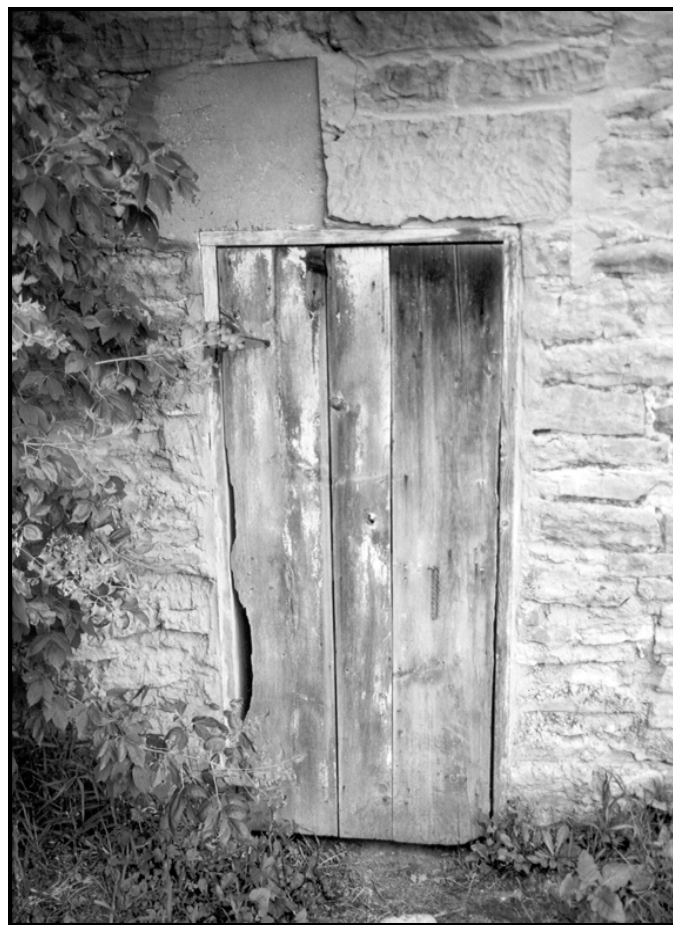
this central arched entrance were 4'-2"-wide (stone-to-stone) doorways; that were wide enough for livestock (see Figure 72). In a classic Lancashire Barn, these narrower doorways would have served the manure aisles that flanked the central feeding aisle. The basement at the north end of the barn was accessed at grade through three exterior doorways. Two of these were 4'-2"-wide livestock doors, which were located on the north elevation, while the third was a narrower personnel-access door located on the north end of the west elevation (see Figure 72).

None of the existing doors on the barn appear to be original to the building. This is not entirely surprising, given regular wear and tear they would have been subjected to by the movement of livestock and equipment in and out of the building. Nonetheless, the vertical-plank-and-cross-braced construction used on the majority of the existing doors may very well reflect the character of the original doors. The exceptions to this are the doorways accessing the cow house. The doorways associated with the central arched entrance have been removed altogether and the opening has been converted into a window, while the doorways located either side of it have had more substantial residential doors installed.

Figure 72. (Left) View of the western door that accesses the cow house section of the barn. This doorway originally serviced livestock, but now functions as the principal entrance to the living quarters that have been installed in the cow house. (Right) View of the personnel door on the west side of the barn. The plank construction of this door was probably typical of the original doors on the barn (FRR June 2001).

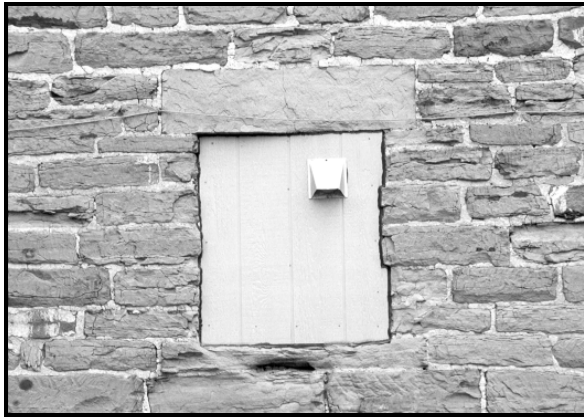
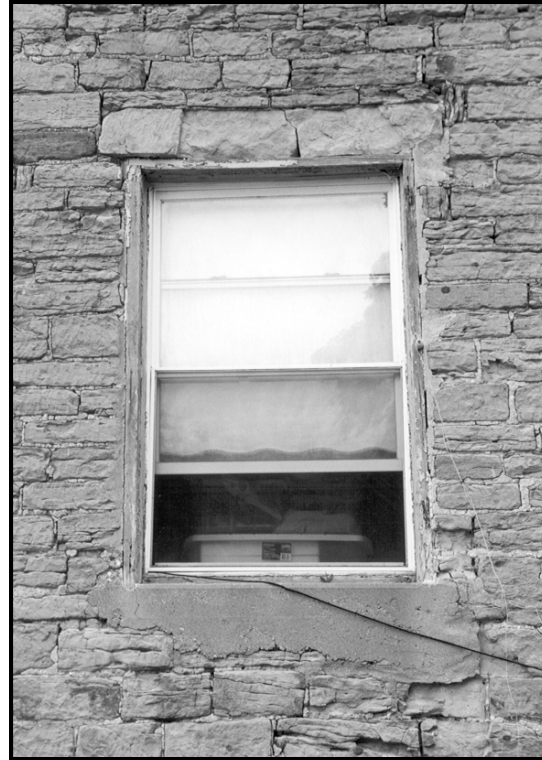
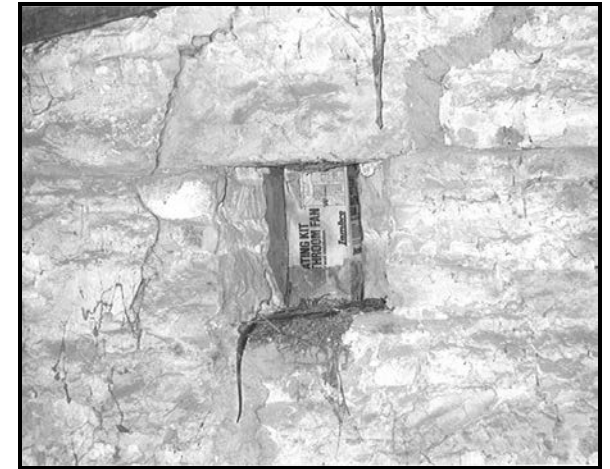
Windows: There are three window openings on the south elevation of the barn. Two of these are located on the second floor level and measure 3'-8"x5'-8" (rough opening). Although these openings currently hold double-hung sash with one-over-one lights, they originally may have served as mow doors for the loft (see Figure 73). The third window opening is smaller, measuring 2'-7"x4'-0", and is located nearly at the peak of the gable. A number of shorter window openings are located on the east, west, and north elevations. These vary in width between 2'-0" and 2'-6", and most have had their sash removed and have been framed in (see Figure 73).

In addition to standard window openings, air vents are interspersed around the periphery of the barn, as well as along the interior wall that separates the cow house from the main barn (see Figure 73). The vents vary in size between 8"x8" and 10"x12." Oral tradition holds that these openings originally were intended to serve as gun slits for fighting off the Indians (*Peoria Journal-Star* 5 December 1963, p. E-3). This hardly seems likely, however, considering that the barn was constructed more than two decades after the last Native-American groups were removed from Illinois. Instead, the openings served an equally functional, but agricultural, role in venting the interior of the barn. The storage of large amounts of cut hay in an enclosed space always posed a threat of spontaneous combustion, so it was a matter of prime importance to assure adequate ventilation in the barn. Three of the six vents originally present in the north gable-end wall were eliminated when the upper section of this wall was demolished in circa 1900 (compare Figures 64 and 65).

Figure 73. Representative examples of the three types of original window openings that are present in the Howarth Barn. (Right) A small window on the west elevation that has been framed in. Similar-sized windows are present on the east and north elevations. (Center) A large window openings on the south elevation that formerly served as a mow door for the hay loft over in the cow house. (Left) One of the small vents that punctuate the exterior walls, as well as the interior wall that separates the main barn and cow house (FRR July 2001).

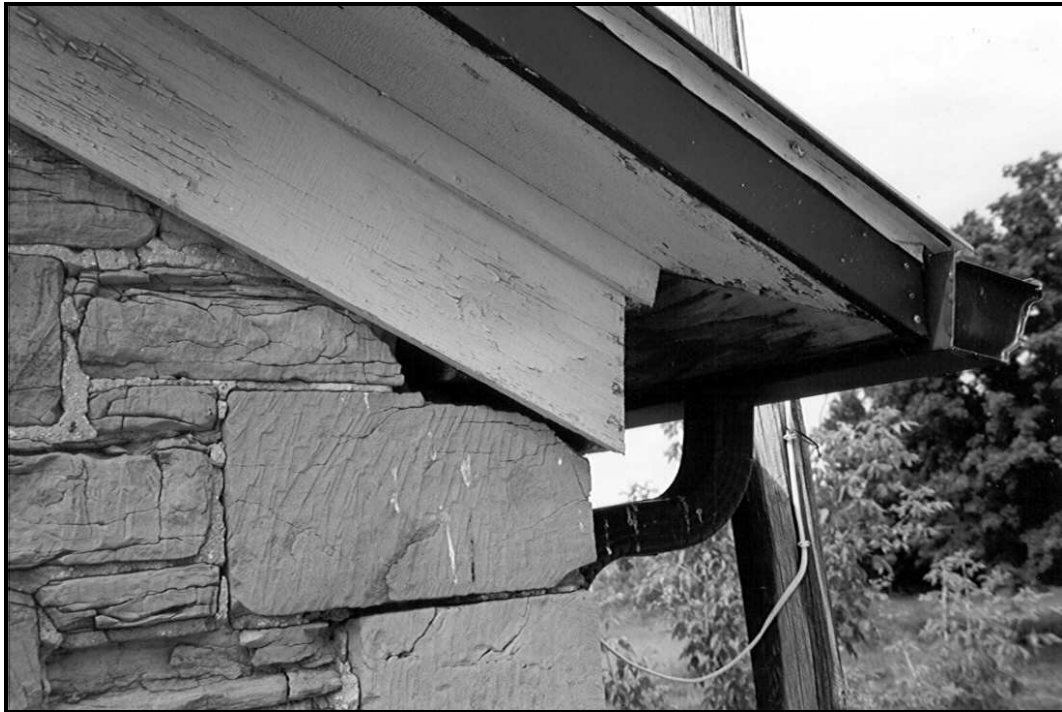
Cornice, Eaves: The barn has open eaves with enclosed rafters that measure roughly 11” deep. The cornice is adorned with a 1”-thick flat frieze board (with 7-½” exposure) and a plain, square bed molding. The frieze board and bed molding continue along the rake on the south gable-end of the building (Such also likely would have been the case on the north gable-end wall prior to removal of the stone gable here).

Figure 74. View of the eave and cornice at the southeast corner of the barn.

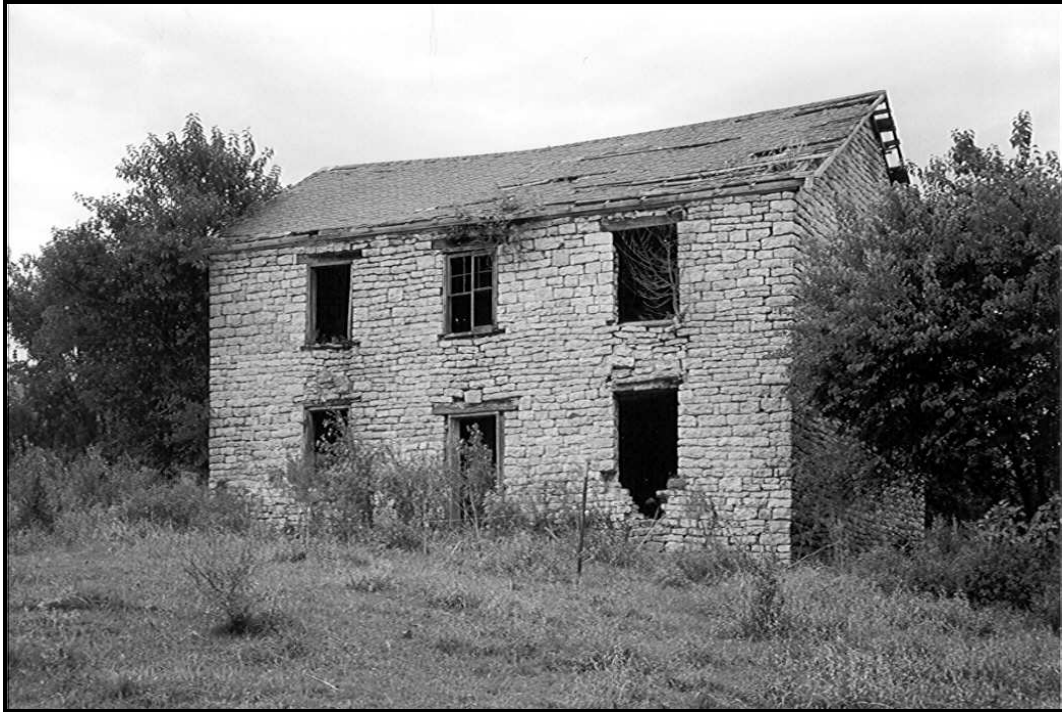
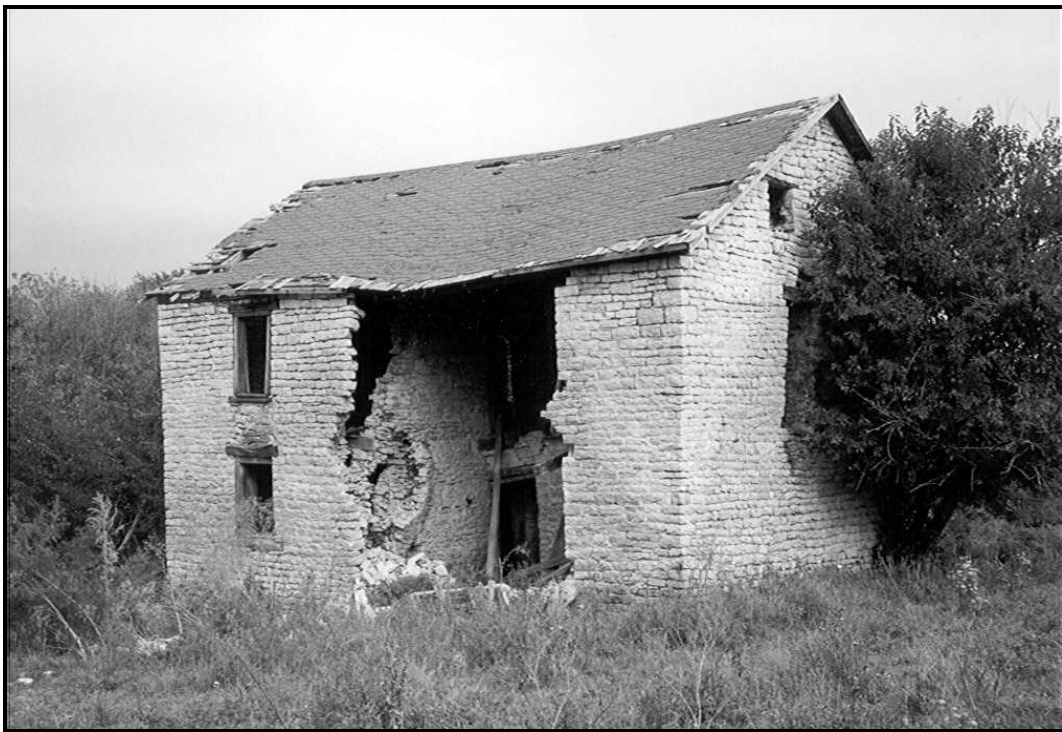
Appendix Figure 1. Exterior views of the Lonsdale House. (TOP) The front, or east, elevation, looking southwest. (BOTTOM) The rear elevation, showing the partially collapsed wall here (FRR September 2002).

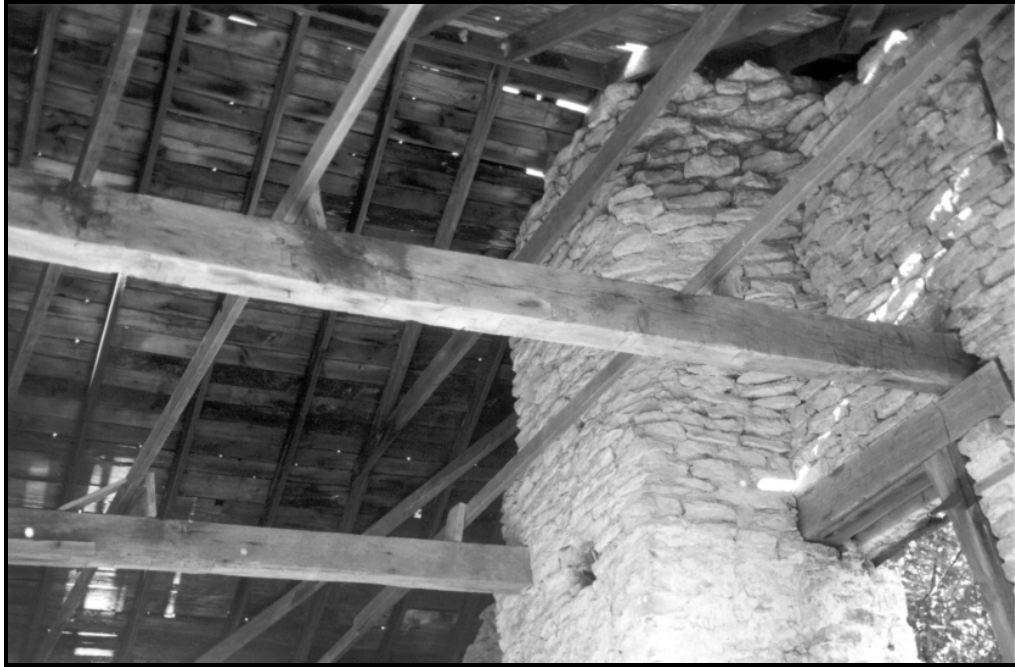
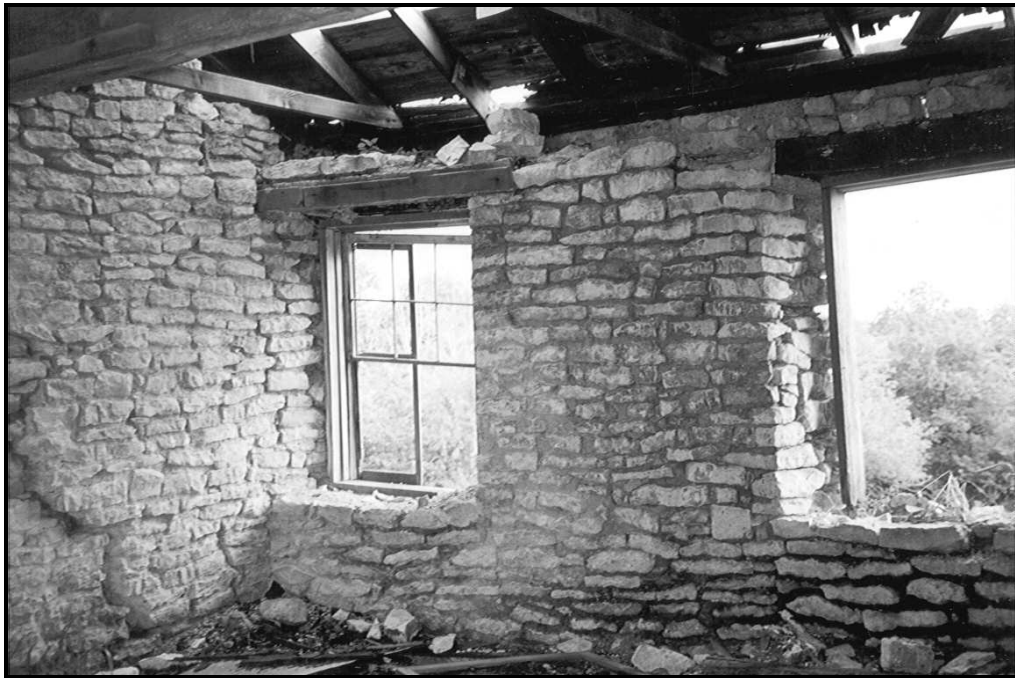
Appendix Figure 4. (TOP) View of the large stone chimney on the south gable-end of the house. Note the original hand-hewn beams whose ends are incorporated into the chimney. The roof was replaced in the twentieth-century. (BOTTOM) Interior view of Room 201, illustrating the unfinished character of the walls and ceilings on the upper floor. Also note the surviving six-light sash in the left window (FRR September 2001).
