Illinois State Capitol Historic Structure Report

March 17, 2009

Wiss, Janney, Elstner Associates, Inc.

WJE Project Number: 2007.0701

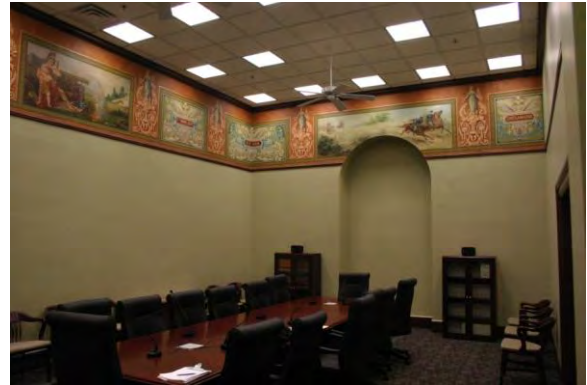
Figure B32. Decorative frieze restored in Room 115.

The existing flooring is carpet in the meeting rooms and terrazzo in the corridor. The original painted frieze on the walls was restored in 2001 on the north and east walls of room 100 (formerly called 115A) (See Figure B32). The design depicts Civil War battle scenes with panels bearing the names of Civil War battles between. Note that the panel at the southeast corner of the room was incorrectly restored, with the spelling “Chickamaoga” rather than “Chickamauga” (Figure B33). Other fragments of the original frieze exist above the suspended ceiling in storage closet 115B. Room 115 has wallpaper, non-original wood wainscot, and non-original plaster cornice molding below the suspended ceiling. The three windows in Room 115 have their original stained wood surrounds (Figure B34), and the original window surround remains in place at the non-original exit door at the west end of the corridor (Figure B35). The fifth window of this historic space is now within the non-original stairwell. The original door opening to the corridor from this space is now within the non-original elevator shaft. The present-day opening to the central corridor is arched and finished with a stone wainscot matching the corridor walls; possibly, this opening was originally a window to the corridor but was converted to an open archway when the elevator shaft was created circa 1916. The central portion of the original ceiling design is exposed in the central corridor, with a depiction of President Abraham Lincoln at the west end (Figure B36). The meeting rooms have suspended acoustic tile ceiling which conceals the remainder of this original ceiling design.

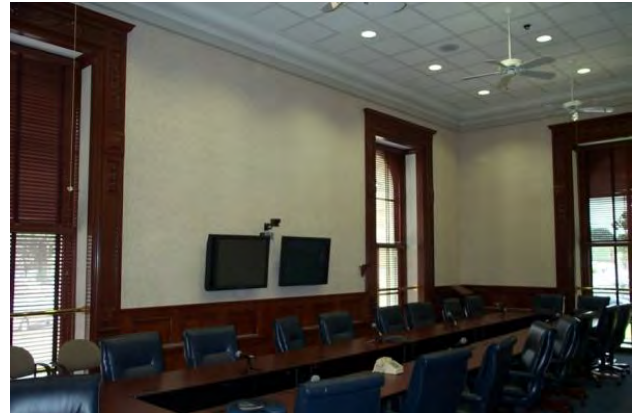
Figure B34. Room 115 original window trim.

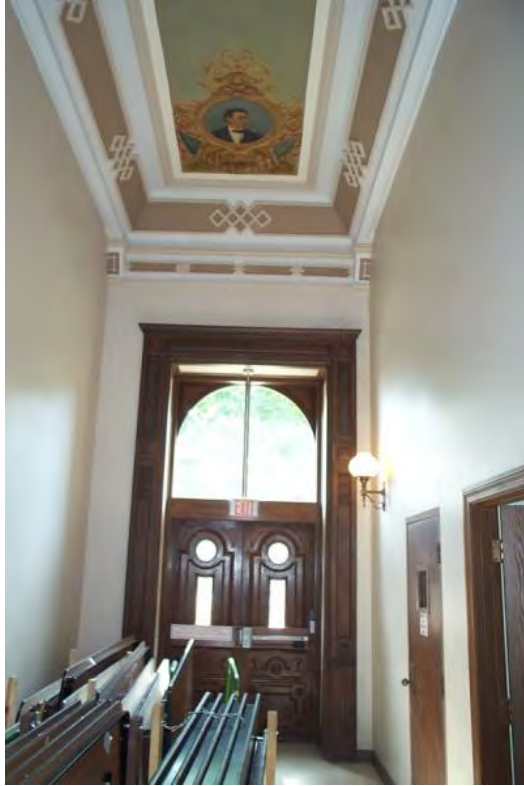
Figure B35. Original window trim in place around added exit door.

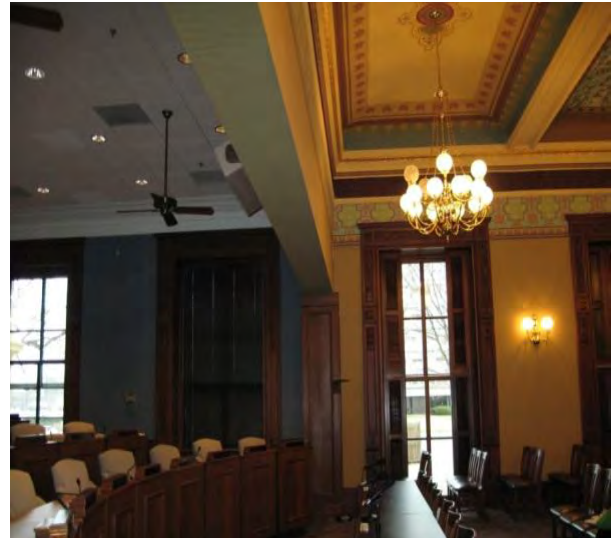
Figure B38. Box beam support in Room 114 at the former bearing wall.

Room 114 (south half, formerly room 114) / West Side, Middle Room. This space was historically one office, but the bearing wall at the north side has been opened to create a larger hearing room. A boxed-out beam divides the hearing room at the former bearing wall (Figure B38). The existing flooring is carpet and includes tiered desk seating. The walls have non-original wood wainscot with a simple rectangular inset panel pattern. The original door to the corridor retains the original wood trim and transom (Figure B39), and the two windows in this room retain the original wood surrounds. The original corridor window has been closed up. The existing ceiling is suspended acoustic tile with a non-original plaster cornice molding. The suspended ceiling conceals a previous ceiling.

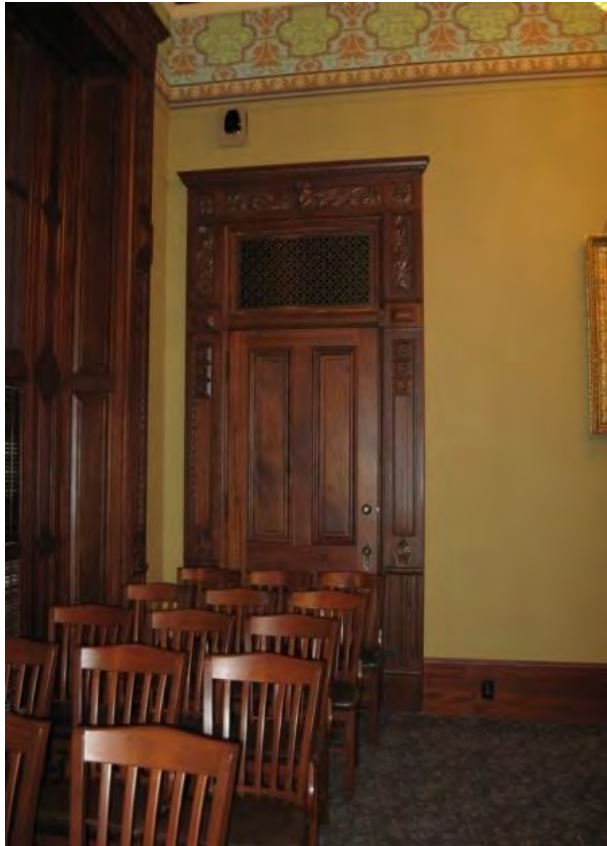
Figure B41. Non-original door in original door surround.

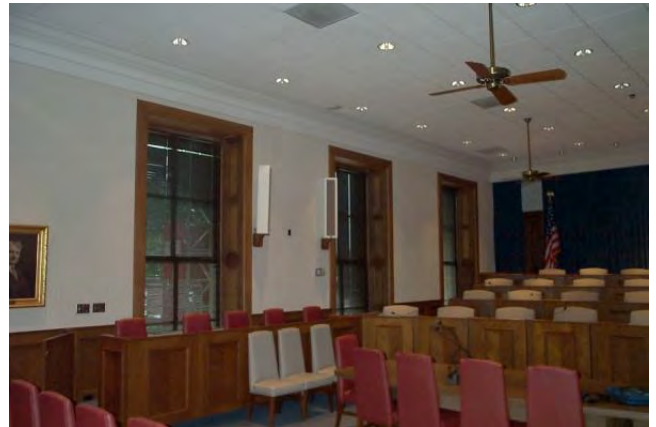
Figure B43. The non historic windows in Room 118.

This area of the building was historically subdivided as offices but is currently one room. The existing flooring is carpet, including tiered desk seating at the west end of the room. The three windows in the room have plain non-historic wood trim (Figure B43). The two door openings into the corridor have original wood trim and transoms (Figure B44). It appears that both pairs of doors opening to the corridor are original. The walls have non-original wood wainscot similar in type to the rectangular inset panel wainscot in the south half of room 114. The ceiling has non-original plaster cornice molding and suspended acoustic tile. A non-original structural column extends through this space near the northeast corner (Figure B45); this column existed prior to 1931. The existing suspended ceiling conceals acoustic tile on wood furring strips over a flat plaster ceiling.

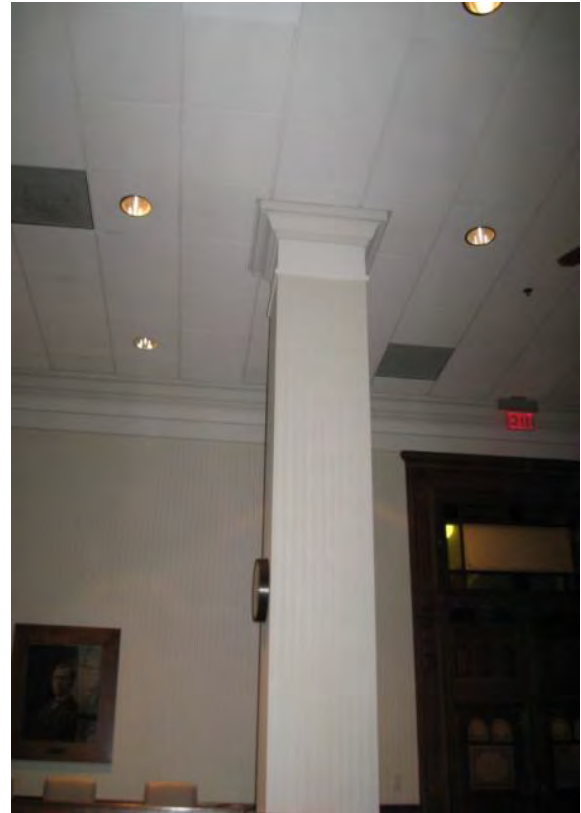
Figure B45. Non original column in Room 118.

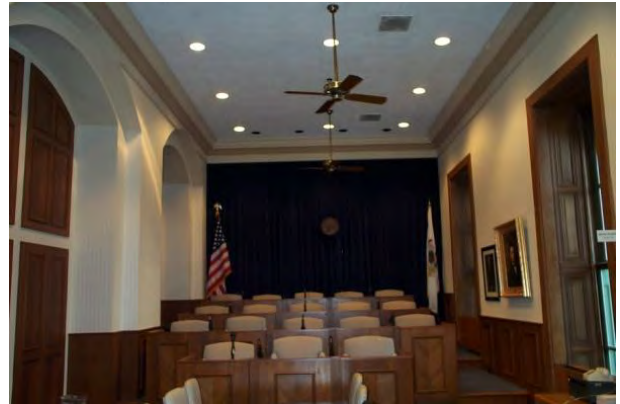
Figure B47. Non-original wood trim on windows to the right in Room 122.

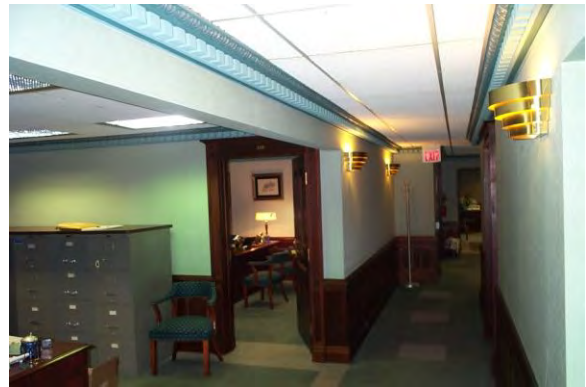
Figure B60. Non-original decorative plaster below mezzanine level.

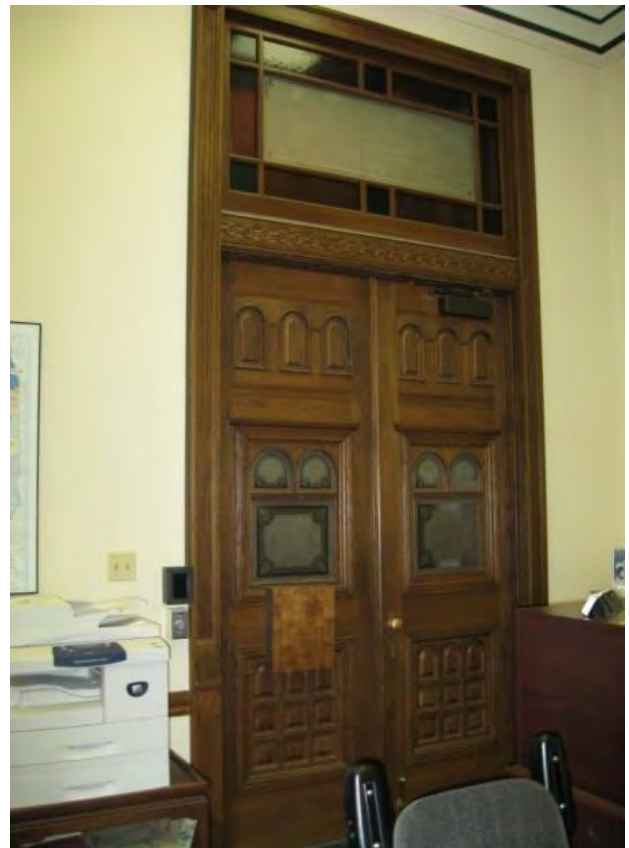
Figure B65. Original door with replacement wood trim.

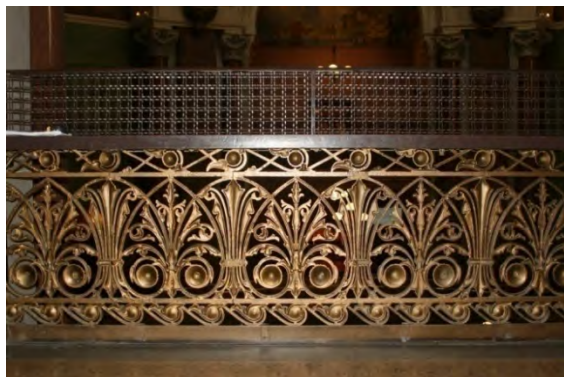
Figure B259. Fourth floor guardrail.

The fourth floor handrails are located around the rotunda at the north, east, and south overlooking the lower floors (Figure B259). They have a continuous organic motif with leaves and floral elements. The original portion of the handrail has a distinct lower band, central band, and upper band. This has been altered with the addition of supplemental woven steel wire material attached to the top of the handrail to increase its height. The original height of the handrail was 3'-1" and the current height is 4'-1 1/2".

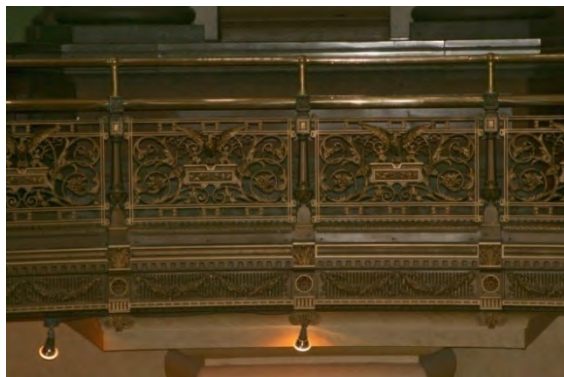
Figure B260. Third floor guardrail.

The third floor handrail surrounds the circumference of the rotunda (Figure B260). It is composed of forty total panels each measuring approximately 4'-2 1/2" in length and 4'-1" at the modified height, and 3'-2 1/2" at the presumed original height. A copper alloy rail is attached to the top of the handrail to extend its height. The additional rail appears to match the rail running through the handrail's posts. The theme of the handrail features a central eagle on a pediment projecting out towards the center of the rotunda. The eagle is surrounded by scrolling vines with fruit and flowers. Open mouthed wolves face the eagle from the edges of each panel. The panel was examined was tentatively identified as cast iron coated to imitate bronze. Using field microscopy, two coating layers were observed on the panel suggesting that the panels had been refinished and likely do not include their original coatings. There is a panel extending between posts below the handrail at the interior of the rotunda. Field microscopy

suggest that the panels are stamped copper coated to resemble bronze. The panel contains a swag decoration with rosettes at the central and end points. Above the swag there is a dental detail. Thirty of the decorative rosettes located within the panels under the handrail are currently missing.

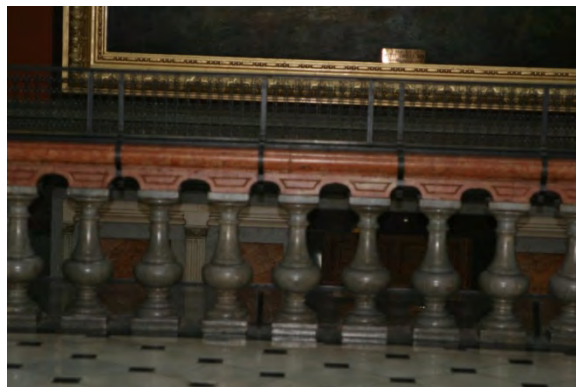
Figure B261. Third floor guard rail at grand staircase.

An additional handrail is located on the third floor at the top of the grand staircase (Figure B261). This area is a stone balustrade; however, past modifications included the addition of metal elements to increase the balustrade's height. A woven steel wire screen is currently strapped to the stone at the top of the balustrade and diamond pattern steel mesh has been added at the bottom of the balustrade to form a toe-kick.

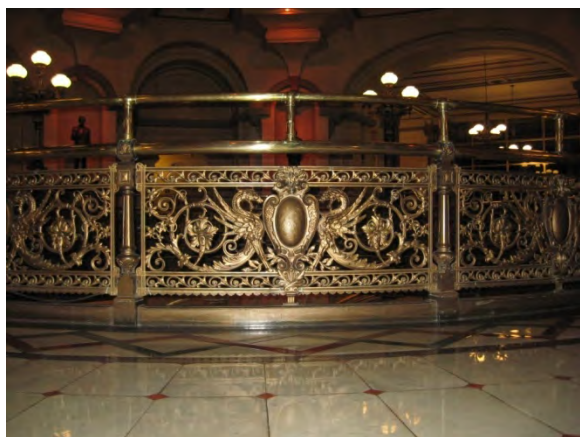
Figure B262 .Second floor guardrail.

The second floor handrail also surrounds the circumference of the rotunda (Figure B262). It is composed of sixteen total panels each measuring approximately 6'-1" in length and 4'-3" at the modified height and 3'-4 1/2" at the presumed original height. A copper alloy rail is attached to the top of the handrail to extend its height. The additional rail appears to match the rail running through the handrail's posts. The theme of the handrail features a central shield with two scrolled dragons facing inward. The panel was examined was determined to likely be cast iron coated to imitate bronze. Using field microscopy, two coating layers were observed on the panel suggesting that the panels had been

refinished and likely do not include their original coatings. There is a panel below the handrail at the interior of the rotunda that extends between rail posts. Field microscopy suggest that the panels are stamped copper coated to resemble bronze. Each panel is subdivided into two subpanels each containing a swag arcing between two rosettes. A horizontal dentil runs between rail posts along the top of the panels (Figure B263). Four decorative rosettes located within the panels under the handrail are currently missing.

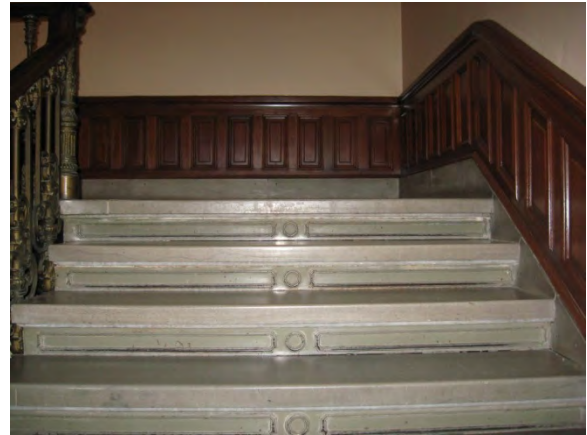
The staircases located at the north and south wings on the east side adjacent to the rotunda each have additional metal elements that are both decorative and structural. The stone stair treads are supported by cast iron risers which are currently painted grey to blend with the stone treads (Figure B269). The risers are an integrated part of the stair structure. Currently the risers are in fair condition; however, the coating is wearing thin in places likely due to impact caused by foot traffic.

Figure B269. Stair riser at the north and south staircases.

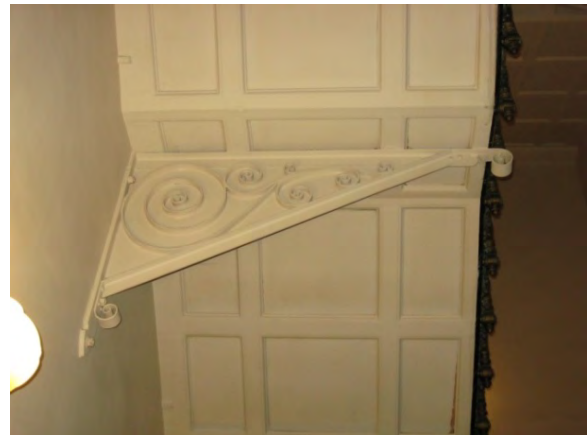
A modern steel support bracket has been added to the underside of each rise of the north and south wing stairs in circa 1968² (Figure B270). The bracket is painted to match the adjacent wall color as well as the color of the underside of the stairs. Each bracket is constructed of steel angles with an interior panel decorated with applied scrollwork. The brackets were observed to be in good condition with no apparent distresses.

Figure B270. Added bracket at the north and south staircase.

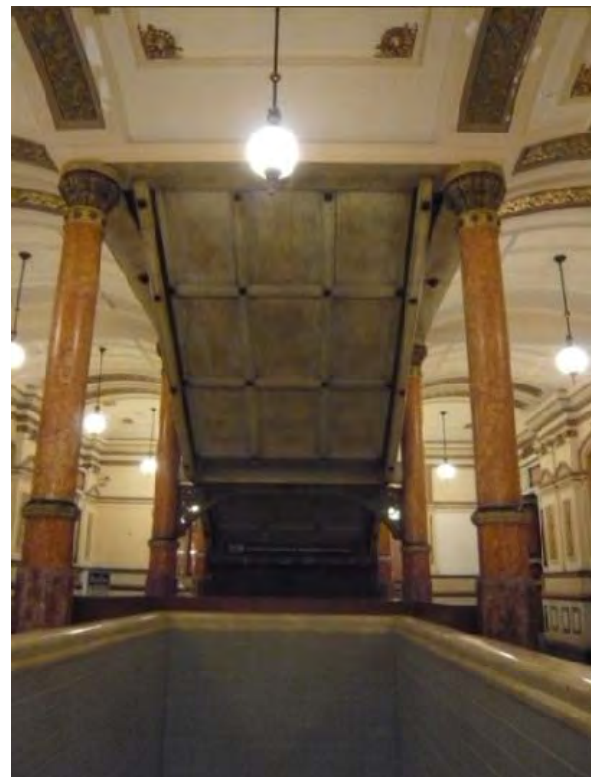
Many of these decorative rosettes were missing when this area was observed.

Figure B272. Rosettes underneath central Staircase.

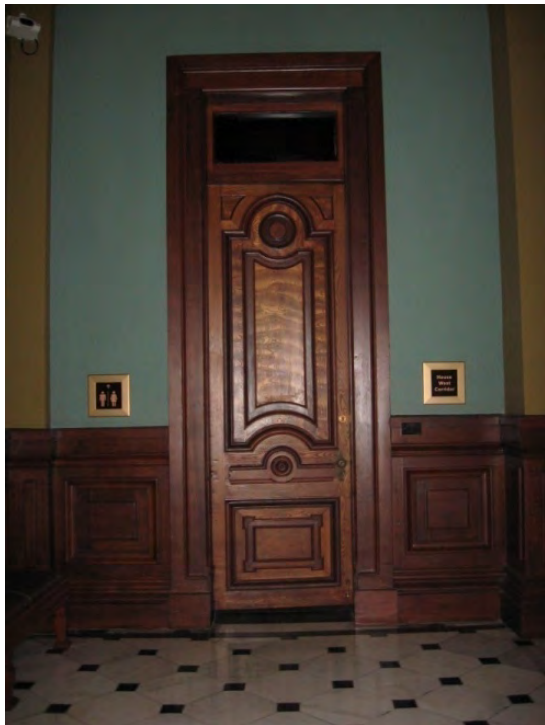
The door to the House of Representatives corridor is also similar to second floor doors (Figure B297). The differences include its very distinct wood grain pattern, different treatment of the interior of the upper panel, a less decorative central panel, and a different bottom panel. Other unique elements include undecorated hinges, and the sunburst and weave door knob with the scrollwork patterned escutcheon plate. The hinge side of the door has a considerable amount of impact markings and indentations around the hinge indicate that the current hinges are not original to the door.

Figure B297. Door to the corridor adjacent to House Chamber.

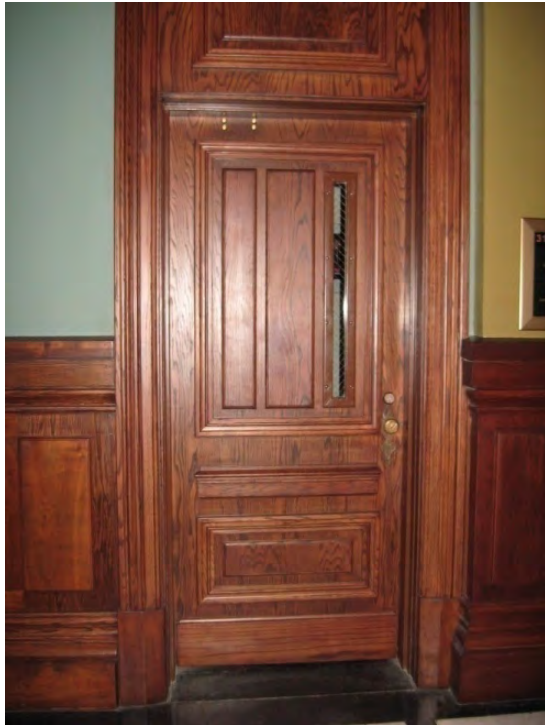
The third floor also has modern doors similar to those located on the west wing of the second floor. The modern door at Room 311 features hardware including a cruciform escutcheon plate and an eagle and shield door knob (Figure B298). The door knob does appear to be less worn than other door knobs observed throughout the building. One of the door's upper panels has been replaced with wire glass. The modern door at the escape staircases has panic hardware.

Figure B298. Modern door at Room 311.

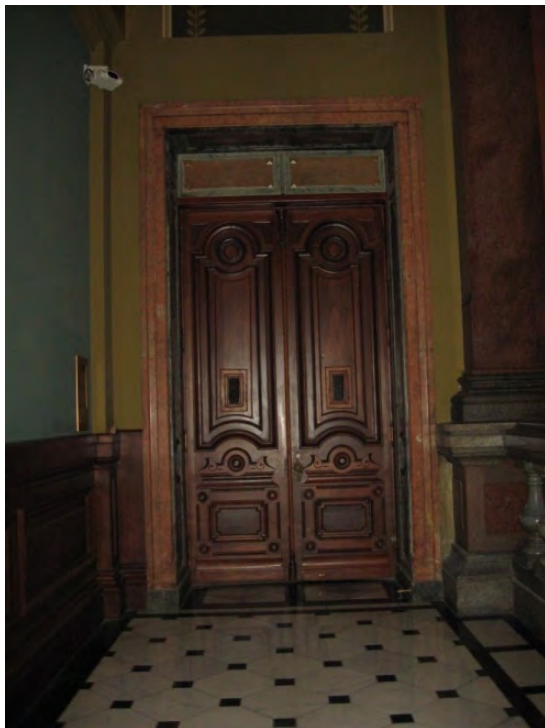
The doors to Room 309 appear identical to the primary door type on the second floor (Figure B299). The doors at Room 309 have been modified with wire glass in the upper panel. They also have four plain hinges per door, unlike the second floor doors. The doors at Room 309 have one of the rare flanged versions of the eagle and shield door knob.

Figure B299. Doors to Room 309.

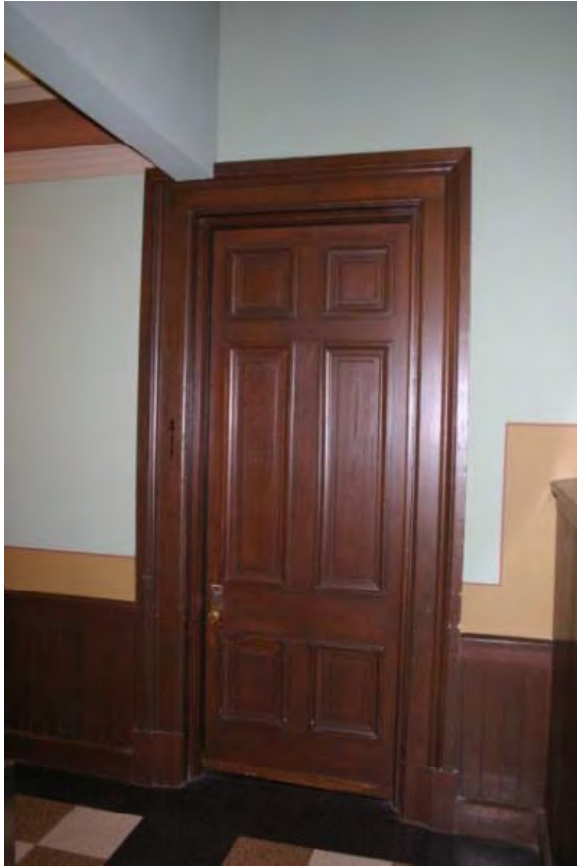
Other unique door types were also observed on the fourth floor. One is a hollow core door with wire glazing (Figure B304). A pair of modern four-panel doors was observed. The inside top panes have been replaced with wire glass (Figure B305). One possibly historic door was located on the fourth floor. The six-panel door has simple brass hardware and a brass kick plate (Figure B306).

Figure B306. Modern doors on the fourth floor.

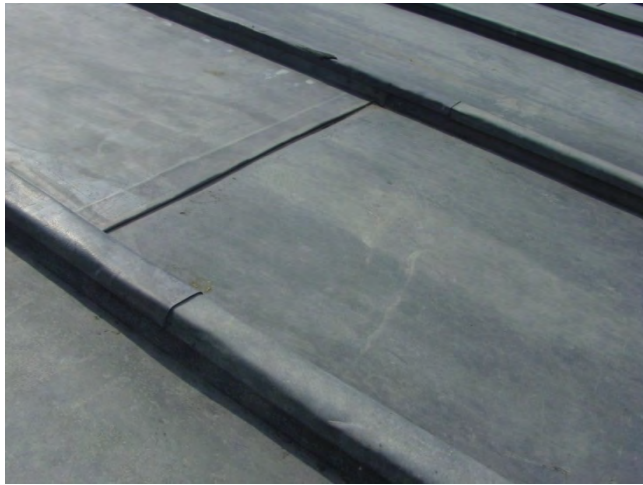
Figure C1. Uniform gray patina on the exposed surfaces of the lead coated copper.

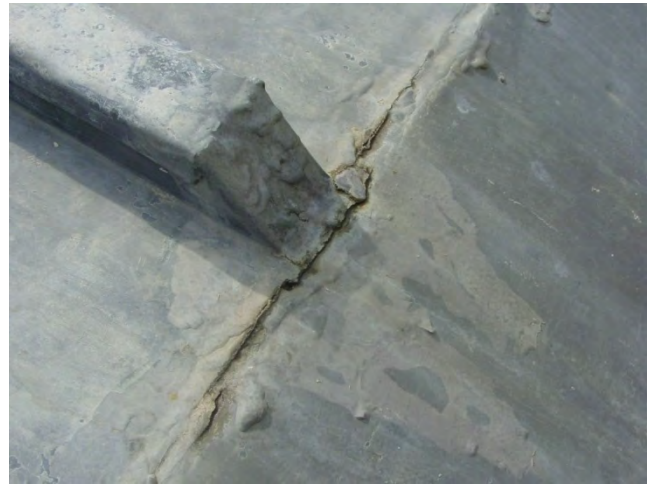
- Water flowed out of the seam between the flat seam roofing and the bottom end of the batten seam roofing. (Figure C3)
- The solder joints in the flat lock roofing around the balustrades are typically cracked. (Figure C4)

Figure C4. Cracked solder joints in the flat lock roofing around the balustrades.

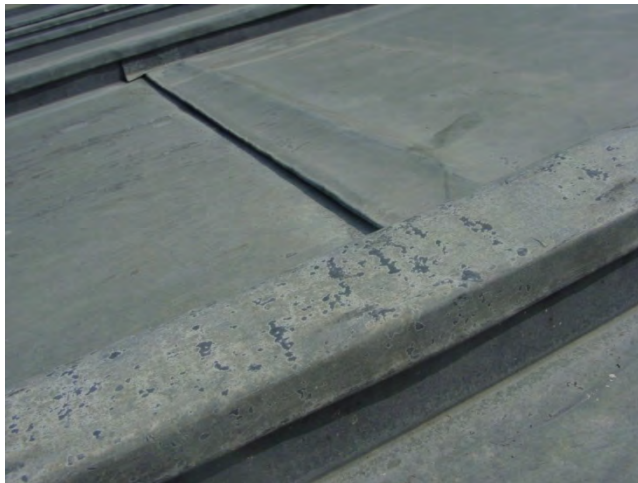
Figure C2. Minor pitting in the surface of the lead coated copper.

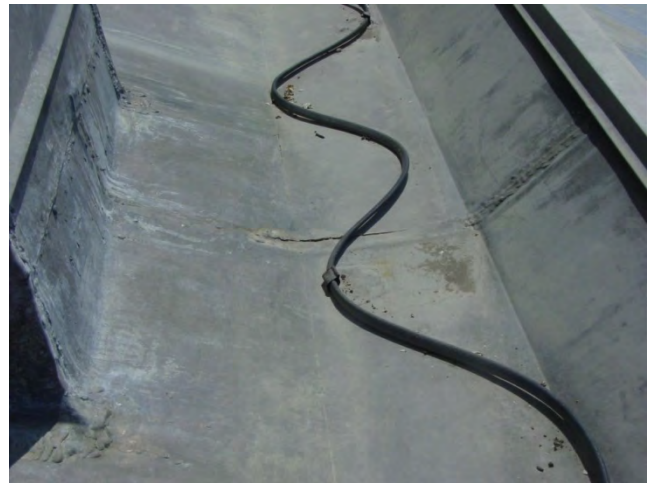
- The solder joints in the flat lock built-in gutter liners are typically cracked. (Figure C5)
- The solder joints at the intersection of the battens and the ridge batten are typically cracked. (Figure C6)

Figure C5. Cracked solder joints in the flat lock roofing in the built-in gutters.

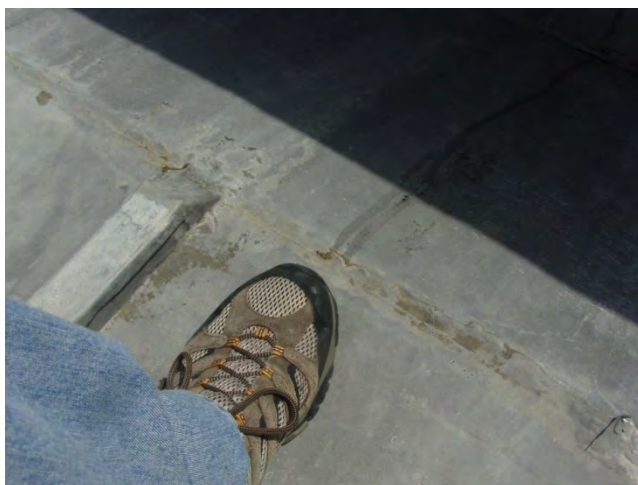
Figure C3. Water flowing out of the seam between the flat seam roofing and the batten seam roofing.

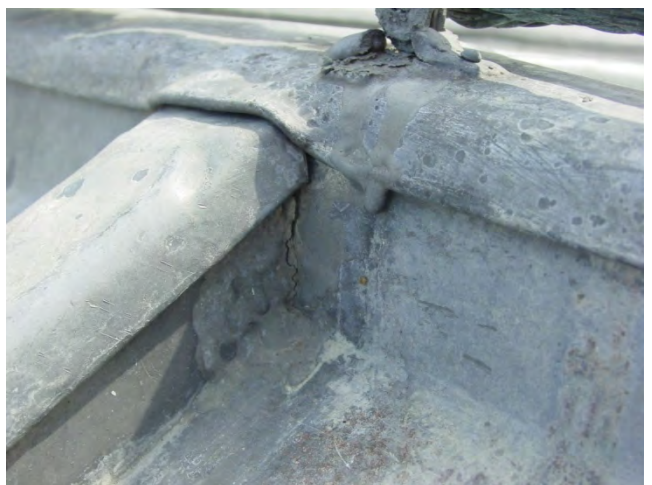
Figure C6. Cracked solder joints at the intersection of a typical batten and the ridge batten.

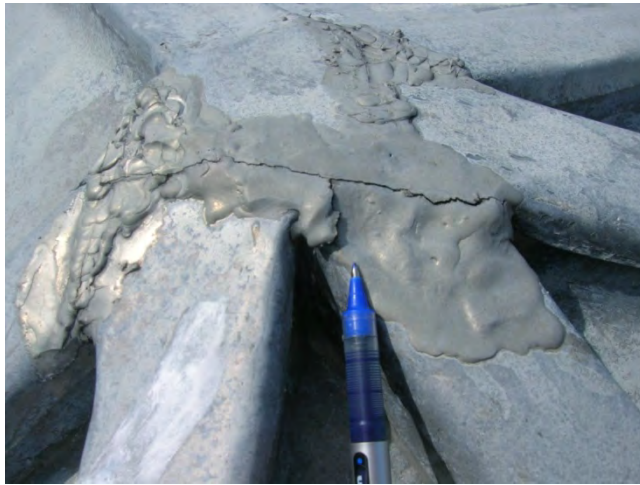
- The solder joints at the intersections of multiple battens are typically cracked. (Figure C7)
- The batten seams stop short of the dome walls. The wall flashings at the base of the dome do not include expansion provisions. (Figure C8)

Figure C7. Cracked solder joint at the intersection of multiple battens.

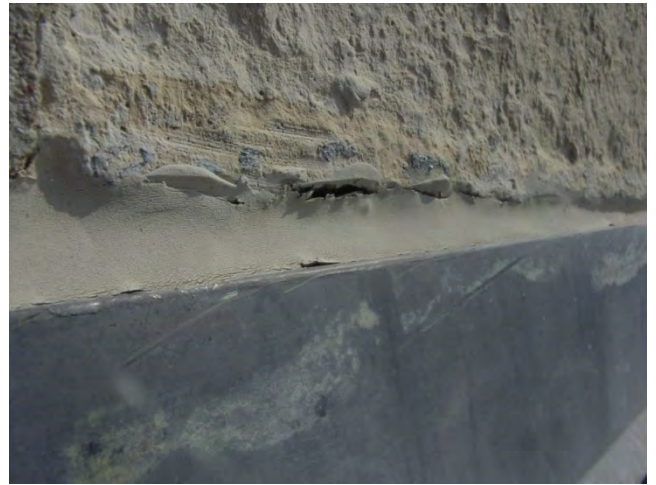
Figure C10. Failed sealant at the masonry bed joint above the counterflashing.

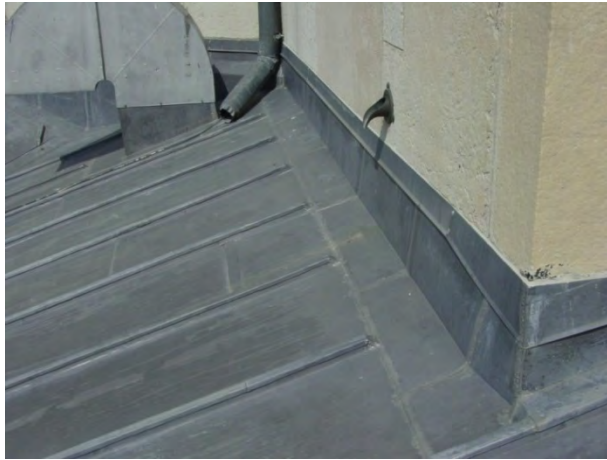
Figure C8. Batten seams that stop short of the dome and the wall flashings that do not include expansion provisions.

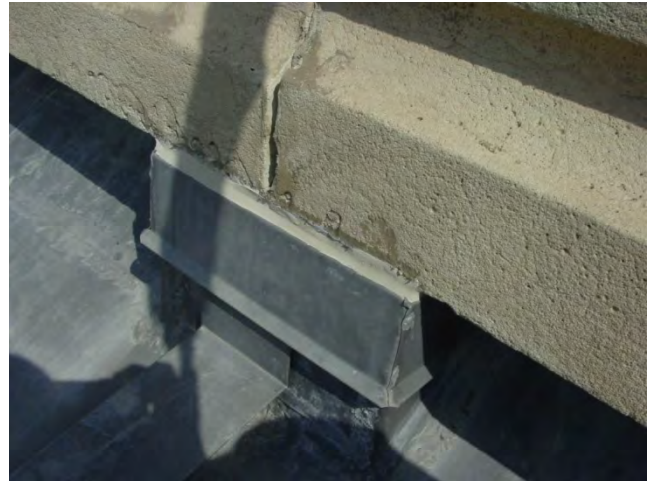
Figure C11. Open joints between sections of the balustrade.

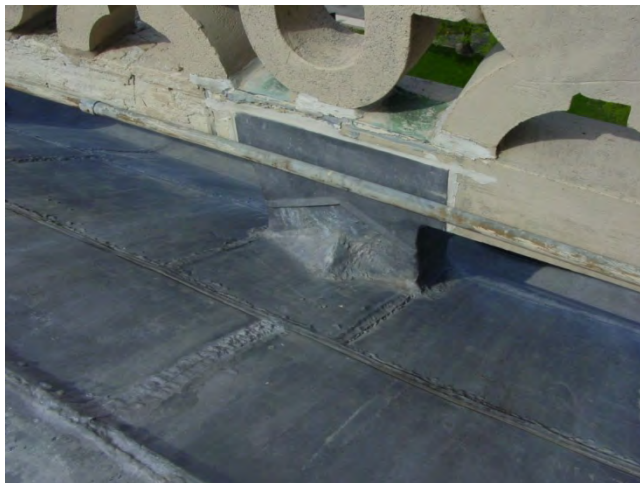
- The sealant above the sheet metal counterflashings attached to the balustrades has been repaired several times due to deterioration of the balustrades. (Figure C9)

Figure C9. Failed sealant between the counterflashing and balustrade.

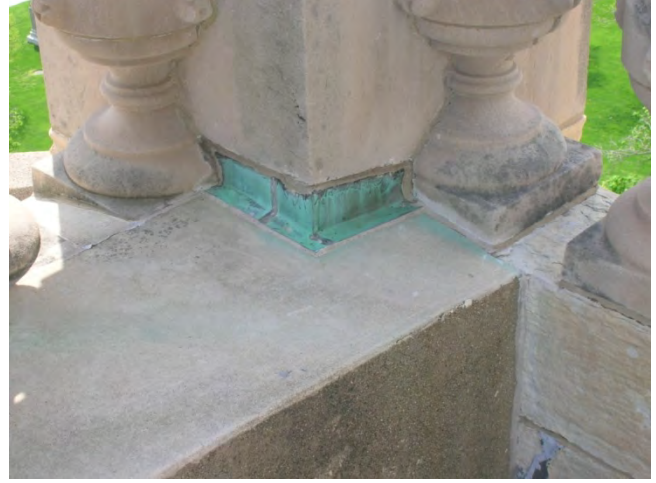
- Run off from copper flashings at the corners of the balustrades has stained the limestone. (Figure C12)
- Previous renovations to roof top equipment have included the replacement of batten seam panels and caps. (Figure C13)

Figure C12. Run off from copper flashings have stained the balustrade.

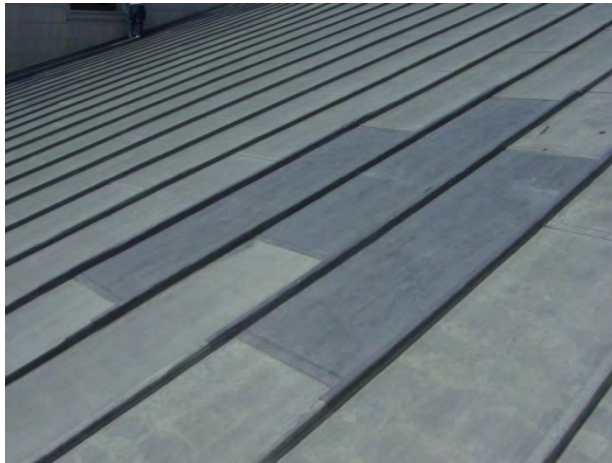
Figure C13. Replaced batten seam panels and batten caps.

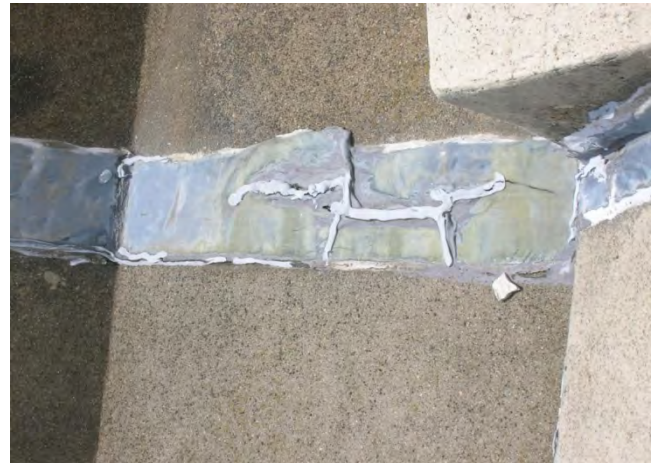
- Previous repairs include soldering lead coated copper patches to the batten seam pans and the valley flashings. (Figure C15)
- Sealant and strips of lead coated copper applied over joints gables at the ends of the east and west wings have failed. (Figure C16)
- Cast-in-place concrete copings above the gables on the east and west wings have deteriorated. (Figure C17)

Figure C16. Failed previous repair at the east and west gables.

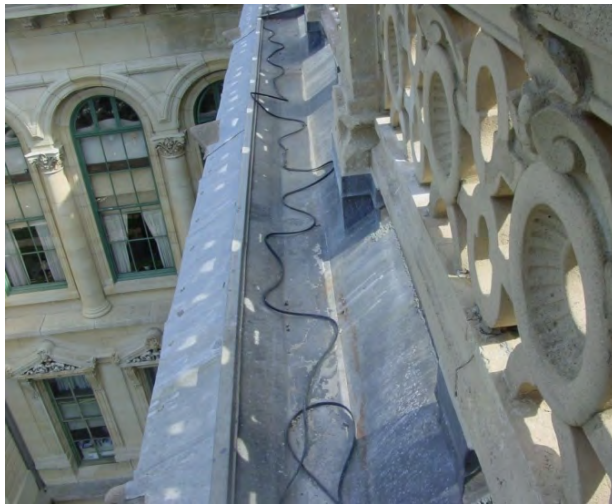
Figure C14. Heat trace cables added to the built-in gutters.

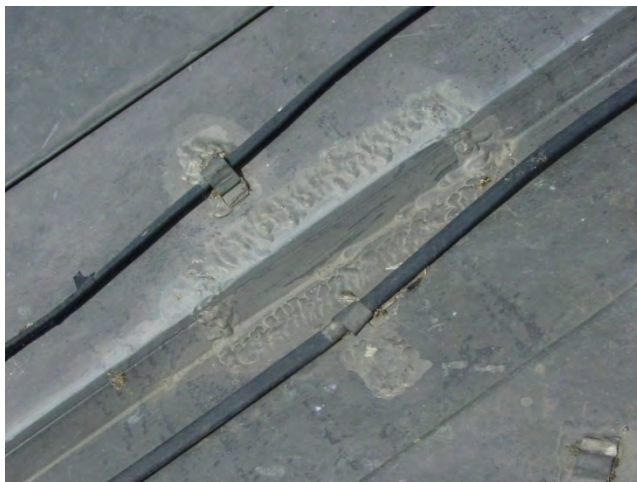
Figure C15. Previous repair that included soldering a patch to the existing lead coated copper.

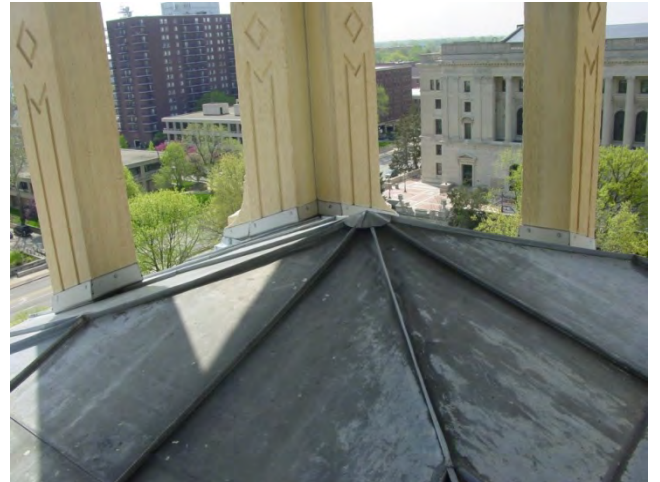
- A uniform gray patina exists on the exposed surfaces of the lead coated copper. (Figure C18)
- The ridges include a typical standing seam rather than a ridge cap. At the intersection of the ridge seam and the typical seams, the ridge seam was bent open and the typical seam was laid flat. Some of these seams are open. (Figure C19)
- The washers around the fasteners anchoring the apron flashing on the south side of the north tower have deteriorated. The apron flashing is loose and easily lifted by the wind. (Figure C20)
- Previous repairs include the installation of membrane clad sheet metal counterflashings at the base of the columns. (Figure C21)

Figure C18. Uneven gray patina on the exposed surfaces of the lead coated copper.

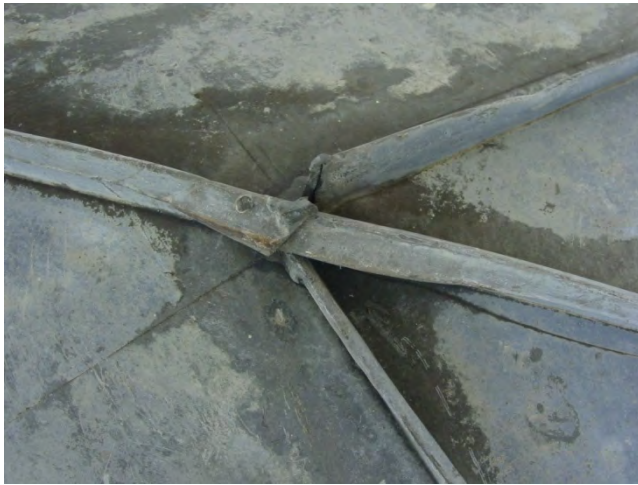
Figure C19. Open standing seams at the intersection of the typical seam and the ridge seam.

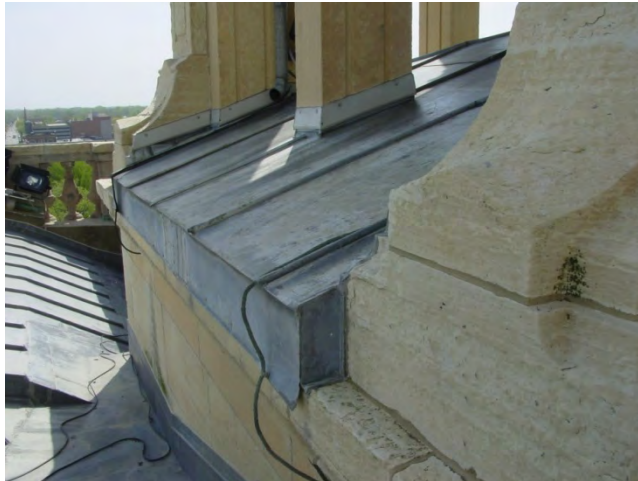
Figure C20. Deteriorated plastic washers and the loose apron flashing at the south side of the north tower.

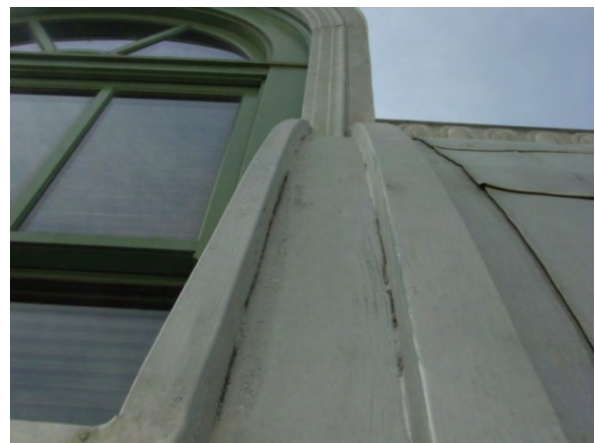
- An aluminum emulsion coating has been applied to the mansard shingles. (Figure C22)
- Screws with neoprene washers were installed at the bottom of the first course of shingles to prevent uplift of the shingles. (Figure C23)
- Water stains indicate that water may flow out below the shingles and into the built in gutter. (Figure C24)
- Guy wires and supports were flashed with pitch pockets that will require routine maintenance to remain water tight. (Figure C25)
- Heat trace cables have been installed in the built-in gutters. (Figure C26)

Figure C22. Aluminum emulsion coating applied to the shingles.

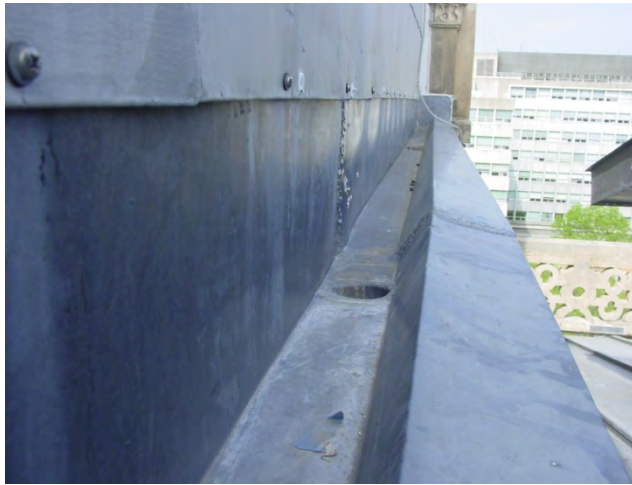
Figure C23. Screws with neoprene washers installed through the first course of shingles to resist wind uplift.

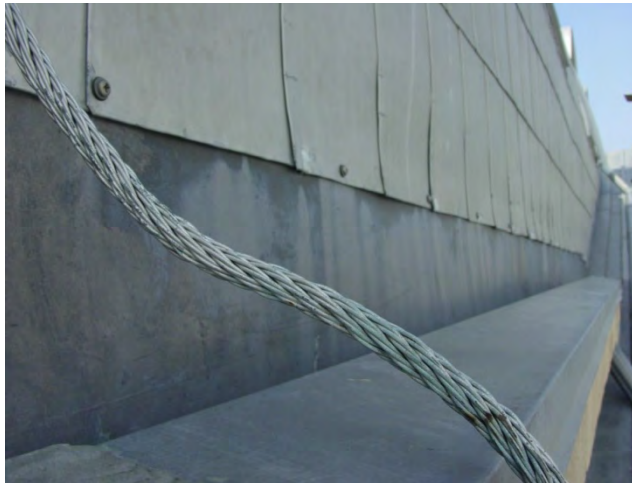
Figure C24. Water stains below the first course of shingles indicate that water may be able to get behind the shingles.

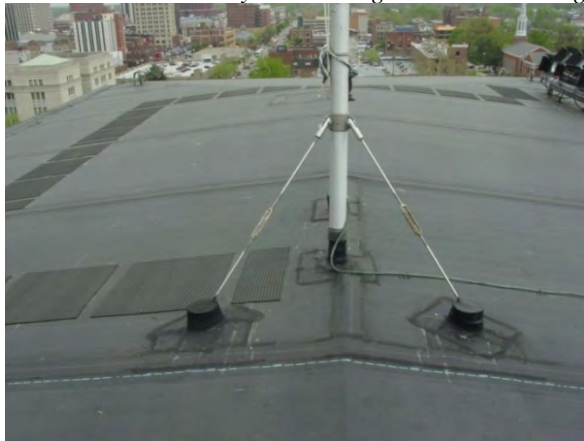
Figure C25. Penetrations flashed with pitch pans will require routine maintenance.

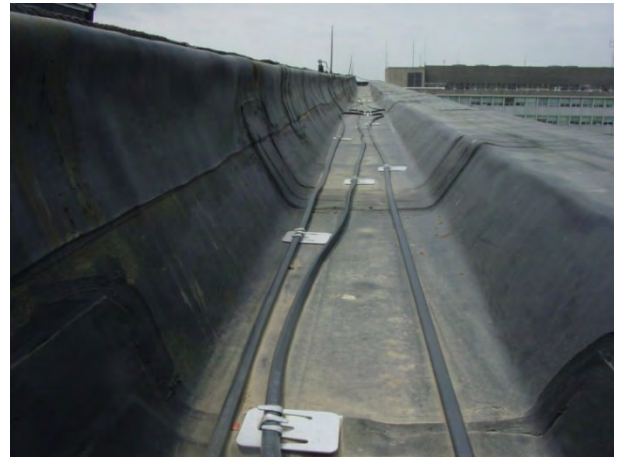
Figure C26. Heat trace cables installed in the built-in gutters.

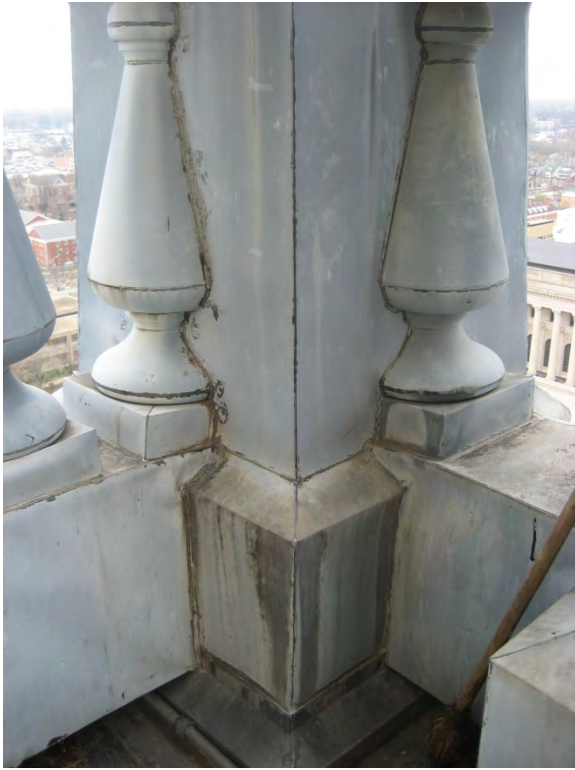
- A uniform gray patina exists on the exposed surfaces of the zinc ornament (Figures C27 and C28).
- Joints between sheets are typically pop riveted together and soldered.
- Several of the solder joints at the seams have split.
- Many of the decorative features are dented, displaced and bent.
- Several of the open joints have been previously sealed with sealant (Figure C29).
- Sheet metal patches of various sizes have been installed at various areas (Figure C30).
- A black coating has been applied to various areas of the zinc. In many locations the underlying metal was not covered or the coating has failed leaving the underlying zinc exposed (Figure C31).
- A few of the soffit panels in the area between the columns and the drum have portions which have corroded completely away (Figure C32).

Figure C27. Uniform gray patina on exposed zinc ornament.

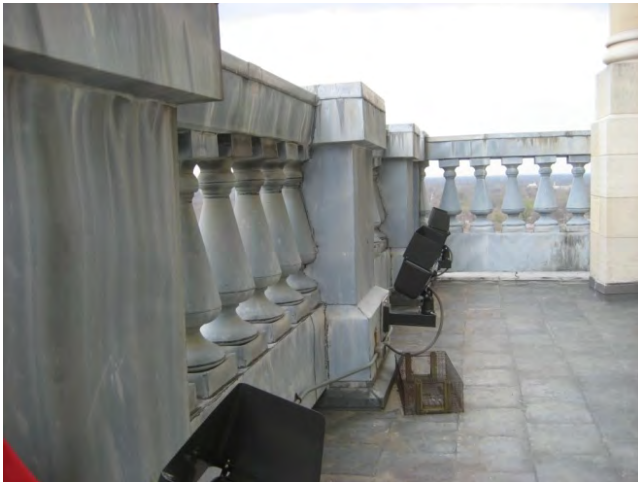
Figure C28. Uniform gray patina on exposed zinc ornament.

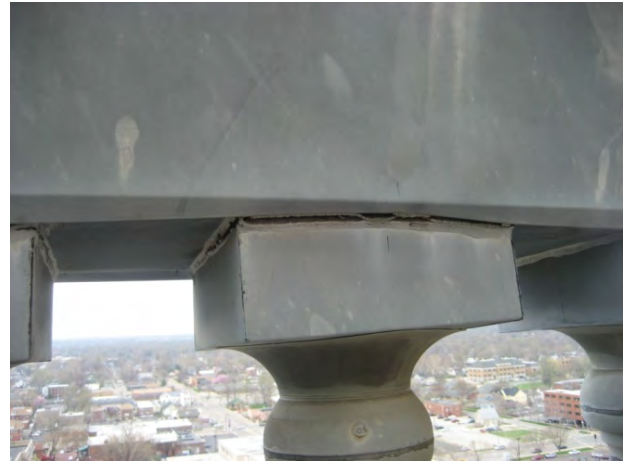
Figure C29. Open joint previously sealed with sealant.

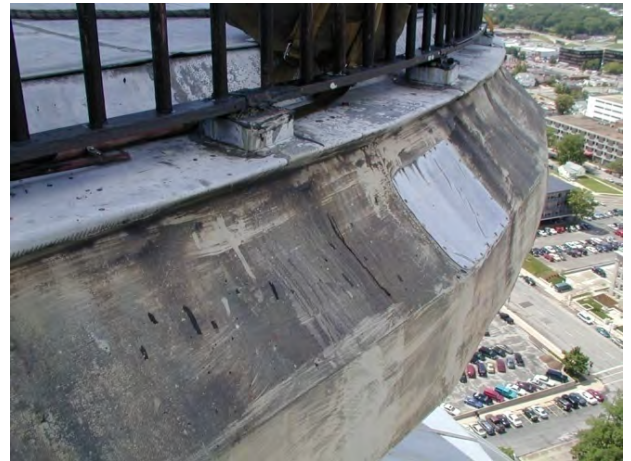
Figure C30. Sheet metal patches.

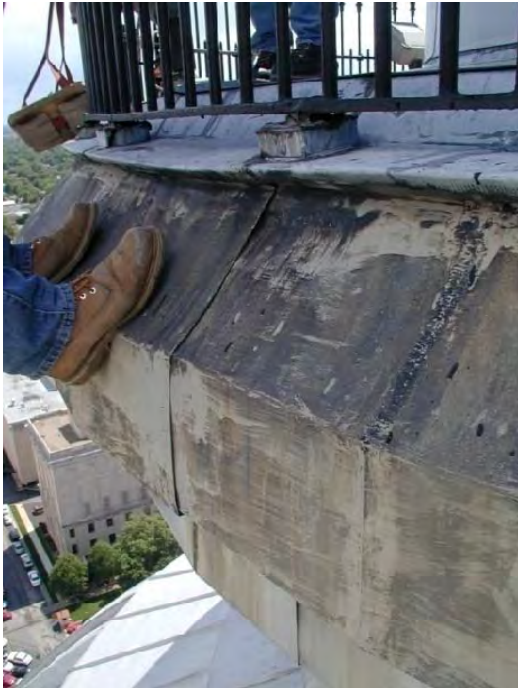
Figure C31. Black coating applied to zinc.

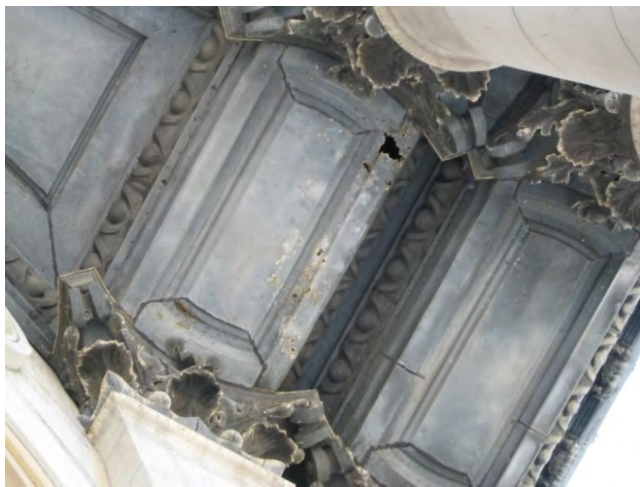
Figure C32. Area of corrosion on metal soffit panel.

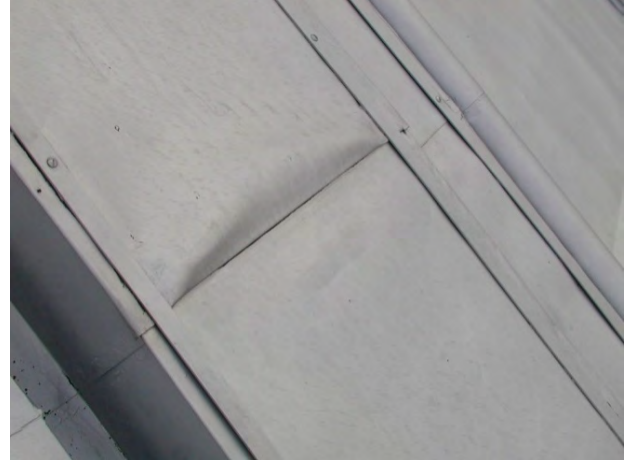
Figure C33. Buckled metal cladding at dome.

- Strips of a thicker metal, roughly 1/8 inch (referred to as anchor straps in repair drawings), have been installed roughly parallel to the ribs. The strips have been screwed down to the underlying sheet metal and typically span over joints in between the cladding panels with regularly spaced fasteners along the length of the straps. A most locations where the straps span over the joints, the underlying material has buckled (Figure C33).

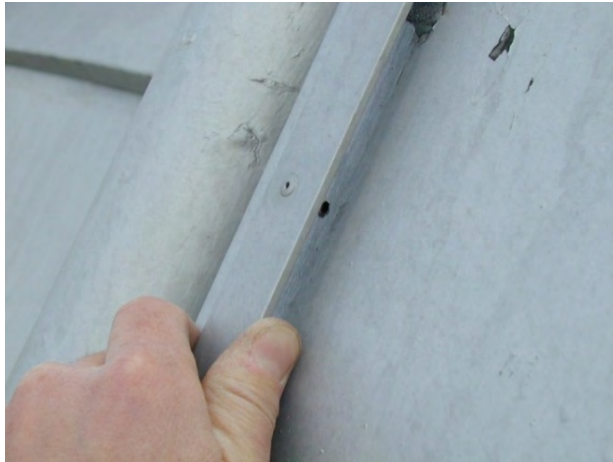
- The joints between sections of the main ribs are typically covered with sealant which is cracked and debonding from the substrate (Figures C34 - C36).

Figure C34. Open joint at rib.

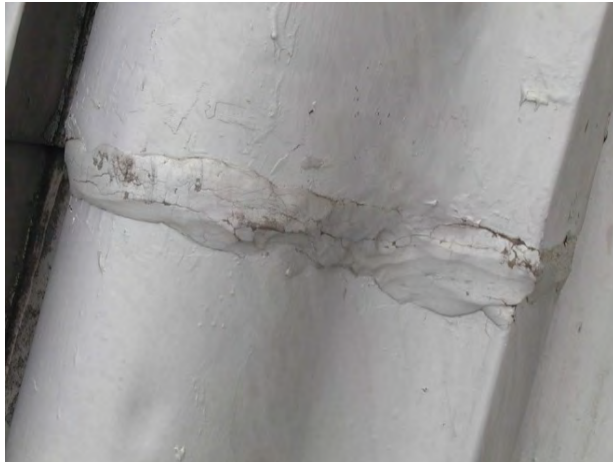
Figure C35. Open joint previously sealed at rib.

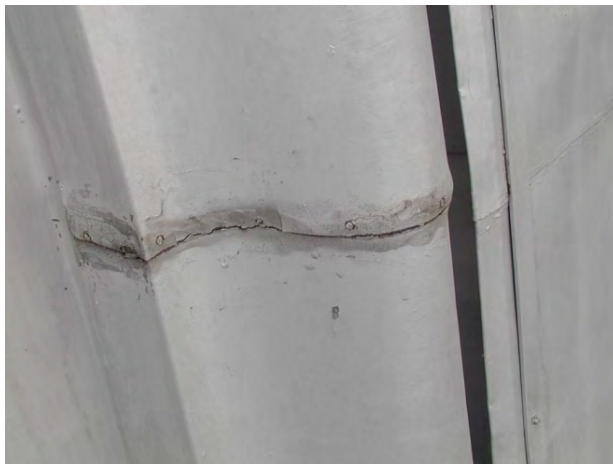
Figure C36. Open joint previously sealed at rib.

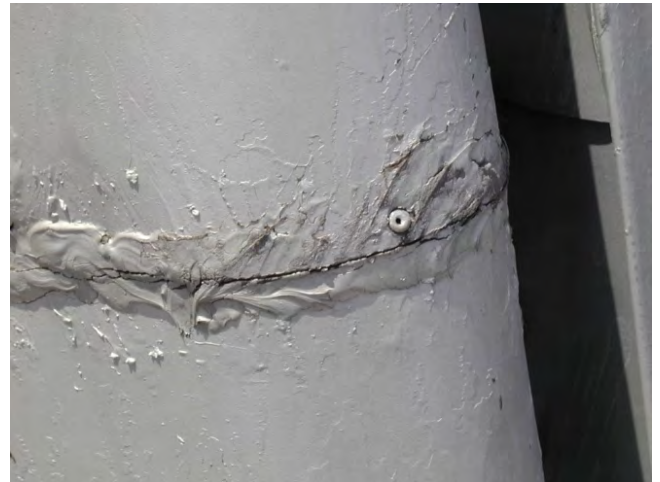
- Joints between rib sections are typically pop riveted, soldered and sealed (Figure C37). This tends to indicate that the joints were originally soldered and subsequently repaired with pop rivets and finally sealant.

Figure C37. Joint repaired with sealant and pop rivet.
