Illinois State Capitol Historic Structure Report

March 17, 2009

Wiss, Janney, Elstner Associates, Inc.

WJE Project Number: 2007.0701

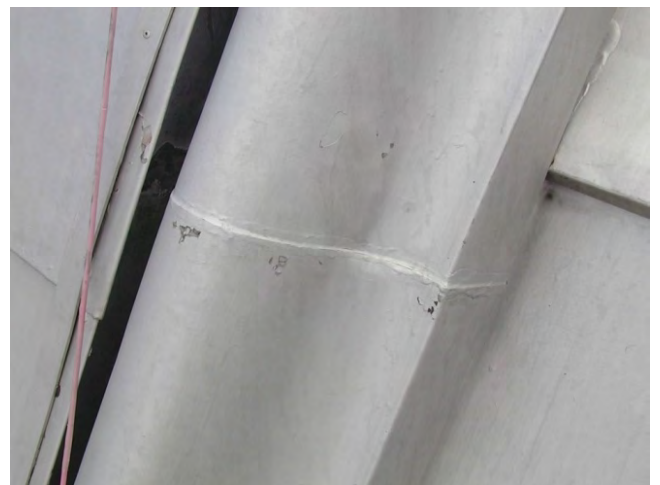
- Joints between some of the sections of the main rib are lapped such that the water is directed into the joints between rib sections rather than over the joint (Figure C38).

Figure C38. Lapped joint at rib.

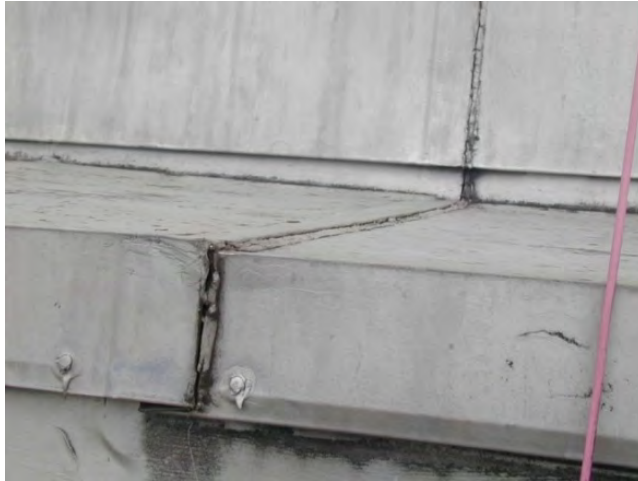
- Joints between flat sections have had sealant applied over the original solder joints. These joints are typically deteriorated and open (Figure C39).

Figure C39. Deteriorated sealant joint at deteriorated solder joint.

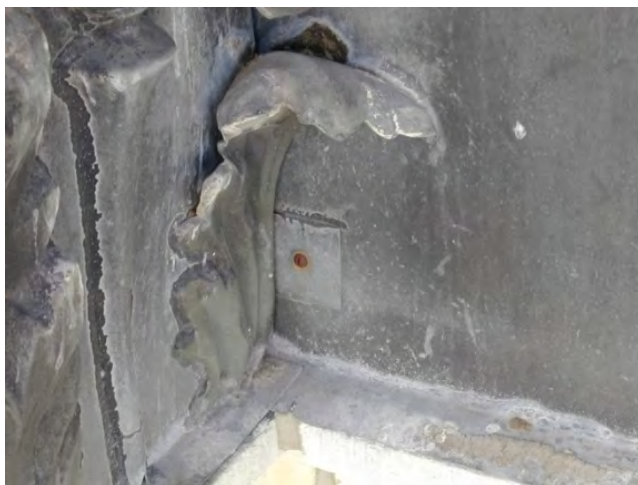
- Anchors connecting the ornament to the field of the cornice were visible at a few locations and consisted of a sheet metal clip screwed to the substrate with a carbon steel anchor. The anchor was typically corroded, but showed no significant loss of cross sectional area. (Figure C40).

Figure C40. Corroded steel anchor. Lapped joint at rib.

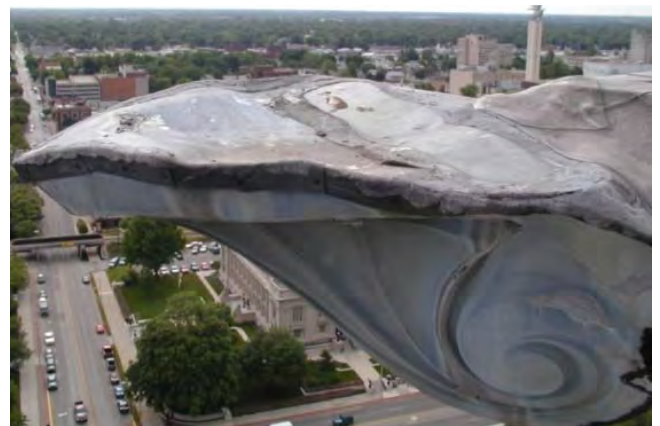
- Many of the decorative projecting cap units are dented or have holes which have been previously patched (Figures C42-C43).

Figure D42. Dented projecting cap.

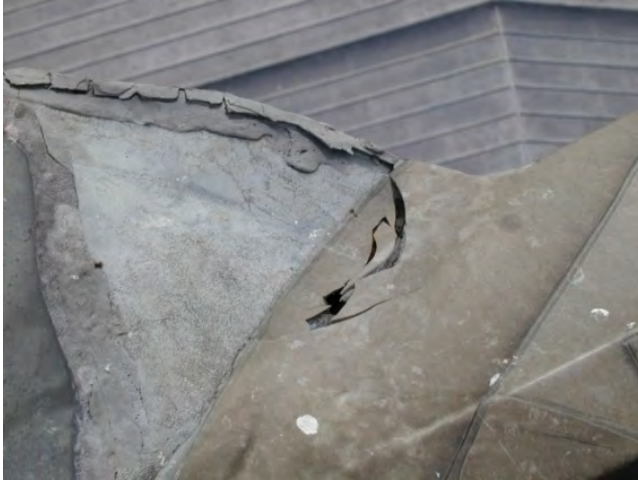
Figure D43. Open hole in projecting cap.

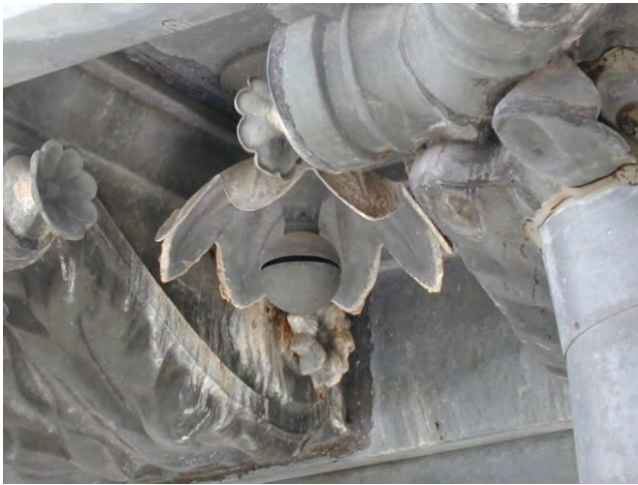
- Many of the decorative hanging floral pieces in the cornice are failing (Figure D44 and D45).

Figure D44. Cracked ornamental piece.

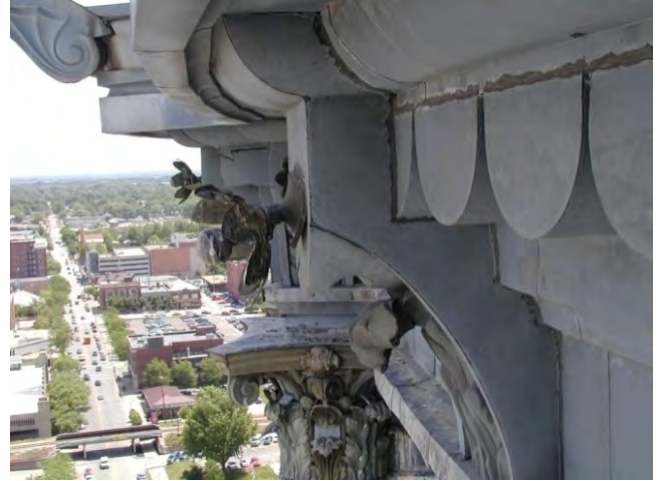
Figure D45. Corroded ornamental metal.

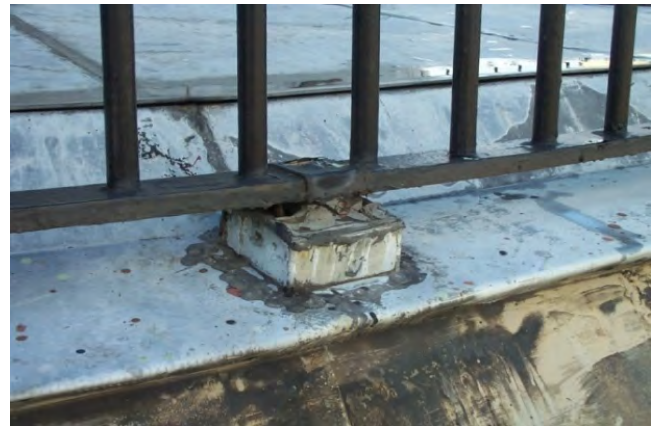
- The cast iron railing at the perimeter of the lantern is embedded into the dome cladding at discrete locations (Figure D46). The solder around the perimeter of the embedments is typically cracked.

Figure D46. Cracked solder joint at embedment.

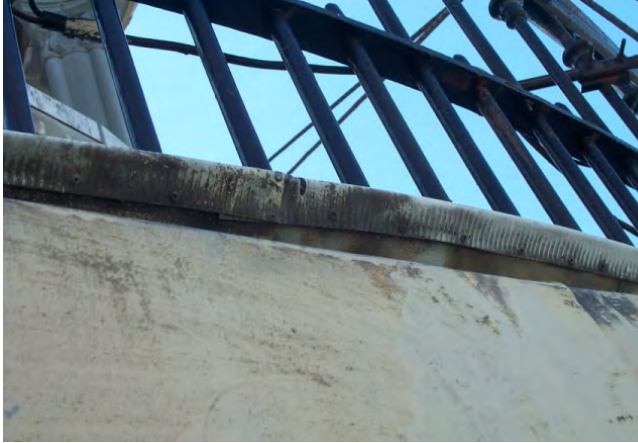
- The front lip of the lantern floor extends past the cast iron railing and laps over the dome cladding and is pop riveted on the underside (Figure D47).

Figure D47. Front lip of cladding riveted to underside.

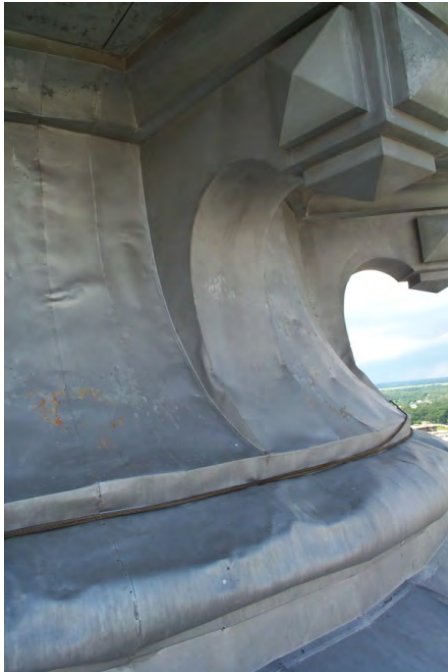
- The various ornamental pieces and drip course at the base of the lantern are typically dented (Figure D48) and the joints between sections are typically cracked, previously sealed or open.

Figure D48. Typical dented portion of cladding.

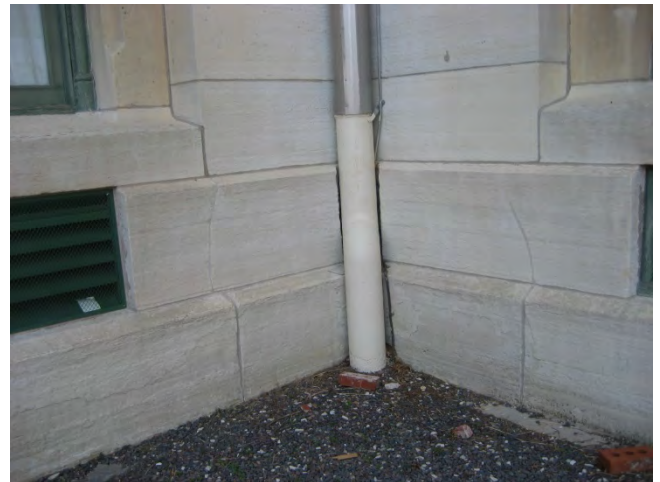
- Ashlar units exhibit weathering consistent with more than 125 years of exposure including roughening of the surface due to loss of fine particles. Bedding planes are visible on many of the units as well as layers of blue-gray clays. Bedding planes are typically oriented perpendicular to the face of the building.
- Stone units are typically weathered to a light orange brown as a result of oxidation of iron containing miners. AT the time of construction, the Joliet likely more closely resembled the Indiana limestone elements.
- A few of the ashlar units were face bedded which has resulting in scaling of the stone along the bedding planes.
- A few of the ashlar units are cracked vertically (Figure D49). These cracks have typically been repaired by epoxy injection or repointing with mortar.

Figure D49. Cracked ashlar limestone unit.

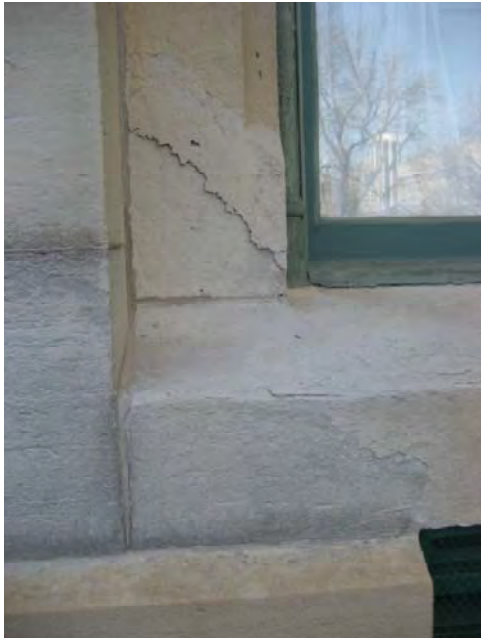
- Some of the areas exposed to splashing water are exhibiting exfoliation of the surface of the stone (Figure C50).

Figure C50. Exfoliation of limestone.

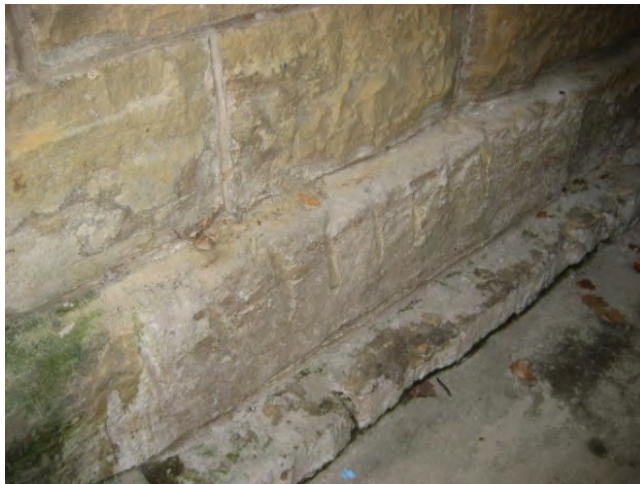
- Original quarry marks are evident on the exposed portion of the foundation near the northwest corner on the exterior (Figure C51).

Figure C51. Original quarry marks on limestone.

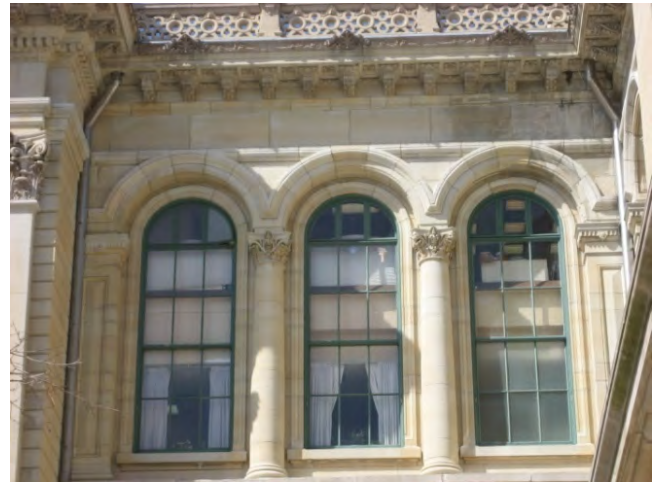
- Ashlar units below the cornice exhibit evidence of surface erosion from water penetrating the cornice above (Figures C52 and C53). No active leaks were observed at the time of our evaluation. It is likely that the leakage precipitated the built-in gutter repairs.

Figure C53. Surface erosion of limestone below cornice.

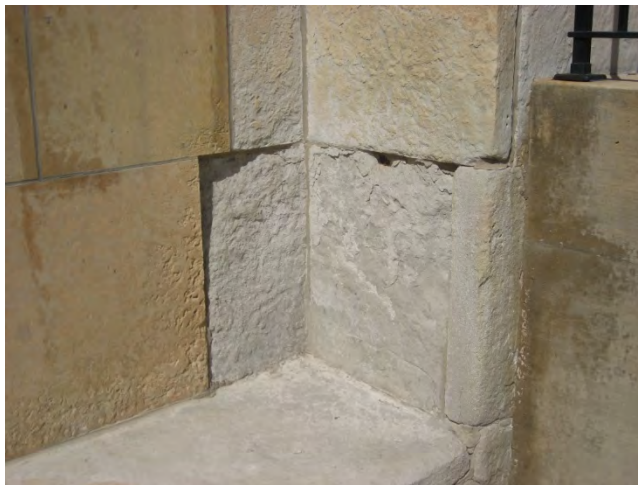
- Embedded anchors were found sporadically throughout the areas of ashlar units. The anchors were typically installed in the bed joints (Figures C54 and C55). Larger units tended to have been installed with three equally spaced anchors along the top of the unit. Smaller units were installed with a single anchor at the midpoint of the bed joint.

Figure C54. Spall of limestone from embedded anchor.

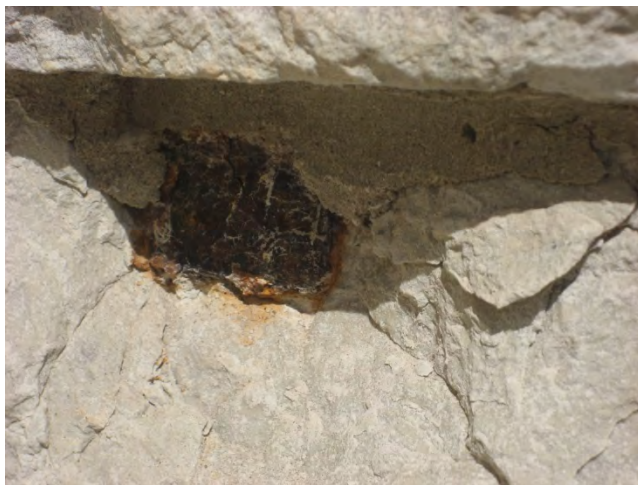
Figure C55. Detail of anchor.

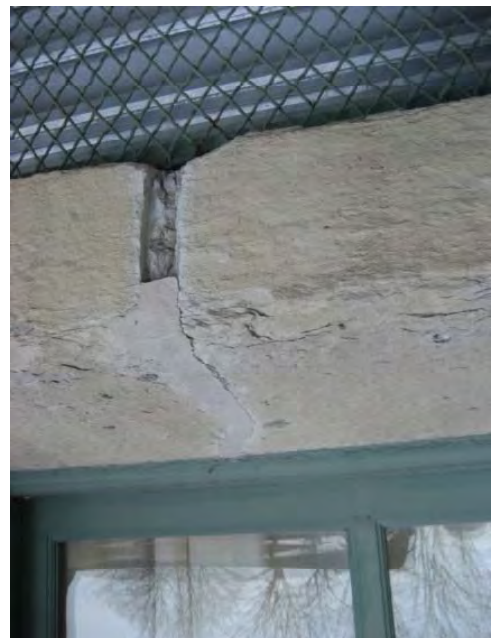
- A few spalls at anchor locations have been previously patched with a cementitious patch or repaired with Dutchman.
- Many of the lintel units which span window openings have cracked at roughly the midspan of the unit (Figures C56 and C57). Many of these units have been previously epoxy injected with minimal penetration of the epoxy or ground out and pointed with mortar. No significant deflection or displacement of the lintel exists.

Figure C56. Cracked limestone at lintel.

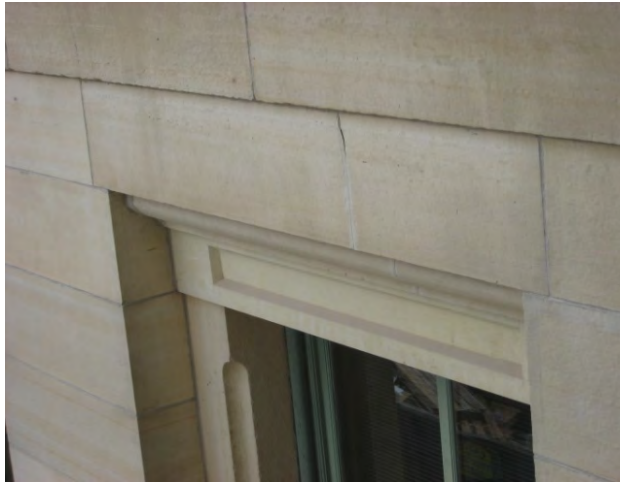
Figure C57. Cracked limestone at lintel.

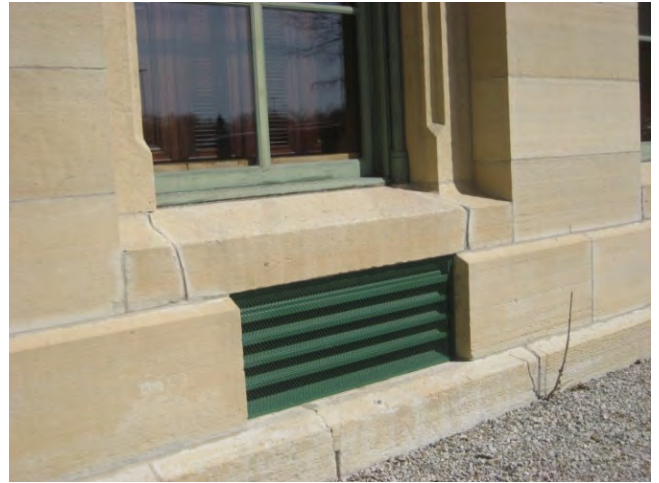
- A few of the lintel units above the basement windows are cracked near the support (Figures C58 and C59). These cracks have typically been repointed during prior repair work.

Figure C59. Cracked limestone lintel.

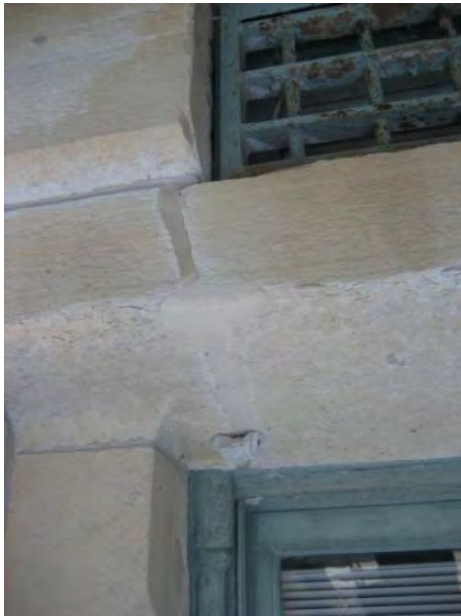
Figure C58. Detail of cracked limestone lintel.

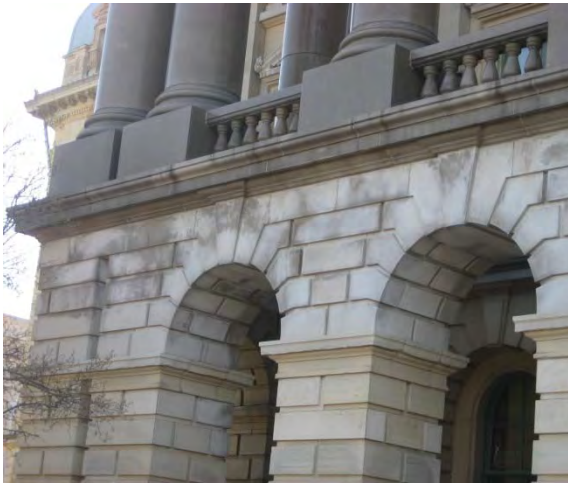
- Generally the Indiana limestone is in serviceable condition. Older units have a rougher surface due to the prolonged exposure.
- The pediment areas at the four main facades are clad with Indiana limestone.
- At the majority of carved areas, Indiana limestone was used in lieu of Joliet limestone presumably since the oolitic limestone had greater resistance to weathering.
- Carved units exhibit minor loss of detail and crispness also due to prolonged exposure.
- Many of the units exhibit a black and green biological growth.
- Arch units on the north and east portico appear to have been coated at some point (Figures C61 and C62).

Figure C61. Remnants of previous coating of limestone arch.

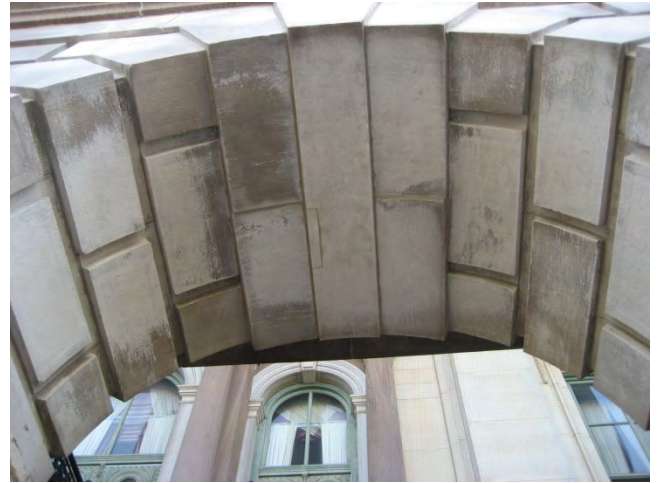
Figure C62. Detail of remnants of previous coating on arch.

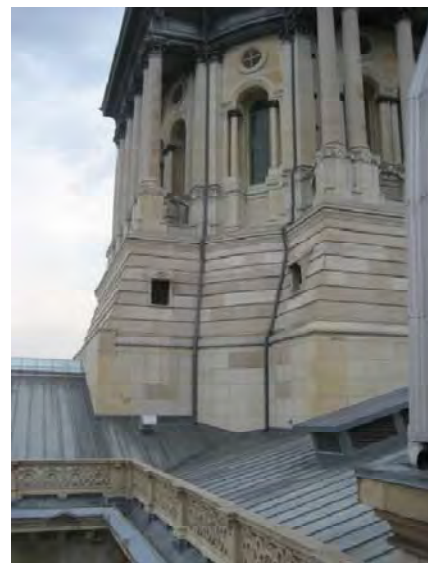
- Selective Joliet limestone units have been replaced with Indiana Limestone. With the exception of the wash course between the first and second floor windows, there is no consistent pattern to the replacement.
- A few of the ashlar units in the battered portion of the drum appear to have been replaced. There is no consistent pattern to the location of the replacement Indiana limestone (Figure C63).

Figure C63. Replacement Indiana limestone units at drum of dome.

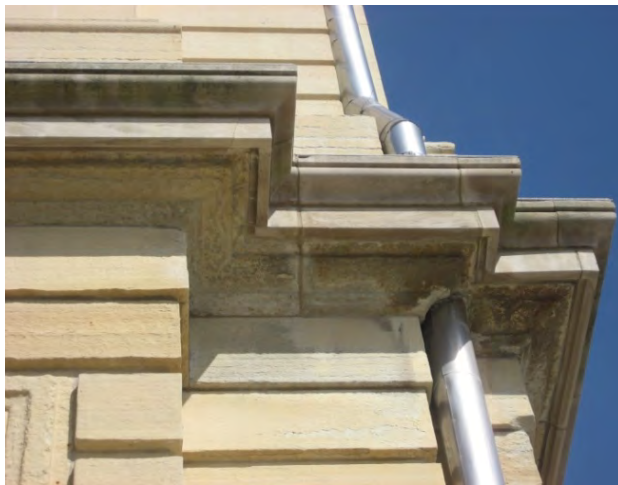
- The Joliet limestone wash course between the first and second floors was previously removed and replaced with a wash course consisting of Indiana limestone units topped by a granite wash course. Based on observations, it appears that the original wash course was cut back to sound material which was approximately 8 inches from the face ashlar units (Figure C64). Aluminum clips were anchored to the remaining area of stone and the new Indiana limestone units were kerfed and set on the new support clips.

Figure C64. Replacement wash course.

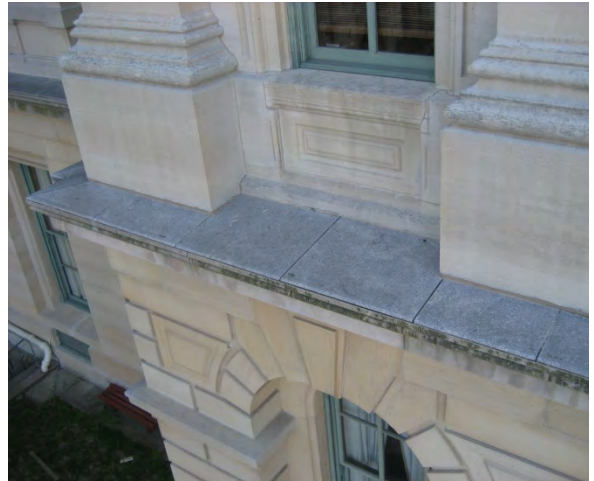
- The granite wash above the water table is approximately 1 inch thick and is set on a mortar spots with intermittent metal shims (Figure C65). Joints at the perimeter of each granite unit are filled with sealant and backer rod. In general the sealant was in serviceable condition with limited areas of adhesive and cohesive failures. The deterioration of the sealant is consistent with urethane which is between five and ten years old.

Figure C65. Granite wash above water table.

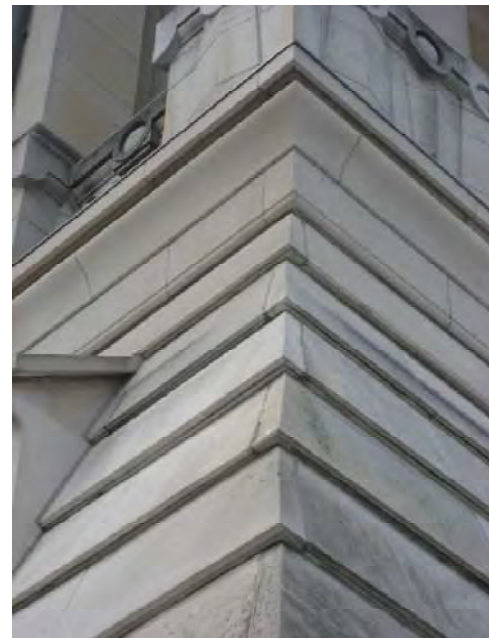
- The battered walls appear to have been removed and reinstalled or replaced during one of the repair programs which occurred in the last 25 years. The edges of the units appear to have been rabbited to create a thinner exposed edge creating a shingle appearance (Figure C66).

Figure C66. Battered walls at the base of the dome.

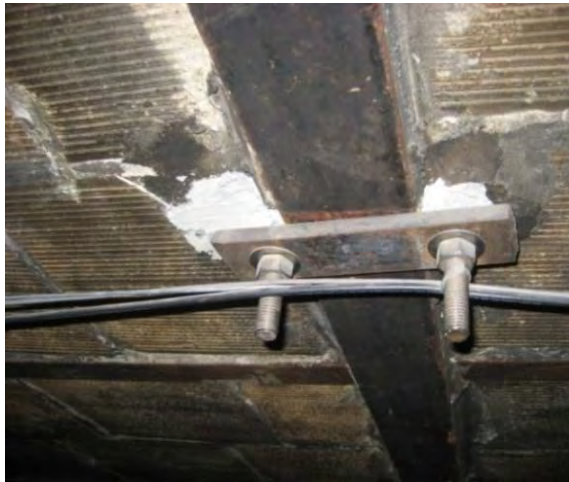
- The backup wall of the battered area consists of clay tile spanning between regularly spaced vertical metal members. Newer anchors are regularly spaced along the length the vertical members. The newer anchors consist of discrete steel plates positioned on the interior side of the vertical members. Bolts extend through the plates into the backup wall and presumably engage the limestone panel (Figure C67).

Figure C67. Detail of new anchor from backside.

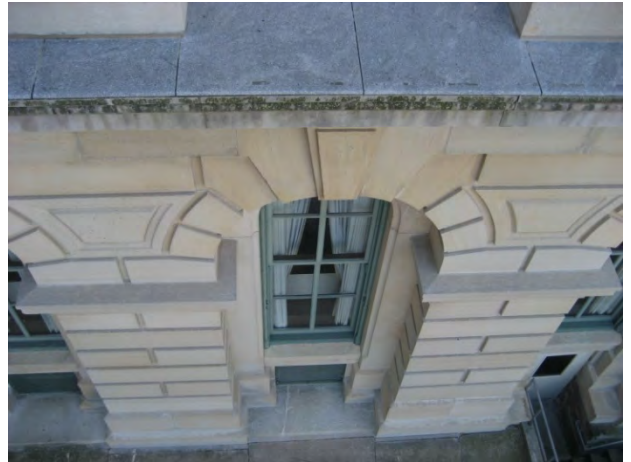
- Various shims have been installed between the plate and the back of the clay tile presumably to secure the panels in place.
- Biological growth exists on many of the face of the limestone units which are exposed to repeated wetting and drying (Figures C68 and C69) such as wash courses and raked and flat copings and sills.

Figure C68. Biological growth on limestone.

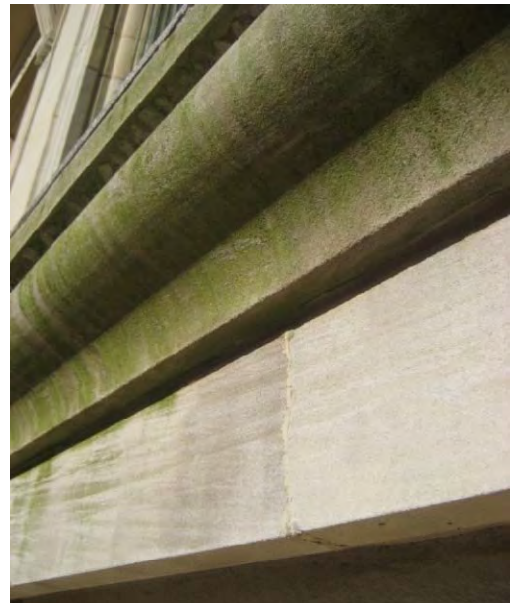
Figure C69. Biological growth on limestone.

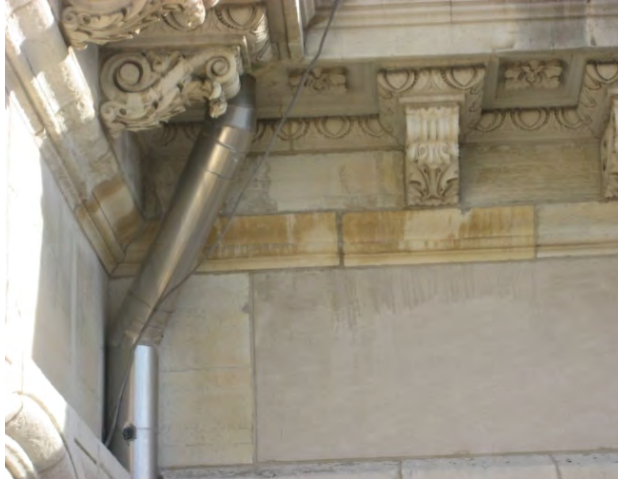
- During one the previous repair programs, deteriorated Joliet limestone appears to have been replaced with a buff colored limestone. These units were installed around the inside corners (downspout locations) (Figure C70), outside corners (Figure C71) and other selective units around the building (Figure C72).

Figure C70. Replacement limestone.

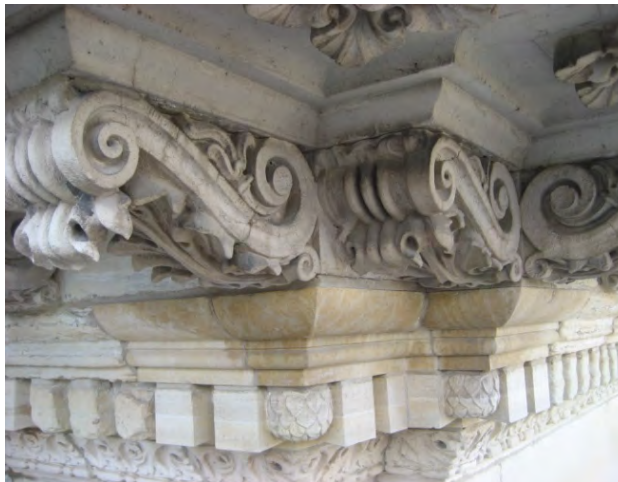
Figure C71. Replacement limestone.

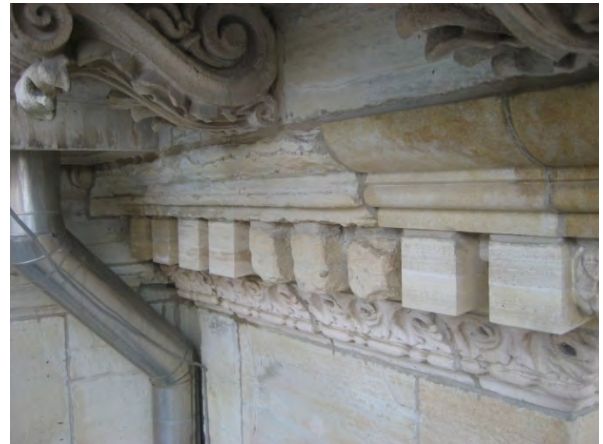
Figure C72. Replacement limestone.

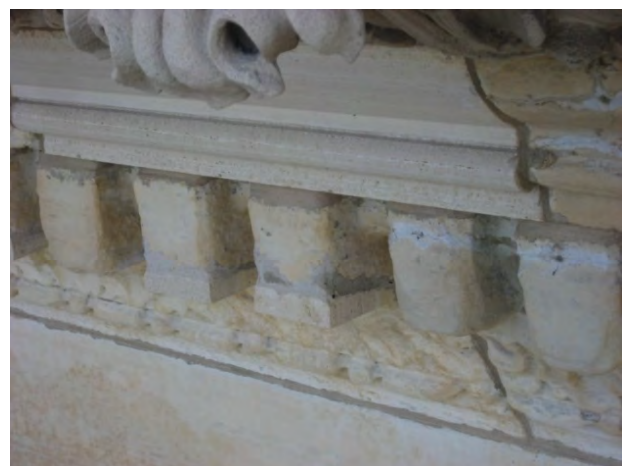
- Previous repair of severely weathered areas of the Joliet limestone have included installation of travertine Dutchman to reestablish the general profile of the eroded element. Examples include dentils in the cornice as well as the course above (Figure C73).

Figure C73. Travertine Dutchman.

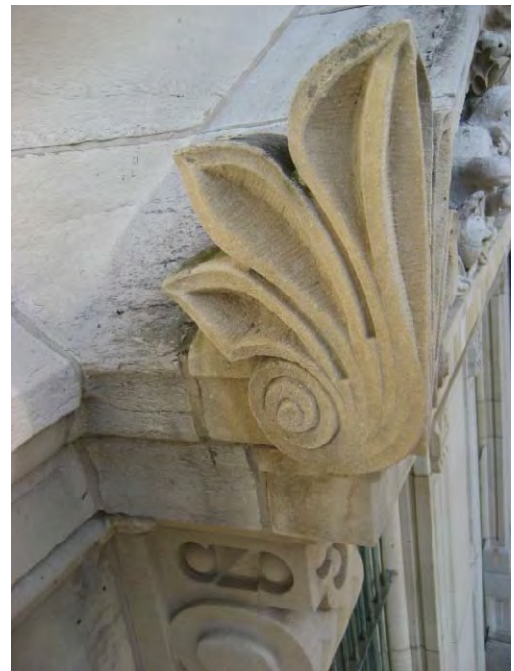
- Replacement floral units have been installed at various second floor windows pediments (Figure C74). These units replaced the original Joliet limestone units, which likely were highly eroded based on the condition of the remaining units (Figure C75).

Figure C74. Replacement floral unit.

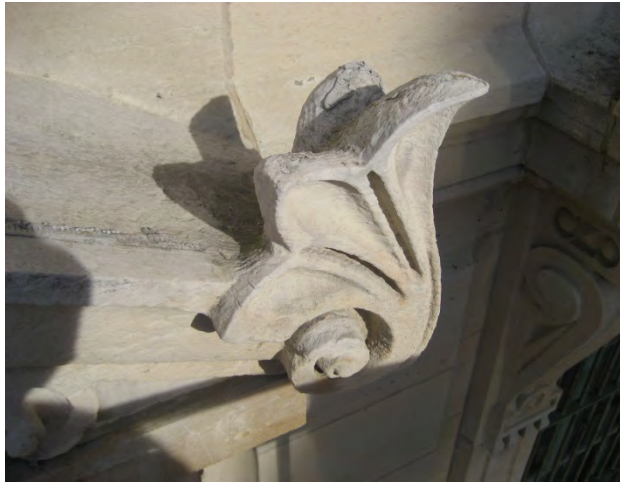
Figure C75. Eroded limestone unit.

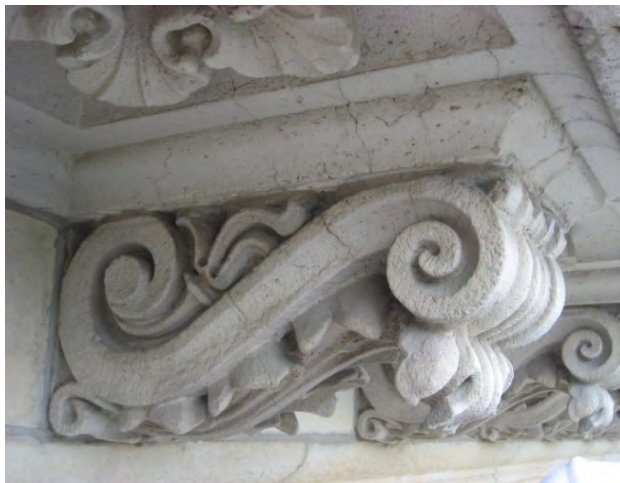
- The cornice at the top of the main facades of the building incorporates a two course cast in place concrete cornice.
- The concrete exhibits regularly spaced shrinkage cracks (Figure C76), but no distress consistent with corrosion of embedded steel reinforcement.

Figure C76. Regularly spaced shrinkage cracks in cast-in-concrete ornament.

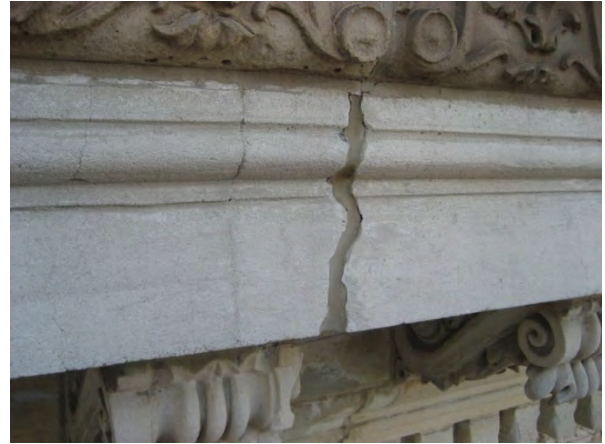
- Each section of the cornice exhibits a vertical crack roughly at the midpoint of the length of the cornice. This crack has

typically been filled with sealant (Figures C77 and C78).

Figure C77. Crack in concrete repaired with sealant.

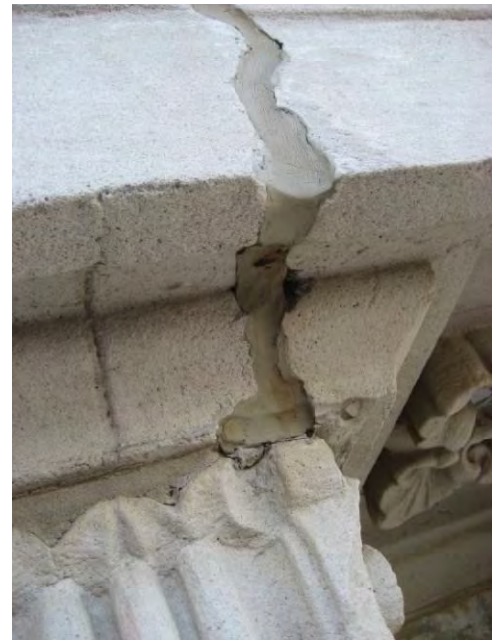
Figure C78. Detail of sealant installed in cracked concrete.

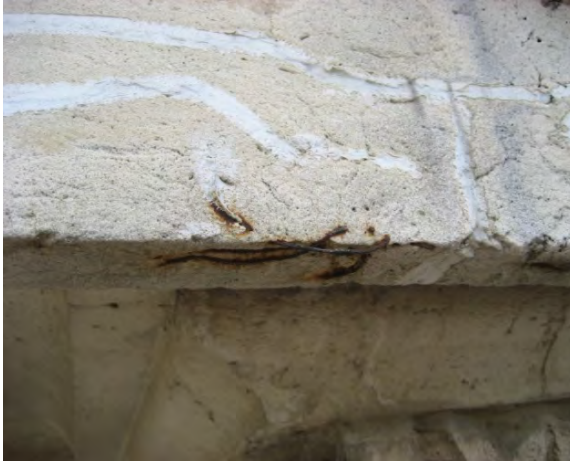
- The surface of the concrete consists of a relatively uniform matrix of white sand with regularly spaced dark specs of roughly the same size as the white sand.
- The concrete in some areas of the cornice are poorly consolidated.
- Fragments of wire exist at various areas of the cornice. The wire is approximately 1/32

inch diameter and moderately corroded. Due to the proliferation of the wires throughout the cornice, it is likely that the wires were originally used to support the formwork for the cornice (Figure C79). No significant distress was observed which could be attributed to the corrosion of the wire.

Figure C79. Fragment of wire in cast concrete.

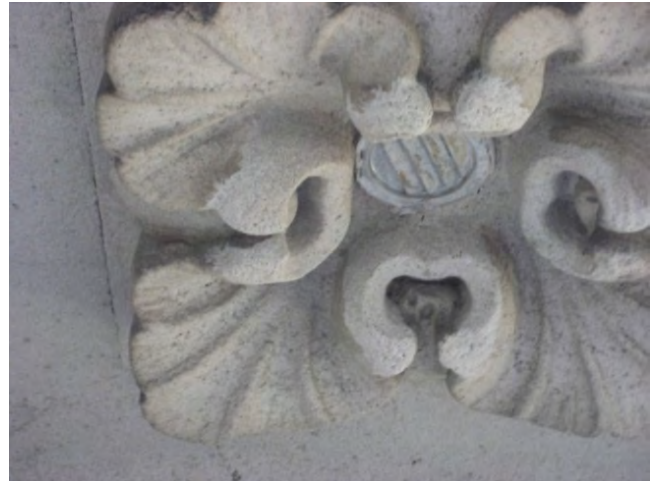
- A previous repair program, likely related to the built-in cornice gutter repairs, included installing regularly spaced vents with the soffit area of the cornice. The vents were installed by drilling a 2 inch diameter hole through the center of the space between the brackets which required removing the floral piece (Figure C80). The 2 inch diameter hole was typically drilled to a depth between 2 and 5 inches. At approximately half of the vents evaluated, the drilling of the hole was stopped when a reinforcing bar was encountered (Figure C81). When the bar hit, a 1 inch diameter hole was drilled to the top of the cast stone course above. The cast stone was topped by a lead gutter. Therefore, the vents extend from the bottom to below the lead gutter. The vents presumably were installed to provide air flow in the spaced between the lead gutters.

Figure C80. Added vent in flower at cornice.

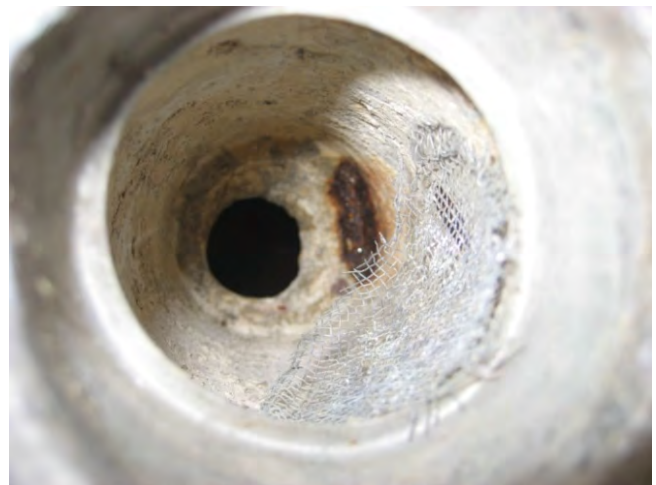
Figure C81. Detail of added vent.

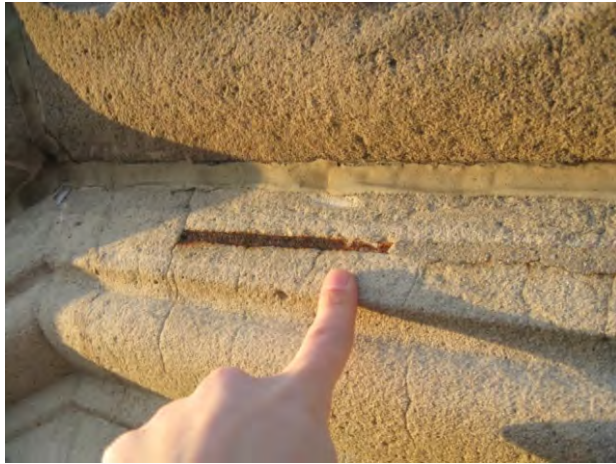
- The metal detector survey revealed that reinforcing steel was installed as part of original the cast in place cornice. No consistent pattern or spacing could be determined due to interference caused by the various fasteners used to install the gutter termination and substrate components.
- At a few locations limited lengths of reinforcing steel were expose on the surface of the concrete (Figure C82 and C83). When reinforcing steel was observed, it was typically corroded with no significant loss of cross sectional area.

Figure C82. Corroding reinforcing steel at cornice.

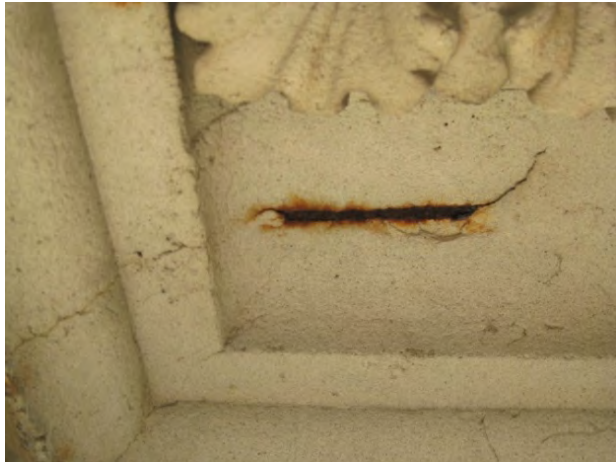
Figure C83. Corroding reinforcing steel at cornice.

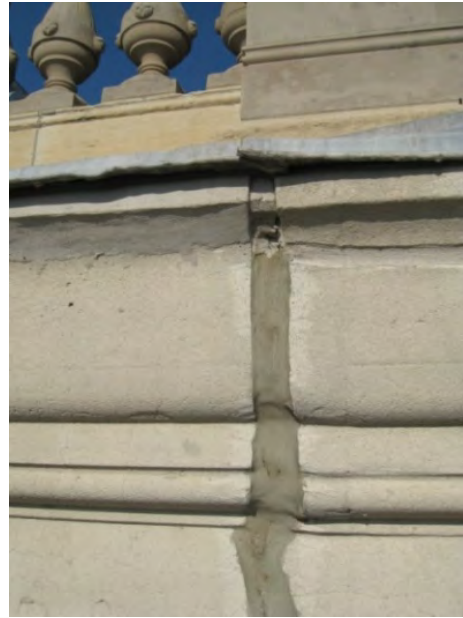
Portions of the concrete directly below the lead gutter have been patched with the cementitious material (Figure C84).

Figure C84. Patched concrete cornice.

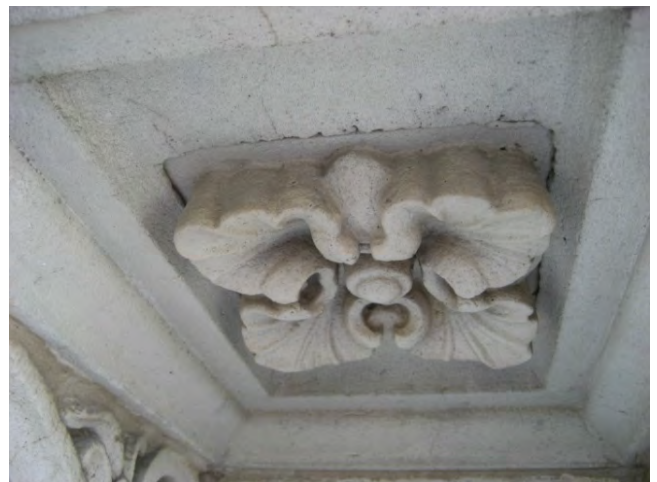
- At various areas, evidence of the edges of the form used to cast floral units into the soffit between the brackets (can be seen on Figure C85). No discontinuity along the edge around the perimeter of the floral areas, which tends to indicate that the floral units were cast concurrently with the soffit portion.

Figure C85. Detail of edges of cast unit.

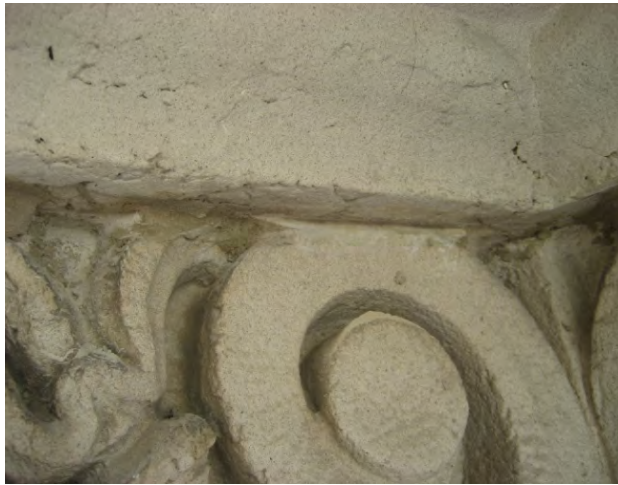
- Mortar has been previously installed at the transition from the scroll area of the bracket to the ogee portion. Limited removal of the mortar indicated that the mortar had been applied to the area, but that no joint exists (Figures C86). The scroll and ogee portion of the bracket were cast integrally with the rest of the cornice.

Figure C86. Area painted where no joint exists.

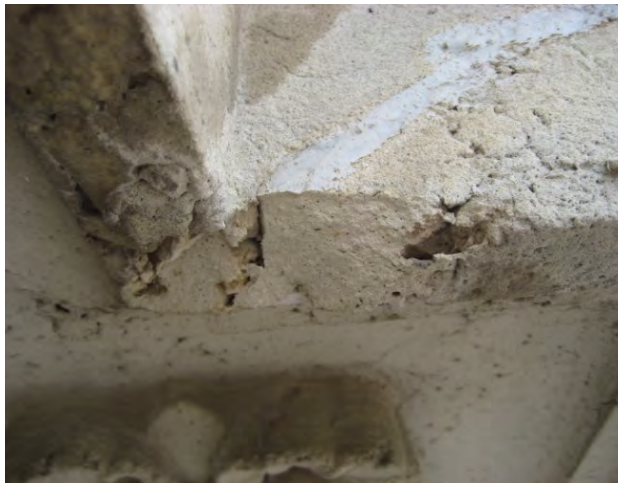
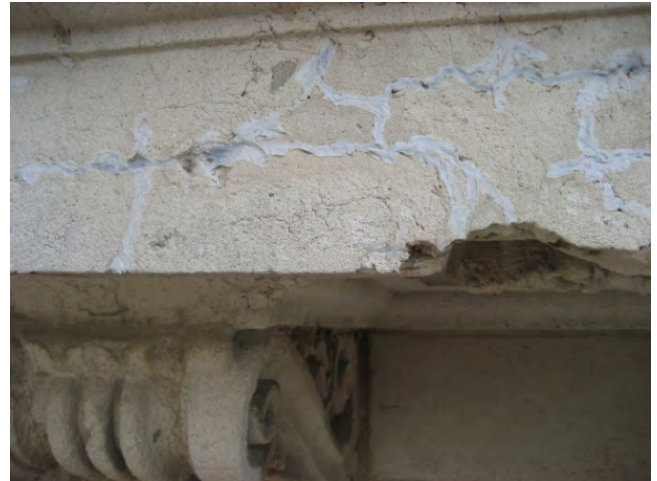
- A skim coat of sealant has been applied over some of the wider shrinkage cracks at selected areas (Figures C87 and C88) as well as some poorly consolidated areas of the concrete.

Figure C87. Skim coat of sealant applied to cracks.

Figure C88. Slim coat of sealant.

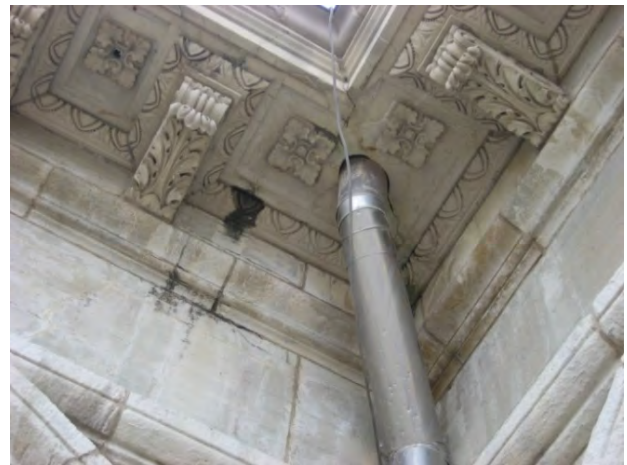
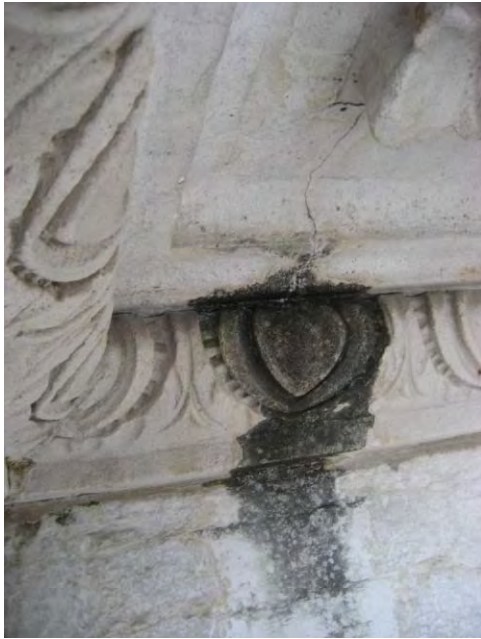
- A black substance has penetrated some of the cracks in the cornice (Figures C89 and C90). This substance appears to have leached through from the gutter and may be some previous mastic applied to the built in gutter as a remedial repair.

Figure C89. Overall view of black deposit.

Figure C90. Detail of black deposit at cornice.

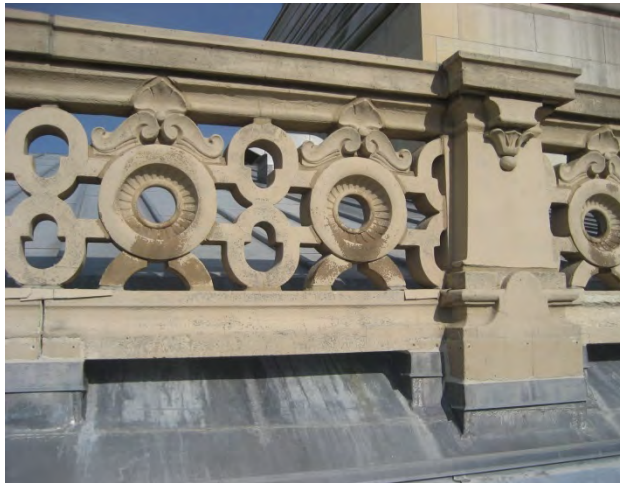
- A coating appears to have been applied to the replacement cast stone elements on the circular motif railing (Figure C91).

Figure C91. Deteriorated coating on cast stone.

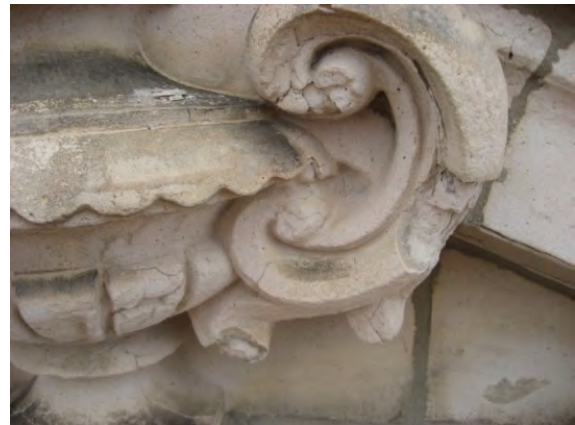
- Window surrounds at the dormer above the main facade incorporate unglazed terra cotta.
- Units above the window were typically cracked. The metal detector survey revealed that these units were hung from a continuous metal member roughly corresponding to bed joint at the top of the hung unit.
- Several of the units had portions of the unit which were not integral to the remaining portion of the unit. This appears to have occurred when the mold was originally packed (Figure C92).

Figure C92. Coated terra cotta unit.

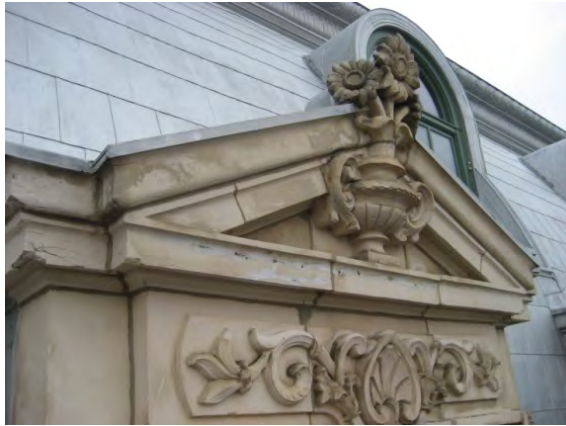
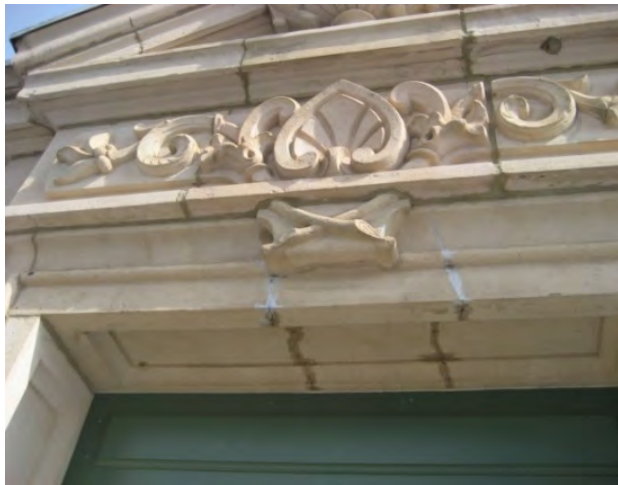
- The color of the units varied throughout the window surrounds and included a pinkish color as well as various shades of beige and buff colors.
- Several of the cracked units have been previously epoxy injected in a similar application as the epoxy injection on the Joliet limestone (Figures C93 and C94).

Figure C93. Epoxy injected on limestone.

Figure C94. Epoxy injected repairs.

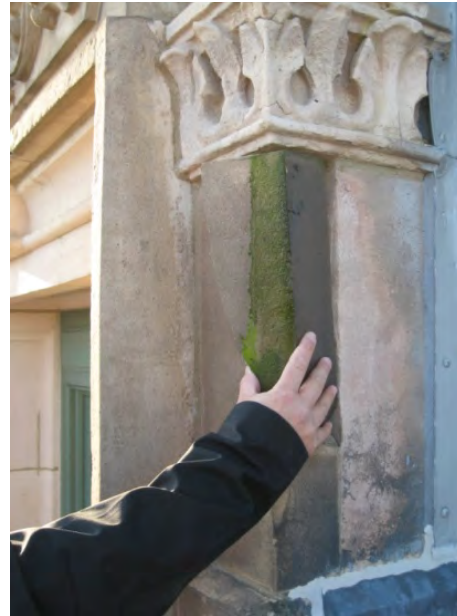
- At one location on the north facade one of the terra cotta units was cracked (Figure C95). The cracked section was removed at the time of our inspection revealed the cells of the terra cotta unit which were partially filled with brick (Figure C96).

Figure C95. Spall of cracked terra cotta.

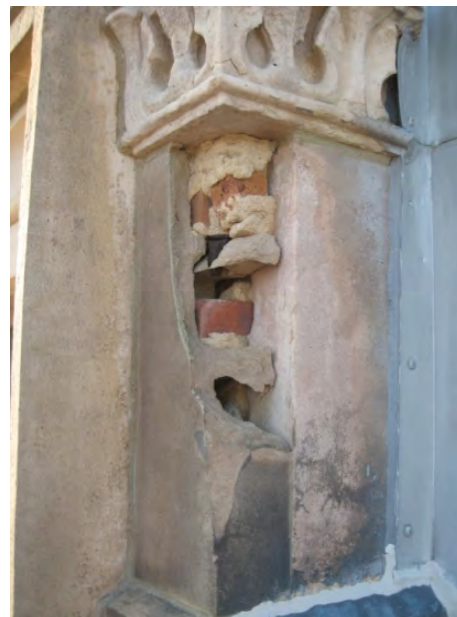
Figure C96. Removed terra cotta spall.

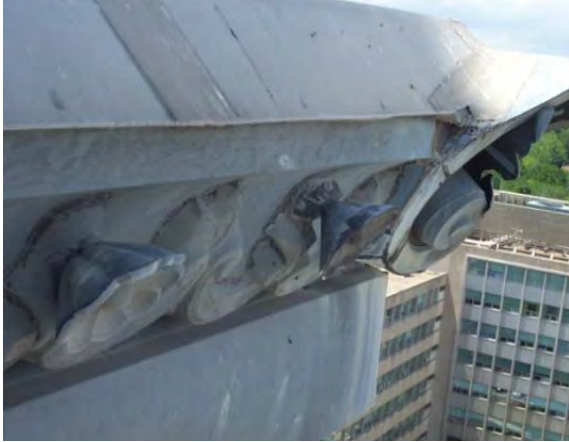
- During one of the previous repair programs, selected cast stone units appear to have been replaced with unglazed terra cotta. These units were found in the balustrades on the main facade as well as some of the

decorative floral units defining the corners of the main cornice (Figure C97).

Figure C97. Replacement terra cotta units.

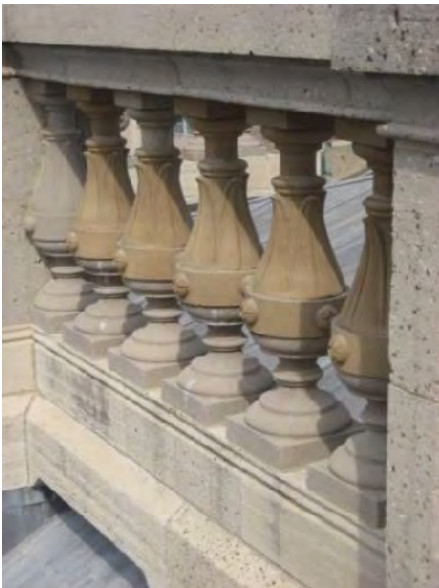
- The floral corner units on the cornices were typically cracked. No steel was detected using the metal detector.
- Various balustrades have been replaced with no consistent pattern (Figure C98). The replacement units are darker than the original and not steel pins were found in the replacement units. The glaze on some of the replacement units is weathered exposing the clay body of the unit.

Figure C98. Replacement balustrades.

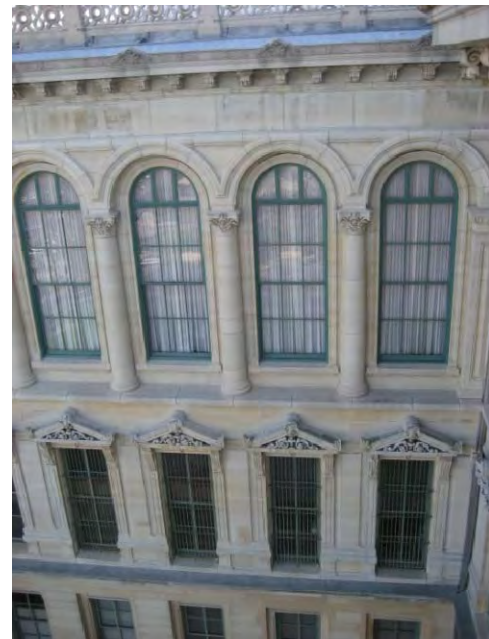
- Windows at the third floor are double hung units and double hung units with arch topped transom (Figure C99).

Figure C99. Double hung windows at 3rd floor.

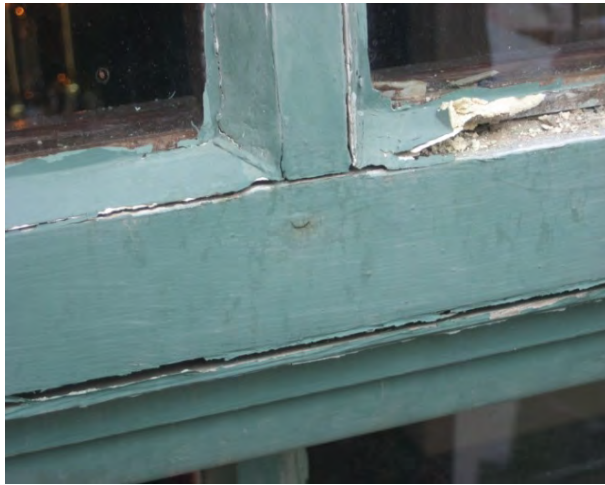
- Each sash is divided into four sections creating a four-over-four window. The transom is divided in half vertically.
- These windows have been previously restored. The restoration included replacing the original sash with new single glazed sash installed with putty and points.
- In general, the putty was brittle, cracked and separating from the glass and frame (Figure C100).

Figure C100. Cracked glazing compound.

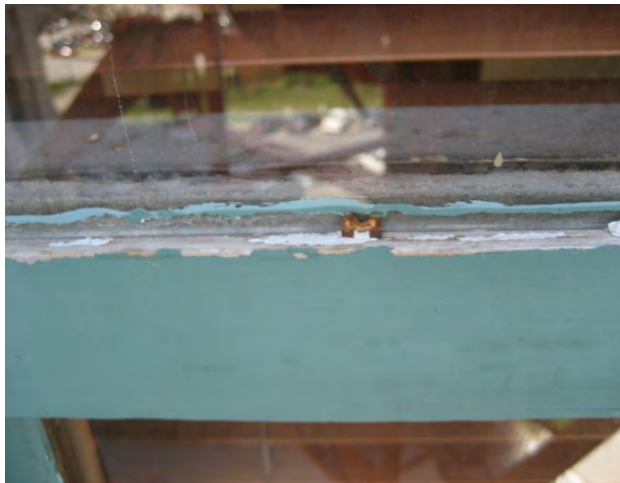
- Glazing points were found to be spaced at approximately 12 inches around the perimeter of the individual lites. A few of the points were exposed and exhibited surface corrosion (Figure C101).

Figure C101. Exposed glazing points.
