Illinois State Capitol Historic Structure Report

March 17, 2009

Wiss, Janney, Elstner Associates, Inc.

WJE Project Number: 2007.0701

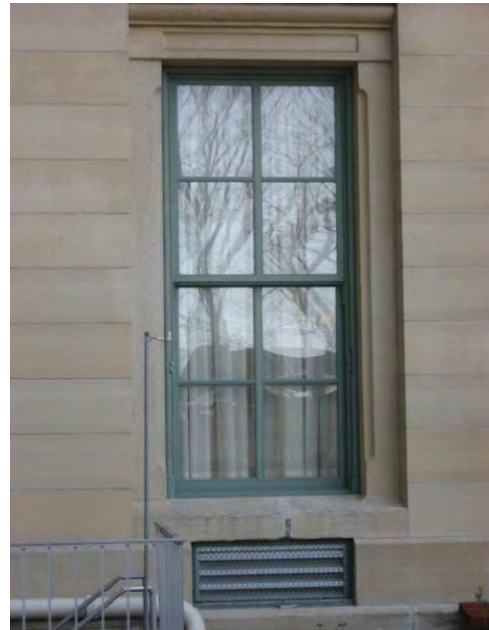
- According to available drawings, the sashes at the first and second floors were replaced during the 1990s repair work.
- Windows at the first and second floors are double hung units (Figure C102).

Figure C102. Typical first floor window.

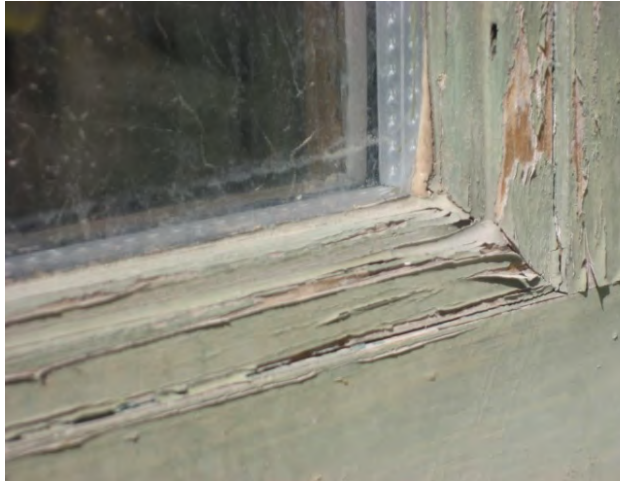
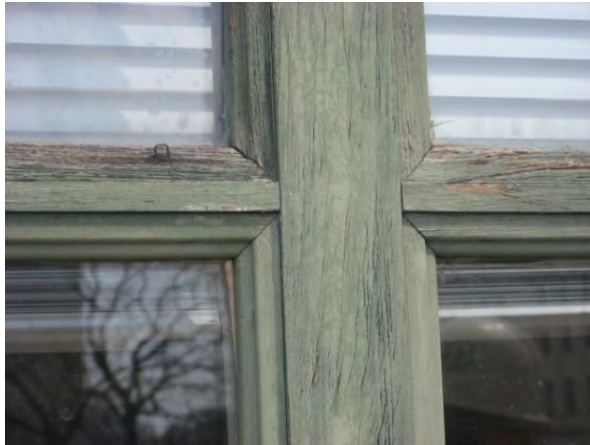
- In general, the stops are in serviceable with some evidence moisture absorption into the stop and glazing pocket. Some of the stops on the south and west facades are beginning to show evidence of deterioration, specifically peeling paint and raised grains, as a result water infiltration through the untreated end grain (Figures C103 and C104).

Figure C103. Deteriorated painted wood stop.

Figure C104. Deteriorated painted wood stop.

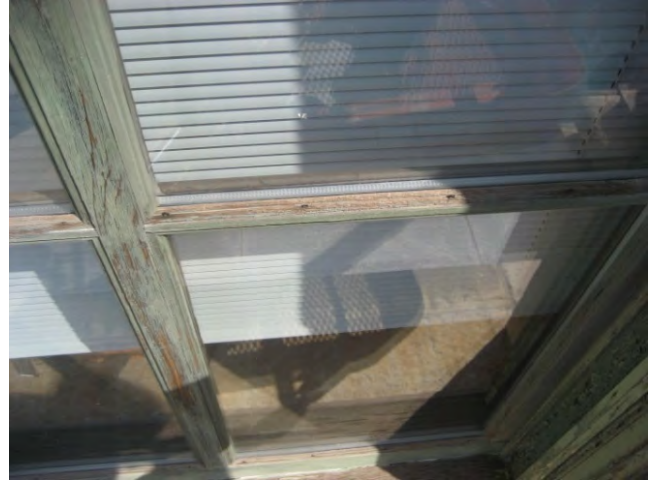
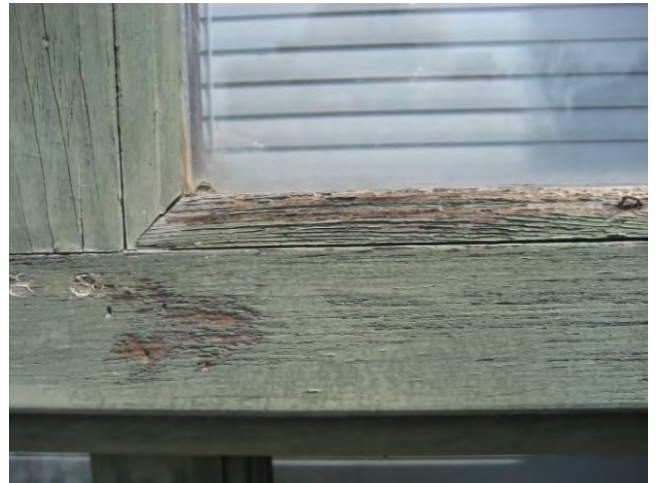
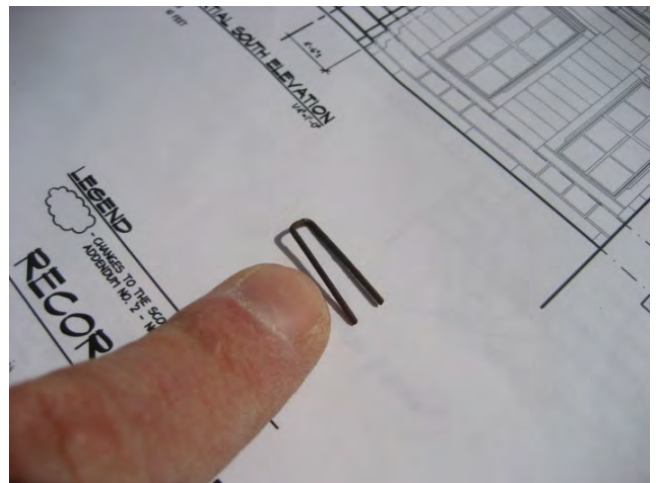
- Staples were found to be spaced at 4 to 8 inch centers around the perimeter of the individual lites (Figures C105, C106 and C107).

Figure C105. Staple at wood stop.

Figure C106. Staple at wood stop.

Figure C107. Detail of staple from wood stop.

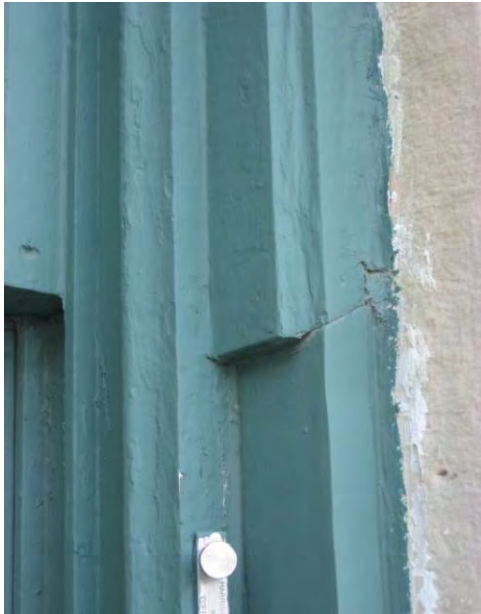
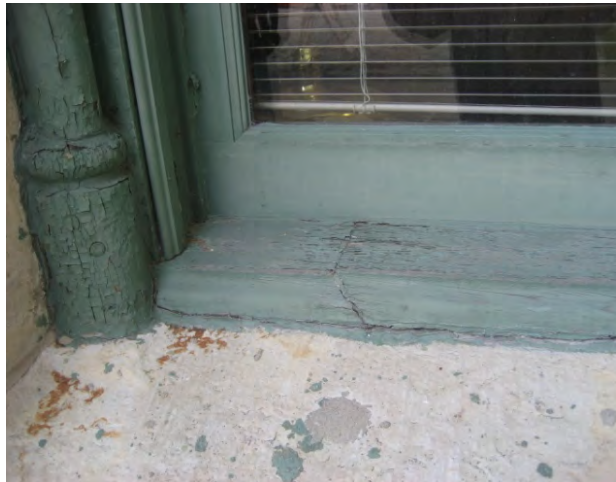
- The original frames and brick molding was generally scraped and painted or Dutchman were installed to replace deteriorated components of the frame (Figures C108 and C109) and brick molding.

Figure C108. Dutchman component on frame.

Figure C109. Dutchman installed on sill.

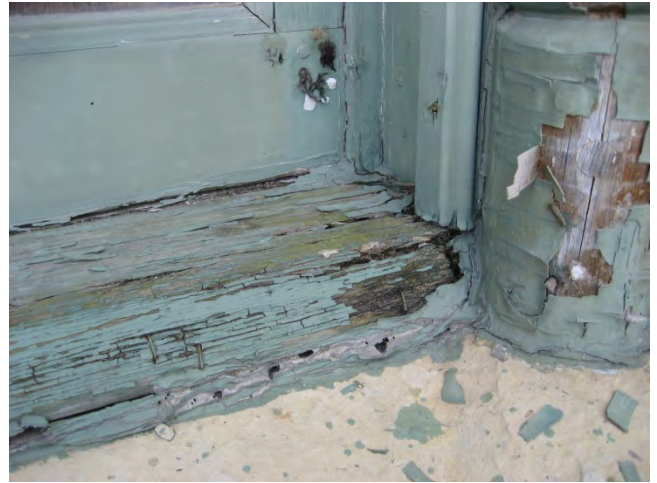
- The lower portions of the brick molding and the sill exhibit deterioration consistent with moisture absorption through unprotected end grain conditions (Figure C110).

Figure C110. Deteriorated wood at sill and brick molding.

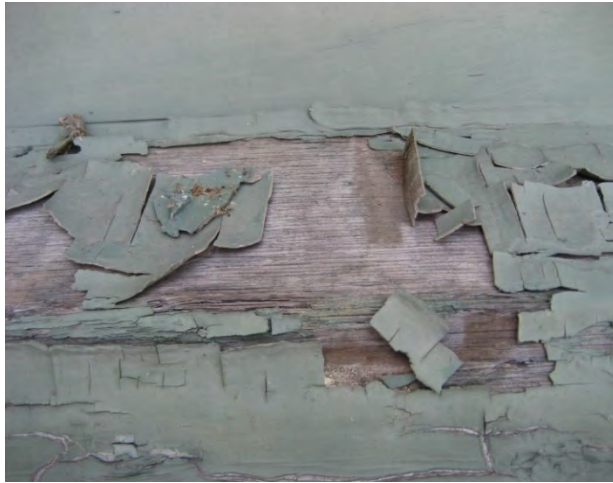
- Many of the sills on oriented toward the south and west exhibited had complete failure of the paint coating and swelling of the wood fibers (Figures C111 and C112).

Figure C112. Detail of paint failure and wood deterioration at sill.

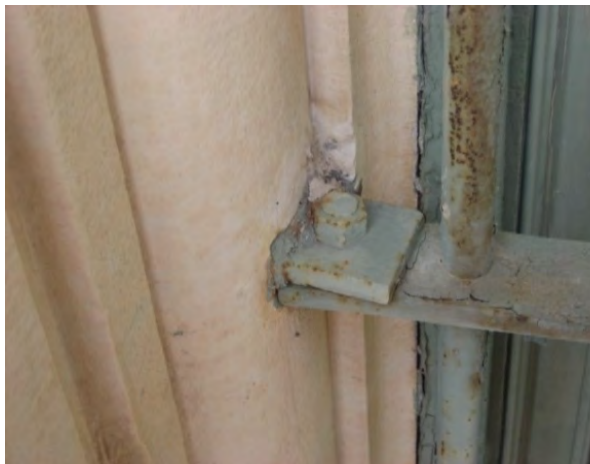
- The perimeter sealant is typically in poor condition. The sealant was poorly installed and not properly tooled. Numerous areas of the sealant are debonded and brittle.
- Security grills have been installed at the second floor windows adjacent to the Treasure Department. The grills consist of horizontal plates with circular bars penetrating the bars. The grills are anchored into the window jambs by means of a separate segment of plate embedded into the limestone and bolted to the horizontal plate of the grill (Figure C113). The grills exhibit peeling paint and some surface corrosion (Figure C114).

Figure C113. Security grill anchor.

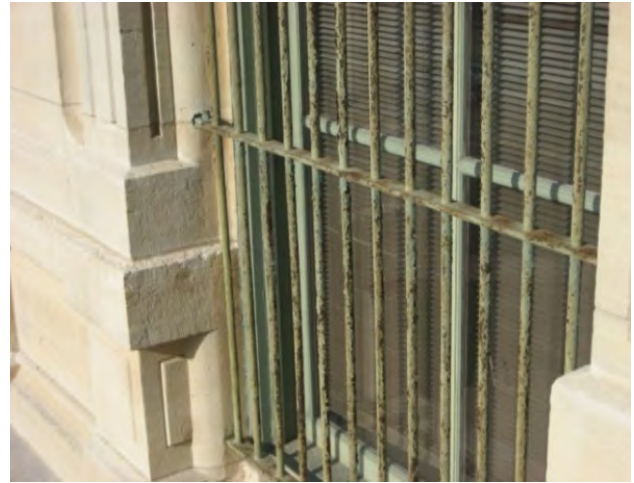
Figure C114. Peeling paint and corrosion of security grills.

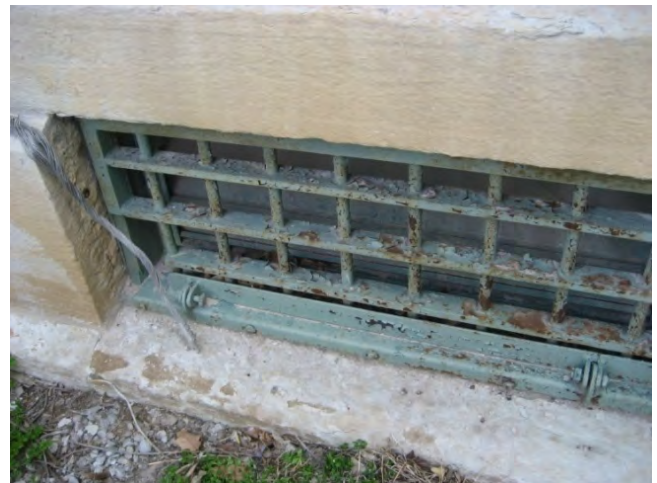
- The basement windows are replacement fixed wood frame units.
- Pivoting steel security grates were installed in front of some of the windows (Figure C115). The grates consist of horizontal steel plates with vertical bars extending through the plates.

Figure C115. Security grate.

- The coating on the security grates is typically peeling.
- Surface corrosion exists on grates. The most severe corrosion occurs on the upward facing portion of the horizontal plates.

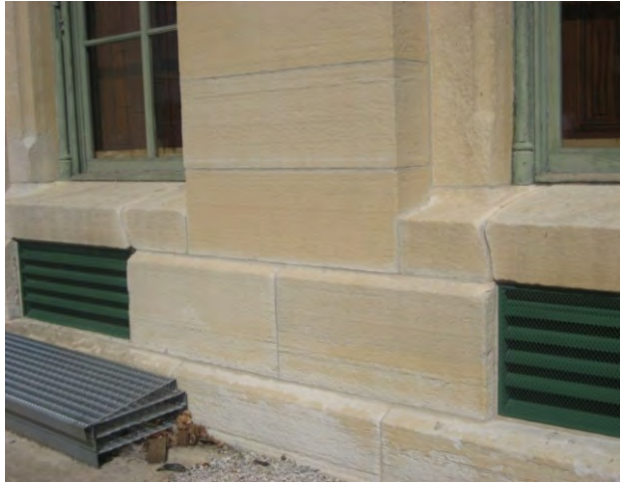
- Several of the basement windows have been removed and replaced with aluminum frame louvers (Figure C116) and various security devices.

Figure C116. Replacement aluminum louvers.

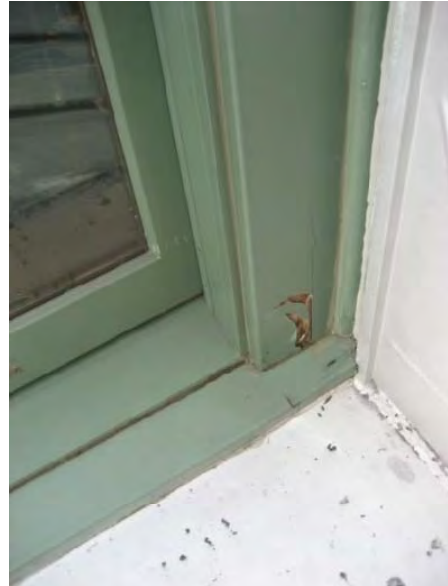
- The 1969 repair drawings indicate that the original wood dormer windows were to be replaced.
- The windows in the dormers are all replacement double hung units with arched tops.
- Several of the replacement units were severely deteriorated with significant areas of rot at the ends of individual pieces of the perimeter trim (Figure C117).

Figure C117. Deteriorated replacement wood window frame.

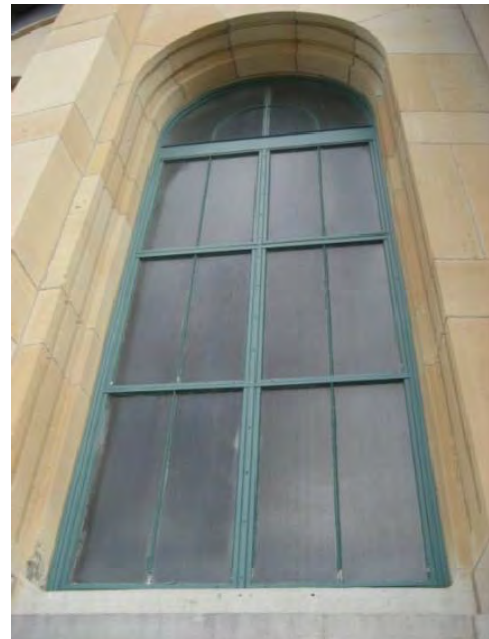
- According to the available drawings, the original windows in the drum were replaced in the 1930s with steel windows glazed with wired glass (Figure C118).

Figure C118. Replacement steel window.

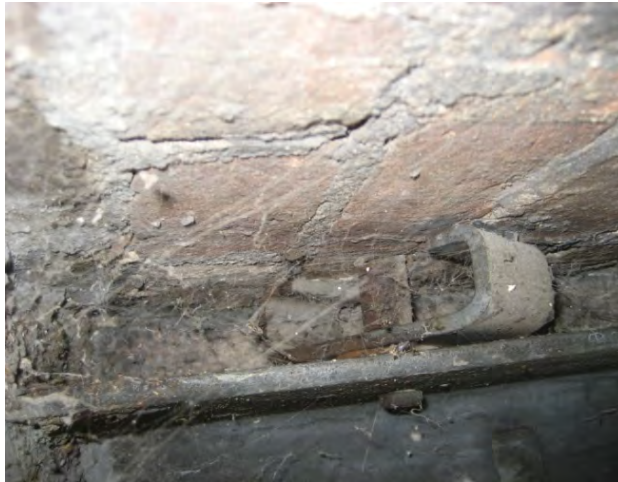
- Minor surface corrosion and limited areas of paint failures exist on the windows.
- The anchors for the window were visible around the perimeter from the inside of the drum (Figure C119). Only minor surface corrosion was visible and no cracking or spalling of the adjacent masonry was observed.

Figure C119. Window anchor with surface corrosion.

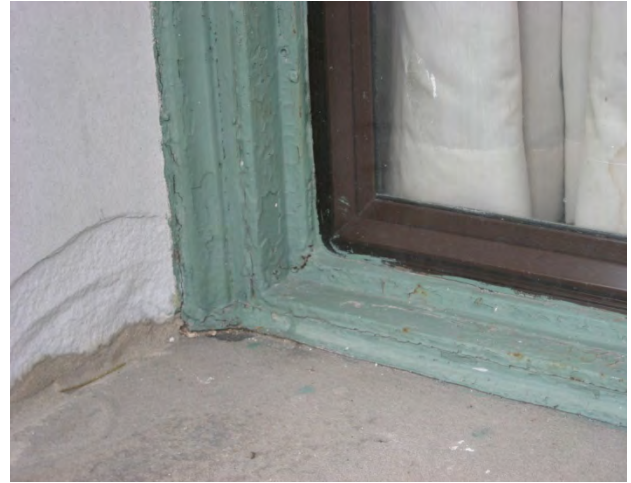
- No significant corrosion of the cast iron window surrounds exists.
- Minor areas of peeling paint as well as minor surface corrosion were visible at some limited areas (Figures C120 and C121).
- Numerous layers of paint are evident on the surface of the cast iron resulting in a loss of sharpness of the decorative relief.

Figure C120. Peeling paint and minor surface corrosion on cast iron windows.

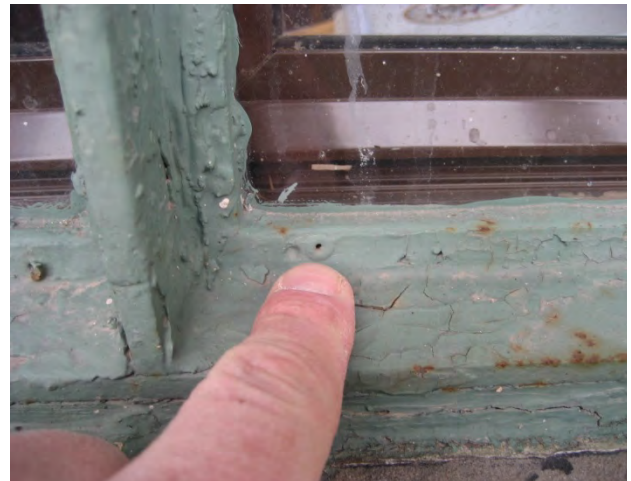
Figure C121. Detail of peeling paint and minor surface corrosion on cast iron windows.

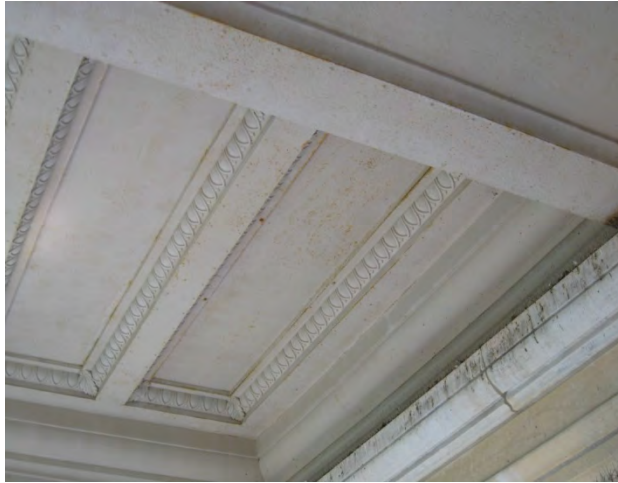
- No significant corrosion of the cast iron soffit was evident.
- Minor areas of peeling paint with some minor corrosion bleed-through of the paint were evident (Figure C122).

Figure C122. Minor peeling paint and corrosion of cast iron soffit.

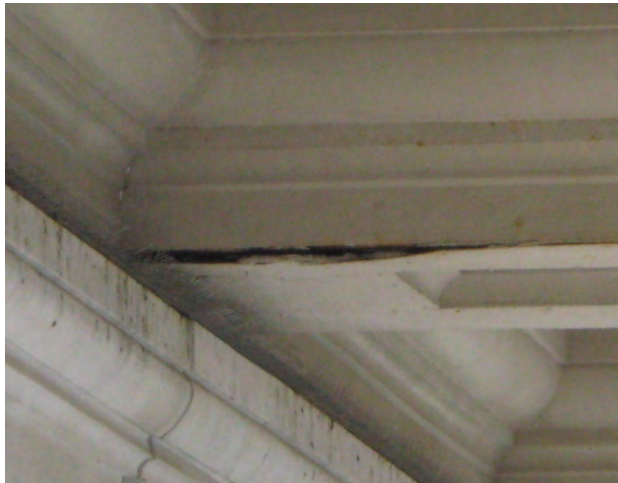
- A few of the cast iron panels exhibited corrosion scale accumulation between adjacent panels (Figure C123).

Figure C123. Corrosion scale at cast iron soffit panels.

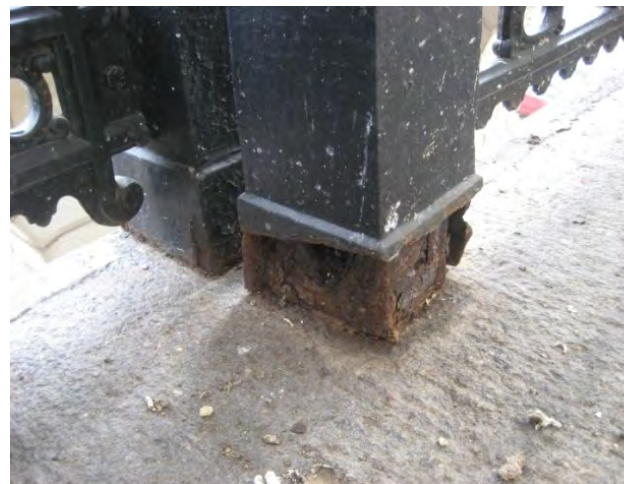
- Numerous layers of paint exist on the railings. In generally the paint is well adhered with only minimal areas of exposed metal.
- The bases of the rail posts are typically cracked or have missing sections (Figures C124 and C125). Significant corrosion scale exists in the base of the railings. The condition is most pronounced on the north portico and to a lesser extent on the east portico. Significant corrosion scale and construction debris has accumulated at the bottom of the posts. The scale appears to be a combination of corrosion from the steel clips and to a lesser extent, corrosion of the interior surface of the cast iron post (Figure C126).

Figure C124. Cracked rail post.

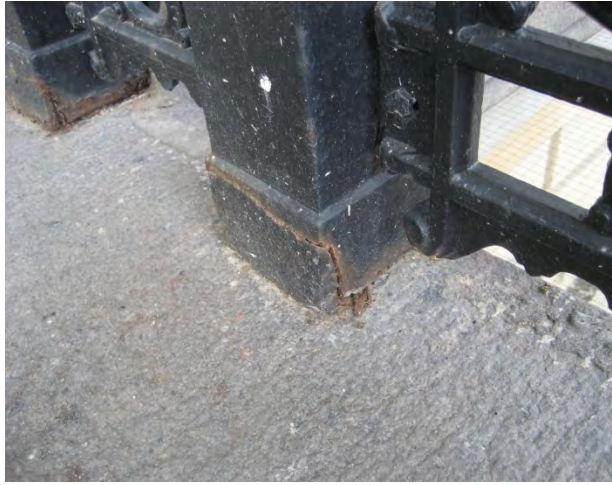
Figure C125. Cracked rail post.

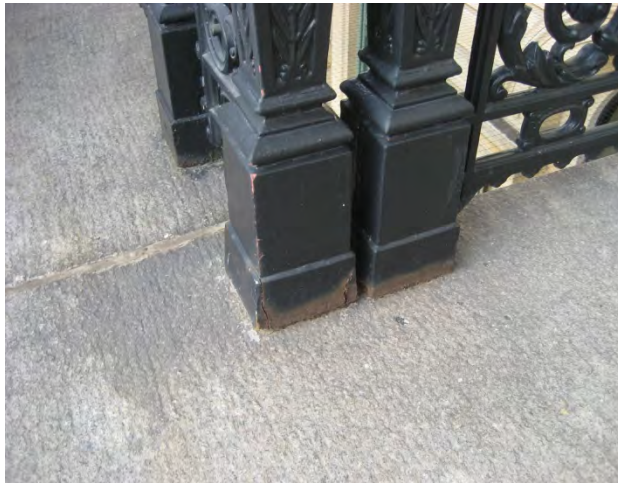
Figure C126. Corrosion of cast iron post.

- The interior surface of the cast iron posts was noticeably pitted from corrosion, but exterior observation did not indicate that it has lost significant cross sectional area.

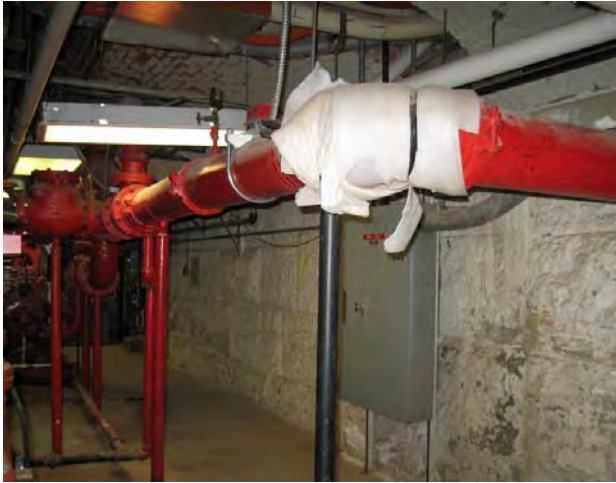
The interior face of portions of the Joliet Limestone foundation walls, supporting the building and porticos, is visible from the basement spaces beneath the north and east porticos. See Figures C129 and C130. Although the foundation stones generally appear to be in satisfactory condition, there is some evidence of water infiltration.

Figure C129. Interior face of Joliet limestone foundation walls beneath north portico.

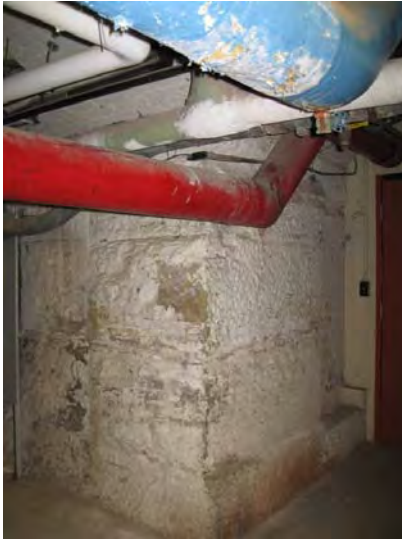
Figure C130. Interior Joliet limestone foundation wall beneath north portico.

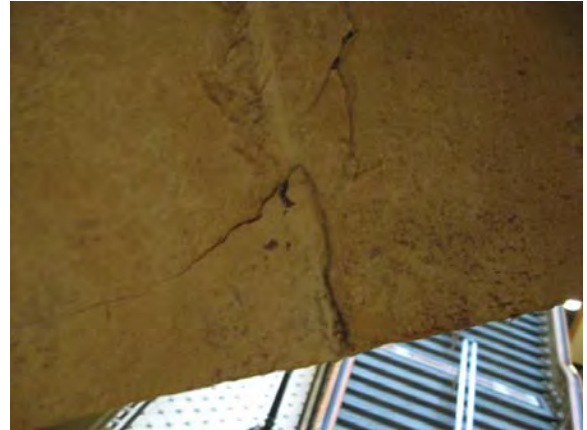
and rotunda framing. The four wings of the third floor radiating from the rotunda are supported by masonry arches, which frame the corridors of the wings of the rotunda on the second floor. Typically, the masonry arches are cracked, ranging in width from 0.05 to 0.1 inches, at the center of each arch, as seen in Figure C148, and beginning at the beams supporting the drop pendants. See Figure C149. Telltale monitors were installed at some of these cracks at a previous unknown date. See Figures C150 and C151. Readings were taken on 23 April 2008, each of the gauges read approximately 0.0. The cracks were measured and recorded during this investigation, as this information had not been previously recorded. It is assumed structure as these locations is composed of a masonry brick arch, as indicated by the specifications, previous drawings and reports.

Figure C148. Cracking at the center of the masonry arches surrounding the rotunda on the second floor.

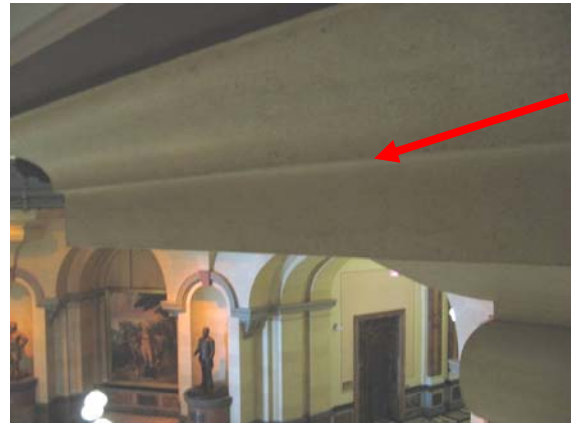
Figure C149. Hairline cracks running along the plaster clad wrought iron beams framing the drop pendant.

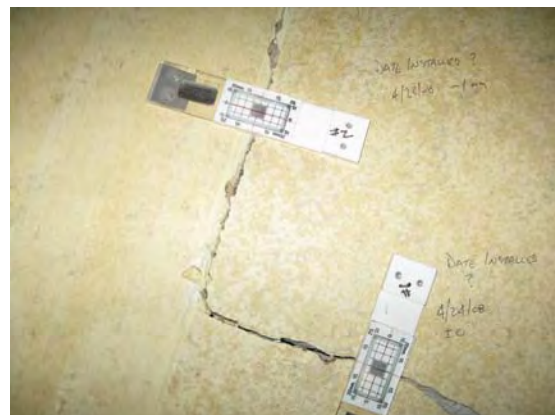
Figure C150. Cracking of the plaster clad masonry arch at the second floor north wing where tell tale monitors have been previously installed.

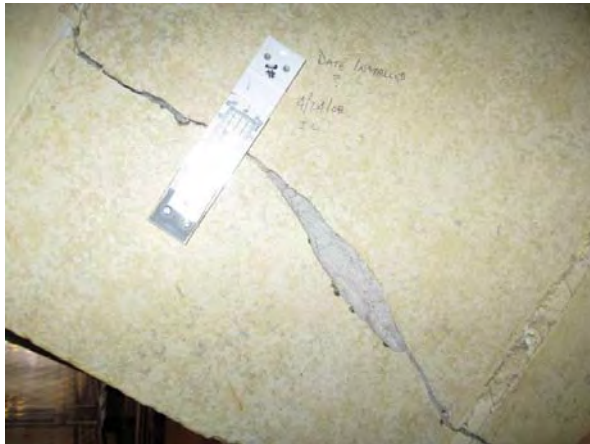
Figure C151. Cracking of the plaster clad masonry arch at the second floor south wing where tell tale monitors have been previously installed.

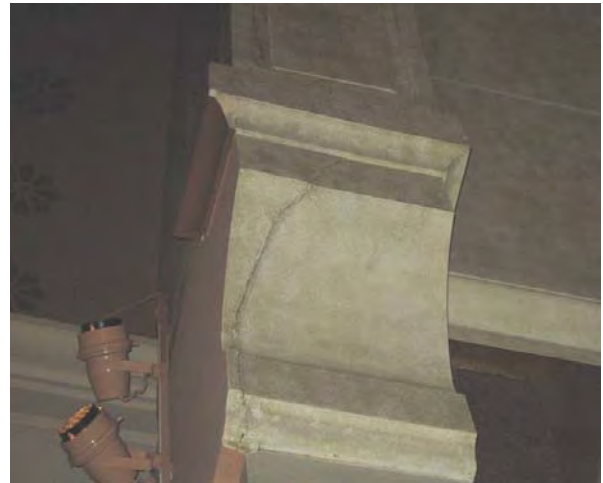
The load bearing masonry walls of the fourth floor exist at either side of the large archways, the rear portion of the arch, large piers surrounding the rotunda as well as the drum wall transitioning to the interior portion of the archway. The load bearing masonry walls are four wythes thick. Cracking of the plaster is occurring in the load bearing masonry portion of the plaster arches at the east and west wings, beginning at the spring point of the arch and continuing vertically at the recess in the wall. The cracks range from hairline to approximately 0.1 inches wide. See Figure C156. This cracking is most likely related to the differential movement of the drum with relation to the rest of the structure.

Figure C156. Cracking of the plaster of the spring point of the brick arch above the fourth floor.

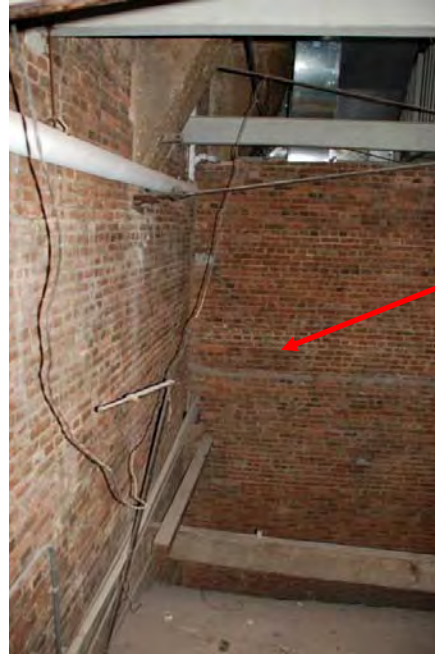
Masonry wing walls radiate out from the drum of the dome at the north and south wings, surrounding the large plaster archways, as observed from the attic spaces. These wing walls are experiencing significant cracking, ranging from 0.5 inches to nearly 0.75 inches wide, which most likely attributed to the differential movement of the drum load bearing masonry relative to the rest of the structure. See Figure C159. The significant load of the dome has caused the masonry of the drum to settle a greater amount than the masonry of cruciform plan portion of structure. These cracks most likely occurred shortly after construction, with the initial differential settlement of portions of the building.

Figure C159. Cracking, indicated by the arrow of the radial wing walls surrounding the inner dome masonry walls.

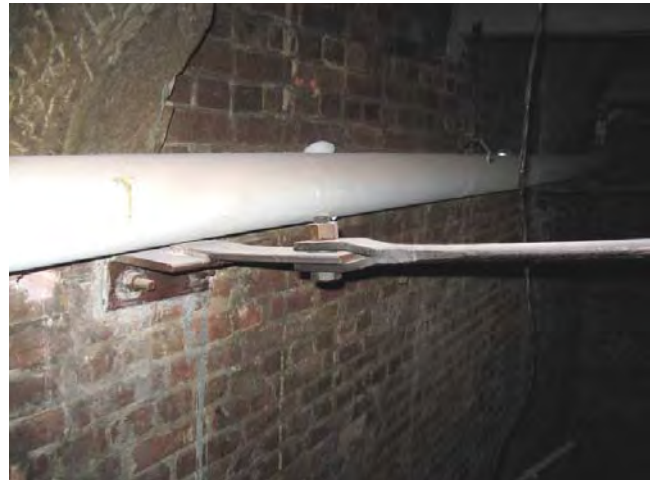
Tie rods have been added in order to tie the drum masonry with the other load bearing masonry walls, as seen Figure C160. It appears the movement is no longer occurring, as no deformation in the tie rods exists.

Figure C160. Added steel tie rods, tying drum of dome to load bearing masonry walls of the main structure.

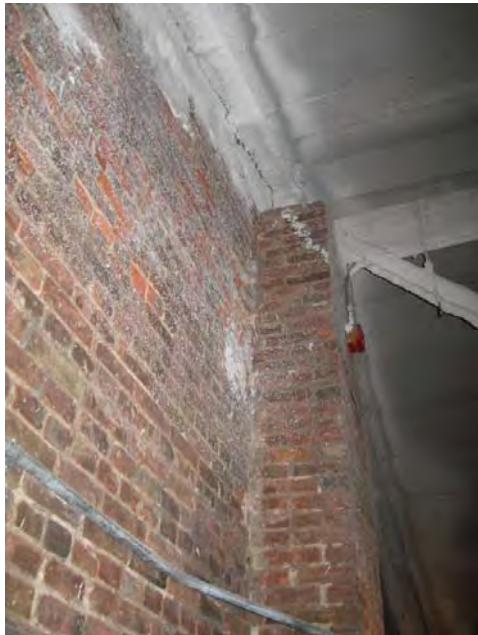
The backup brick masonry of the exterior walls in the attic spaces of the west wing supporting the roofing structure is experiencing distress. The upper portion of the west wall has rotated outward and is cracked near the roofline, as seen in Figures C176, and C177. The integral masonry piers supporting the trusses along the west wall have also cracked, as seen in Figure C178. It appears that some of this movement has occurred after the installation of the fireproofing, as the fireproofing is also cracked. Evidence of the fireproofing material exists on the precast concrete planks, indicating the fireproofing was installed in the late 1960s early 1970s, when this retrofit was made to the roof. The cracking of the upper portion of the west wall is most likely attributed to the moment induced in the west wall by the load created by the large concrete gutter. The weight of the gutter will tend to cause the wall to rotate outward, thus pulling it away from the roofing structure, in turn causing a large crack, running the entire length of the gable. A similar gutter exists on the north and east walls, yet no cracks exist in these locations, as the gutter is supported by the granite columns of the portico, and therefore a moment is not induced at the top of the walls.

Spalling, flaking and mortar erosion of the backup brick masonry of the west wall of the west wing can be attributed to prolonged water infiltration. When observed from roof side, many cracks and open joints exist in the concrete gutter directly above the west wall. These open joints and cracks allow free water entry into the building at the face of the west wall. Efflorescence, also present at this location, is indicative that moisture infiltration is occurring at this location.

Figure C176. Cracking near roofline between backup masonry wall and roof framing to the south of main high truss.

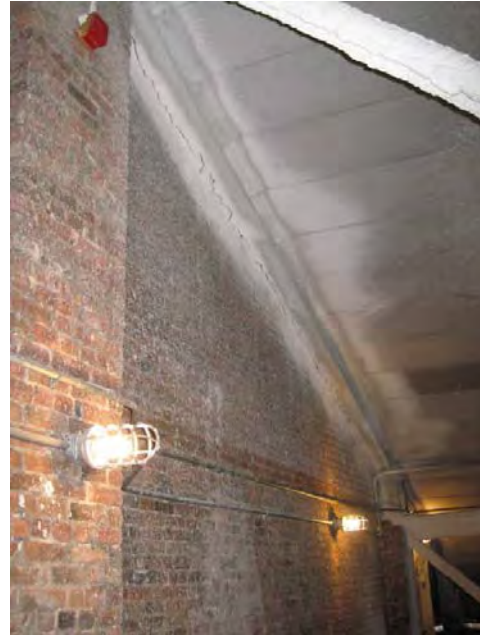
Figure C177. Cracking near roofline between backup masonry wall and roof framing to the north of main high truss.

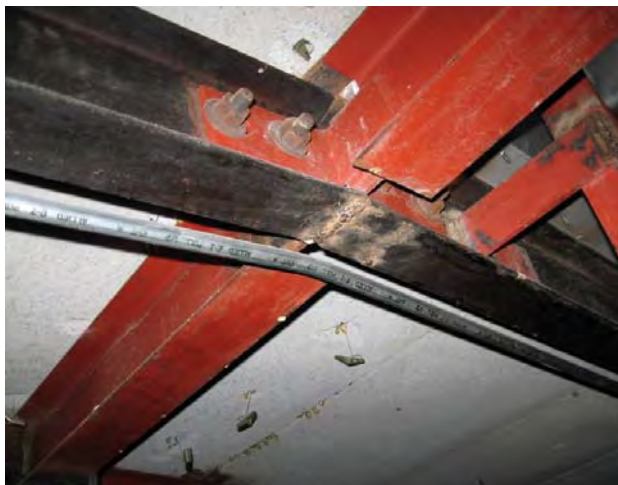
Figure C186. Close up view of connections between wrought iron framing and steel retrofits of south wing mansard roof framing.

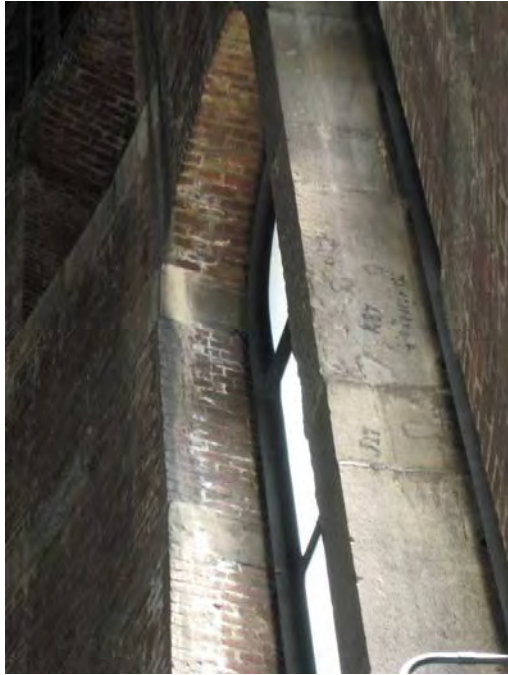
Figure C188. Masonry portion of the drum of the dome, showing limestone units keyed into brick masonry.

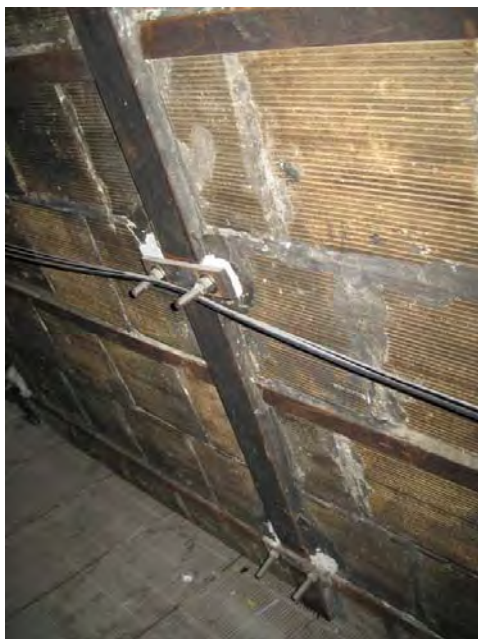
Figure C189. Retrofit anchorage at stone portion of the battered base of the dome, showing wrought iron framing and clay tile infill between framing.

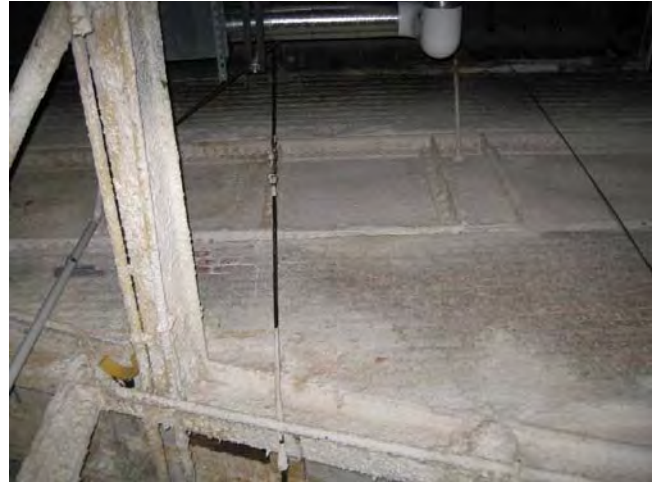
Figure C190. Transfer girder supporting the stone battered base of the dome.

During the course of our field investigation, we observed that the transfer girders described above are located directly above two adjacent wrought iron trusses, and that the space between the transfer girder and trusses is in-filled with brick masonry. Based on our field observations, it appears that the original design intent was for the two adjacent trusses to support the loads from the transfer girder and brick above. However, it appears that during construction it was determined that the two adjacent trusses were not able to carry these loads, subsequently large square cast iron columns were added beneath the ends of each transfer girder. Two added columns exist at both the east and the west wing of the building.

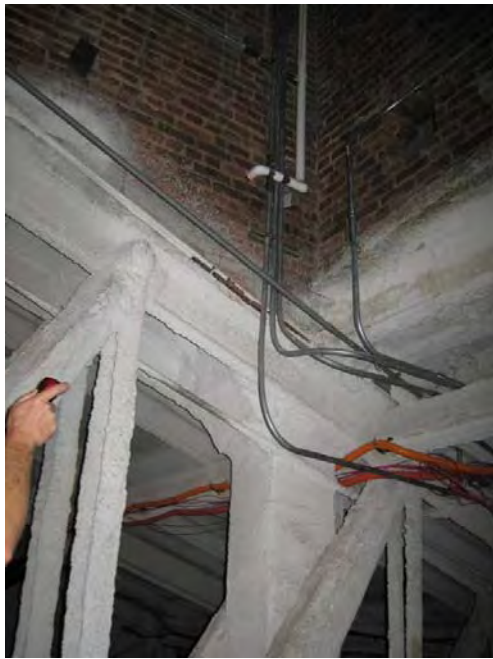
This is evidenced in the attic spaces, as seen in the following Figures C191 and C192. As seen in this historic image, Figure C193, these columns appear to have been added early in the life of the structure, most likely during construction, as based on field conditions. The placement of the cast iron columns in the finished space is prevalent on the third floor, in the west wing near the grand stair as seen in Figure C194 and in the east wing corridors leading to the gallery spaces of the house and senate chambers as seen in Figures C195. Historic drawings indicating the placement of the cast iron columns were not reviewed, as many of the early drawings of the building have been lost over the years. However it has been noted that the original architect raised the height of the dome and made it wider in 1871 after the foundations had been laid. These columns were probably added as a necessity to address these changes to this heavy structure.

Figure C191. Square cast iron column, between double truss elements, added to support the transfer girder and loading of the battered base of the dome, showing load-bearing masonry above column.

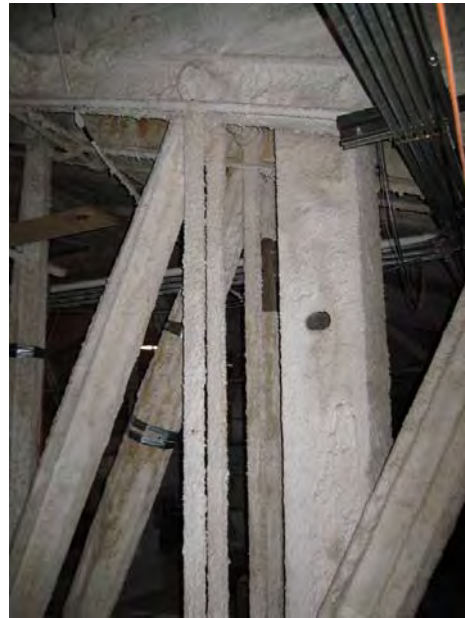
Figure C192. Square cast iron column, between double truss elements, added to support the transfer girder and loading of the battered base of the dome.

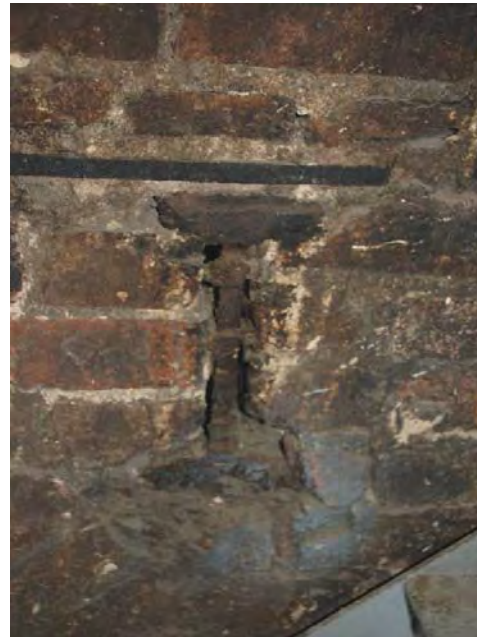
specifications.⁷ The cast iron extended 4 inches into the wall and to the center of the railing, remnants of the cast iron framing exist in the load bearing masonry drum of the outer dome structure, as seen in Figure C200. Balcony floors were reinforced as part of the 1932 dome repairs, and clad with sheet metal, as seen in Figure C201.

Figure C200. Slightly corroded remnants of cast and wrought iron framing elements of the porches and balustrades clad in sheet zinc.

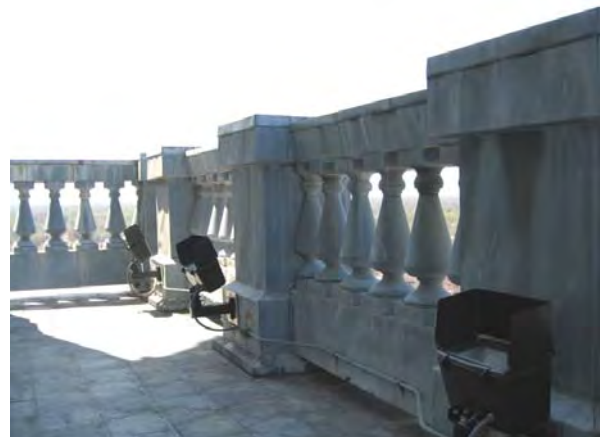
Figure C201. Exterior porches clad in sheet metal, framed into masonry drum of the outer dome structure.

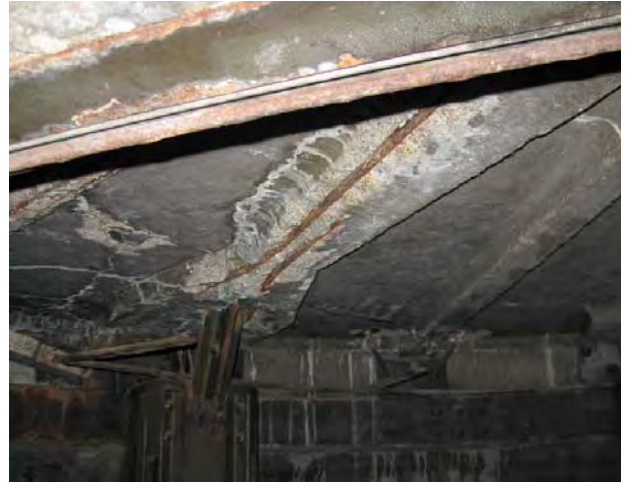
The floor of the attic space of the lantern roof contains two reinforced concrete decks separated by approximately two feet. The steel reinforcing bars in the reinforced concrete flooring slabs of the lantern attic space are significantly corroding. Spalling of the underside of the concrete decks has also occurred at these locations. Figure C223.

Figure C223. Underside of the attic floor, showing corroded reinforcing steel and spalled concrete.
