**A HISTORIC STRUCTURE ASSESSMENT
OF
THE ZEINE CABIN,
WILDLIFE PRAIRIE STATE PARK,
PEORIA COUNTY, ILLINOIS**

by
Christopher Stratton

Fever River Research
Springfield, Illinois

December 2001

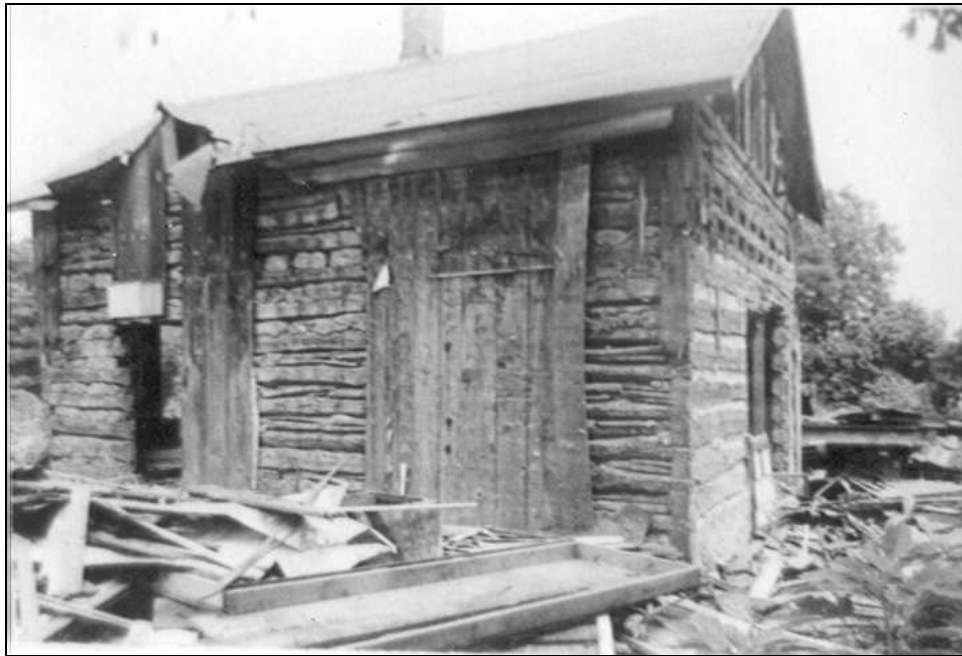
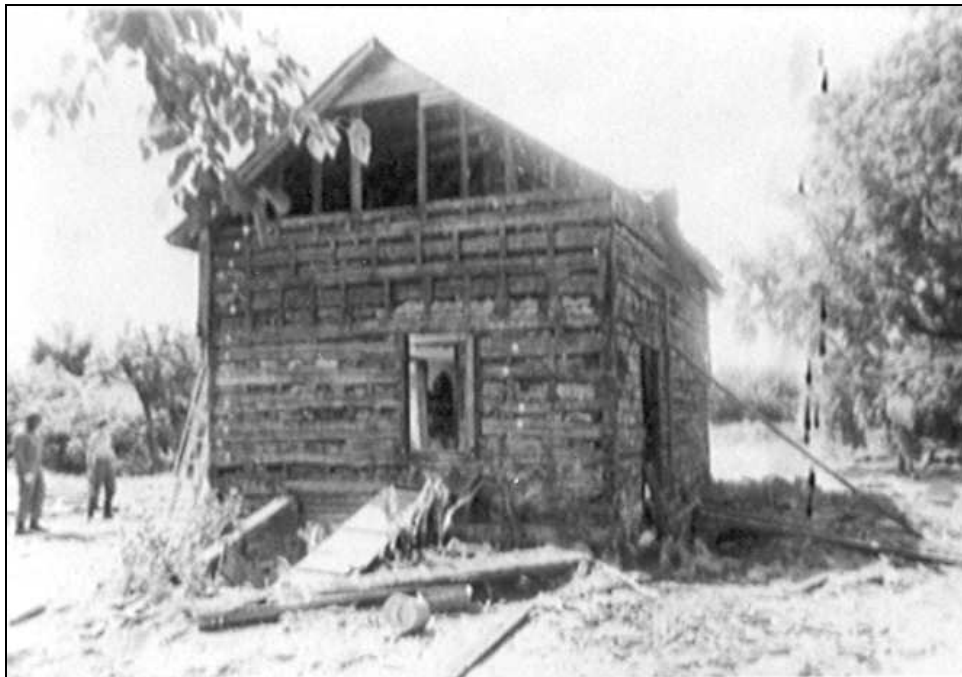
At later date one, if not two, frame additions were made to the Zeine Cabin. One of these additions was built along west side of the cabin and was demolished when the original log dwelling was disassembled in 1974. A second frame wing may have been located on the opposite elevation. The possibility of an east frame wing being present is suggested by two things: 1) the presence of two of door openings in the east elevation (which seems excessive if both doors simply opened to the outdoors); and 2) the pile of debris that is visible on this side of the house in one of the photographs that was taken during the cabin's disassembly in 1974 (reference Figure 1).

Figure 1. Two views of the Zeine Cabin during the course of its dismantlement in 1974. (Top) Oblique view, showing the present west and south elevations of the cabin. The demolition debris in the foreground is from a later frame addition. (Bottom) View of the cabin after the partial clean up of demolition debris. The gable-end wall shown is now the north elevation of the building. Note the bulkhead entrance to the cellar (WPSP August 1974).

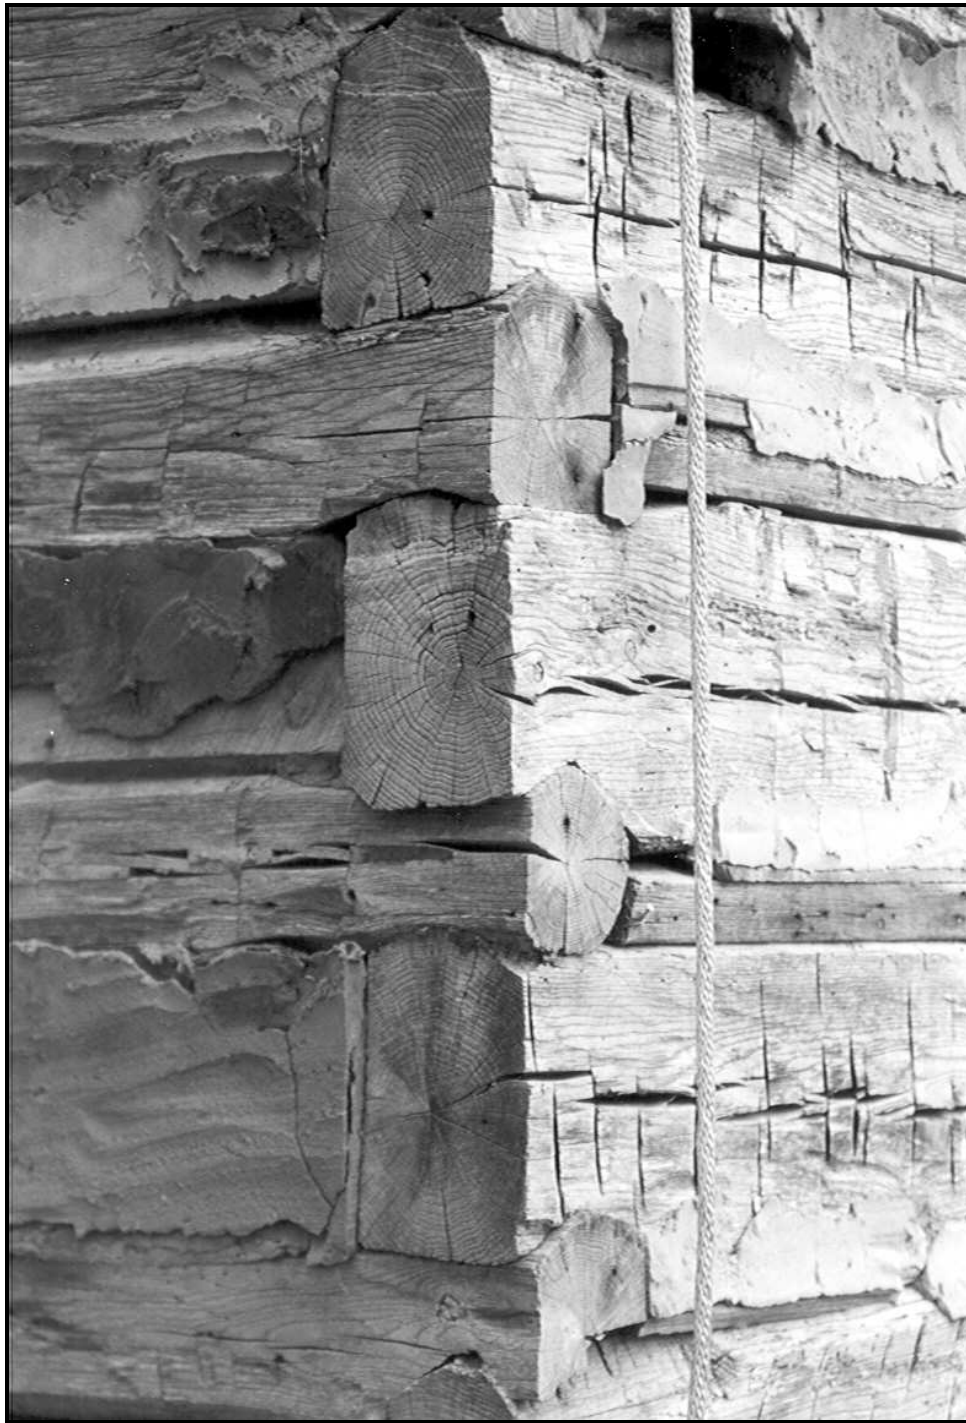
Figure 4. Detail of the northeast corner, showing the corner notching and hewing methods utilized in the construction of the cabin (FRR September 2001).

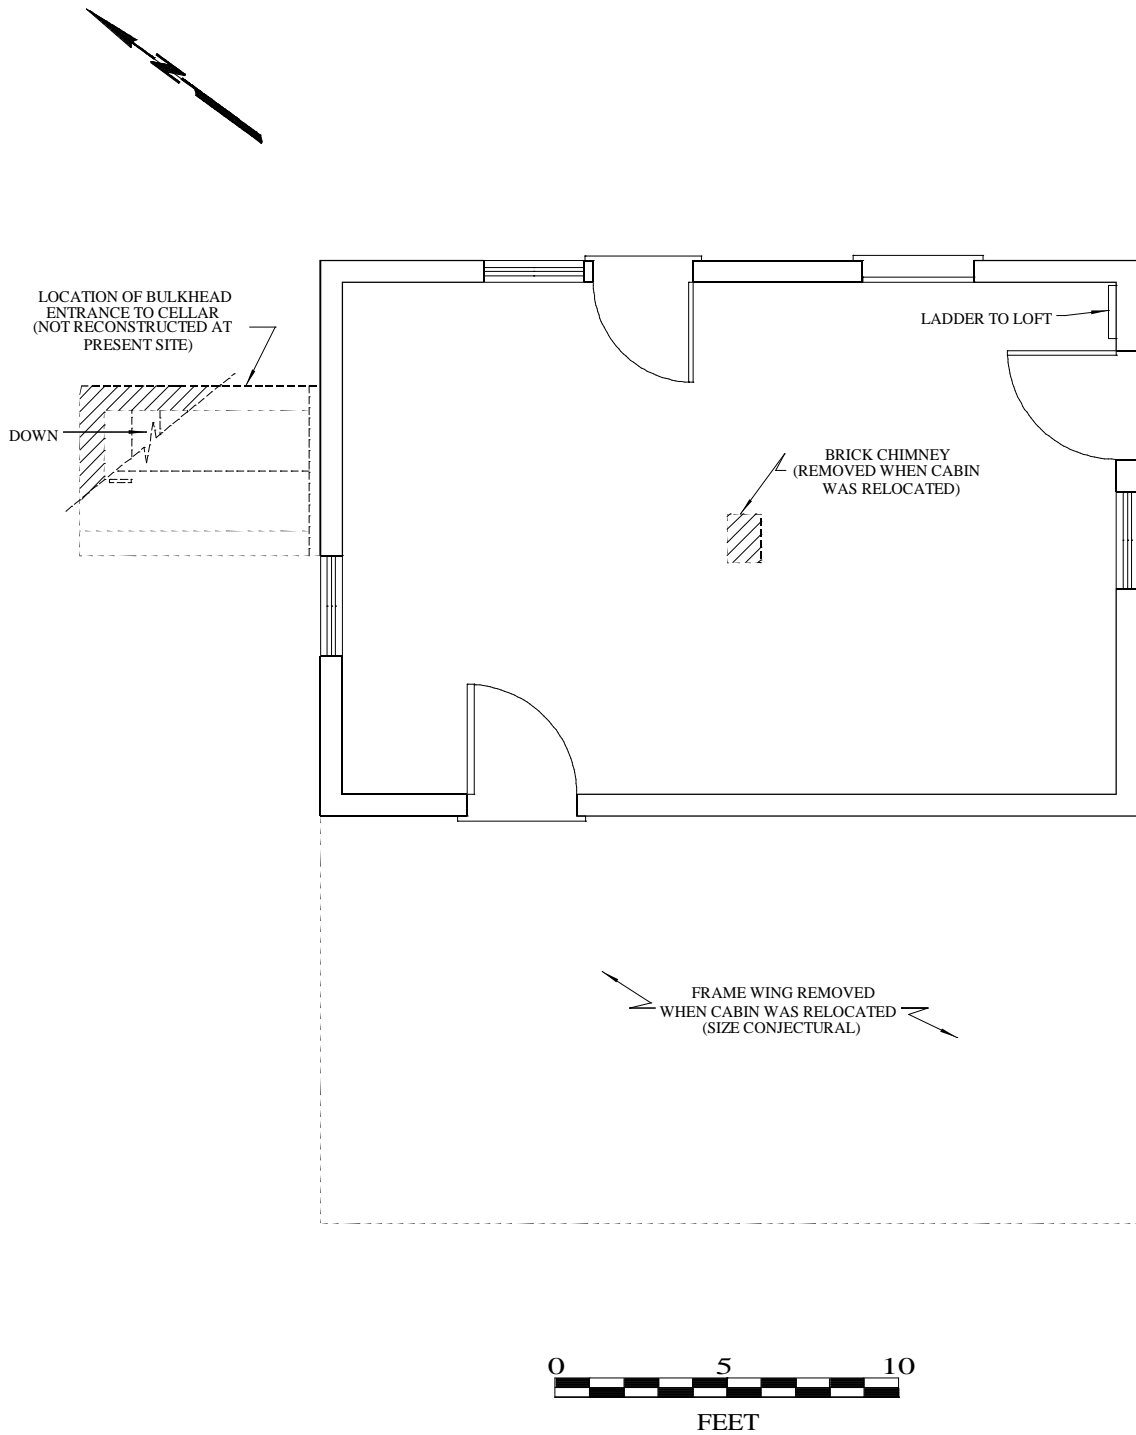
Figure 6. Floor plan of the Zeine Cabin, showing existing conditions. The dashed lines indicate features that were removed when the cabin was dismantled in 1973 (FRR 2001).

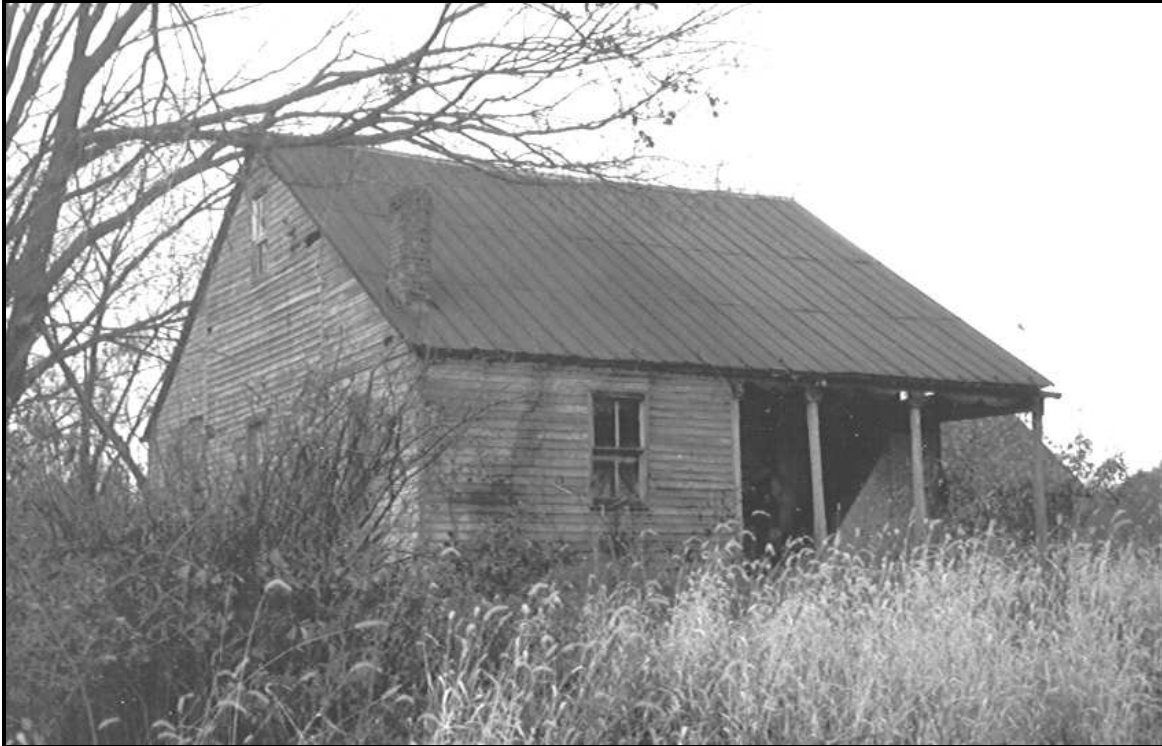
Figure 10. The Hoerr House in rural Monroe County, Illinois. This log house was constructed by a German family circa 1870 and is contemporary with the Zeine Cabin. The exterior is covered with beveled weatherboard siding, except for a short section of wall that is sheltered by the front porch (FRR October 1996).

have one section of wall where the logs are exposed, but this wall has always been sheltered within a front porch (Stratton and Mansberger n.d.) (see Figures 10 and 11). Part of the confusion about whether log houses were, or were not, sided historically derives from the failure to distinguish between round-log, saddle-notched cabins and the hewn-log houses of the type represented by the Zeine Cabin. Its formal name notwithstanding, the Zeine Cabin is in fact a log house. Whereas the cabins usually represented the first generation of housing and were meant to be temporary, hewn-log houses in the Midwest were built with permanence in mind and many were sided for aesthetic reasons, as well as practical ones (Elbert and Sculle 1982:2, 4; Bomberger 1991:2, 6; Roberts 1996:82-6). There are always exceptions to the rule of course (the log house erected by Thomas Lincoln in Coles County, Illinois being a notable one), but most nineteenth-century builders of hewn-log houses wanted to their homes to appear more formal and finished rather than rustic, in contrast to modern log homes. Historic log housing should be viewed in the context of *method of construction* as opposed to an architectural style in of itself (Elbert and Sculle 1982:2).

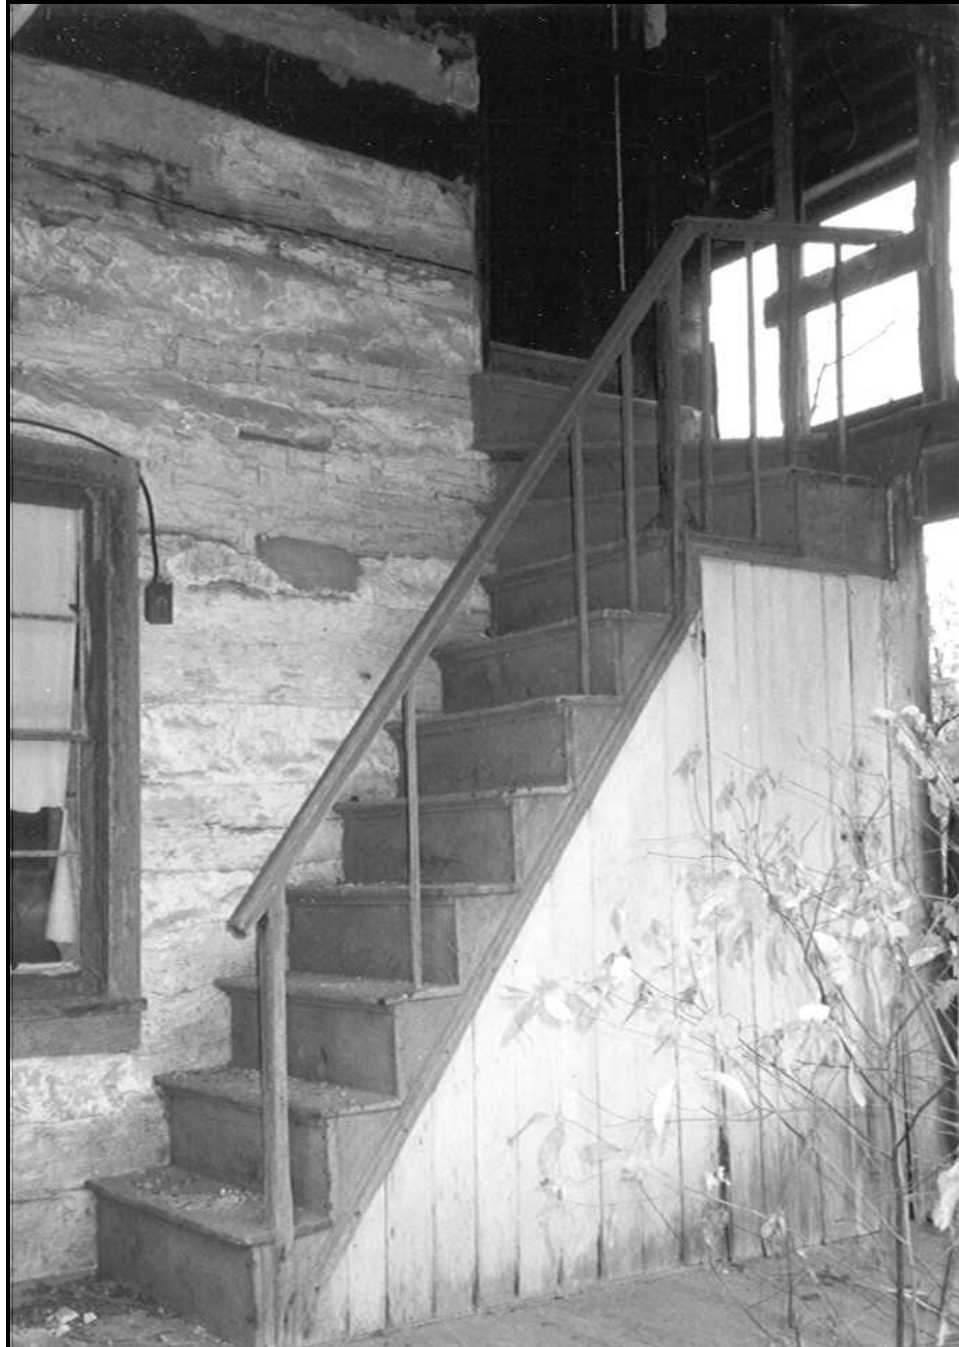
Figure 11. View of the front porch of the Hoerr House, showing the section of log wall that was not covered with siding. The logs have been coated with whitewash to provide a more finished appearance, as well as to protect them from infestation by insects. The exterior stairway shown provides the only access to the upper floor of the house (FRR October 1996).

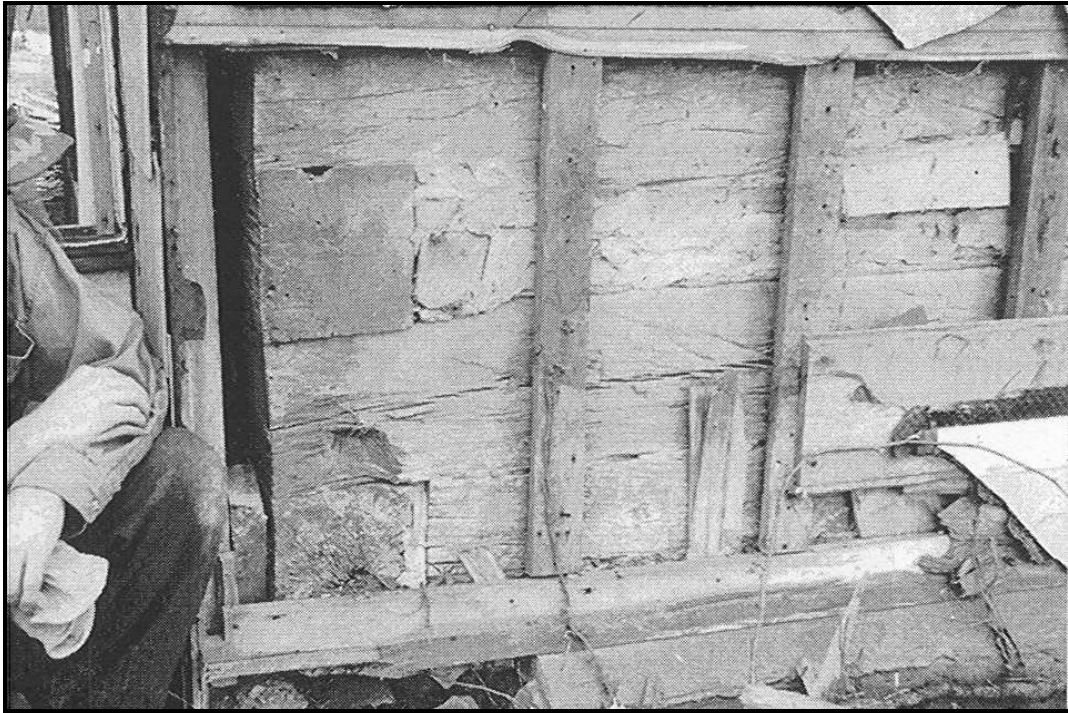
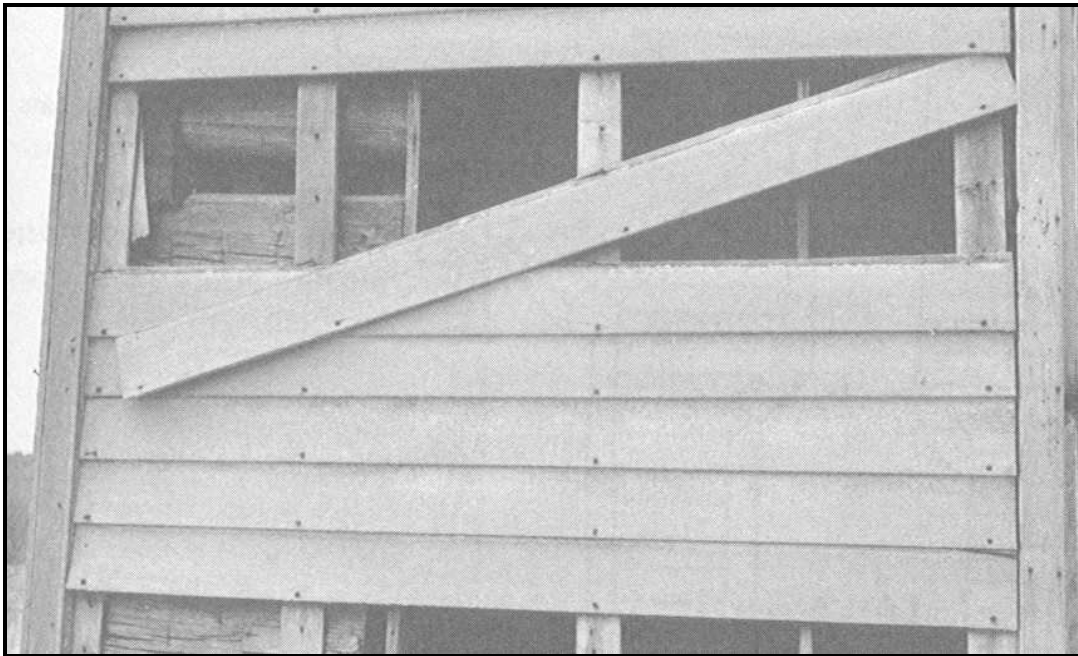
Figure 12. Two views illustrating the manner in which horizontal siding was attached to log buildings using vertical furring strips. A similar procedure should be used on the Zeine Cabin. (Top) The Barth House, in rural Carroll County, Illinois (Stratton and Mansberger 1998:39). (Bottom) A log house in southern Indiana (Roberts 1996:plate 14).

We recommended that the exterior of the cabin be covered with beveled horizontal weatherboard with a 4-1/2" exposure. This siding appears to be similar to that originally used on the cabin and also would be appropriate for the period of construction. The siding should be nailed to vertical furring strips in the same manner as was originally utilized on the cabin. Figure 11 provides representative illustrations of the application of horizontal siding on two other log houses. The vertical plank siding now in place on the gable ends should be removed and

replaced with horizontal weatherboard, as was the case prior to the cabin's dismantlement (see Figure 12). It would be appropriate to finish out the corners and openings with flat trim boards, perhaps 1"x4" or 1"x5" stock. The exterior siding should be primed and painted.
