STALEY PUMPING STATION AND CLUB HOUSE  
Lake Decatur, North of U. S. Highway 36  
Decatur  
Macon County  
Illinois

HABS No. IL-1258

HISTORIC AMERICAN BUILDINGS SURVEY  
STALEY PUMPING STATION AND CLUB HOUSE

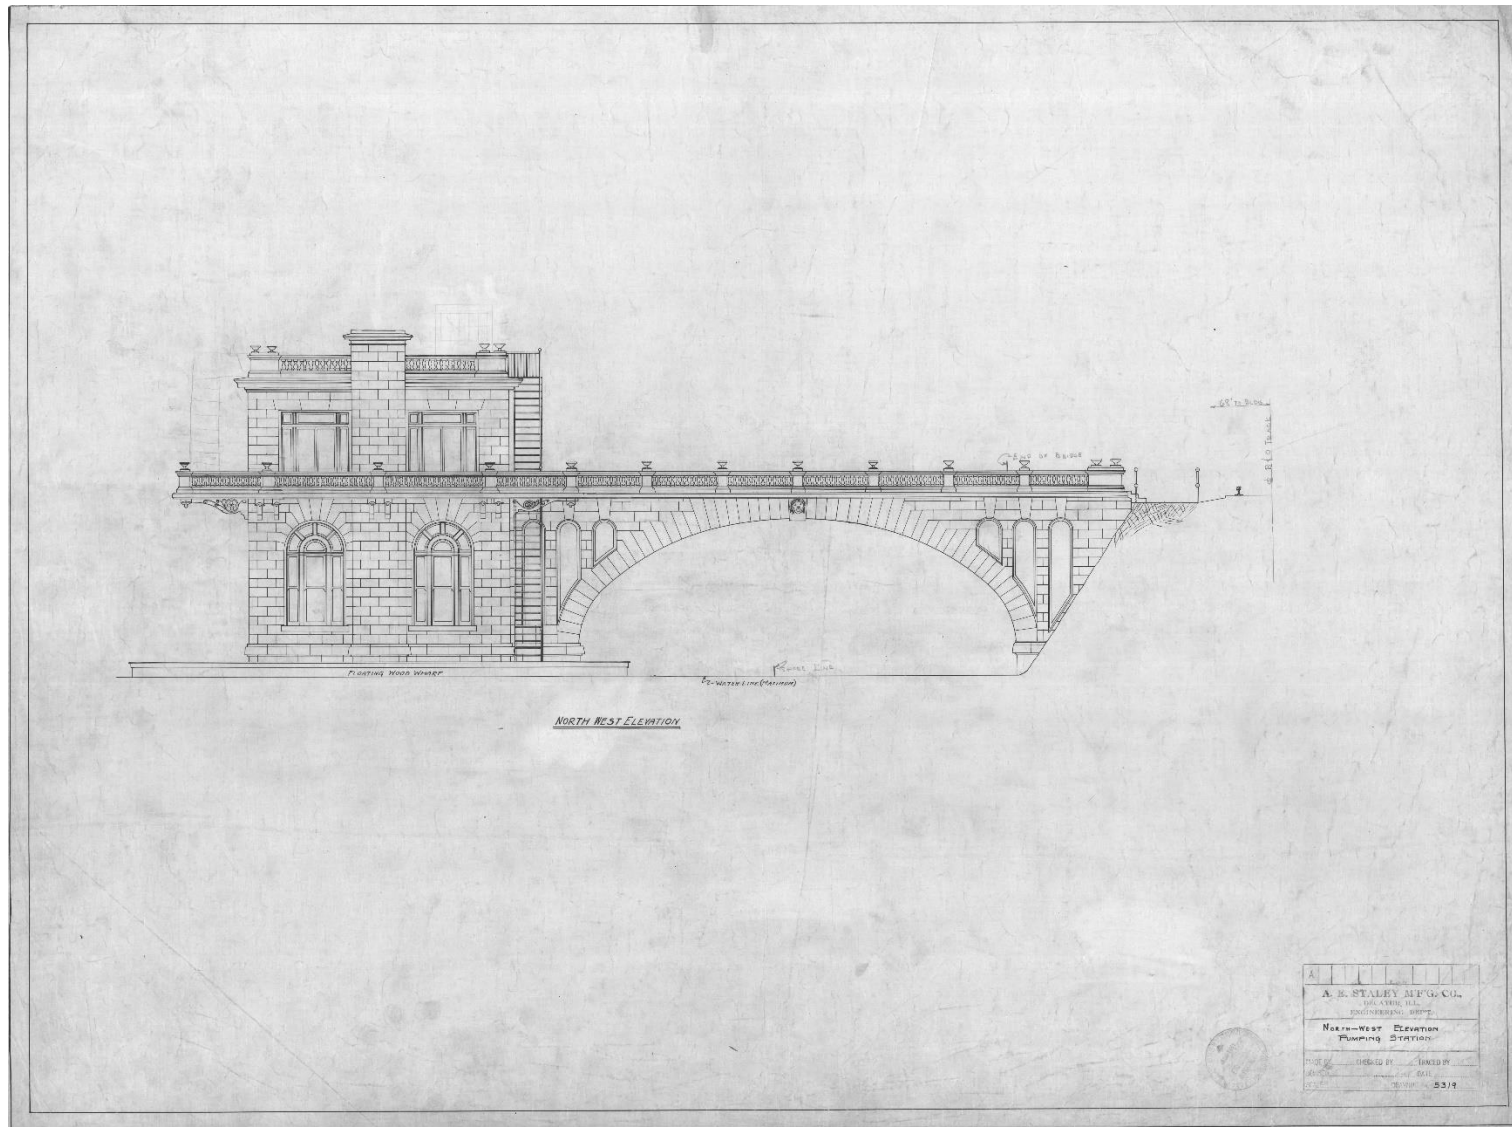
Figure 2. North-West [West] Elevation; Pumping Station (AES, Drawing No. 5319, [1919]).

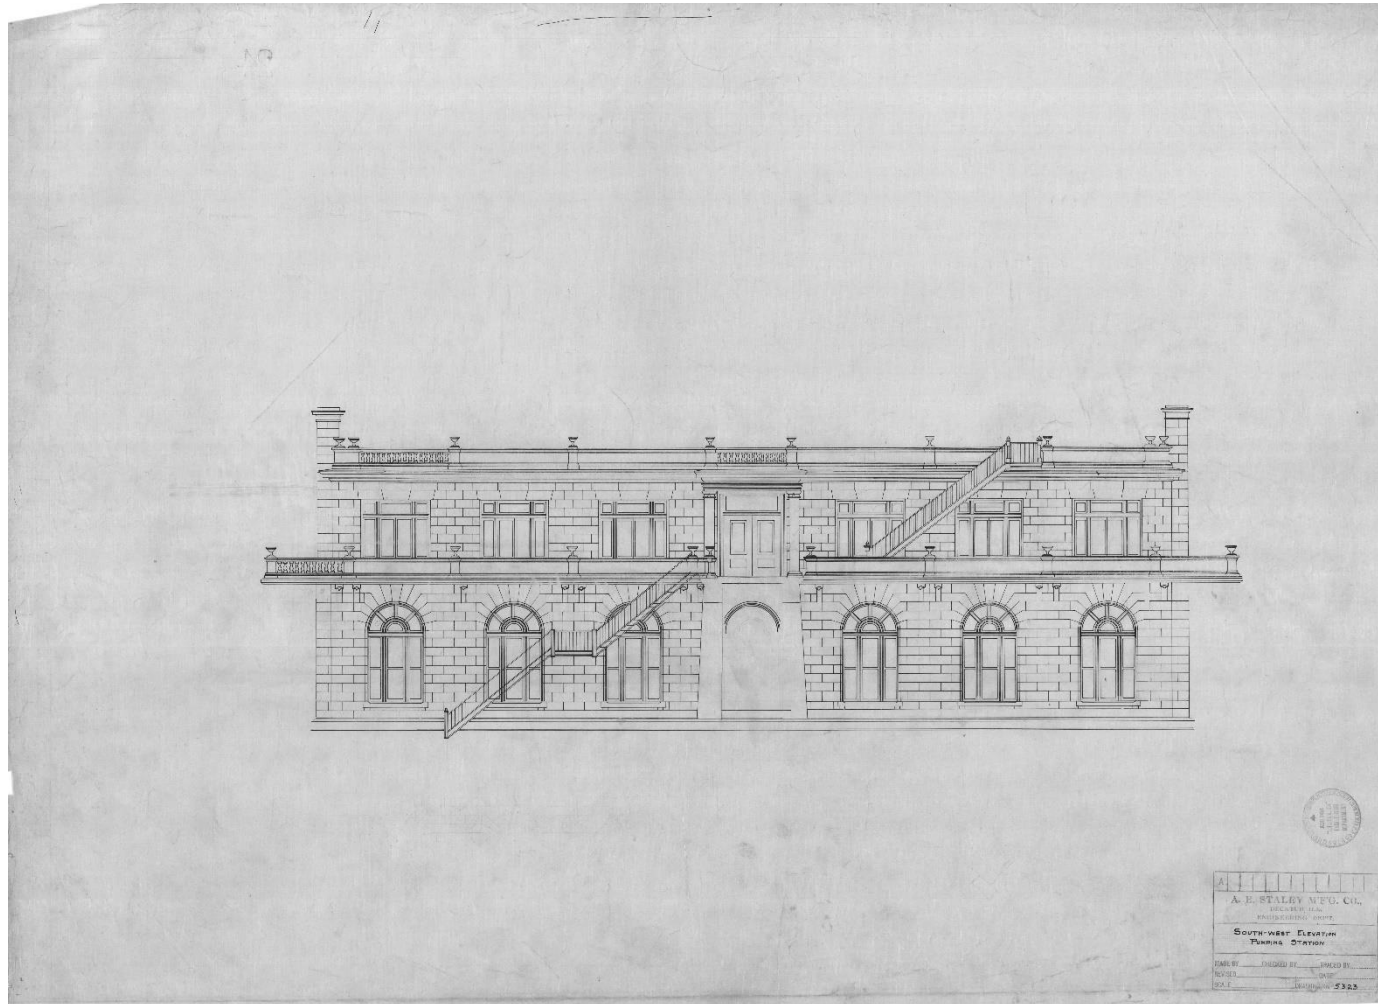
**Figure 3. *South-West [South] Elevation; Pumping Station (AES, Drawing No. 5323, [1919])*** This is the view that would have been seen from the landward approach of the building, via the railway causeway. There is some discrepancy between these drawings and the as-built conditions illustrated in the early 1920s photographs of the building. Neither of the exterior stairways shown on this elevation was built (though one was built on the opposite elevation in order to access the roof). Similarly, the large classical columns flanking the Balcony Level doors also were removed from the final design.

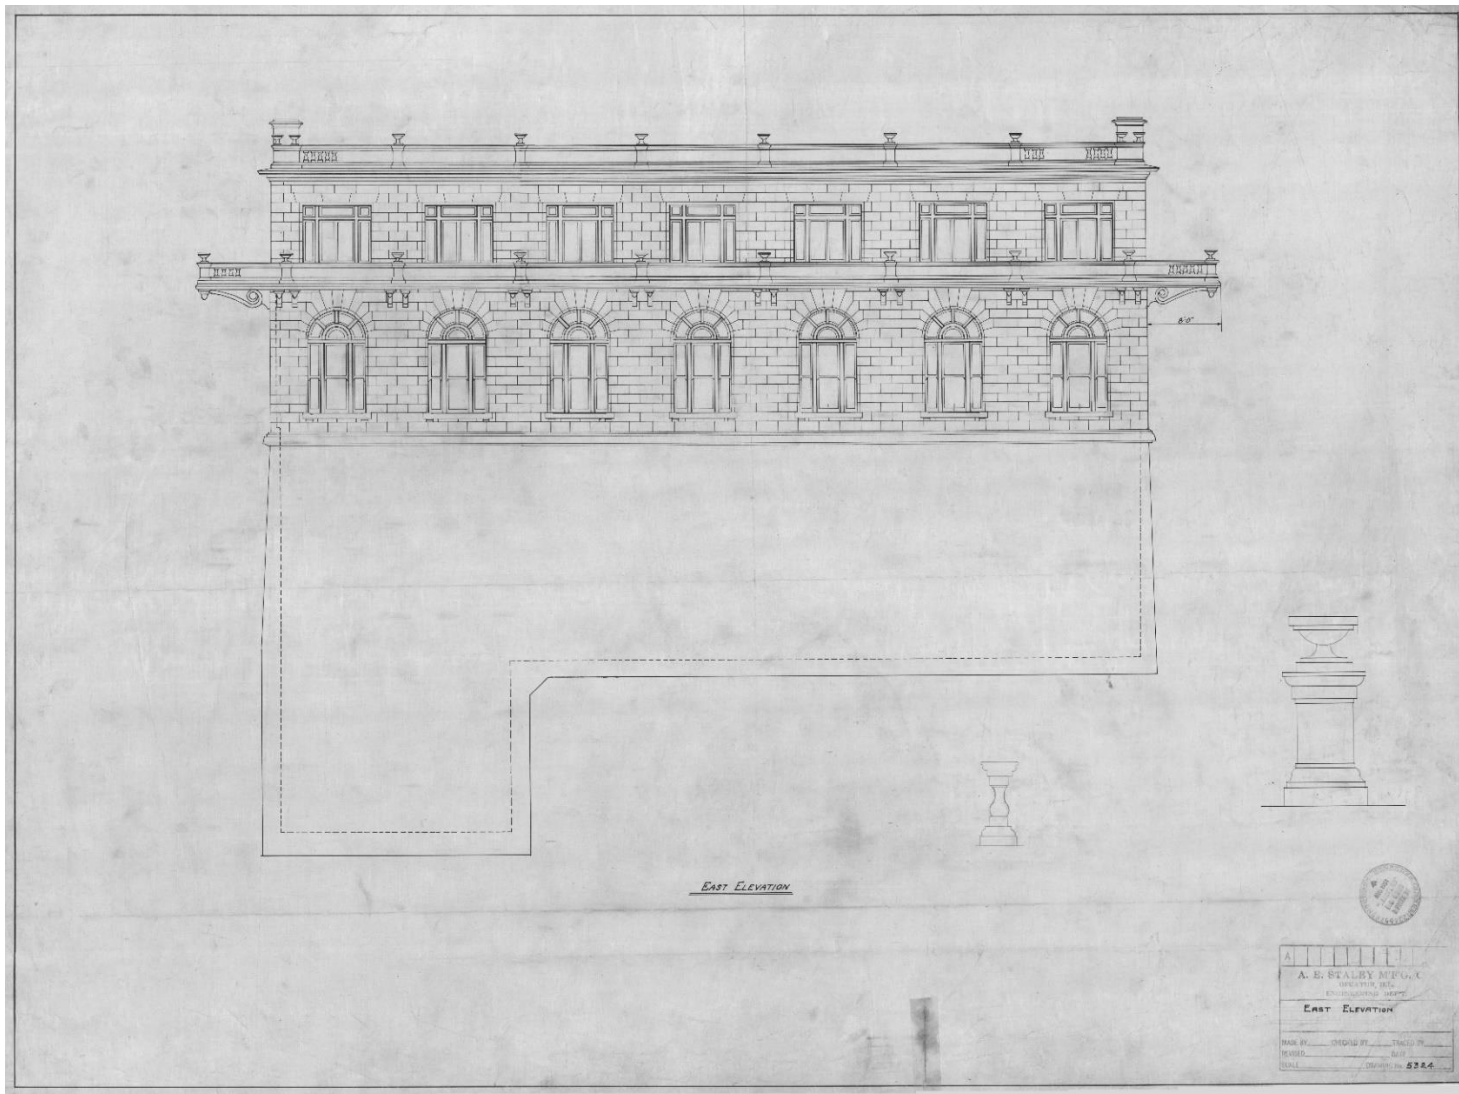
Figure 4. *East [North] Elevation* (AES, Drawing No. 5324, [1919]). This is the view of the Pumping Station that would have been seen from the lake side of the building.

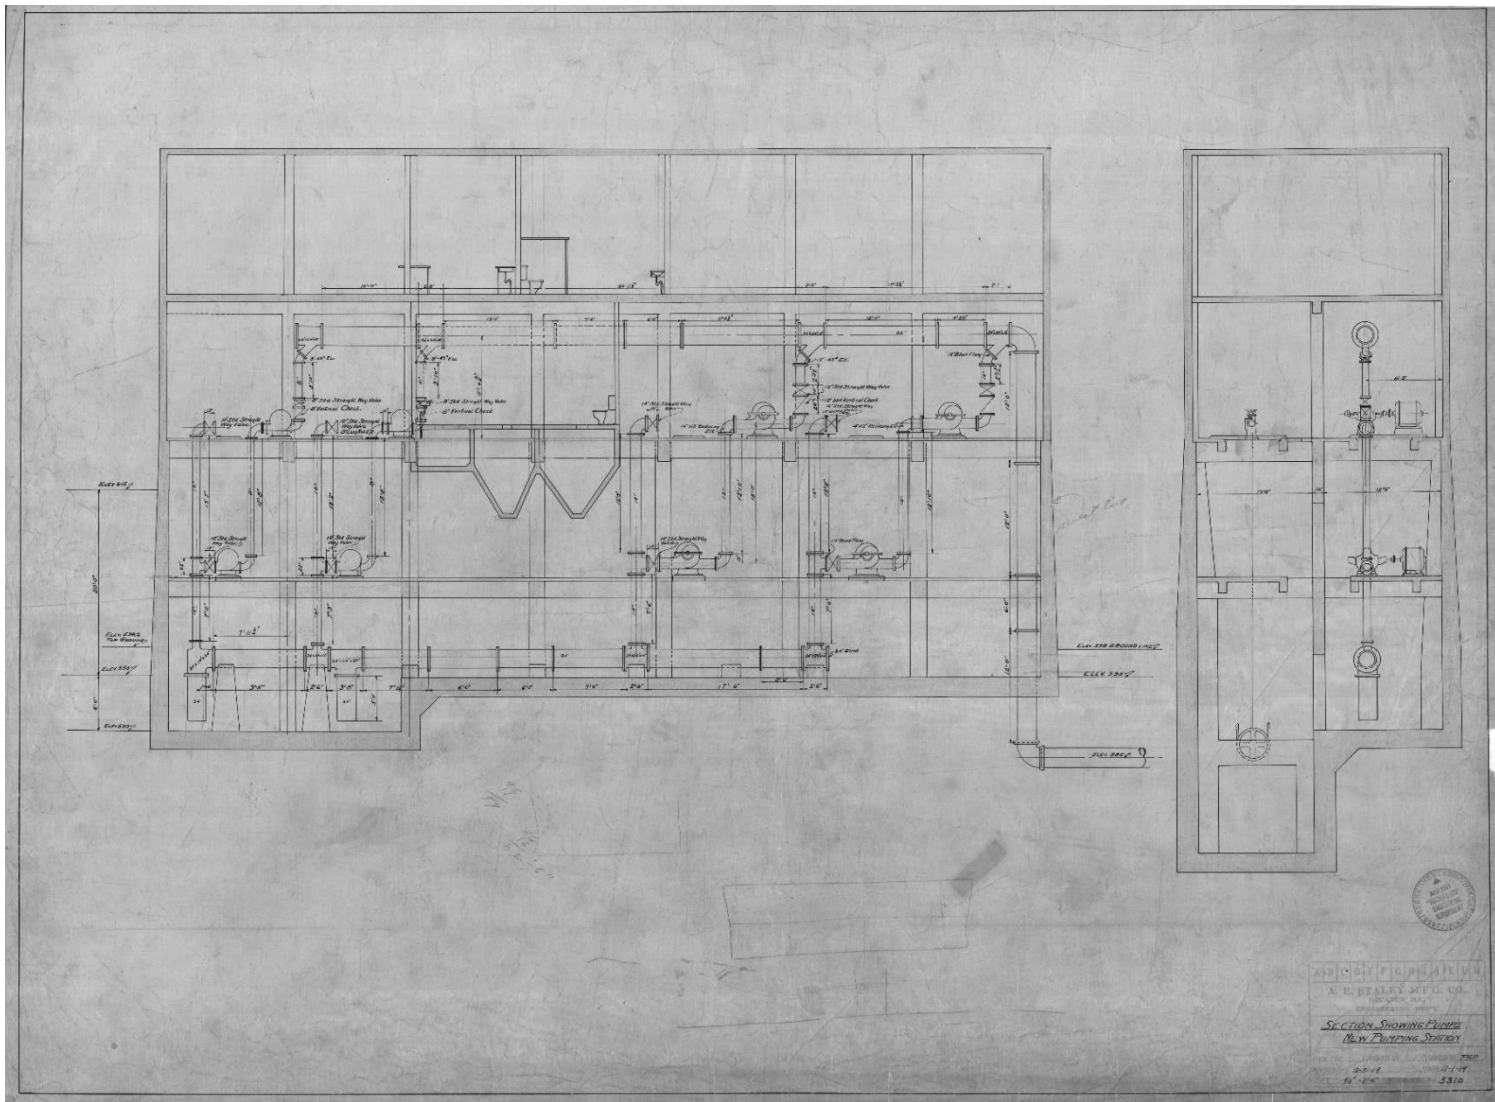
Figure 10. Section Showing Pumps New Pumping Station (AES, Drawing No. 5310; 31 December 1919).

intake pipes extend down into the pit, and these connect to a 2'-diameter supply line that runs horizontally down the greater length of the gallery and which has branch lines running up to the pumps. The 2' supply line rests on concrete piers. The south gallery has an intermediate level within it that functioned as a temporary pump floor until Lake Decatur was filled. Engineering drawings indicate that four pumps could be accommodated here. Once the level of the lake had risen sufficiently, these pumps were moved up to the permanent pump floor. The south gallery is 30'-6" deep at its lowest point (see Figure 10).

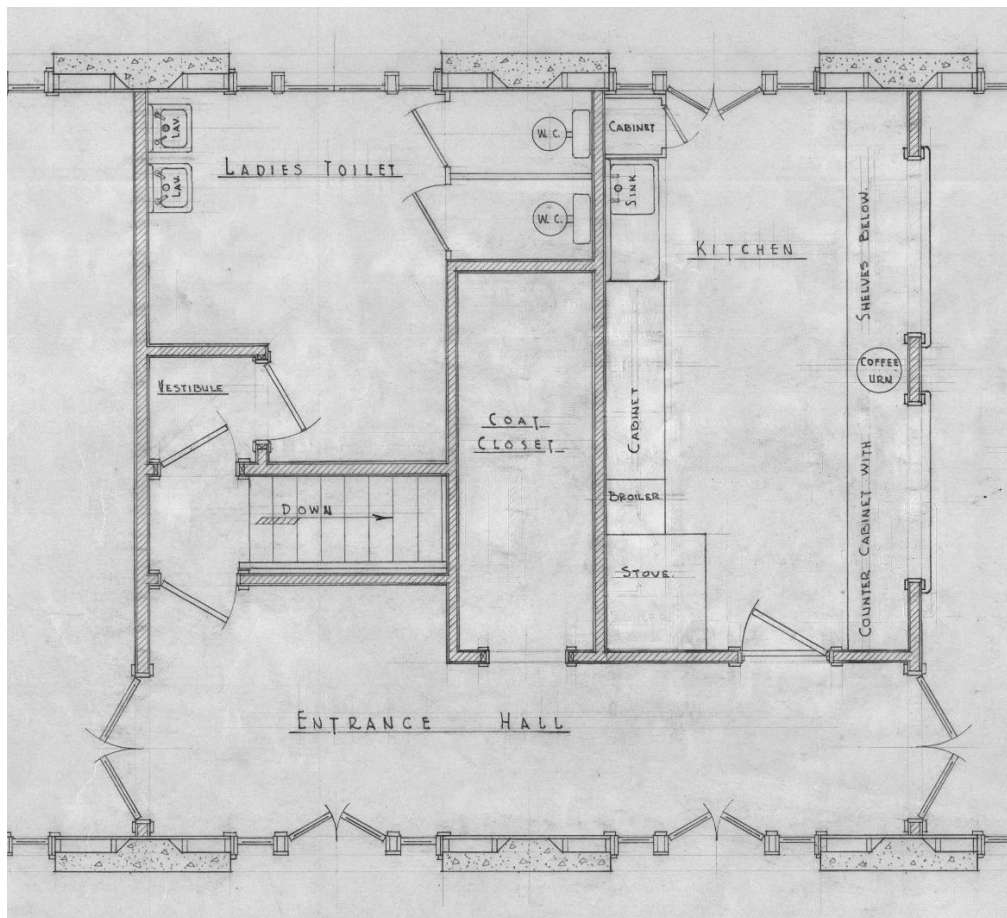
Figure 13. Detail of *Entertainment Floor Plan at Pumping Station on Lake Decatur* (AES, Drawing No. 5350, 29 September 1944). Modifications at this time included the enlarging of the Kitchen, and the reconfiguration of the Coat or Check Room.

During the 1944-1945 remodeling, the kitchen was enlarged by roughly 50% by eliminating the original check room. A larger serving counter was installed in the kitchen, as were new cabinets and a broiler. The original electric range was retained, but it was relocated within the room and had a vent hood installed above it. Also, during the remodeling, the previously spacious women's bathroom was partitioned up to allow space for a new coat closet. As the coat closet was built out where the original bathroom doorway was located, a new entrance point to the bathroom needed to be constructed. This new entrance was located off the head (or west side) of the pump-floor stairway and had a vestibule associated with it. The women's bathroom was further partitioned in 1951, when a small men's bathroom was built out within it. Both bathrooms were accessed via the vestibule mentioned, although a new doorway had to be added for the women's bath (see Figures 6 through 8, and 13 through 15).

- a. Doorways and Doors: No original interior doors on the club house level remained in place at the time of the documentation. Construction plans indicate that the door sizes varied from 2'-4" to 3'-0" in width and 6'-6" to 7'-0" in height (with 7'-0" being more typical), depending on location. The doors were hardwood (most-likely oak) and had five-panels. Both the club room and dining room had a set of double doors from the hallway. New doors installed in club house for the 1944-1945 remodeling were five-paneled, like the originals. A three-paneled sash door, with frosted glass, was added between the club-house hallway and stairway to the pump-floor, following the enclosure of the stairway (see Figure 13). These doors were finished in a clear coat to highlight the oak details.

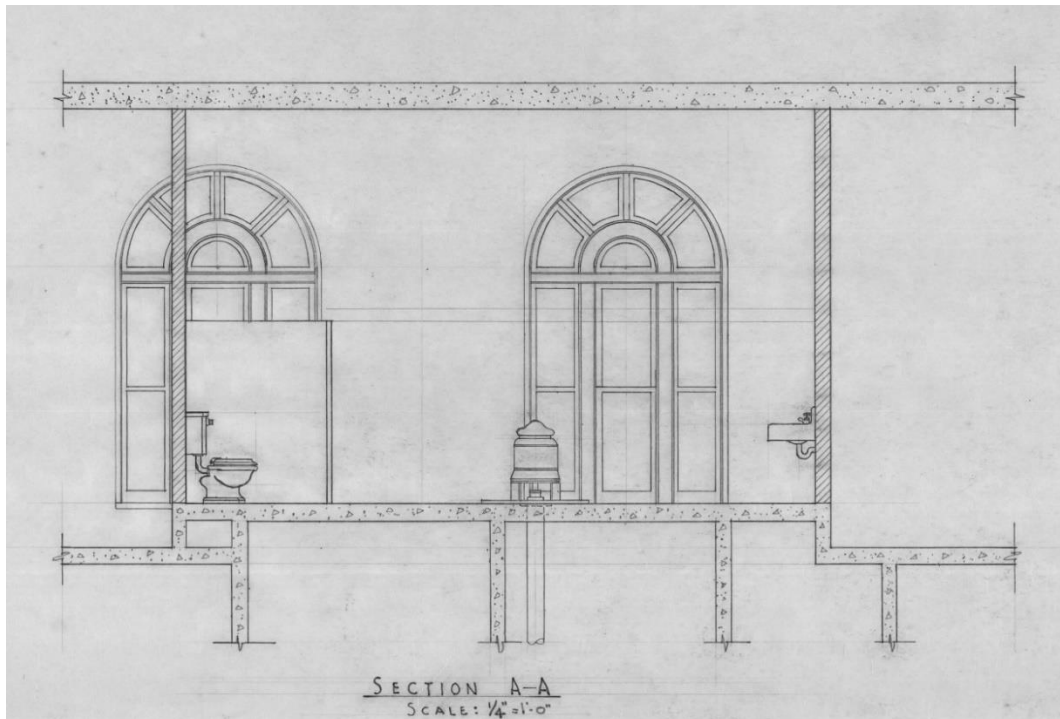
**Figure 16. Details of Miscellaneous Details For Butler's Pantry and Men's Toilet at Pumping Station on Lake Decatur (AES, Drawing No. 5351, 2 October 1944). Note relationship of stair landing to raised floor of men's toilet room. Kitchen Pantry was also reconfigured at this time.**

A bathroom is centered along the north side of the pump-floor level and has a raised floor. The bathroom has tile walls and measures 8'-11"x20'-11" on the interior. As originally designed, this bathroom had two toilets, and a shower stall along its west end and a double basin sink on the east. Although only penciled into the final plans (see Figure 9), a trough urinal on the south wall may have been an original feature added when the adjacent stairs were modified late in the construction schedule (and resulting in the shifting of the door location into this room). A large coat and hat rack was added to this room in 1944, positioned in the center of the room over the sewage pump. These construction plans from 1944 suggest that the trough urinal was in place, and that two single-basin sinks were located along the east wall. It is presumed that these 1944 drawings represent the as-built configuration of the men's toilet room in 1920. All of these bathroom fixtures had been removed at the time of the field research. A frame cabinet hangs in the southeast corner of the room. There also is a sewage pump in the bathroom. Prior to the addition of a men's bathroom in the club house in 1951, male guests had to use the bathroom on the pump-floor level (see Figure 16).

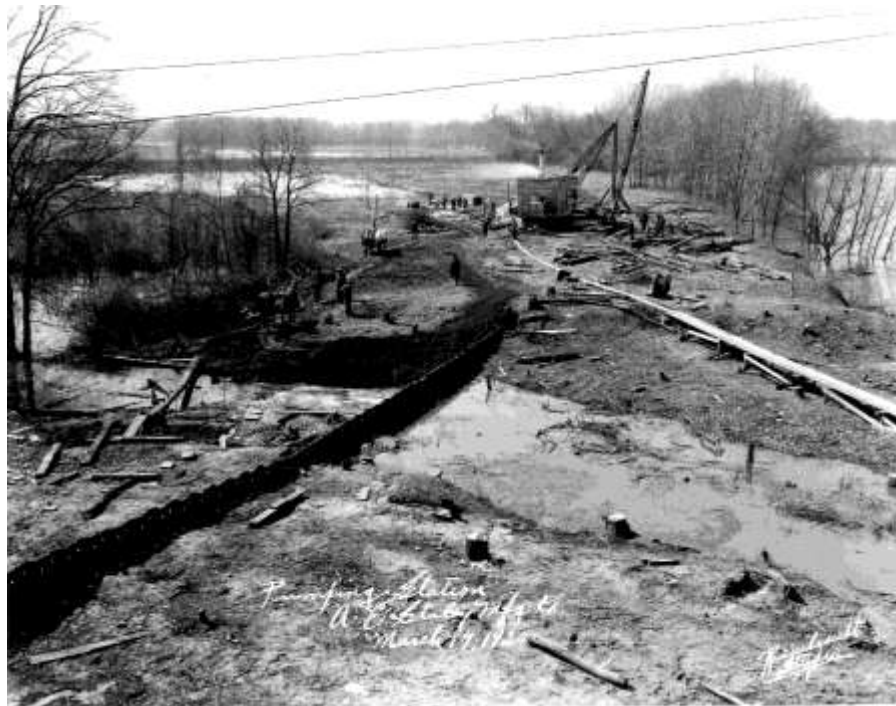
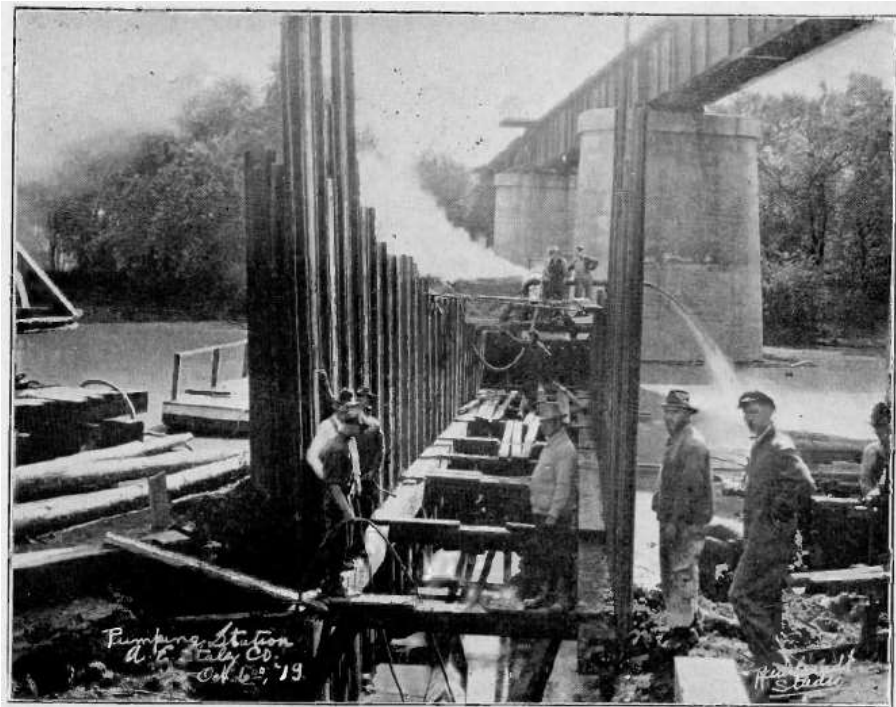
**Figure 10. (Top) Photograph labeled “Pumping Station” and dated March 1920, illustrating work on the intake pipeline and/or water line along Sangamon River (Staley Museum). (Bottom) Photograph Labeled “Pumping Station,” dated October 1919, with caption that read “The coffer dam which permits laying the large intake pipe to the pumping station many feet below the surface of the water” (Staley Fellowship Journal [November 1919], p. 17).**

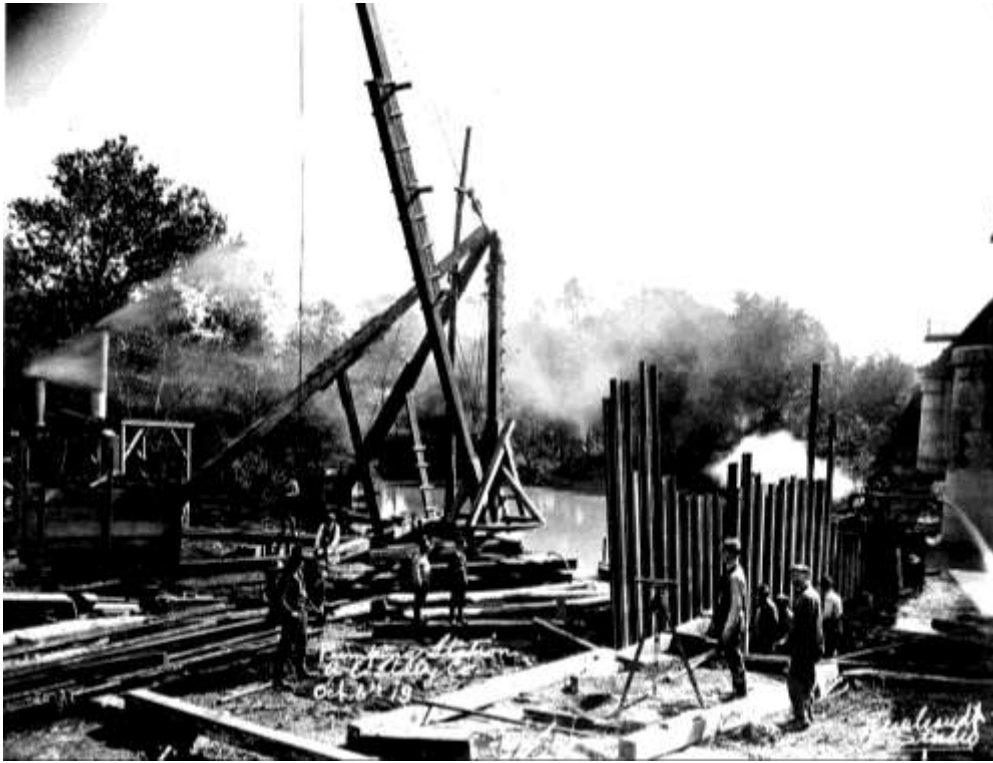
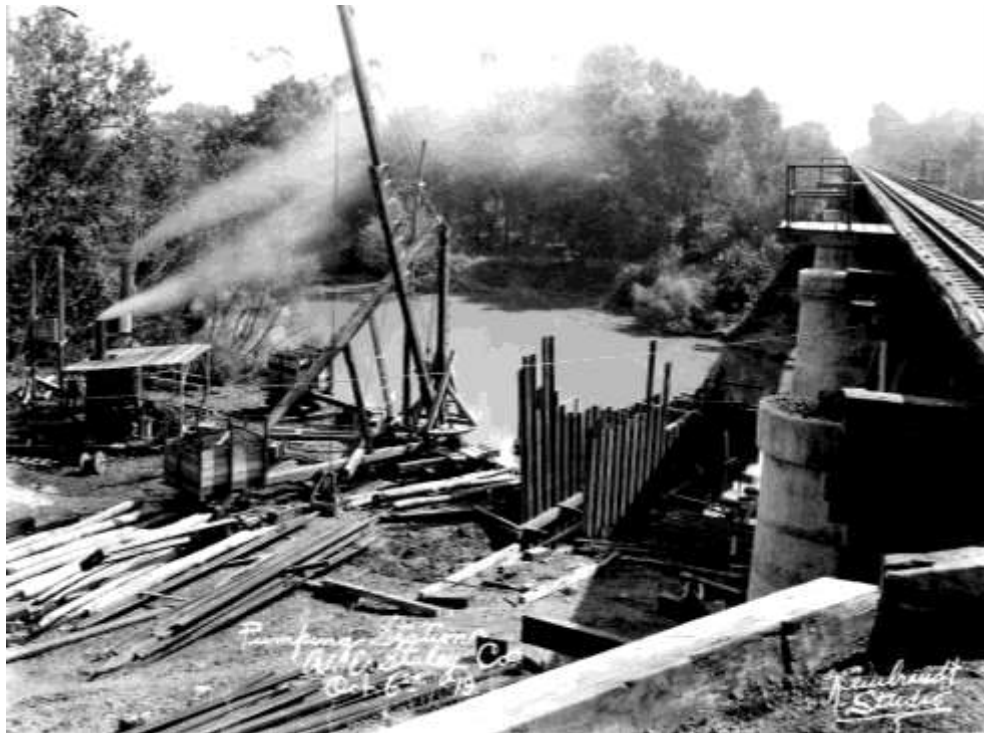
**Figure 11. Two views of work on the intake pipe to the Pumping Station, both dated 6 October 1919. The bottom image was published as “View of Work on Pumping Station from the I. C. Tracks” (Staley Museum; *Staley Fellowship Journal* [November 1919], p. 14).**

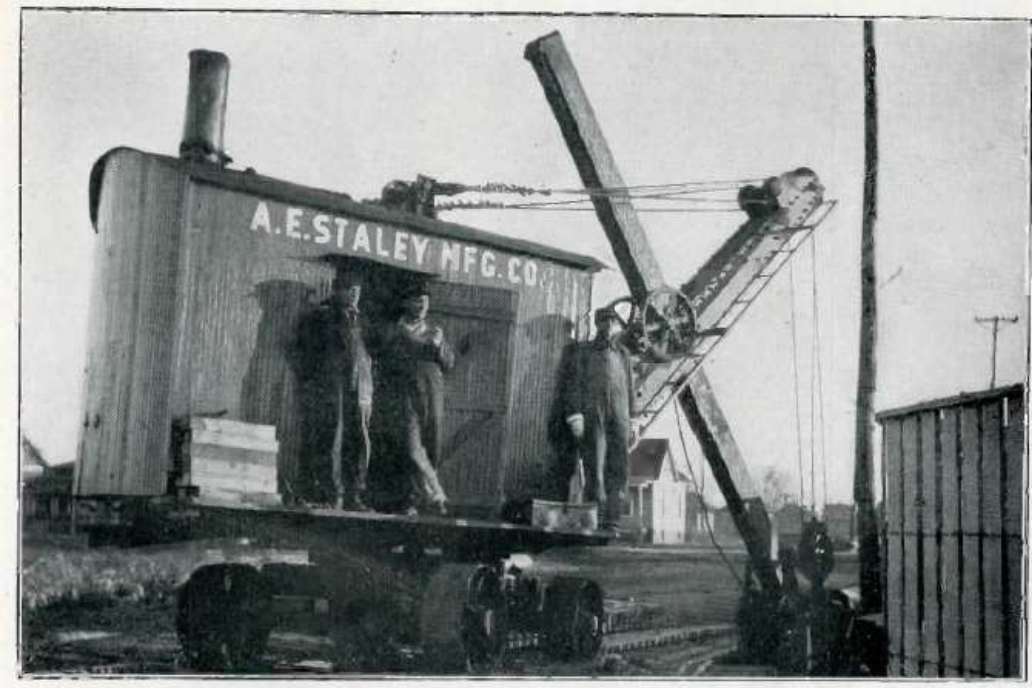
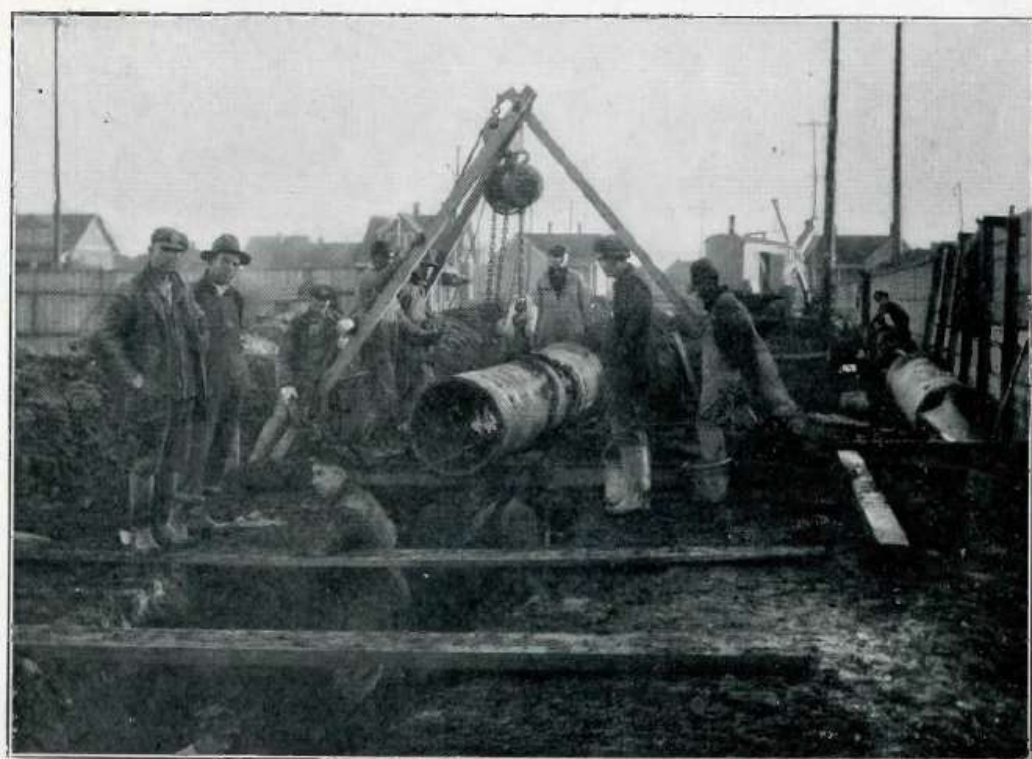
Figure 12. (Top) “Robinett and his affinity, the steam shovel, which digs the ditch for the water main from the river” (*Staley Fellowship Journal* [December 1919], p. 3). (Bottom) “Laying the water main from the new pumping station. The quiet, mild appearing gentleman on the left is Zeke Coover, a caulking (corking) expert” (*Staley Fellowship Journal* [December 1919], p. 3).

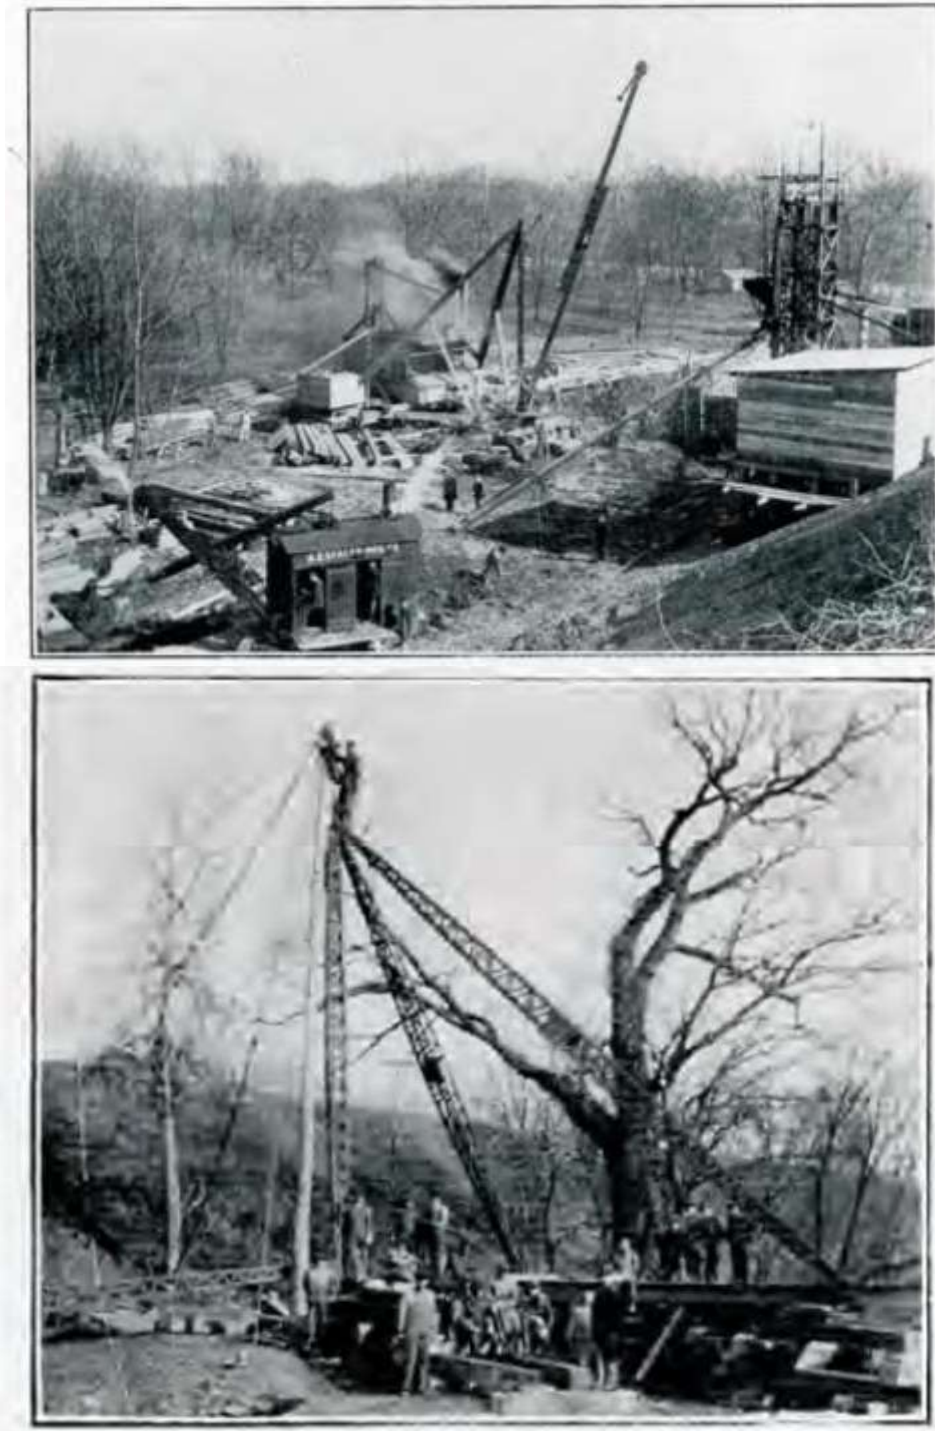
**Figure 16. (Top) “Pouring Concrete for the Foundation of the Pumping Station.” (Bottom) Photograph dated March 1920, and with published caption that read: “The River’s Rise of 8 Feet Completely Flooded the Site of the Pumping Station” (Staley Fellowship Journal [April 1920], pp. 2, 16).**

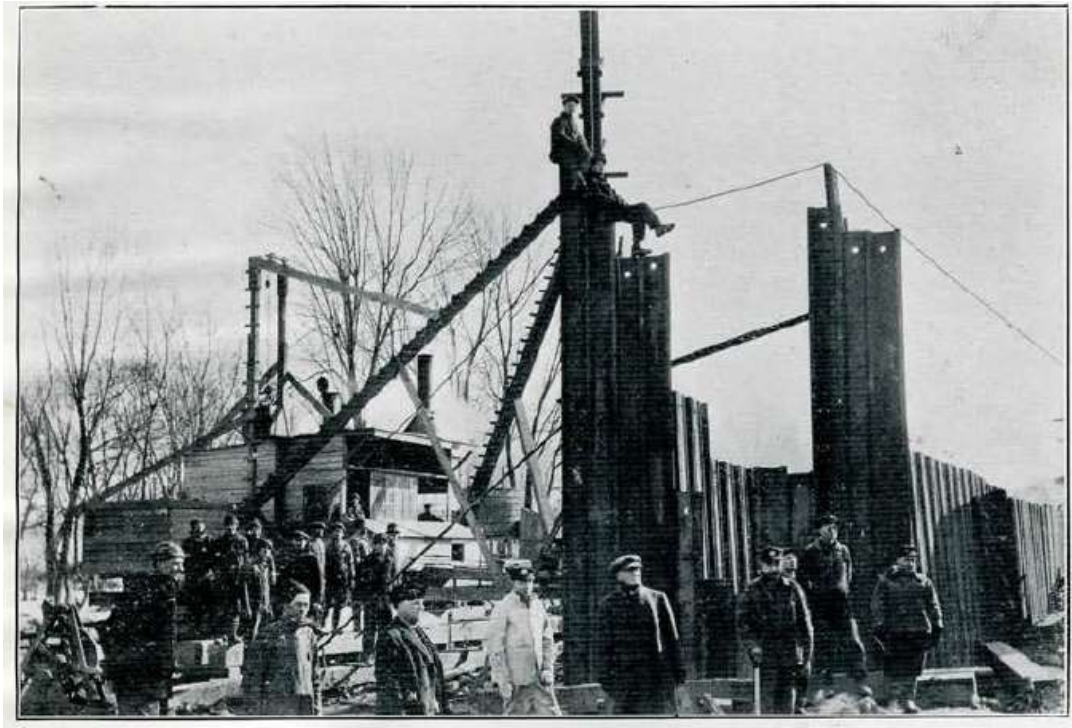
**Figure 17. Two photographs of work at the Pumping Station (*Staley Fellowship Journal* [April 1920], pp. 11, 17). (Top) “Showing the Steam Shovel Near the End of the Job of Digging the Ditch from the Plant to the Pumping Station.” (Bottom) “Beginning the Construction of Staleys Temporary Dam.” The temporary dam was located immediately to the south of, on opposite side of, the railroad trestle.**

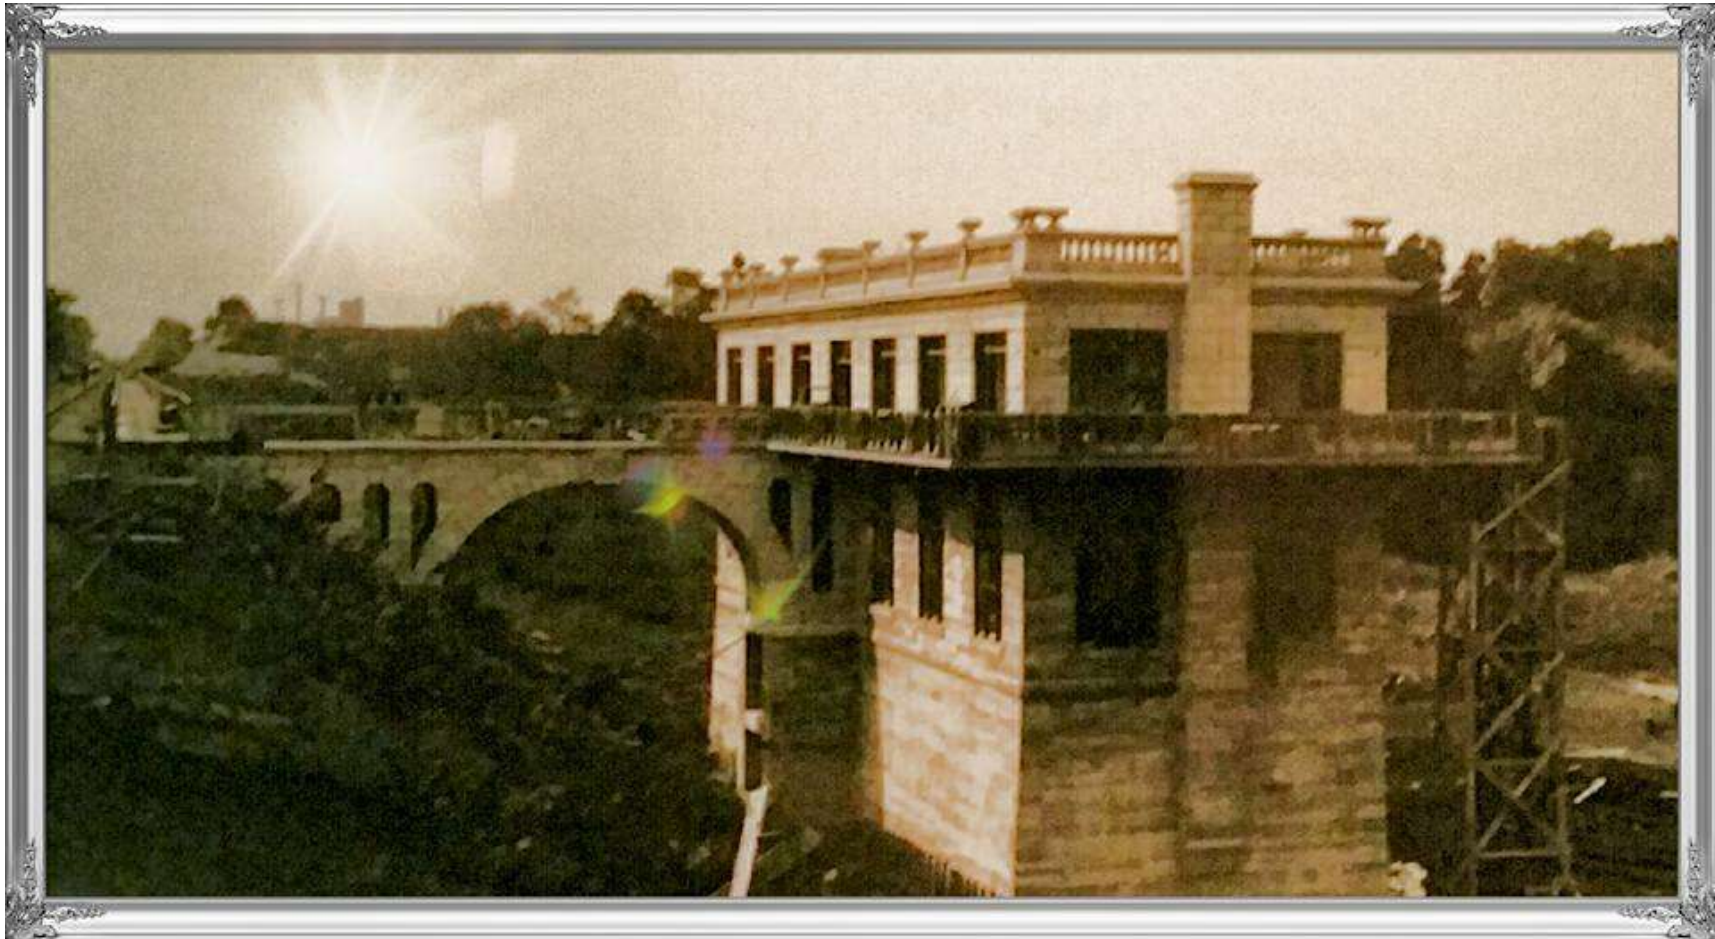
**Figure 20.** Although reproduced poorly at a small scale, this is a rather unique image of the Staley Pumping Station and Club House prior to the filling of Lake Decatur. Also illustrated are the railroad trestle and temporary impoundment dam (*Staley Fellowship Journal* [March 1921], p. 15).

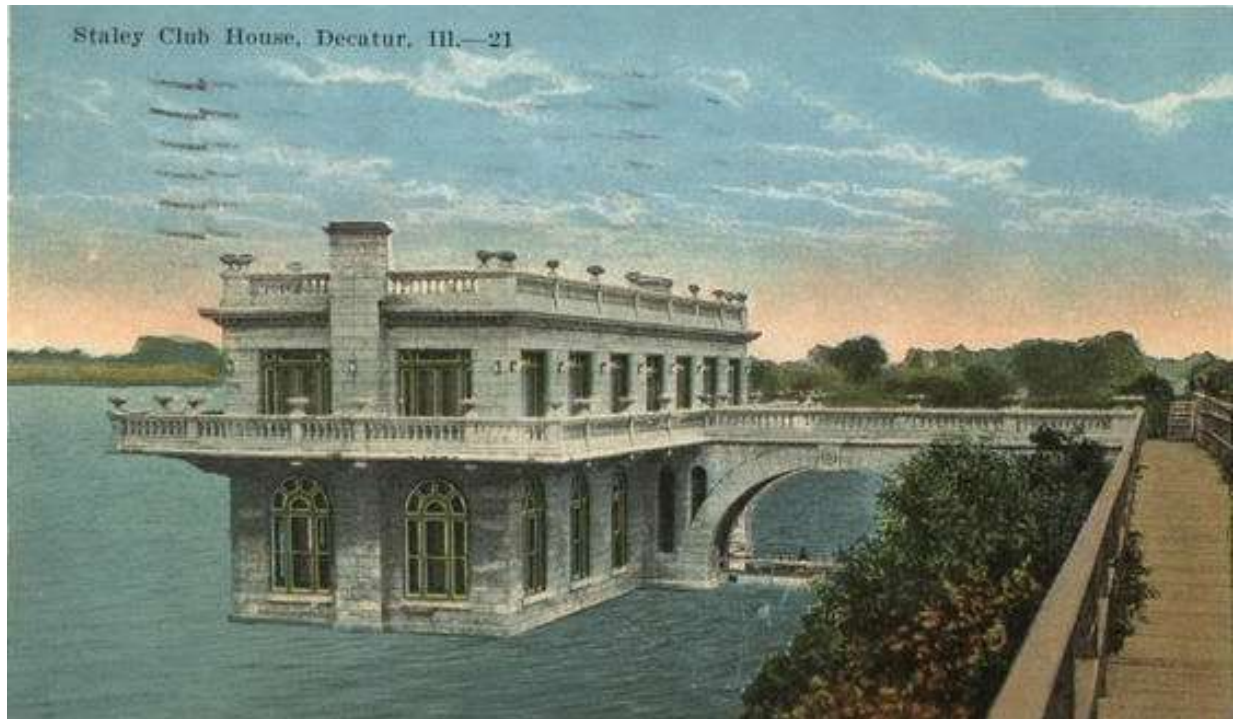
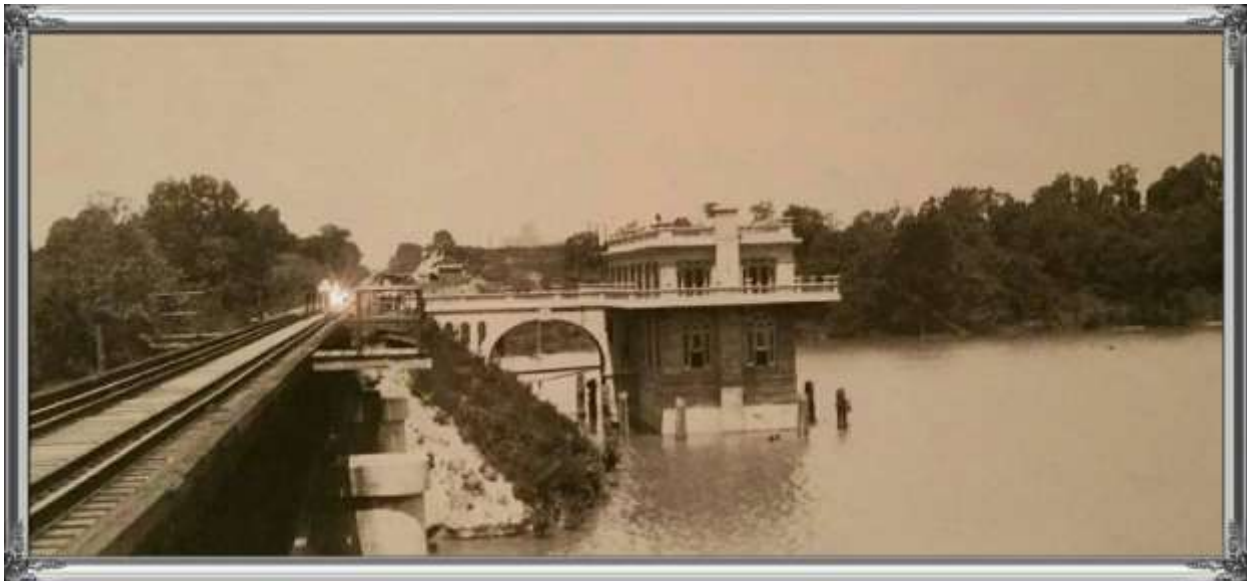
Figure 26. Early 1922 illustration of the Staley Pump House and Club House in all of its glory, shortly after its opening. Note the use of the electrical lights outlining the balcony, cornice, and arch of the entrance bridge, as well as the torch lights on top of the decorative pedestal urns on the roof level balustrade (*Staley Journal*, February 1922, Cover).

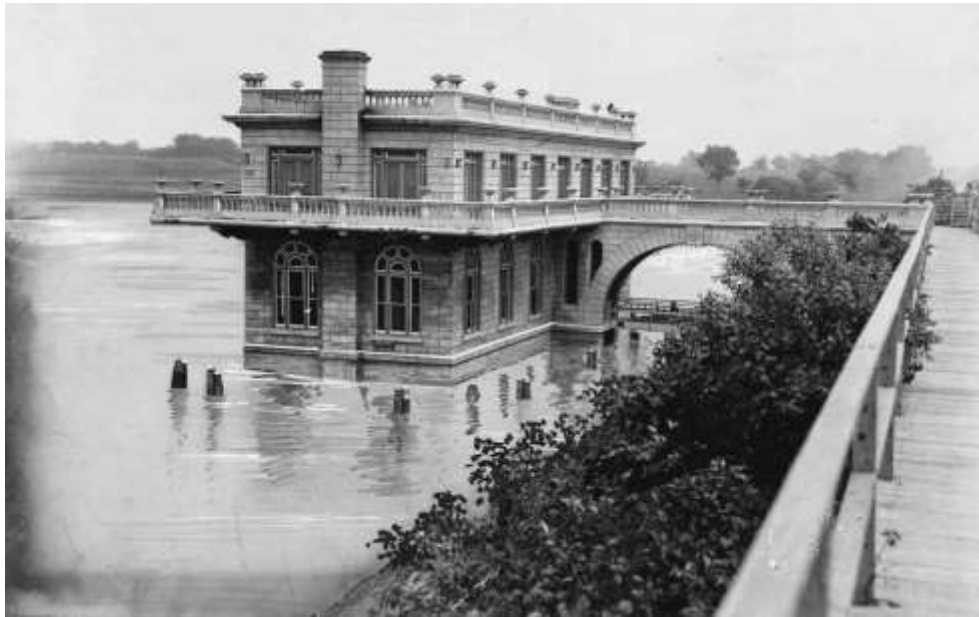
**Figure 28. (Top) Boardwalk under construction (Staley Museum). (Middle and Bottom) Photographs taken in 1921 looking down the boardwalk leading to the Staley Club House, which appears in the distance (*Staley Journal* [June 1921], pp. 1, 8). Note the slight difference in construction, with the use of diagonal corner blocks in the top photograph.**

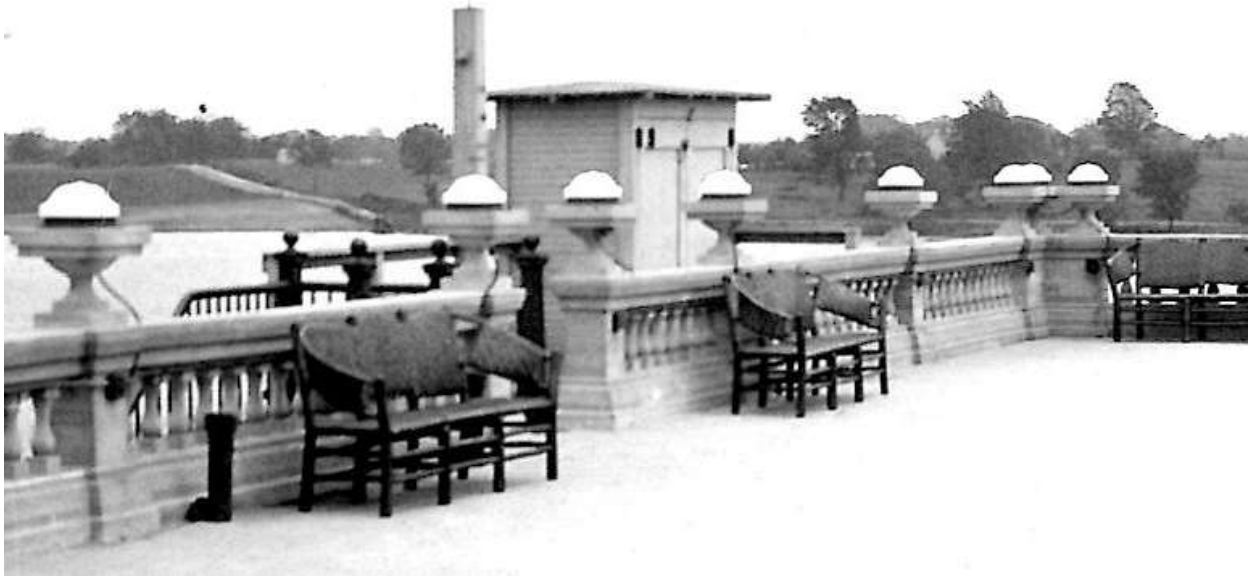
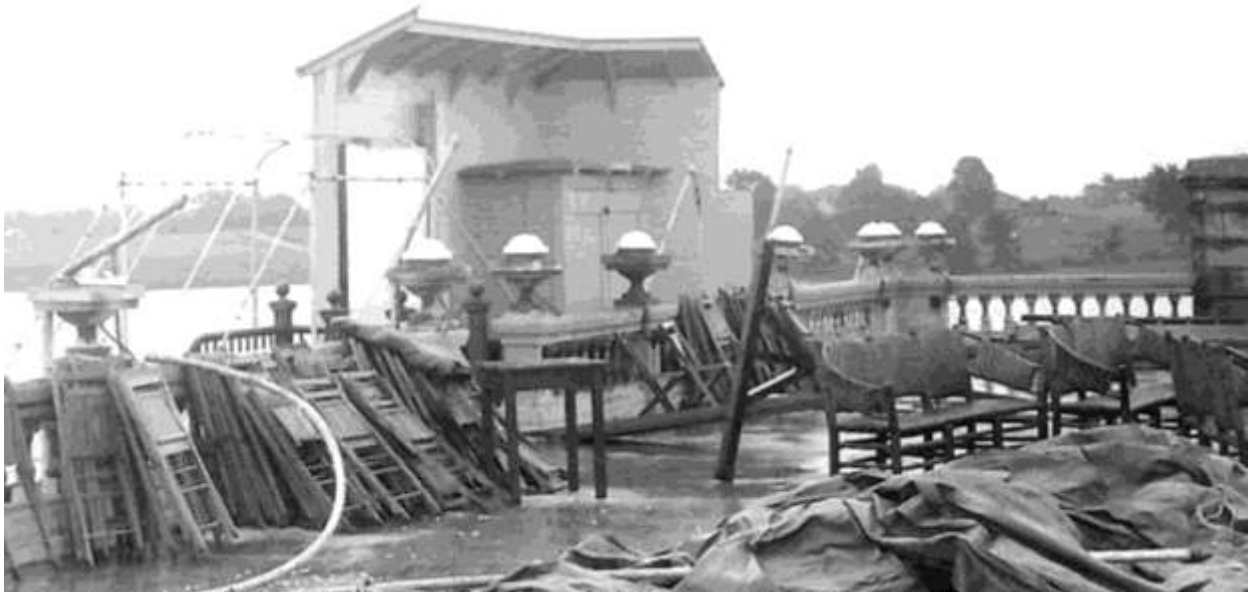
**Figure 31. Pre- and Post-Canopy details of a small frame structure located at the northeast corner of the Roof Level. This small structure was accessed from the stair landing located at the Roof Level. (Top) Detail of a 1923 photograph showing the north and west elevations of the Staley Pumping Station and Club House (Coyle 1923:4). (Bottom) Detail of undated photograph (Staley Museum). Although the function of the structure adjacent to the top of the stairway is not known, it probably functioned as a “bathroom” for use by guests on the roof deck.**

Although not “plumbing” per se, the building also was equipped with the outdoor toilets on the roof-top level early in its history (as previously discussed in the historic context). These are believed to have been removed after the roof suffered significant storm damage in ca. 1929.
