STALEY PUMPING STATION AND CLUB HOUSE  
Lake Decatur, North of U. S. Highway 36  
Decatur  
Macon County  
Illinois

HABS No. IL-1258

HISTORIC AMERICAN BUILDINGS SURVEY  
STALEY PUMPING STATION AND CLUB HOUSE

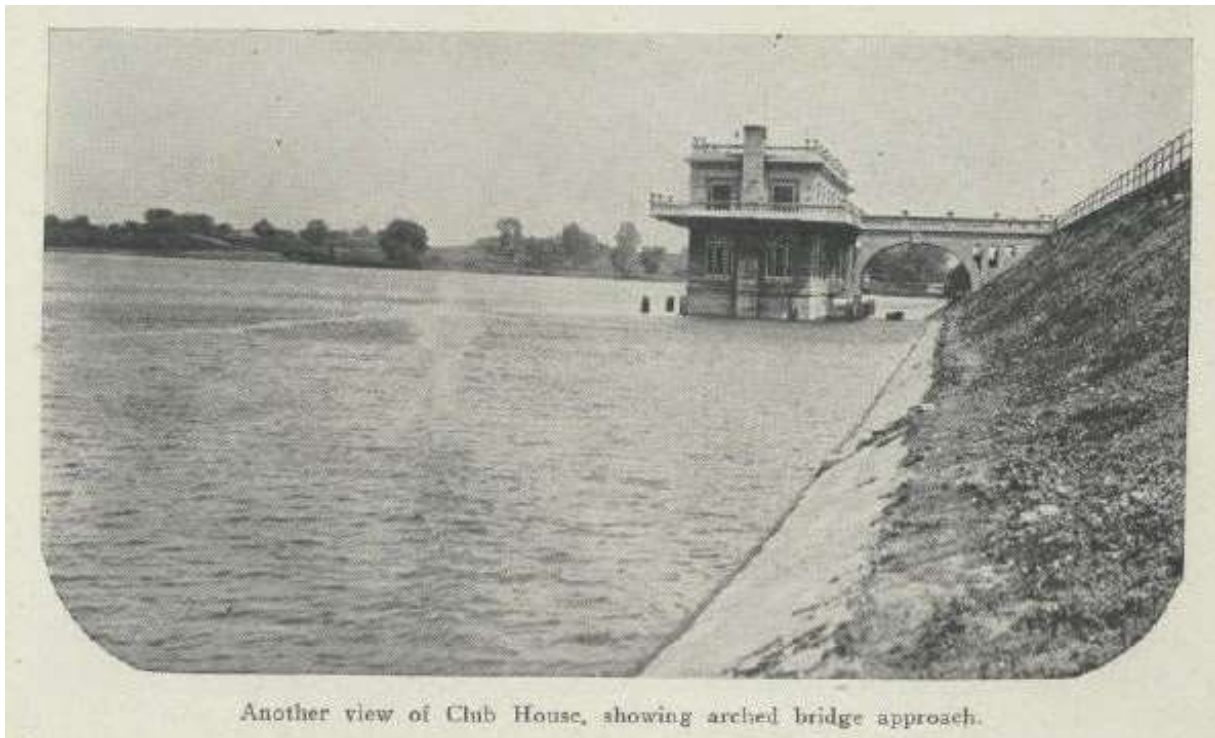
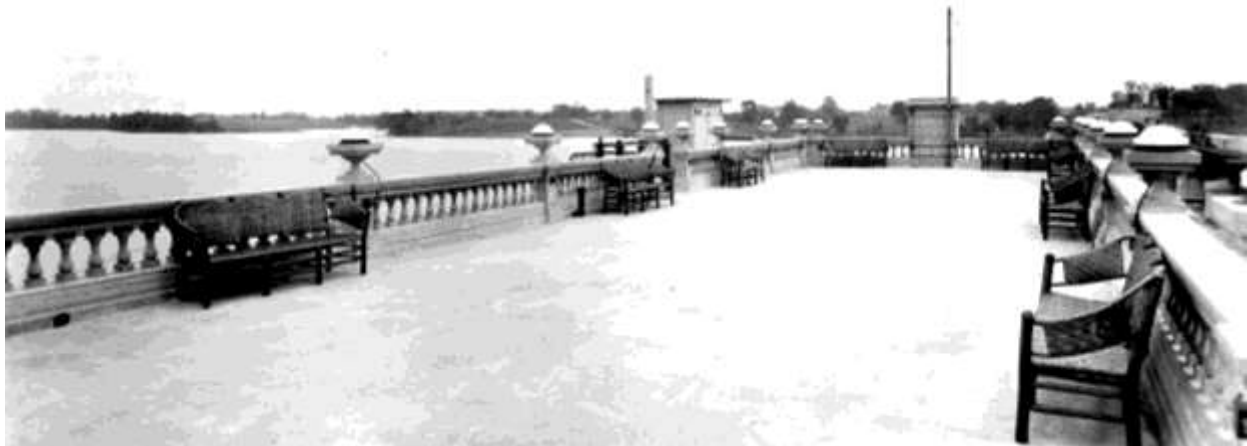
**Figure 33. Ca. 1928 image of the Staley Pumping Station and Club House, looking northeast (Staley Museum). Note the presence of the canopy, with chimney flue extension only on the west chimney. This would suggest that the east fireplace was not used as much as the west one. The frame canopy is present over the two side-by-side privies present along the north side of the building, adjacent to the steps at the northeast corner of the structure.**

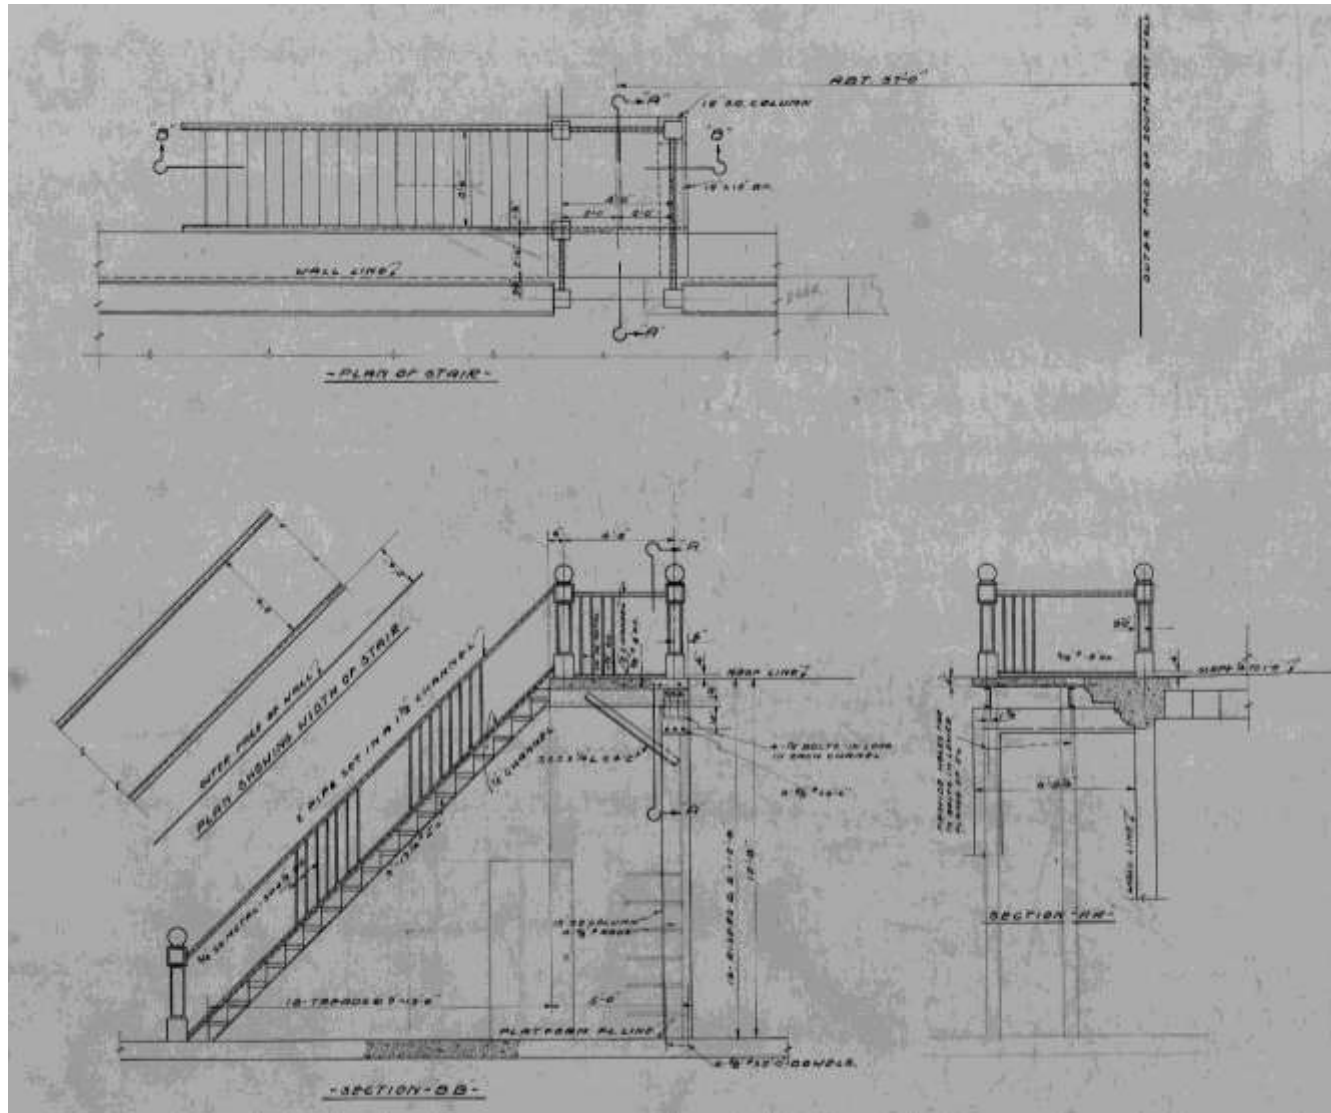
Figure 37. Pumping Station, Inside Stair Plan and Section (AES, Drawing No. 5321, 11 June 1920; see also Drawing No. 4345 for sectional view). This image depicts the redesigned, as-built stairs.

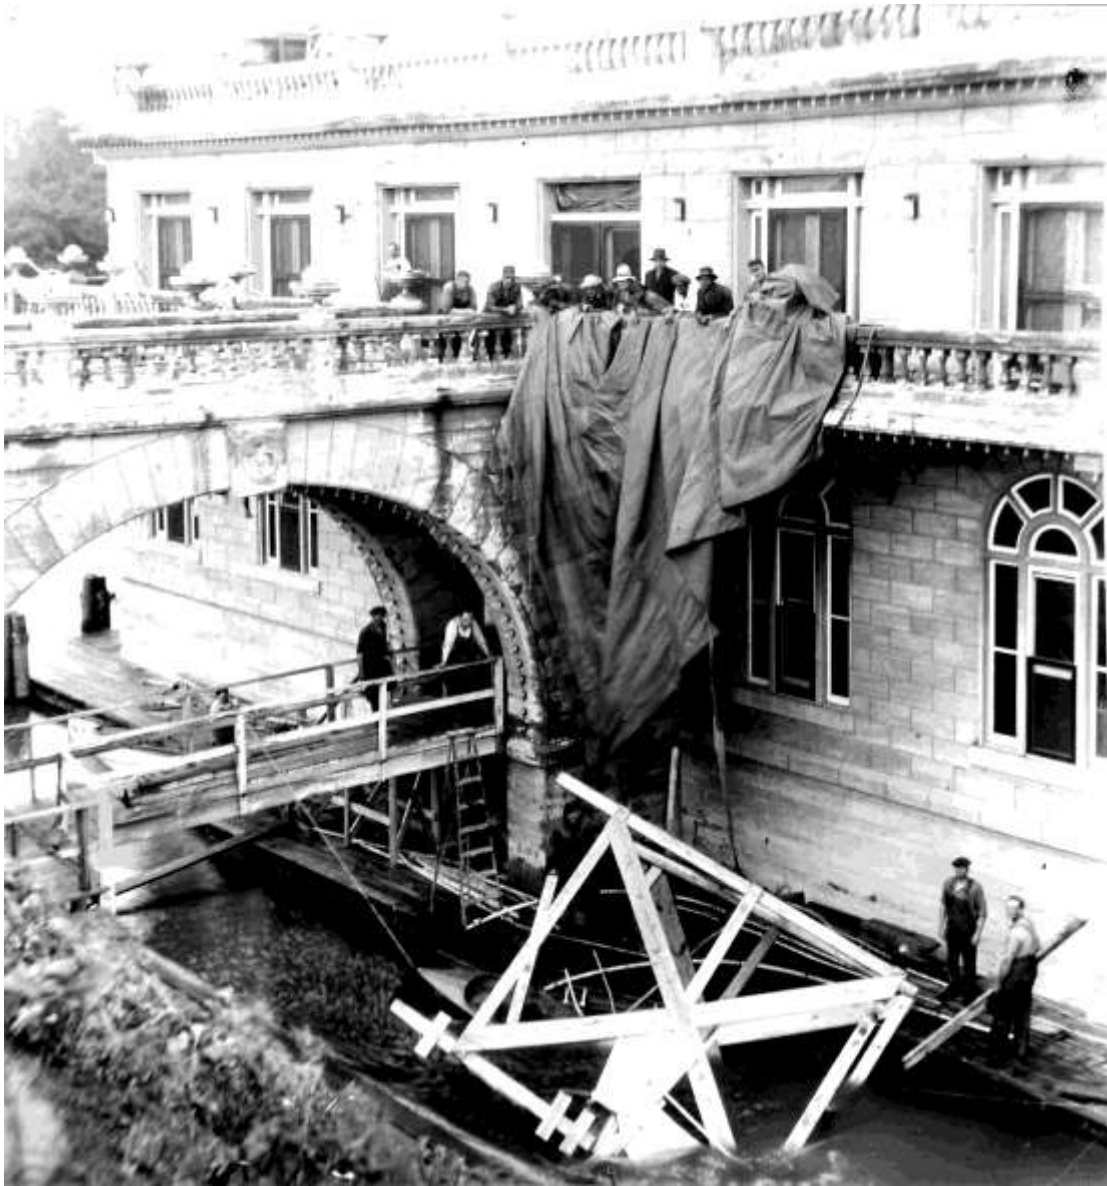
**Figure 41. View of Roof Level illustrating storm damaged canopy and a couple of lamp globes (looking east). Note frame toilet structure at the far end, adjacent to the stair landing (Undated [ca. 1929] photograph; Staley Museum).**

In August 1923, plans were drawn up for a fabric canopy with a metal frame to be installed over the roof.<sup>108</sup> The canopy provided welcome shade for the gatherings, as well as protection from rain. In ca. 1929, the roof-top level of the Staley Club House was severely damaged by strong storm. The canopy was completely wrecked, and the Club House experienced some damage (broken torch lights, potentially some windows) (see Supplemental Figures 39, 41-42). The use of the roof for public gatherings apparently ceased after this storm.

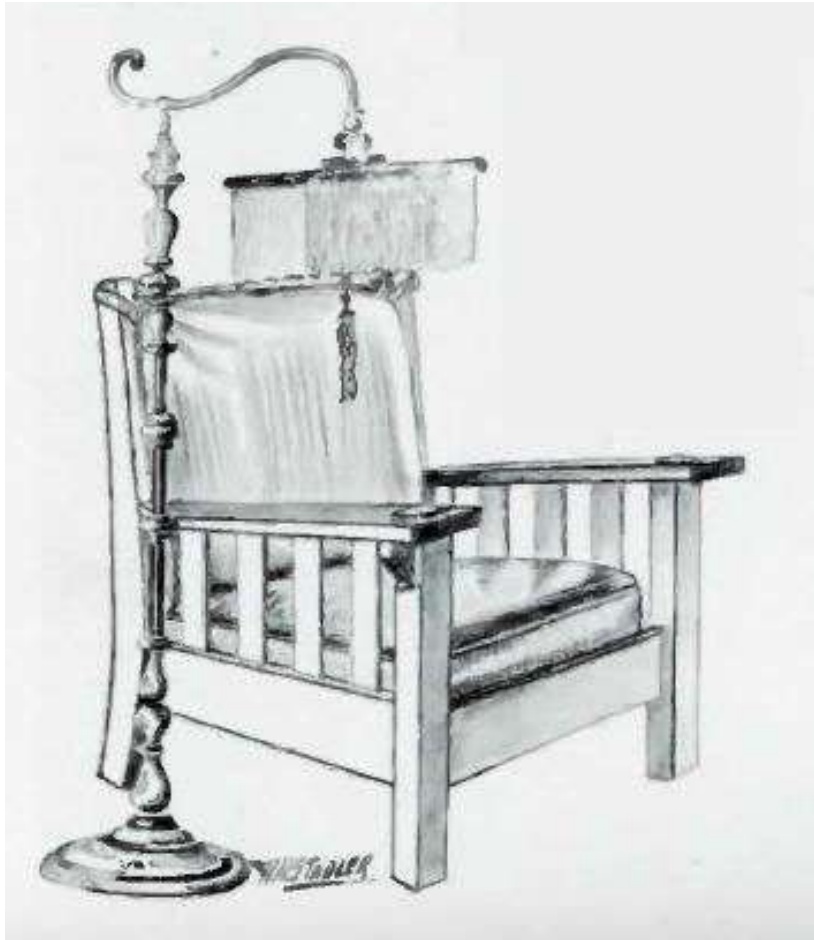
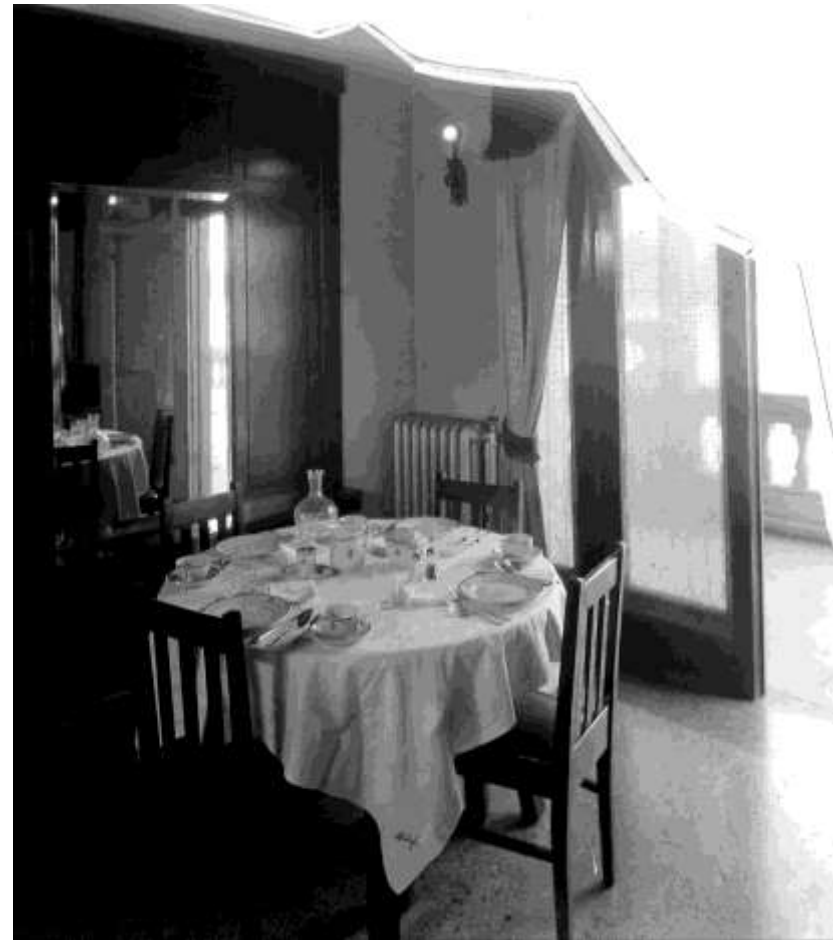
**Figure 50. (Left) Photograph of one of Club House fireplaces, originally published in Coyle (1923:8-9) (Staley Museum). (Right) Line drawing of fireplace (*Staley Journal* [February 1922], p 11). Note the electric sconces above the mantle.**

The most prominent decorative features in the Club House interior were the "Jacobean style" fireplaces in the club and dining rooms. Both fireplaces had heavy wood mantels framed by columns and pyramidal-shaped overmantels of masonry construction. The Staley logo was integrated into the mantel design (see Supplemental Figure 50). Unfortunately, both mantels had been removed from the building prior to the field documentation (one of which is at the Staley Museum).

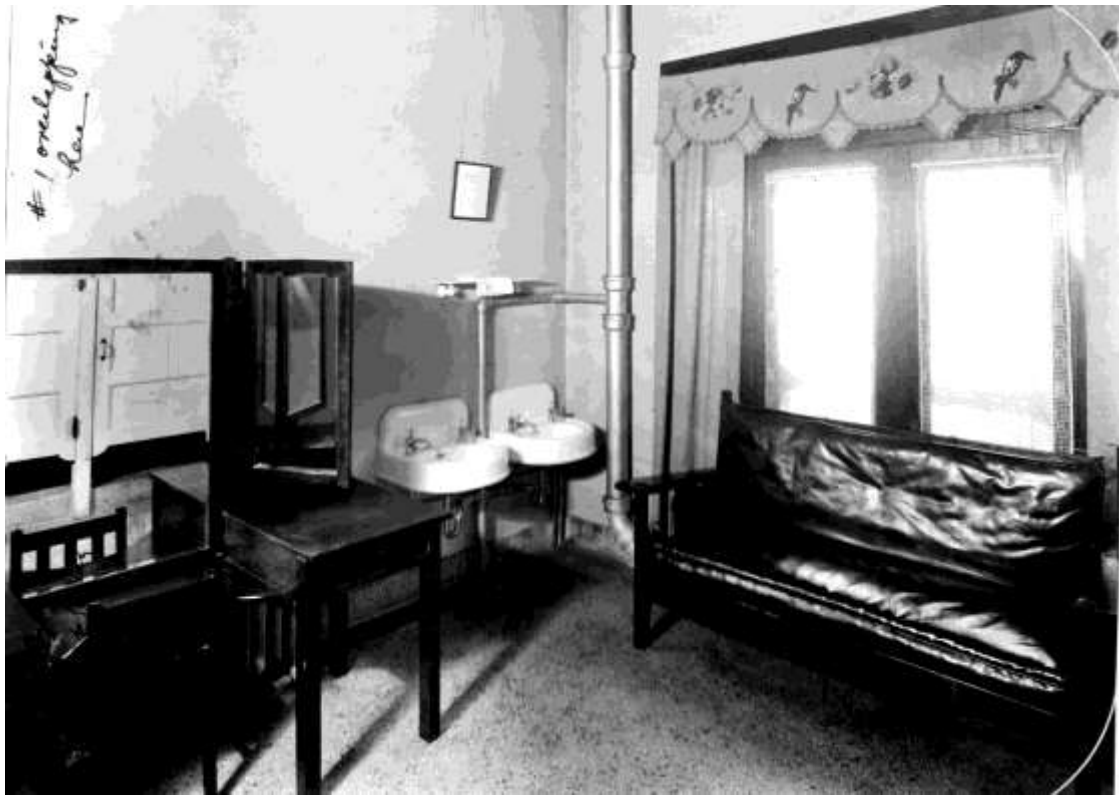
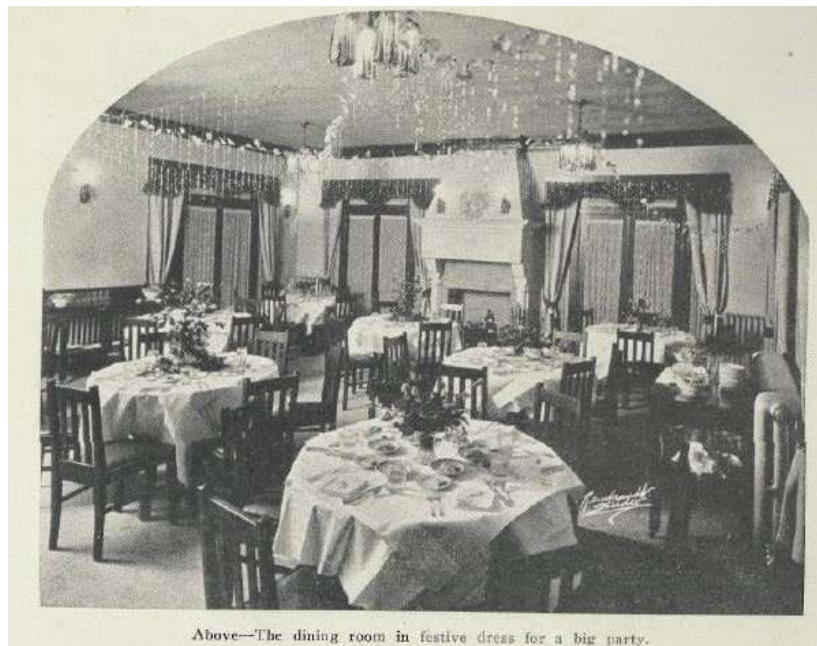
**Figure 52. Details of the interior of the Staley Fellowship Club House (Coyle 1923:10). One of the characteristics of the Club House was the all-electric kitchen, complete with an electric kitchen range. In the middle 1940s, this kitchen was dramatically expanded and remodeled.**

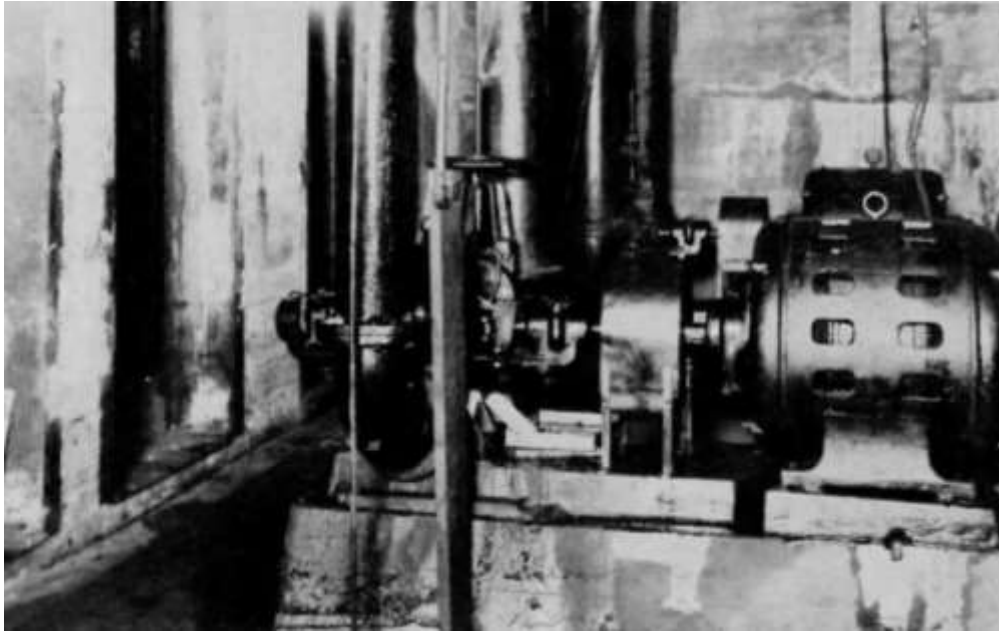
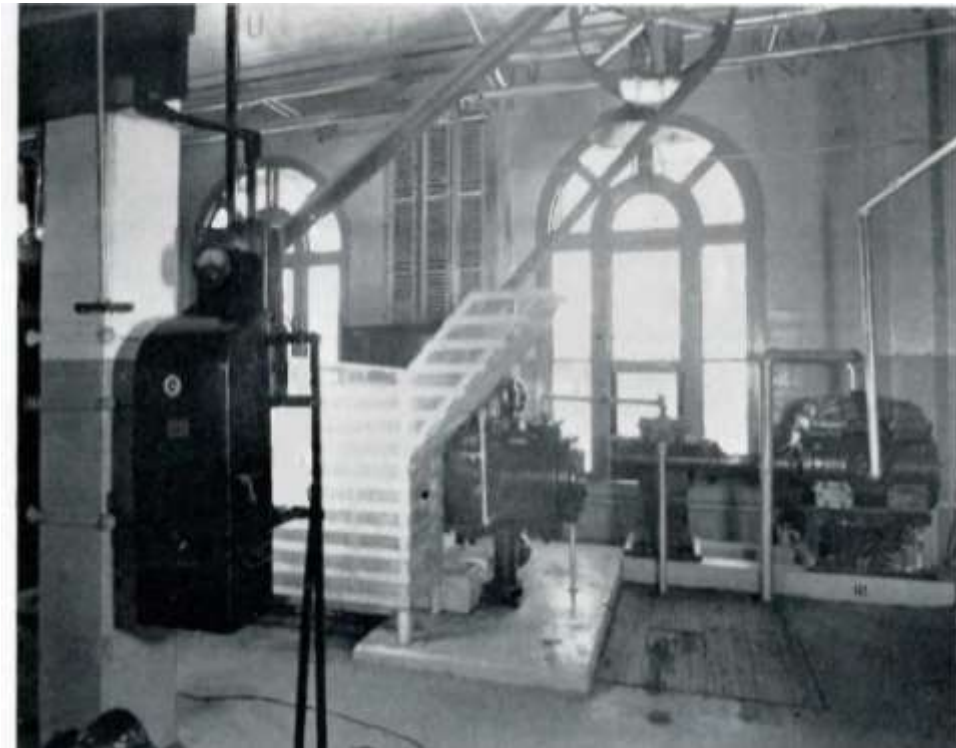
**Figure 55. Two early views of the interior of the Staley Pump House, illustrating the interior of the pump room (or “landing”) level of the building (Watson 1923:6). (Top) “First Floor Pumping Station—The two 100 H. P. pumps in the foreground. Intake valves in background.” (Bottom) “First Floor Pumping Station—West End, 150 H. P. pump in foreground.”**

In comparing pictures of the pumps and their motors from ca. 1923 (see Supplemental Figures 55 and 56) to those in place in ca. 1938 (see Supplemental Figures 59-61), it appears that the motors are indeed slightly different. In the earlier pictures, the motor bodies are perforated with exposed wire on the interior. The later pictures indicate the motors are completely enclosed. These may still be the same motors, albeit with covers retrofitted to the motor bodies to enclose the interior copper coils.

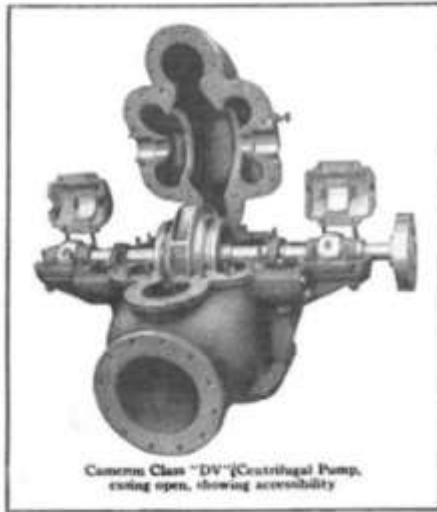
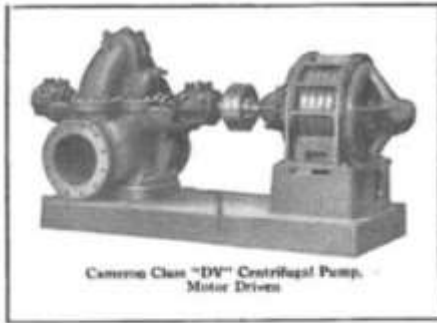
Cameron Class "DV" Centrifugal Pump,  
casing open, showing accessibility

Cameron Class "DV" Centrifugal Pump,  
Motor Driven

Figure 57. Advertisement from 1917 for Cameron Centrifugal pumps (*Engineering News-Record*, 5 April 1917).

Six Cameron motor-driven pumps, manufactured by the Ingersoll-Rand Company, are present on the pump-floor level (see Supplemental Figure 57). Some of the pumps have a capacity of 2,400 gallons per minute (GPM), while others are rated at 4,300 GPM. All operate at 1,750 RPM. They are powered by 200 HP induction motors manufactured by General Electric.<sup>148</sup> As originally designed and constructed, the facility utilized a series of “suction pumps” that raised water from the lower well to the upper level, and “discharge pumps” which pushed the water through the pipeline to the plant. Although it is unclear, it appears that the pumps and

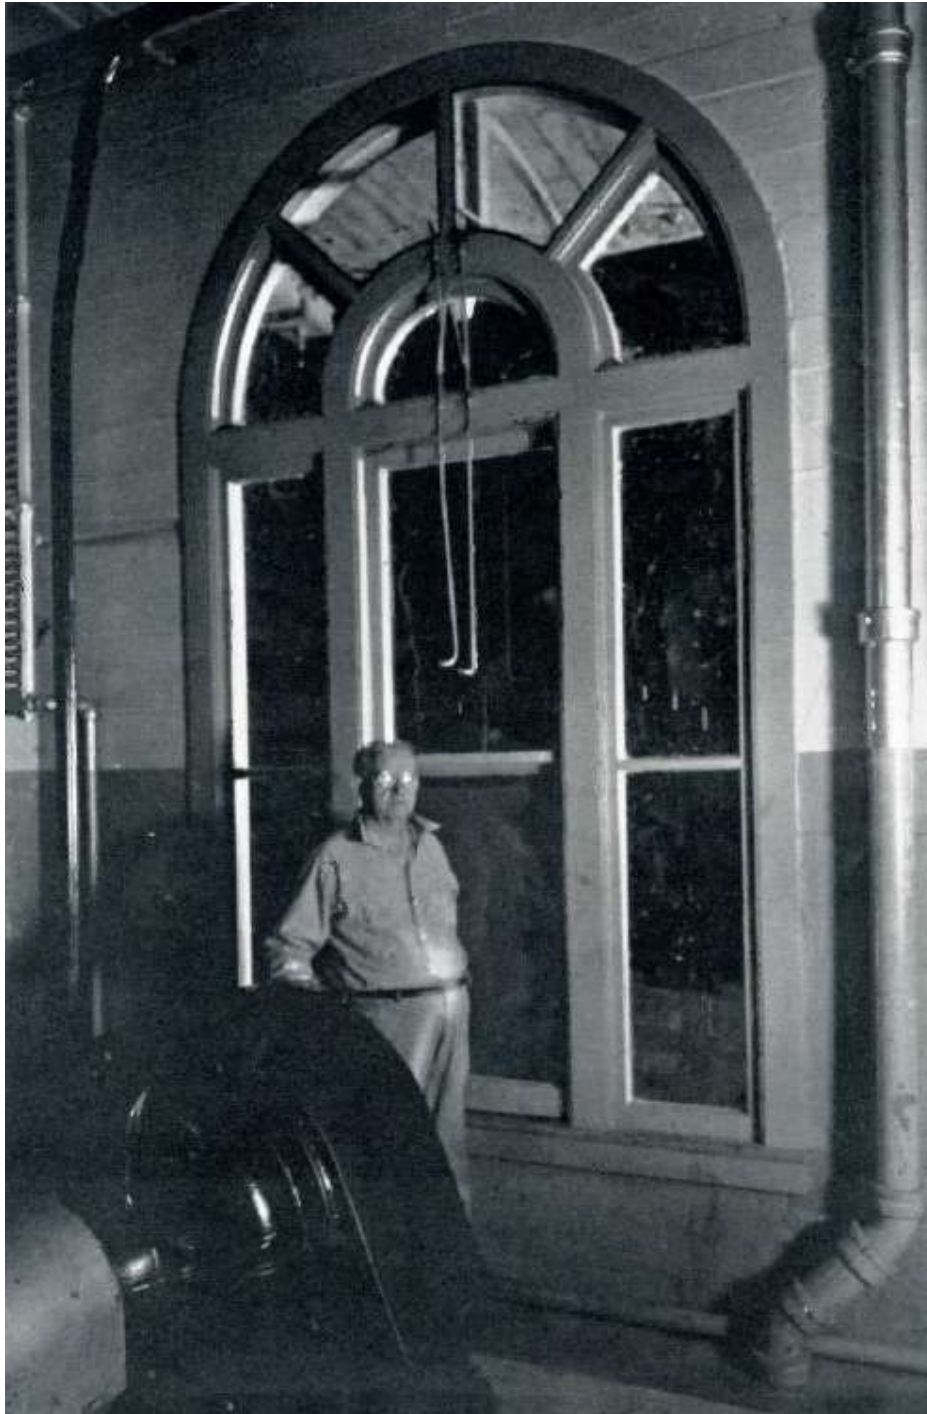
**Figure 59.** “W. C. Pollard, Dean of the Staley water department, alongside one of the pumps at the Staley Pumping Station and Club House, looking out over the lake” (*Staley Journal* [September 1938], p. 2).

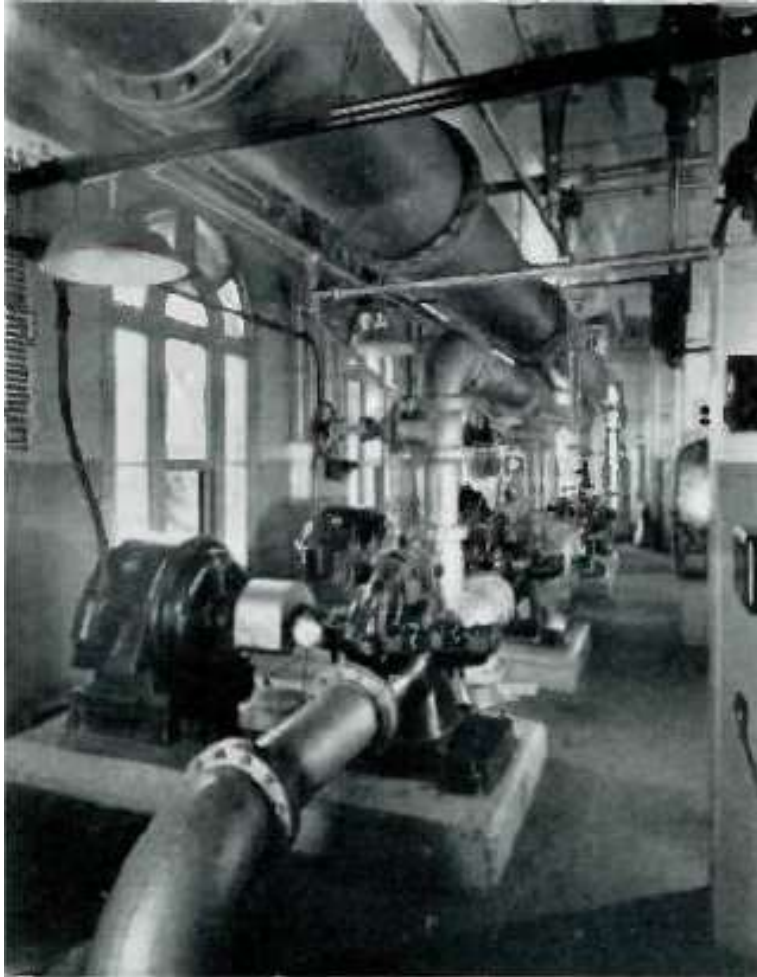
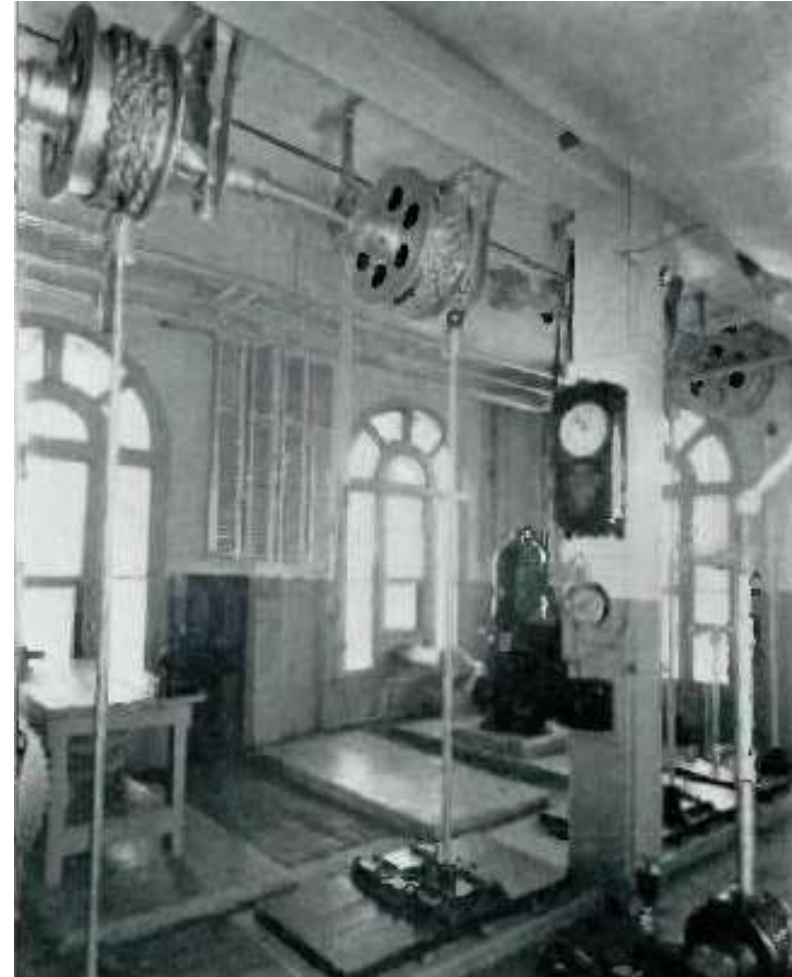
**Figure 61. (Left) “Henry Meyer polishing the deep well pump.” (Right) “A and B pumps at the south end of the pump room”**  
(*Staley Journal* [September 1938], p 5).

motors currently in the plant are not original to the building. One source from 1938 states that “the original pumps installed at the station developed about half the pressure of the present ones... [and] the present installations are of an improved type having greater capacities, developing higher individual pressures with much greater efficiency.” It is unclear as to whether this statement is in reference to the original arrangement of pumps on the lower pump level, and the improved efficiency being achieved after the placement of the pumps in the permanent upper-level position, or whether the pumps (and motors) were at one time replaced sometime prior to 1938.<sup>149</sup> At an unknown date, prior to 1938, a deep well pump was added. This pump, located at the far eastern end of the pump level floor, removed water from the deep well during maintenance and repair activities. This pump ejected the water out the side of the building, through a pipe positioned in the base of one of the adjacent window openings (see Supplemental Figure 61, Left image).

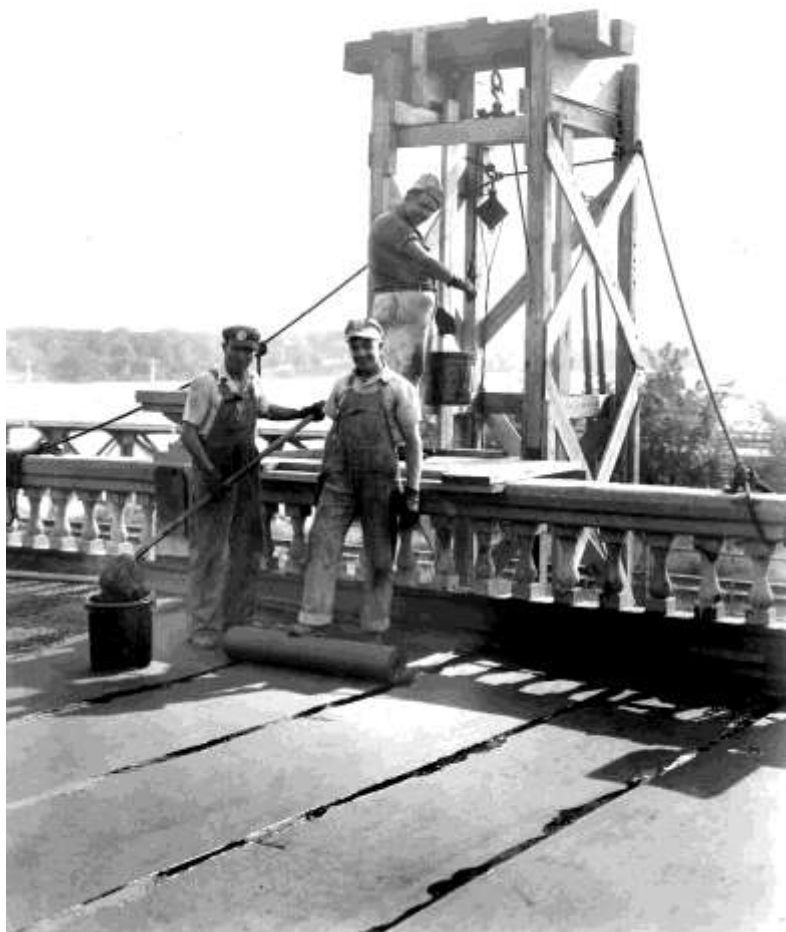
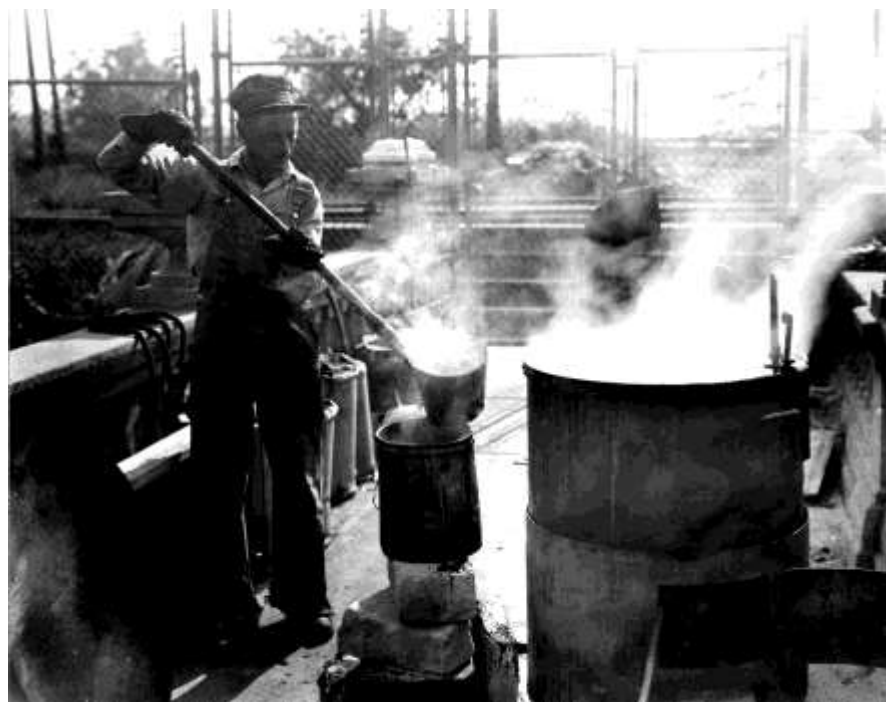
**Figure 69.** New tar roof being applied to the upper deck of the Staley Pumping Station and Club House, during renovation work of late 1944. By this time, the canopy had disappeared, and the use of the upper floor as a social space had been abandoned (Staley Museum). According to the *Staley Journal*, the use of the roof top of the Club House had been abandoned sometime ca. 1929 (“Work Starts on Renovation of Club House,” *Staley Journal* [October 1944], pp 25-26).

The Staley Club House was closed after the attack on Pearl Harbor due to a government order requiring that all pumping stations and power plants be closed to the public during World War II. Furniture and other furnishings were placed in storage, and the club house remained closed until April 1945.<sup>113</sup> During the interim, the roof of the building—which was no longer being used for social events—was redesigned to provide a low pitch (1/4" in 12") surface for better drainage. Although plans for this work (which included the removal of the steel exterior stairs, were drawn up in December 1943, the work was apparently not conducted until late 1944.<sup>114</sup> Pictures of the reroofing job were published in the October 1944 issue of the *Staley Journal* (see Supplemental Figure 69). The article to which these photographs were attached states that originally, “the flat roof was an open air dance floor, but for the last 15 years has not been used for such purposes. It is now being rebuilt, and insulated, but not finished for traffic.”<sup>115</sup> This implies that the outdoor use by patrons of the roof-top level was abandoned sometime ca. 1929, likely following the disastrous storm noted earlier which destroyed the roof-top canopy.

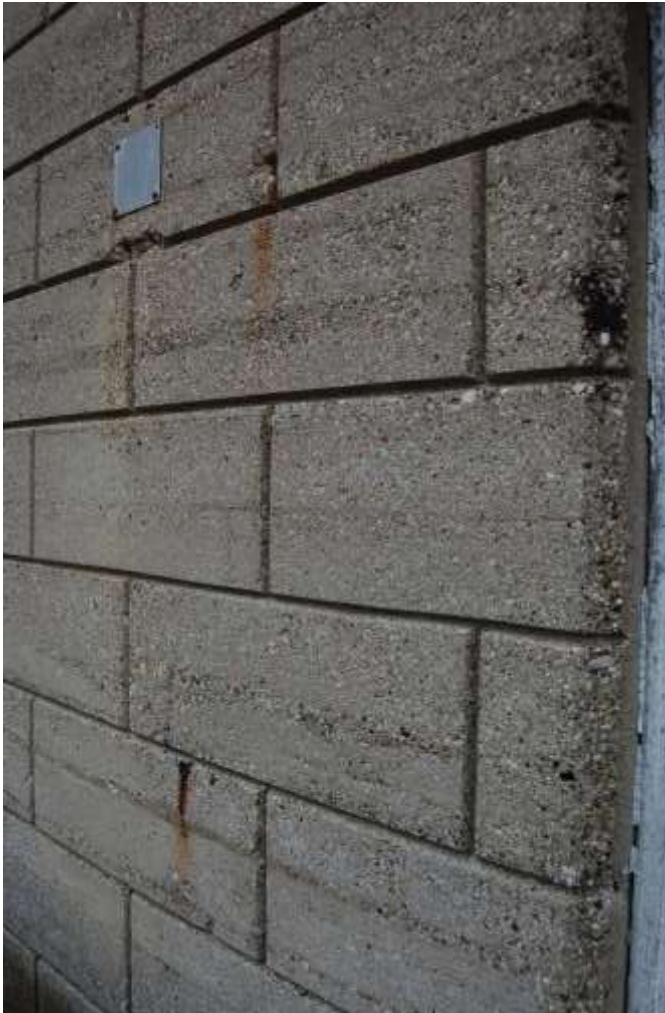
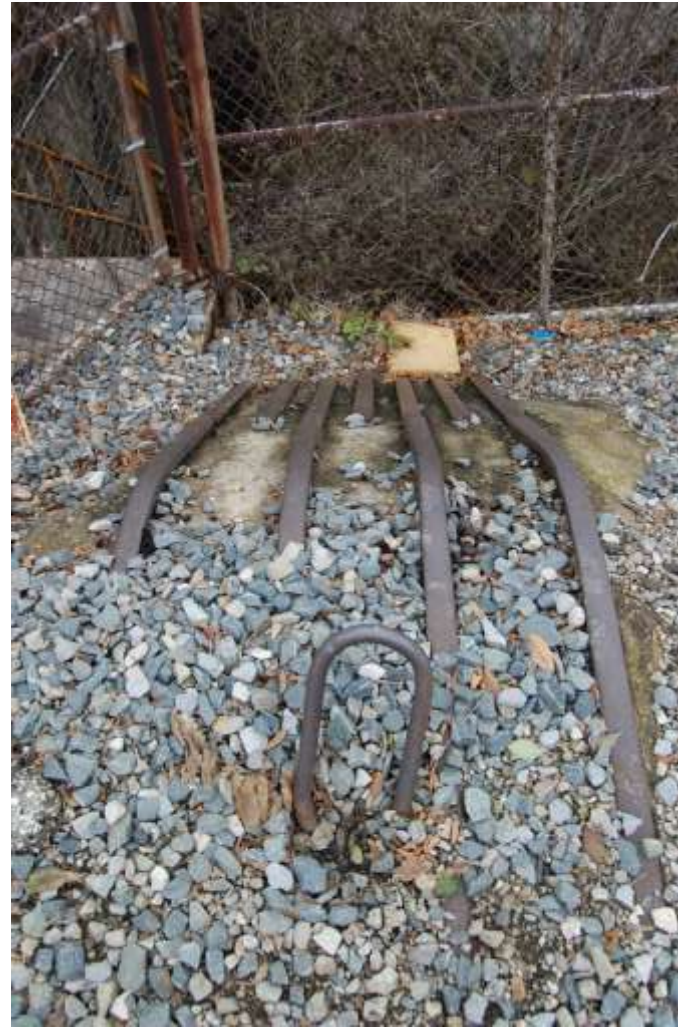
**Figure 76. (Left) Close-up detail of the exterior finished concrete surface on the building, emulating ashlar masonry. (Right) Rail incline located along east side of causeway bridge, for raising and lowering heavy machinery into the pump floor level.**

A set of flanged T-rails (seven in number) runs down the bank of the causeway, just east of the steel stairway. The rails are parallel, evenly spaced, and have their ends set in concrete. None of the engineering drawings available depict this feature, so its purpose is open to speculation. However, it seems likely that the set of rails was used to move heavy equipment (such as motors and pumps) and/or materials intended for the pumping station down the bank. The presence of a heavy steel loop (an apparent tie-down point) at the top of the rails suggests this use as well (see Supplemental Figure 76, right image).

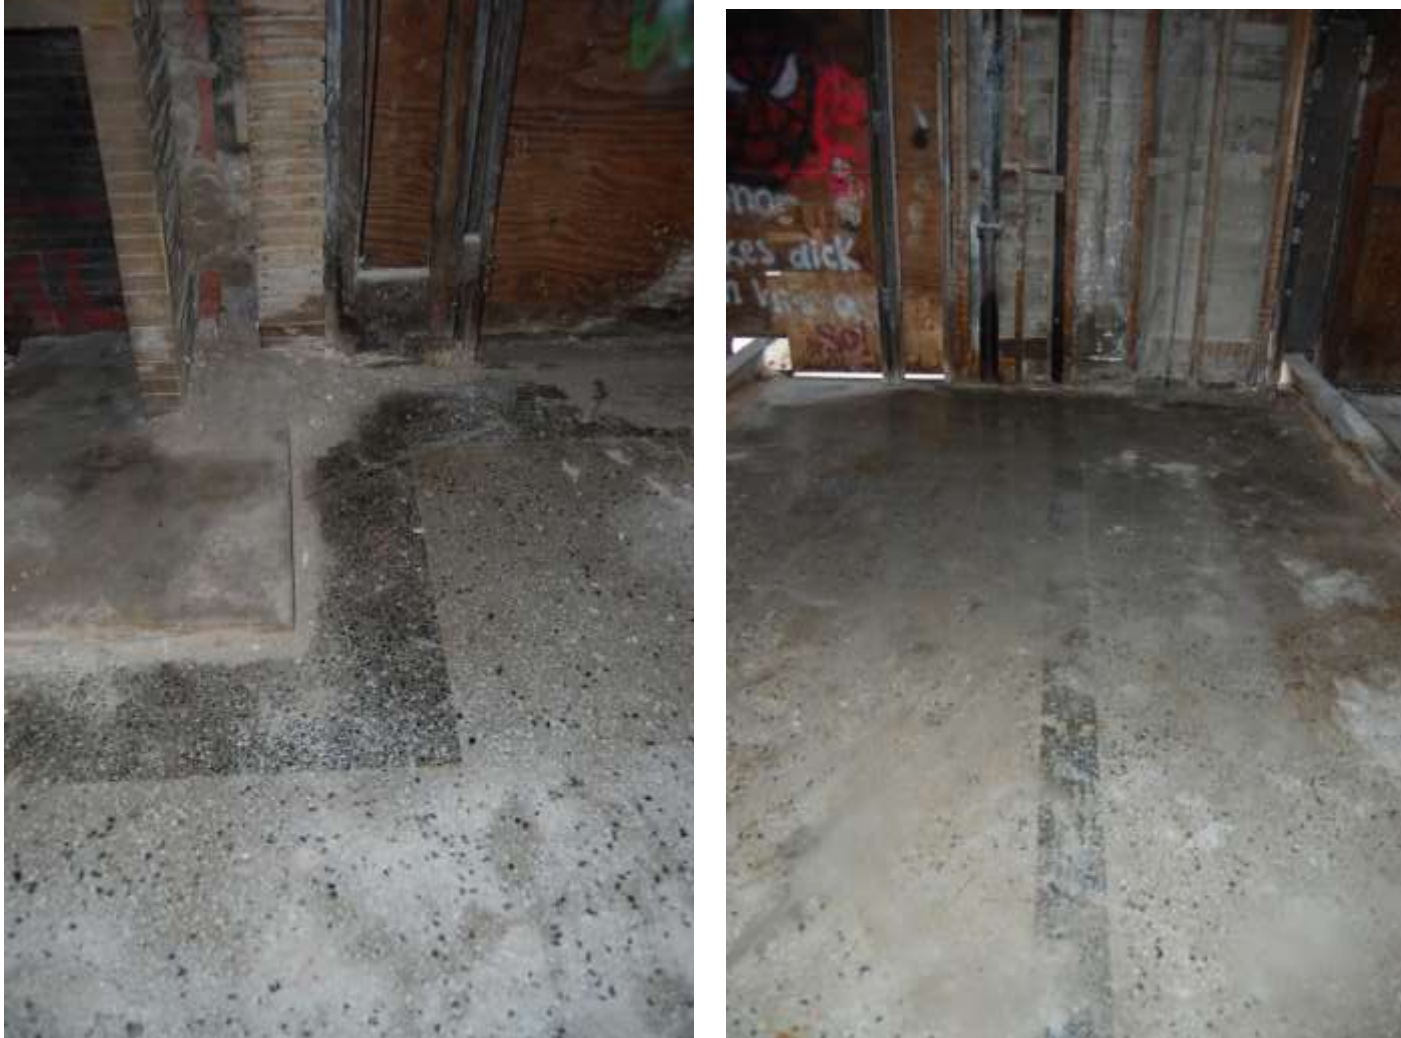
**Figure 77. Two views of the darker border used on the terrazzo floor in the Club Room. (Left) Wide border around the perimeter of the room, and the edge of the fireplaces. (Right) Narrow band across the rooms, dividing the large floor into panels (See also Figures 63, 64, and 66 for historic views of floor).**

3. Flooring: The rooms in the club-house level have terrazzo floors. The terrazzo is carried up the base of the walls to create a curb (or baseboard). A darker-colored border runs around the perimeter of the floors, as well as through the center of the floor, dividing the large floors into smaller "panels" (see Supplemental Figures 65 and 77). The pump-room level has plain concrete floors.
4. Wall and Ceiling Finishes: The walls and ceilings on the Balcony Level are plastered and painted. The walls and ceilings on the Pump Level are unfinished concrete.
5. Openings:
