BRADLEY-BORK FARM, BARN
32W660 Fabyan Parkway
West Chicago
Geneva Township
Kane County
Illinois

HABS IL-1274

BRADLEY-BORK FARM, BARN

Significance: The Bradley-Bork Barn embodies the distinctive characteristics of a method of construction that was widely utilized in the early twentieth century for Midwestern dairy barns. Specifically, it is an excellent and intact example of plank frame construction with a gambrel roof framed by a Shawver truss. Plank framing called for two-inch milled lumber that was readily available at lumberyards and joined together by bolts or nails. It was cheaper, faster, and required considerably less skill than traditional barn construction, which featured heavy, squared timbers that were special ordered from sawmills. Plank framing also allowed for taller, wider barns with self-supporting roofs. The Shawver truss, featuring long, diagonal wood braces, was one of the first roof trusses developed for a gambrel roof, which featured a dual-pitch shape that allowed a larger loft space to store hay than a gable roof allowed.

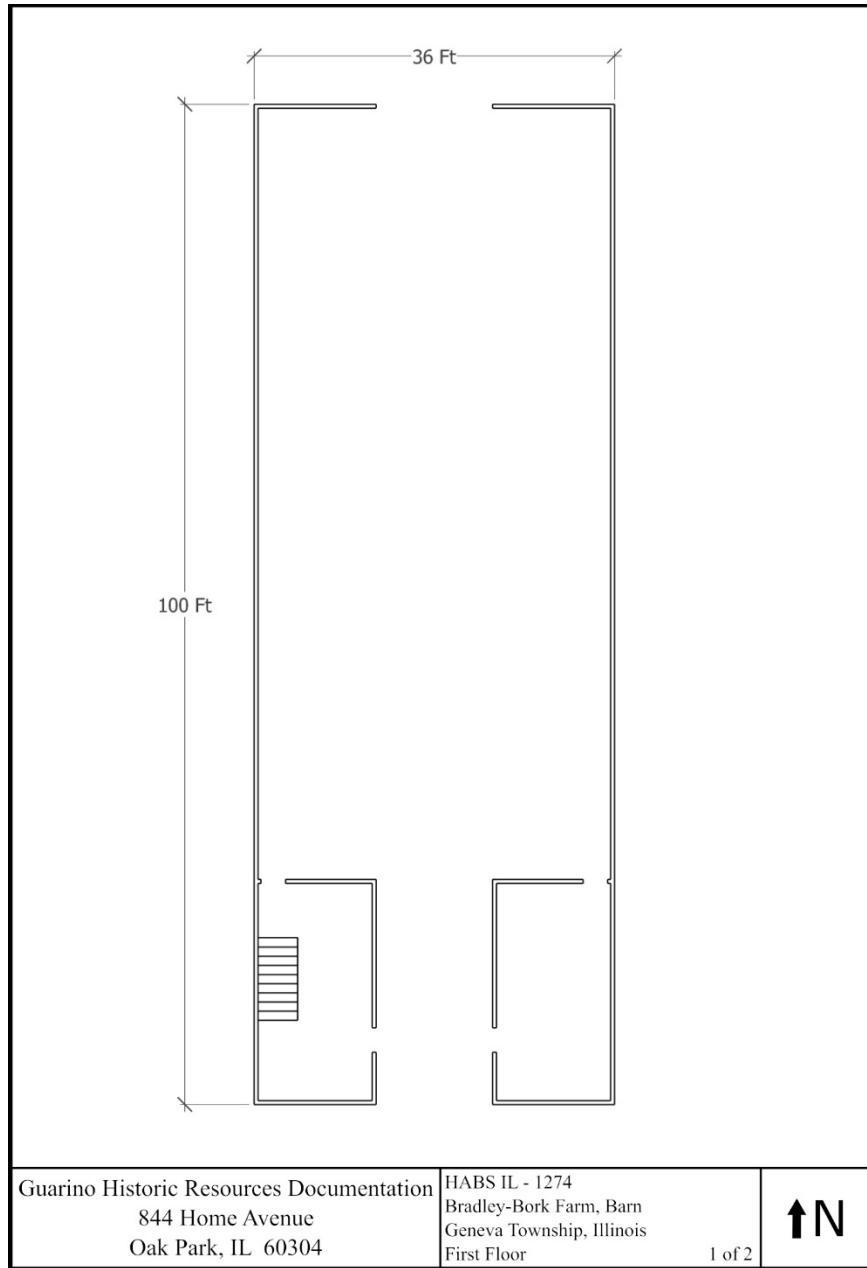
Figure 1: First Floor Plan of the Bradley-Bork Farm Barn, drawn by Lucas Howser, August 2021.

Figure 1: First Floor Plan of the Bradley-Bork Farm Barn.

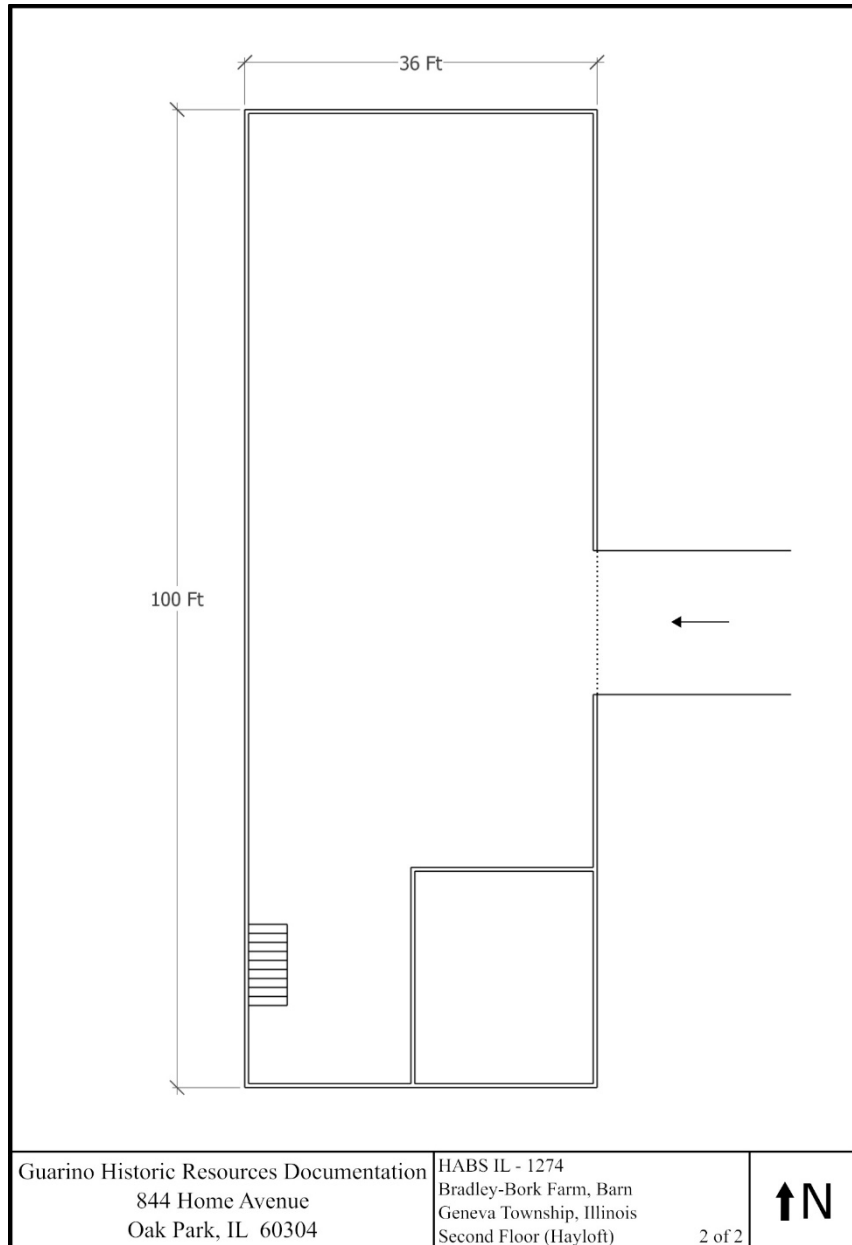
Figure 2: Second Floor (Hayloft) Plan of the Bradley-Bork Farm Barn,
drawn by Lucas Howser, August 2021.

Figure 2: Second Floor (Hayloft) Plan of the Bradley-Bork Farm Barn.
