**ARCHITECTURAL DOCUMENTATION
FOR
THE HALLSTEIN BARN,
HITTLE TOWNSHIP, TAZEWELL COUNTY, ILLINOIS**

by
Christopher Stratton
and
Floyd Mansberger

Fever River Research
Springfield, Illinois

November 2002

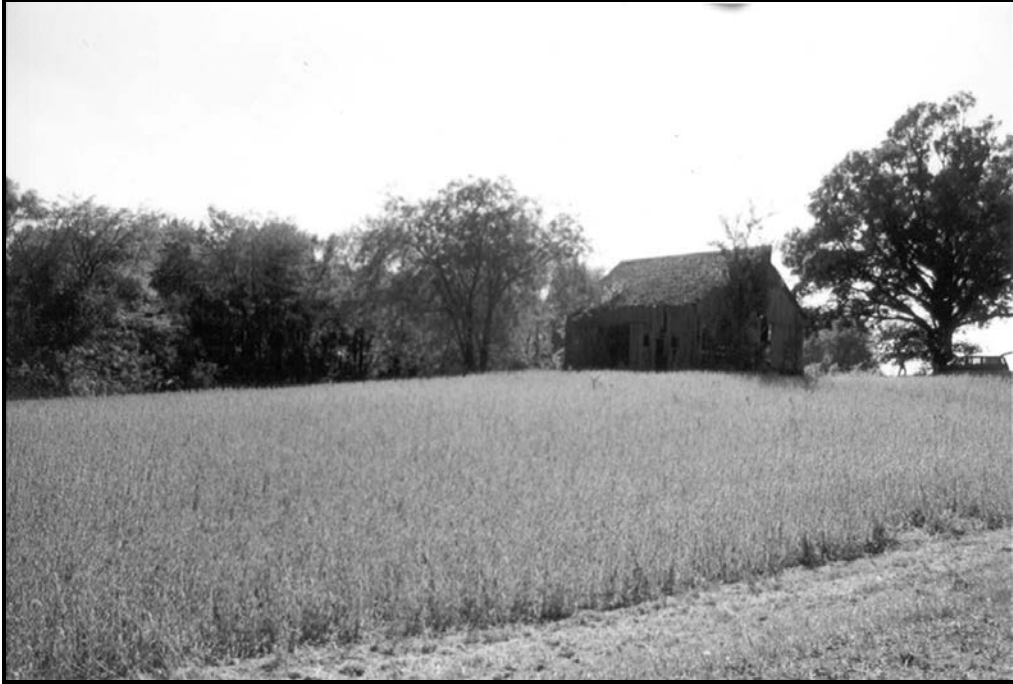
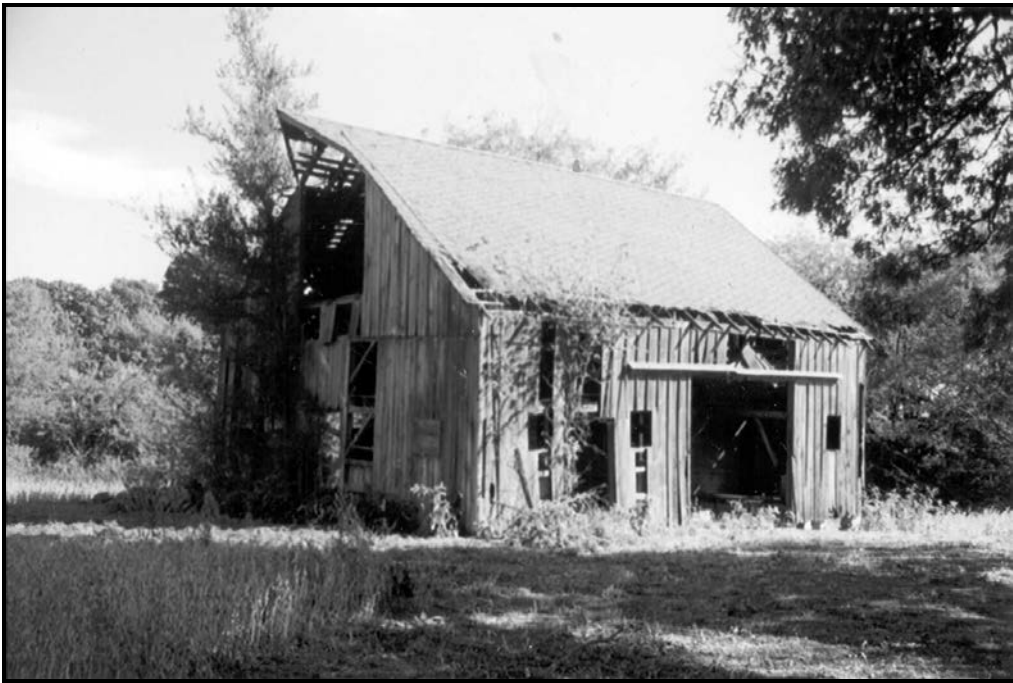
Figure 7. (TOP) View of the Hallstein Barn, looking southwest from the public road that passes by the site. Note the timber lying beyond the barn, which represents a remnant of the historic woodland along the West Fork of Sugar Creek. The terrain slopes down from the barn towards the creek. (BOTTOM) View of west and north elevations of the barn. Note the wide vehicle doorway in the west elevation and mow door in the north gable end (FRR October 2002).

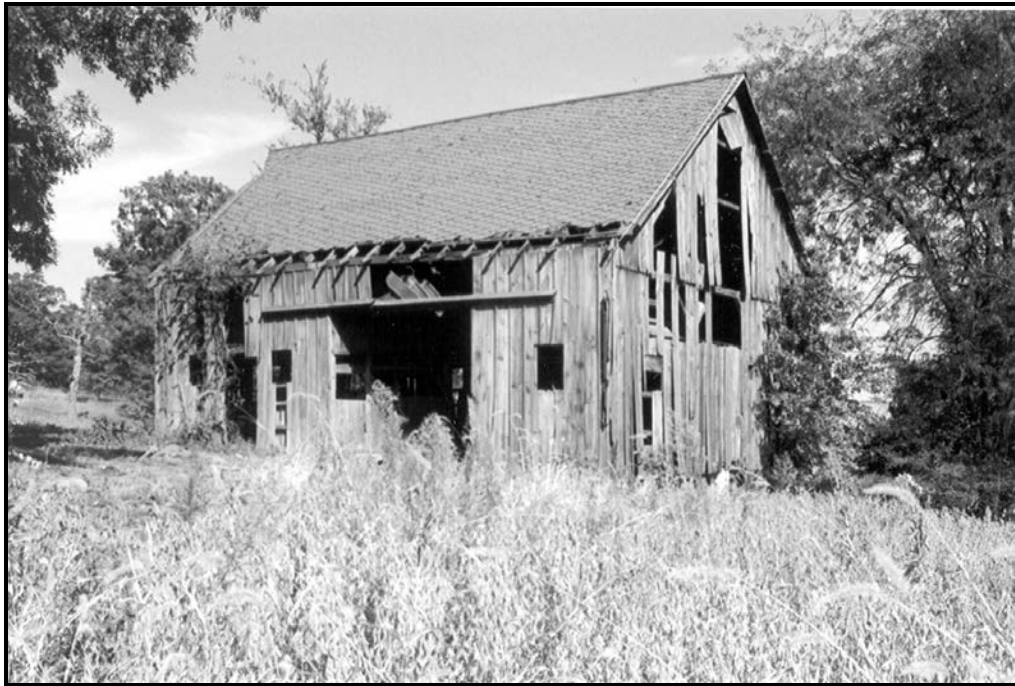
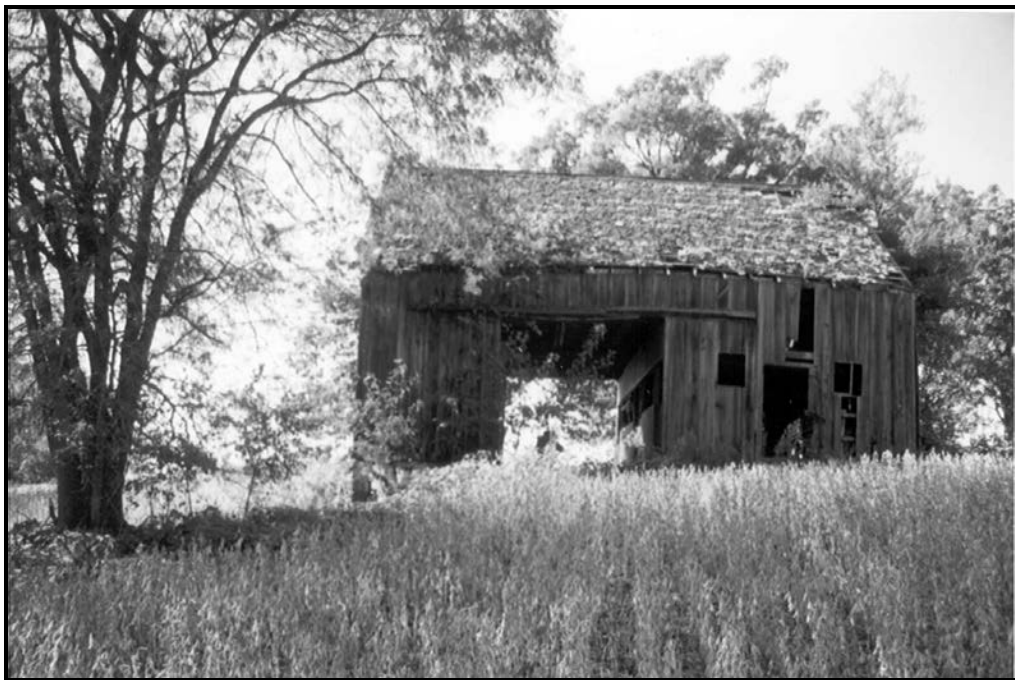
Figure 8. (TOP) View of the west and south elevations of the barn, looking northeast. (BOTTOM) View of the east elevation. This photograph illustrates the tripartite division of the barn, with livestock stalls on the right, a driveway in the center, and grain bins to the left. Note the wider width allowed for the livestock stalls compared to grain storage (FRR October 2002).

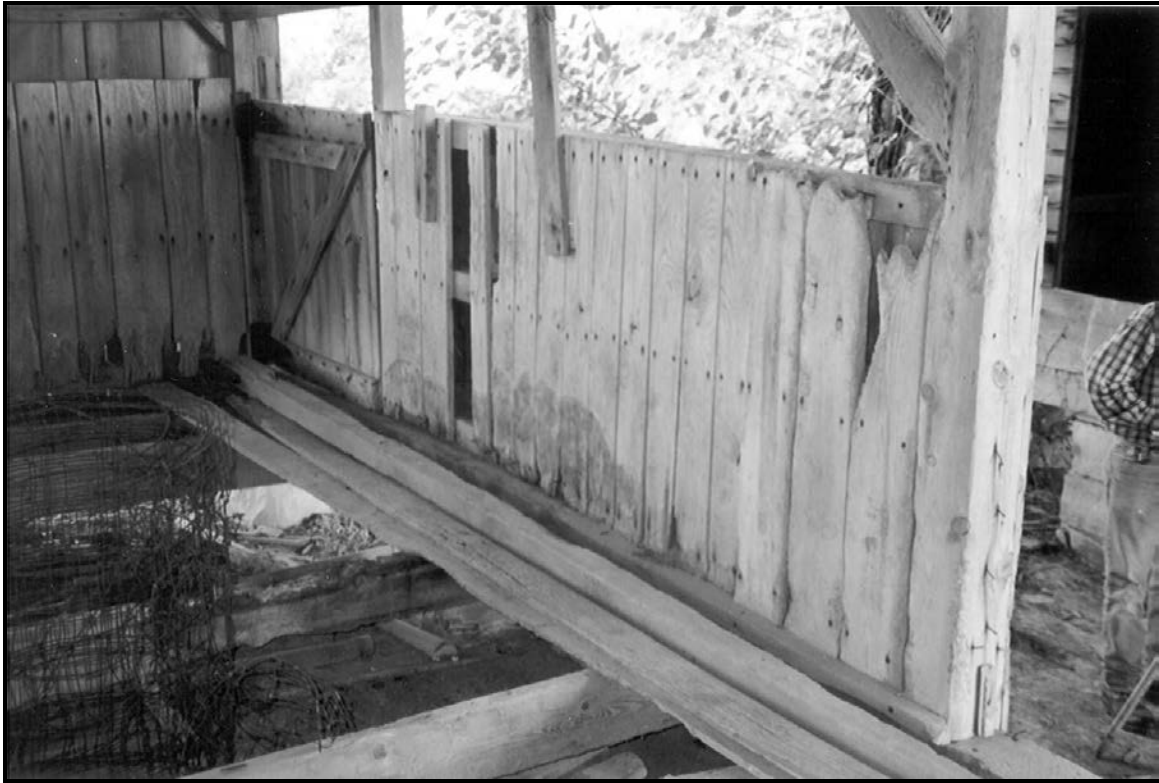
Figure 9. View of the eastern box stall, looking towards the southeast corner. Note the hinged livestock door in the background. The door opening at the far right is associated with a central service aisle that formerly divided the two box stalls. The partitions framing the aisle have been removed (FRR October 2002).

The Hallstein Barn is oriented north/south and measures 40'-2" (north/south) by 30'-2" (east/west).¹ Typical of a Three-Bay Barn, the structure has a tripartite division of its interior. But unlike many early examples of this barn form, which often have equal (or nearly equal) sized bays, the Hallstein Barn has bays with dramatically different widths. The north bay is the widest and takes up nearly half of the barn's entire length (see Figures 7 and 8). Although difficult to discern (due to the removal of much of the interior framing in this bay), the space in this bay appears to have been originally divided between two large box stalls separated by a personnel aisle. The partition walls separating the stalls and aisle have since been removed, but there is physical evidence of them, in the form of nails left behind after the central support posts had been removed. The box stalls each measure 17'-0"x15'-6" and are lined by 1"-thick, 4'-high vertical planking that extends around three of their sides. This planking protected the framing and exterior siding from being damaged by livestock rubbing or kicking against it. On the side facing the central aisle, the box stalls appear to have had a feed bunk; these, too, have been ripped out, but their presence is suggested by the thicker (2") wall planking found at the what would have been their ends. The bunks appear to have been approximately 2' wide. Livestock could enter either box stall through one of two points: exterior doors positioned on the east and west sides of the barn, and through interior doorways entered off the central drive. Each stall also had three windows. These windows consisted of a single sideways sliding 4-light sash. Additionally, each stall had a series of tack hooks (consisting of both formal cast iron hooks and more expeditious nails) located along the back walls of the box stalls (opposite the feed bunks). These tack hooks probably served for hanging harness and bridles upon when not in use, and strongly suggests that horses were kept in these box stalls. Although it is possible that other livestock, such as cattle, may have been housed in these stalls at some point in time, it would appear that these stalls were constructed to house draft horses for a working farm complex. The aisle dividing the two stalls ran north/south and had doorways at both ends. It was intended for farm personnel and would have been used to feed livestock (with feed being dumped into the feed bunks flanking the aisle) and also a general passageway through the barn (see Figures 9 and 10). Access to the loft was located over the north end of this aisle.

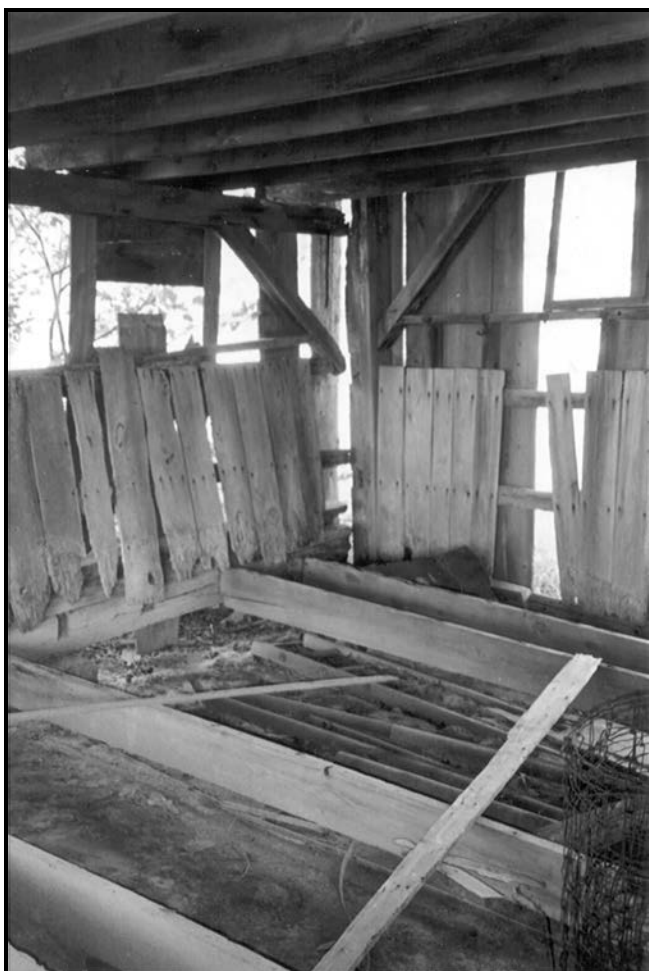
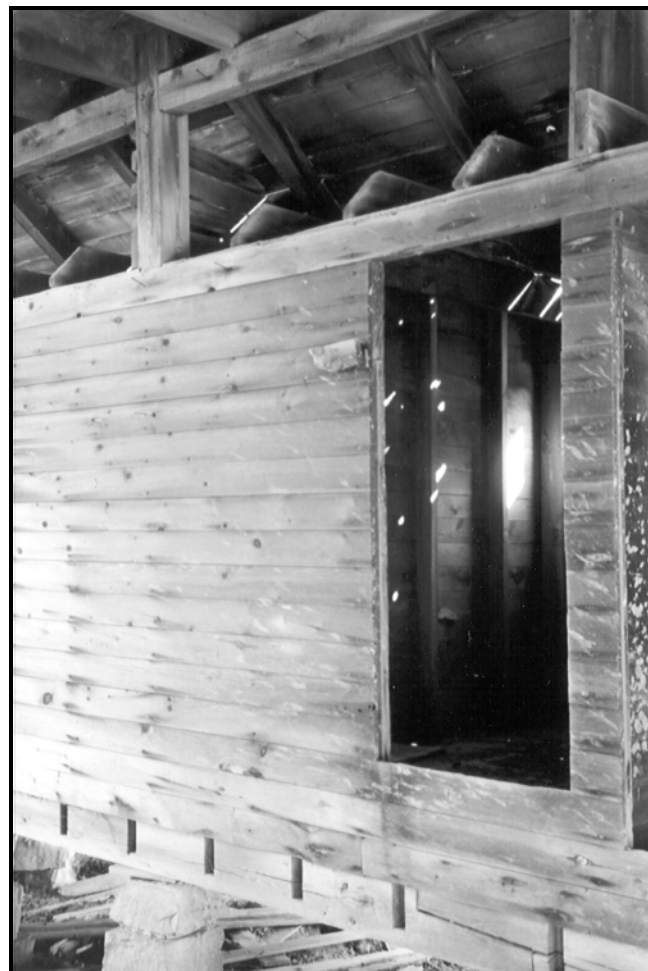
Figure 10. (LEFT) Interior view of the eastern box stall in the north bay of the barn. The vertical planking nailed around the lower part of the walls served as a rub guard, protecting the main framing and exterior siding from wear or damage by livestock. The flooring in this part of the barn also has been removed, as have many of the joists. (RIGHT) View of one of the grain bins located in the south bay of the barn. The ceiling and wall adjacent to the central drive was left open in order allow grain to be tossed into the bins. Tight siding used to enclose the grain bins is indicative of small-grain storage, in contrast to the spaced-out slats typical of corncribs. (FRR October 2002).

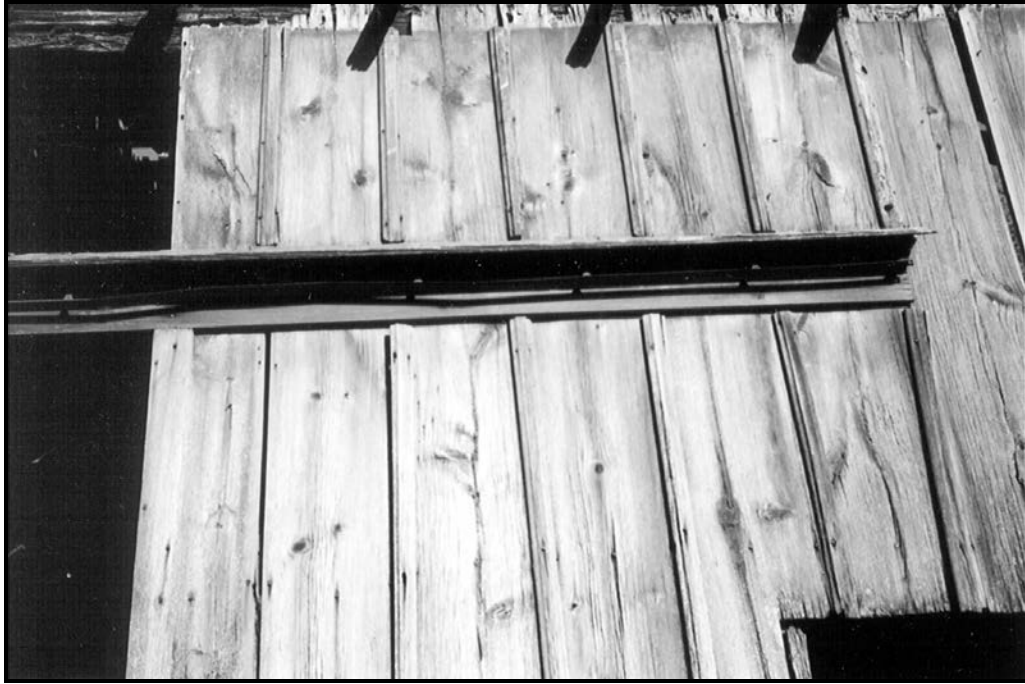
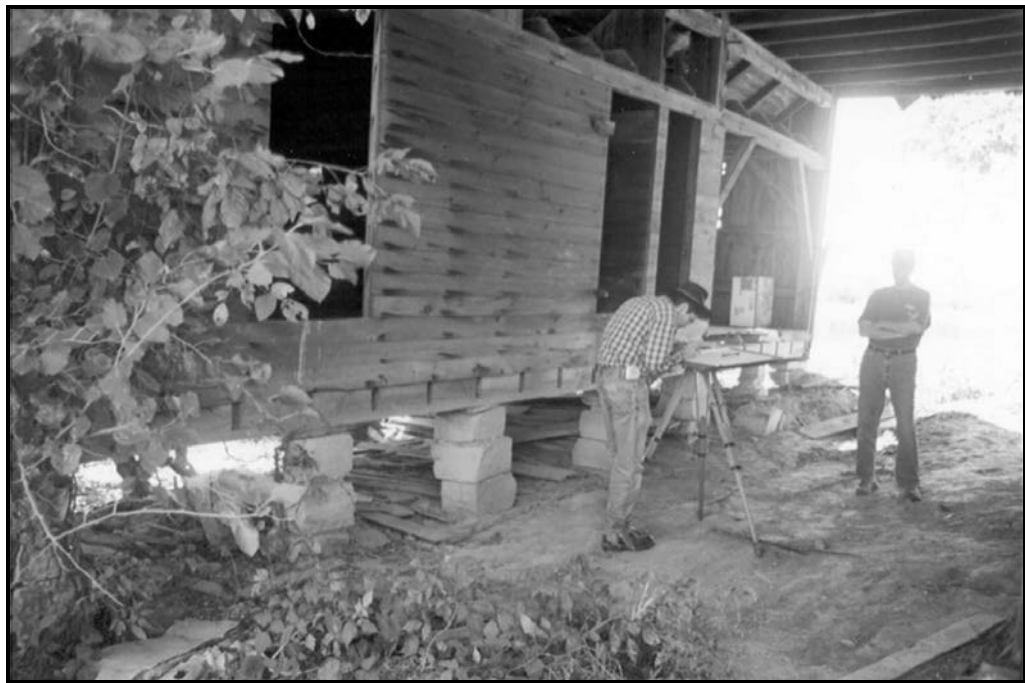
Figure 11. (TOP) Rather than having traditional hinged doors that swung outward on its central bay, the Hallstein Barn was equipped with sliding doors on a track. This is one of the “modern” features original to the barn. Also note the vertical board-and-batten siding used to cover the exterior walls. **(BOTTOM)** Interior view of the central drive, showing the storage bins for small grains in the south bay. The floor joists and flooring of the driveway have been removed (FRR October 2002).

originally had a frame floor consisting of floor joists and floorboards. This floor system has recently been removed (apparently in an effort to salvage lumber from this “abandoned” structure) (see Figure 11). Due to the fact that this barn was constructed on a prominent hill with the ground sloping sharply to the east, the central aisle was raised substantially above the ground level necessitating ramps leading into the driveway. It is suspected that frame ramps were located on each end of the central driveway of the building. The ceiling in the drive is higher than either of the end bays and allows for the additional headroom for unloading of grain into bins in the south bay. The bins were filled from the top, so the elevated ceiling height allowed a farmhand to stand in a wagon and still have room to shovel grain over the wall into the bins. The flooring over the bins was constructed to allow for the grain to be pitched over these walls into the bins. In addition to this use, the central drive likely was used to store agricultural equipment, such as wagons.

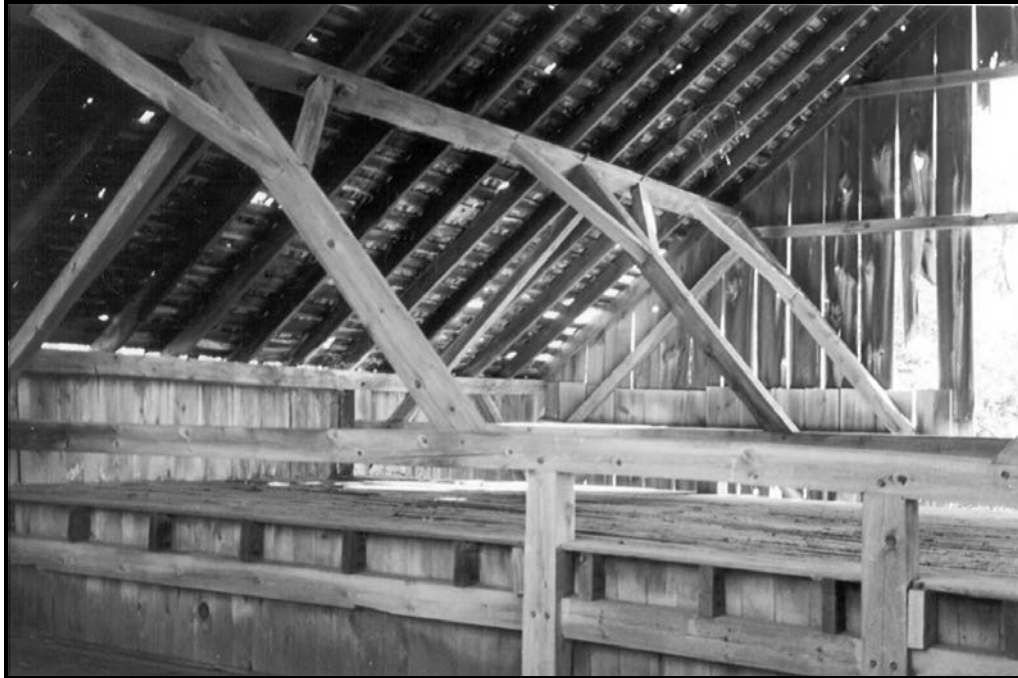
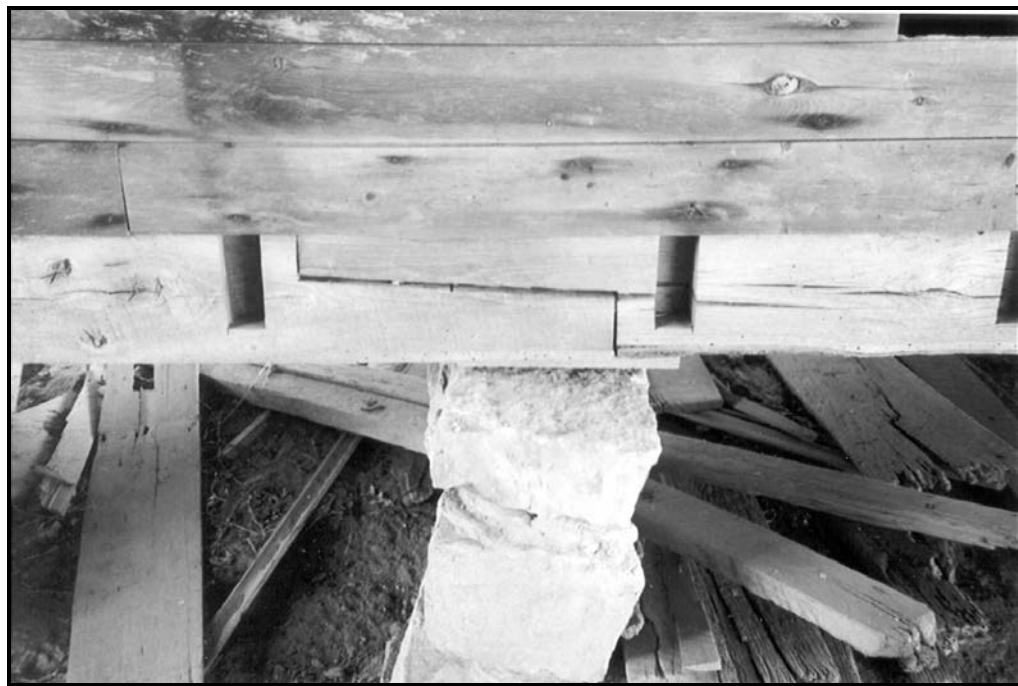
Figure 12. (TOP) View of the hay loft in the upper floor of the barn, looking towards the south gable end. The floor in the center in the loft is raised to accommodate a higher ceiling in the central drive below, thereby allowing the grain bins to be filled from their tops. **(BOTTOM)** Detail of one of the cut-stone piers on which the barn sits. This photograph also shows the sill plat along the south side of the central drive. Note the scarf joint that bridges the two halves of the sill plate and pockets in which the removed floor joists formerly rested (FRR October 2002).

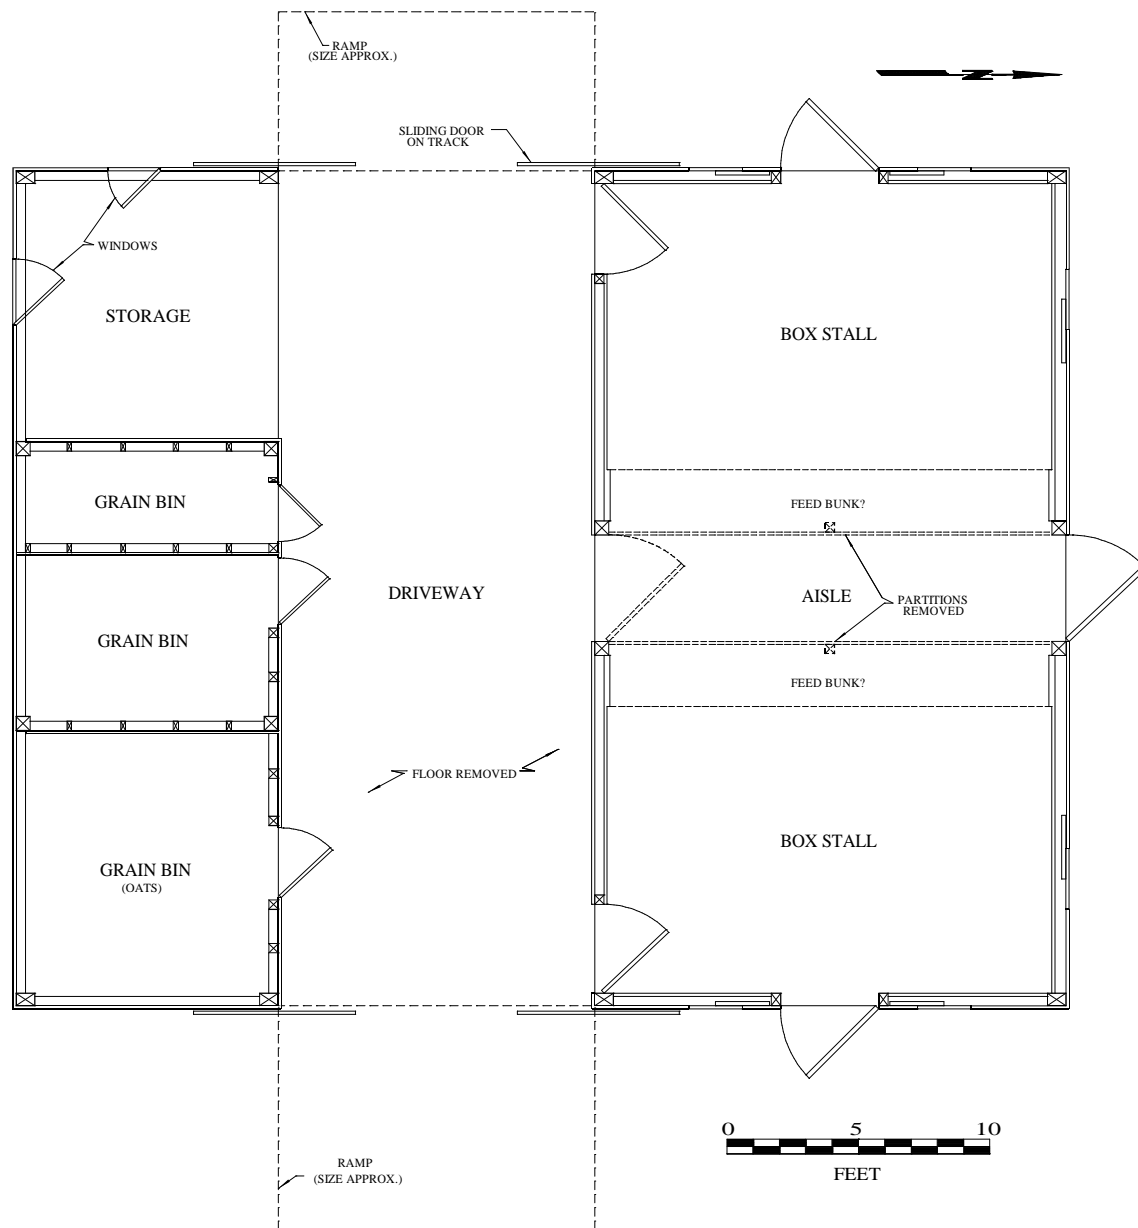
Figure 13. First floor plan of the Hallstein Barn. Conjectural and approximated features are dashed (FRR 2002).

in the central drive. It was for this reason that the central bay in earlier Three-Bay Barns was left open between the first floor and the rafters, rather than being bridged by a permanent loft as is the case of the Hallstein Barn. A hay bonnet is present over the mow door. The distinctive splayed queen post structure of the roof framing allowed the unencumbered access of the hayfork to the loft space. Floor plans and section views of the barn are attached as Figures 13 through 15.

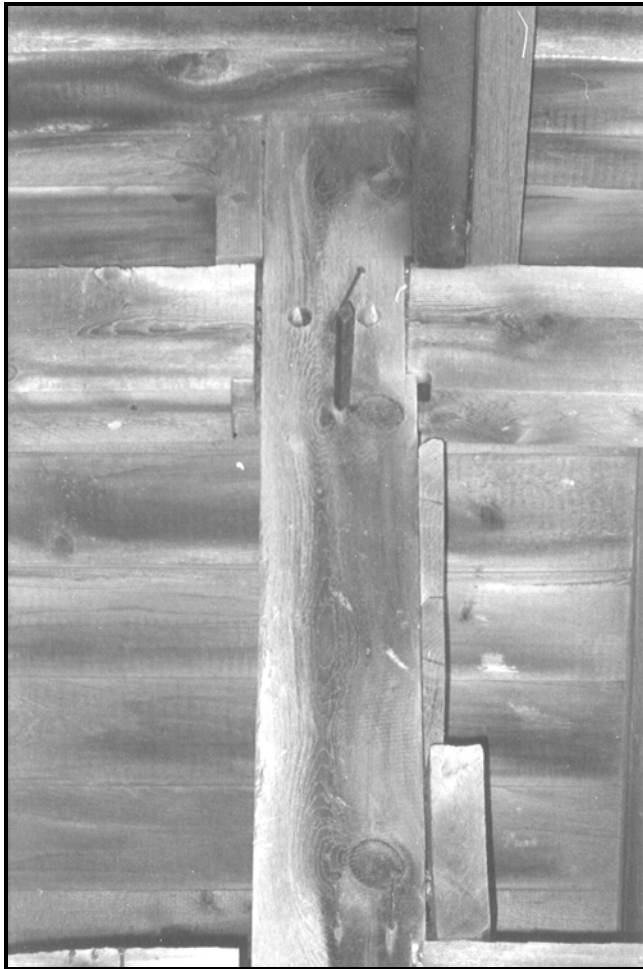
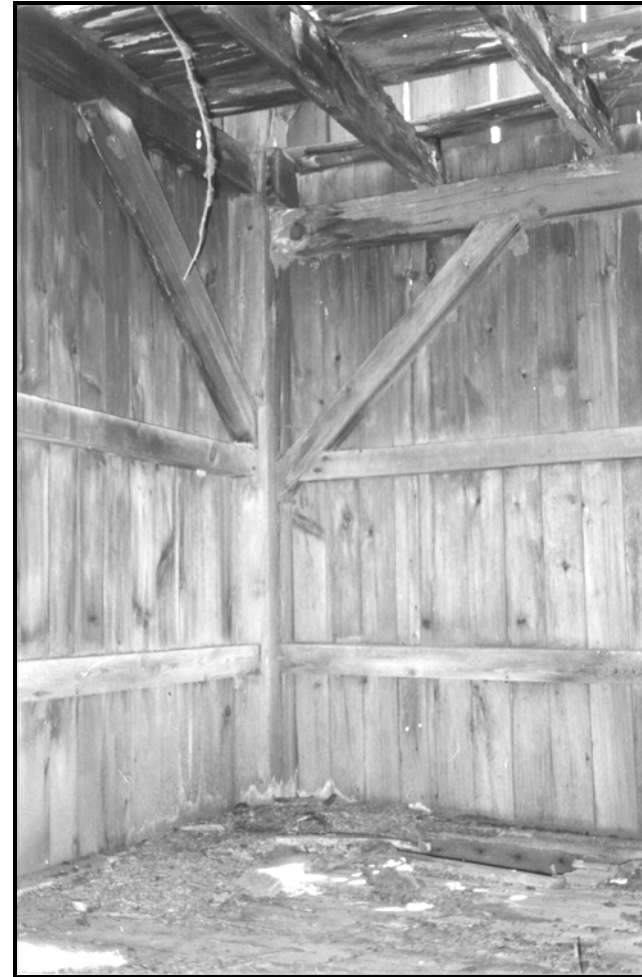
Figure 16. Framing details in the south bay of the barn. (LEFT) Larger framing members in the barn are joined with mortise-and-tenon joints, such as the pictured here, which connects a post and two girts in the interior bent along the south side of the central drive. (RIGHT) Interior view of easternmost grain bin, showing the framing at the southeast corner of the barn. The corner posts are supported by diagonal braces, set at 45-degrees, and by horizontal braces that double as nailers for the exterior siding (FRR October 2002).

In respect to its method and materials of construction, the Hallstein Barn is in many ways a very traditional structure. The barn, for example, rests on dry-laid, cut-stone piers, even though concrete was in relatively common use as a foundation material when the building apparently was erected. “Square Rule” timber-framing also was heavily relied upon in the barn’s construction. The sills are 8”x8”, circular-sawn oak and are joined with half-lap joints at the corners and scarf joints in the middle of a span. The four bents of the barn are framed with 6”x8” corner posts, 6’x6” intermediate posts, and two sets of 4”x6” horizontal girts. The lower girts support the floor joists of the hayloft (which measure 2”x8”), while the upper girts tie the corner posts together. Diagonal braces, which measure 4”x4” and are set at a 45-degree angle, extend between the posts and girts. Additional 4”x4” bracing runs horizontally between the posts; these strengthen the frame but also serve as nailers for the exterior board-and-batten siding. The bents are joined together by an 8”x8” top plate that also support the lower ends of the rafters. The spacing of the posts in the northern two bents is different from those on the south, in order to accommodate the different uses of these areas (i.e. livestock versus grain storage). The roof framing is the same across the entire length of the barn. The rafters are 2”x6” with 2’ centers and are supported by a braced-purlin system. The purlins themselves measure 6”x6” and are supported by 6”x6” splayed queen posts that extend diagonally off the upper girt of the bents. As in the bents, 4”x4” diagonal braces run between the posts and purlins. The purlin posts also are supported by a separate 4”x4” brace that set at a 90-degree angle to them and extends off the same upper girt as they do. Lighter interior partitions, such as the walls of the grains bins are framed with 2’x4” studs. The roof originally was covered with sawn-wood shingles, but these later were overlain with asphalt shingles. All of the larger framing in the barn is joined with mortise-and-tenon joints, while secondary framing materials are attached with wire-drawn nails. Except for the sill plats, which are oak, the lumber in the barn appears to be yellow (or southern) pine and is a mixture of circular-sawn and band-sawn stock typical of the late nineteenth and/or early twentieth centuries (see Figures 15 through 18).

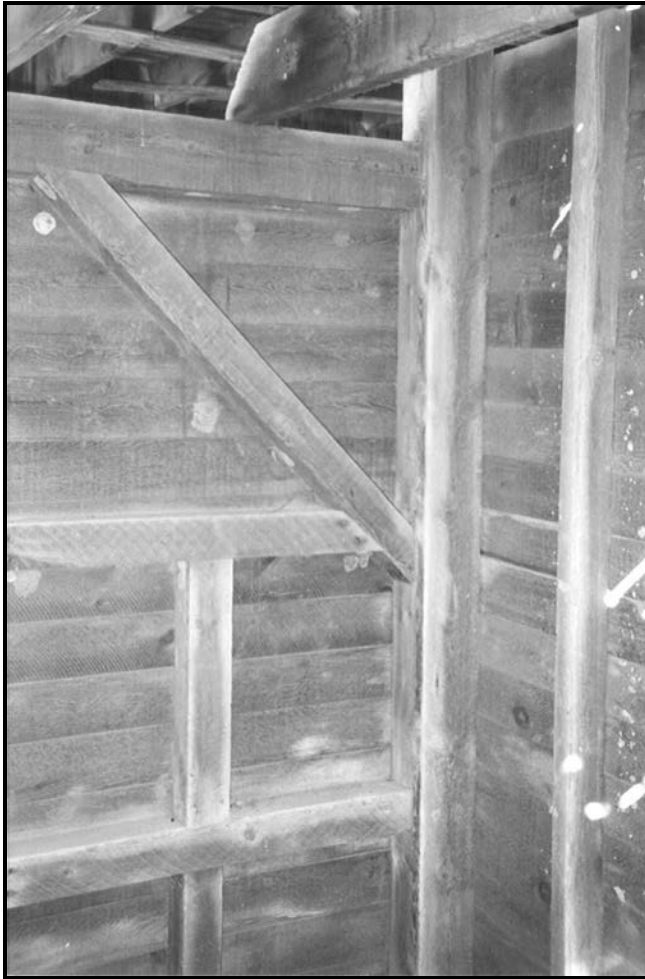
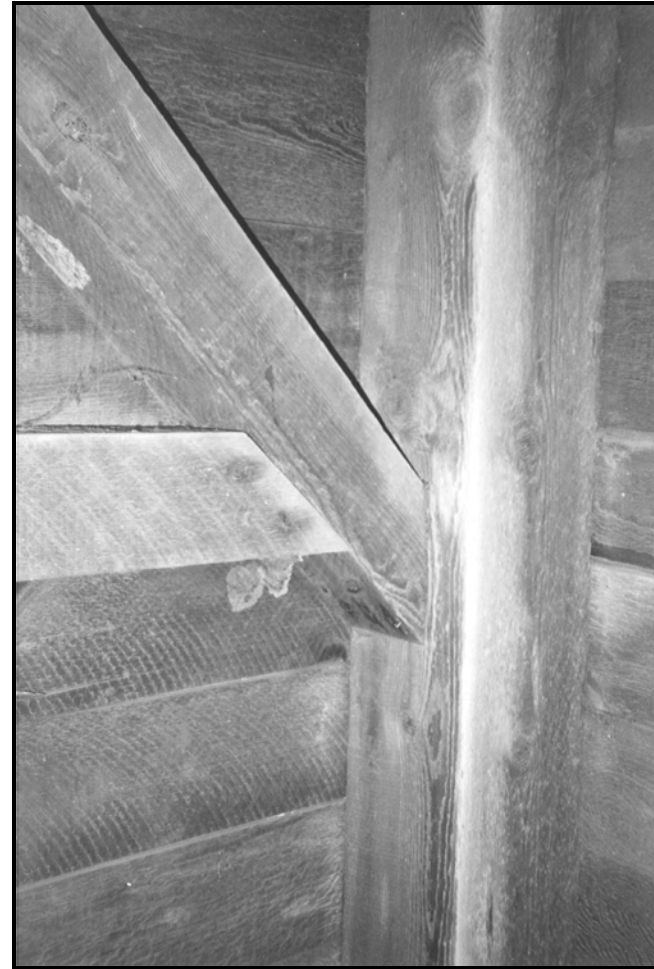
Figure 17. Additional framing details on the interior of the grain bins. In contrast to the north and south bents, the diagonal bracing on the two center bents are nailed together, rather than being connected with mortise and tenon. Note the heavy cross bracing used on the walls of the grain bins. The walls bore a great deal of weight and pressure when the bins were filled with grain (FRR October 2002).

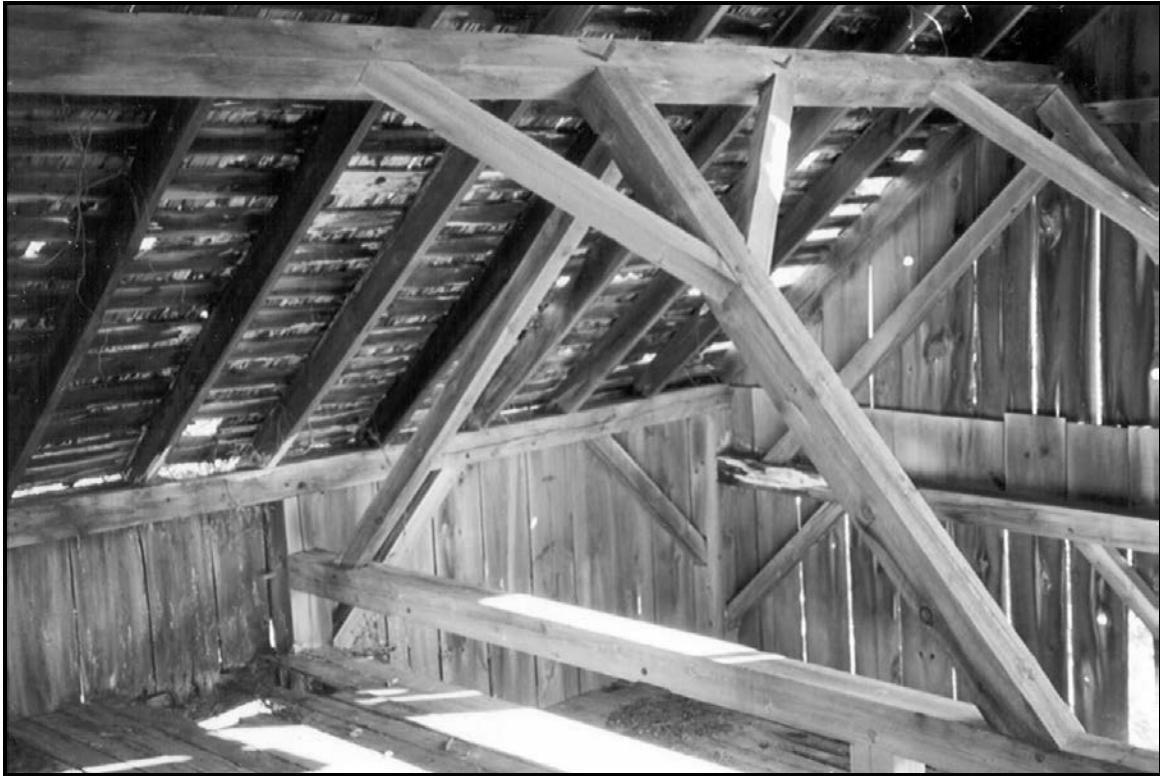
Figure 18. The roof of the barn is supported by a braced purlin system formed by heavy timbers joined with mortise and tenon. The diagonal positioning of the purlin bracing frees the center of the barn of framing, thus allowing the hay fork to pass unobstructed down the length of the loft (FRR October 2002).
